## Hunters Point Shipyard

# FINAL HISTORICAL RADIOLOGICAL ASSESSMENT

History of the Use of General Radioactive Materials  
1939 – 2003

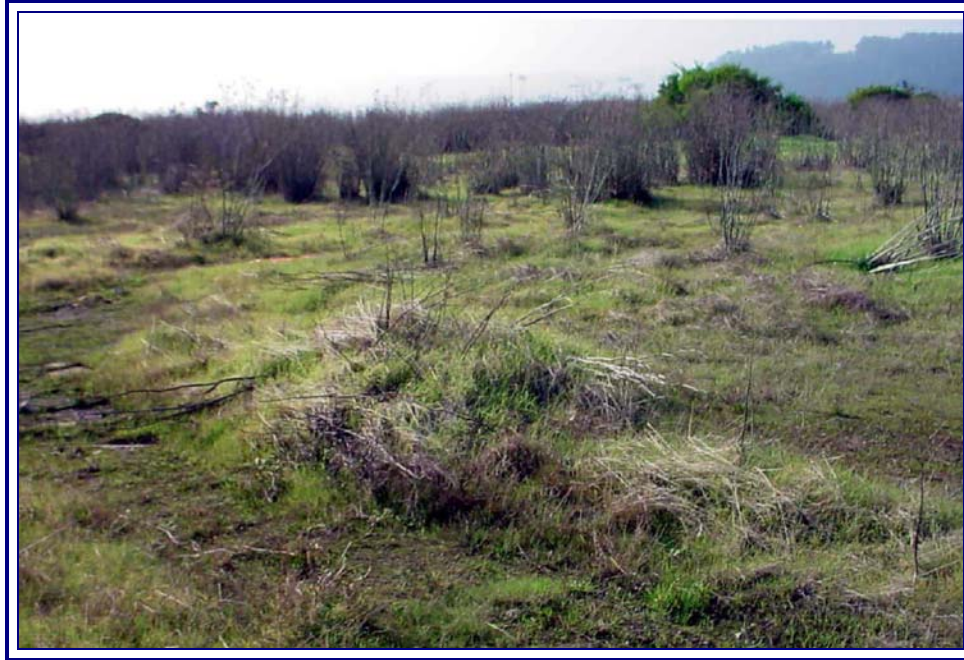
8.3.5.29 *IR-02, Bay Fill Area*

**Site Description:** An irregular land area immediately adjacent to and east of IR-01 and immediately south of “J” Street comprising approximately 2,042,650 square feet. A site plan is provided in [Figure 8.3.5.29](#).

**Former Uses:** Bay Fill Area was used for disposal of assorted shipyard wastes, which included Ra-226 and Sr-90 devices. The area known as IR-02 Northwest and Central contains a suspected concentration of the devices. Potentially used for disposal of wastes from decontamination of OPERATION CROSSROADS ships.

- 1996 PRC Phase III trenching study. Identified numerous point sources below the ground surface.
- 1992 PRC Phase II investigations. Walkover survey and radon flux testing indicates radioactive material identified as radium point source anomalies.
- 1991 PRC Phase I investigation. Over 300 point sources observed.
- 1988 HLA site reconnaissance survey. Gamma readings exceeding background observed.

**Recommended Actions:** Characterization Survey. Remediate known areas of elevated readings. Perform Final Status Survey.

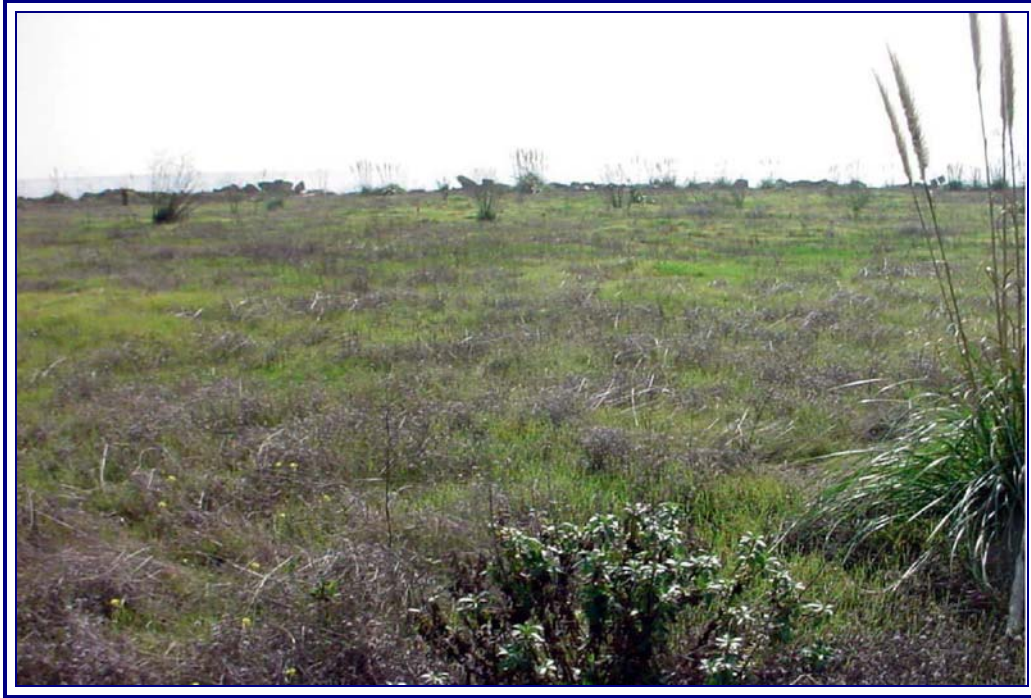
**8.3.5.30 IR-03, Former Oil Reclamation Plant Area**

**Site Description:** An irregular-shaped property, measuring approximately 45,000 square feet, located inside of IR-02. A site plan is provided in [Figure 8.3.5.29](#) above.

**Former Uses:** HPS Fuel Oil Reclaiming Plant ([HRA-4755](#)). Possible area for disposal of assorted shipyard wastes, which may have included Ra-226 and Sr-90 devices, and oil.

**Recommended Actions:** Scoping Survey. Characterization Survey and remediation if contamination is identified. Final Status Survey.

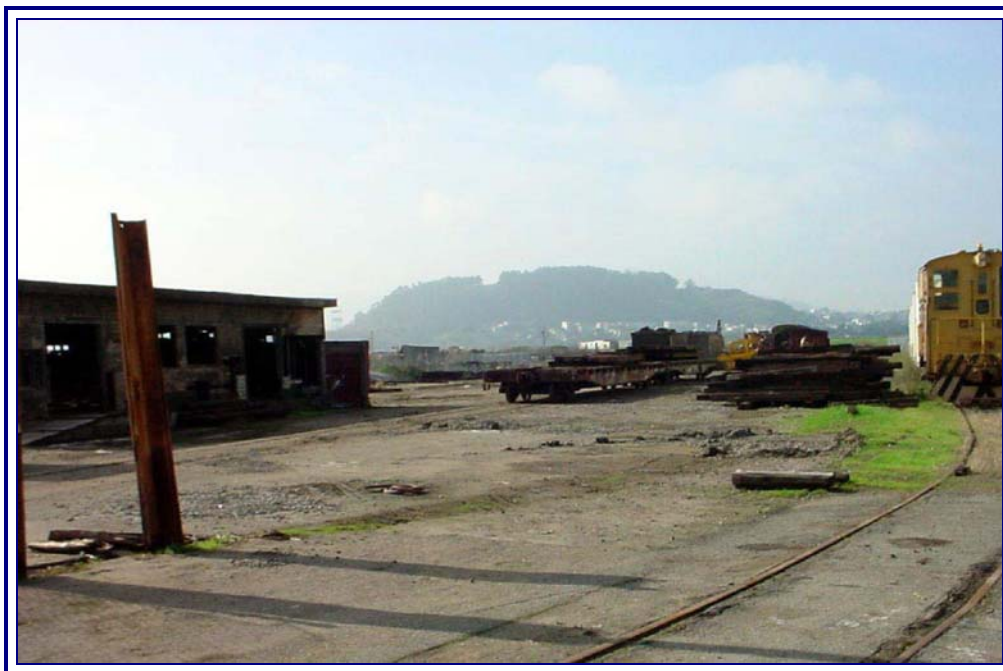
8.3.5.31 *IR-04, Former Scrap Yard*

**Site Description:** An irregular property, measuring approximately 100 feet by 600 feet, bounded by Spear Avenue to the east and south, Building 812 access road to the west, and Building 810 to the north. A site plan is provided in [Figure 8.3.5.20](#) above.

**Former Uses:** Post-disassembly area for metals, equipment, and other unusable items from the Salvage Yard that could have contained Ra-226 devices and other contaminants ([HRA-523](#)).

2001 NWT Phase V investigations. Gamma survey and sampling indicated several locations containing elevated levels of Cs-137 and Ra-226. Site boundary expanded following surveys as contamination was found on the boundary. Areas remediated and resurveyed. Additional contamination found.

**Recommended Actions:** Review Phase V Survey Report. Remediate known contamination. Further characterization surveys of boundary areas and remediation if further contamination identified. Final Status Survey.

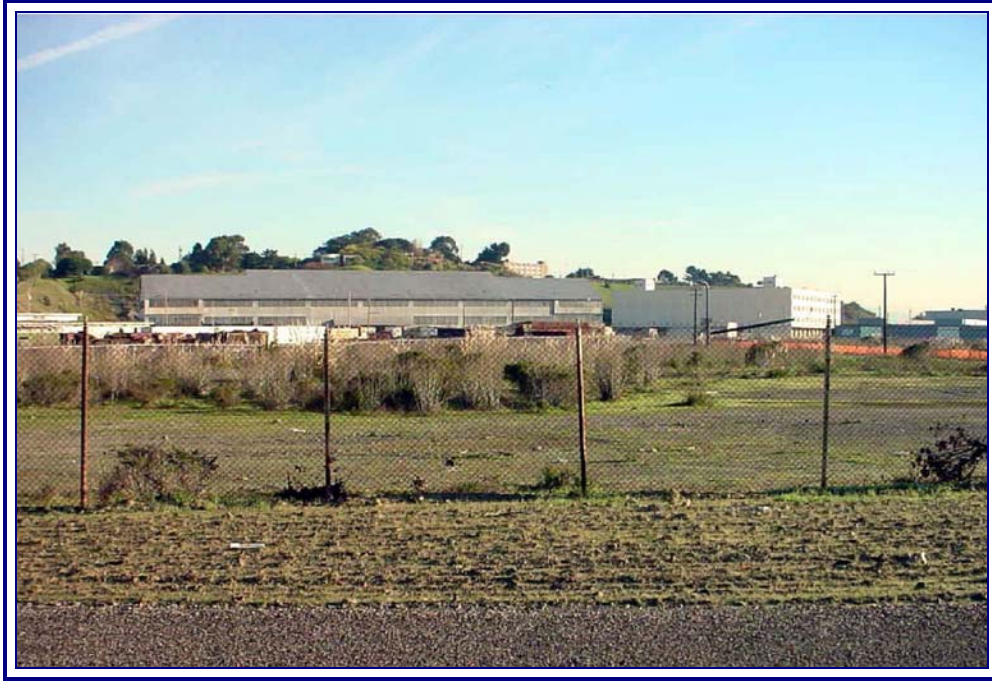
**8.3.5.32 IR-12, Former Salvage Yard and Disposal Trench Area**

**Site Description:** An irregular pentagonal-shaped property, measuring approximately 75,000 square feet, bounded by Spear Avenue to the north and 6th Avenue to the east. It is immediately southwest of the former Building 702 site fully contained within IR-12. A site plan is provided in [Figure 8.3.5.20](#) above.

**Former Uses:** Pre-disposal disassembly area for metals, equipment, and other reusable items that could have contained Ra-226 devices and other contaminants ([HRA-523](#)).

**Recommended Actions:** Scoping Survey. Characterization Survey and remediation if contamination is identified. Final Status Survey.

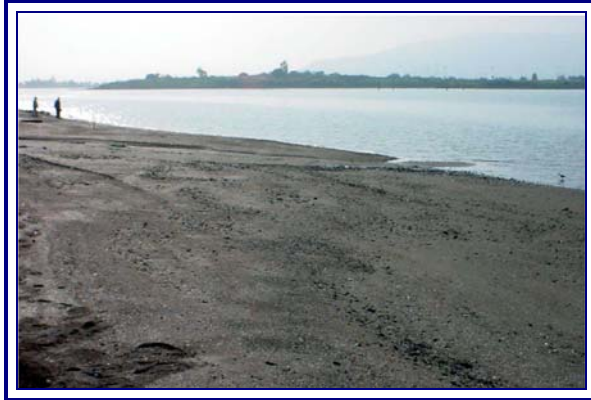
Mid-Point of Shoreline at Low Tide

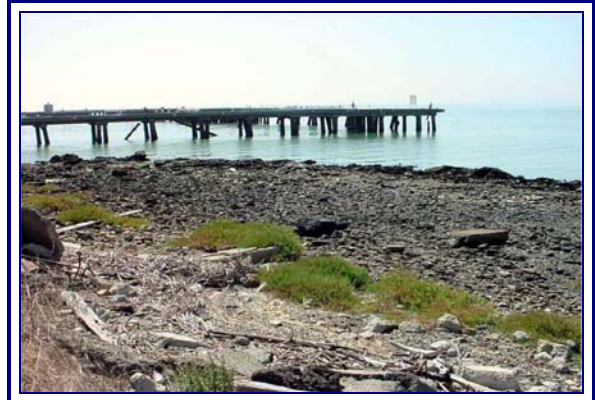
Metal Reef Area on the Southeast Shoreline

2001 NWT interim investigations. Gamma scan of shoreline found several areas of elevated levels. Analysis indicated Ra-226 as contaminant.

**Recommended Actions:** Characterization Survey. Remediation of known and any identified contamination. Final Status Survey.

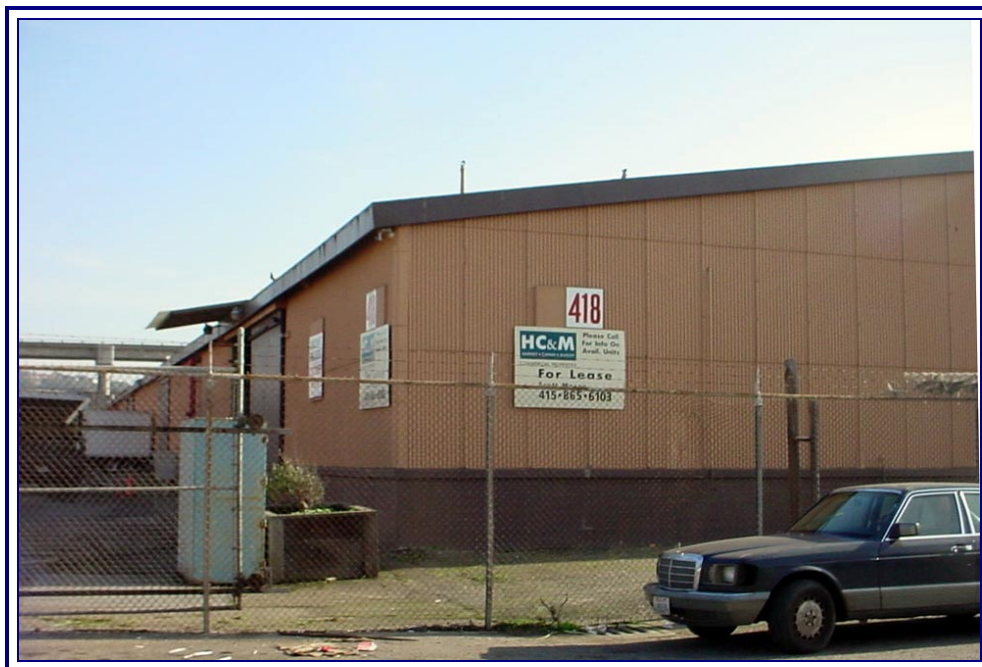
#### 8.3.8.1 ICW 418 (W-418)

**Site Description:** A shallow, gable-roofed, metal warehouse building covering approximately a city block. A site plan is provided as [Figure 8.3.8.1](#).

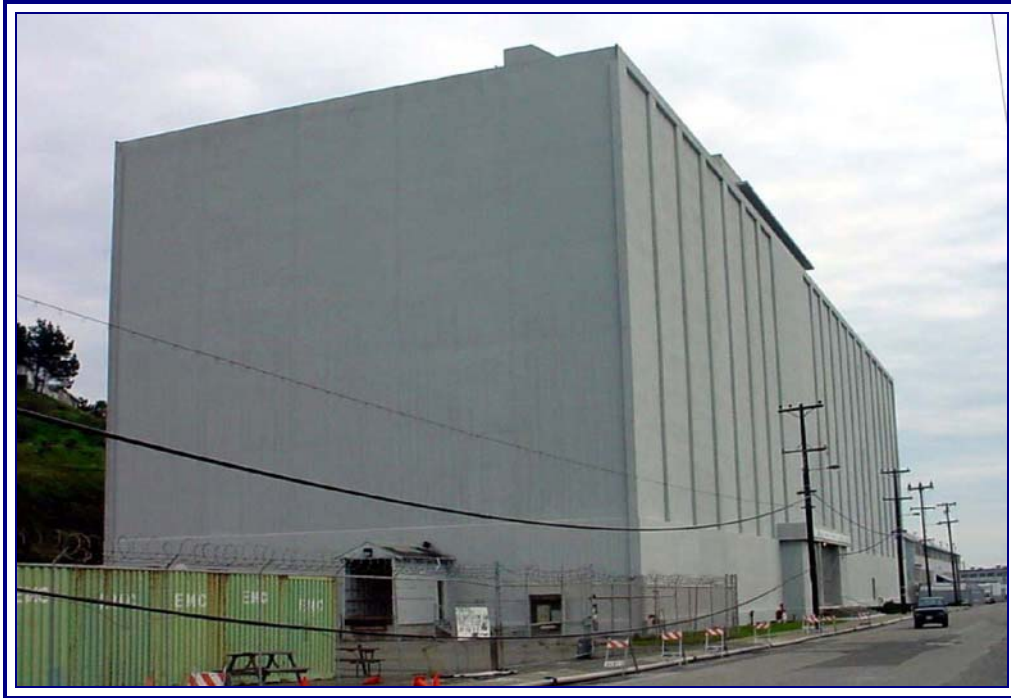
**Site Description:** A seven-story flat-roofed steel and concrete structure built in the early 1950s as NRDL's main research facility and headquarters ([HRA-1633](#); [HRA-2036, p 1](#)). NRDL occupied the building from 1955 ([HRA-235](#); [HRA-2427](#); [HRA-2466](#)) through its closure in 1969 ([HRA-413](#); [HRA-2918, p 1](#)). The entire building was classified as a restricted area. Generally, each floor of the facility was occupied as follows ([HRA-599, p 2](#); [HRA-2772, pp 4-9](#); [HRA-2910](#); [HRA-2918, p 2](#); [HRA-2927](#)):

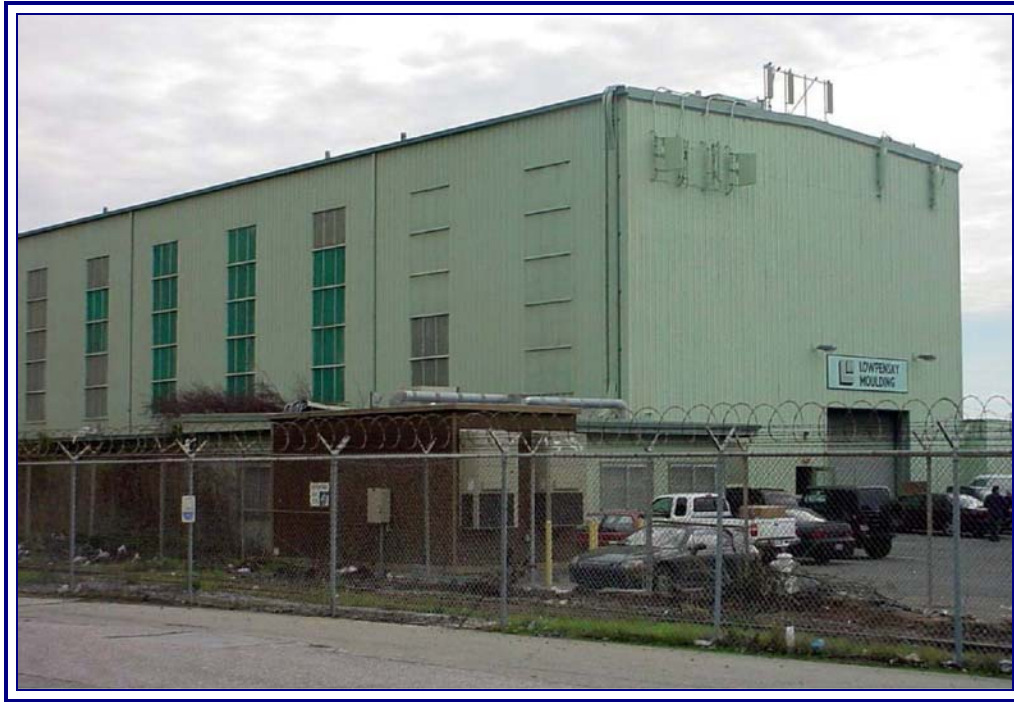
### 8.3.9.2 *Building 820*

**Site Description:** An irregular-shaped, reinforced concrete building, measuring approximately 19,840 square feet at its foundation. No longer Navy property. A building site plan is provided as [Figure 8.3.9.1](#) above.

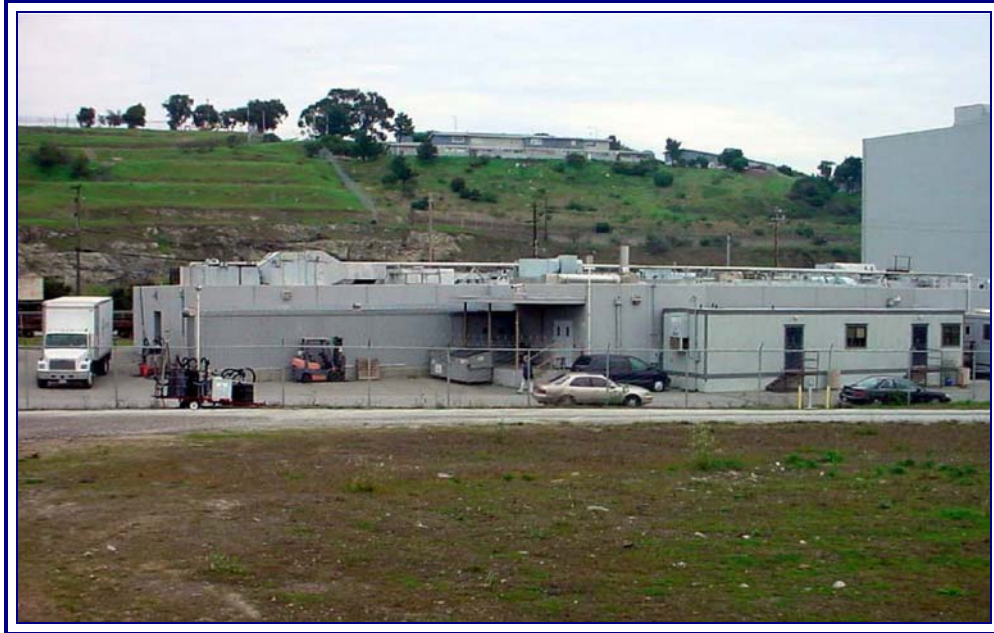
8.3.9.3 **Building 830**

**Site Description:** A pre-engineered, large, irregular-shaped metal shed, measuring approximately 16,500 square feet at its foundation. No longer Navy property. A building site plan is provided in [Figure 8.3.9.1](#) above. A floor plan is in Reference [HRA-4733](#).

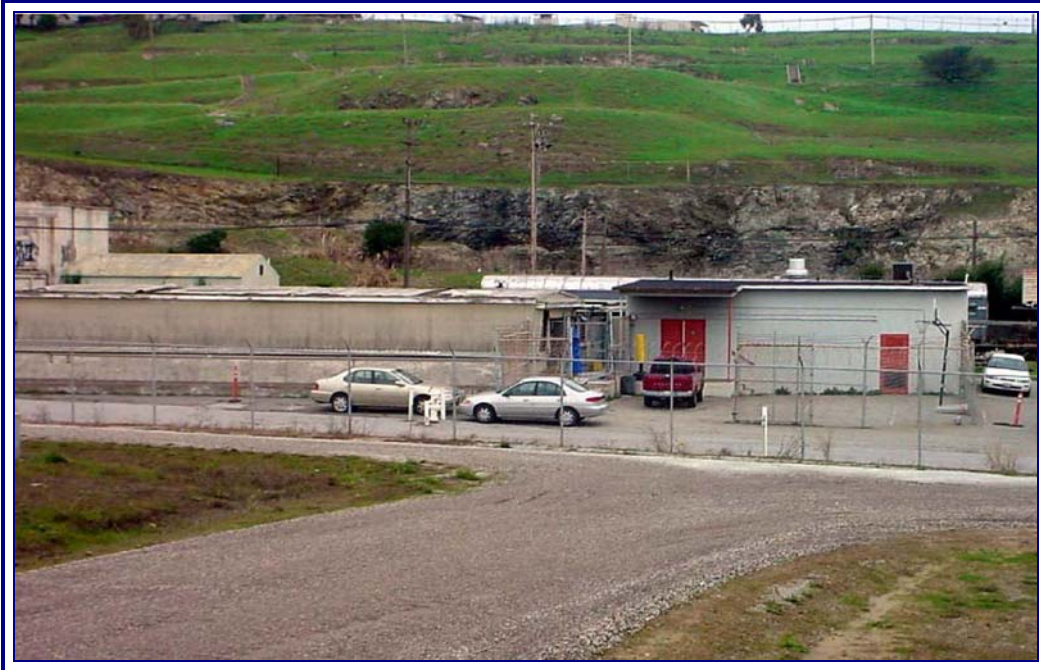
8.3.9.4 *Building 831*

**Site Description:** The building is irregular in construction and measures 4,400 square feet at its foundation. No longer considered Navy property. A building site plan is provided in [Figure 8.3.9.1](#) above.
