Contract Program or
Project Title: Heavy-Section Steel Technology (HSST) Program

Subject of this Document: Experimental Program for Investigating the Influence
of Cladding Defects on Burst Pressure

Type of Document: Letter Report

Date of Document: September 2004

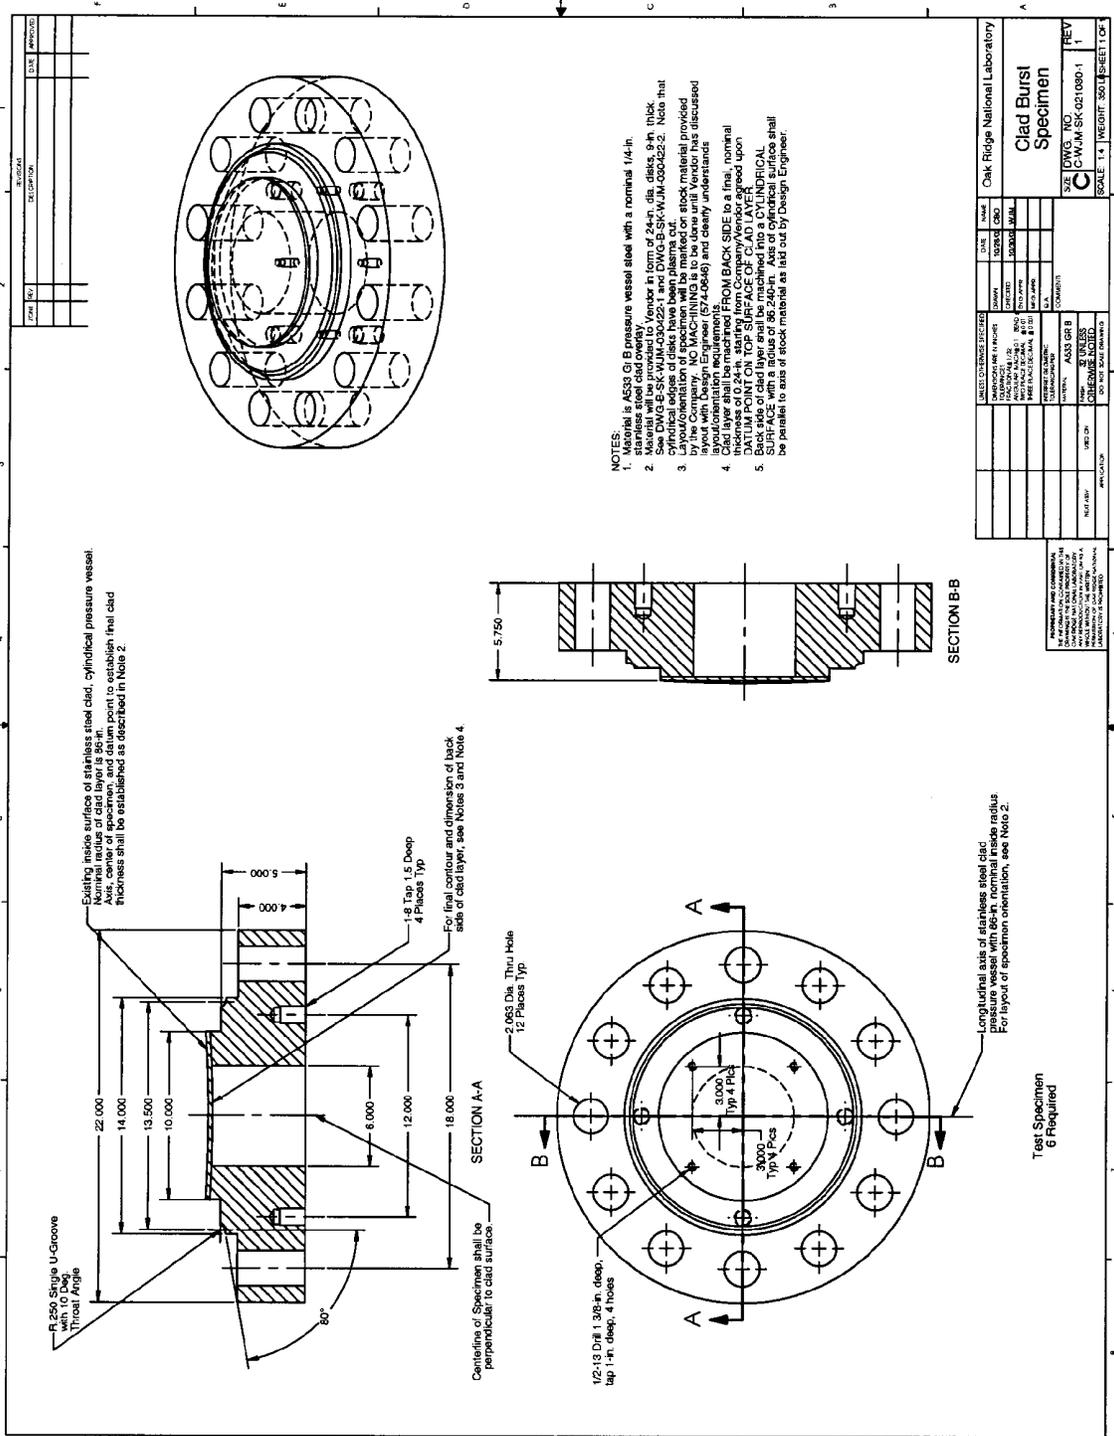
Fig. 2.1. Test specimen design utilized in the HSST clad burst testing program.

The test specimen (shown in Fig. 2.1) is machined from a 22 in. diameter blank extracted from the beltline region of the PVRUF shell (the vessel head and bottom were no longer available). The inner surface of the cladding in the test section is left in the “as found” condition, i.e., no machining is performed on that surface. (Here, the inner surface of the test specimen cladding corresponds to the inner surface of the parent RPV). The ferritic material in the test specimen consists of PVRUF plate exclusively, i.e., no weld metal was utilized.

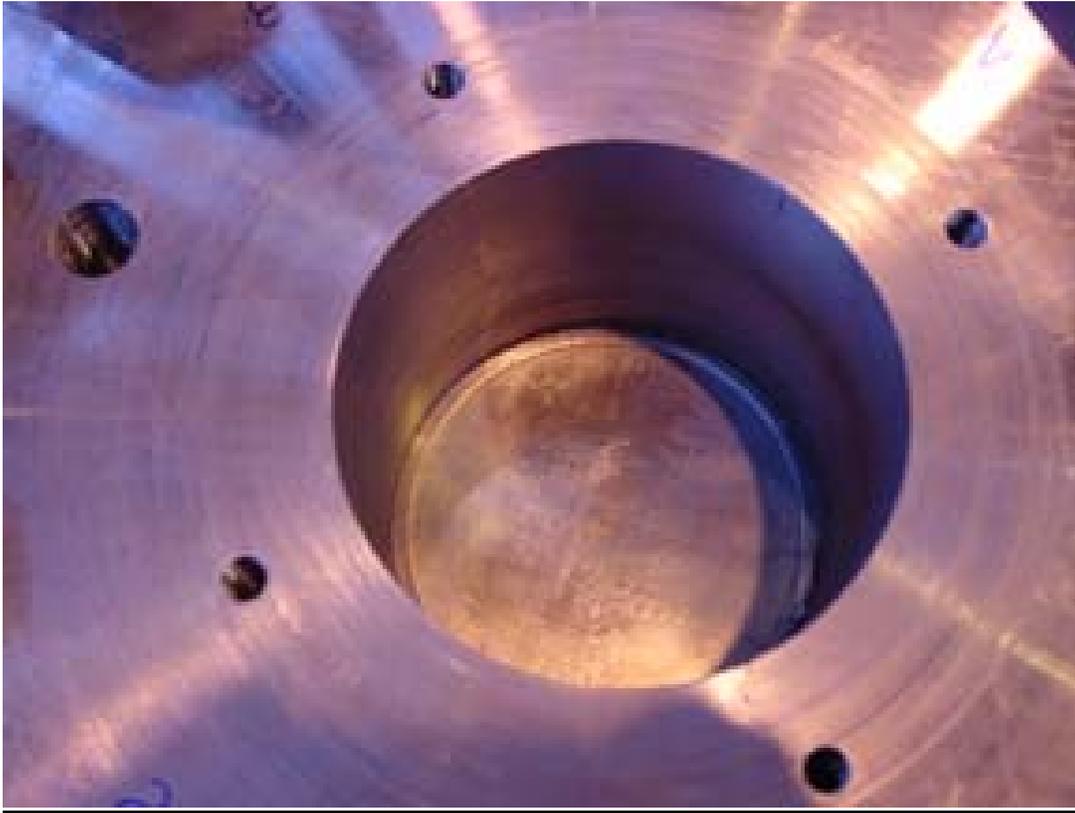
Fig. 2.2. Clad layer at the bottom of the machined cavity (6-in. diameter) of the test specimen.

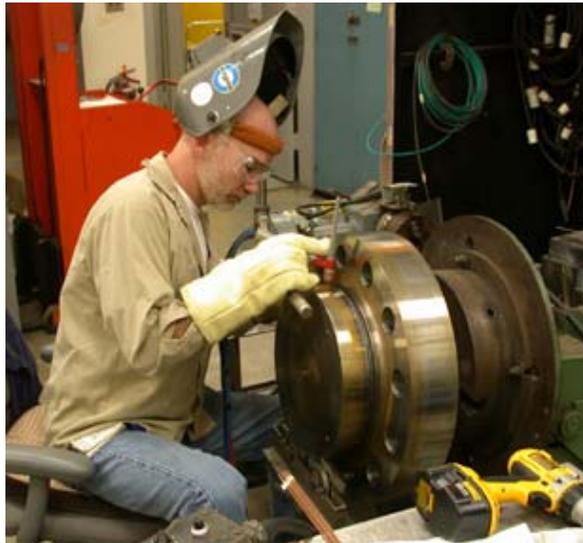
Fig. 2.3. Cavity plate/clad specimen assembly prior to attachment of backing plate: (a) plan view and cross section; (b) cavity plate being welded to clad specimen. The cavity plate provides a thin, sealed cavity that is bounded on one side by the inner clad surface.

A 2 in.-thick cavity plate is welded to the clad specimen to produce a thin, sealed cavity over the inner clad surface (see Fig. 2.3). A high-pressure connection through the center of the cavity plate (see Fig. 2.4) allows for pressure loading of this cavity bounded on one side by the inner surface of the clad layer. During a typical test, pressure over the clad inner surface is increased until structural failure of the clad layer is detected. Structural failure of the specimen is indicated by a

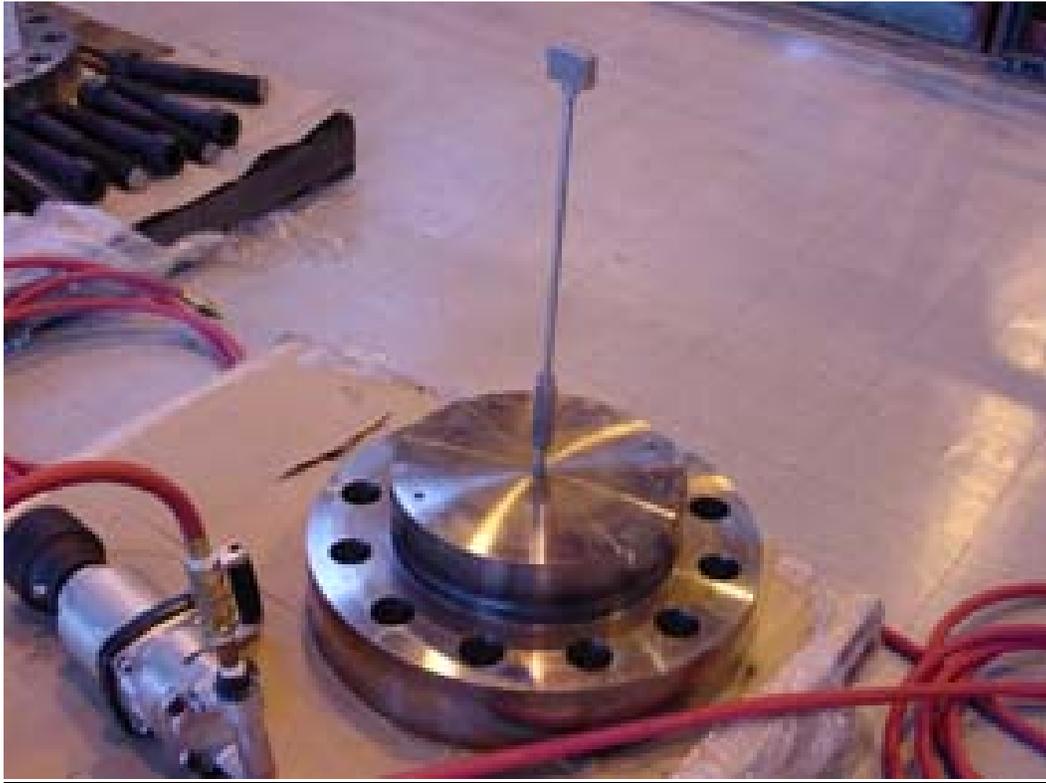
Fig. 2.4. High-pressure connection through the cavity plate of the test specimen assembly.

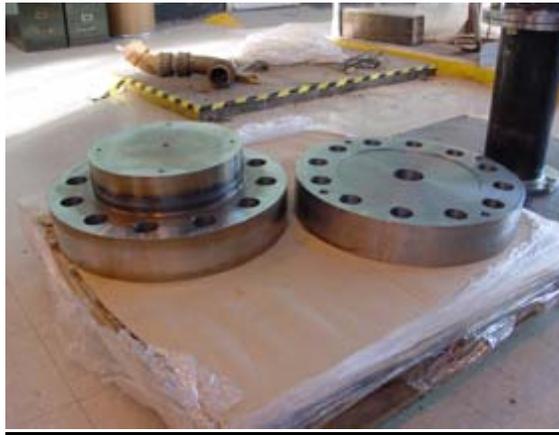
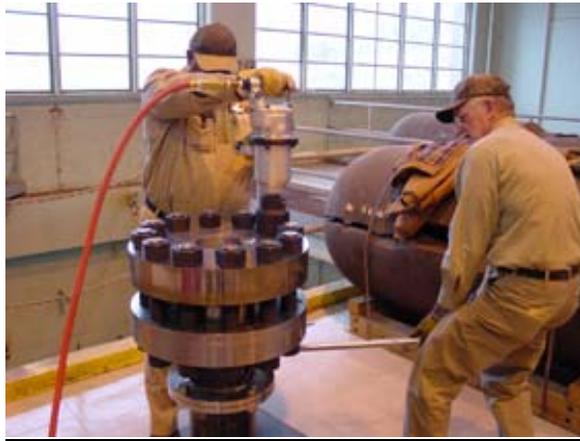
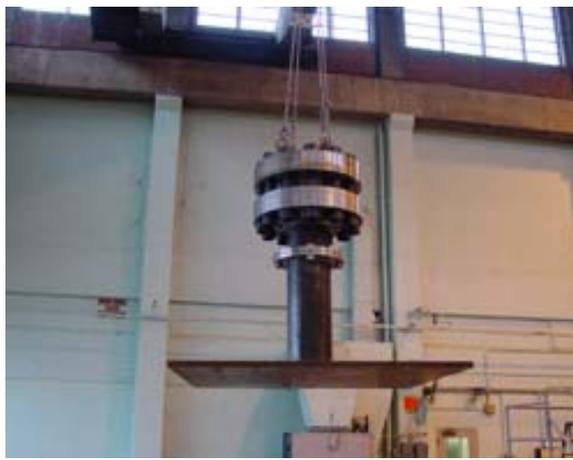
Fig. 2.5. Test specimen assembly: (a) test specimen and backing plate; (b) backing plate being attached to specimen/cavity-plate assembly; and (c) assembly being moved to containment facility.

A backing plate [see Fig. 2.5(a)] is bolted to the test specimen/cavity plate unit to produce an assembly ready for testing (except for instrumentation described below). Tension in the 12 hold-down bolts [2 in. diameter, SA540, or equivalent, spaced at equal intervals around the circumference of the specimen, shown in Fig. 2.5(b)] is increased sufficiently such that the weld used to attach the cavity plate to the test specimen will not experience tensile stress at any time during the loading transient. This configuration is intended to prevent failure of the seal weld during the high-pressure loading transient. In Fig. 2.5(c), the test specimen assembly is ready for placement into the containment vessel of the test facility (described below).

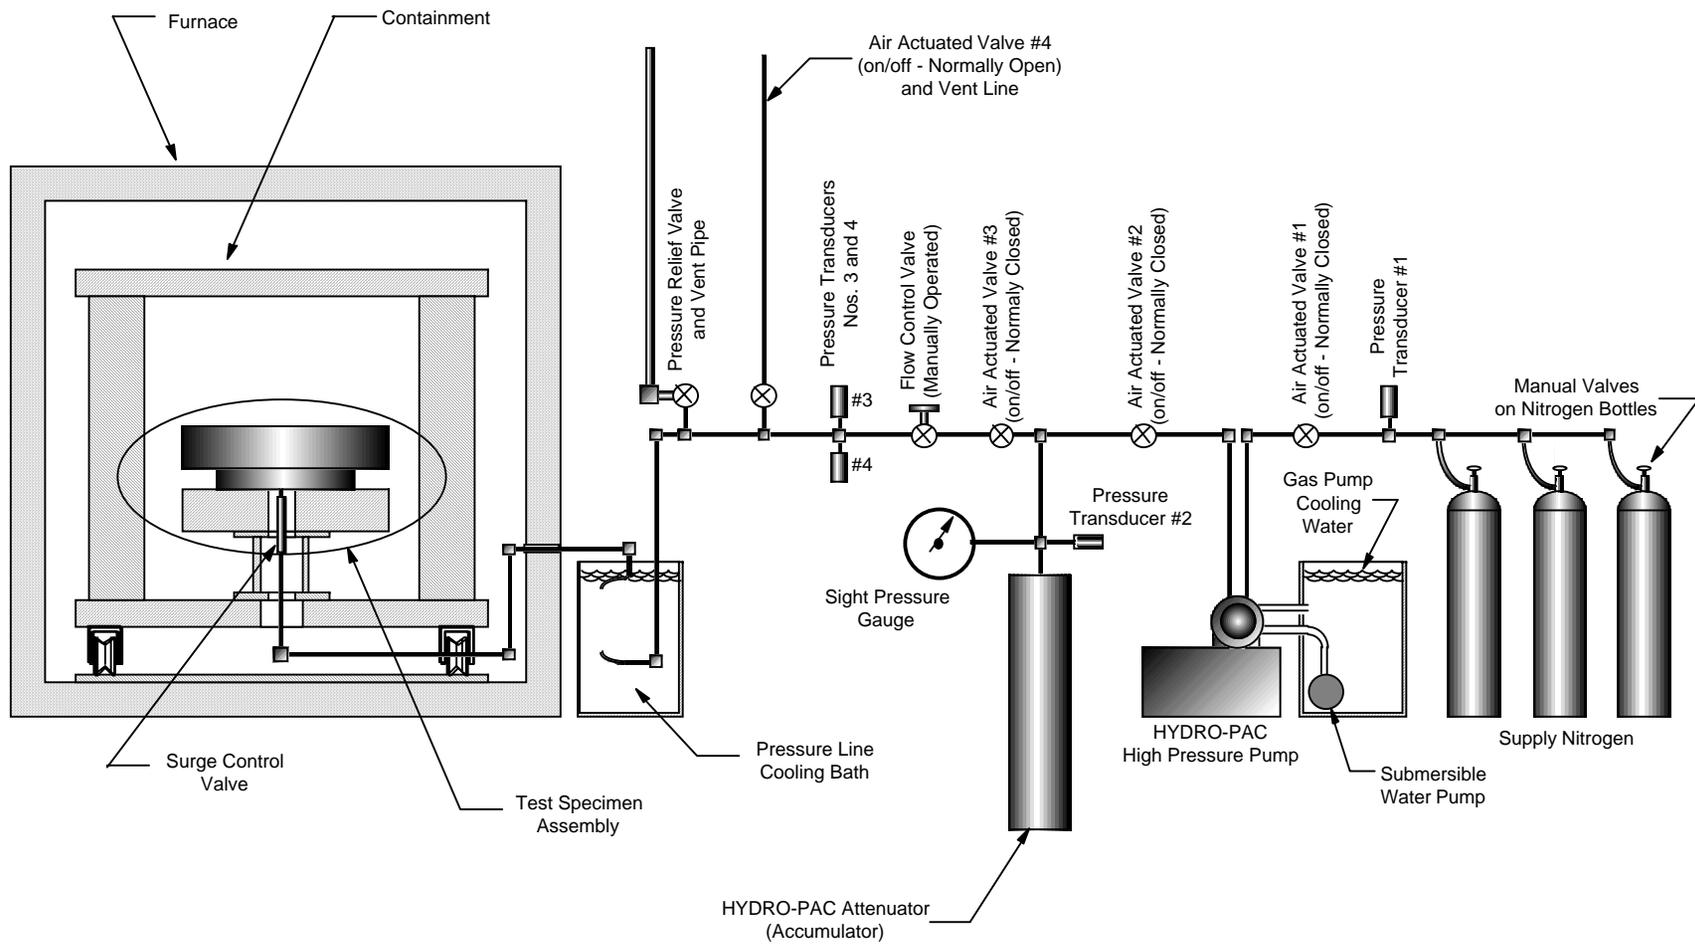
Fig. 2.6. Schematic drawing of ORNL/HSST clad burst test facility.

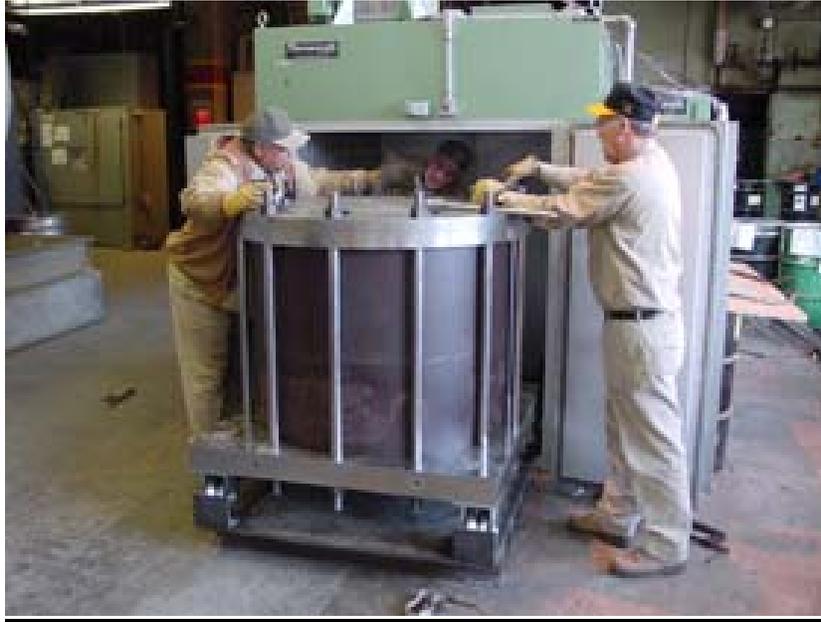
Fig. 2.8. Containment vessel prior to being rolled into thermal oven.

Control of test temperature is achieved by placing the containment vessel and test specimen assembly into a Thermcraft floor-model heat-treatment oven; a photograph in Fig. 2.8 shows the containment vessel in front of the oven. Maximum operating temperature for the Thermcraft is 750°F. The digital controller shown in Fig. 2.9 maintains the oven environmental temperature to within ± 2 °F of the controller set point.

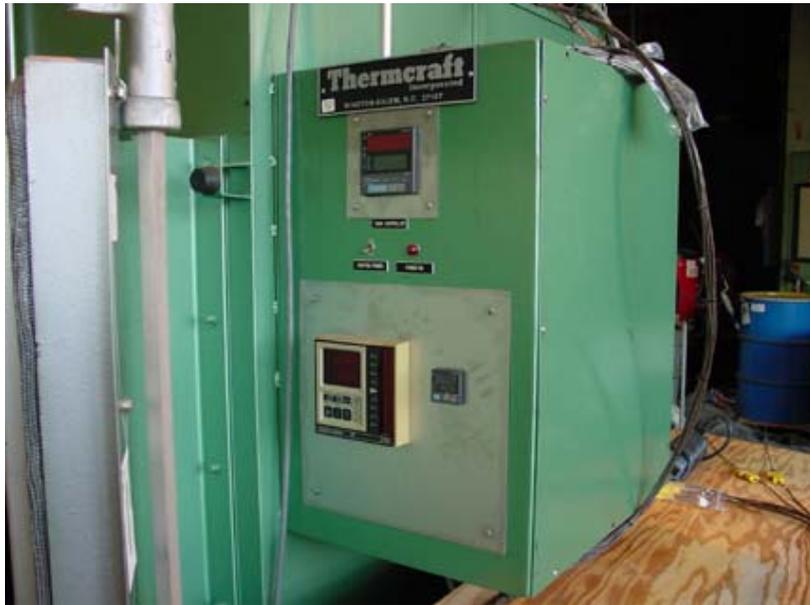
Fig. 2.9. Digital controller unit for Thermcraft heater oven.

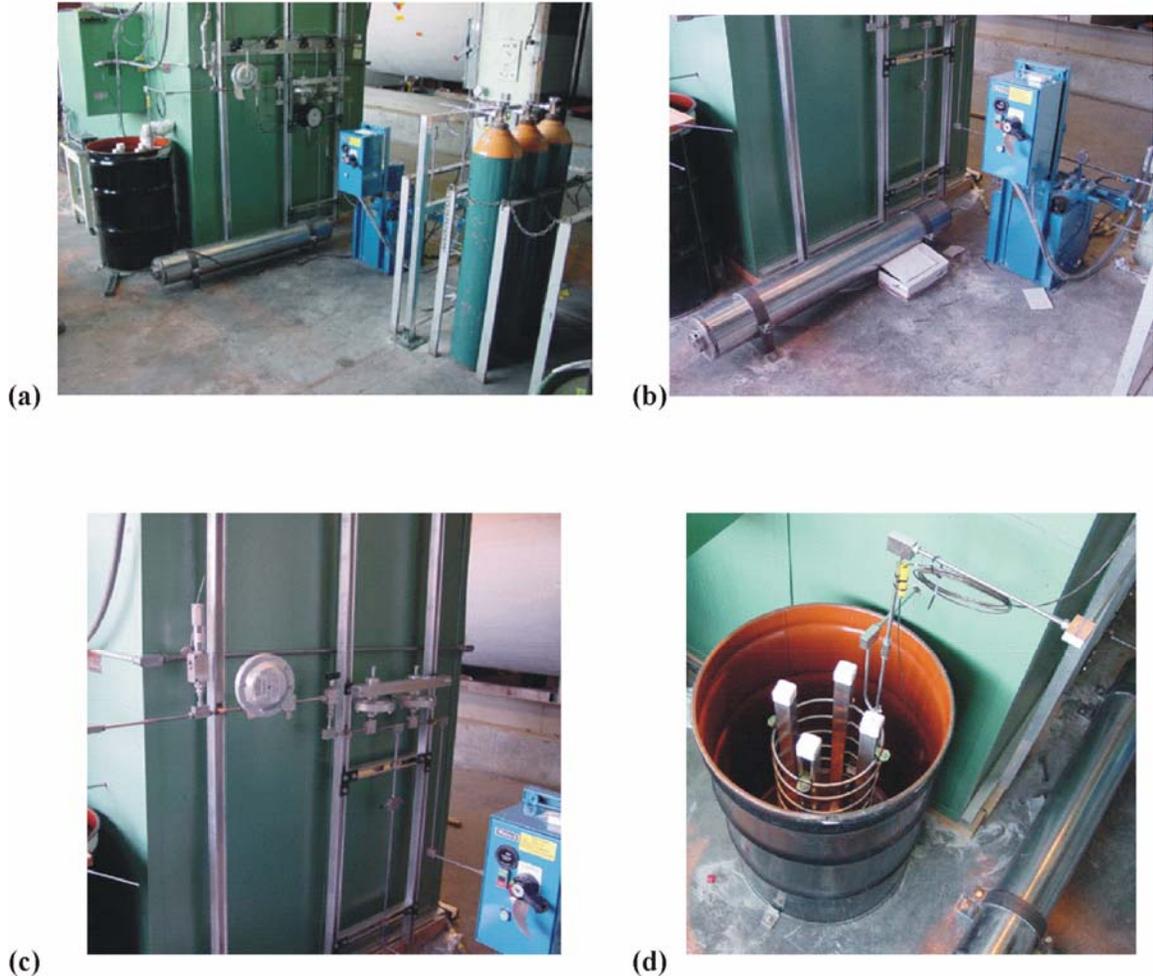
Fig. 2.10. High-pressure system: (a) system overview; (b) intensifier unit and accumulator tank; (c) air-actuated control valves; and (d) cooling tank.

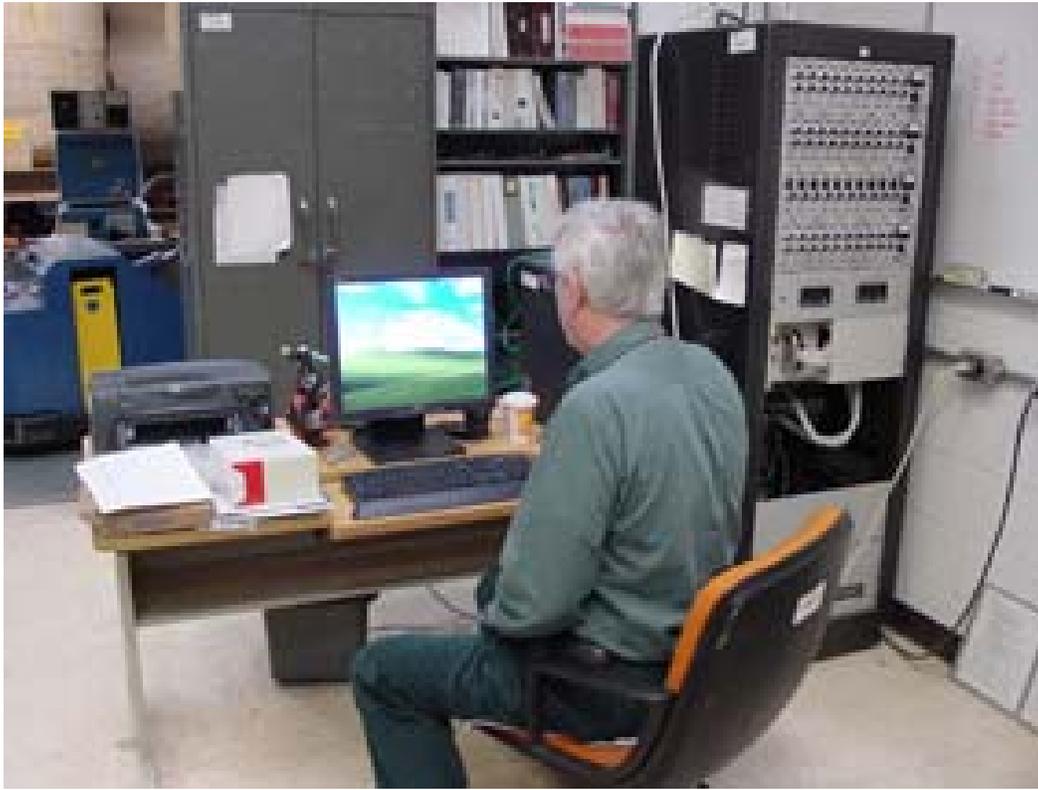
Fig. 2.11. Console of data acquisition system used to control clad-burst test facility during failure test.

The computer-controlled data acquisition system is used to perform the following functions: (a) monitor transducer output from thermocouples, pressure gages, proximity displacement gage, and CMOD gage; (b) write transducer data to disk at a sampling rate controlled by the user; (c) control all valves and gas supply and display their configuration; and (d) control operation of the intensifier unit. A photograph of the computer console and signal-conditioning unit is included in Fig. 2.11.

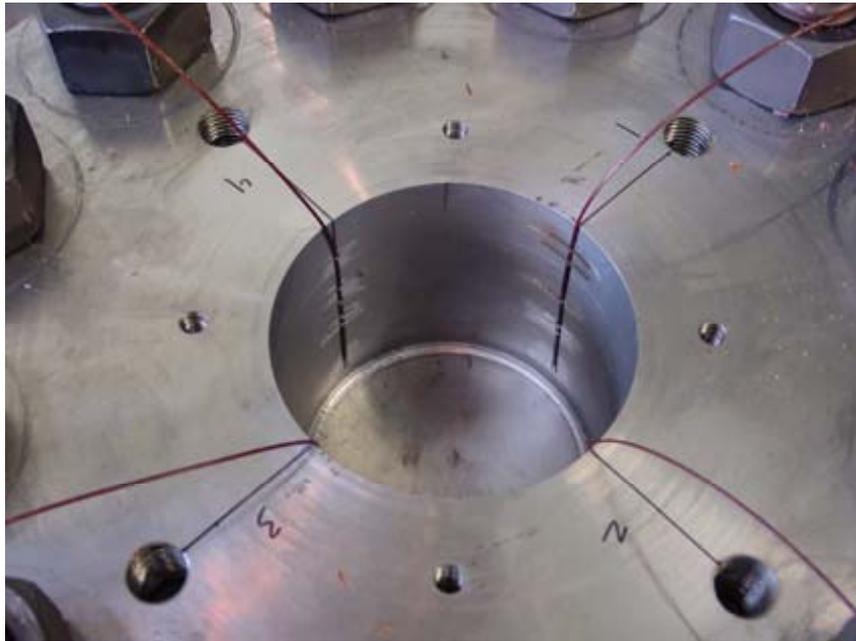
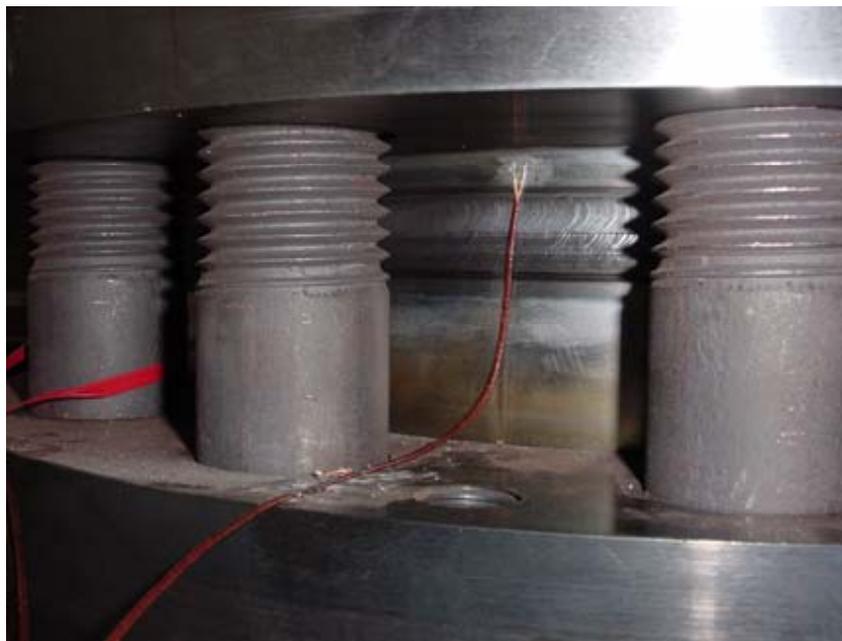
Fig. 2.12. Photographs of thermocouple gages placed on test specimen: (a) gages interior to the specimen cavity; and (b) an exterior gage.

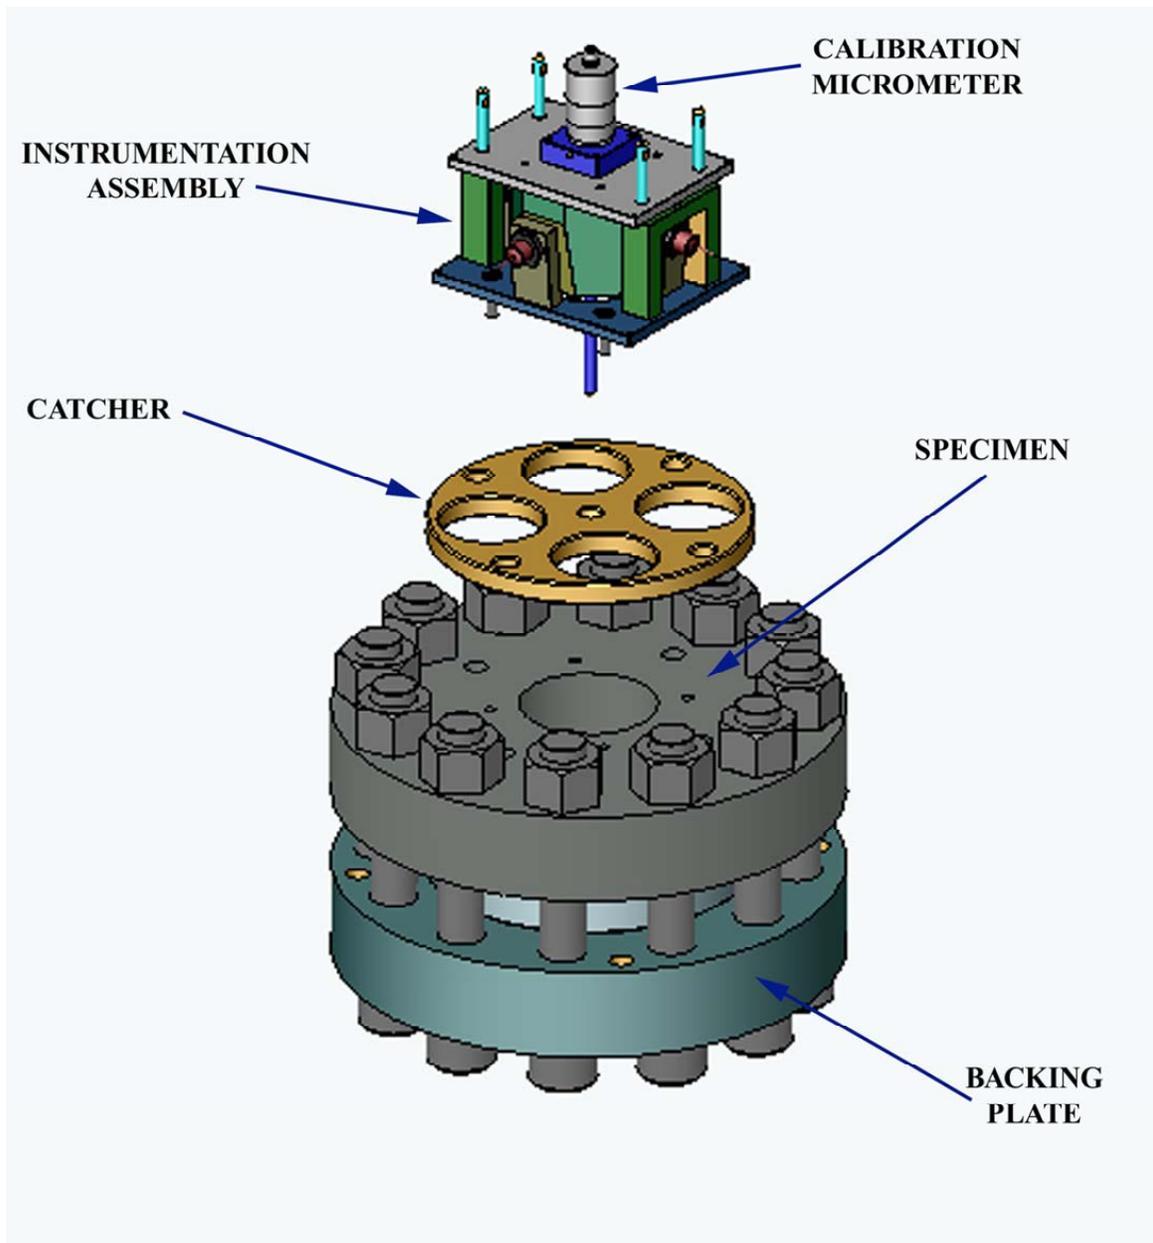
Fig. 2.13. Exploded view indicating orientation of instrumentation assembly (proximity transducer for measuring center-point clad deflection) and catcher plate relative to the test specimen assembly.

Following complete cool-down to room temperature, the containment vessel was disassembled to provide access to the test specimen assembly. Inspection of the assembly revealed that the clad layer failed by tearing completely around the circumference of the cavity (see Fig. 3.1). Impact of the unrestrained clad disk with the displacement transducer probe resulted in severe tearing/deformation of a portion of the disk as well as some damage to the instrumentation since this first test did not have the catcher plate shown in Fig. 2.13.

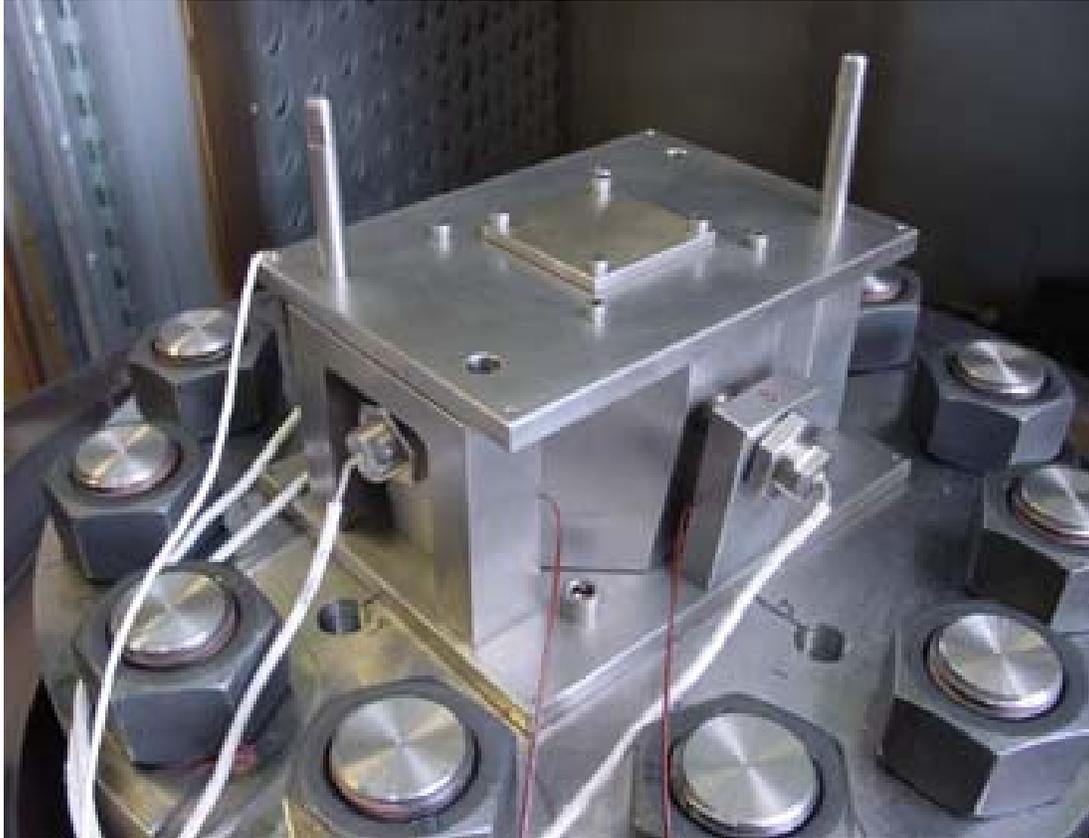
Fig. 2.14. View of proximity transducer for measuring center point deflection of the clad layer under applied pressure loading.

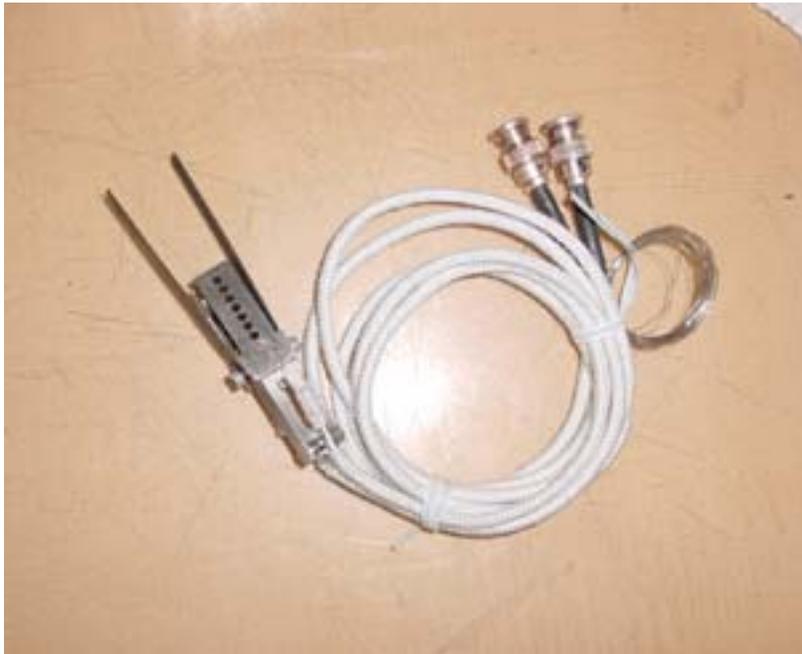
Fig. 2.15. CMOD gage used in Phase 2 test matrix: (a) capacitance-type gage; (b) knife-edge attachment of CMOD gage to clad burst specimen CB-11.

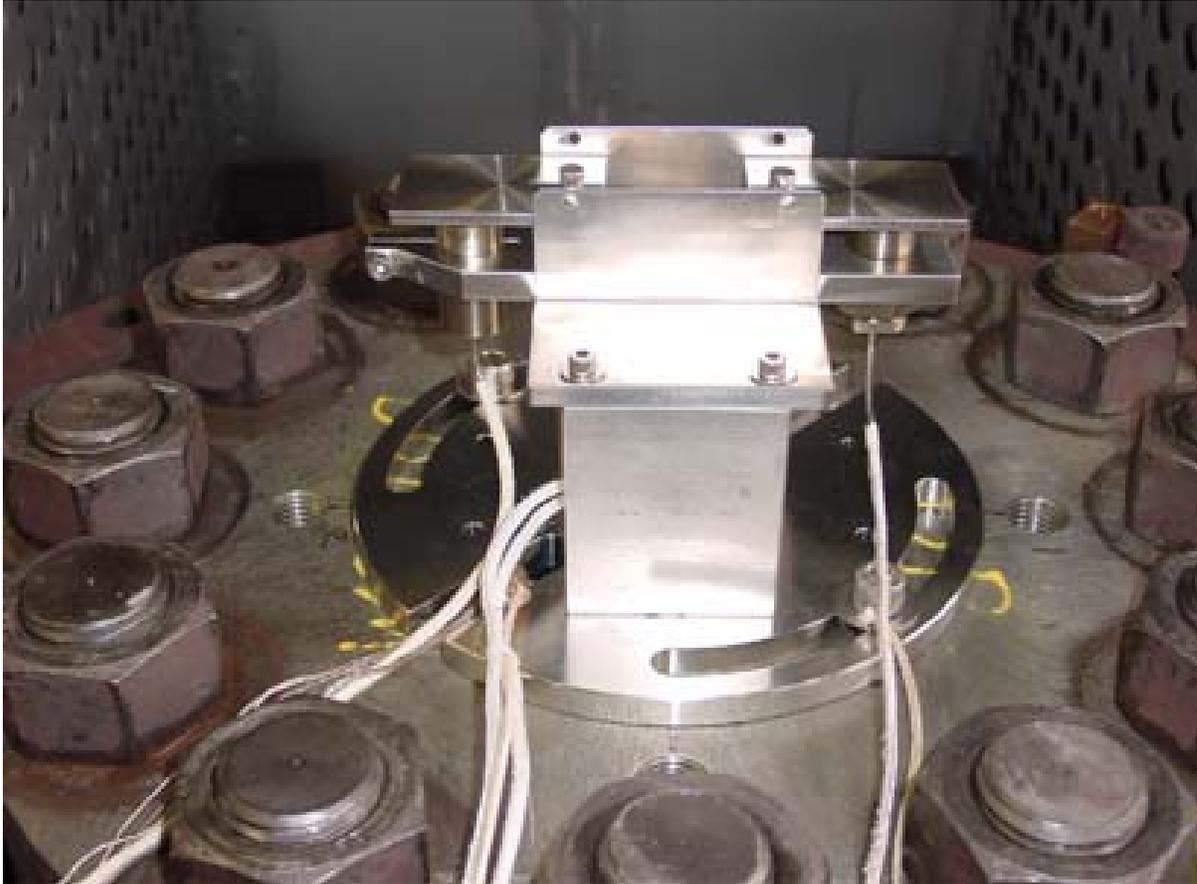
Fig. 2.16. Modified fixture for measuring lateral deflection of the clad disk at quarter-point locations, designed and fabricated to be compatible with simultaneous use of the capacitance-type CMOD gage.

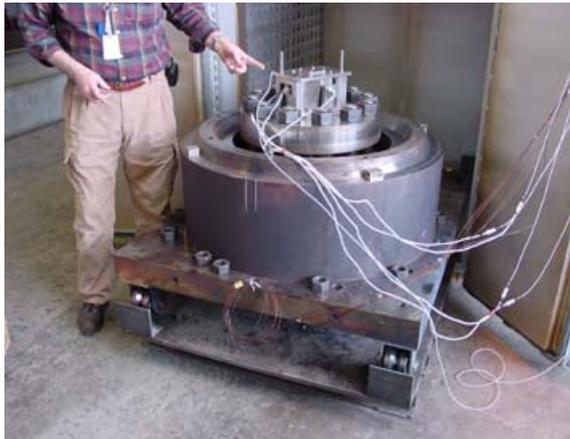
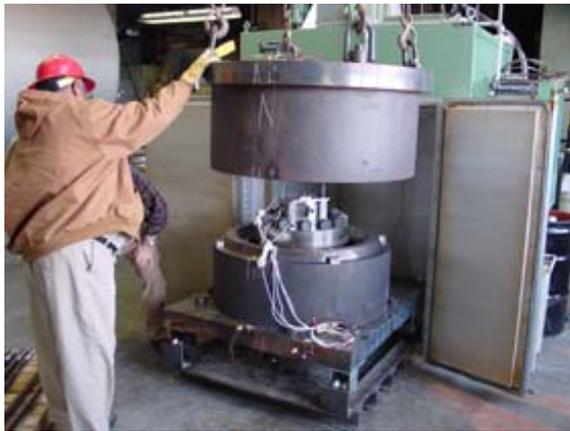
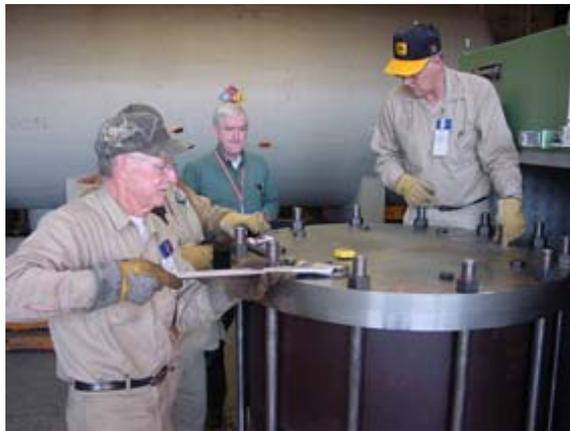
Fig. 2.17. Final assembly of vessel containing the test specimen assembly: (a) attachment of proximity transducer; (b) closure head lowered into position; and (c) bolting down of closure head.

Final preparations for a test include attachment of the displacement transducer to the test specimen, which is followed by lowering of the upper closure head over the transducer/test specimen assembly, and bolting down of that closure head (see Fig. 2.17).

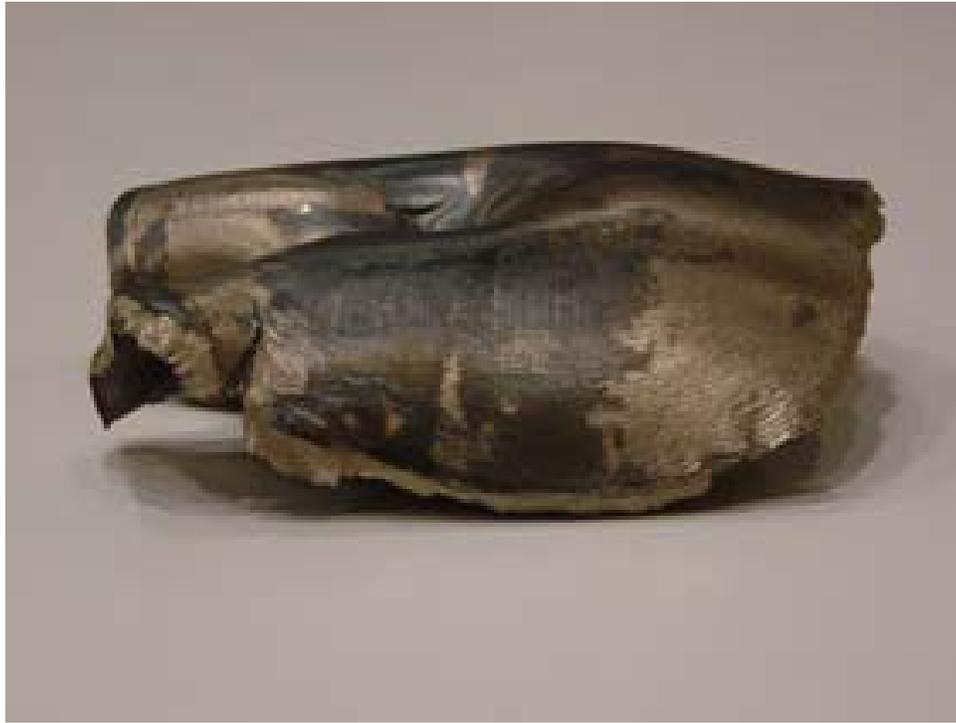
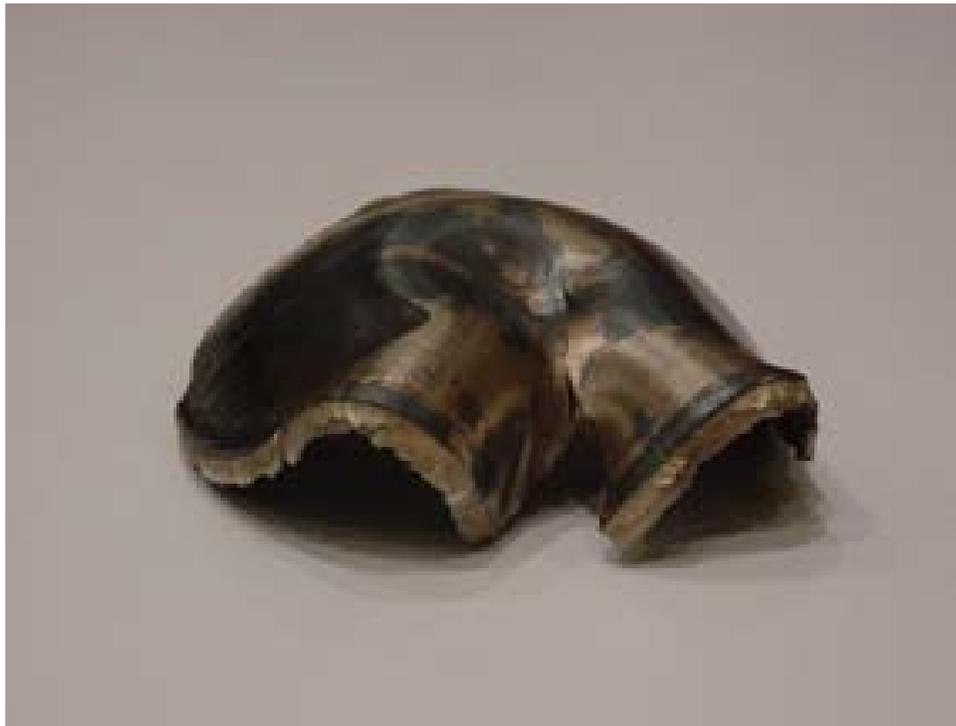
Fig. 3.1. Views of the deformed clad layer segment resulting from the first clad-burst test: (a) surface of clad layer corresponding to clad/base metal interface prior to machining of cavity; (b) deformation of surface due to impact with proximity gage probe used to measure center point deflection of cladding under pressure loading.

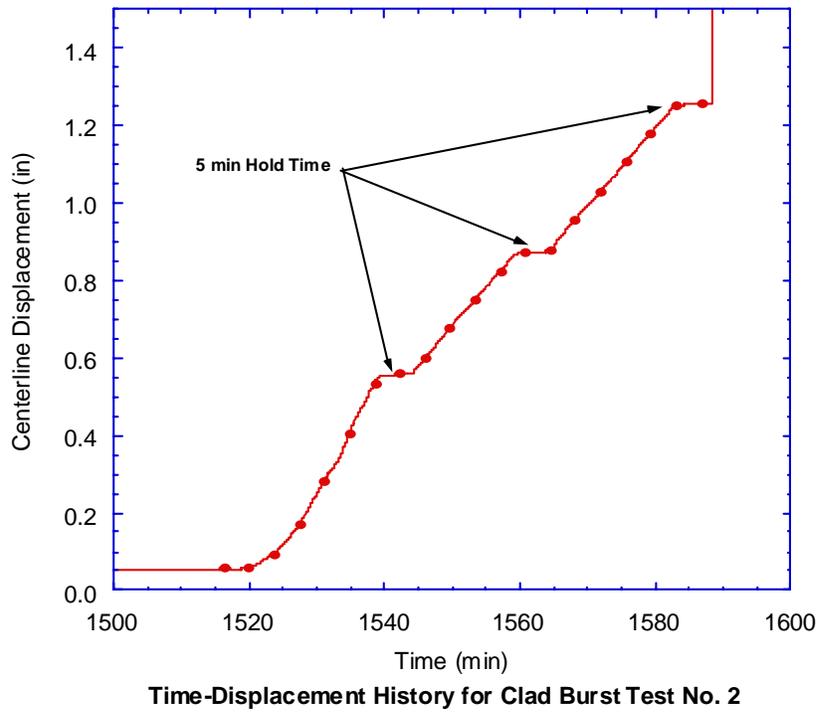
Fig. 3.2. Centerline displacement versus time as recorded during the second clad burst disk experiment, CB 2.

Figures 3.2–3.7 depict some of the measured data from the second test, as well as analytical interpretations derived from elastic-plastic finite element analyses. In Fig. 3.2, the measured centerline displacement is plotted as a function of time; the three pressure hold intervals are shown in the plot. The applied pressure versus time is depicted in Fig. 3.3; the complete loading history is shown in Fig. 3.3(a), while the loading history near failure is given in Fig. 3.3(b).

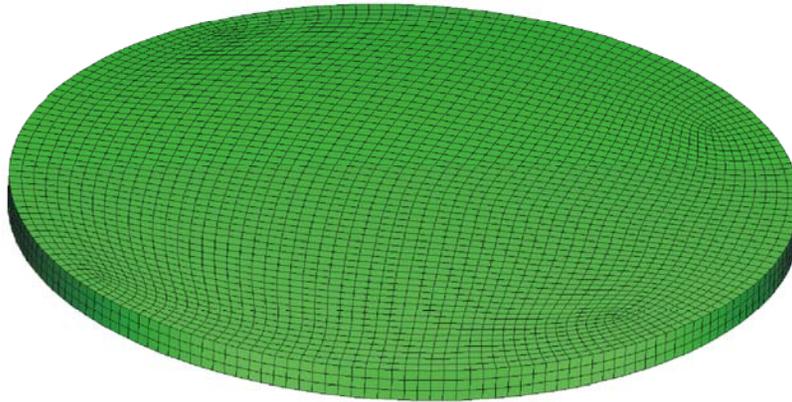
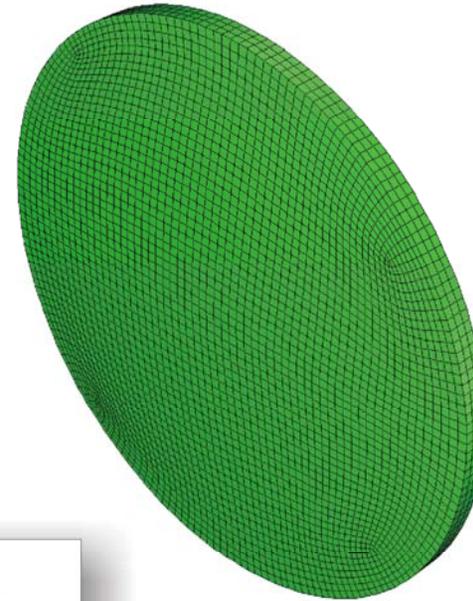
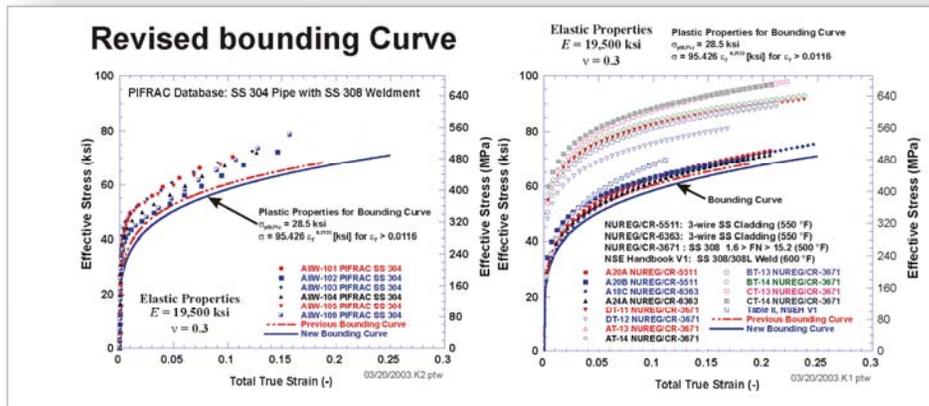
13,896 nodes
10,134 C3D8R

Fig. 3.4. Finite-element model used for ORNL analyses of clad-burst specimens (unflawed).

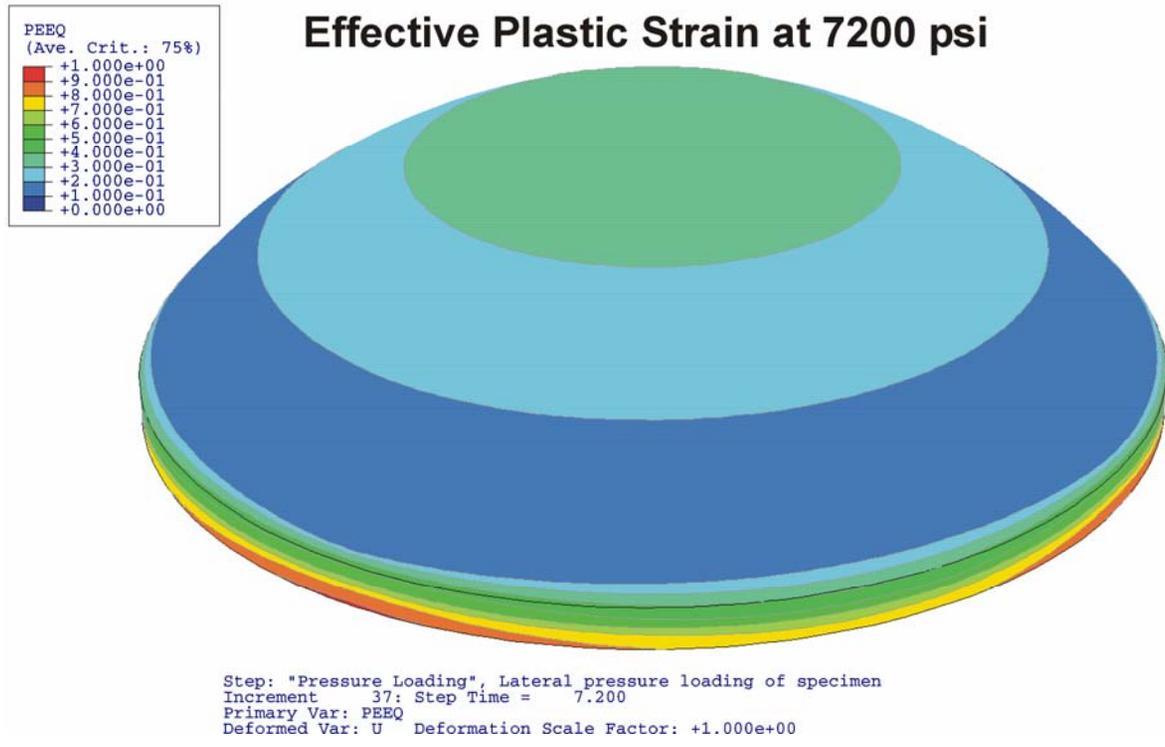
Fig. 3.5. Contours of effective plastic strain computed from finite element model of clad disk specimen.

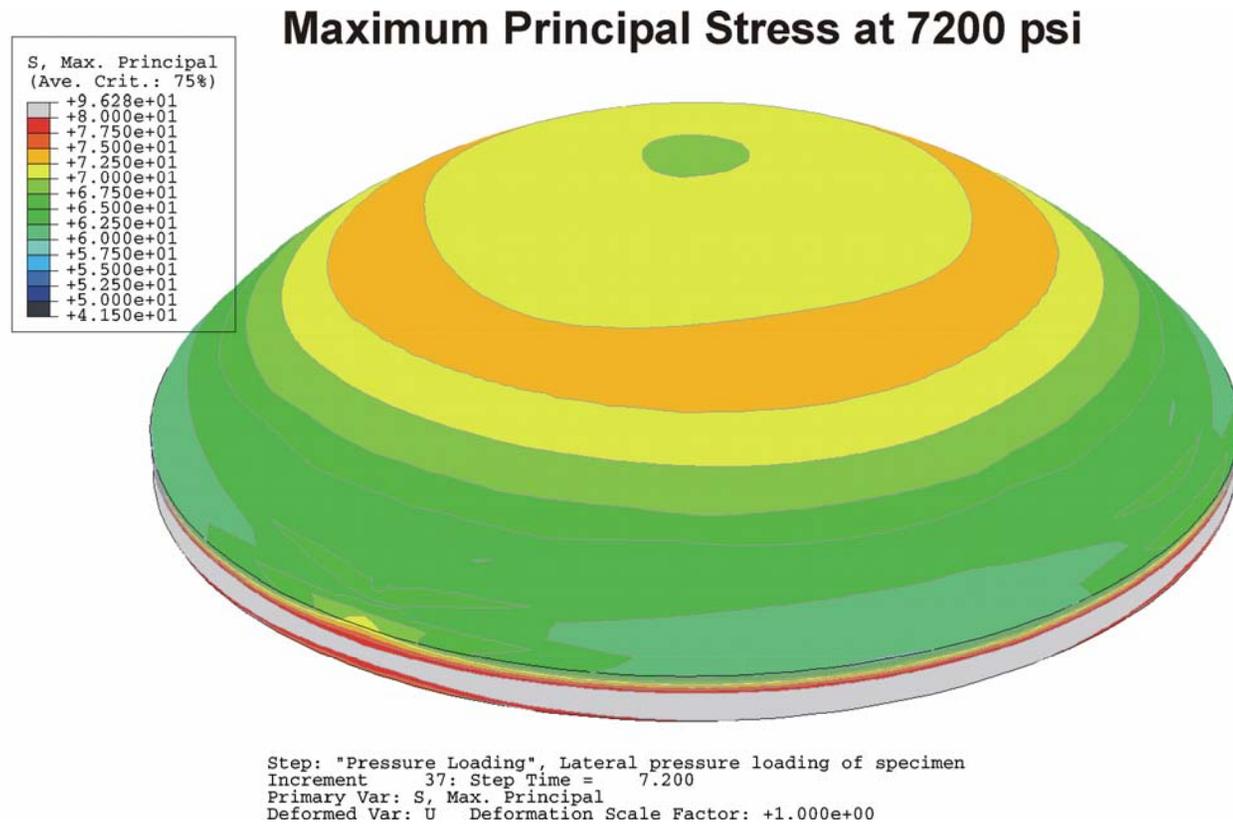
Fig. 3.6. Contours of maximum principal stress computed from finite element model of clad disk specimen.

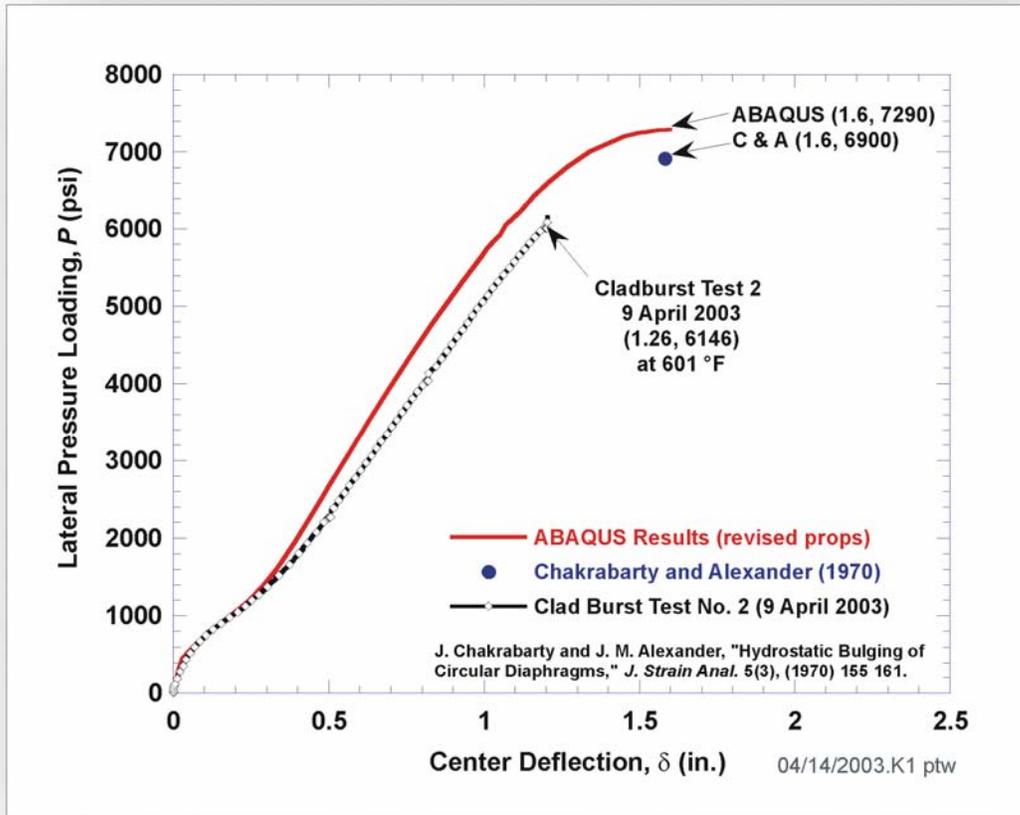
Fig. 3.7. Applied pressure versus clad center-point deflection and instability pressure for the second clad burst experiment: comparison of ABAQUS finite-element predictions with measured data.
