Contract Program or
Project Title: Heavy-Section Steel Technology (HSST) Program

Subject of this Document: Experimental Program for Investigating the Influence
of Cladding Defects on Burst Pressure

Type of Document: Letter Report

Date of Document: September 2004

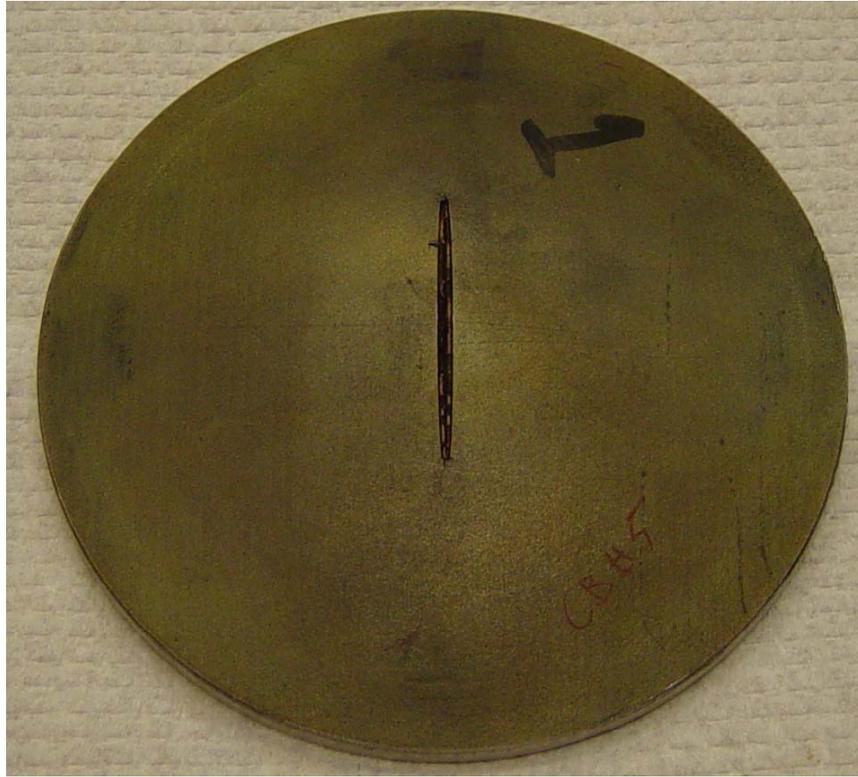
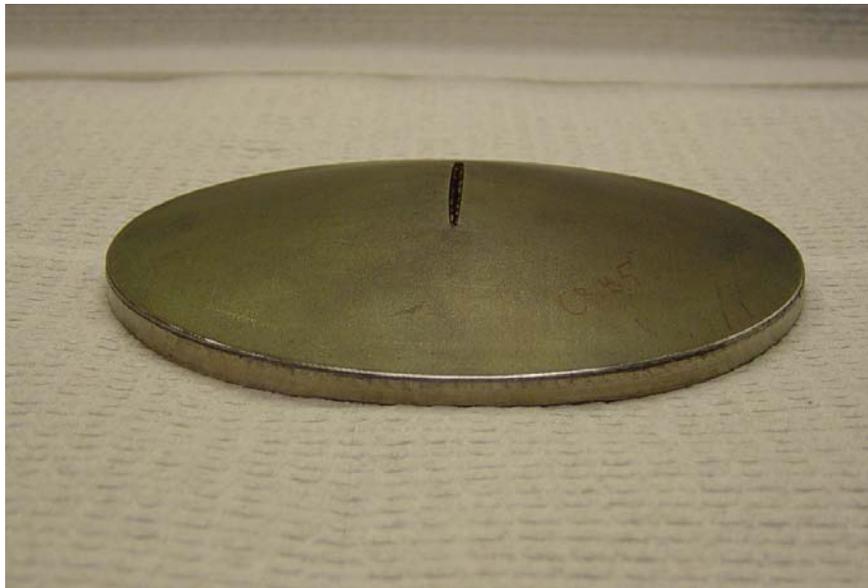
Fig. 4.1. Clad disk removed from specimen CB 5, containing a notch of 0.050 in. initial depth; the specimen failed at a pressure of 2,641 psi.

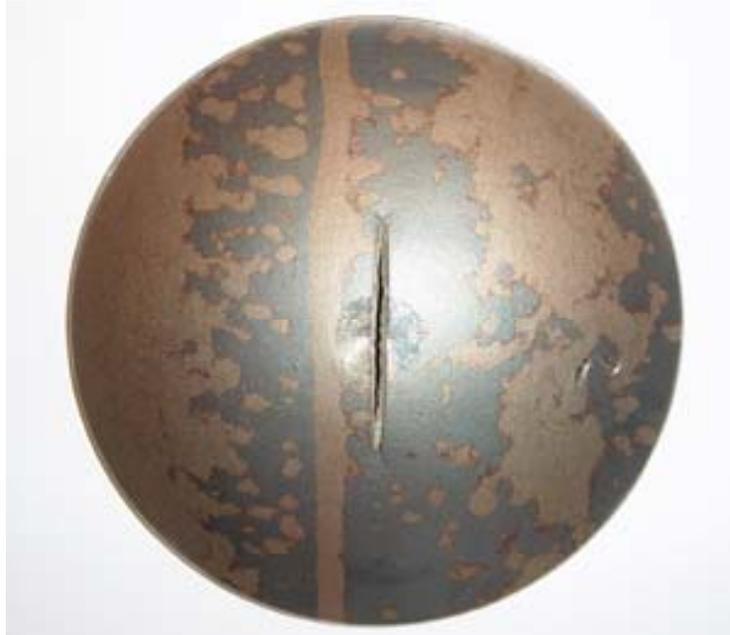
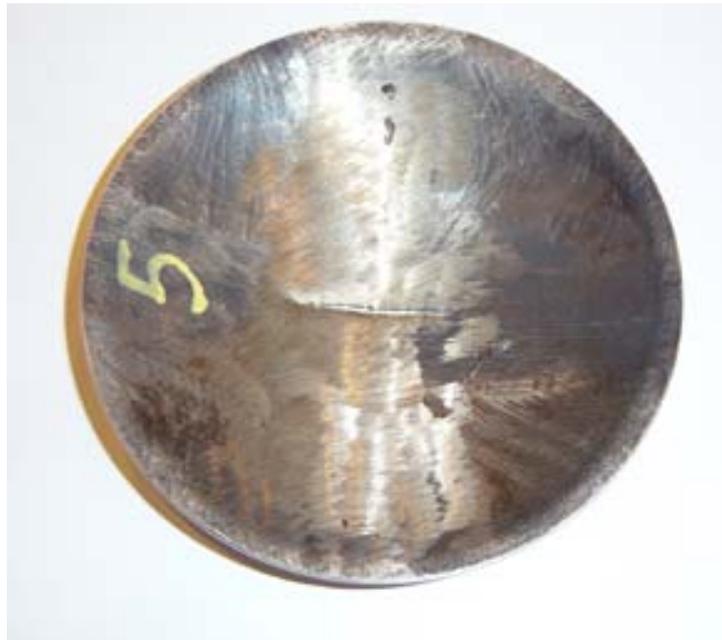
Fig. 4.2. Clad disk removed from specimen CB 8, containing a notch of 0.025 in. initial depth (the specimen failed at a pressure of 3,139 psi): (a) flawed surface; and (b) clad surface corresponding to inner surface of vessel.

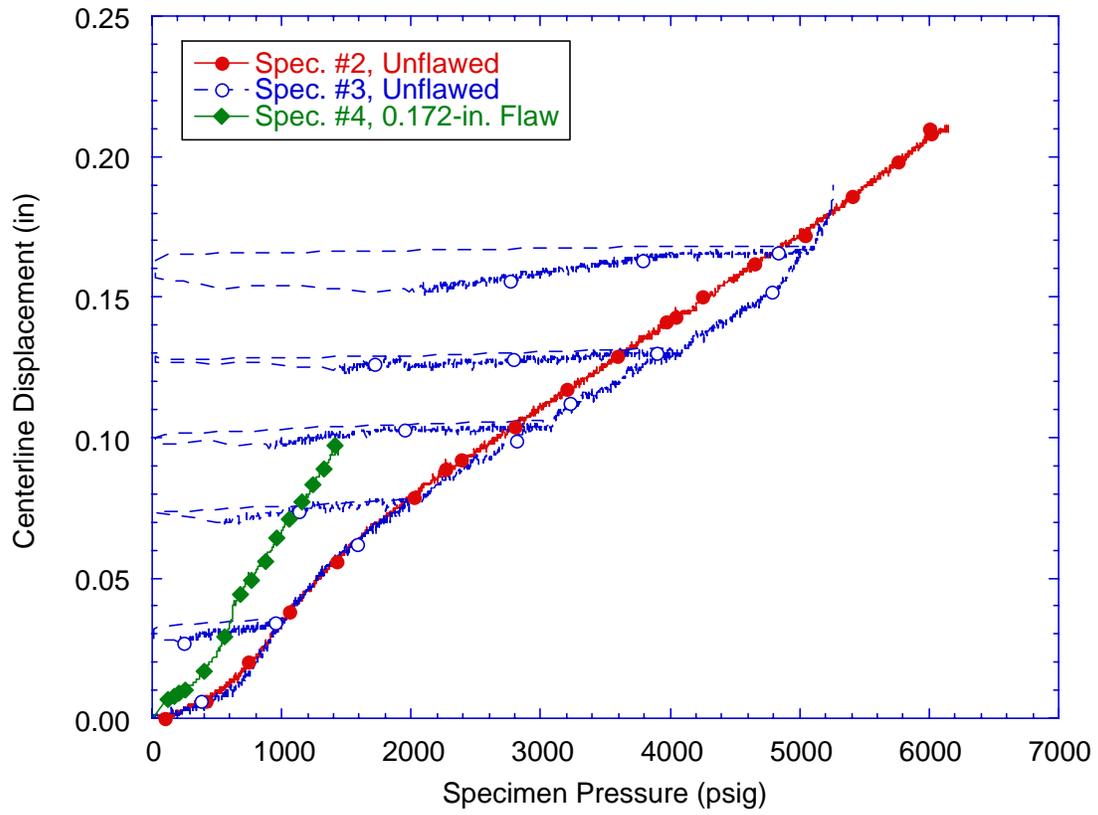
Fig. 4.3. Centerline displacements versus lateral pressure loading for clad-burst specimens CB 2, 3, and 4.

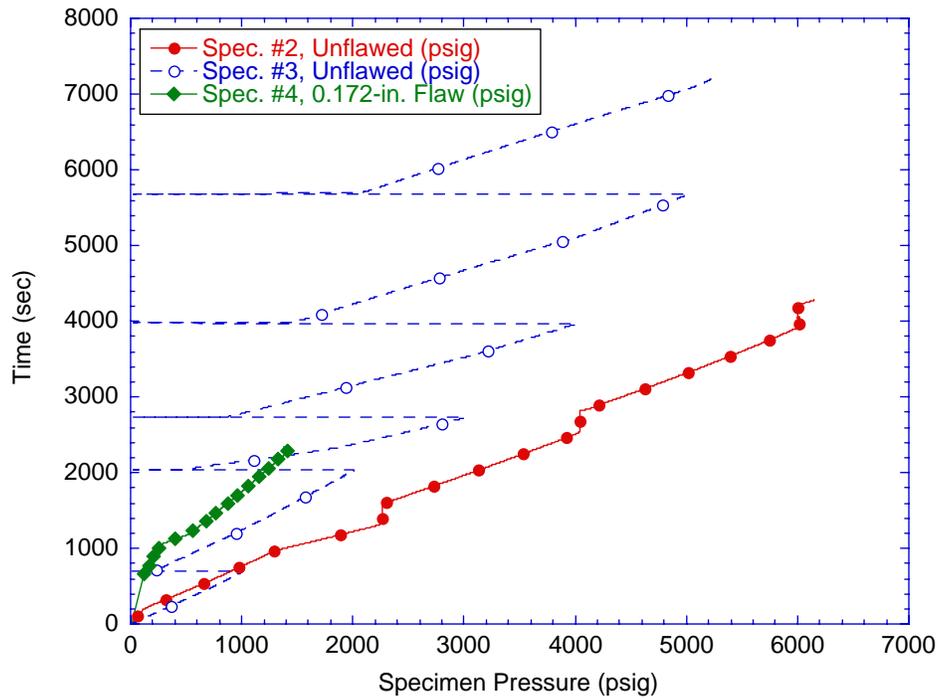
Fig. 4.4. Elapsed time versus lateral pressure loading for clad-burst specimens CB 2, 3, and 4.

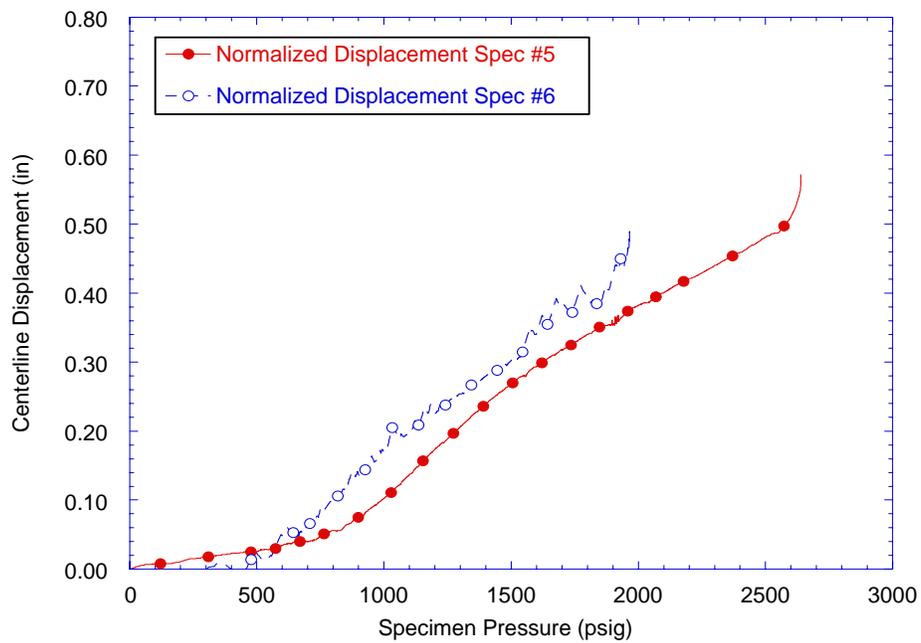
Fig. 4.5. Centerline displacements versus lateral pressure loading for clad-burst specimens CB 5 and CB 6.

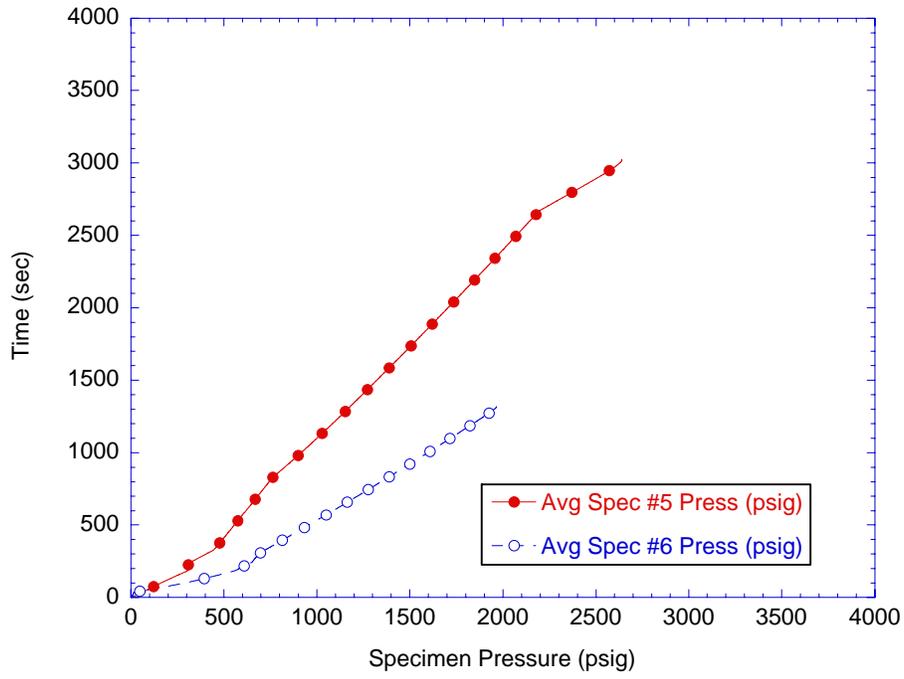
Fig. 4.6. Elapsed time versus lateral pressure loading for clad-burst specimens CB 5 and CB 6.

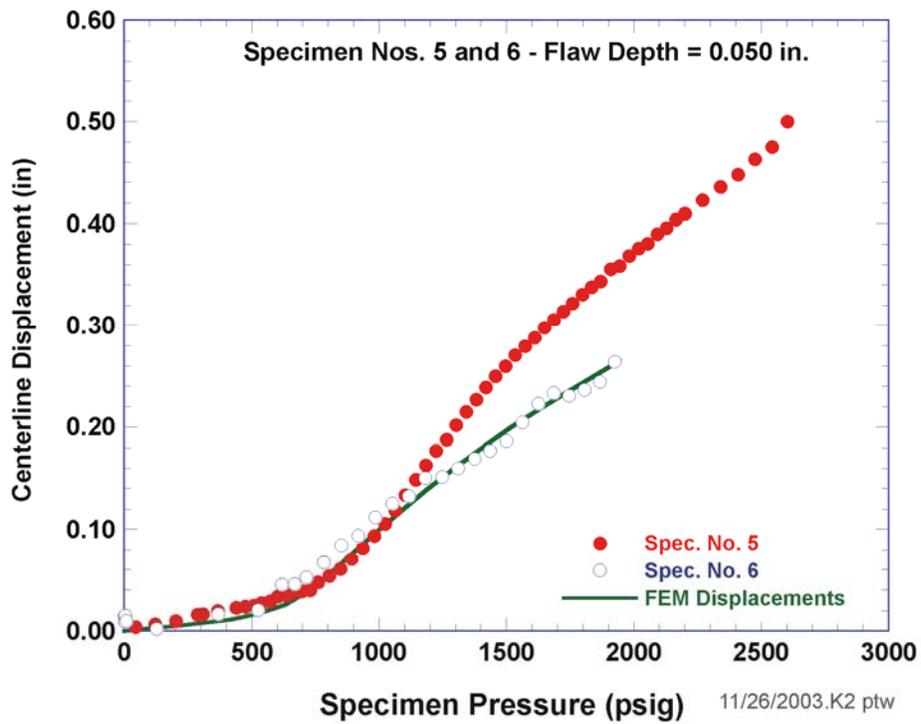
Fig. 4.7. (continued) Comparison of measured centerline displacements to finite-element model predictions for (c) specimens CB 5 and CB 6.

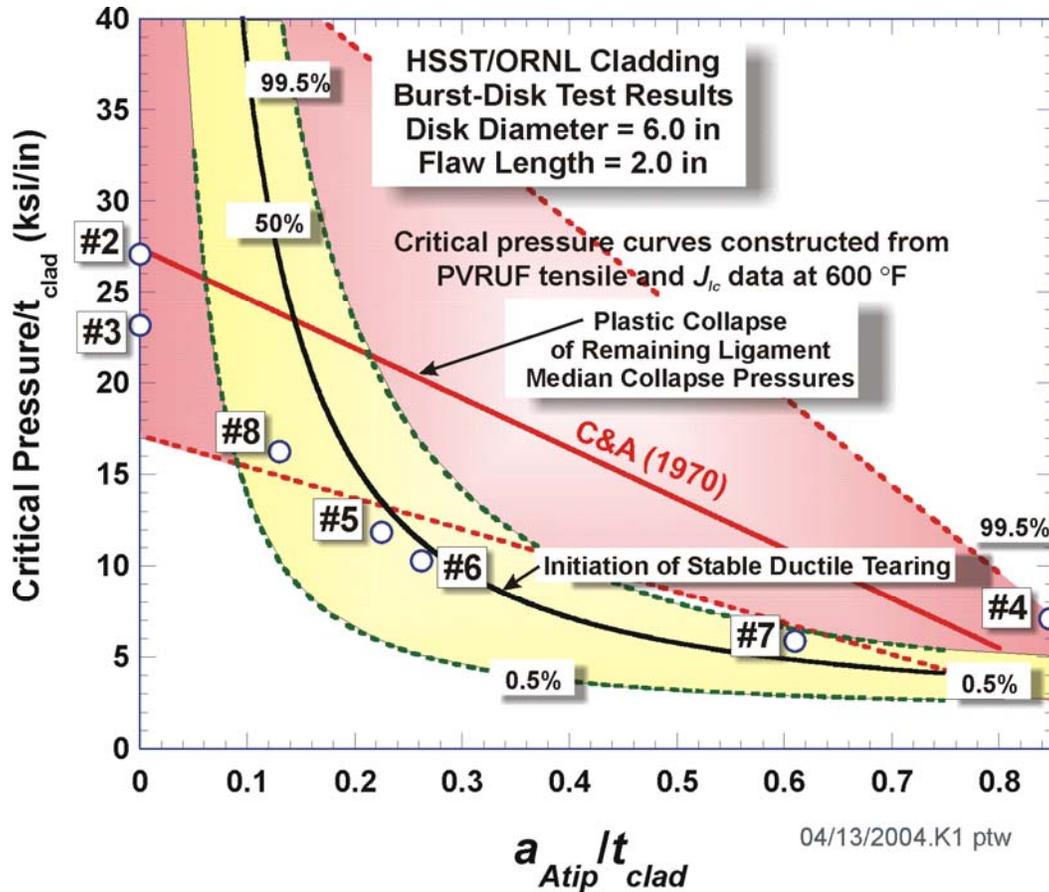
Fig. 4.8. Experimentally-observed failure pressures compared to two modeled failure mechanisms: (1) plastic collapse of remaining ligament based on modified theory of Chakrabarty and Alexander (1970) for median prediction and (2) ductile tearing: (a) using J_{Ic} data from pre-cracked Charpy specimens for PVRUF cladding at 316°C (600°F). The 99% confidence interval for the plastic-collapse mode is based on combined model and material uncertainties. The 99% confidence interval on ductile tearing initiation is based on a Weibull distribution fitted to the PVRUF J_{Ic} data only (see Fig. 5.8).

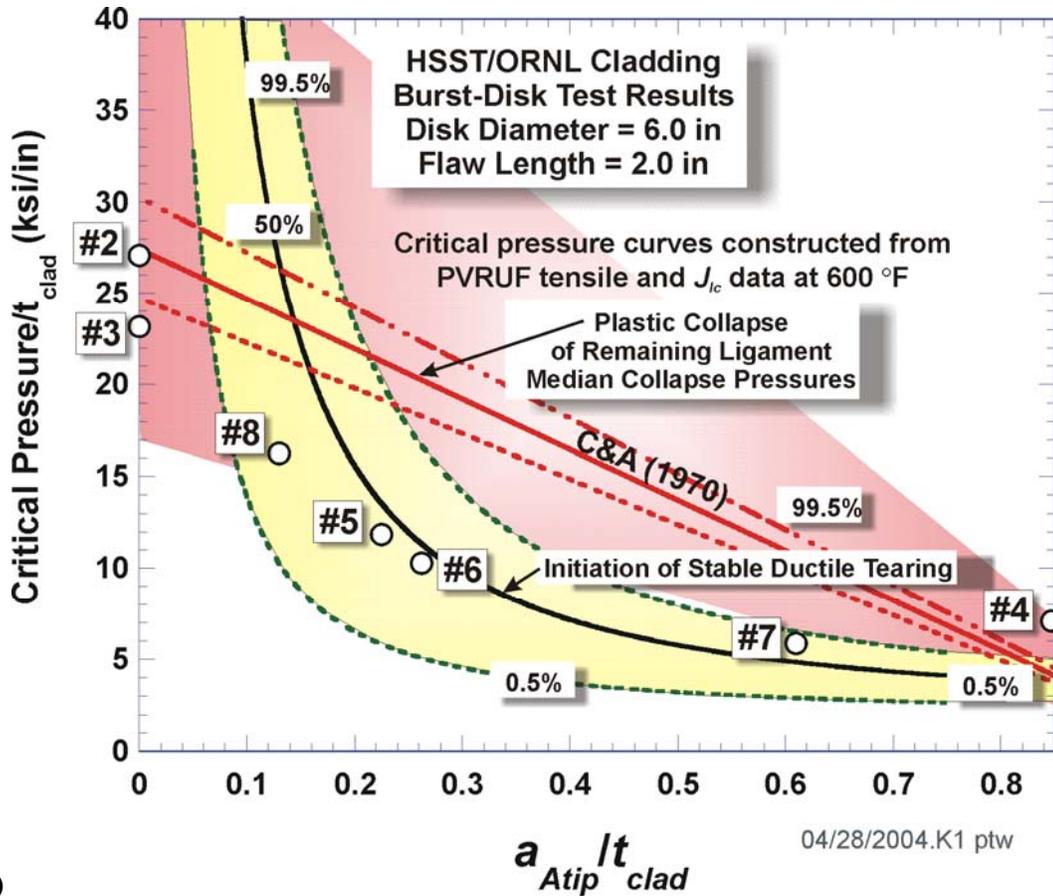
Fig. 4.8. (continued) (b) using J_{Ic} data from pre-cracked Charpy specimens for PVRUF cladding at 316°C (600°F). The 99% confidence interval for the plastic-collapse mode is based on material uncertainty only and is derived from a bivariate lognormal distribution that includes correlated uncertainties in the yield and ultimate true stresses. The 99% confidence interval on ductile tearing initiation is based on a Weibull uncertainty model fitted to the PVRUF J_{Ic} data only (see Fig. 5.8).

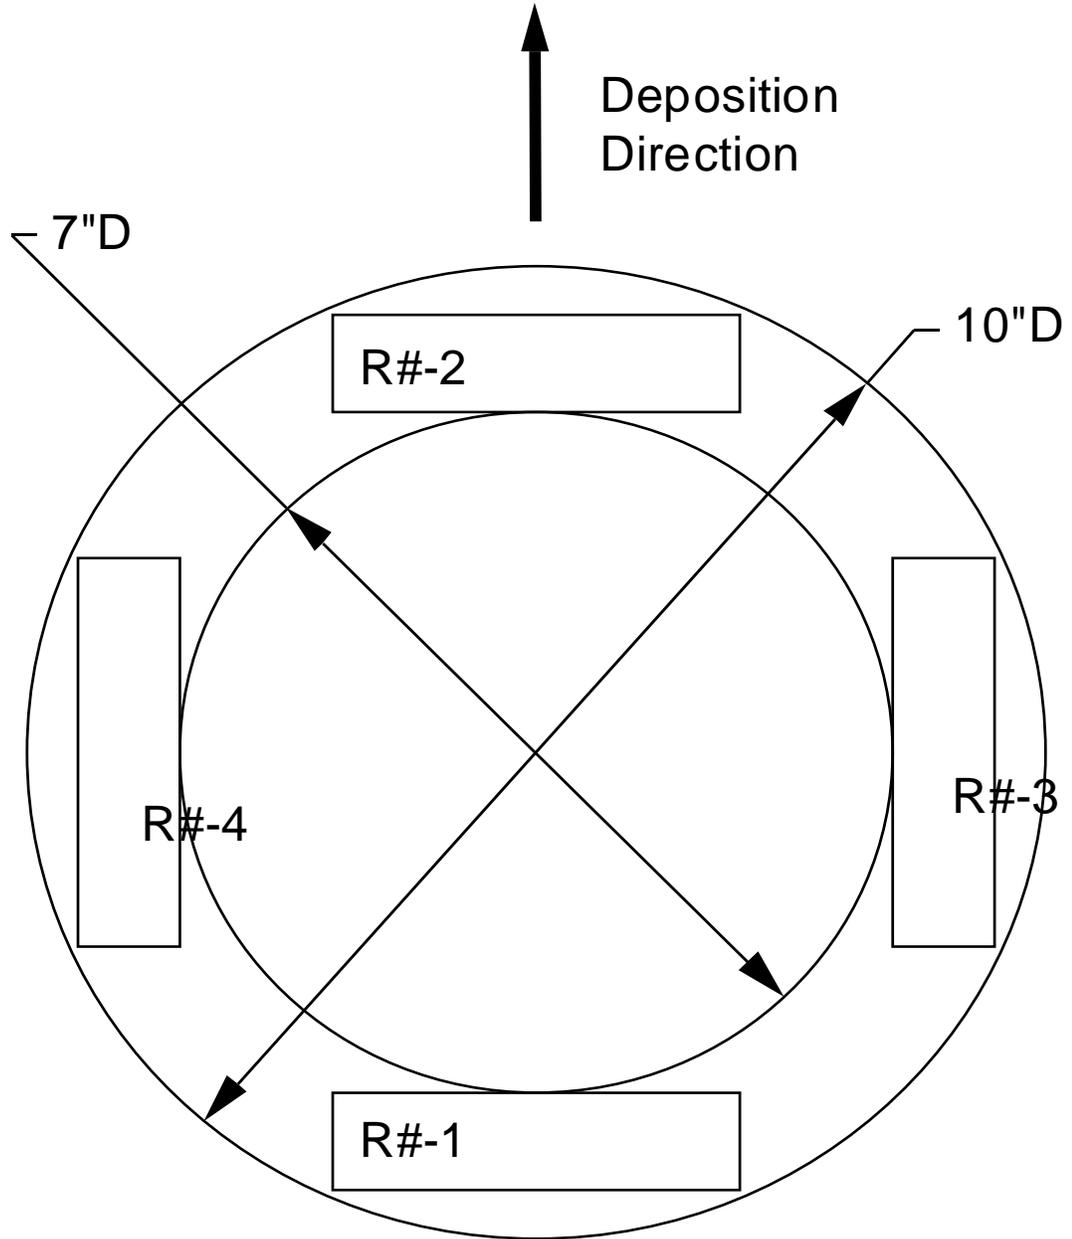
Fig. 5.1. Cutting plan for fabrication of tensile specimens. “R#” refers to the ring number R1 or R2 from which the tensile specimens were extracted; ring R1 was taken from clad burst specimen CB 4 and R2 from CB 5.

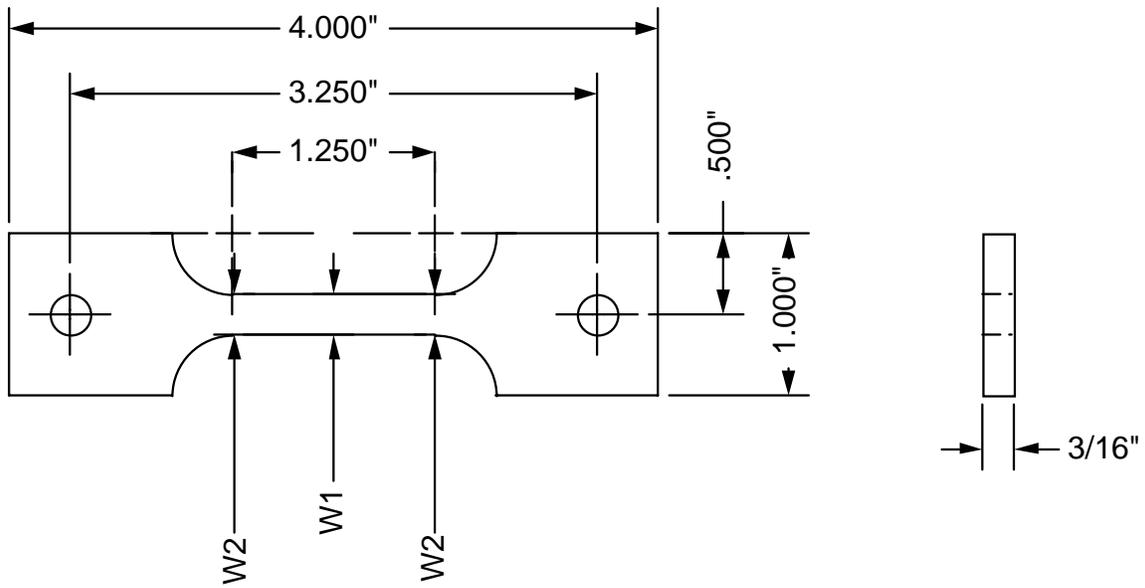
NOTE:
 $W_1 = 0.250" \pm 0.001$
 $W_2 = \text{FROM } 0.0010" \text{ TO } 0.0015"$
 GREATER THAN W_1 .

Fig. 5.2. Dimensions of clad tensile specimens.

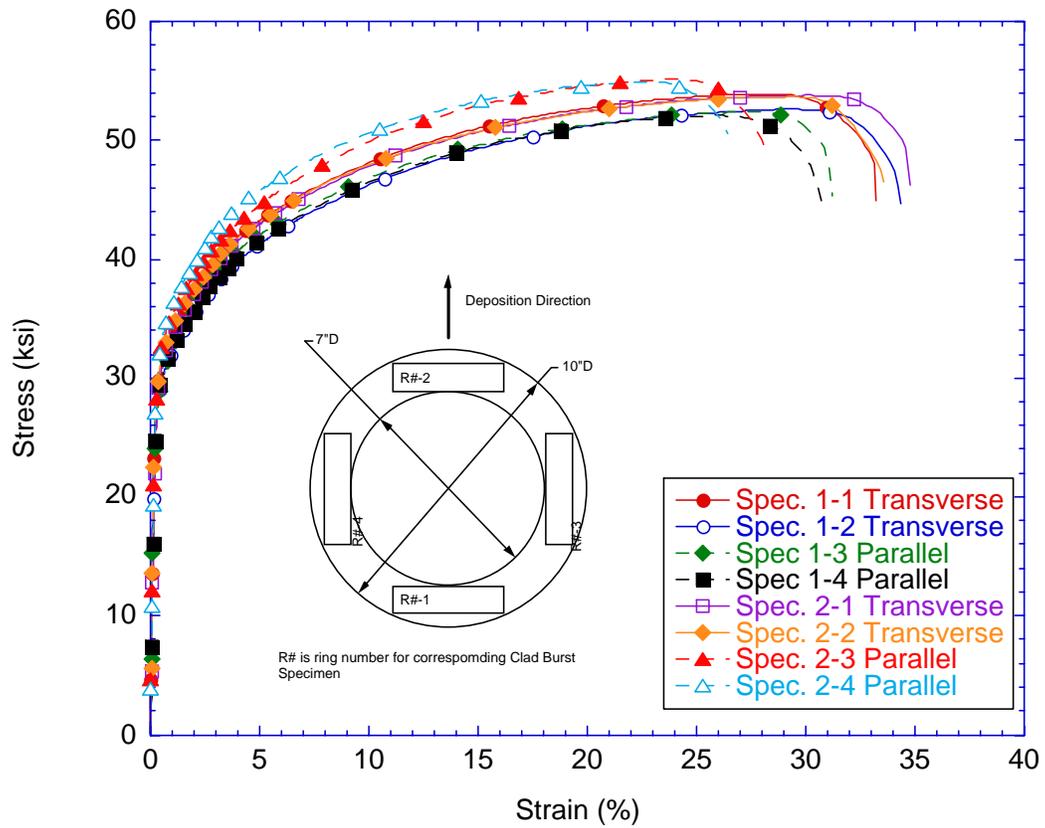
Fig. 5.3. Plots of stress versus strain (engineering) from eight clad tensile specimens.

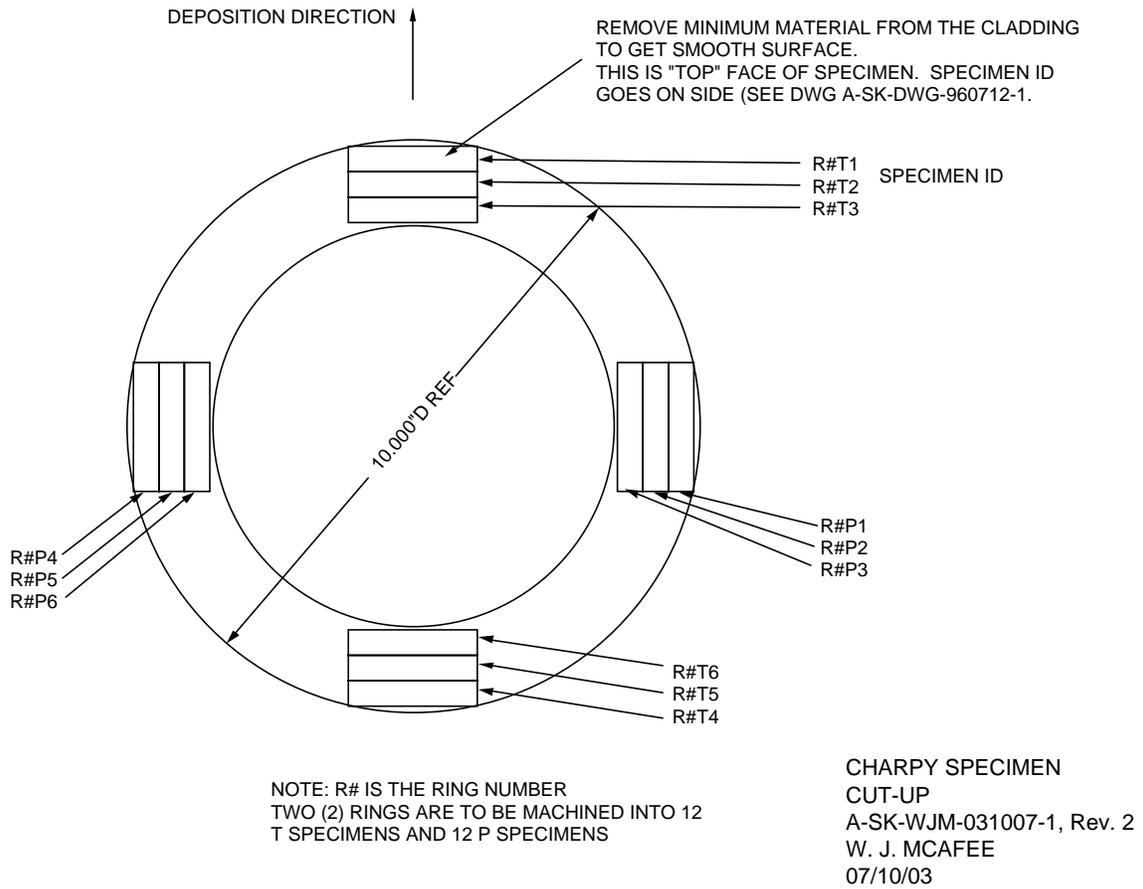
Fig. 5.5. Cutting plan for Charpy specimens taken from clad burst specimens CB 6-8 for generation of J-R curves in the T-S and L-S orientations.

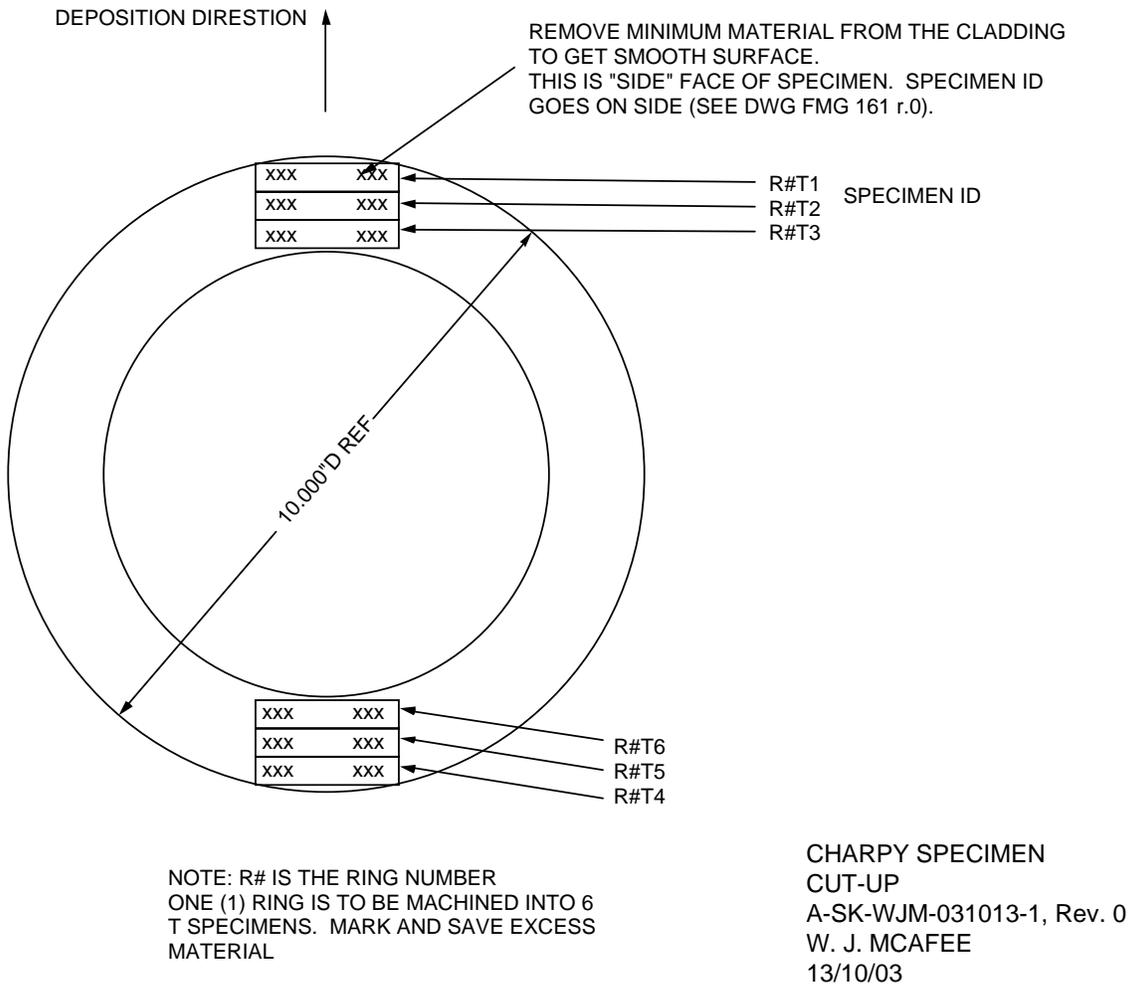
Fig. 5.6. Cutting plan for one-half thickness Charpy specimens taken from clad burst specimen CB 3 for generation of J-R curves in the T-L orientation.

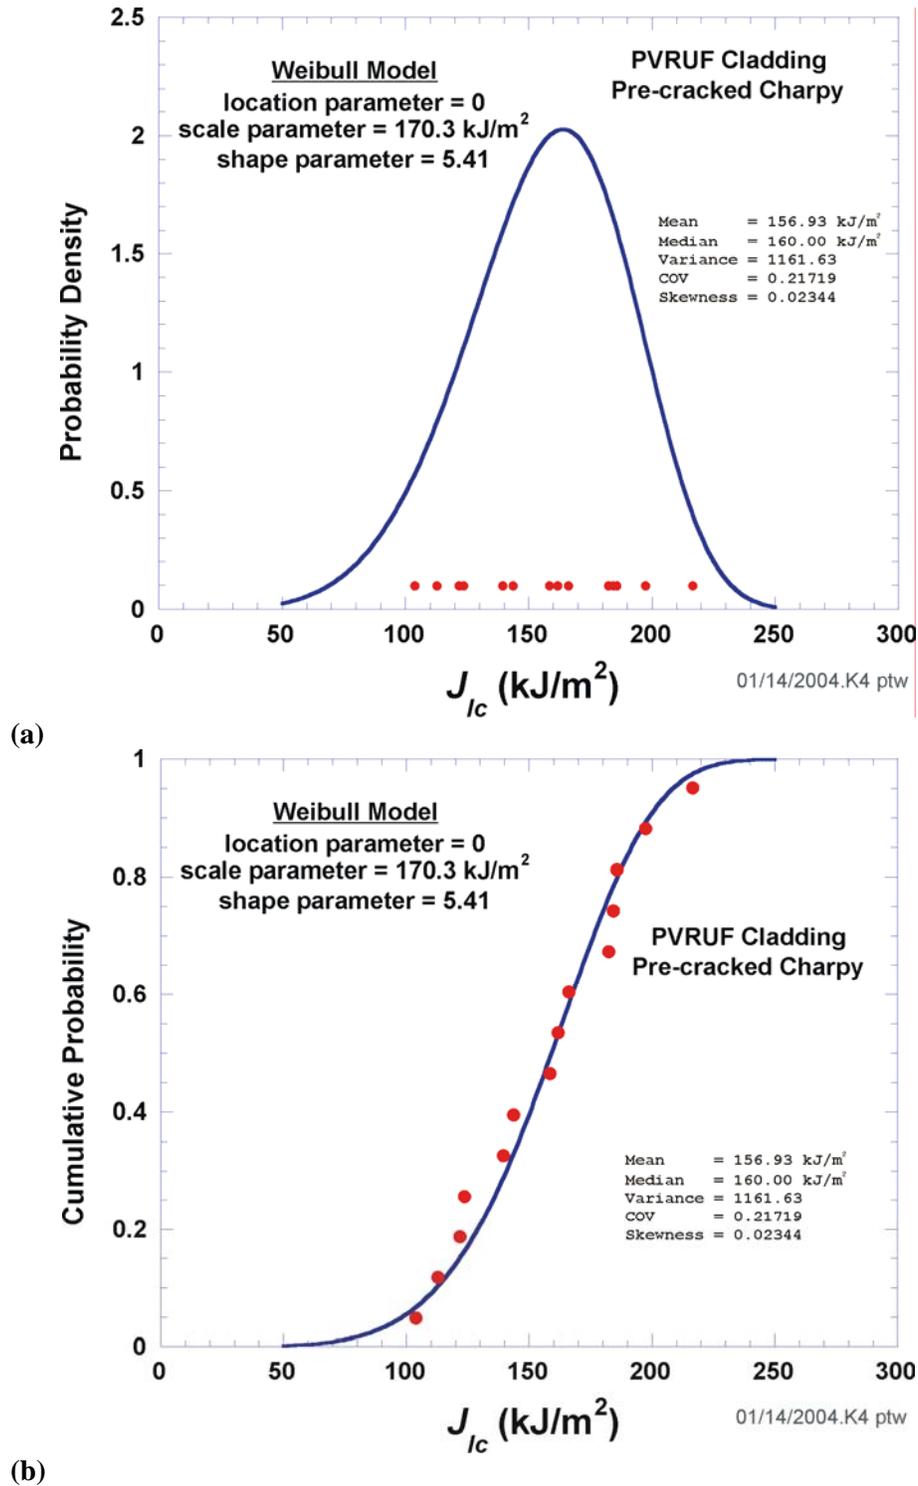
Fig. 5.8. Statistical distribution for PVRUF J_{Ic} (a) probability density with fitted Weibull density and (b) Weibull cumulative distribution function compared to cumulative probabilities of J_{Ic} data from pre-cracked Charpy specimens from PVRUF (estimated by median rank order statistic $p = (i-0.3)/(n+0.4)$).

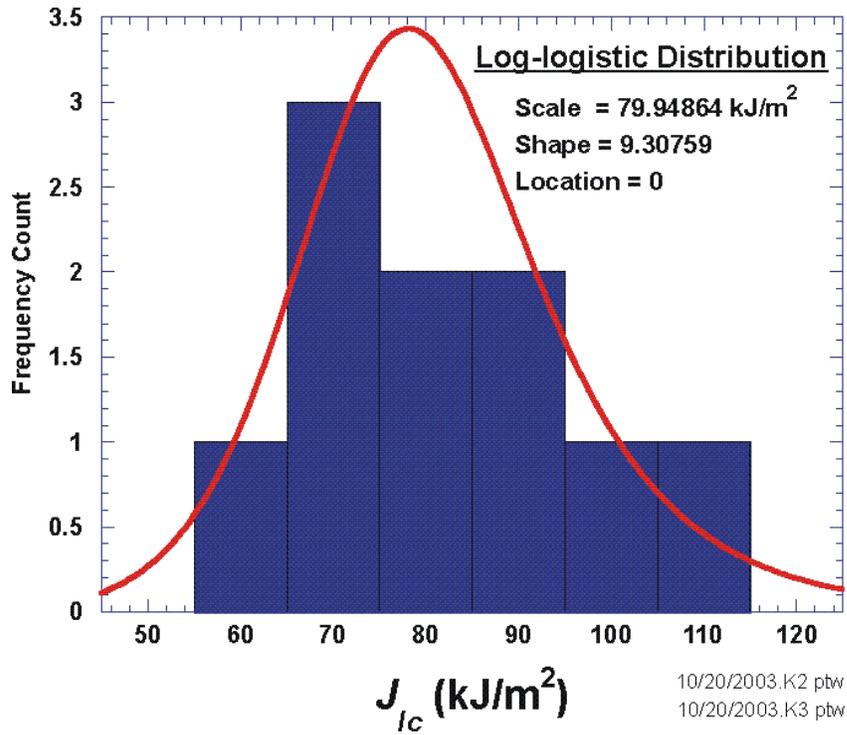
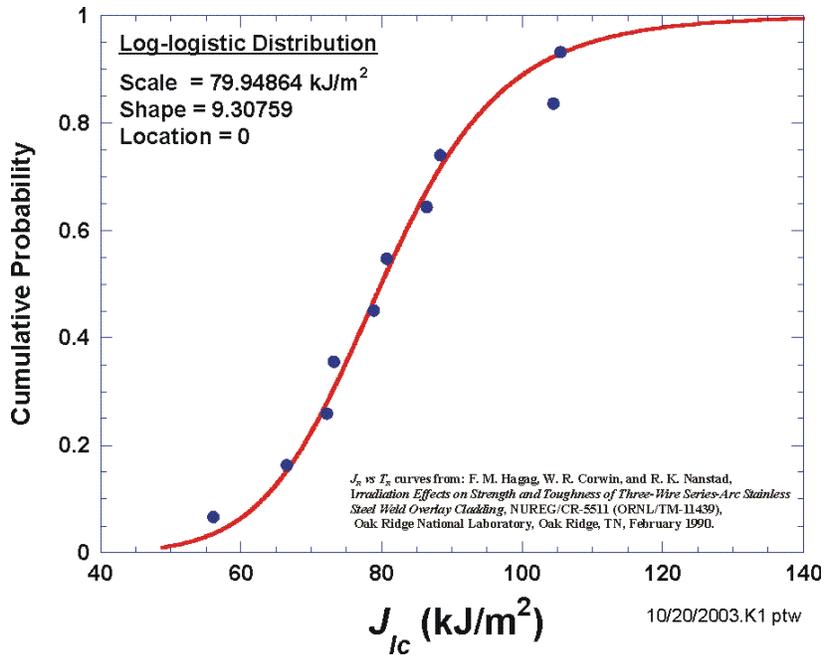
Fig. 5.9. Statistical distribution for J_{Ic} (a) histogram of data from NUREG/CR-5511 and 6363 extrapolated to 318°C (605°F) with fitted log-logistic density overplot and (b) log-logistic cumulative distribution function compared to cumulative probabilities of J_{Ic} data from NUREG/CR-5511 and 6363 estimated by median rank order statistic $p = (i-0.3)/(n+0.4)$.

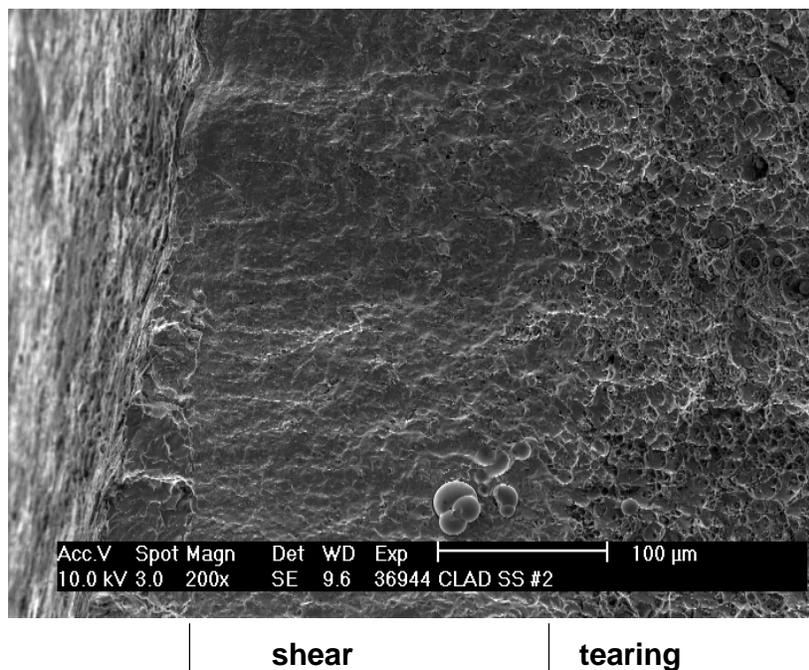
Fig. 6.2. Clad-burst specimen CB 4 containing flaw with depth 0.172 in.: shear band reaches the surface.

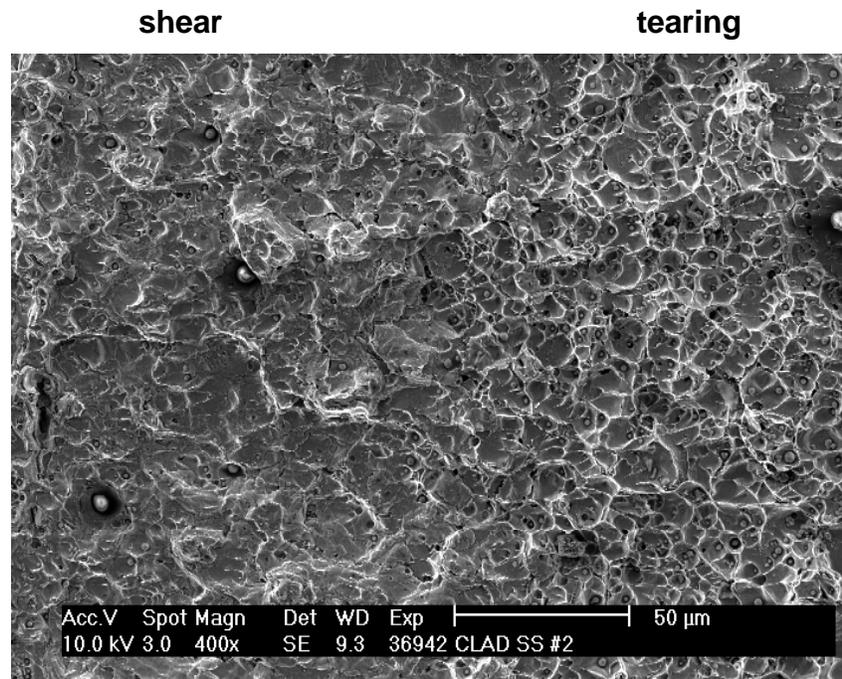
Fig. 6.3. Clad-burst specimen CB 4 containing flaw with depth 0.172 in.: transition from tearing to shear mode of fracture.

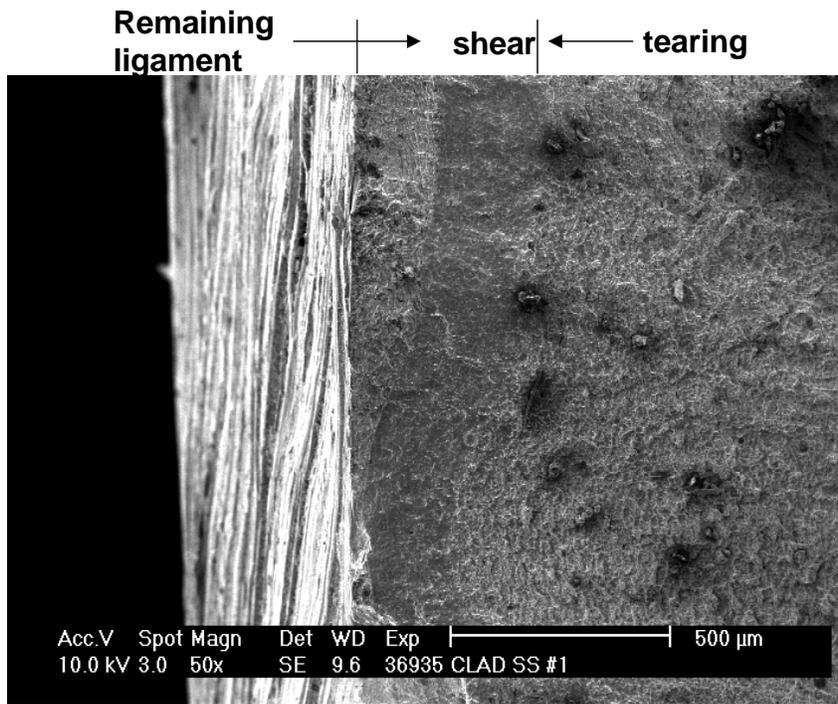
Fig. 6.4. Clad-burst specimen CB 5 containing flaw with depth 0.050 in.

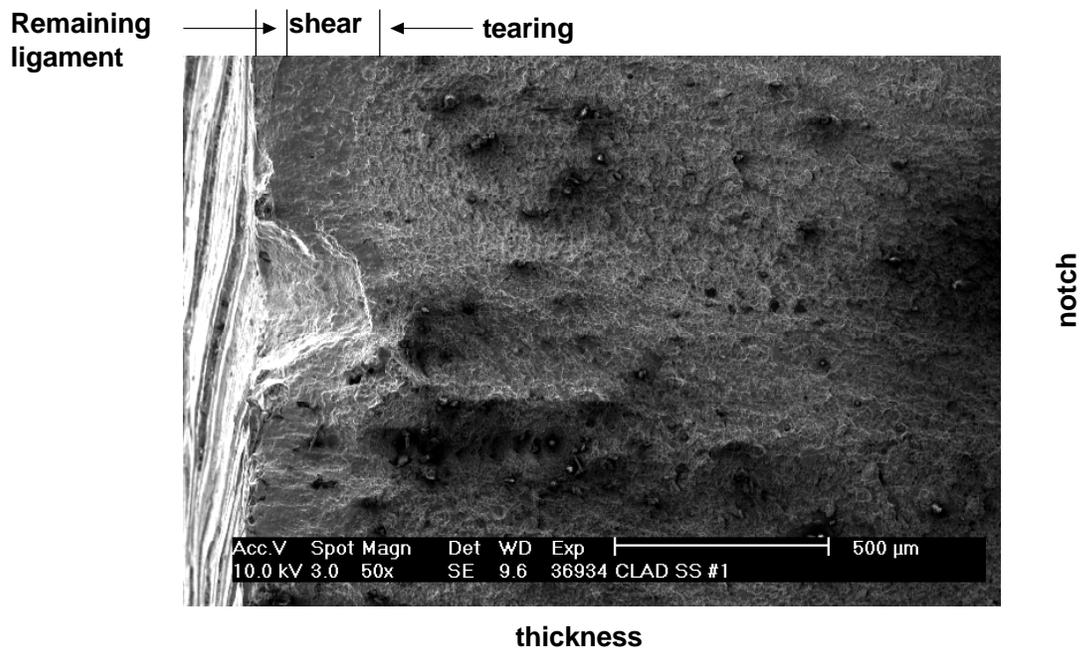
Fig. 6.5. Clad-burst specimen CB 5 containing flaw with depth 0.050 in.

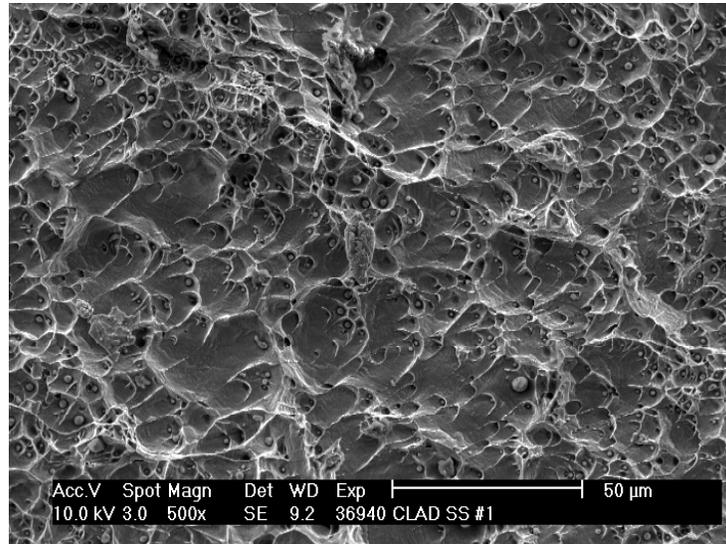
Fig. 6.6. Clad-burst specimen CB 5 containing flaw with depth 0.050 in.: typical fracture surface within tearing region.

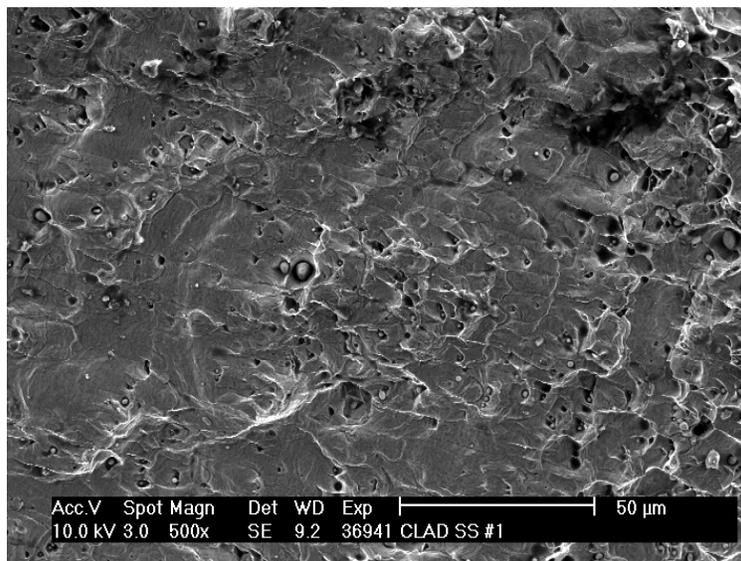
Fig. 6.7. Clad-burst specimen CB 5 containing flaw with depth 0.050 in.: typical fracture surface within shear region.

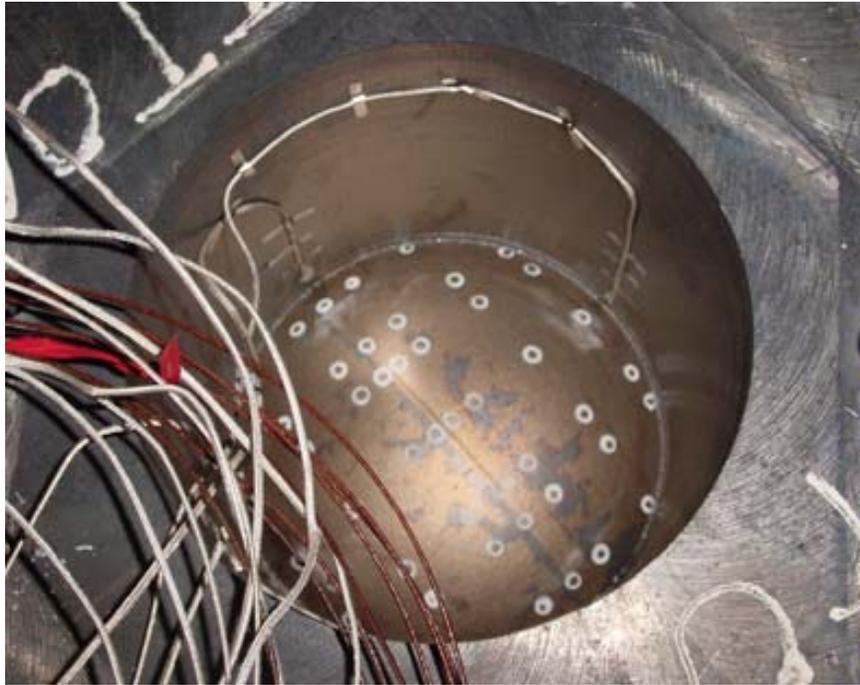
Fig. 7.1. Locations of pre-test clad thickness measurements made on Phase 2 clad burst specimens.

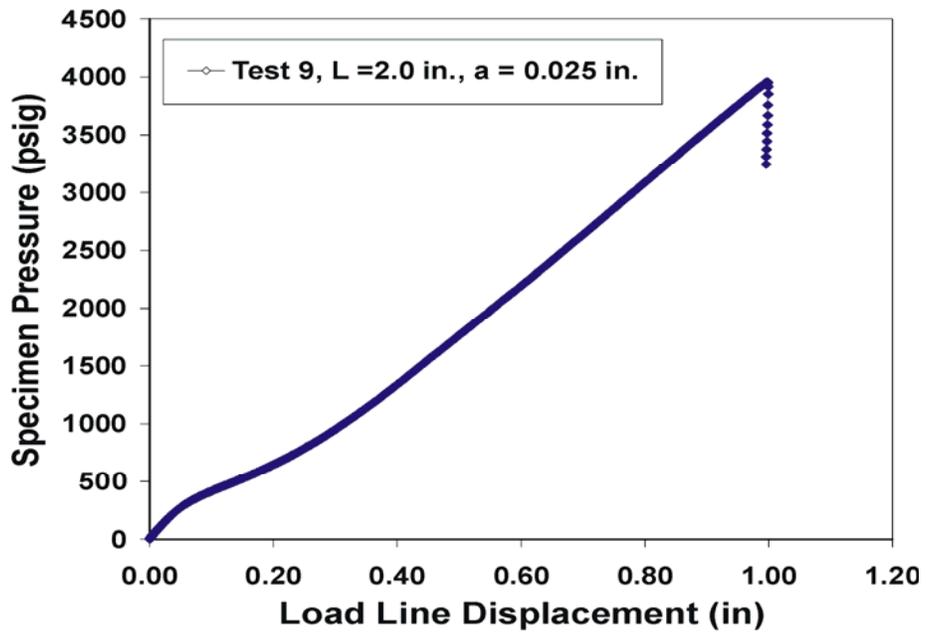
Fig. 7.2. Pressure versus load-line displacement data for clad-burst specimen CB 9. Load line displacement is the clad-layer deflection with pressure.

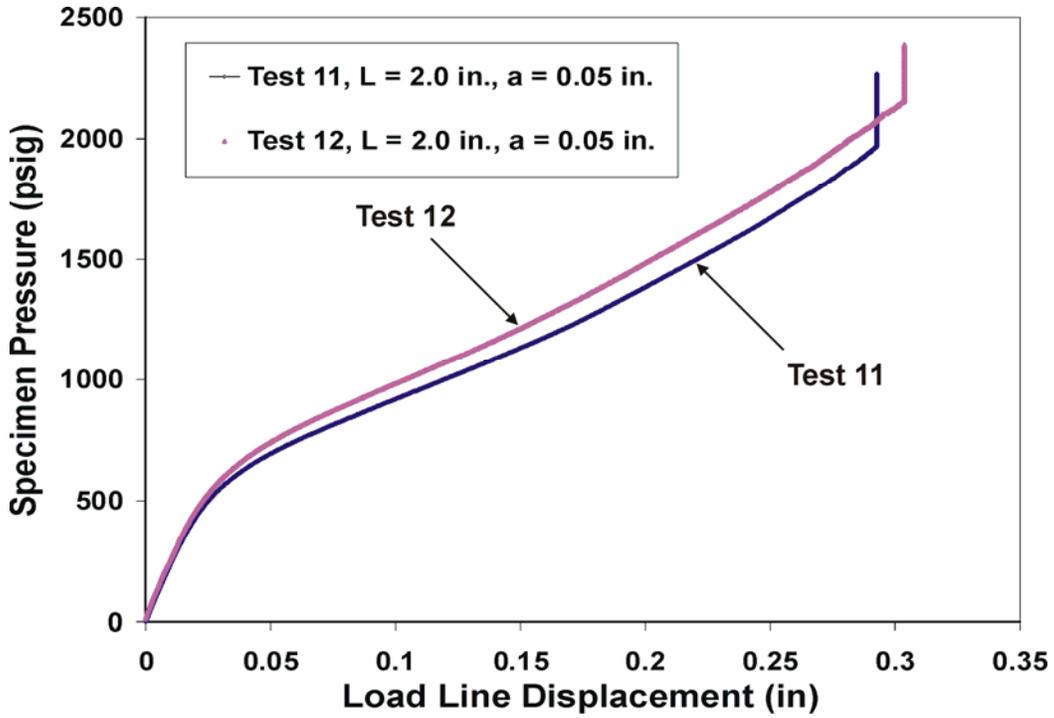
Fig. 7.3. Pressure versus load-line displacement data for clad-burst specimens CB 11 and CB 12. Load line displacement is the clad-layer deflection with pressure.

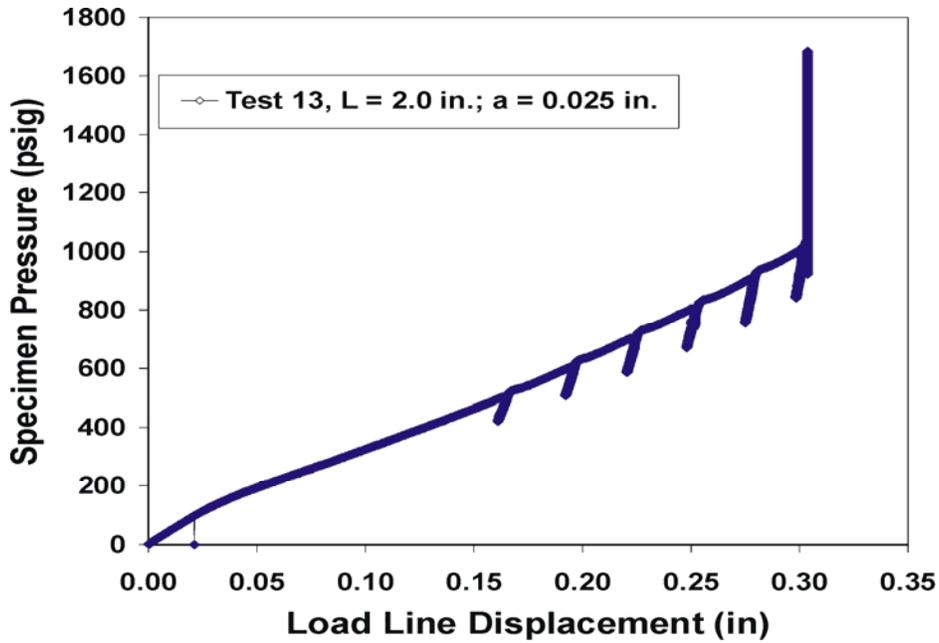
Fig. 7.4. Pressure versus load-line displacement data for clad-burst specimen CB 13. Load line displacement is the clad-layer deflection with pressure.

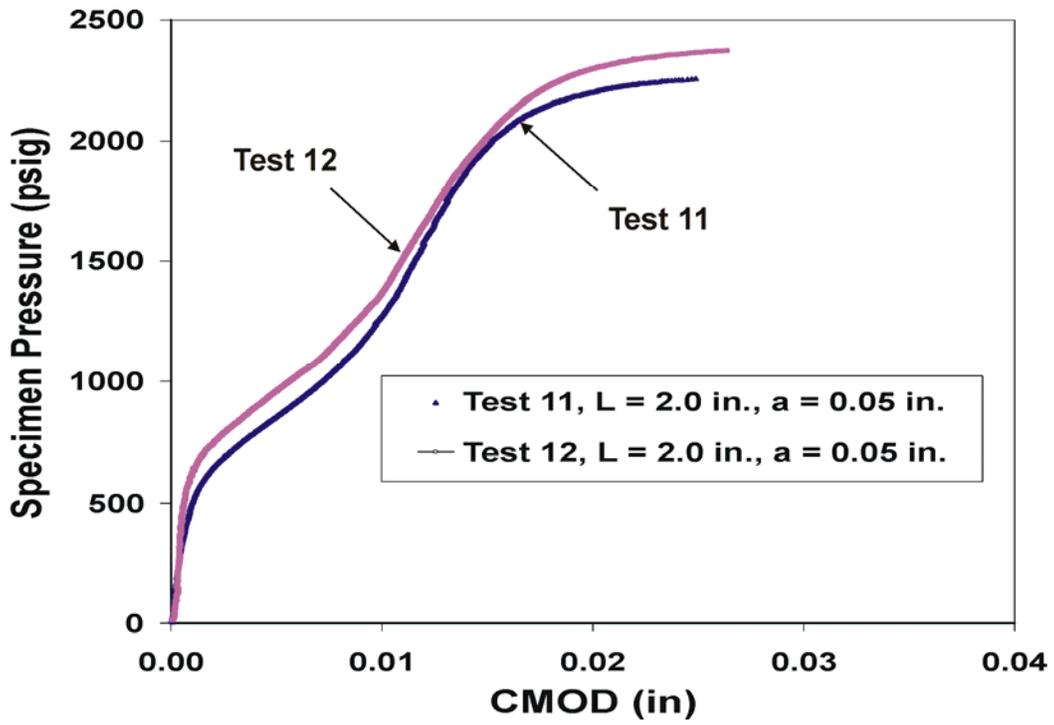
Fig. 7.5. Pressure versus CMOD data for clad-burst specimens CB 11 and CB 12.
