Contract Program or
Project Title: Heavy-Section Steel Technology (HSST) Program

Subject of this Document: Experimental Program for Investigating the Influence
of Cladding Defects on Burst Pressure

Type of Document: Letter Report

Date of Document: September 2004

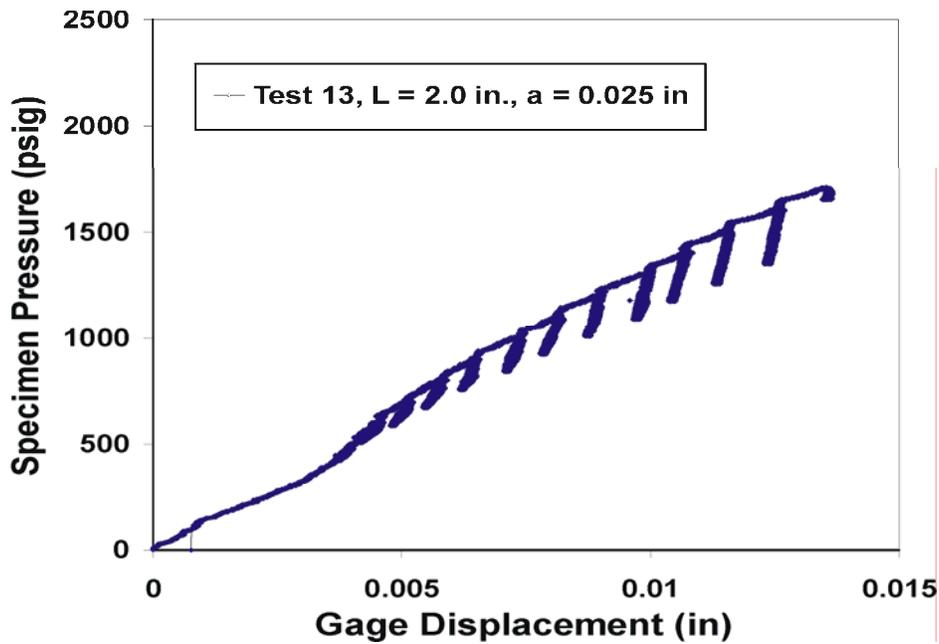
Fig. 7.6. Pressure versus gage displacement data for clad-burst specimen CB 13; no correction has been applied to data for elevation of capacitance gage above the clad surface.

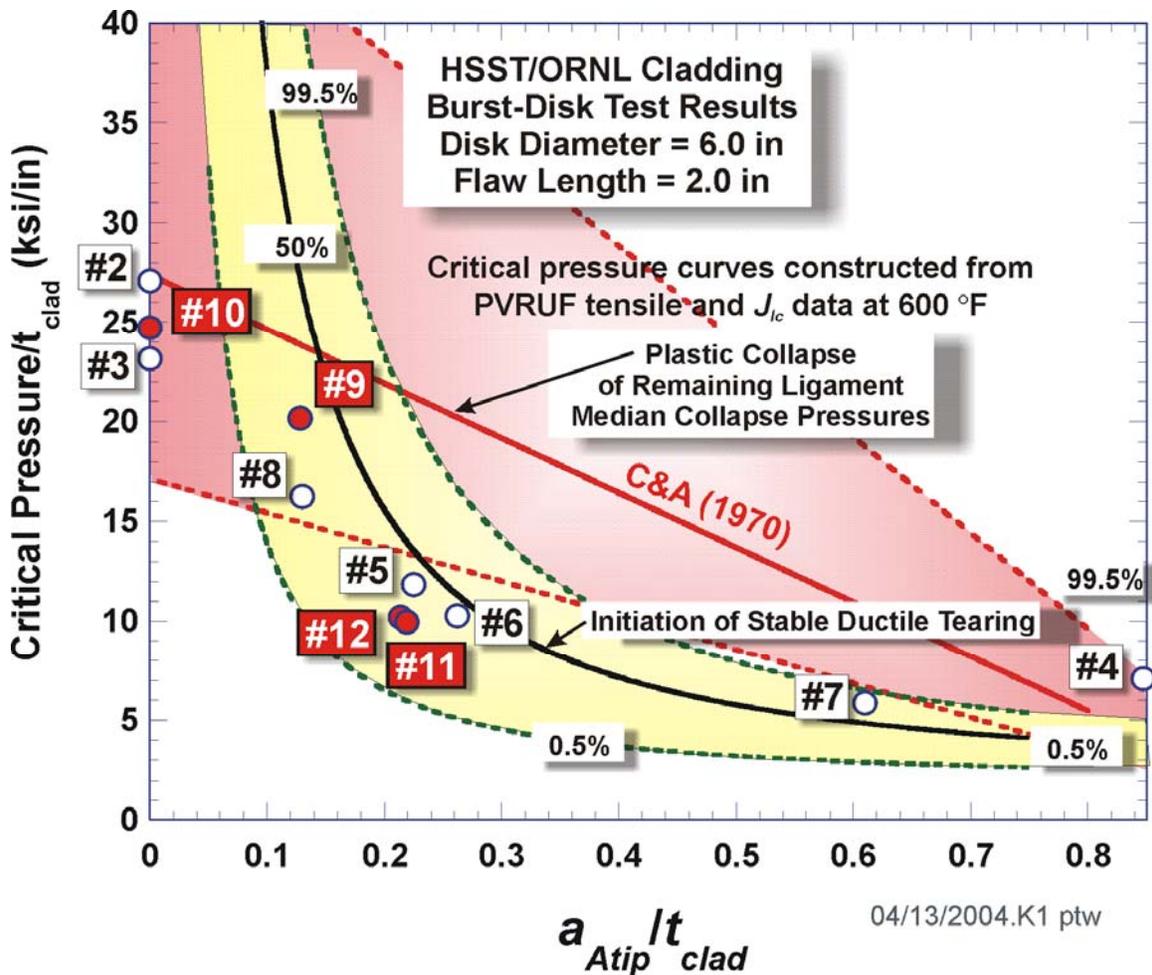
Fig. 7.7. Comparisons of failure pressure versus crack depth, both normalized by clad thickness, for the Phase 1 (open symbols) and Phase 2 (filled symbols) test series consisting of CB 9 through CB 12; test CB 13 was terminated prior to failure. The test results are compared with predictions for ductile tearing initiation (based on Weibull statistical distribution derived from PVRUF J_{Ic} PCCVN data) and predictions of plastic collapse of the remaining ligament using a statistical model of PVRUF plastic-flow tensile properties.

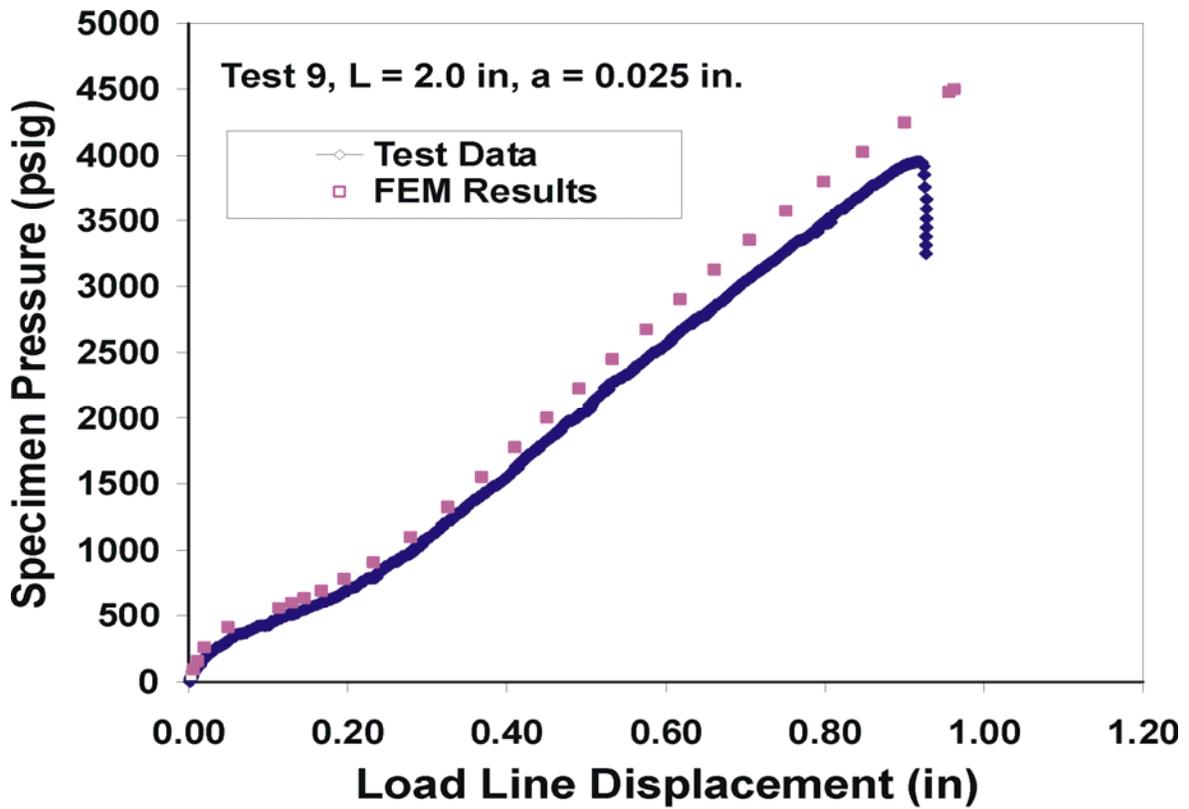
Fig. 7.8. Comparison of calculated and measured pressure versus load-line displacement for clad-burst specimen CB 9. Calculations and data represent deflections at the center of the clad disk. Initial root radius of FEM was 0.01 in.

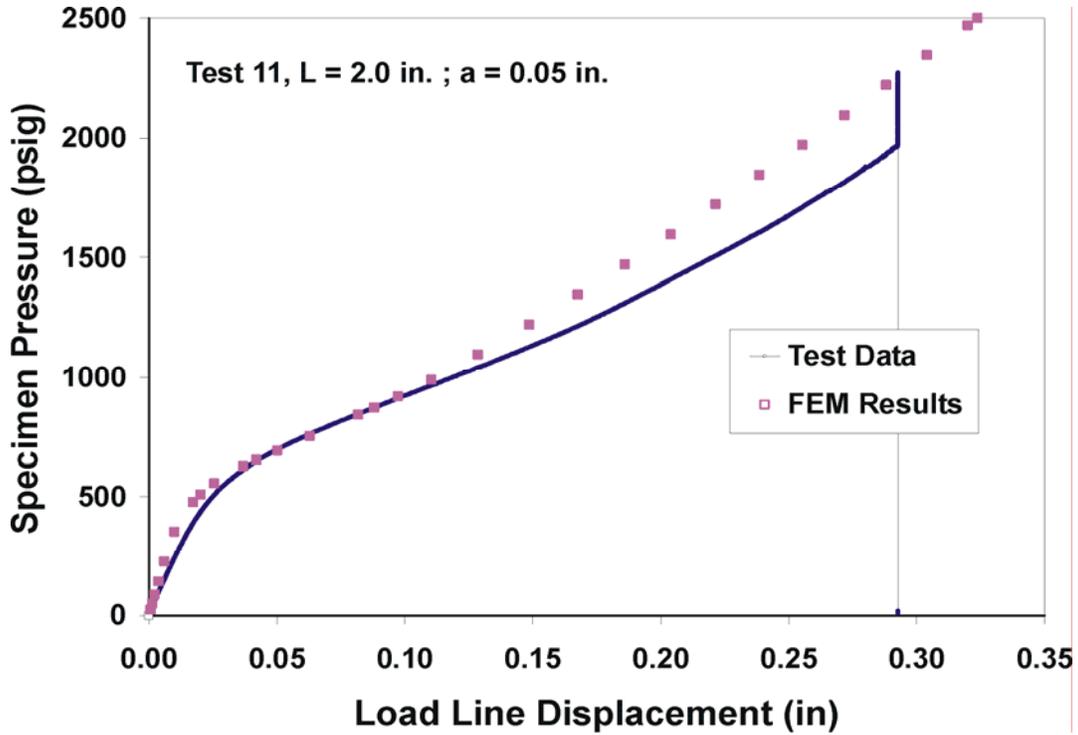
Fig. 7.9. Comparison of calculated and measured pressure versus load-line displacement for clad-burst specimen CB 11. Initial root radius of FEM was 0.01 in.

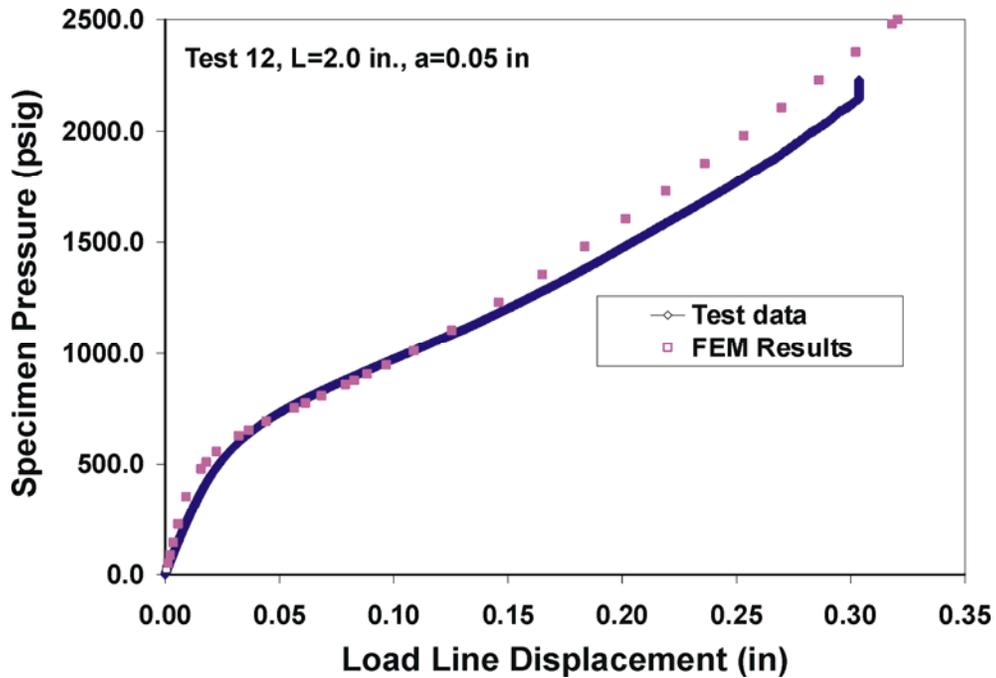
Fig. 7.10. Comparison of calculated and measured pressure versus load-line displacement for clad-burst specimen CB 12. Initial root radius of FEM was 0.001 in.

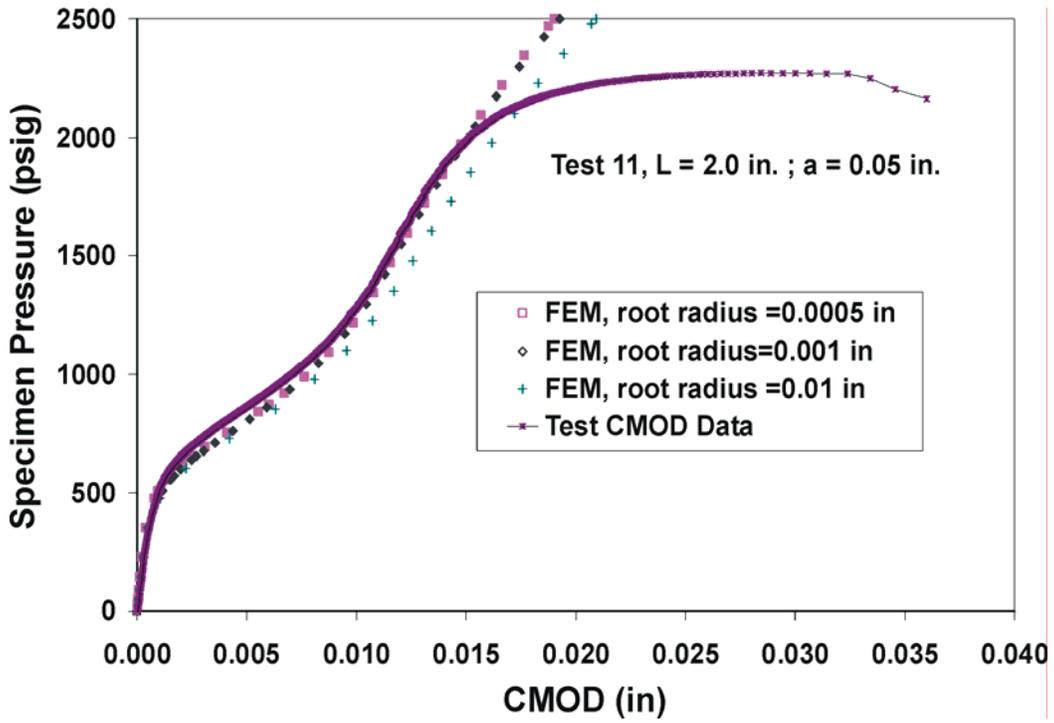
Fig. 7.11. Comparison of calculated and measured pressure versus CMOD for clad-burst specimen CB 11.

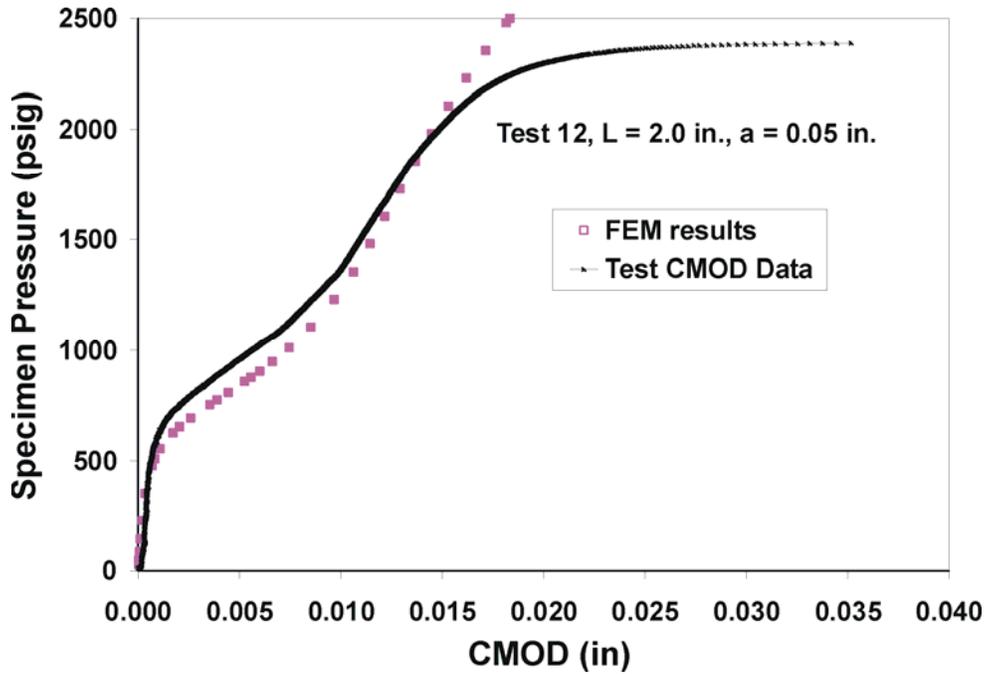
Fig. 7.12. Comparison of calculated and measured pressure versus CMOD for clad-burst specimen CB 12. Initial root radius of FEM was 0.001 in.

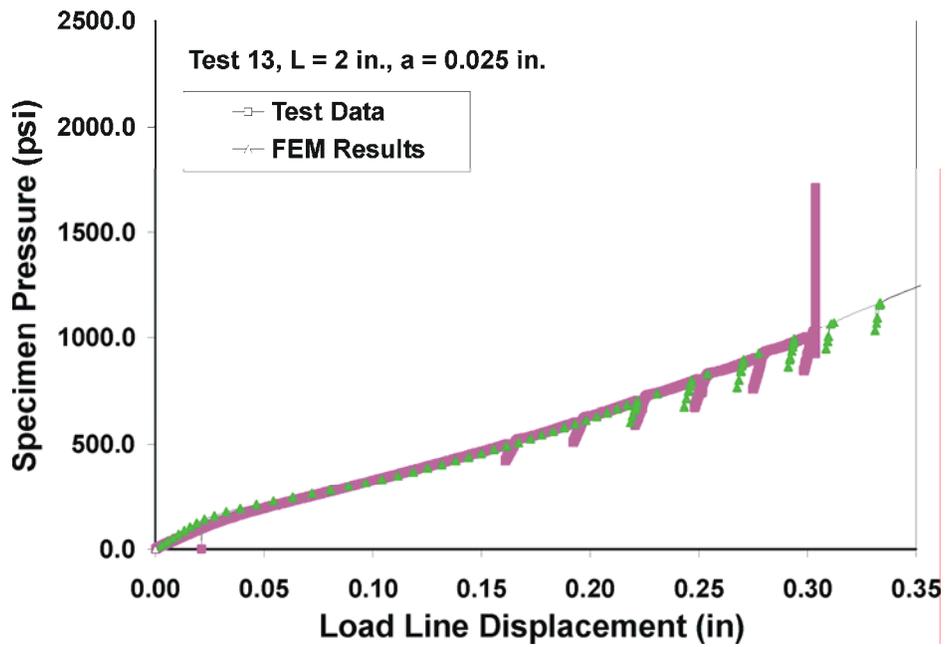
Fig. 7.13. Comparison of calculated and measured pressure versus load-line displacement for clad-burst specimen CB 13. Initial root radius of FEM was 0.01 in.

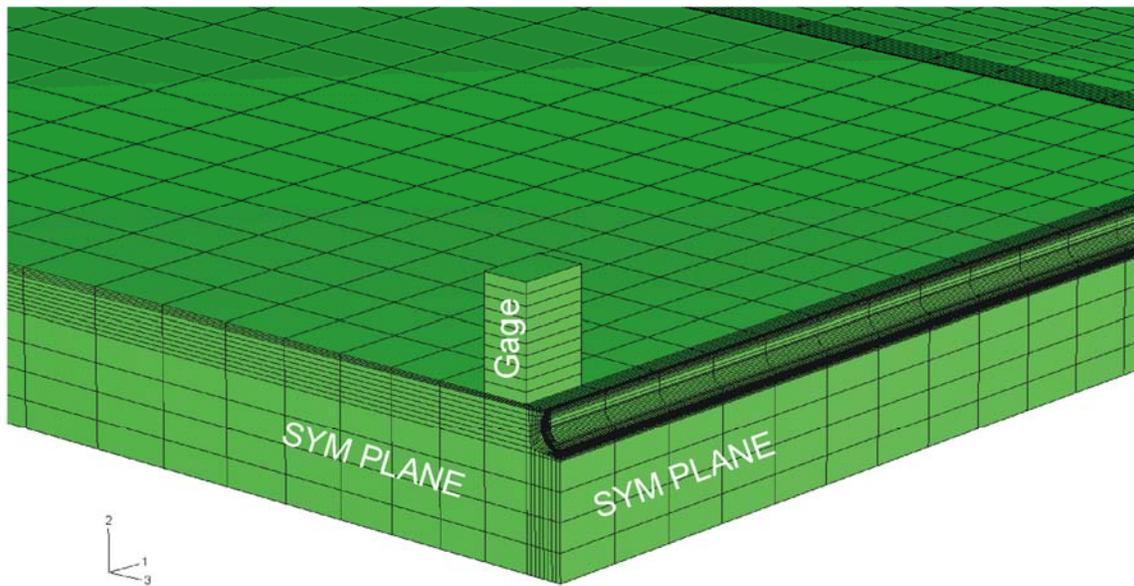
Fig. 7.14. Finite element model with simulated gage height above the clad surface used in analysis of test CB 13.

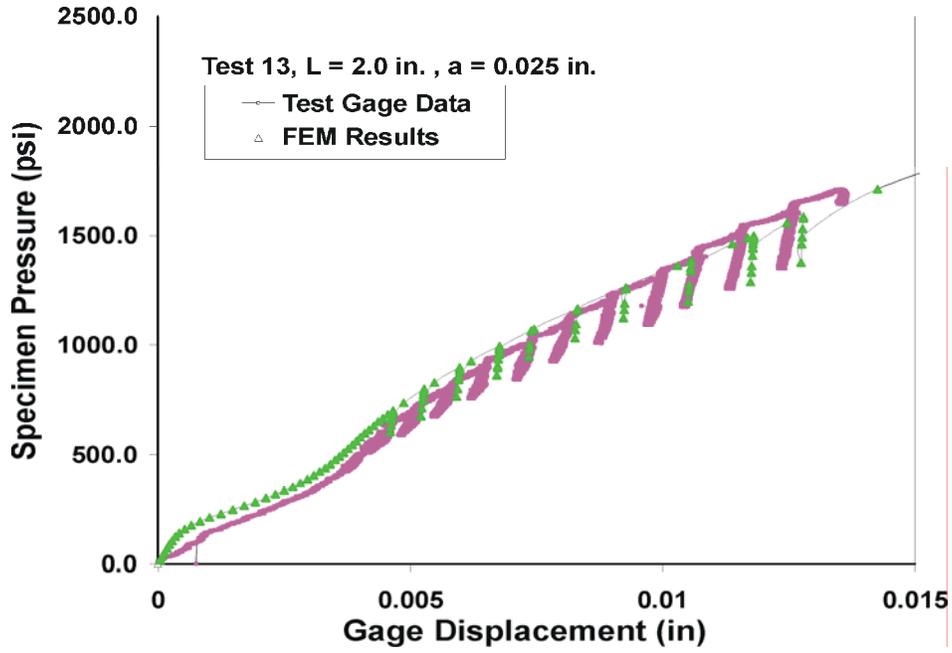
Fig. 7.15. Comparison of calculated and measured pressure versus gage displacement at 0.07 in. above the clad surface for clad-burst specimen CB 13.

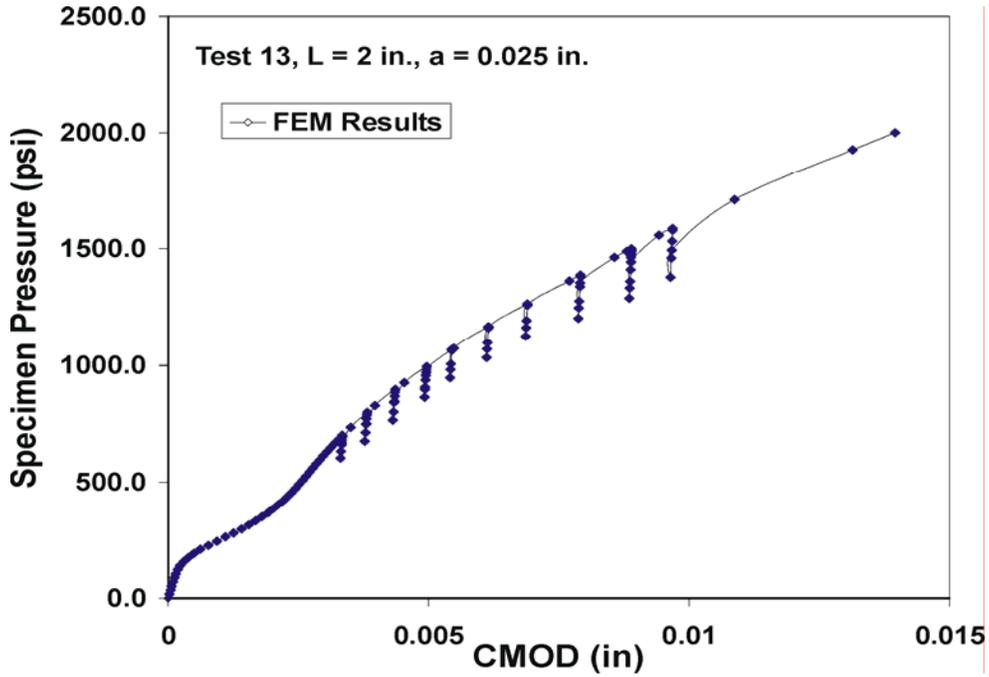
Fig. 7.16. Calculated pressure versus CMOD for clad-burst specimen CB 13.

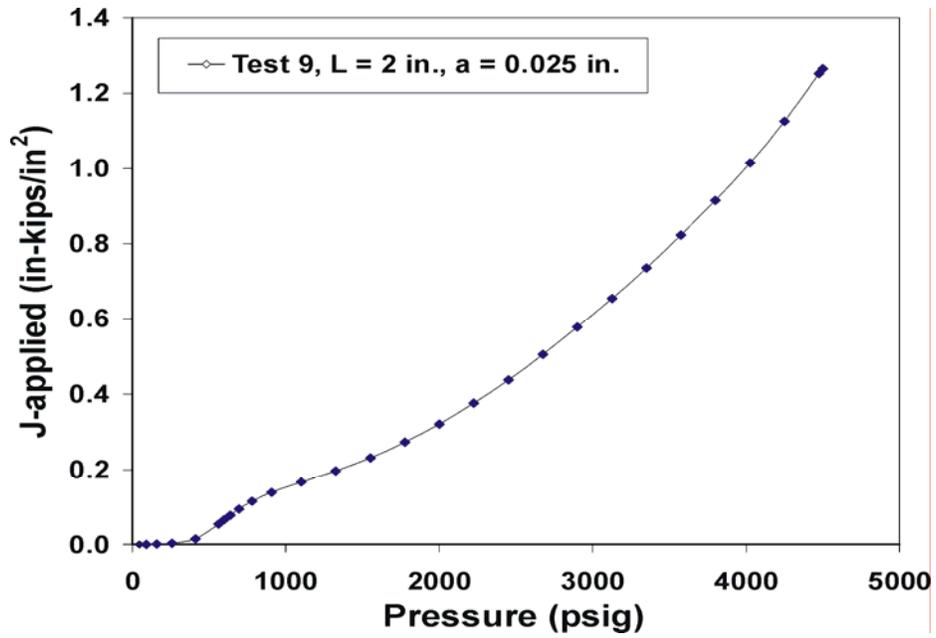
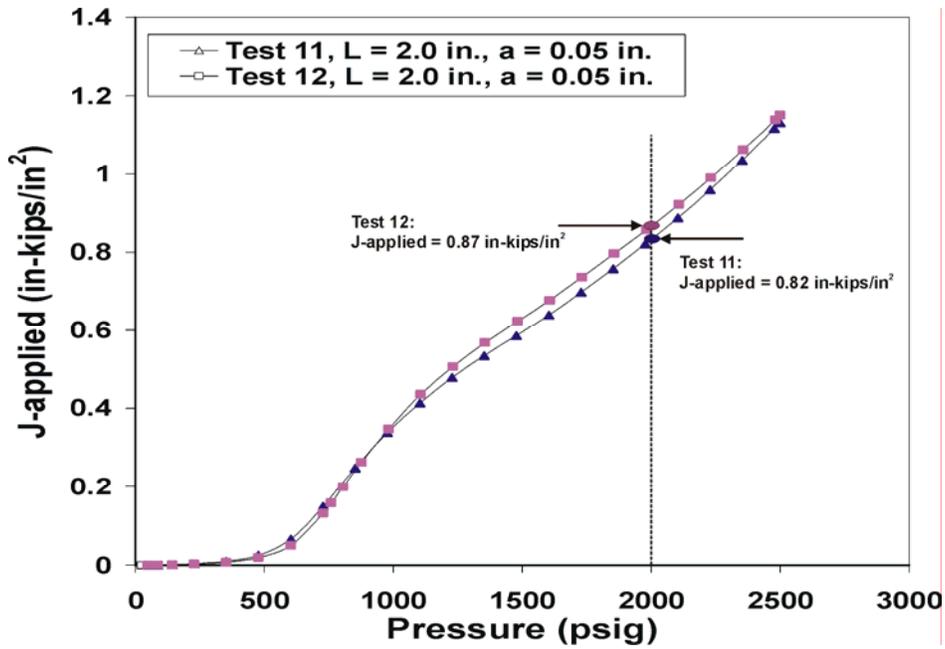
Fig. 7.17. Applied J versus measured pressure for clad-burst specimens: (a) CB 9 (failure pressure was 3,955 psi), and (b) CB 11 and CB 12. Initial root radius of FEMs was 0.01 in.

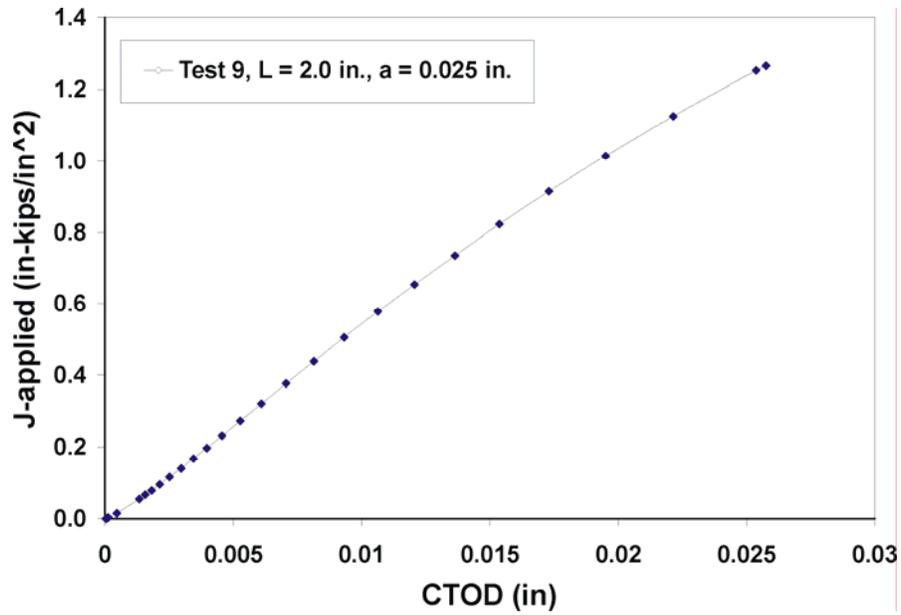
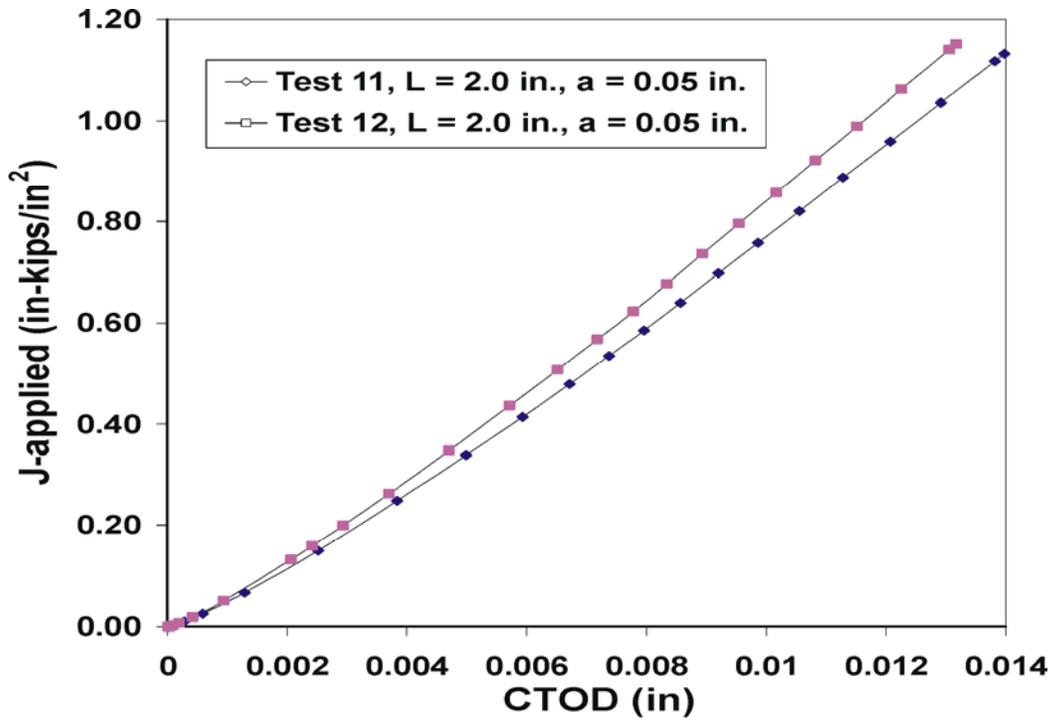
Fig. 7.18. J-applied versus CTOD: (a) CB 9, and (b) CB 11 and CB 12.

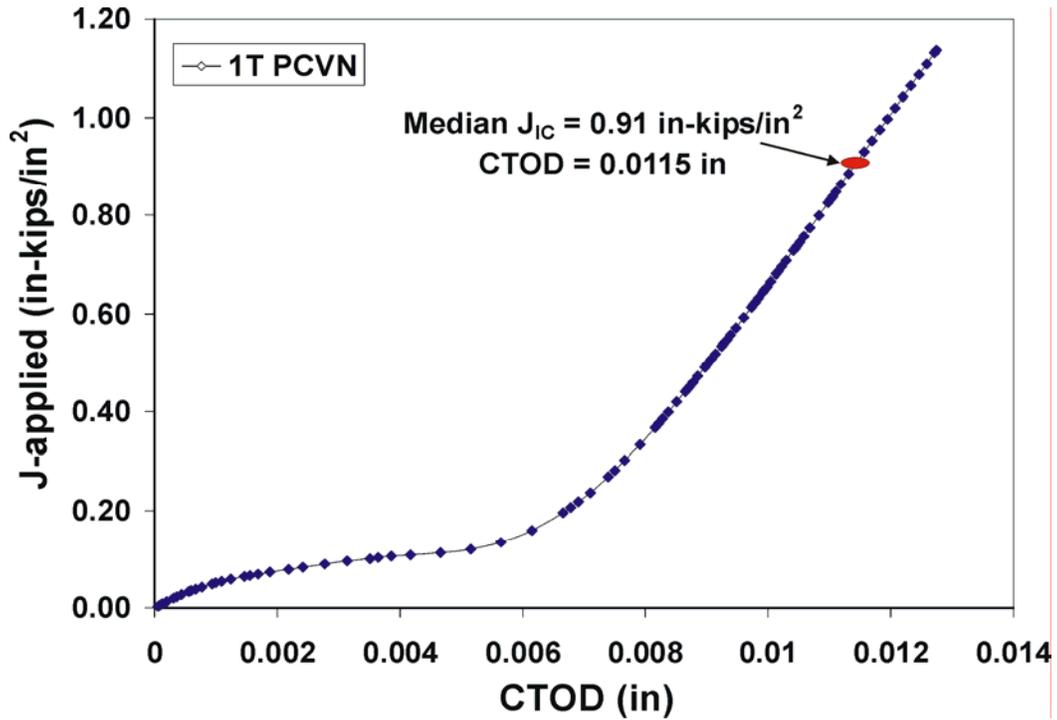
Fig. 7.20. Analysis of pre-cracked Charpy specimen: (a) 3-D finite element model of PCVN specimen; (b) applied J versus CTOD curve generated from analysis

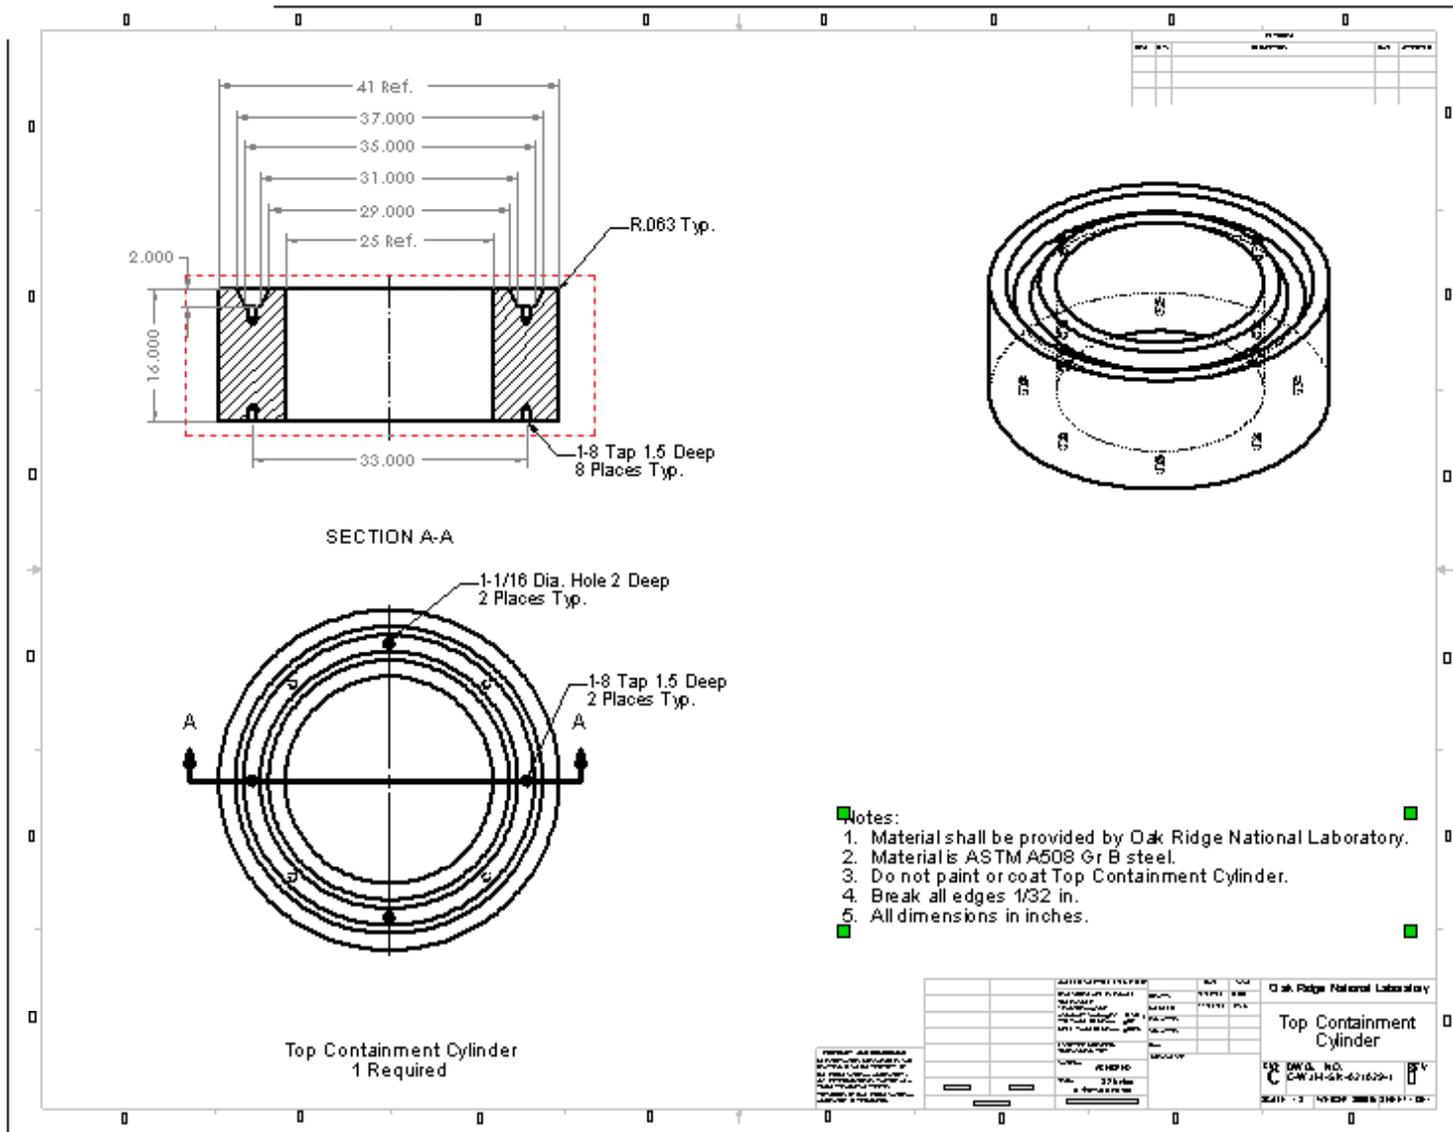
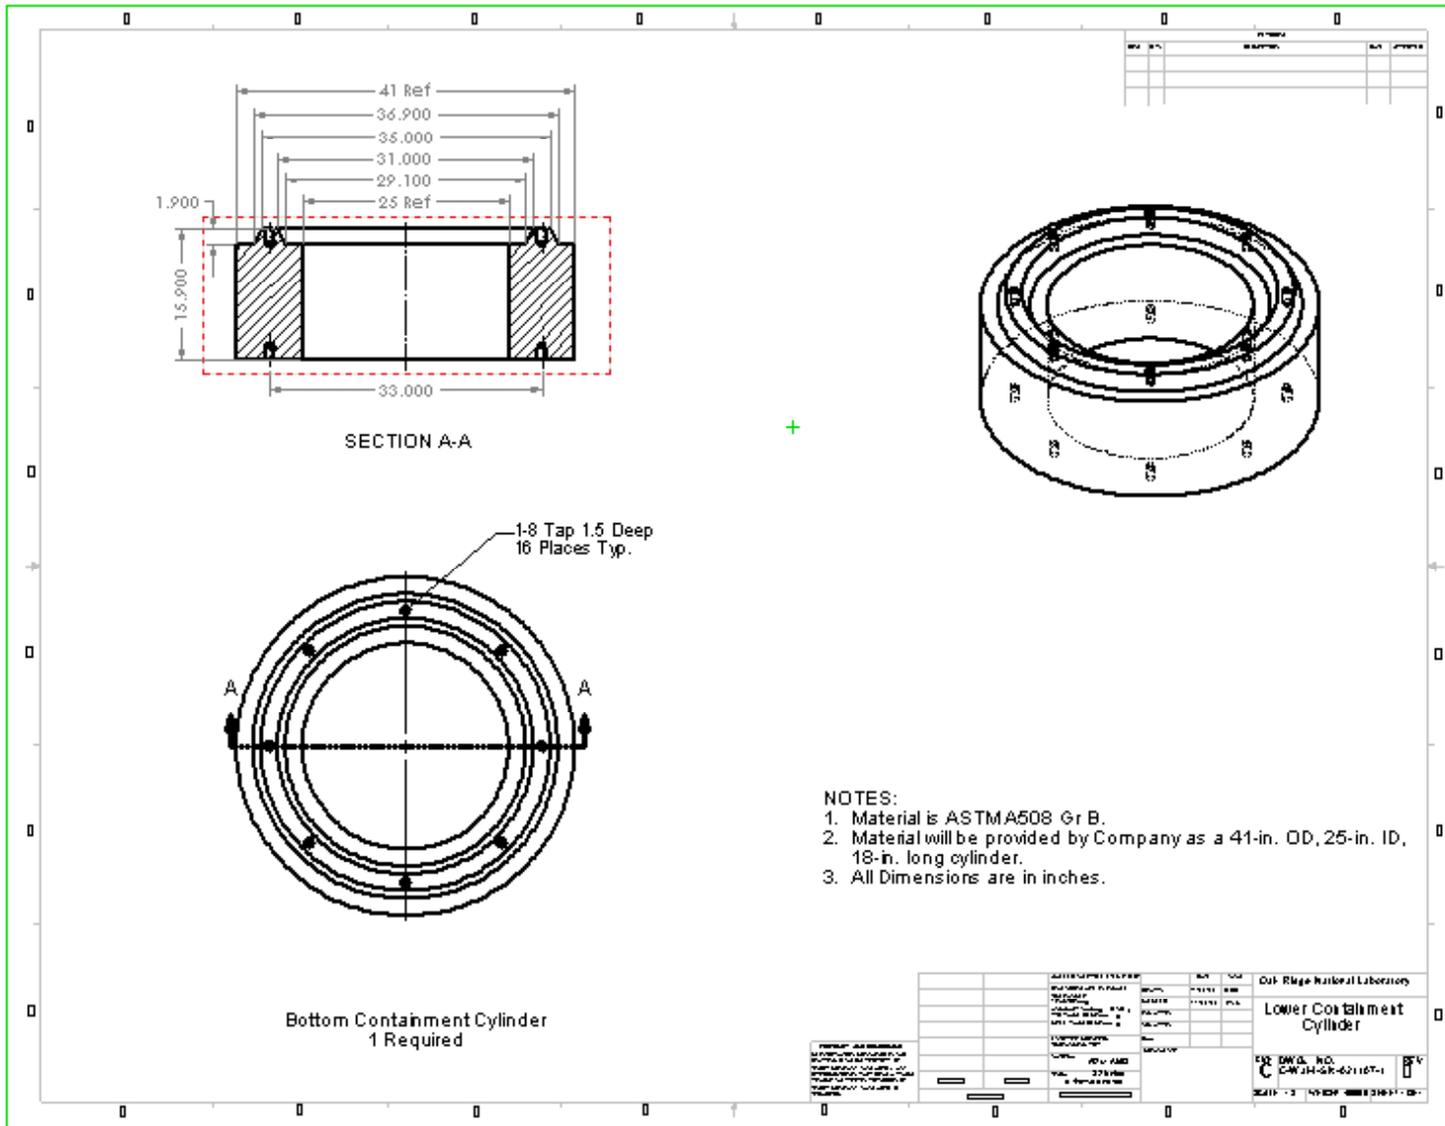
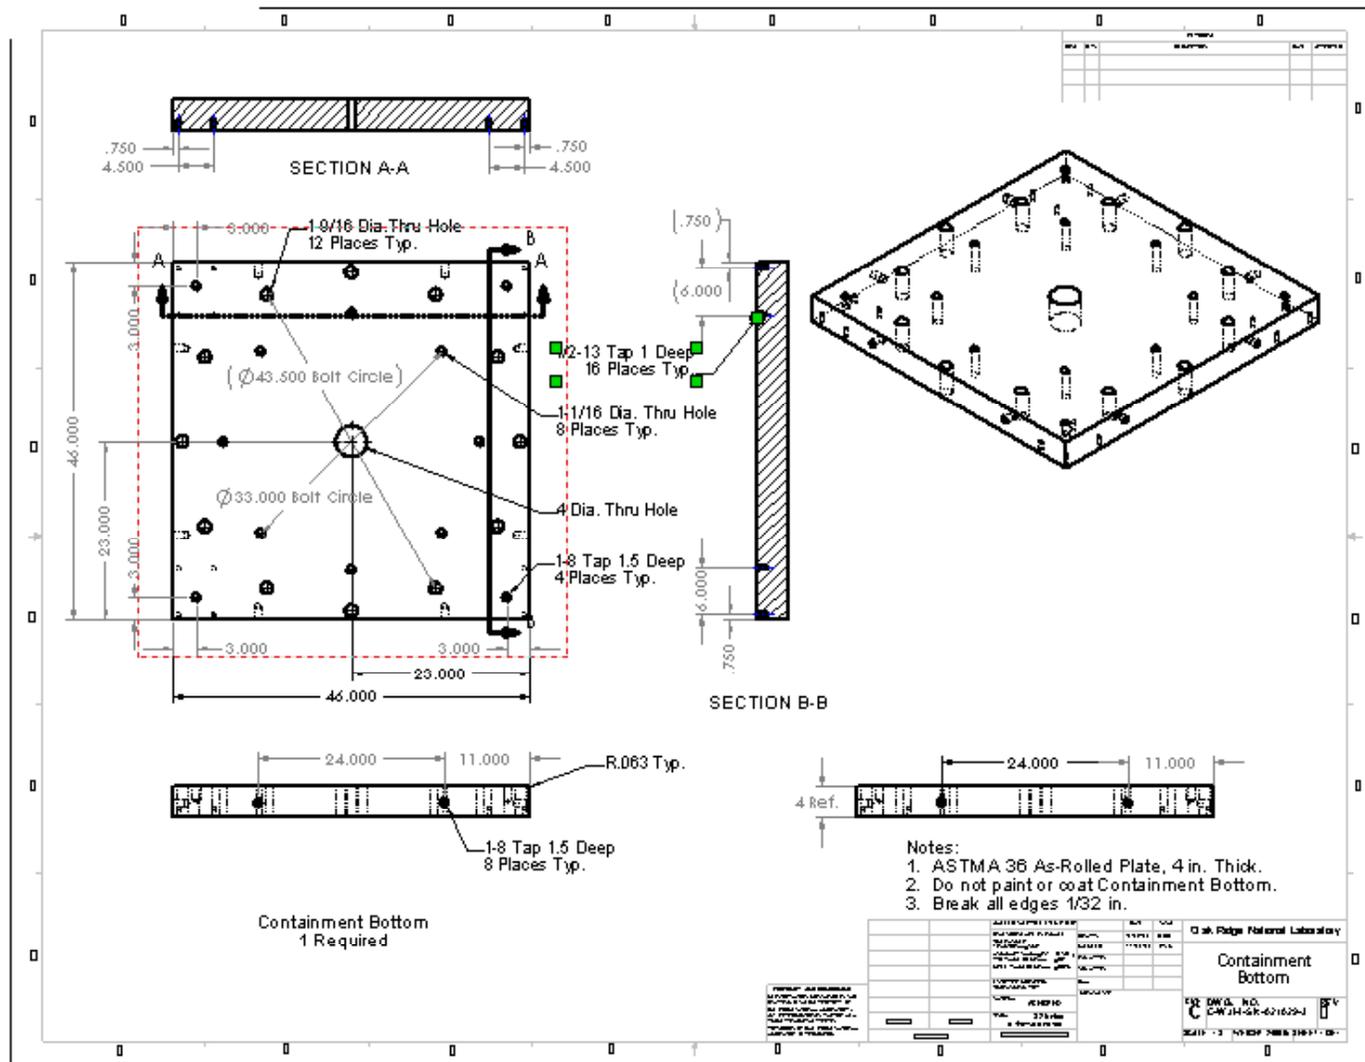
**MACHINE DRAWINGS FOR FABRICATION OF CONTAINMENT VESSEL ASSEMBLY
ORNL/HSST CLAD-BURST TEST FACILITY**

A two-part cylindrical vessel is used to contain the test specimen assembly during a test intended to produce failure of the specimen cladding; the overall dimensions of the vessel are 25 in. inner diameter, 8 in. wall thickness, and 48 in. height. The containment vessel is designed to capture any elements that could be ejected from the test assembly following failure of the cladding. Four inch thick plates provide upper and lower closure of the vessel. Castors are attached to the lower plate to allow the vessel to be rolled in and out of the thermal oven on steel tracks. Isometric drawings of the vessel and rail track assembly are shown in Fig. 2.7; machine drawings of the vessel are include as Appendix B.
