MAINE YANKEE
FINAL STATUS SURVEY RELEASE RECORD
FB-2600 WAREHOUSE 5 FOOTPRINT
SURVEY UNIT 1

Survey Unit FB-2600-01 consists of soil media, which lay below the now demolished Warehouse 5 (location shown on Map FB2600-01, Attachment 1).

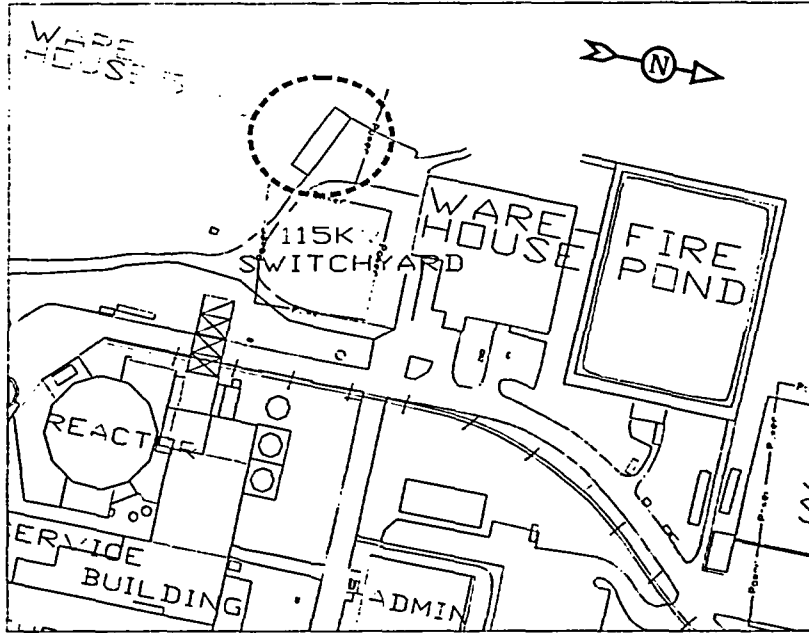
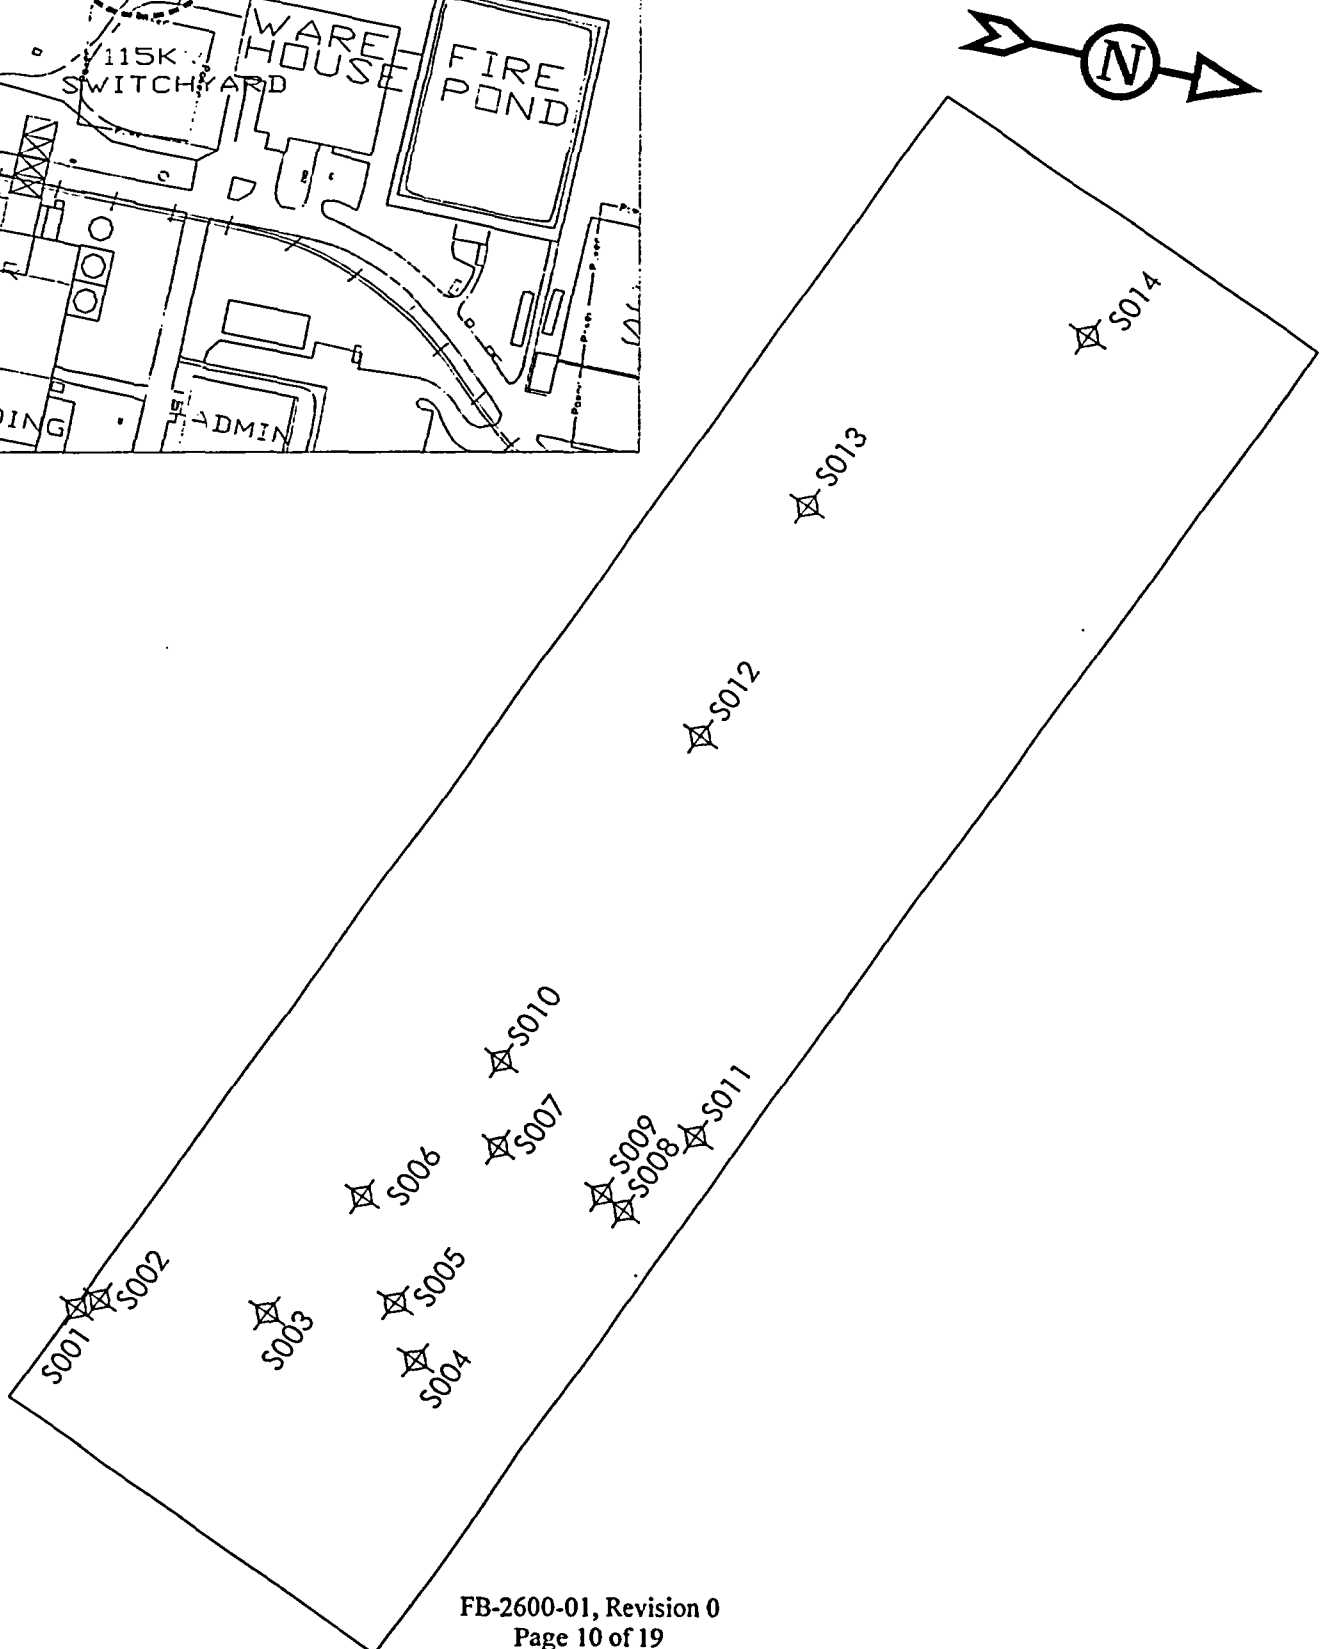
Survey Area Name: Warehouse #5 Soil Samples

The survey unit design parameters are shown in Table 1. Given a relative shift of 3.0, it was determined that 14 direct measurements were required for the Sign Test. Measurement locations were randomly determined and are illustrated on the map FB2600-02 (Attachment 1). All direct measurements consisted of soil samples obtained at the required locations. The samples are analyzed with laboratory gamma spectroscopy.

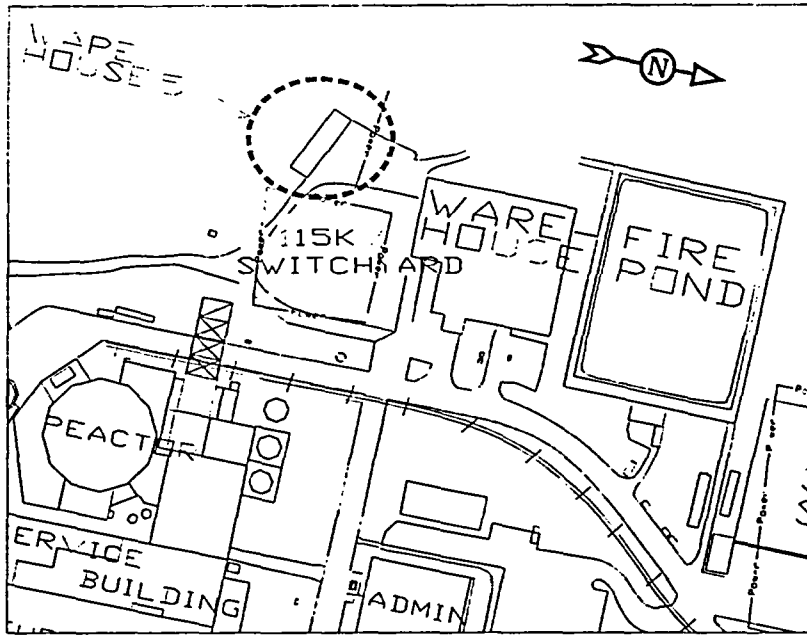
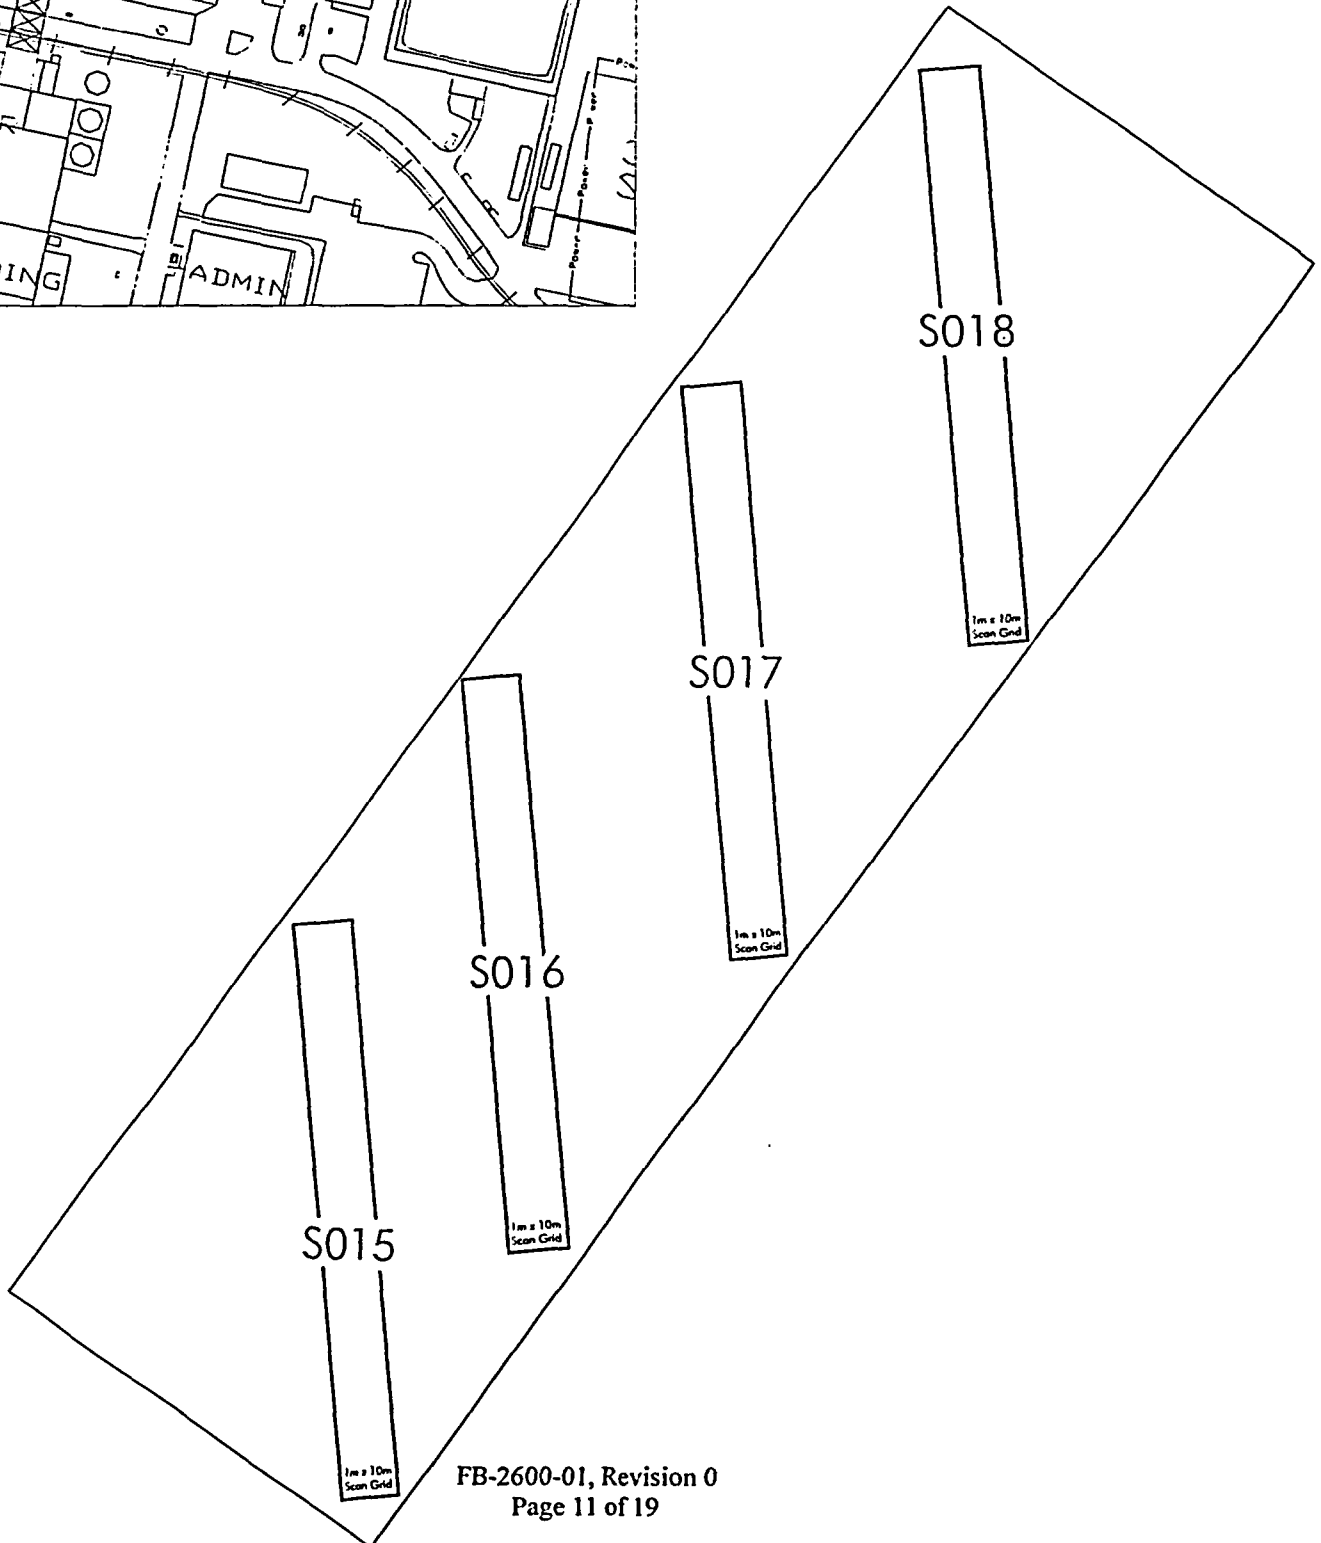
Survey Area Name: Warehouse #5 Scan Grids

Scan grids of 1 m by 10 m were established, as indicated on survey map FB2600-03. A 1% to 10% scan coverage of the area was required. To meet this requirement, four 1-meter wide "scan lanes" were made at regularly spaced intervals across the rectangular survey unit. This produced 40 m² of scan area, exceeding the 10% requirement. The survey instruments used, their MDCs, and alarm setpoints are provided in Attachment 2.

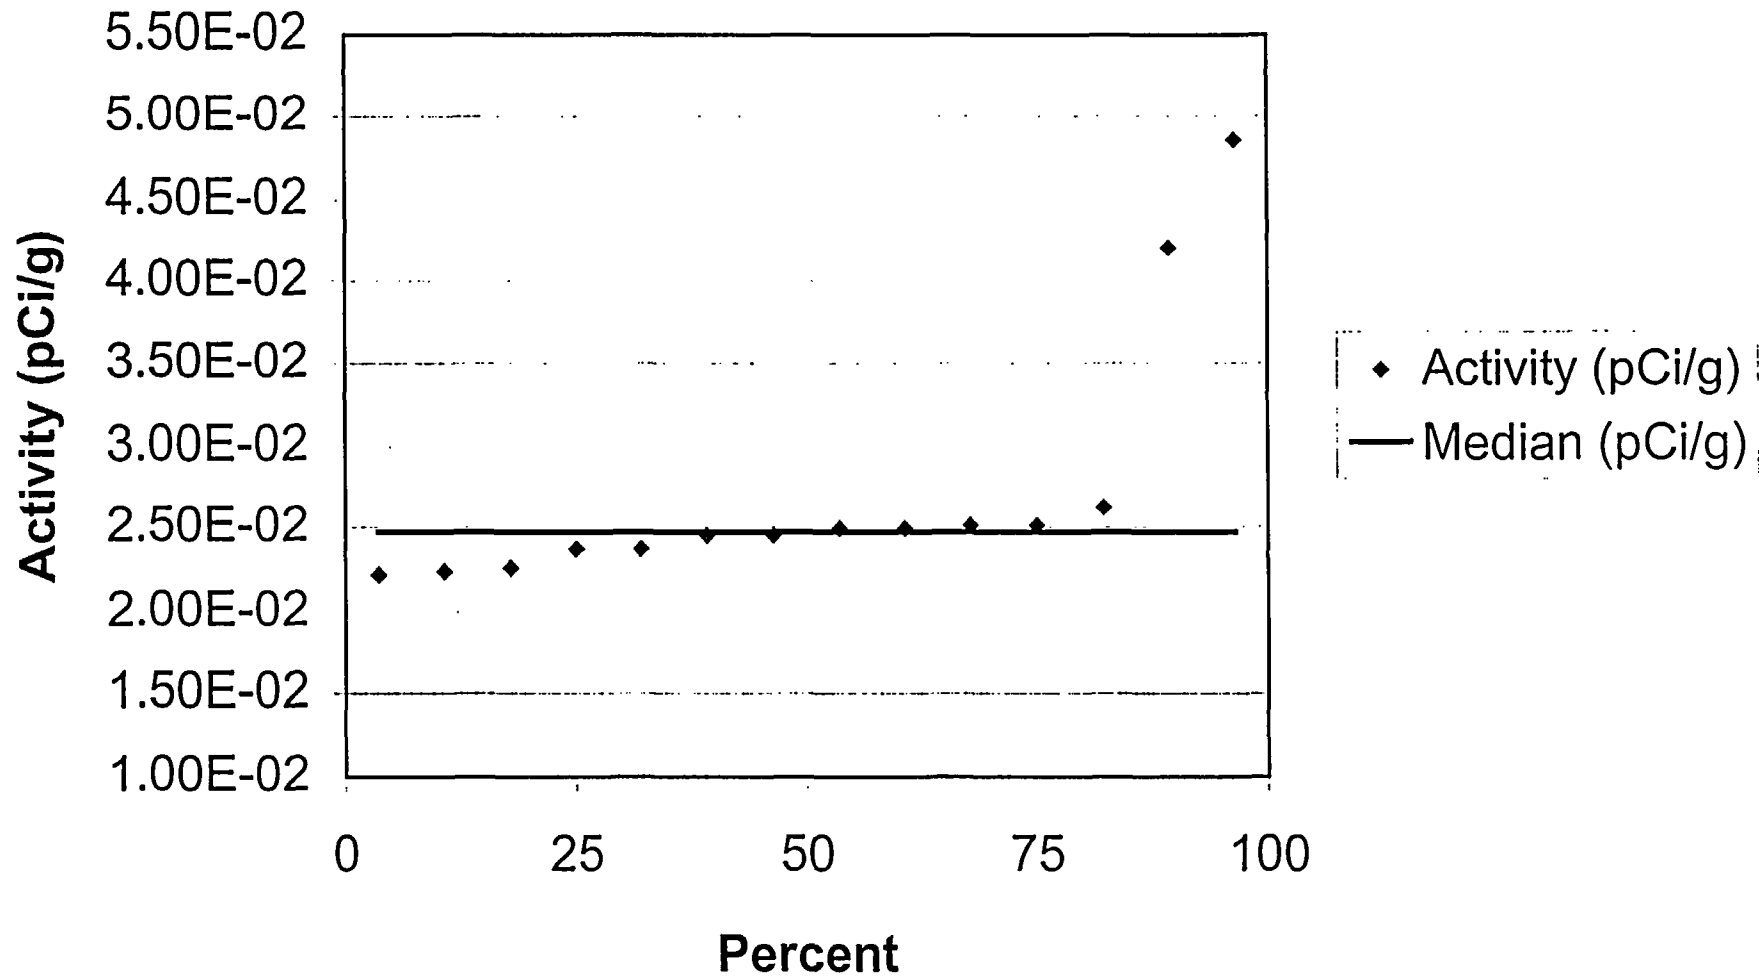
FB-2600 SU-1 Quantile Plot

2. The Quantile Plot was generated from direct measurement data listed in Table 2. The data set and plot are consistent with expectations for a Class 3 survey unit. All of the measurements are well below the DCGL of 4.2 pCi/g.

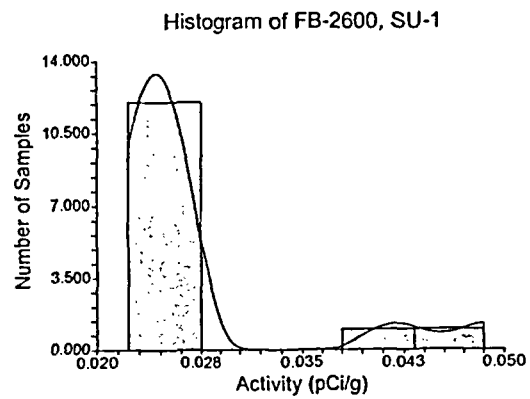
Plots Section

3. A Histogram Plot was also developed based on the direct measurement values. This plot shows that the direct data were essentially a normal distribution with two outliers due to recounting samples to resolve the MDA.

The Retrospective Power Curve shown in Attachment 4 confirmed that sufficient samples were taken to support rejection of the null hypothesis, providing high confidence that the survey unit satisfied the release criteria and the data quality objectives were met. Attachment 4 also revealed that direct measurement data represented essentially a normal distribution with two outliers.

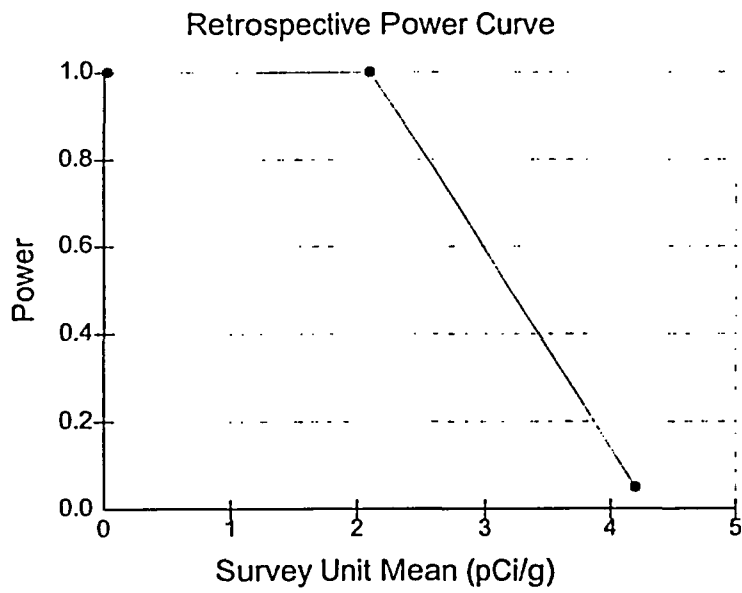
One-Sample T-Test Power Analysis

4. A Retrospective Power Curve was constructed, based on FSS results. The curve shows that this survey unit having a mean residual activity at a small fraction of the DCGL, has a high probability ("power") of meeting the release criteria. Thus, it can be concluded that the direct measurement data support rejection of the null hypothesis, providing high confidence that the survey unit satisfied the release criteria and that the data quality objectives were met.
