An Assessment of Visual Testing

Pacific Northwest National Laboratory

**U.S. Nuclear Regulatory Commission
Office of Nuclear Regulatory Research
Washington, DC 20555-0001**

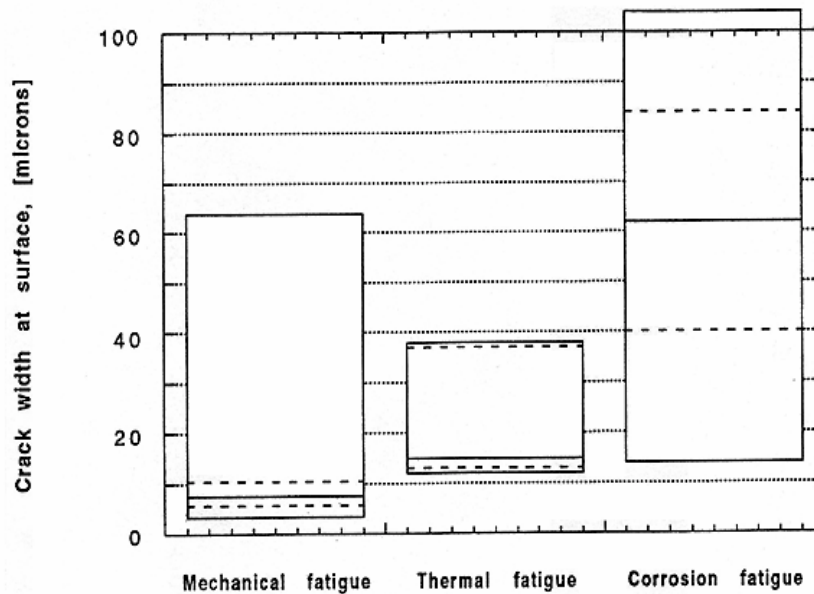
Figure 3.5 Crack Opening Dimension Distribution for Fatigue Cracks (Ekström and Wåle 1995)

Figures 3.5 and 3.6 contain charts that show a compilation of work done by several groups who have characterized the CODs of fatigue cracks and SCCs. The middle line in each bar represents the median crack size, and the upper and lower dashed lines represent the sizes of the 75% and 25% limits. Figures 3.7 and 3.8 show the distributions of CODs to crack through-wall depth.

Figures 3.5 and 3.6 show that cracks in reactor components have a wide distribution of CODs with a significant number of cracks having a COD below $12 \mu\text{m}$ (0.0005 in.). Figures 3.7 and 3.8 further reinforce the premise that there is a weak relationship between the COD of a crack and its through-wall penetration.

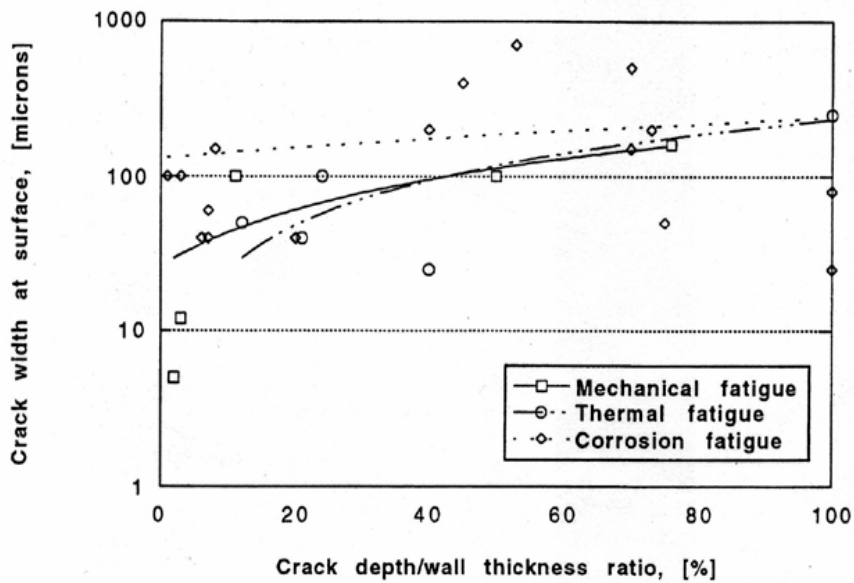
Figure 3.7 Crack Opening Dimension Versus Crack Depth for Fatigue Cracks in Ferritic Steel (Ekström and Wåle 1995)

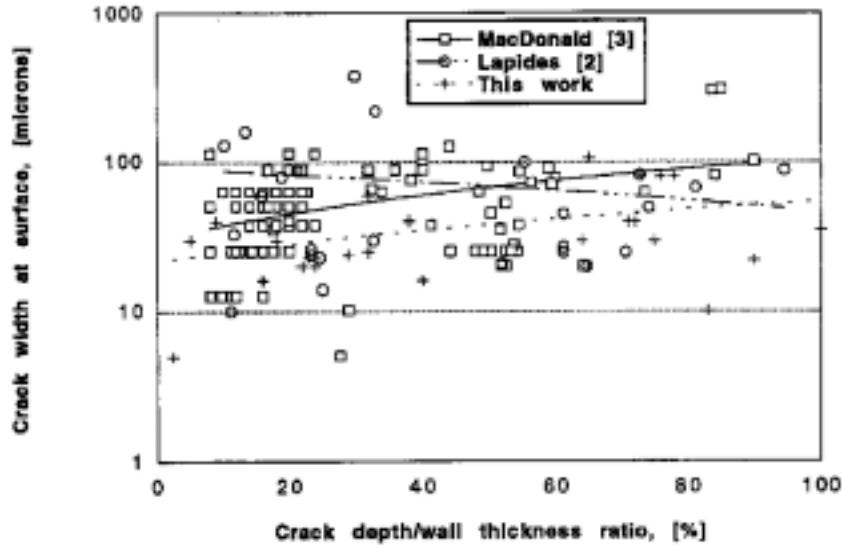
Figure 3.8 Crack Opening Dimension Versus Crack Depth for IGSCCs in Austenitic Stainless Steel (Ekström and Wåle 1995)

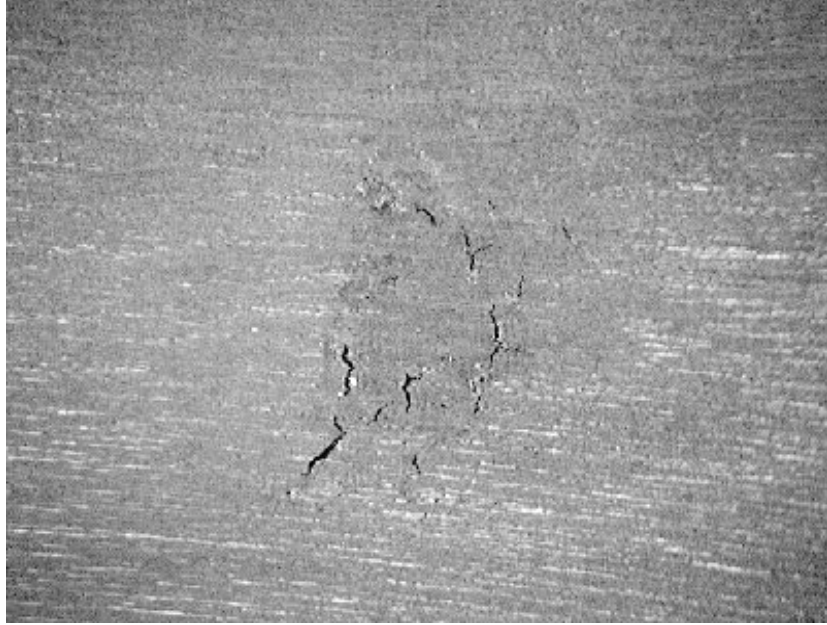
Figure 4.1 Cracking in Reactor Pressure Vessel Cladding as Imaged by a DIAKONT Closed Circuit Video System (Vasiliev et al. 1999)

The results of a remote visual examination on the interior of the Russian Kalininskaja VVER reactor pressure vessel using a DIAKONT reactor TV inspection system are shown in Figure 4.1 (Vasilev V. G. et al 1999). The cracks are in the cladding of the pressure vessel and have CODs of between 50 to 200 μm (0.002 to 0.008 in).

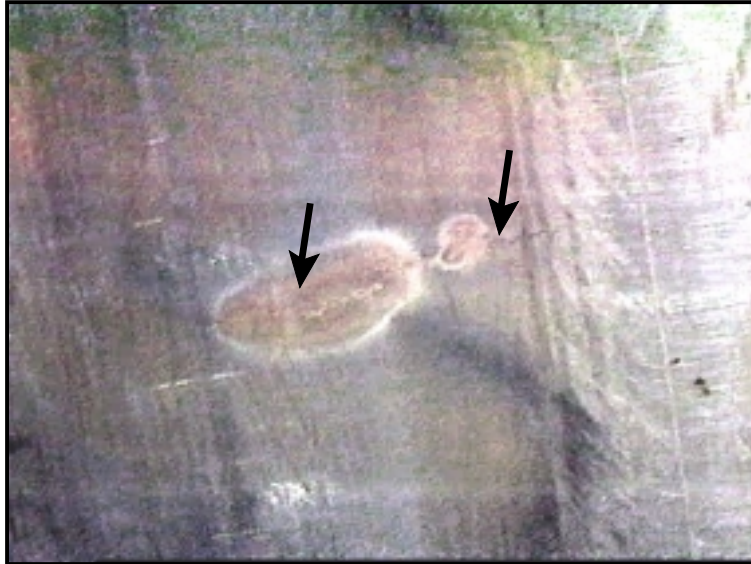
Figure 4.2 Axial PWSCC Crack in V.C. Summer Nuclear Station Pressure Vessel Nozzle to Pipe Weld. The COD of the crack is not known.

One crack imaged using VT was a through-wall axial crack in the piping of V.C. Summer Nuclear Station. The crack was detected by indirect means; specifically, boric acid deposited from primary coolant leaking through the pipe was the first indication of a crack. The pipe was visually examined twice. The first examination used a video camera on the end of a long pole; the second used a robotic scanner. The first VT test missed the crack, while the second, performed by WesDyne, successfully detected the crack. The contrast and size of the crack image was enhanced as there was corrosion of the ferritic steel of the pressure vessel nozzle forging which bled back through the crack, lining it with reddish corrosion products. The crack is shown in Figure 4.2.

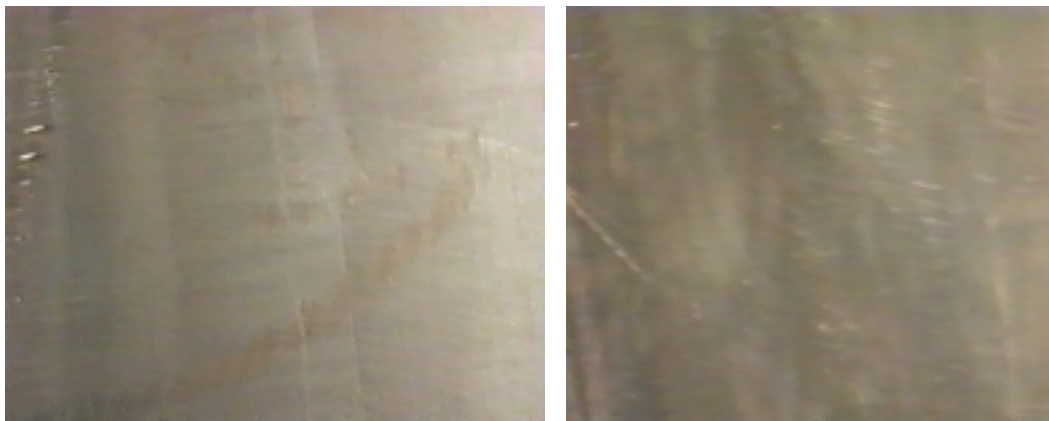
Figure 4.4 Reduction of Visual Acuity During Scanning. Left: a screen capture from when the camera is not moving. The vertical lines are sharp and the picture is relatively clear. Right: a screen capture of different area when the camera is moving. The vertical lines are blurred, as is the rest of the picture.

An example of the loss of visual acuity when a camera is scanning is shown in Figure 4.4. The picture is significantly sharper when the camera is stationary (system normal visual acuity) over a zone as opposed to scanning (system kinetic visual acuity). This lower kinetic visual acuity demonstrates that a system capable of passing a resolution test when not moving can possibly fail when the camera is being scanned.

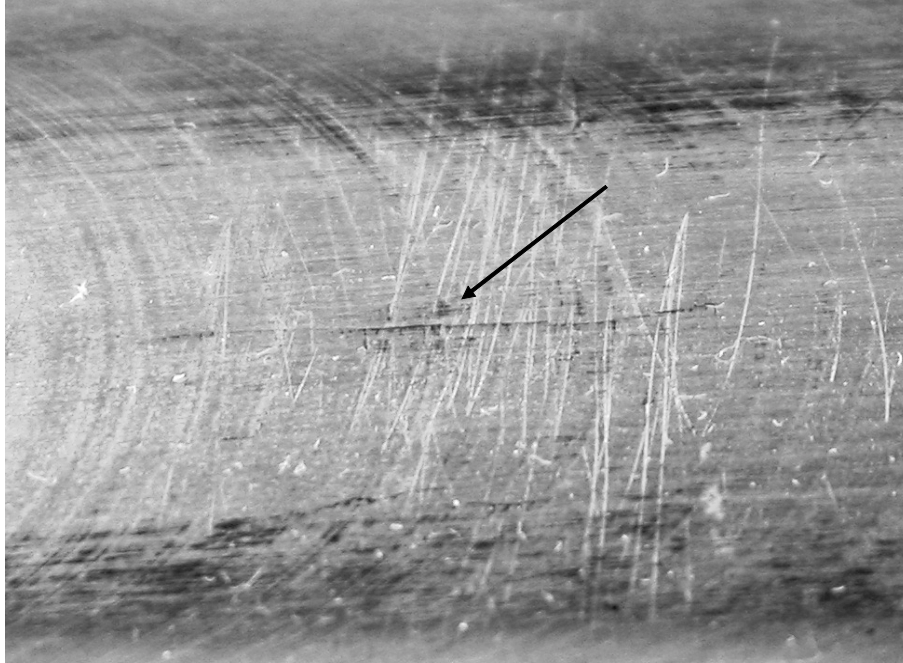
Figure 4.7 12- μm (0.0005-in) COD Thermal Fatigue Crack on Machined Surface. The crack is clearly visible despite its small COD, as there is discoloration around the crack opening

The photography of the cracks demonstrates that a digital camera able to detect a 25- μm (0.001-in.) wire may not be able to resolve similarly-sized cracks. In several cases a very close visual inspection could find cracks that were invisible to the digital camera. During the direct visual inspections we were able to examine the specimens at a much shorter distance than with the digital camera, allowing for better detection.

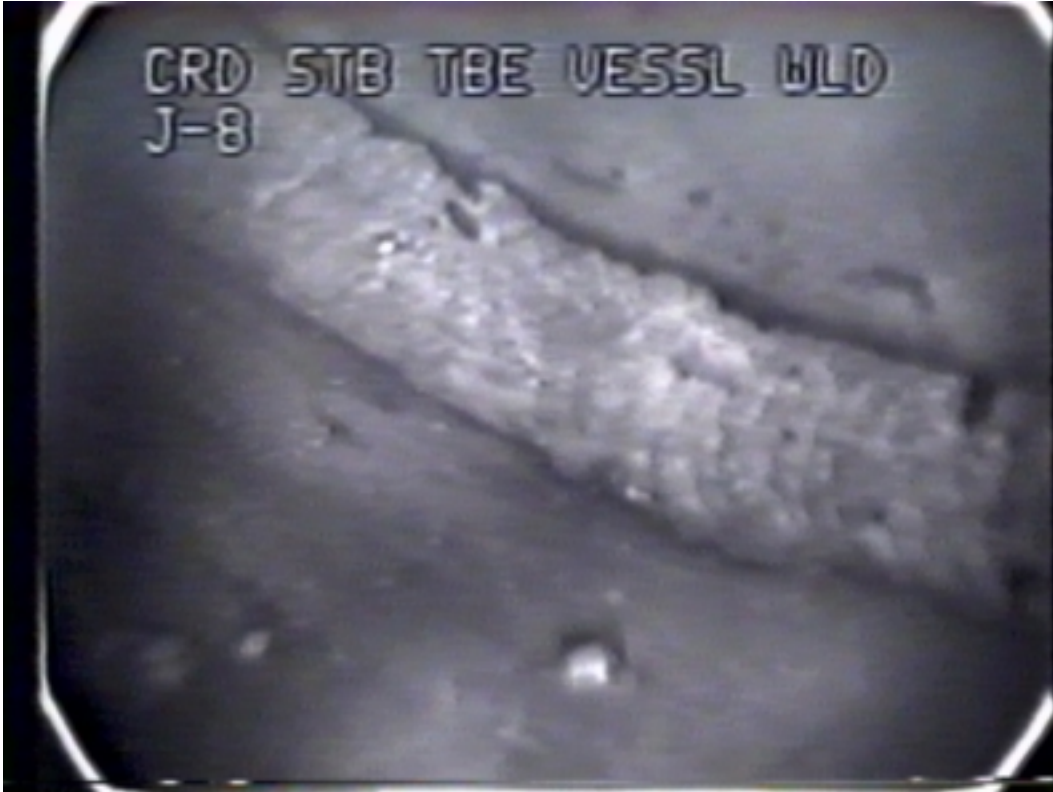
Figure A.7 Frame Capture from Videotaped Visual Inspection of a Control Rod Drive Stub Tube Weld. Note the relatively soft focus.
