Scientific Notebook No. 149: Fracture
Mechanics Wedge Open Loading Stress
Corrosion Cracking Tests (02/21/1997 through
09/19/2000)

INITIAL ENTRY FOR FRACTURE MECHANICS TESTS

Objectives: Determine the propagation rate for stress corrosion cracking of 316L SS as a function of applied potential in chloride containing environments.

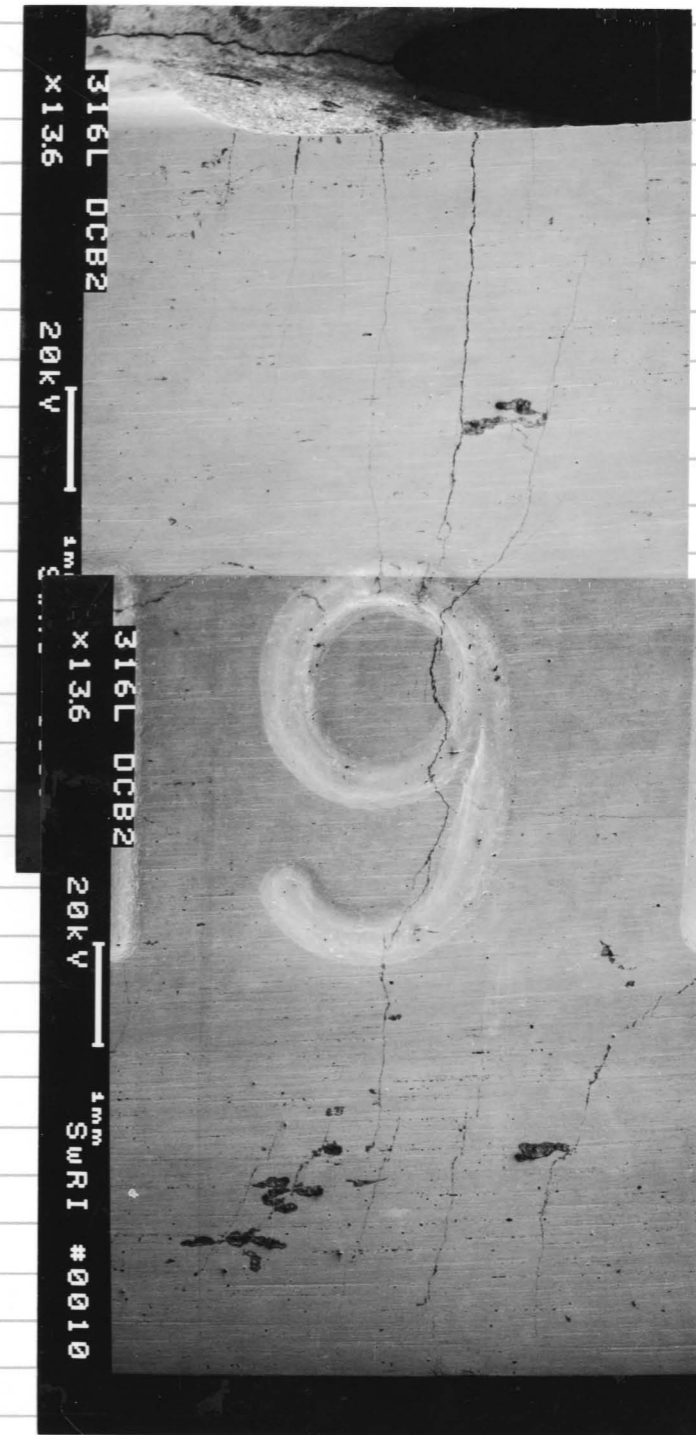
Photo No. 94857

5. 316L DCB2 - Transverse Cracks

No crack advance has been observed for all four DCB specimens. However, transverse cracks perpendicular to the groove have been observed in specimen 316LDCB 2.

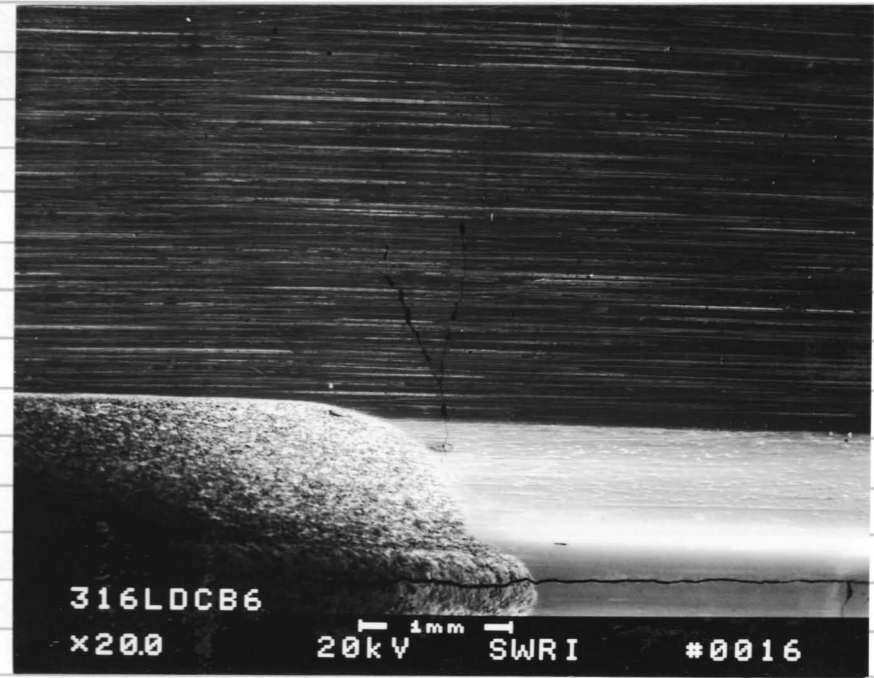
photo No. 95976

3. Transverse Crack

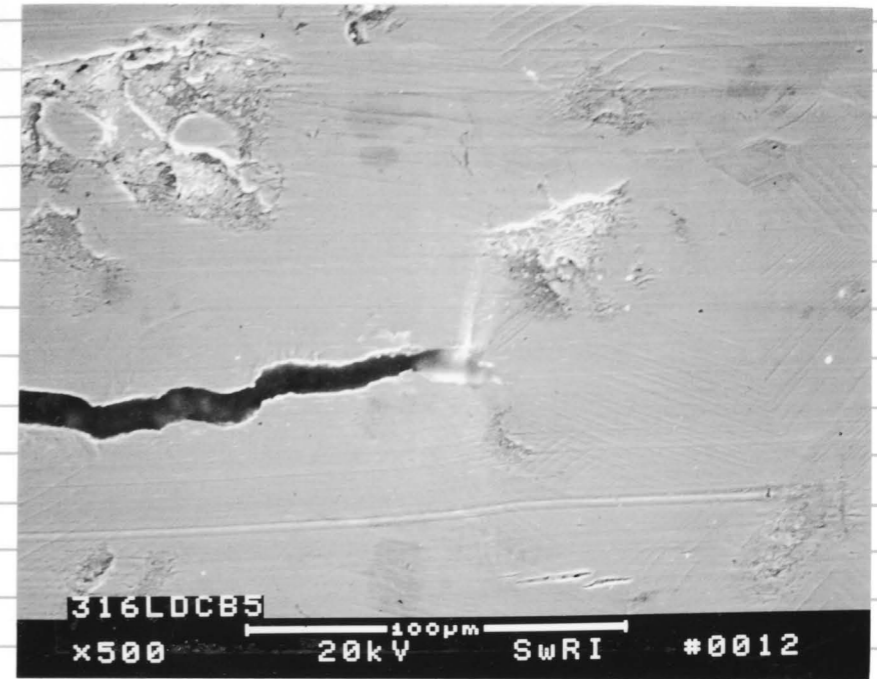
photo No. 96252

SEM Micrographs of Crack Advance in 316LDCB5 Disassembly on 4/1/99

1. Engraved side with Test Sample ID: No crack advance observed.

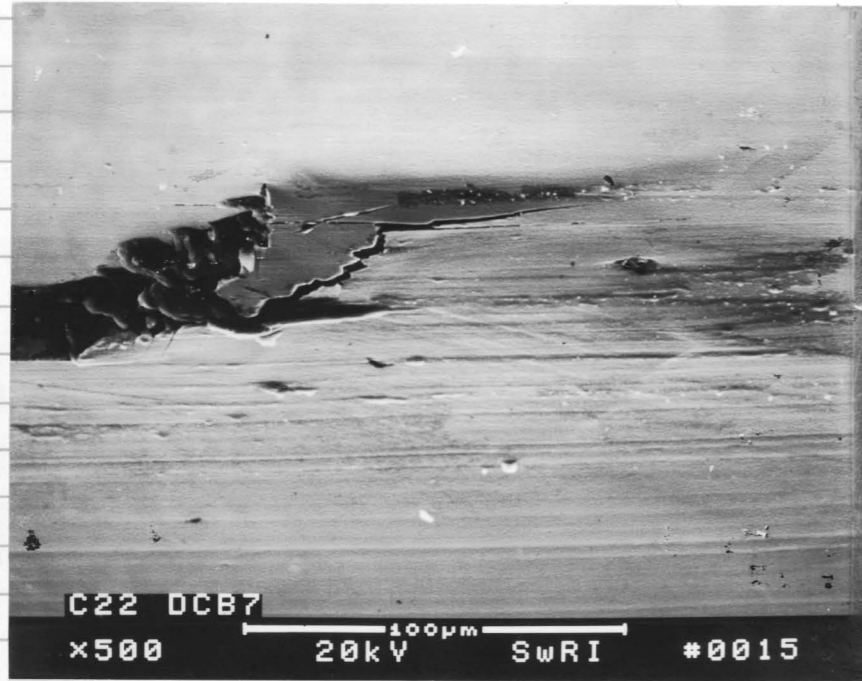
Photo No. 96383

2. C22 DCB7 shows secondary cracks near the main crack, but no main crack advance.

2a. Main crack tip.

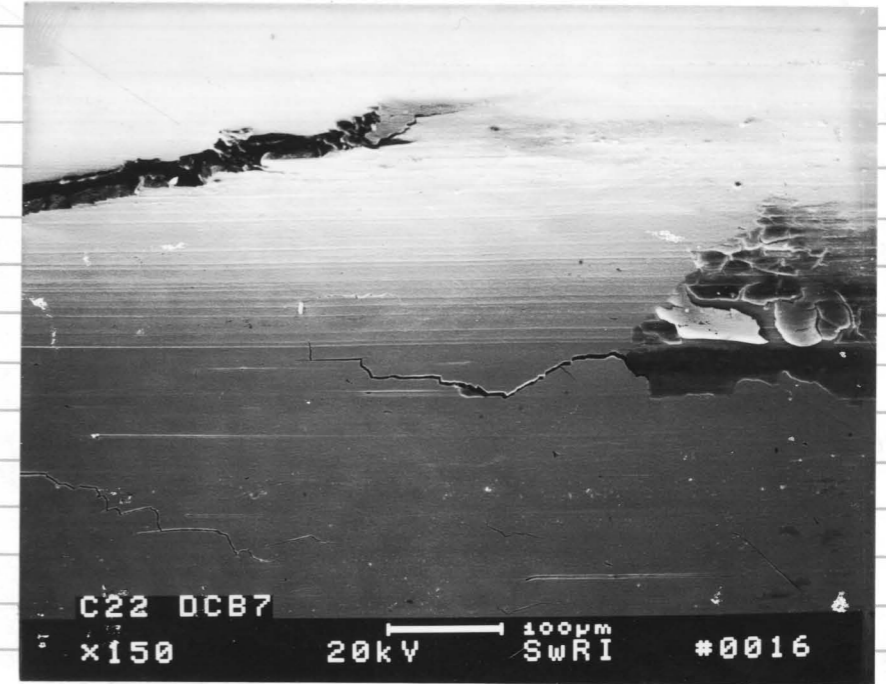
Photo No. 96384

2b. Secondary cracks
