H.B. Robinson High-Burnup PWR Oxidation and Post-Quench Ductility

M. Billone, Y. Yan, T. Burtseva and H. Chung
Energy Technology Division
Argonne National Laboratory
February 10, 2005

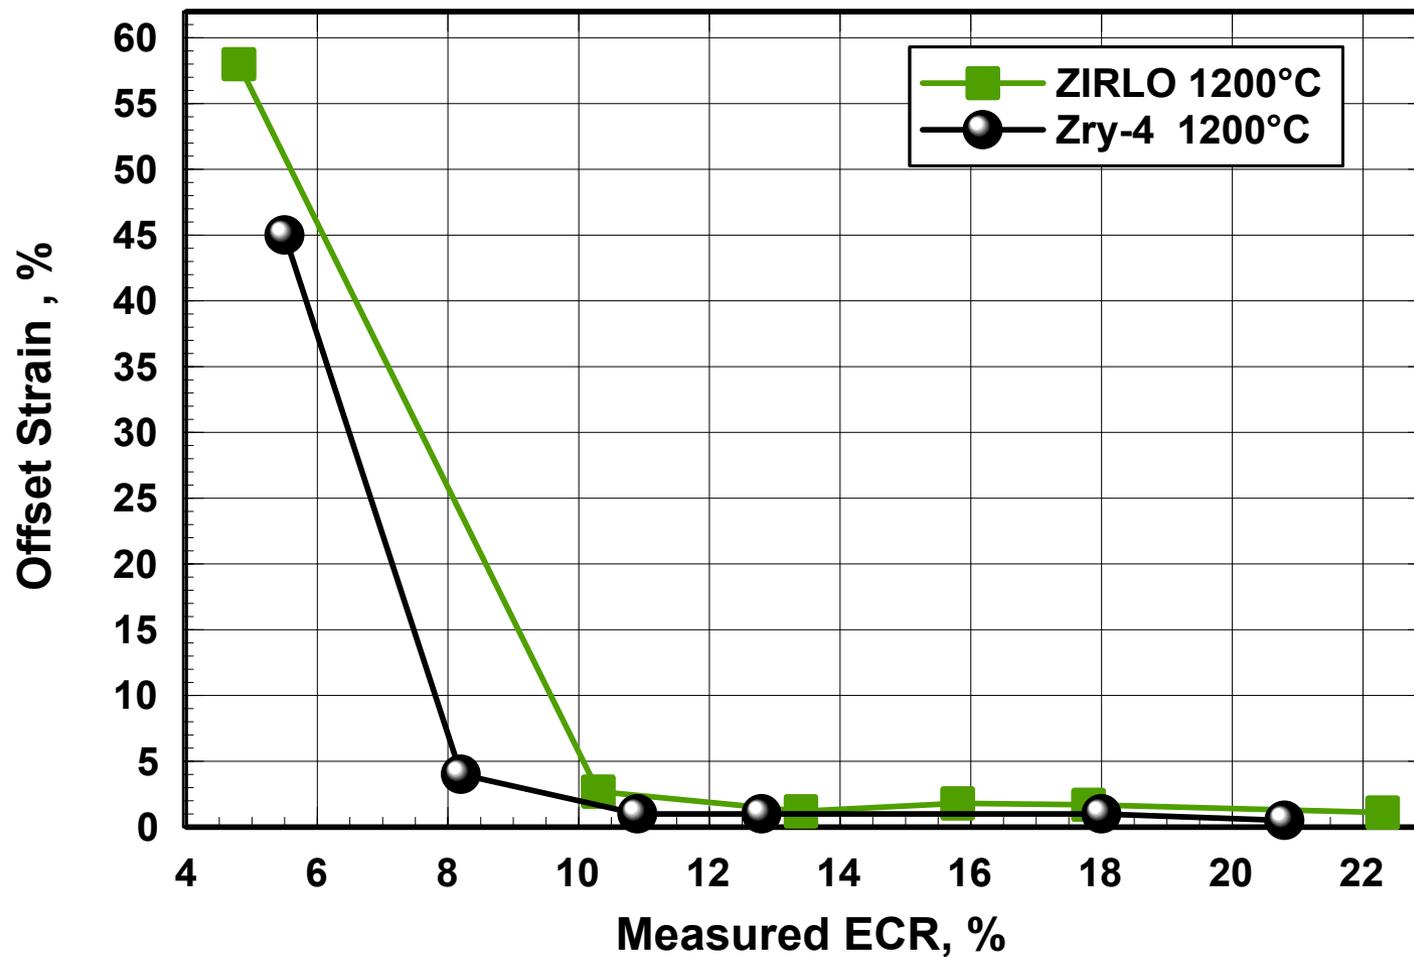
RT Offset Strain for 1200°C-Oxidatized ZIRLO vs. Zry-4

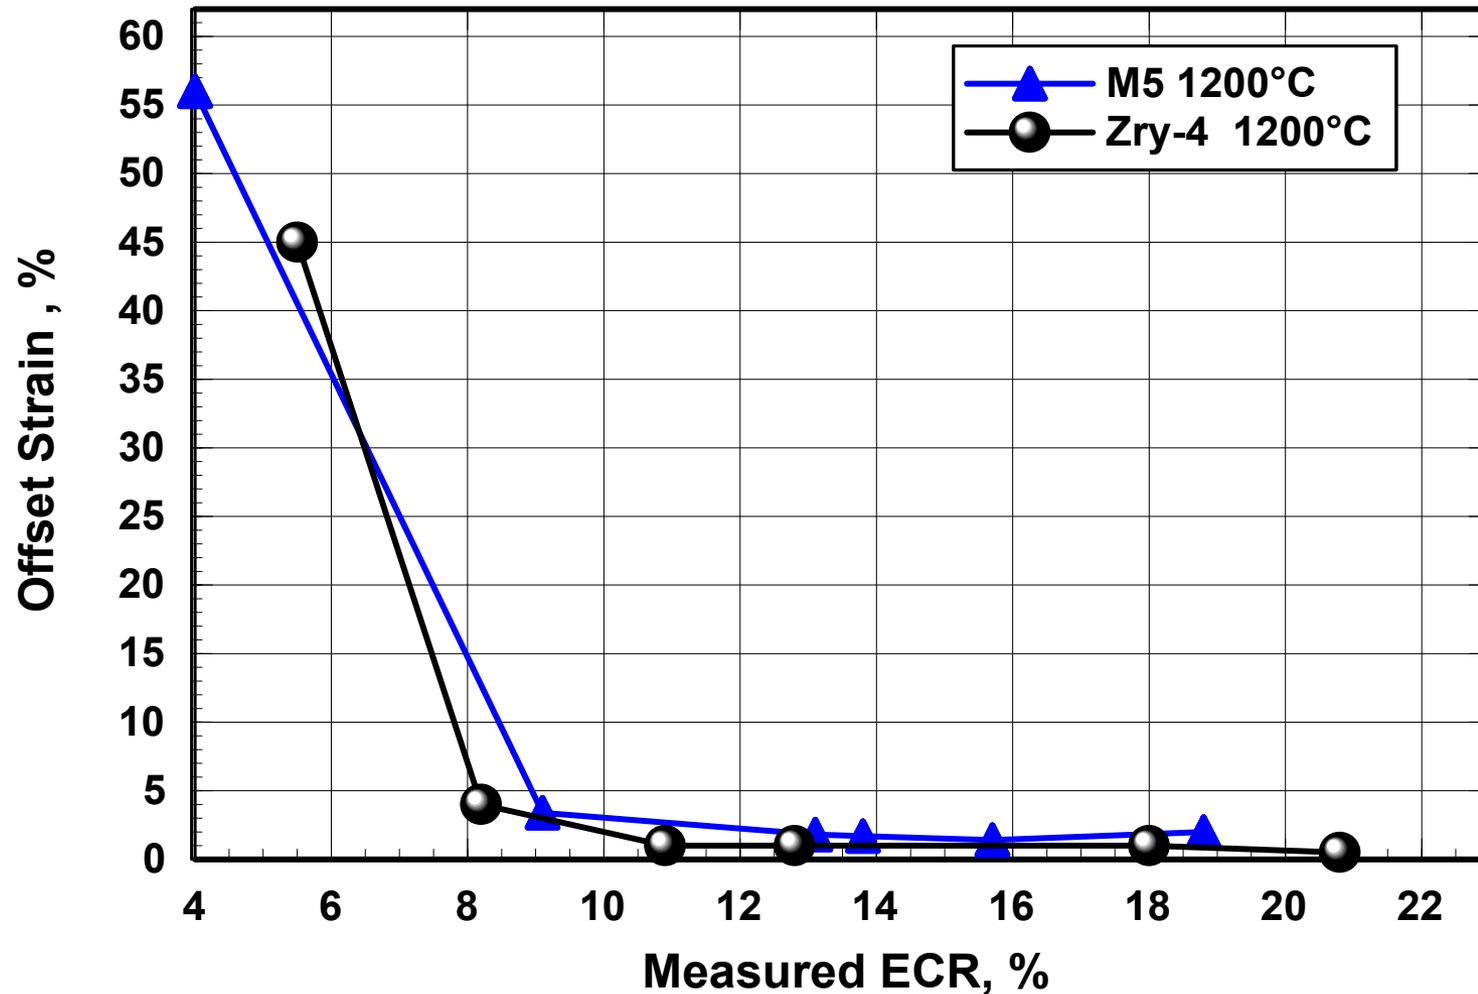
RT Offset Strain for 1200°C-Oxidatized M5 vs. Zry-4

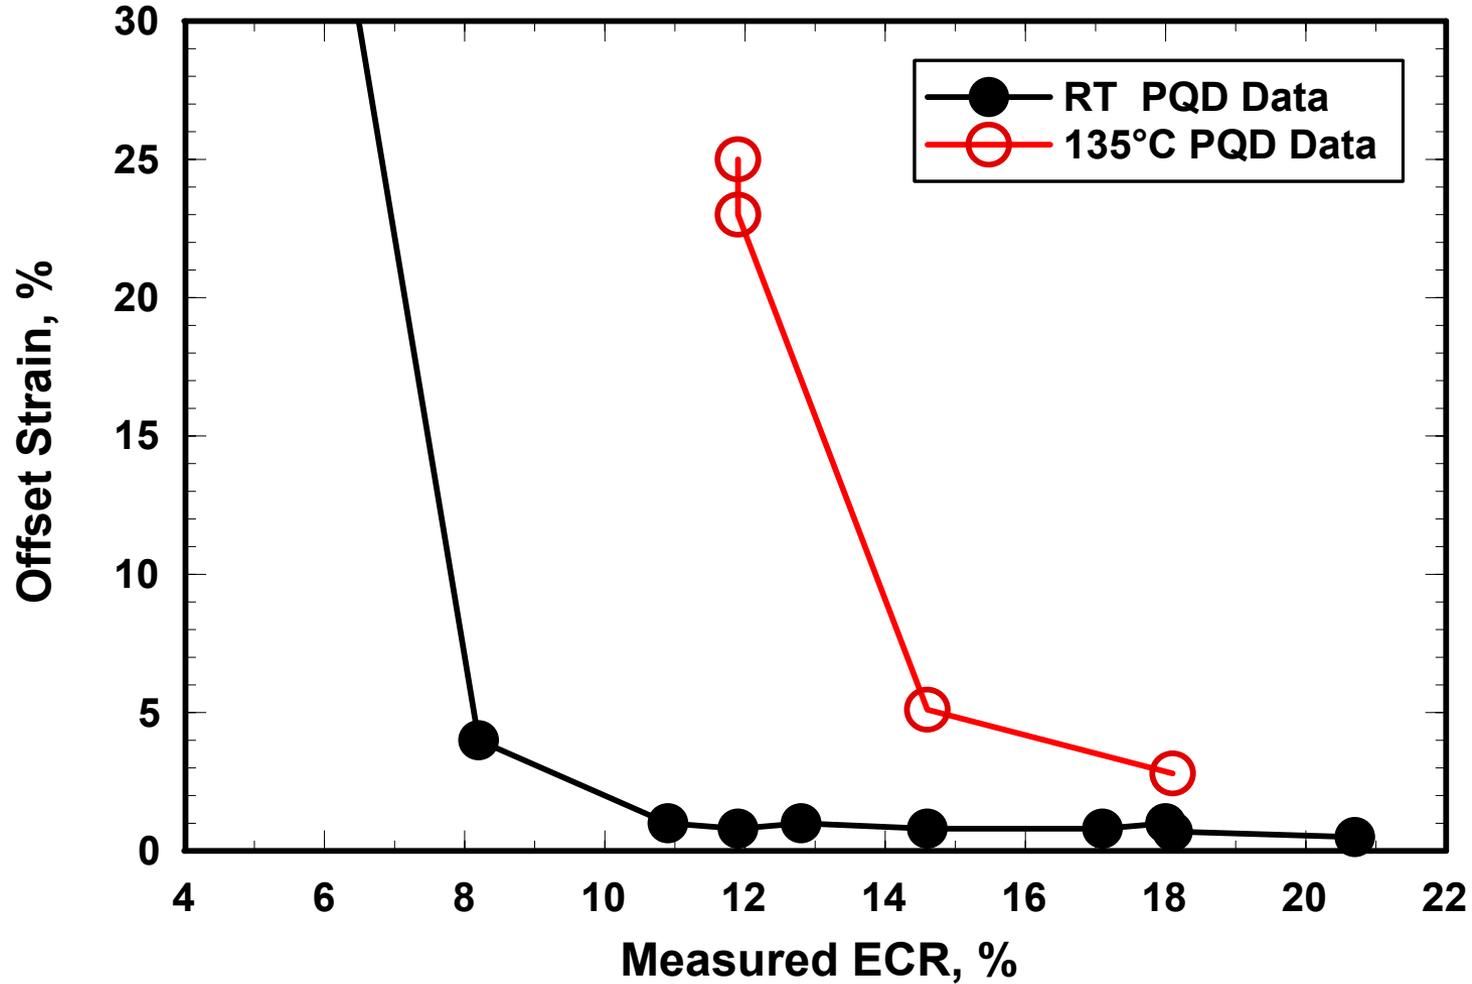
135°C Offset Strain for 17x17 Zry-4 Oxidized at 1200°C

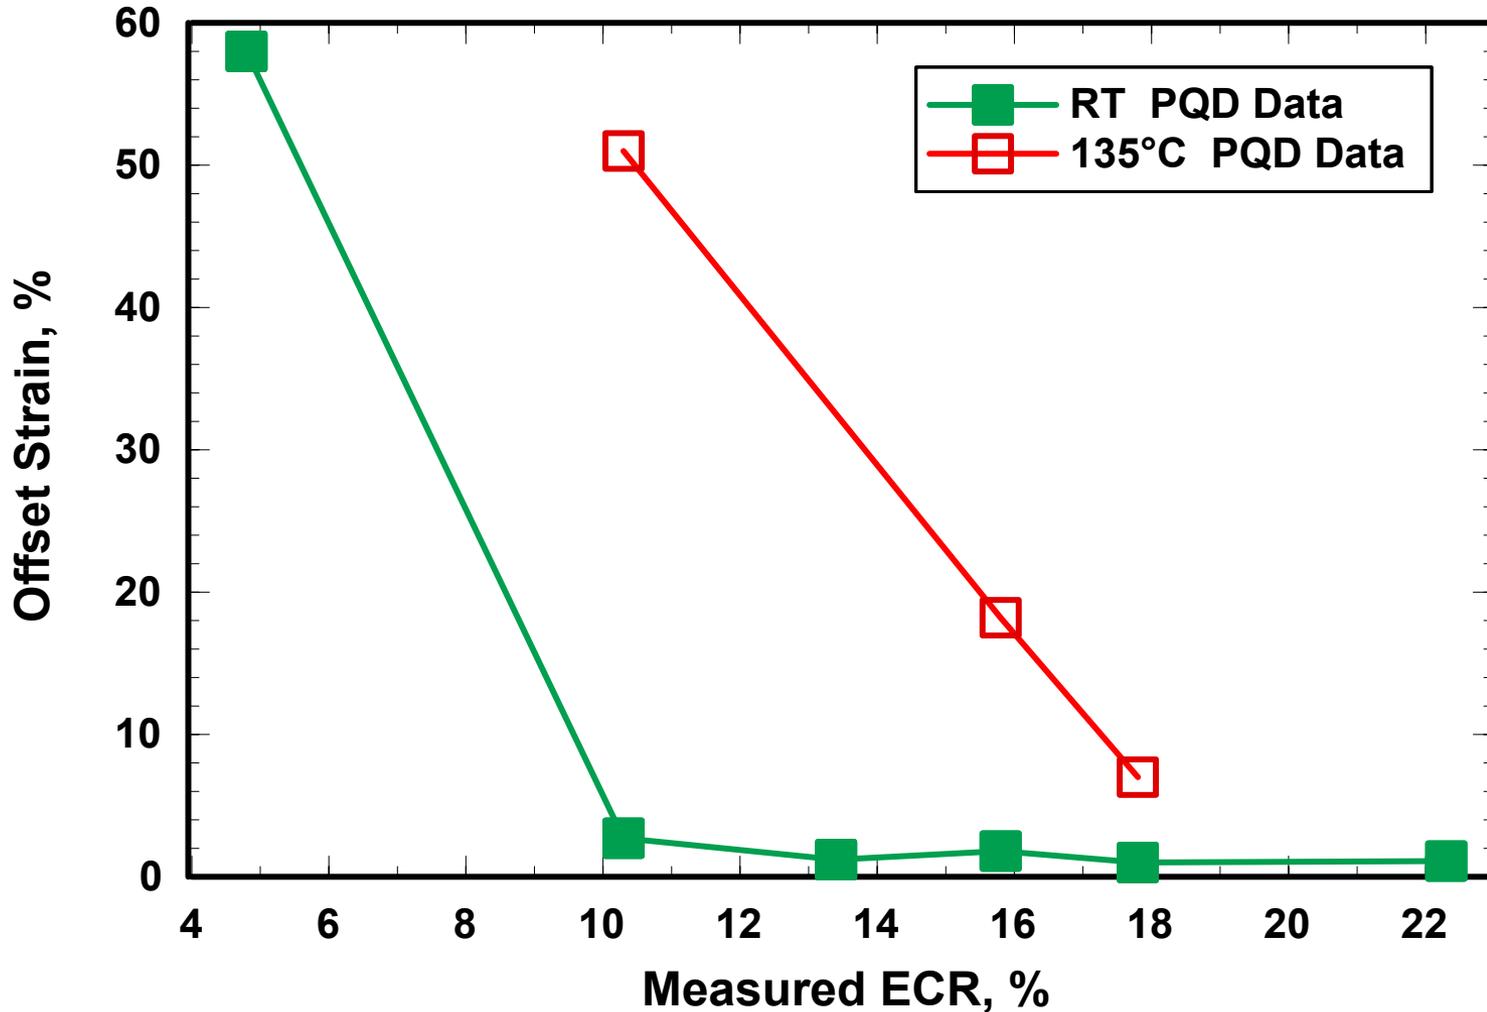
135°C Offset Strain for 17x17 ZIRLO Oxidized at 1200°C

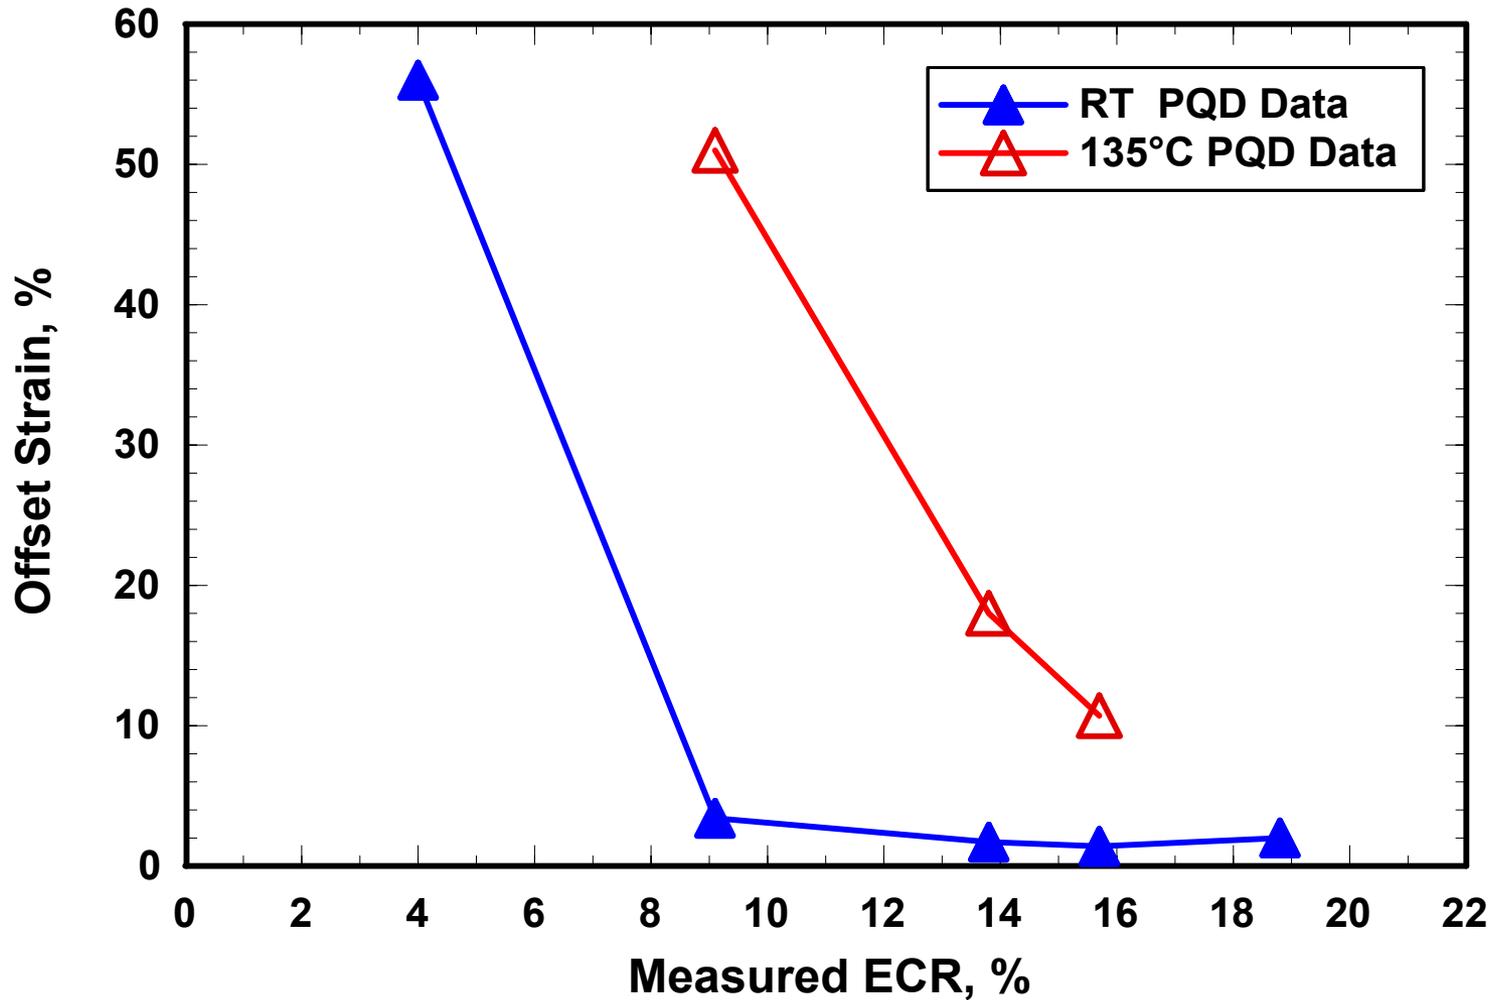
135°C Offset Strain for 17x17 M5 Oxidized at 1200°C

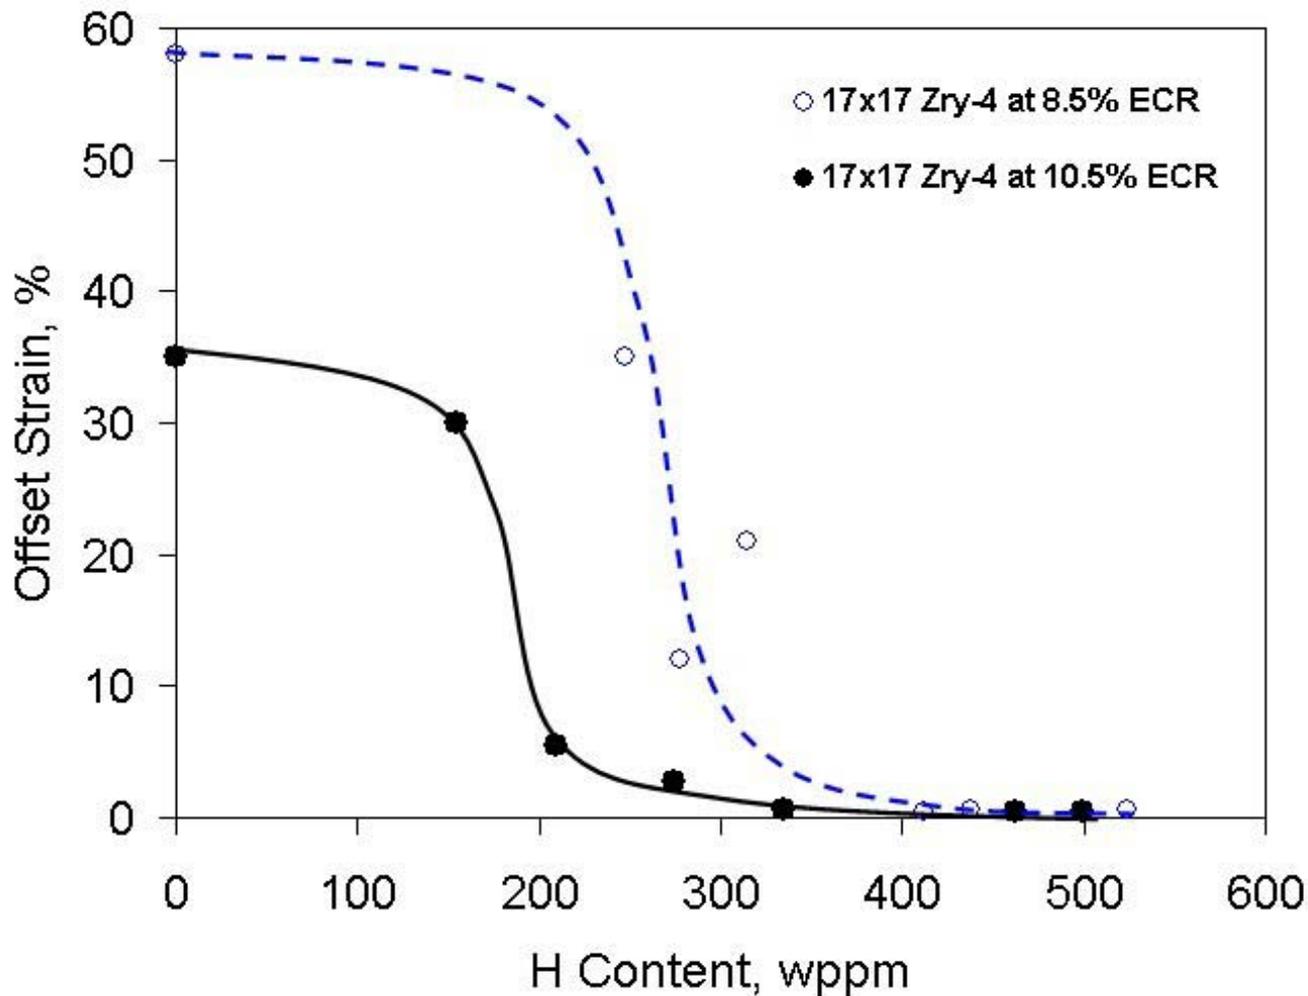
135°C Offset Strain for Prehydrated 17x17 Zry-4 Oxidized at 1200°C

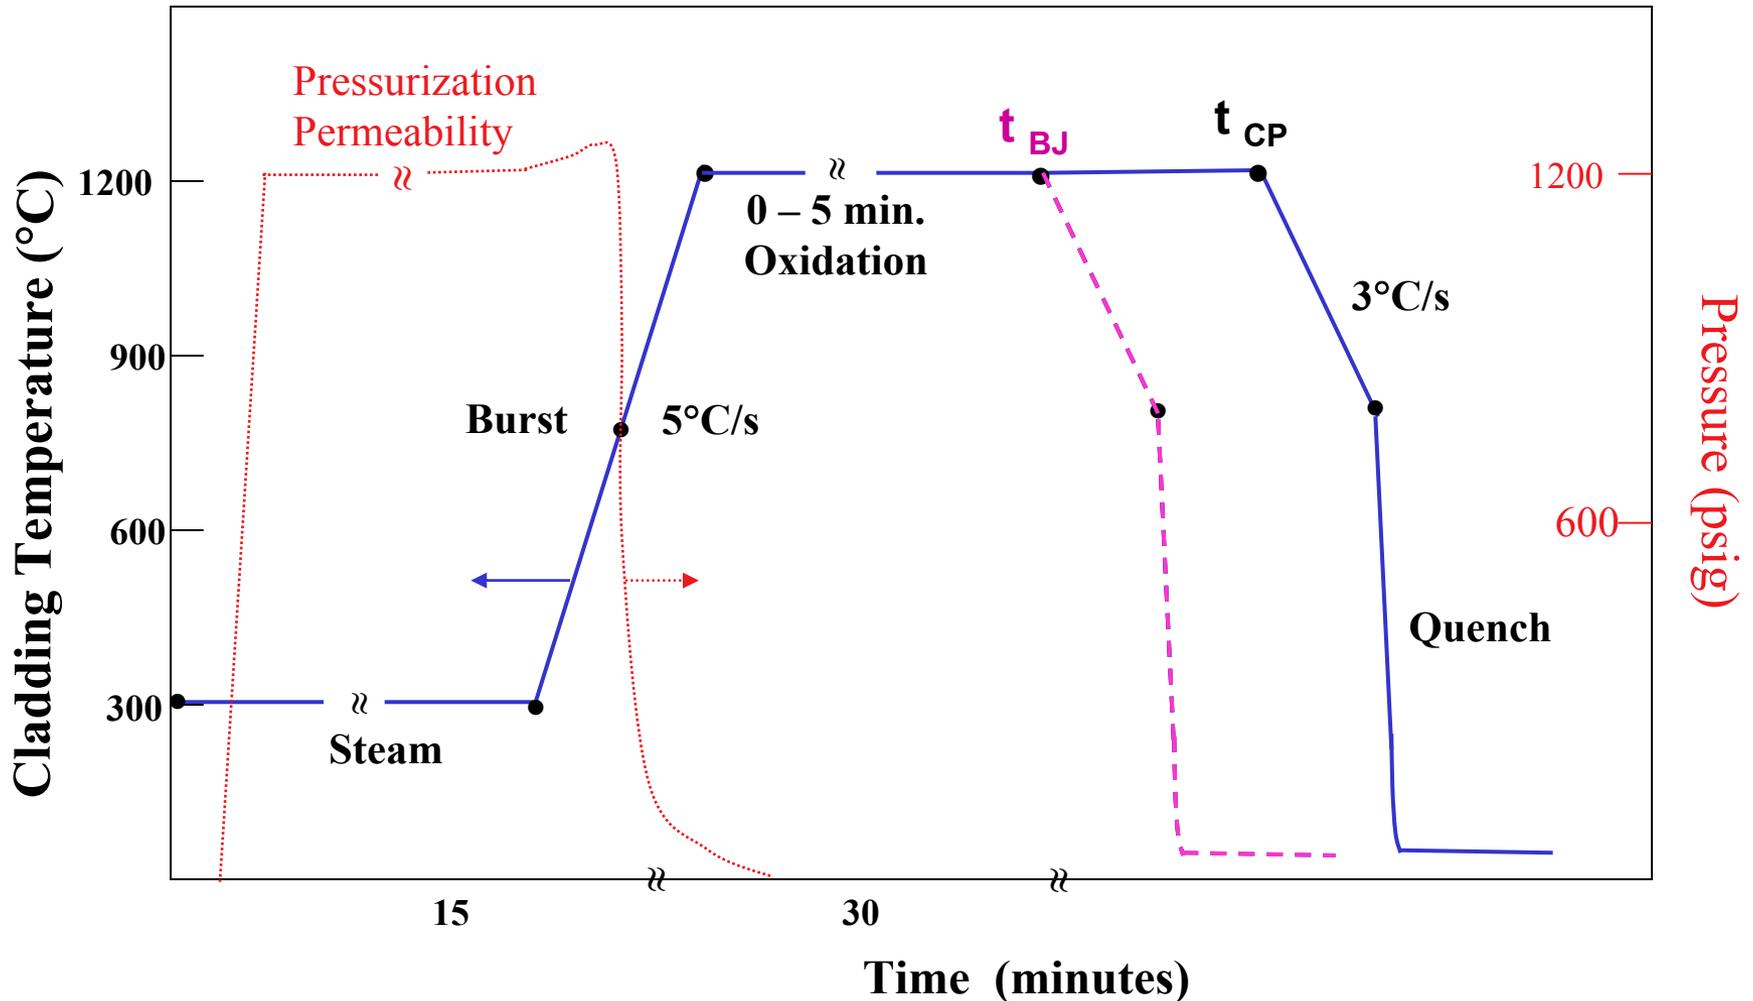
LOCA Integral Test Sequence & Time

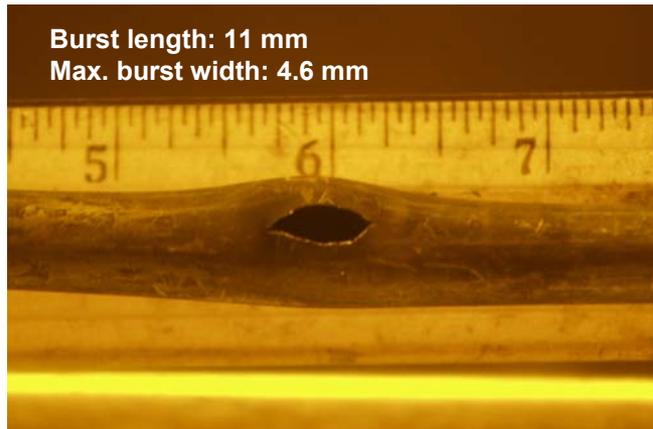
ICL#2: LOCA sequence with 5-minute oxidation at 1204°C and slow-furnace cooling

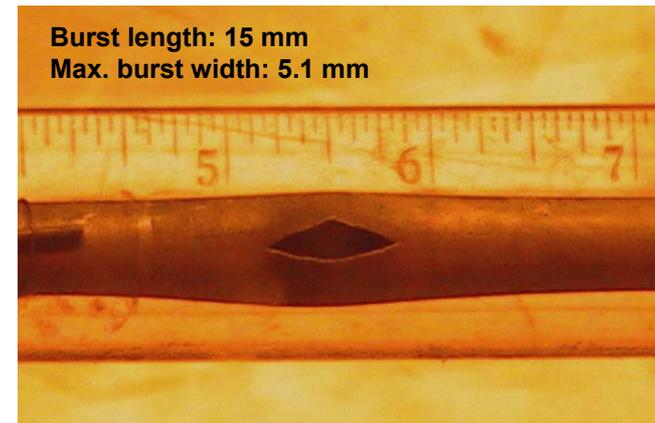
ICL#3: 5-min. oxidation at 1204°C followed by quench at 800°C (quartz tube failed at 480°C)

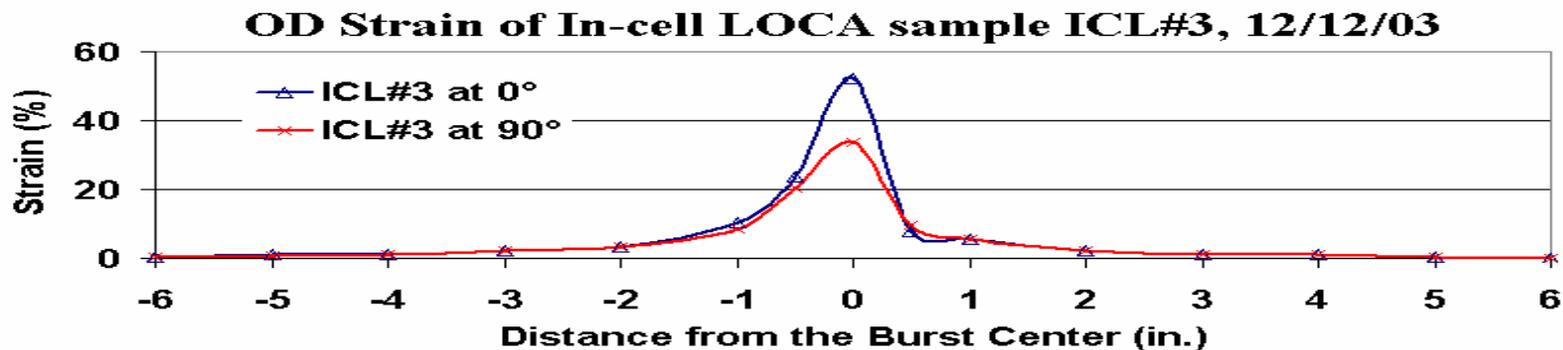
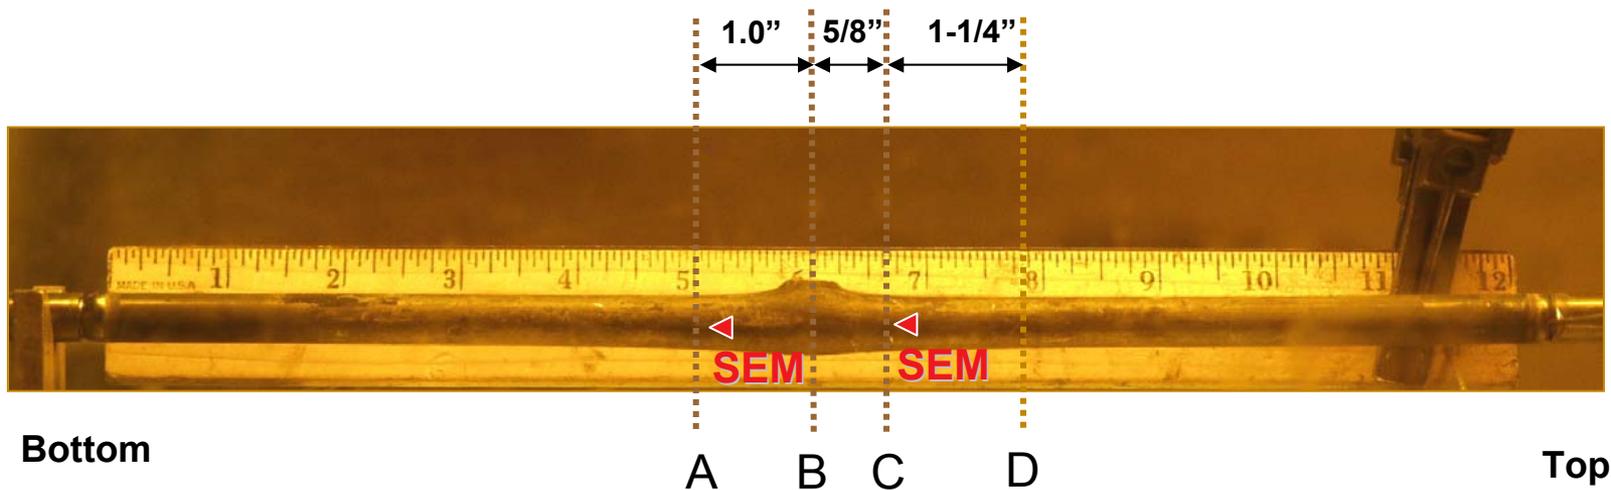
Post-test Characterization for ICL#3 Specimen

Sample ICL#3 was broken at locations A, B and C during the sample handling before the sectioning was performed at location D.

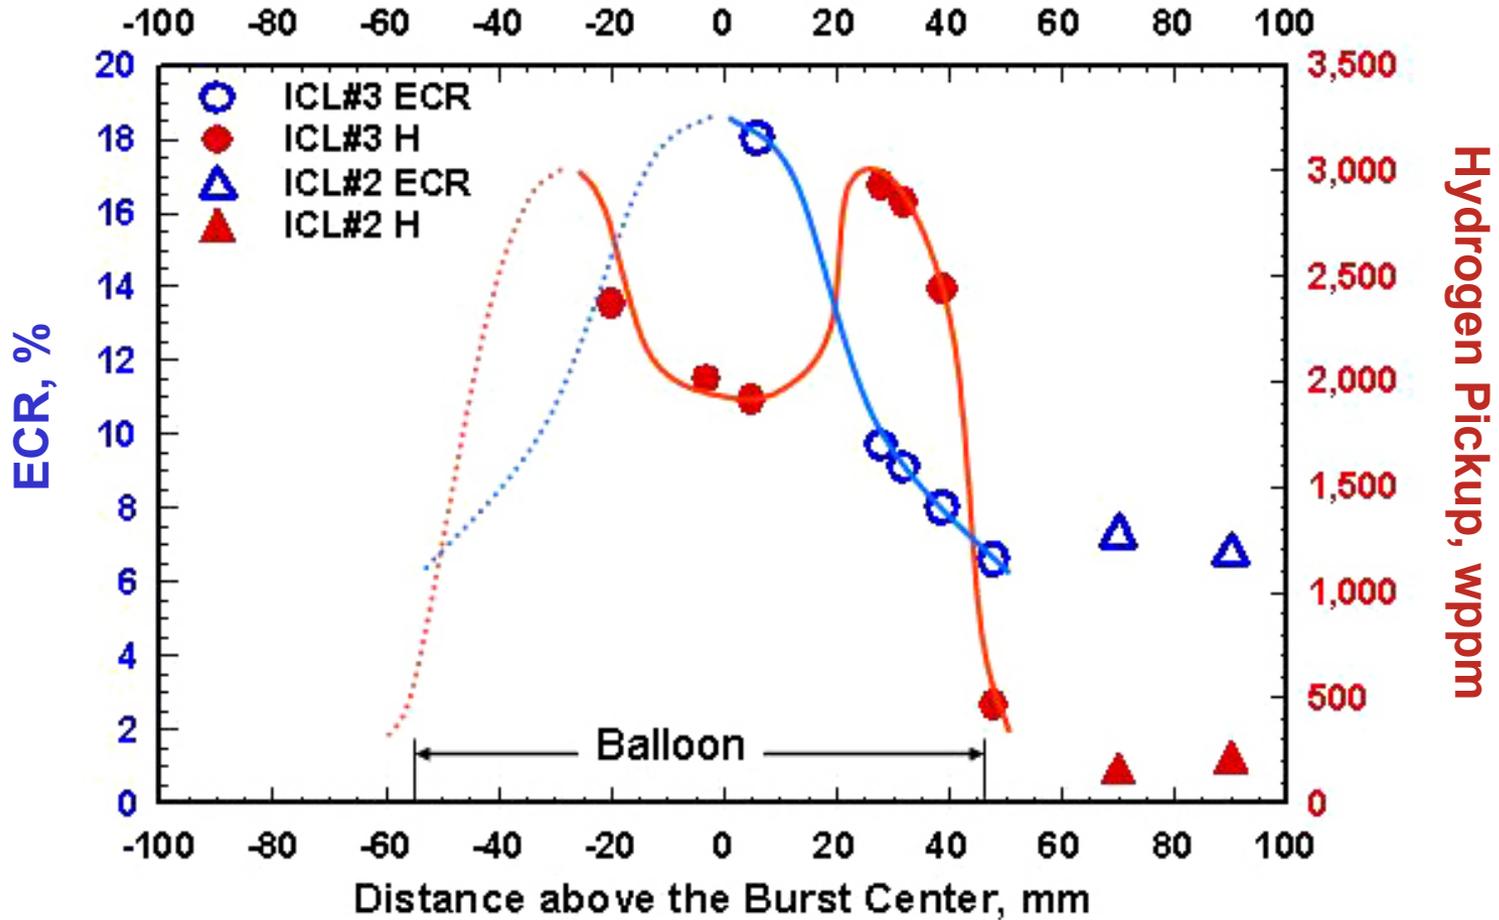
H and O Analyses of ICL#2 and ICL#3

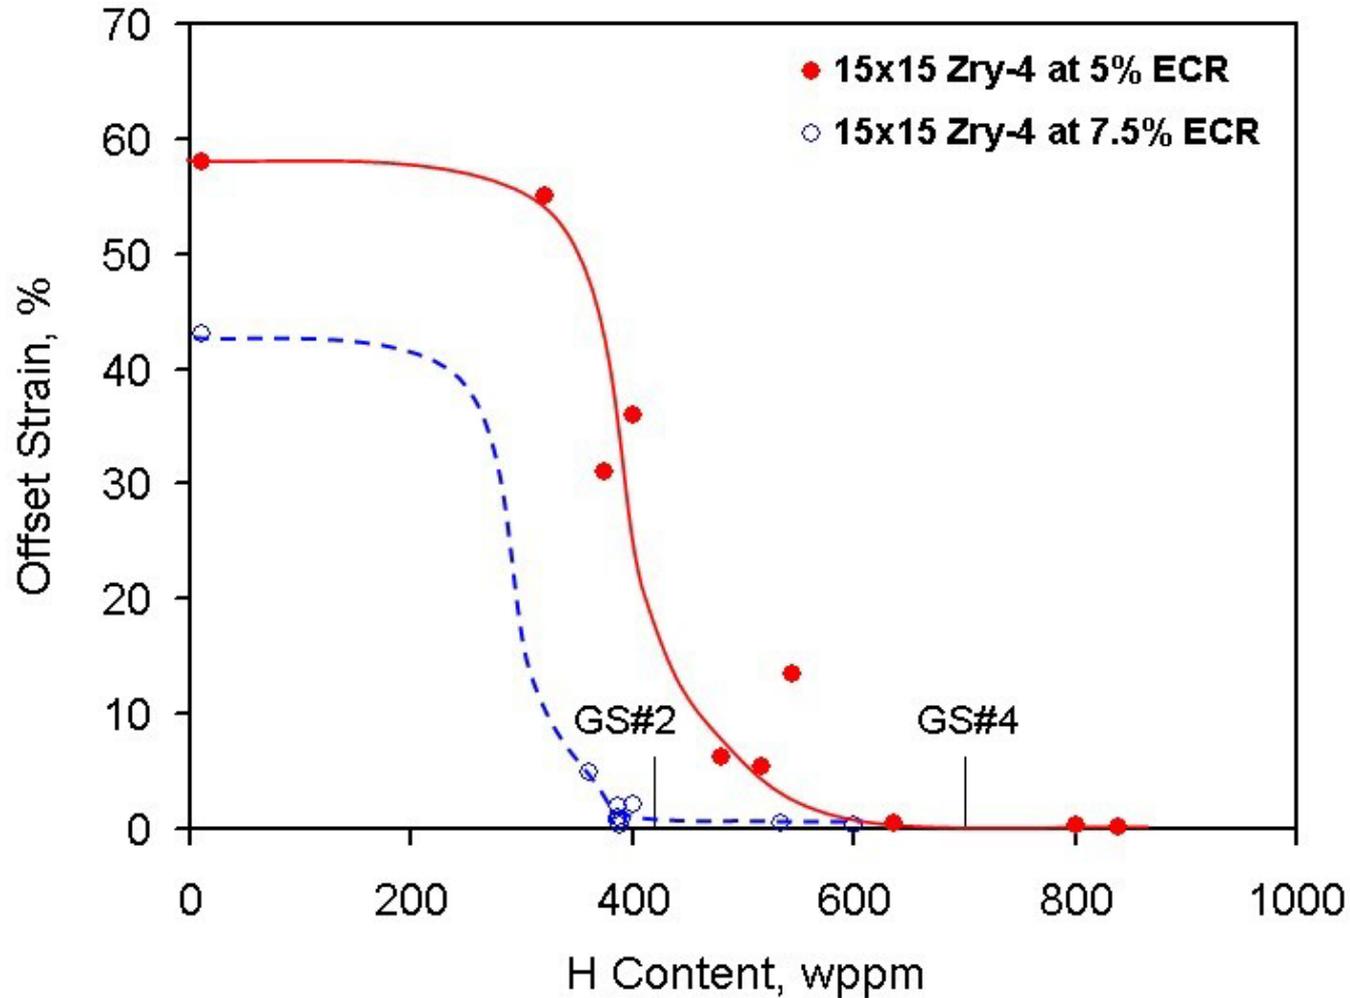
Post-Quench Ductility at 135°C vs. Hydrogen Content for Prehydrated 15x15 Zry-4 Oxidized at 1204±10°C

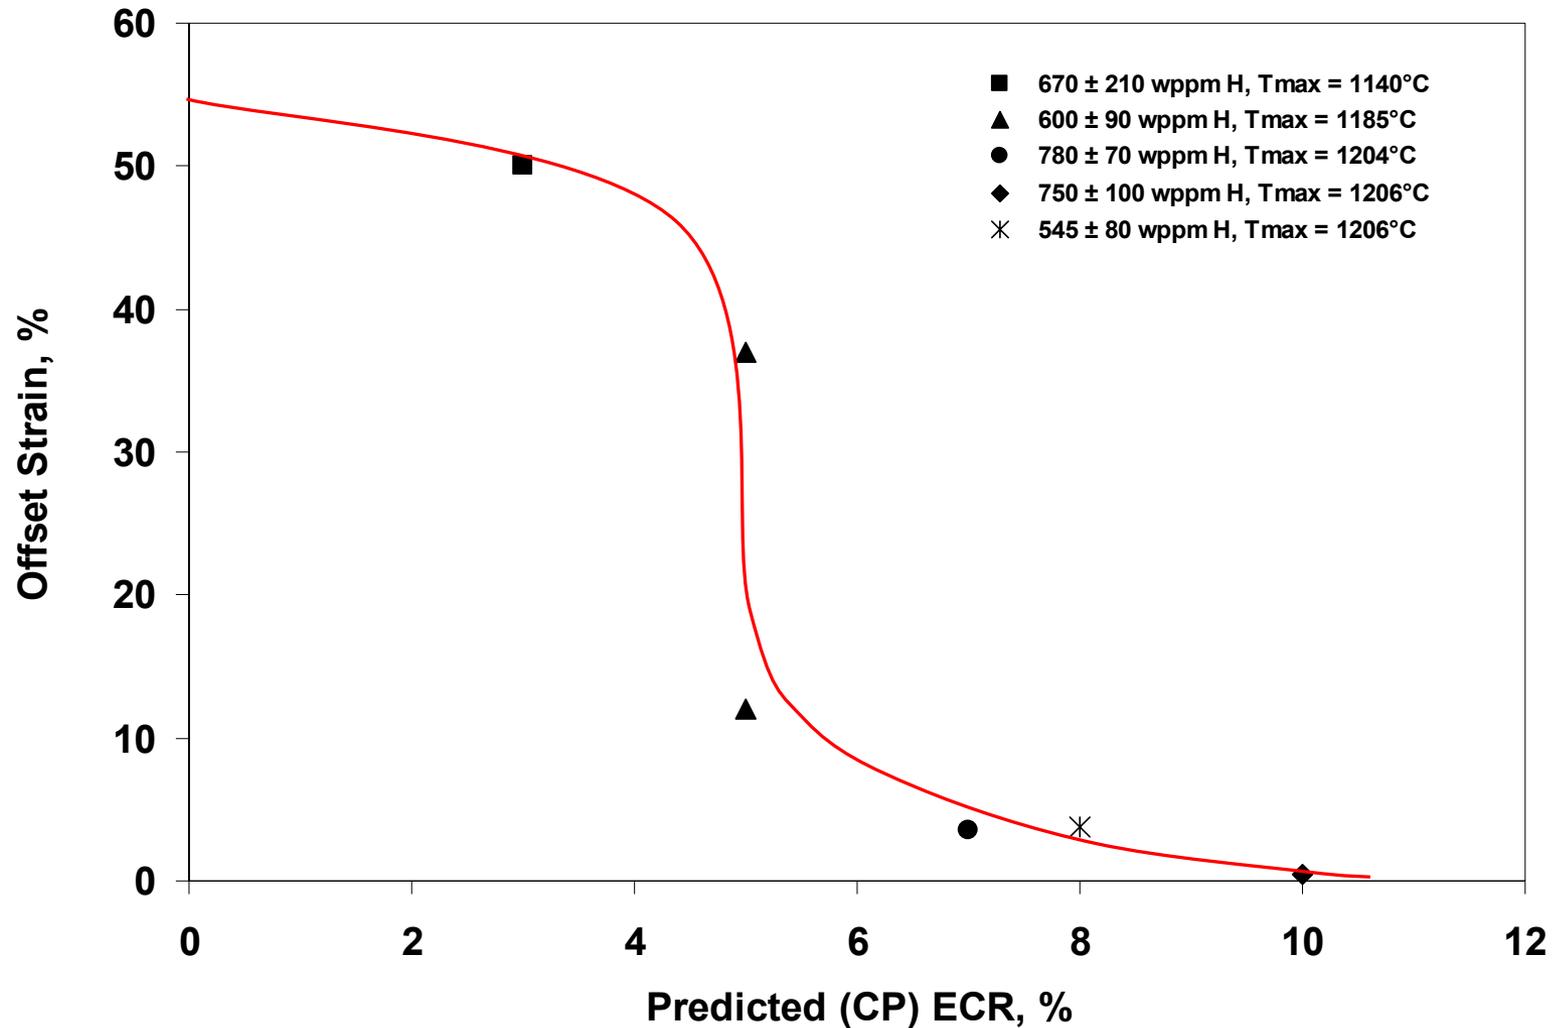
Summary of Post-Oxidation Ductility (Offset Strain) at 135°C vs. CP-ECR for High-Burnup Zry-4 Cladding

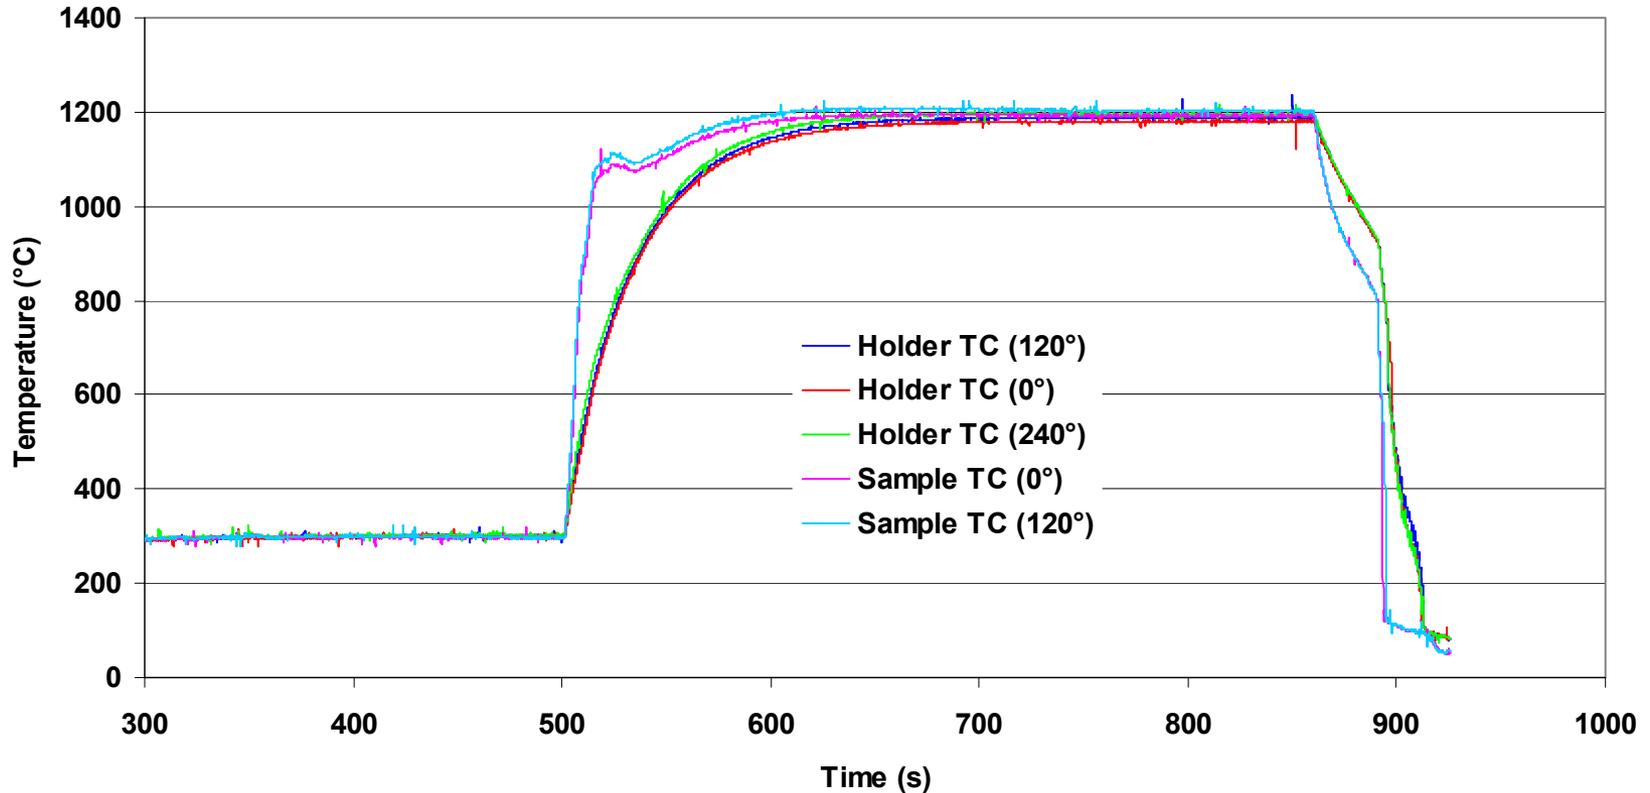
Comparison of Inconel Holder TC Readings vs. Cladding Sample TC Readings

Benchmark Test HBRU#20 at 1204°C, 6/16/2004

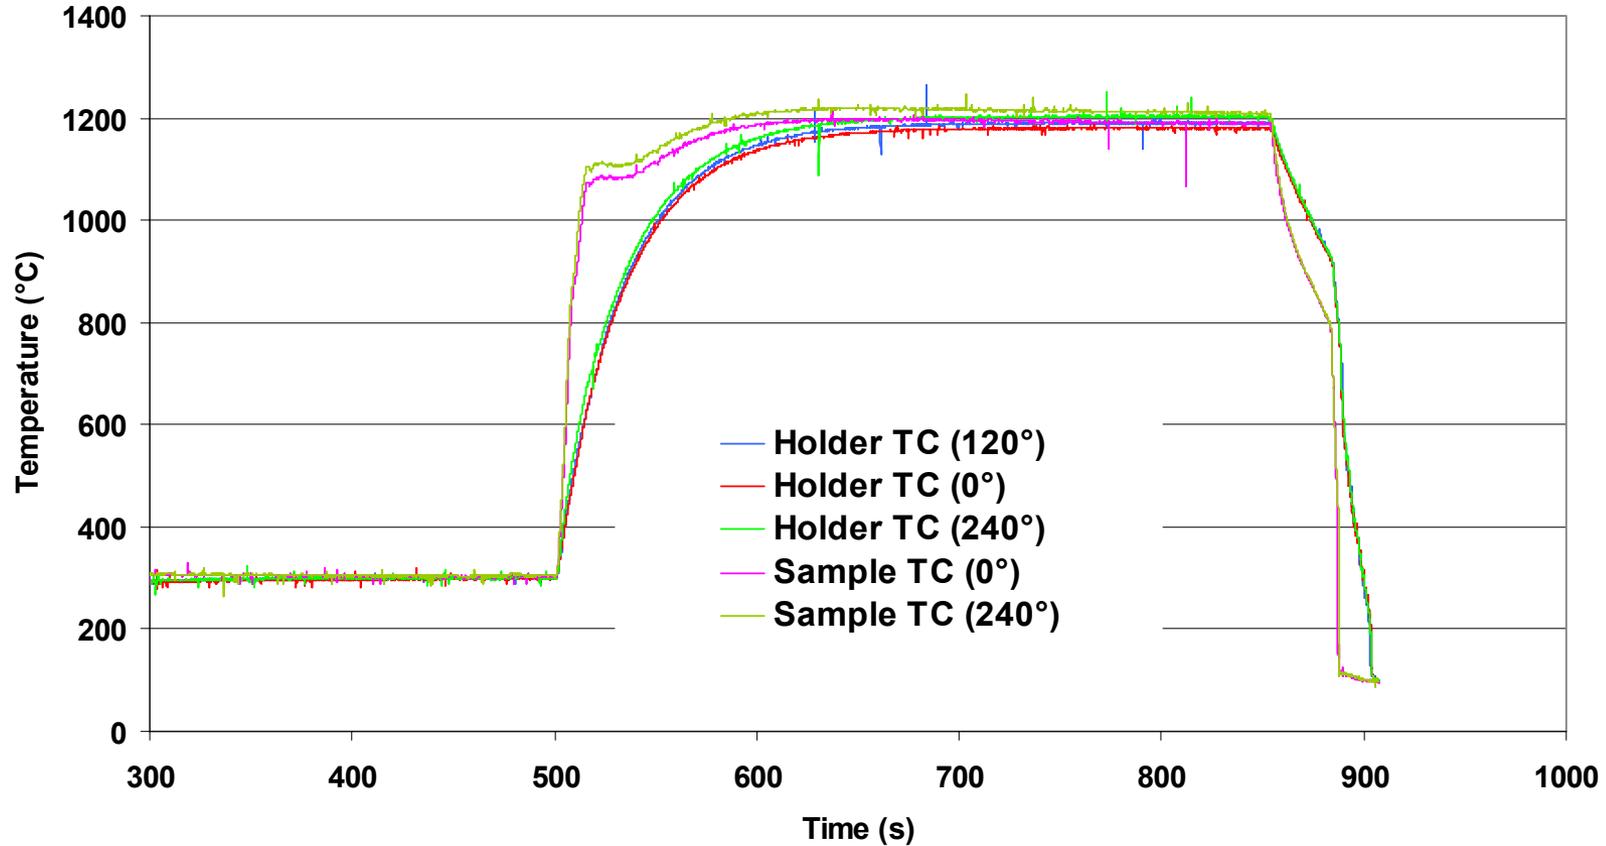
Comparison of Inconel Holder TC Readings vs. Cladding Sample TC Readings (Cont'd)

Benchmark Test HBRU#29 at 1204°C, 6/29/04

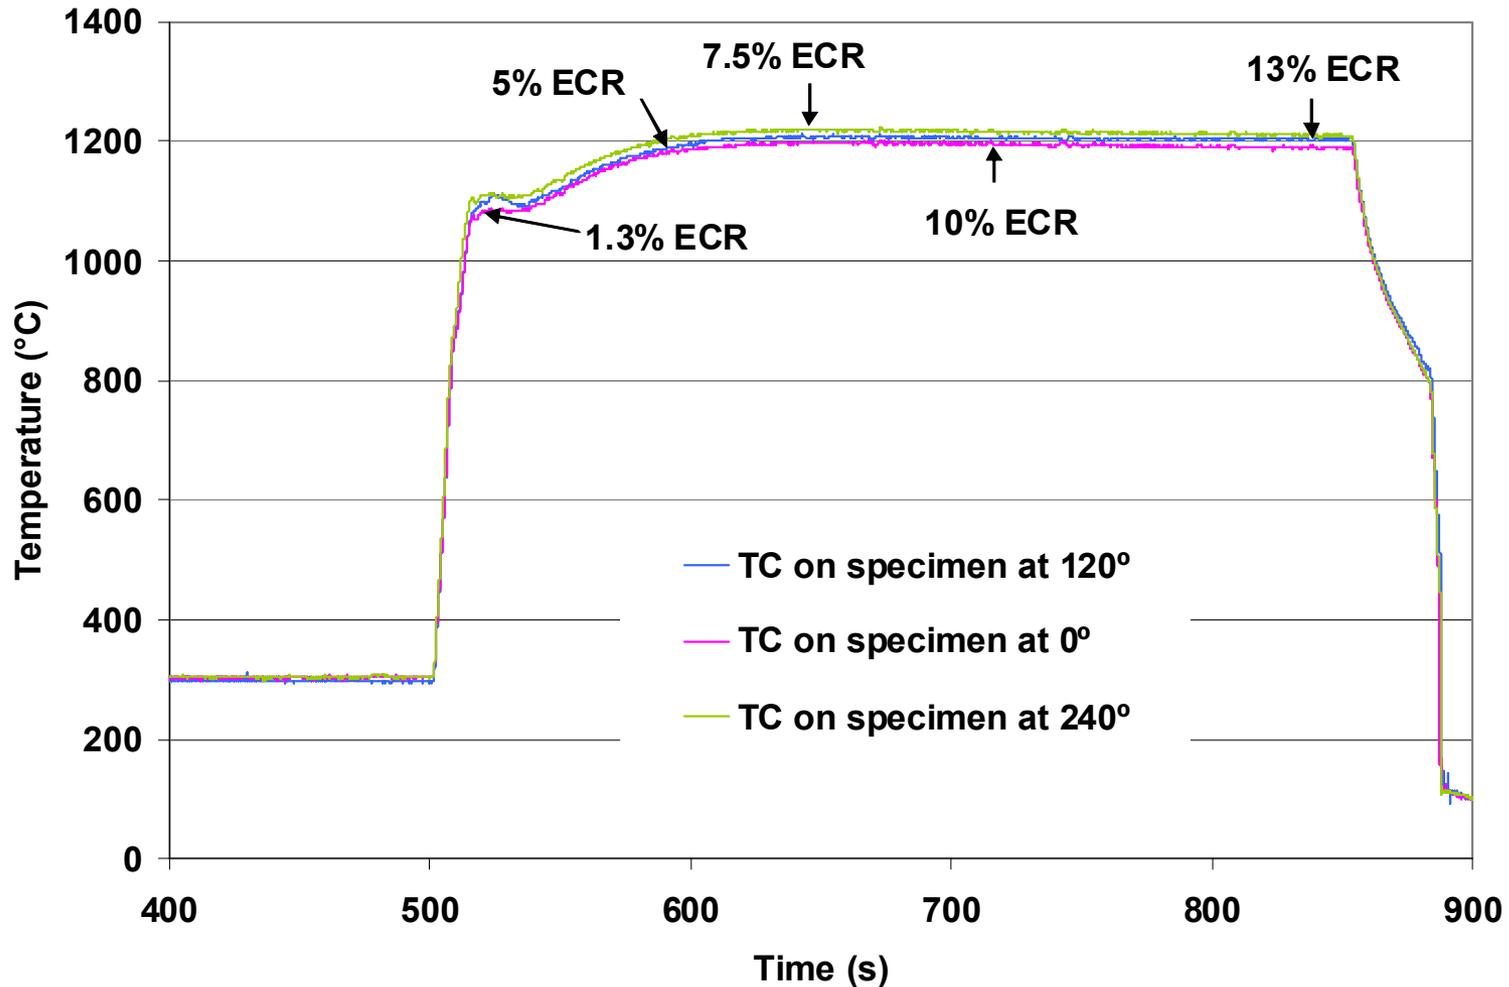
Temperature History for $1204 \pm 10^\circ\text{C}$ Steam Oxidation of 15×15 Zry-4 Post-Quench-Ductility Samples

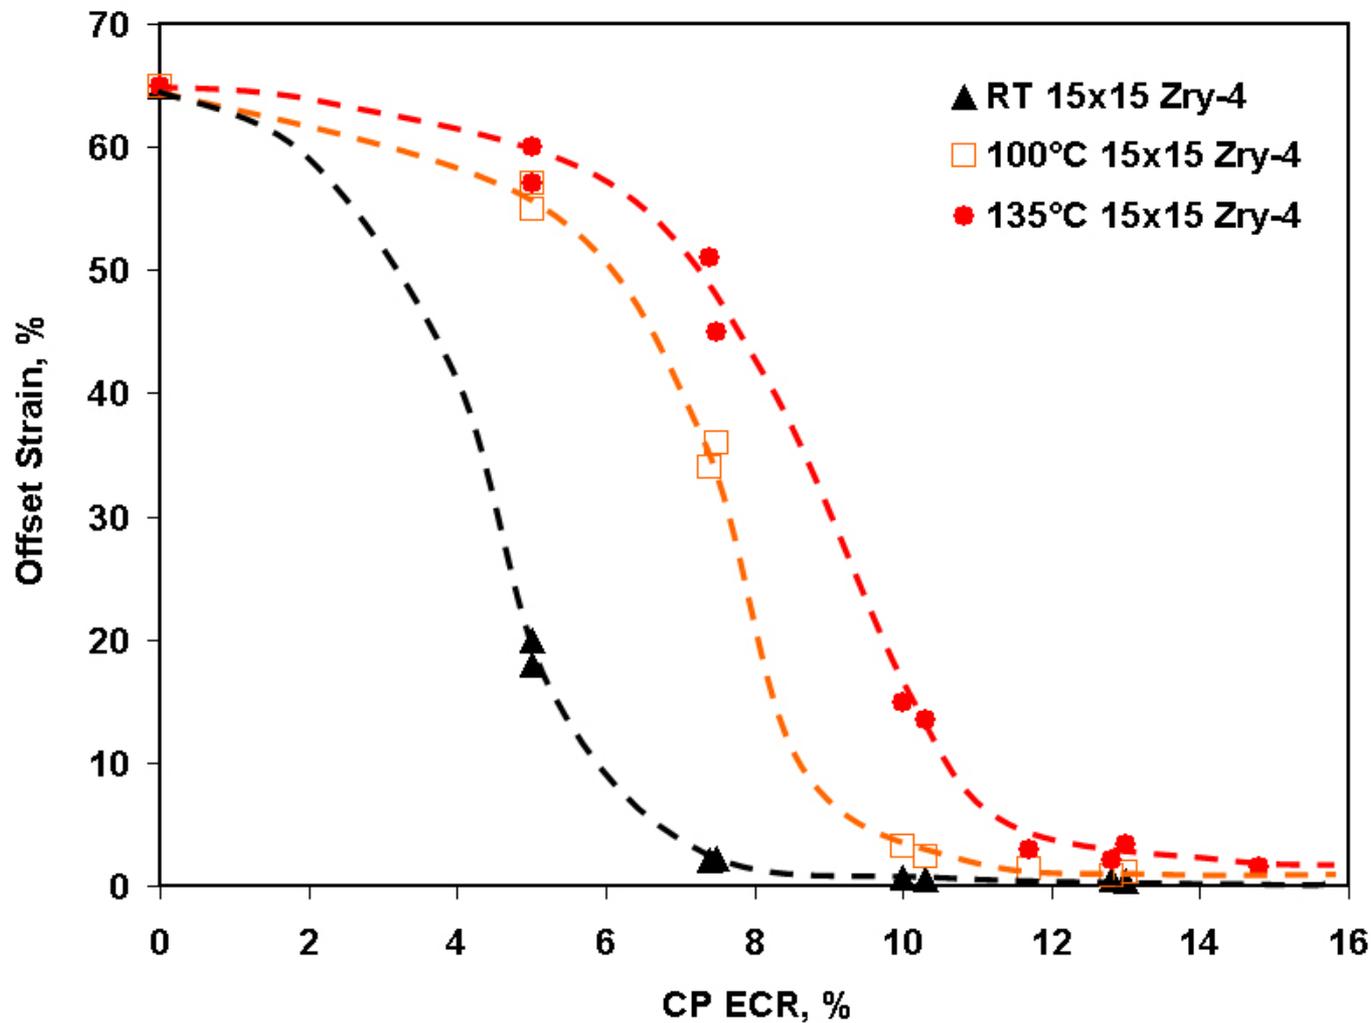
Offset Strain vs. CP-ECR for As-Received 15x15 Zry-4 Oxidized at 1204±10°C
