H.B. Robinson High-Burnup PWR Oxidation and Post-Quench Ductility

M. Billone, Y. Yan, T. Burtseva and H. Chung
Energy Technology Division
Argonne National Laboratory
February 10, 2005

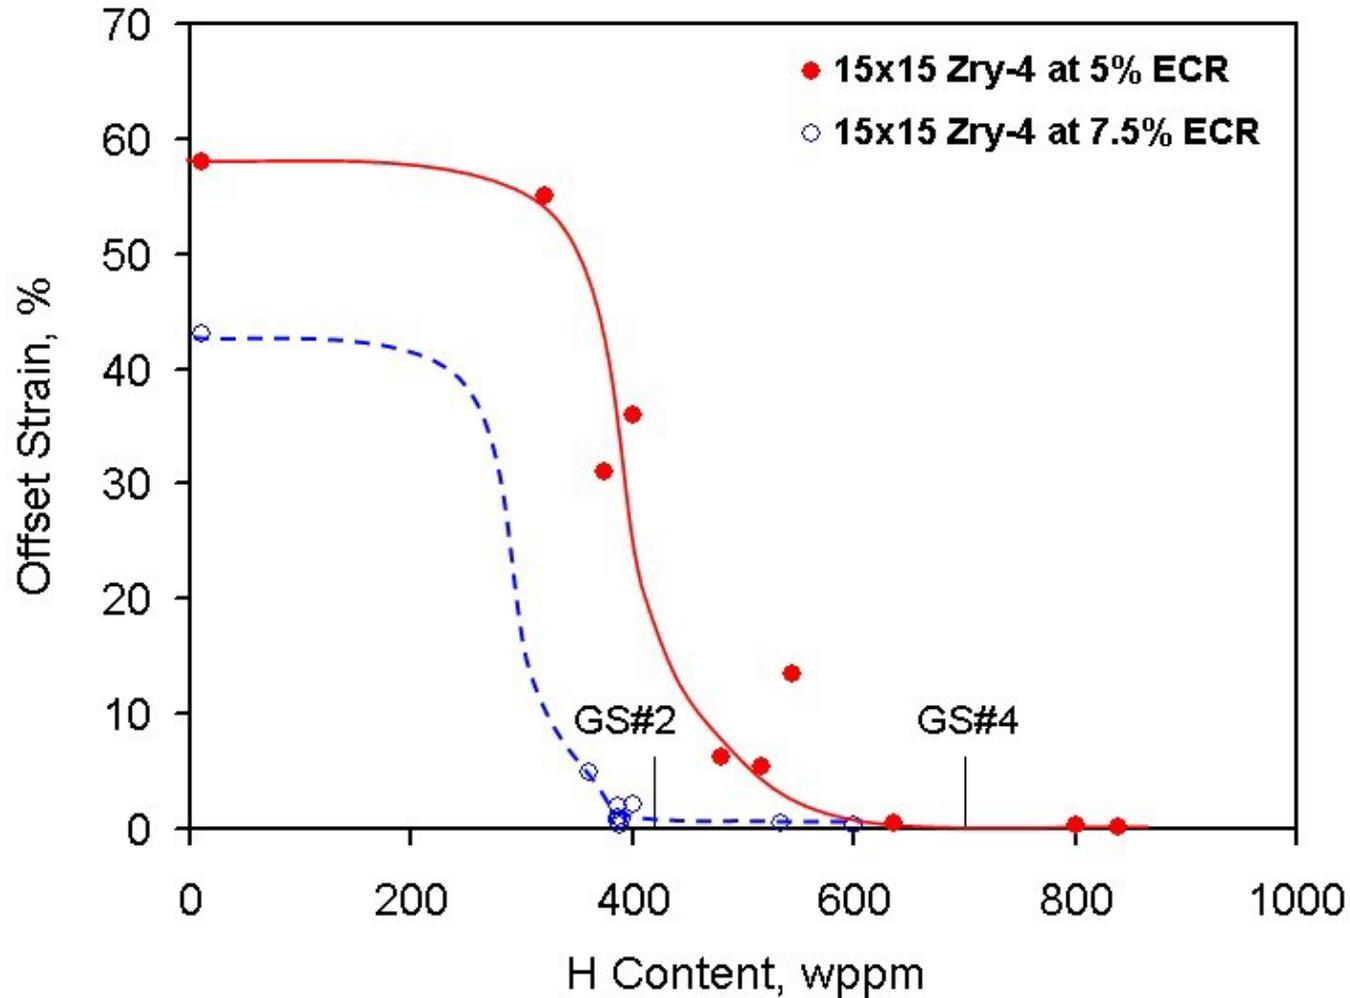
Post-Quench Ductility at 135°C vs. Hydrogen Content for Prehydrated 15x15 Zry-4 Oxidized at 1204±10°C

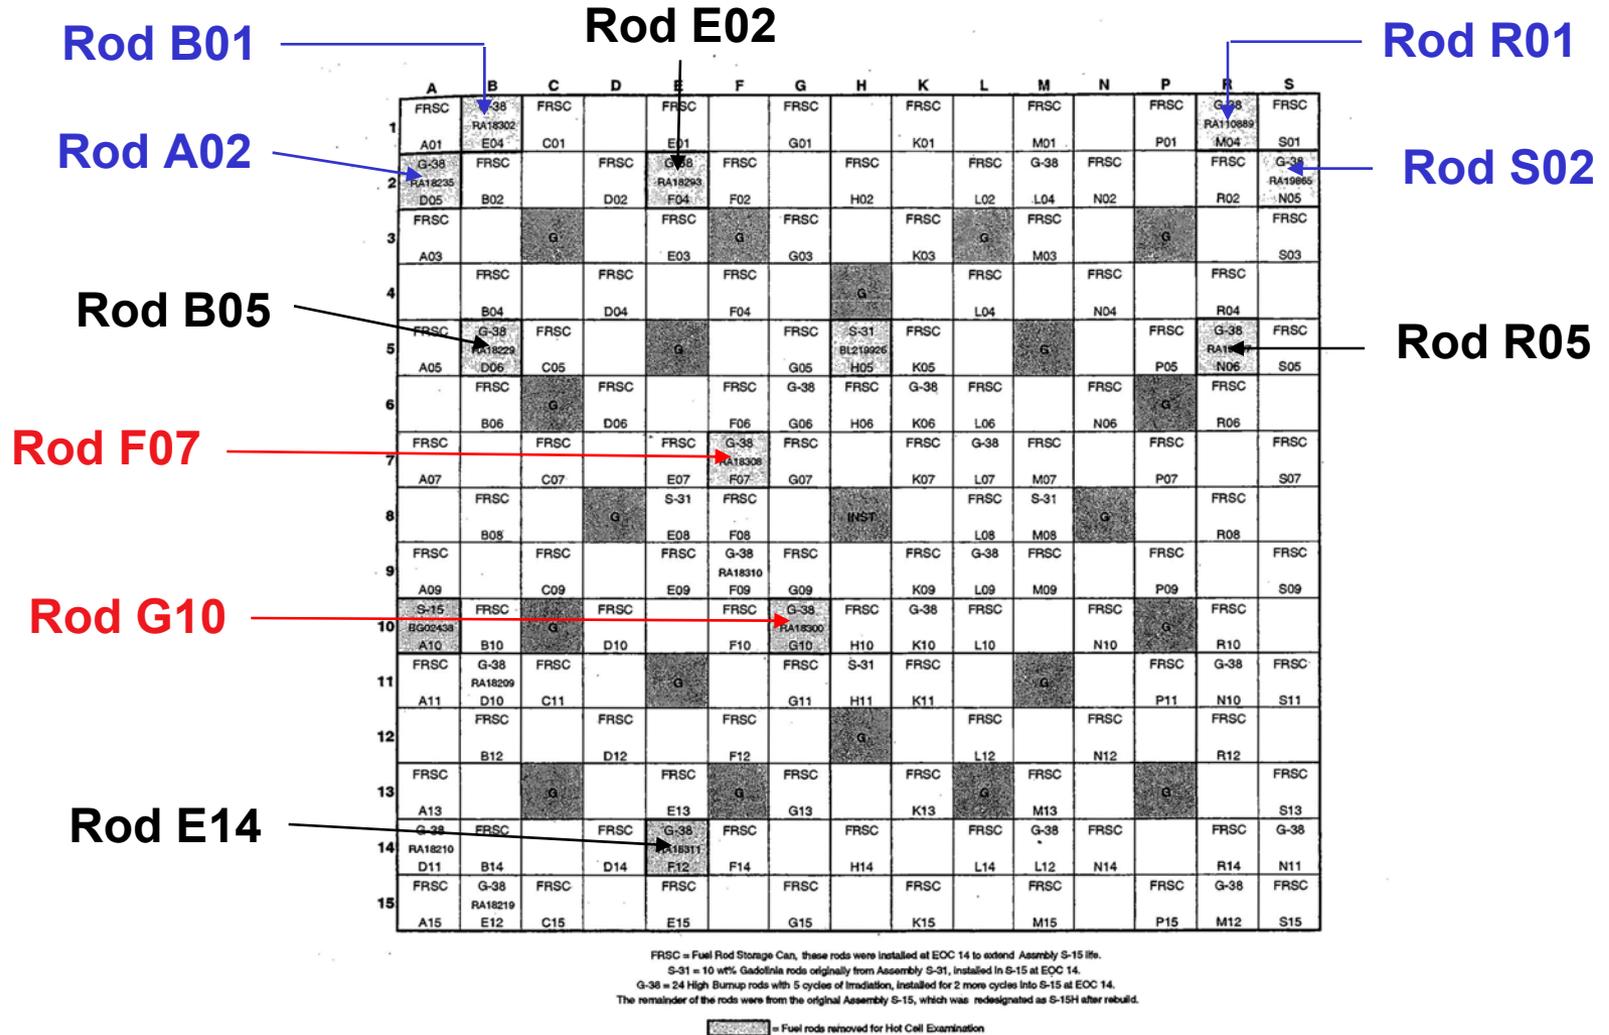
Final Configuration of HBR Rods

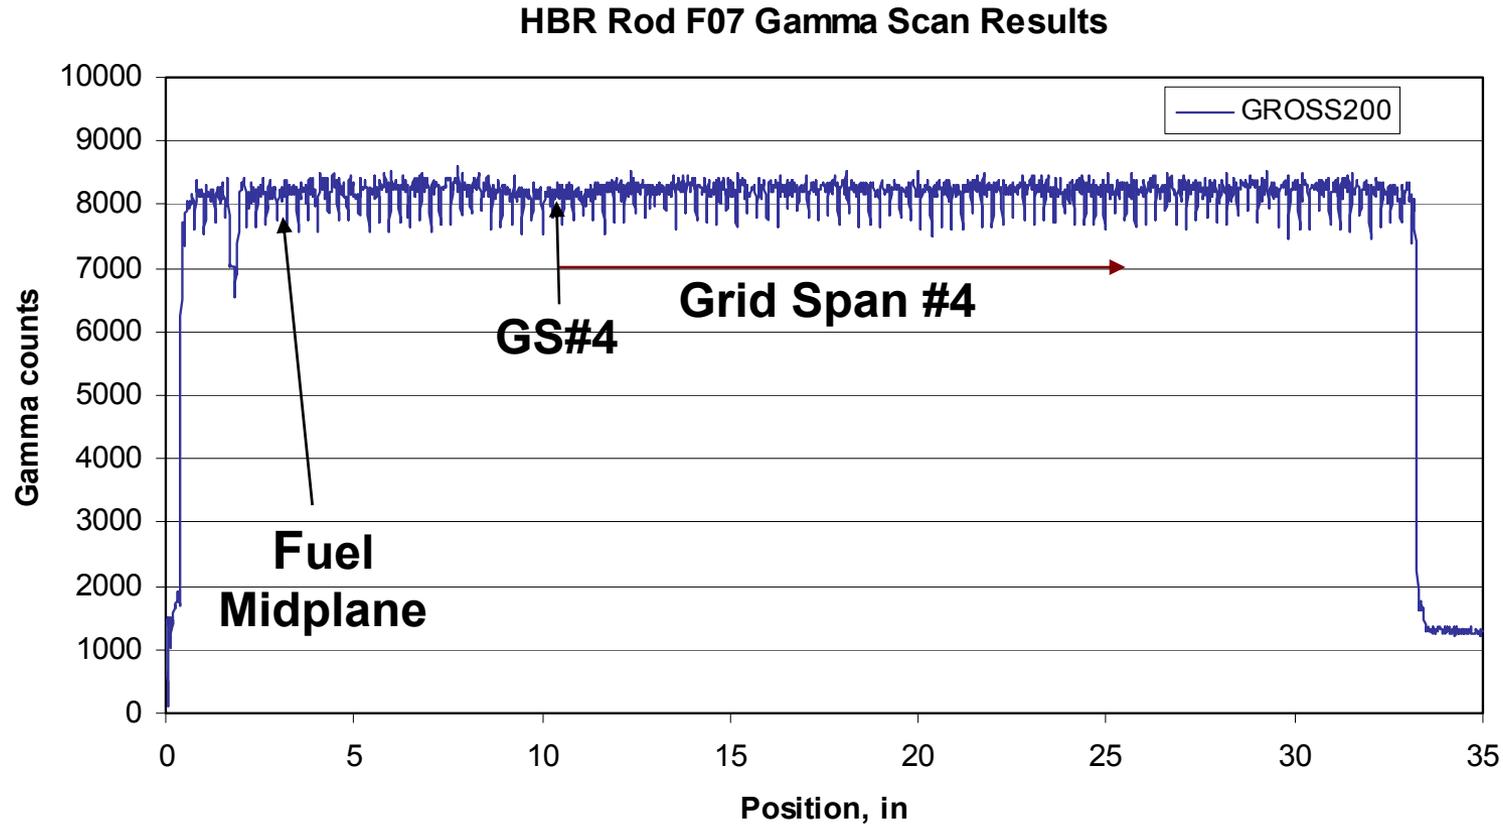
Gamma Scan Results: Mid-segment (C) of HBR Rod F07

Note: Dips at Pellet-Pellet Interfaces Every ≈ 7 mm

- **Gamma Scanning of Middle Segment (C)**
 - Middle of grid spacer #4 is ≈ 250 mm from bottom of Segment C
 - Fuel midplane is ≈ 160 mm below center of grid spacer #4
- **Characterization, Oxidation, LOCA Sample Locations**
 - Metallography at 50 mm, 300 mm & 660 mm above fuel midplane
 - H & O analysis at 25 mm, 320 mm and 650 mm above fuel midplane
 - Oxidation samples at -40 to 100 mm above fuel midplane
- **Characterization Results**
 - **Fuel morphology: heat generation and T are not axisymmetric!**
 - **Metallography at +50 mm : oxide layer thickness = 71 ± 5 μm**
Hydride morphology: relatively uniform in hoop (θ) direction
 - **H-content: 760 ± 60 wppm at +13 mm; 670 ± 80 wppm at +32 mm**
Too high and too much axial variation: pellet-pellet interfaces??
 - **O-content: 2.08 ± 0.19 wt.% at +35 mm above midplane**

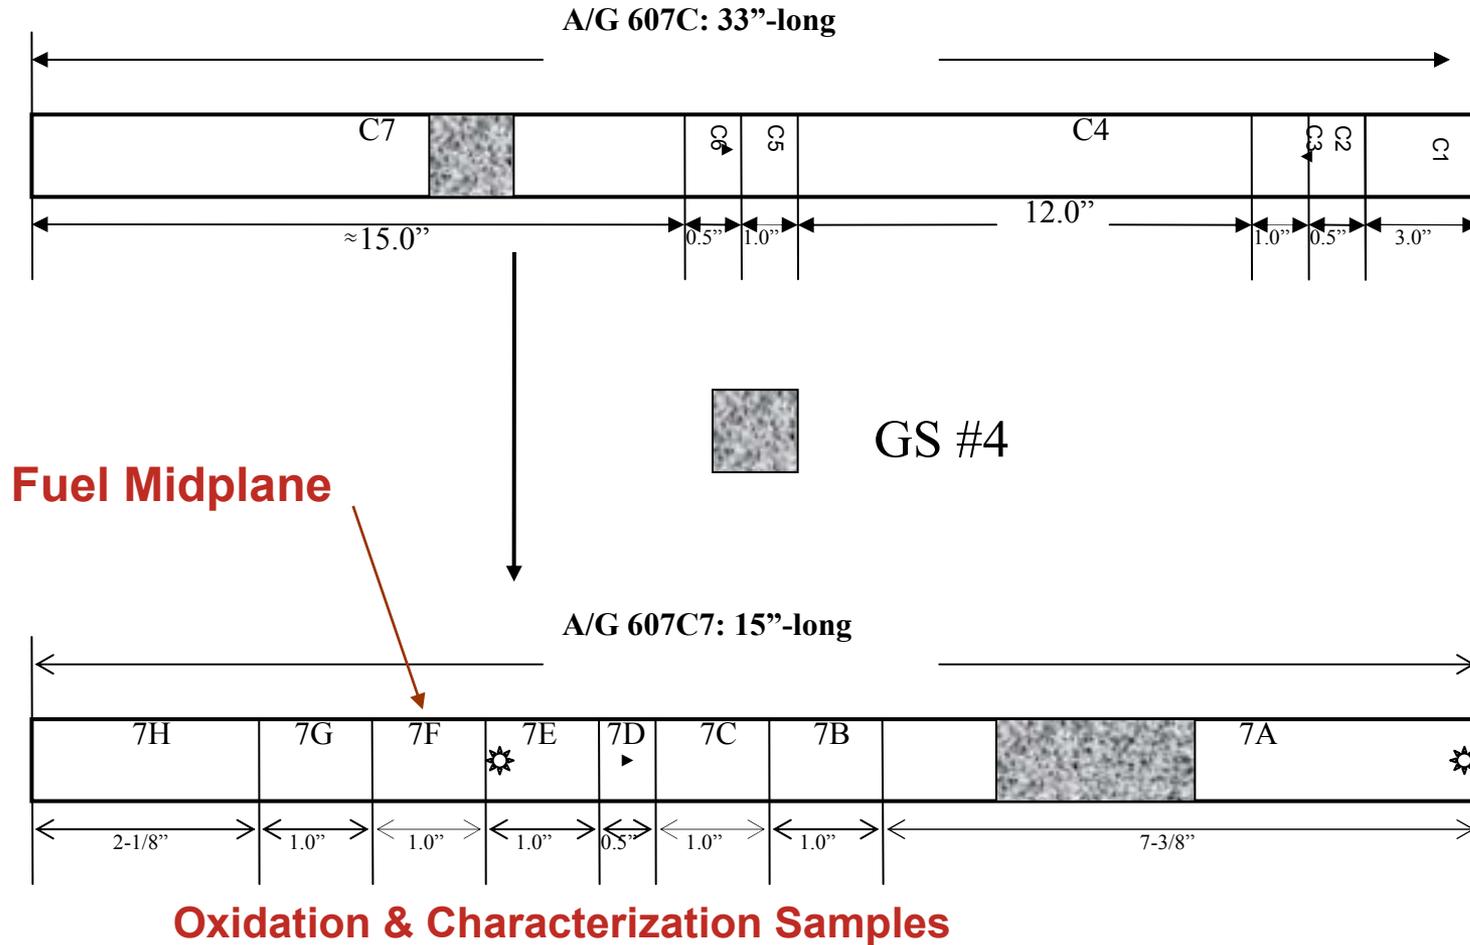
Sectioning Diagram for HBR Rod F07 Segment C

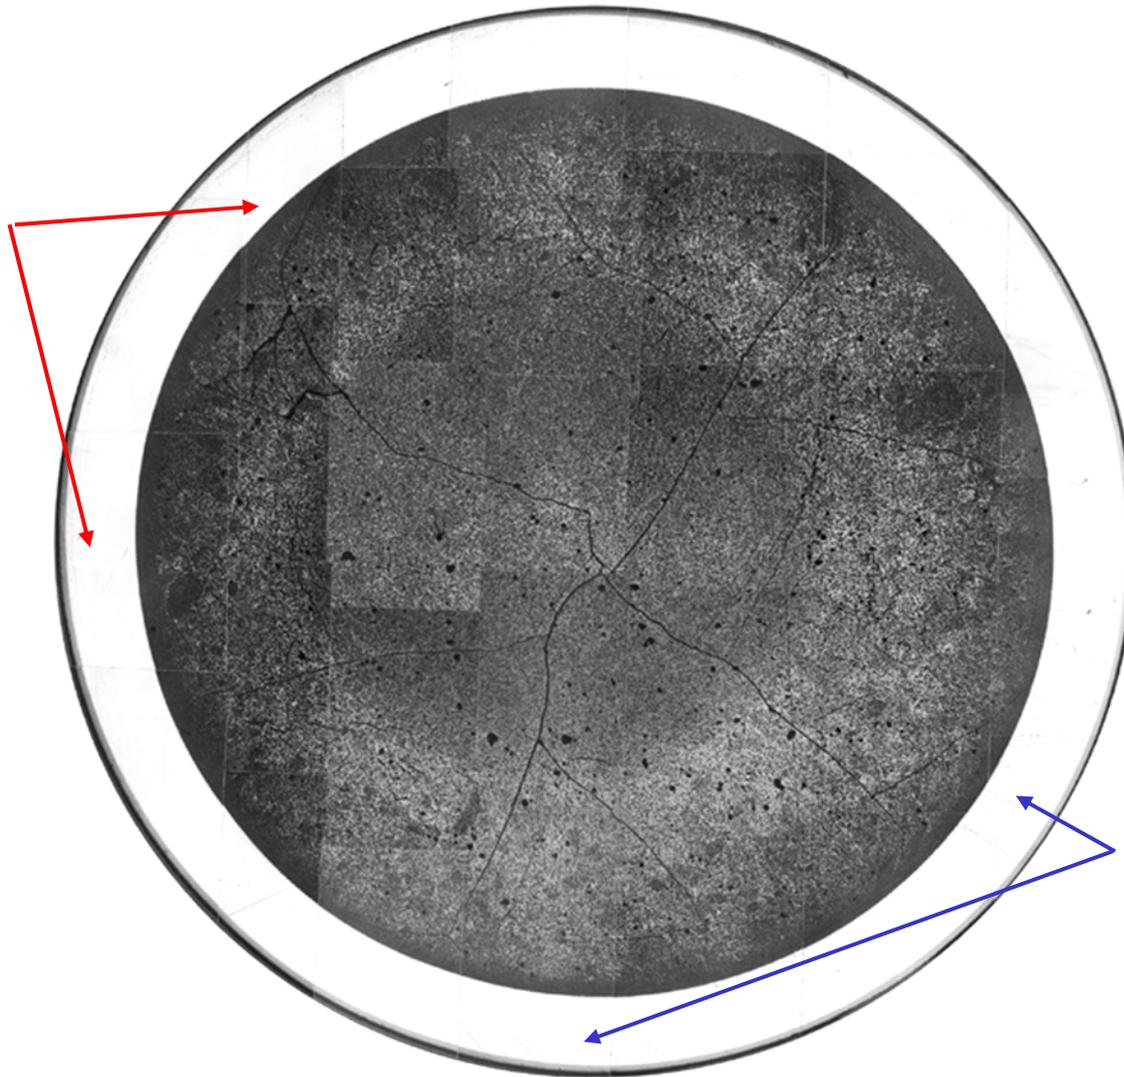
Fuel Mosaic for HBR Rod F07 Cladding at ≈50 mm above Fuel Midplane

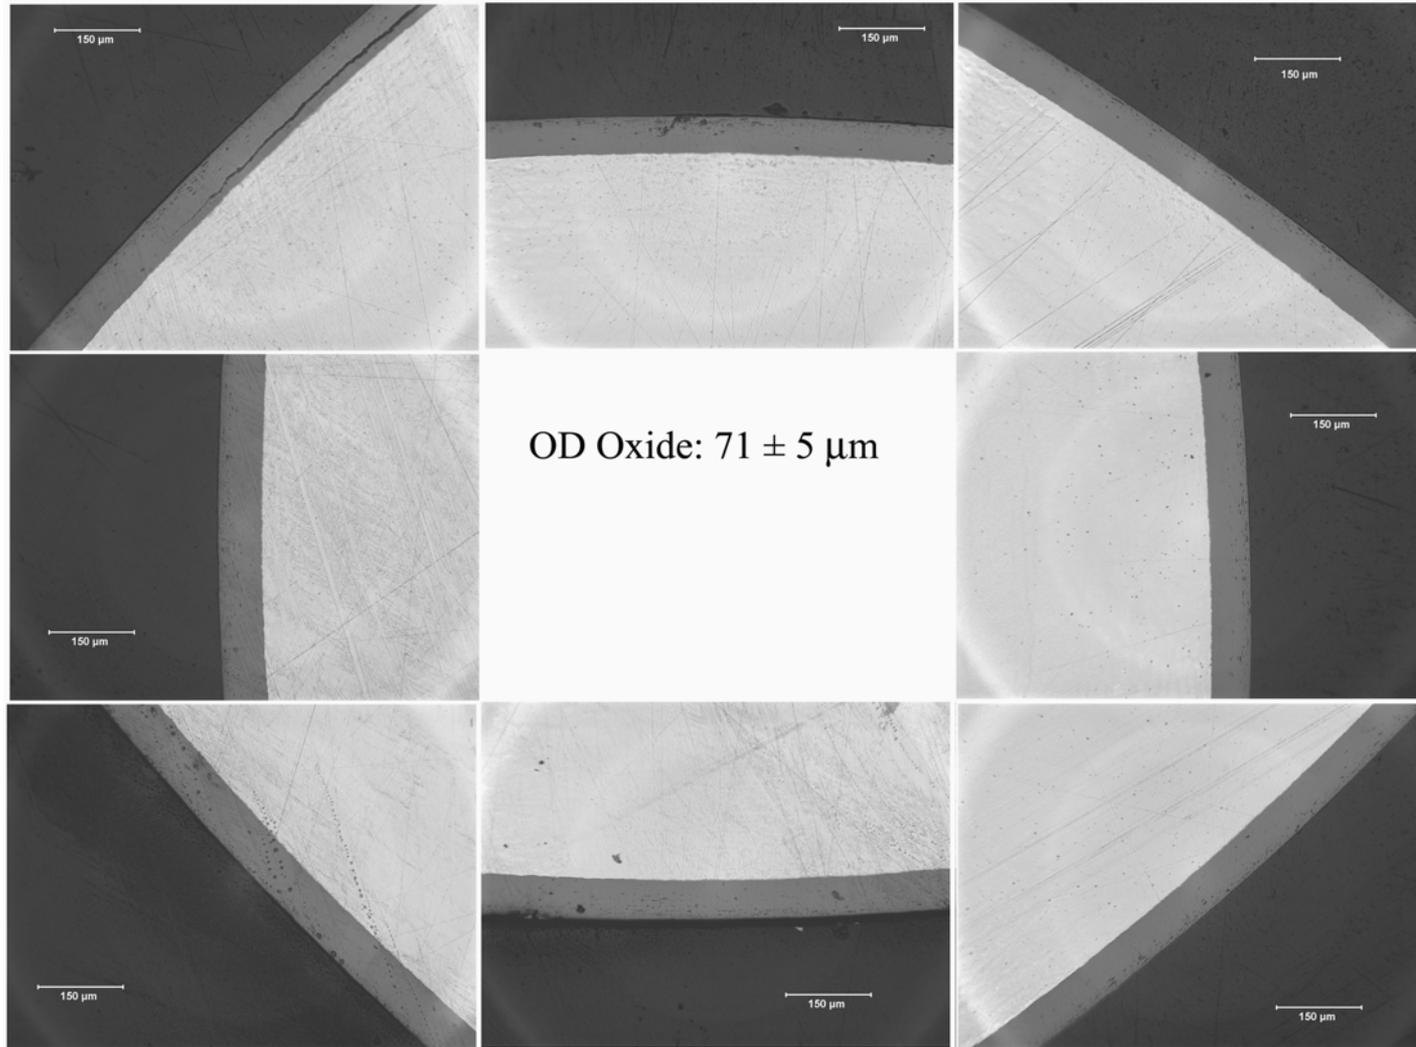
Oxide Layer Thickness for HBR Rod F07 Cladding at ≈ 50 mm above Fuel Midplane

- Oxide layer thickness: F07 ($71 \pm 5 \mu\text{m}$) consistent with A02 ($70 \pm 5 \mu\text{m}$)
- Oxygen content of as-irradiated cladding
Predicted assuming PB ratio of 1.75: 2.09 wt. %
Measured at +35 mm: 2.08 ± 0.19 wt. % (good agreement)
Measured at +10 mm: 1.99 ± 0.40 wt. % (some oxide lost during cutting)

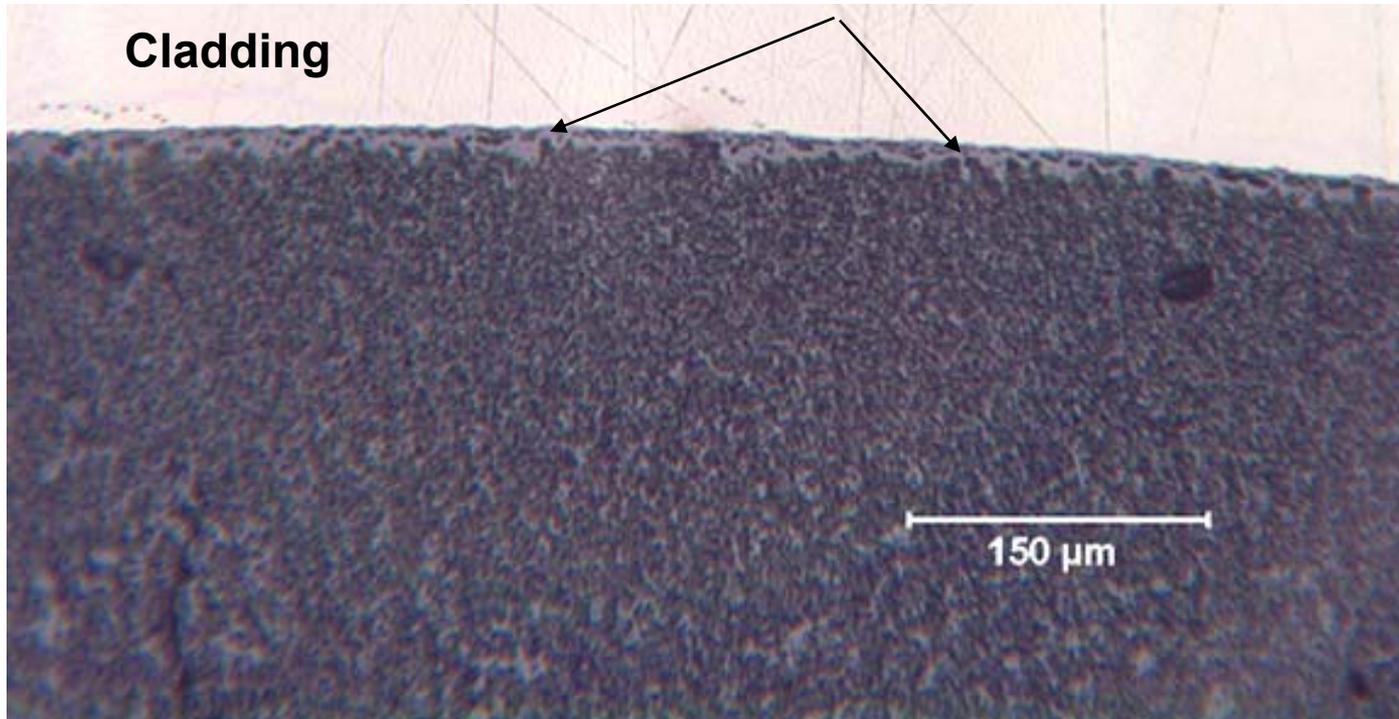
Fuel-Cladding Interface for HBR Rod F07 Cladding at ≈50 mm above Fuel Midplane

**Fuel-Cladding Bond: $\approx 11 \pm 4 \mu\text{m}$
(Remains after Defueling in RT HNO_3)**

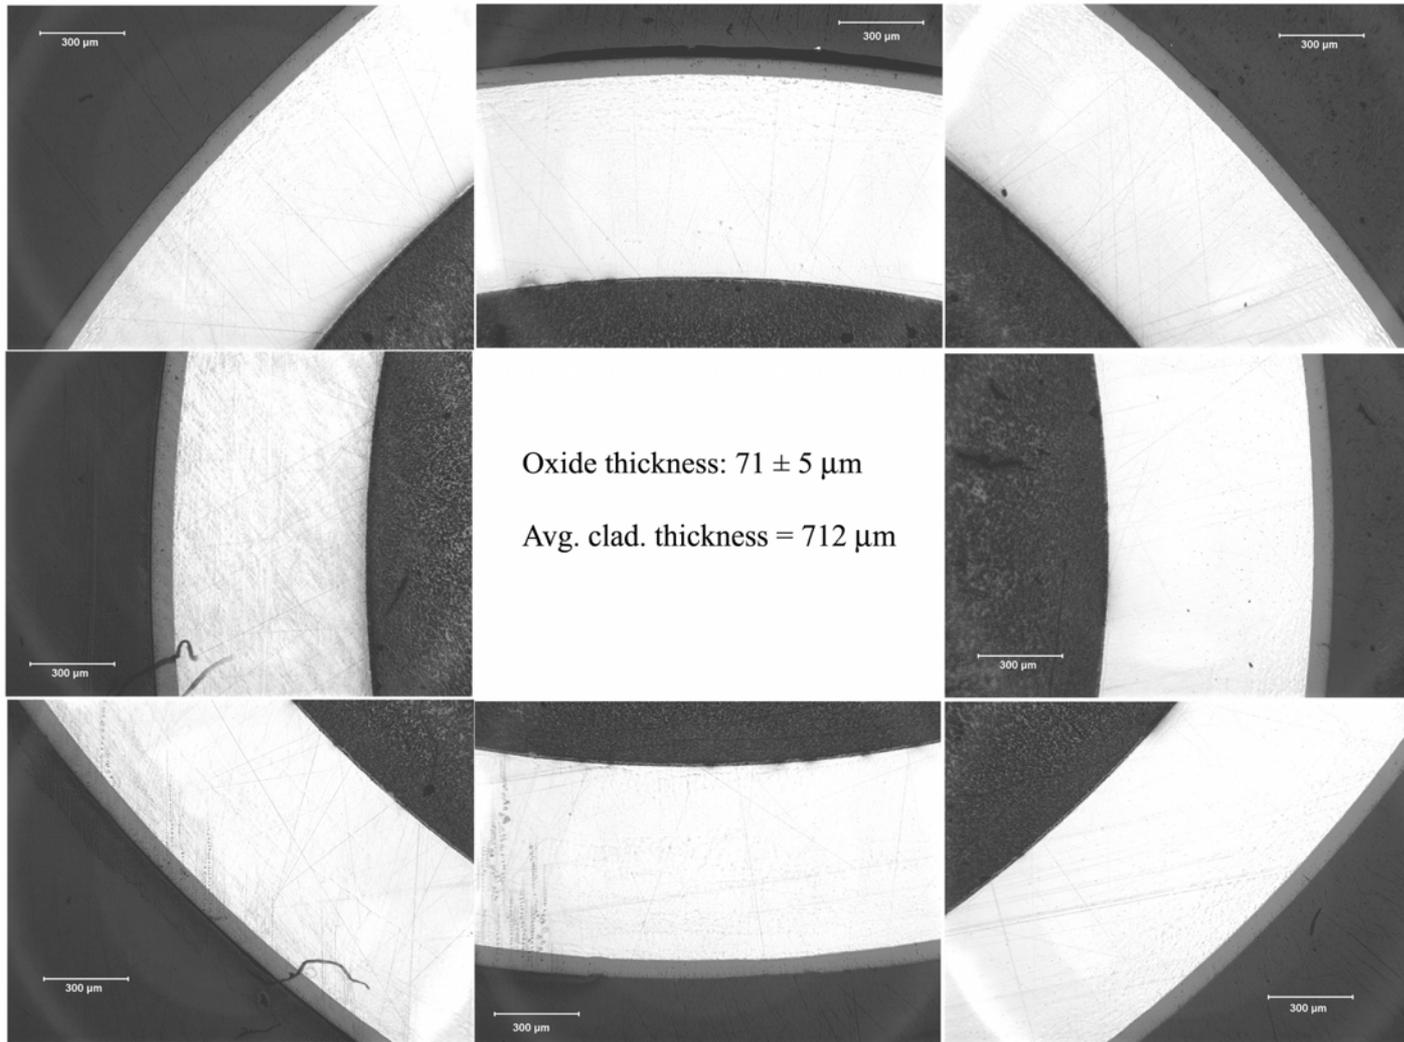
Average Wall Thickness for HBR Rod F07 Cladding at ≈ 50 mm above Fuel Midplane

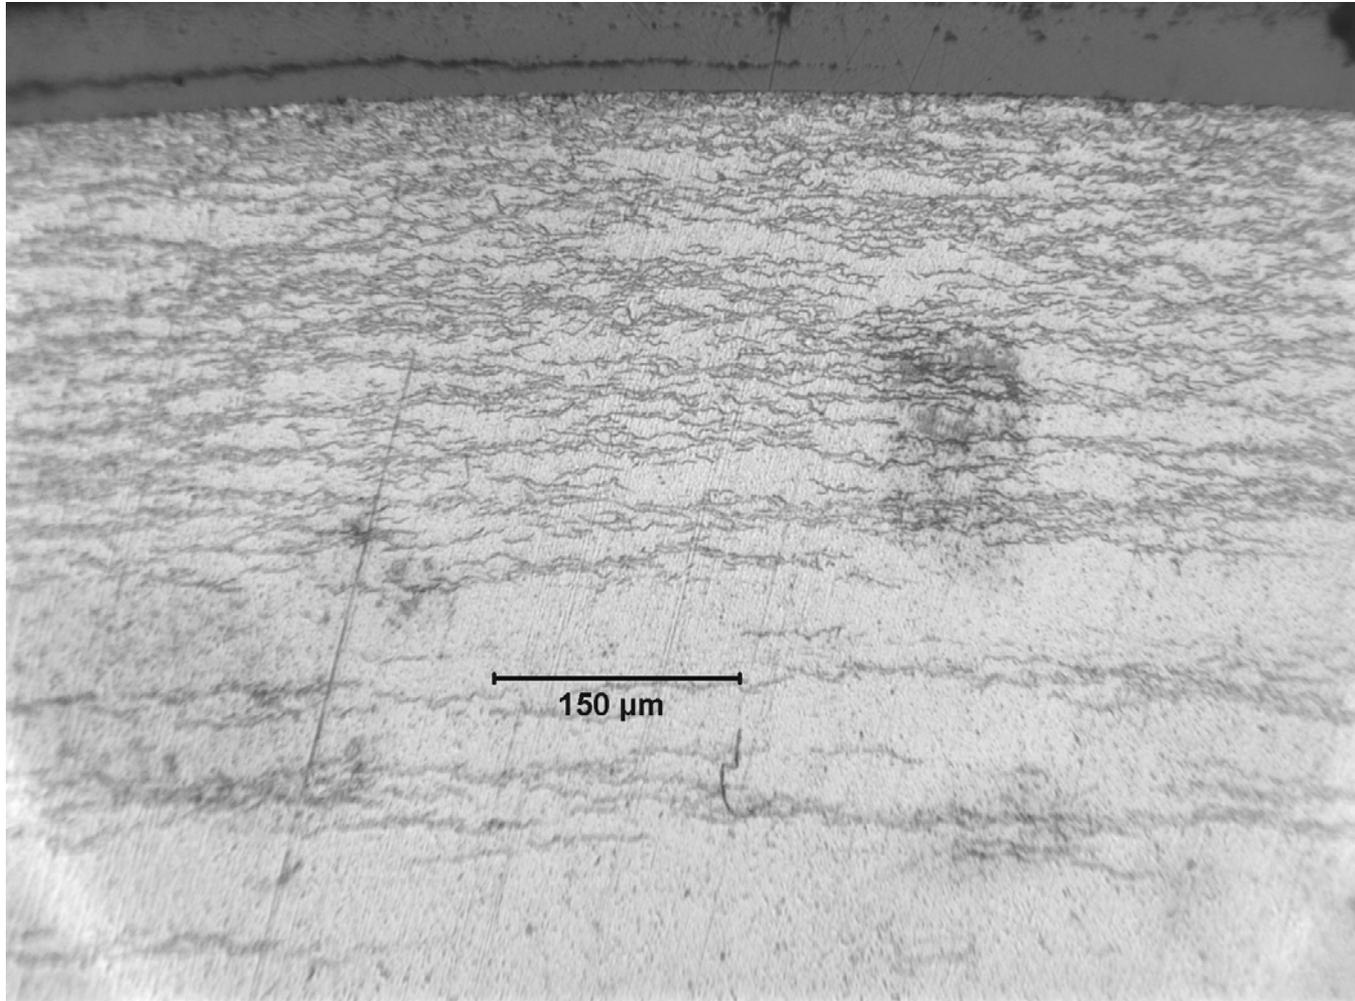
Hydride Morphology for HBR Rod F07 Cladding at ≈ 50 mm above Fuel Midplane (High Mag.)

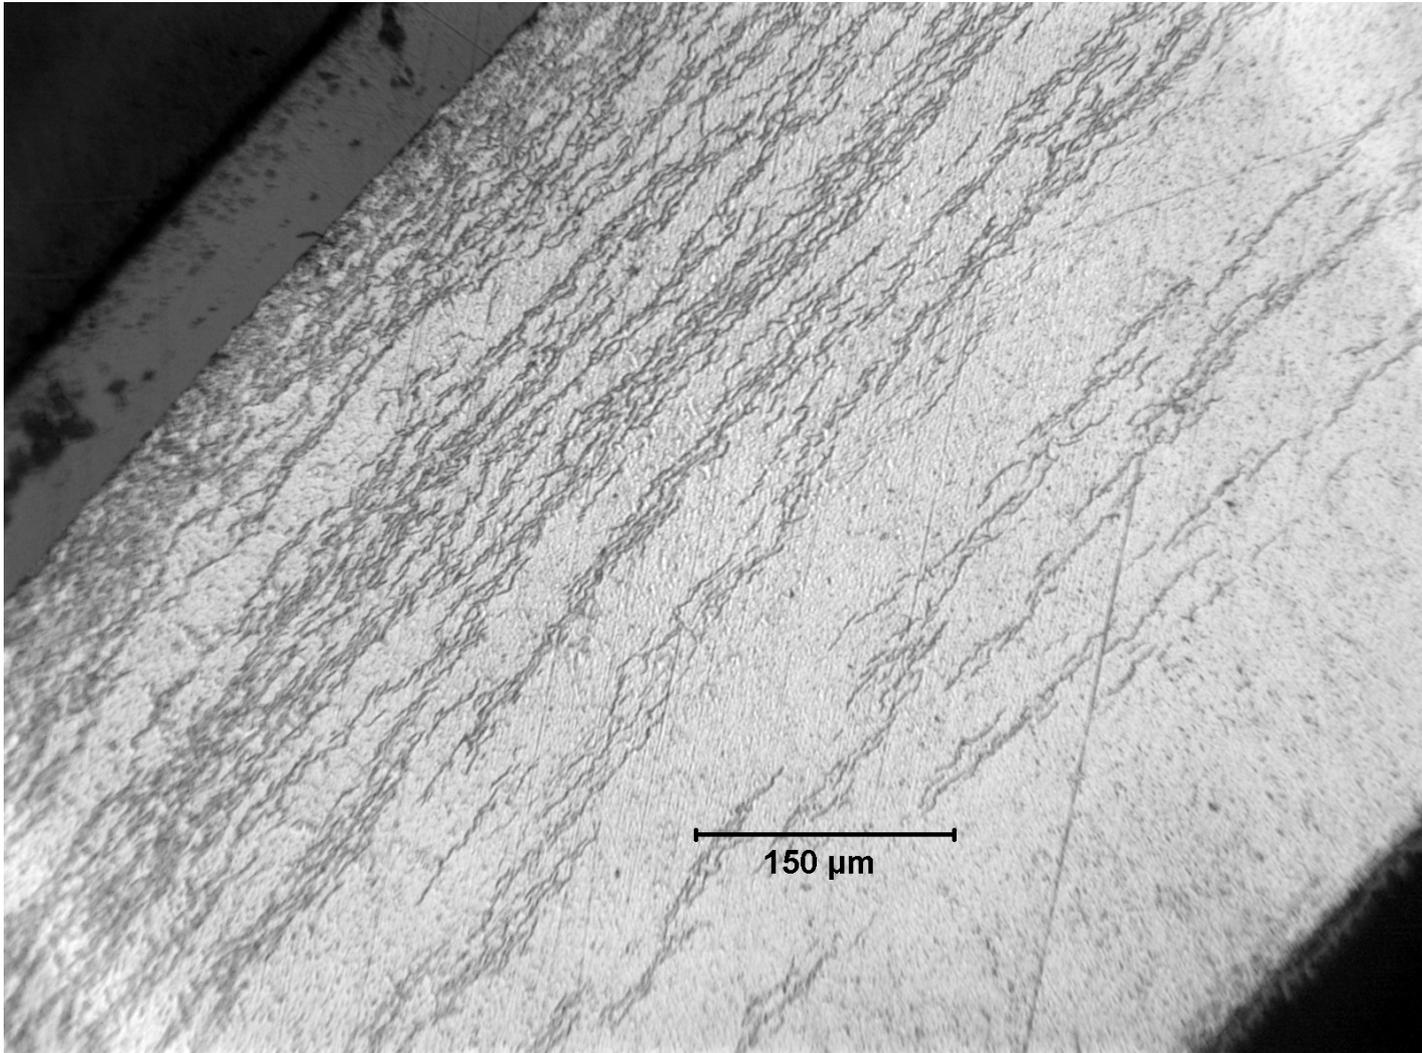
Hydride Morphology for HBR Rod F07 Cladding at ≈ 50 mm above Fuel Midplane (High Mag.)

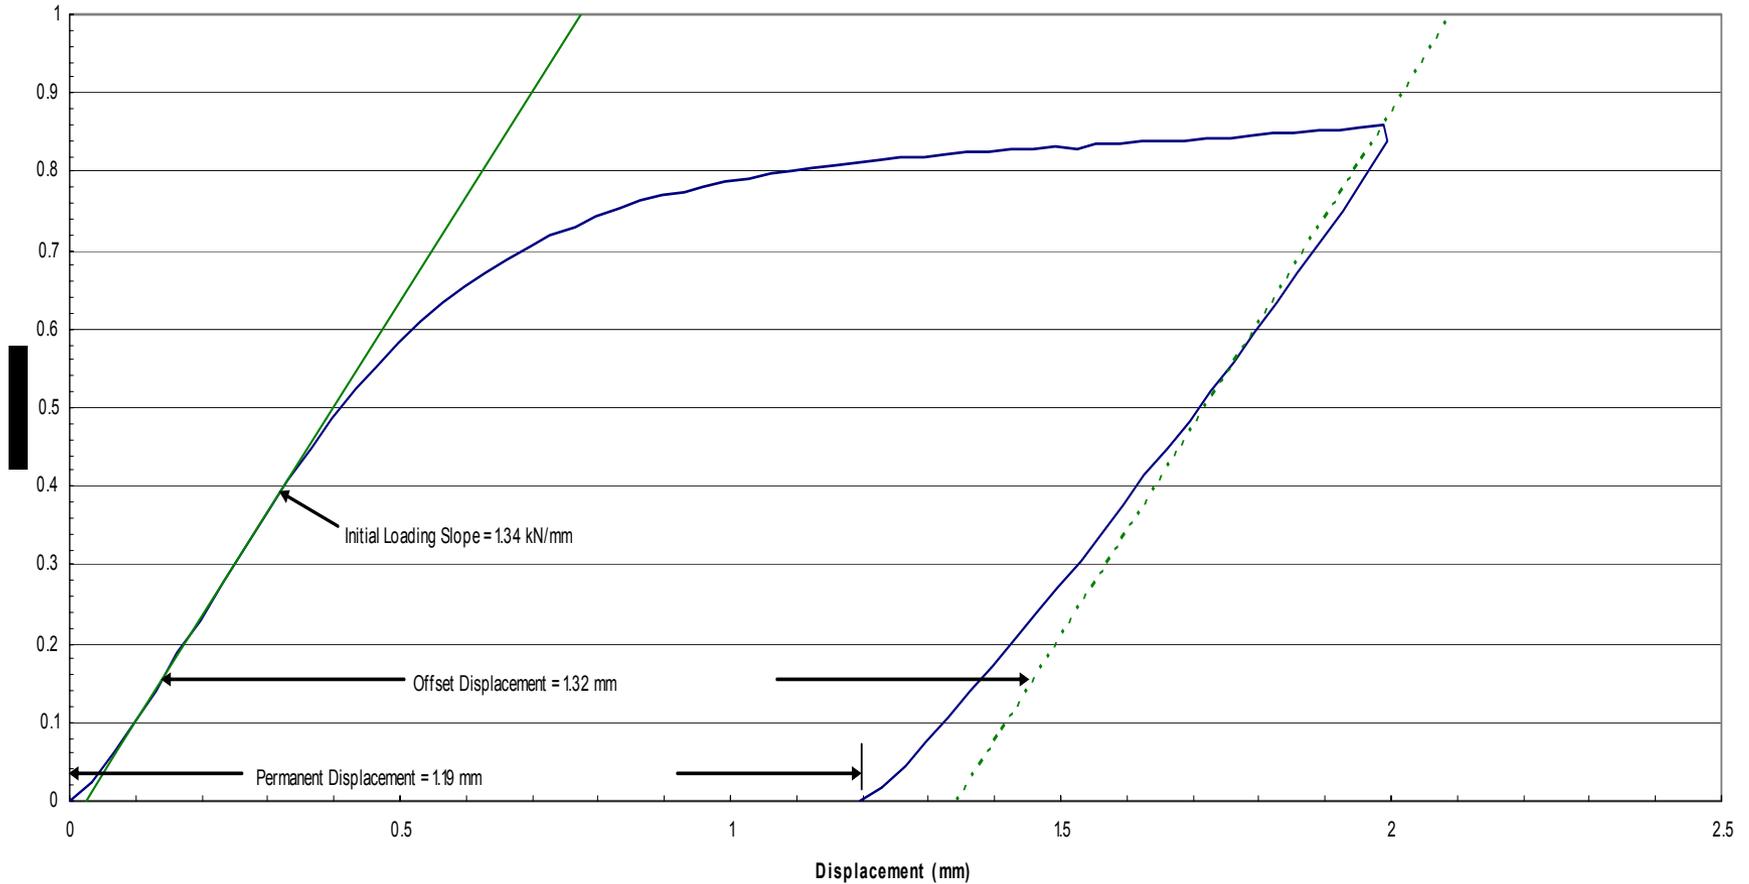
Benchmark RT Ring-Compression Test Results for Non-Irradiated, HBR Baseline 15×15 Zry-4

- **RT Ring Compression: Non-Irradiated 15×15 Zry-4**
 - 8-mm-long sample displaced to 2 mm and unloading at RT
Loading stiffness (1.34 kN/mm) consistent with elastic model
Unloading stiffness < loading stiffness
Offset displacement is 0.13 mm (1.2%) > permanent displacement
 - 8-mm-long sample displaced to 2 mm and unloading at RT at 135°C
Larger decrease in yield strength than in stiffness (Young's modulus)
- **RT Ring Compression: Prehydrided Zry-4**
 - 8-mm-long rings compressed to failure (full-length through-wall crack)
Circumferential hydrides (≈ 300 wppm): high ductility = 45%
 - Radial-Hydride-Treated (RHT) samples cooled from 400°C under σ_θ
RHT (400°C \rightarrow RT at 150 MPa, ≈ 750 wppm): low ductility = 3.1%
RHT (400°C \rightarrow RT at 190 MPa, ≈ 300 wppm): brittle = 0% ductility

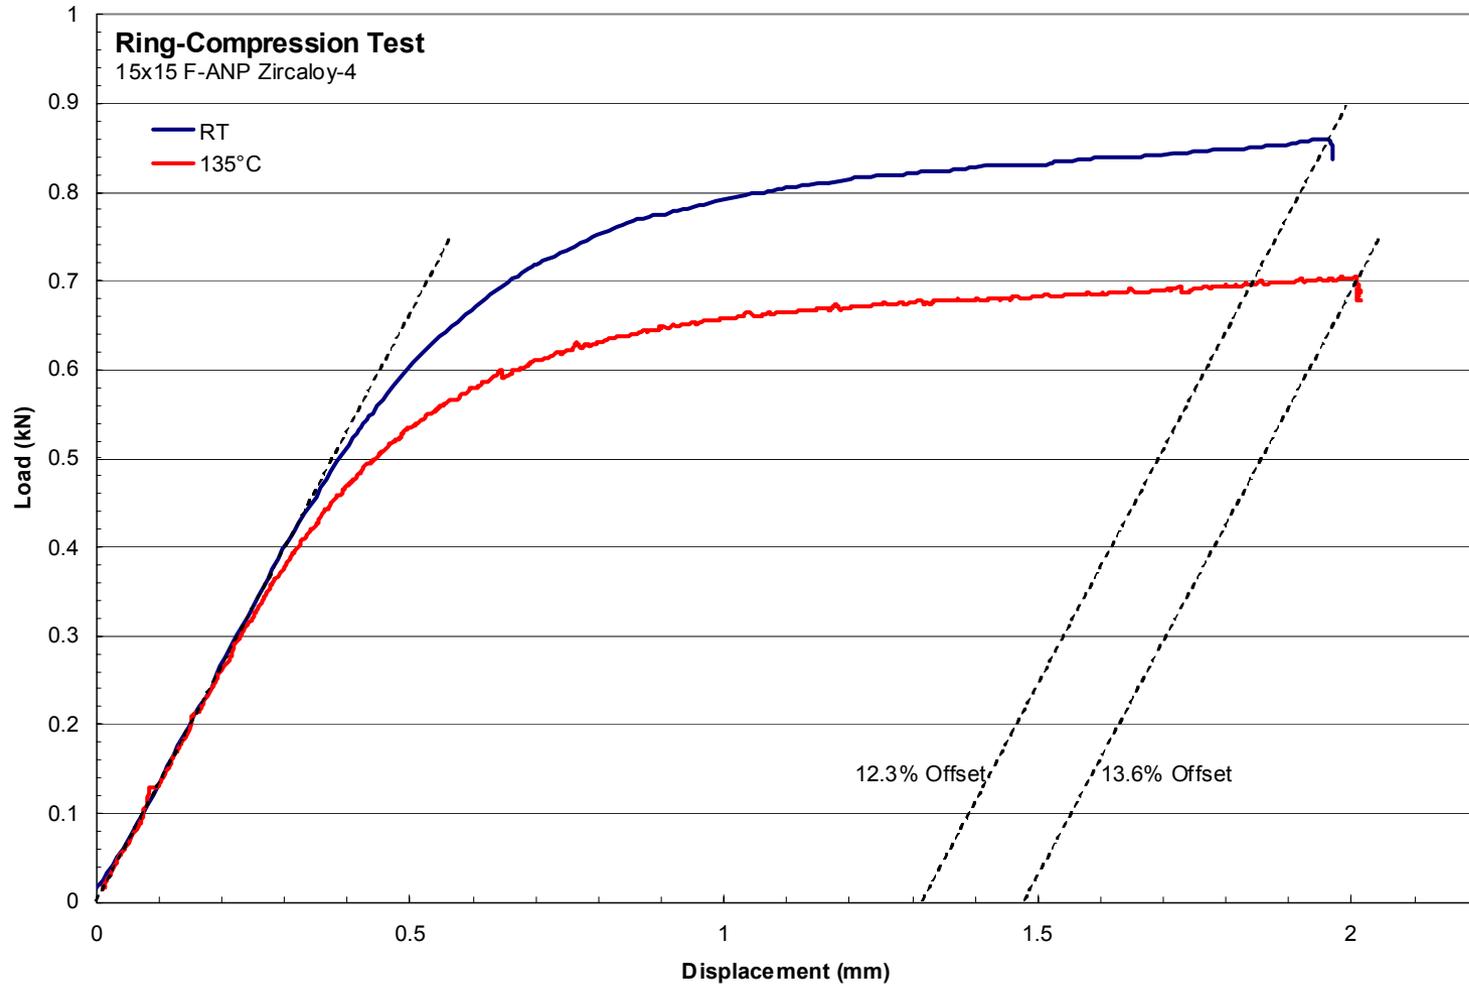
Comparison of RT and 135°C Ring-Compression Test Results for Non-Irradiated, HBR Baseline 15×15 Zry-4

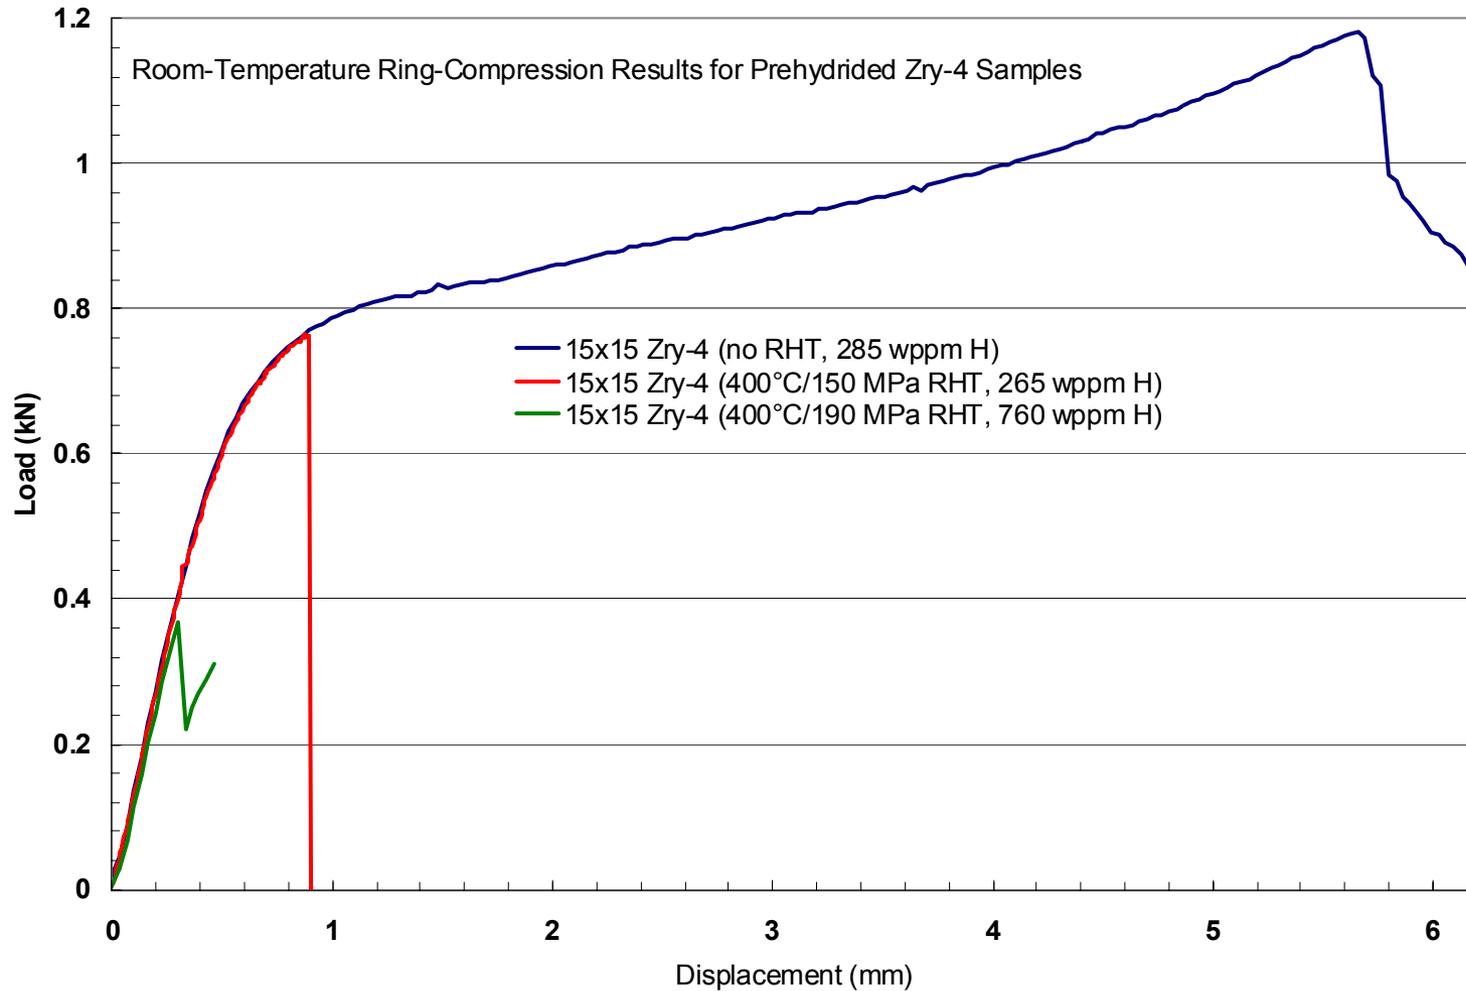
RT Ring-Compression Test Results for Prehydrided, HBR Baseline 15×15 Zry-4

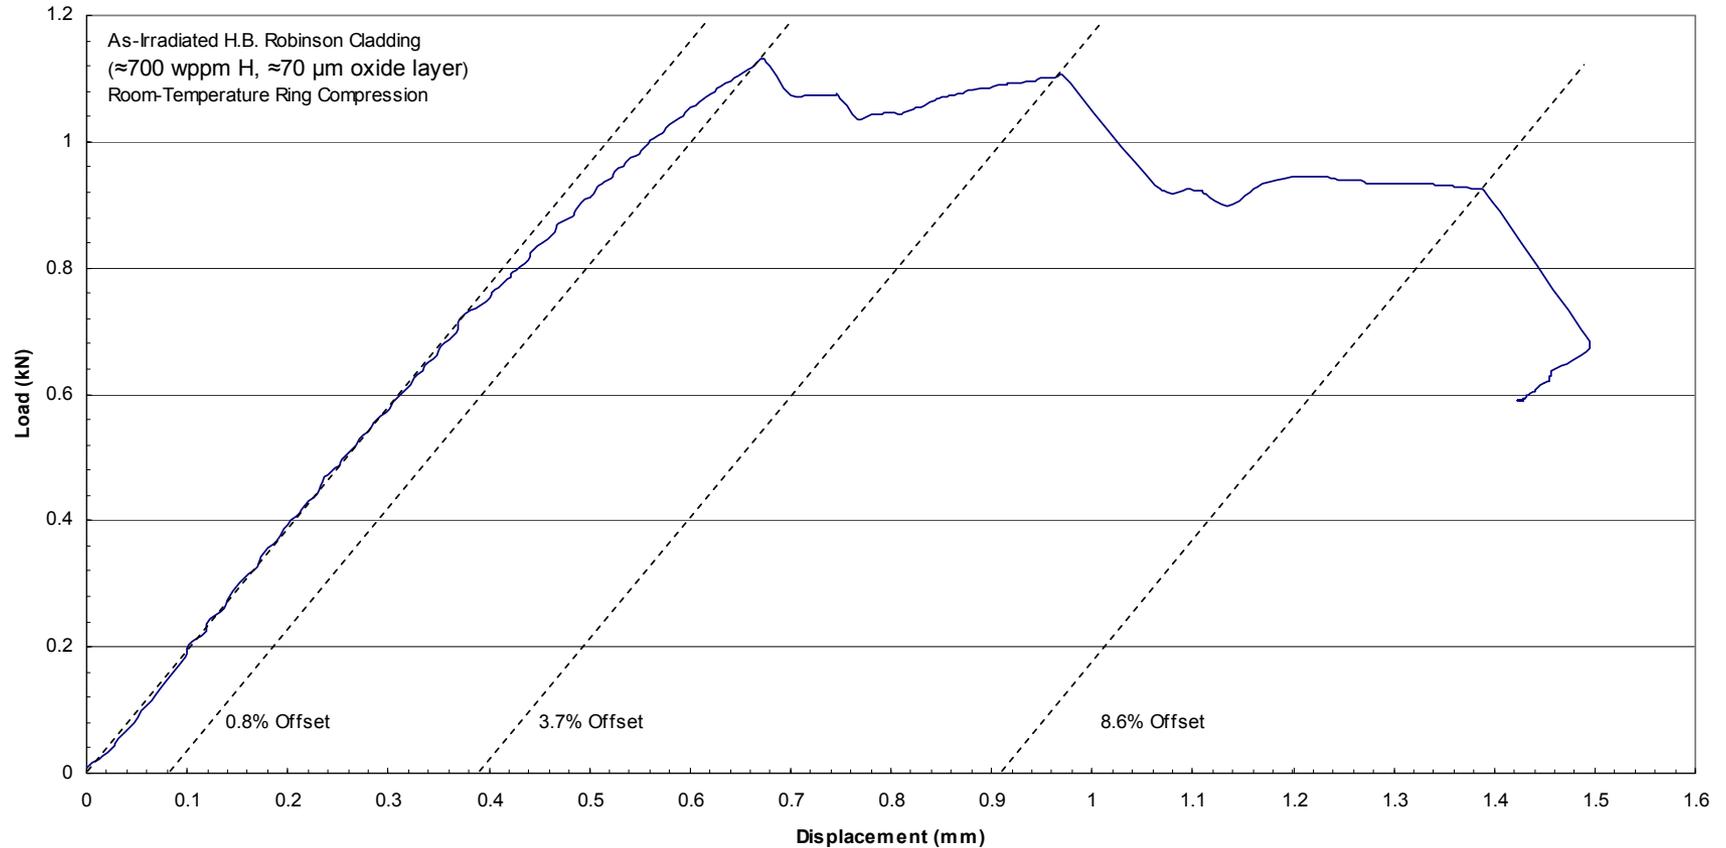
RT Ring-Compression Test Results for High-Burnup HBR Cladding Near Fuel Midplane

- 9.4-mm-long ring with ≈ 70 μm corrosion layer and ≈ 700 wppm H Near midplane of Rod F07 (see specimen 7E in Slide 15)
- Loading stiffness (1.92 kN/mm) consistent with increased modulus (E)
- Evidence of small load drops due to oxide cracking from 0.8-3.7% offset
- 1st large load drop (≈ 0.2 kN) at 3.7% offset \rightarrow partial wall crack
- 2nd large load drop (≈ 0.2 kN) at $\approx 8.3\%$ offset \rightarrow crack extension
Test stopped at 8.6% offset and 6.3% permanent strains
Sample crack at 90° from loading line, extending $\approx 75\%$ from OD to ID
- Test results for cladding with corrosion layer removed
Smooth load-displacement curve with load drop at 10.6% offset strain
2 partial-wall cracks at +90° and -90° extending over full length of ring

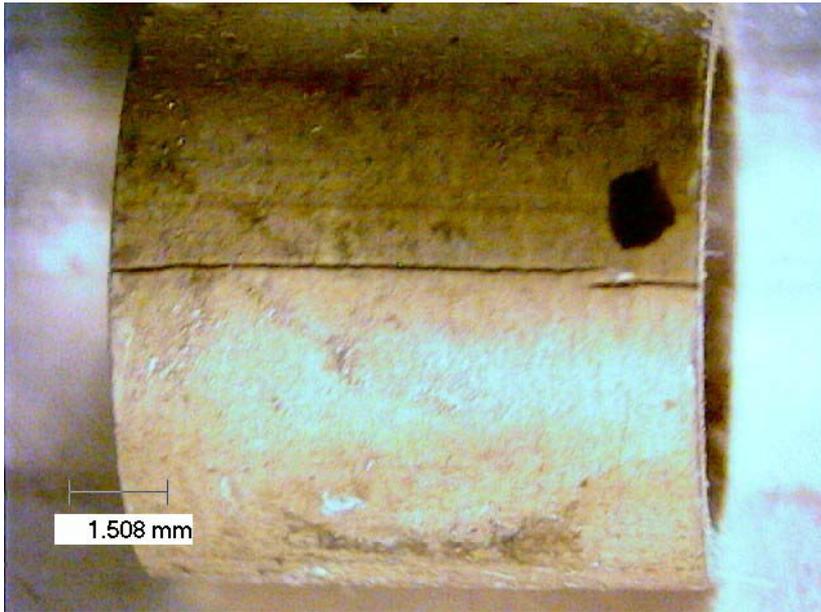
Low-Magnification Images of Crack in HBR Sample

**1X View of Crack
at 90° from
Loading Line**

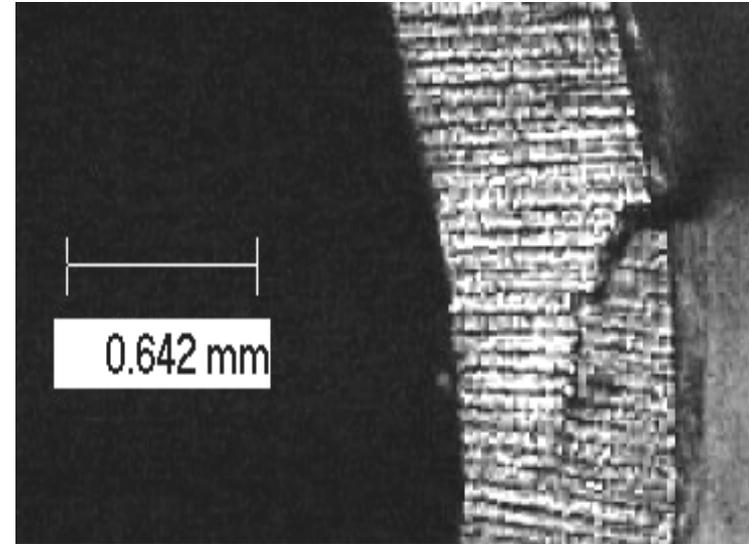
**3X View of Crack
along Side of Ring**

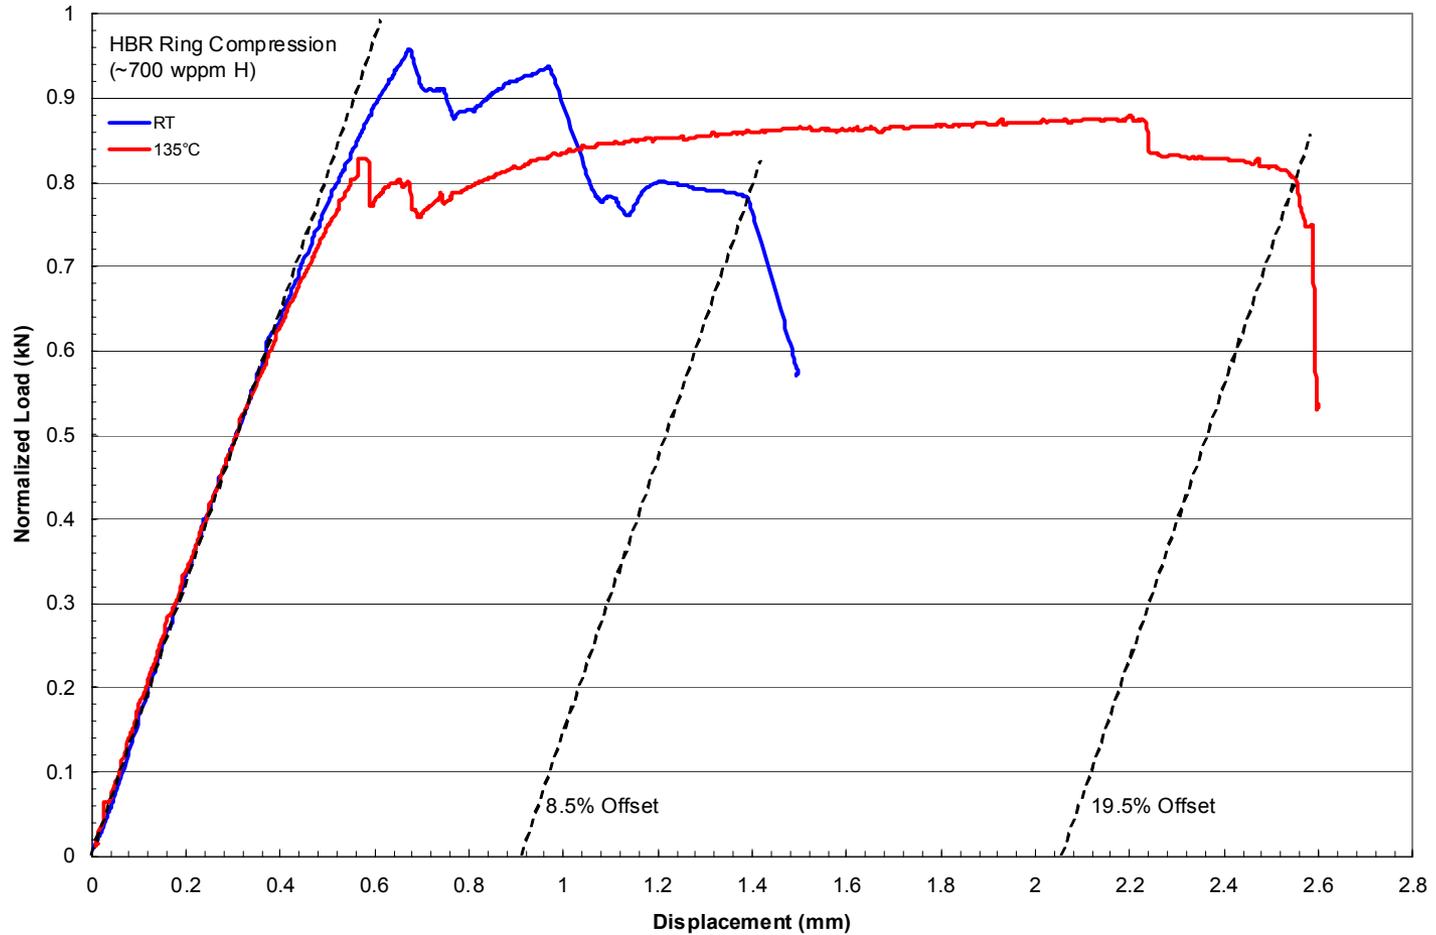
135°C Ring-Compression Test Results for High-Burnup HBR Cladding Near Fuel Midplane
