H.B. Robinson High-Burnup PWR Oxidation and Post-Quench Ductility

M. Billone, Y. Yan, T. Burtseva and H. Chung
Energy Technology Division
Argonne National Laboratory
February 10, 2005

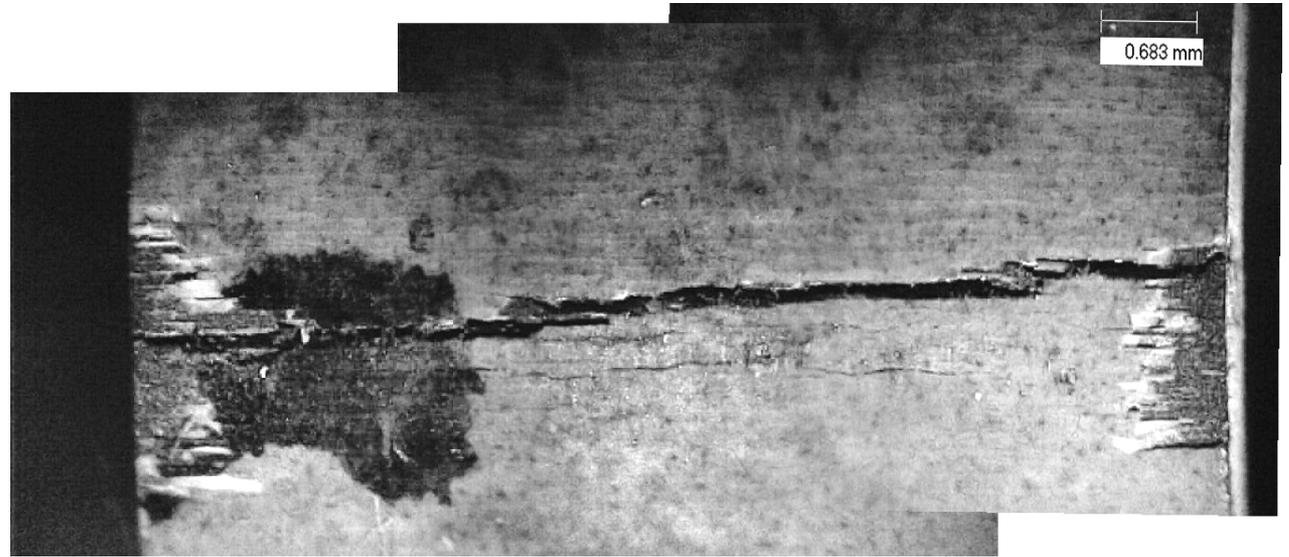
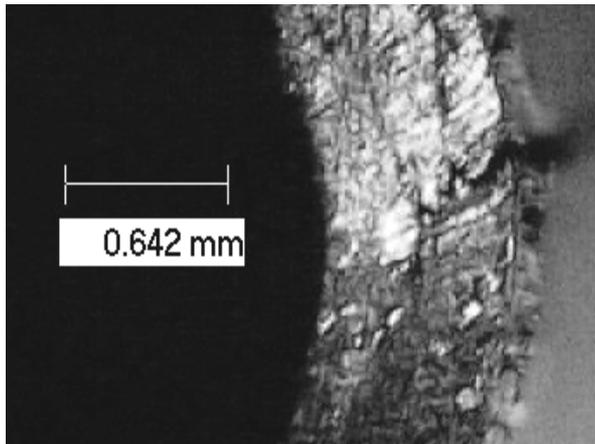
Low Mag. Images of Crack in HBR Ring Tested at 135°C

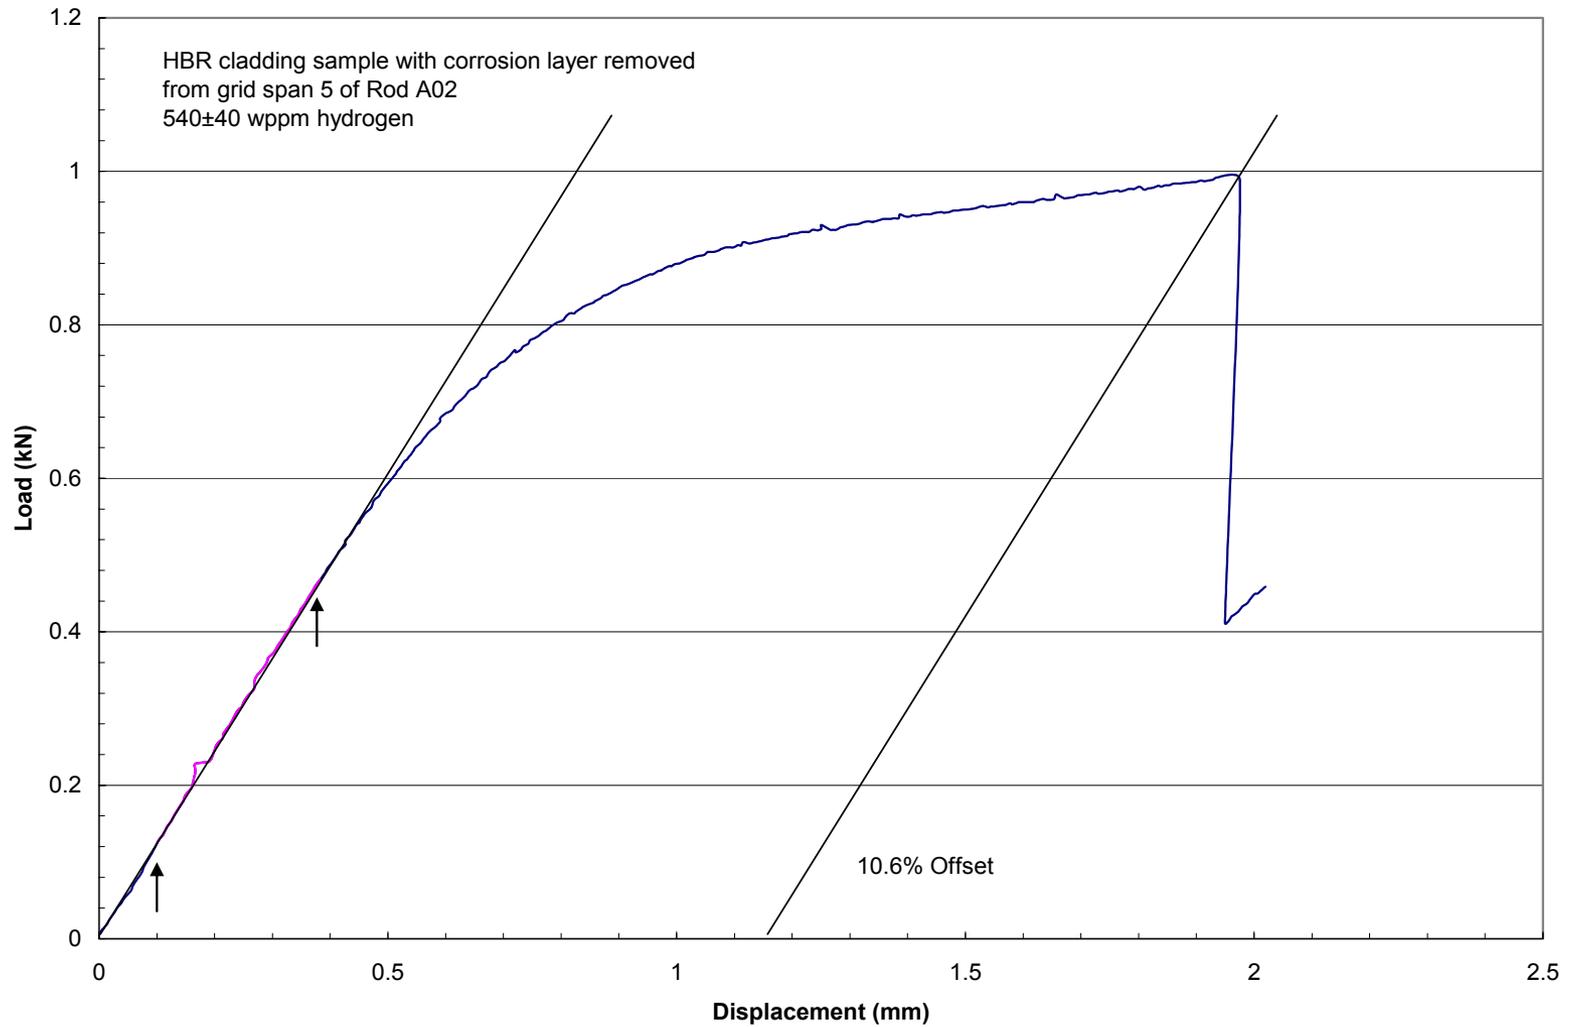
RT Ring-Compression Test Results for High-Burnup HBR Cladding with Corrosion Layer Removed

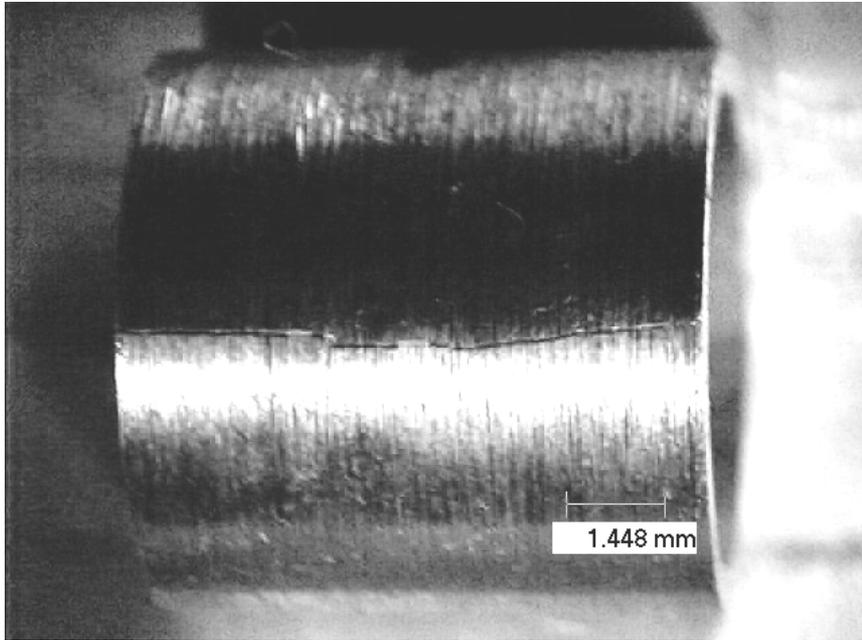
Low-Magnification Images of Crack in HBR Ring with the Corrosion Layer Removed Prior to RT Testing

**1X Image at 90°
from Loading Line**

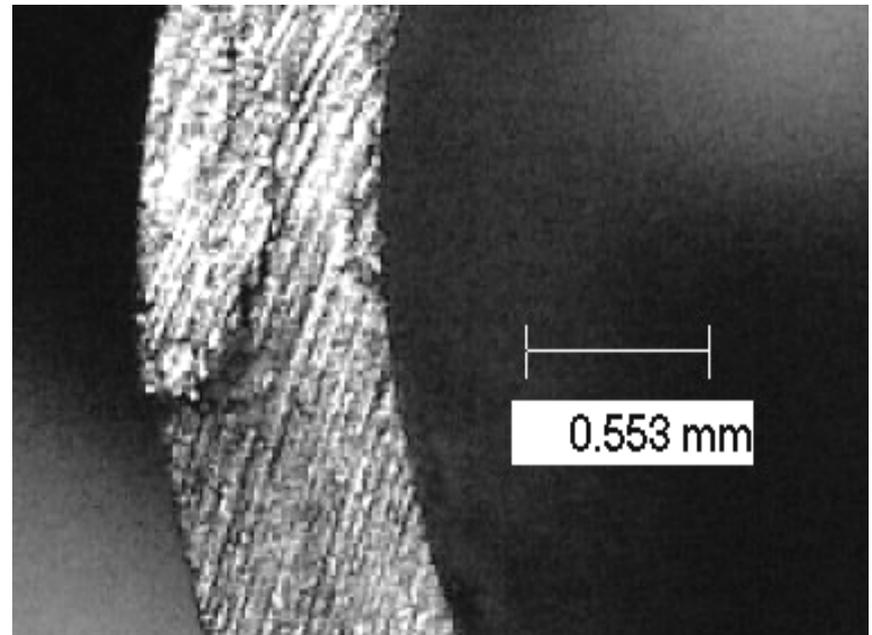
**3X Image of Crack Growth
through Side Wall**

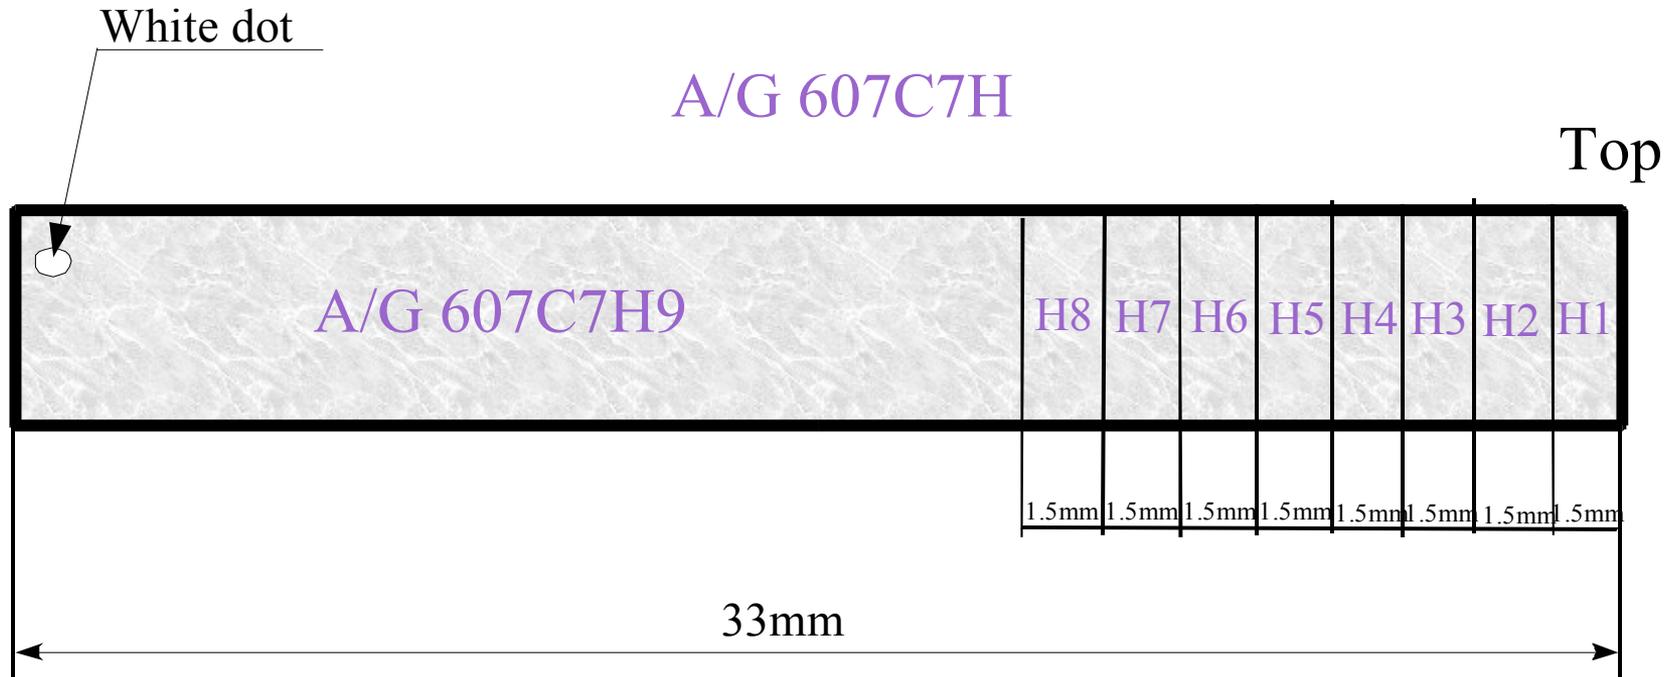
Re-Measurement of Hydrogen Content

H1: 545±85 wppm H; H2: 530±80 wppm H
H3: 530±90 wppm H; H4: 535±85 wppm H
H5: 555±85 wppm H; H6: 575±80 wppm H
H7: 535±80 wppm H; H8: 565±70 wppm H

- Expected = 550-580 wppm based on A02 and R01
- Measured: 760 ± 60 wppm at +13 mm; 670 ± 80 wppm at +32 mm
- **Re-measured over 14 mm (7H) just below midplane: 550 ± 90 wppm**

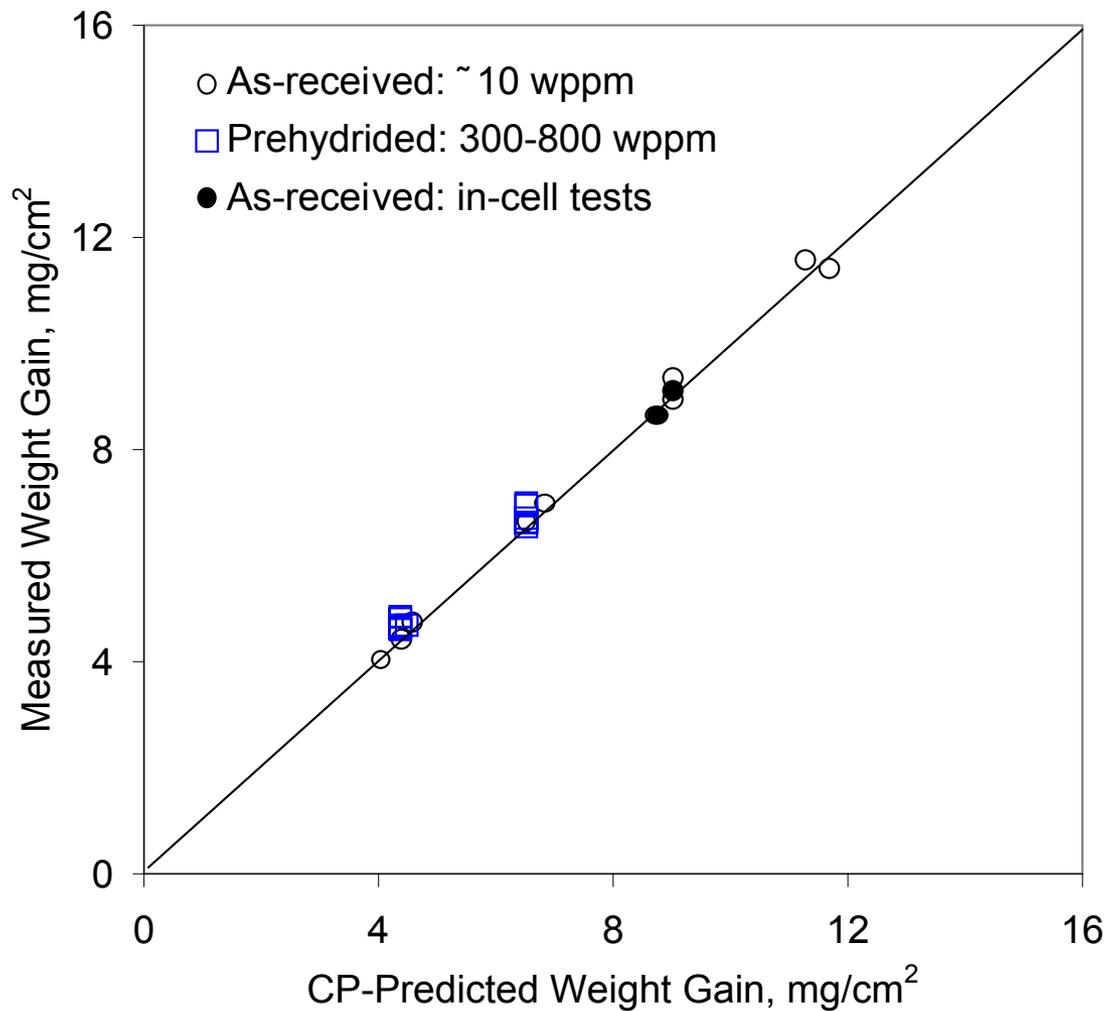
Weight-Gain Results for Nonirradiated 15×15 Zry-4 (0604 and 1204 Test Trains)

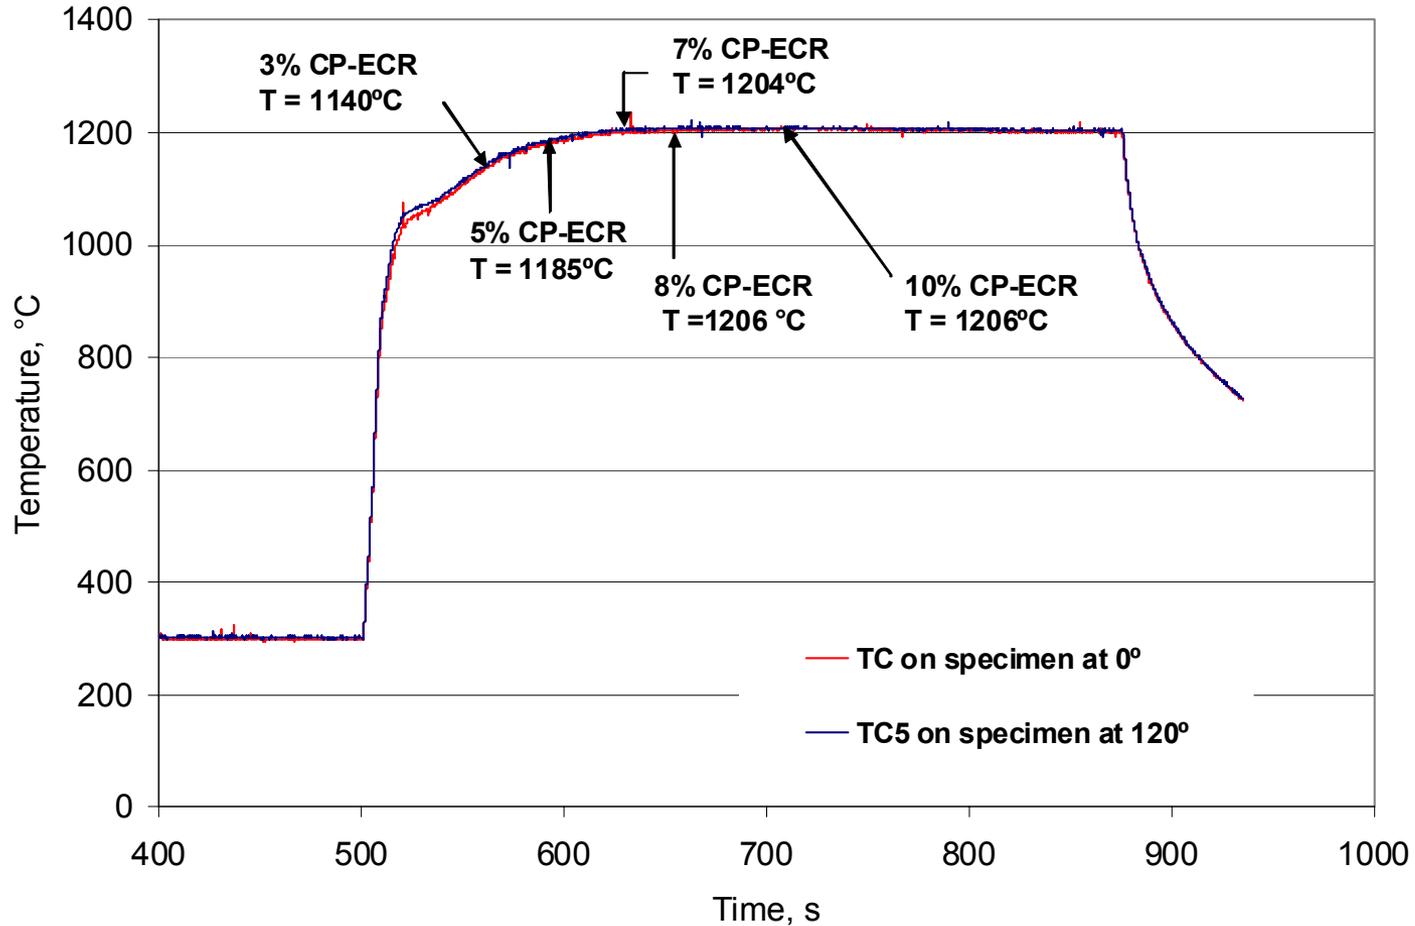
Thermal History of In-Cell Oxidation Tests with New Test Train (12/29/2004)

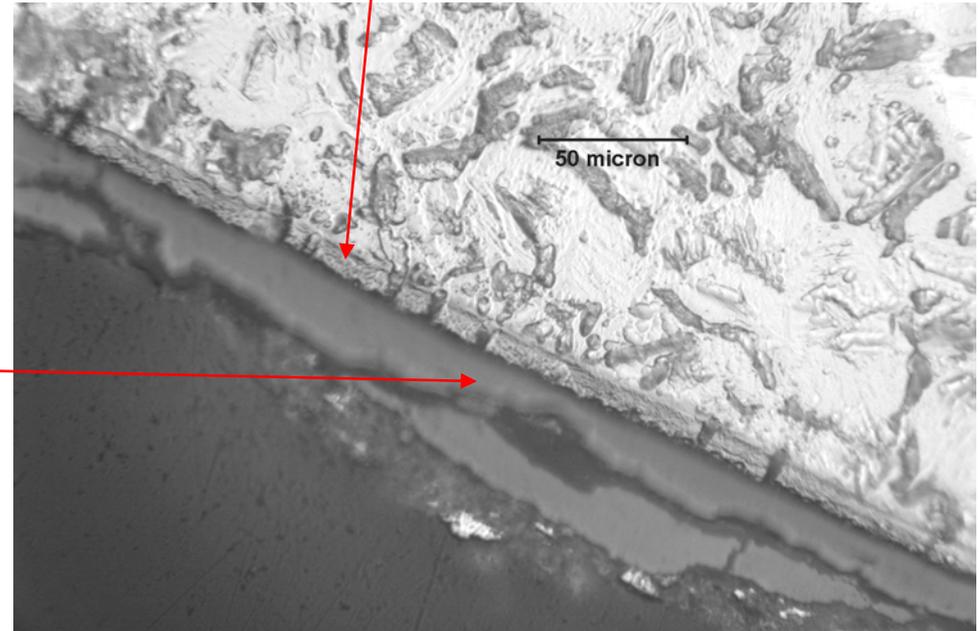
Metallography of 3% CP-ECR Sample – Outer Surface (After Grinding off $\approx 2\text{mm}$, Polishing and Etching)

**Oxygen-Stabilized
Alpha Layer**

**Corrosion
Layer**

**No Steam
Oxide Layer**

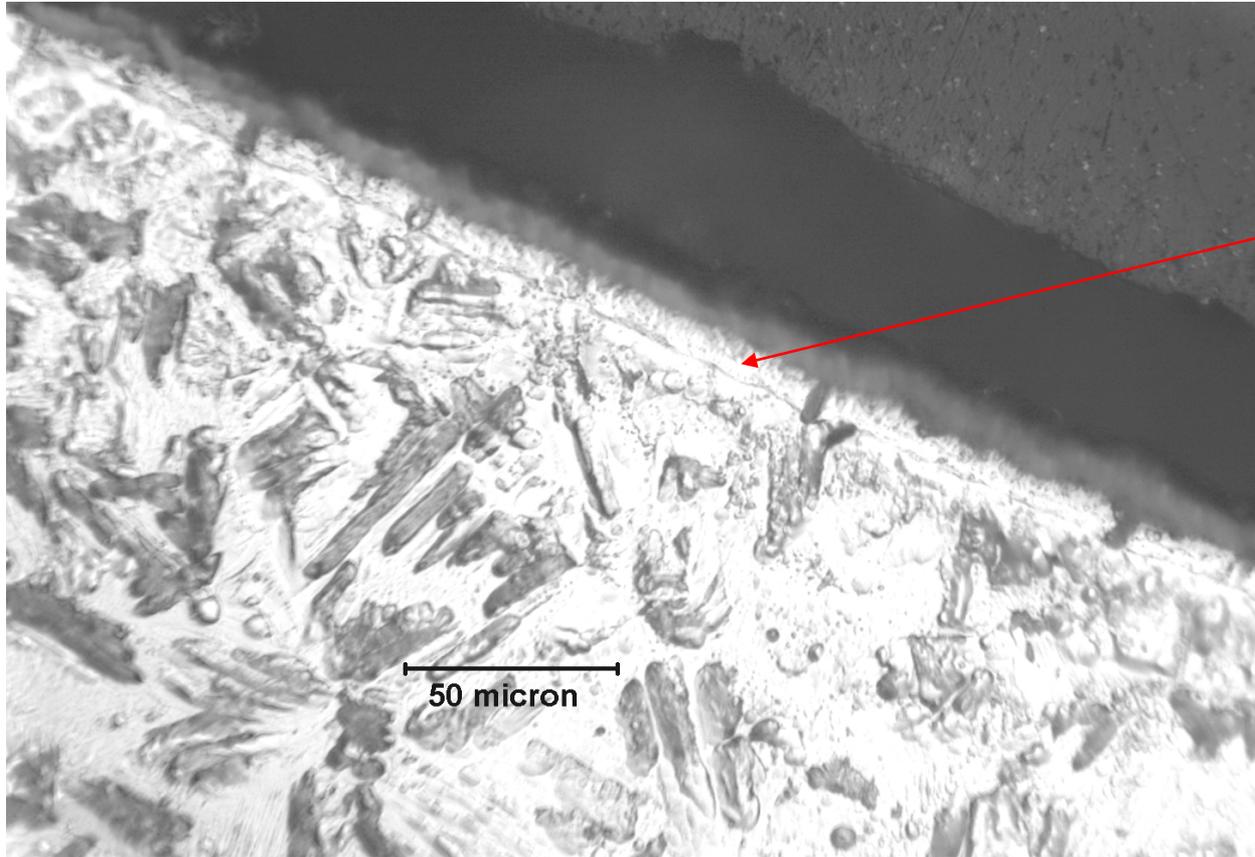
Metallography of 3% CP-ECR Sample – Inner Surface (After Grinding off $\approx 2\text{mm}$, Polishing and Etching)

**Alpha
Layer**

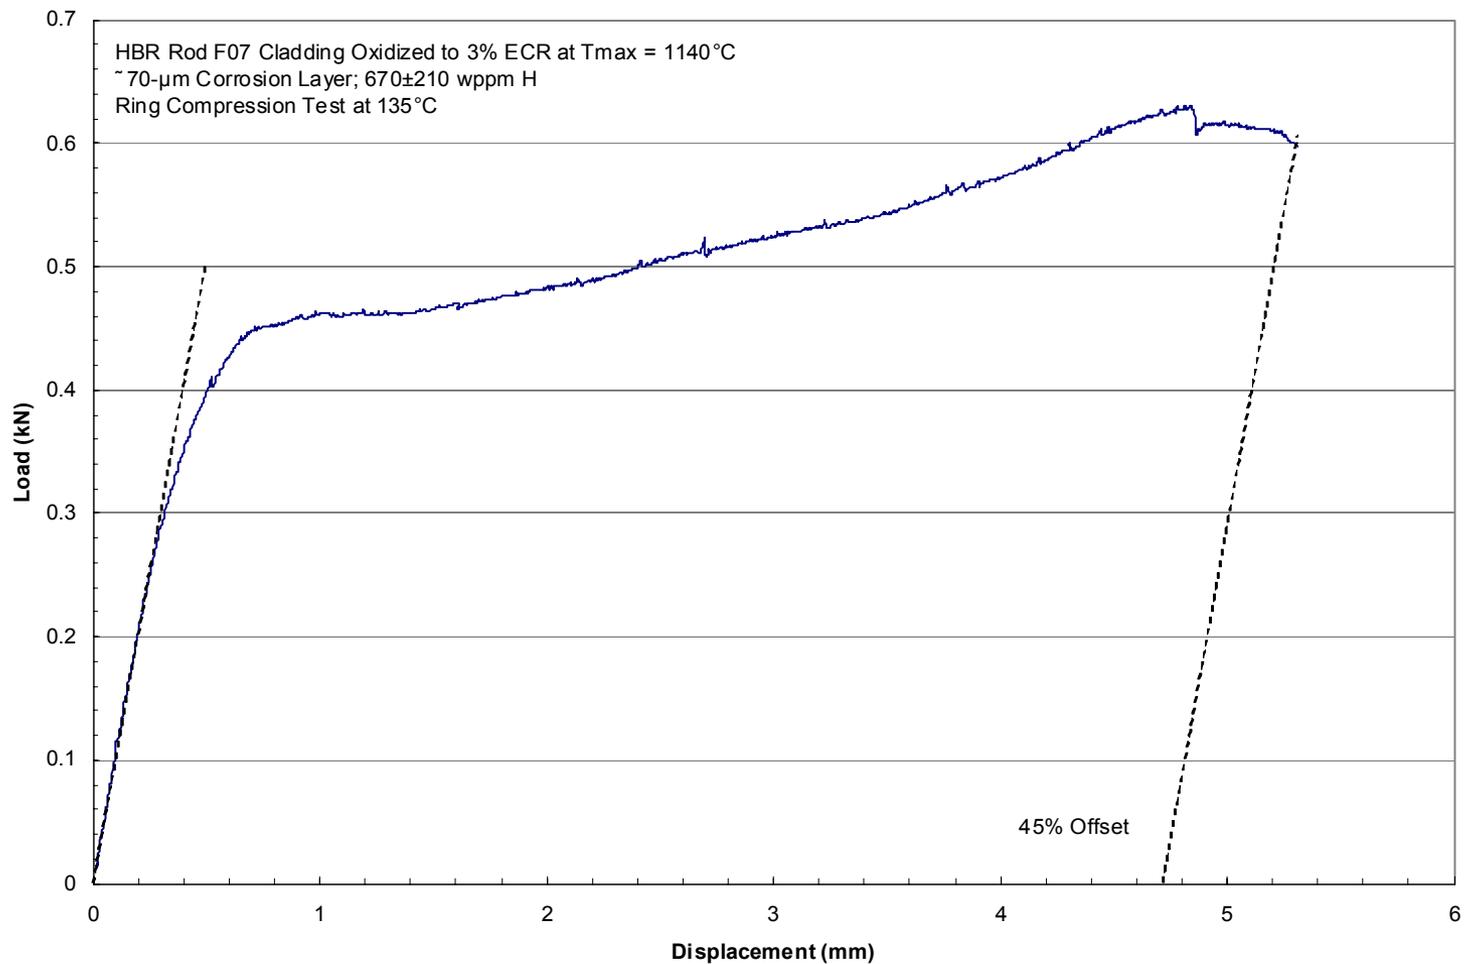
Load-Displacement Curve (at 135°C) for 3% CP-ECR HBR Zry-4 Ring with 670 ± 210 wppm H (Post-Oxidation)

- Ring-compression ductility > 45% (test stopped before failure)

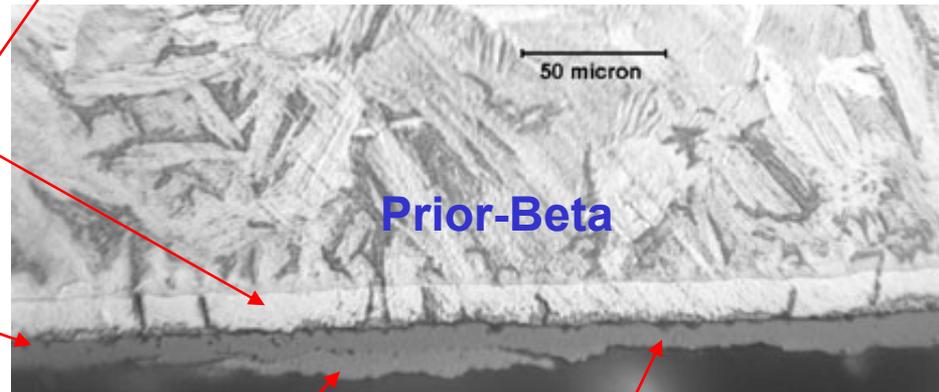
Metallography of 5% CP-ECR Sample

Alpha

Corrosion

Steam Oxide??

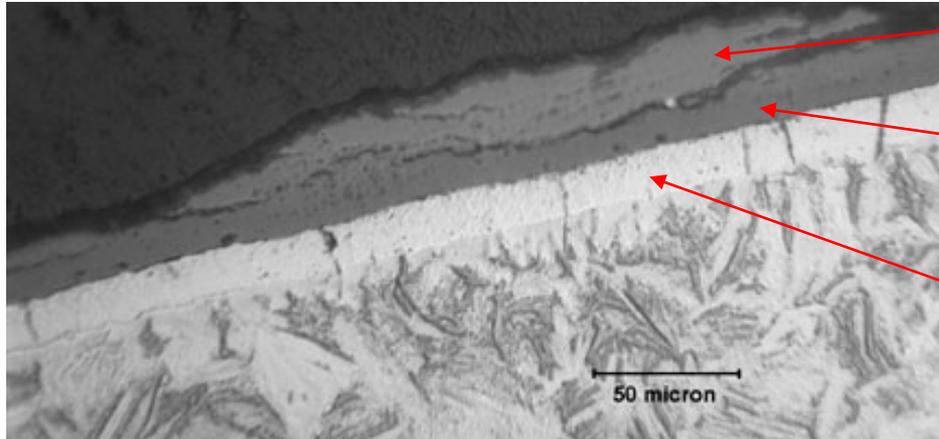
Metallography of 5% CP-ECR Sample (Cont'd)

Corrosion

Steam Oxide

Alpha

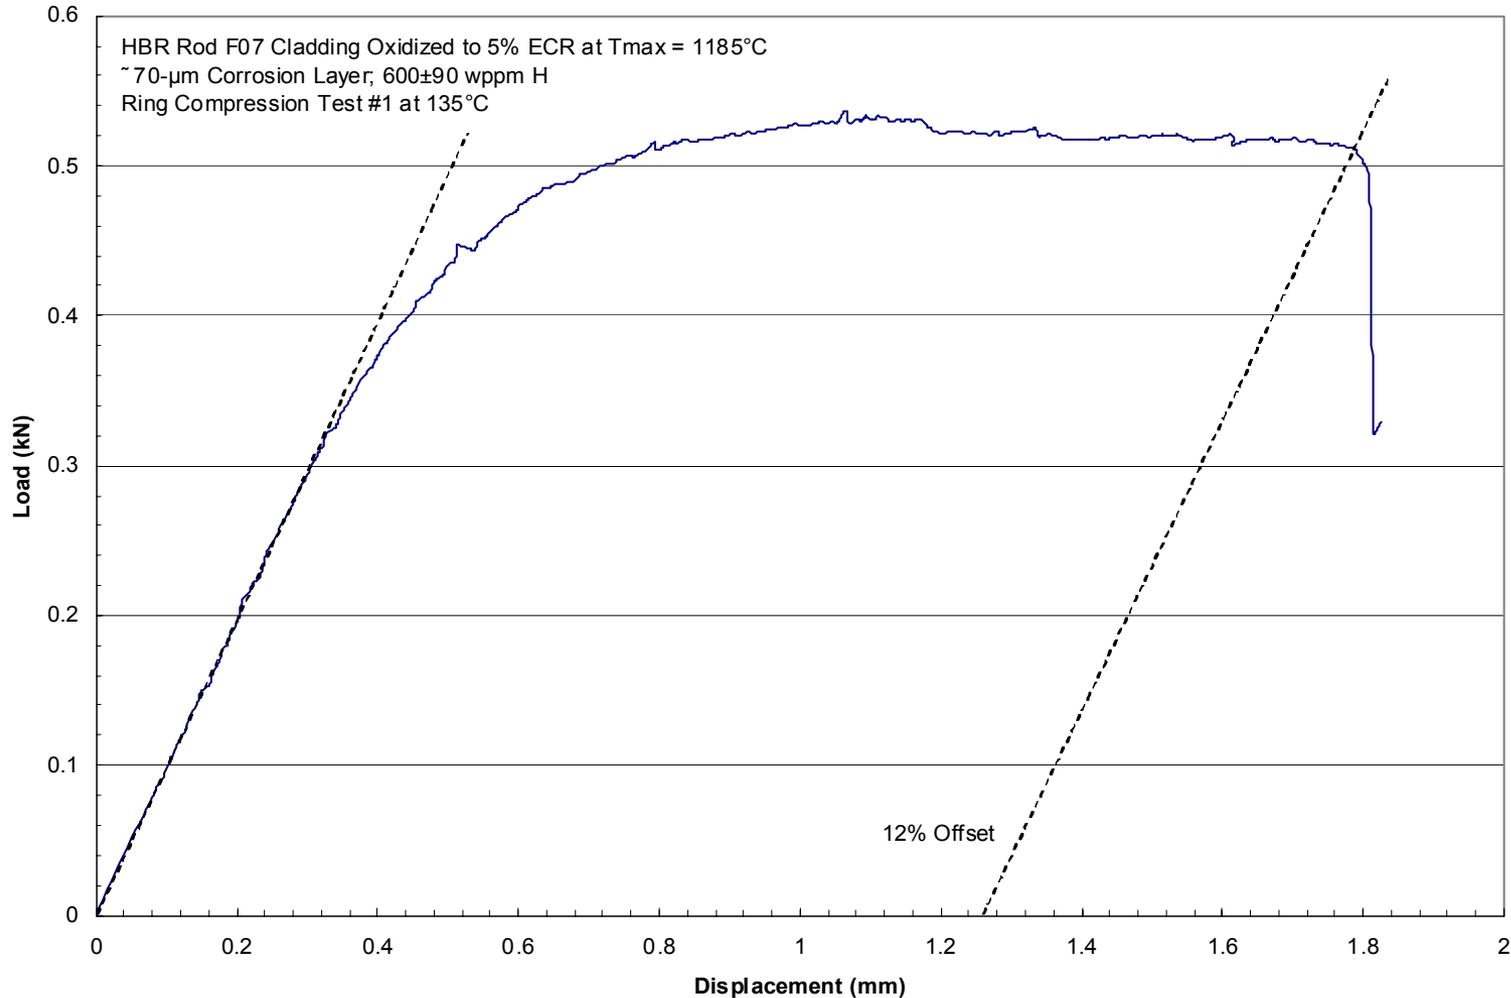
Load-Displacement Curve #1 (at 135°C) for 5% CP-ECR HBR Zry-4 Ring with 600 ± 90 wppm H (Post-Oxidation)

- Ring #1: test stopped after 40% load drop at 12% offset strain
no through-wall crack seen at 3X mag.; need metallography
- Ring #2: test run to max. displacement; no sharp load drops;
through-wall crack at bottom; ductility is ≈40%
- **Assessment: medium-to-high ductility**

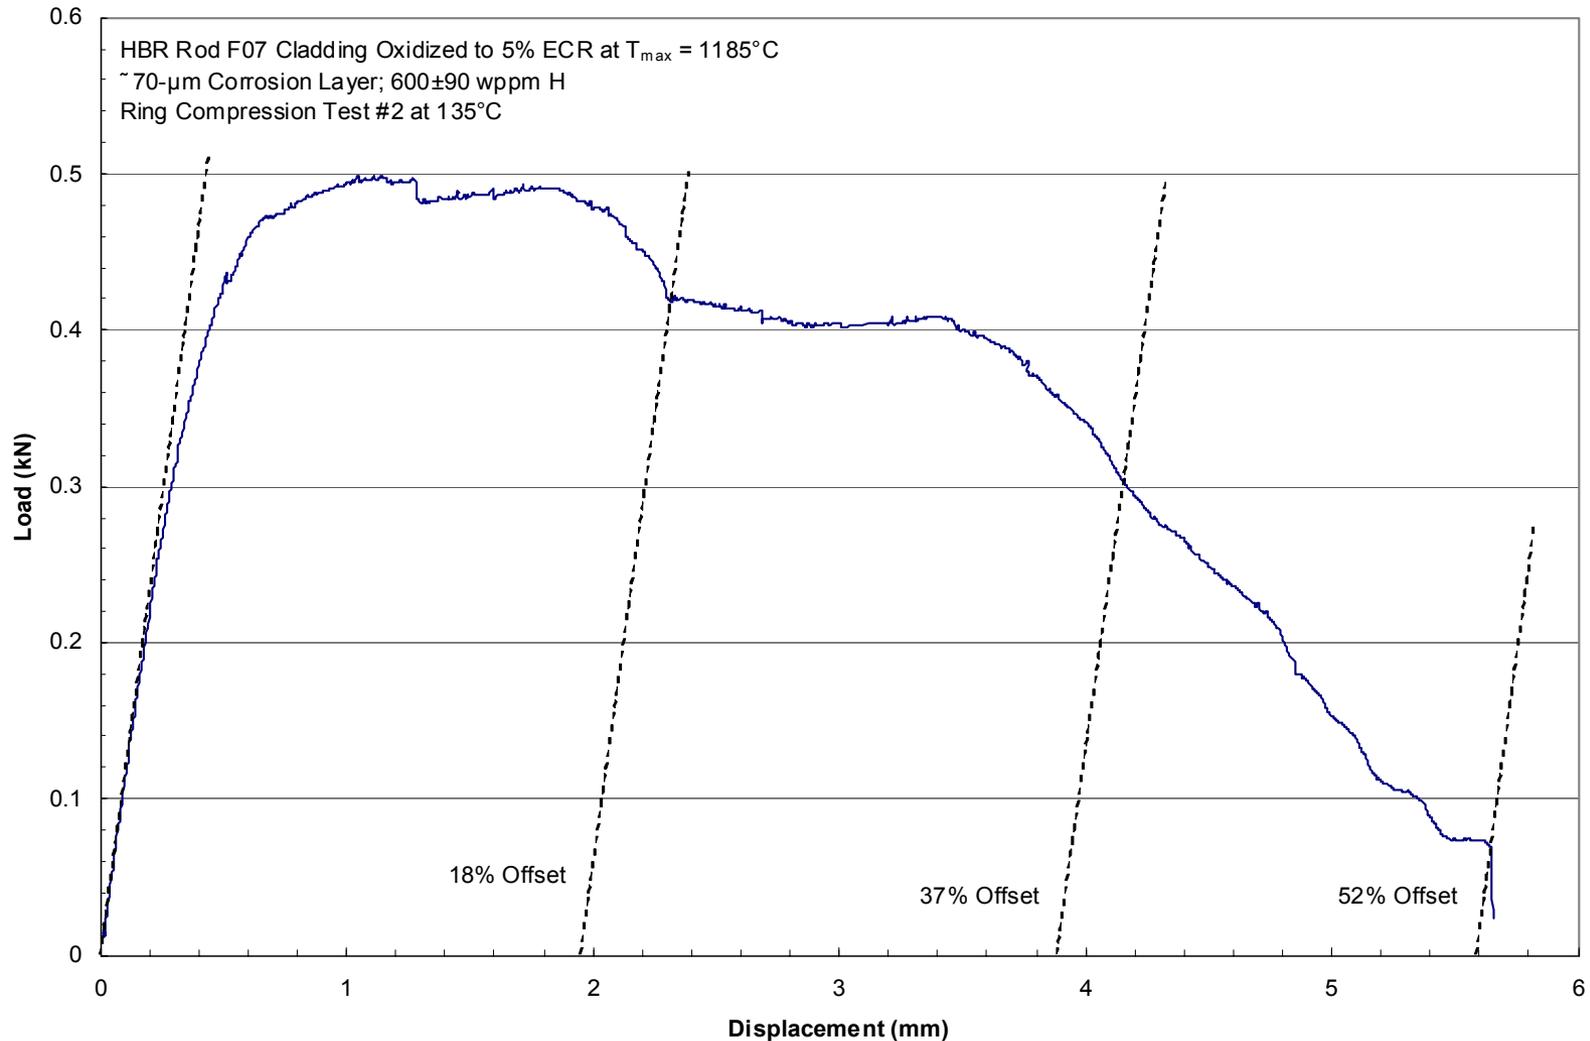
Load-Displacement Curve #2 (at 135°C) for 5% CP-ECR HBR Zry-4 Ring with 600 ± 90 wppm H (Post-Oxidation)

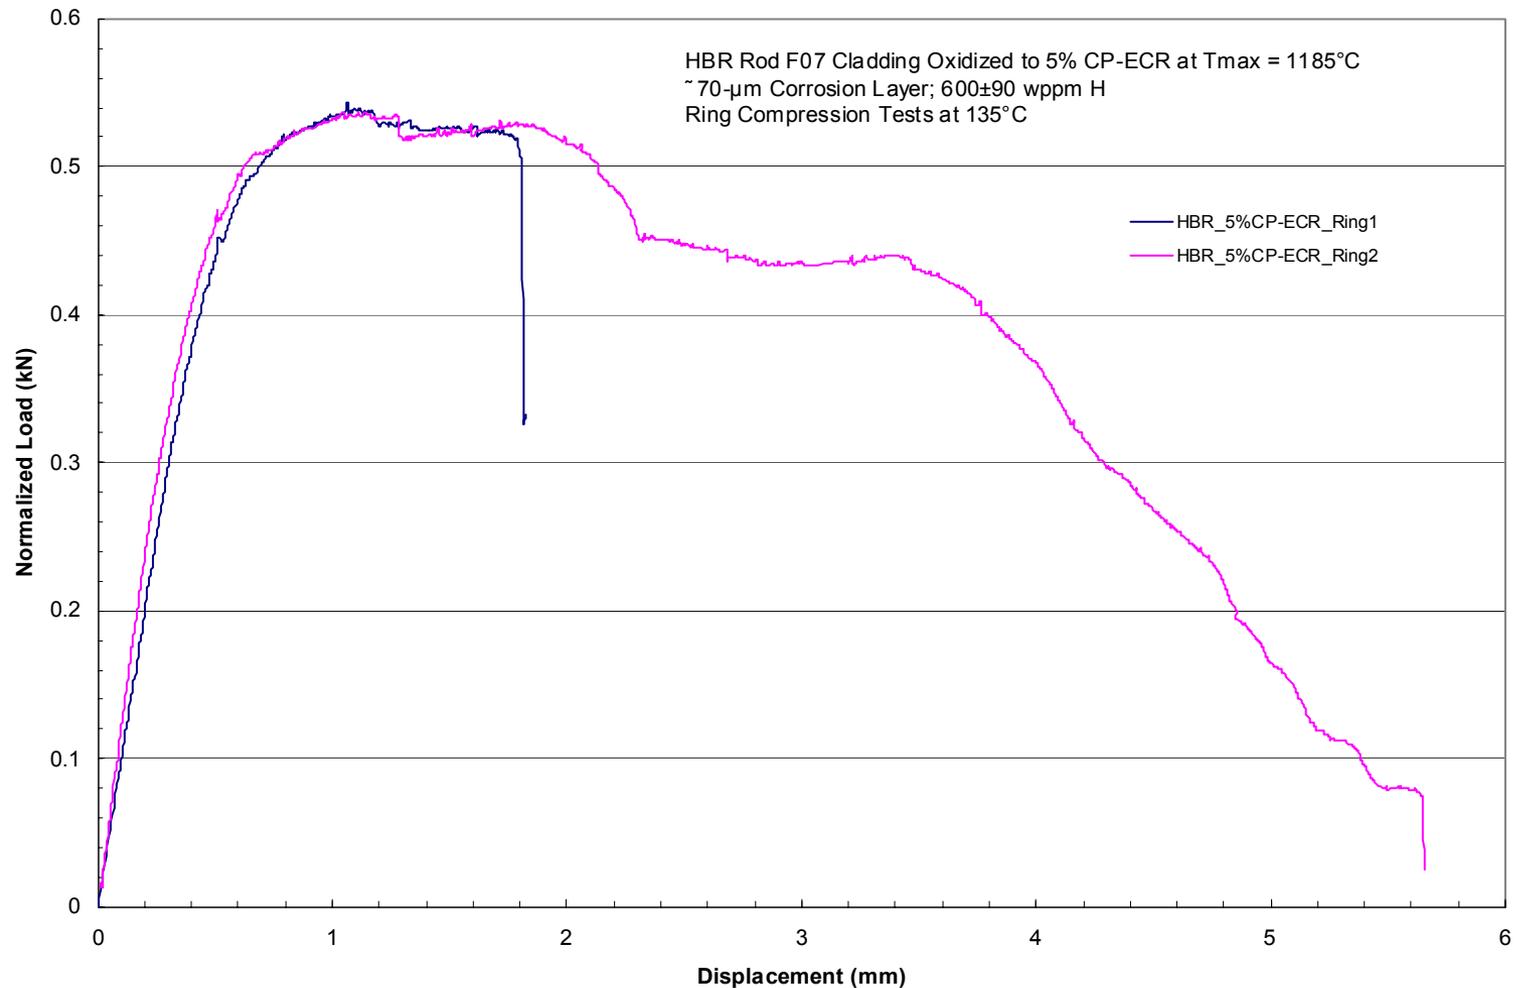
Load-Displacement Curves (at 135°C) for 5% CP-ECR HBR Zry-4 Ring with 600 ± 90 wppm H (Post-Oxidation)

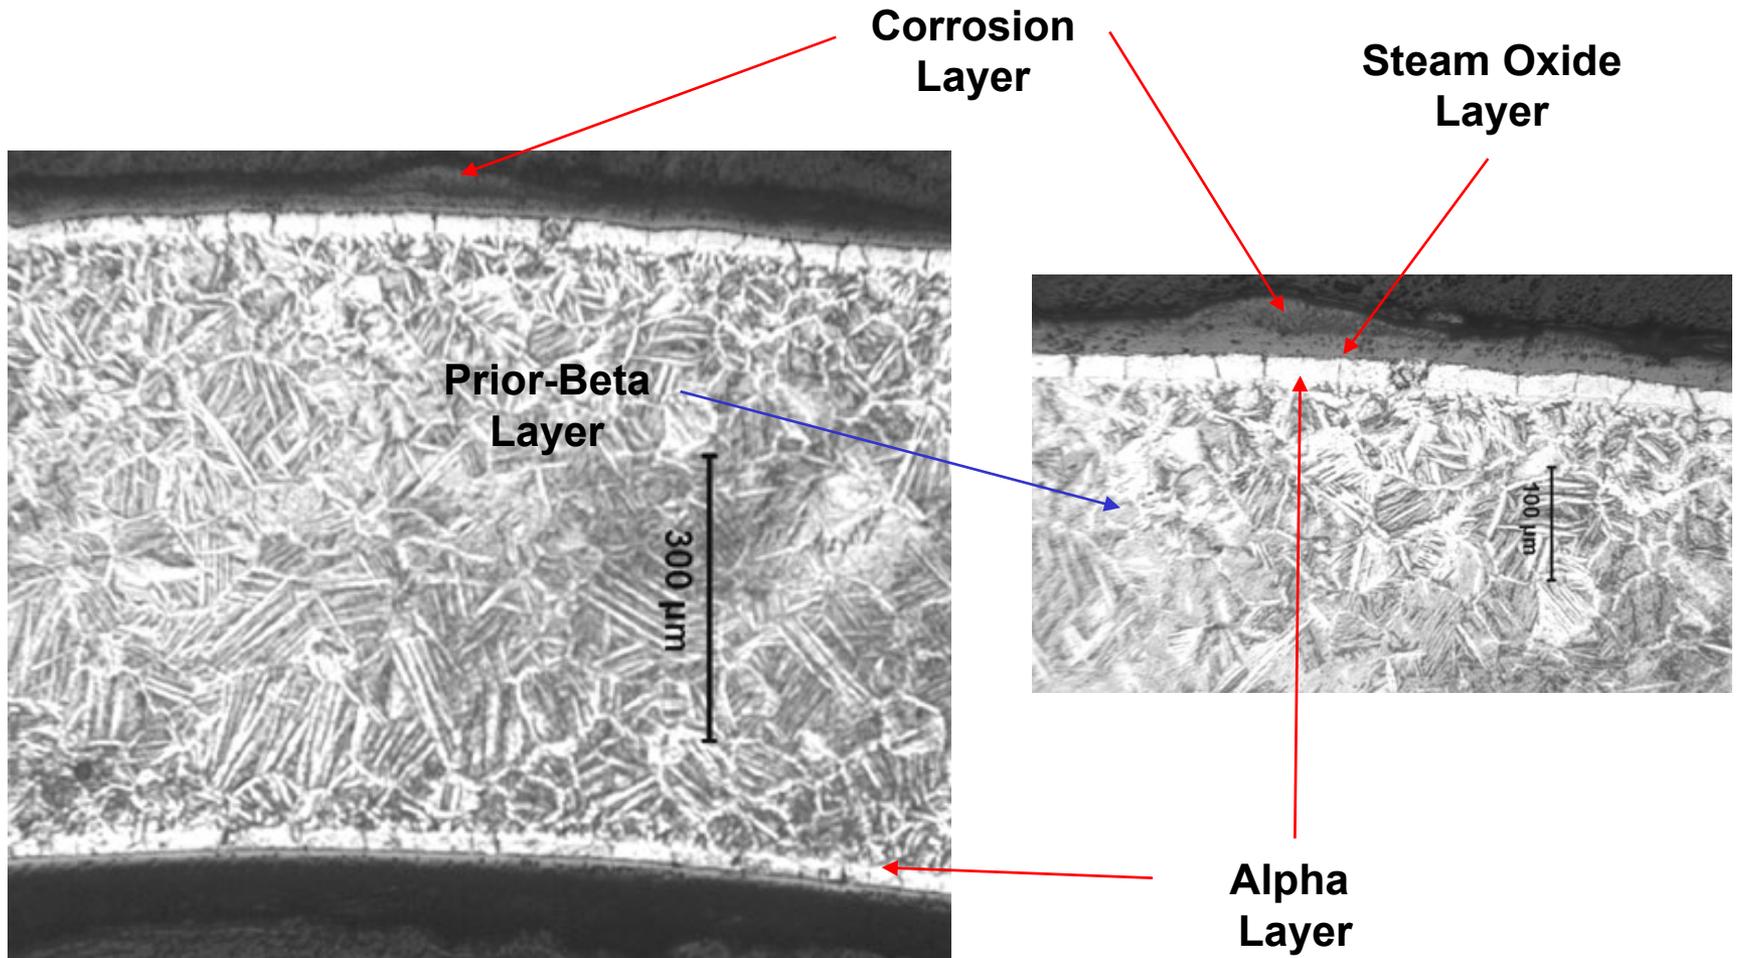
Metallography of 7% CP-ECR Sample – Outer Surface

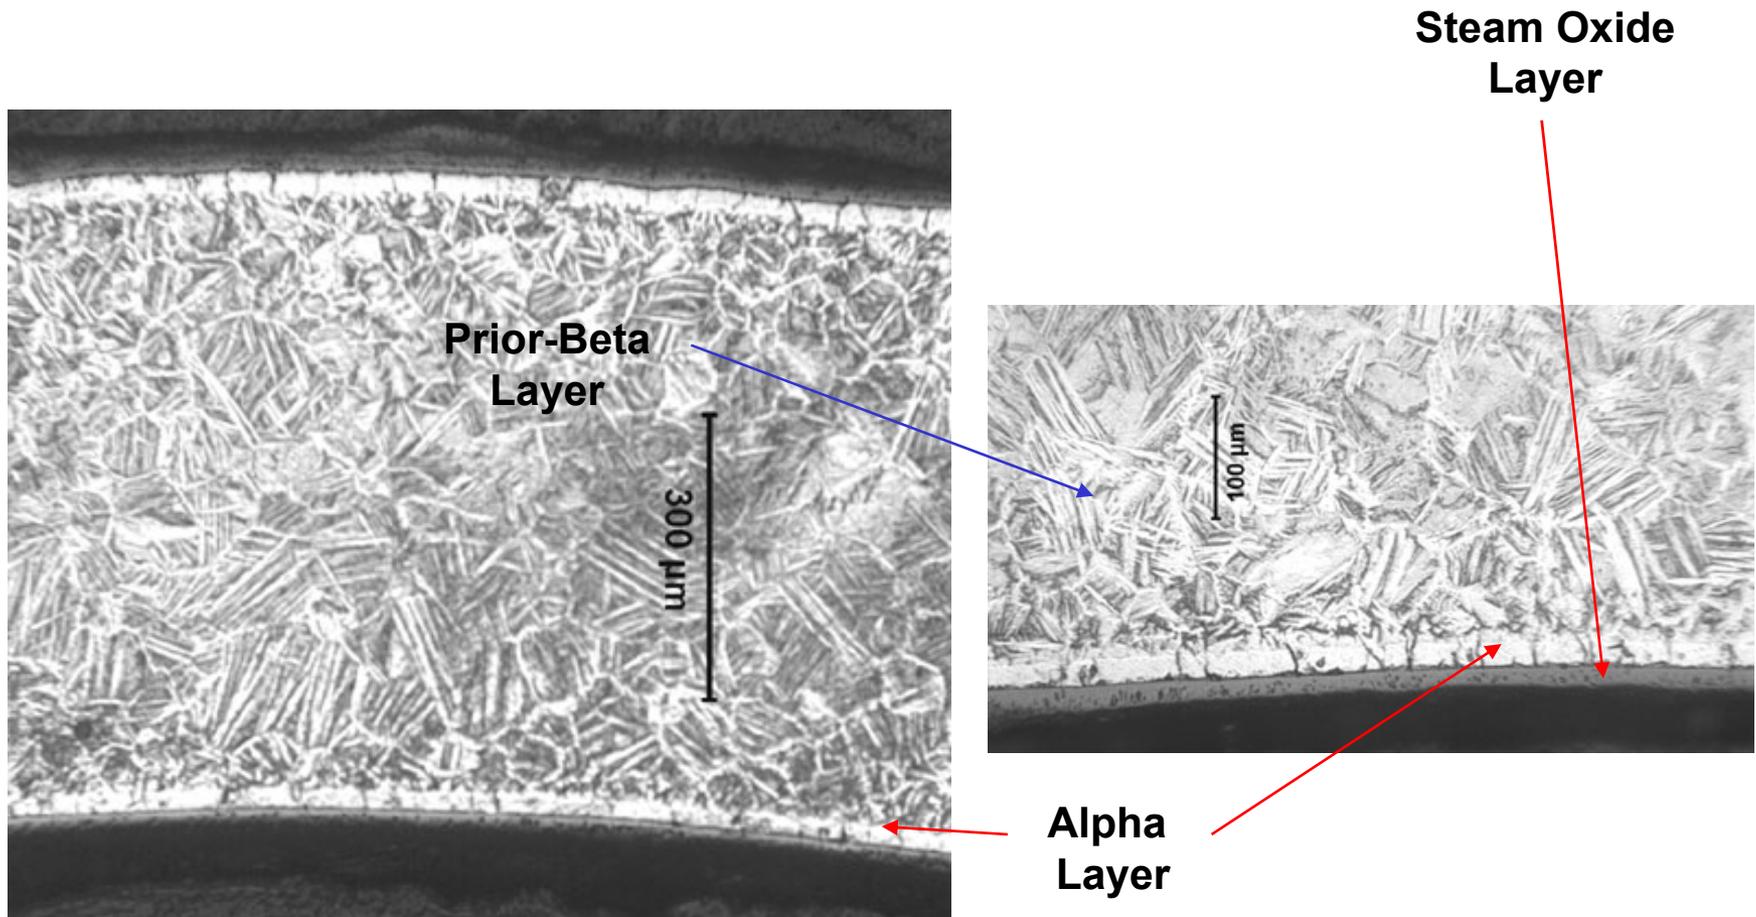
Metallography of 7% CP-ECR Sample – Inner Surface

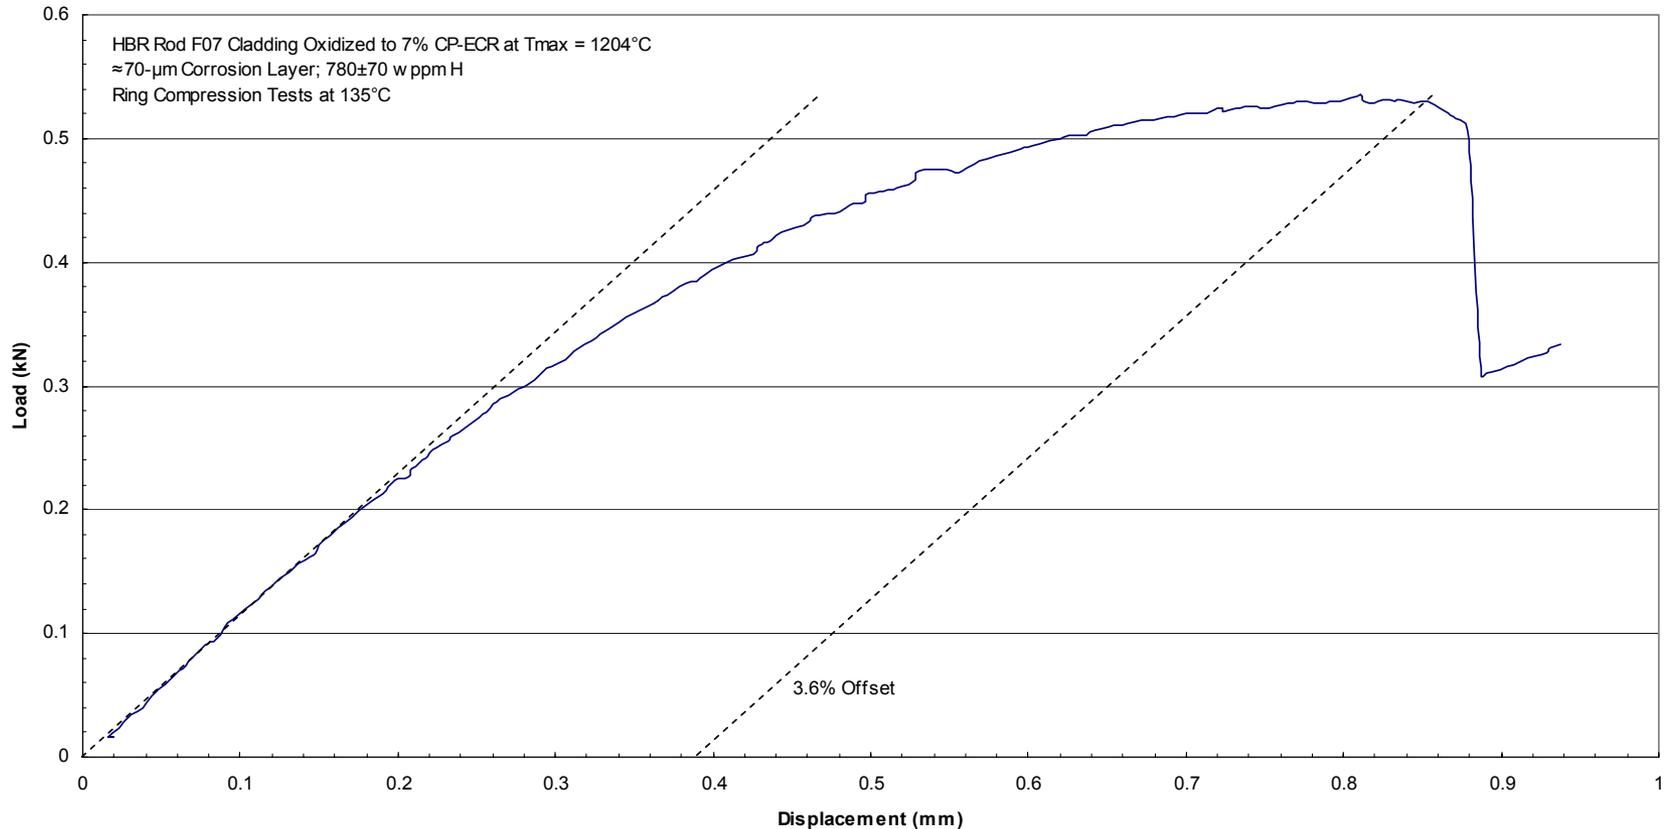
Load-Displacement Curve (at 135°C) for 7% CP-ECR HBR Zry-4 Ring with 780 ± 70 wppm H (Post-Oxidation)

- Note: sample was heated to $\approx 900^\circ\text{C}$, control TC failed, cooled to 300°C , reheated to 1204°C based on working TC
- Post-test hydrogen: 780 ± 70 wppm (2-mm rings sides of sample)
too high; probably not all in metal cladding
- Metallography
 - Outer-surface: partial corrosion layer, growth of steam-oxide layer
growth of uniform O-stabilized alpha layer
 - Inner-surface: growth of steam-oxide layer; some fuel-clad. bond
growth of O-stabilized alpha layer
 - Summary: effects of corrosion layer $\rightarrow \text{ECR}_t < \text{CP-ECR}$
- Ring-compression ductility = 3.8% offset strain, 2.6% permanent strain
- **Assessment: low ductility**

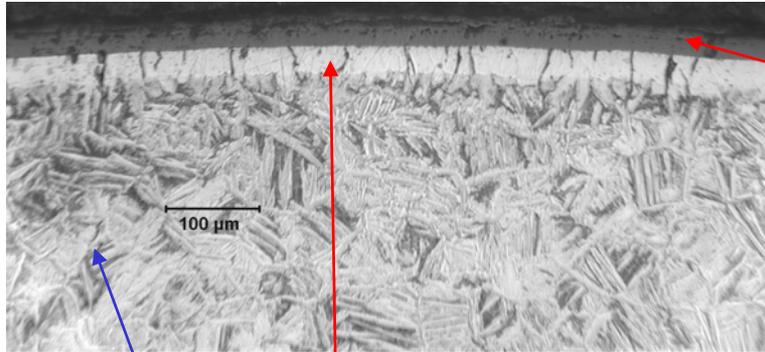
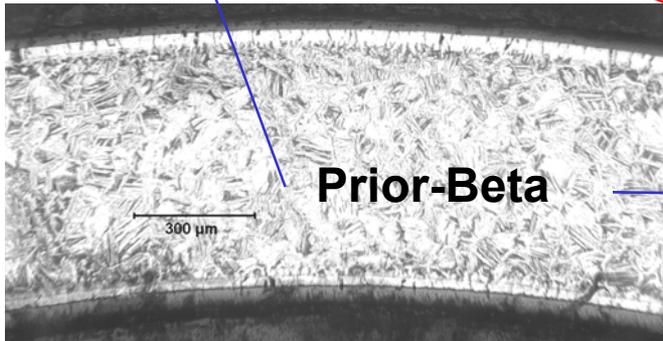
Metallography of 10% CP-ECR Sample – Outer Surface

Steam Oxide Layer

Corrosion Layer???

Alpha

Prior-Beta

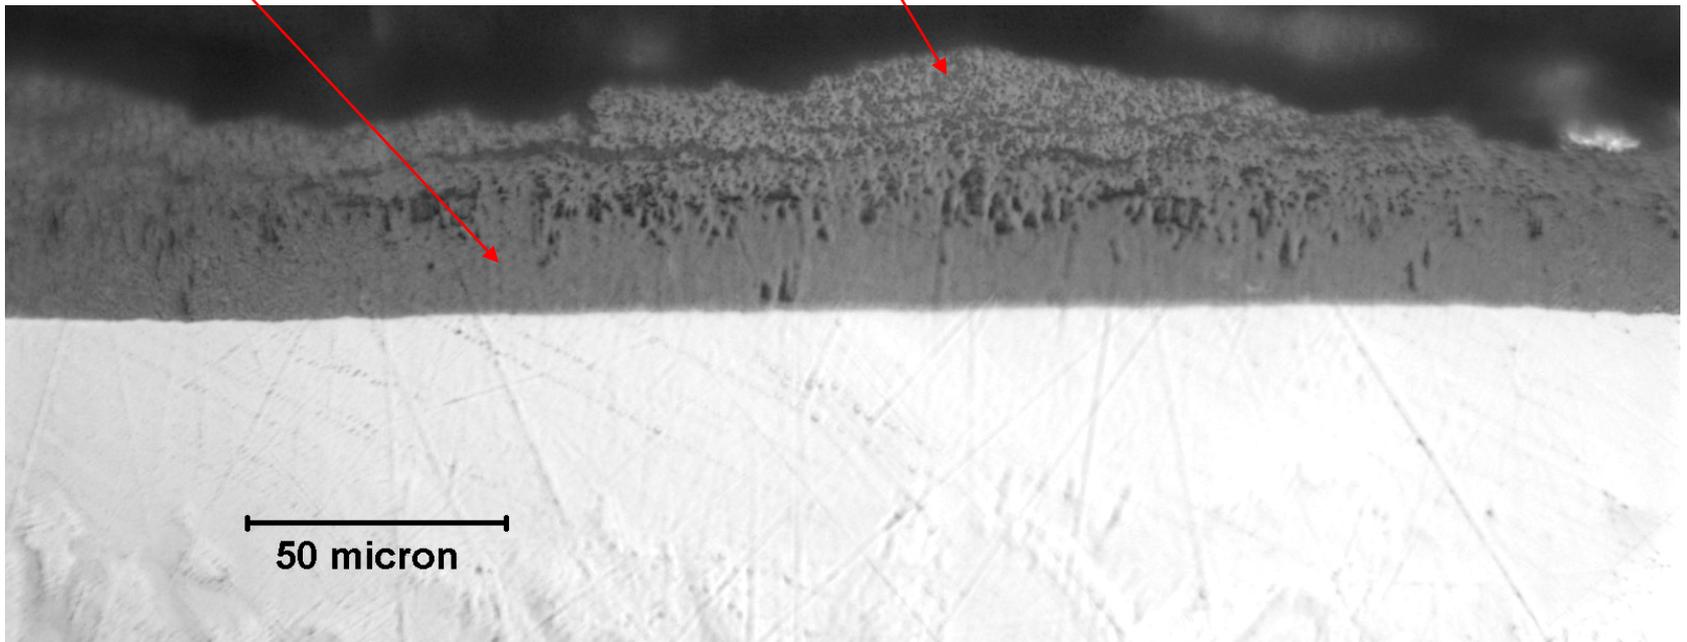
As-Polished Metallography of 10% CP-ECR Sample Outer Surface

Steam Oxide

Corrosion
