H.B. Robinson High-Burnup PWR Oxidation and Post-Quench Ductility

M. Billone, Y. Yan, T. Burtseva and H. Chung
Energy Technology Division
Argonne National Laboratory
February 10, 2005

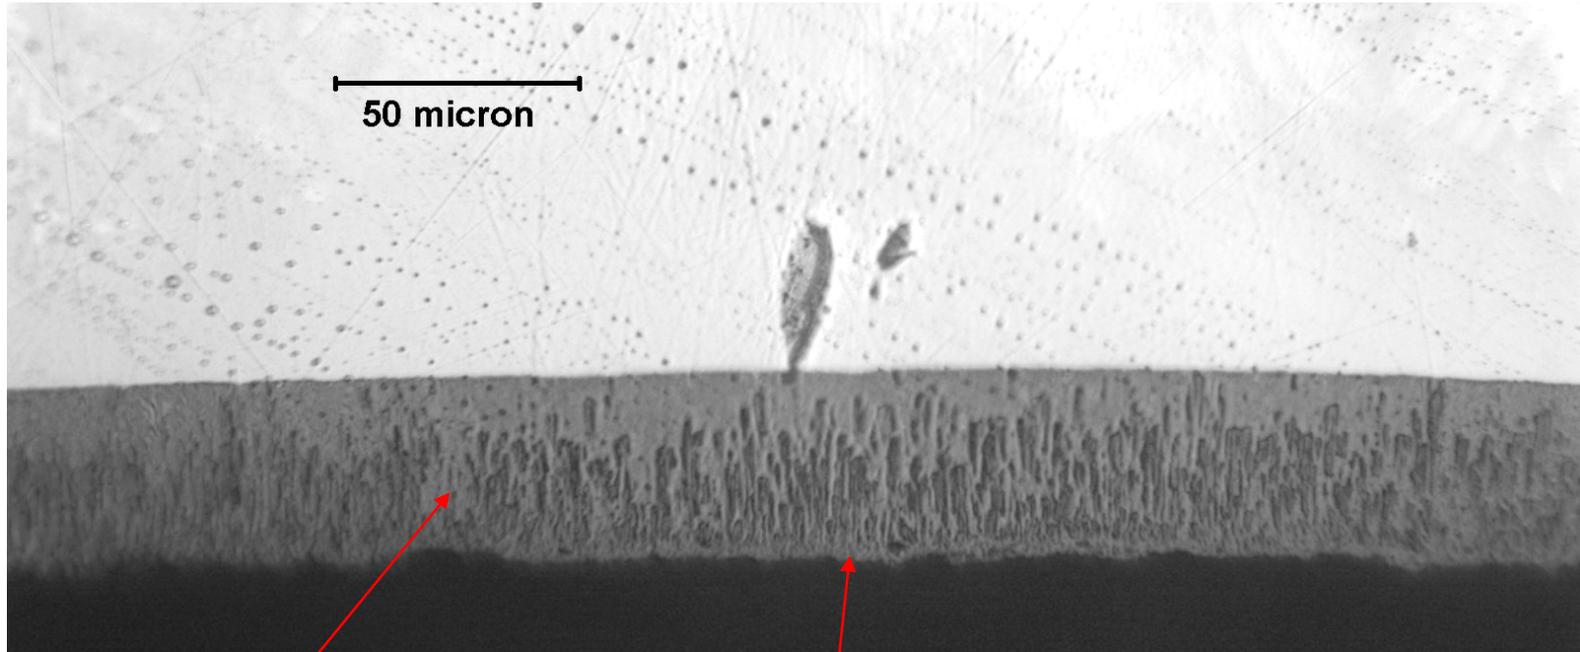
As-Polished Metallography of 10% CP-ECR Sample Inner Surface

Steam Oxide

**Fuel-Cladding
Bond??**

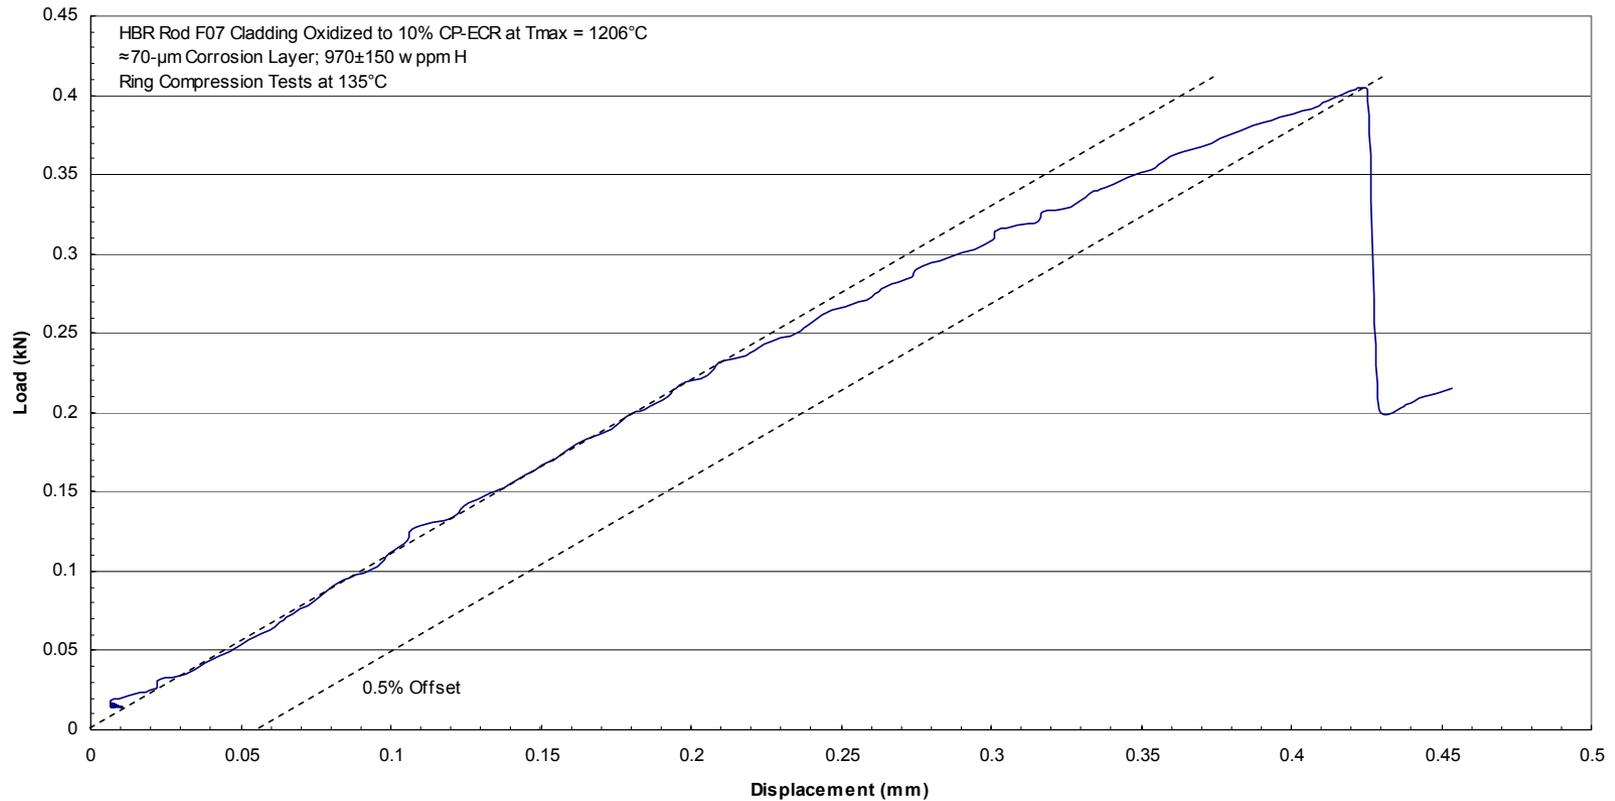
Load-Displacement Curve (at 135°C) for 10% CP-ECR HBR Zry-4 Ring with 970 ± 150 wppm H (Post-Oxidation)

- **10% CP-ECR with T = 1206°C Prior to Cooling**
 - Post-test hydrogen: 970±150 wppm (2-mm rings sides of sample)
750±100 wppm based on 8-mm-long ring
too high; may not all be in the metal
 - Metallography
 - Outer-surface: corrosion layer??. growth of steam-oxide layer
steam-oxide < O-stabilized alpha layer thickness
 - Inner-surface: growth of steam-oxide layer; fuel-clad. bond??
steam-oxide > O-stabilized alpha layer thickness
 - Summary: alpha layer thickness < pre-H, non-irr. sample
need better metallography → measured ECR
 - Ring-compression ductility = 0.5% offset strain, 0.6% permanent strain
 - **Assessment: very brittle**

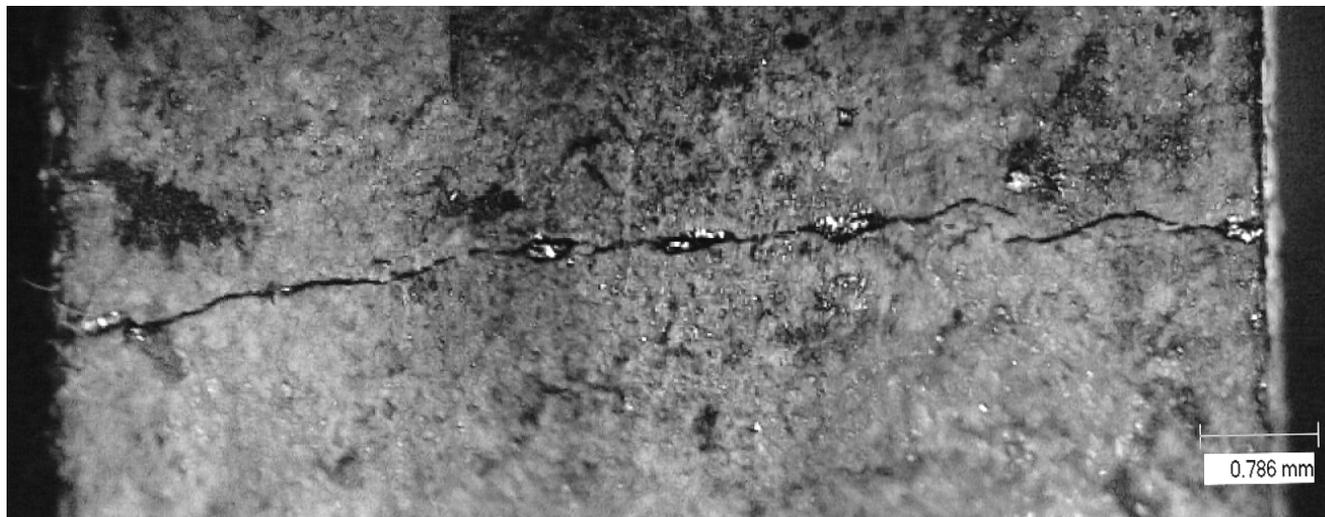
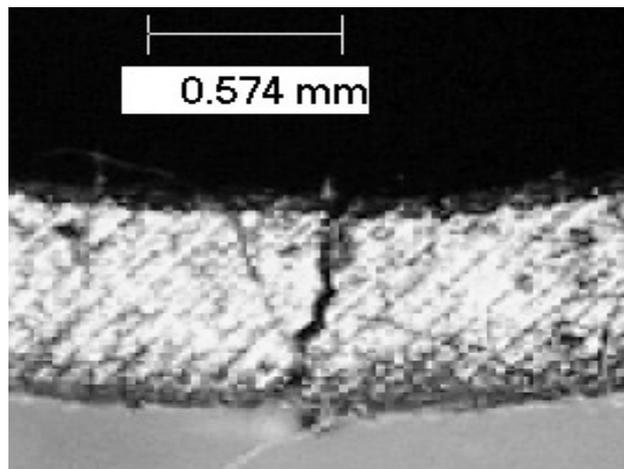
Low Mag. Images of Crack at Bottom Support Plate in 10% ECR Sample

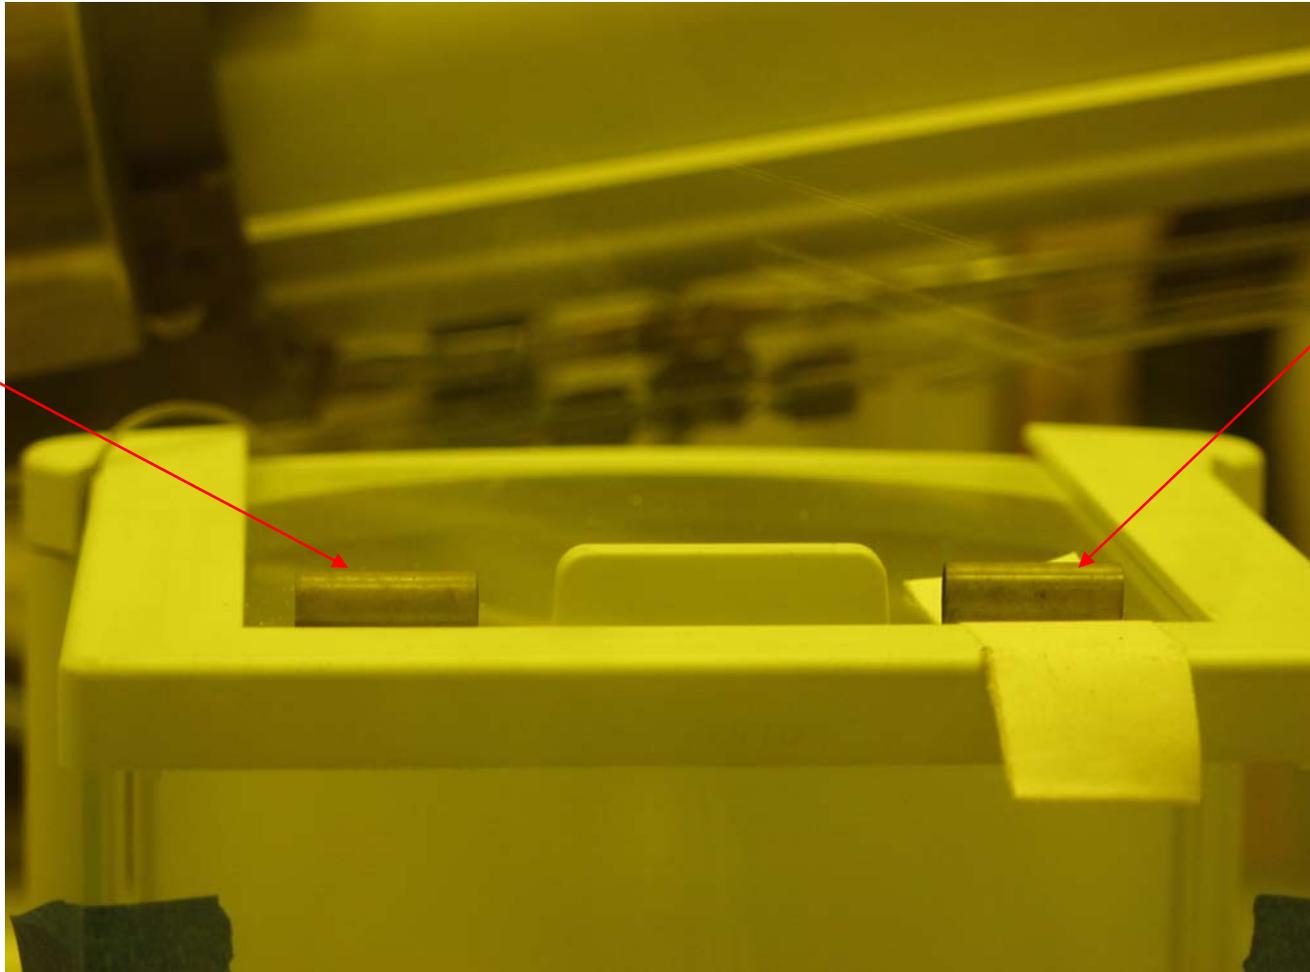
Pre-Test Visual Appearance of Sample

**Untested
Sample**

**Sample
Prior to
Testing**

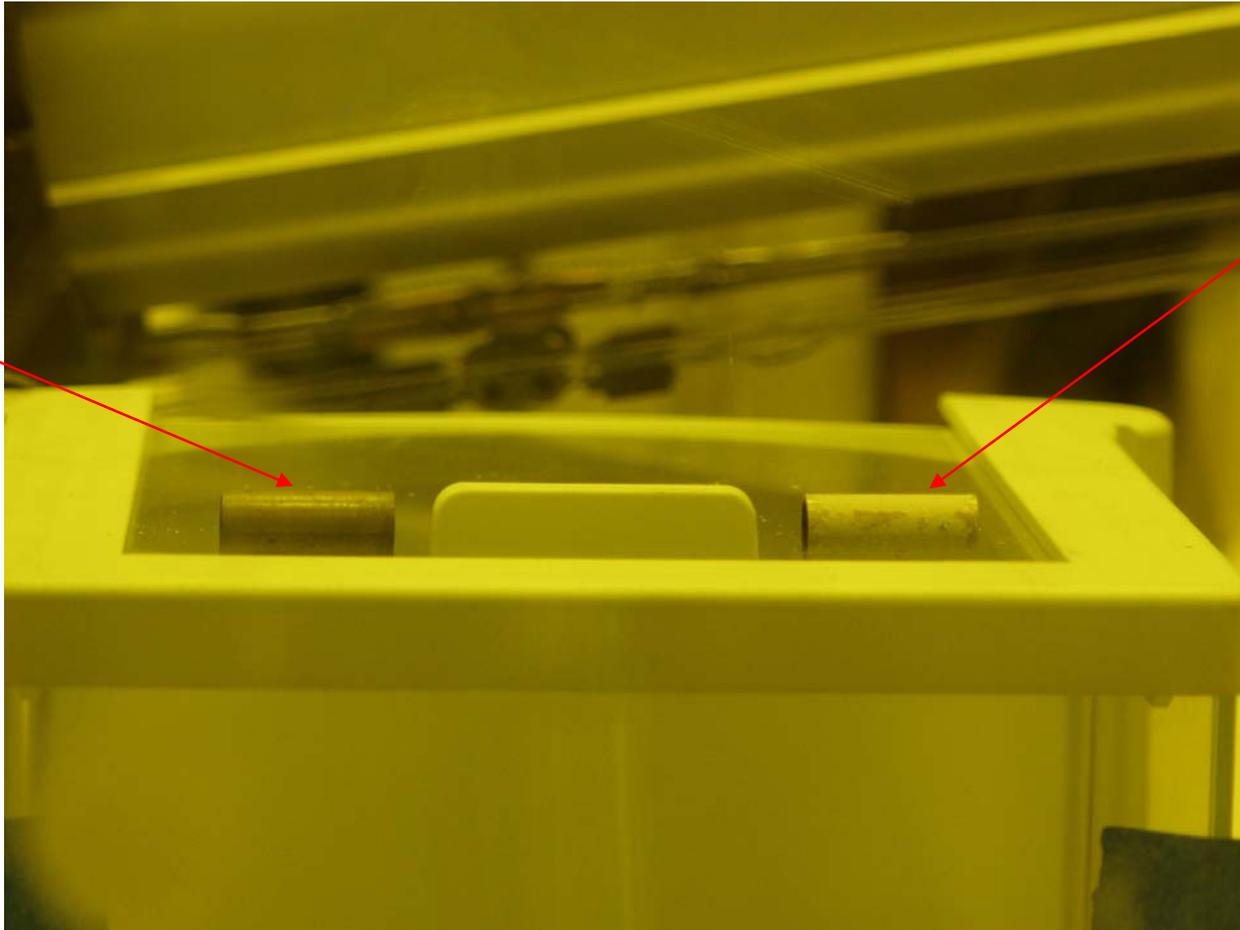
Post-Test vs. Pre-Test Visual Appearance of Sample

**Untested
Sample**

**Sample
After
Oxidation**

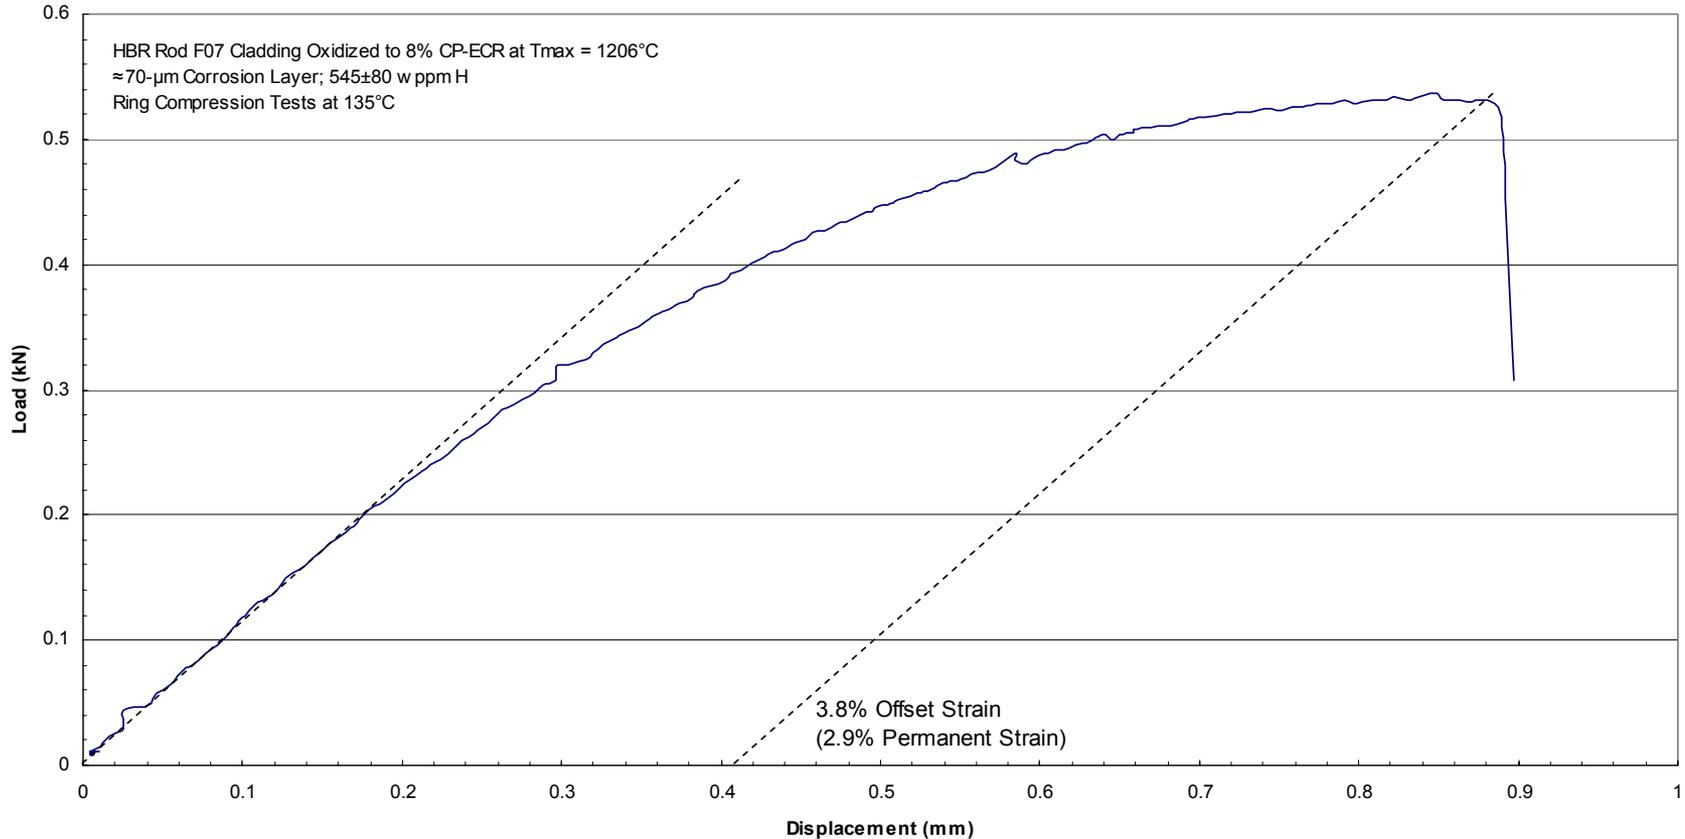
Load-Displacement Curve (at 135°C) for 8% CP-ECR HBR Zry-4 Ring with 545 ± 80 wppm H (Post-Oxidation)

- Ring-compression ductility = 3.8% offset strain, 2.9% permanent strain
- **Assessment: low ductility**

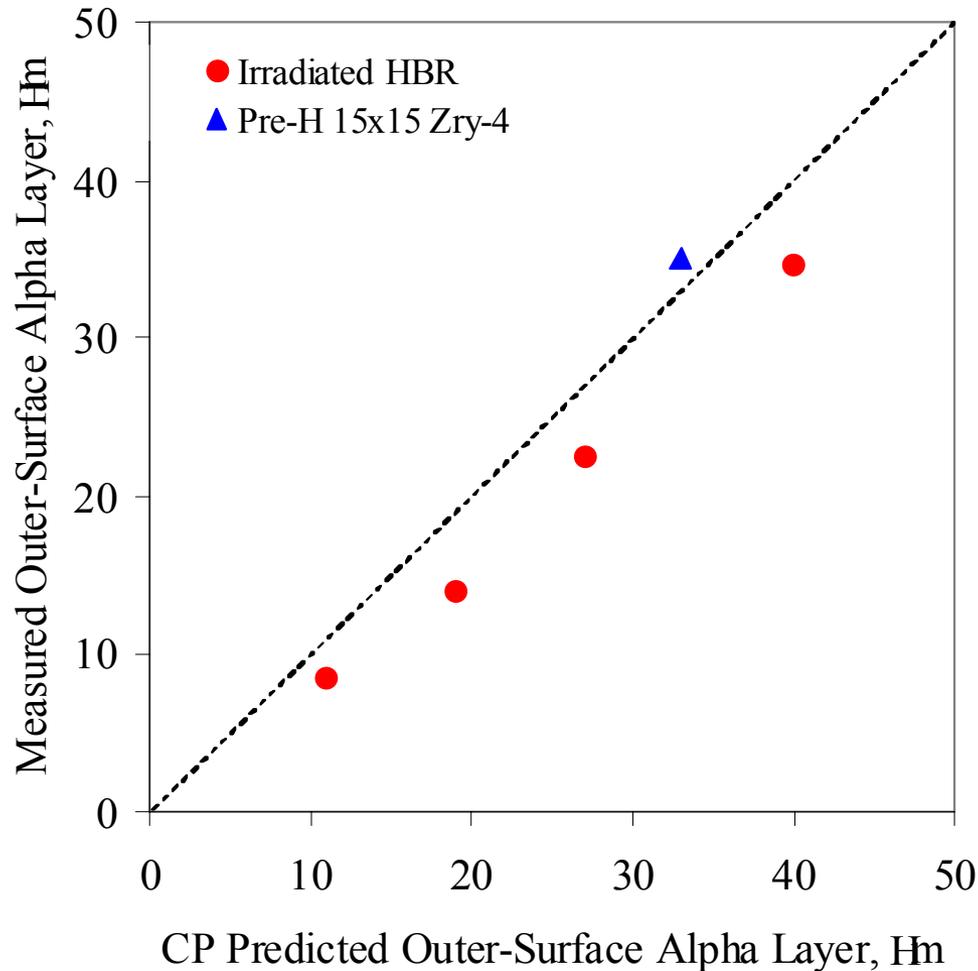
Measured vs. Predicted Alpha Layer Thickness Preliminary Results for Outer-Surface Alpha Layer

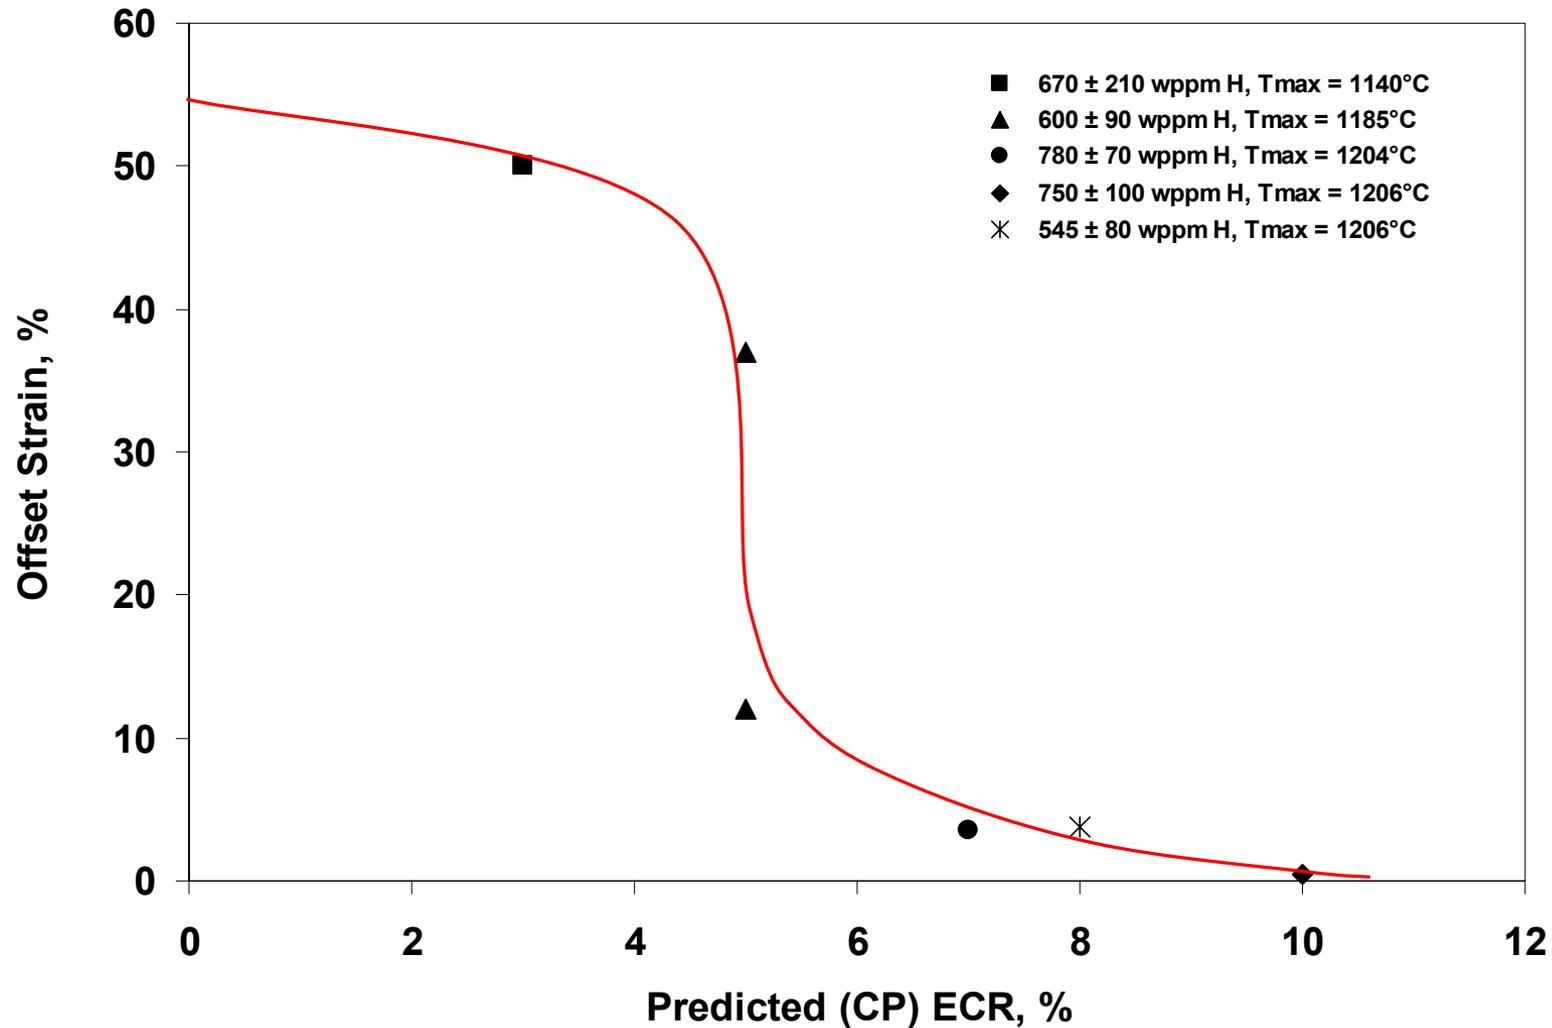
Summary of Post-Oxidation Ductility (Offset Strain) at 135°C vs. CP-ECR for High-Burnup Zry-4 Cladding

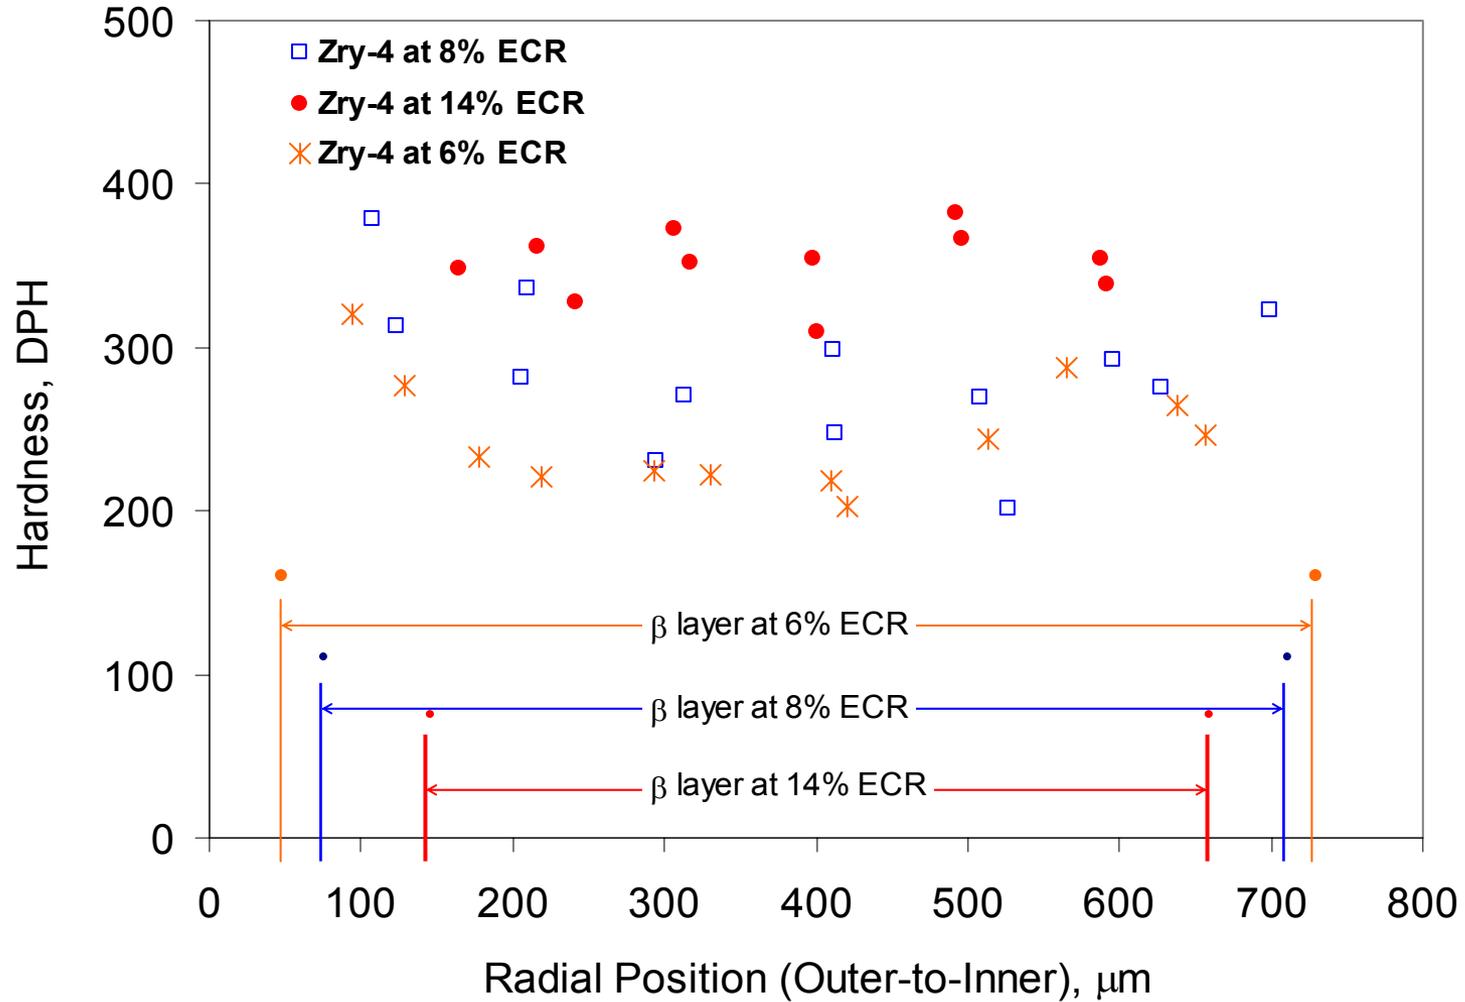
Microhardness Profiles for 15×15 Zry-4 Oxidized at 1200°C to 6%, 8% and 14% ECR

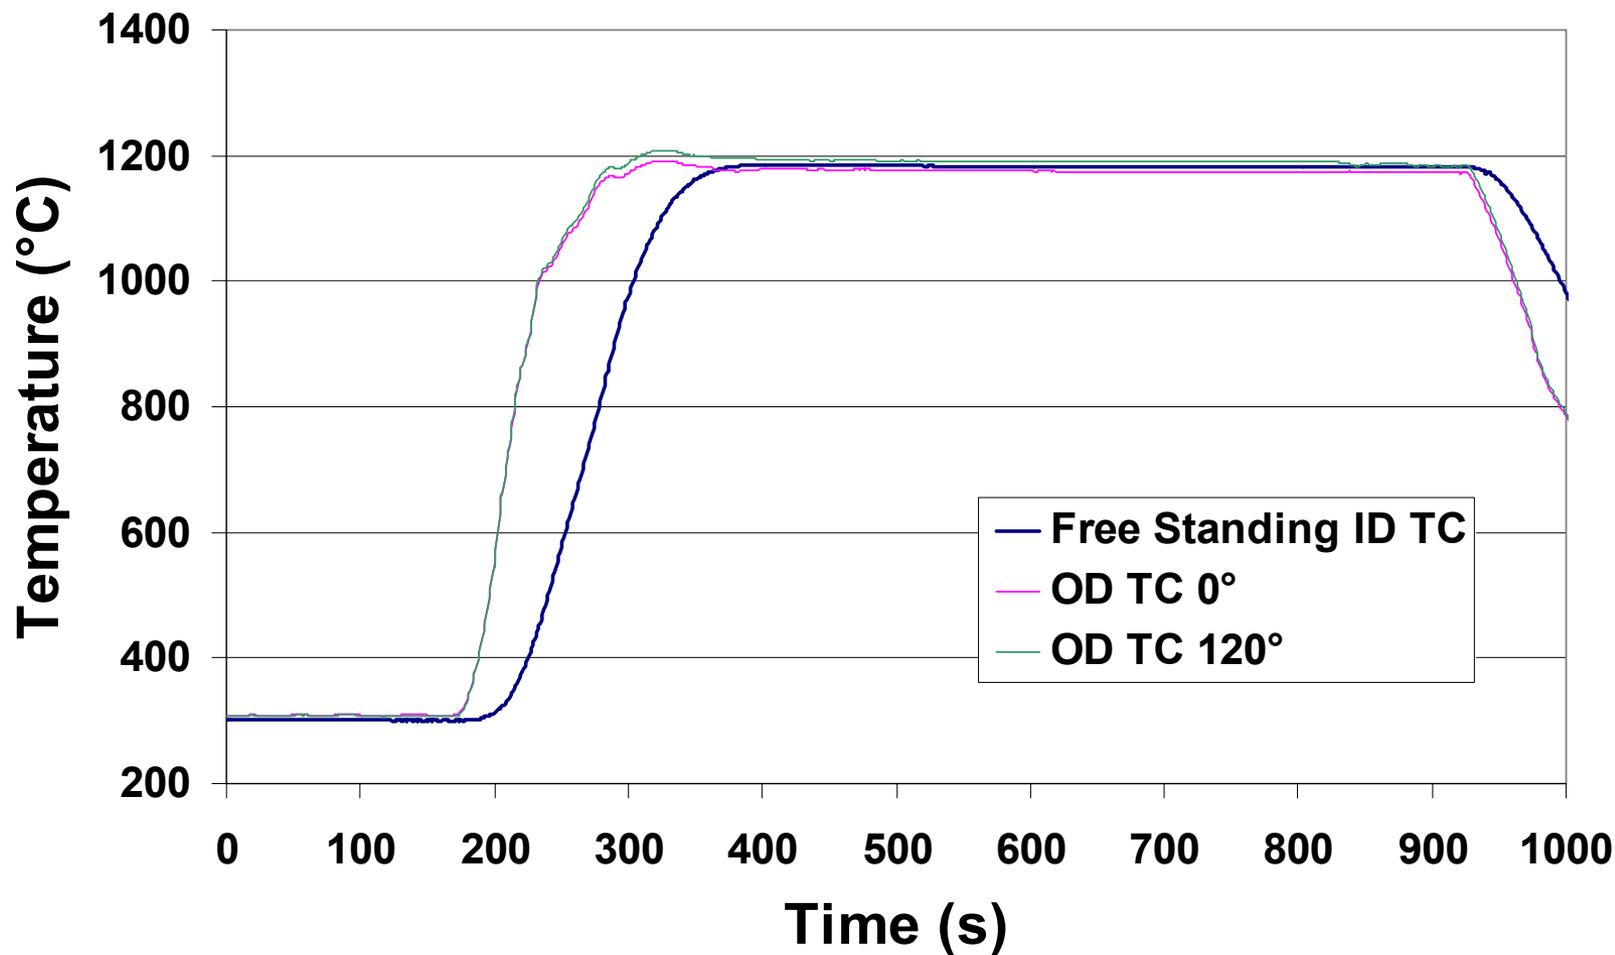
Temperature Distribution in 10-minute Test with Unirradiated Zry-2 Sample
