PSEG Nuclear

HOPE CREEK PIPE FAILURE ROOT CAUSE

HIGH PRESSURE COOLANT INJECTION (HPCI) TURBINE EXHAUST PIPING

RECIRCULATION PUMP AND SYSTEM

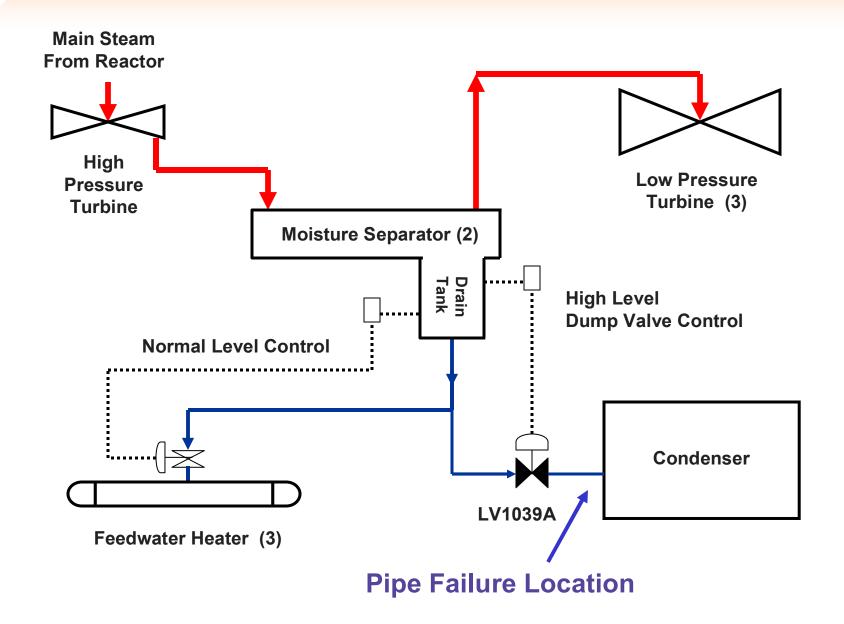
PIPE FAILURE

Root Cause	Actions Taken
Extended operation with the dump valve open caused the pipe to fail due to fatigue.	Piping repairedNozzle design improvedVibration monitoring on piping
Operating procedures did not limit operation with the dump valve open.	Procedure changes to incorporate limitations
The evaluation and decision to operate with the dump valve open did not consider all of the possible failure mechanisms.	A formal Operational & Technical Decision Making process to enable the execution of consistently good decisions

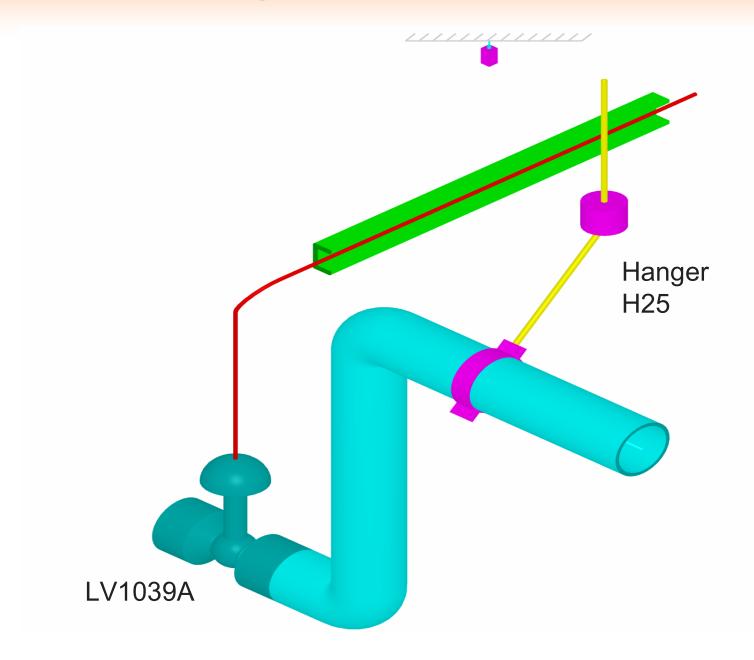
FAILED HANGER

- Hangers
- Condenser Nozzles
- Operating Procedures
- Operational & Technical Decision Making

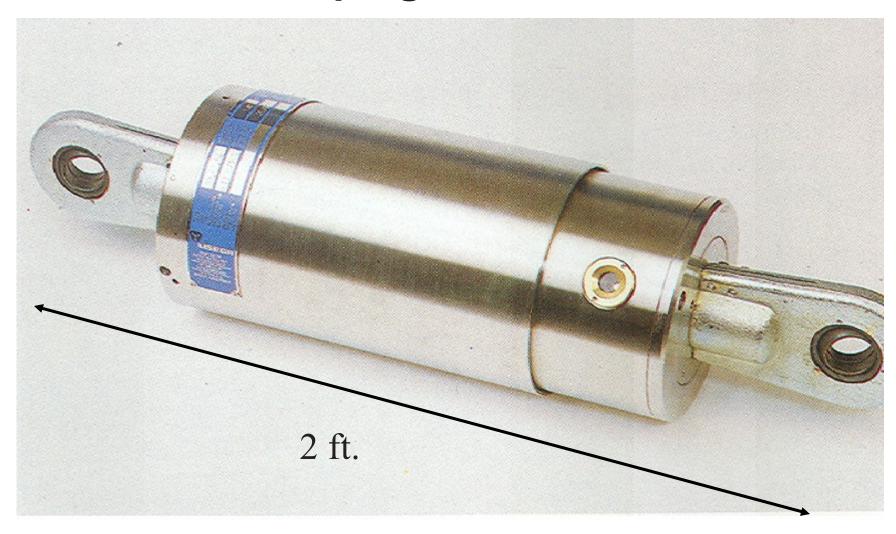
Piping Snubber

- Two HPCI exhaust piping snubbers were damaged during dynamic bench testing.
- One additional snubber had bent extension tube.
- Performed extensive walkdowns and examinations of the system.
- The HPCI exhaust piping was not damaged.

- The damaged snubbers were returned to the manufacturer.
- The manufacturer's analysis determined that internal components were damaged.
- The bent snubber extension tube was visually examined.
- Damaged components did not prevent the snubbers from performing their function.

- Exhaust line check valve cycling following October 10th event because of unusual system operational alignment.
- •Vibration due to presence of small amounts of water in system during system operation.
- Isolated manufacturing problem with the two damaged snubbers.

- Damaged snubbers were replaced.
- System Piping Supports were inspected.
- All Exhaust Line Snubbers were inspected and tested.
- Repaired steam leakage through Turbine Inlet Valve.
- Installed modifications to improve water removal and monitoring for water accumulation in the system.
- Repaired the equipment problems to resolve the extended low flow operation of the system.
- Exhaust line components will be monitored during system startup and operation.

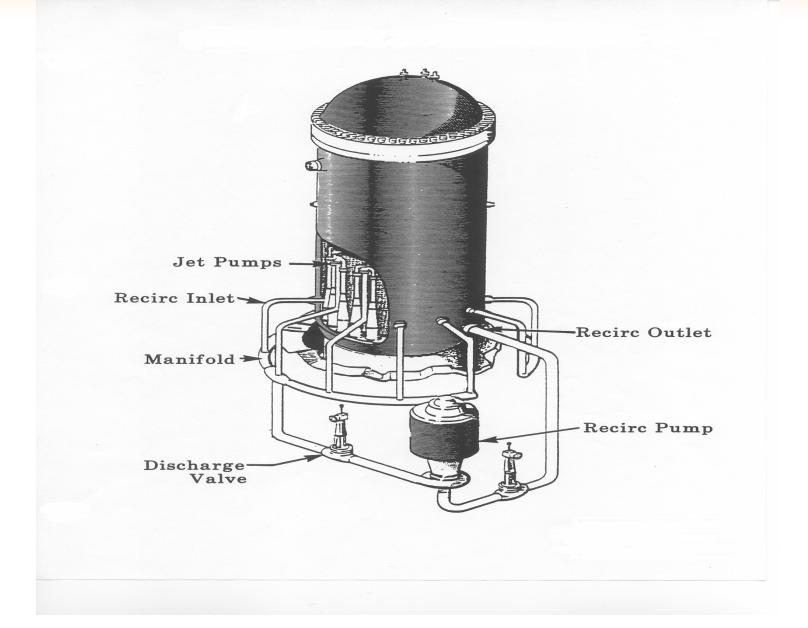
REACTOR RECIRCULATION SYSTEM

- B' Recirculation Pump Shaft Vibration
- Recirculation System Vane Passing Frequency Vibration
- Containment Harmonic Vibration Noise

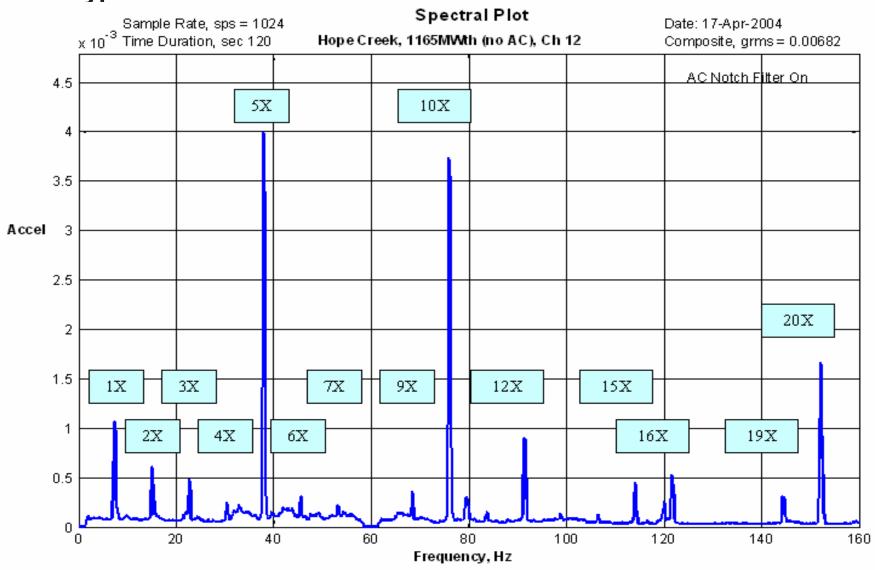
Typical Vibration Accelerations

- System flow and pumps are vibration sources in piping systems.
- Vibration in piping systems is expected.
- Source of energy for vibration in the system is the Recirculation Pump impeller vane pass and not the pump shaft vibration.
- Start-up testing is performed on all new piping systems to assess vibration baselines.

- Damaged subcomponents have been repaired, and specific components have been reinforced.
- Instrumentation has been installed on selected components.
- •Acceptance criteria has been developed.
- We will monitor system vibration during start up and steady state operation.
