Three Mile Island, Unit 1 (TMI Unit 1)
Facility Operating License No. DPR-50
NRC Docket No. 50-289

Subject: M5TM Lead Test Rods - 15R Refueling Outage Post Irradiation Examinations

**Framatome ANP Report BAW-2485, Revision 1
“Post Irradiation Examination for Advanced Materials
at Burnups Exceeding the Current Limit”**

**Post Irradiation Examination for
Advanced Materials at Burnups
Exceeding the Current Limit**

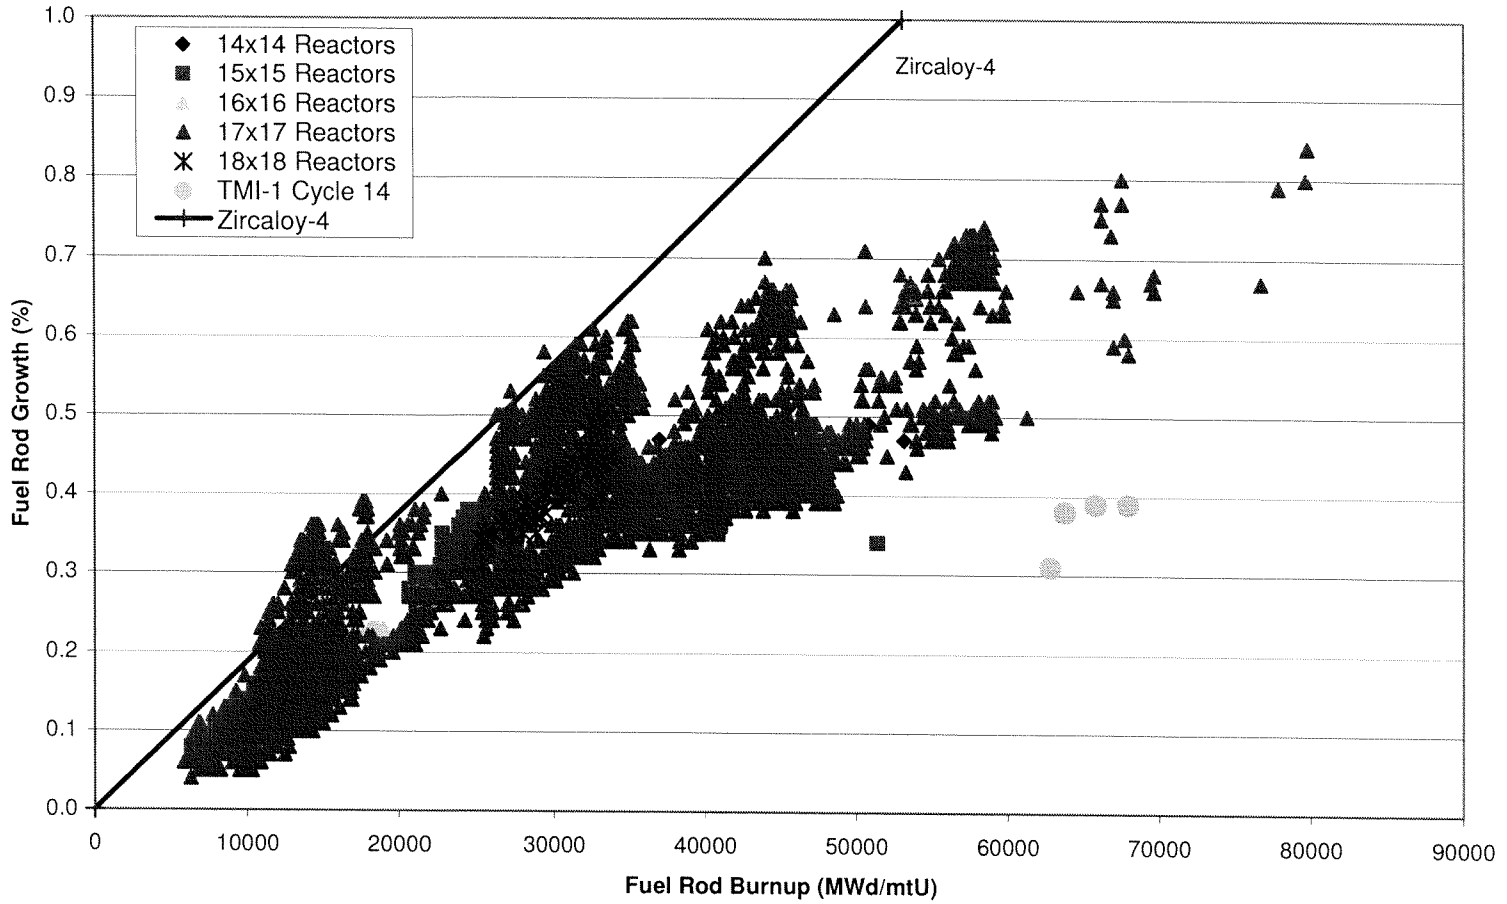
Figure 4.1 - Fuel Rod Growth Versus Burnup

As expected, more shoulder gap closure was observed on the Zircaloy-4 fuel rods than on the M5 fuel rods in fuel assembly NJ07U9. The average Zircaloy-4 fuel rod growth in NJ07U9 after three cycles of irradiation is about twice the average growth of the M5 fuel rods after four cycles of irradiation. Figure 4.1 shows Framatome ANP M5 fuel rod growth data as a function of fuel rod burnup. The average TMI-1 M5 LTA fuel rod growth is on the low end of the observed data to date. This data confirms that fuel designed with M5 cladding can achieve significantly higher burnups than present designs with Zircaloy-4 based on fuel rod growth considerations.

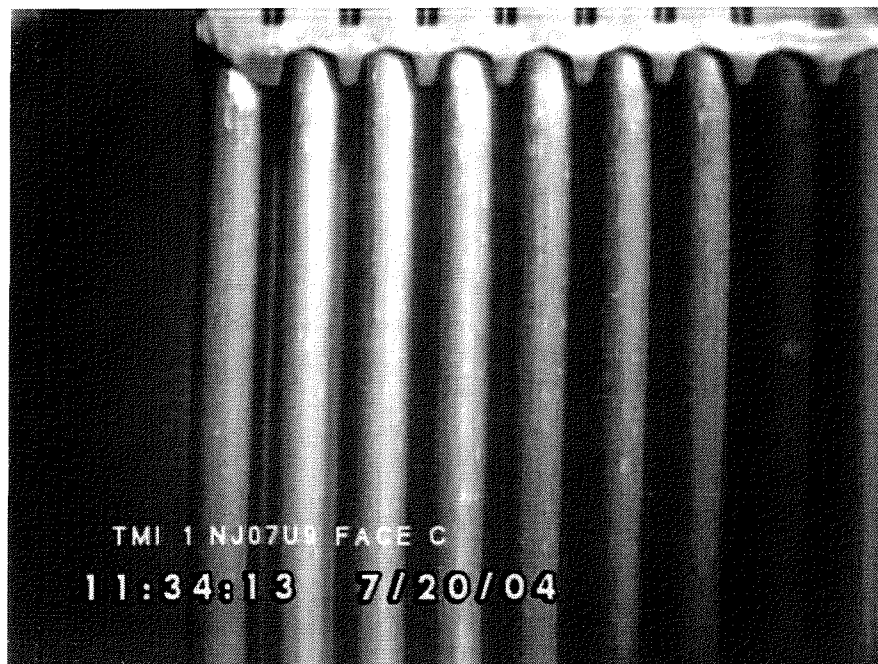
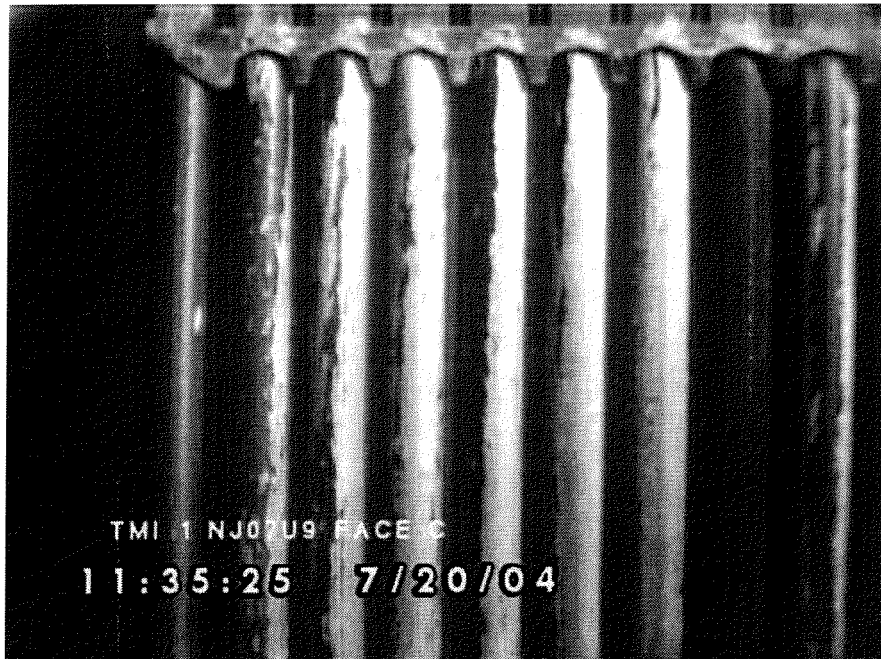
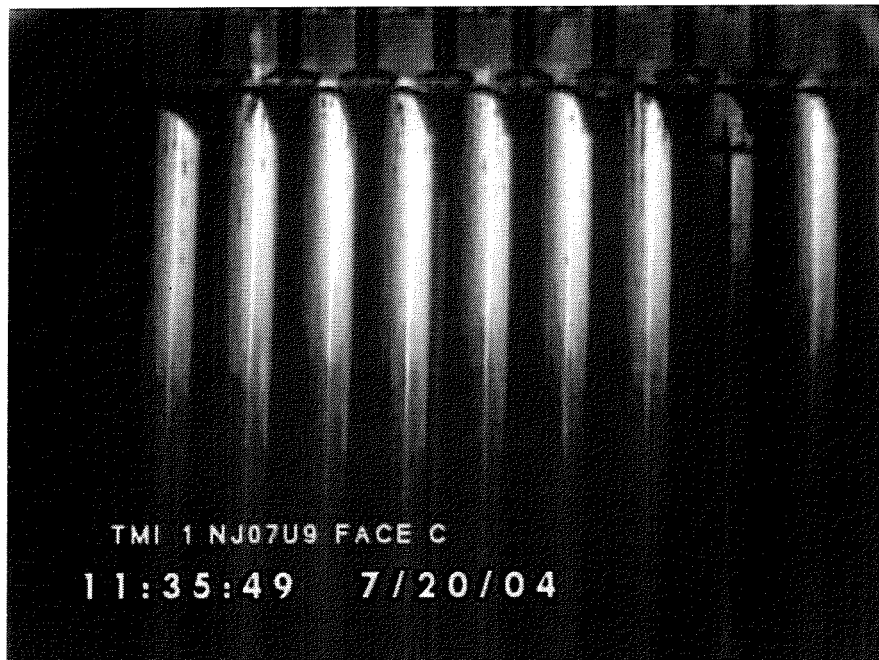
Full-length visual examinations were performed in the spent fuel pool on the LTA at the end of Cycle 14. In-mast sipping confirmed that the fuel assembly NJ07U9 was leaker-free following the fourth irradiation cycle. Representative photographs of assembly NJ07U9 are shown in Figures A1 through A9 in Appendix A. The M5 cladding is clean and smooth throughout the active fuel length on all four faces.

Figure A1: Photograph of Assembly NJ07U9 Showing Fuel Rods Seated on Lower End Fitting (M5 Fuel Rod eighth from left)

Figure A2: Photograph of Assembly NJ07U9 First (Bottom) Grid Span (M5 Fuel Rod Eighth From Left)

Figure A3: Photograph of Assembly NJ07U9 Second Grid Span
(M5 Fuel Rod Eighth From Left)

Figure A4: Photograph of Assembly NJ07U9 Third Grid Span
(M5 Fuel Rod Eighth From Left)

Figure A5: Photograph of Assembly NJ07U9 Fourth Grid Span
(M5 Fuel Rod Eighth From Left)

Figure A6: Photograph of Assembly NJ07U9 Fifth Grid Span
(M5 Fuel Rod Eighth From Left)

Figure A7: Photograph of Assembly NJ07U9 Sixth Grid Span
(M5 Fuel Rod Eighth From Left)

Figure A8: Photograph of Assembly NJ07U9 Seventh (Top) Grid Span
(M5 Fuel Rod Eighth From Left)
