Final Status Survey Report Gas Hills, Wyoming Site

Addendum 2

FINAL STATUS SURVEY REPORT

Gas Hills, Wyoming Site

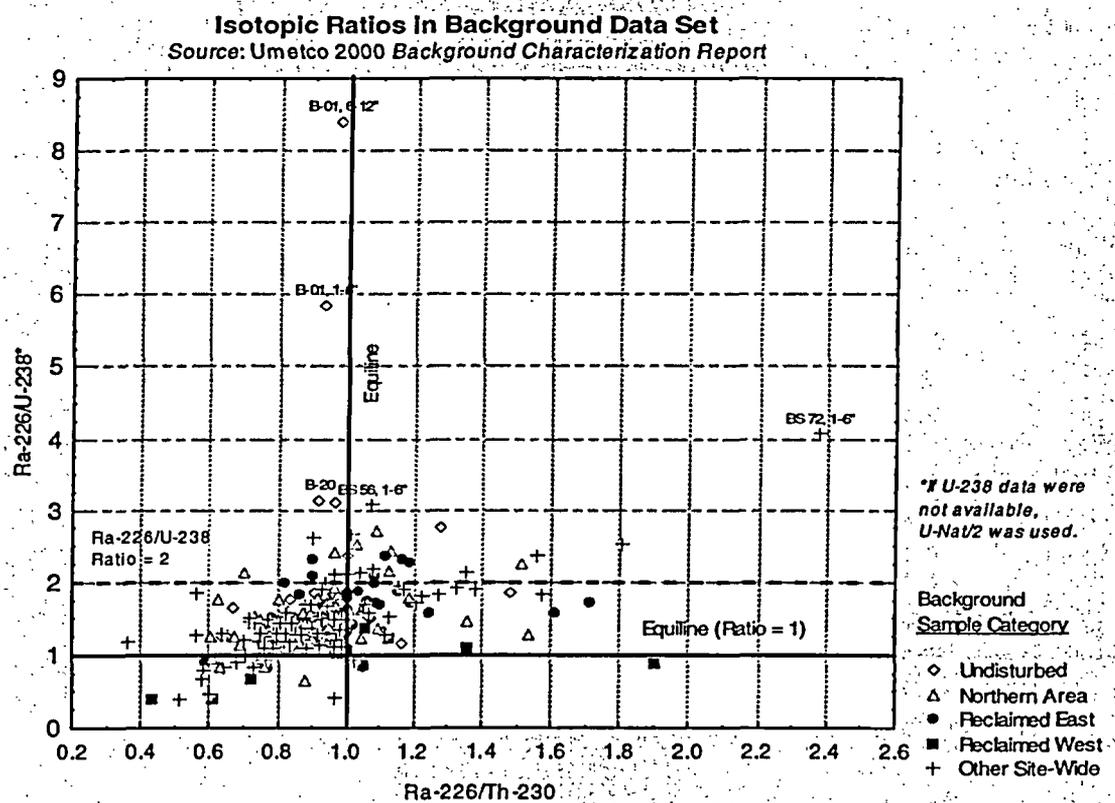
Table 3.2

The disequilibrium apparent along the Susquehanna Haul Road, where Ra-226/0.5*U-nat ranges from 0.98 to 3.37 with an average of 2.01, is not considered indicative of mill tailings impacts as this ratio is well within the range of ratios calculated for the approved background data set. As discussed in Section 3.1 of Umetco's *Background Characterization Report* (Umetco, 2000), although using Ra-226/U-238 ratios to identify milling-related impacts is recommended by the NRC and has been applied at other sites, such evaluation has not yielded compelling results at the Gas Hills. This finding is demonstrated graphically in Figure 3.10 of the *Background Characterization Report* and in the following plot:

Note: For samples analyzed for total U-nat and lacking isotopic data for U-238, the U-238 component was estimated by dividing the U-nat value by 2. This approach assumes that the U-nat source term is represented as percent activity by 49.2% U-238, 49.2% U-234 and 1.6% U-235.

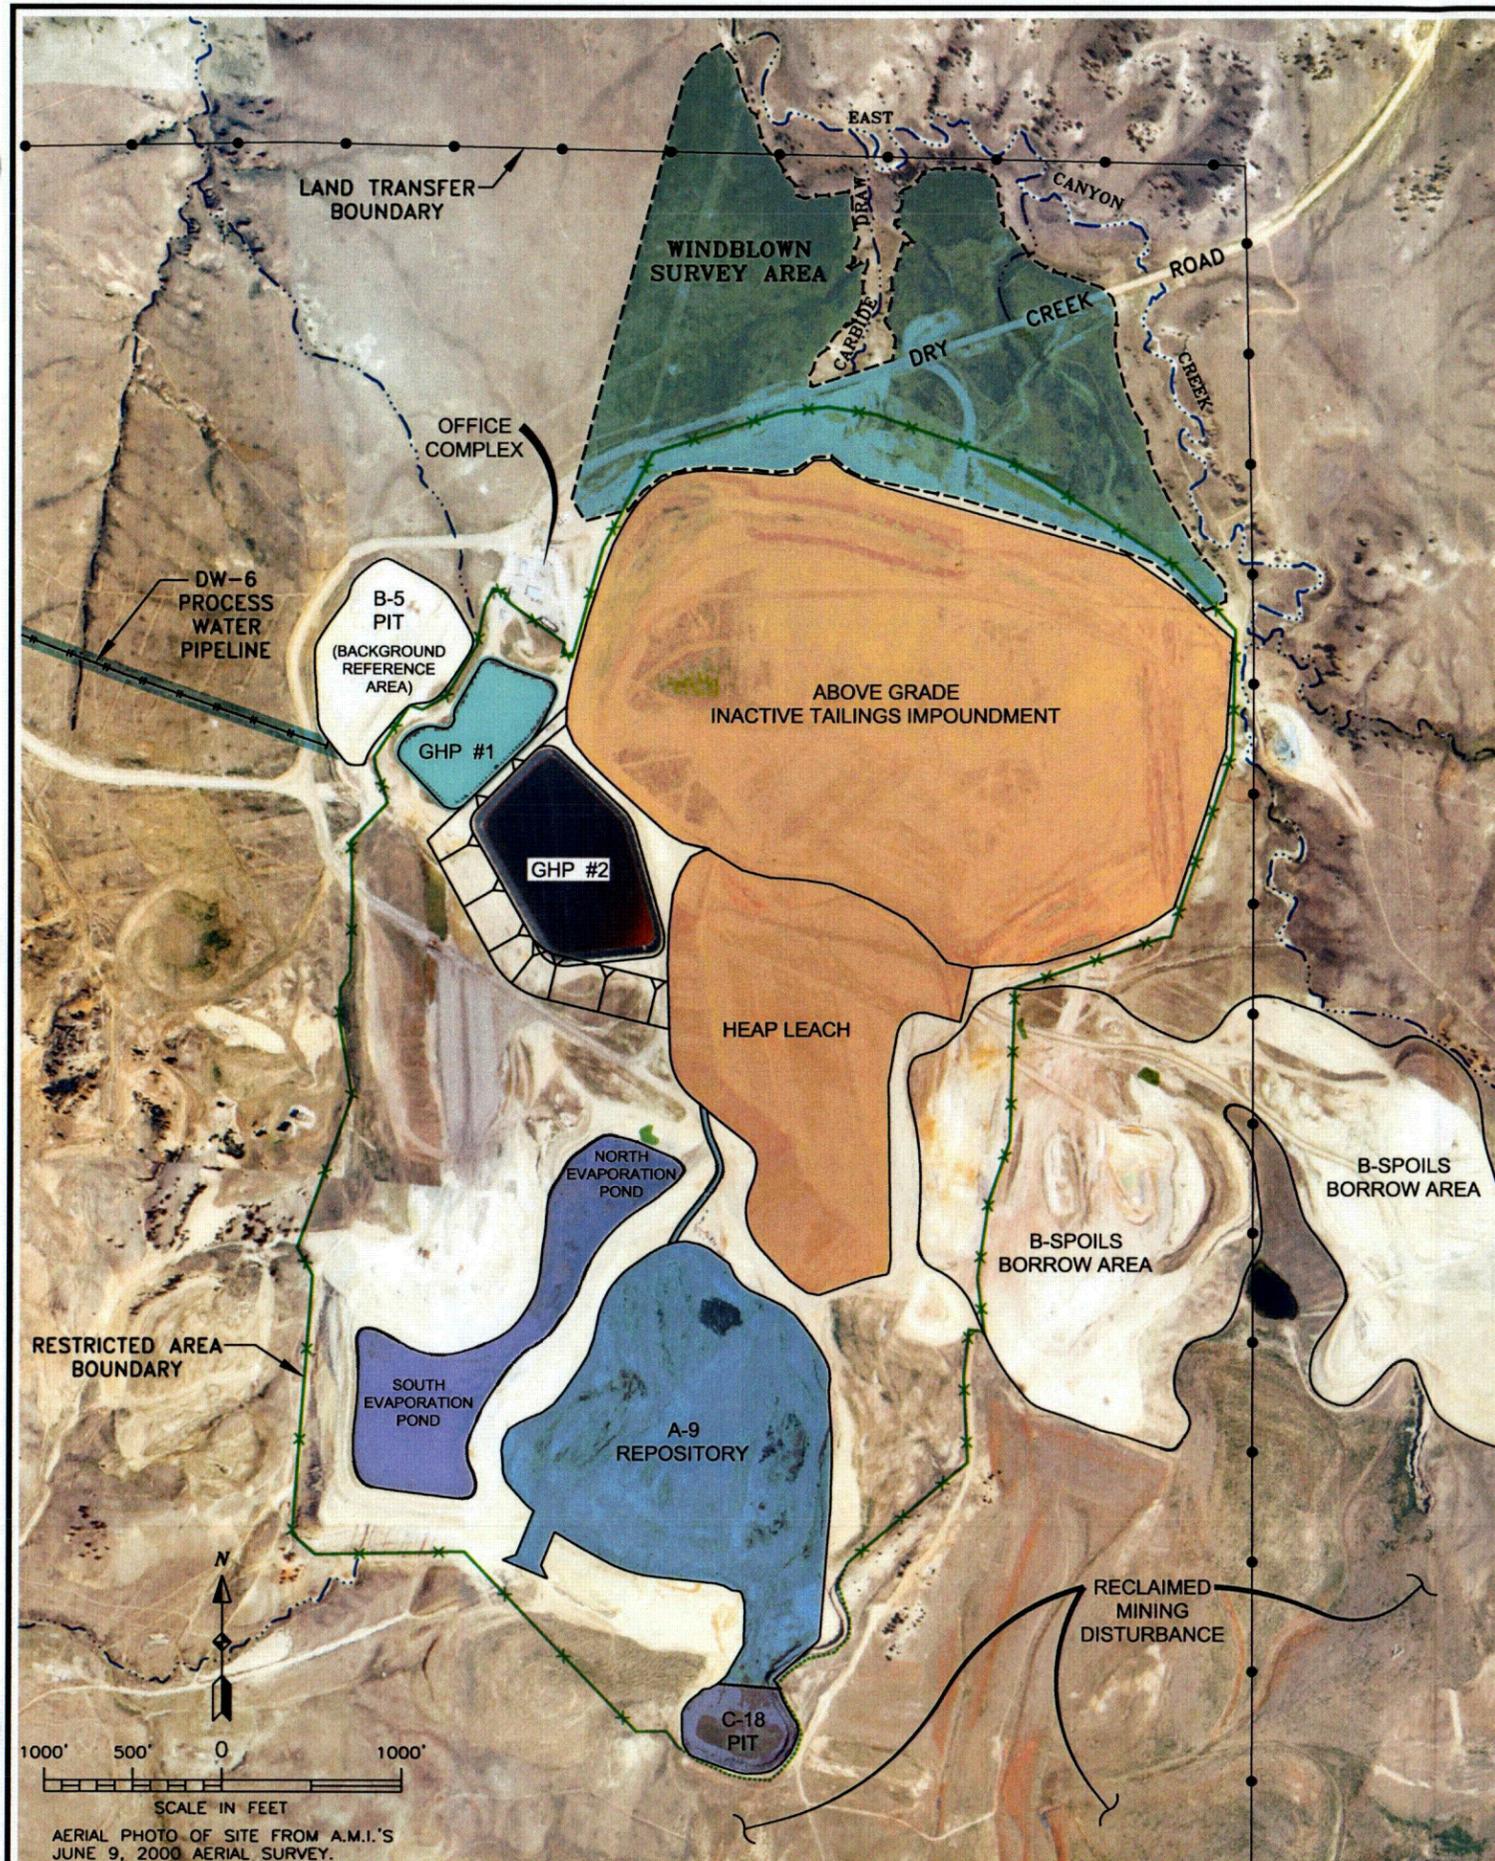
FIGURE 1.1

Figure 1.1 shows the site plan and location map reflecting the status of Final Status Survey efforts for all areas on the site.

**SITE PLAN AND LOCATION MAP
GAS HILLS, WYOMING**

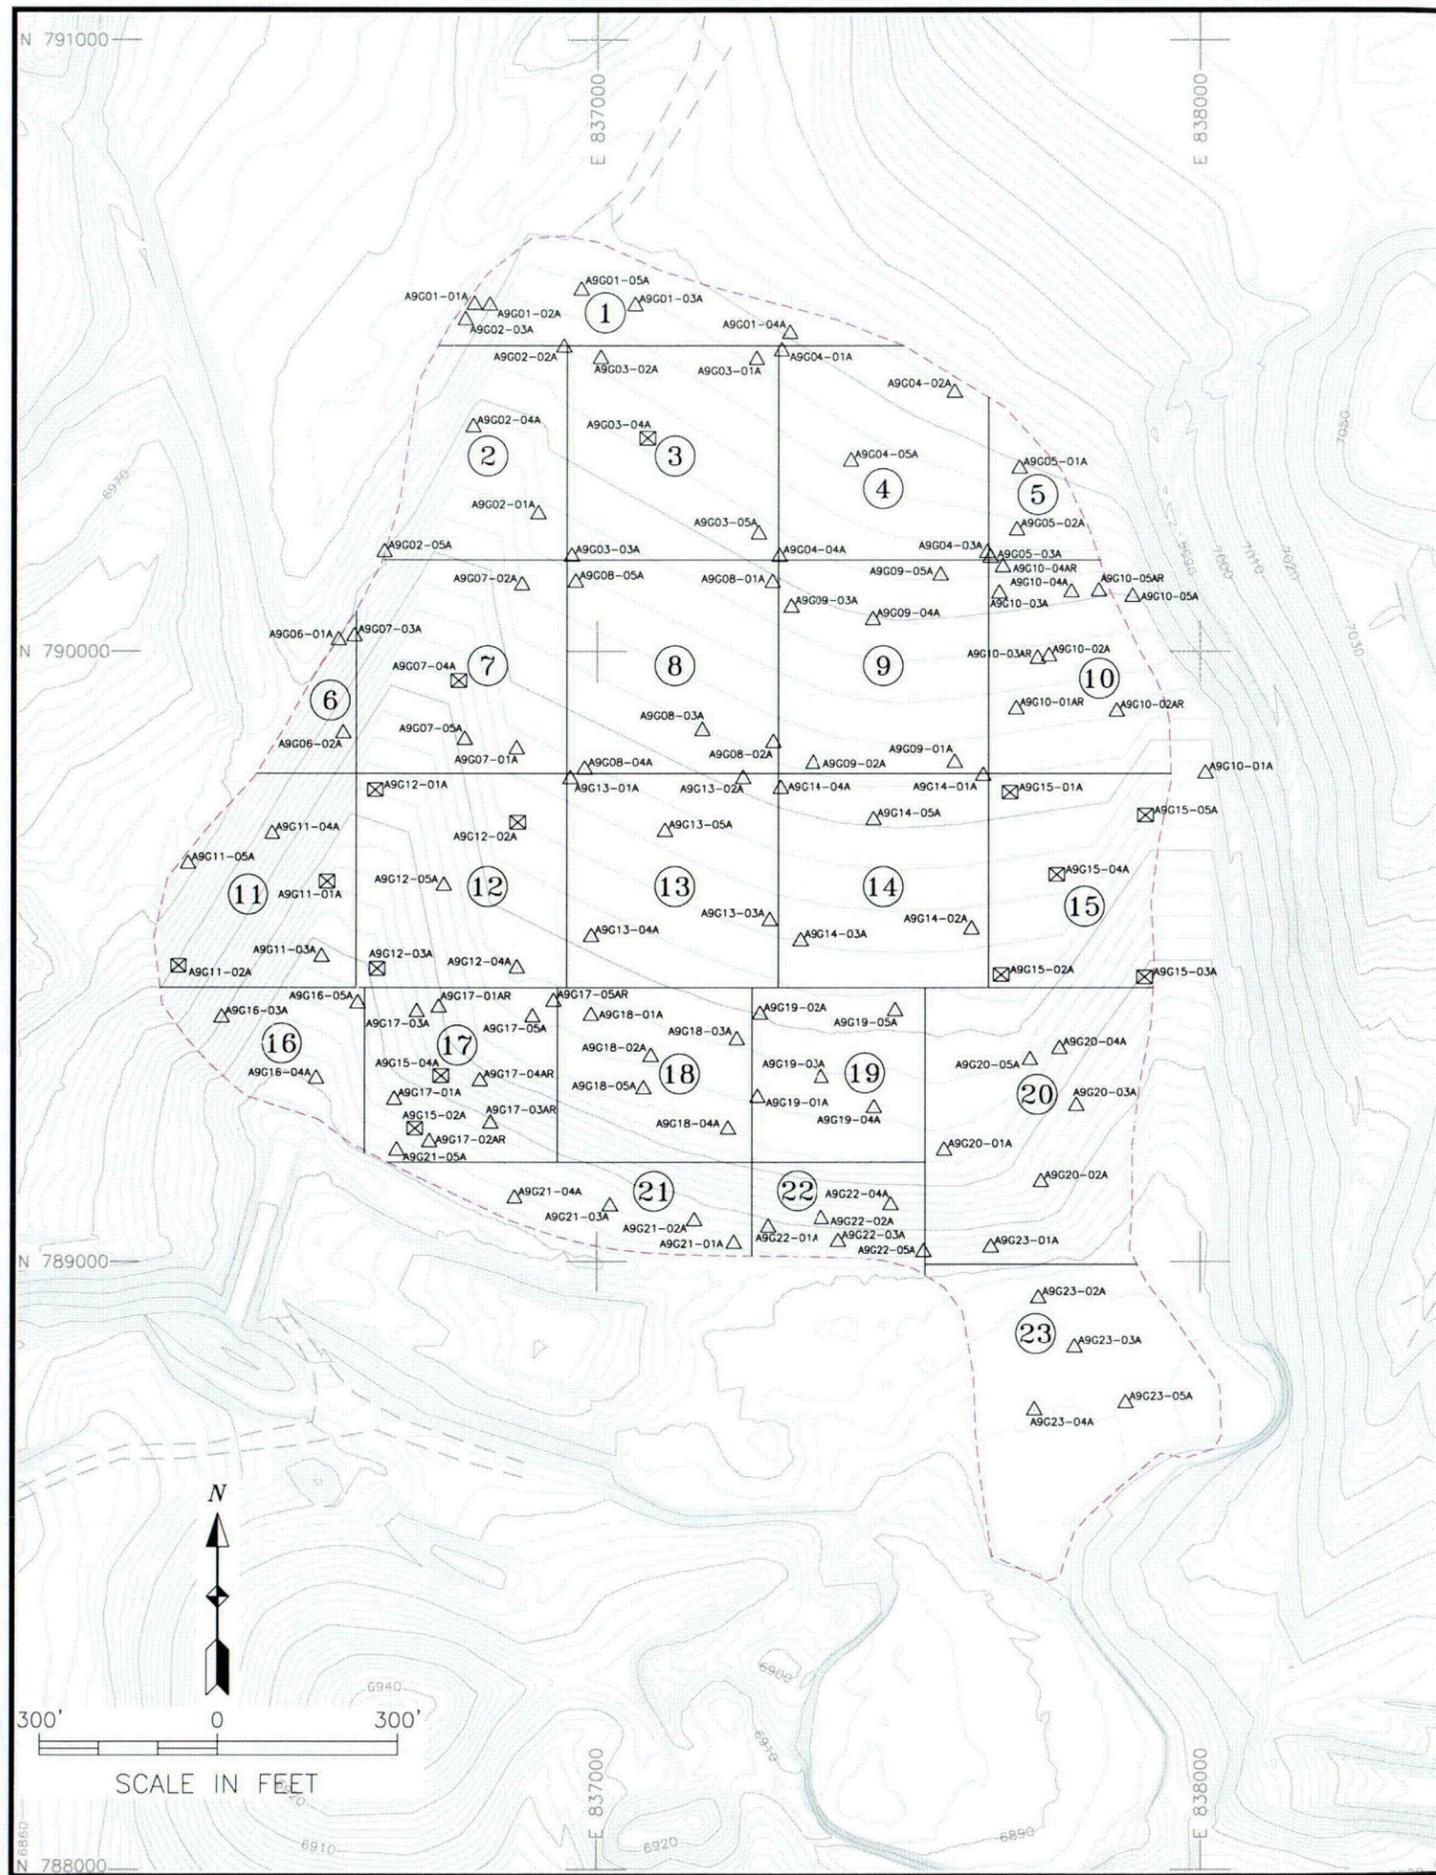
MAY, 2005 FIGURE 2.1

For the A-9 there were 23 grid locations that were sampled to demonstrate placed cover materials were 10 pCi/g or less for Ra-226 content. Results of the A-9 soil sampling are illustrated in Figures 2.1 and 2.2.

Location	Ra-226 pCi/g	±	Analytical Date
A9G1A	3.74	0.73	9/12/2002
A9G2A	5.78	0.84	9/12/2002
A9G3A	5.8	1.1	10/30/2001
A9G4A	6.4	1.2	10/30/2001
A9G5A	6.36	0.95	9/12/2002
A9G6A	7.07	1.01	9/12/2002
A9G7A	5.25	0.82	9/12/2002
A9G8A	8.9	1.7	10/30/2001
A9G9A	8.4	1.5	10/30/2001
A9G10A	6.9	0.32	3/7/2005
A9G11A	9.4	0.42	3/7/2005
A9G12A	9.57	0.43	3/2/2005
A9G13A	8.8	1.6	10/30/2001
A9G14A	8.2	1.5	10/30/2001
A9G15A	7.73	0.38	3/9/2005
A9G16A	9.2	0.35	2/24/2004
A9G17A	4.94	0.41	7/20/2004
A9G18A	10.3	0.47	3/2/2005
A9G19A	9.45	0.4	2/25/2004
A9G20A	9.97	0.5	2/25/2004
A9G21A	8.38	0.4	2/25/2004
A9G22A	6.58	0.3	2/26/2004
A9G23A	10.45	0.47	3/23/2004

A-9 REPOSITORY

SOIL SAMPLE LOCATIONS

0 TO 1 FOOT DEPTH

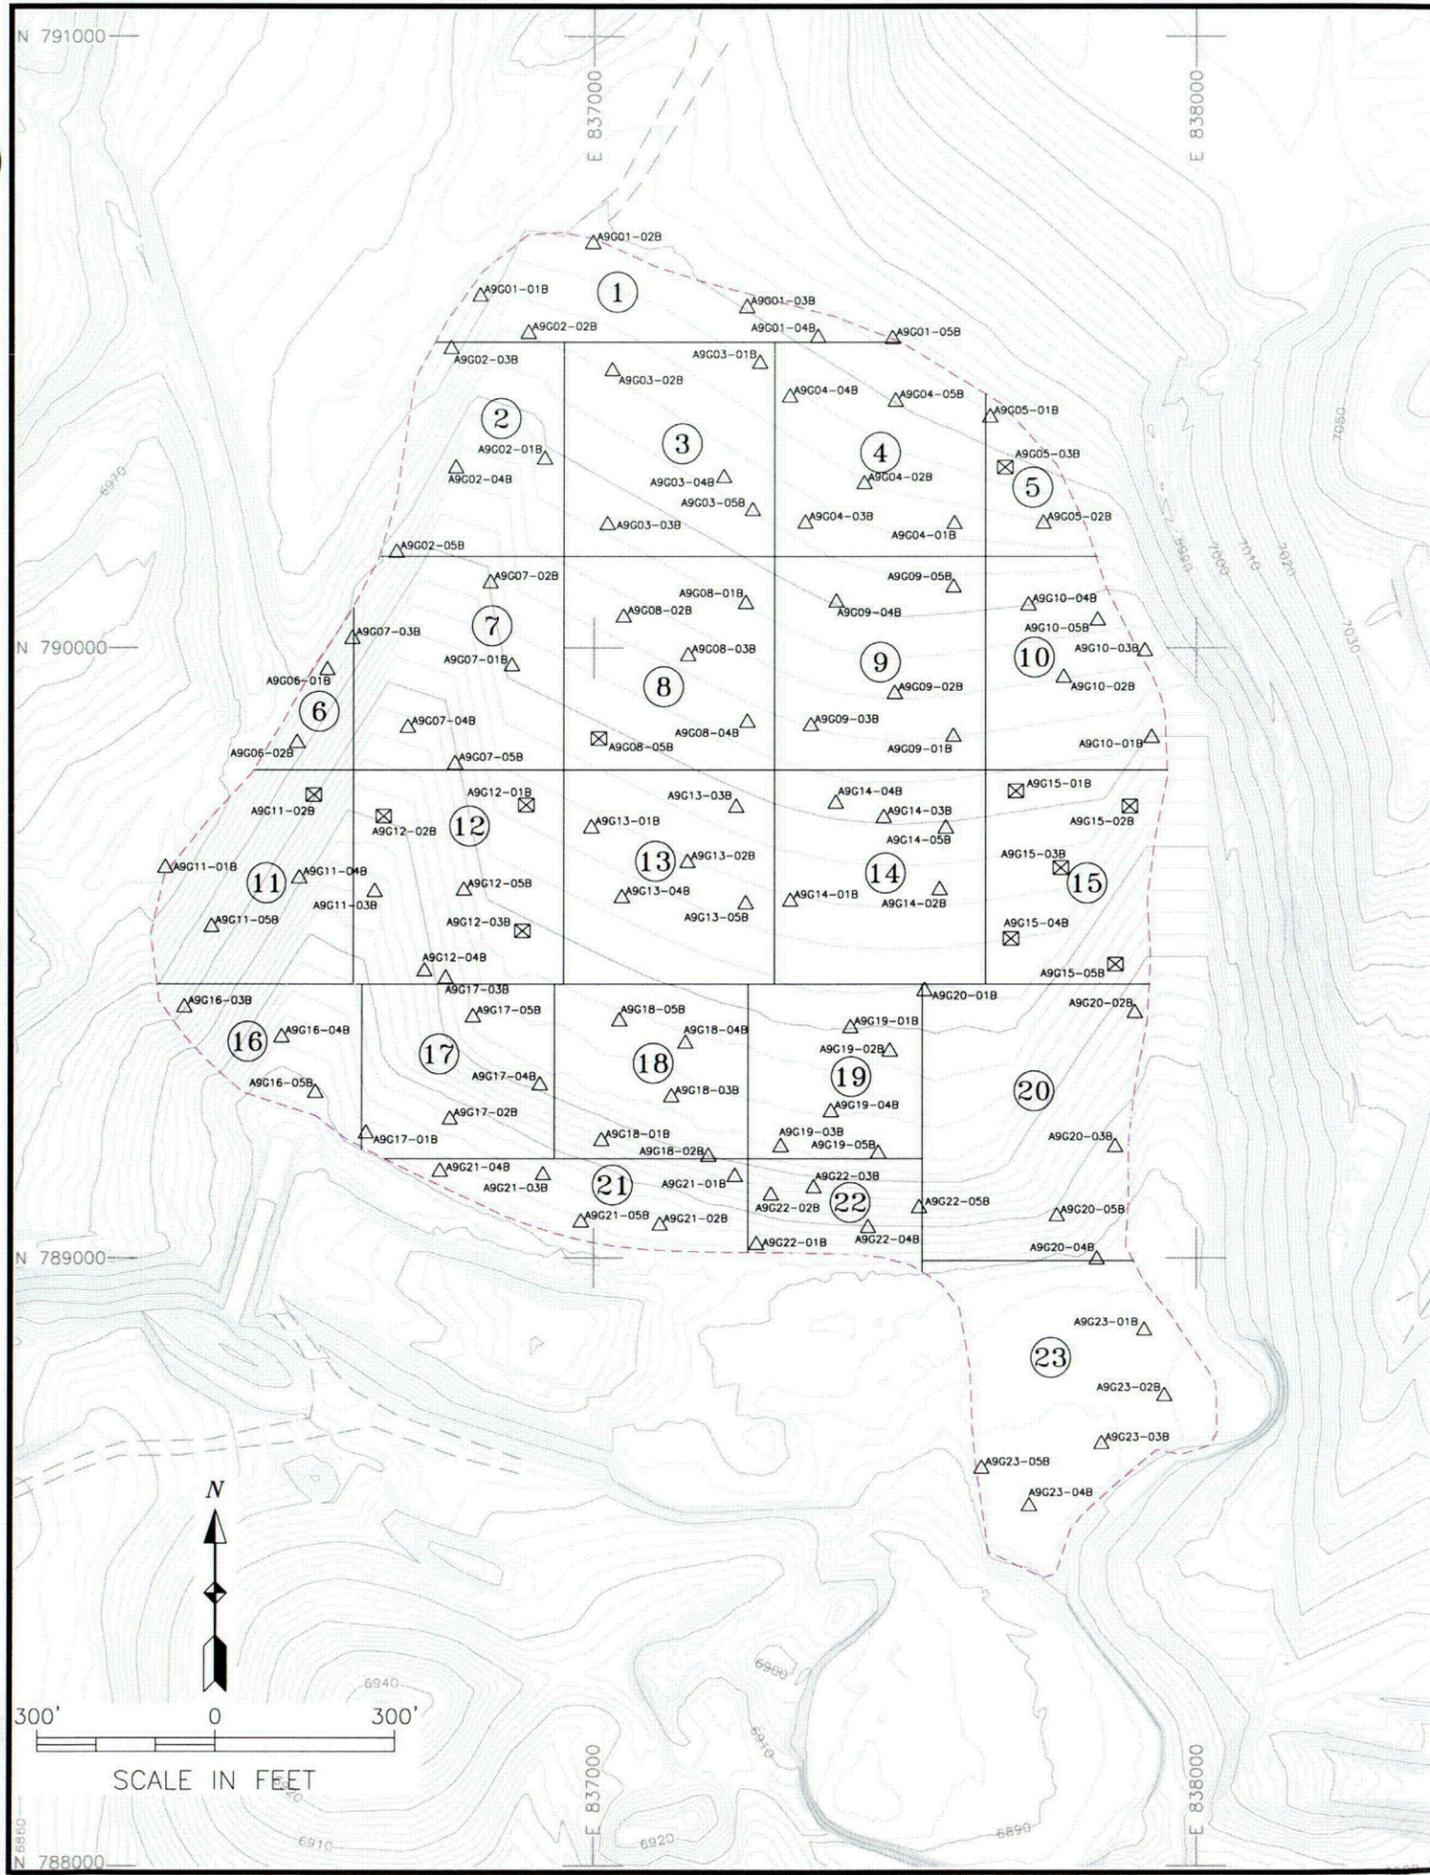
MAY, 2005 FIGURE 2.2

Location	Ra-226 pCi/g	±	Analytical Date
A9G1B	4.7	0.8	9/9/2002
A9G2B	6.41	1.04	9/12/2002
A9G3B	7.7	1.4	10/30/2001
A9G4B	7.74	1.3	10/30/2001
A9G5B	6.2	0.88	9/12/2002
A9G6B	7.26	1.1	9/12/2002
A9G7B	6.7	0.98	9/12/2002
A9G8B	7.9	1.4	10/30/2001
A9G9B	8.3	1.5	10/30/2001
A9G10B	6.63	0.34	6/7/2002
A9G11B	9.85	0.44	3/2/2005
A9G12B	9.52	0.46	3/2/2005
A9G13B	7.6	1.4	10/30/2001
A9G14B	8	1.5	10/30/2001
A9G15B	6.36	0.32	2/24/2004
A9G16B	8.57	0.3	2/24/2004
A9G17B	8.45	0.3	2/24/2004
A9G18B	10.3	0.6	2/24/2004
A9G19B	9	0.4	2/25/2004
A9G20B	8.2	0.35	2/25/2004
A9G21B	6.58	0.3	2/26/2004
A9G22B	7.4	0.4	2/23/2004
A9G23B	9.5	0.4	3/27/2004

A-9 REPOSITORY

SOIL SAMPLE LOCATIONS

1 TO 2 FOOT DEPTH

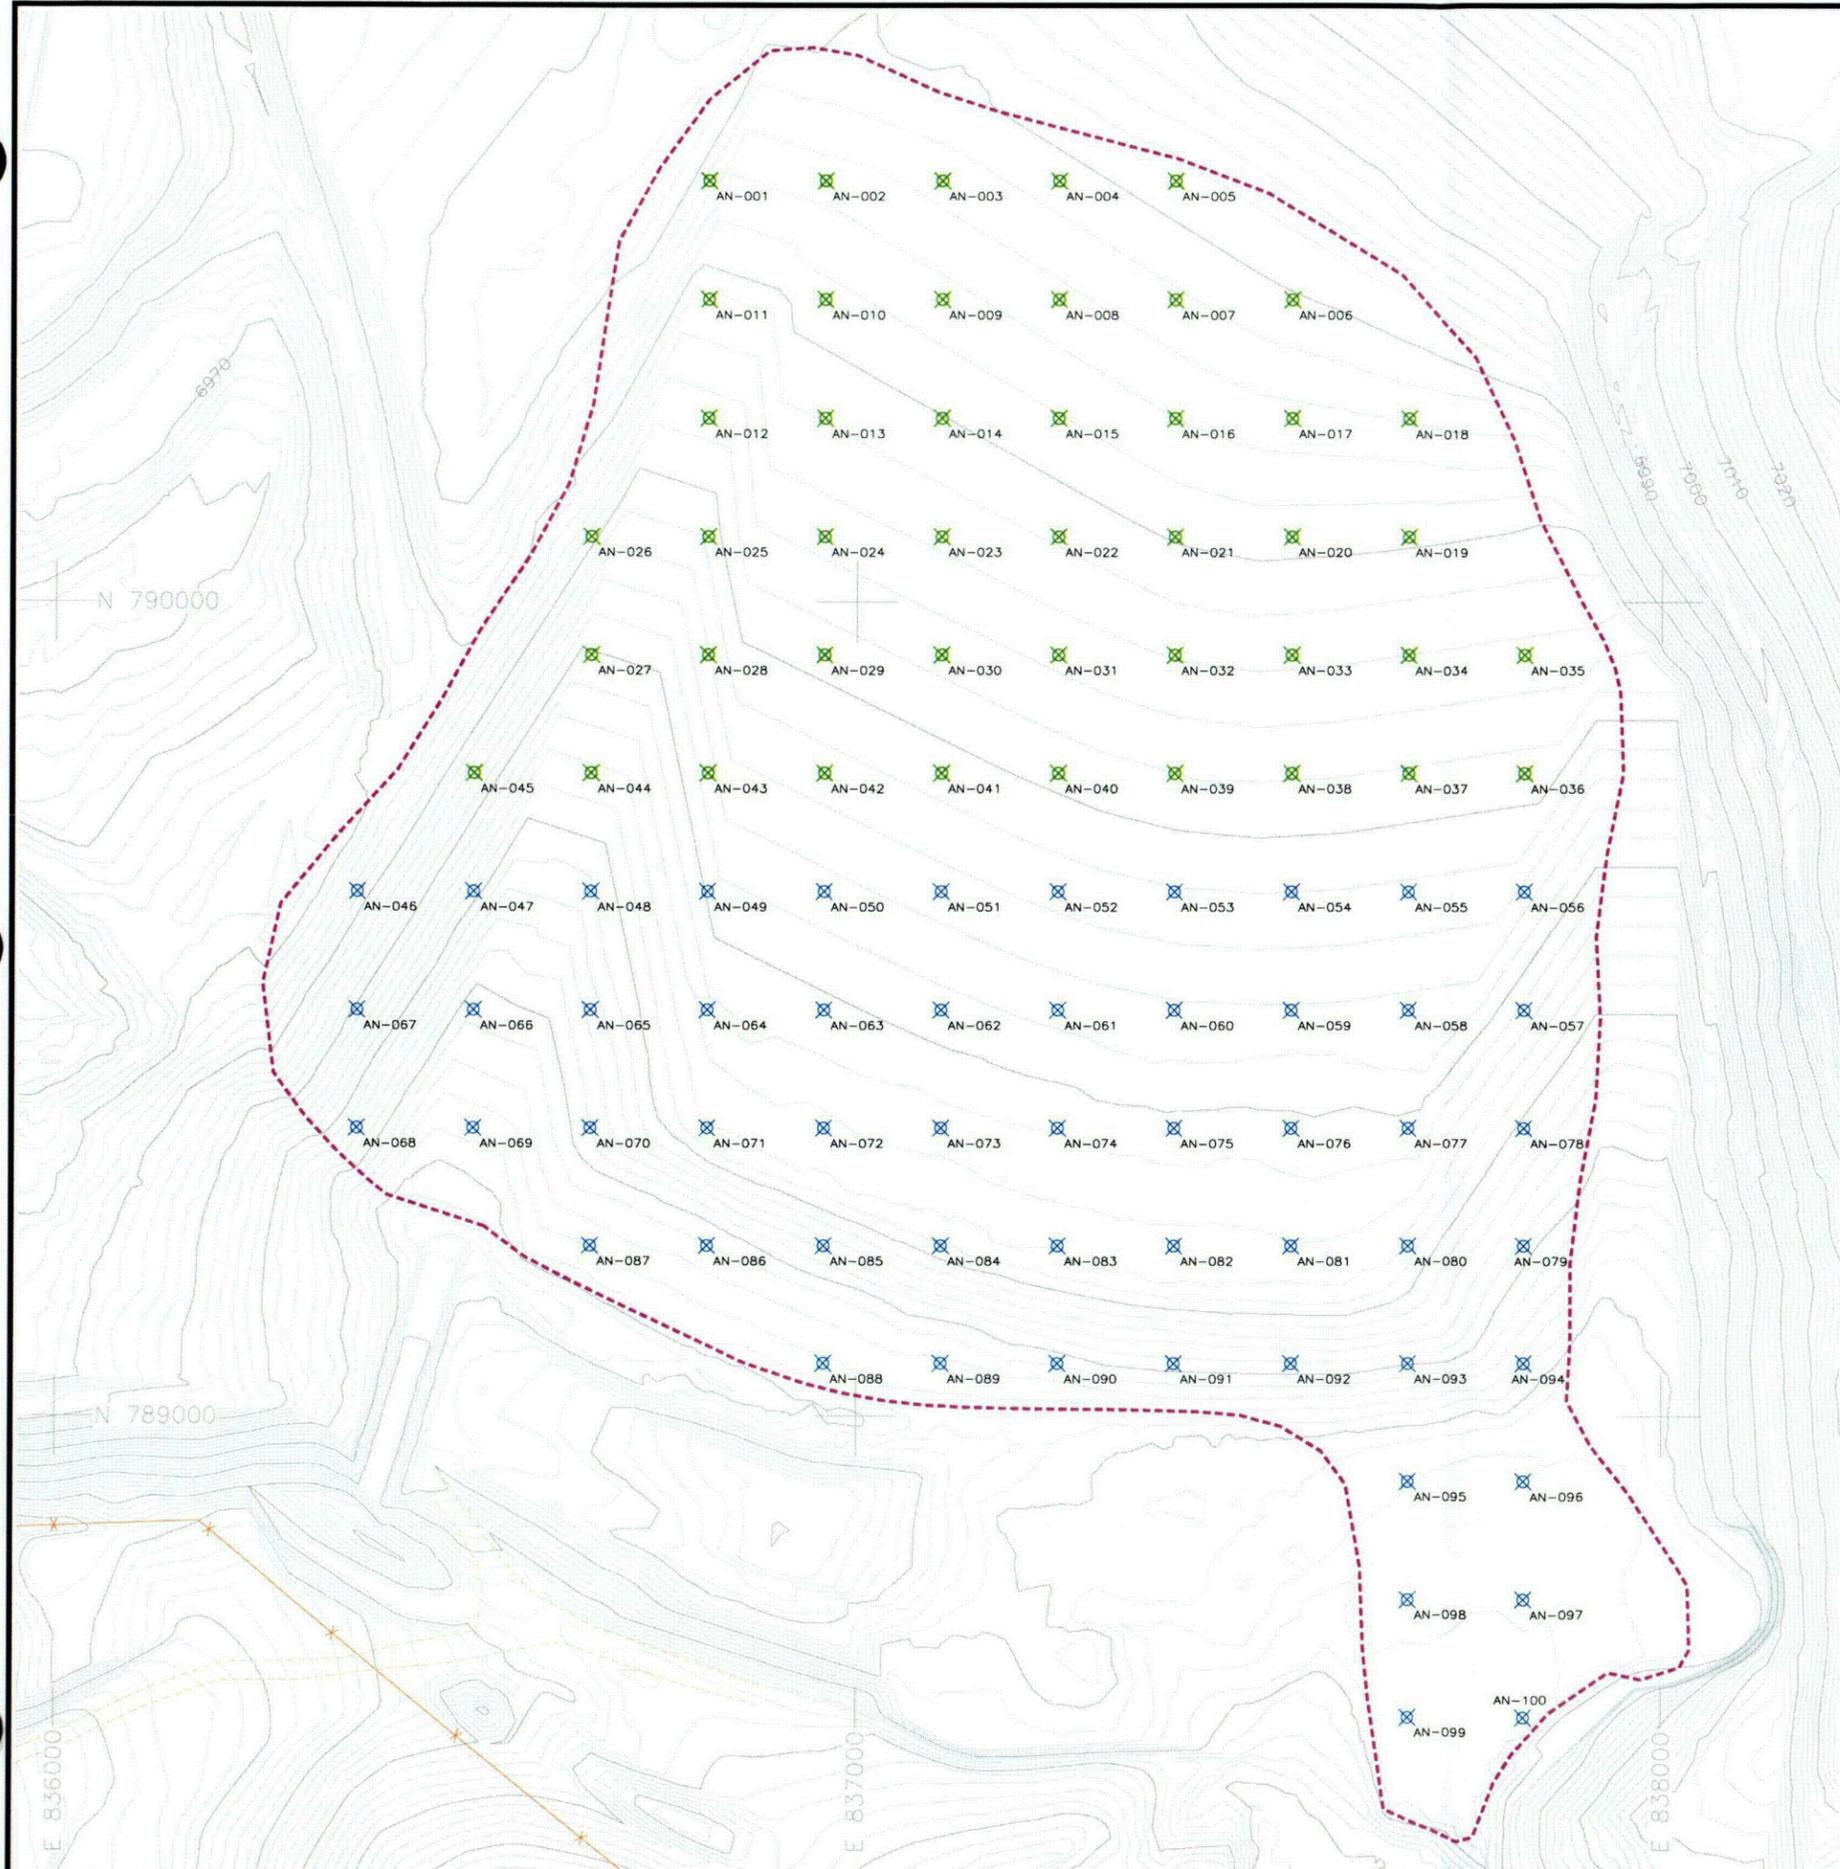
UMETCO MINERALS CORPORATION
 2002/2003 NESHAPS
 SAMPLE LOCATIONS
 GAS HILLS, WYOMING
 MAY, 2005 FIGURE 2.3

Location of the NESHAPS sampling for the A-9 are shown in Figure 2.3.

A-9 CANISTER LOCATION
AN-001 THRU AN-045
DEPLOYED -> 5/27/02
RETRIEVED -> 5/28/02
-

A-9 CANISTER LOCATION
AN-046 THRU AN-100
DEPLOYED -> 8/13/03
RETRIEVED -> 8/14/03

NESHAPS sampling for the each of the Repositories show that all meet the 20 pCi/m²/sec standard and the repositories are similar in radon flux release rates. If the elevated readings were due to the materials placed in the A-9 rather than shine, seeing significant differences in the radon flux rates between the repositories would be expected. Listed below are the radon flux rates for each of the repositories:

- A-9 3.5 pCi/m²/sec
- Above Grade 1.4 pCi/ m²/sec
- Heap Leach 1.1 pCi/ m²/sec

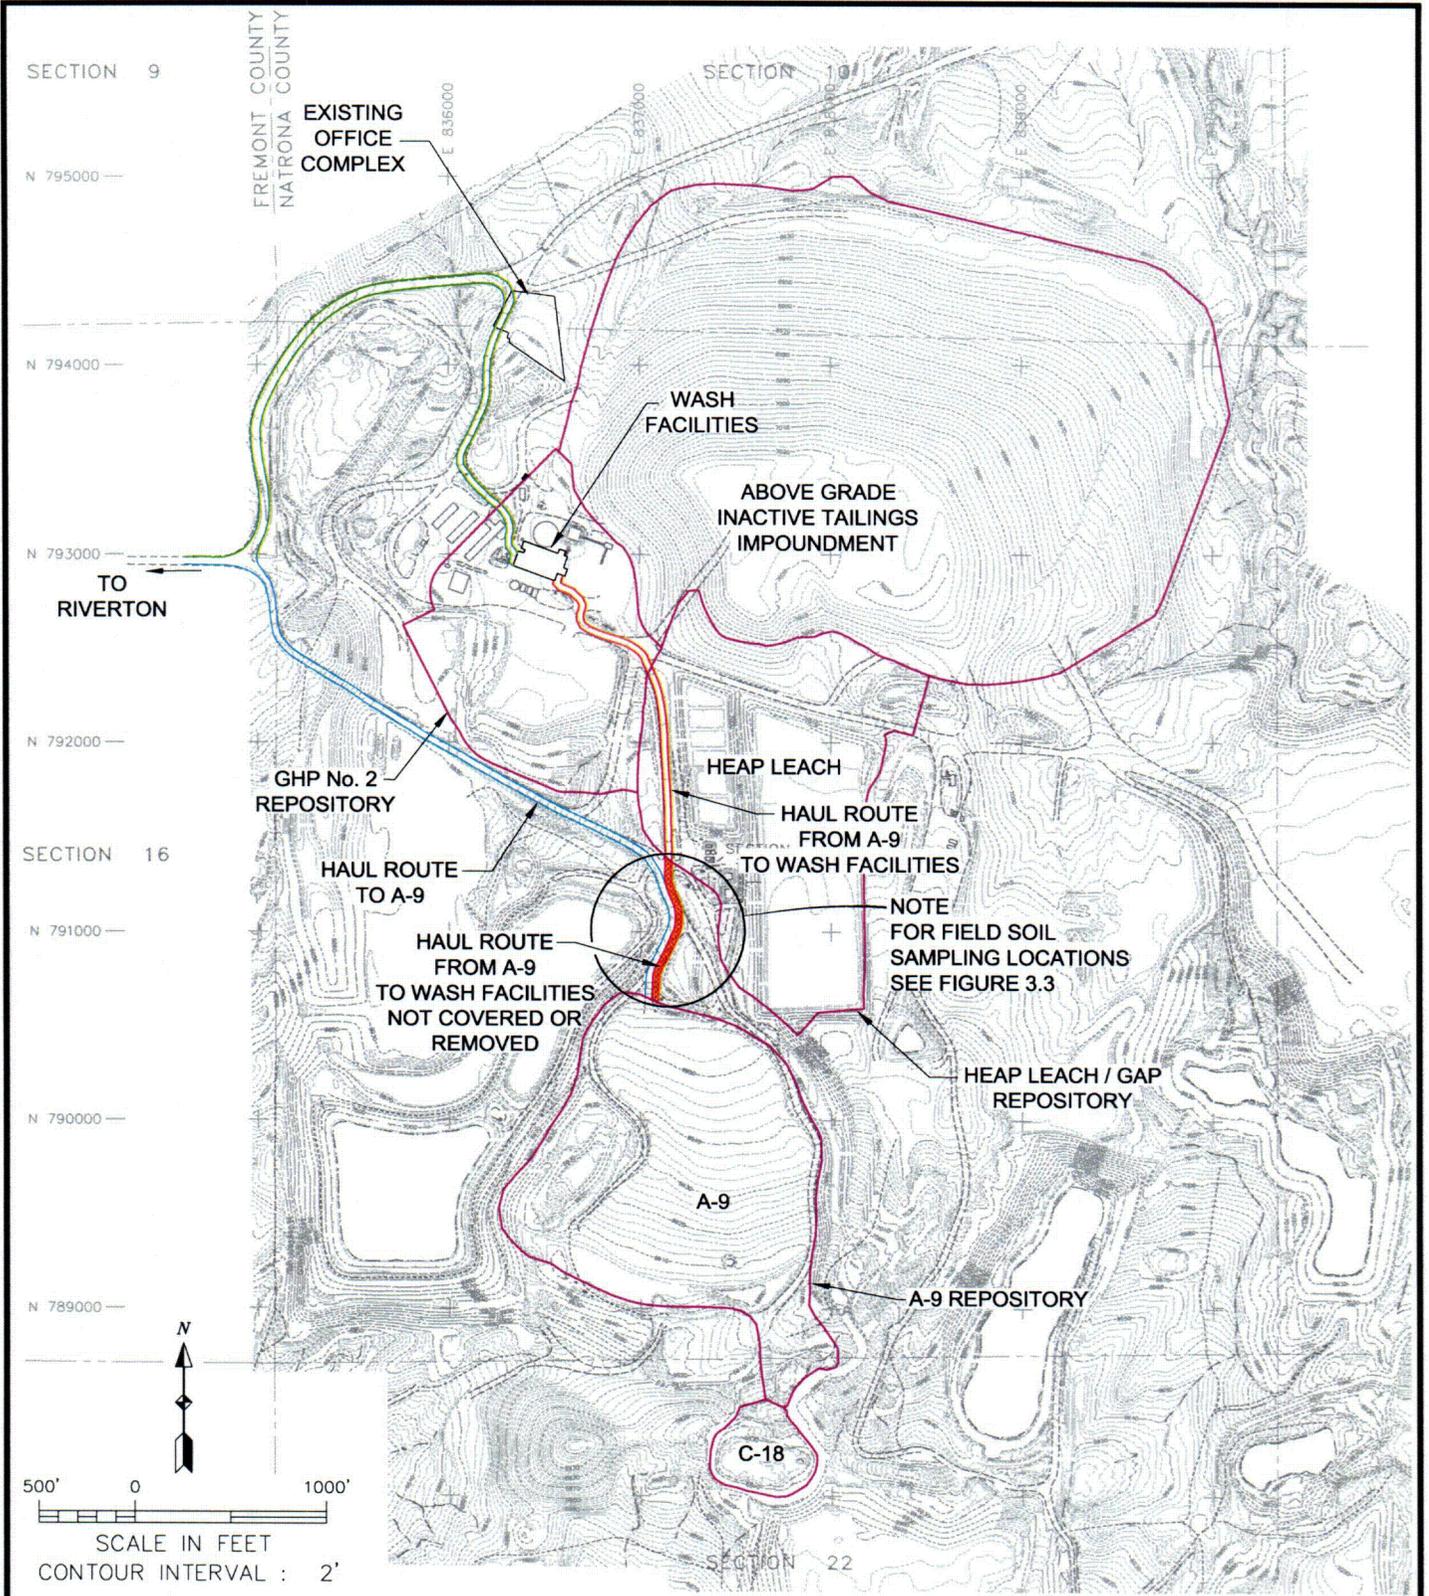
MAY, 2005
FIGURE 3.1

The portion of the road in question of contamination from tailings materials is from the A-9 disposal cell to the decontamination pad as shown in Figure 3.1. At present the only section of this roadway not contained within a NRC approved disposal cell, is a section approximately 722 feet in length between the Heap Leach and the A-9 Repository as depicted in red on Figure 3.2.

**SUSQUEHANNA TAILINGS
HAUL ROUTES
1990 CONDITIONS**

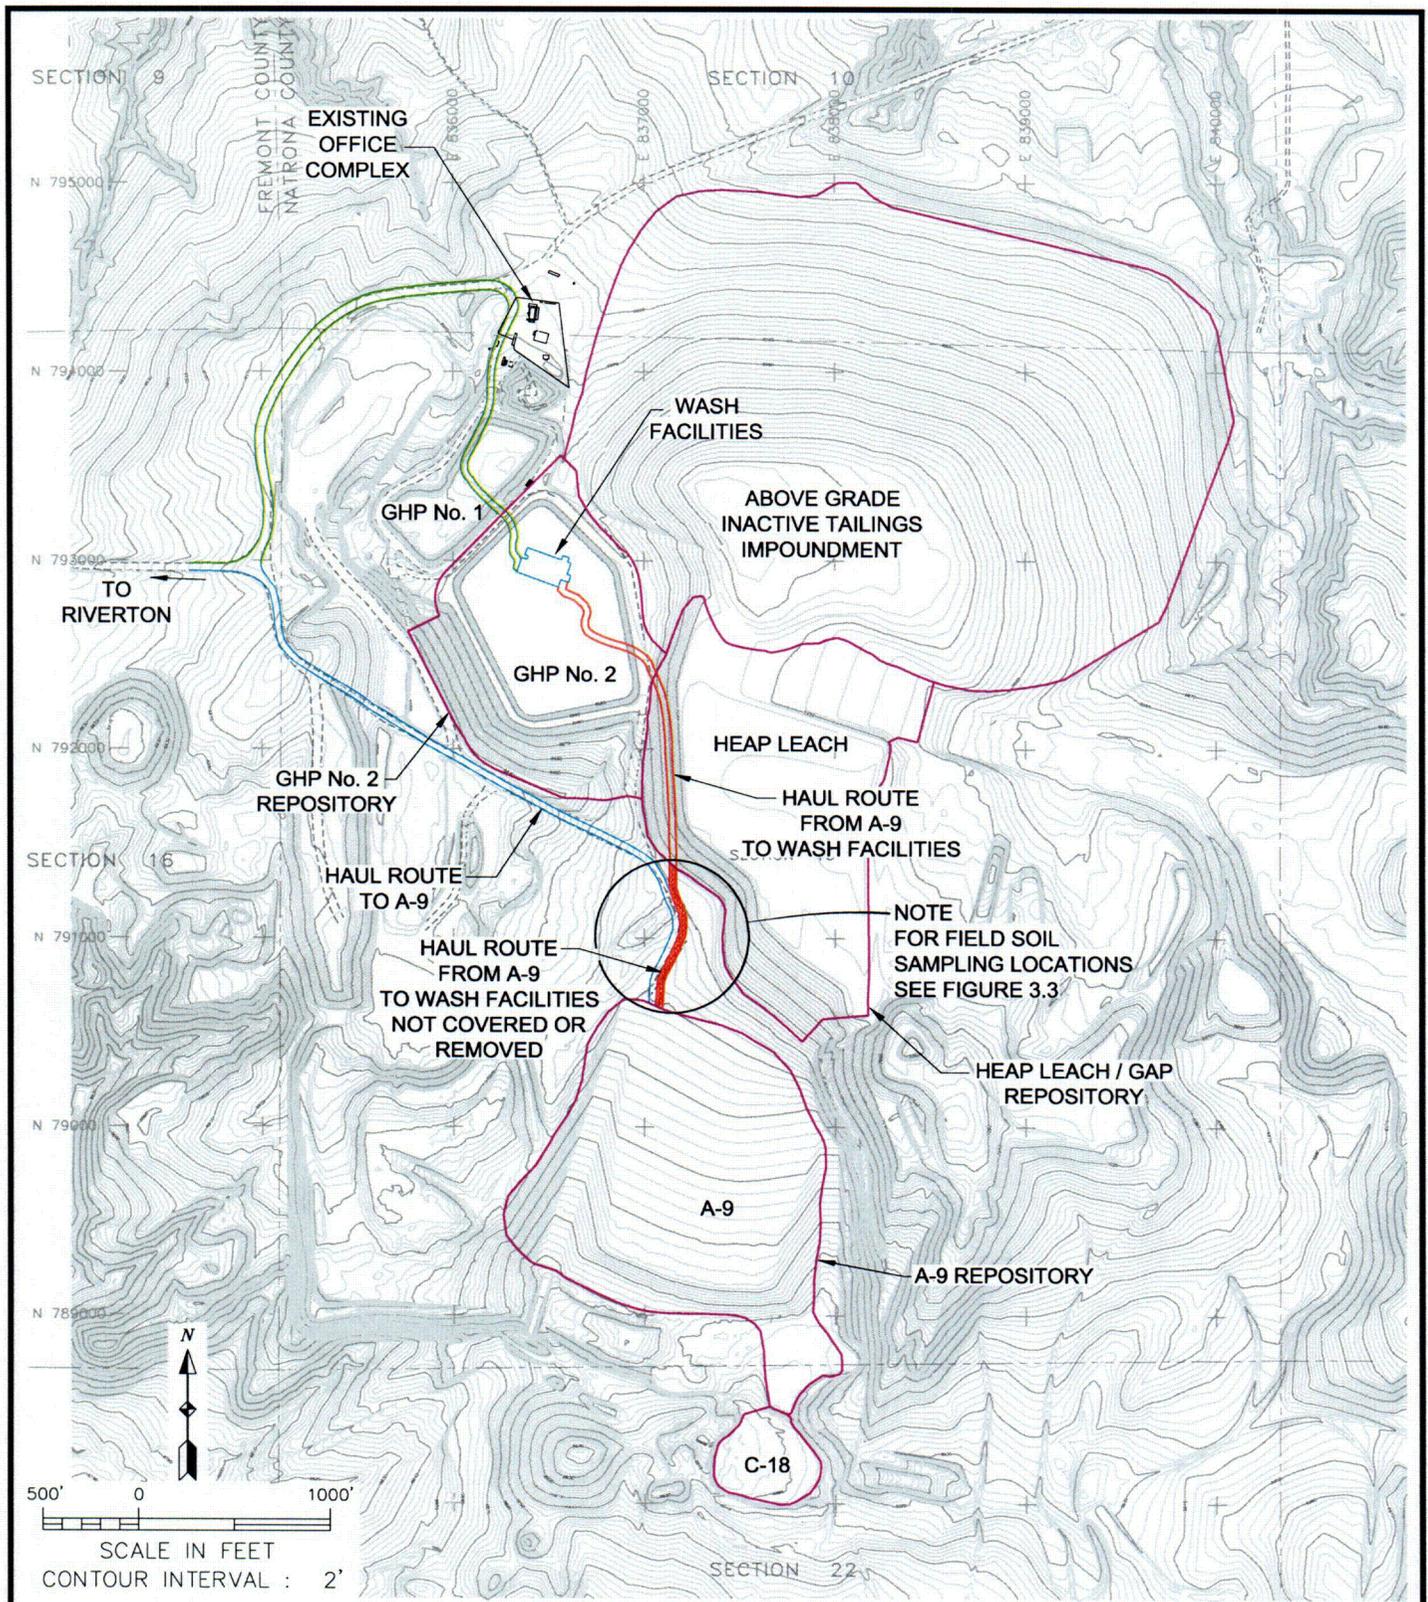
MAY, 2005 FIGURE 3.2

The final Status Survey Plan calls investigation into the presence of byproduct material contamination from where haul trucks would leave the A-9 Repository to the decontamination facilities. The portion of the haul road to the decontamination facility not under the footprint of the Heap or GHP-2 disposal cells is the area addressed in this submittal. (see Figure 3.2)

**SUSQUEHANNA TAILINGS
HAUL ROUTES
2004 CONDITIONS**

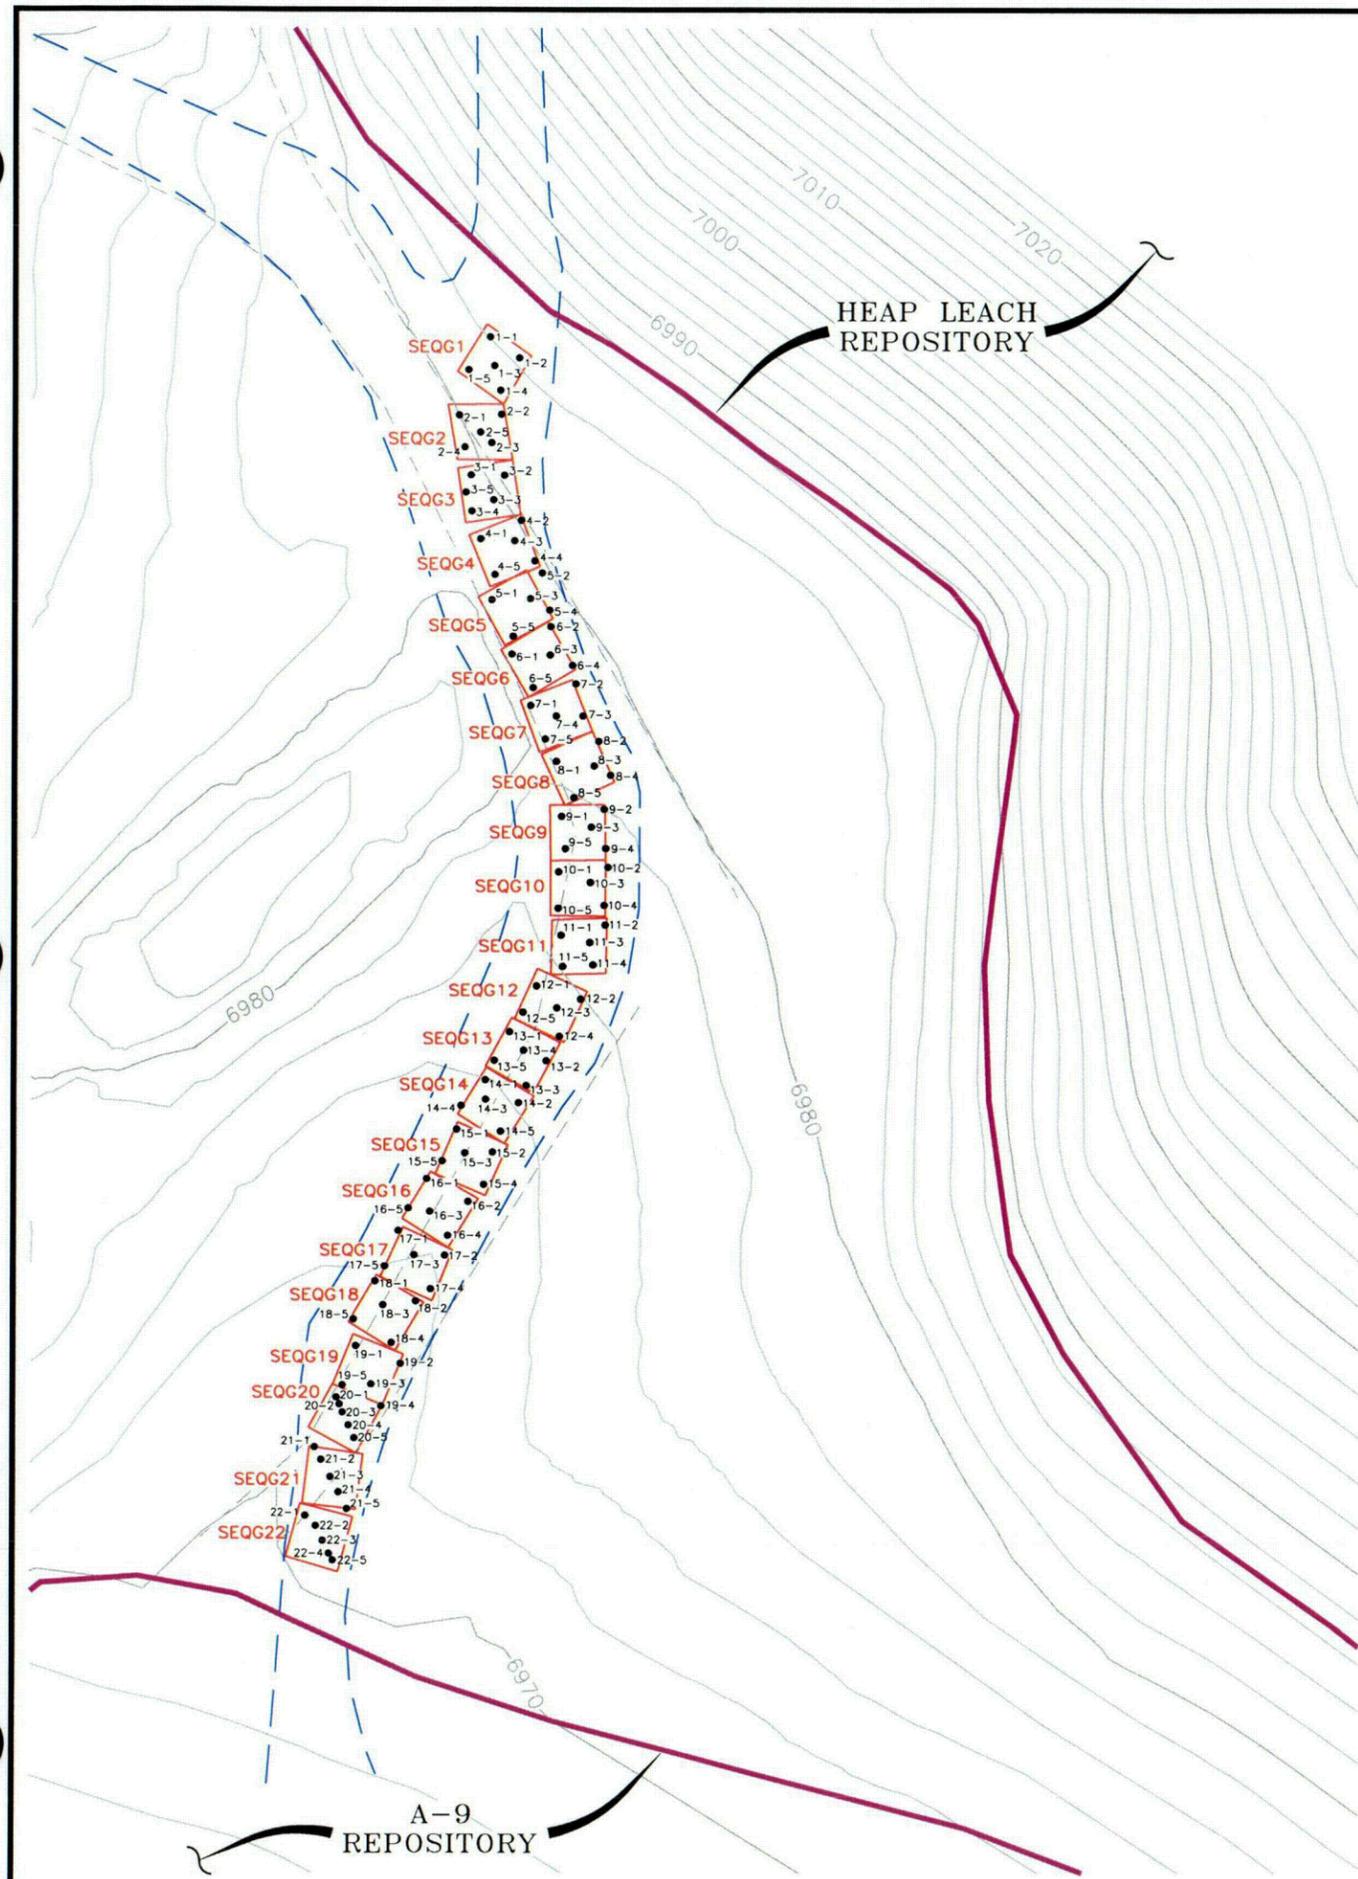
FIGURE 3.3

A total of 22 grids were placed over the center of the Susquehanna Haul Road. Five sample locations were selected from within each grid to form a composite sample for each grid. Gamma measurements, visual observations and photographs were collected from each of the five sample locations. When sample locations reached elevation horizons as indicated during the 1990 aerial photo a sample was collected from that location. In addition to the soil samples, gamma measurements and visual observation were made to help establish if byproduct materials were present. This process was followed for all five sample locations in each of the 22 grids sampled (Figure 3.3).

The ratio of Unat, Ra-226 and Th-230 utilized to determine the presence of byproduct material from the disposal of the Susquehanna Uranium mill tailing in the A-9 tailings cell, however, indicates the materials are in disequilibrium with a average Ra-226/U-nat ratio of 2.01. (See Figure 3.3)

Grid Id	Date	Unat pCi/g	Ra-226 pCi/g	Th-230 pCi/g	Ratio Ra-226 to U-238	Comments
SEQG1	9/8/2004	34.46	20.8	14.4	1.21	Soil samples collected from 1.6 feet below present ground surface
SEQG2	9/8/2004	28.84	44.1	41.4	3.06	Soil samples collected from 1.6 feet below present ground surface
SEQG3	9/8/2004	30.19	45.8	35.3	3.03	Soil samples collected from 1.6 feet below present ground surface
SEQG4	9/8/2004	28.16	43.6	33	3.10	Soil samples collected from 1.77 feet below present ground surface
SEQG5	9/8/2004	26.54	44.7	33.4	3.37	Soil samples collected from 1.93 feet below present ground surface
SEQG6	9/8/2004	26.34	38.1	29.5	2.89	Soil samples collected from 1.82 feet below present ground surface
SEQG7	9/8/2004	34.39	49.9	34.7	2.90	Soil samples collected from 1.25 feet below present ground surface
SEQG8	9/8/2004	24.85	28.1	20.8	2.26	Soil samples collected from 1.09 feet below present ground surface
SEQG9	9/8/2004	33.58	32.9	25.2	1.96	Soil samples collected from 1.75 feet below present ground surface

SEQG10	9/8/2004	26.54	21.7	17.7	1.64	Soil samples collected from 2.02 feet below present ground surface
SEQG11	9/8/2004	30.26	29.1	24.8	1.92	Soil samples collected from 2.24 feet below present ground surface
SEQG12	9/8/2004	31.95	28.4	21.1	1.78	Soil samples collected from 2.4 feet below present ground surface
SEQG13	9/8/2004	32.97	23	19.4	1.40	Soil samples collected from 2.42 feet below present ground surface
SEQG14	9/8/2004	37.51	26.8	21.7	1.43	Soil samples collected from 2.17 feet below present ground surface
SEQG15	9/8/2004	40.69	27.5	19.9	1.35	Soil samples collected from 3.15 feet below present ground surface
SEQG16	9/8/2004	39.74	19.4	19.2	0.98	Soil samples collected from 3.67 feet below present ground surface
SEQG17	9/8/2004	35.81	23.5	21.3	1.31	Soil samples collected from 4.18 feet below present ground surface
SEQG18	9/8/2004	38.86	27.3	24.6	1.41	Soil samples collected from 4.59 feet below present ground surface

SEQG19	9/8/2004	35.27	28.1	19.3	1.59	Soil samples collected from 5.17 feet below present ground surface
SEQG20	9/8/2004	31.82	23.9	17.4	1.50	Soil samples collected from 5.34 feet below present ground surface
SEQG21	9/8/2004	29.25	35.7	25.4	2.44	Soil samples collected from 5.26 feet below present ground surface
SEQG22	9/8/2004	25.18	20.2	14.7	1.60	Soil samples collected from 7.0 feet below present ground surface

SUSQUEHANNA TAILINGS
HAUL ROAD
FIELD SAMPLING LOCATIONS
GAS HILLS, WYOMING
