TEST REPORT

M.T. (3-Hour) Electrical Raceway Fire Barrier Systems Performance Testing

Conduit, Junction Box & Electrical Cable Air Drop Raceways

Project No. 14790-123265

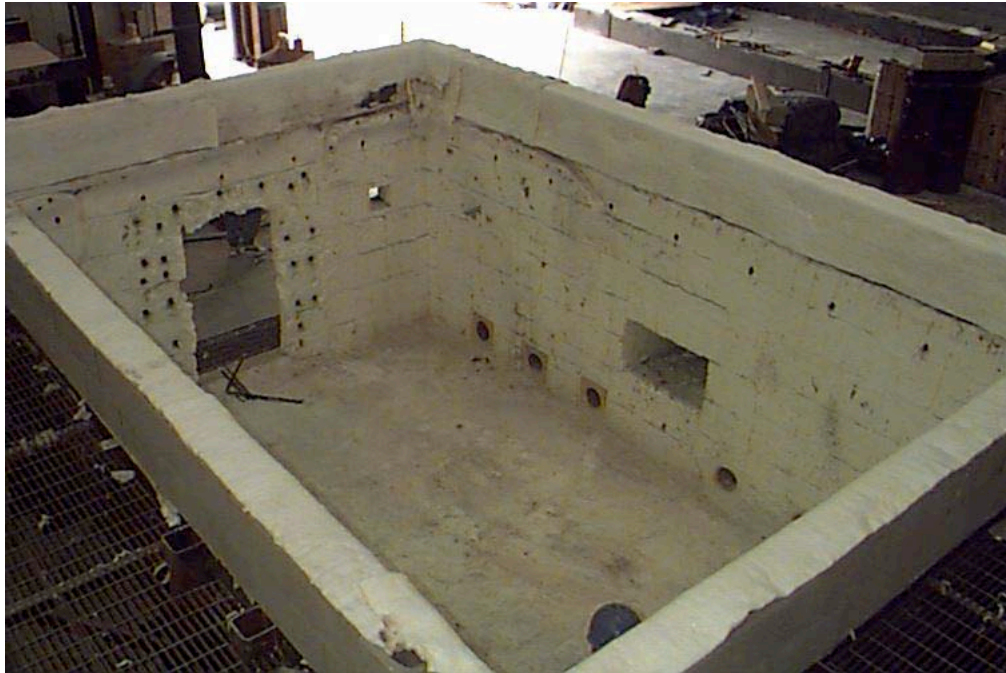
The 12' x 18' x 7' deep horizontal test furnace used in these evaluations was designed to allow the specimen to be uniformly exposed to the specified time-temperature conditions. It is fitted with 12 symmetrically-located premixed air/propane gas burners designed to allow an even heat flux distribution across the exposed surface of a horizontal test specimen. Furnace pressures may be maintained at any value from +0.03" W.C. to -0.05" W.C. The furnace consists of a structural steel frame, lined with sheet metal and insulated with a six inch thick layer of ceramic fiber.

12' x 18' Horizontal Furnace (Overhead View)

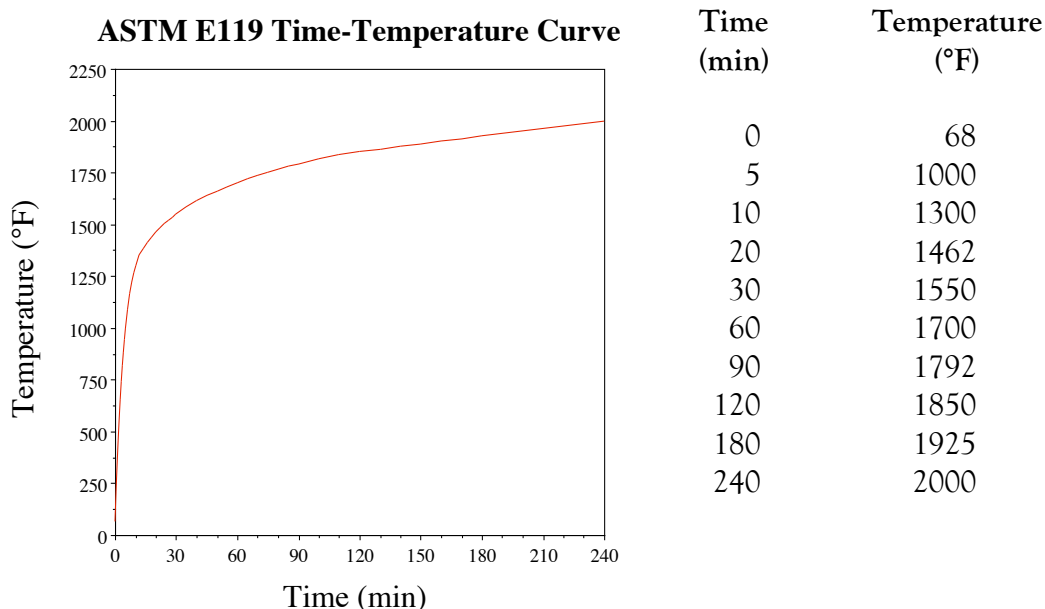
Figure 1 E119 Temperature Exposure

The fire exposure is controlled to conform with the standard time-temperature curve shown in Figure 1, as determined by the tables below:

The furnace interior temperature during a test is controlled such that the area under the time-temperature curve is within 10% of the corresponding area under the standard time-temperature curve for 1 hour or less tests, 7.5% for those less than 2 hours and 5% for those tests of 2 hours or more duration.

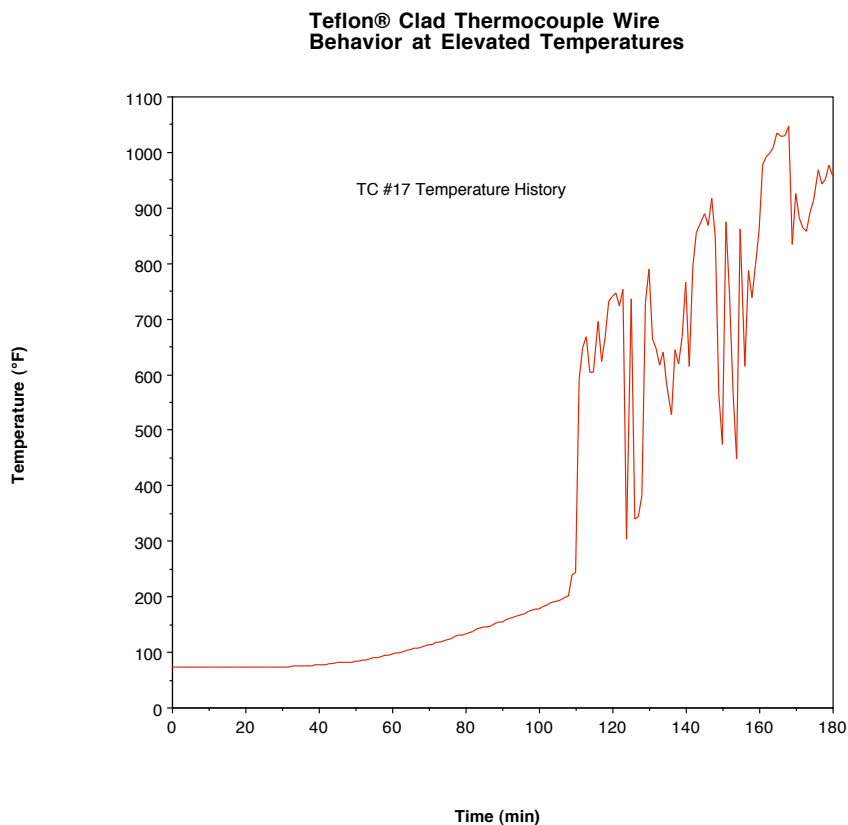
Due to the fact that the M.T. system releases moisture upon activation, and that water vapor can condense upon contact with metal cooler than 212°F , it was necessary to utilize thermocouples which can withstand being wetted without affecting their readings. Due to the excessive cost of metallic-clad thermocouples (such as those utilized on the junction box below, but chosen for use there because they also had to traverse a very hot section of the junction box supports), the decision was made to use Teflon® clad thermocouple wire (Teflon® PFA [perfluoroalkoxy] insulation extruded on the single conductors which are then laid parallel and jacketed with Teflon® PFA, manufactured by PMC Corporation). This wire, while completely unaffected by moisture, does have an upper temperature limitation of around 700°F (depending upon the time spent at elevated temperatures). Above that, the Teflon® cladding can melt and allow the chromel and alumel thermocouple wires to touch and short out; thus giving intermittent and unreliable results. However, since this temperature is hundreds of degrees above the failure temperatures for the raceway systems, this was not considered to be a significant factor. This factor should be borne in mind however, when irregular ("jumpy") thermocouple readings are encountered in the data (see example below).

As a typical example, the graph above shows the behavior of TC #17 (located in Item 3A, empty 4" conduit). The temperatures are well-behaved until a temperature of around 650°F was reached. At that point the insulation melted and the leads shorted together, yielding unreliable information. It must be considered that the observed temperatures in this situation may or may not be indicative of the temperatures at the location of the intended thermojunction.

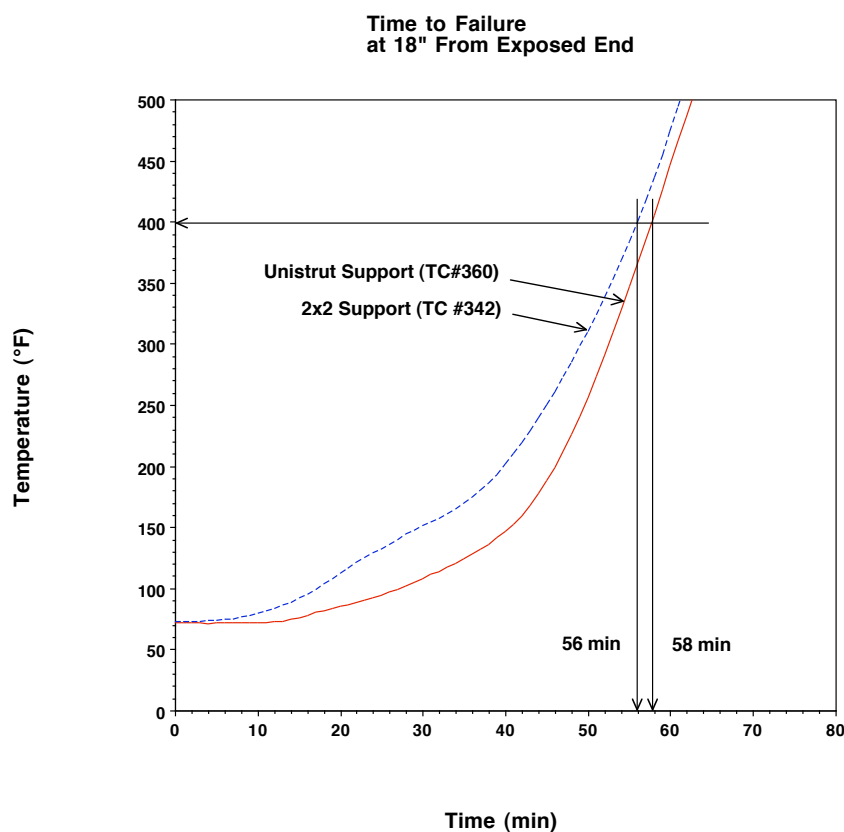
Item #3G: Unistrut Support & Item #3H: 2" x 2" Steel Support

The temperatures at a location 18" from the edge of the cladding on the exposed end of each of the two supports were determined, and are shown in the graph below. Item 3G, TC#360 and Item 3H, TC #342 were located at that distance. As the graph indicates, the temperature 18" from the edge of the cladding on Item 3G (Unistrut®) achieved a fire endurance rating of 58 minutes, while the fire endurance rating at the same position on Item 3H (2" x 2" steel support) was reached at 56 minutes. These comparative results are as expected, since the 2" x 2" steel material has a higher cross-section of metal, and hence will conduct more heat.
