## Appendix C

### SEM/EDS Data for Test-1 Day-30 Fiberglass and Filtrate

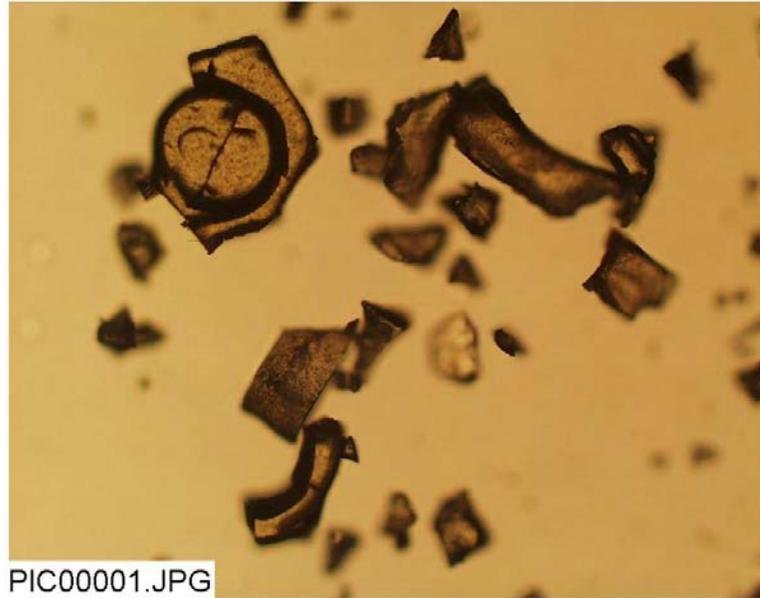
**Figure C-3.** Plane-polarized optical microscope photograph (PIC00001) for the Day-21 precipitation from the filtered water sample magnified 10 times on the scattered dry fragments.

Frame		I.D.	PIC	×	Description
1			PIC00001	10	scattered dry fragments
2			PIC00002	10	desiccated fragments
3			PIC00003	50	single fragment with contraction dome
4			PIC00004	50	similar fragment at adjacent area
5			PIC00005	10	general cracking pattern
6			PIC00006	50	edge of previous area as in PIC00005 larger cracks in the interior and finer cracks near the edge

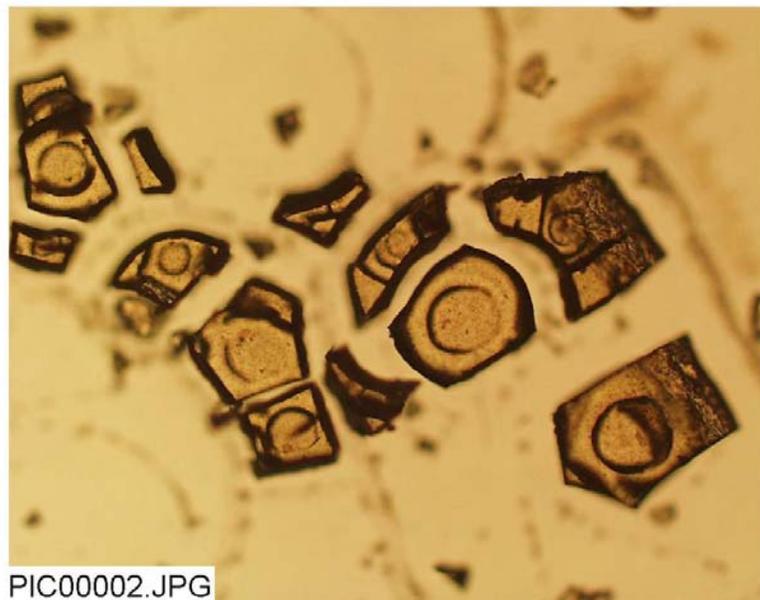
**Figure C-4.** Plane-polarized optical microscope photograph (PIC00002) for the Day-21 precipitation from the filtered water sample magnified 10 times on the desiccated fragments.

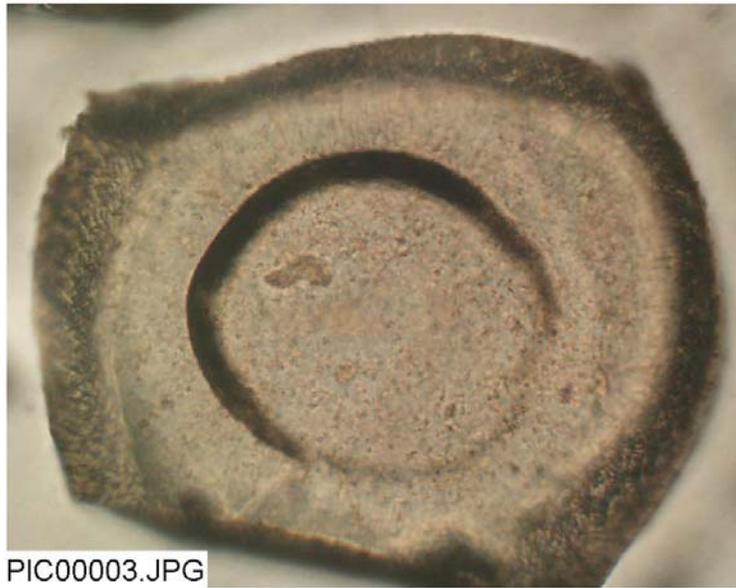
**Figure C-5.** Plane-polarized optical microscope photograph (PIC00003) for the Day-21 precipitation from the filtered water sample magnified 50 times on the single fragment with contraction dome, as shown in Figure C-4.

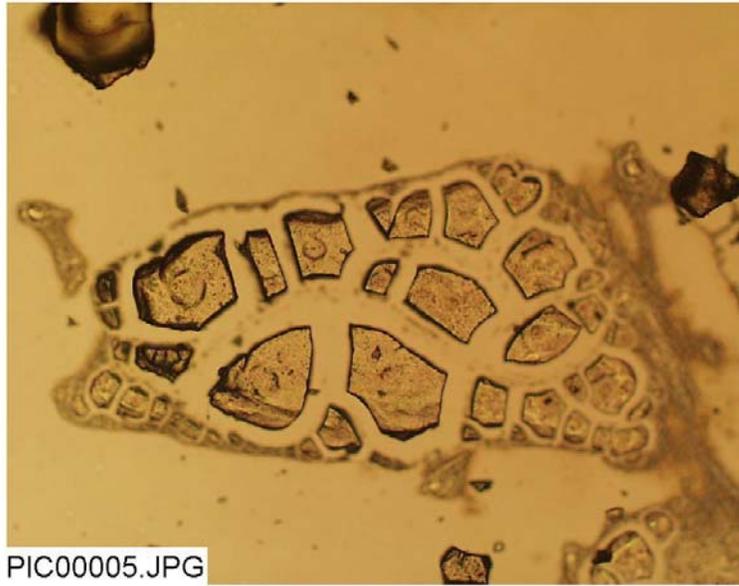
**Figure C-7.** Plane-polarized optical microscope photograph (PIC00005) for the Day-21 precipitation from the filtered water sample magnified 10 times on the dry fragments, showing the general cracking pattern.

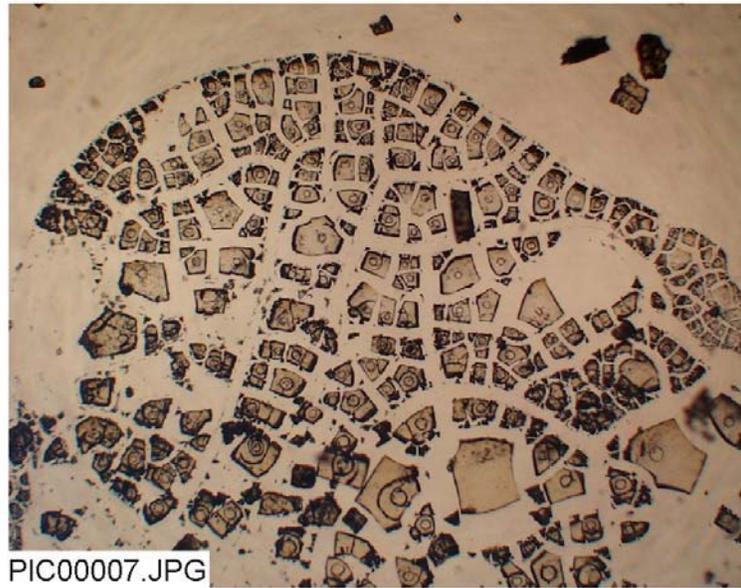
**Figure C-9.** Plane-polarized optical microscope photograph (PIC00007) for the Day-21 precipitation from the 46-ml high-volume filter magnified 2 times on the desiccated fragments.

Frame		I.D.	PIC	×	Description
7			PIC00007	2	general desiccated fragments
8			PIC00008	5	general desiccated fragments
9			PIC00009	5	same field with cross polarized filters showing some evidence of crystal highlights
10			PIC00010	5	same field with different exposure time
11			PIC00011	10	similar contraction bubbles on desiccated fragments
11b			PIC00012	50	zoom in on one of the contraction bubbles

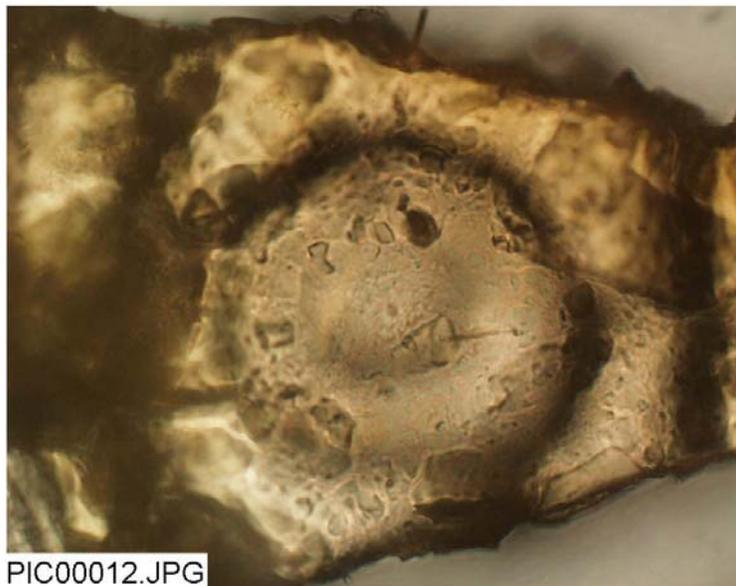
**Figure C-14.** Plane-polarized optical microscope photograph (PIC00012) for the Day-21 precipitation from the 46-ml high-volume filter magnified 50 times on a single desiccated fragment, showing contraction bubble.
