Section 2:
Session 1: Inspection Techniques, Results,
and Future Developments

NDE of Austenitic Materials A Review of Progress and Challenges

*Conference on Vessel Head Penetration
Inspection, Cracking, and Repairs*

September 29-October 1, 2003

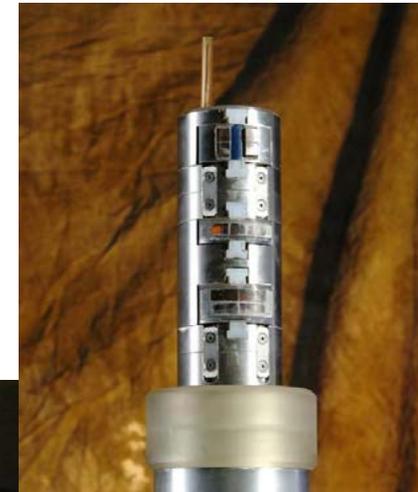
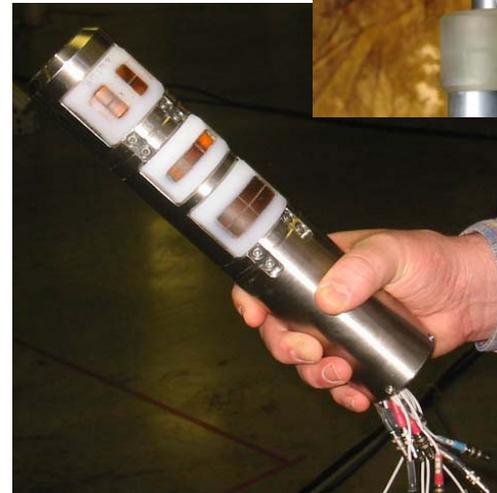
> Ultrasonic Inspection

- ◆ **Rotating UT**
 - **Penetrations without Thermal Sleeves/Lead Screws**
 - **Circumferential and Axial Crack Detection and Sizing**
 - **Initial Inspection of CRDM Nozzles and Inspection of IDTB Repair**
 - **Leak Path Detection**
- ◆ **SumoROCKY delivery**

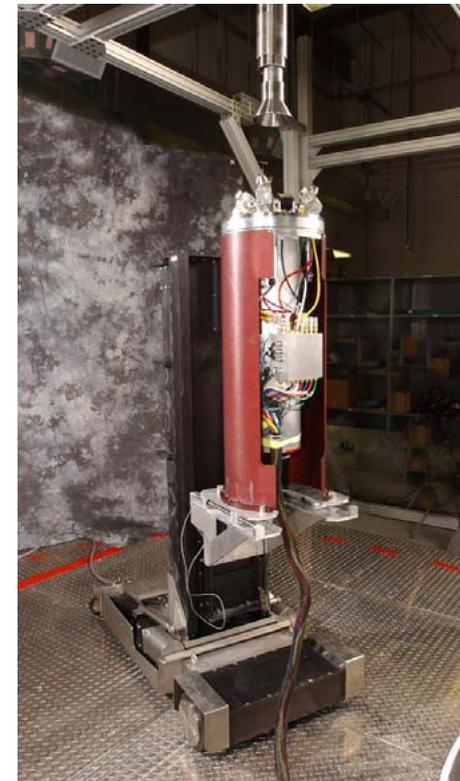
UT Blade Probe with SumoROCKY Manipulator

- > **Ultrasonic Inspection**
 - ◆ **Circumferential Blade UT**
 - **Penetrations with Thermal Sleeves/Lead Screws**
 - **Flexible Blade Inserted in the Narrow Gap**
 - **Detection and Sizing of all Circumferential Cracks and Most Axial Cracks**
 - **Leak Path Detection**
 - ◆ **Range of Axial Blade Probes Available, If Needed**
 - ◆ **SumoROCKY Delivery**

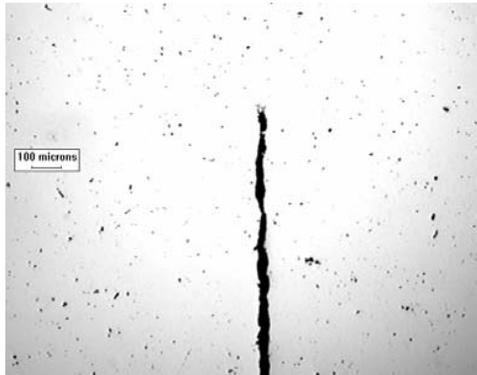
- Photos show field-removed flaw (top) & CIP flaw
- Tip of CIP flaw has similar crack tip size
- Ultrasonic tip response equivalent to findings from several plants

- Demonstrated that UT and ET responses & dynamic characteristics were equivalent to flaws removed from Bugey VHP penetration

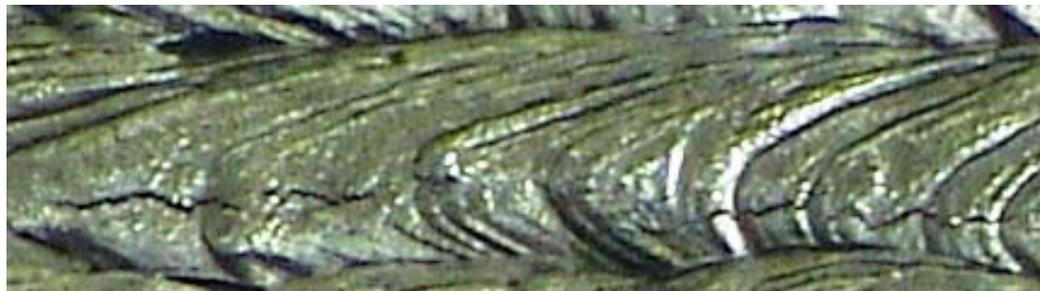
Stress Corrosion Weld Crack Specimens

- Laboratory-grown SCC
 - Three-point bend stress applied
 - Corrosive fluid applied to selected area only
- As-welded and ground surfaces
- Flaws vary in:
 - Length, width, orientation with respect to weld direction

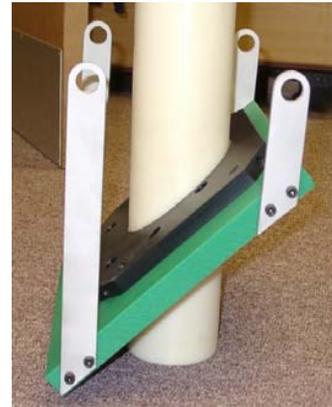
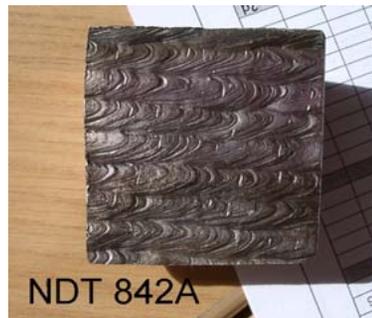
- Contains SCC flaw coupons for demo of ET on wetted surface
- Coupons contain cracks of varying
 - width
 - length
 - Orientation

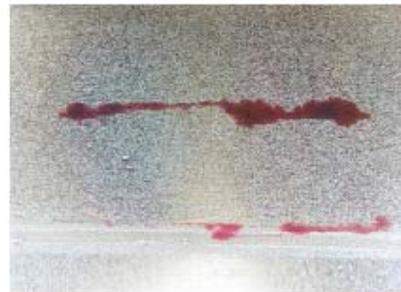
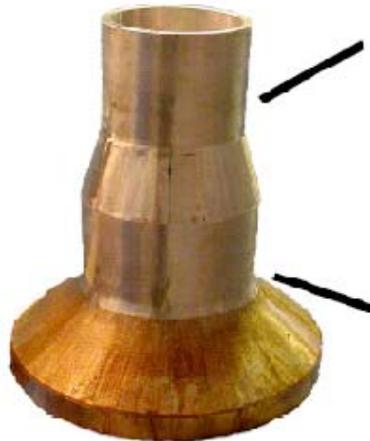
- HAZ of the buttering weld
- 14,2 mm x 5 mm
- Size controlled by the process and confirmed by UT

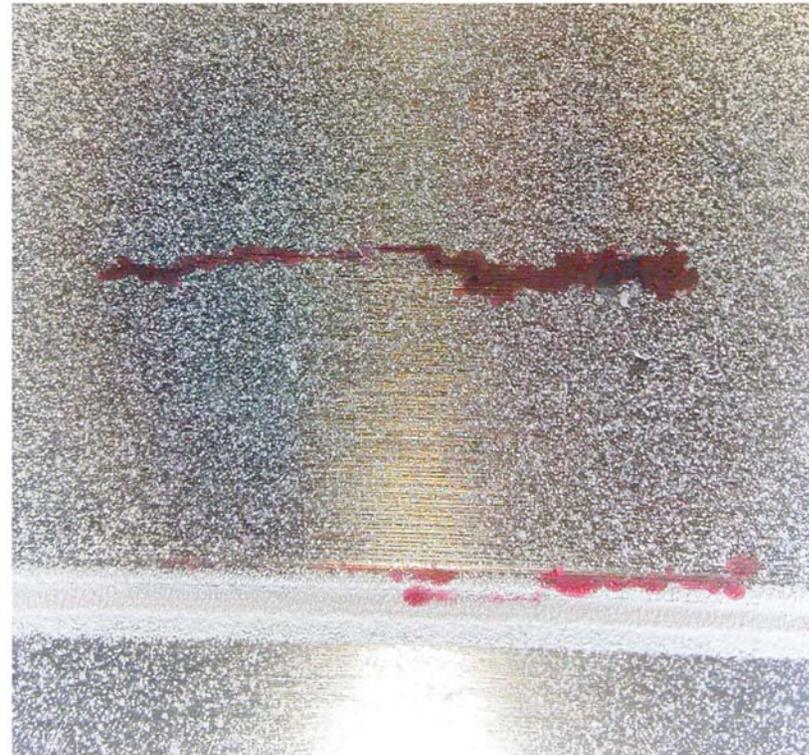
Dye penetrant test

=> 14,2 mm x 5 mm
