# Proceedings of the Conference on Vessel Penetration Inspection, Crack Growth and Repair

Held at  
Gaithersburg Marriott at Washington Center  
Gaithersburg, MD  
September 29 – October 2, 2003

Manuscripts

U.S. Nuclear Regulatory Commission  
Office of Nuclear Regulatory Research  
Washington, DC 20555-0001

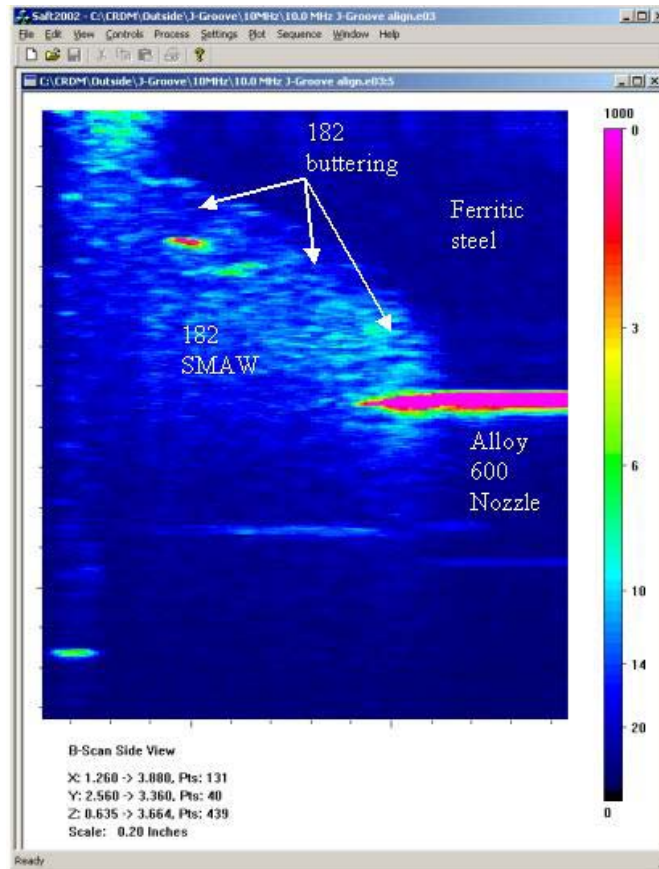
**Figure 2. UT results using normal incidence at 10 MHz spherically focused insonification showing the four product forms.**

a number of 1 to 2 mm flaws detected. The response of these weld flaws was about -35 dB while the response from the weld grains was typically -42 dB while that from the ferritic base metal was -57 dB when compared to the reference standard.

What we found in this study was that fusion zone fabrication flaws could be detected using normal incidence. However, these could only be detected for the near fusion zone. If the sound field had to pass through the weld, then it was not successful in detecting these small fabrication flaws on the far side fusion zone. Future work will evaluate the capability of UT to detect and to characterize fabrication flaws on all of the fusion zones as a function of the flaw size.

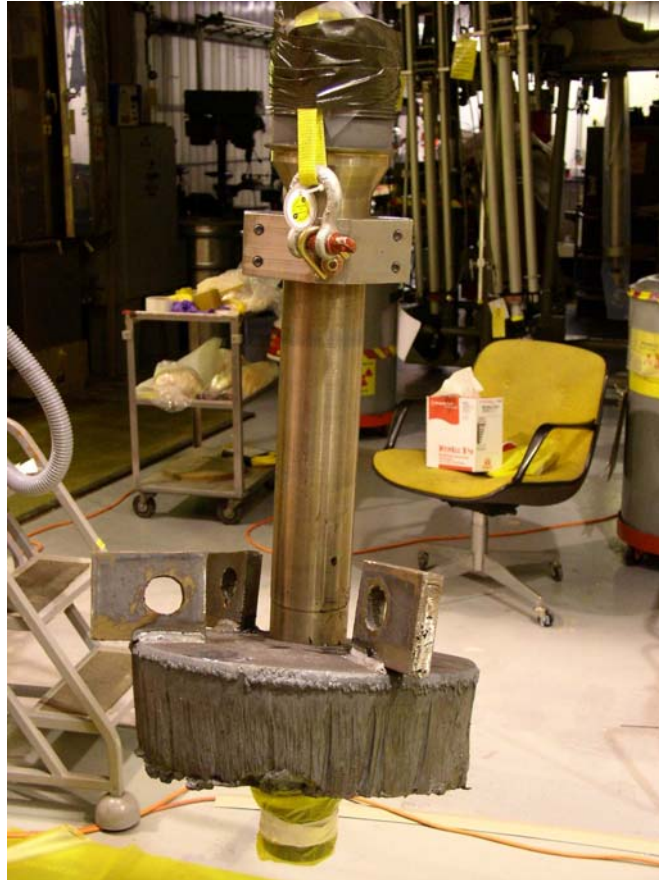
**Figure 3. North Anna 2 CRDM that has been decontaminated and is ready for moving to a stand for NDE inspections.**

Figure 3 shows a CRDM that has been decontaminated and is being readied for transit to a stand where it will reside during NDE inspections. Four CRDMs will be inspected by the commercial NDE vendors. The really fantastic opportunity that the North Anna 2 CRDMs offer is realistic NDE studies on service induced PWSCC coupled with flaw validation. This will allow us to fully understand how effective the NDE is in detecting PWSCC at all of the locations found in these samples. For the first time, we will also know what was found and what was not found. In addition we will for the first time understand how accurate the NDE techniques are in sizing the PWSCC.

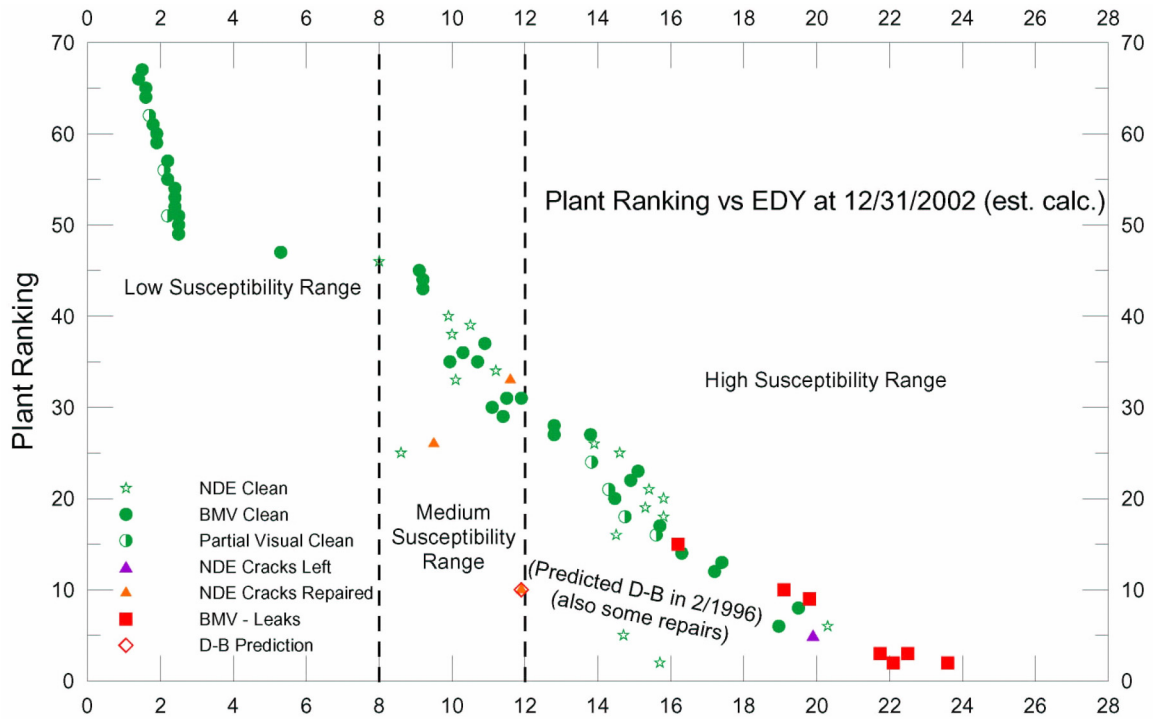
Figure 5  
NRC Chart for Tracking Inspection Results<sup>1</sup>

Figure 1. Ranking of domestic plants according to the EDY formula, showing results of inspections, evidence of leakage, and repairs. Many plants are shown with multiple symbols, indicating a “clean” inspection at inspection opportunity, followed by a different finding at a subsequent inspection (e.g., Oconee 2: clean NDE @ EDY=15.7, leaks and circ. flaws @ 22.1)

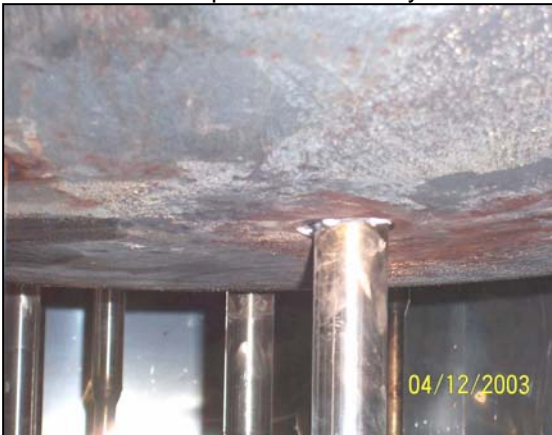
Figure 2: STP penetration 1

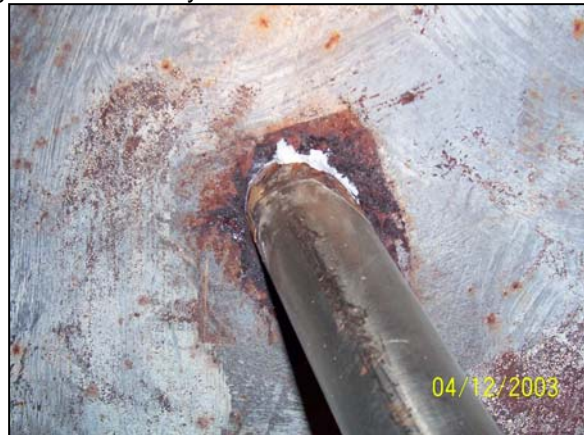
Figure 3: STP penetration 46

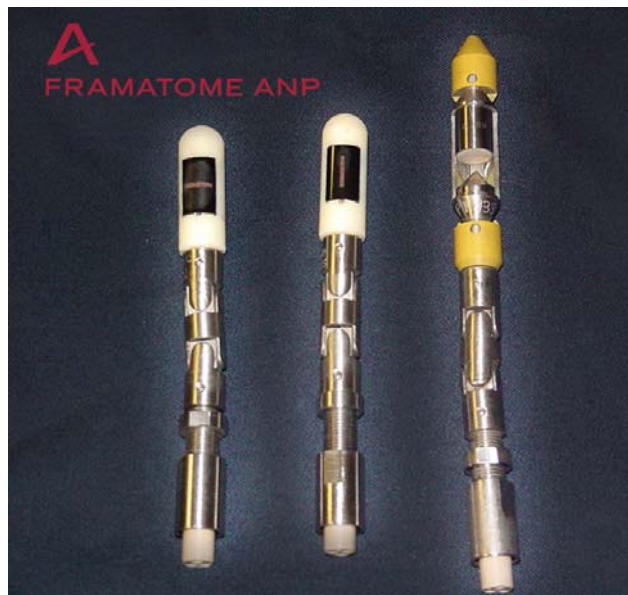
Figure 5: UT probes for BMI examination included circumferential, axial & 0° configurations

The probe selections include an axial, a circumferential, and a zero degree probe. The zero degree probe focuses a narrow sound beam at the BMI tube wall OD to fully interrogate the wall material for anomalies and for weld profiling. The axial probe transmits a circumferentially oriented beam and a corresponding receiver “listens” for Time of Flight Diffraction (TOFD) to detect an axial crack. The circumferential probe uses a similar approach but the beam is directed axially to detect circumferential flaws. Although efforts are ongoing to combine these examinations into one probe, at the time of the South Texas Project campaign, the scan sequence was repeated three times – once for each probe type.

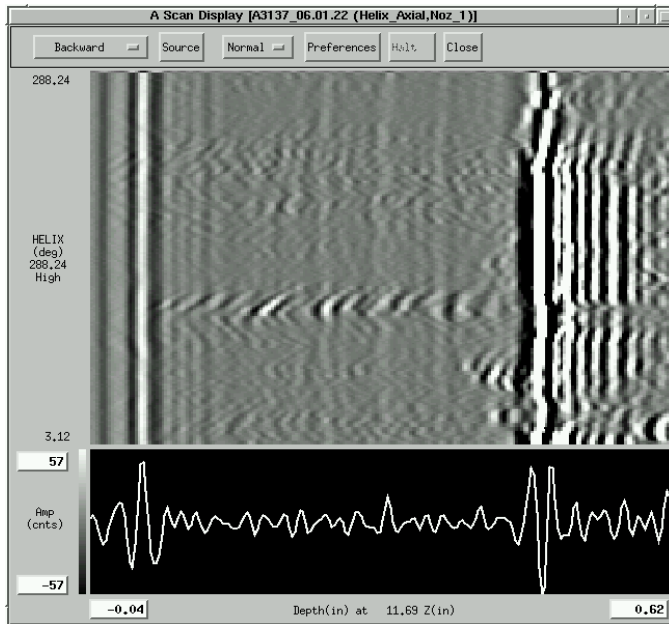
Figure 6: Penetration 1 axial probe with three axial indications and one full-penetration leak path

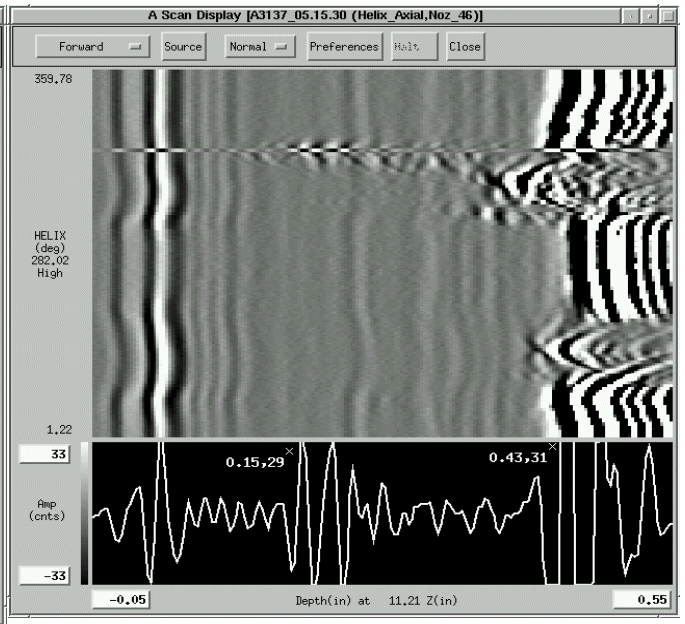
Figure 7: Penetration 46 with 2 axial indications and one leak path.

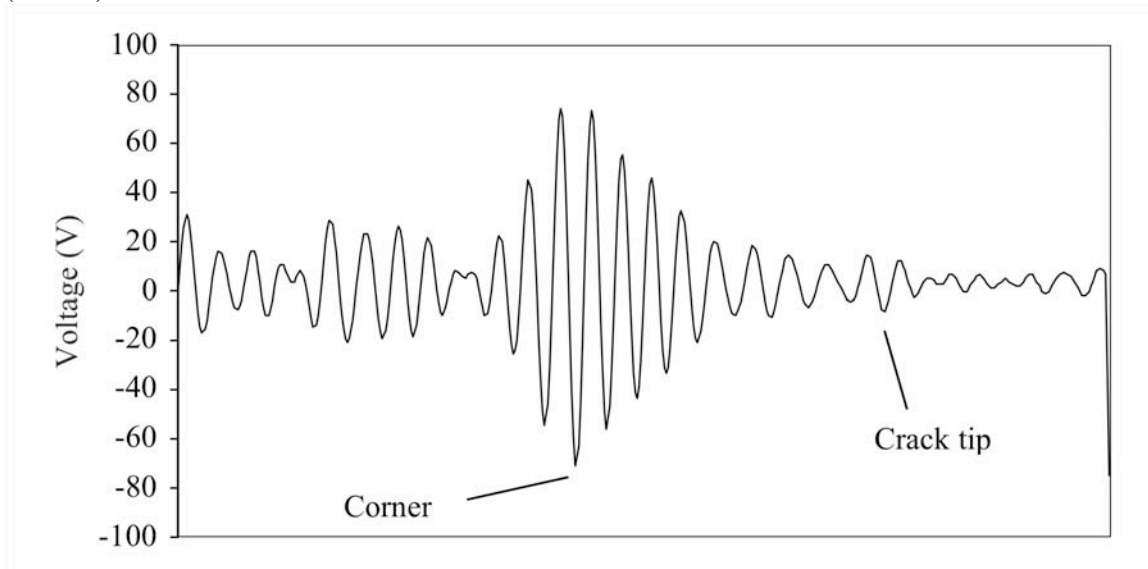
**Figure 5** A-scan obtained from the crack at room temperature (41°, 1.5 MHz, shear wave probe).

The size of the crack was controlled by process control during the production and confirmed by ultrasonic testing. The obtained signal from the crack at room temperature is shown in Figure 5. The reflections from crack opening corner and subsurface parts of the crack are visible in the figure. The ultrasonic inspection sized the crack to be 18 mm long and 6 mm deep. The measured length by ultrasonic testing is clearly bigger than the actual value as seen from Figure 4. Also the measured depth differs from the given process value, but it lies inside the production tolerances ( $\pm 1$  mm).

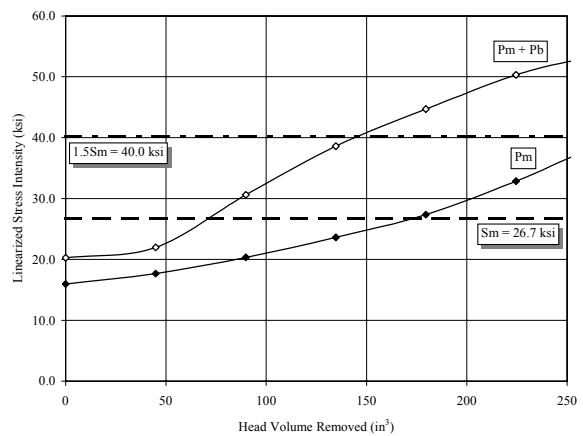
**Primary Membrane and Membrane Plus Bending Stress as Function of Wastage Volume**

**Finite Element Model of Representative Head**

Figure 2  
Tolerance to Boric Acid Wastage

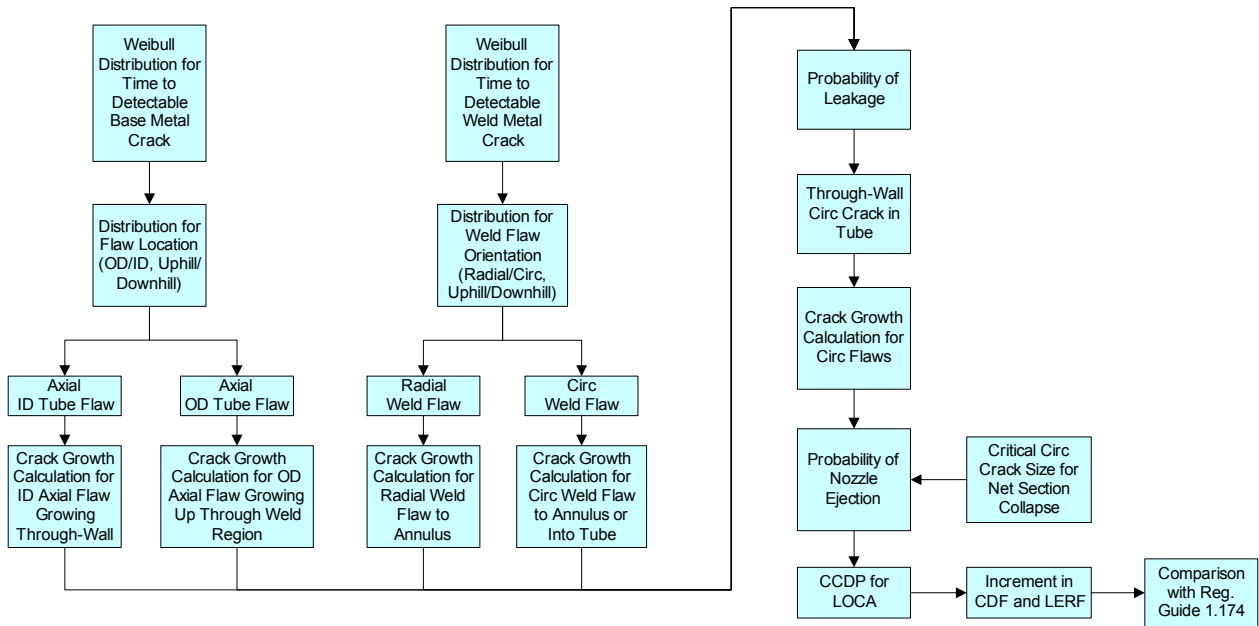
Figure 7  
Simplified Flowchart of Monte Carlo Risk Assessment Model
