Section 5:
Session 5: Mitigation of Nickel-base Alloy Degradation
and Foreign Experience

Belgian Activities on Alloys 600 and 182 Issues

R.Gérard, Ph.Daoust (Tractebel Engineering, Brussels, Belgium)

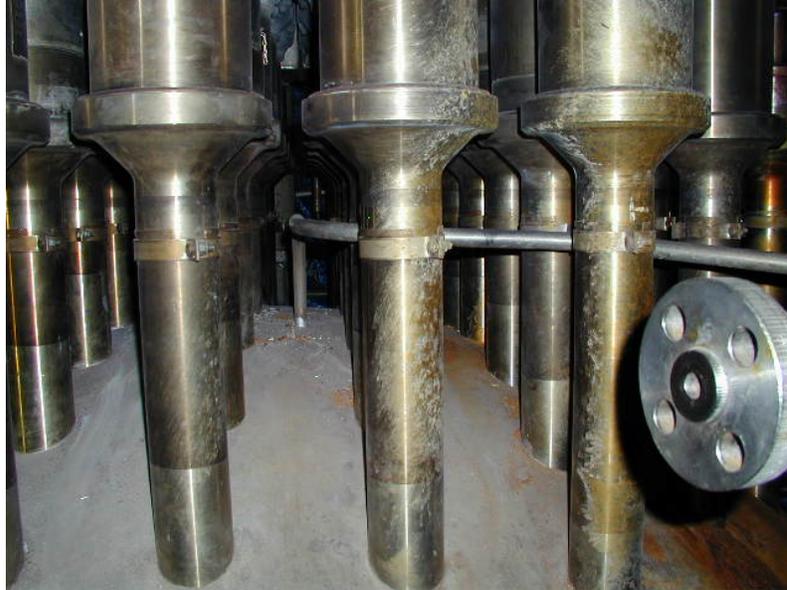
Figure 2

5 units were inspected in 2002 and the last one in 2003. (Tihange 1 will not be inspected in the near future since the head was replaced in 1999). Even though the accessibility was not always as good as on figure 2 and it was not always possible to inspect visually 100% of the surface, the heads were generally clean with locally some rusty streaks or small boric acid crystals attributed to previous canopy seals leaks. No evidence of RPV head corrosion was seen. The heads that could not be visually inspected at 100%, or where some of boric acid traces from canopy leaks made the interpretation more difficult, will be reinspected at the next outage.

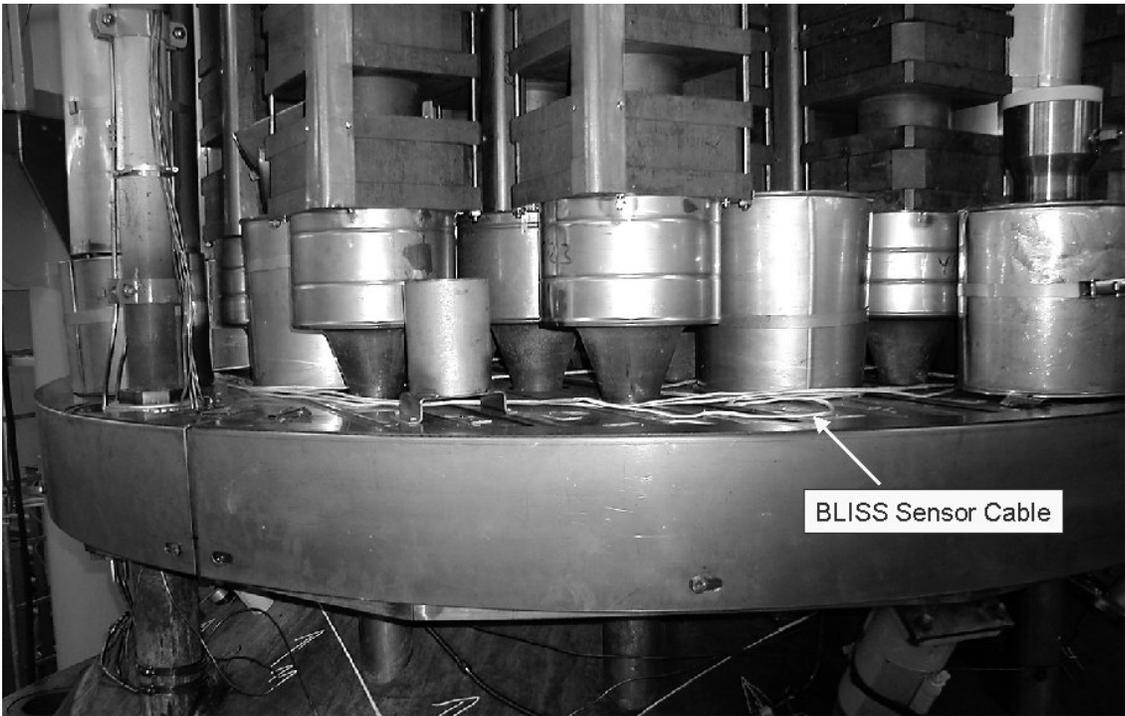
For local leakage monitoring of penetration flanges, the very sensitive system BLISS (Bartec Leakage Indication Sensor System) is installed that can detect volumes of water as low as 1 cm³ (corresponding to 0.00026 gal), see Figure 4. In addition, another very sensitive system FLÜS (Feuchte Leakage Überwachungs System - Humidity Leakage Monitoring System) is installed on the RPV head amongst the protruding penetrations, see Figure 5. This system allows both the detection of actual leakage rates and location of the problem area. This system detects leak rates as low as 1 liter/hour (corresponds to 0.0042 gpm).

Figure 4 BLISS Sensor Cable installed on RPV Head

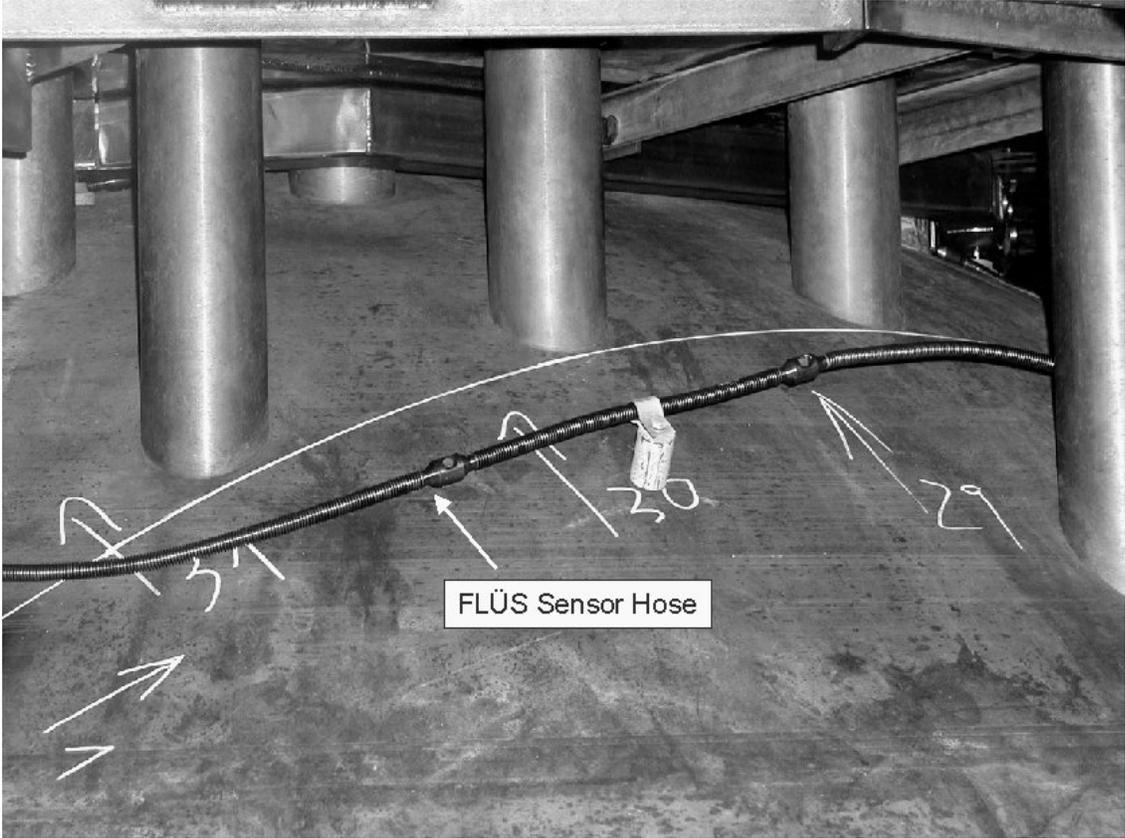
Figure 5 FLÜS Sensor Hose installed on RPV head of KWO

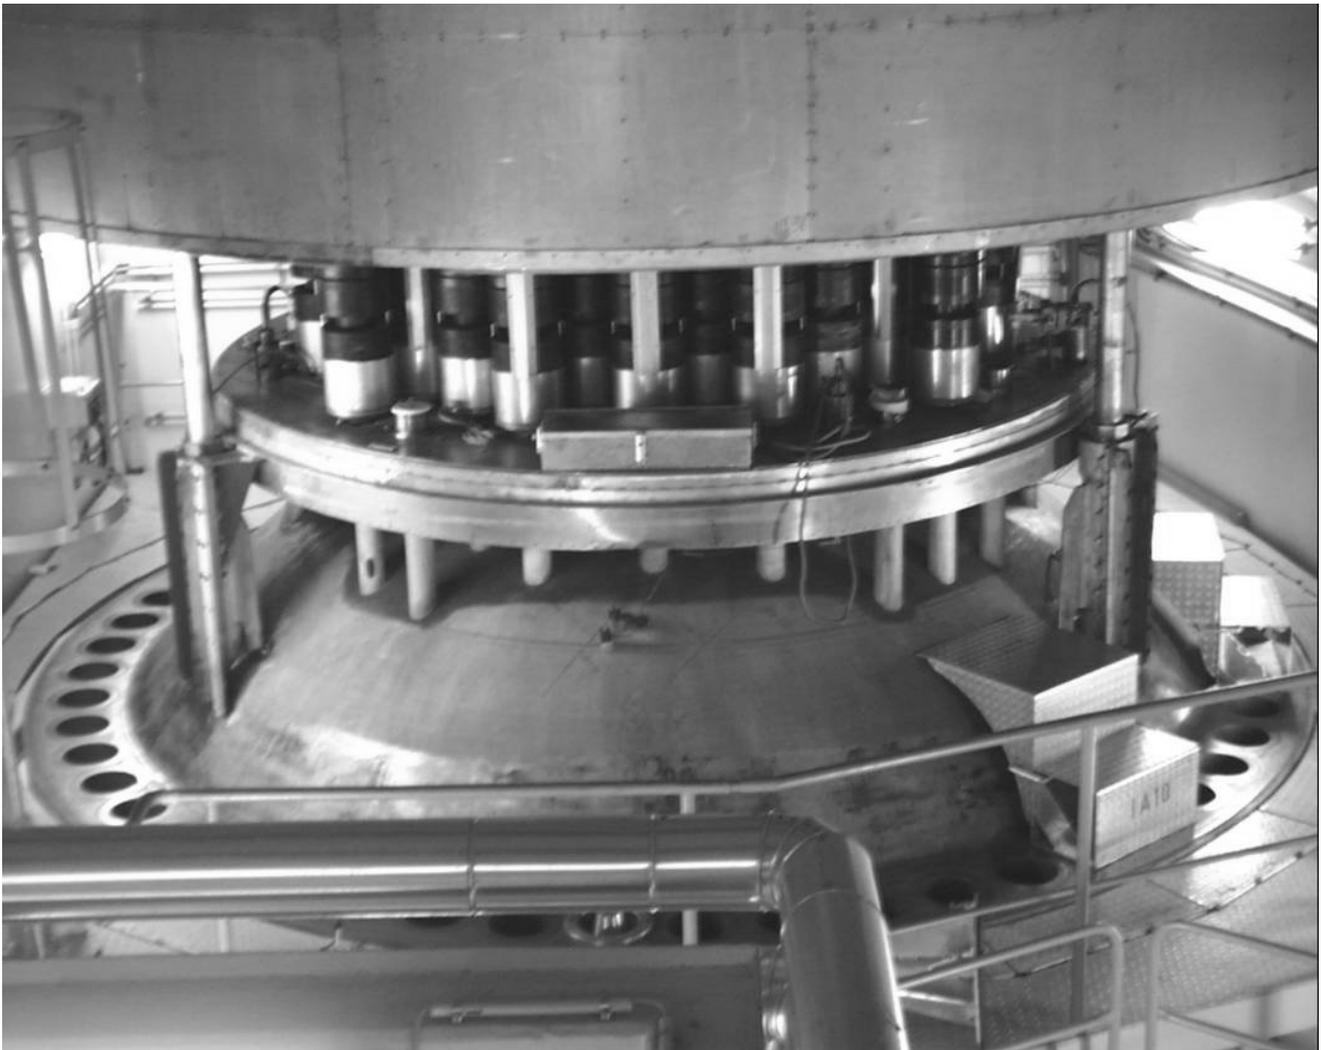
Figure 10 RPV head on its storage location during outage

In the context of evaluating the RPV head a comprehensive annual visual inspection is conducted during the outage. As can be seen in Figure 10 and Figure 11, there are no constraints from encasings or insulation material. Boric acid deposits, even very small ones, would have been detected with certainty.

As stipulated in KTA 3201.4 non-destructive testing is conducted at intervals of 4 and 5 years, respectively. Since 1989 ultrasonic testing (phased array technique) is being utilized to inspect closure head ligaments of the entire internal and external RPV head surfaces.

No inspections conducted at Siemens/KWU plants have revealed any reportable indications.
