Request for Relief No. 21, for the Unit 2 3rd 10-year Interval Inservice
Inspection Program

ISI Relief Request No. 21 (Rev. 0), Prairie Island Unit 2, 3rd Interval

Limited Examination

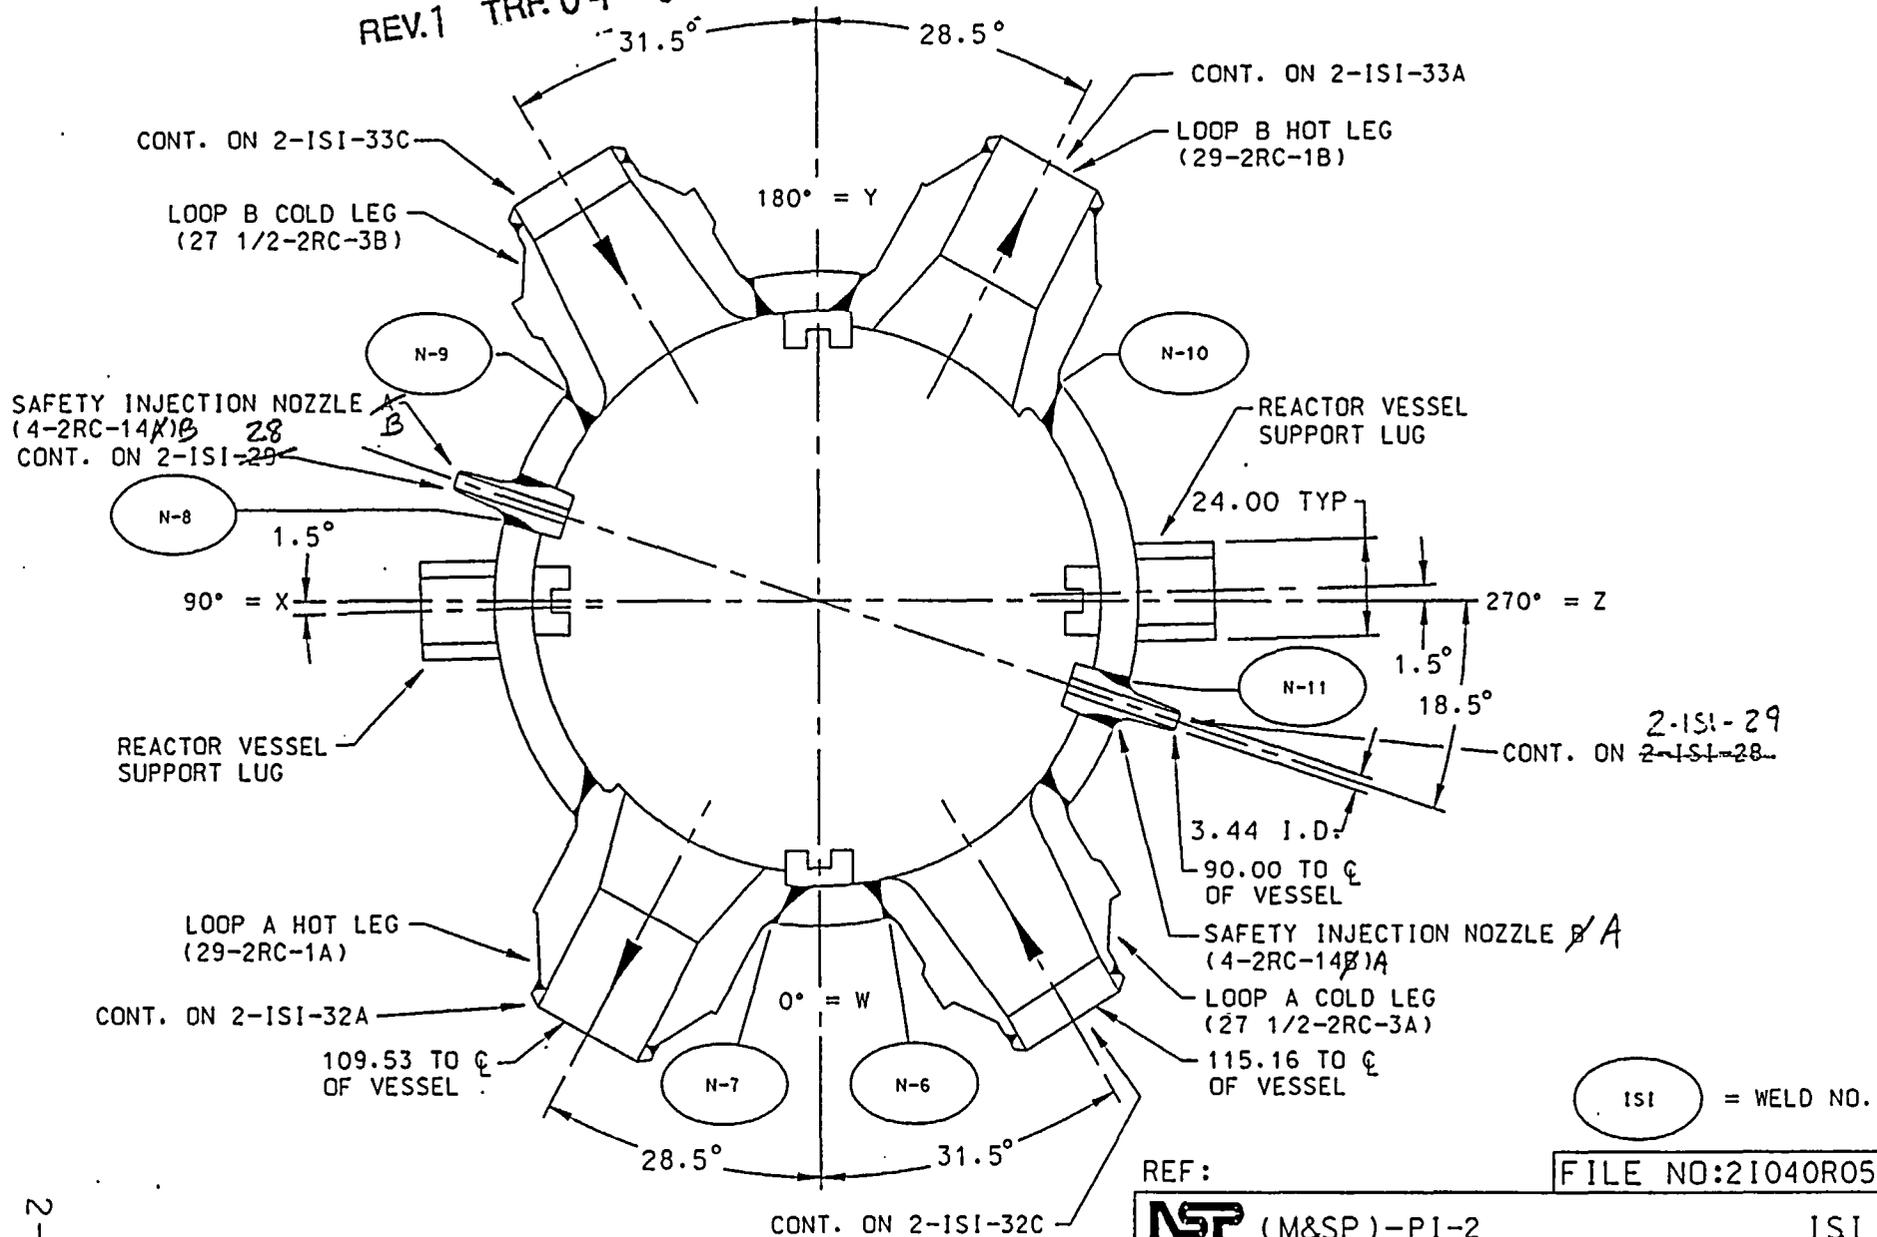
2-ISI-40

REACTOR VESSEL NOZZLES

The Reactor Vessel Nozzle-to-Vessel weld is subject to a volumetric examination. The volumetric examination was performed using personnel and procedures qualified in accordance with Appendix VIII, Supplements 4,6 and 7. The examination was conducted using 45-degree transducers. The nozzle and vessel material are SA 508. The examination was limited in both the parallel and perpendicular scans from the vessel ID to 78.56% due to the proximity of the outlet nozzle protrusion to the nozzle to shell weld. As an alternative to the ultrasonic examination, radiography was considered and determined to be an unacceptable substitute due to no outside access and weld configuration.

The Reactor Vessel Nozzle-to-Vessel weld is subject to a volumetric examination. The volumetric examination was performed using personnel and procedures qualified in accordance with Appendix VIII, Supplements 4, 6, and 7. The examination was conducted using 45-degree transducers. The nozzle and vessel material are SA 508. The examination was limited in both the parallel and perpendicular scans from the vessel ID to 78.56% due to the proximity of the outlet nozzle protrusion to the nozzle to shell weld. As an alternative to the ultrasonic examination, radiography was considered and determined to be an unacceptable substitute due to no outside access and weld configuration.

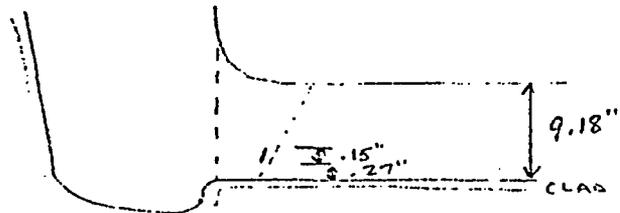
weld # N-7
Flaw View

$a = 2 1/2$
 $a = 1 1/2$
 $a = .10$
 $.4d = 2 1/2 \times 0.4$
 $.4d = 1 1/2 \times 0.4$
 $.1d = 0.03$
 if $s > .4d$ flaw = surface
 $.27 > 0.03 = \text{sub surface}$

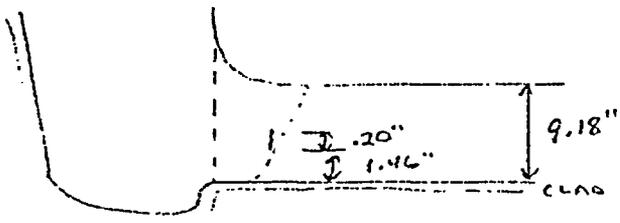
weld # N-7

$.4d = 2\frac{1}{2} \times 0.4$
 $.4d = 1 \times 0.4$
 $.4d = 0.4$
 $1.46 > 0.4$ flaw = sub surface
 $a = 2\frac{1}{2}$
 $a = .292$
 $a = .10$

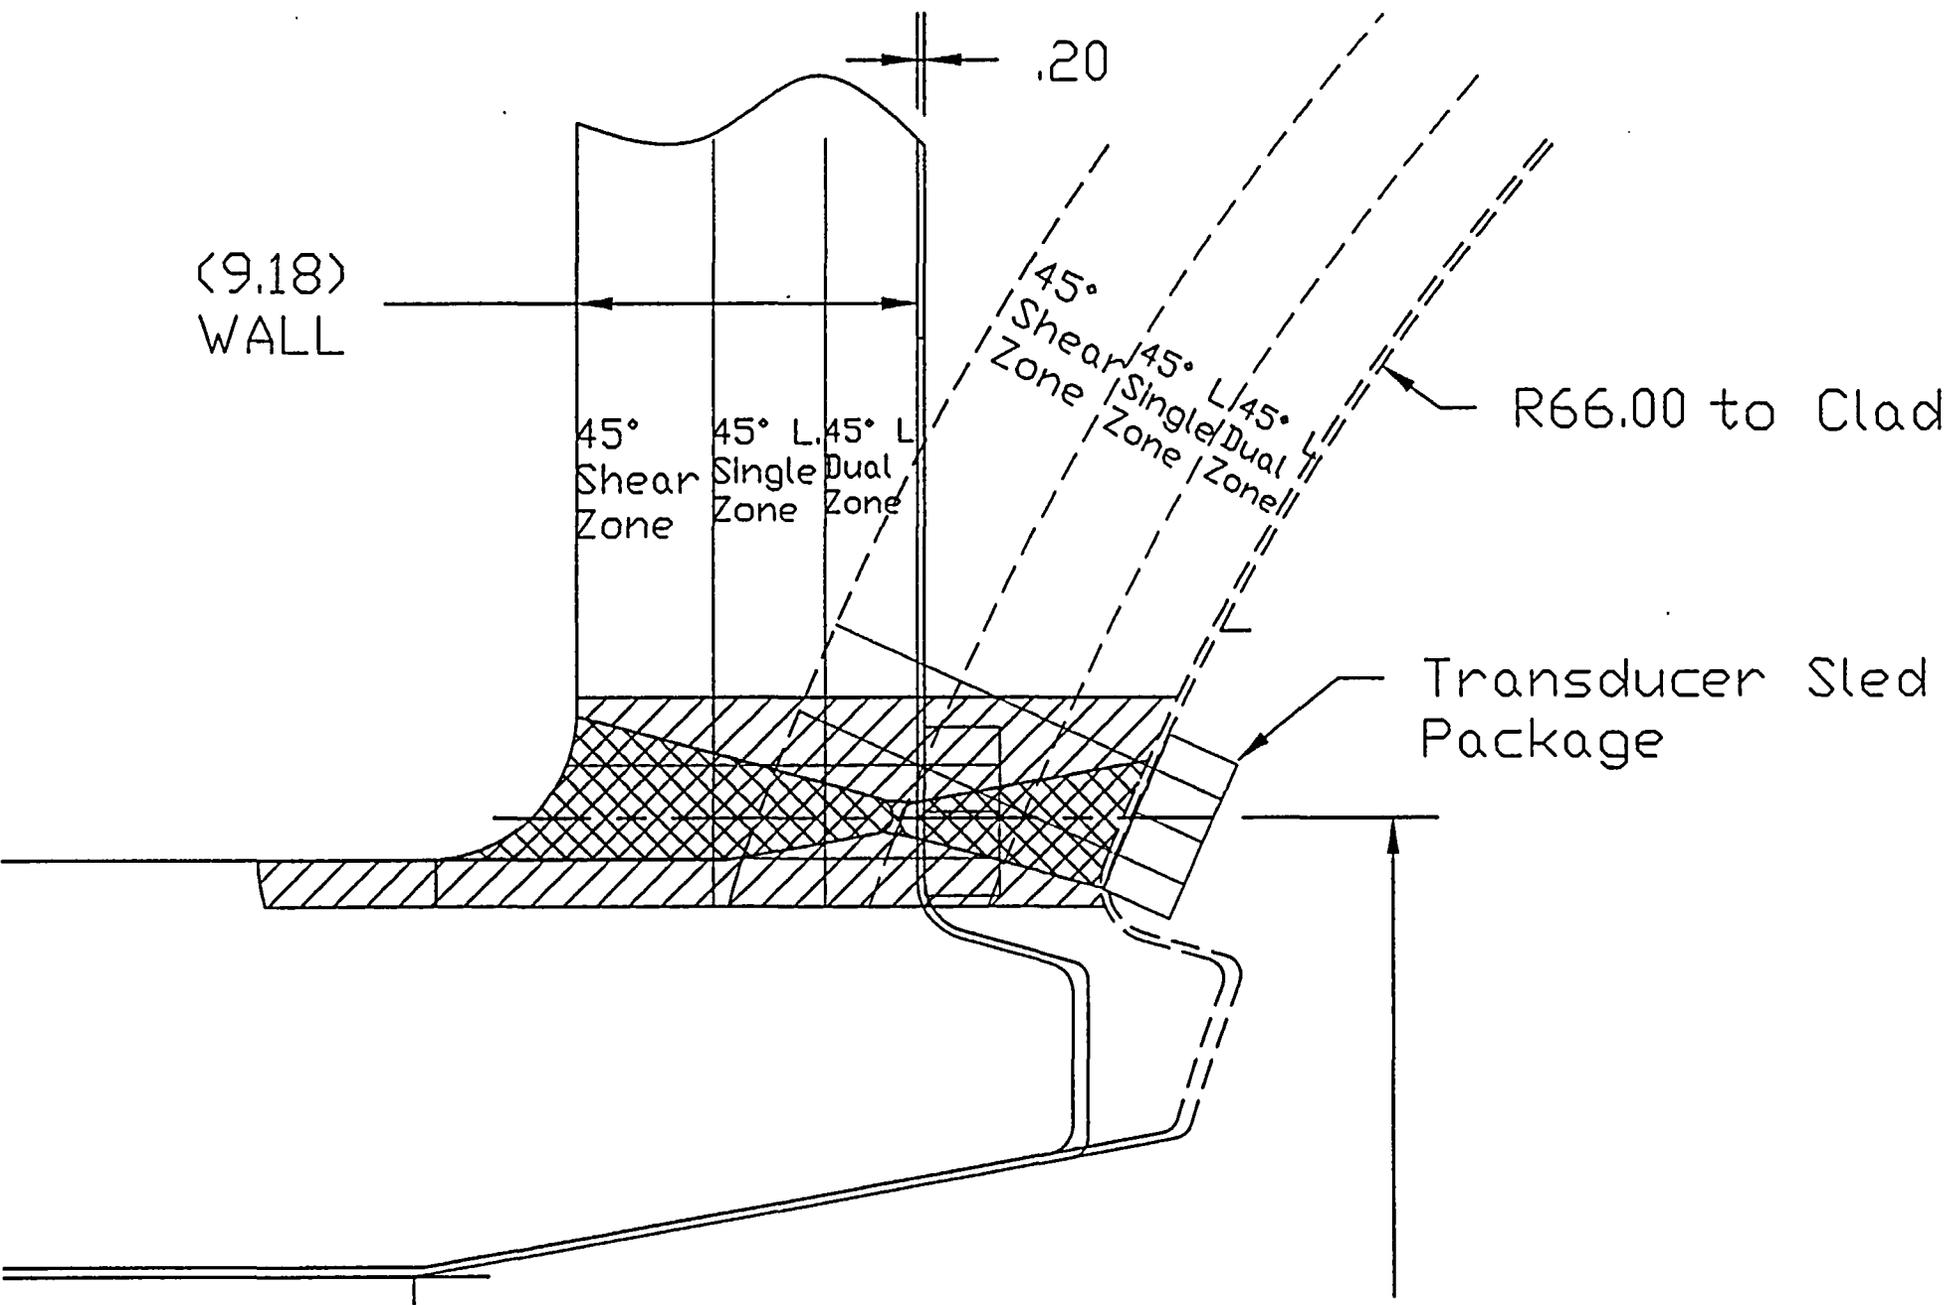
Figure 1
 Tan Coverage Illustration
 Primary Outlet Nozzle
 Protrusion Limitation

* 78.56%, See WesDyne final report

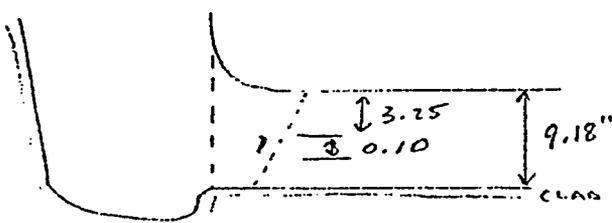
1) Flaw Number <u>2</u>	3) ISI Interval <u>3F</u>	OK Reviewer <u>gms</u>
2) Item Number <u>B3.90</u>	4) Code Edition & Addenda <u>1989 No Add.</u>	OK Reviewer <u>gms</u>
	5) Method <u>UT</u>	OK Reviewer <u>gms</u>
weld # <u>N-10</u>	6) Flaw Sketch (See Below)	
Flaw View		$.4d = 2\frac{1}{2} \times 0.4$ $.4d = 0.10 \times 0.4$ $.4d = 0.02$ <p>if $s > .4d$ flaw = <u>sub surface</u></p> $3.25 > 0.02 = \text{sub surface}$ $a = 2\frac{1}{2}$ $a = 0.10 \times 2$ $a = 0.05$

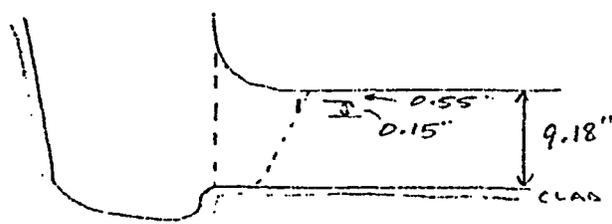
weld # N-10
Flaw View

$0.4d = 2\frac{1}{2} \times 0.4$
 $0.4d = 0.15 \times 0.4$
 $0.4d = 0.03$
 $\therefore 0.55 > 0.4d$ flaw = subsurface
 $0.55 > 0.03 =$ subsurface
 $a = 2\frac{1}{2}$
 $a = 0.15$
 $a = 0.10$

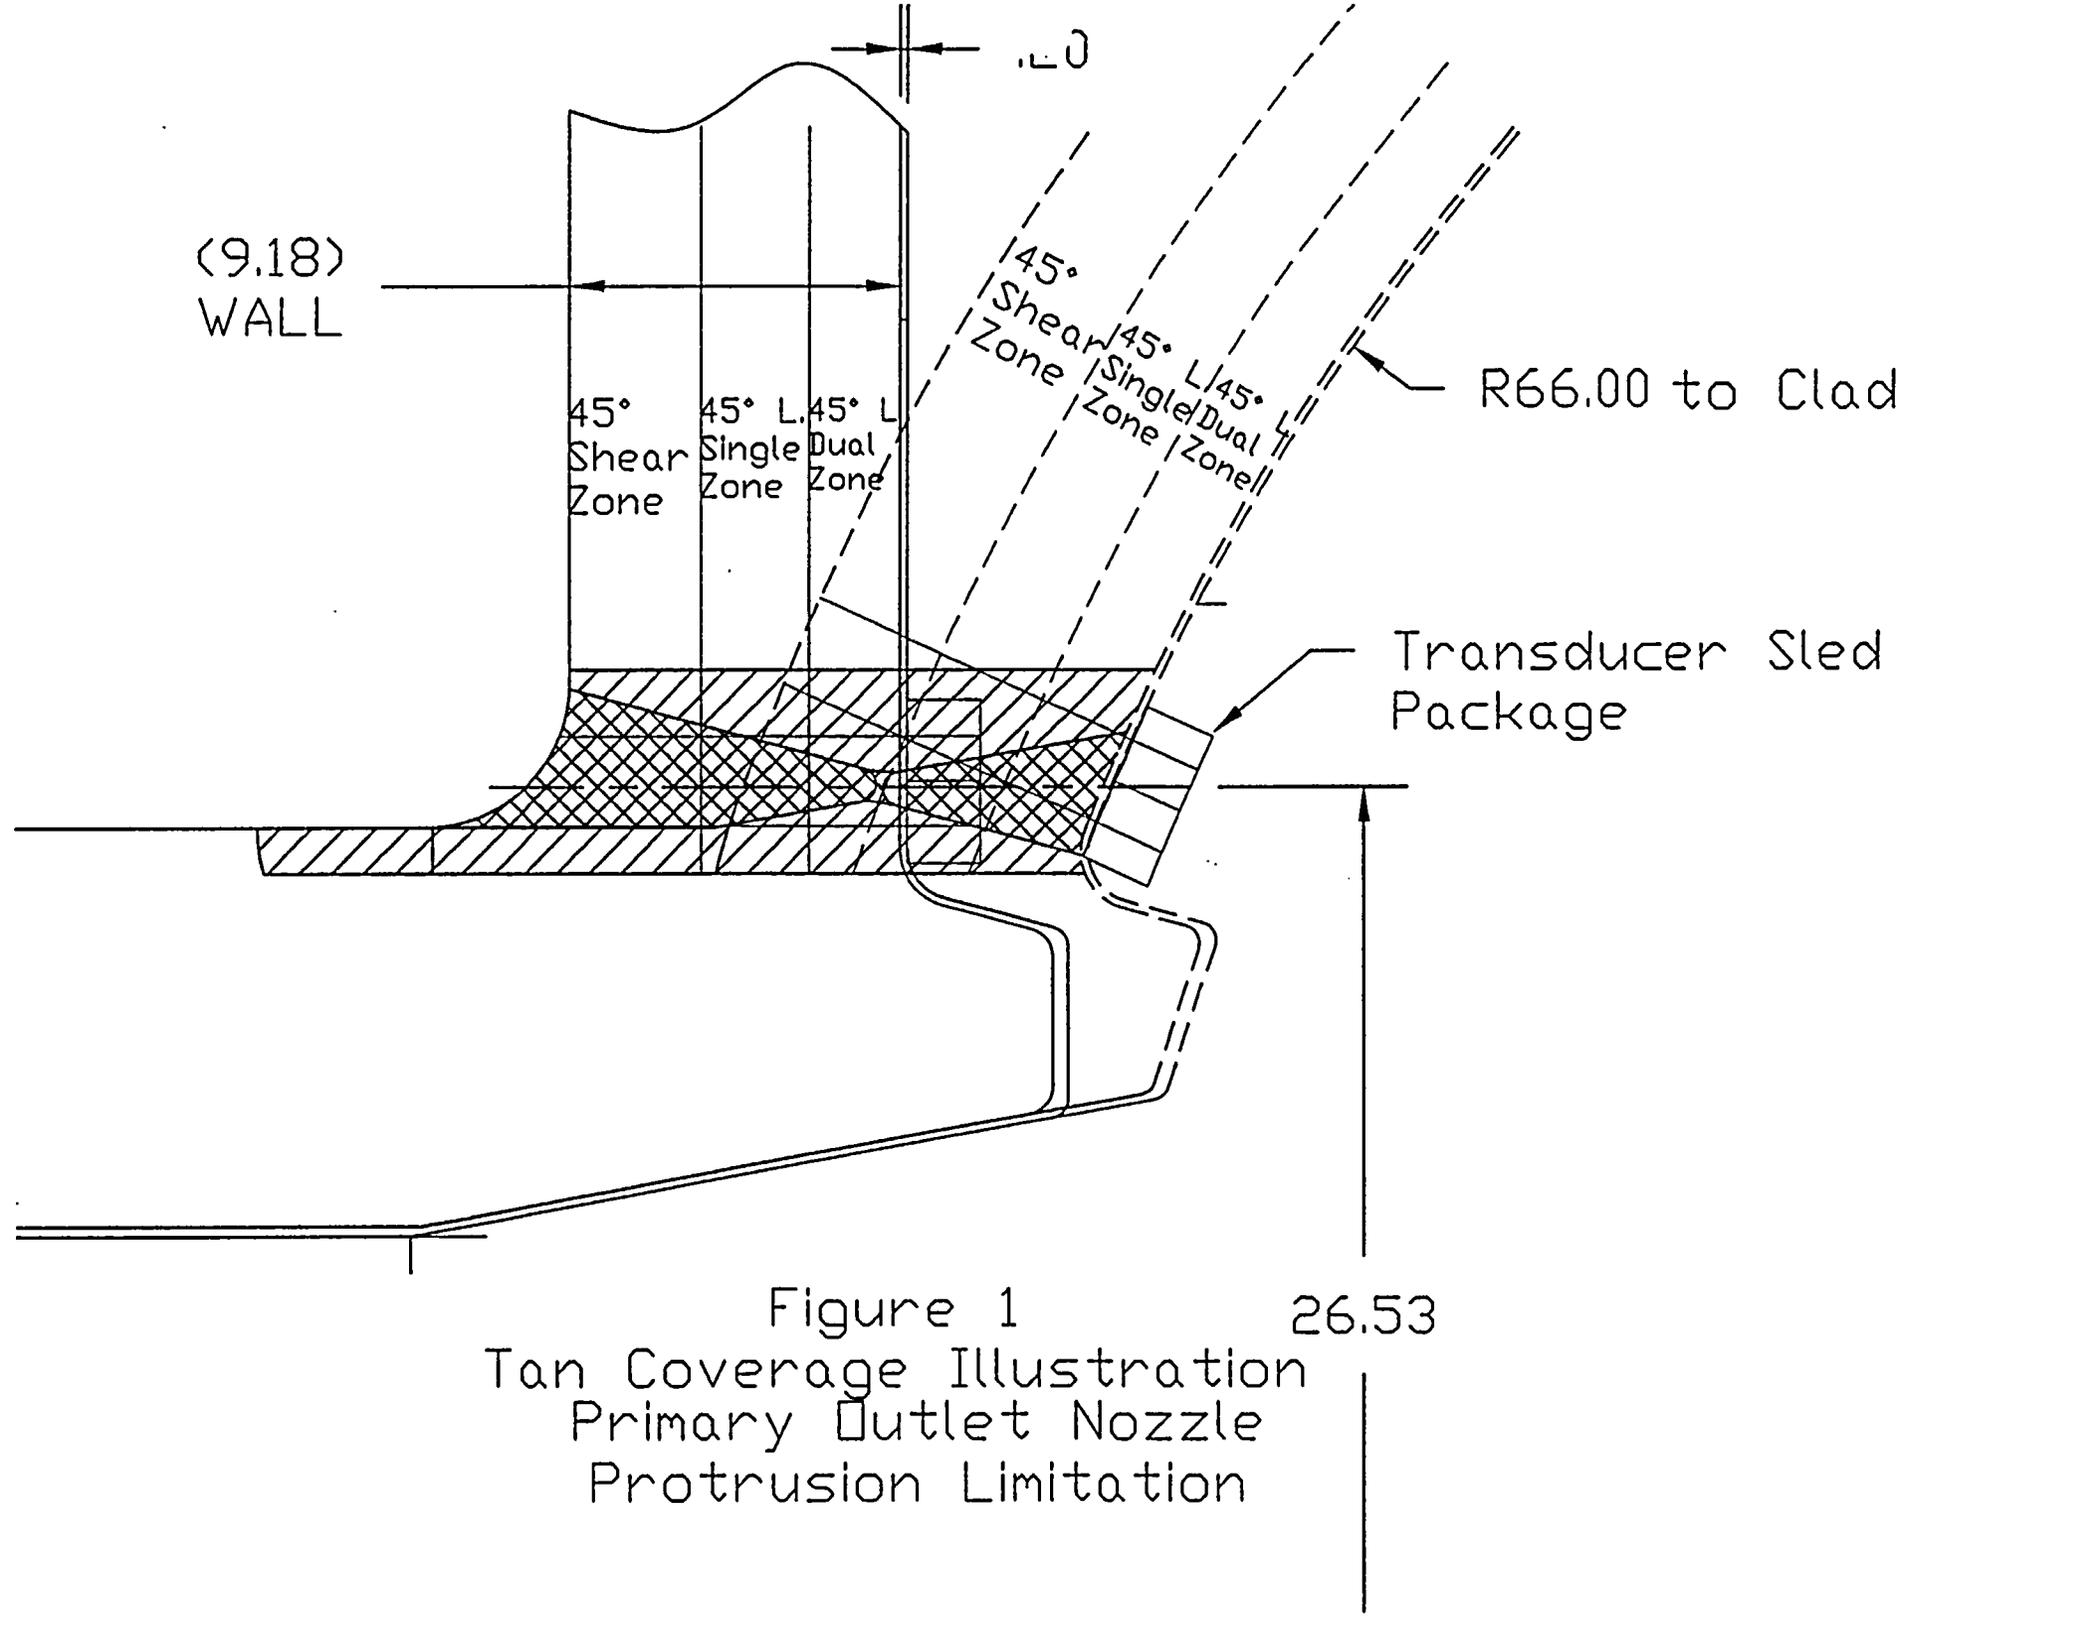
Tan Coverage Illustration
Primary Outlet Nozzle
Protrusion Limitation

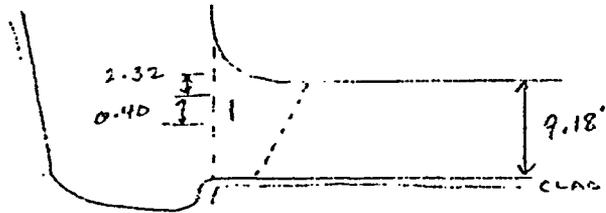
weld # N-8
Flaw View

$0.4d = 20/2 \times 0.4$
 $0.4d = 0.40/2 \times 0.4$
 $0.4d = 0.08$
 $2.32 > 0.08 = \text{sub surface}$
 $a = 20/2$
 $a = 0.40/2$
 $a = 0.20$

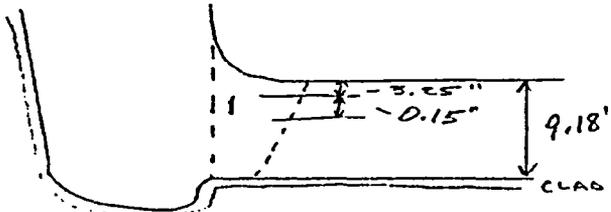
weld # N-8

$.4d = 20/2 \times 0.4$
 $.4d = 0.15/2 \times 0.4$
 $.4d = 0.03$
 if $.4d > .4d$ flaw = sub surface
 $3.25 > 0.03 =$ sub surface
 $a = 20/2$
 $a = 0.15/2$
 $a = 0.10$

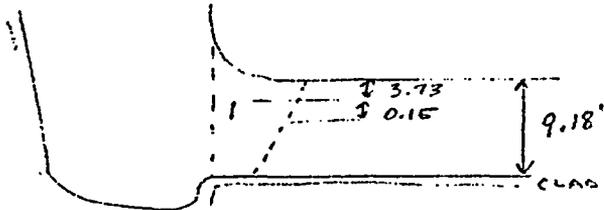
weld # N-8

$4d = 2\frac{1}{2} \times 0.4$
 $4d = 0.15 \times 0.4$
 $4d = 0.03$
 $3.73 > 0.03 = \text{sub surface}$
 $a = 2\frac{1}{2}$
 $a = .15/2$
 $a = 0.10$

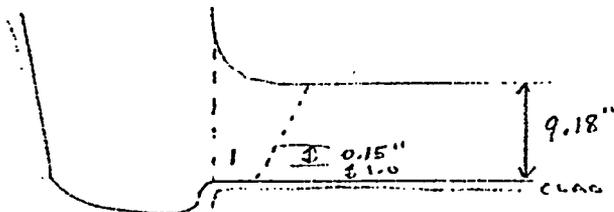
weld # N-8

$0.4d = 2\frac{1}{2} \times 0.4$
 $0.4d = 1.5 \times 0.4$
 $0.4d = 0.03$
 $1.0 > 0.03 = \text{sub surface}$
 $a = 2\frac{1}{2}$
 $a = 0.15/2$
 $a = 0.10$

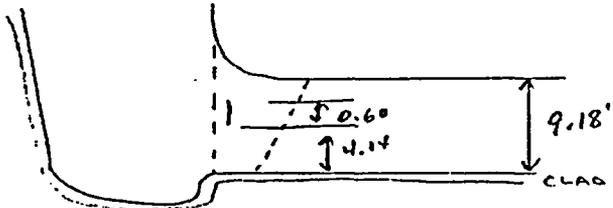
weld # N-11

$4d = 2\frac{1}{2} \times 0.4$
 $4d = 0.60 \times 0.4$
 $4d = 0.12$
 if $s > .4d$ flaw = sub surface
 $4.14 > 0.12 = \text{sub surface}$
 $a = 2\frac{1}{2}$
 $a = 0.692$
 $a = 0.30$

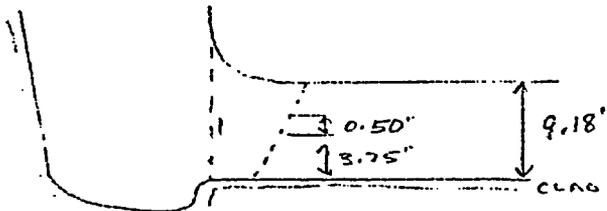
weld # N-11

$.4d = 20/2 \times 0.4$
 $.4d = 0.50/2 \times 0.4$
 $.4d = 0.10$
 $.4d > .4d \text{ flaw} = \text{subsurface}$
 $3.75 > 0.10 = \text{subsurface}$
 $a = 20/2$
 $a = 0.50/2$
 $a = 0.25$

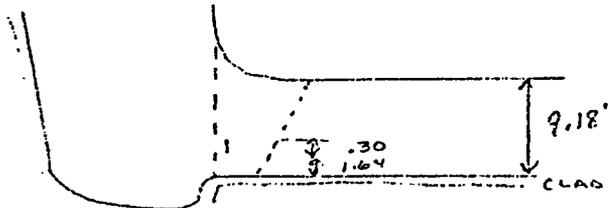
weld # N-11

\bullet $4d = 2\theta/2 \times 0.4$
 \bullet $4d = 0.30/2 \times 0.4$
 \bullet $4d = 0.06$
 \bullet if $s > .4d$ flaw = sub surface
 $1.64 > 0.06 =$ sub surface
 $a = 2\theta/2$
 $a = 0.30/2$
 $a = 0.15$

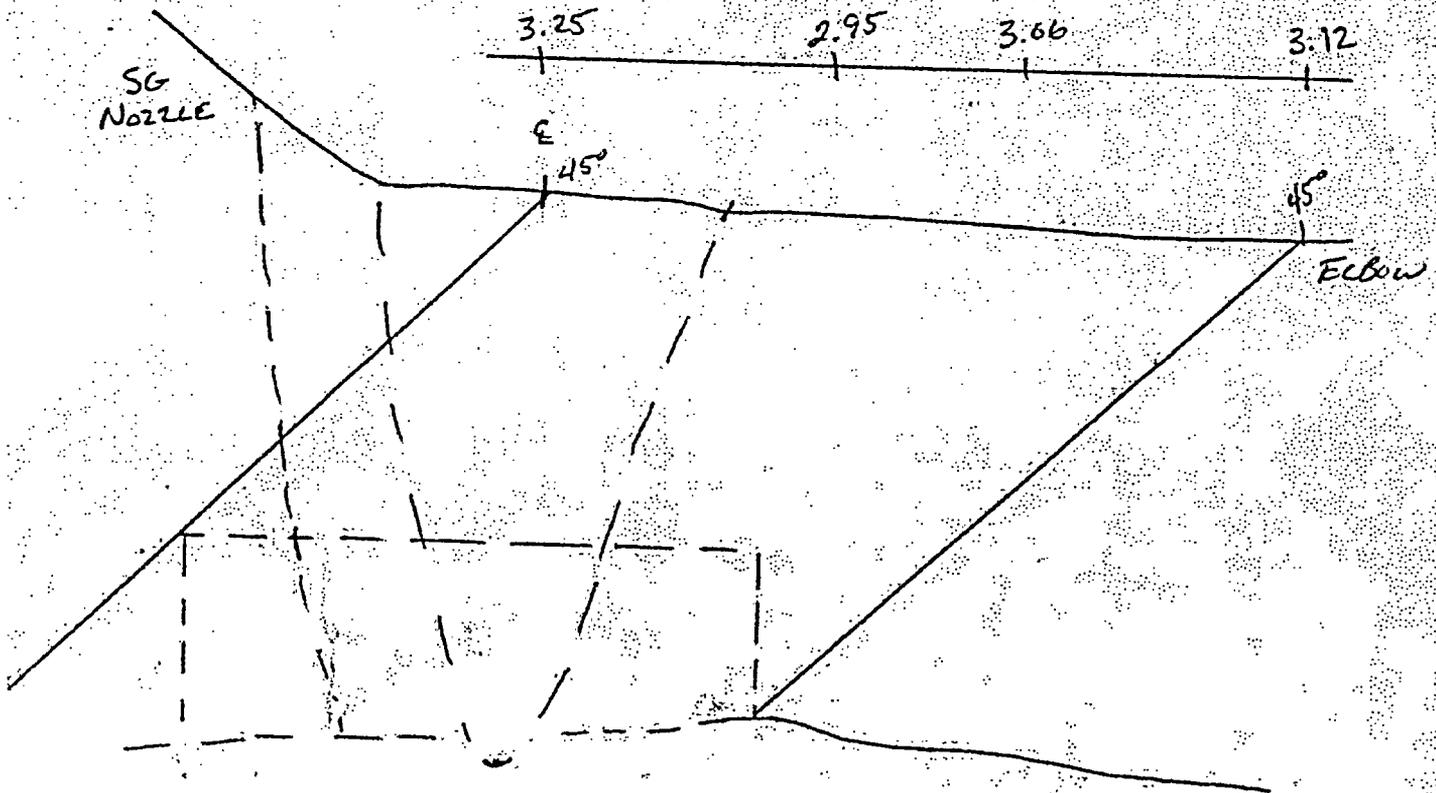
Comments: **W-5 Coverage Plot**

The Elbow to Safe End weld is subject to a volumetric examination and surface examination. The volumetric examination was performed using personnel and procedures qualified in accordance with Appendix III. The examination was conducted using 45-degree refracted longitudinal transducers. The elbow and safe end material are SA 351-CF8 cast austenitic stainless and 308L stainless (this joint contains no Alloy 82/182 or 600). The examination was limited to 78.46% due to the OD profile of the cast stainless steel elbow. The UT examination is further hindered from the elbow side of the weld for obtaining meaningful ultrasonic data because of the elbow material being cast austenitic stainless steel. UT sound beam attenuation and propagation properties in cast stainless steel are extremely difficult. The ASME Code Committee and the industry Performance Demonstration Initiative (PDI) recognized that such examinations are difficult. ASME Section XI, Appendix VIII, Supplement 9 has been in "course of preparation" for several years, hence, there are no qualified examination procedures or personnel to conduct the required examinations. As an alternative to the ultrasonic examination, radiography was considered and determined to be an unacceptable substitute due to radiological constraints, the reactor vessel level would be required to be at reduced inventory below the center line of the hot leg, weld configuration, and the undue hardship imposed without offering any commensurate increase in safety with cost benefit.

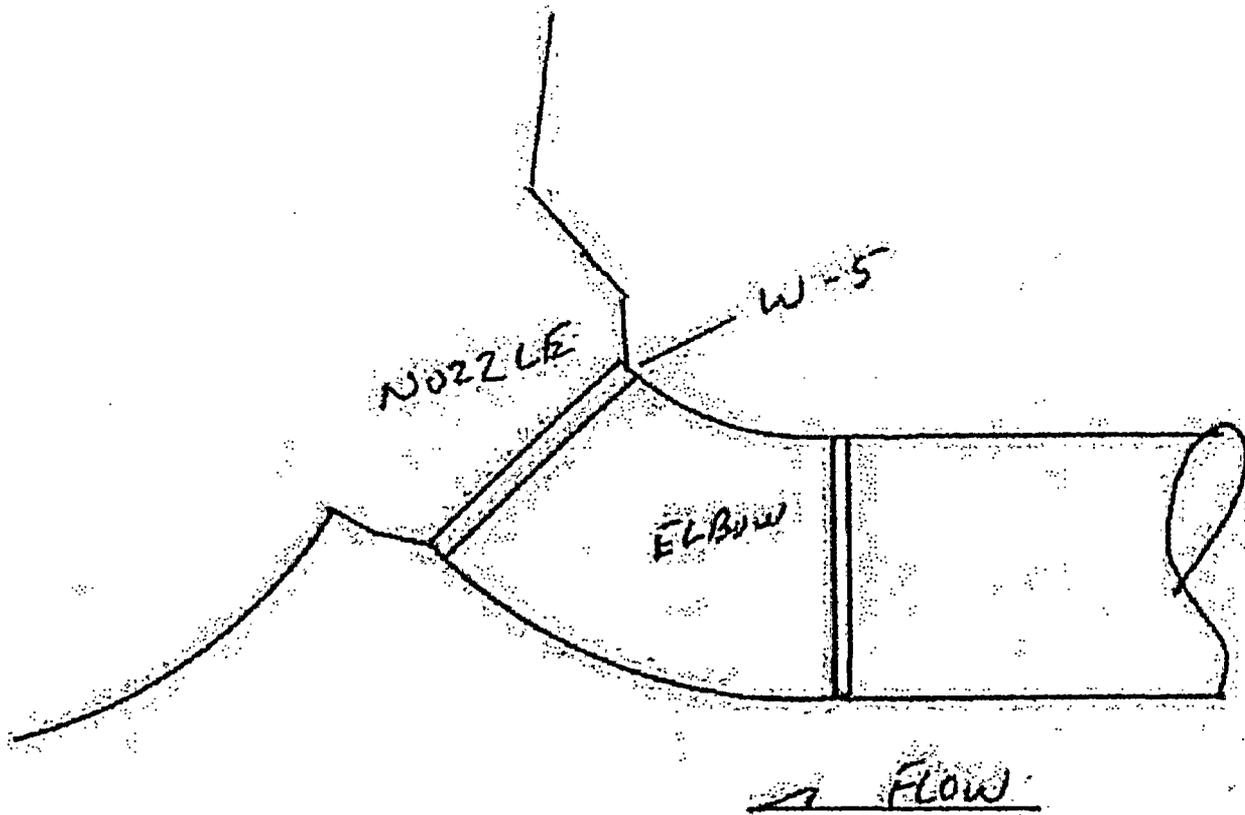
Comments: **Limitation sketch W-5. No scans on nozzle side due to configuration.**

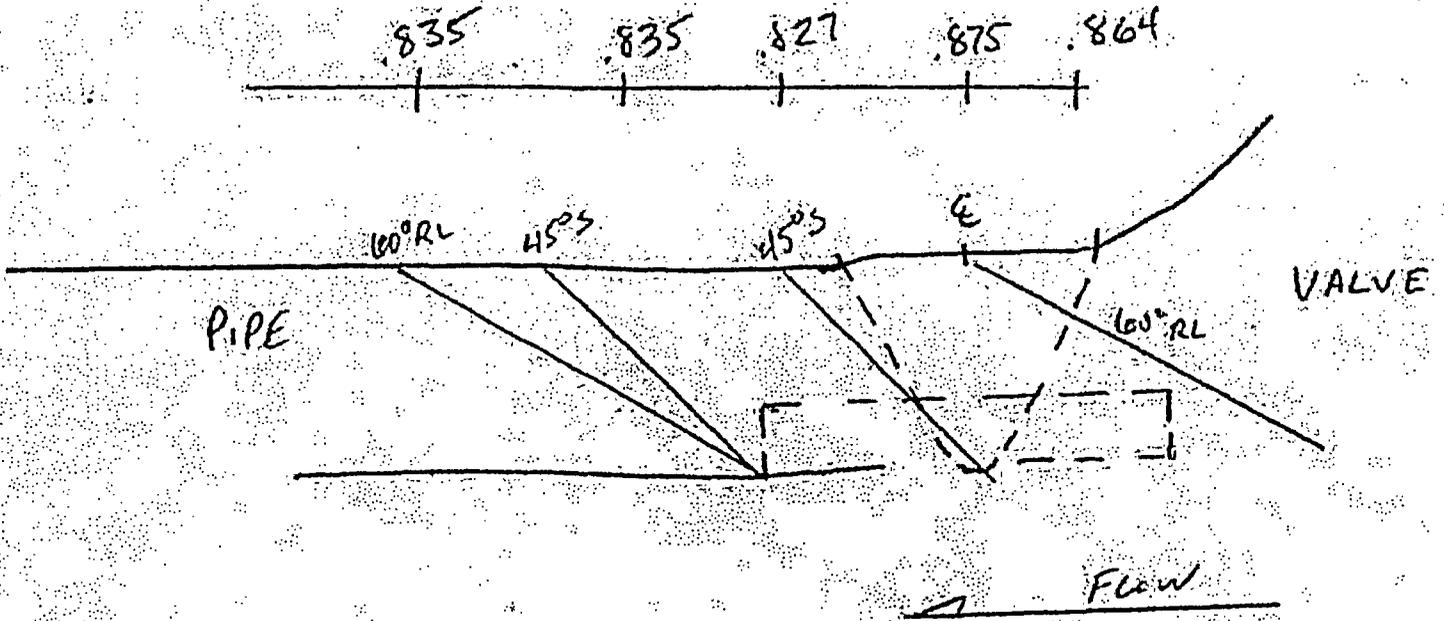
Comments: **W-11 coverage plot**

Required Volume (WRV) was limited to 47.77% and only a single-sided examination could be performed. It should be noted that the volumetric examination was performed through 100% of the Code WRV; however, the PDI Appendix VIII procedure used is not qualified for the detection of flaws on the far side of single sided access examinations on austenitic stainless steel piping welds. The techniques employed for the examination provide for a best effort examination. As an alternative to the ultrasonic examination, radiography was considered and determined to be an unacceptable substitute due to radiological constraints, weld configuration, and the undo hardship imposed without offering any commensurate increase in safety with cost benefit.

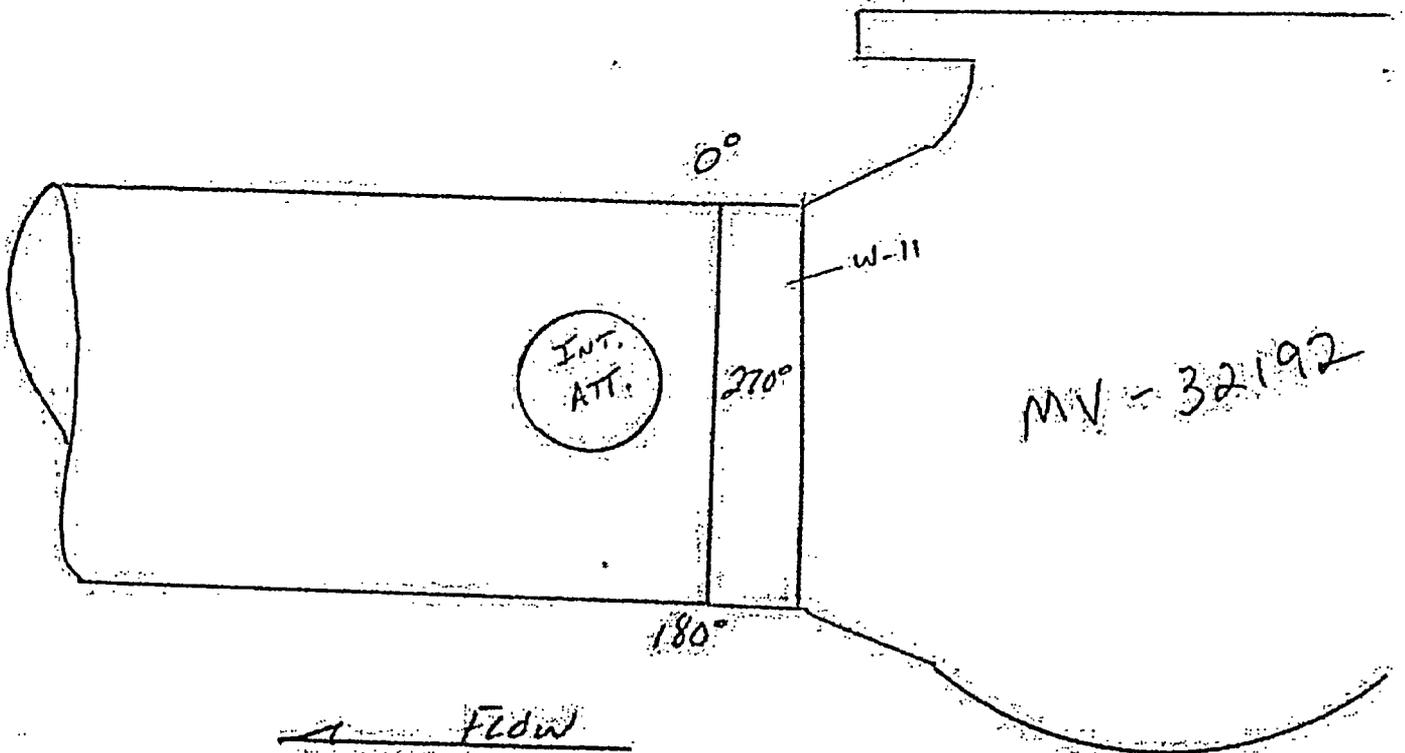
Comments: No upstream exams due to valve body taper. Integral attachment limits downstream exam @ 270° for 3".

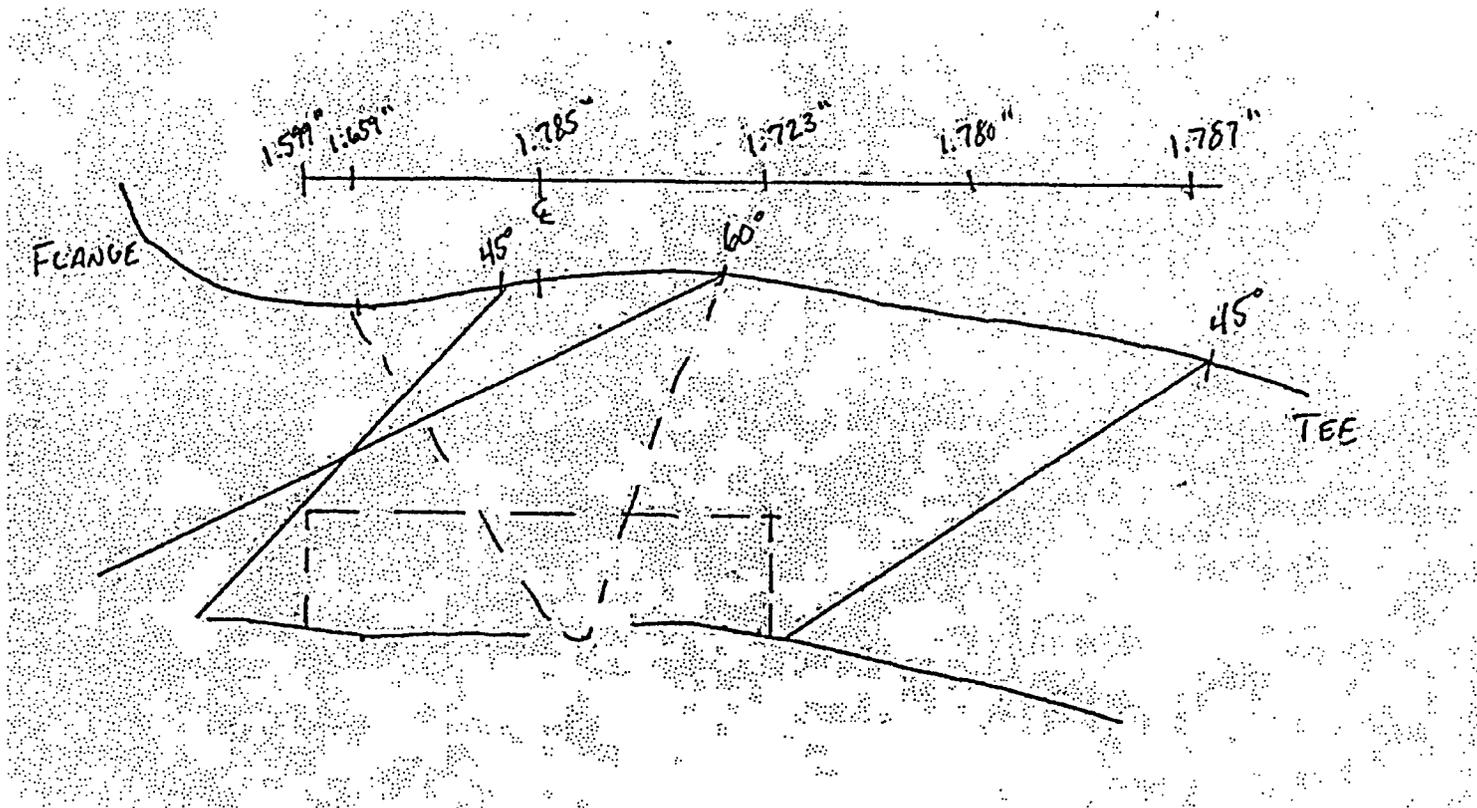
Comments: **W-14 Coverage plot**

This tee to flange pipe weld is subject to be examined by both volumetric and surface examination methods. The reducer tee and pipe materials are carbon steel. The volumetric examination was performed using personnel and procedures qualified in accordance with Appendix VIII, Supplement 3. The examination was conducted using 45 and 60-degree transducers. The piping materials are A155 KC70 . The credited volumetric examination of the WRV was limited to 74.85%. As an alternative to the ultrasonic examination, radiography was considered and determined to be an unacceptable substitute due to radiological constraints, weld configuration, and the undo hardship imposed without offering any commensurate increase in safety with cost benefit.

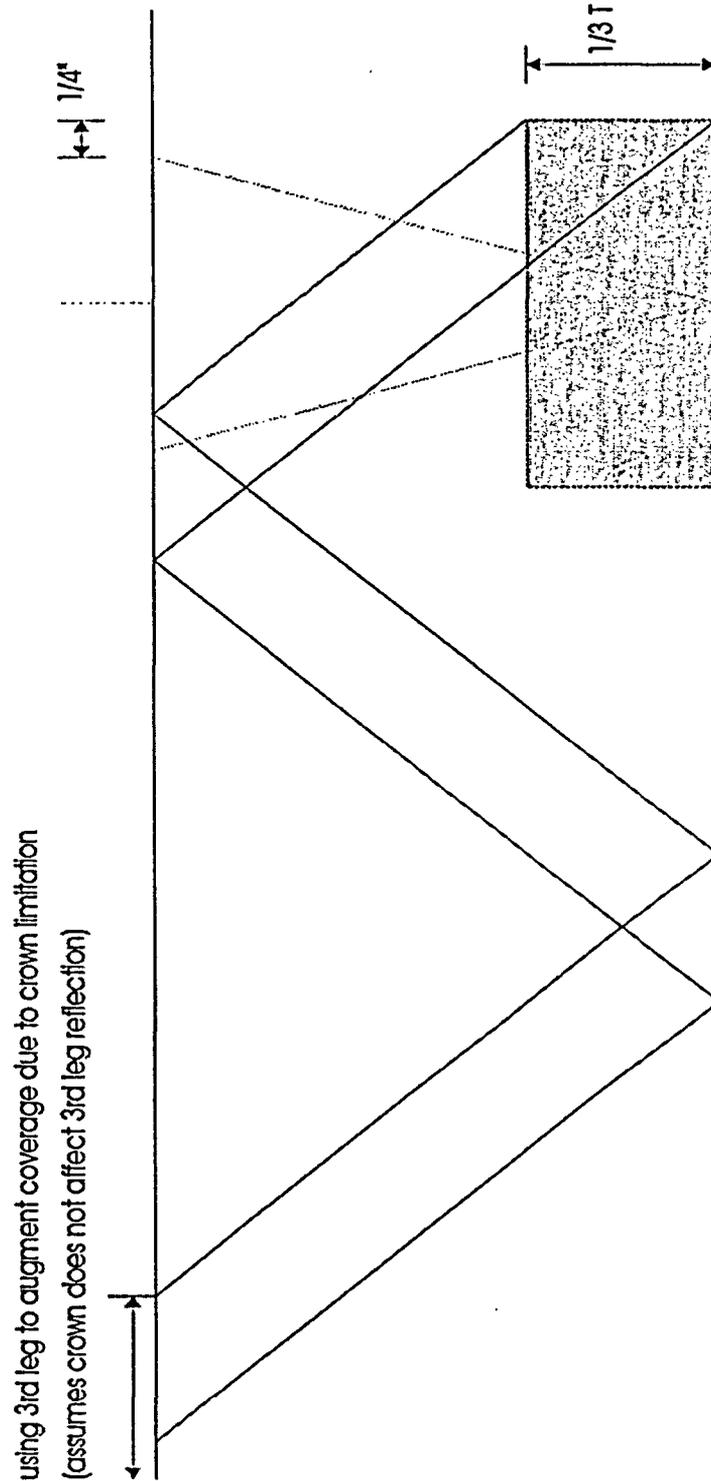
Figure 2 - Example of UT, One Sided Exam, Supplemental Coverage

Note: Supplemental coverage may be achieved by use of other angles / methods. When used, the coverage for volume not obtained with angles as noted above shall be calculated and added to the total to provide the percent total for the complete examination.
