# **Gamma Survey Data Evaluation Report**

**Rev 1**

**WESTINGHOUSE ELECTRIC COMPANY**  
Hematite, Missouri

**MAY 2004**

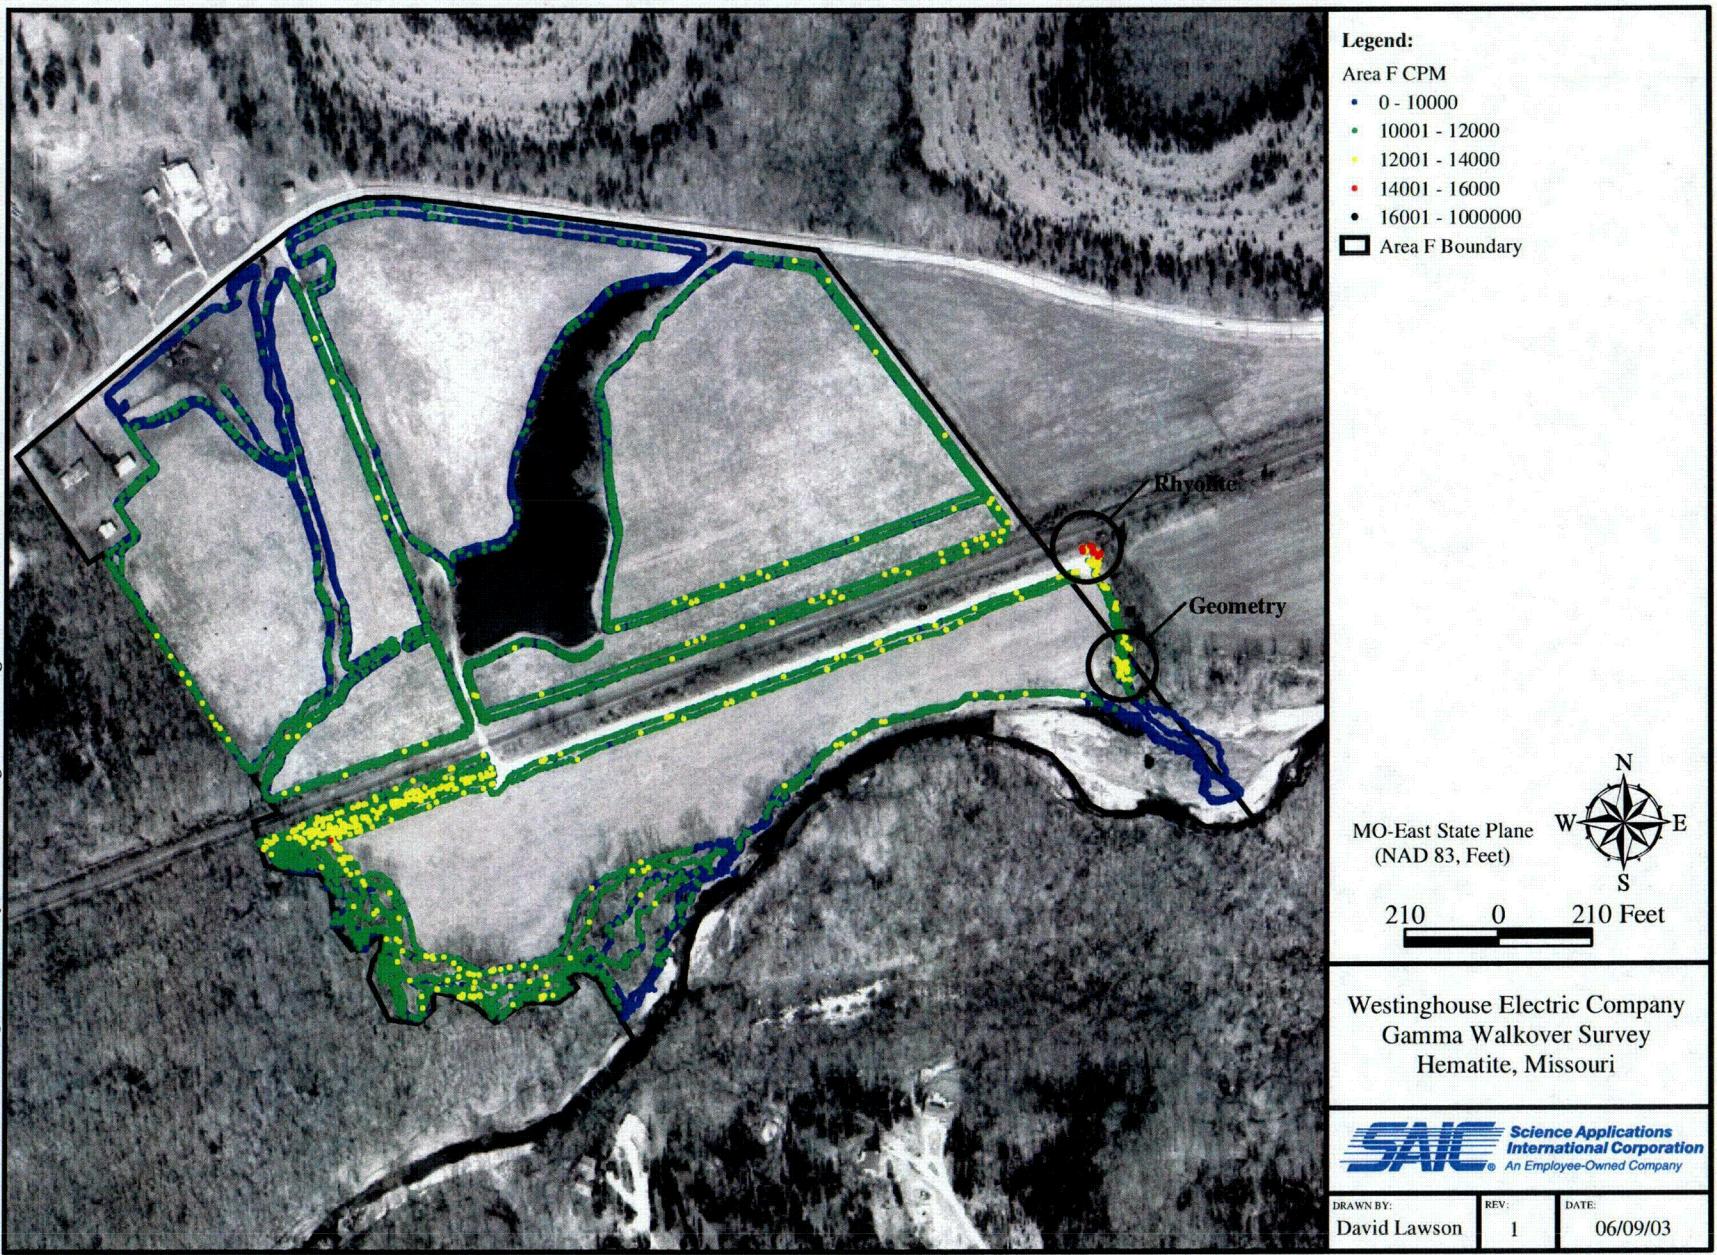
Figure 17. Area 'F' Gamma Walkover Survey

As in Area C and D, relative elevated count rates are identified just south of the railroad in areas covered with mature timber. A drainage ditch was identified during the survey on the far southeast portion of Area F. The survey of this ditch resulted in two areas of interest. The first area was further investigated and the increase in count rate was proved to be due to a change in the geometry of the survey. As the ditch deepened and sidewalls became closer to the detector, an increased count rate was observed. The survey identified elevated gamma radiation levels at the extreme northern portion of the same drainage. This apparent increase was investigated and determined to be due to the presence of Rhyolite.

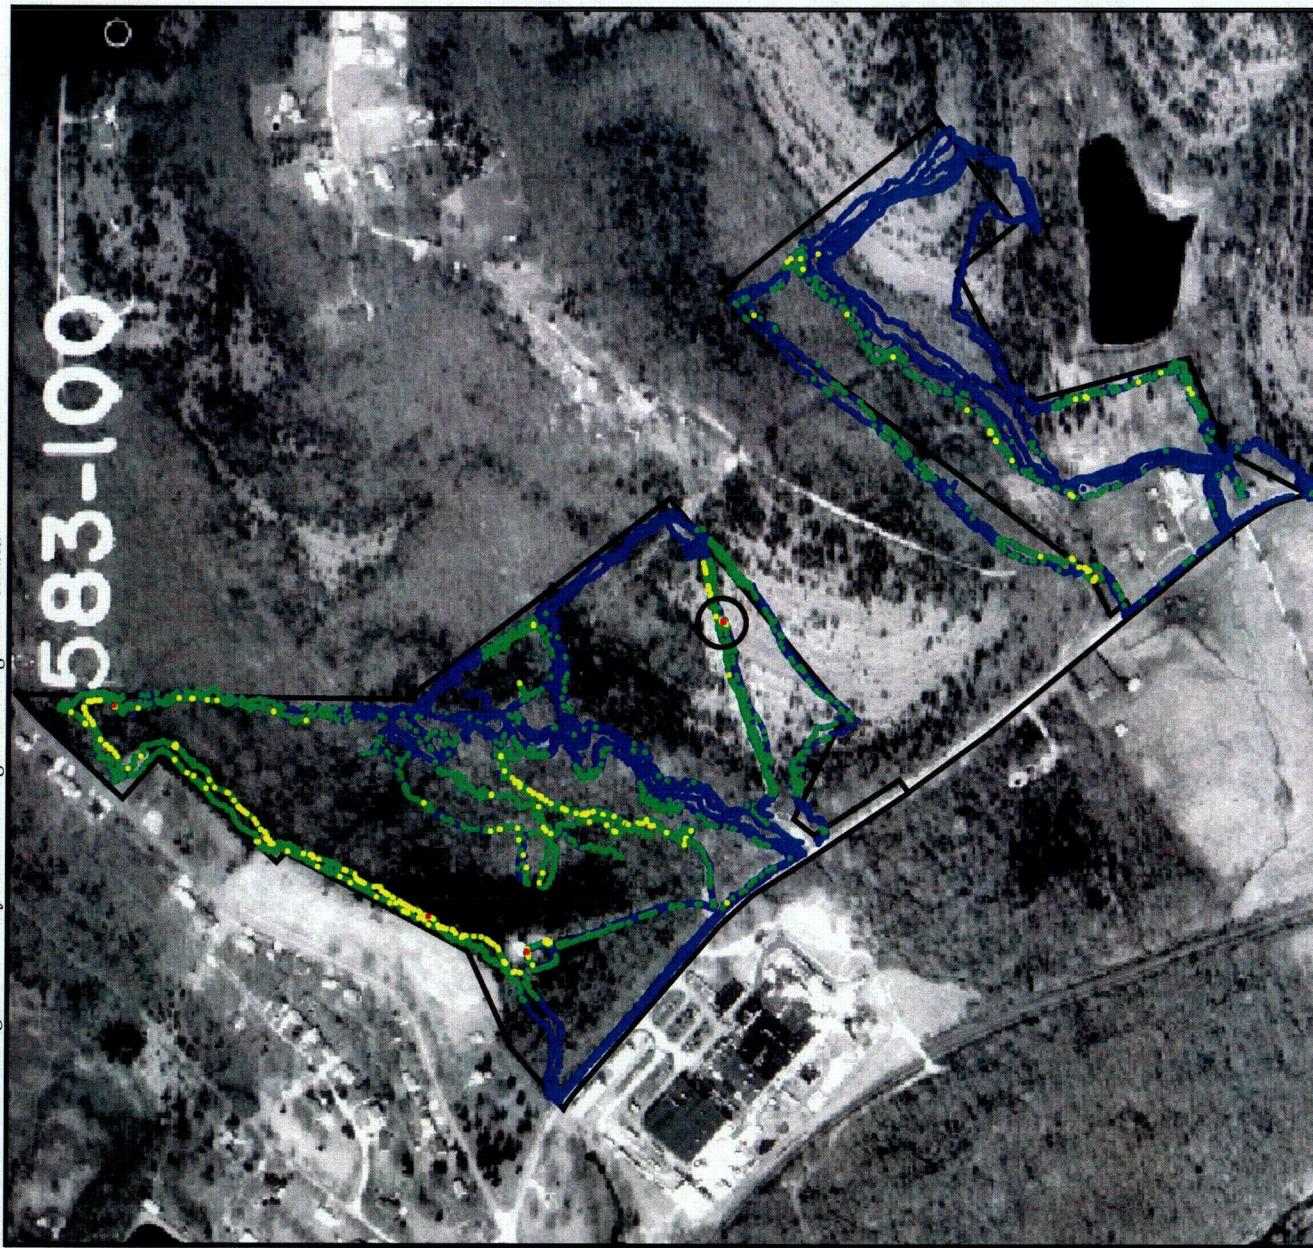
In general, the survey of this area showed only a slight deviation in count rates. The largest deviation occurred due to changing media, switching between gravel, gravel/soil mixture, and soil. One area of interest was discovered on the power line road in the western parcel. This area exhibited count rates around 8,000 cpm with the relative background in this area ranging from 4,000-6,000 cpm. There was no logical explanation or recognized transport mechanism for contamination to have reached this location. The area was resurveyed and the original count rates were verified as accurate.

Figure 18 depicts the data collected for Area G with the standard 2,000 cpm increment starting at 10,000 cpm.
