Subject: Sequoyah Fuels Corporation, SUB-1010, Docket – 40-8027
Changes To The General Arrangement Drawing

**Final Radiological Status Report
Pond 4**

Final Radiological Status Report
Pond 4

Sequoyah Fuels Corporation
Gore, Oklahoma

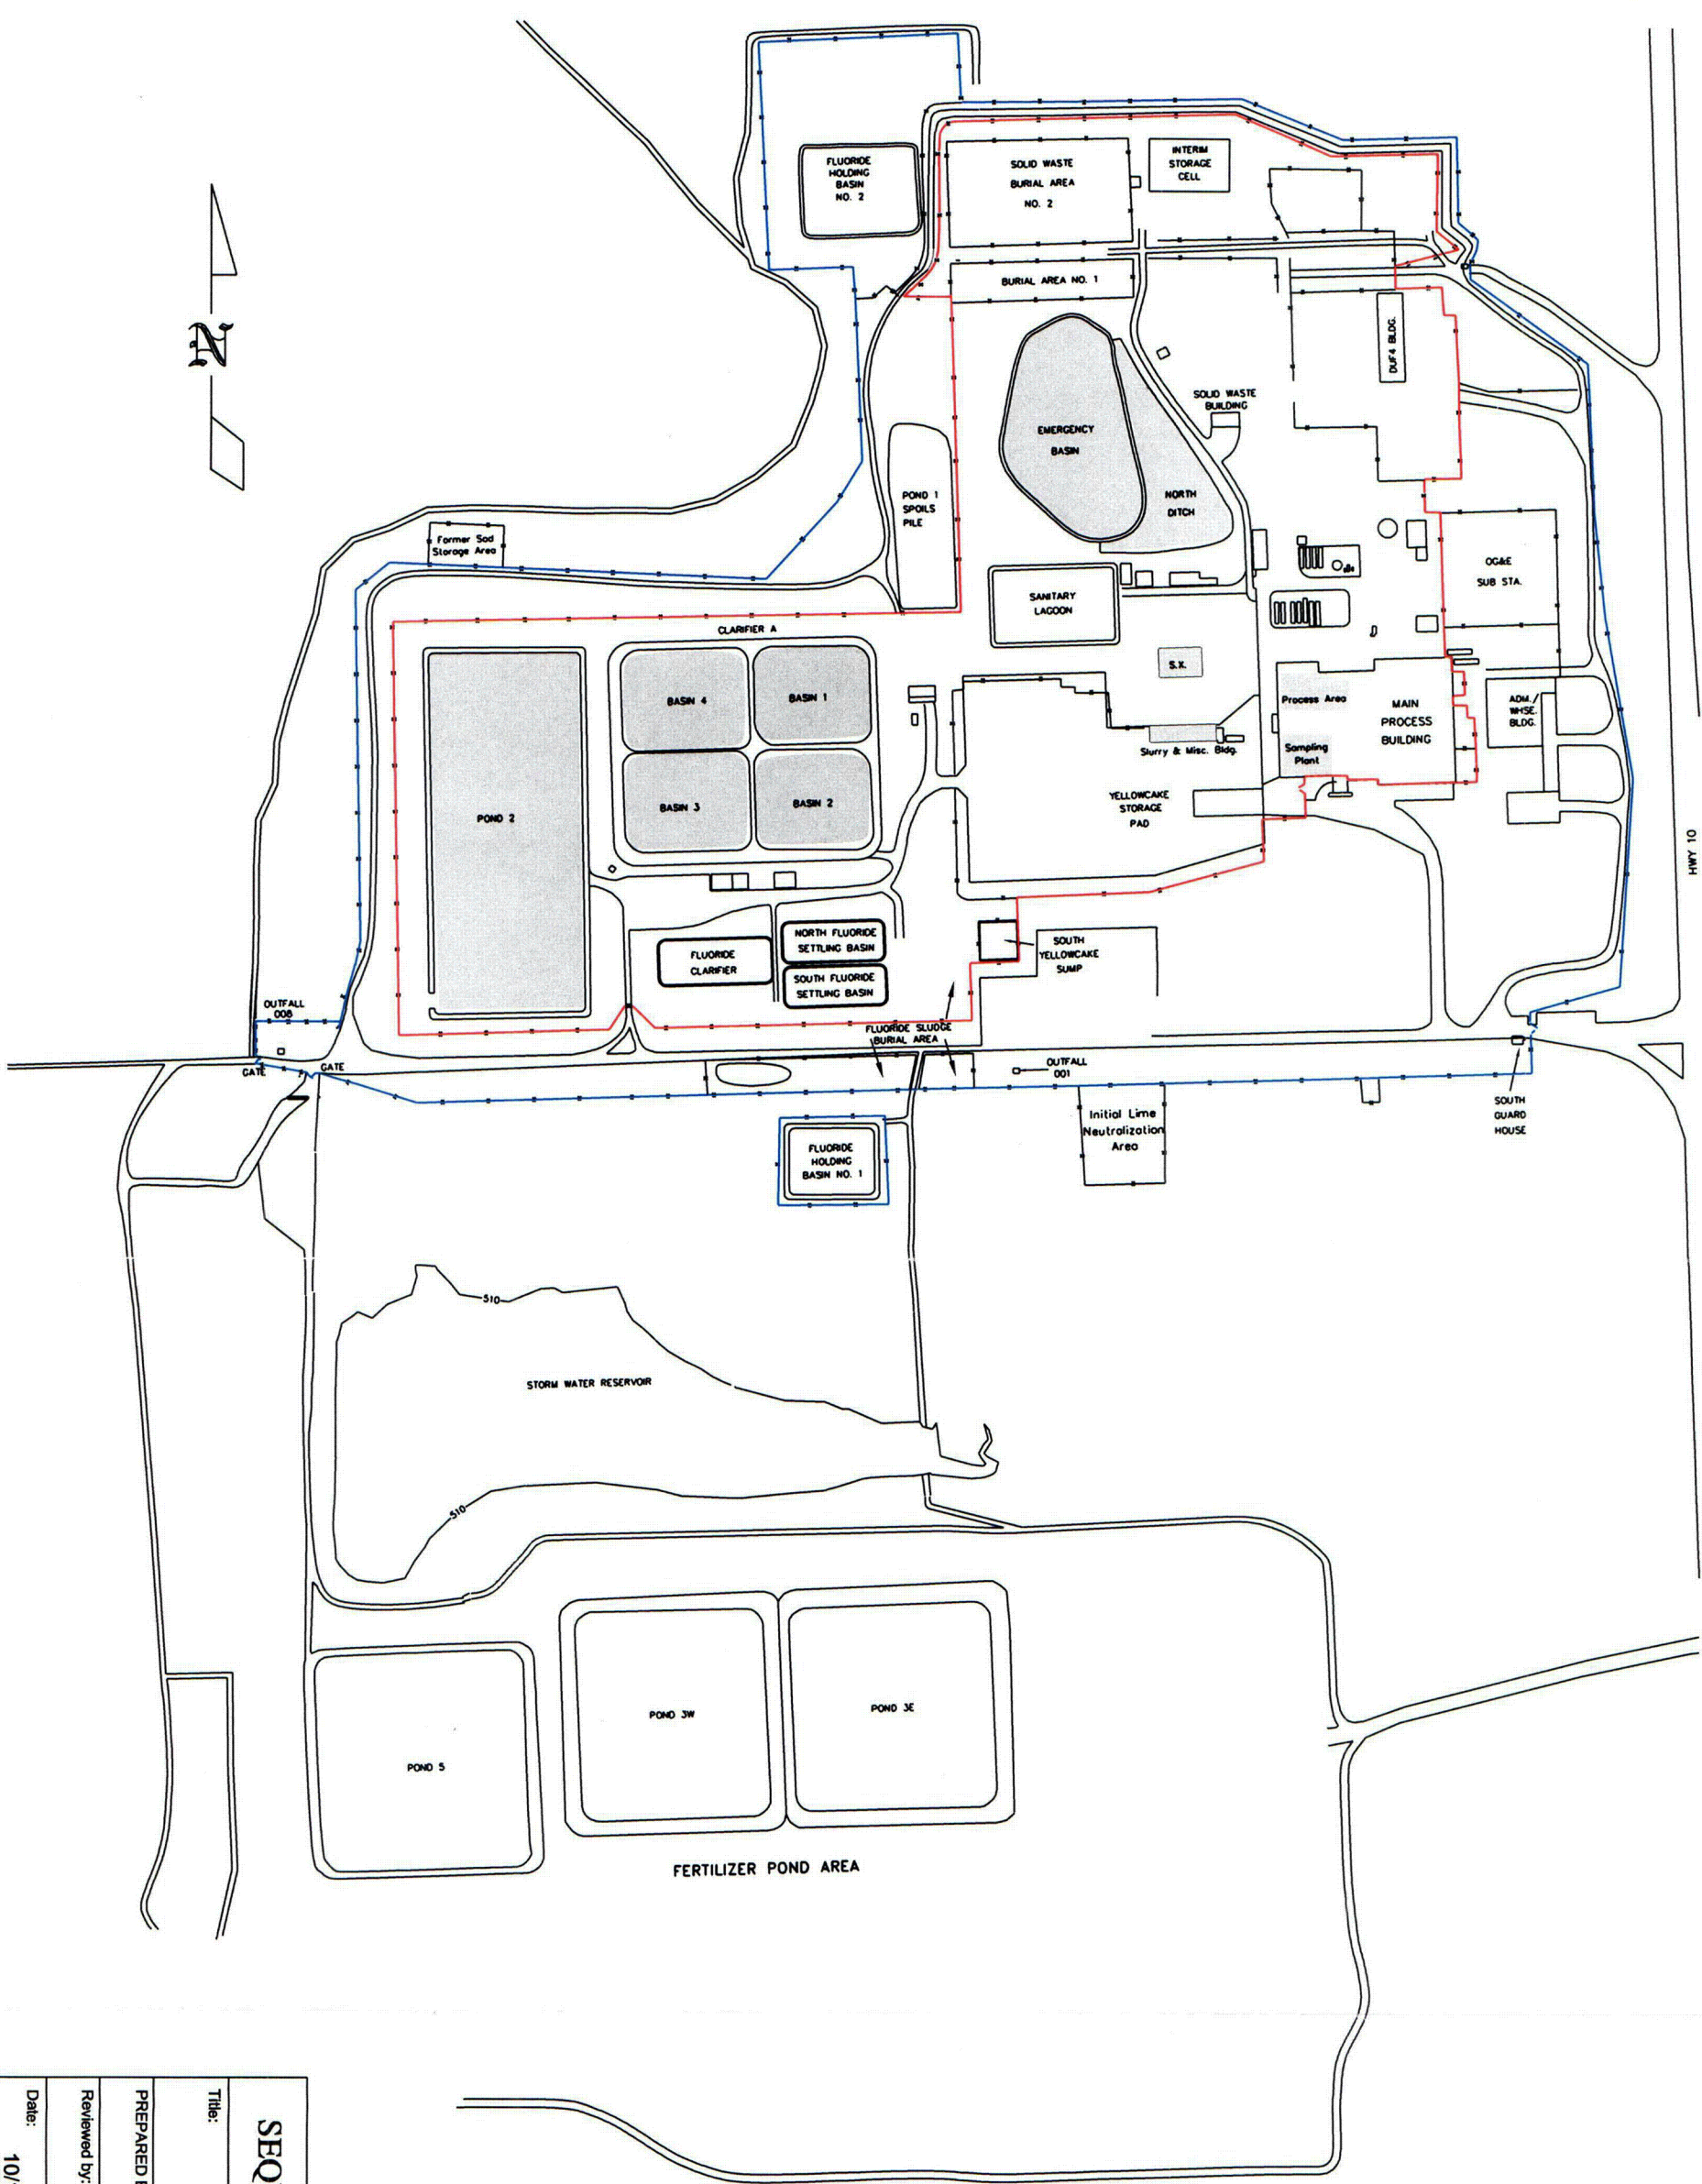
SUB-1010, Figure 3-1

Sequoyah Fuels Corporation (SFC) has revised the General Arrangement Drawing contained in SUB-1010 due to cleanup efforts that have been completed. Pond 4, the fence around the area where Pond 4 was formerly shown, Pond 6 and the Decorative Pond have been removed from the General Arrangement Drawing to reflect current conditions at the Facility. SFC requests that Figure 3-1 of SUB-1010 license renewal application be replaced with the enclosed Figure 3-1 (Enclosure 1). No other changes to the text or conditions of the license are necessary.

SEQUOYAH FUELS CORPORATION	
Title: Sequoyah Fuels Corporation General Arrangement	
PREPARED BY: SFC	Filename: NRC0002E
Reviewed by: CH	
Date: 10/12/2005	Figure No.3-1

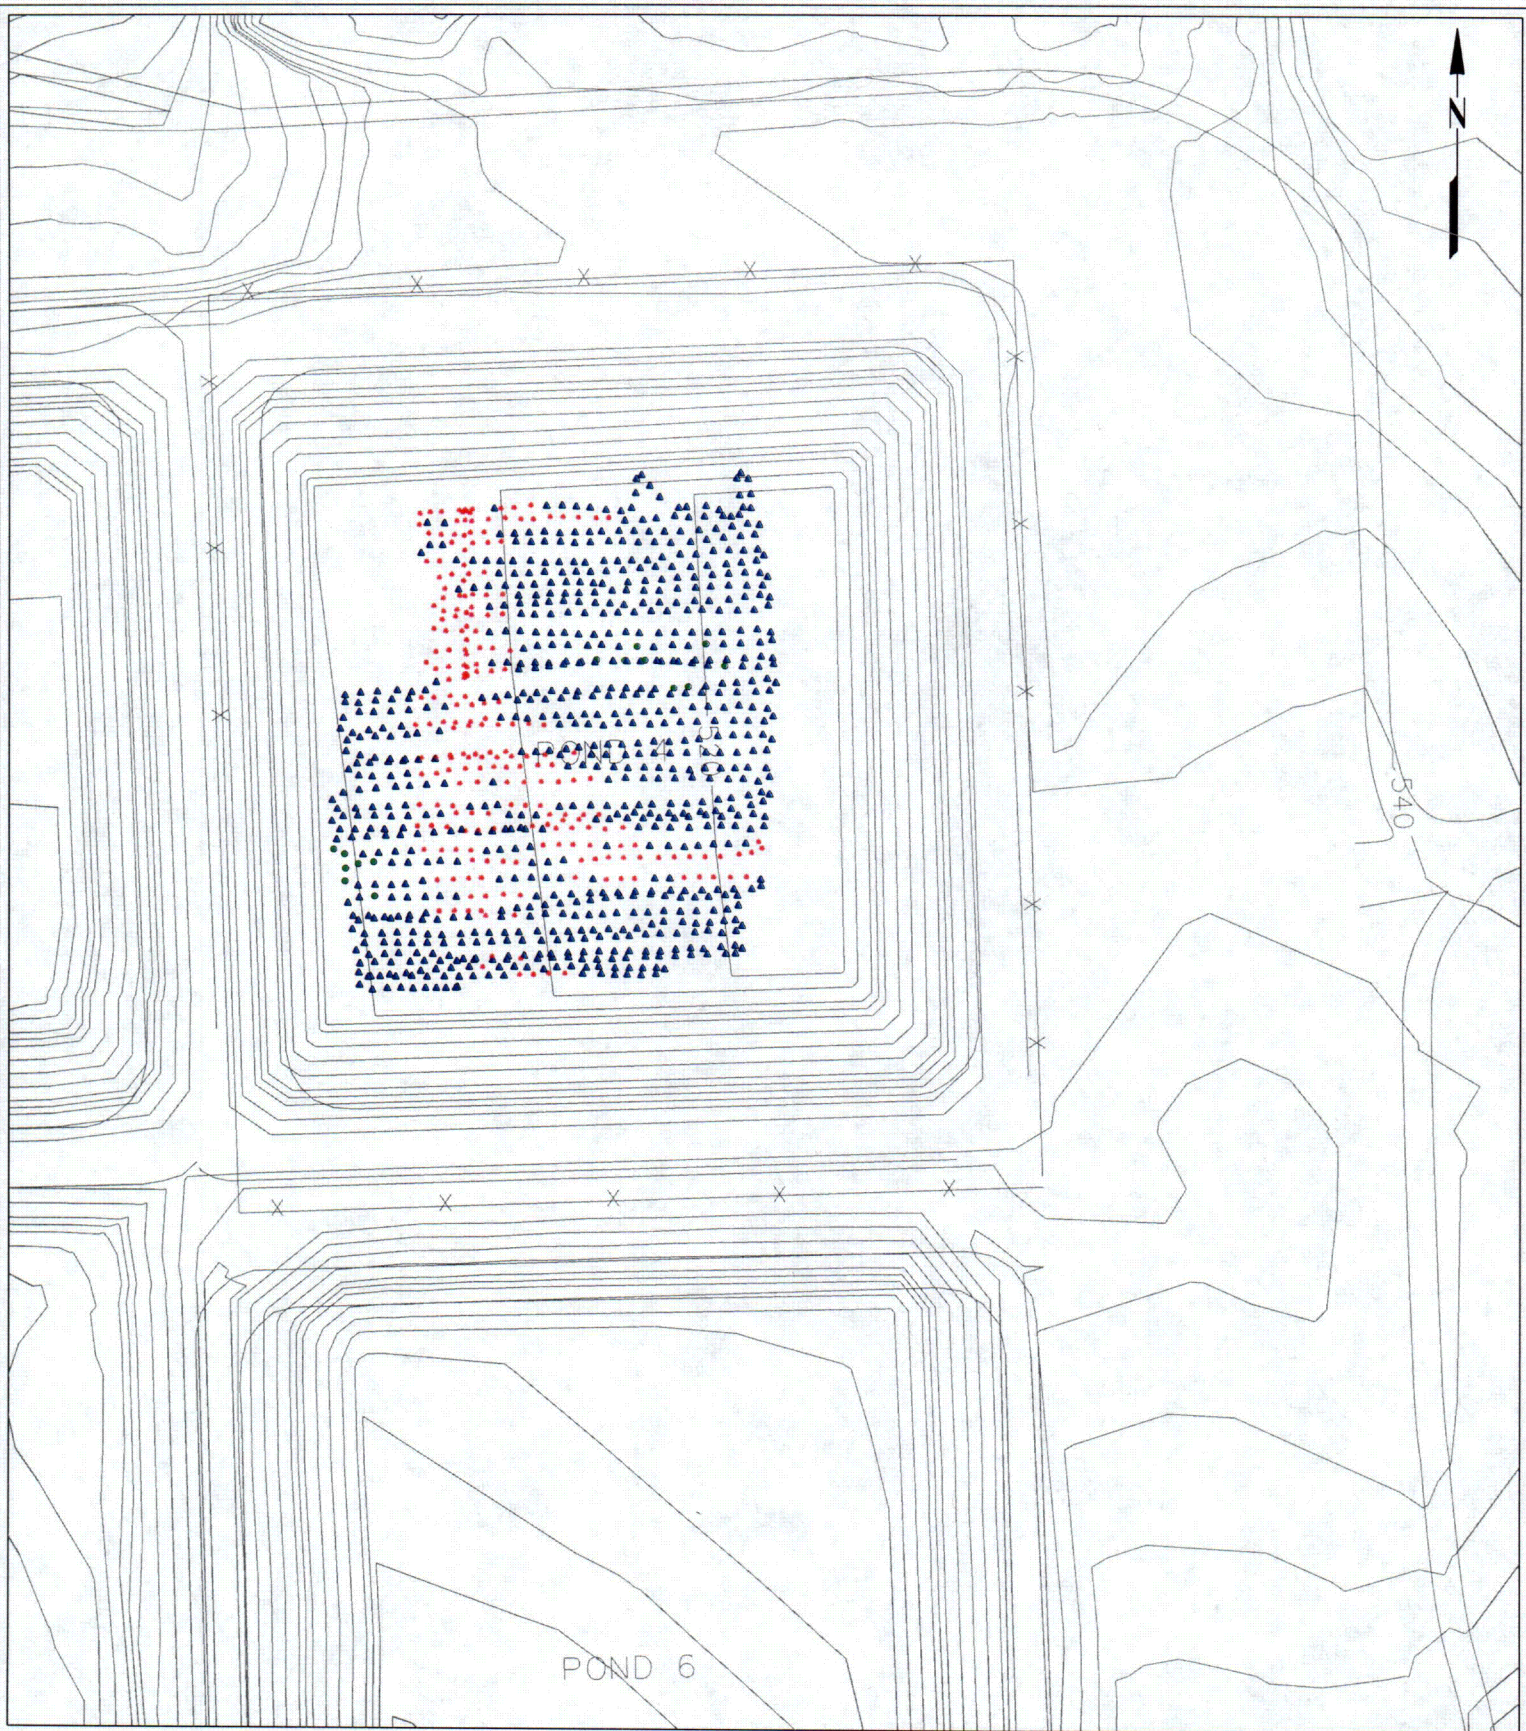
TITLE:		<i>Gamma Scan of July 1998</i>	
PREPARED BY:	<i>SFC</i>	FILENAME:	<i>Pond4_A6.dwg</i>
REVIEWED BY:	<i>RHM</i>	FIGURE NO. A-6	
DATE:	<i>July 2005</i>

- 0 to 13032 : cpm < baseline
- ▲ 13032 to 39096 : baseline < cpm < 3x baseline
- 39096 to Max : 3x baseline < cpm

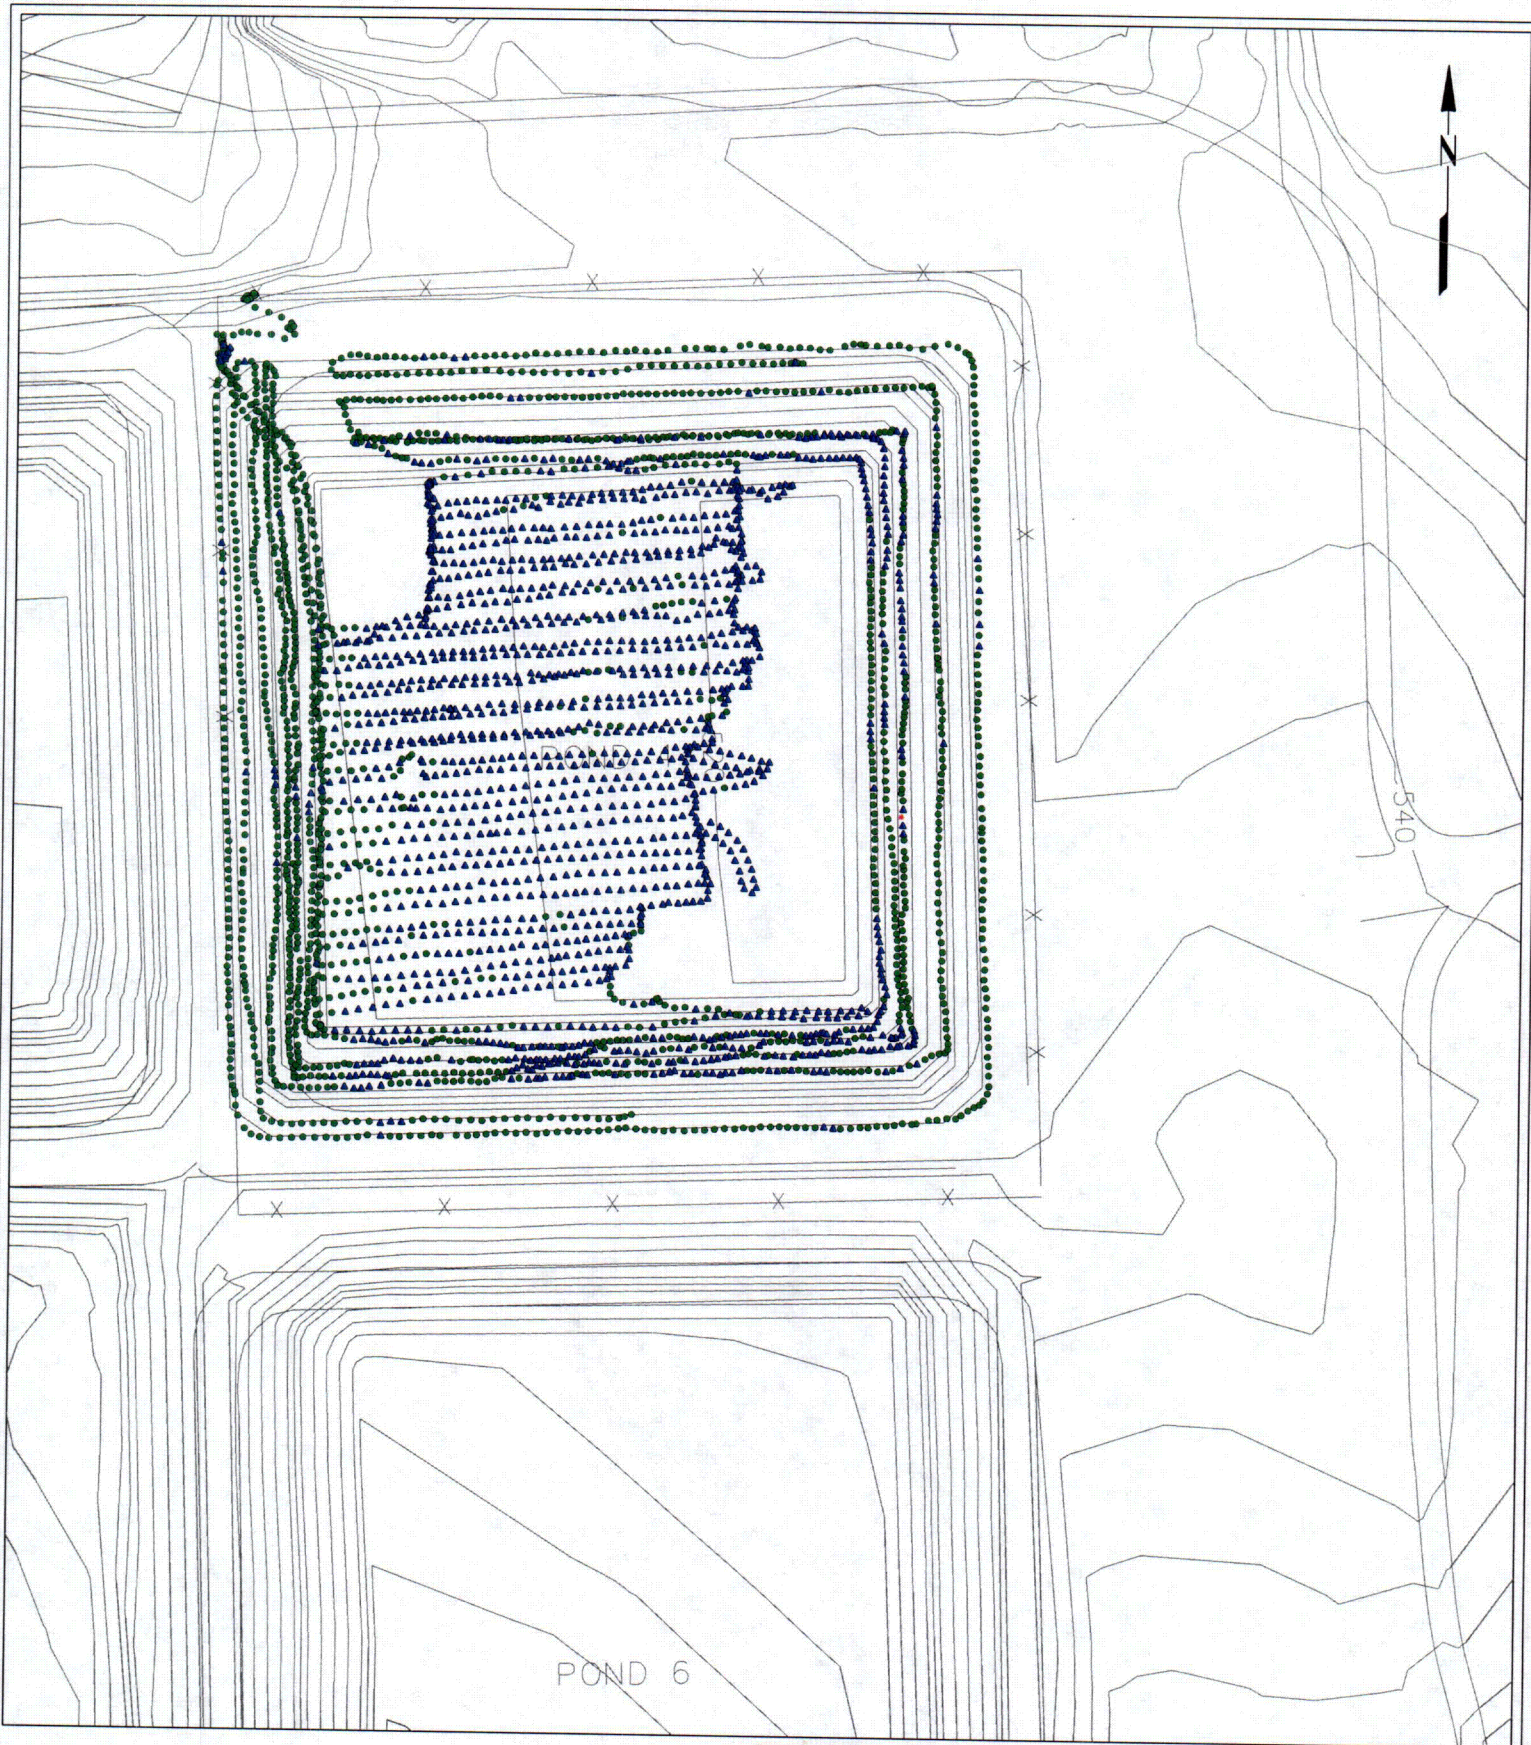
FIGURE NO. A-7

- 0 to 13032 : cpm ; baseline
- ▲ 13032 to 39096 : baseline < cpm ; 3x baseline
- 39096 to Max : 3x baseline < cpm

Gamma Scan September 1998

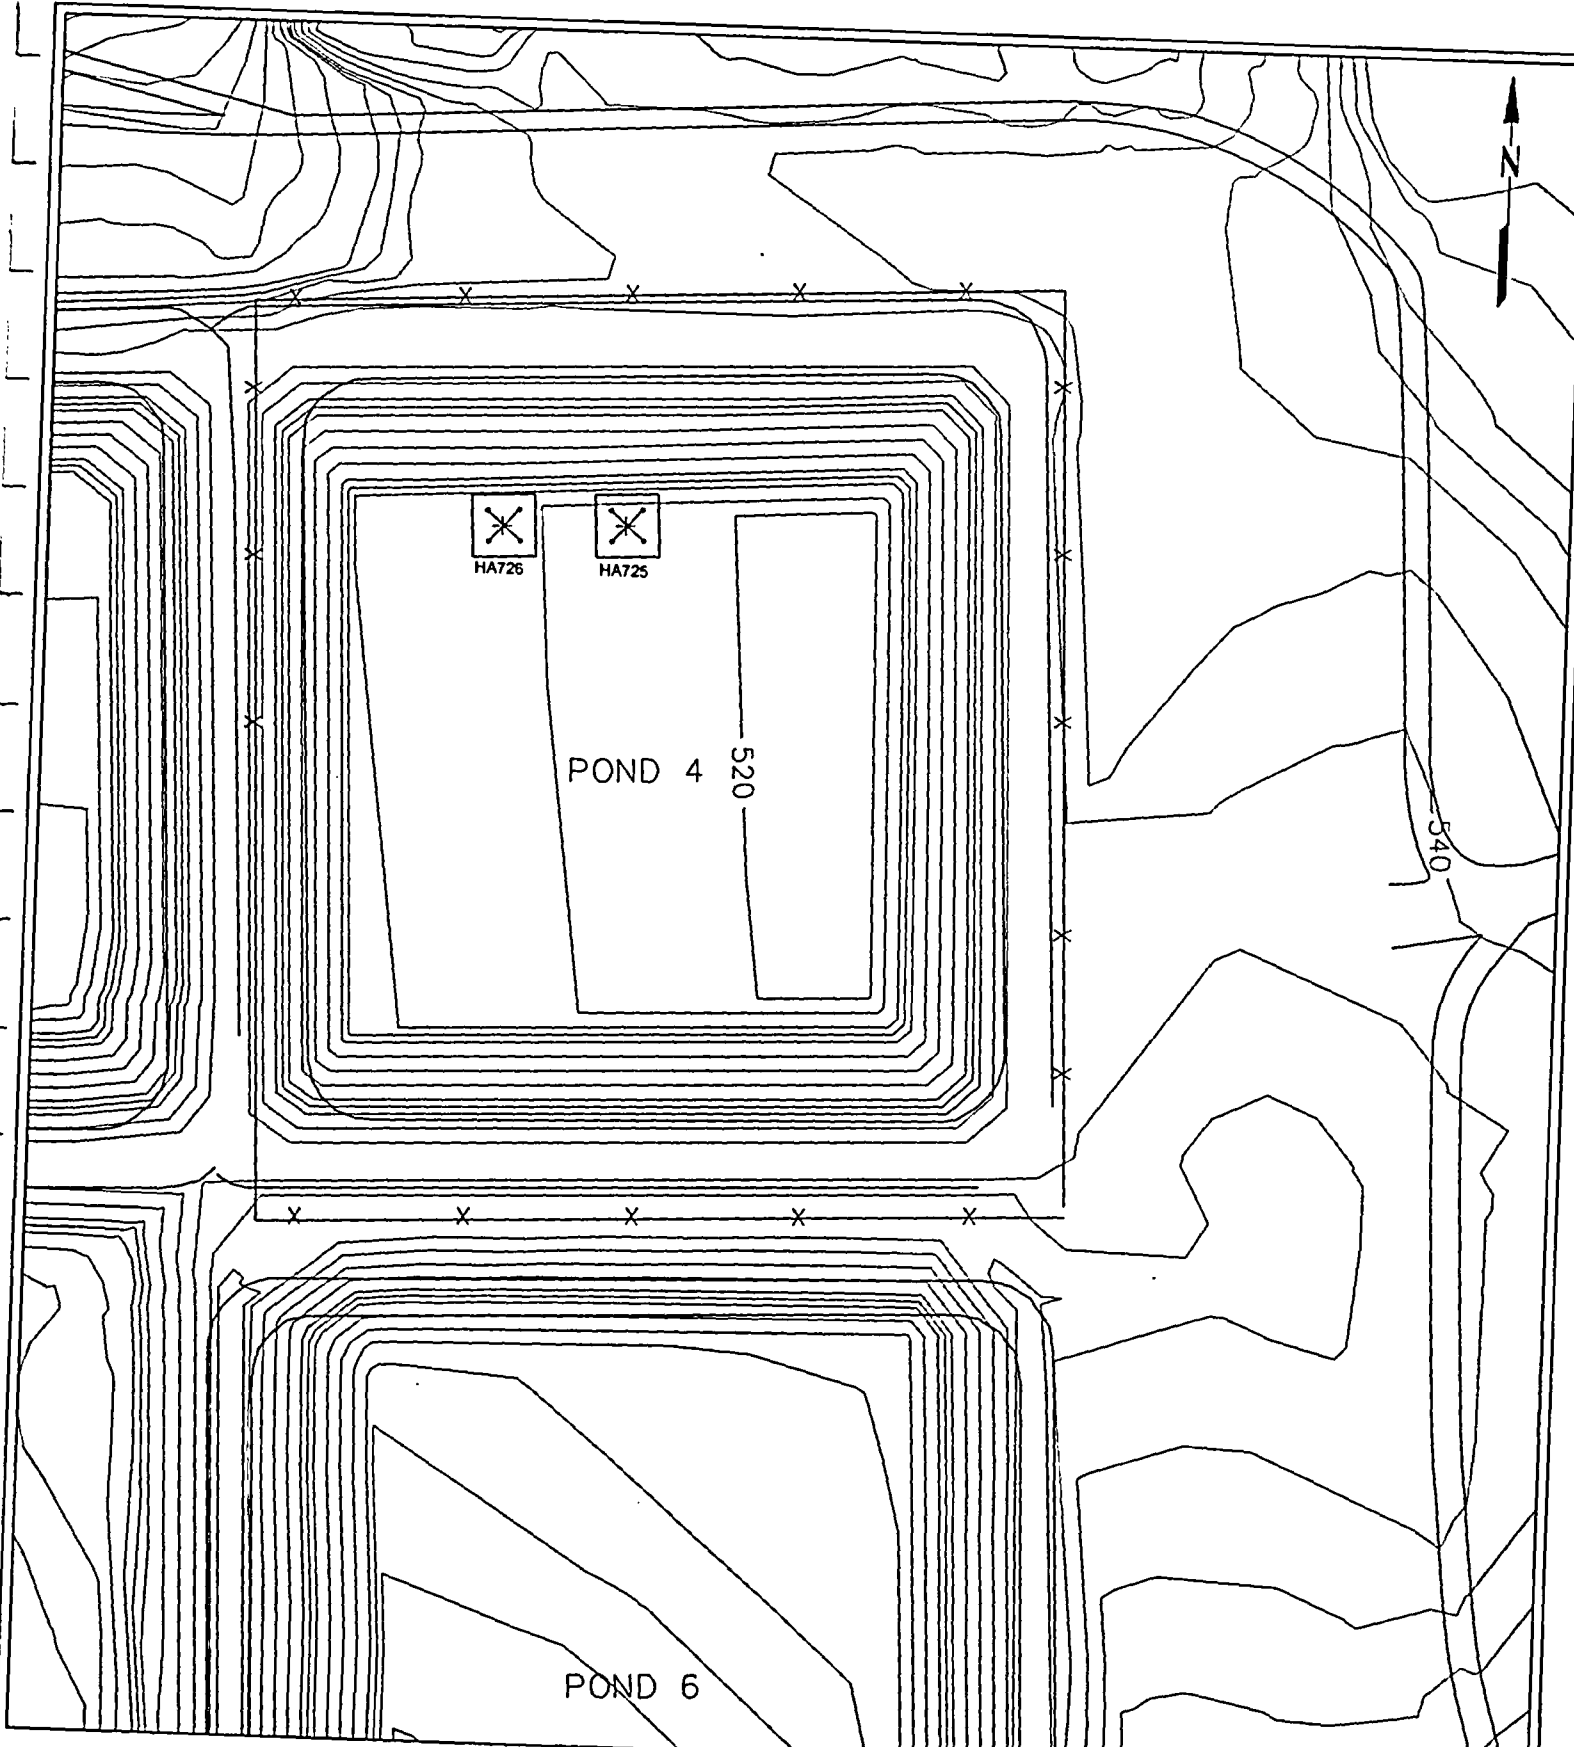
SEQUOYAH FUELS CORPORATION		
TITLE: <i>Location of March 2005 Composite Samples</i>		
PREPARED BY:	<i>SFC</i>	FILENAME: <i>Pond4_A17.dwg</i>
REVIEWED BY:	<i>RHM</i>	FIGURE NO. A-17
DATE:	<i>July 2005</i>

Composite Sample Pattern
 • Sample Plug
