SUBJECT: License Termination

**SUBJECT: FINAL REPORT—HISTORICAL SITE ASSESSMENT OF THE
HAMMOND DEPOT, HAMMOND, INDIANA**

**HISTORICAL SITE ASSESSMENT
OF THE HAMMOND DEPOT
HAMMOND, INDIANA**

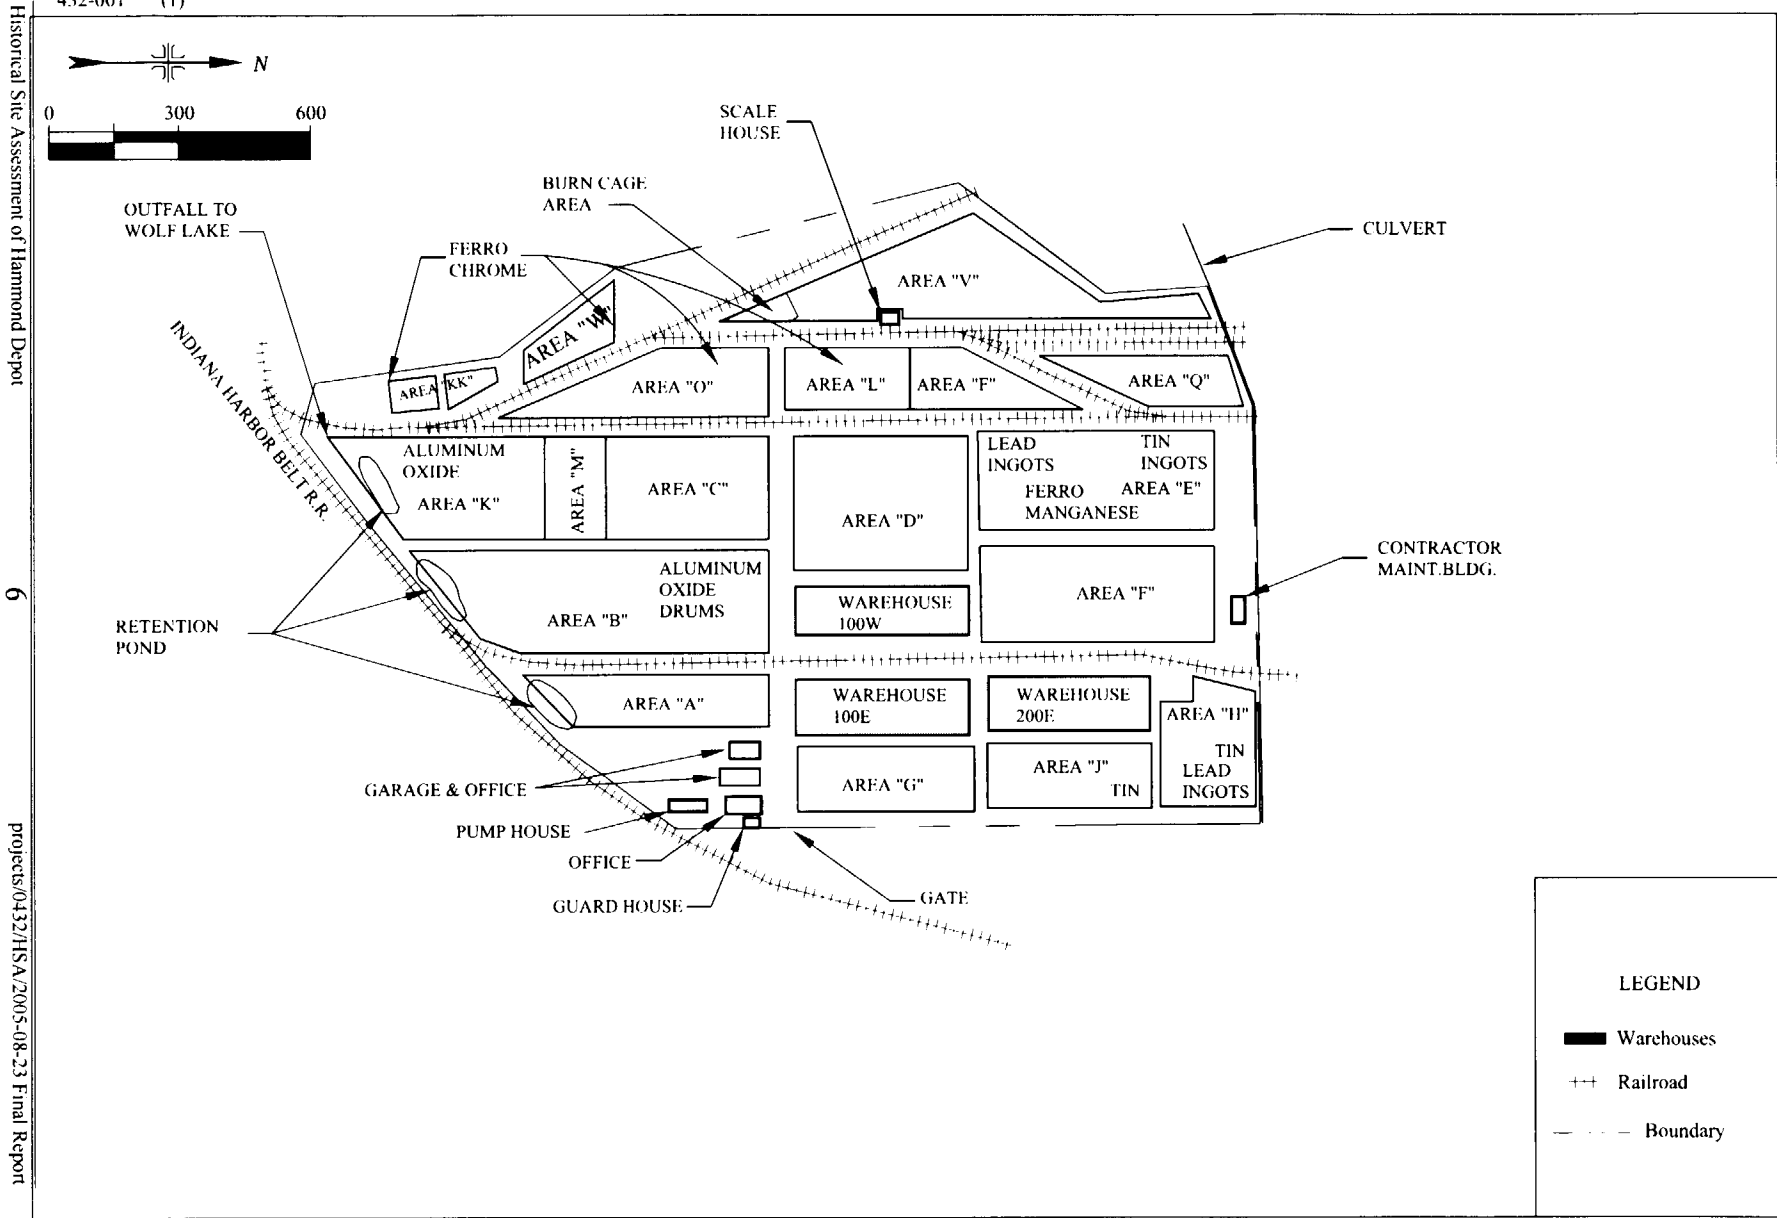
FIGURE 1: Hammond Depot, Hammond, Indiana - Plot Plan

The Hammond Depot property consists of a 57.3-acre parcel of land located on the west side of Hammond, Indiana—about 490 feet east of the Indiana-Illinois state line, within the city limits of Chicago. The depot has eight buildings, mostly in good condition, including three warehouses that are used to store raw materials. Currently, approximately 120,000 ft² of the available 150,000 ft² of indoor storage space is occupied, as well as 60% of the outdoor storage space. Figure 1 indicates the location of buildings and warehouses at the Hammond Depot [4].

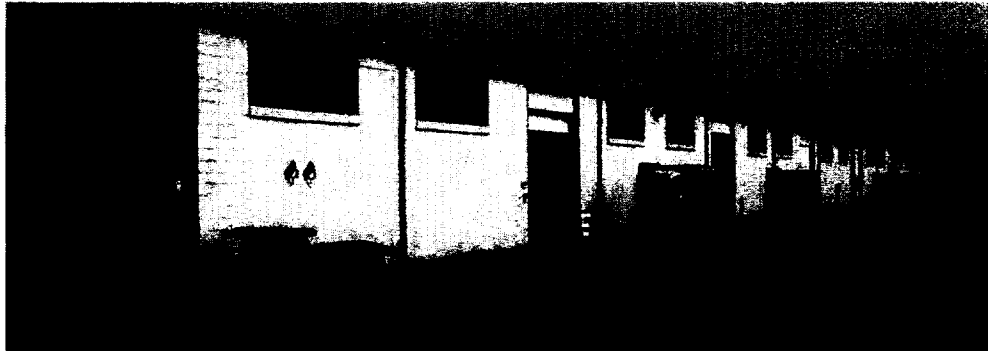
Figure 2 – Warehouse 100W

The warehouse is a concrete structure with dimensions of 401 ft by 126 ft. Exterior walls are cinder block with glass block windows, 14 overhead doors, and two personal doors on each end. The floor is concrete slab on grade and the structure is steel beams, columns, and roof joists. The roof deck is 3-ply gypsum board and the roofing is 3-ply built up asphalt with a smooth surface sloping to the perimeter gutters on the east and west elevations. Electrical conduits and light

fixtures hang from roof joists. A dry pipe sprinkler system is installed [4, 13]. Figure 2 shows Warehouse 100W.

Four commodities listed on the NRC Source License STC-133 (in October 1997) were stored in this warehouse: thorium nitrate in Bays 8 through 16 B, C, and D; tantalum natural minerals and concentrates (tantalum pentoxide (Ta_2O_5)) in Bays 15 D, 16 D, 17 A through D, and 18 A through D; columbium tantalum source material (tantalum natural minerals) in Bays 7 B, 8 A, and 8 B; and columbium tantalum source material (columbium natural minerals) in Bays 8 E and 9 E [14].

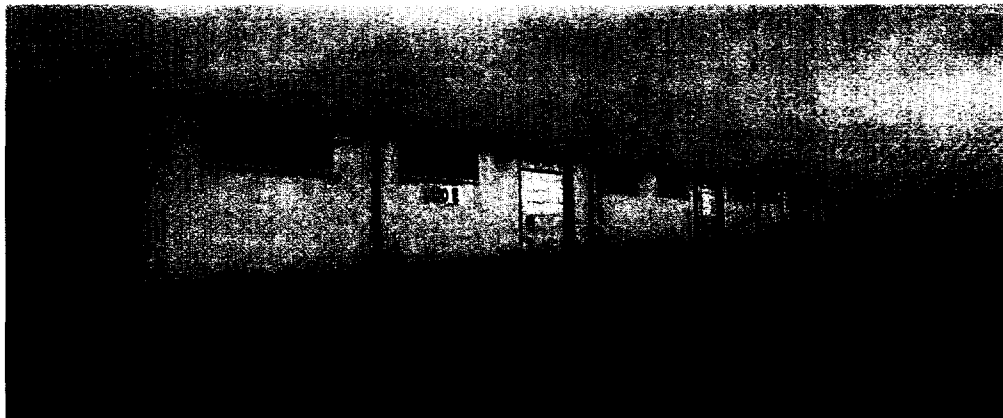
Figure 4 – Warehouse 200E

The warehouse is a concrete structure with dimensions of 401 ft by 126 ft. Exterior walls are cinder block with glass block windows, 14 overhead doors, and two personal doors on each end. The interior is divided into north and south sections by a cinder block partition firewall. The floor is concrete slab on grade except that the south side was completely covered with black-top after the top surface was remediated. The structure is steel beams, columns, and roof joists. The roof deck is 3-ply gypsum board and the roofing is 3-ply built up asphalt with a smooth surface sloping to the perimeter gutters on the east and west elevations. Portions of the roof gypsum board decking were replaced with metal decking after wind tore off the original roof. Electrical conduits and light fixtures hang from roof joists. A sheet metal return air duct is also hung below the roof deck in a north-south direction but is not operational. A dry pipe sprinkler system is installed [4, 13]. Figure 4 shows Warehouse 200E.

From the “Hammond Depot History of Radiological Material Storage”, Warehouse 200E was used to store ThN in Bays 1 through 10 A, B, C, D and E

[15]. Alpha survey records indicate that ThN drums leaked in this warehouse with residual contamination ranging from 100 to 500 dpm [18].

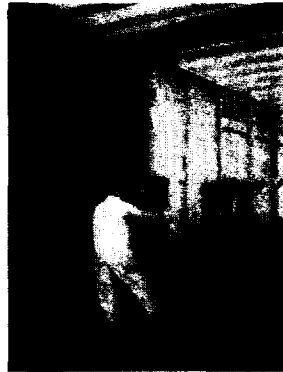
Figure 5 – Overpack Project

Thorium drums were overpacked from 55 to 85 gallon drums in an area west of and adjacent to the building [21]. Right after the overpackaging, the drums were moved to Warehouse 100W [6]. Figures 5 through 7 show the overpack project.

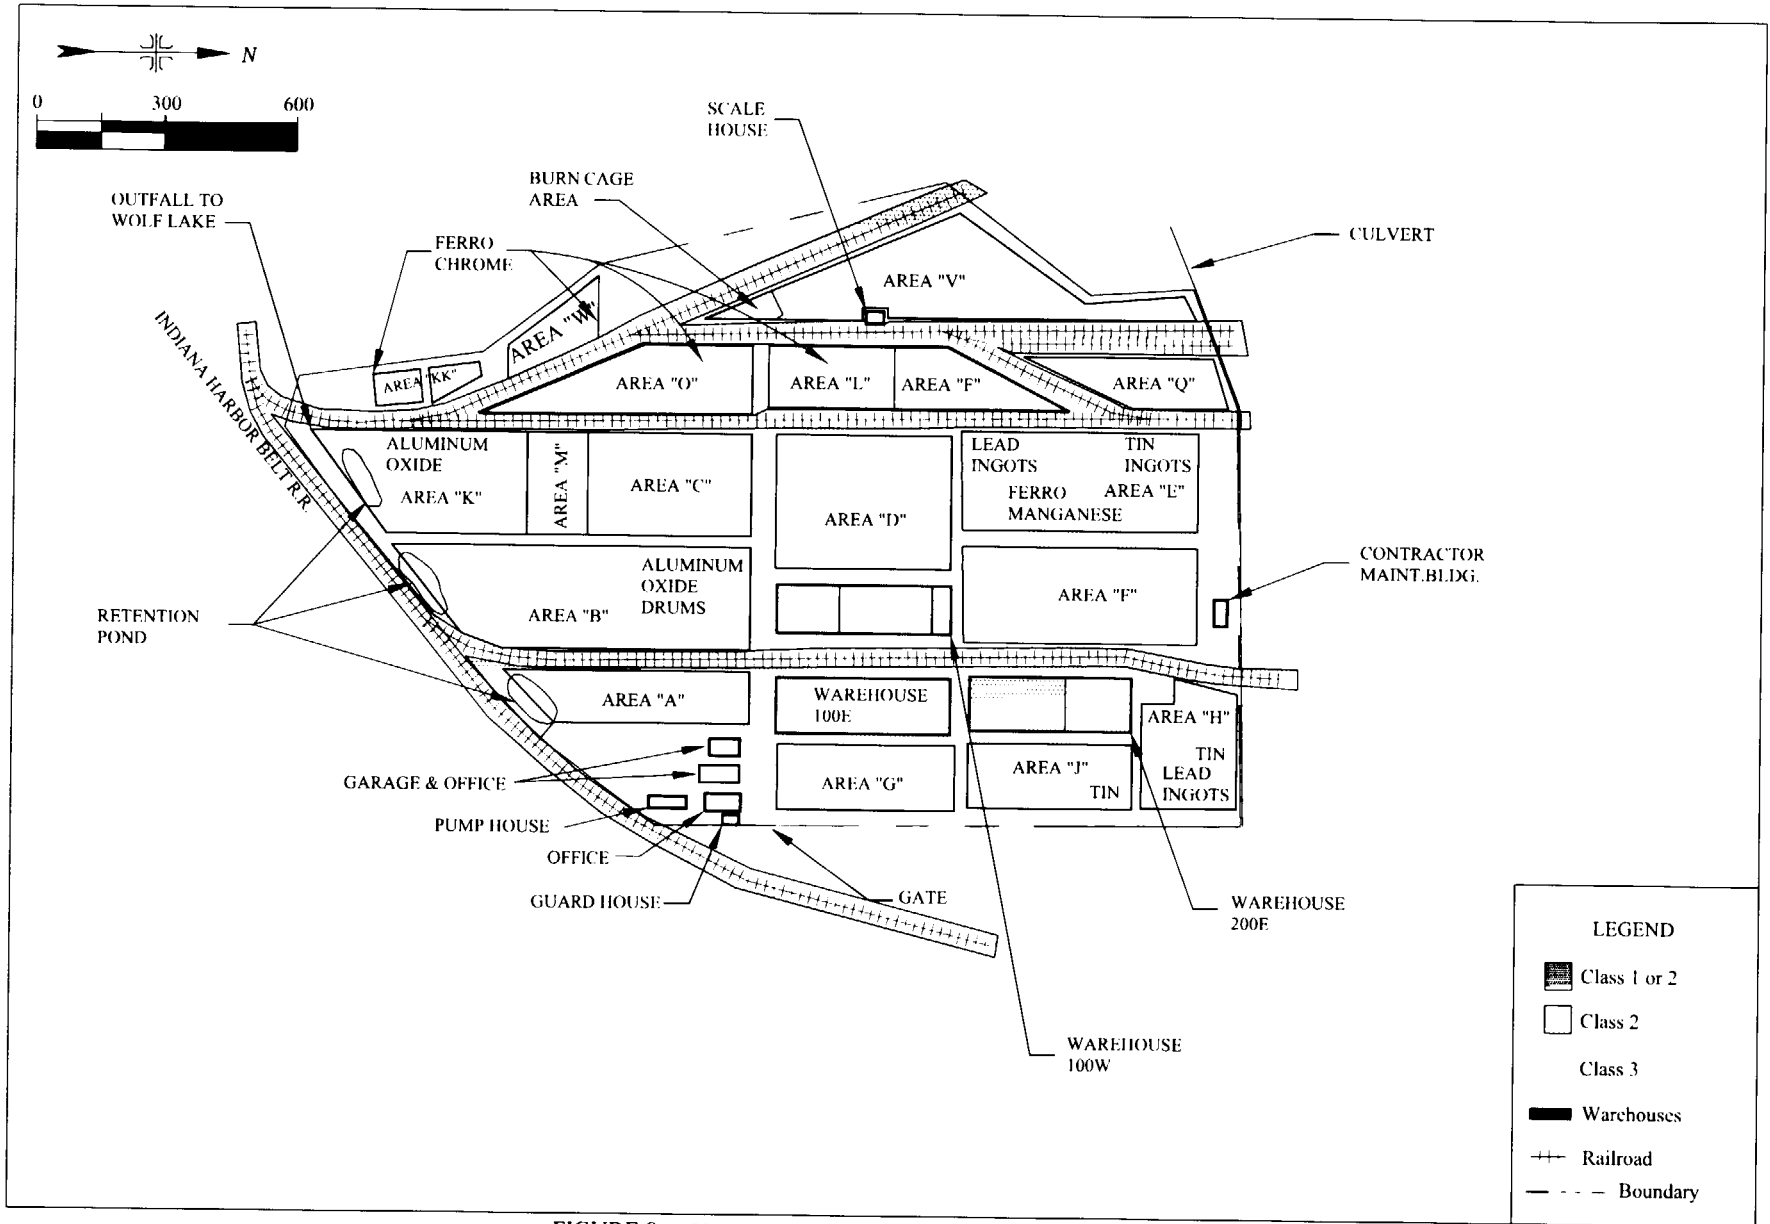
FIGURE 8: Hammond Depot - Conceptual Model

- Class 1 and 2 areas include areas that were previously contaminated and remediated (Warehouses 100W, 200E and the repackaging area outside 200E).
- Additional Class 2 areas that are considered to be potentially contaminated include the burn cage, existing roads and railroad lines, including where railroad lines have been removed, because they served as transportation routes.
- Class 3 areas include Warehouse 100E and the remaining land areas that are considered to have little potential for contamination, due to inadvertent spread of contamination.
