Catawba Nuclear Station Service Water Project Update

December 7, 2005

Service Water Project Status

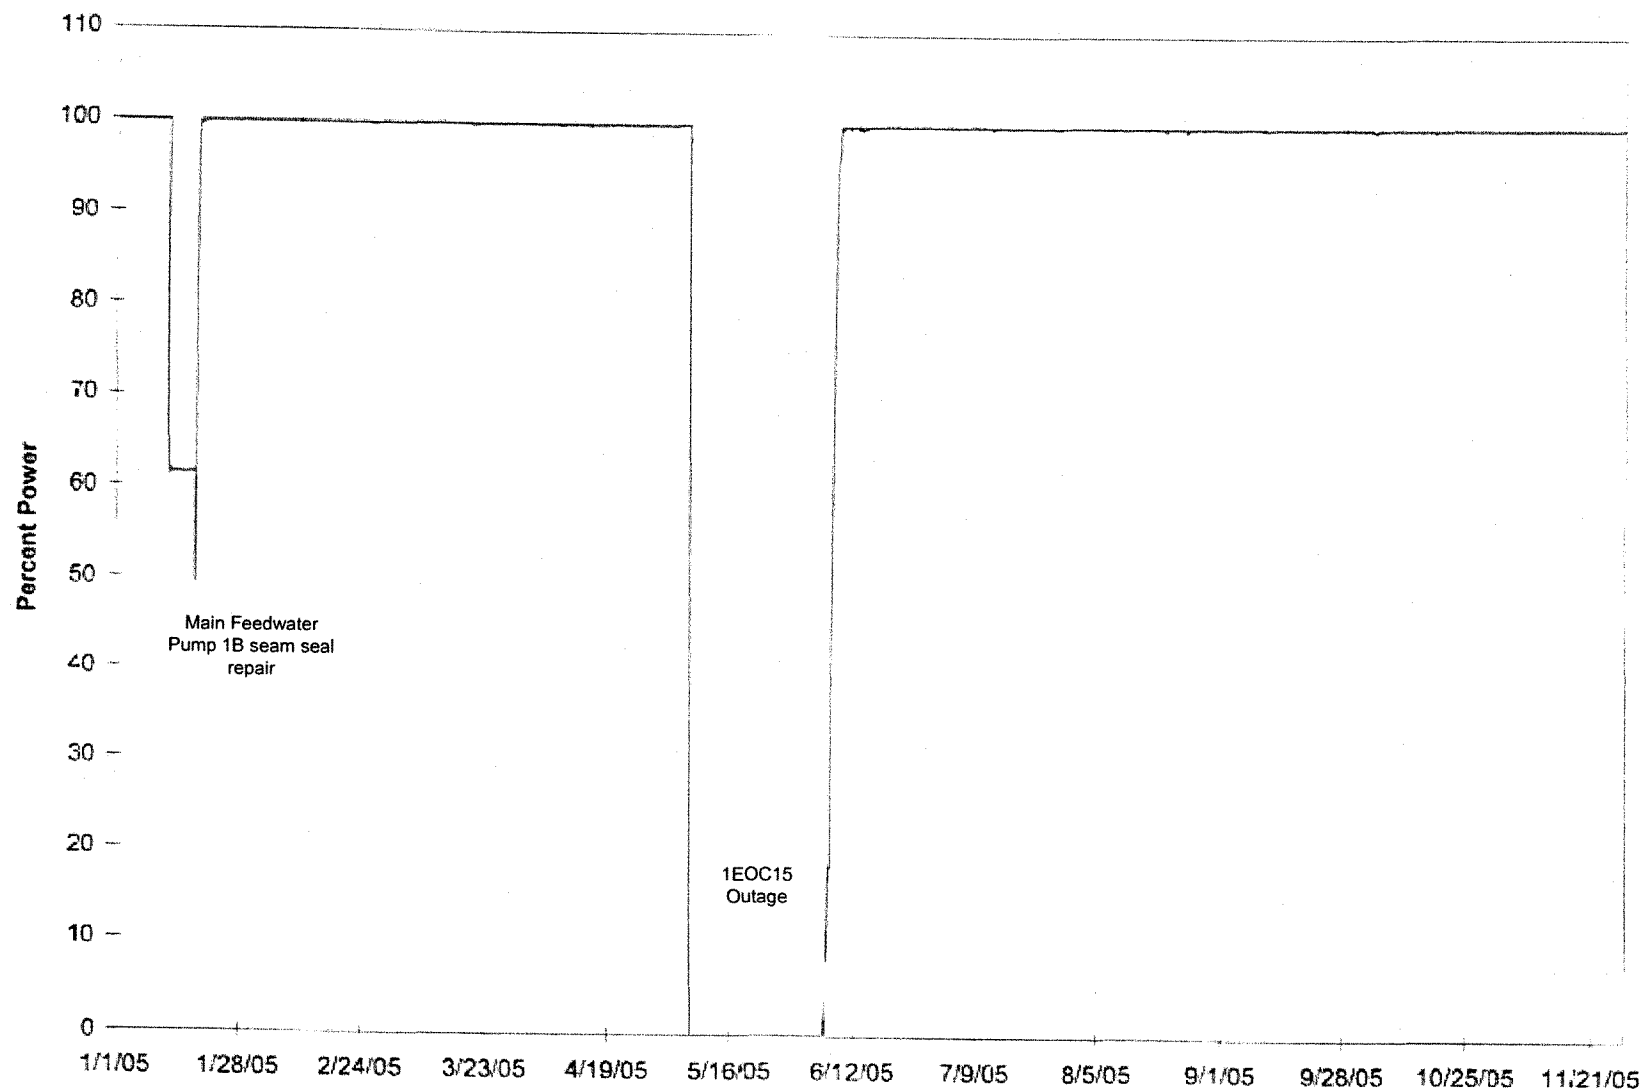
2005 Unit 1 Power History

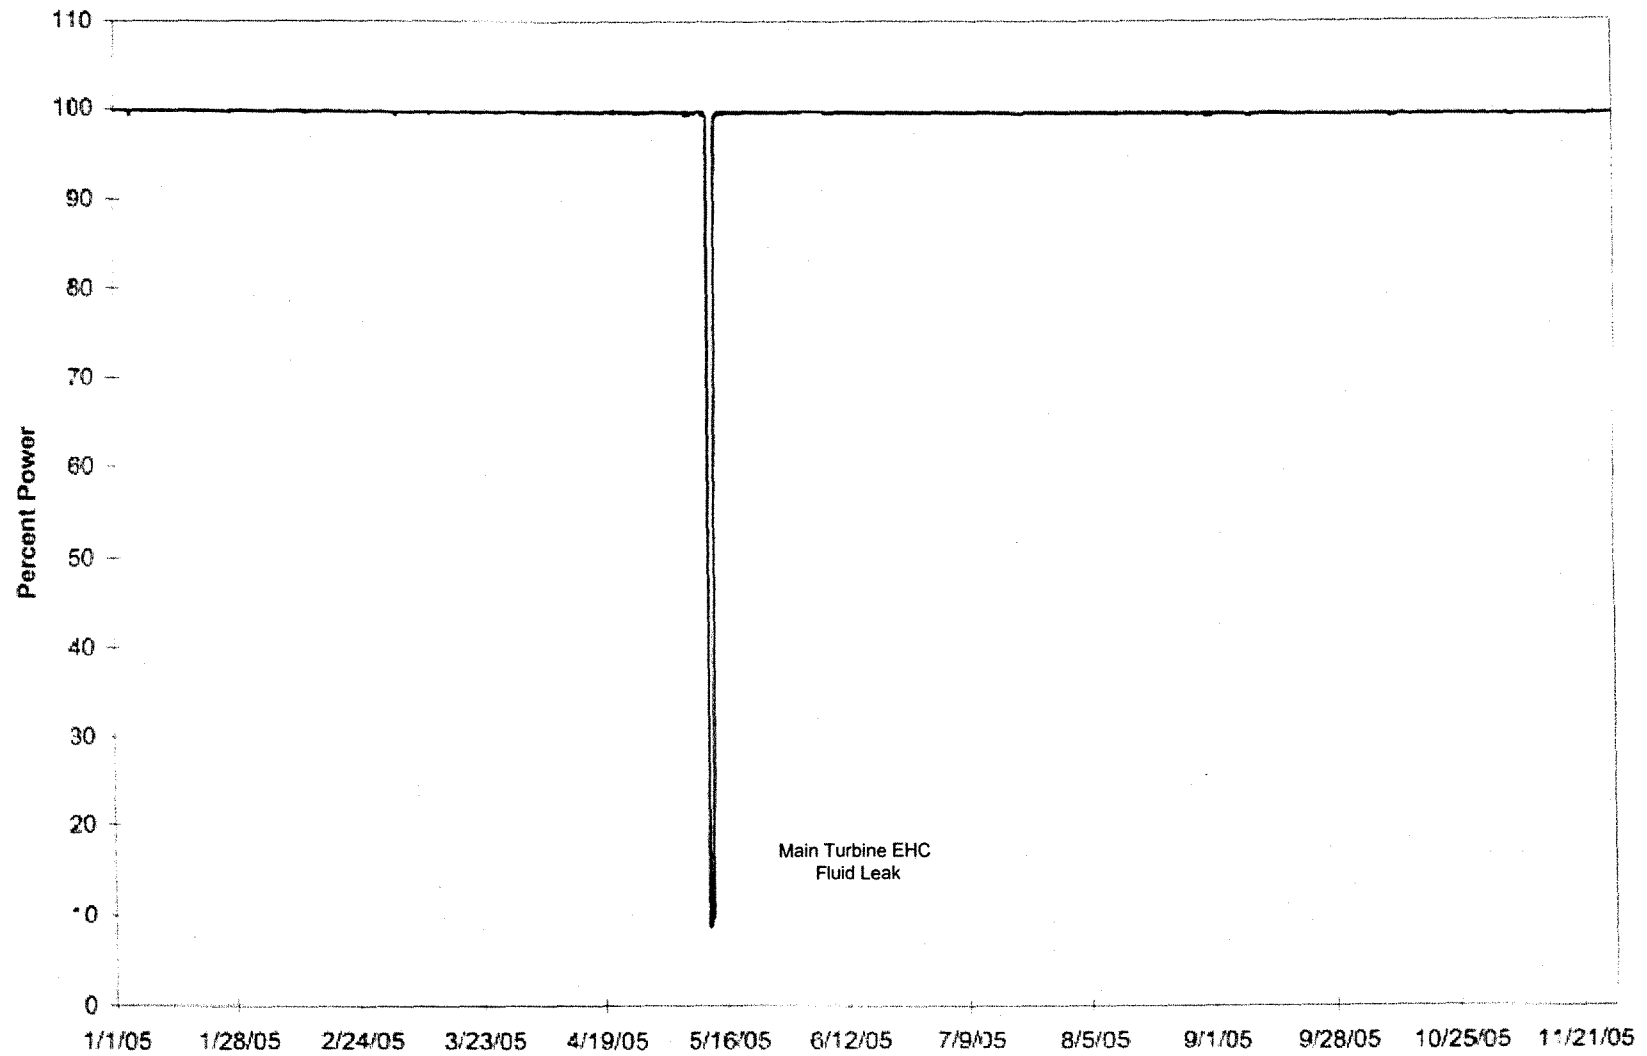
2005 Unit 2 Power History

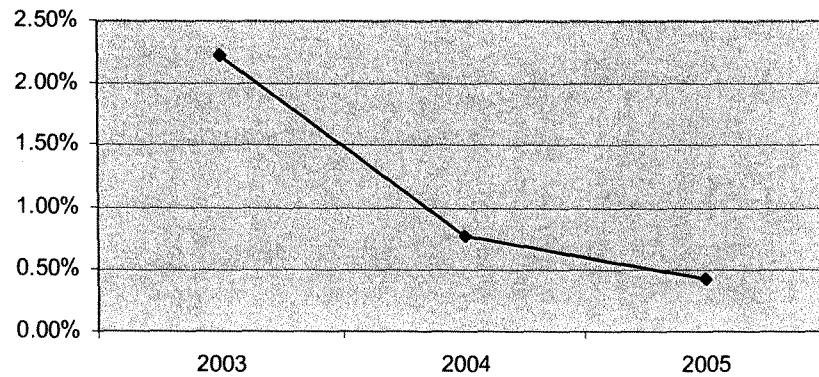
Emergency Power - Unit 2

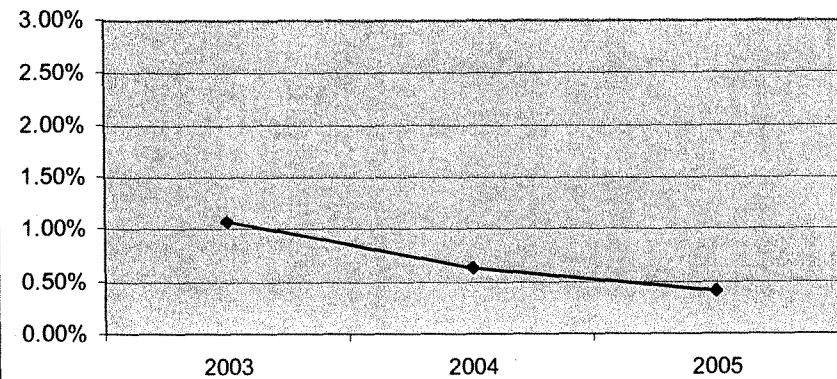
HPI - Unit 2

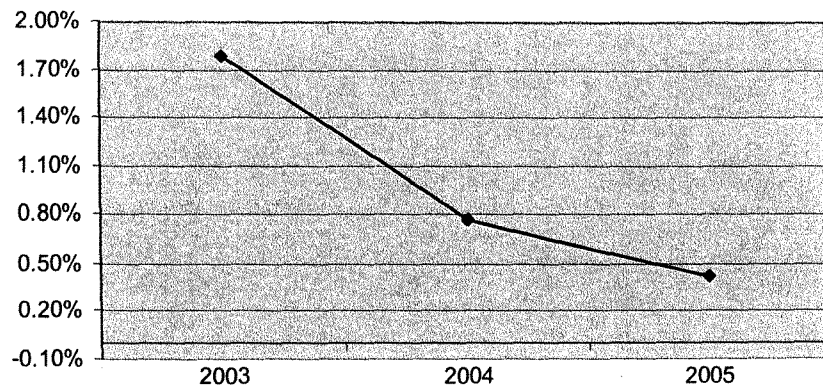
RHR - Unit 2

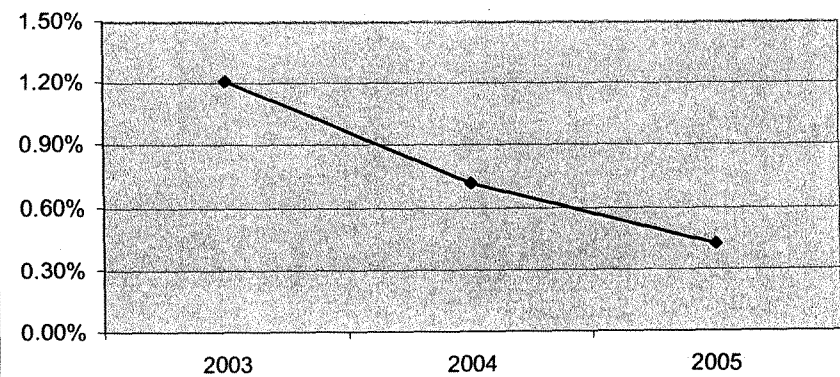
Emergency Feedwater - Unit 2

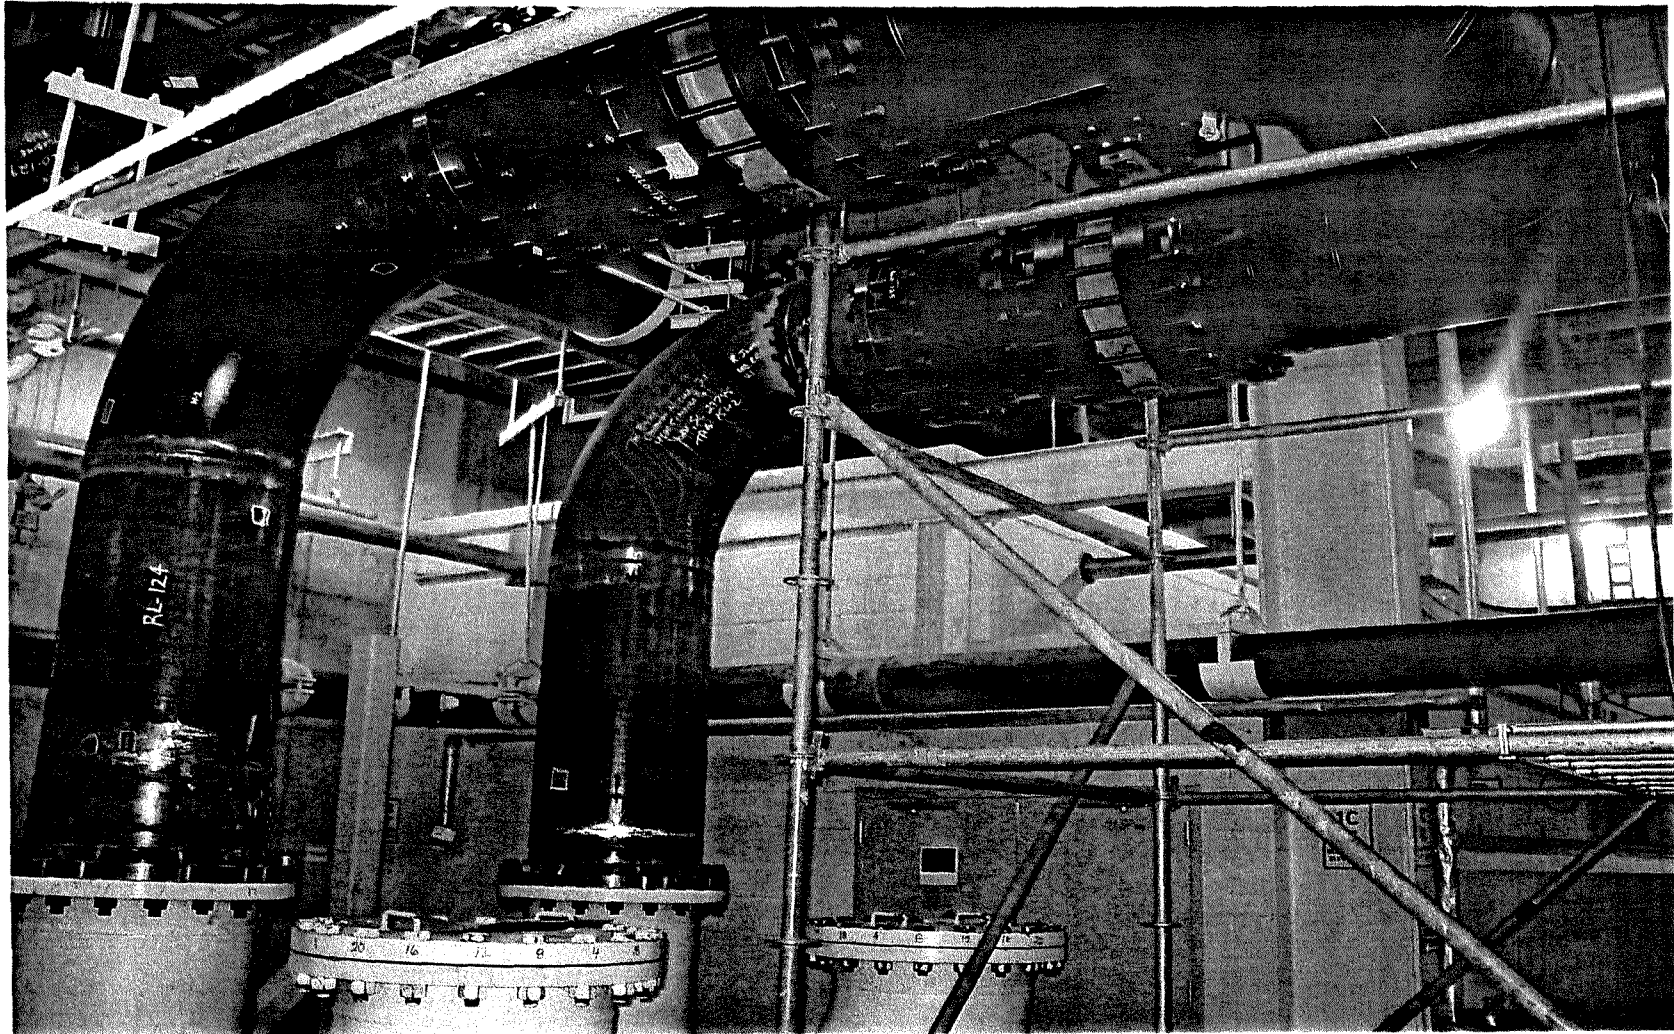
Low Pressure Service Water Supply Header Connections to Unit 1

- System provides makeup to cooling towers, cools turbine and generator auxiliaries, containment chillers and secondary system pump motors
- Carbon steel piping became degraded from corrosion – cooling capacity was marginal during hot weather
- Restoration is to replace piping with High Density Polyethylene Piping (HDPE)
- Cooling Tower makeup has new control valves and HDPE piping headers
- Turbine/Service building distribution piping changed to HDPE
- New HDPE main supply header installation in progress and will be in service by April 2006

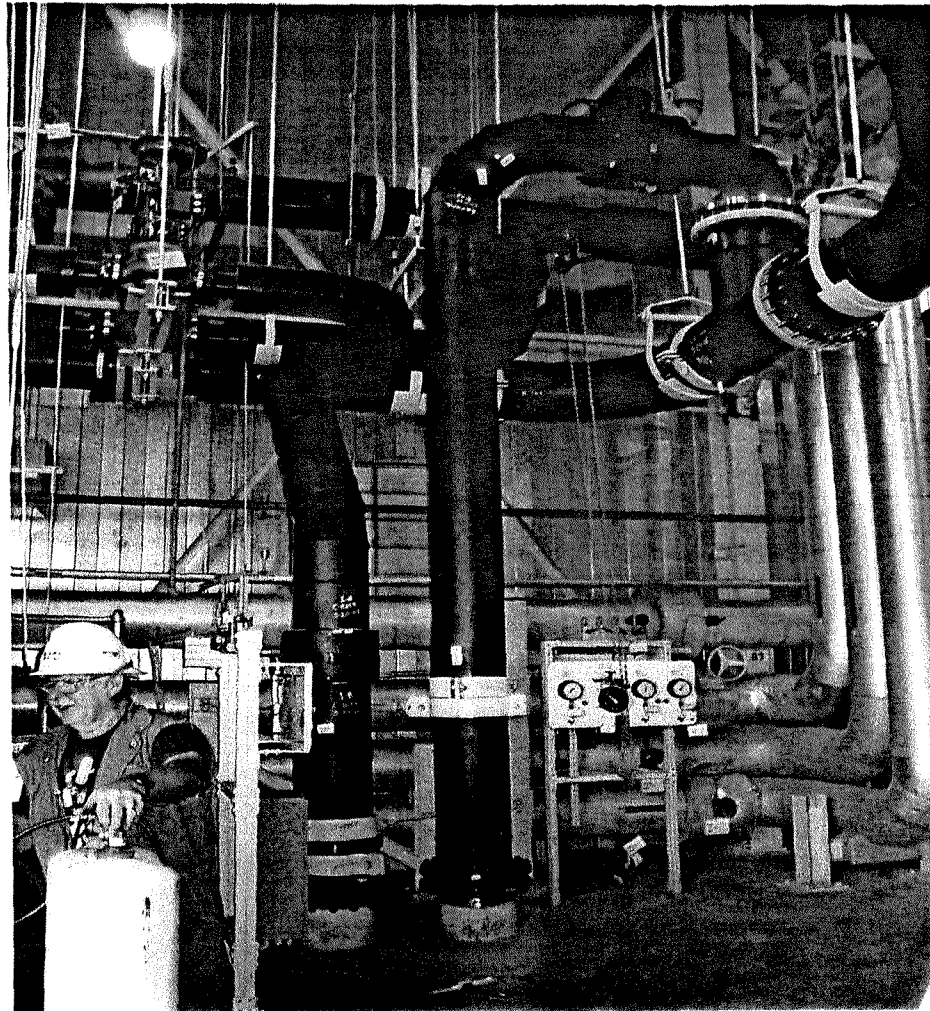
New Low Pressure Service Water Supply and Return Piping to Containment Chillers

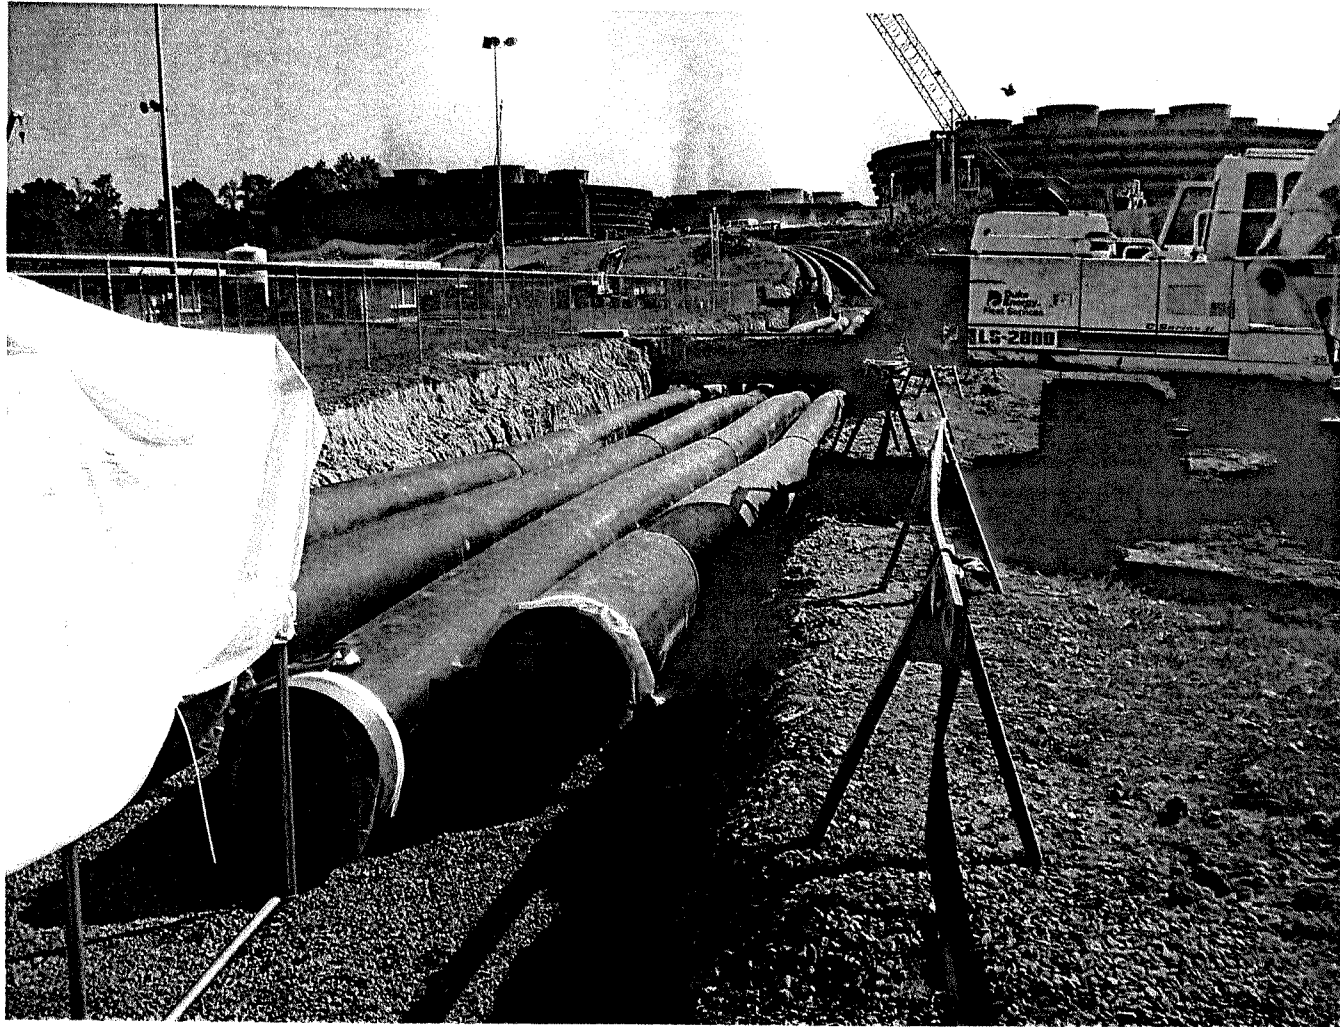
Low Pressure Service Water 32" HDPE Pipe Installation

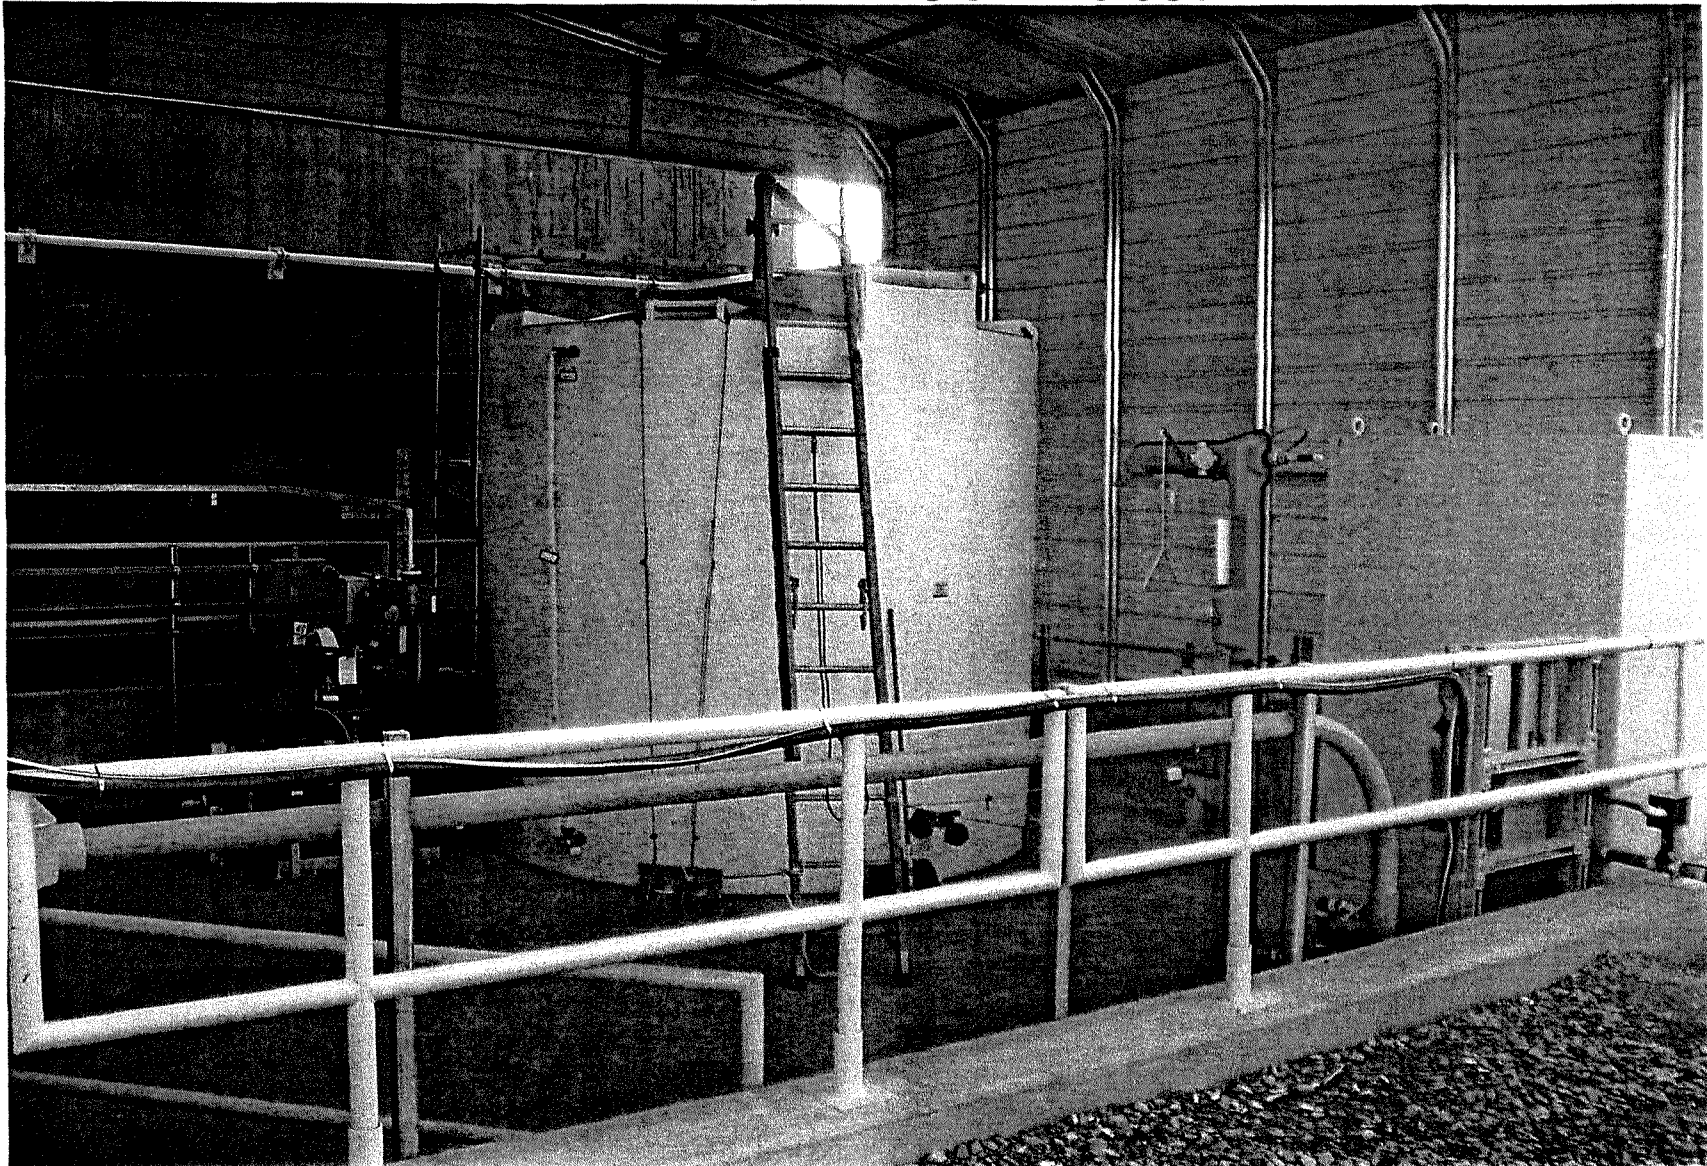
Chlorination Building For Nuclear Service Water

- New System to chlorinate the supply and then de-chlorinate the discharge to the lake or Standby Nuclear Service Water Pond (SNSWP)
- Allows higher concentrations of chlorine for greater biofouling control and reduced Hx Fouling
- De-chlorination prevents exceeding NPDES discharge limits
- Treats both Nuclear Service Water and Low Pressure Service Water
- Portions of System have been placed in operation
- Low Pressure Service Water Chlorination to be operational by May 2006
- Effectiveness of chemical controls for Nuclear Service water will be monitored by sample coupons

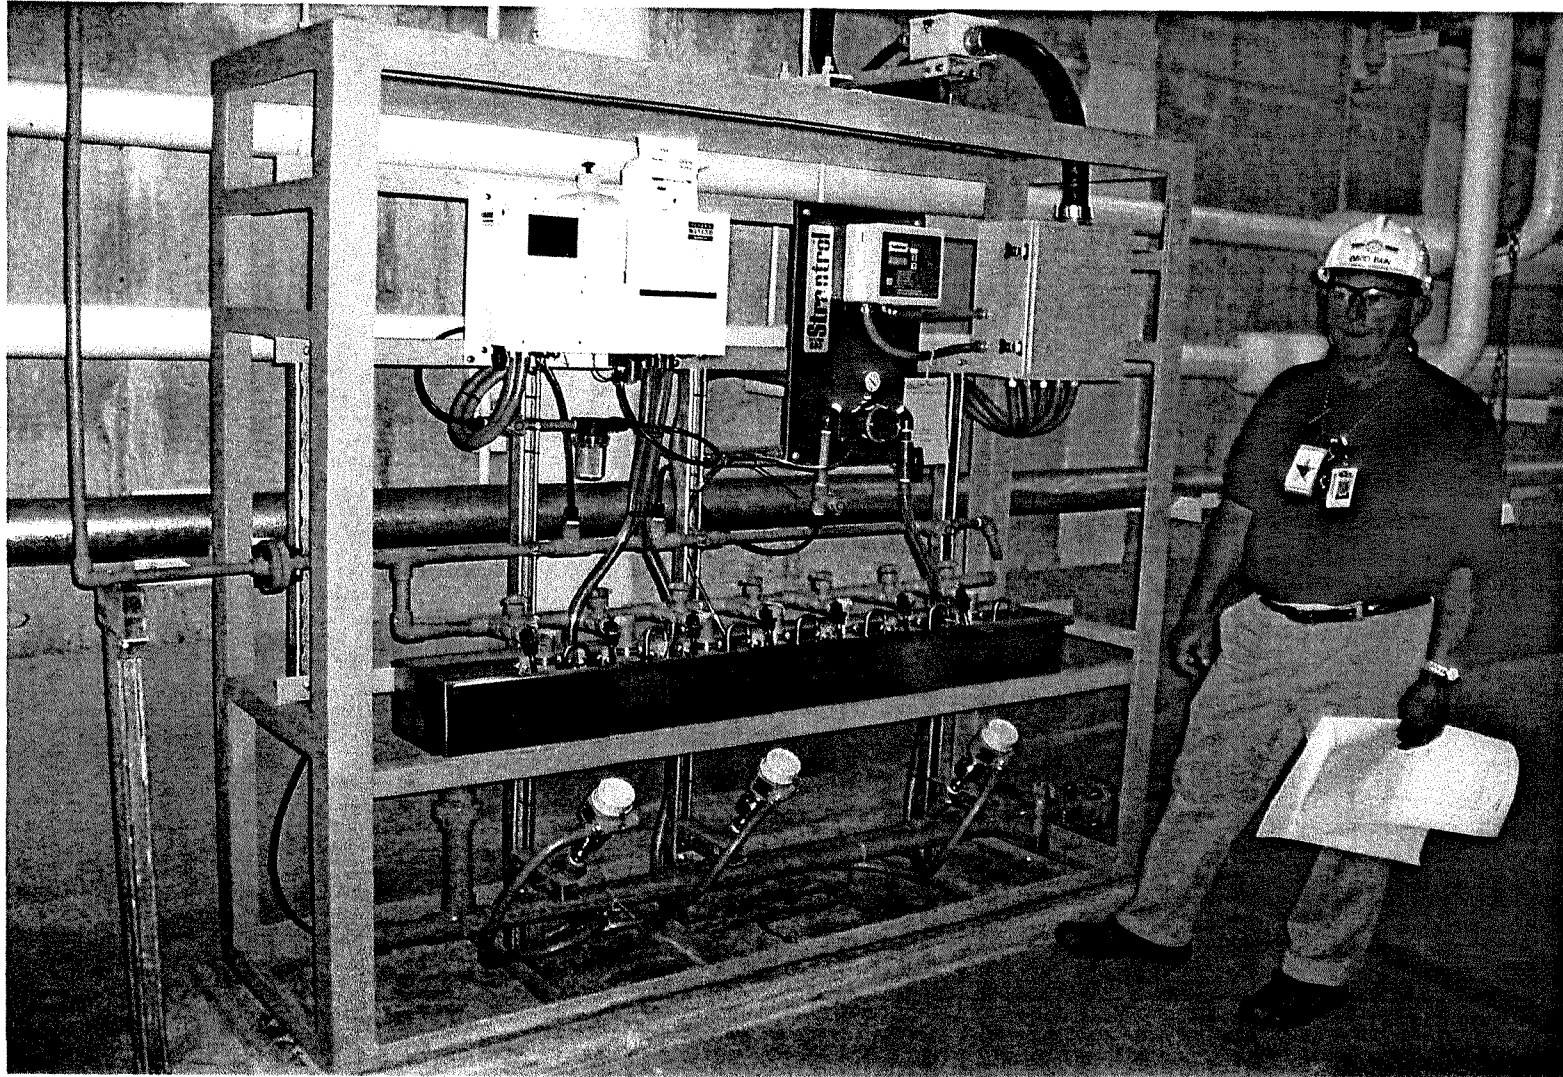
Sample Coupons

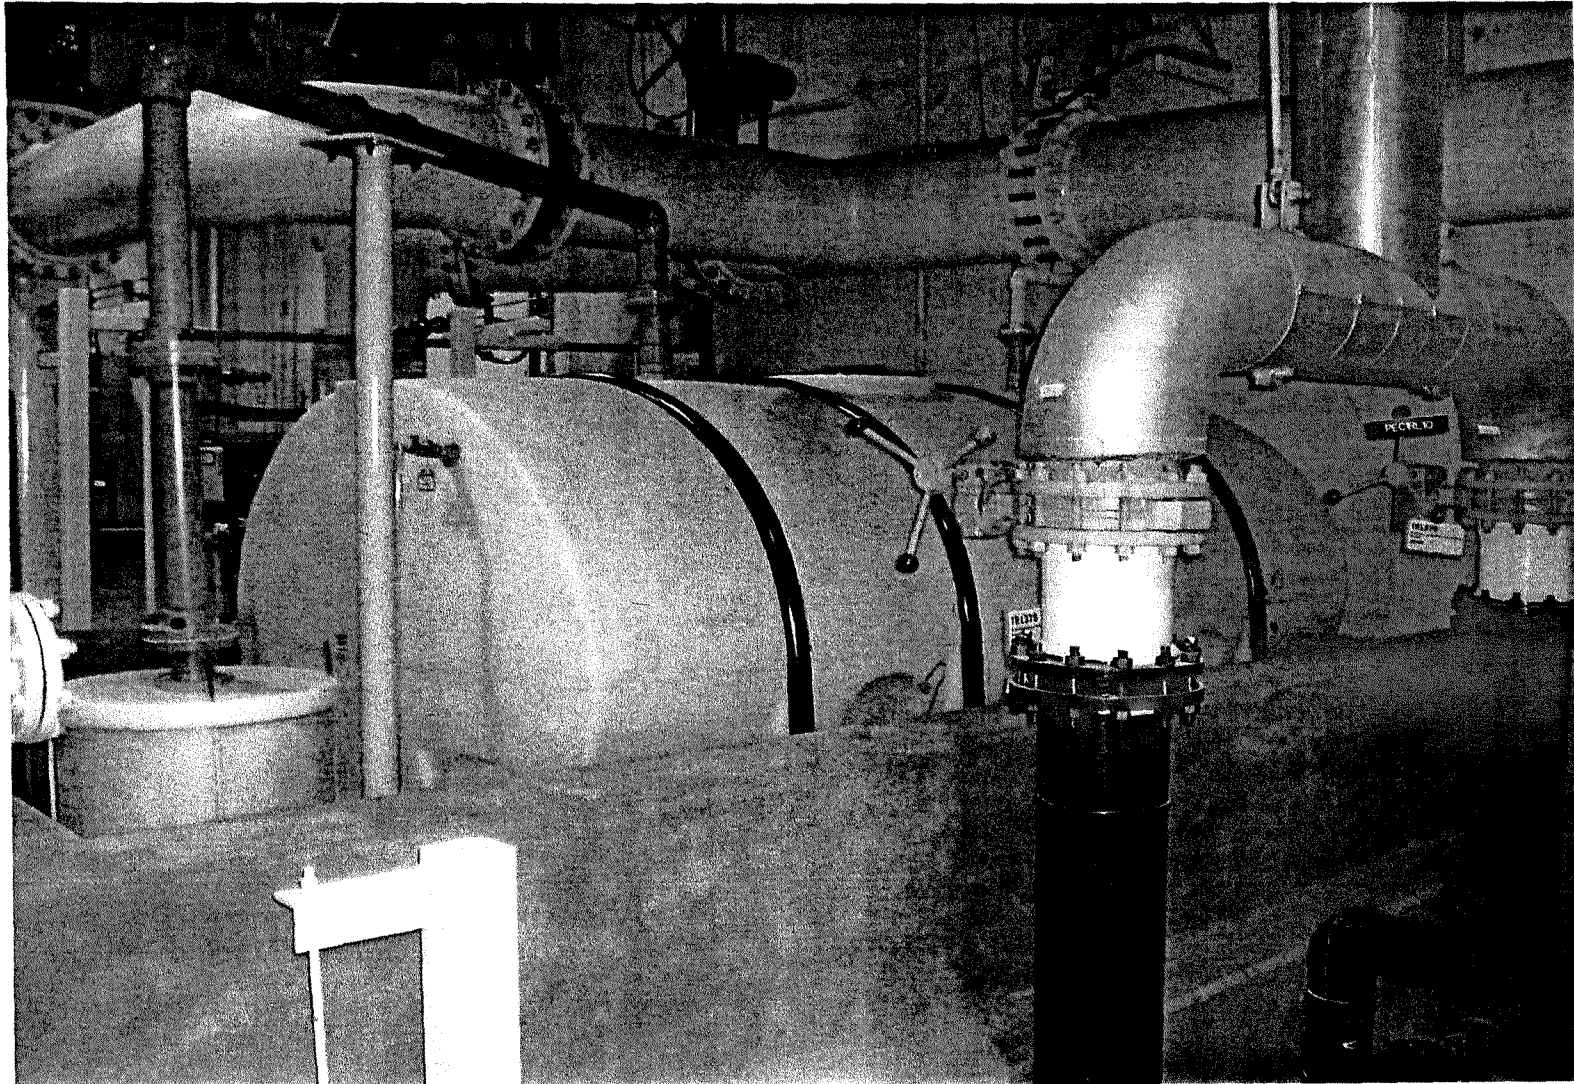
Sodium Bi-Sulfite Tank (De-Chlorination)

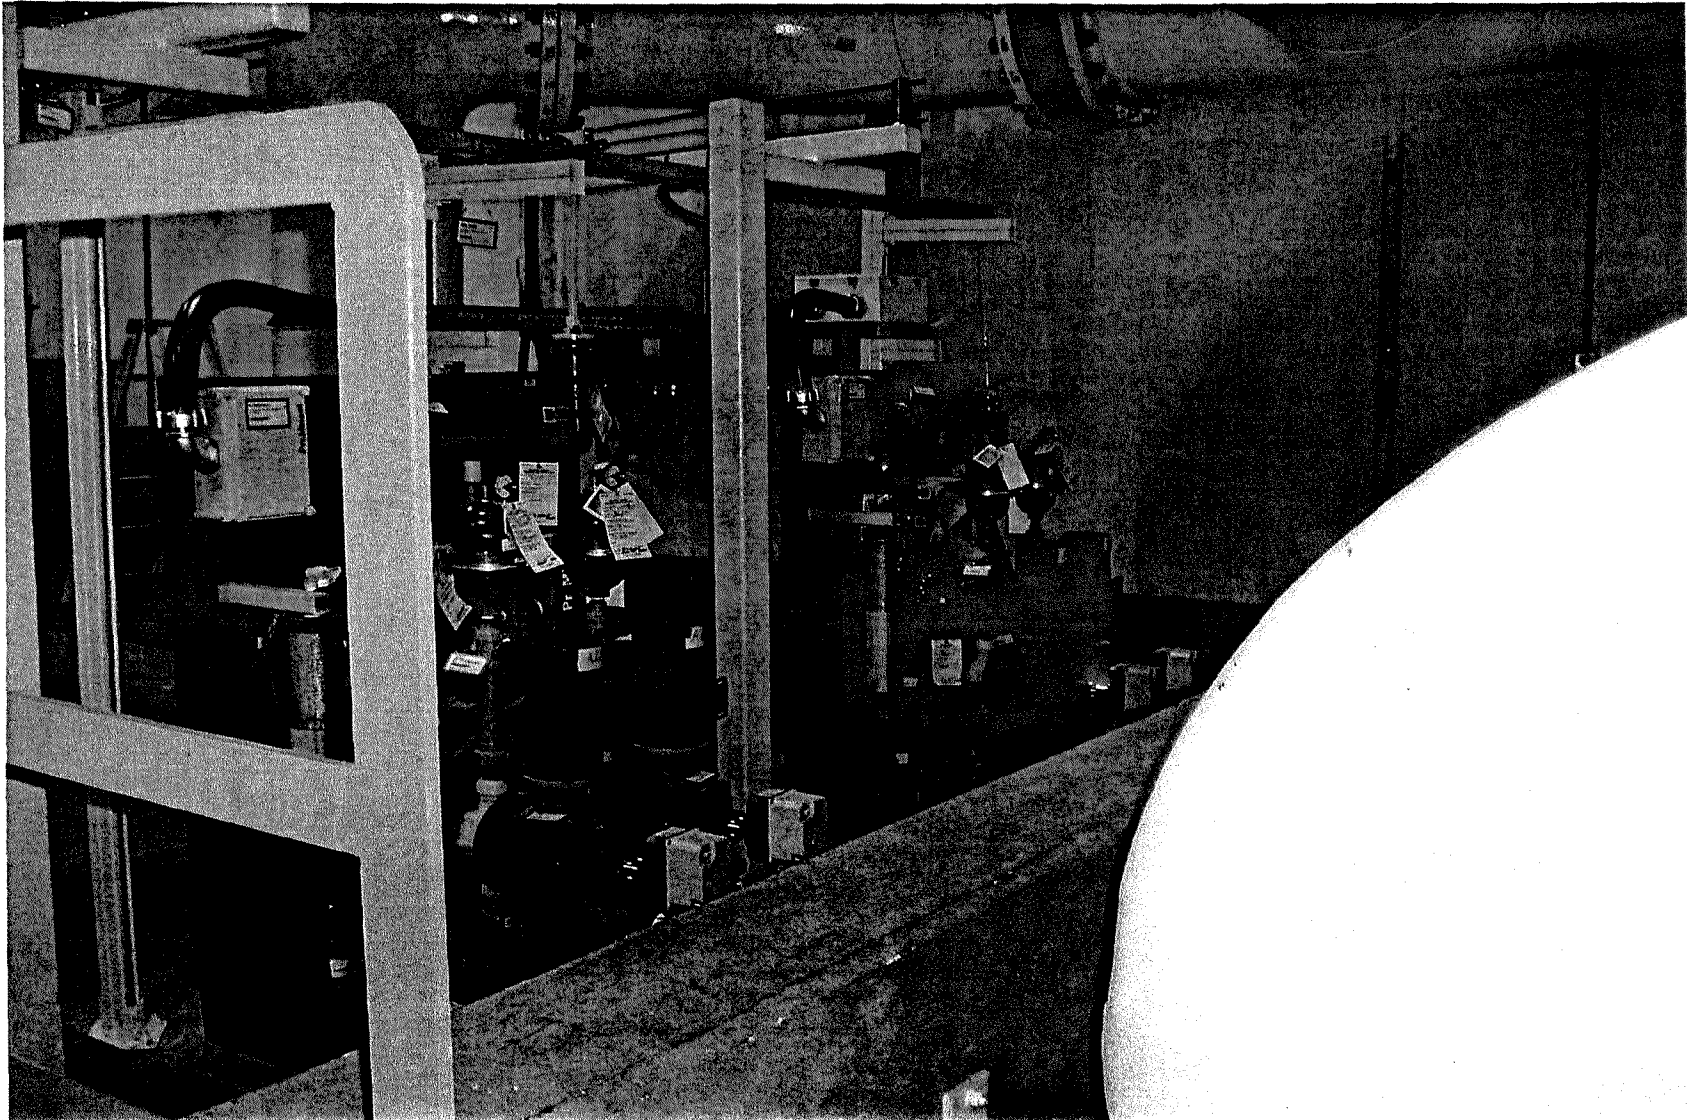
De-Chlorination Equipment Skids

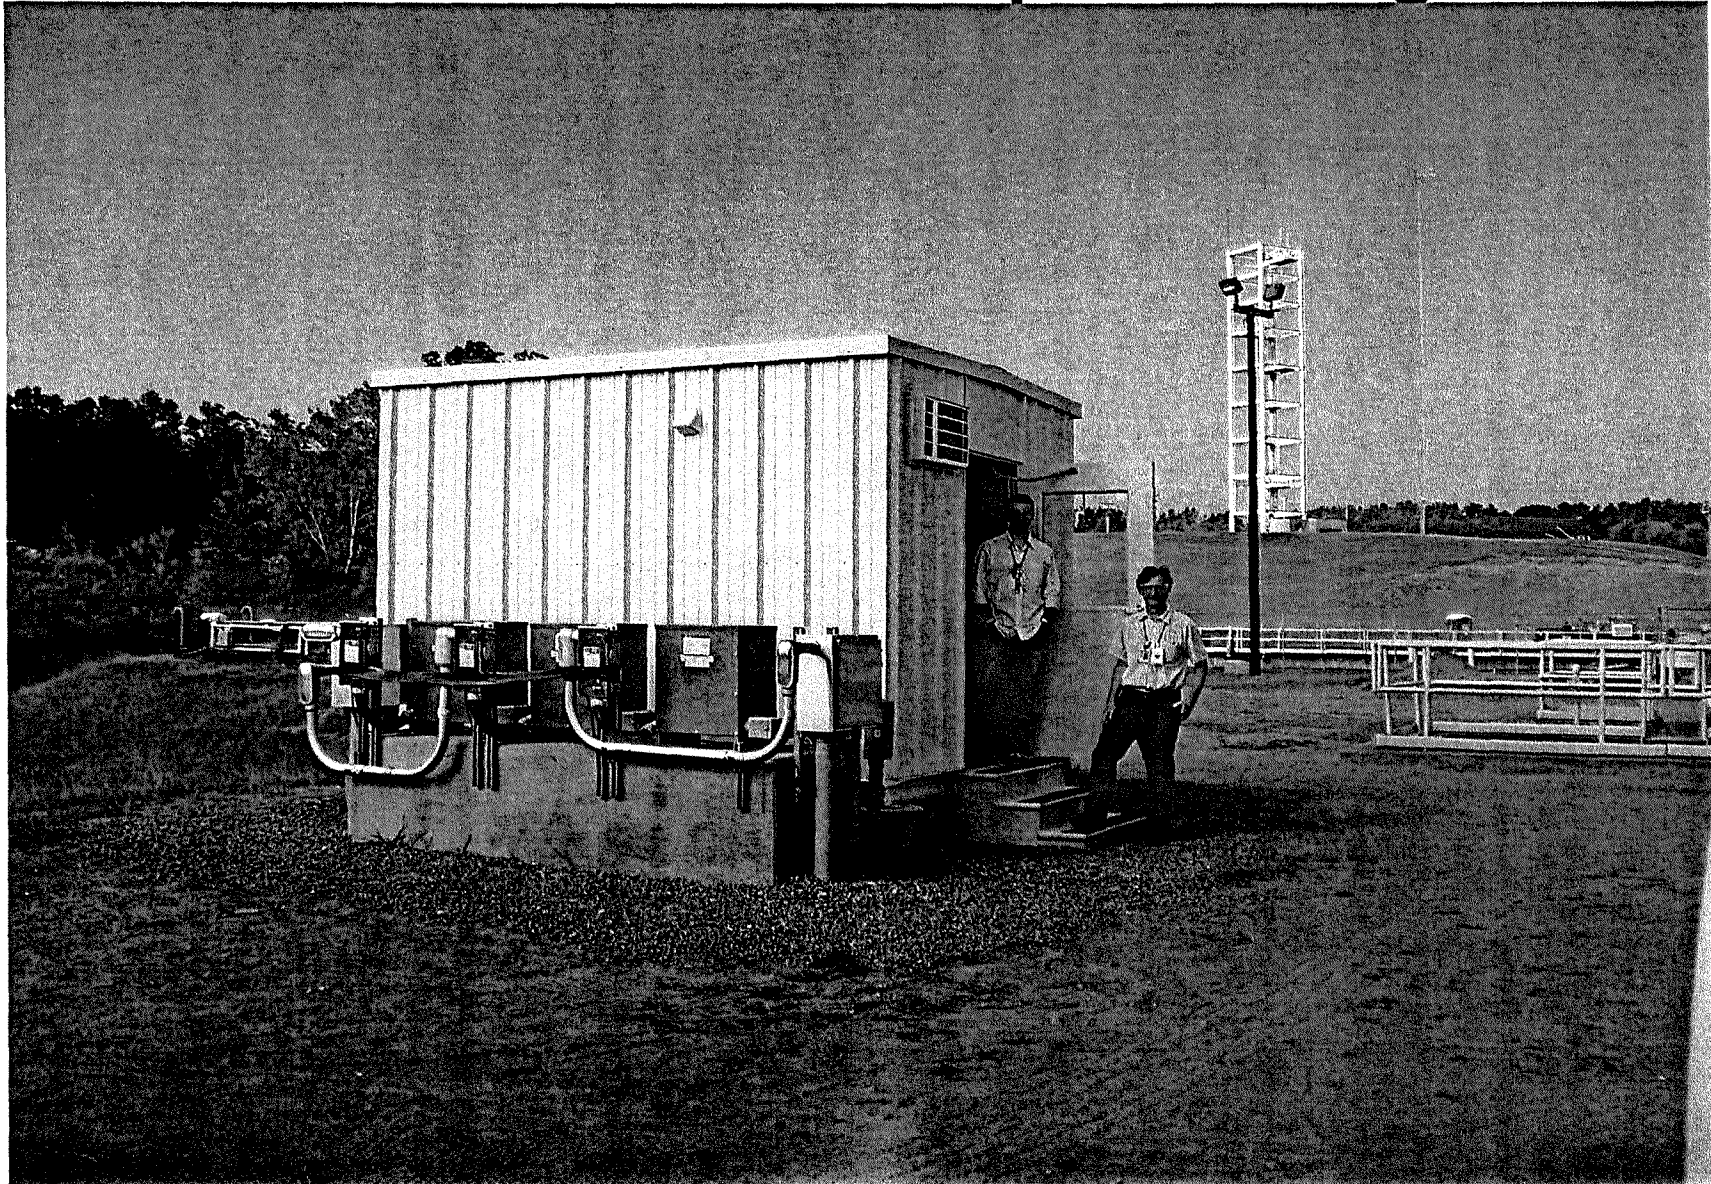
De-Chlorination Sample Building

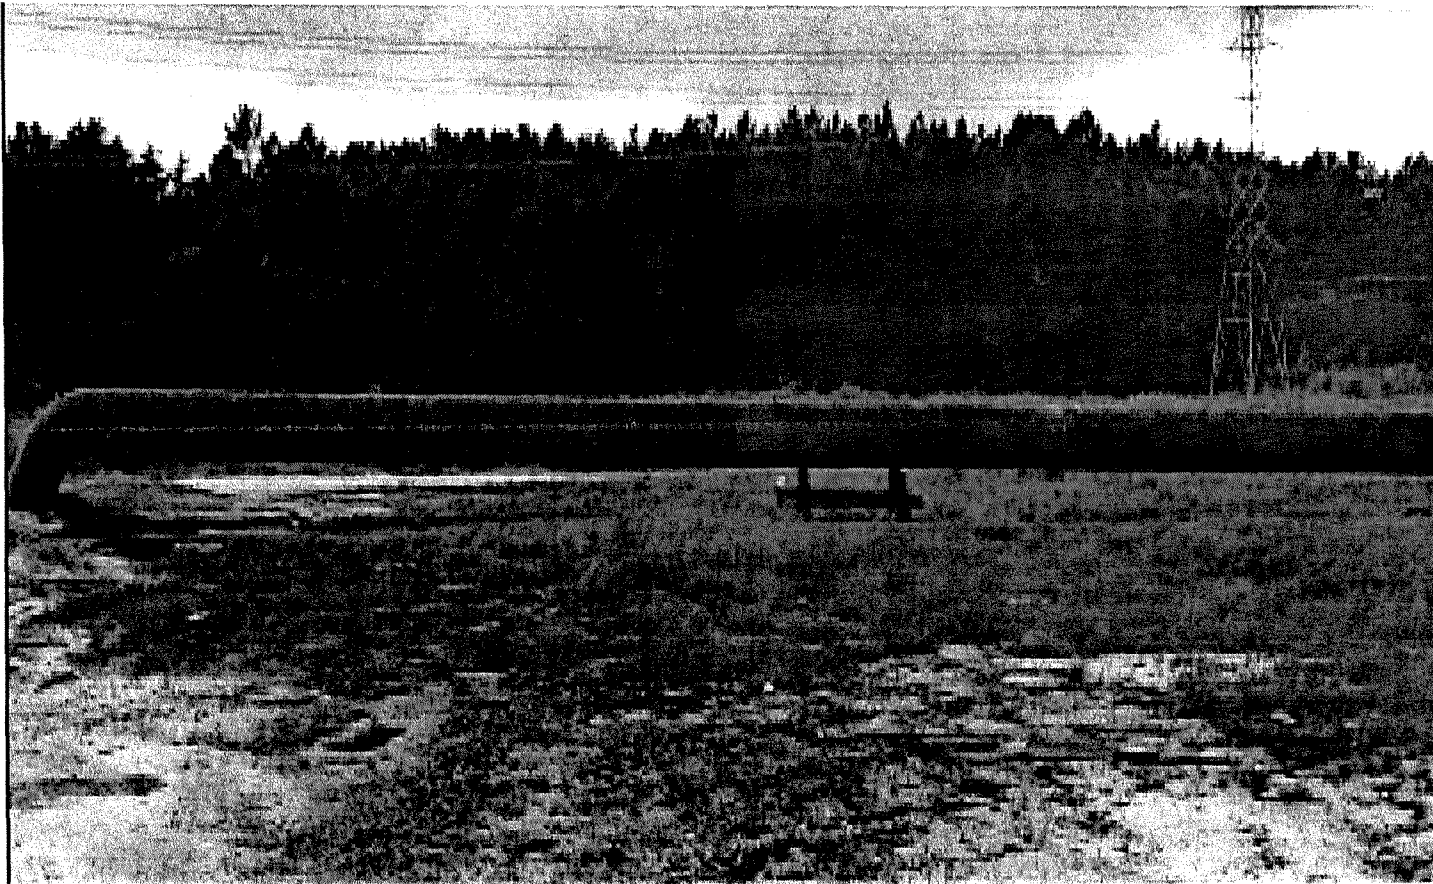
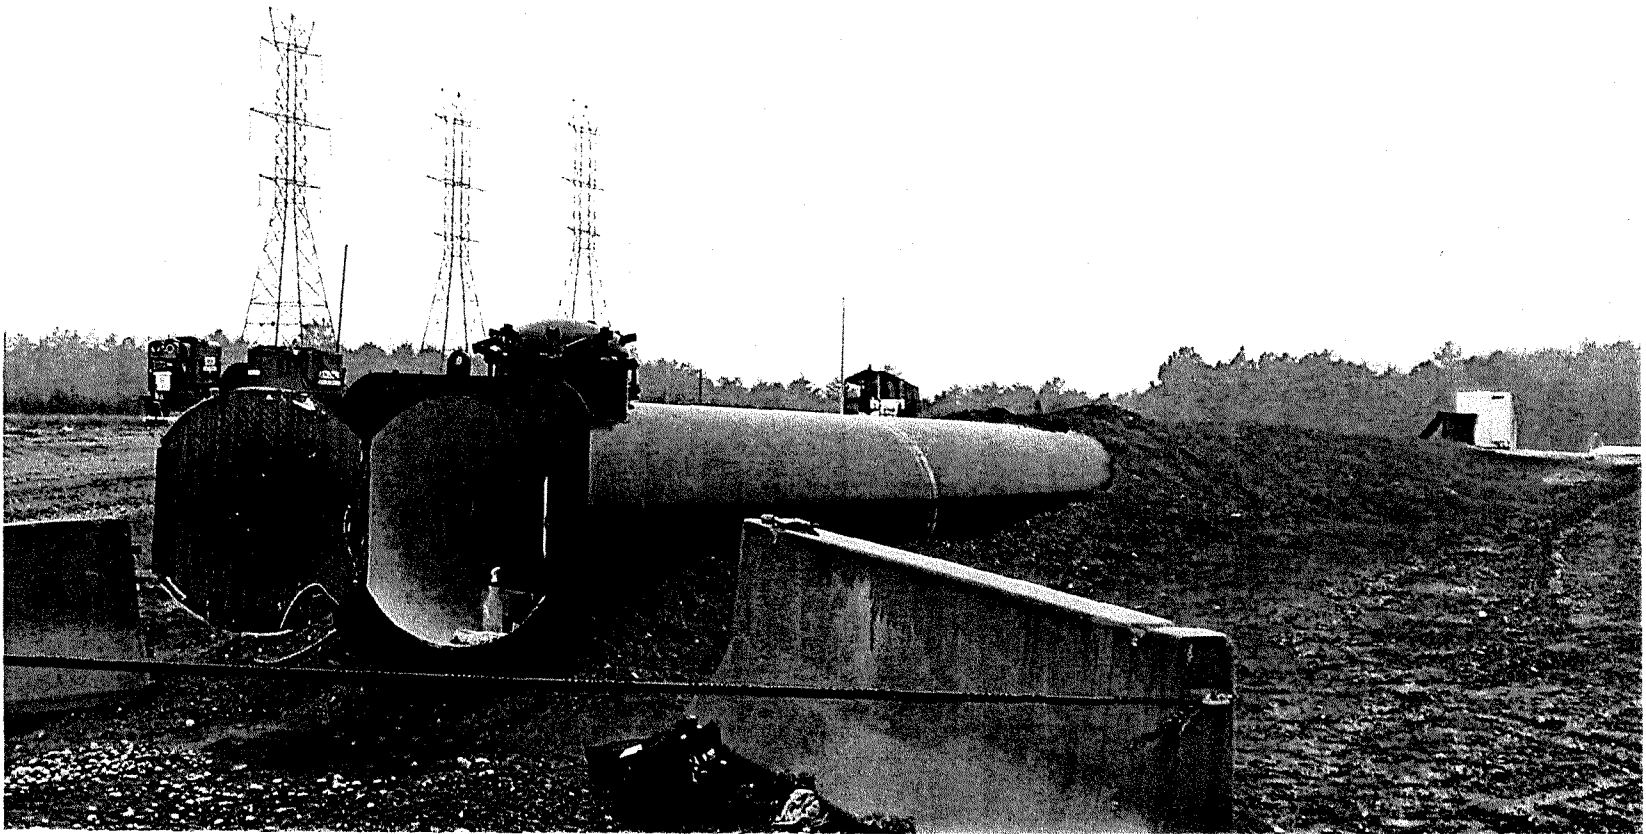
Mock-Up Piping

- Developed mock-up piping -300 Feet of 42 inch pipe and 100 feet of 30 inch pipe
- Demonstrated Capability of Equipment
 - High Pressure Water Cleaning
 - Abrasive Blast
- Proved the clean and coat process
- Trained Craft and Inspection Personnel
- Logistical Improvements Identified
 - Handling of Coating Equipment
 - Removal of Abrasive Material
 - Sequence of Support Personnel (QC, Fire Watch, Hatch Attendant)
- Contingency plans
 - Safety Training For Medical Emergency Response Team
 - Weld Repairs

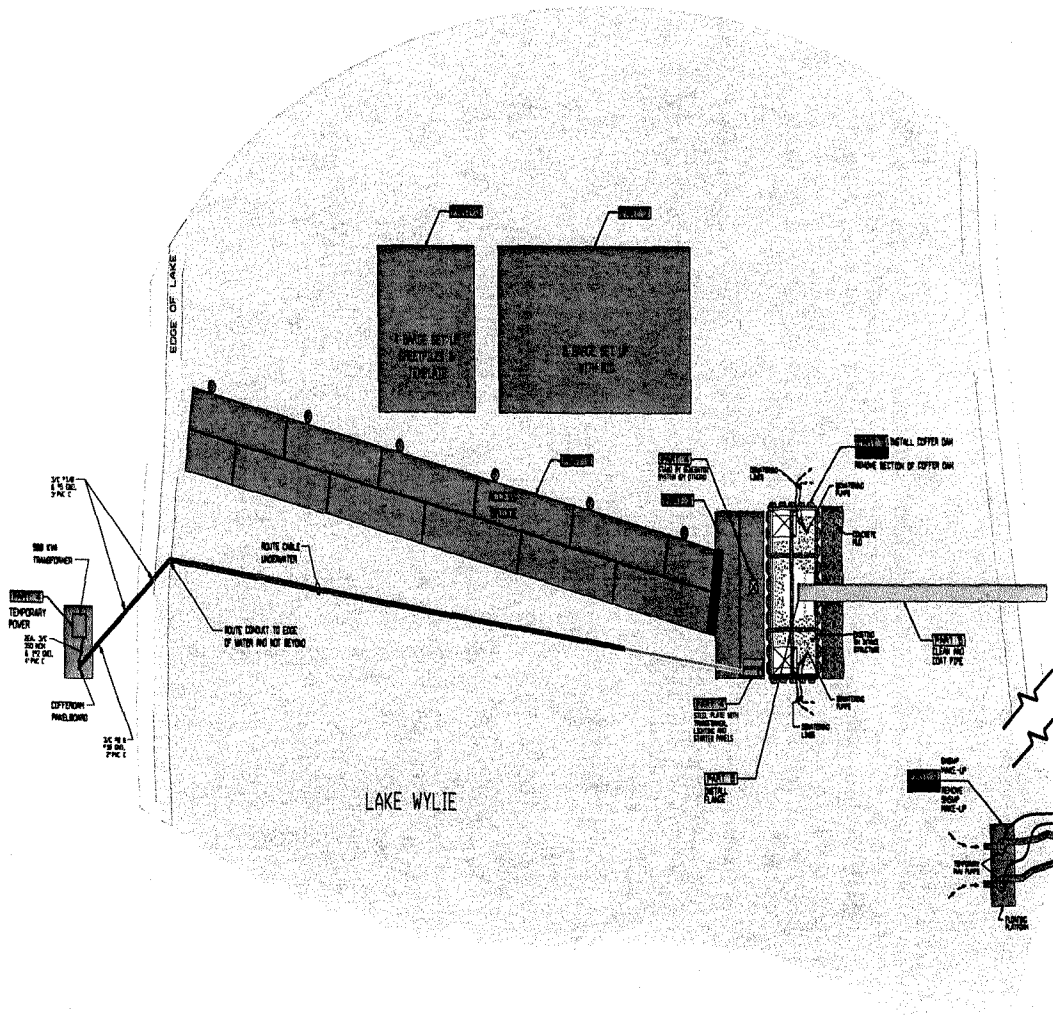
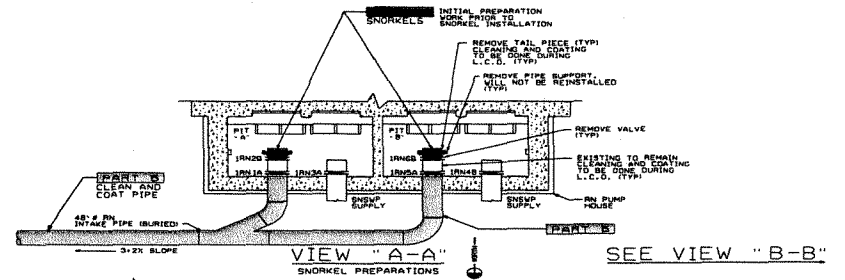
Service Water Project Status Lake Intake Piping Diagram

- Clean/Coat Nuclear Service Water Lake Intake Piping (400 feet of 48" piping)
- Built Two Snorkels in the Nuclear Service Water Pump House
- The Snorkels provide:
 - a QA1 boundary between the SNSWP & Lake Wylie while the plant uses the SNSWP for Nuclear Service Water cooling water
 - alternate access & egress path for personnel working inside the Nuclear Service Water Lake Intake Pipe
- Built Cofferdam at Lake Intake to dewater and allow access
