Catawba Nuclear Station Service Water Project Update

December 7, 2005

Service Water Project Status

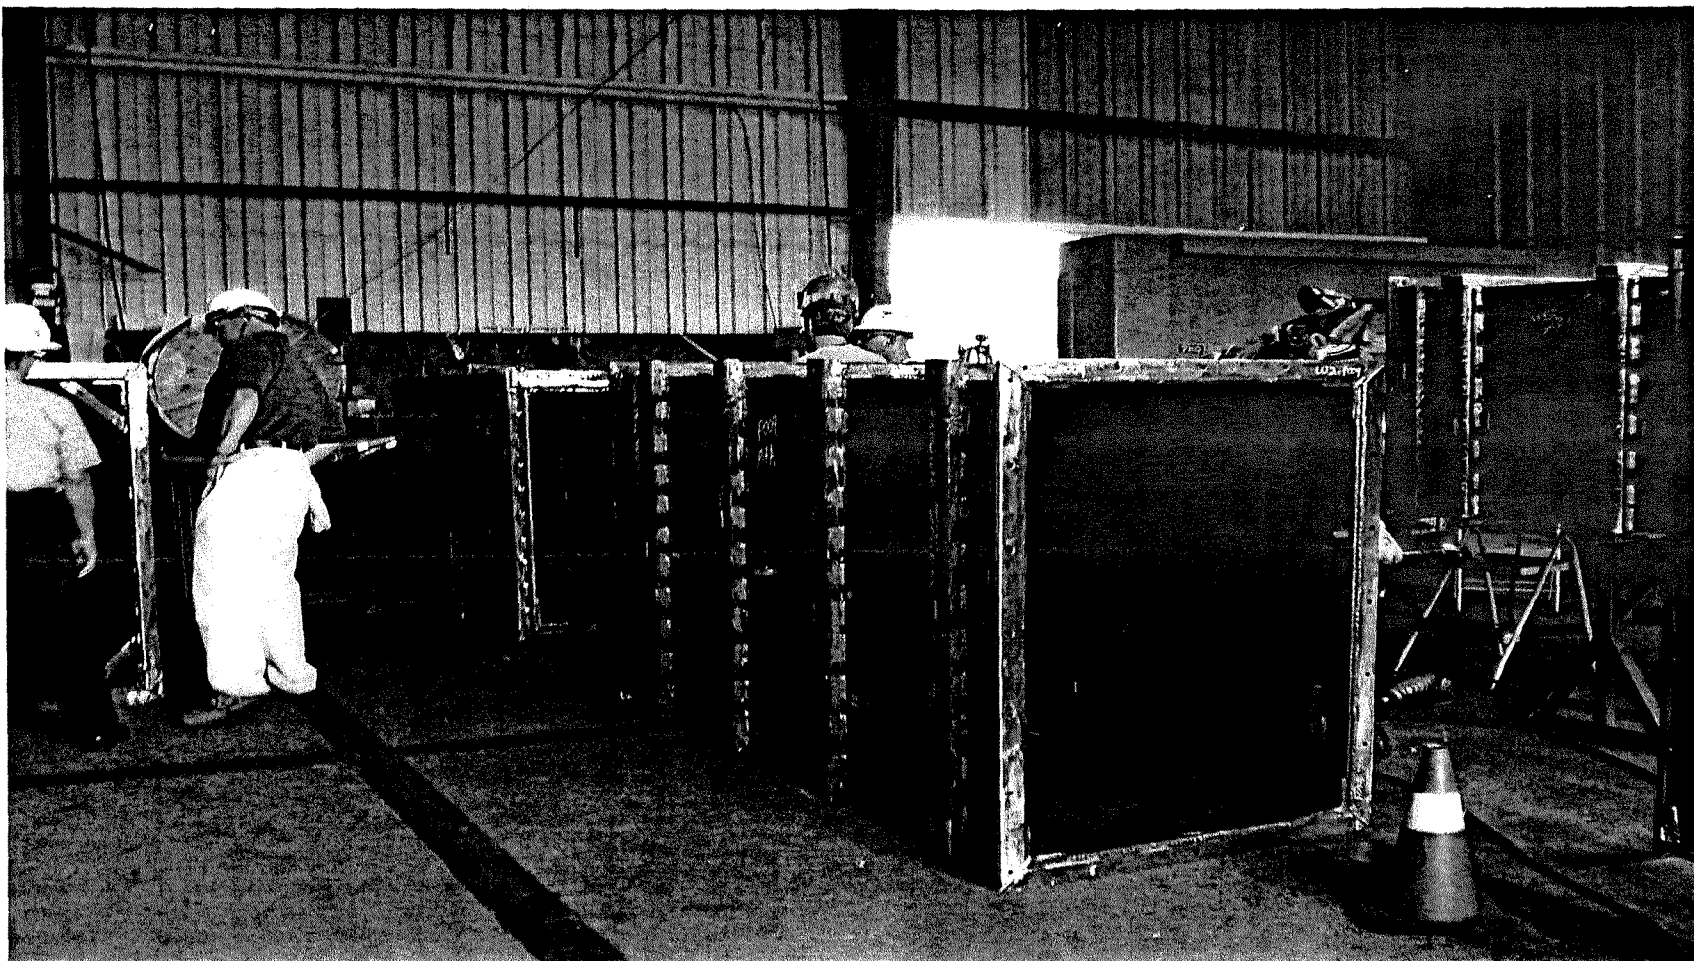
Snorkel Components Being Fabricated

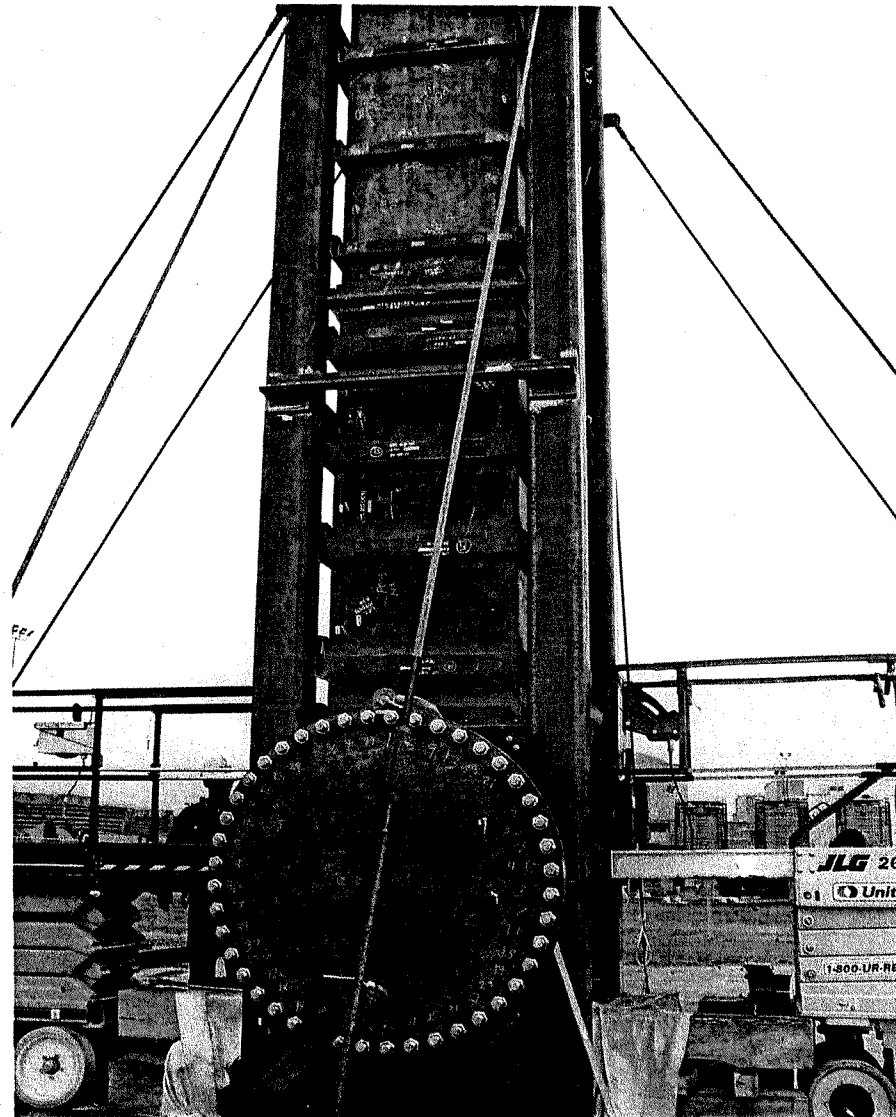
Snorkel Preassembled for Testing

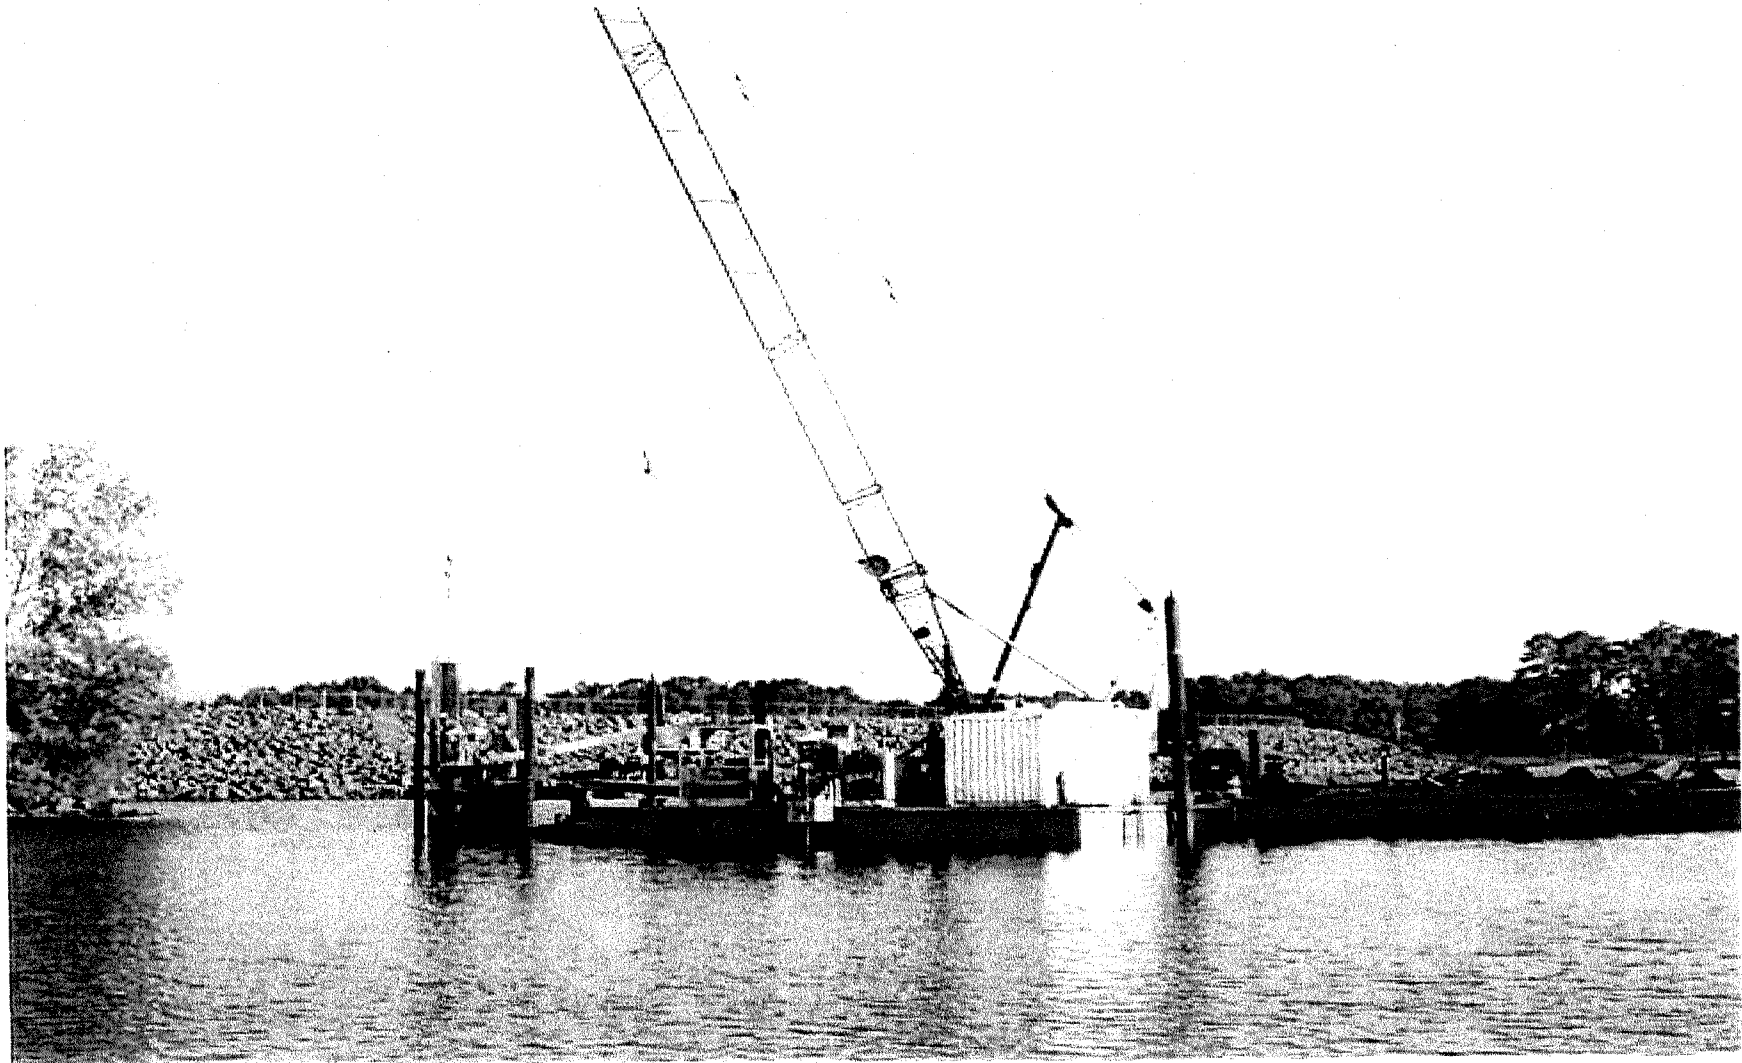
Cofferdam Construction

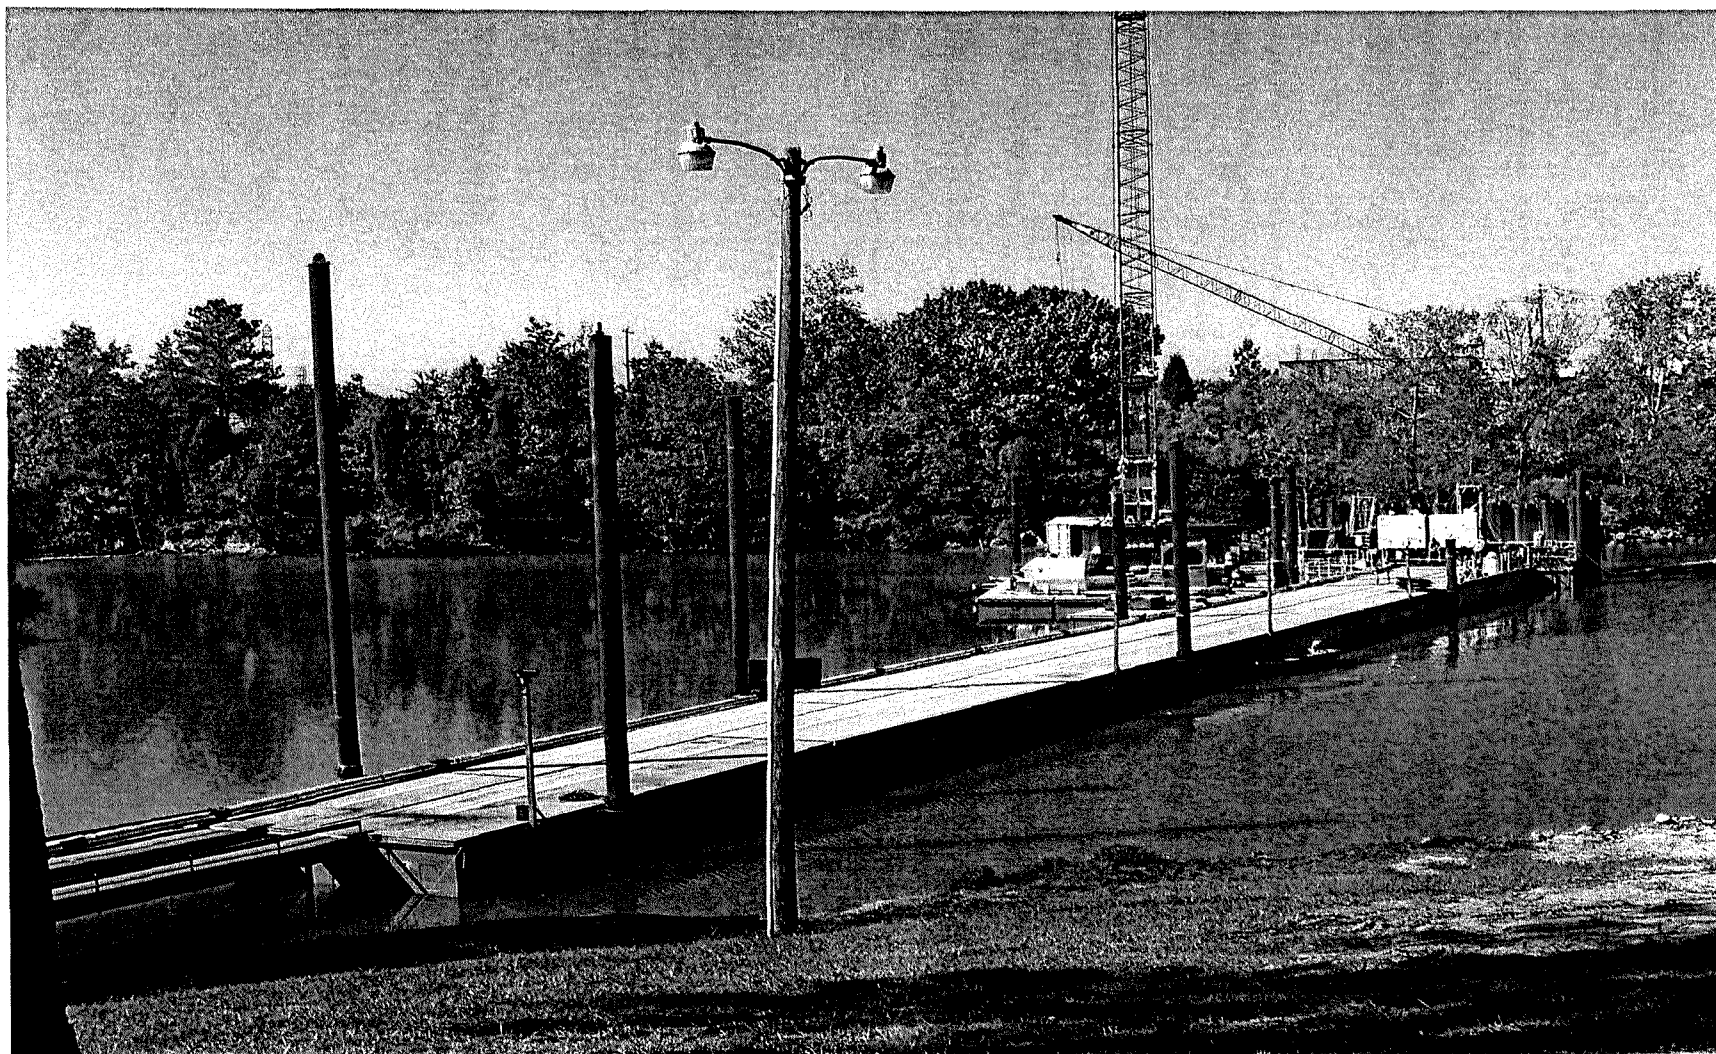
Causeway from the Catawba Park to the Cofferdam

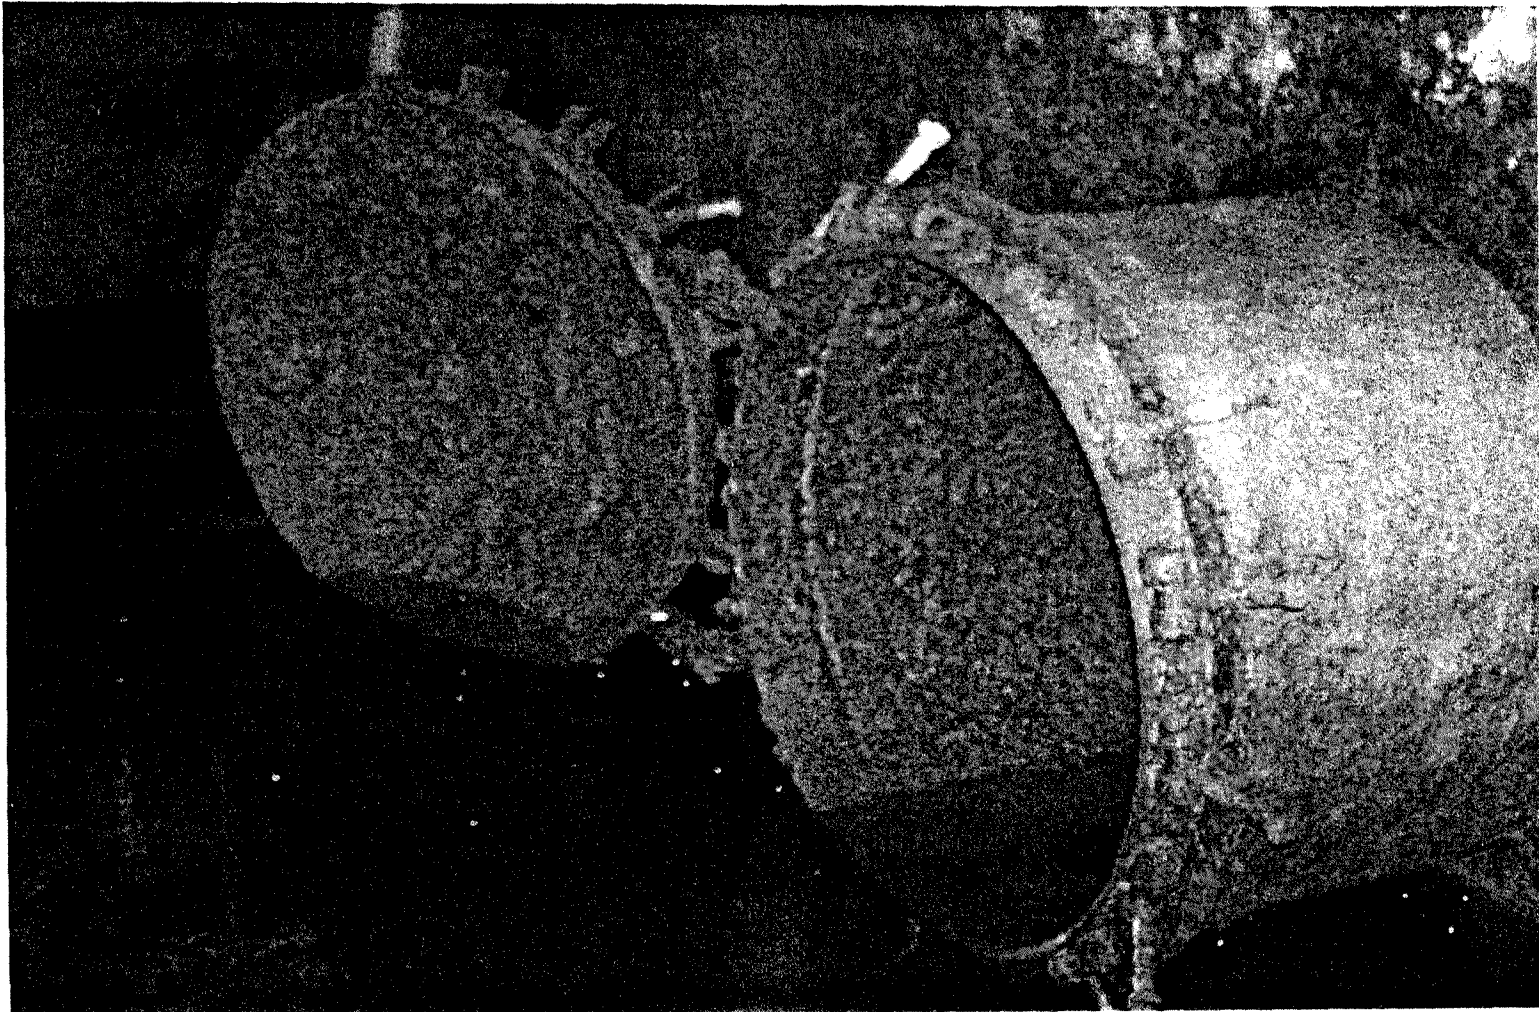
Nuclear Service Water Pipe Prior to Initial Cleaning

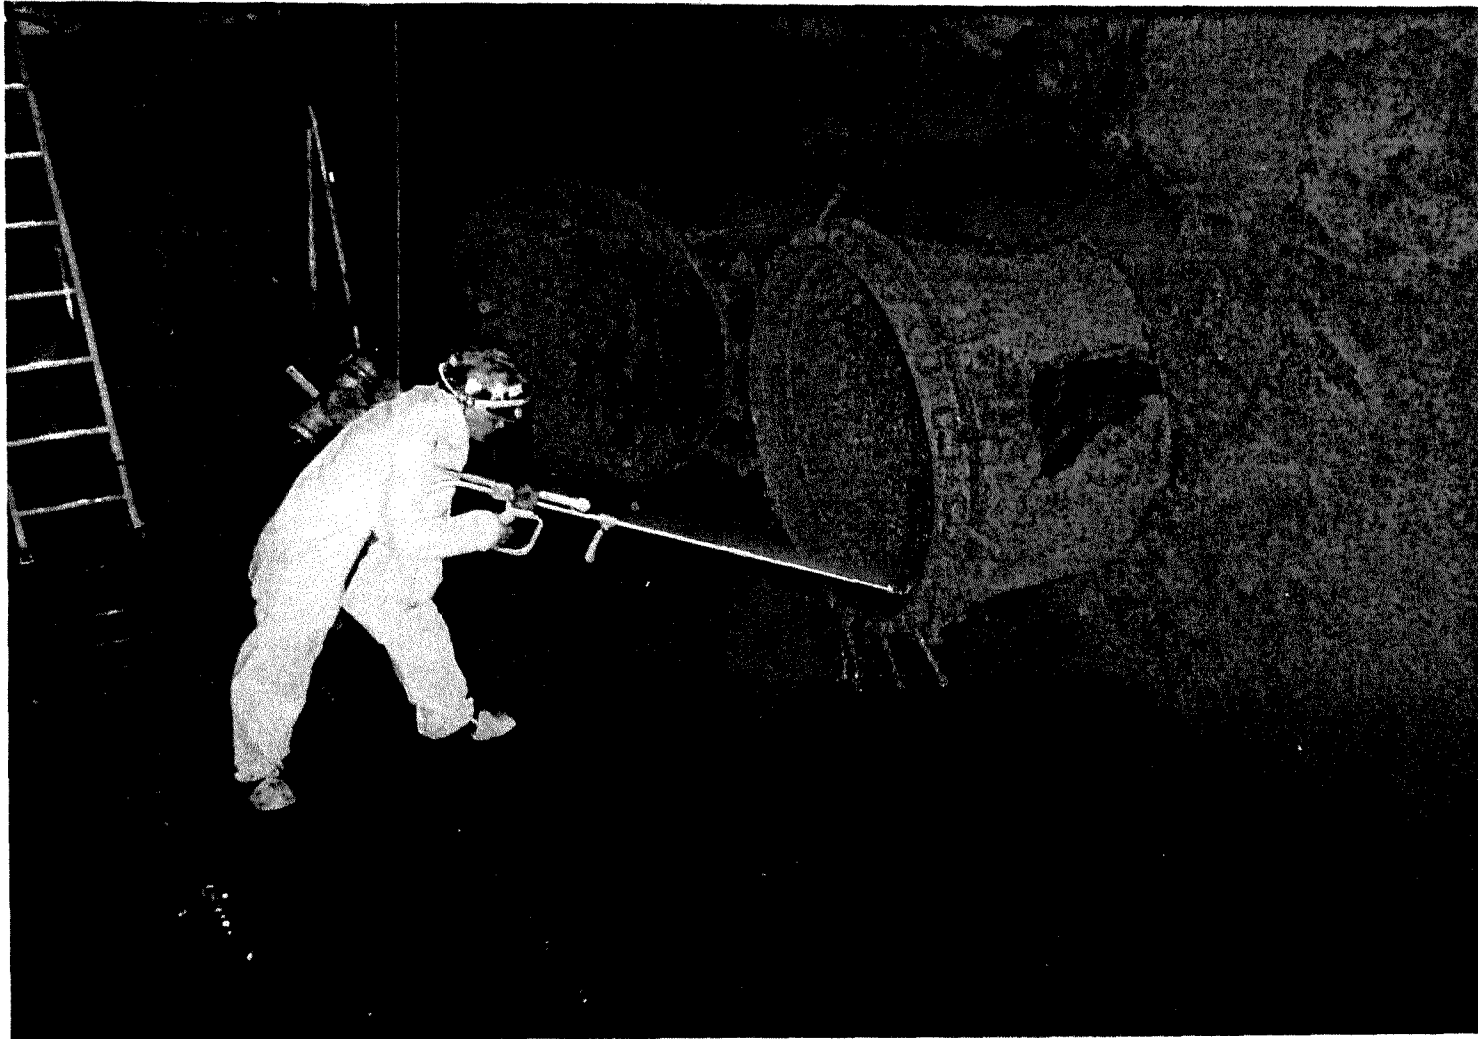
Nuclear Service Water Flange Initial Cleaning

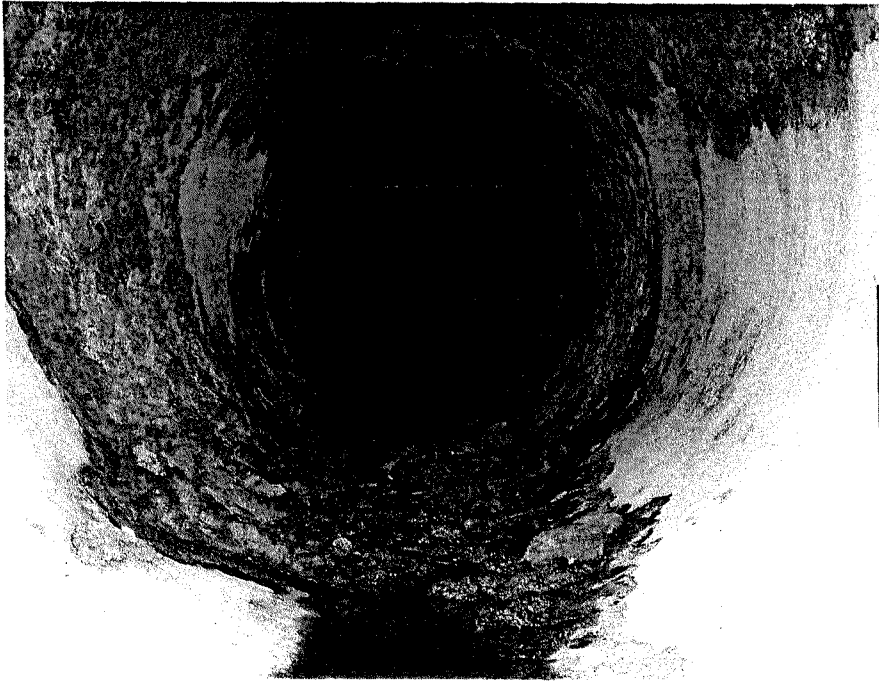
Lake Intake Pipe Before Cleaning

- Coating material has Extensive Service History Within Nuclear Industry and Duke Power
- QA Receipt of Material and Level B Storage of Material
- Coating Manufacturer provided Training and Qualified Coating Contractor
- QA/QC Service Level 1 Inspections of Entire Process
- Process Steps
 - High Pressure Water Cleaning
 - Weld Backing Ring Removal
 - 100% Engineering Condition Inspection
 - Biocide Treatment of Welds
 - Establish Environmental Controls
 - Abrasive Blast
 - Apply 3-Coat Plastacor Coating System
 - Robotic Video Inspection

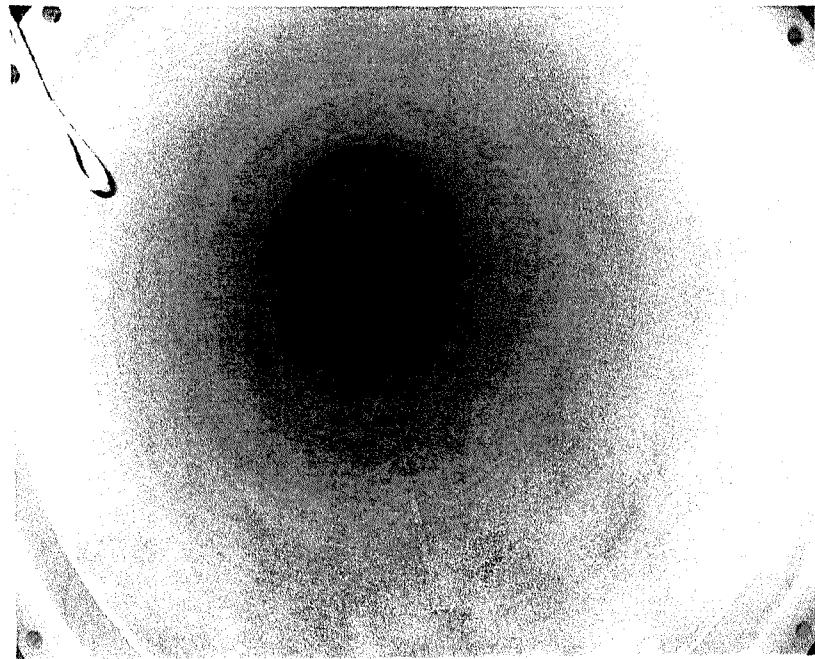
**Lake Intake Pipe After High Pressure
Water Cleaning**

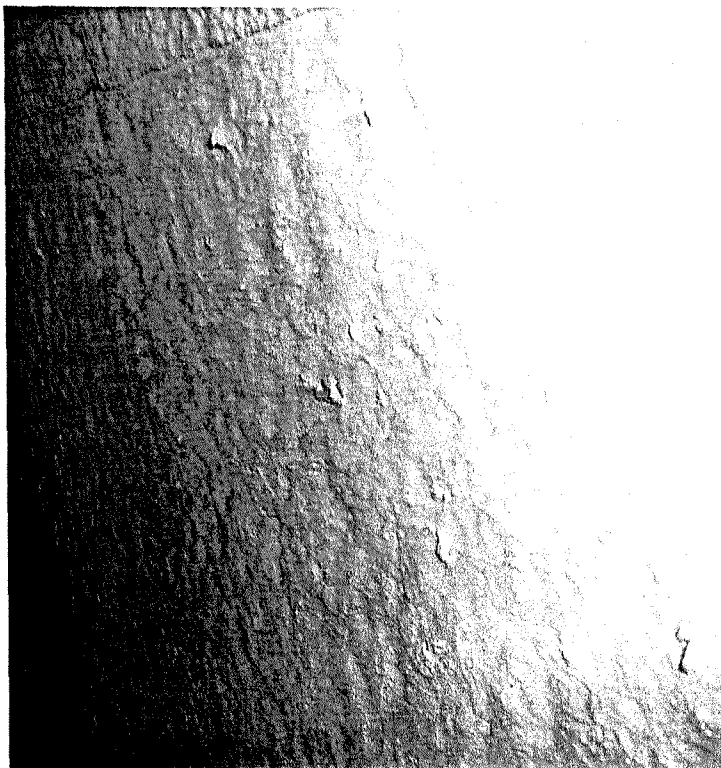
Lake Intake Pipe After Abrasive Blast

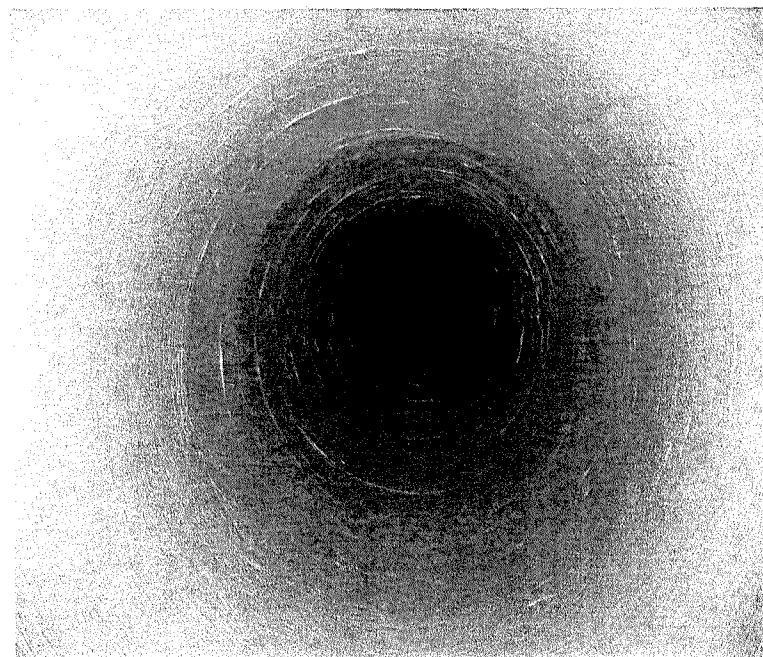
Lake Intake Pipe After Final Coating

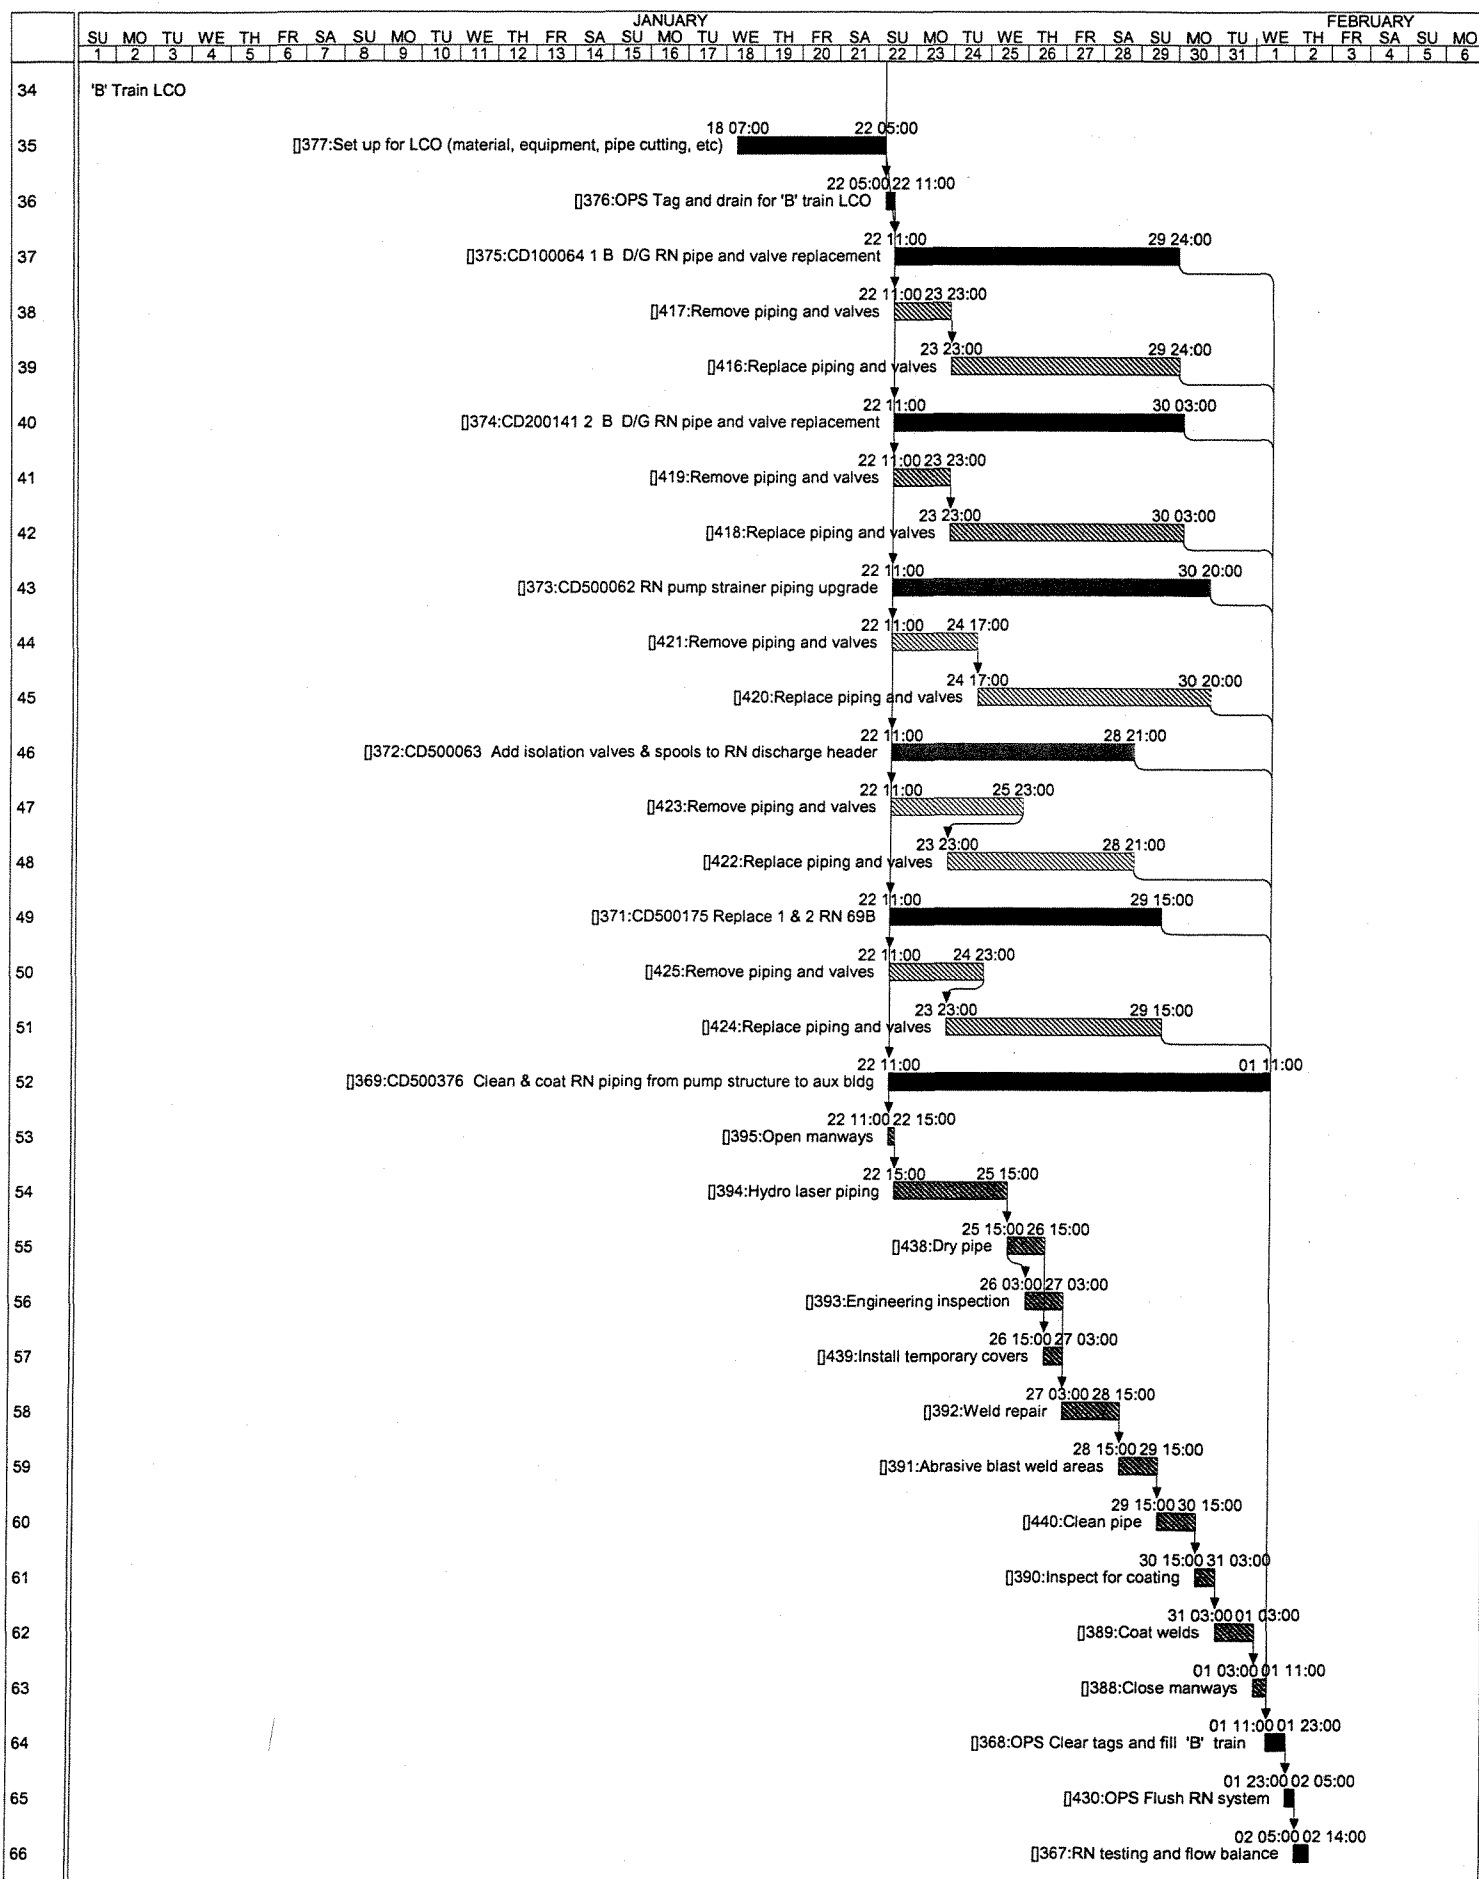
- Sequence for clean/coat of welds in supply piping requires:
 - System drain
 - High Pressure Water Clean and vacuum
 - Establish Environmental Conditions
 - Engineering weld inspection and repair (as required)
 - Abrasive Blasting for surface preparation
 - QC surface prep inspection
 - QA 1 coating application (hand trowel application) of only pipe welds

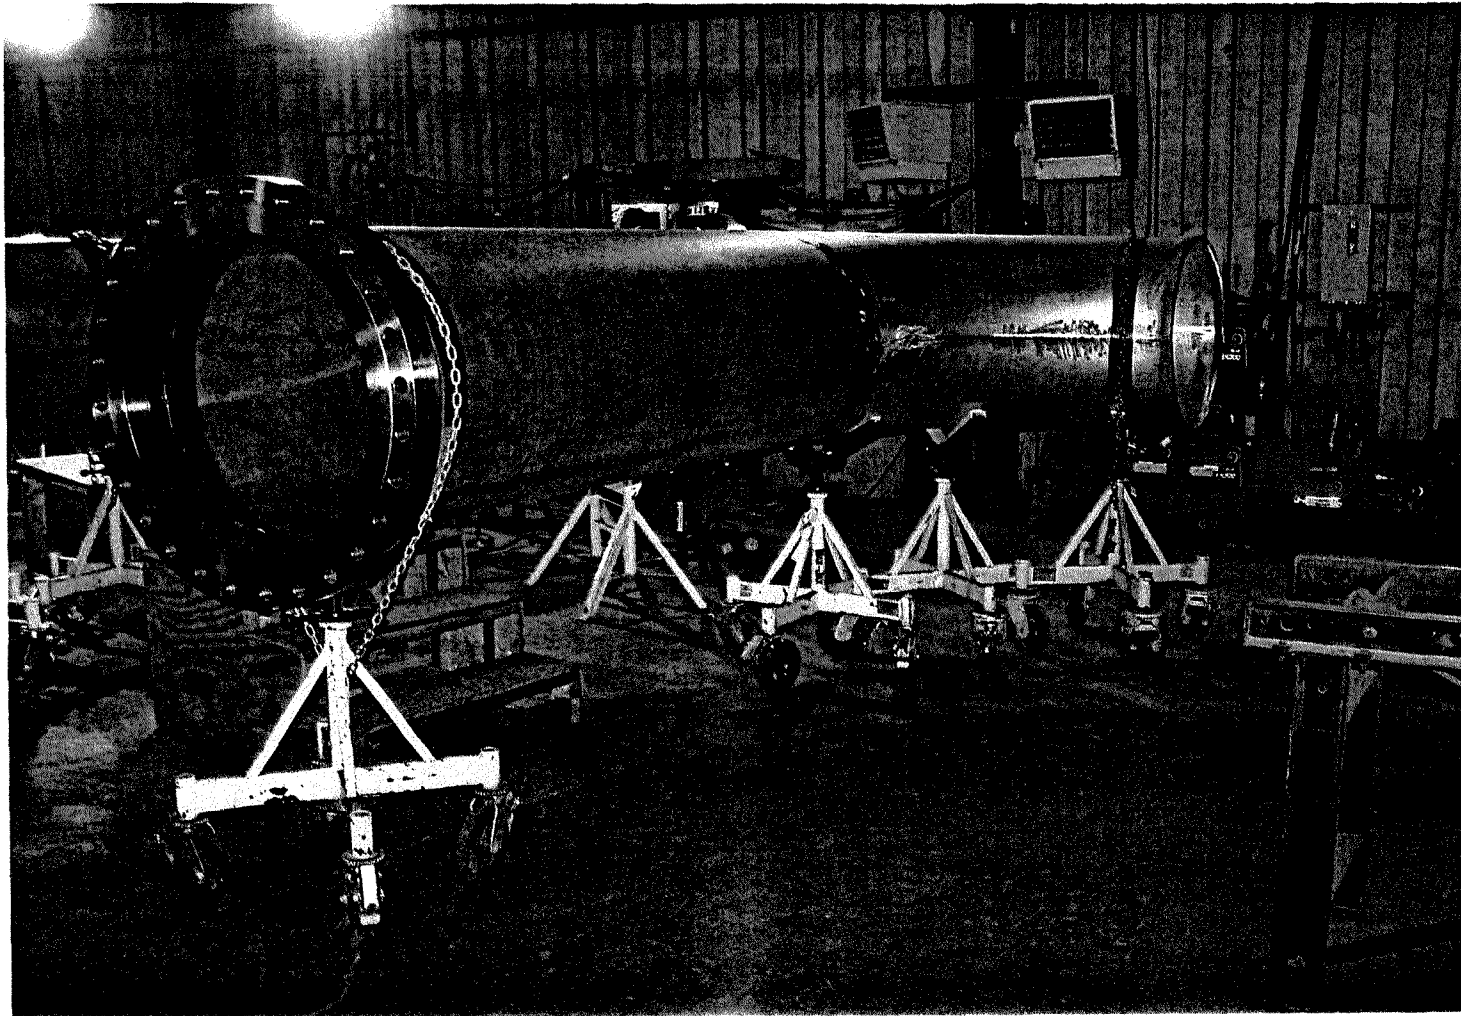
Pre-Fabrication of Piping For The 12 Day Nuclear Service Water Outages

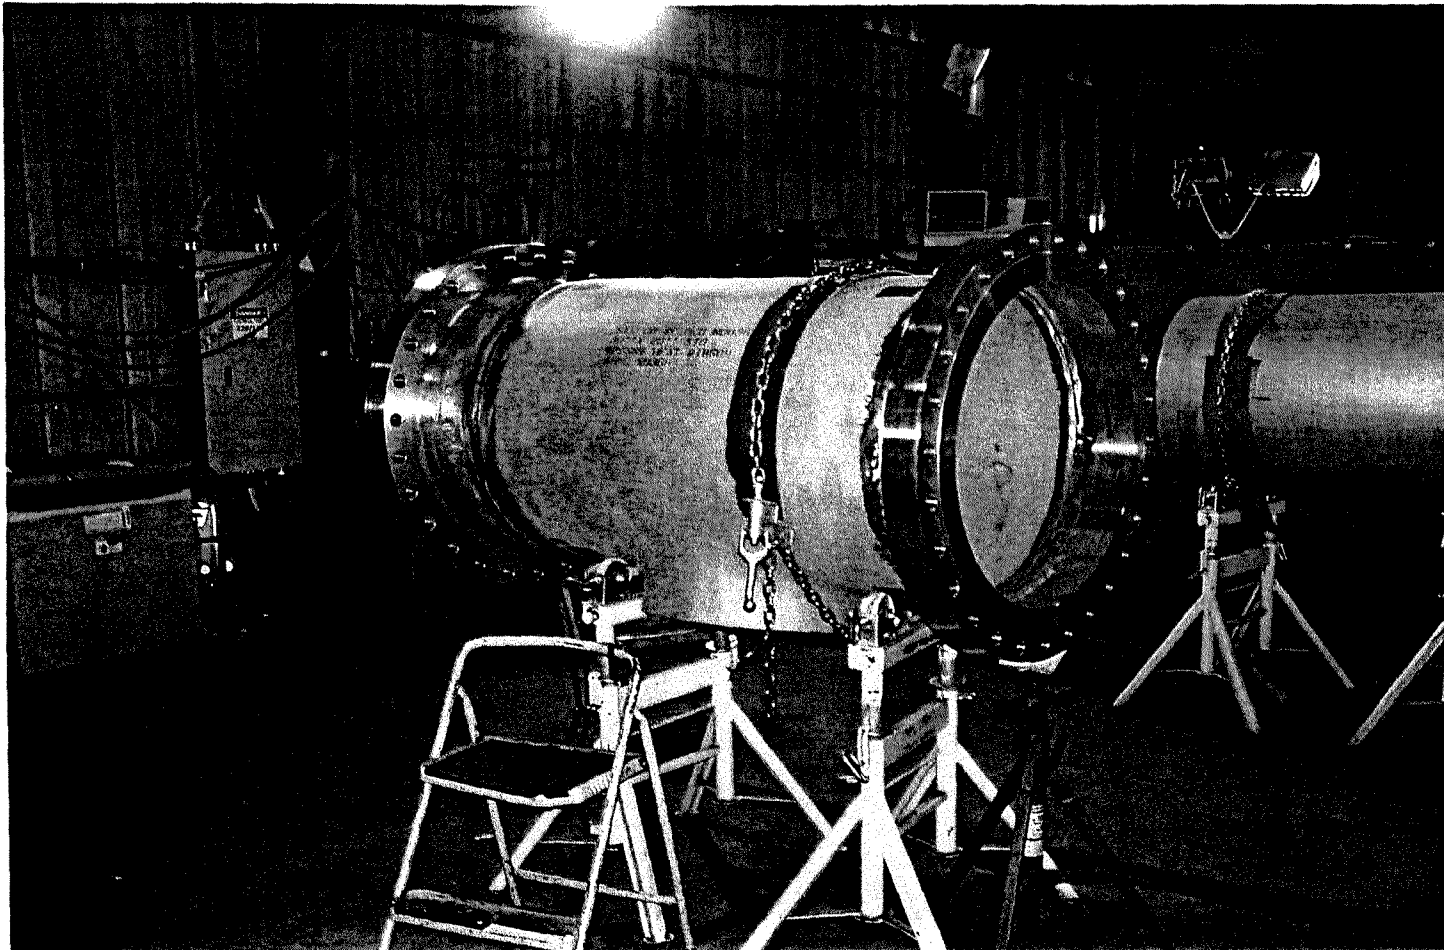
Pre-Fabrication of Piping For The 12 Day Nuclear Service Water Outages
