Section 4:
**Session 4: Crack Growth Rate Studies for
the Disposition of Flaws**

US REGULATORY EXPERIENCE AND PROGNOSIS WITH RPV HEAD DEGRADATION AND VHP NOZZLE CRACKING

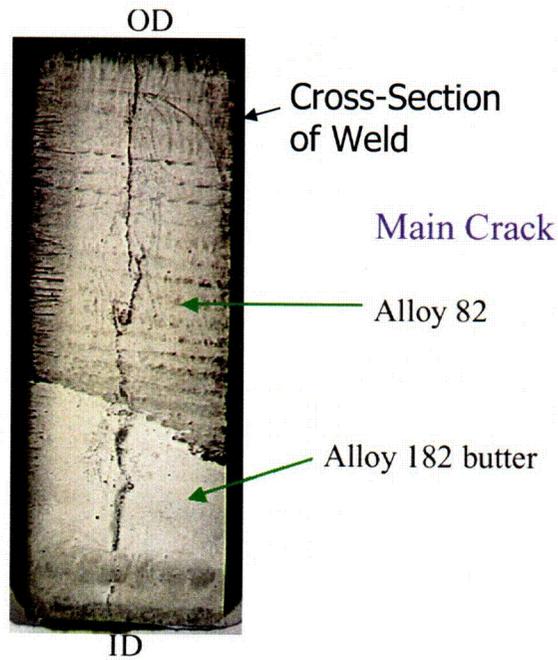
Figure 1. Photographs from the VC Summer hot leg, showing that both Alloys 182 and 82 are susceptible to primary water stress corrosion cracking (source: <http://www.nrc.gov/NRC/REACTOR/SUMMER/index.htm>).

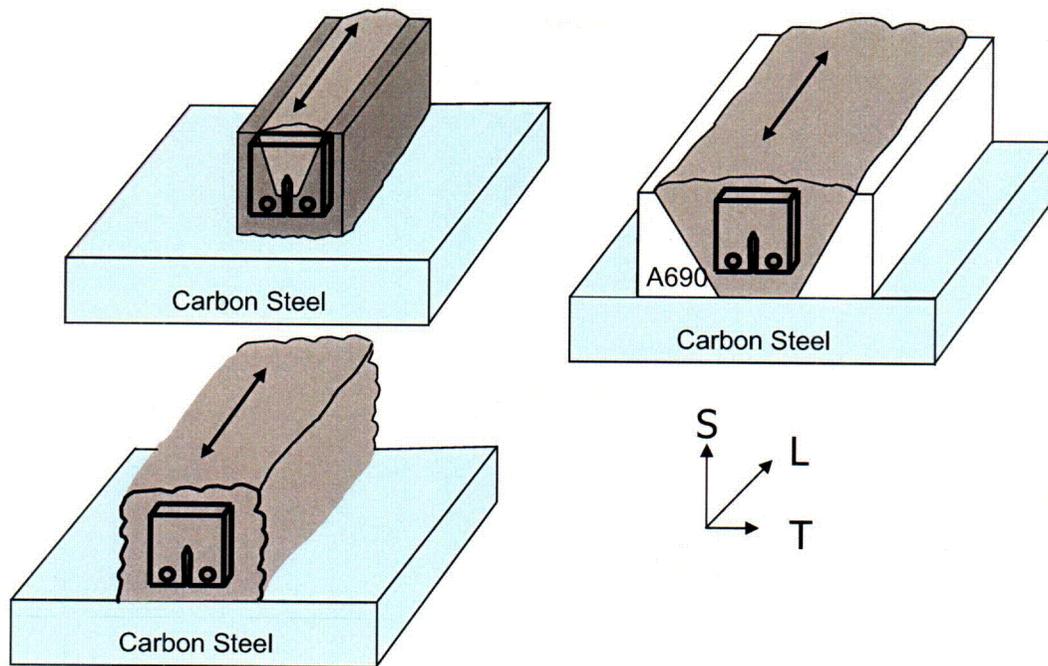
Figure 2. Specimen fabrication methods. Cracks grow from root-to-crown, in the T-S orientation. The arrows denote the welding direction. For the method in the upper left corner, the darker gray weld metal represents Alloy 82 weld buildup, which was subsequently machined to form a groove. Alloy 182 weld metal was then deposited (lighter gray). The end of the notch and the precrack were located in the Alloy 182 material. A similar specimen fabrication method has also been used by Studsvik [7].

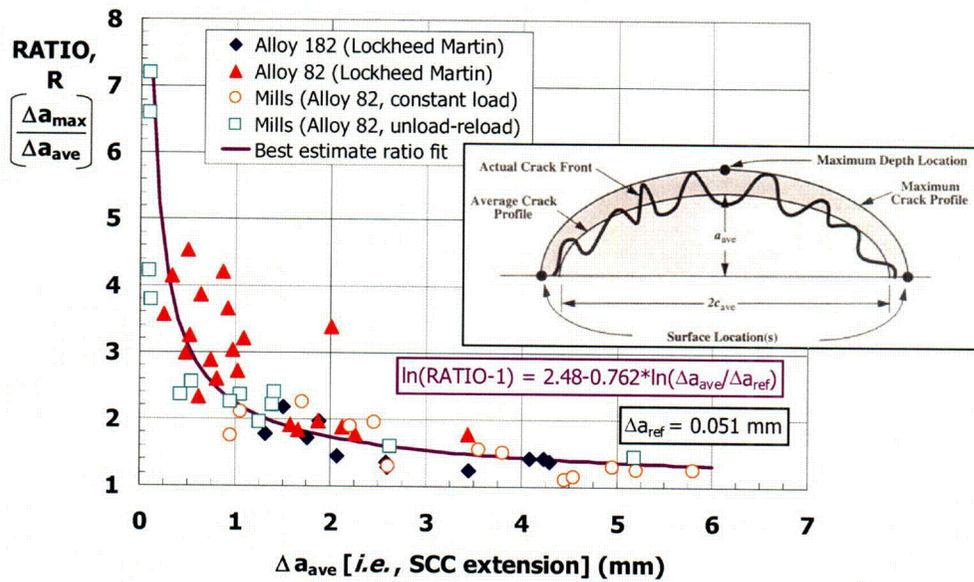
Figure 7. Quantification of the RATIO ($\equiv \Delta a_{max}/\Delta a_{ave}$) as a function of crack depth, based on data from [8] and the present work.

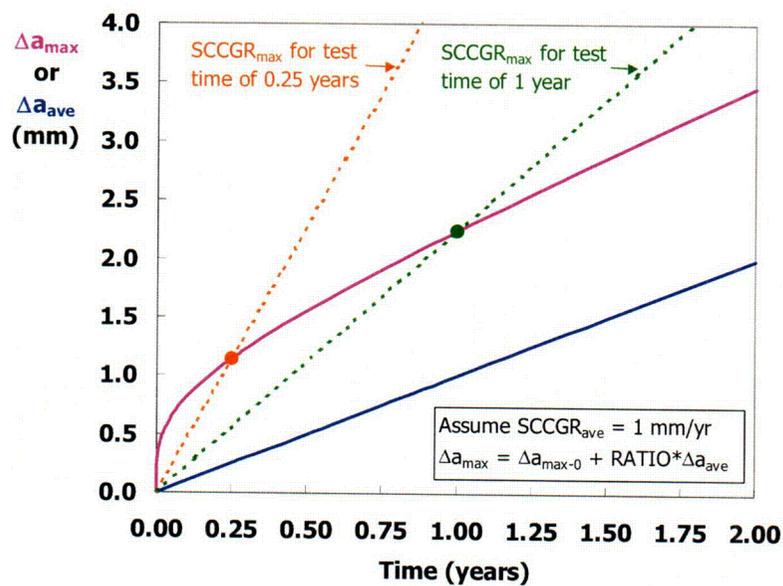
Figure 8. Schematic illustration of the effect of test time on the apparent maximum SCCGR. The Δa_{max} curve (magenta) was obtained by integrating the RATIO data in Figure 7, and by assuming an $SCCGR_{ave}$ of 1 mm/yr.

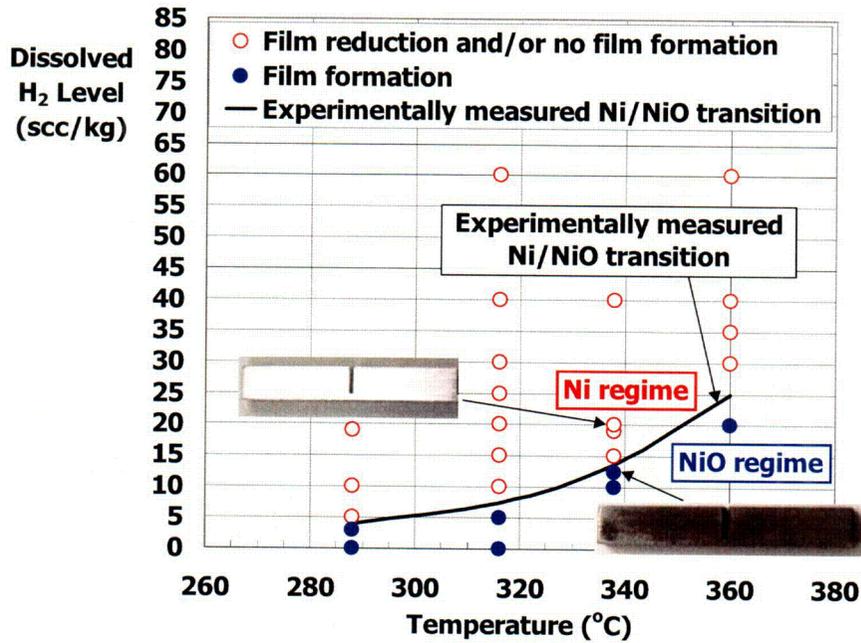
Figure 17. Summary plot of contact electric resistance (CER) and corrosion coupon data [27].

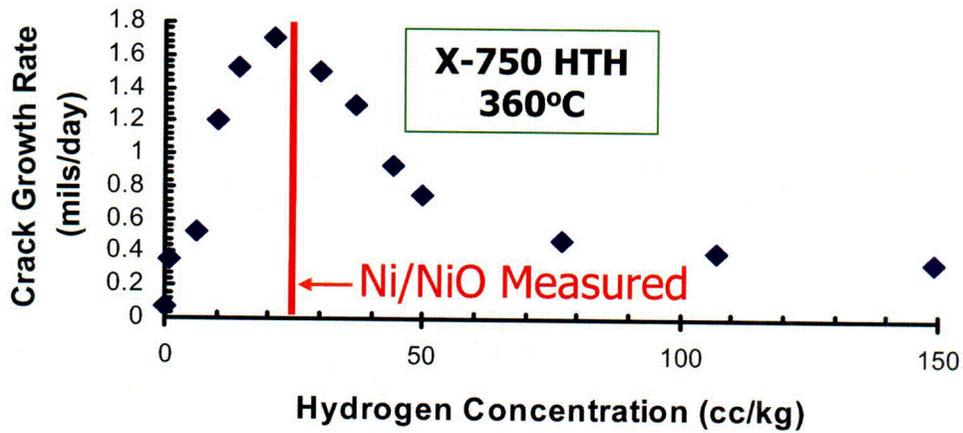
Figure 18. Dissolved hydrogen crack growth rate functionality at 360°C for Alloy X-750 in the HTH heat treatment [18].

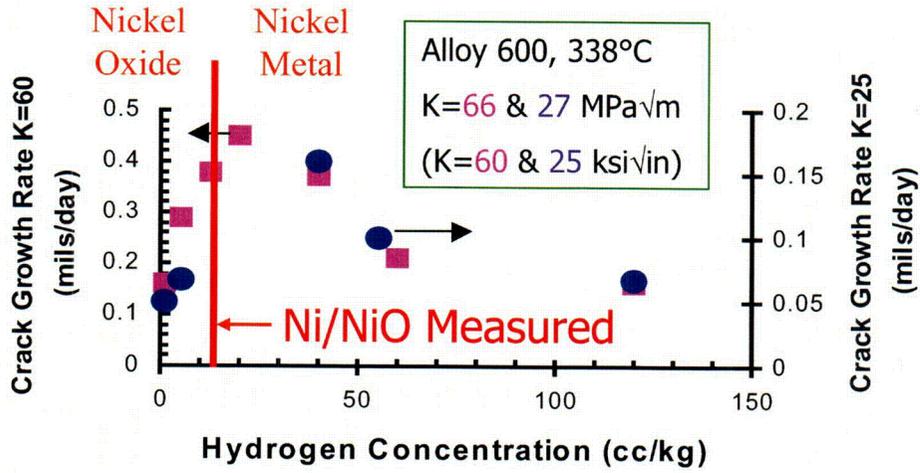
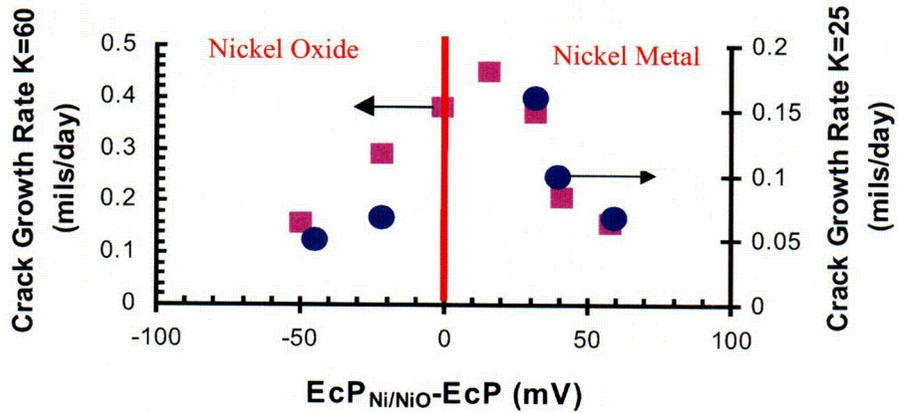
Figure 19. Alloy 600 dissolved hydrogen crack growth rate functionality at 338°C [18]. A value of 13.8 scc/kg H_2 was used as the hydrogen concentration of the Ni/NiO phase transition at 338°C, as shown in Figure 17. Details for calculating the correlating parameter $E_{cP_{Ni/NiO}} - E_{cP}$ are provided in References [17] and [29].

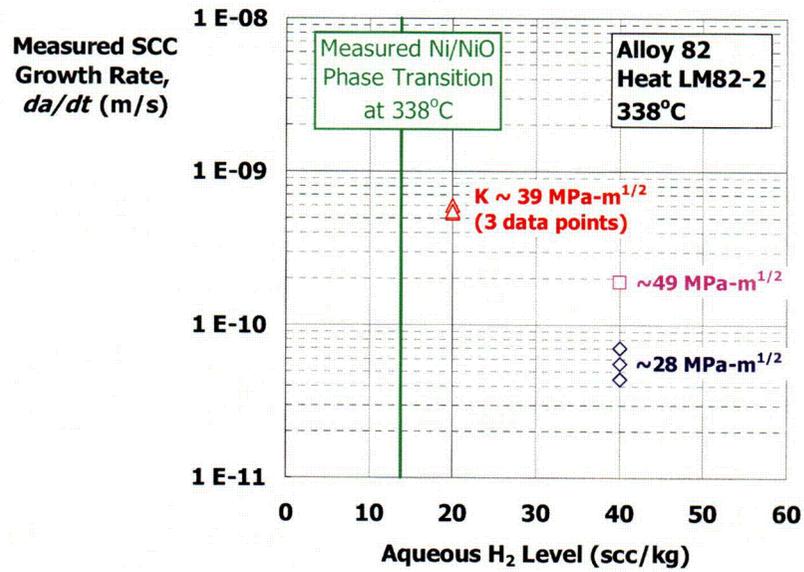
Figure 20. Effect of dissolved hydrogen on SCCGR of Alloy 82 (heat LM82-2) at 338°C. Note that the SCCGRs were not normalized to 325°C.

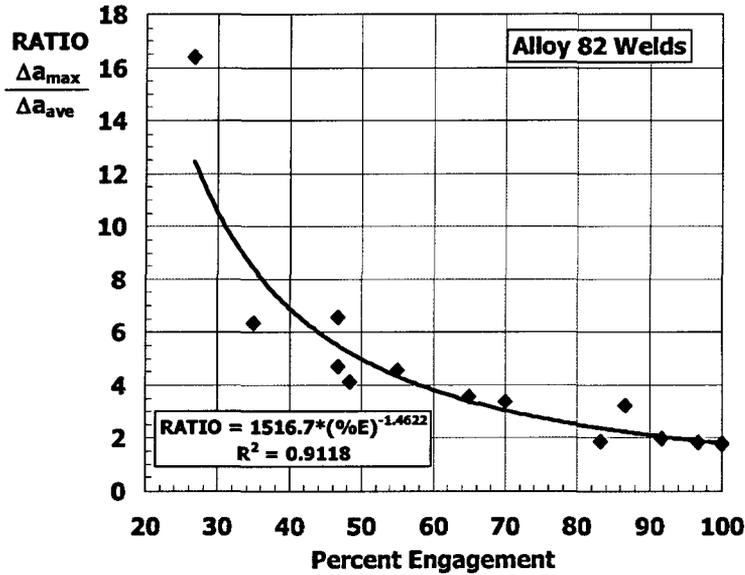
Figure A2. Correlation of maximum-to-average SCC extent ratio with percent engagement (%E). This correlation shows that, consistent with expectations, cracks with high ratios tend to have relatively low engagement. This plot can be used along with Figure 7 to infer the percent engagement for a specimen even if only Δa_{max} is known. This procedure may be of value in screening historical data for which percent engagement is not available.

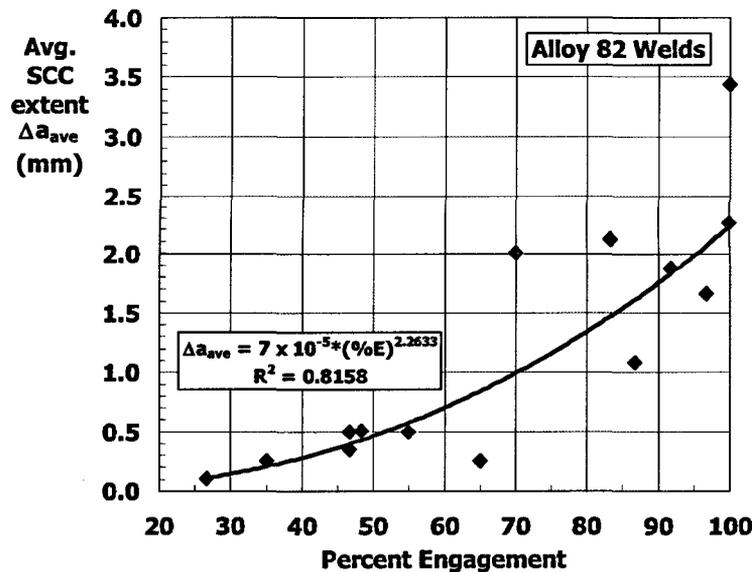
Figure A3. Correlation of average SCC extent (*i.e.*, Δa_{ave}) with percent engagement (%E). This correlation shows that, as expected, cracks with a larger depth of SCC also tend to be closer to full engagement across the precrack. This correlation may also be useful in certain cases for analyzing historical data for which %E is not available.

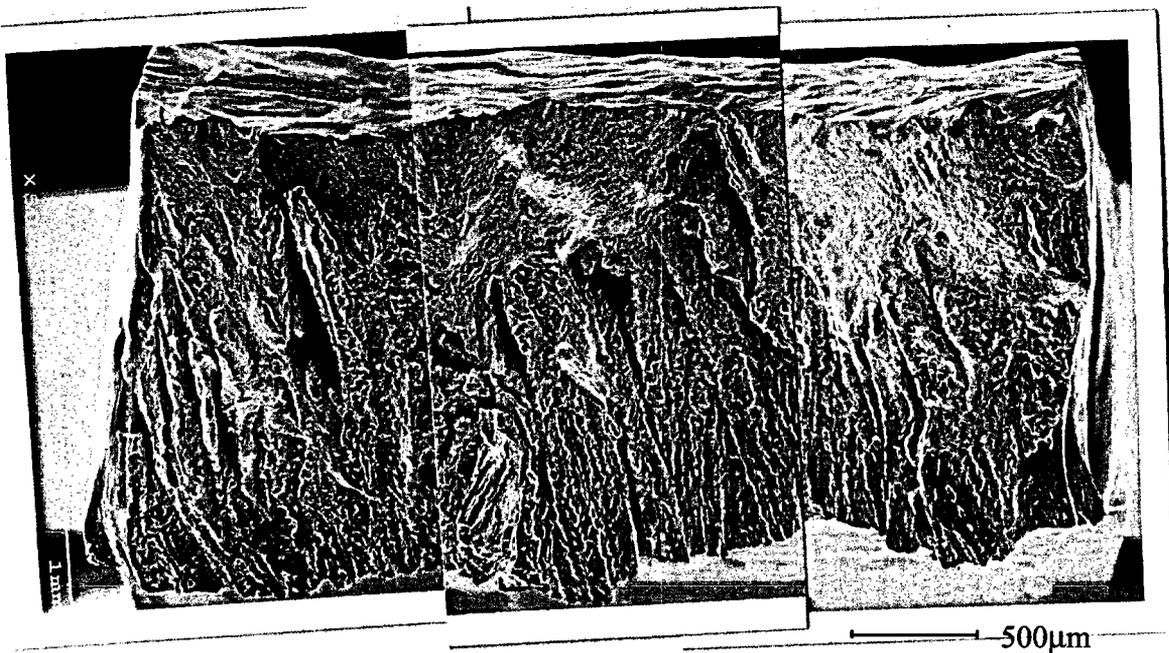
FIGURE 5 - SEM microphotograph of the fractured surface of Alloy 82 weld metal of the SSRT test specimen (Temp.: 360 °C)

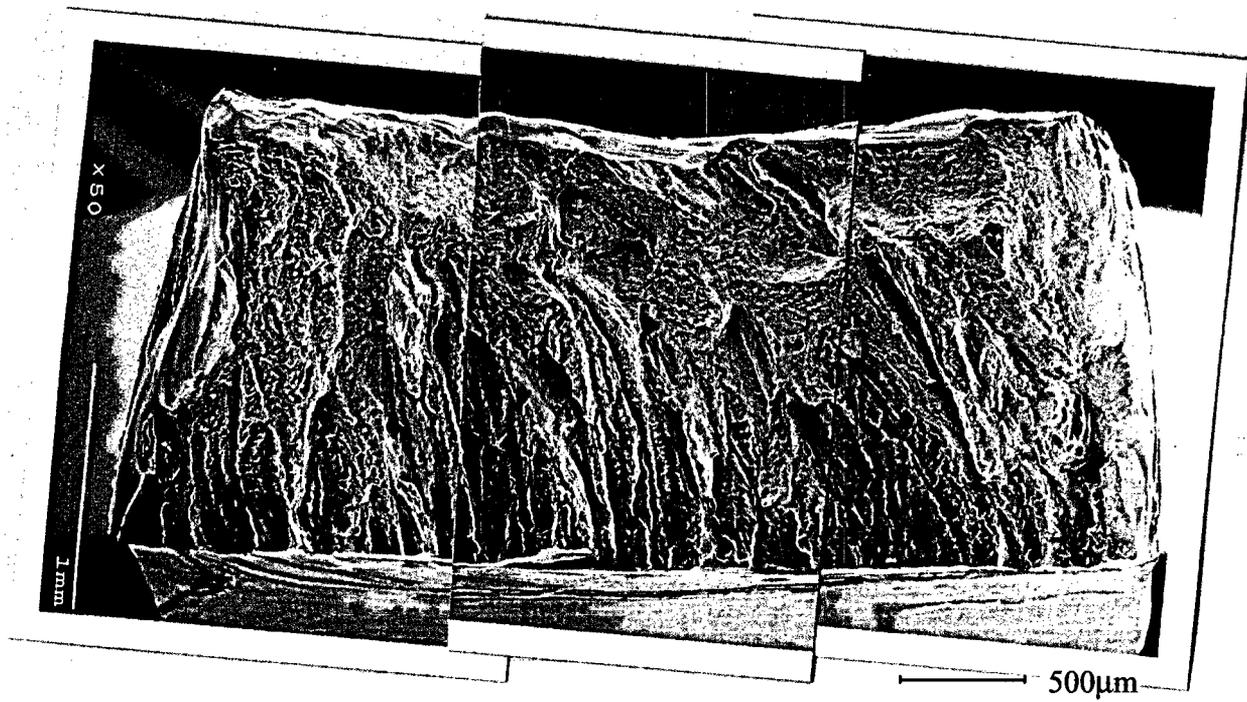
FIGURE 6 - SEM microphotograph of the fractured surface of Alloy 132 weld metal of the SSRT test specimen (Temp.: 360 °C)

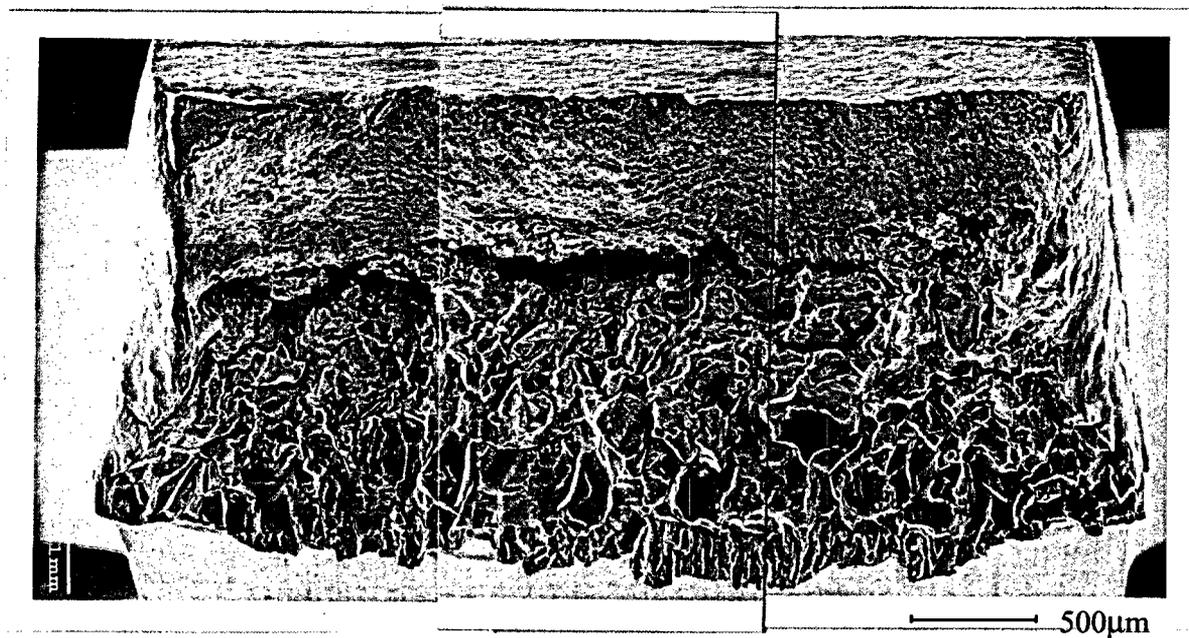
FIGURE 7 - SEM microphotograph of the fractured surface of HAZ welded by Alloy 82 of the SSRT test specimen (Temp.: 360 °C)

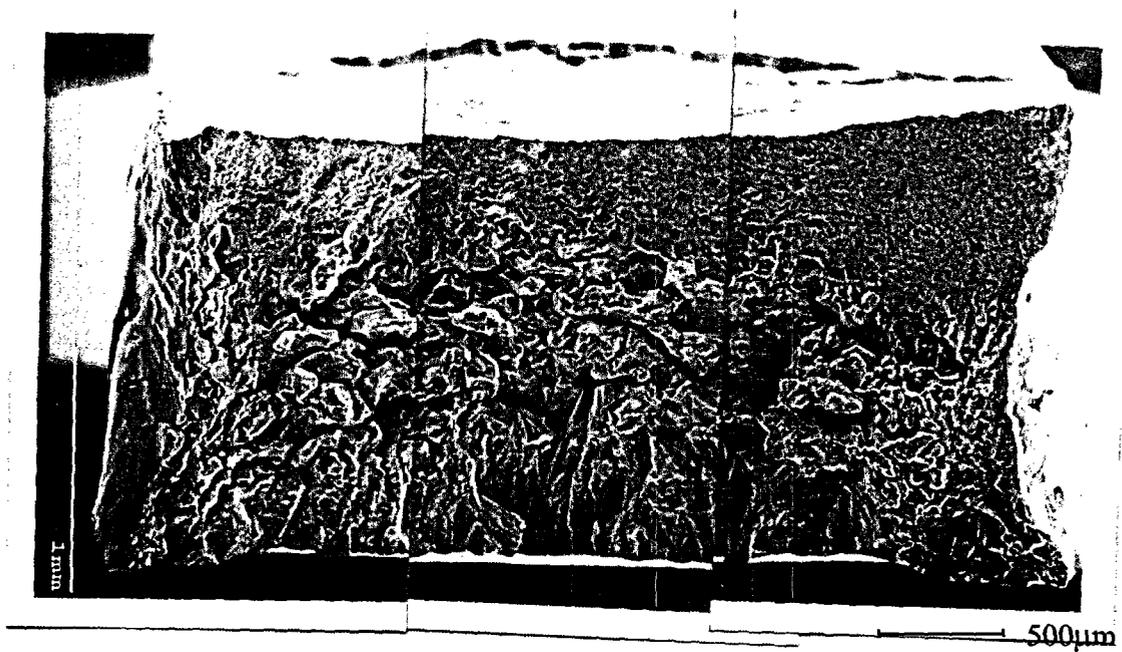
FIGURE 8 - SEM microphotograph of the fractured surface of HAZ welded by Alloy 132 of the SSRT test specimen (Temp.: 360 °C)

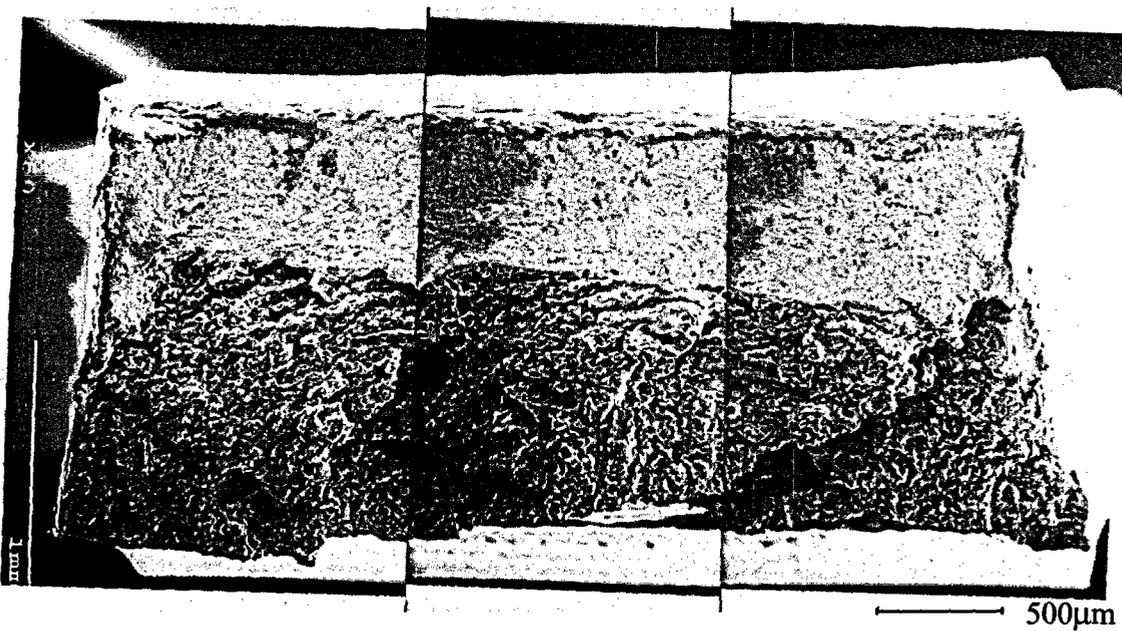
FIGURE 9 - SEM microphotograph of the fractured surface of Alloy 600 base metal of the SSRT test specimen (Temp.: 360 °C)

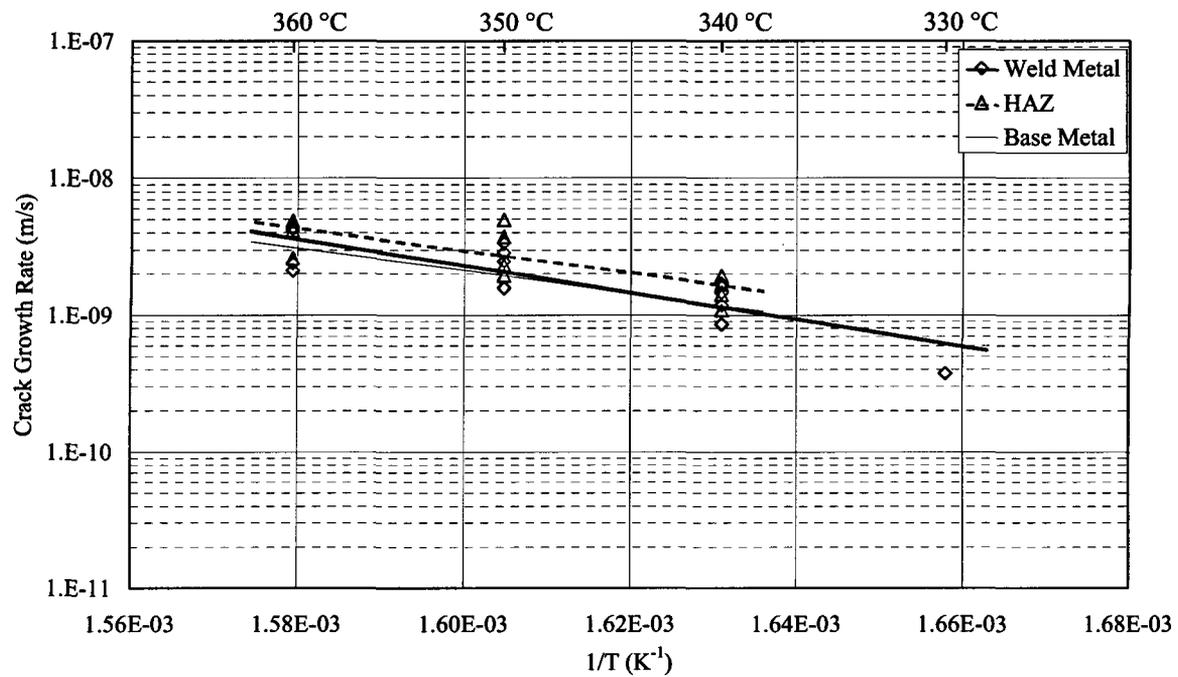
FIGURE 10 - Relationship between Temperature and Crack Growth Rate of Alloy 82 Weld Metal and HAZ in SSRT

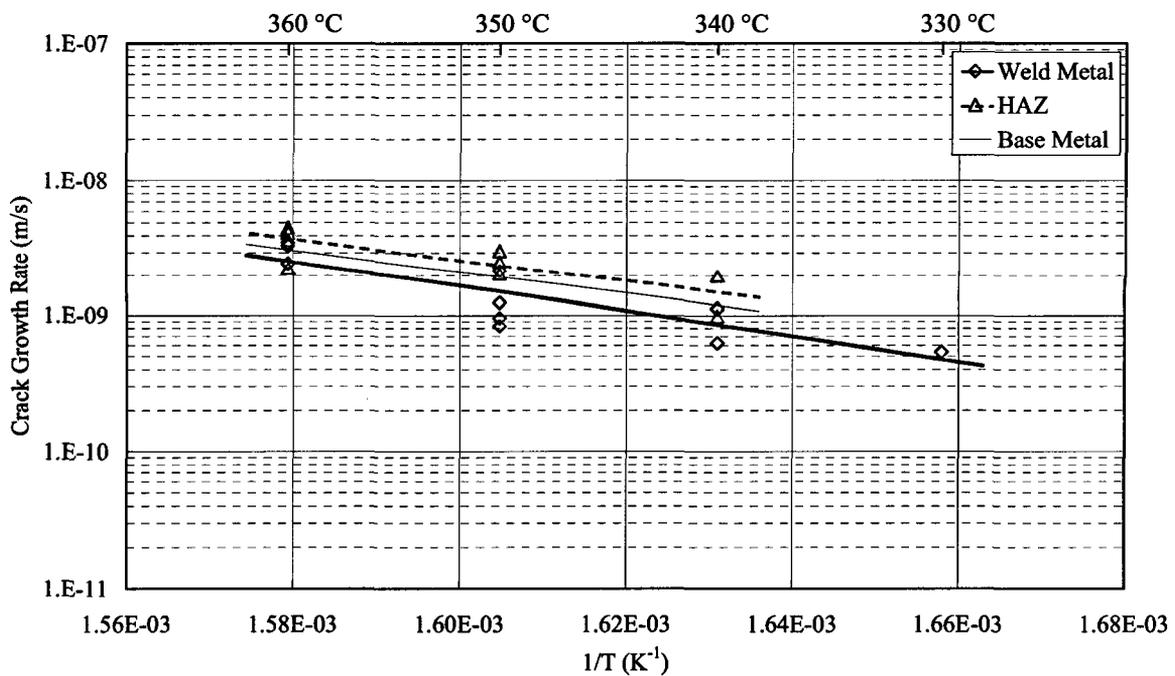
FIGURE 11 - Relationship between Temperature and Crack Growth Rate of Alloy 132 Weld Metal and HAZ in SSRT

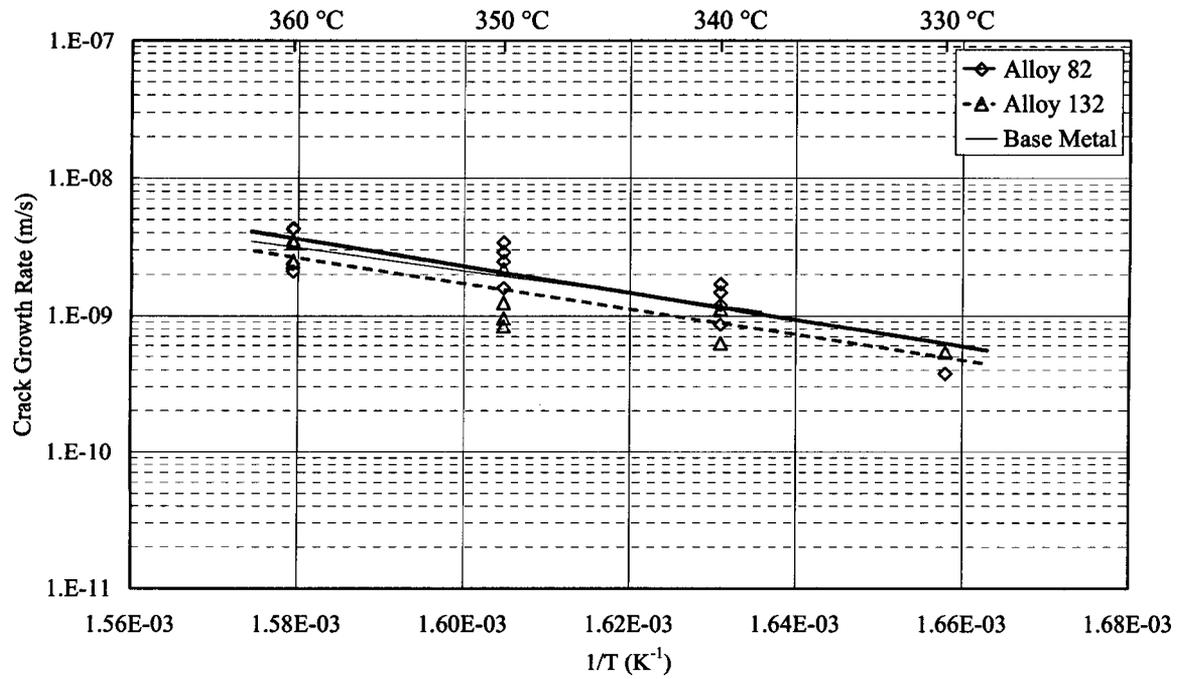
FIGURE 12 - Relationship between Temperature and Crack Growth Rate of Weld Metal in SSRT

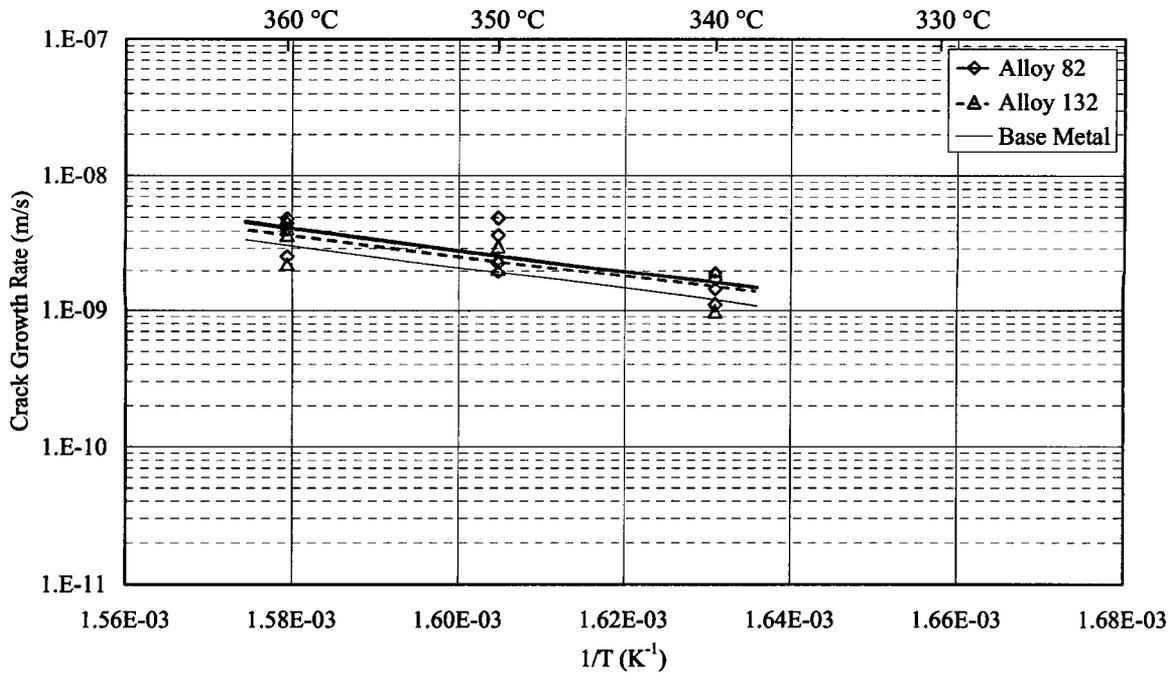
FIGURE 13 - Relationship between Temperature and Crack Growth Rate of HAZ in SSRT

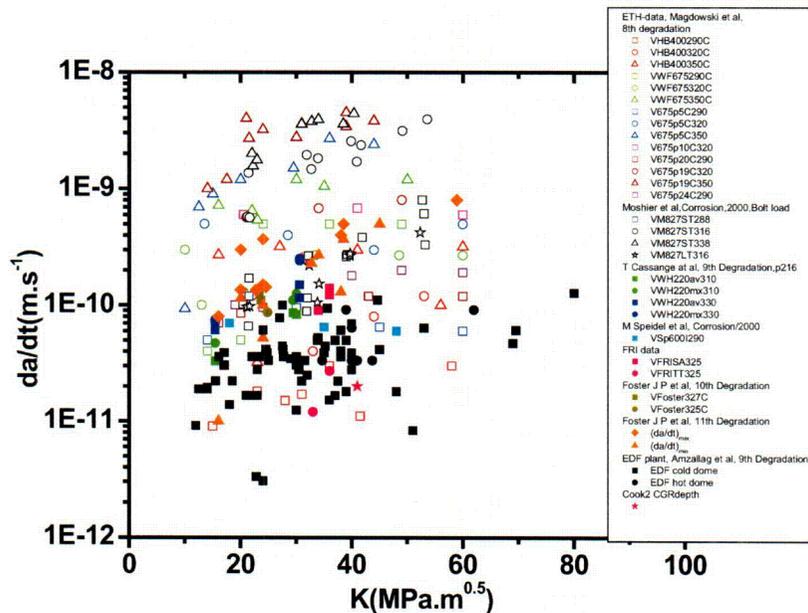
Figure 1 Crack growth rates of alloy 600 thick-plate materials in simulated PWR primary water environments^[4-12].

Laboratory results showed that many factors affect PWSCC of alloy 600. Material chemistry and microstructure, such as the fraction of Coincidence Site Lattice Boundaries (CSLB), coverage fraction and distribution of grain boundary carbides, temperature, stress intensity factor (K), yield strength (YS), loading pattern and dK/dt , are found to have significant effects on the PWSCC CGR of alloy 600. Crack growth rates of alloy 600 thick-plate materials from tests with fracture mechanics specimens in simulated PWR environments from several reference papers [4-11] are summarized in Figure 1. The CGR data from real PWR plants, EDF data^[11] and Cook 2 data,^[12] are shown in Figure 1, along with experimental data. The da/dt data are plotted against the stress intensity factor, K.

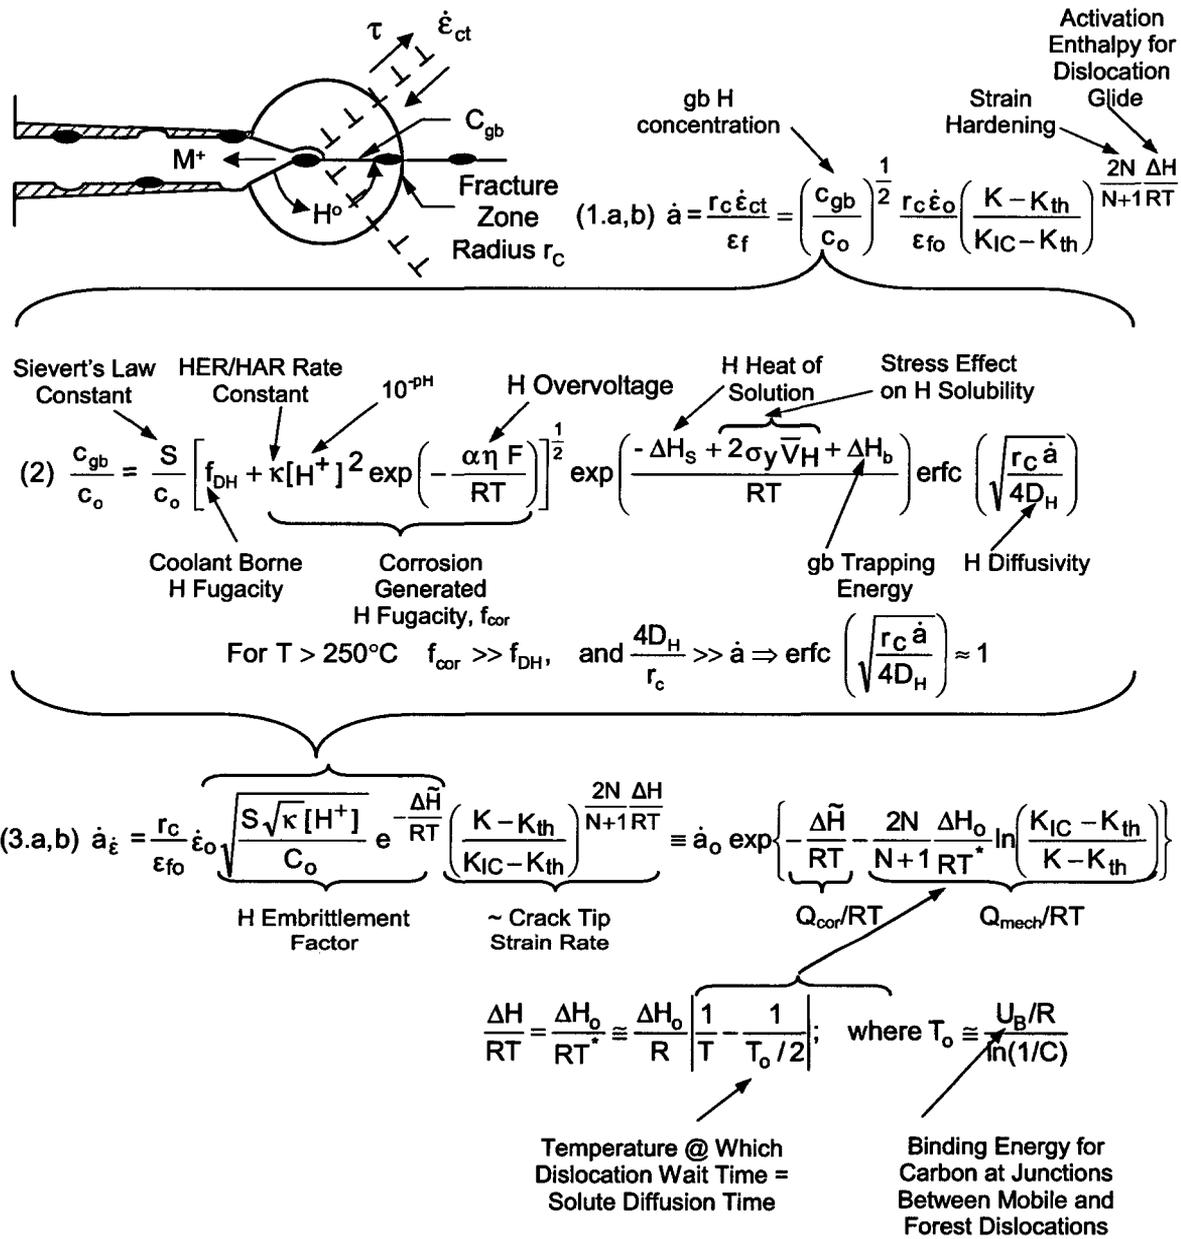
Fig. 1. Essential features of the HACF model with model equations showing corrosion and mechanical contributions to the crack growth rate.

At the temperatures of PWR normal operation ($T > 250$ °C), the cathodic reduction of water produces nascent hydrogen with a fugacity f_{cor} that exceeds the usual coolant-borne hydrogen fugacity, f_{DH} . The fugacity of this corrosion-generated hydrogen is dependent on the crack tip pH and the hydrogen overvoltage of the crack tip corrosion-oxidation reaction. The crack tip hydrogen concentration, equation (2), is a function of both the hydrogen permeation rate as well as the crack velocity. When the hydrogen permeation rate is greater than the Alloy 600 SCC crack velocity (for example, for mill annealed Alloy 600 and $T > 250$ °C), the CGR is independent of the permeability. In this case, the CGR equation can be simplified to obtain a power-law CGR equation, (3.a), which is the form that is commonly assumed for empirical SCC CGR correlations. Note that we have adopted here the logarithmic expression for stress-dependent activation enthalpy discussed by Hall and Symons. This choice is compatible with the available analytic solutions to the crack tip stress-strain rate problem and allows us to obtain the more customary power-law CGR equation in lieu of the exponential-law equation of our previous publication. When the hydrogen permeability does not exceed the crack velocity, equation (2) can be solved to obtain an equation in which CGR is proportional to the hydrogen permeation rate. This low-temperature limiting form of the HACF model is not discussed here.

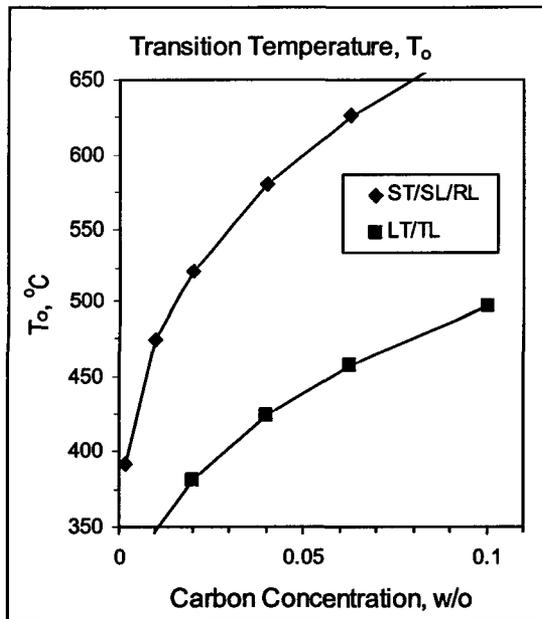
Figure 8. Carbon and Crack Growth Orientation Dependence of the Transition Temperature.

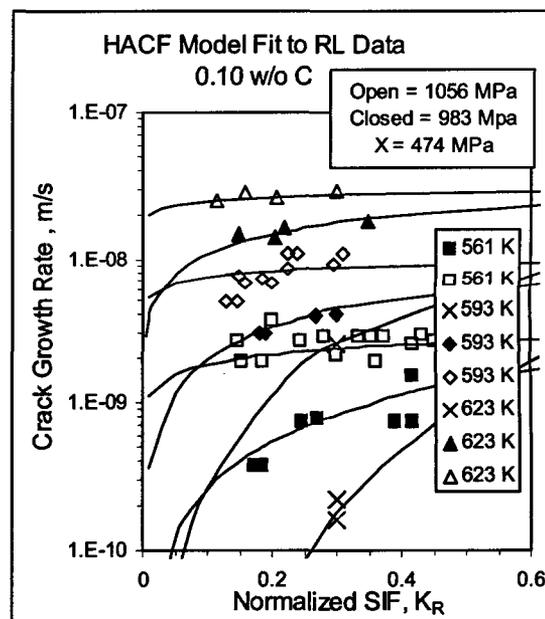
Figure 9. HAF Model Fit to RL CGR Data. Both temperature and yield stress (cold work) effects on CGR are shown.

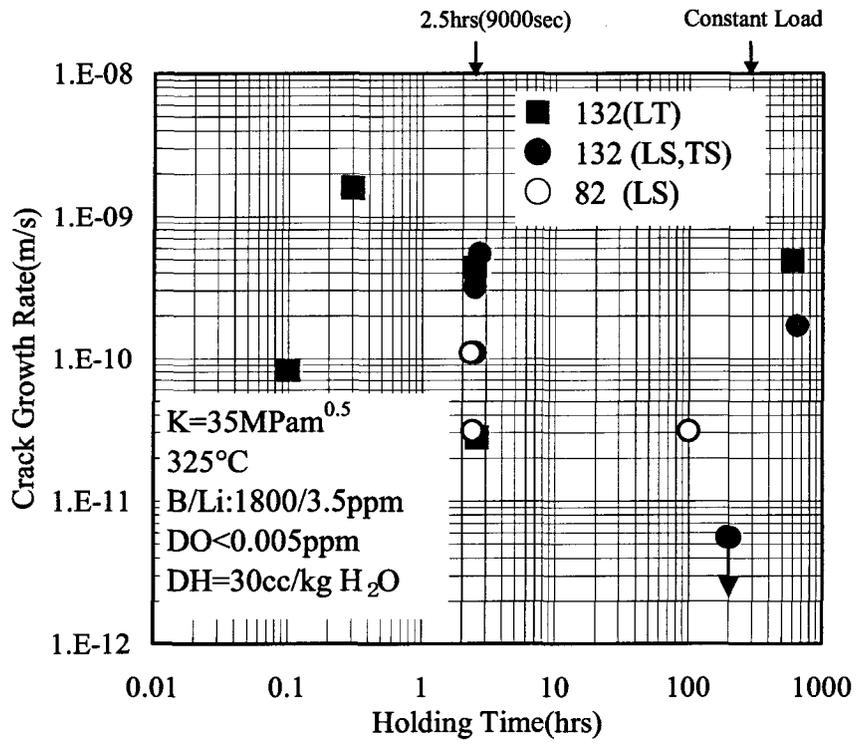
Figure 18 The effect of holding time for cyclic loading on CGRs

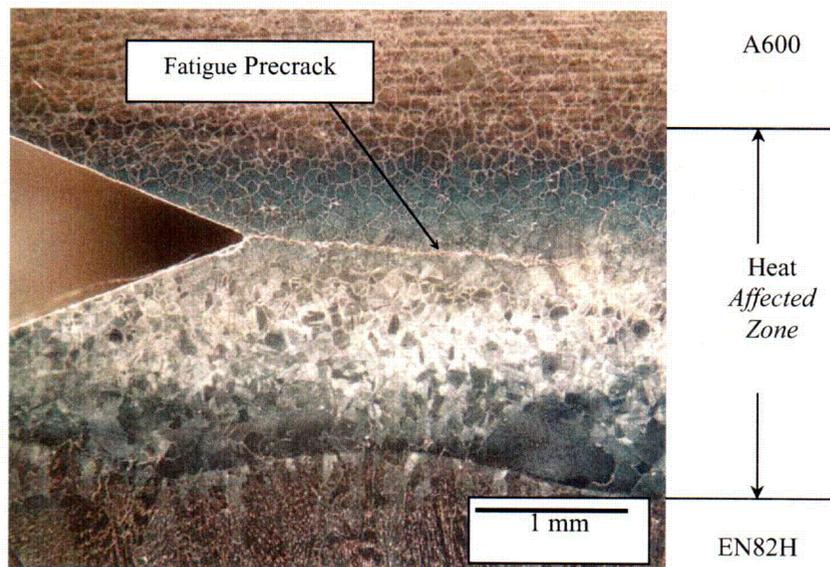
Figure 2. Light macrograph of the CT specimen notch and fatigue precrack. Note that the precrack is entirely within the A600 HAZ. 8:1 Phosphoric Acid, Electrolytic Etch.

For the HAZ samples, post-test inspection revealed that all of the machined notches, fatigue precracks, and subsequent SCC were located within the HAZ. The location of a typical notch and precrack is shown in Figure 2. For some specimens, the notch and precrack were located closer to the EN82H weld metal. As will be shown below, it appears that in the weld investigated, the preferred SCC plane is approximately 20 mils (~0.5 mm) from the EN82H / A600 interface.

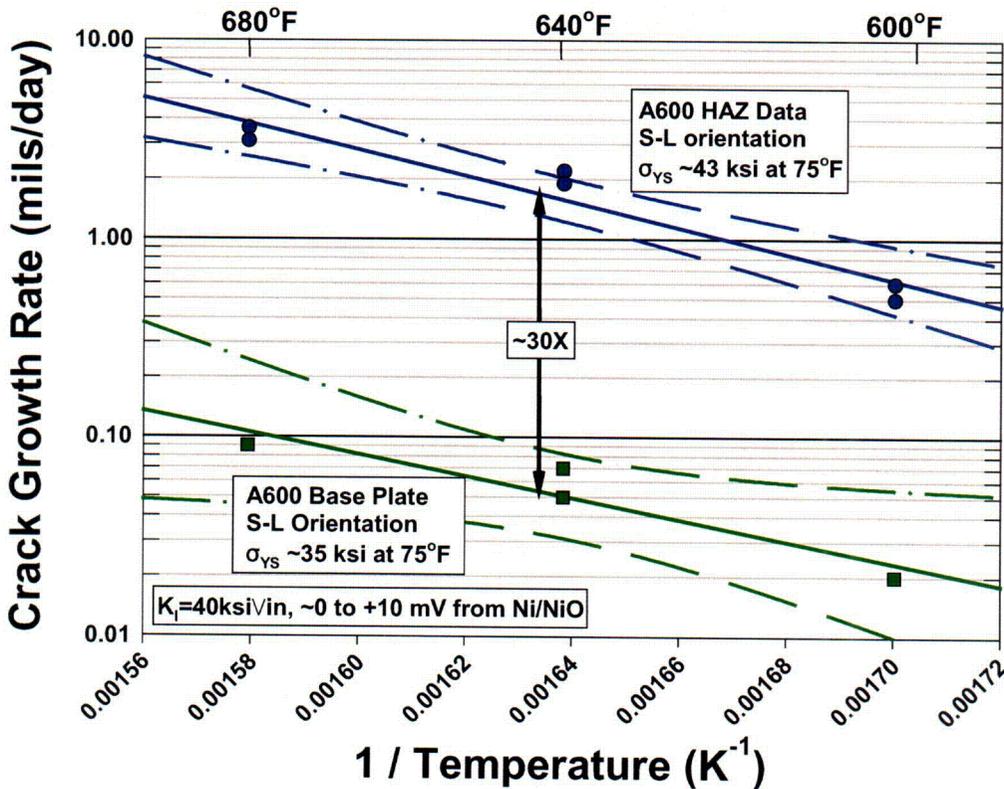
Figure 3. Comparison of the A600 HAZ data (blue points) with a prediction for typical high temperature annealed A600 (i.e. the unaffected base material).

In-situ instrumentation of the crack mouth opening displacement was conducted with linear variable displacement transducers (LVDT's). The LVDT instrumentation was used to define the start of crack growth. However, instrumentation was not used to determine the crack growth rates. Since out of plane cracking and extensive crack branching were observed with the HAZ samples (and likely bias the instrumentation) crack growth rates were calculated from visual measurements of the crack lengths. To facilitate crack measurement, the samples were heat tinted prior to measurement and thirty separate measurements across the CT specimen width were used to determine the average and maximum crack lengths. The SCC test results are summarized in Figure 3 and show that the crack growth rates for HAZ samples range between ~0.5 mils/day at 600°F to ~3.6 mils/day at 680°F. Relative to the A600 base plate (squares) the HAZ samples (circles) crack approximately 30X faster.

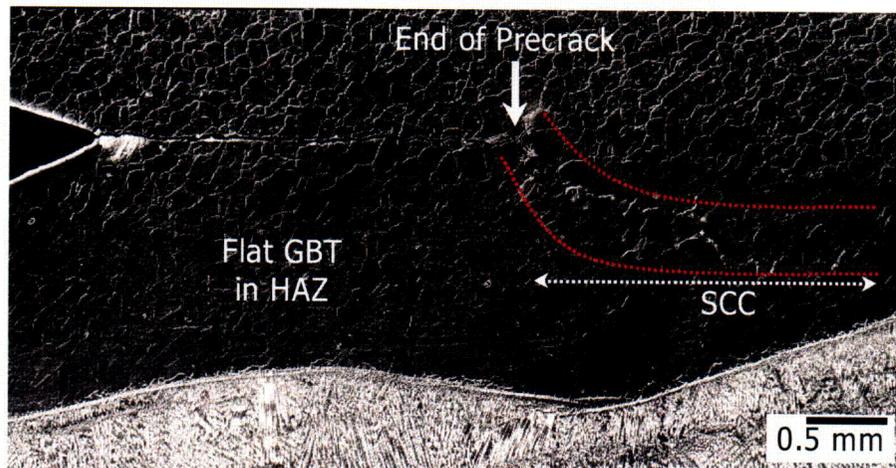
Figure 4. Cross section of the fatigue precrack and SCC crack plane from an A600 HAZ sample at 680°F. GBT refers to the grain boundary topography.

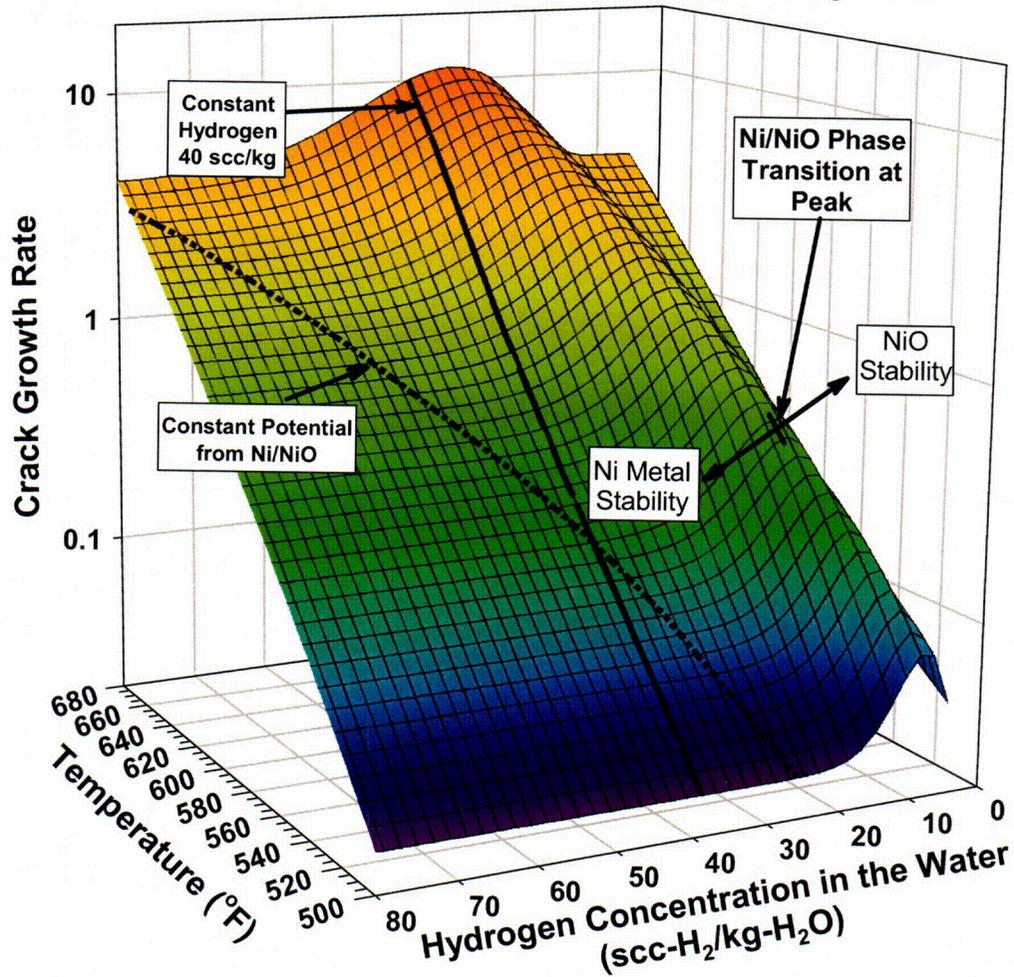
Figure 6. Schematic illustration of the effect of the Ni/NiO phase transition on the stress corrosion crack growth rate of A600-type alloys in high purity water. When determining the activation energy for crack growth, testing should be done at constant potential (dashed line) or far into the Ni metal stability regime to avoid biasing some of the data to faster crack growth rates and larger apparent activation energies.

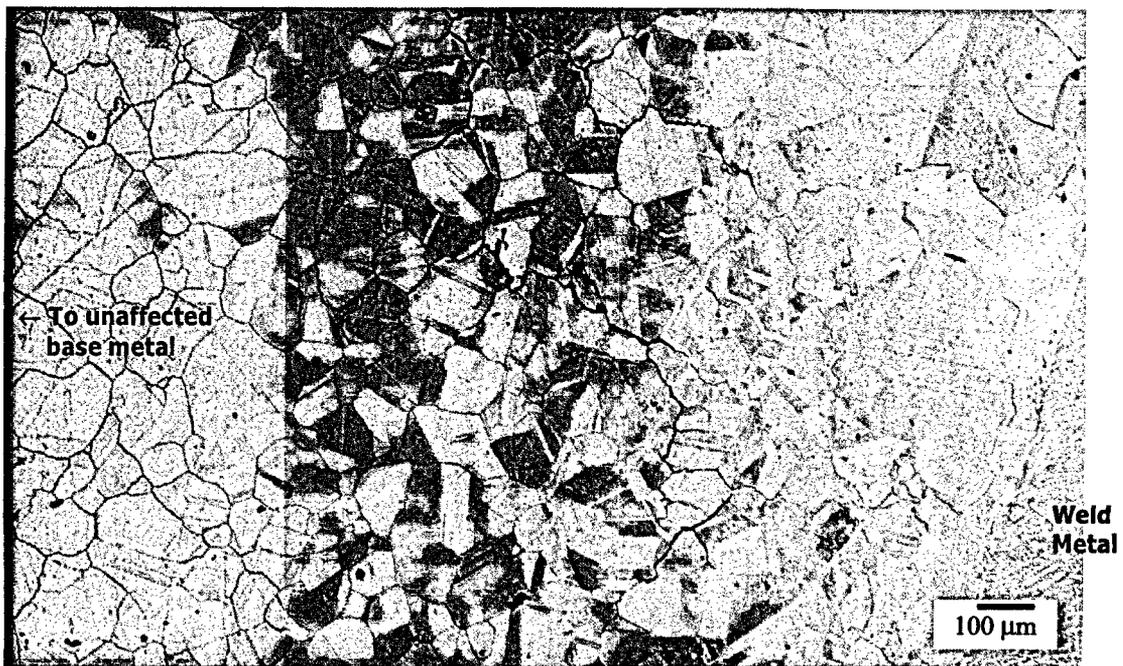
Figure 7. Light micrograph of a HAZ SCC crack. Note the intergranular crack path and crack branching. 8:1 phosphoric acid, Nomarski, DIC.

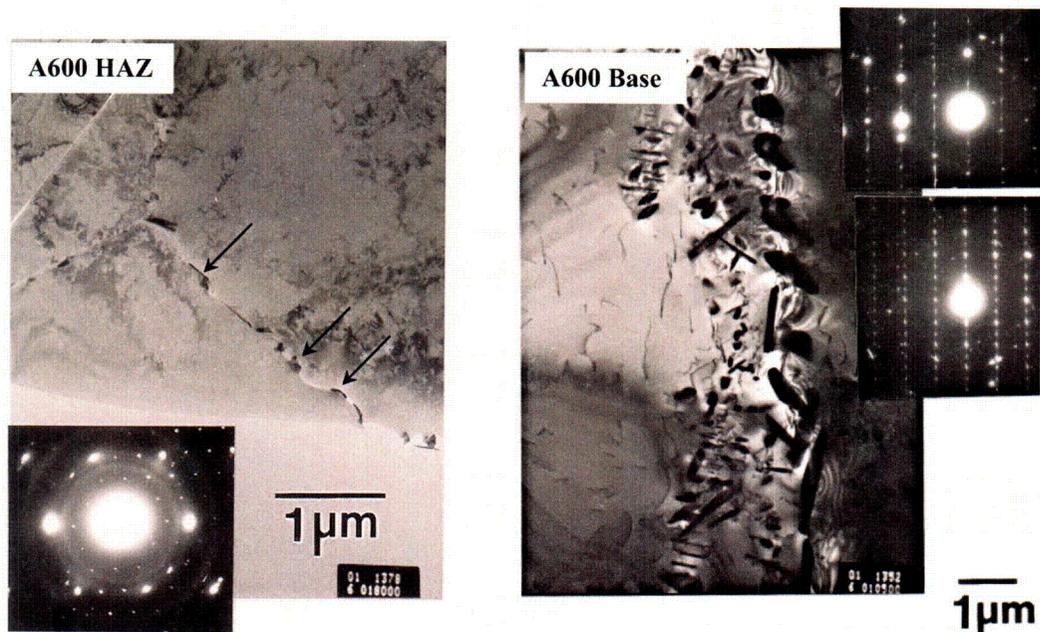
Figure 8. Transmission electron microscopy of the A600 HAZ (left) and the A600 base material (right). Note the few $M_{23}C_6$ -type carbides in the HAZ (arrows) while the unaffected base material displays extensive inter- and intra-granular M_7C_3 -type carbides.

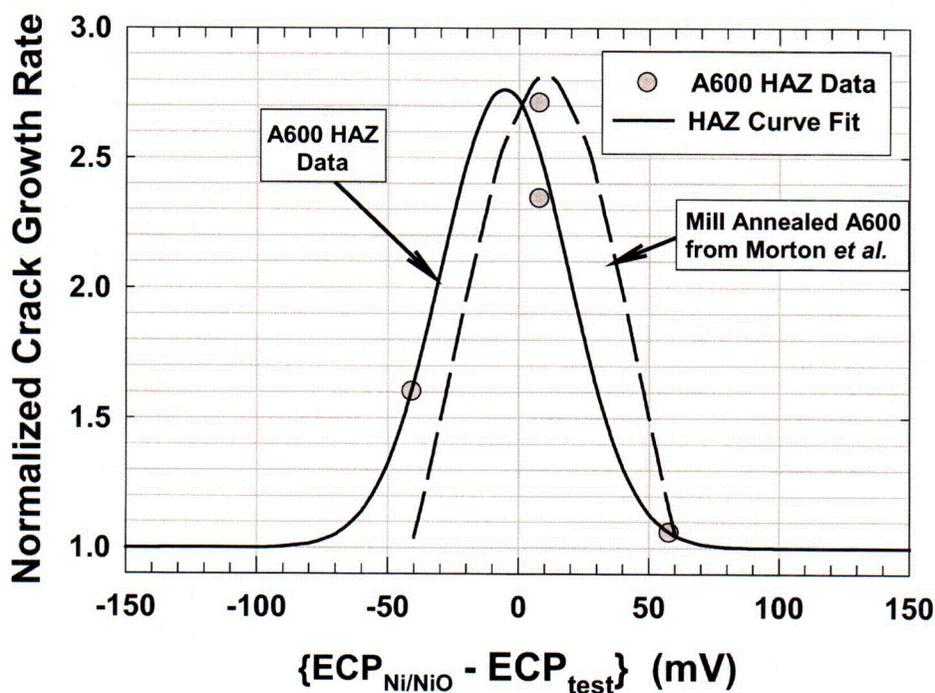
Figure 14. Comparison of the effect of electrochemical potential on the crack growth rate of A600 base material and on the A600 heat affected zone, showing almost identical response. See reference [11] for additional information.
