Section 4:
**Session 4: Crack Growth Rate Studies for
the Disposition of Flaws**

US REGULATORY EXPERIENCE AND PROGNOSIS WITH RPV HEAD DEGRADATION AND VHP NOZZLE CRACKING

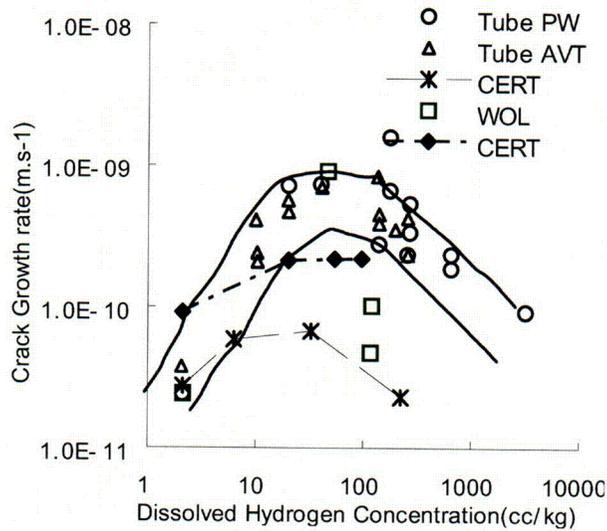
FIGURE 1. Influence of hydrogen concentration on the crack growth rate of PWSCC in Alloy 600 at 360 °C.^{10,11}

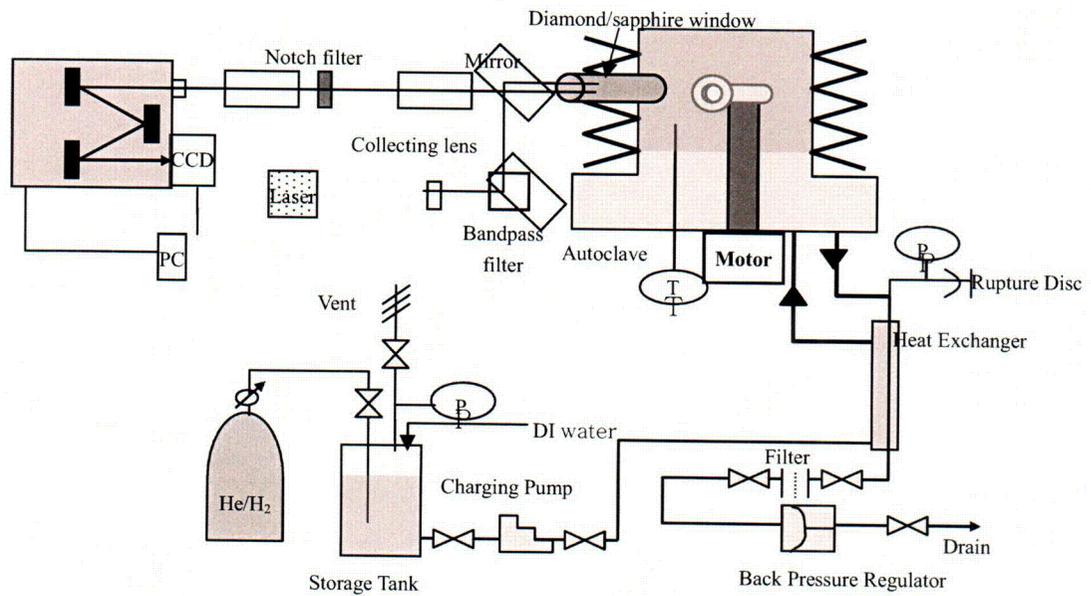
FIGURE 2. Layout of in-situ Raman spectroscopic measurement system in high temperature aqueous environment.

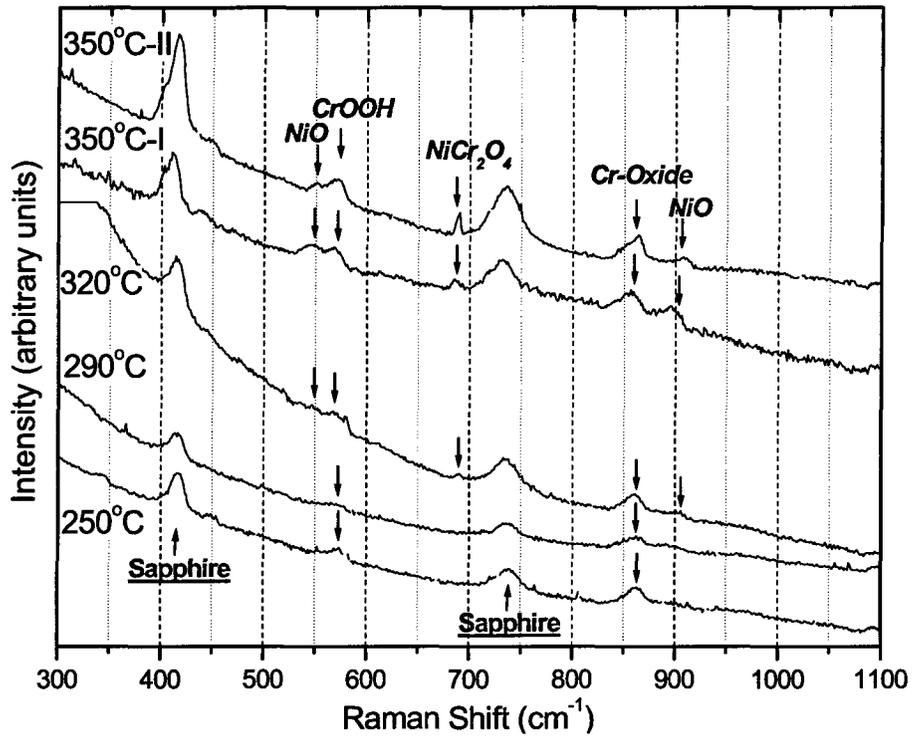
FIGURE 5. In-situ Raman spectra obtained for Alloy 600 by holding at 250, 290, 320 and 350 °C, respectively, during heating up to 350 °C in PWR water condition with $DH_2=30cc(STP)/kg$.

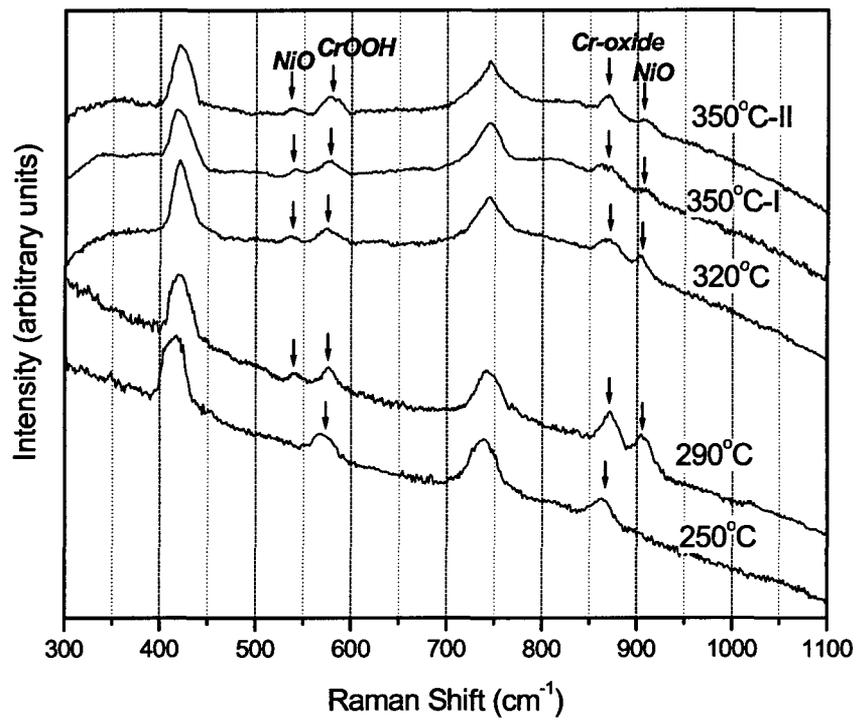
FIGURE 6. In-situ Raman spectra obtained for Alloy 600 by holding at 250, 290, 320 and 350°C, respectively, during heating up to 350°C in PWR water condition with $DH_2=1cc(STP)/kg$.

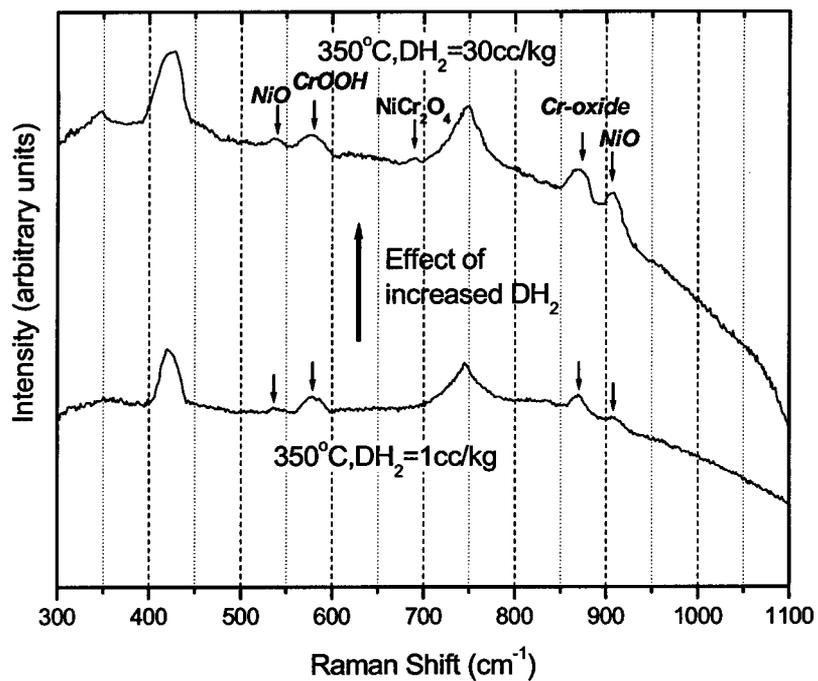
FIGURE 7. In-situ Raman spectra obtained for Alloy 600 at 350°C in PWR water as the DH_2 in water was increased from 1 to 30 cc/kg.

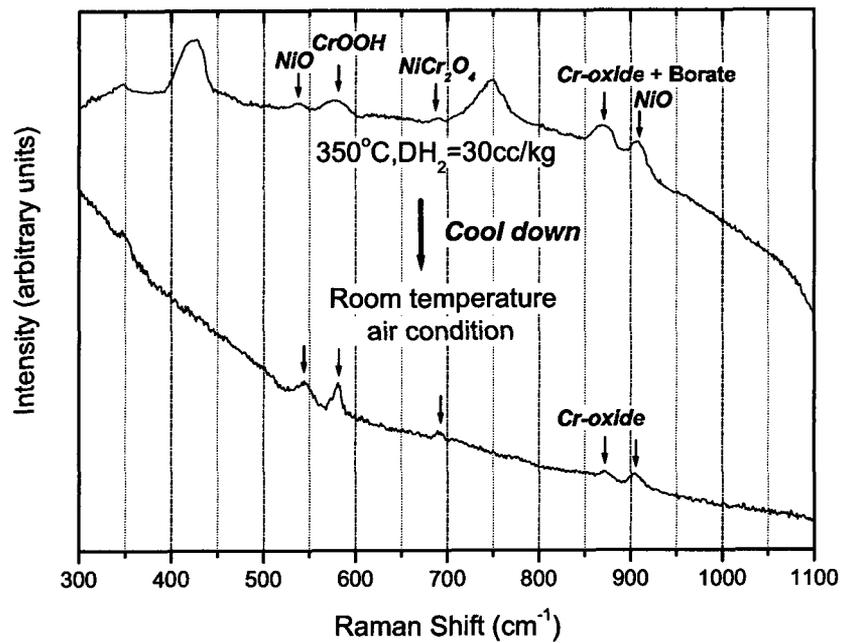
FIGURE 8. Comparison of Raman spectra obtained for Alloy 600 between by in-situ method at 350°C in PWR water with DH₂ =30 cc/kg and by ex-situ method in room temperature and air condition.

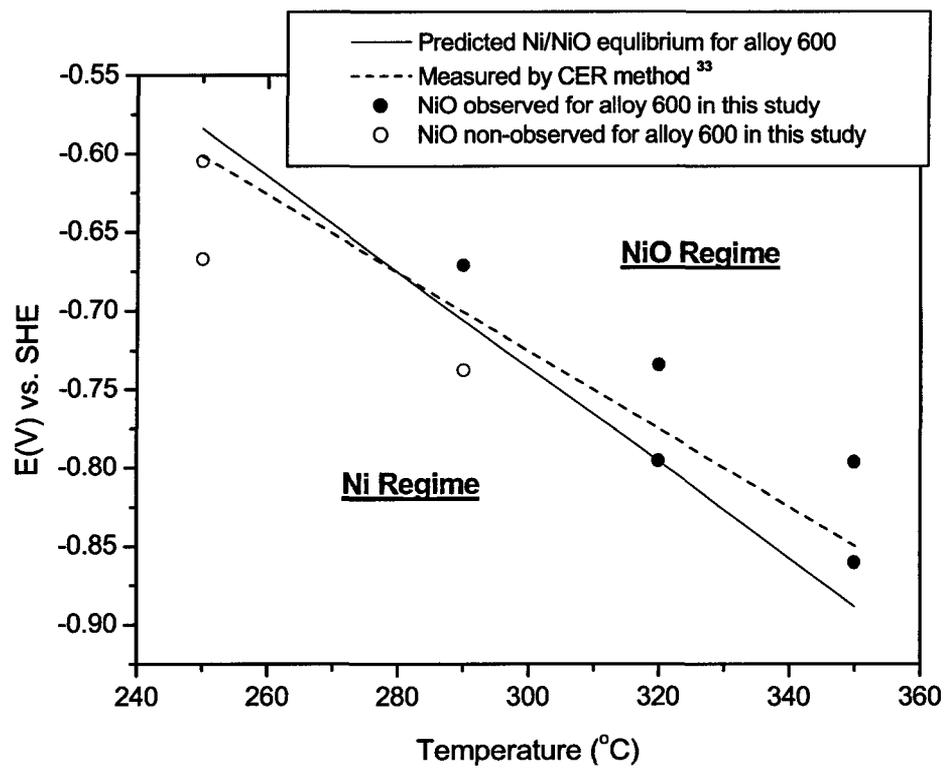
FIGURE 9. Summary plot on electrochemical potential for nickel in the Alloy 600 as a function of temperature.

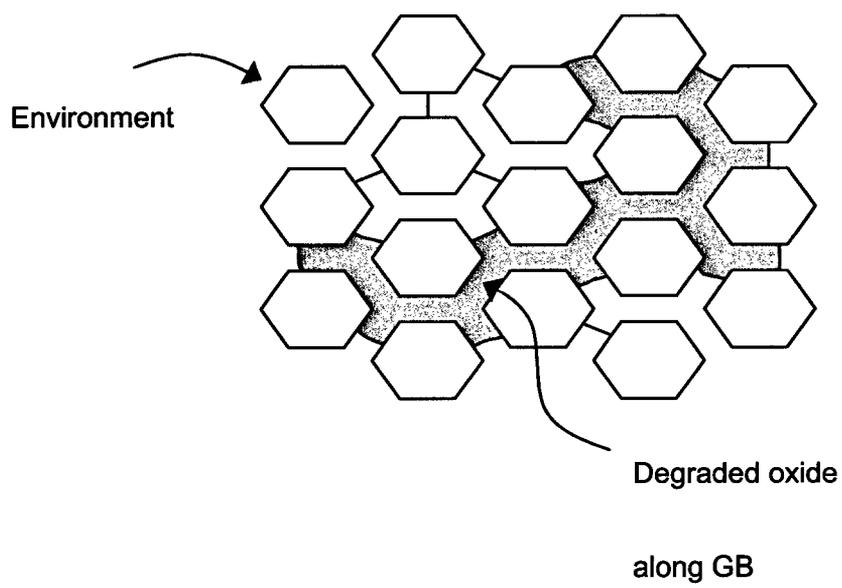
FIGURE 10. Postulated Redox-induced GB Oxide Degradation Mechanism.

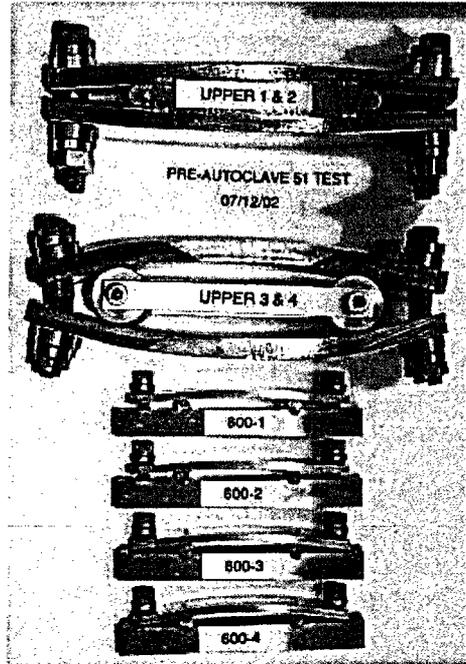
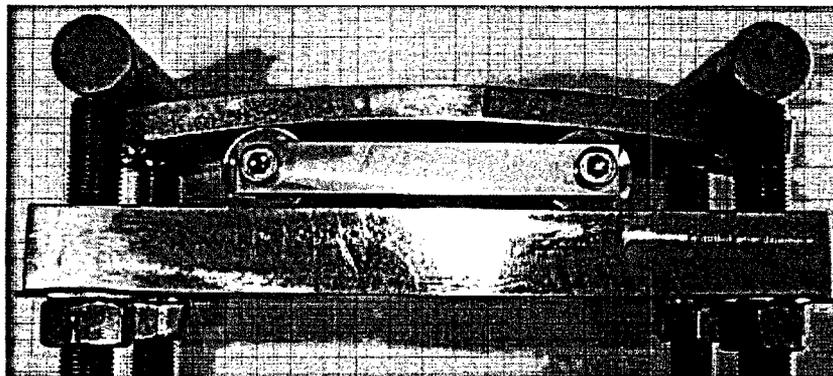
Figure 1 - Photographs of Alloy 52M (Upper 1 thru 4), Alloy 600 (600-1 thru-4), and Alloy 182- 4 (lower photo) bent beam test specimens. [Specimens with suffixes -1 and -2 were strained 0.35%; those with suffixes -3 and -4 wee strained 1.0%]

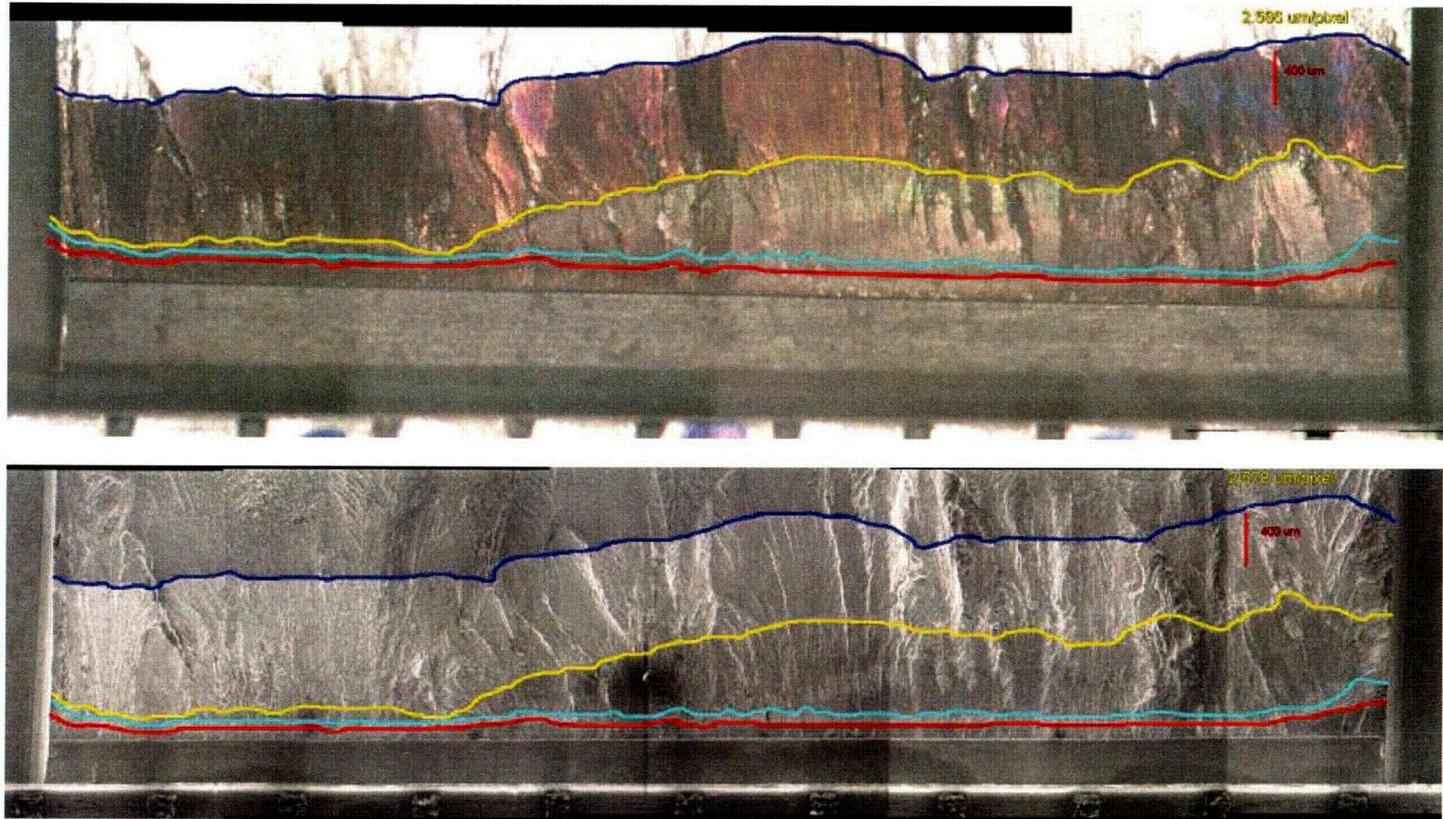
Figure 4 – Optical (top) and SEM (bottom) micrographs of an Alloy 182 crack growth specimen, showing the precrack and environmental crack extension across the face of the specimen.

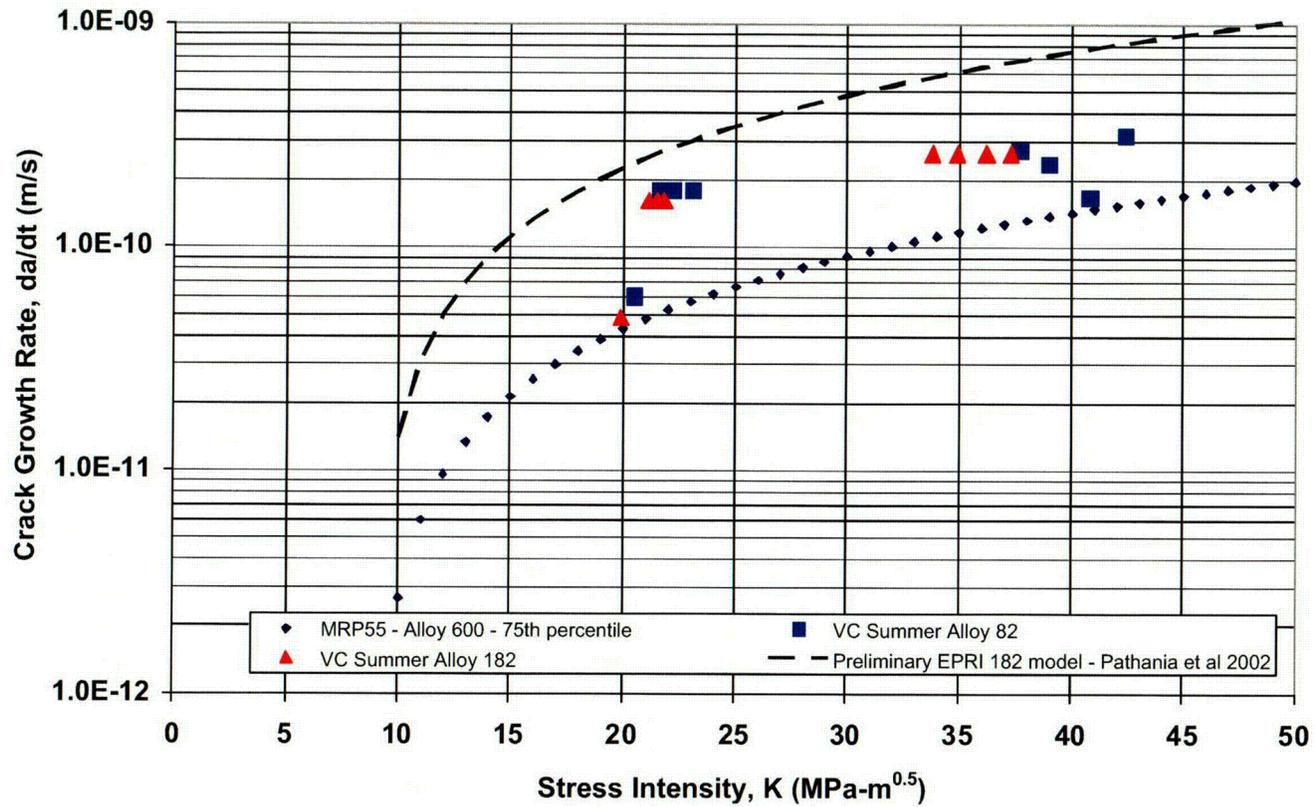
Figure 5 – Crack growth rate results for the Summer Alloy 82 and 182 weld metals compared with published data

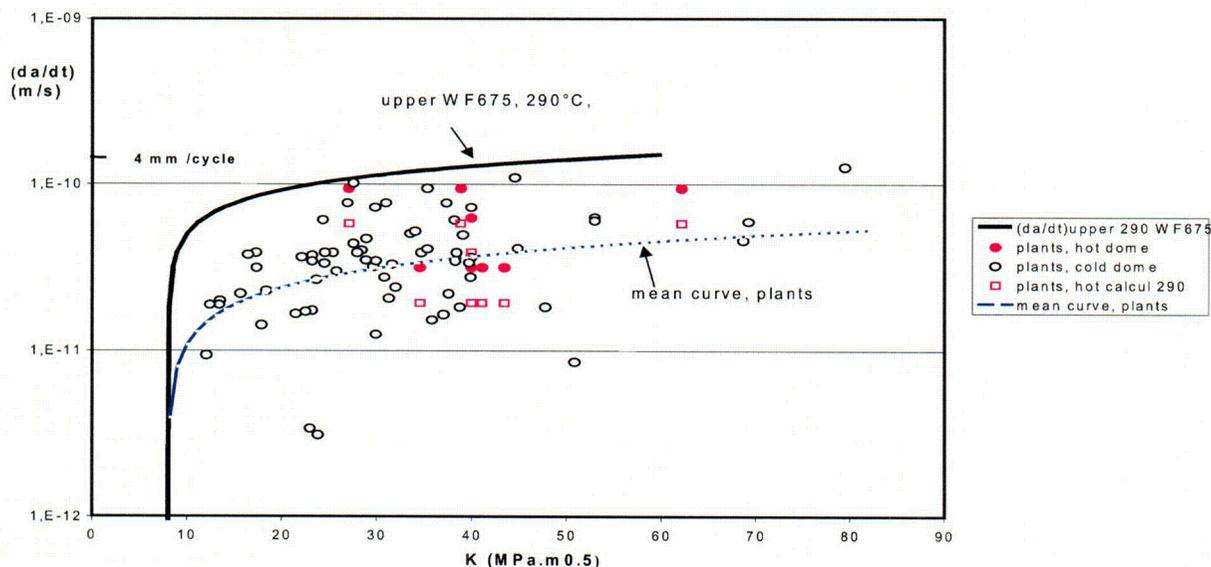
Fig. 2: Comparison between laboratory and field experience (by courtesy of EDF, this conference ref.¹²), Showing the representation of CGR versus the estimated K values for field and laboratory data, expressed either at the assumed temperatures respectively of 300°C and 290°C, some data being converted to 290°C.

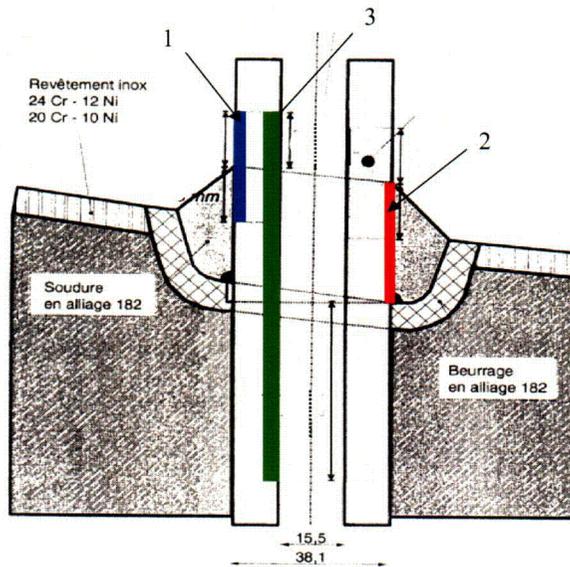
Figure 3, showing schematically the BMI zones covered by NDE examinations

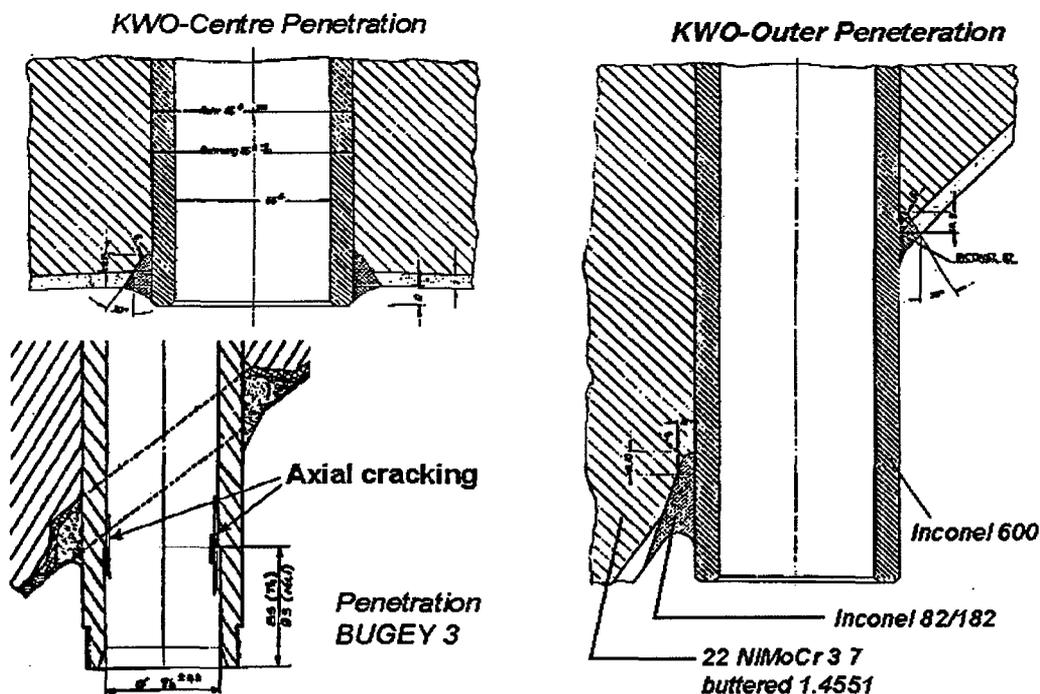
Figure 2 Weld layout at different locations of head penetrations in the RPV head

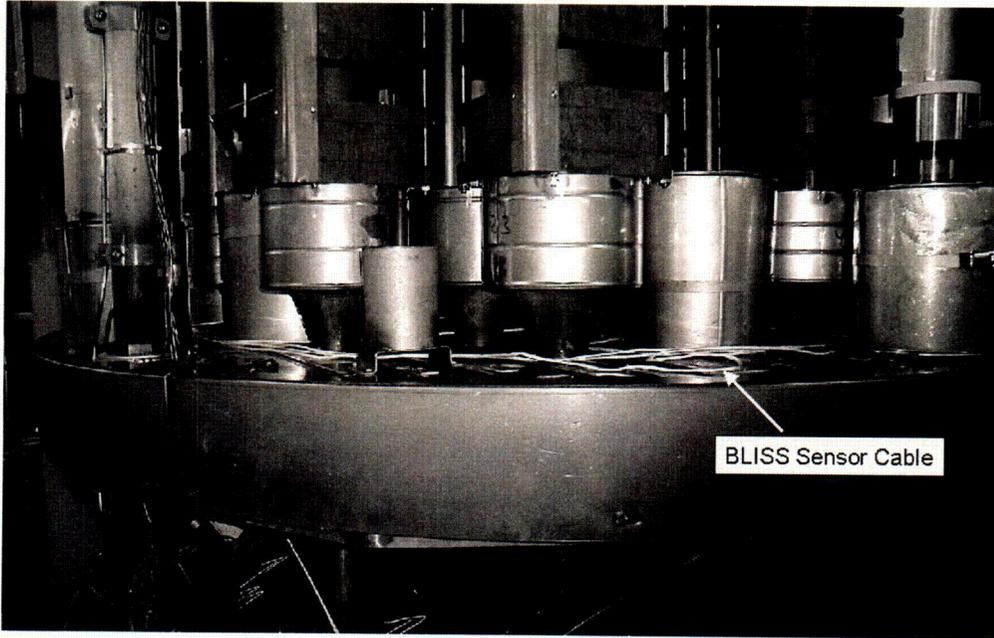
Figure 4 BLISS Sensor Cable installed on RPV Head

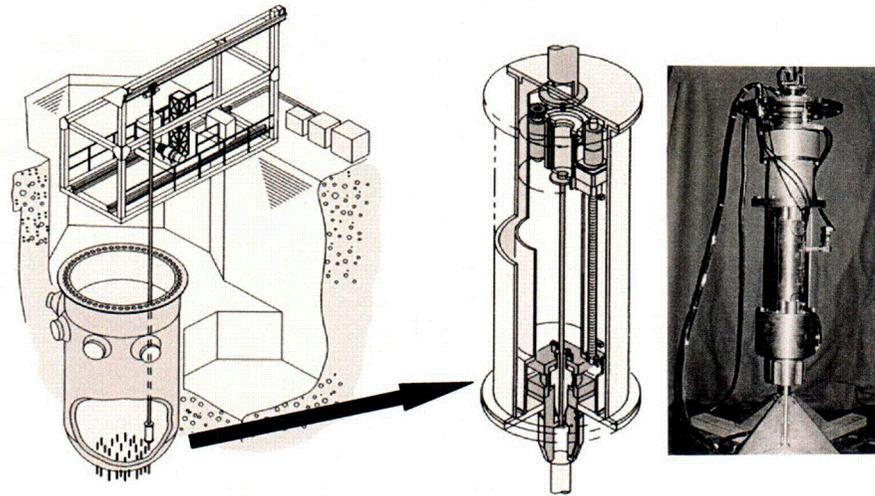
Fig.2 Concept of WJP for BMI nozzle and the system

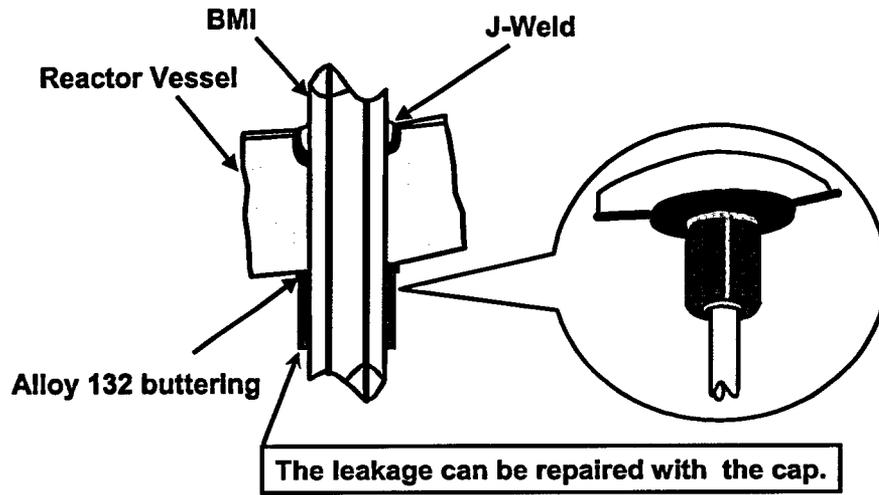
Fig.4 Concept of cap repair method for BMI nozzles

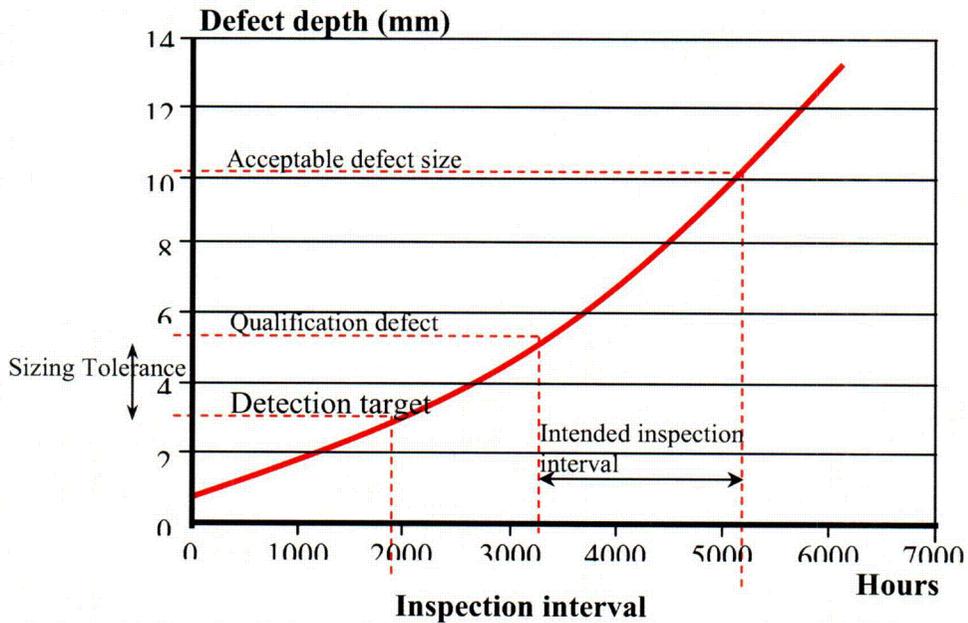
Figure 1, Visualizing the defect tolerance analysis step with regard to the ISI-program.

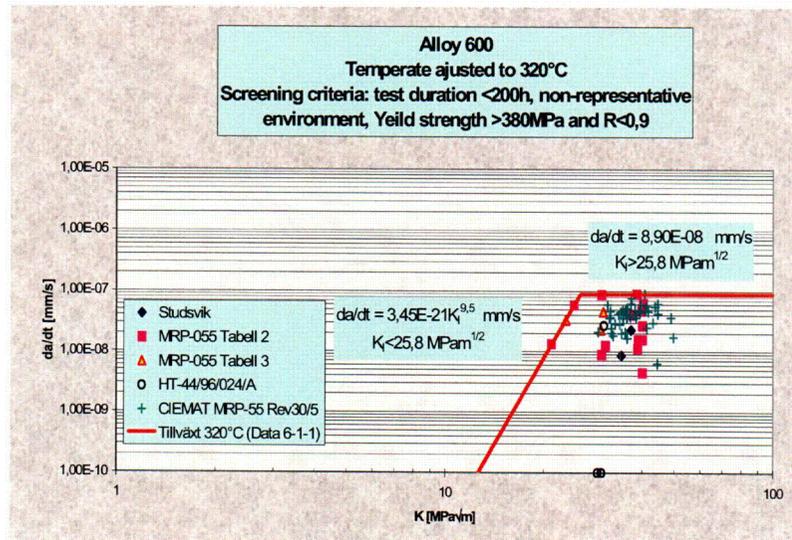
Figure 2, The final results after screening the Alloy 600 database with regards to the criteria presented in [2].

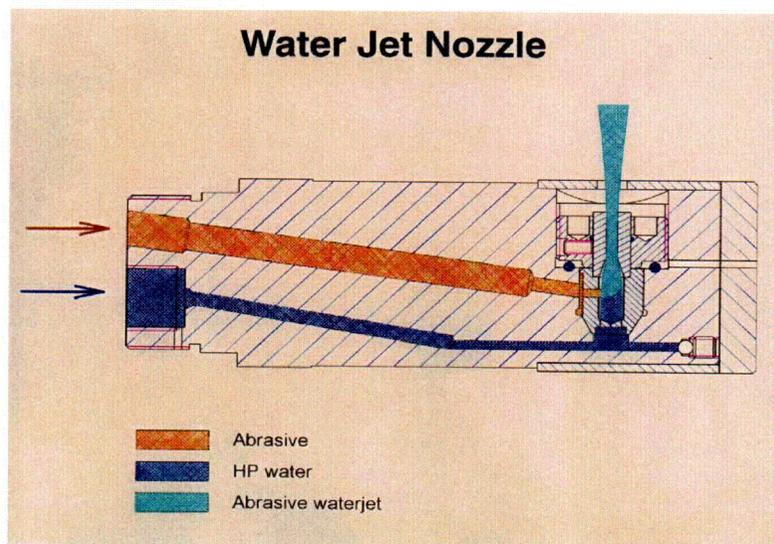
Figure 1. Typical Configuration of an Abrasive Waterjet Conditioning Nozzle.

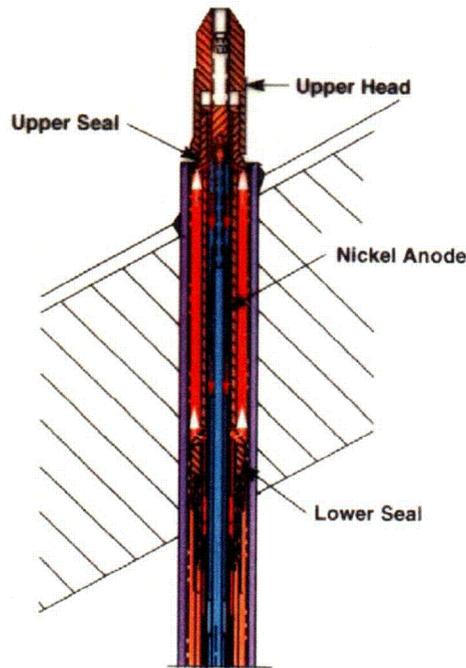
Figure 3. Typical End Effector Tool for Nickel Plating Pressurizer Heater Nozzles.

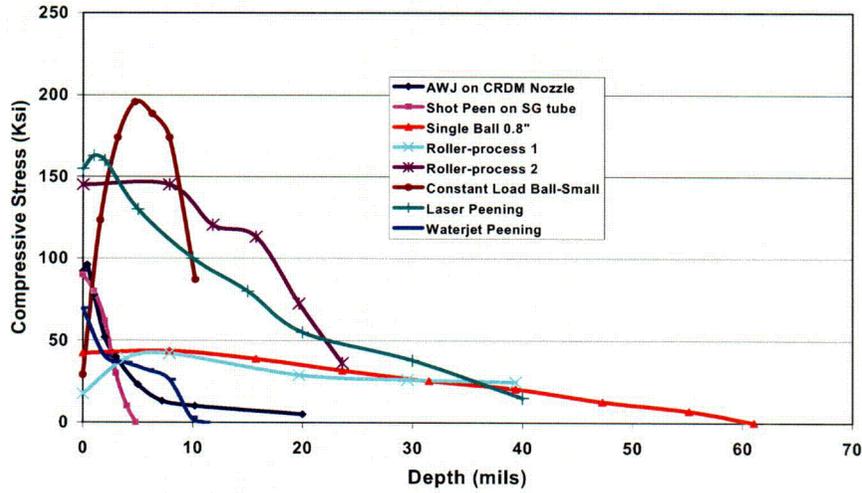
Figure 6. Typical Compressive Stress Distribution Comparison of Several Remediation Techniques.

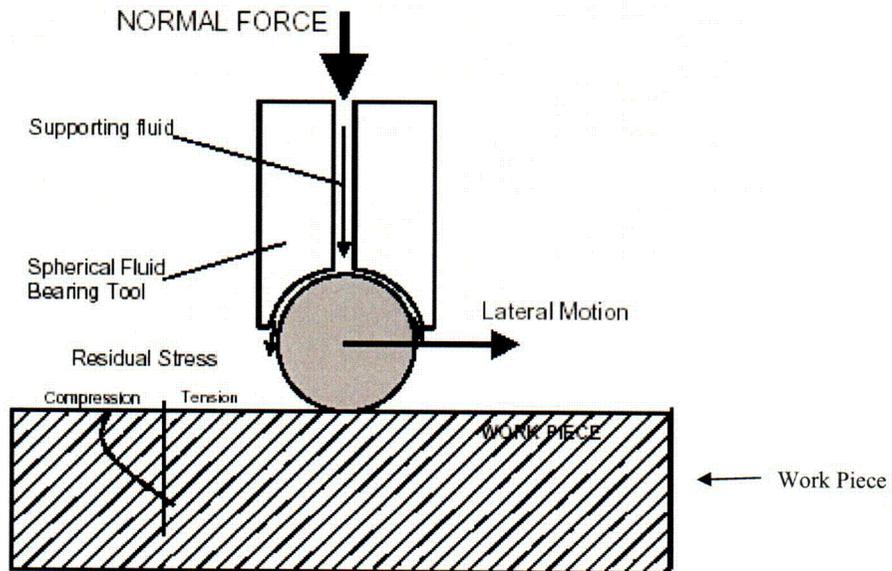
Figure 7. Low Plasticity Burnishing Schematic.

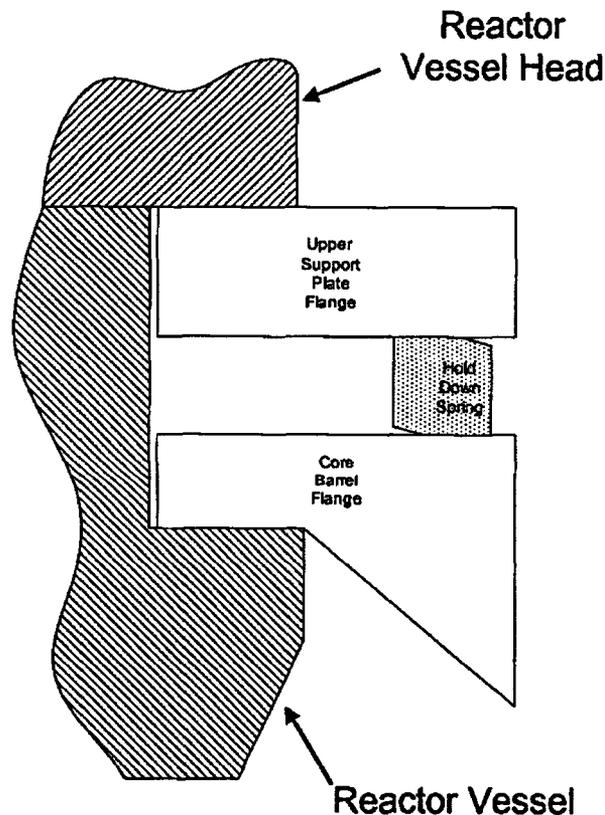
Figure 2: Detail of Components where UHTR Modification is Implemented

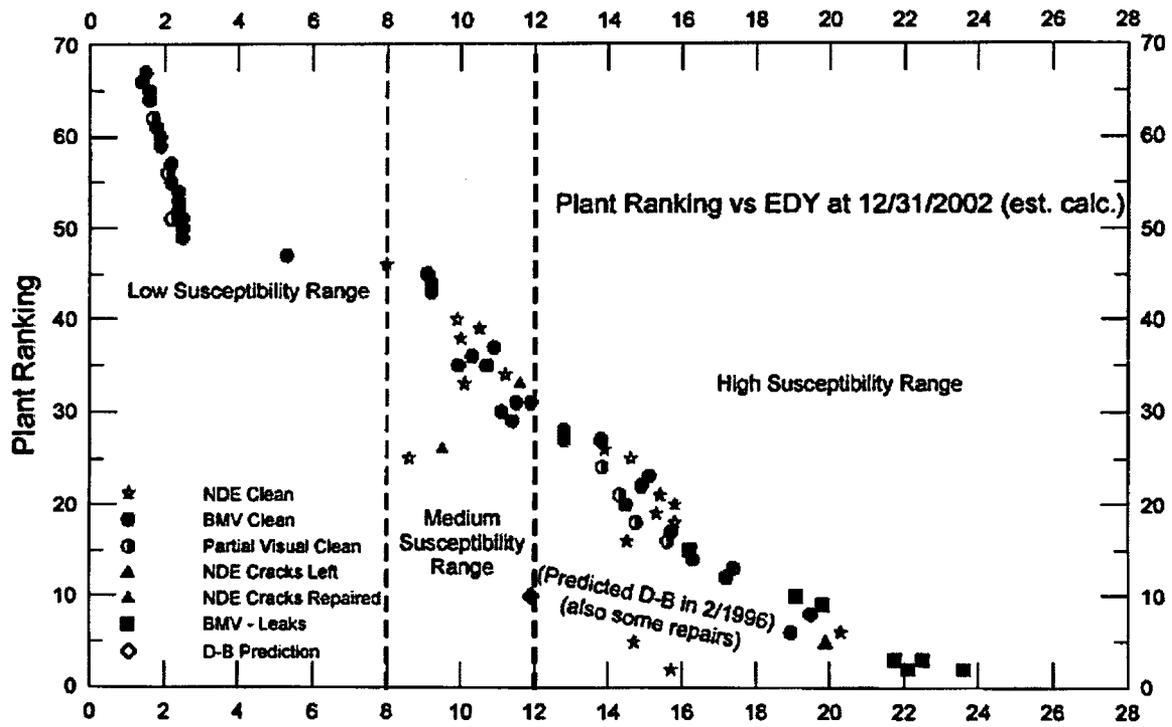
Figure 1. Ranking of domestic plants according to the EDY formula, showing results of inspections, evidence of leakage, and repairs. Many plants are shown with multiple symbols, indicating a "clean" inspection at inspection opportunity, followed by a different finding at a subsequent inspection (e.g., Oconee 2: clean NDE @ EDY=15.7, leaks and circ. flaws @ 22.1)

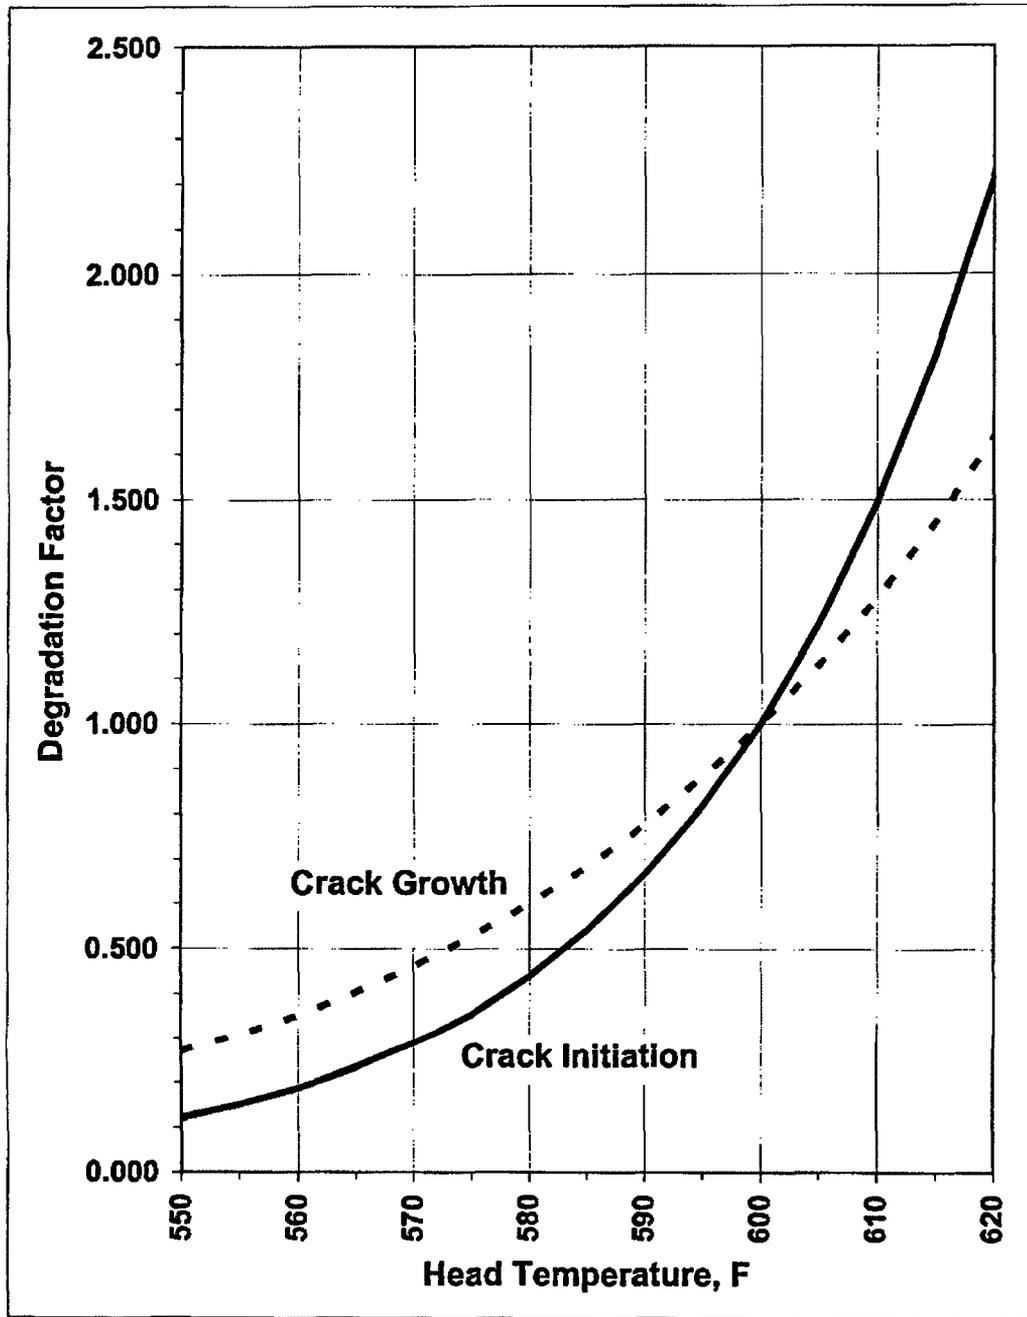
Figure 4: Degradation Factor as a Function of Temperature

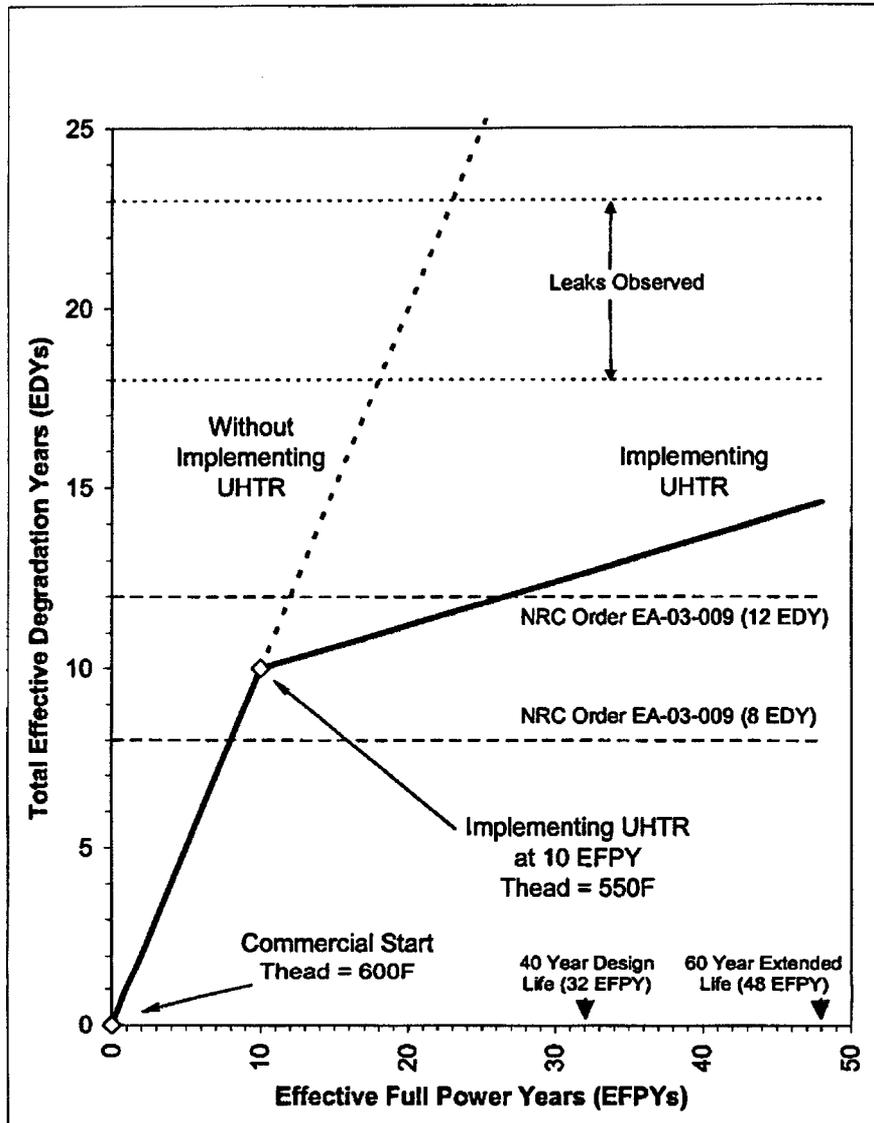
Figure 5: Example of UHTR Effectiveness for a Unit Approaching the 12 EDY Limit (with Respect to NRC Order EA-03-009)

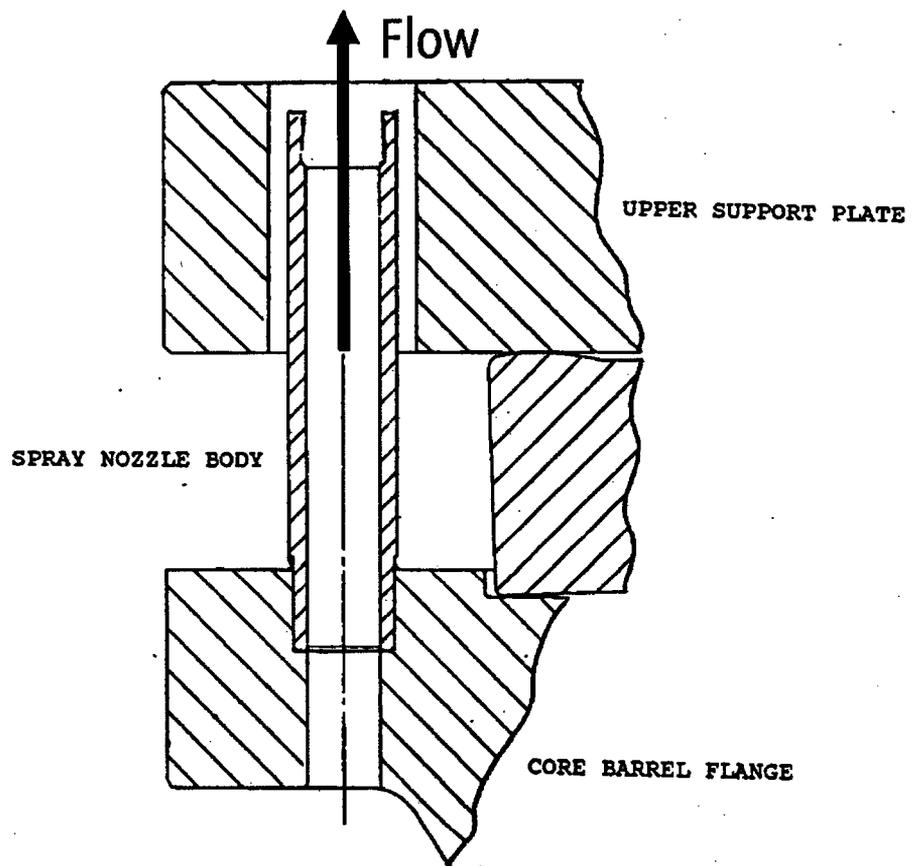
Figure 6: Westinghouse UHTR Implementation Design (3 Units)

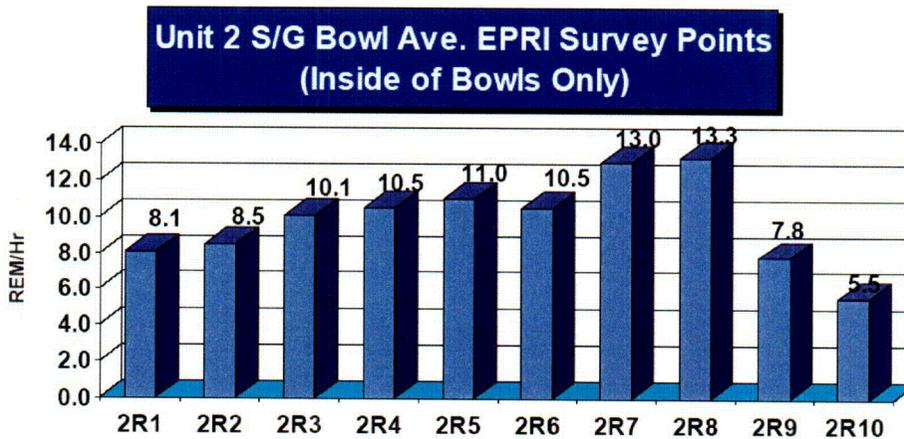
Figure 1 Post zinc dose rate trends for Diablo Canyon Unit 2 (first additions during cycle 9; range 15 to 30 ppb)

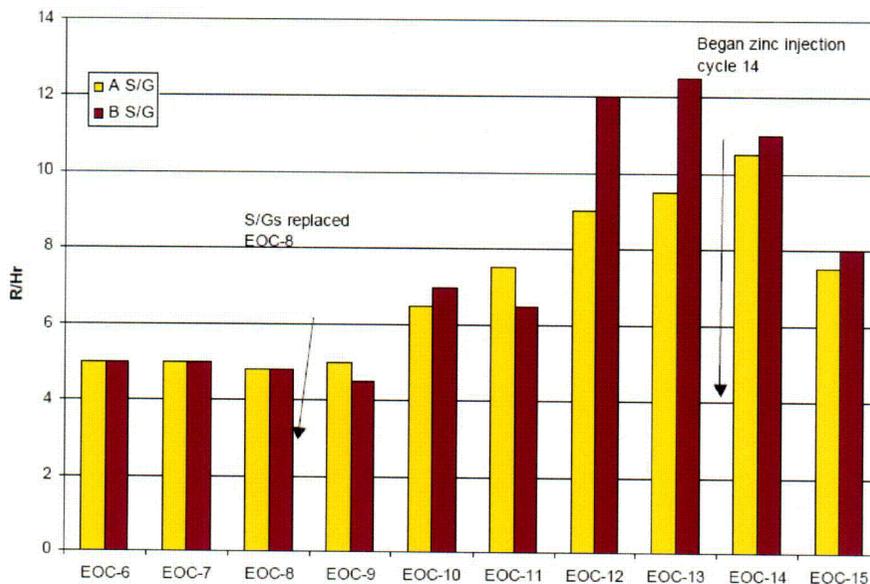
Figure 2 Post zinc dose rate trends for Palisades channel head (levels up to 10 ppb)

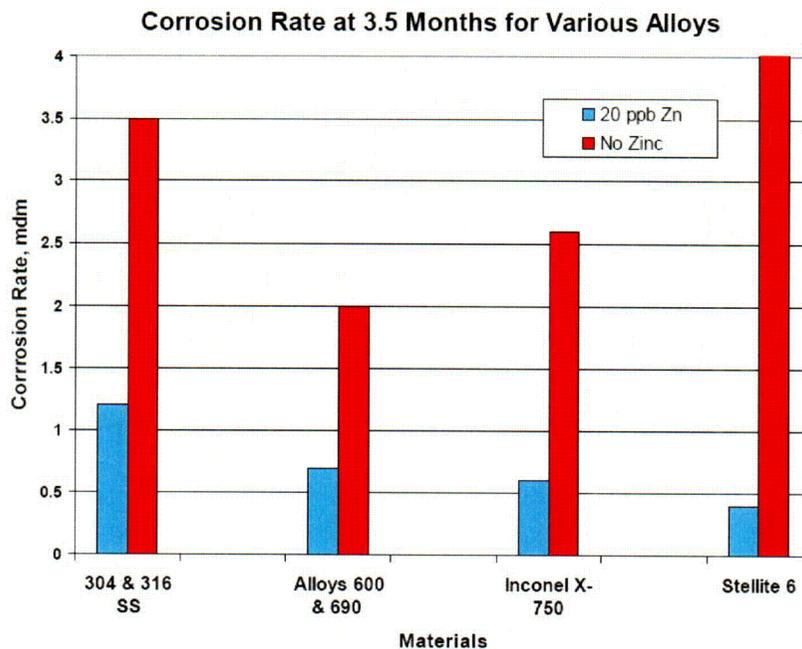
Figure 3 Effect of zinc on corrosion rates of various alloys in laboratory tests (after Esposito et al. [1])

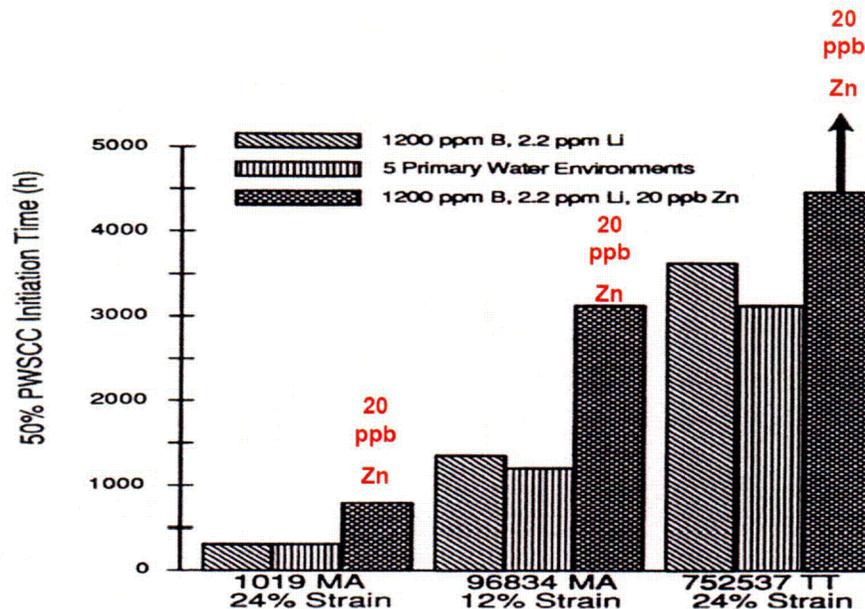
Figure 4 Example for the effect of zinc on time to initiate PWSCC in laboratory tests (after Esposito et al. [1])

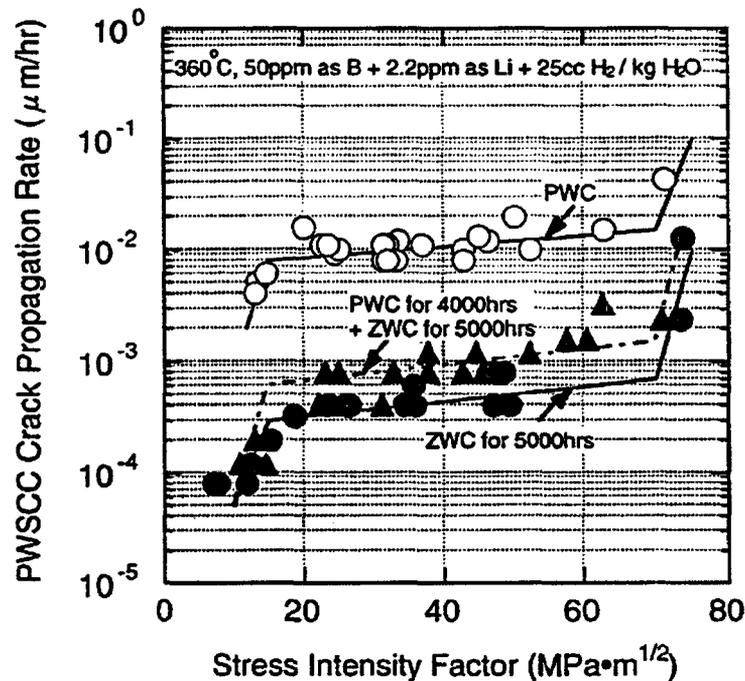
Figure 5 Example for the beneficial effect of zinc on PWSCC CGR in laboratory tests using DCB specimens: PWC = normal primary water chemistry; ZWC = PWC + 10 ppb Zn (after Kawamura et al. [5])

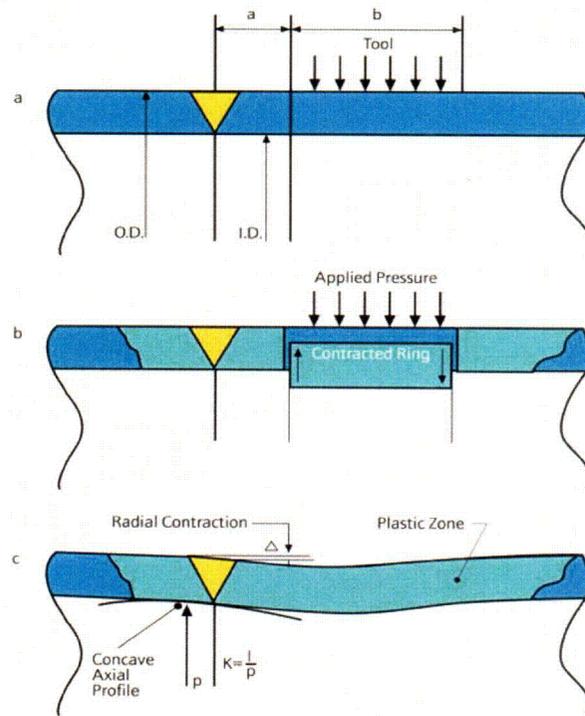
Figure 1 - Schematic Illustration of MSIP Process
