Section 3:
Session 2: Continued Plant Operation

Background and Technical Basis: Evaluation of Upper Head Penetration Flaws in the ASME Code

Warren Bamford, Westinghouse Electric
and
Guy DeBoo, Exelon

MAINTENANCE STRATEGY OF INCONEL COMPONENTS IN PWR PRIMARY SYSTEM IN FRANCE : Bugey Leak

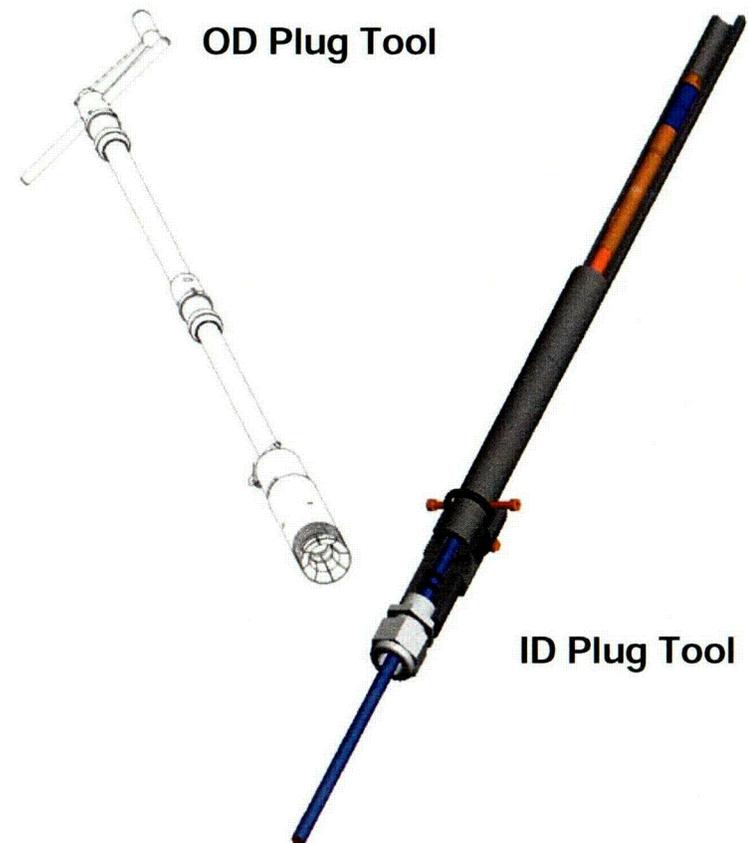
Mechanical Plug

- > **Common Features**
 - ◆ **Redundant seals constructed from rad-tolerant material**
 - ◆ **Mechanically actuated to seal on nozzle surface (I.D. or O.D.)**
 - ◆ **Provides shielding (external or internal)**
 - **Rad-streaming concern after nozzle contents have been drained for below-vessel repair work**
- > **Option to remove I.D. Nozzle Plug from below vessel using freeze seals**

Tool Support Plate

- > ***Lightweight components for rapid, one-man, assembly under the RV head***
- > ***Centering Plate with an alignment fixture allows for accurate alignment to nozzle bore***
- > ***Common interface for weld head, machine tool, and grinder***
- > ***Minimal tools required for installation and assembly***
- > ***Mounts from adjacent BMI nozzles. Custom Tool Support Plate required for each nozzle location***
- > ***Kicker Post reacts to floor below RV head to provide additional support where necessary***
- > ***New tooling platform designs shall be required for each repair location of the BMI nozzle configuration***
