DOMINION NUCLEAR CONNECTICUT, INC. MILLSTONE POWER STATION UNITS 2 AND 3 TECHNICAL SPECIFICATIONS ANNUAL REPORT

Millstone Unit 2 2005 Steam Generator Tube Inservice Inspection

Steam Generator Tube Inspection

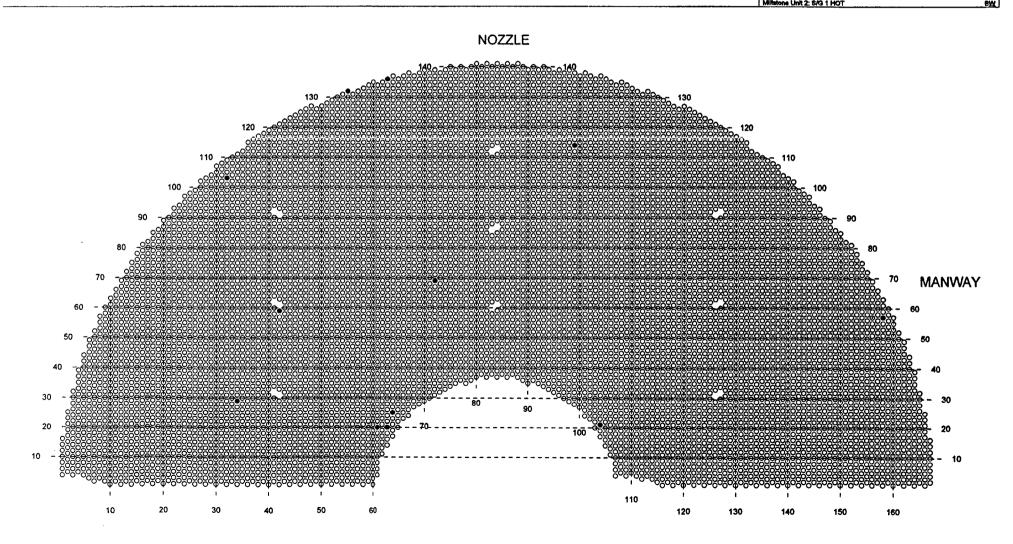
Attachment 2 DNG Indications

DNG Indications

TOTAL TUBES: 8523 SELECTED TUBES: 12 OUT OF SERVICE (#): 1

S/G 1 HOT PRIMARY FACE

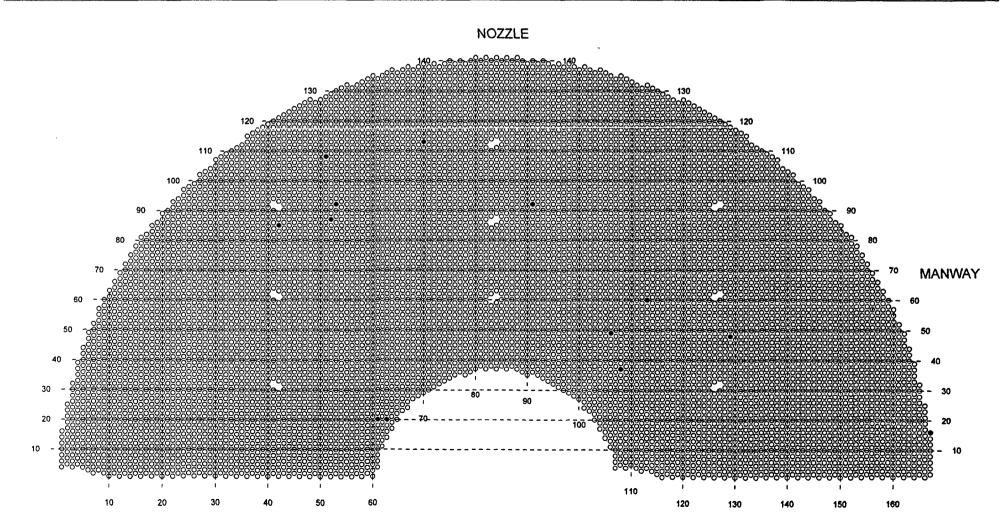
Attachment 3 DNT Indications

DNT Indications

S/G 1 HOT

TOTAL TUBES: 8523 SELECTED TUBES: 13 OUT OF SERVICE (#): 1

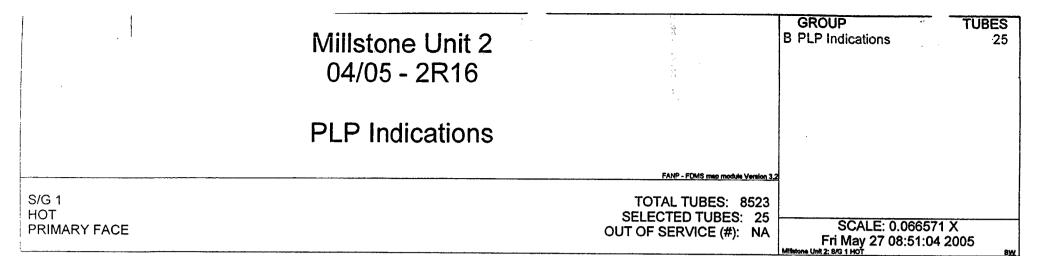
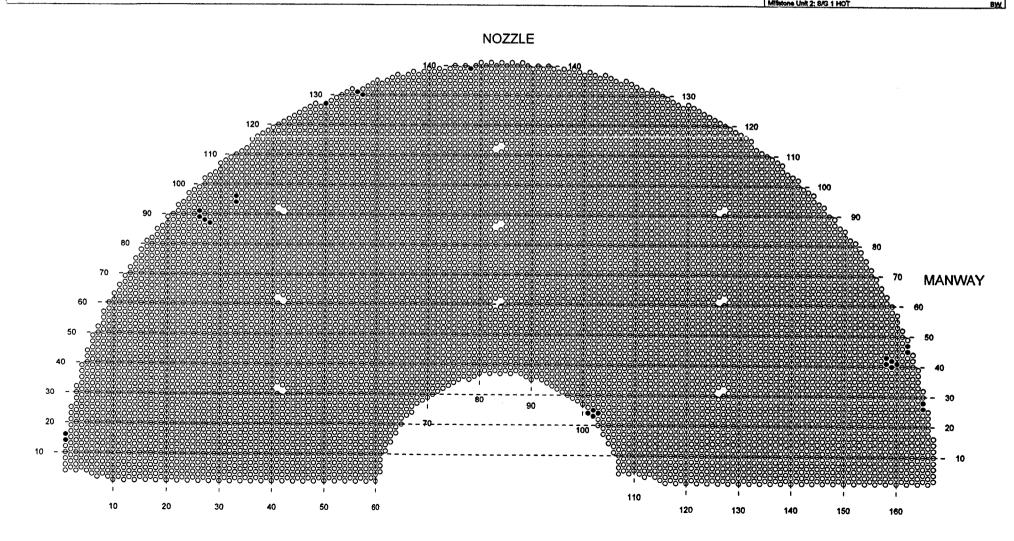
Attachment 4 PLP Indications

Twenty-five (25) PLP indications were also reported. These ECT reported indications were grouped in eleven (11) locations as shown in Attachment 4. Seventeen (17) of the indications were initially reported with the bobbin coil examination and eight (8) with the MRPC examination. Loose parts were observed in an additional three (3) locations during SSI. There were no indications of wear associated with any of the PLP indications or any of the loose parts that were reported. Additional information is included in Table 4.

PLP Indications (including any LPI LPM LPR LPS Indications)

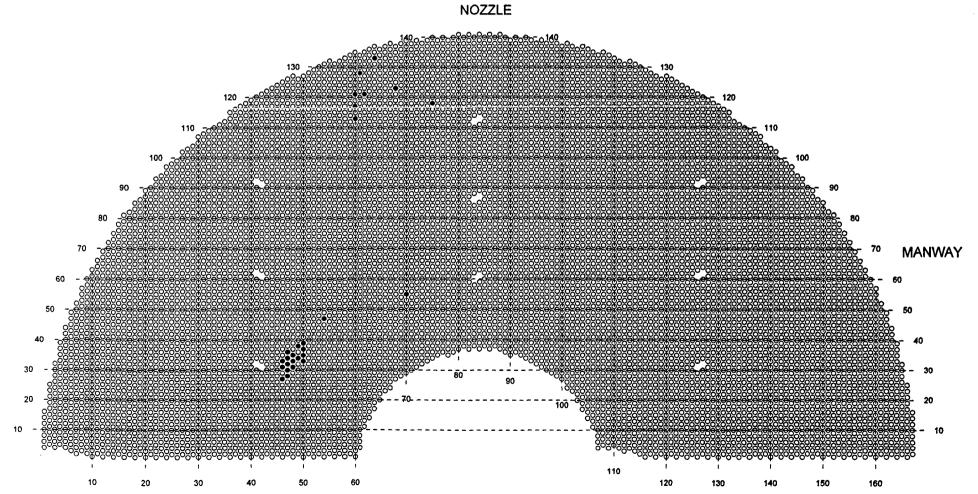
Attachment 5 SLG Indications

locations selected for examination make up fifty percent (50%) of this total sludge region (284 tubes) identified from both SGs. Approximately seventy-four (74%) of the tubes in the sample had previously identified Sludge (SLG) indications in SG 1. SLG indications reported during the current inspection are mapped in Attachment 5. One tube with a historical Partial Tubesheet Expansion (PTE) indication was also examined TSH-TEH.

SLG Indications

S/G 1 HOT PRIMARY FACE

TOTAL TUBES: 8523 **SELECTED TUBES: 27** OUT OF SERVICE (#): 1

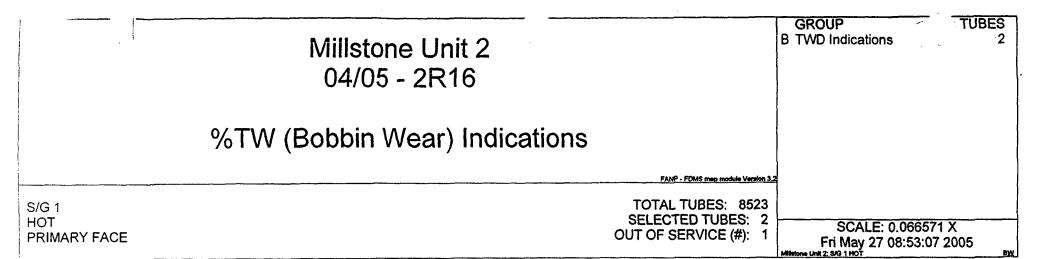
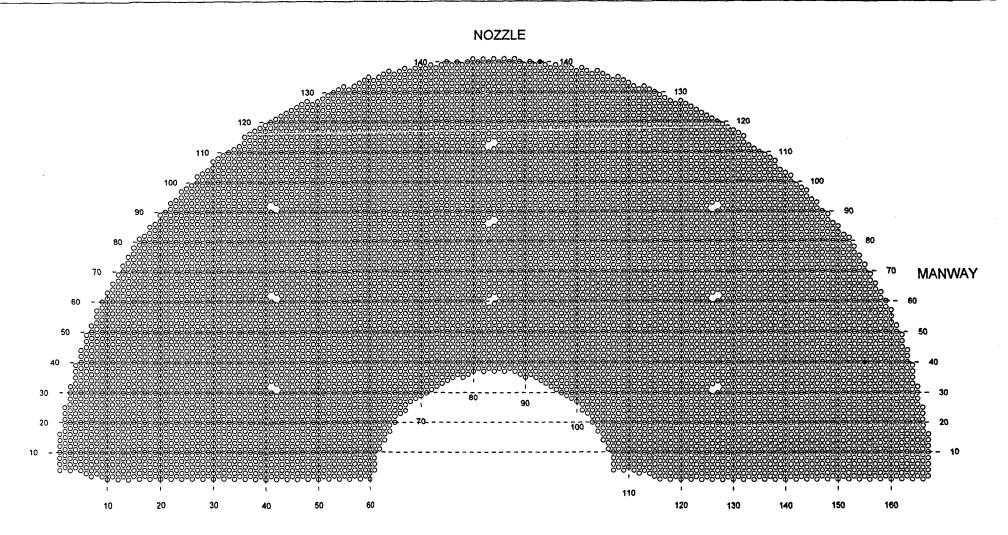
Attachment 6 % TW FB Indications

ECT reported two (2) tubes with nine (9) percent throughwall (%TW) fan bar wear. The ECT results from 2R14 also reported 9%TW wear on these tubes, thus the wear has not progressed over the past two operating cycles. Additional details on fan bar wear in both SGs are provided in Table 3 and Attachment 6.

In summary, 100% of the tubes in SG 1 (8522 tubes) were inspected, TEC-TEH. There were no tubes that required repair as a result of this examination. No tubes were plugged or otherwise repaired on a discretionary basis. As a result of the inspection, SG 1 was classified as C-1. A listing and map of tubes reported with wall-thickness loss is included in Attachment 6. The maximum wall-thickness loss was 9% TW.

%TW (TWD) Indications

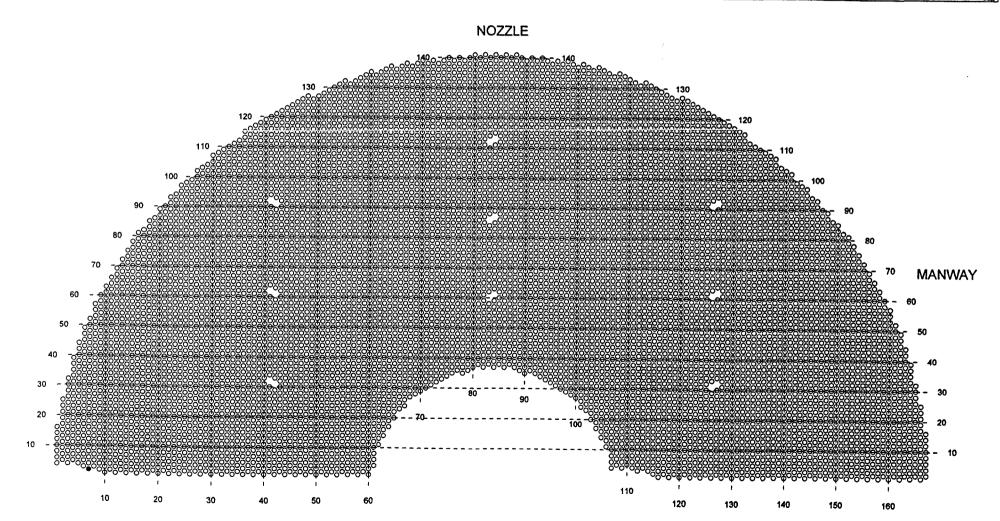
Attachment 7 VOL Indications

One Volumetric Indication (VOL) was reported. This VOL indication has been reported since the June 1997 examination with MRPC. It is believed to be associated with a Manufacturing Buff Mark (MBM) and exhibits no change since first reported. Additional details are provided in Attachment 7.

VOL Indications

S/G 1 HOT PRIMARY FACE TOTAL TUBES: 8523 SELECTED TUBES: 1 OUT OF SERVICE (#): NA
