RADIOLOGICAL SCOPING SURVEY OF THE CURTIS BAY DEPOT, CURTIS BAY, MARYLAND

Prepared for the
Defense National Stockpile Center
Defense Logistics Agency

FINAL REPORT

JANUARY 2006

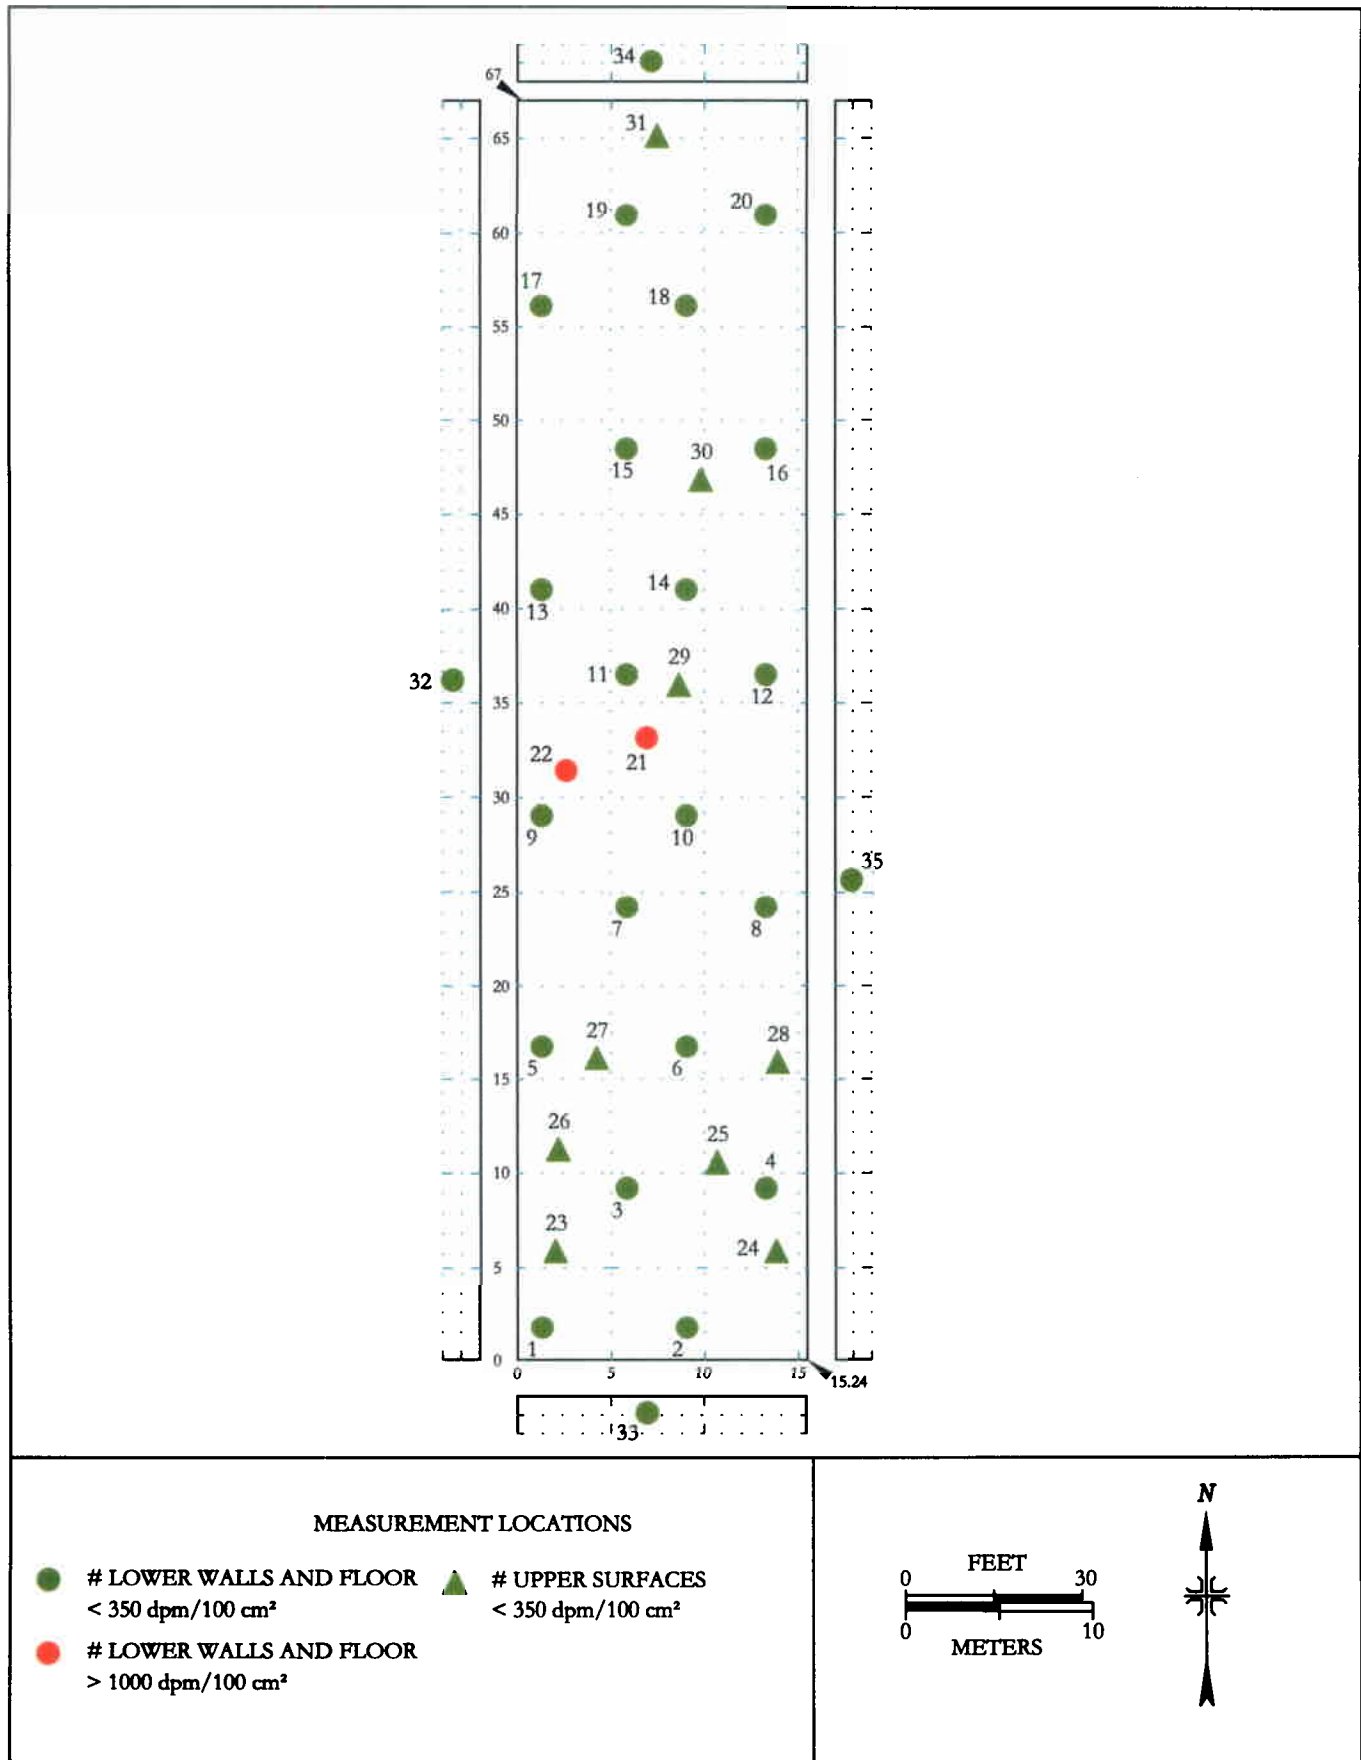
FIGURE 8: Building B-913 - Measurement Locations

The gamma scans of the Class 2 structures and debris piles identified two small locations of elevated gamma radiation on the floor of Building B-913. Visible oily stains were associated with both locations. Alpha plus beta/beta-only scans also identified these two locations with significant radiation levels and as a result, the scan coverage was increased to 100% of the floor in accordance
