## Fact Sheets and Maps

### Off-Site Tritium Map

### Blowdown Line Map

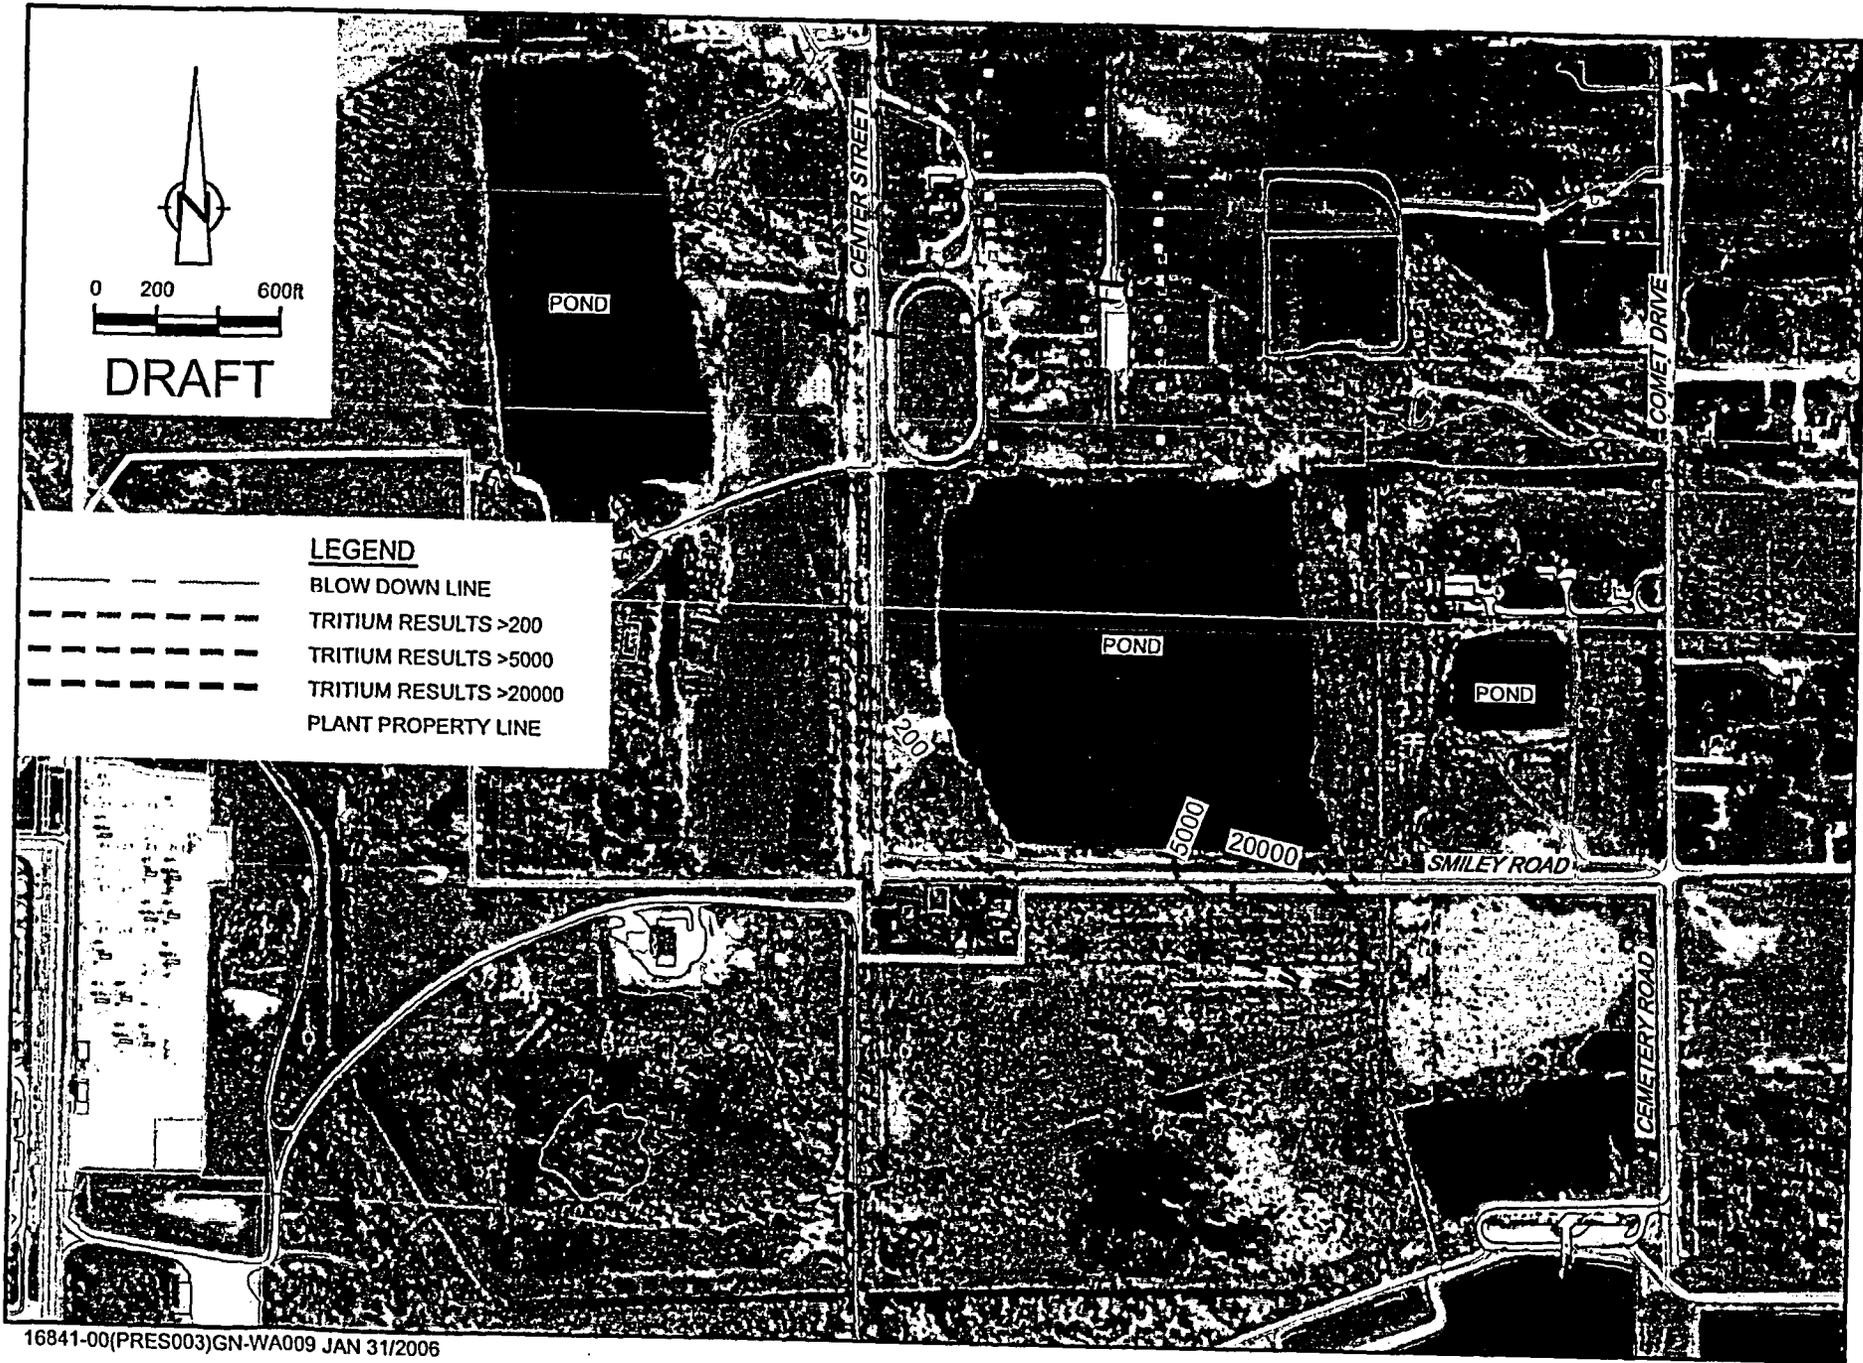
The small area marked with a red line on this aerial photo outlines the area of groundwater tritium that is above the U.S. EPA upper limit for safe drinking water (the limit is 20,000 picocuries of tritium per liter of water). There are no drinking water wells in this area, which is mostly on Braidwood plant property. Water drawn from outside the red area poses no health or safety hazard.

The slightly bigger area marked with a blue line indicates the area in which groundwater test wells have shown above one fourth of the limit. There are no drinking water wells in this area. The larger area marked by the green line outlines the area where lower concentrations of tritium were found. There is one private drinking water well in this area, measuring 1,550 picocuries per liter of tritium.

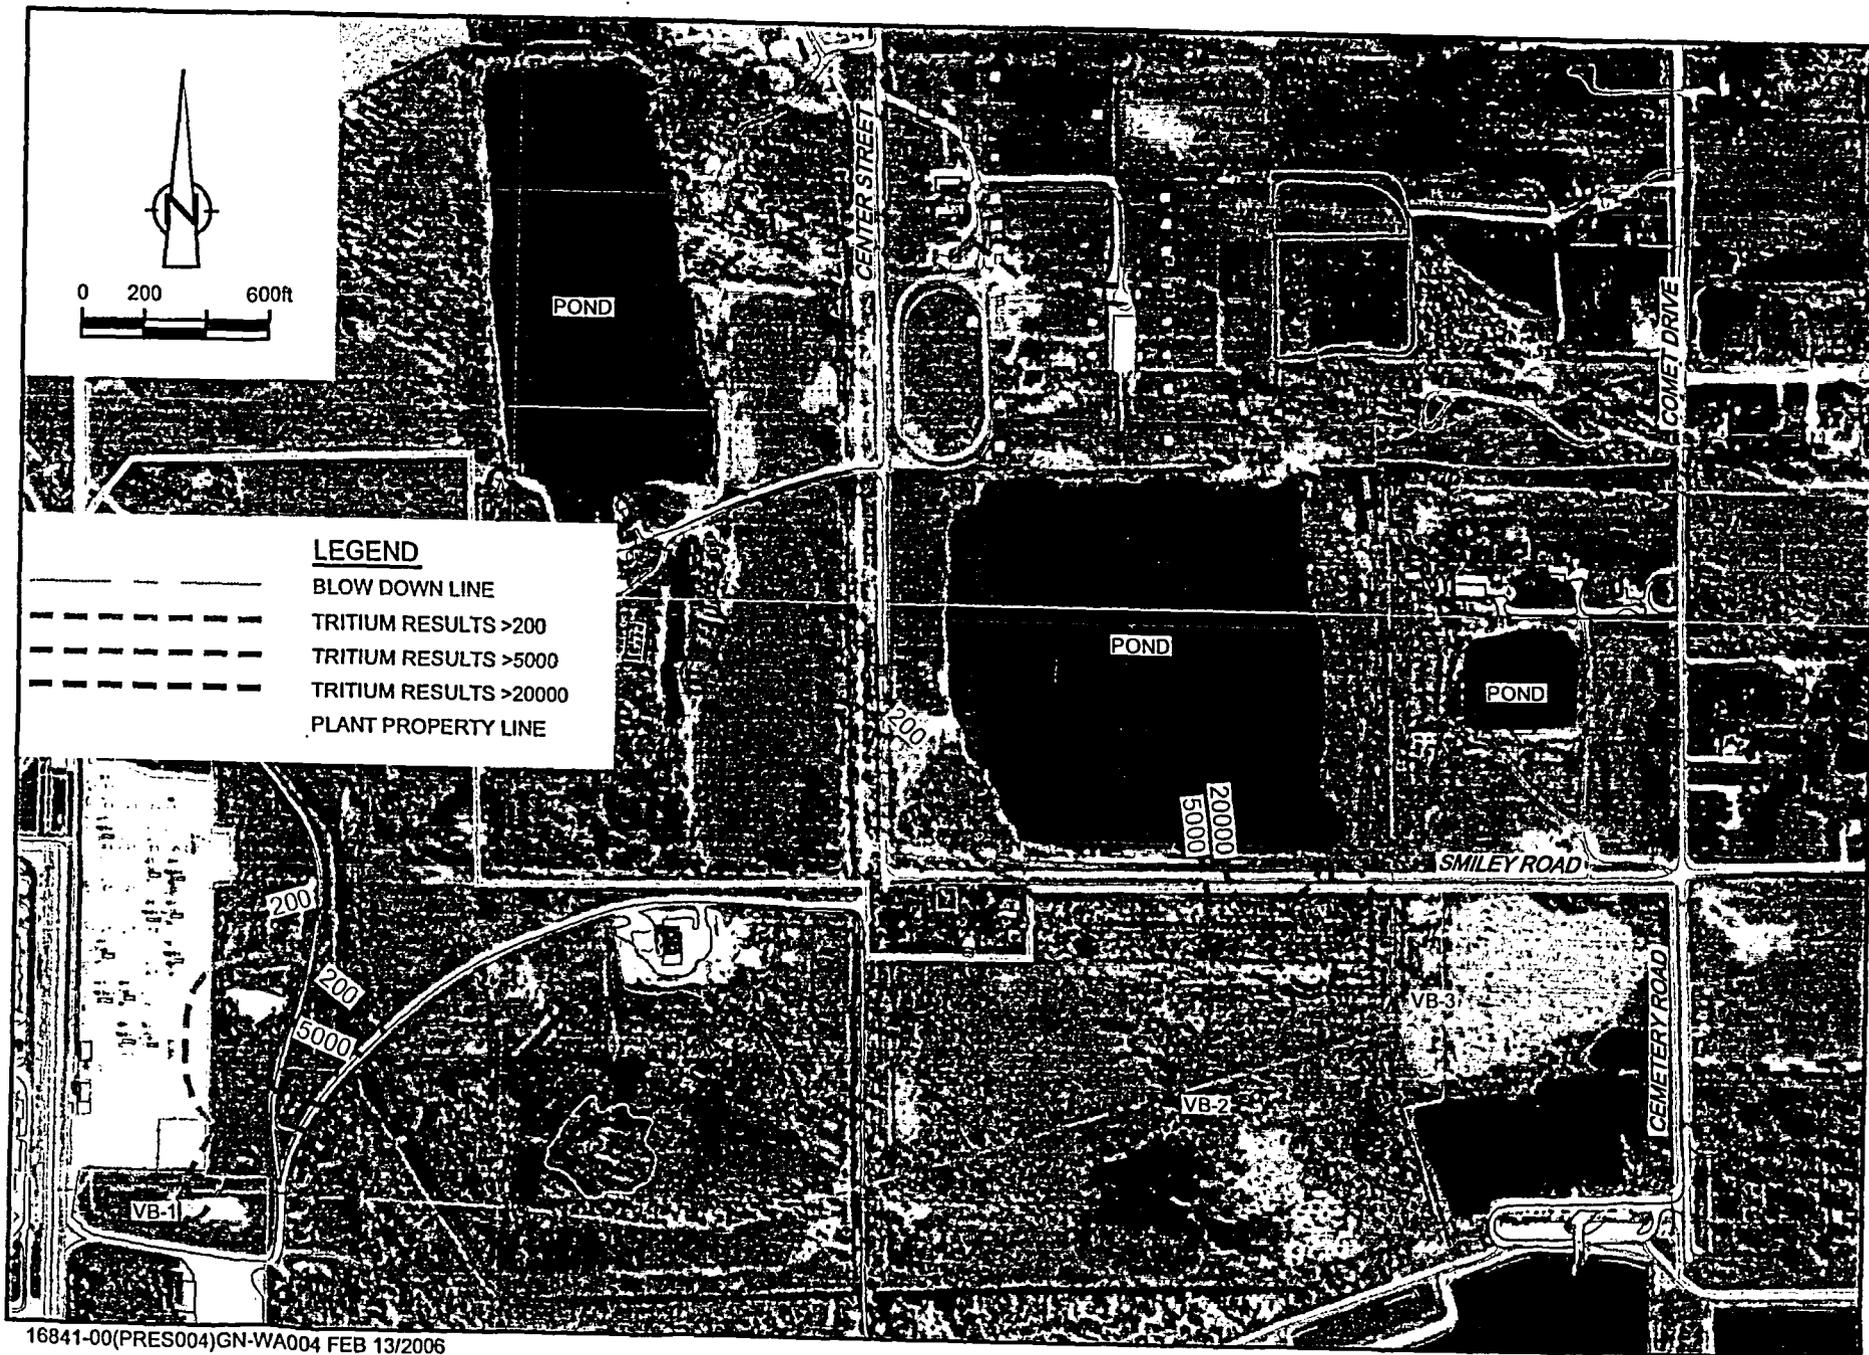
Here is an aerial photo of the Braidwood area with markings indicating the "blowdown line" that carried the tritium prior to Nov. 23, 2005. The "VB" labels along the line indicate locations and numbers of vacuum breakers, the devices that have malfunctioned in the past causing the leaks. Since Nov. 23, the blowdown line has carried only lake water, which is pumped in and out of the lake to keep it fresh. The outflow from the lake is through this blowdown line.
