# Attachment 2: Geology and Seismology

# Attachment 2: Geology

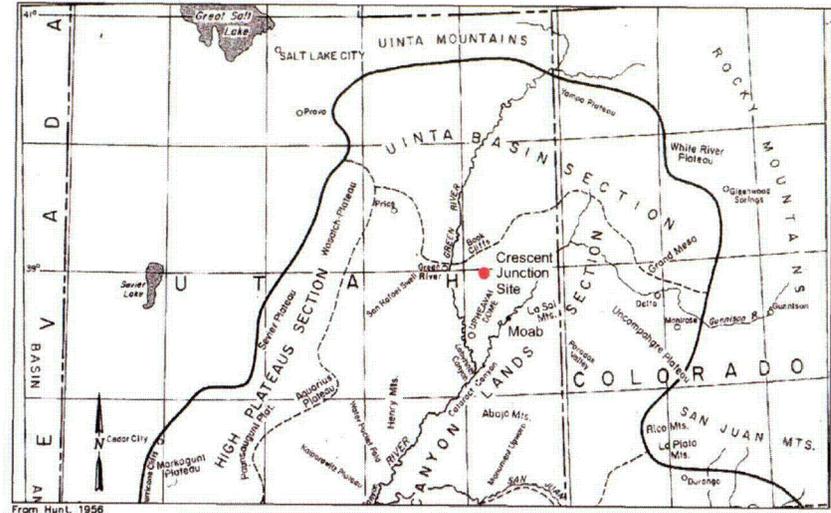
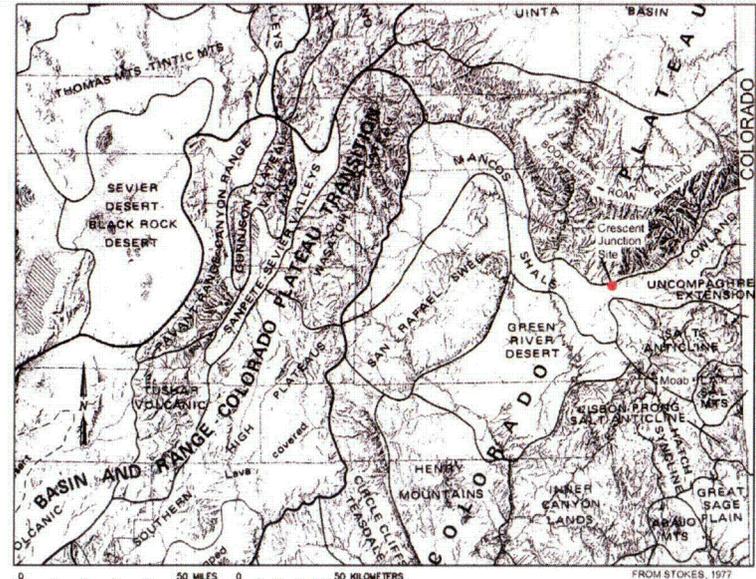
- Site in Canyon Lands section of Colorado Plateau in Mancos Shale Lowland

Site location and relation to physiographic features

75 MILES COLORADO PLATEAU PROVINCE, Northern Part

PHYSIOGRAPHIC SUBDIVISIONS OF UTAH, Central Part

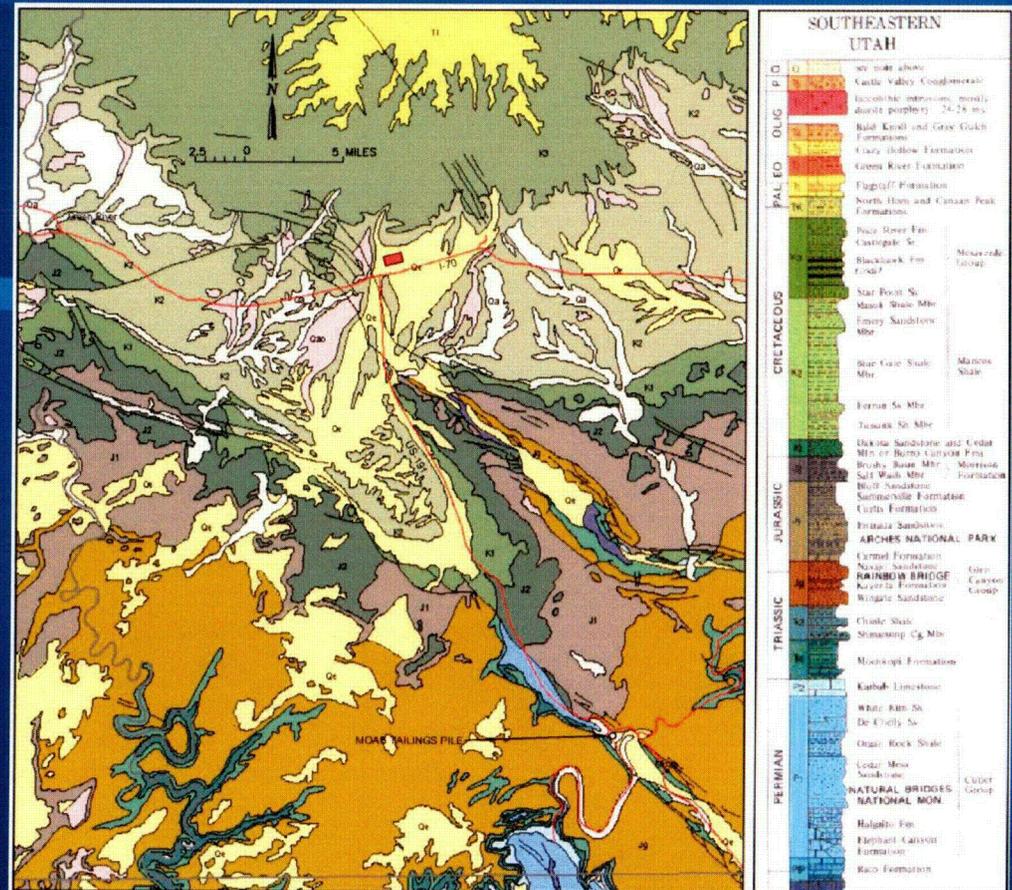
- Regional geologic map

Regional Geologic Map of East-Central Utah  
showing the Crescent Junction Site Location.

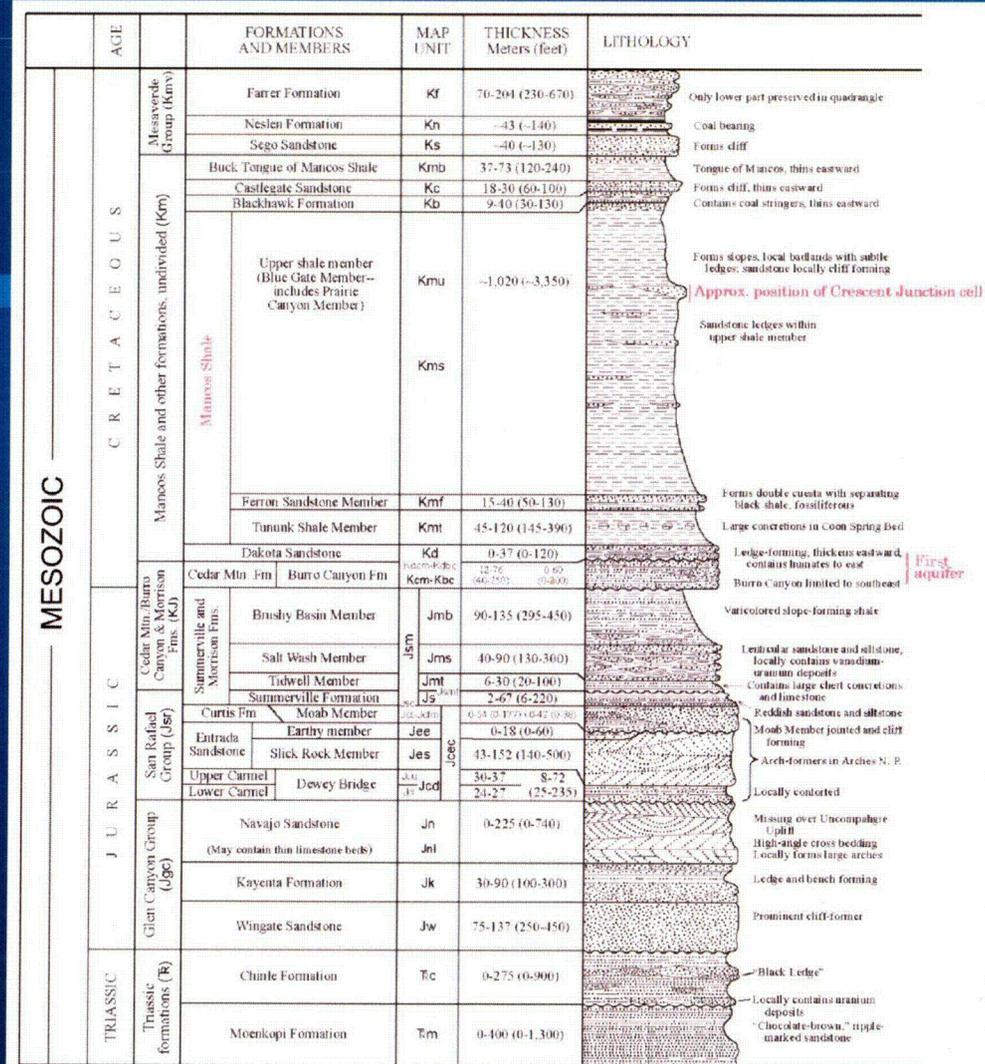
- Rocks in site area dip gently to north toward Uinta Basin
- Approximately 2,400 feet of Mancos Shale below site to first aquifer

Columnar Stratigraphic Section of Mesozoic Rocks  
in the Crescent Junction Site Area

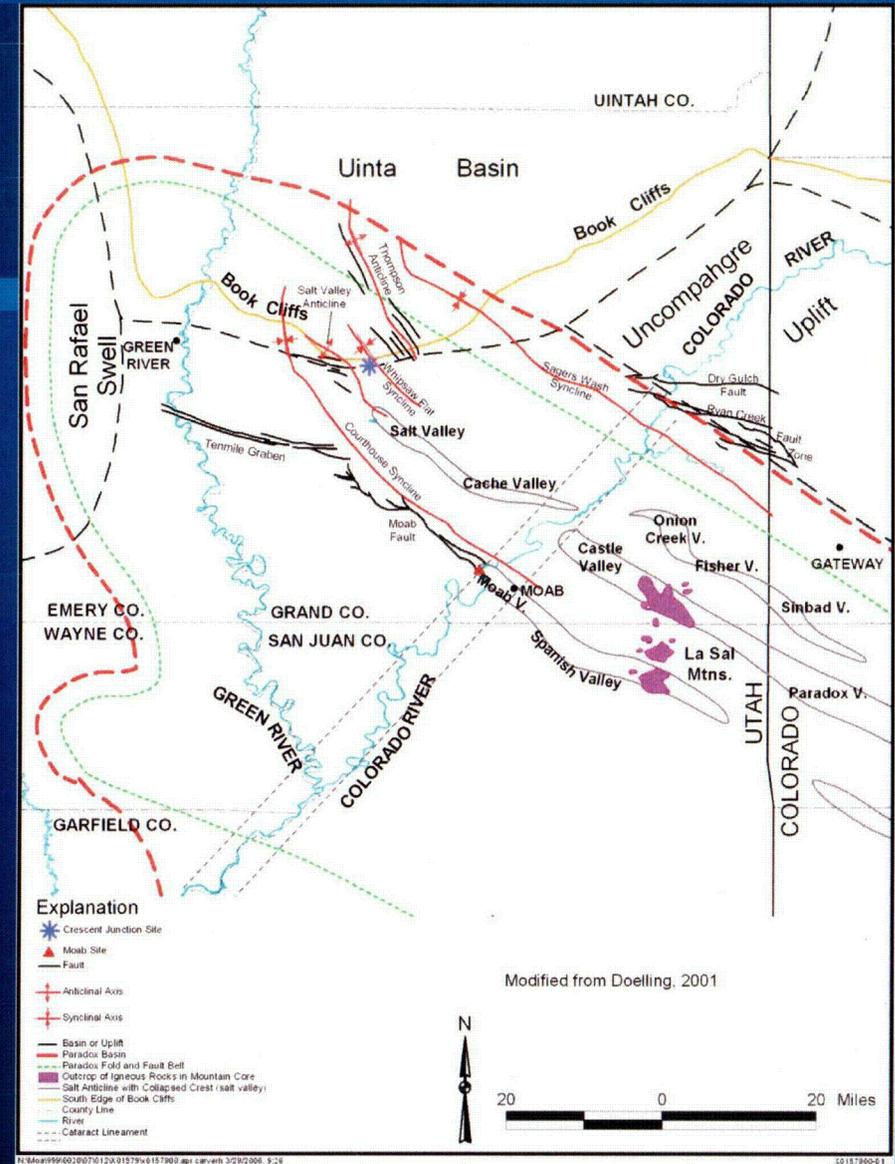
- Site in north part of ancestral Paradox Basin in Paradox fold and fault belt
- Northwest-trending structures

Structural geologic setting of the  
Crescent Junction site area

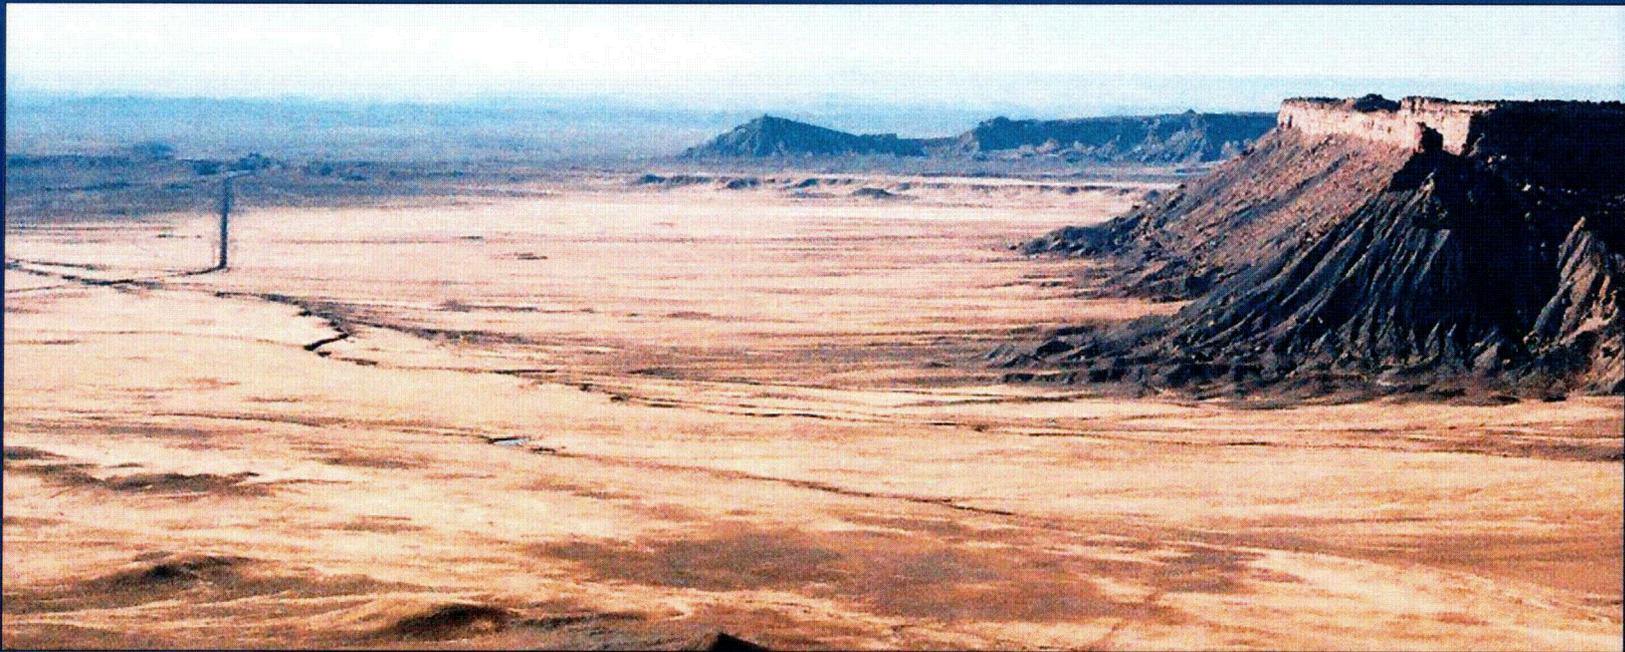
- Site is below the base of the Book Cliffs on Crescent Flat, which dips gently south at 2% to 3% grade

View west-southwest of Crescent Flat and unbroken face of Book Cliffs

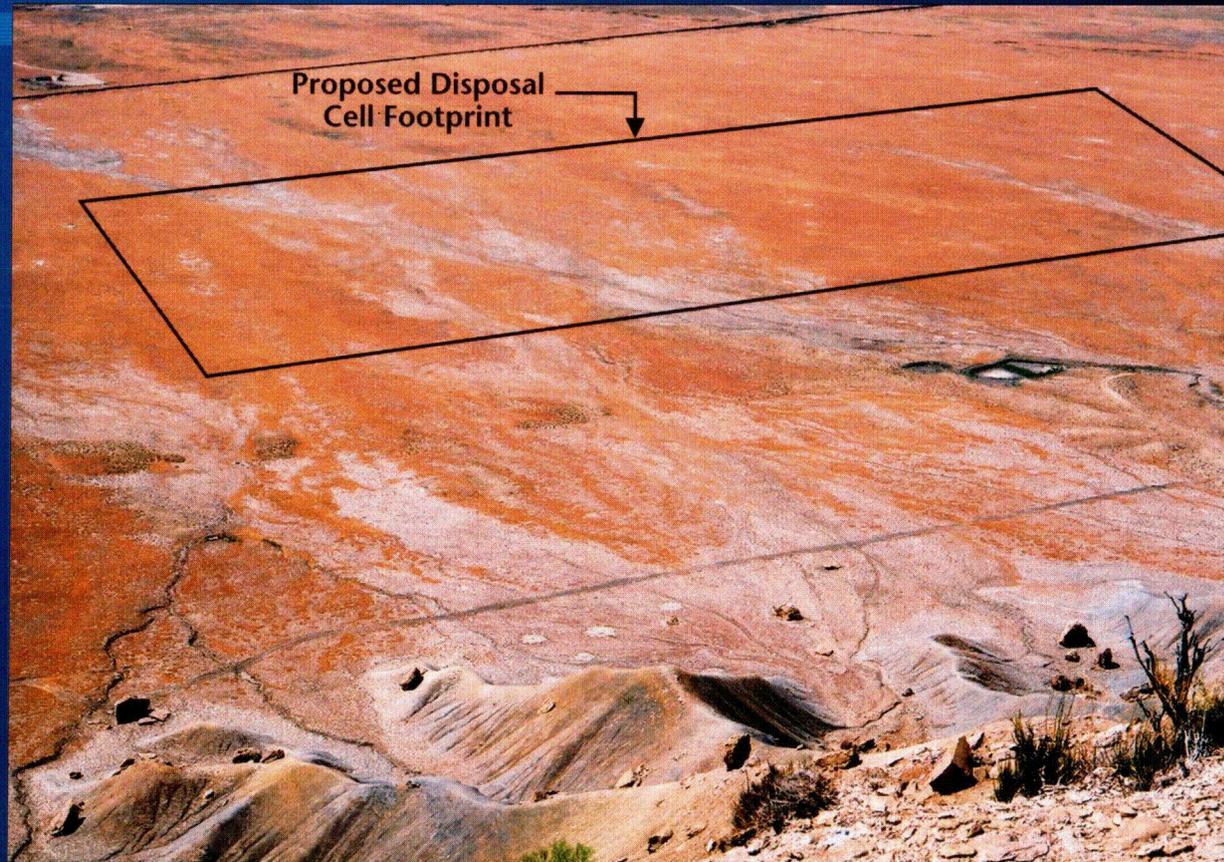
View south-southwest of Crescent Flat and proposed disposal cell footprint from top of Book Cliffs

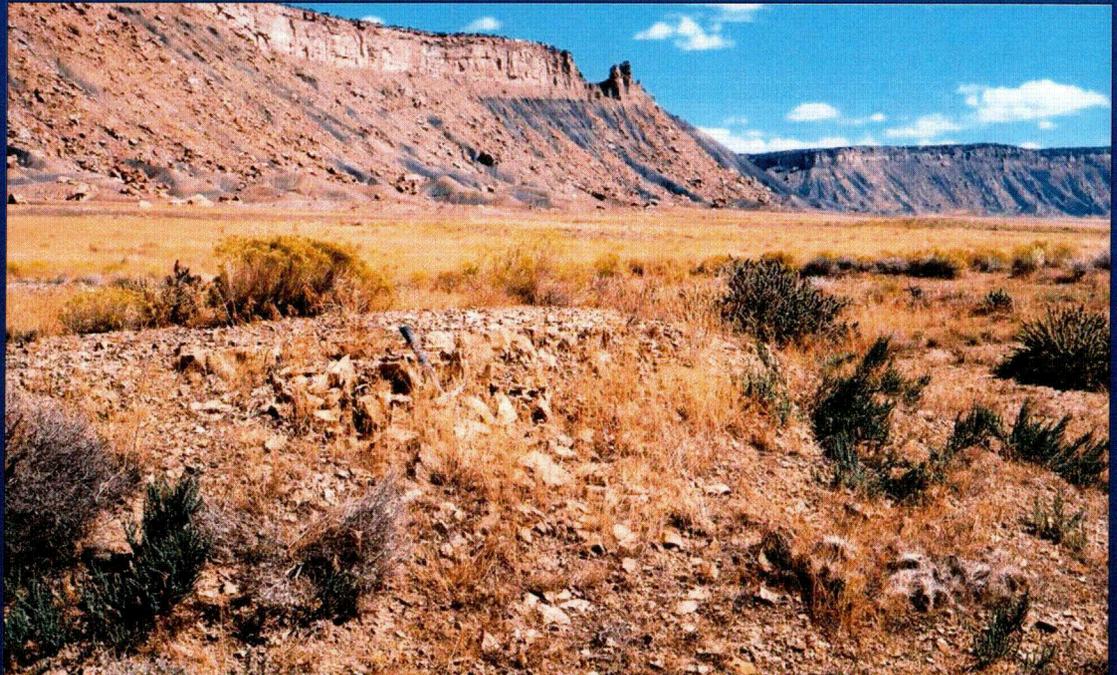
Dolomitic siltstone  
concretion mound at top of  
Prairie Canyon Member

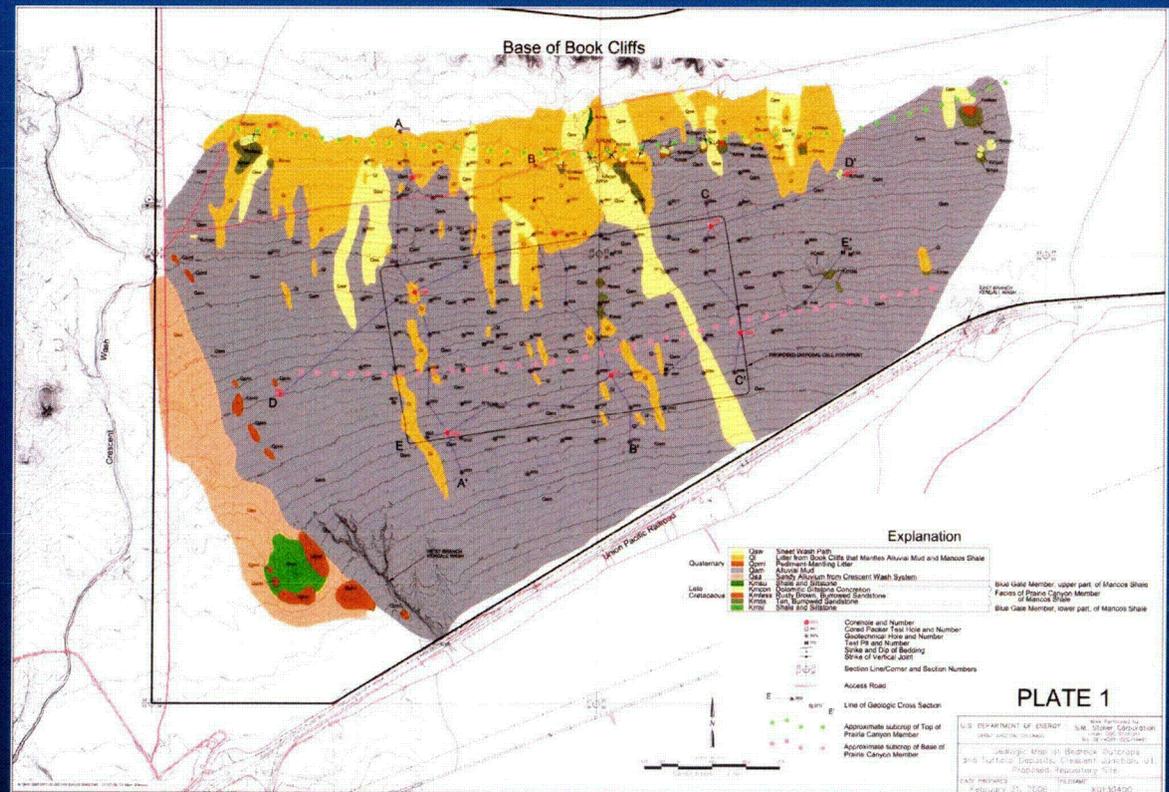
- Geologic mapping
  - Few bedrock exposures at site
  - Site in upper middle part of Mancos Shale
  - One narrow sheet-wash path extends across site

Geologic map of Crescent Junction site area

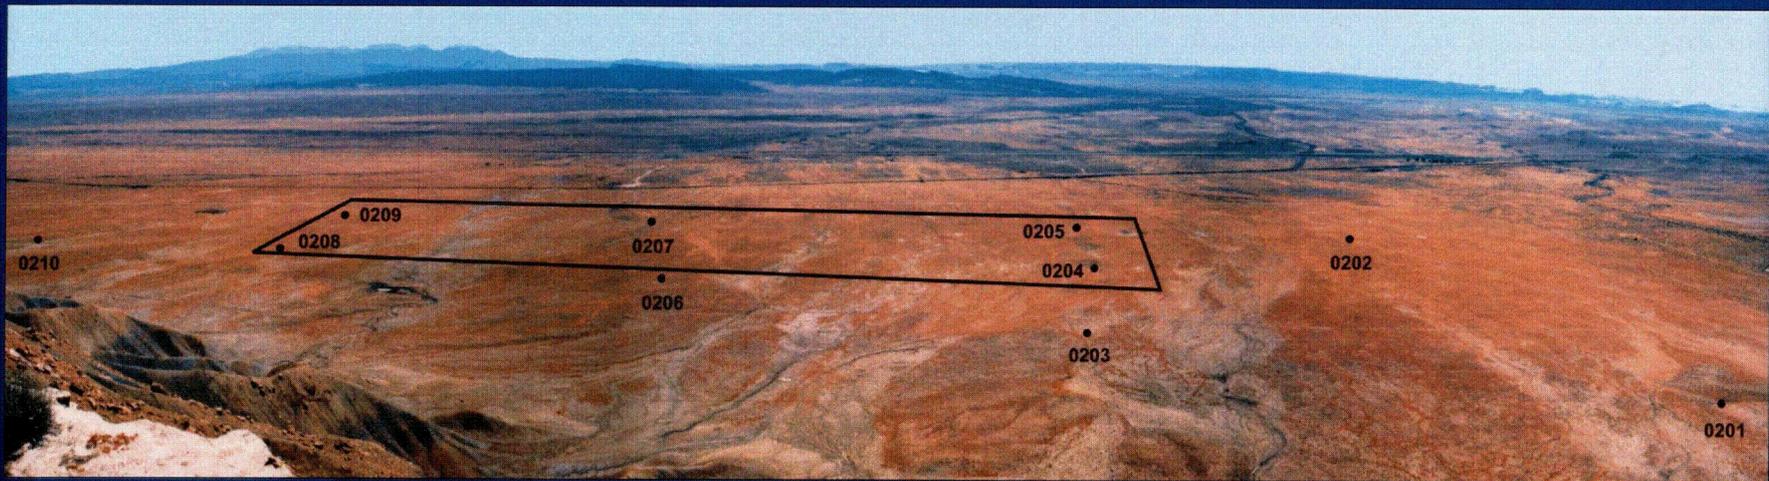
- 10 deep (300-foot) coreholes and 3 shallow (40-foot) coreholes for packer tests
- 100 geotechnical holes to depth of refusal in bedrock

View south of Crescent Flat showing proposed disposal cell footprint and 10 deep coreholes

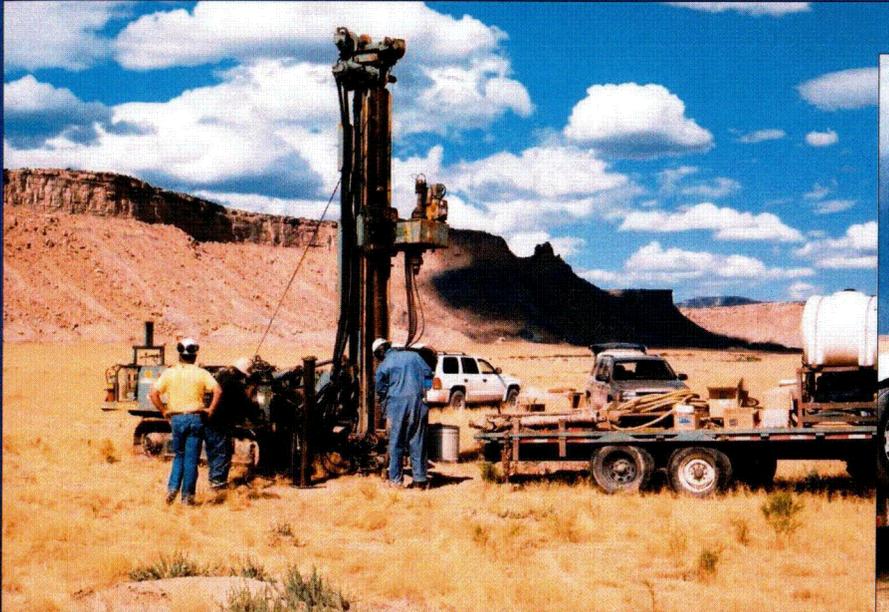
Shallow coring at corehole 0209  
with Terramec 1000 rig

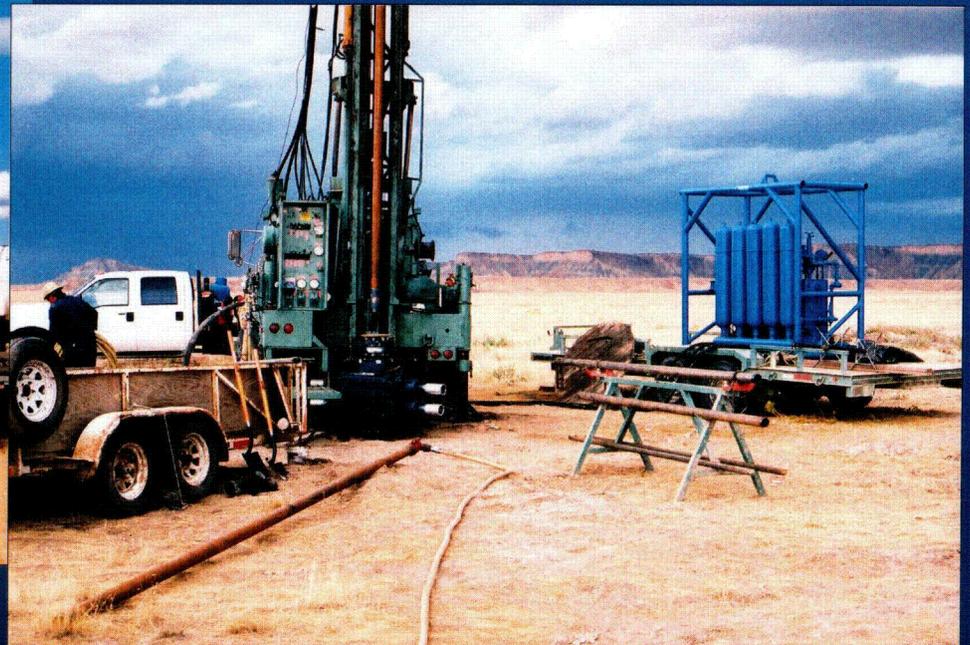
Setting up blowout preventer for deep coring with Acker  
BB-80 rig at corehole 0209

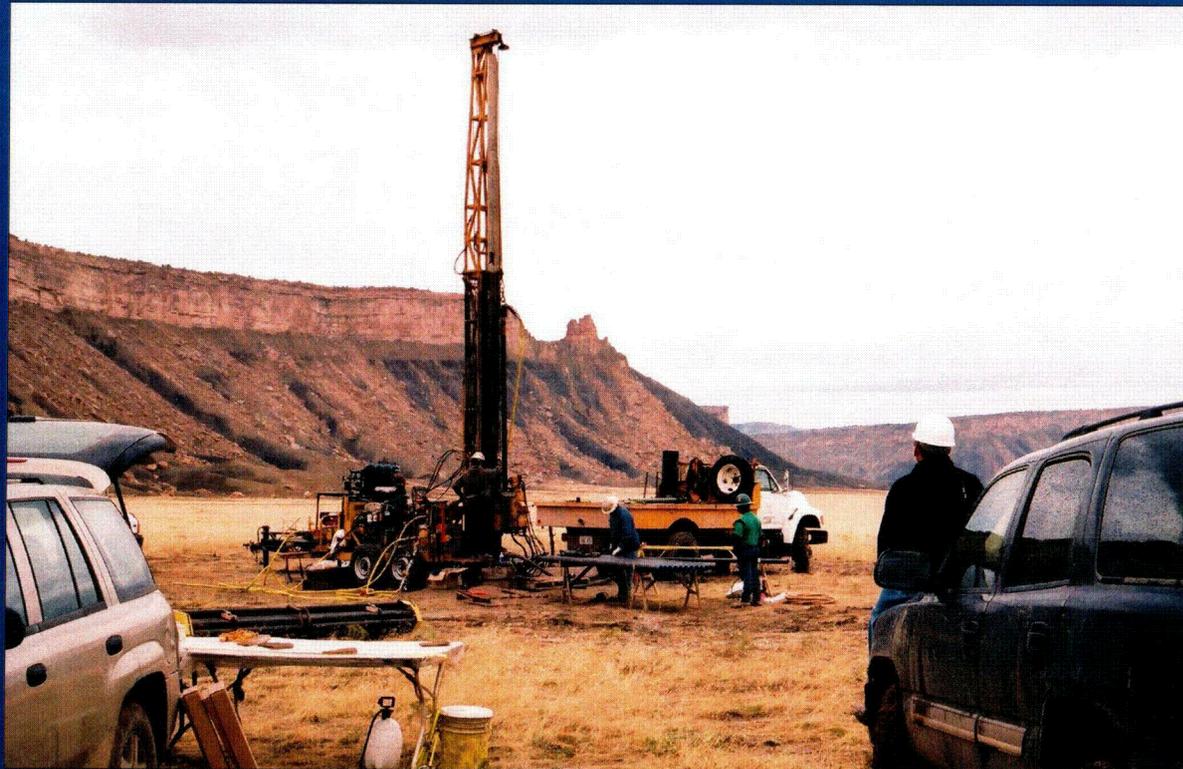
Deep coring with CS-1000 rig at 0210

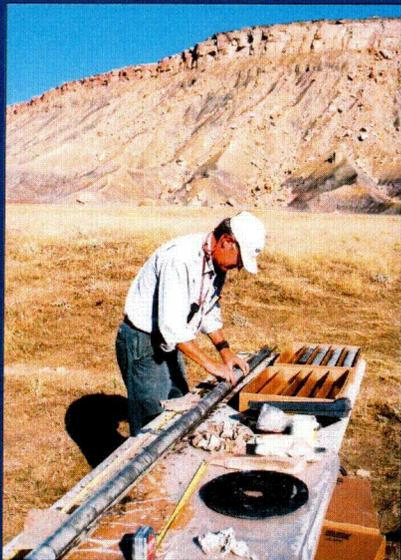
Logging core and placing core in box at corehole 0210

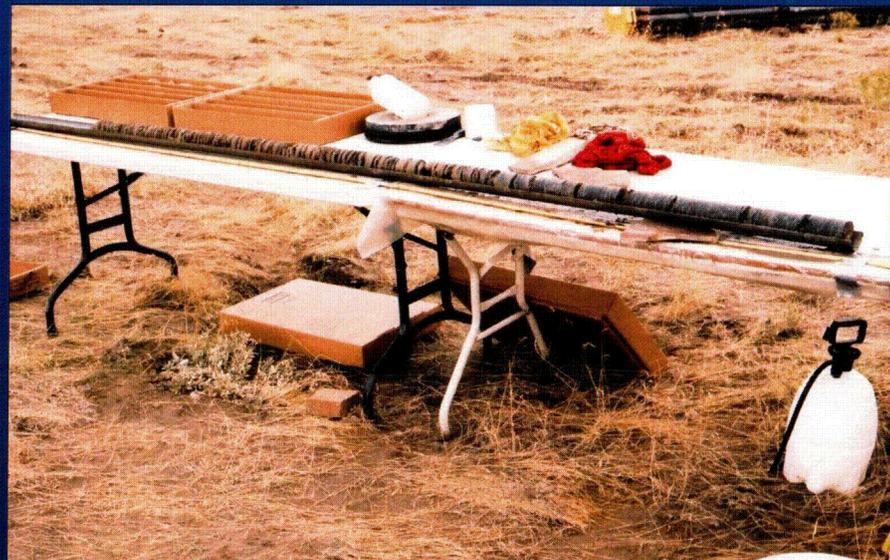
- Drilling
  - Weathering effects observed in core; most fractures within top 20 to 30 feet of bedrock

Weathering decreases from depth of 26 feet (left) to 36 feet (right) in corehole 0210

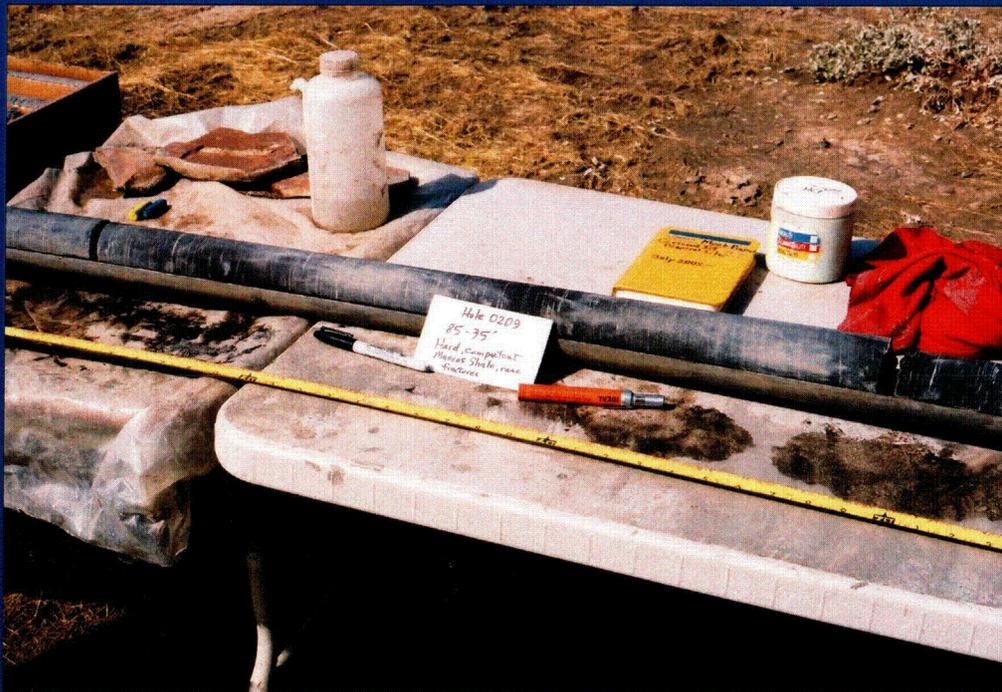
- Drilling
  - Infrequent fractures below 50-foot depth and hard, competent mudstone below 80- to 100-foot depth

Hard, competent mudstone of lower Blue Gate Member at depth of 85 to 95 feet in corehole 0209
