Indian Point Energy Center

Groundwater Investigation

March 28, 2006

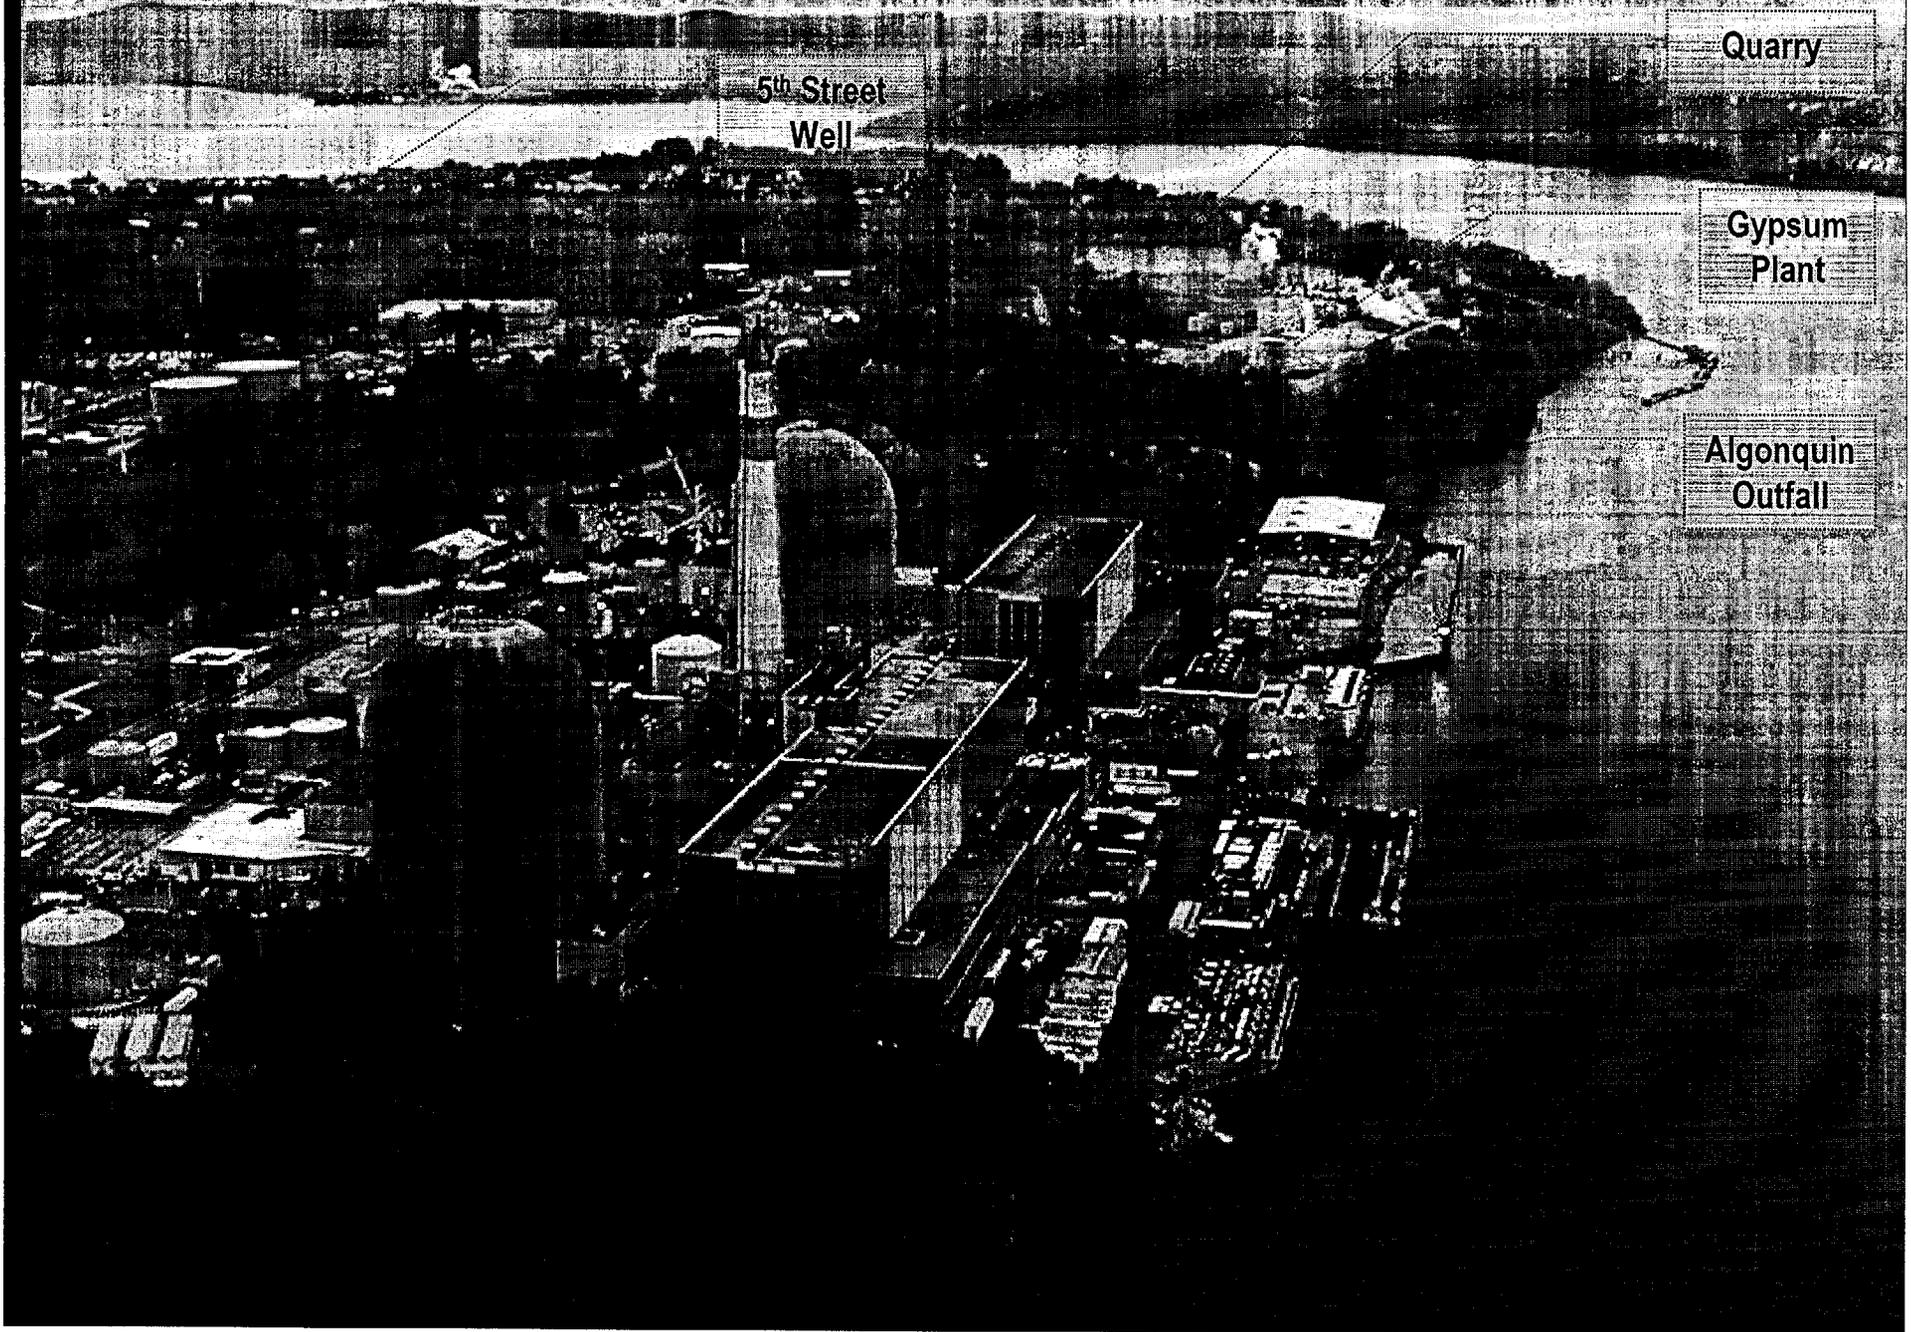
Indian Point Looking South Along the Hudson River

5th Street Well

Quarry

Gypsum Plant

Algonquin Outfall

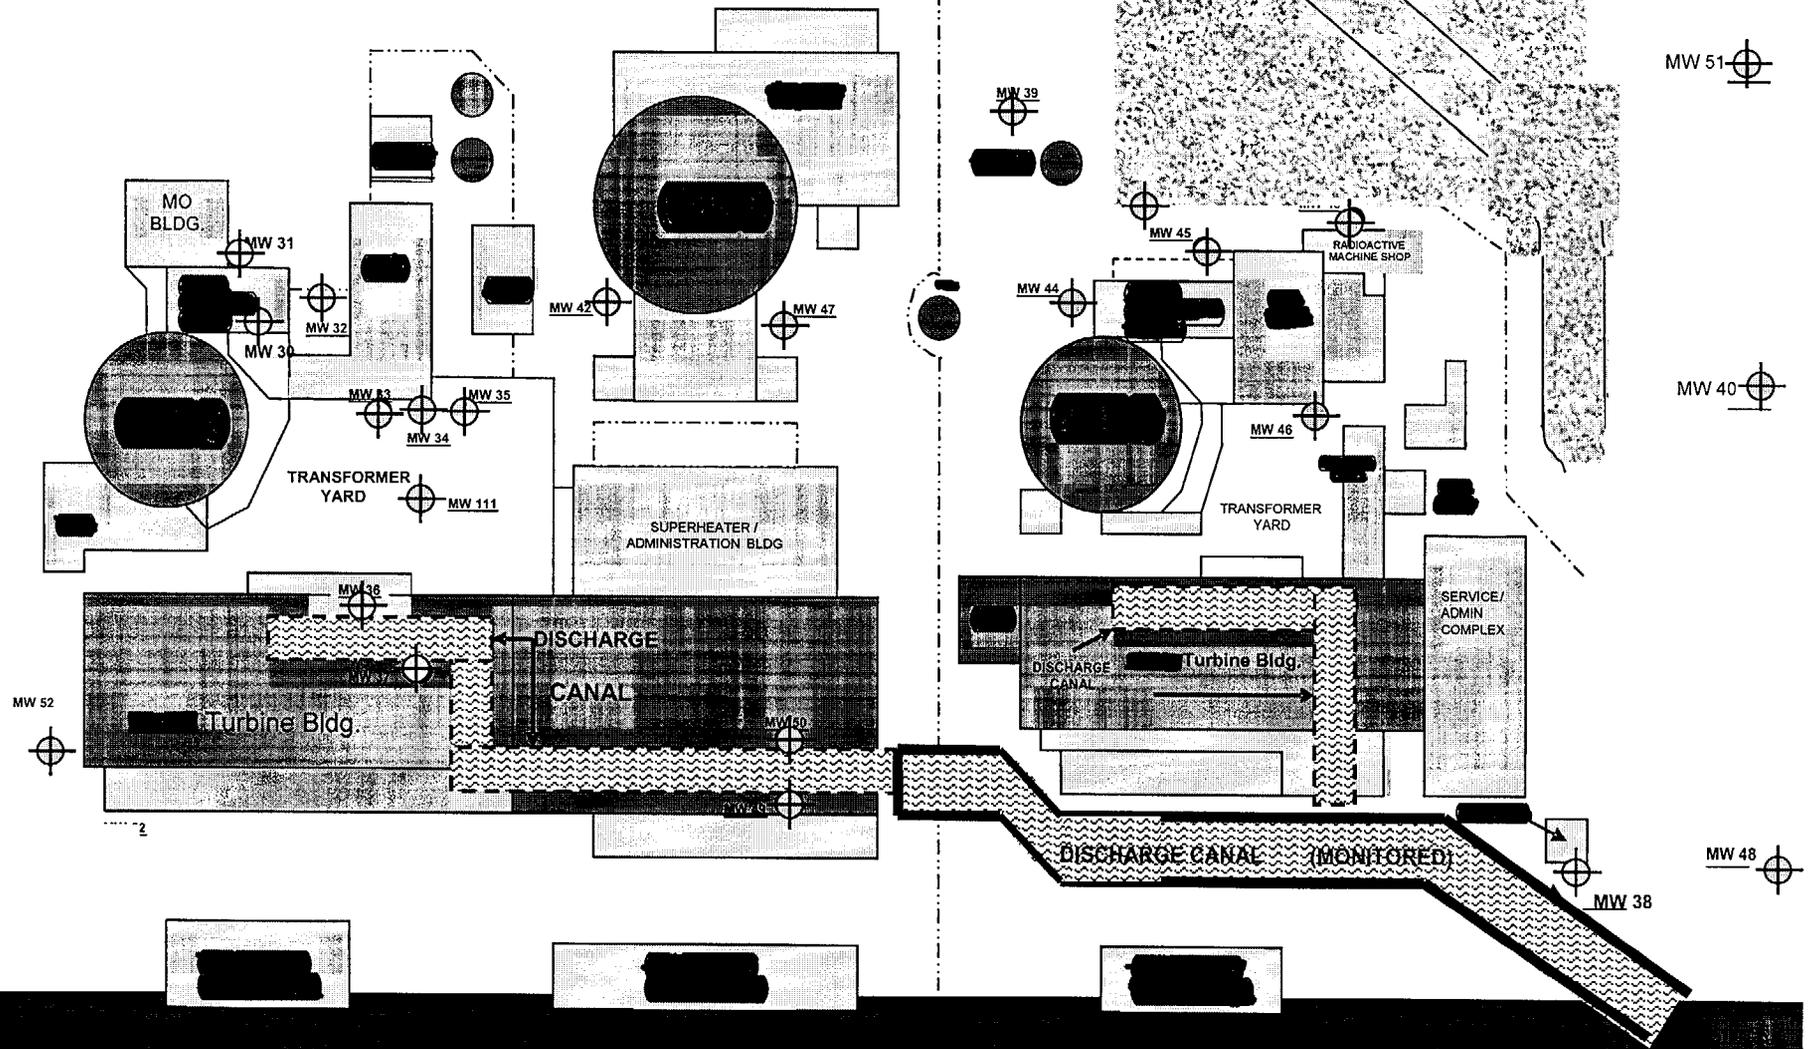
Monitoring Well Locations

Installed 9 new wells to determine groundwater characteristics around IP2
All wells drilled and sampled

Will install approximately 14 wells in phase 2 to characterize ground water flow on site
12 of 14 wells completed
2 in progress

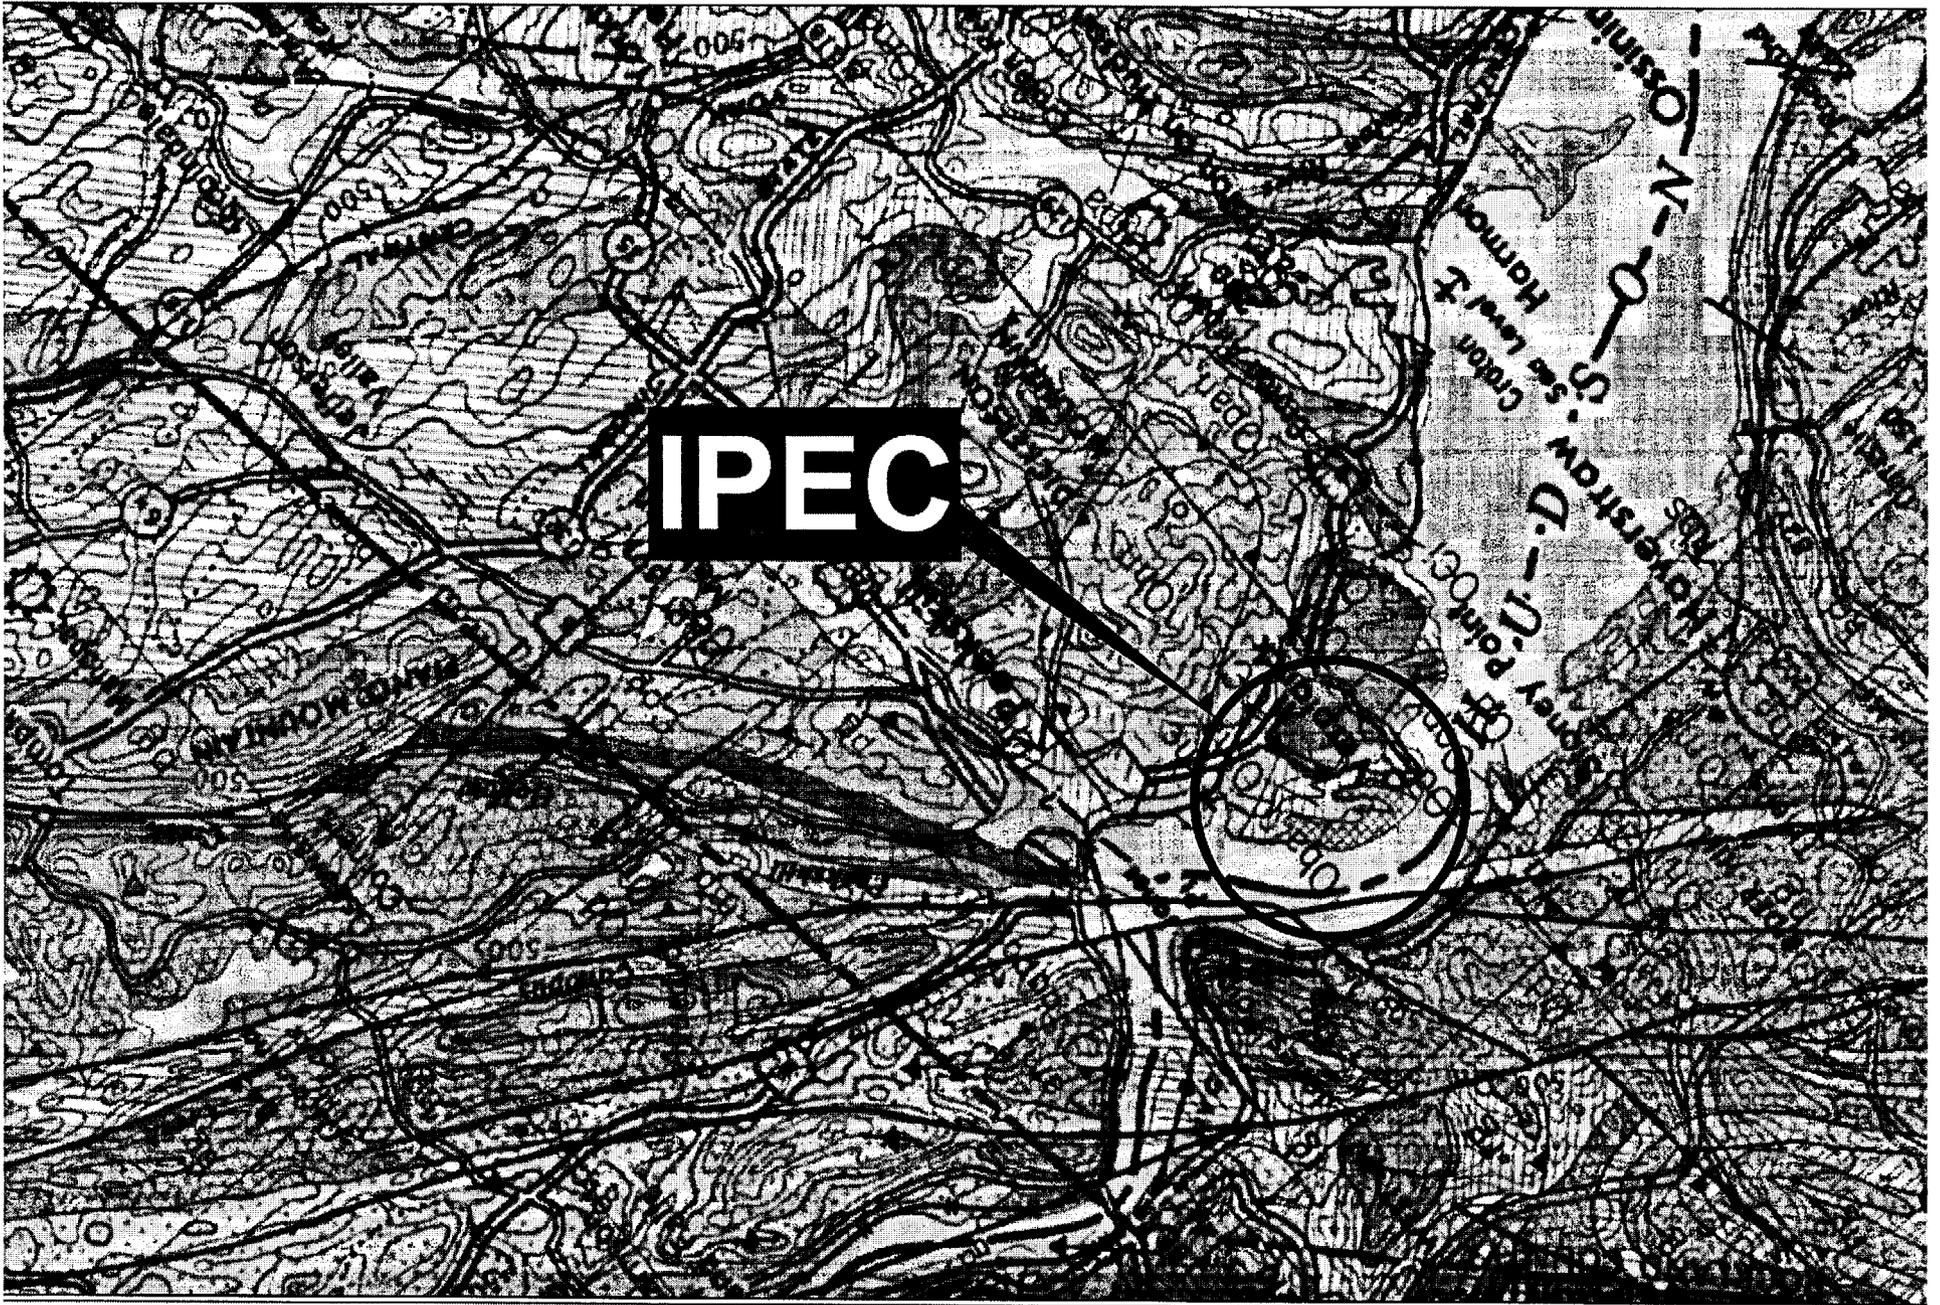
USGS BEDROCK GEOLOGY

GEOLOGIC MAP OF NEW YORK, LOWER HUDSON SHEET,
REPRINTED 1995, NEW YORK STATE MUSEUM AND
SCIENCE SERVICE, MAP AND CHART SERIES NO. 15.

INDIAN POINT ENERGY CENTER, BUCHANON, NEW YORK

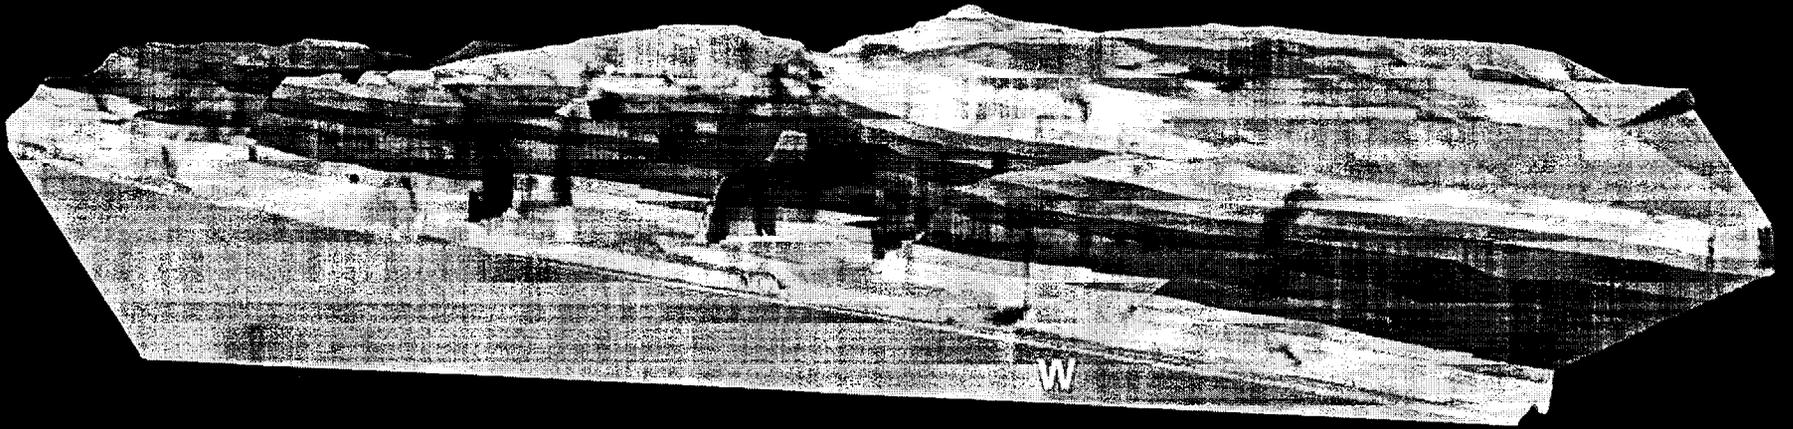
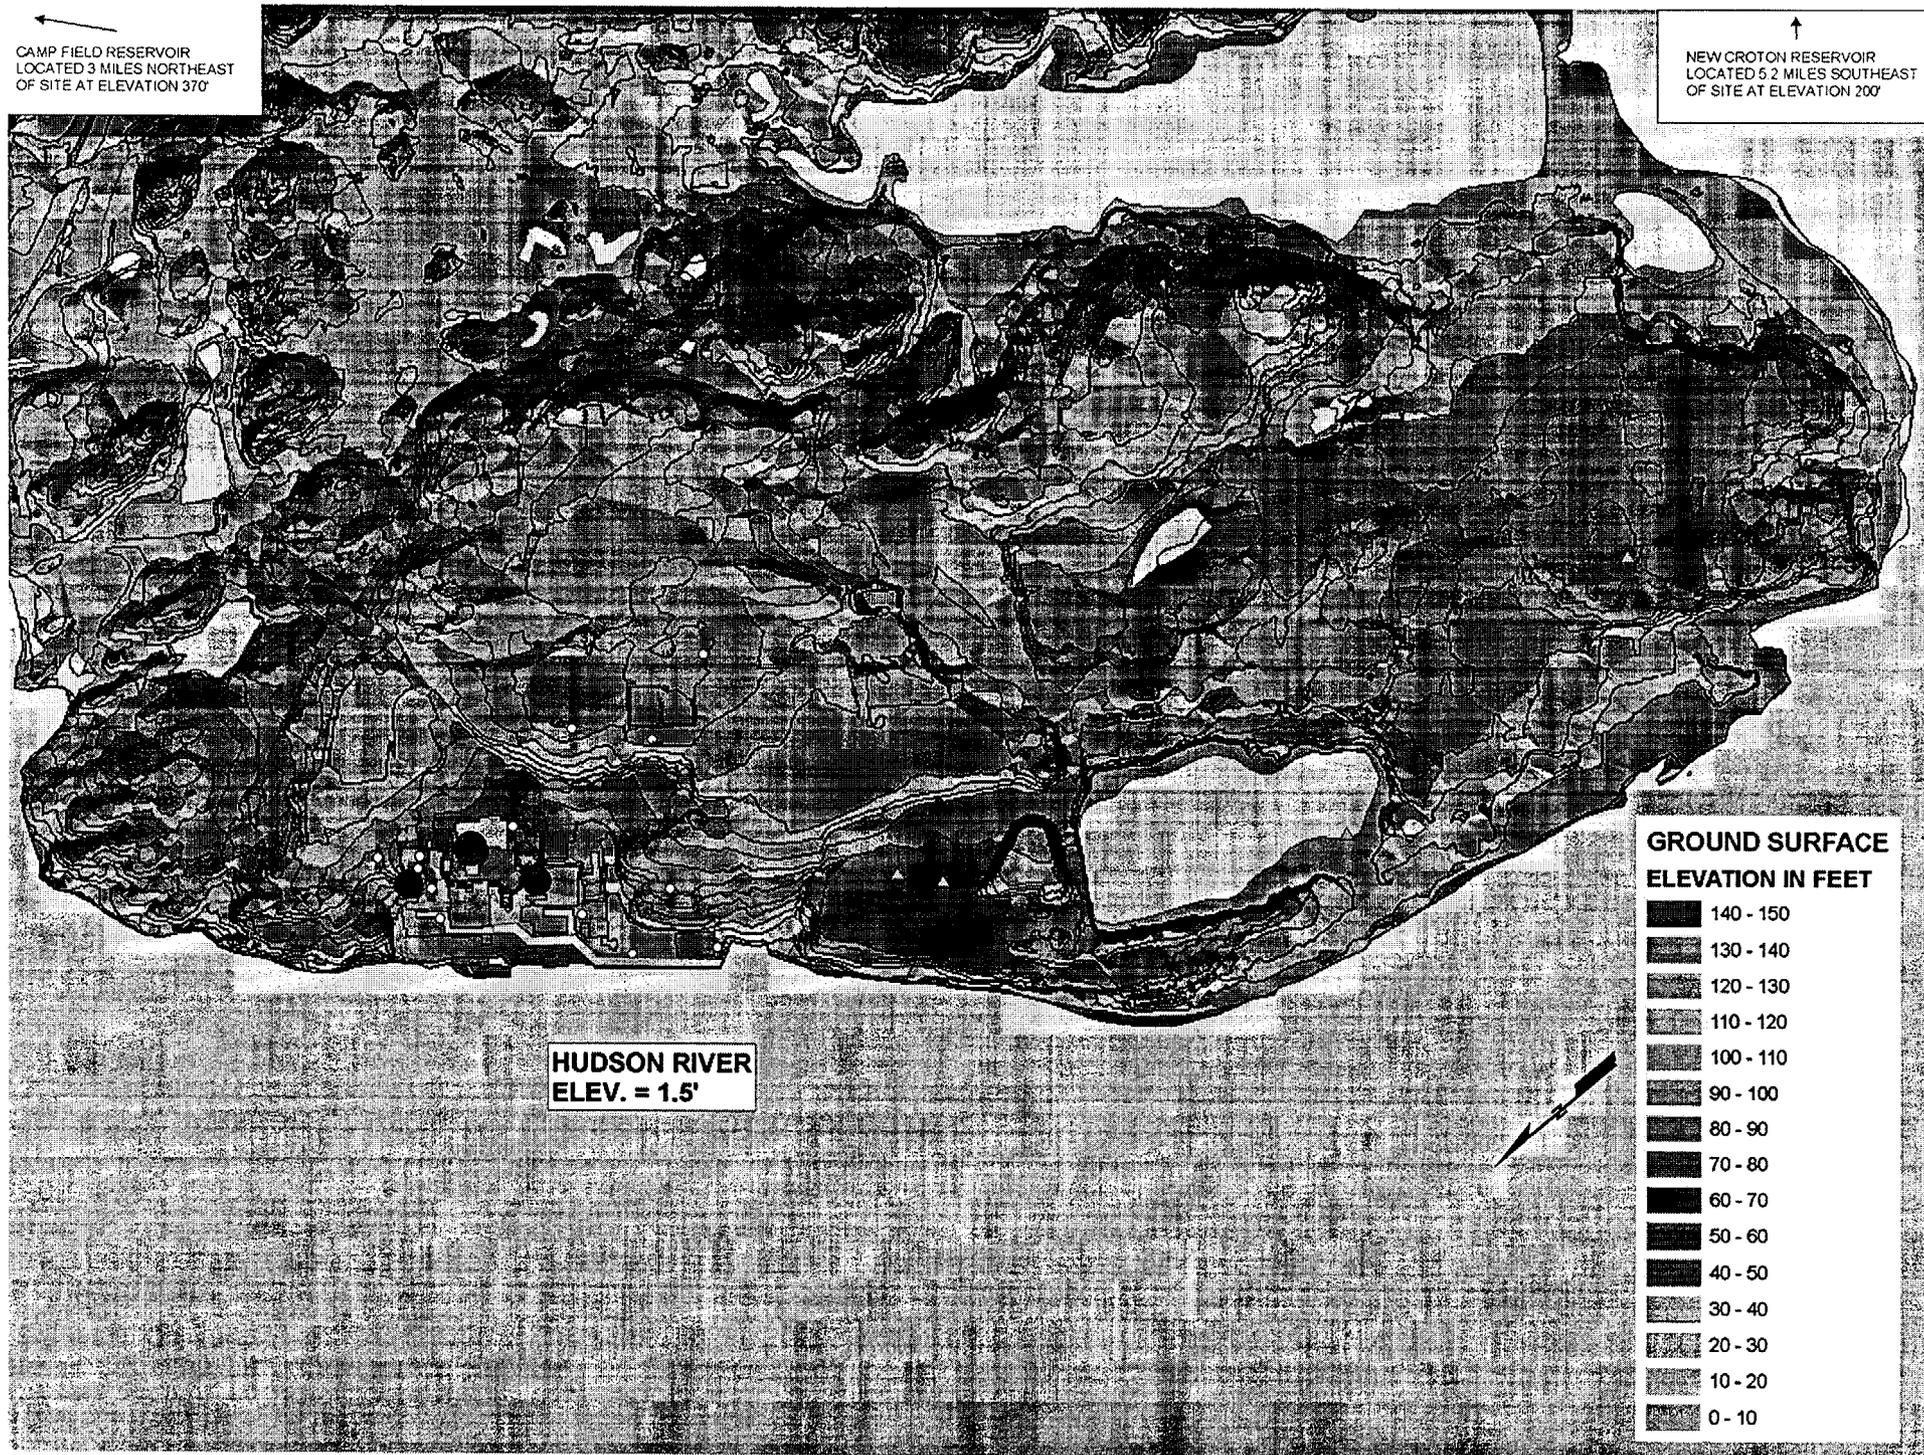
CAMP FIELD RESERVOIR
LOCATED 3 MILES NORTHEAST
OF SITE AT ELEVATION 370'

NEW CROTON RESERVOIR
LOCATED 5.2 MILES SOUTHEAST
OF SITE AT ELEVATION 200'

HUDSON RIVER
ELEV. = 1.5'

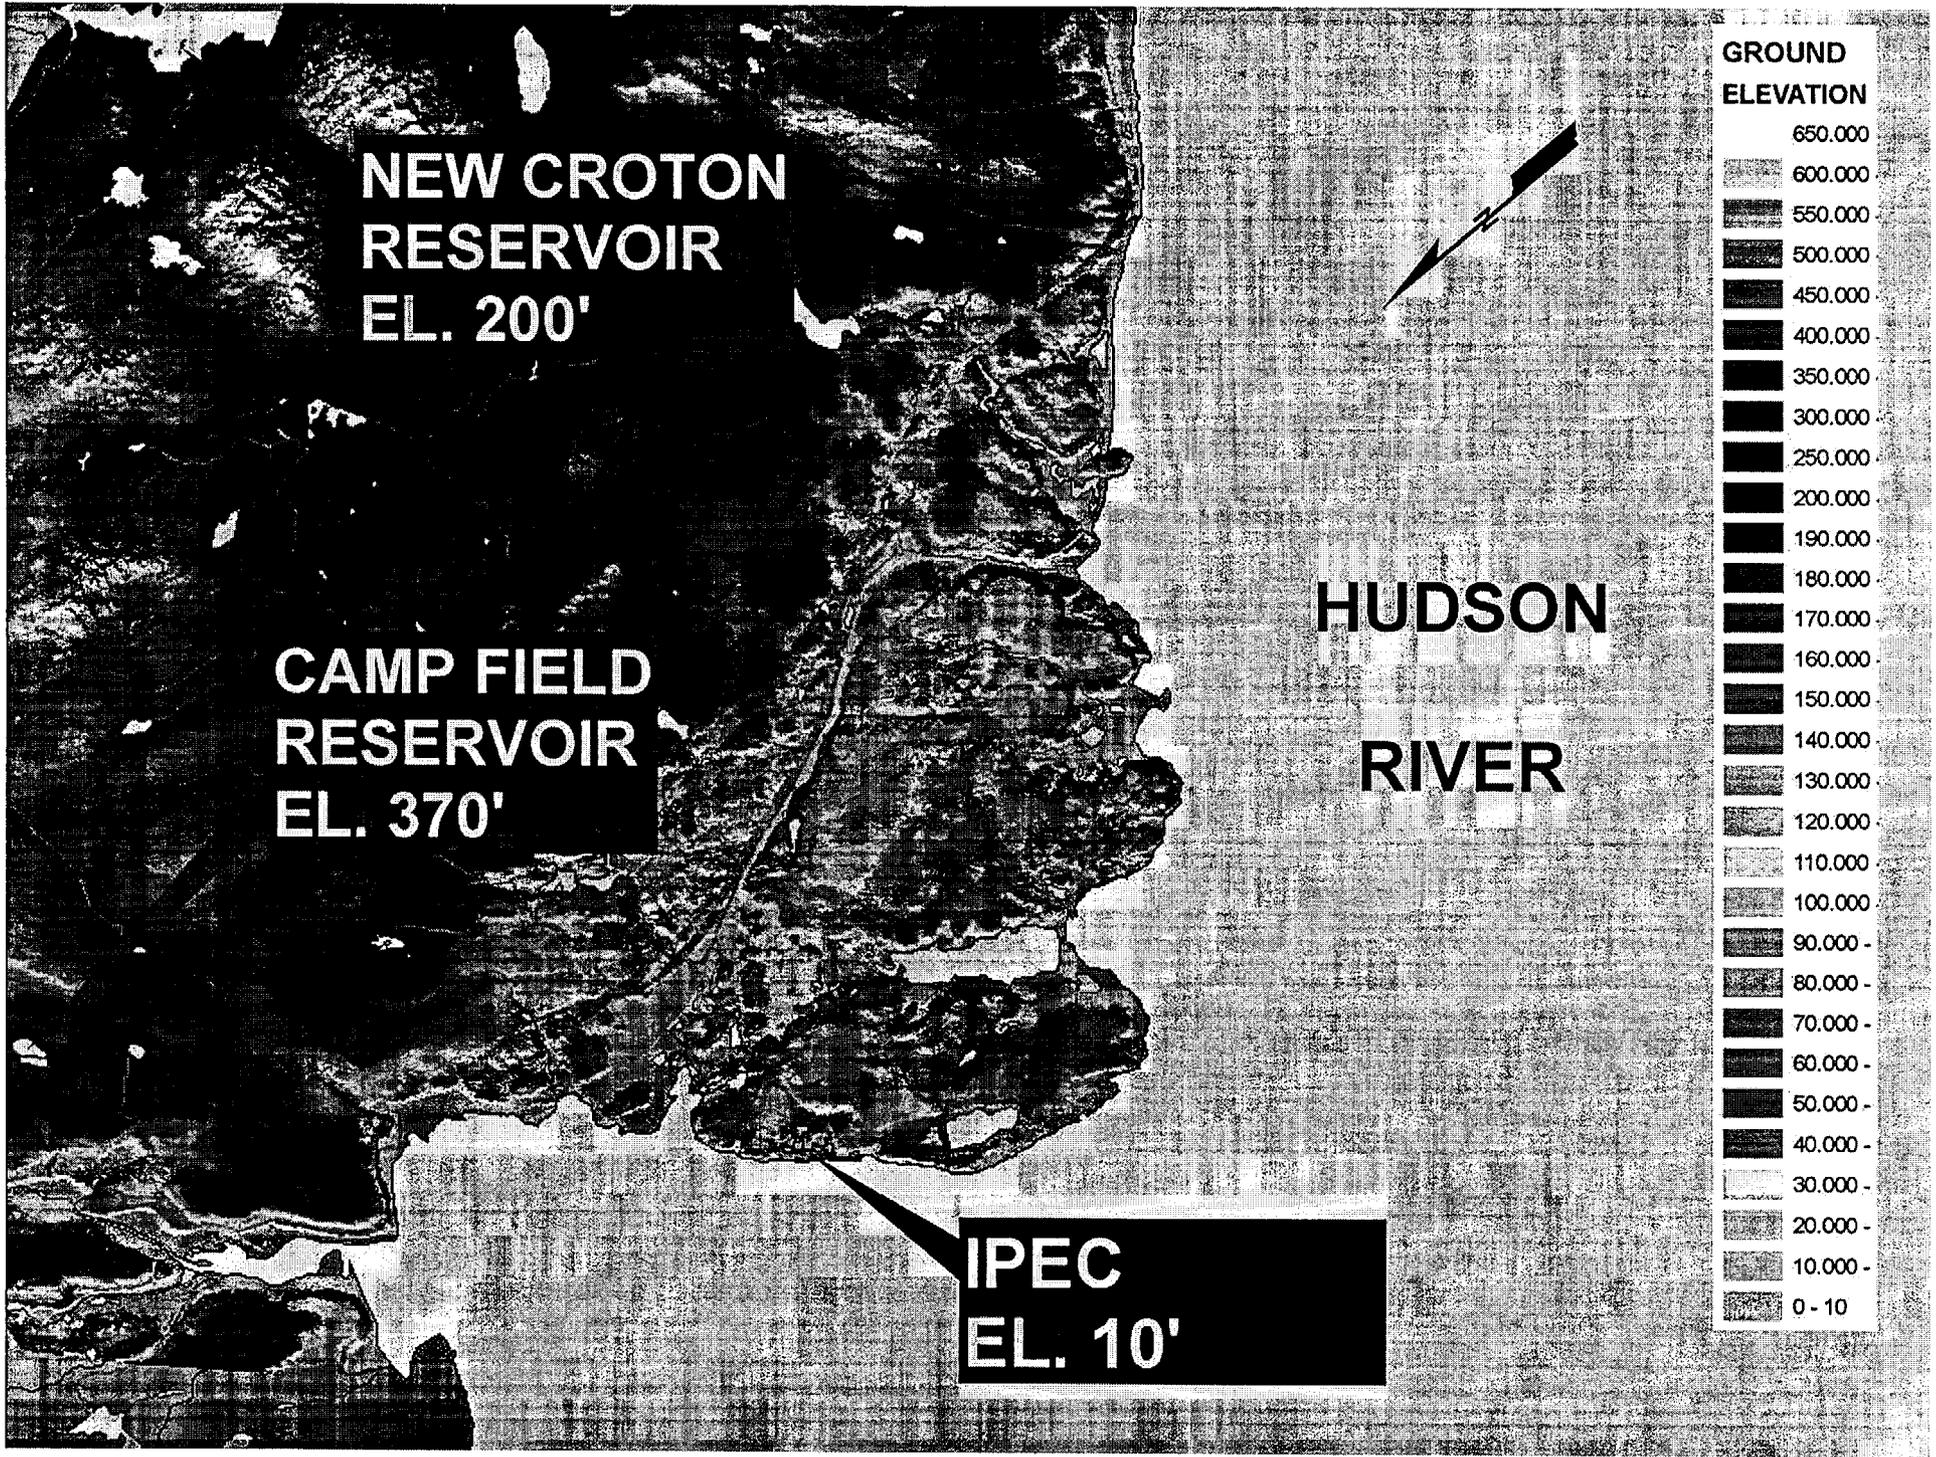
**NEW CROTON
RESERVOIR
EL. 200'**

**CAMP FIELD
RESERVOIR
EL. 370'**

**IPEC
EL. 10'**

**HUDSON
RIVER**

Groundwater movement on site is generally toward the plants; not away from the plants

Groundwater flow is generally from north to west and south toward Hudson River

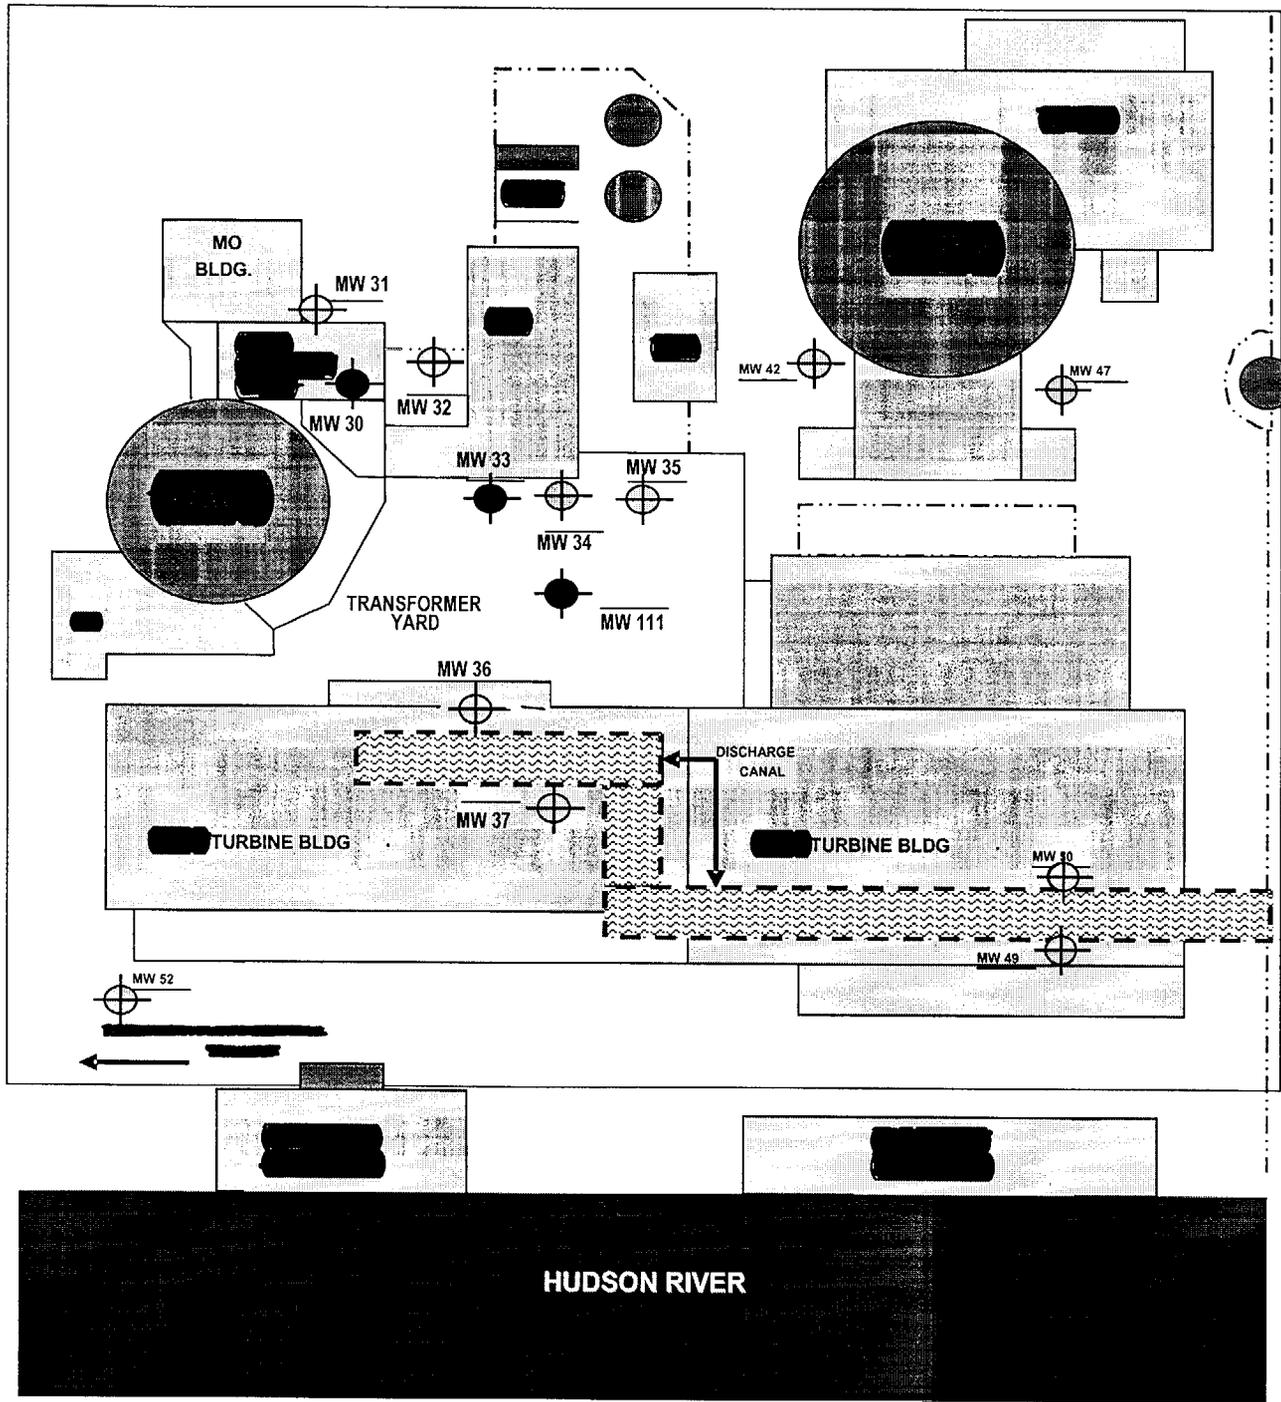
Phase 1 Monitoring Wells

Tritium pCi/L

●	> 250,000
⊕	100,00-250,000
⊕	20,000-100,000
⊕	1000 - 20,000
⊕	< 1000
⊕	Phase 2 wells

- Tritium levels are highest near IP2 spent fuel pool and IP2 transformer yard
- Lower levels of tritium found in other locations including low levels in some storm drainage systems
- Sr-90 found at elevated levels in a well adjacent to discharge canal

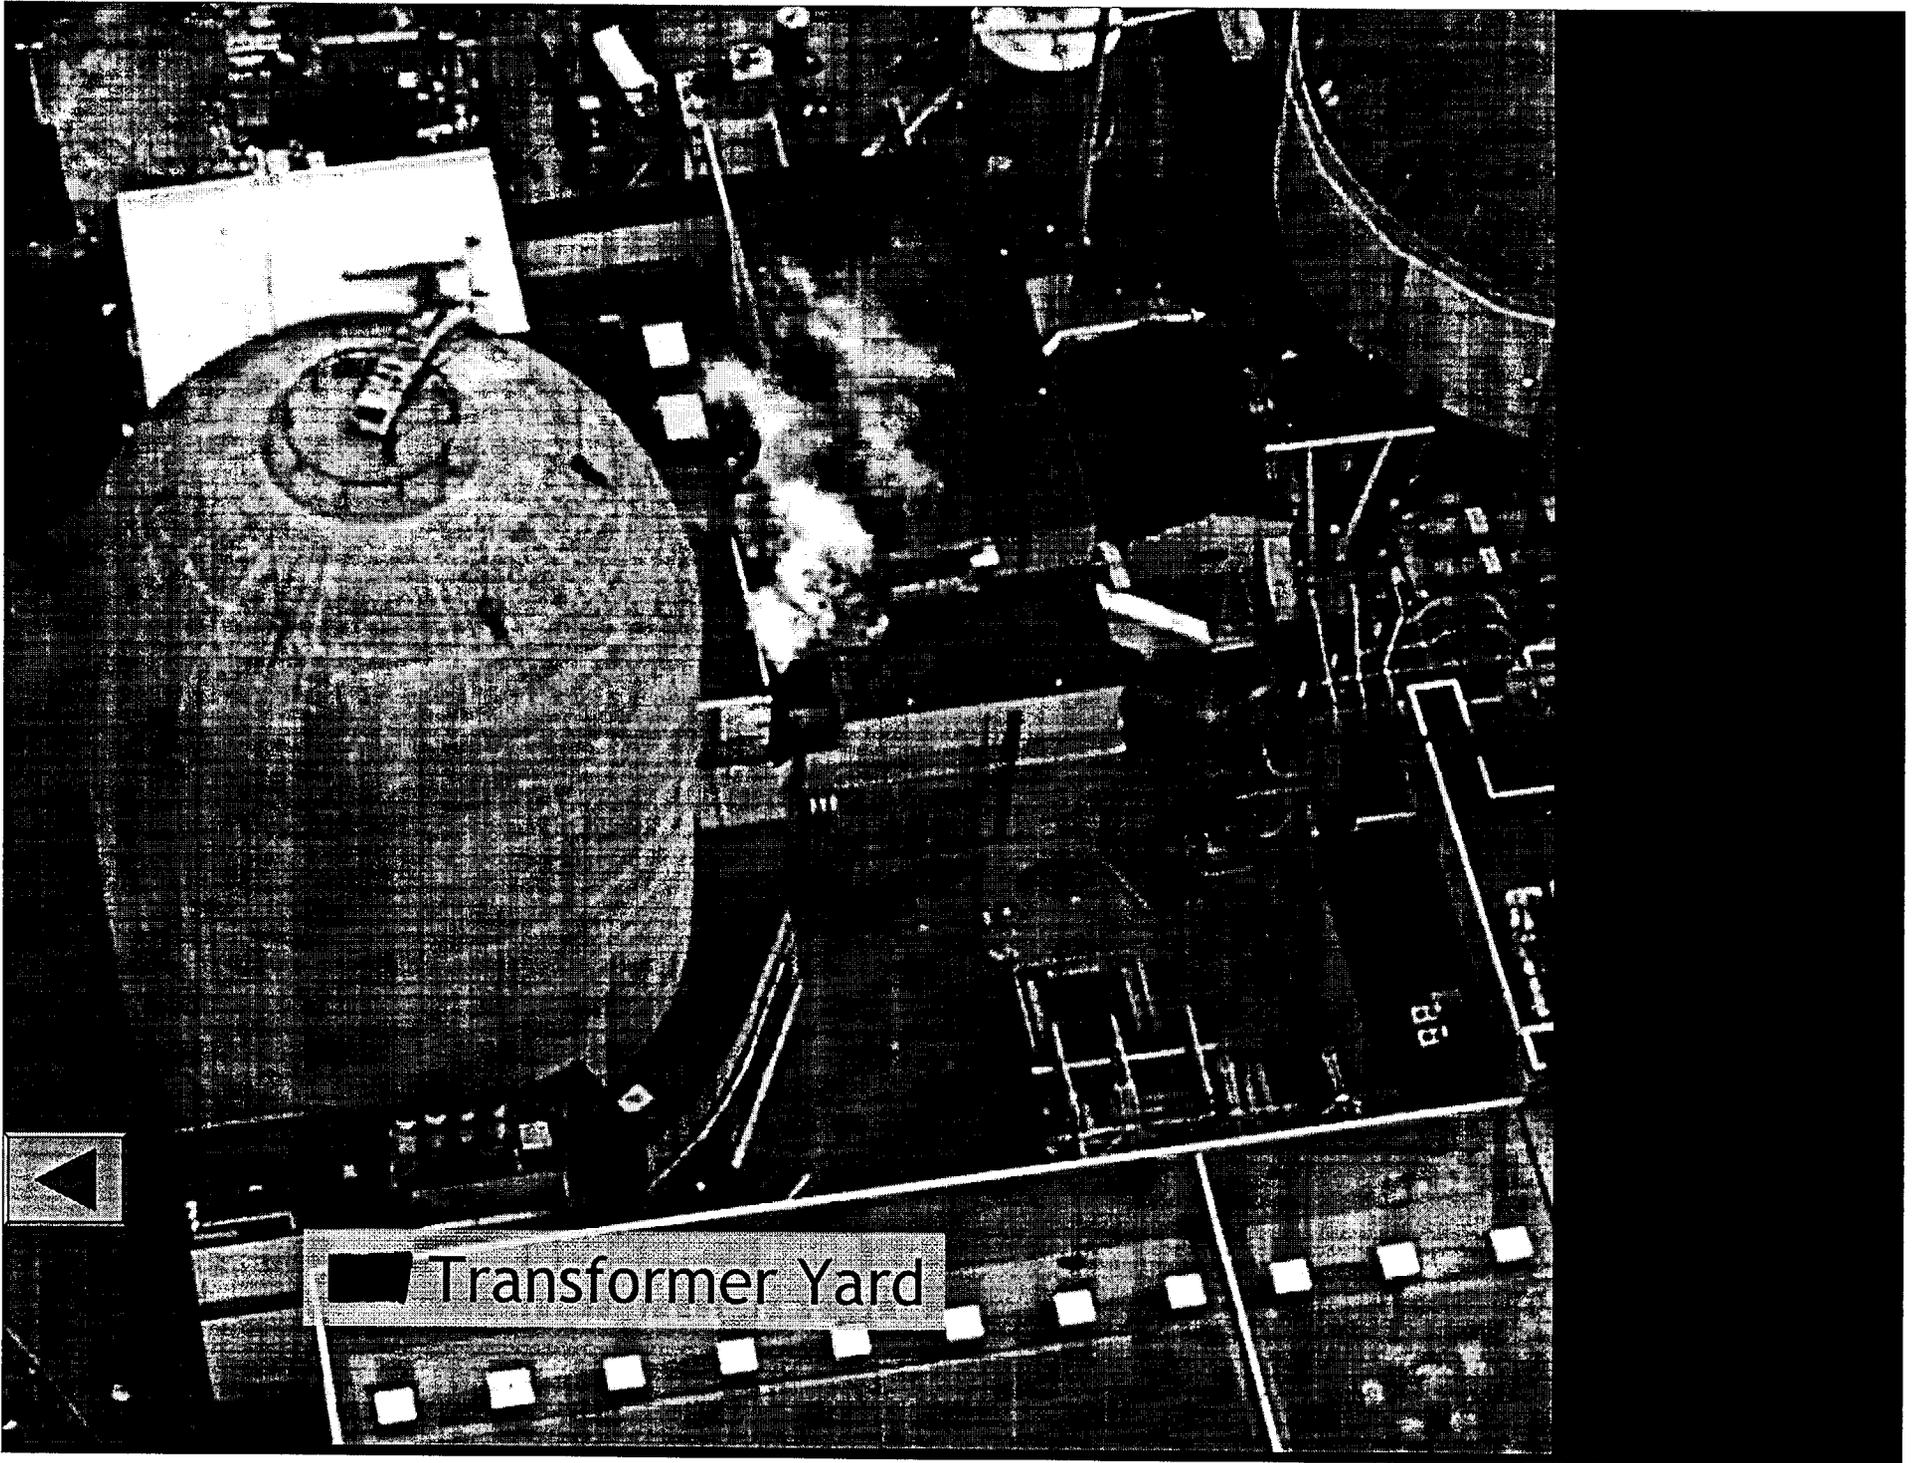
ID	Date	Location	Sample Results Tritium (pCi/L)	
Monitoring Wells on Site				
MW-111	3/3/06	Transformer Yard	236,000	
MW-30	2/7/06	SFB	511,000	
MW-31	2/7/06	Adjacent to SFB	33,100	
MW-32	2/7/06	SFB Alley Way	17,700	
MW-33	3/3/06	Transformer Yard	253,000	
MW-34	3/3/06	Transformer Yard	230,000	
MW-35	3/3/06	Transformer Yard	119,000	
MW-36	2/27/06	IP2 Turbine building	45,800 @ 41'	
MW-37	2/25/06	IP2 Turbine Building	30,500 @ 32'	
MW-38		South perimeter near IP3		
	3/3/06	Entergy (Teledyne)	2630	ND-Sr
	12/8/05	New York State	701	
	12/8/05	Entergy	985	
MW-48		South perimeter		
	2/10/06	Entergy	ND-HTO	ND-Sr
	2/8/06	New York State	250-HTO	
Off Site Locations (Entergy data)				
	2/8/06	Algonquin/Gypsum	ND-HTO	ND-Sr
	2/8/06	Trap Rock Quarry/Hudson River	ND-HTO	ND-Sr
MW-111 Samples Analyzed for Sr-90				
	9/29/05	Entergy Sr-90	ND	
	10/21/05	New York State - Sr-90	3
