**INSPECTION OF INACCESSIBLE REGIONS OF NUCLEAR POWER PLANT  
CONTAINMENT METALLIC PRESSURE BOUNDARIES**

**D. J. Naus  
Metals and Ceramics Division  
Oak Ridge National Laboratory  
Oak Ridge, Tennessee 37831-8056**

**June 2002**

**Prepared for the  
U.S. Nuclear Regulatory Commission  
Office of Nuclear Regulatory Research  
Under Interagency Agreement No. 1886-N604-3J**

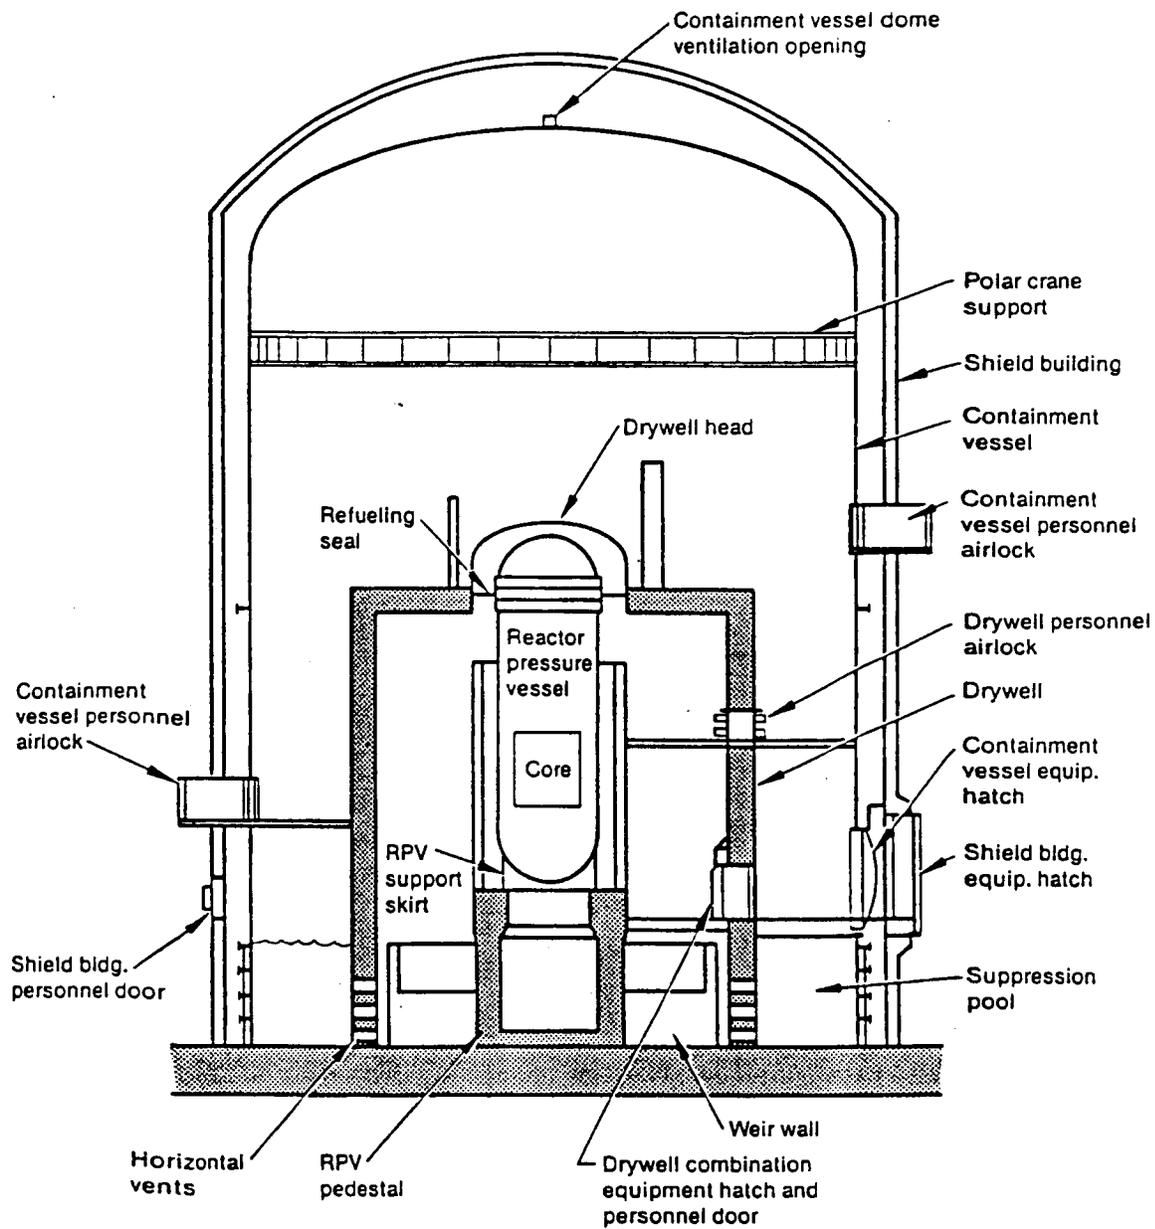
Figure 2.1 Example of a cross section for a BWR MK III freestanding steel containment housed in a reinforced concrete shield building.

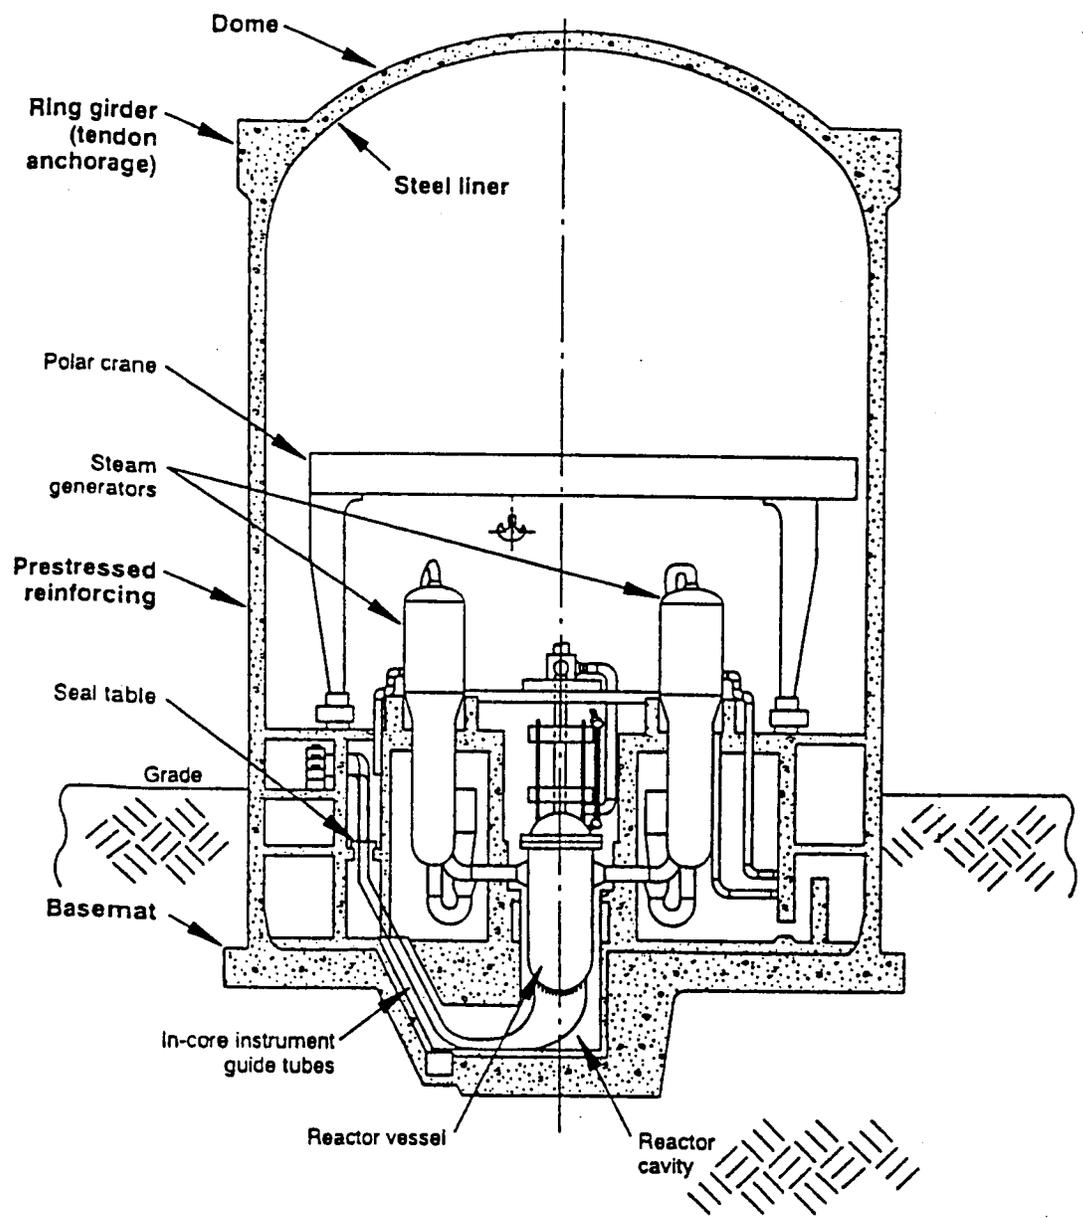
Figure 2.2 Example of cross section for PWR large-dry prestressed concrete containment.

Concrete containments are metal lined, reinforced concrete pressure-retaining structures that in some cases may be post-tensioned. The concrete vessel includes the concrete shell and shell components, shell metallic liners, and penetration liners that extend the containment liner through the surrounding shell concrete. The reinforced concrete shell, which generally consists of a cylindrical wall with a hemispherical or ellipsoidal dome and flat base slab, provides the necessary structural support and resistance to pressure-induced forces. Leak-tightness under conditions encountered throughout the operating life of the plant is provided by a steel liner fabricated from relatively thin plate material, generally 6 to 10-mm thick, that is joined by continuous welding and anchored to the concrete shell by means of stud anchors, rolled structural shapes, or both. Anchorage is such that the overall deformation of the liner is the same as the concrete structure under all loading conditions. Initially, existing building codes, such as American Concrete Institute (ACI) Standard 318, *Building Code Requirements for Reinforced Concrete* [2.4], were used in the nuclear industry as the basis for design and construction of concrete structural members. However, because the existing building codes did not cover the entire spectrum of design requirements and because they were not always considered adequate, additional criteria were developed for design of seismic Category 1 (i.e., safety related) structures (e.g., definitions of load combinations for both operating and accident conditions). Plants that used early ACI codes for design were reviewed by the USNRC through the Systematic Evaluation Program to determine if there were any unresolved safety concerns [2.5]. Current rules for construction of concrete containments are provided in Section III, Division 2 of the ASME Code. The USNRC has developed supplemental load combination criteria and provides information related to concrete and steel internal structures of steel and concrete containments [2.6,2.7]. Rules for design and construction of the metal liner that forms the pressure boundary for the reinforced concrete containments are found in ASME Section III, Division 1, Subsection NE of the ASME Code. Seventy-two of the NPPs licensed for commercial operation in the U.S. employ either a reinforced concrete (37 plants) or post-tensioned concrete (35 plants) containment. Figure 2.2 presents an example of a cross section for a PWR large-dry prestressed concrete containment.

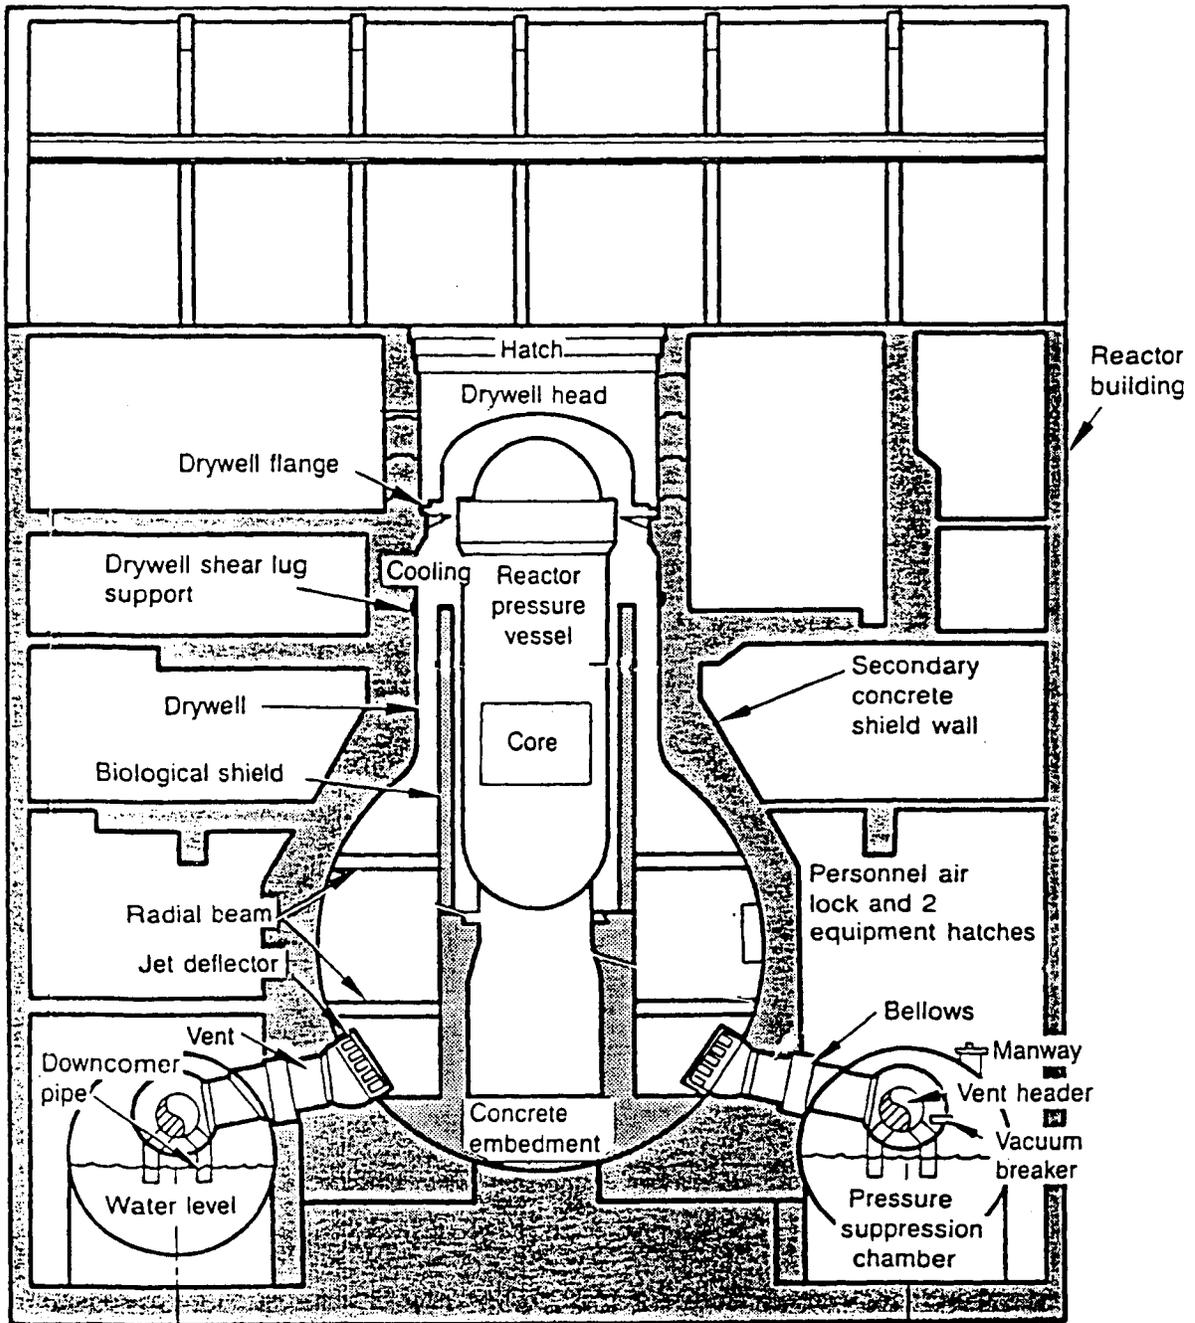
Figure 2.3 Example of BWR MK I metal containment.

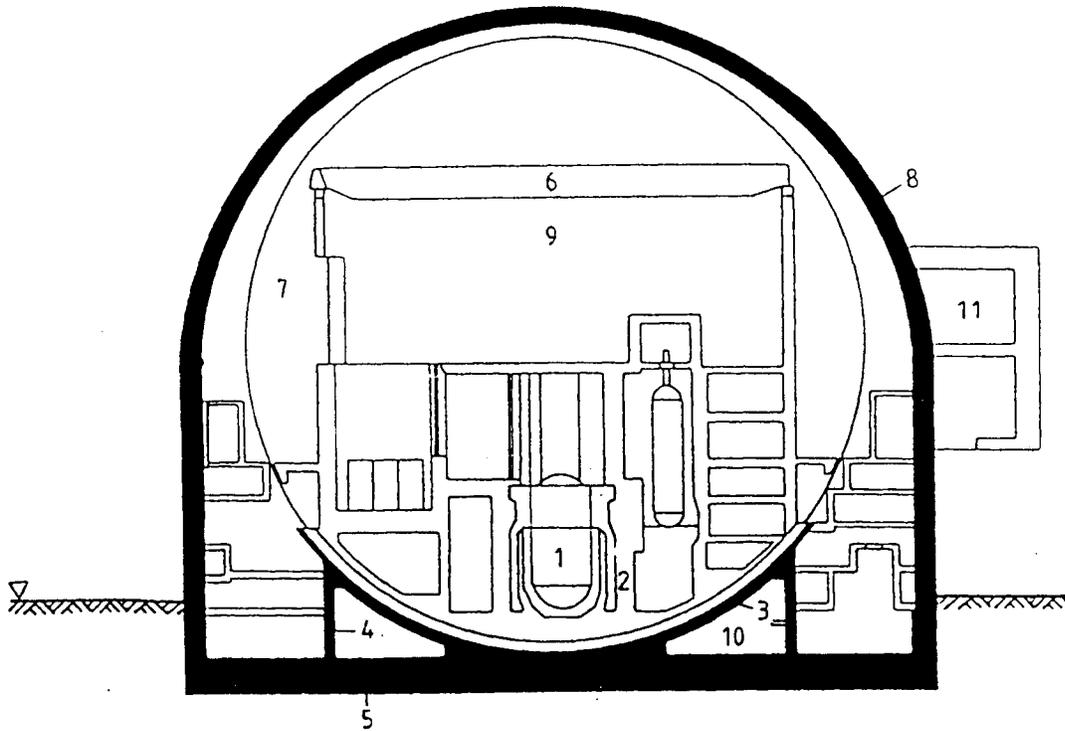
- 1 steel reactor pressure vessel
- 2 biological shield
- 3 spherical section
- 4 circle wall
- 5 foundation plate
- 6 reactor building crane
- 7 primary steel containment
- 8 secondary reinforced concrete containment
- 9 inner rooms
- 10 annular rooms
- 11 steam and feed water valve compartment

Figure 2.4 Example of a cross section for a German PWR spherical steel containment housed in a reinforced concrete containment building.

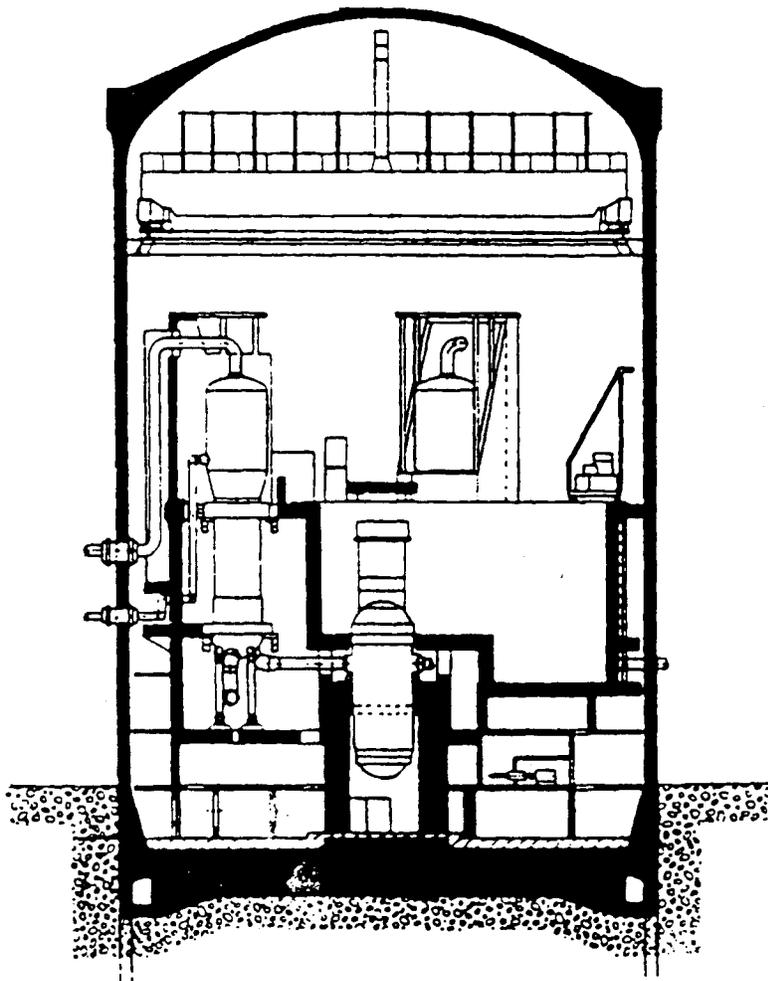
Figure 2.5 Example of a cross section for a French PWR single-barrier prestressed concrete containment.

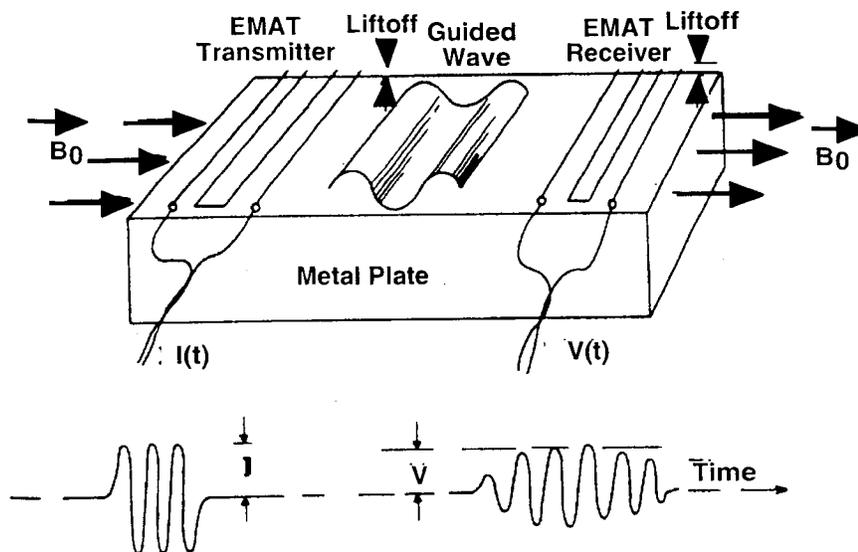
Fig. 3.2 Common EMAT setup for guided waves.

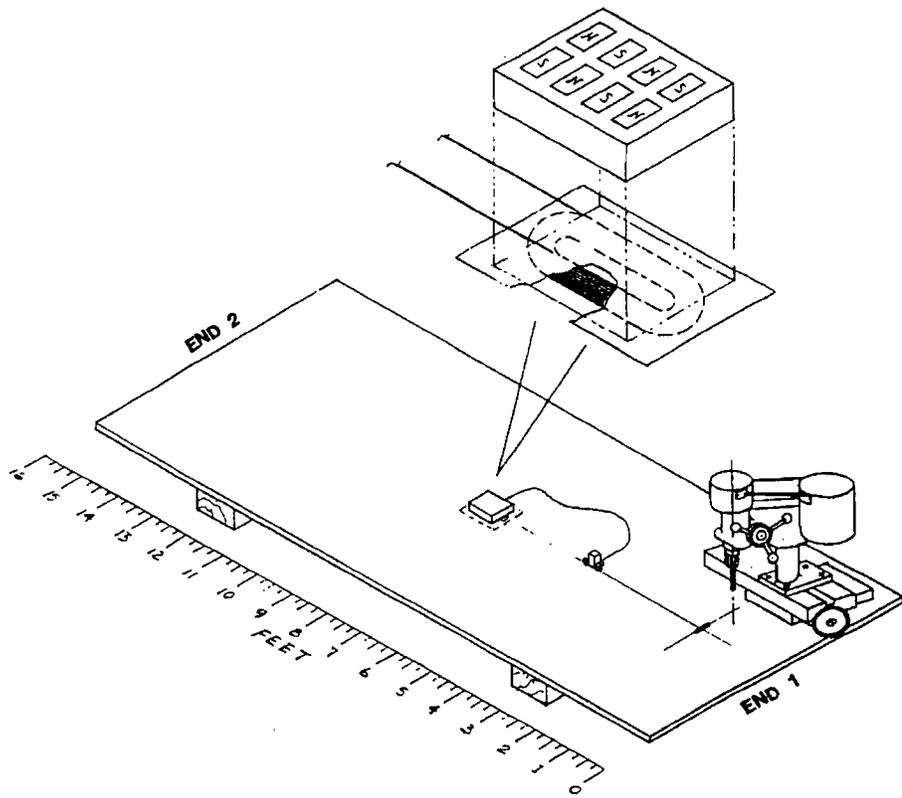
Figure 3.3 General plate, defect, and EMAT layout.

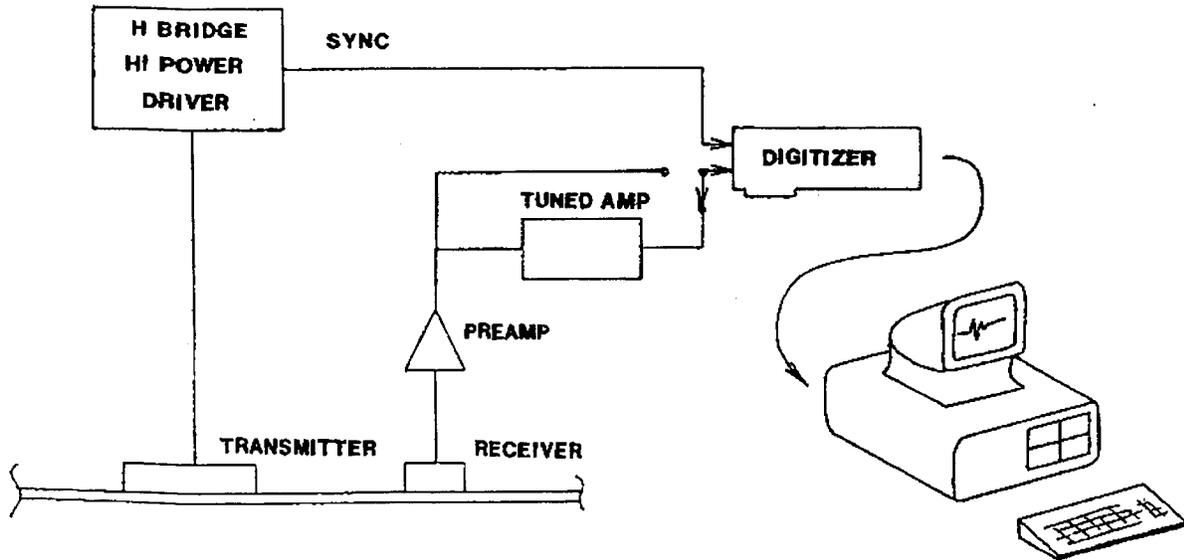
Figure 3.4 Schematic of experimental setup.

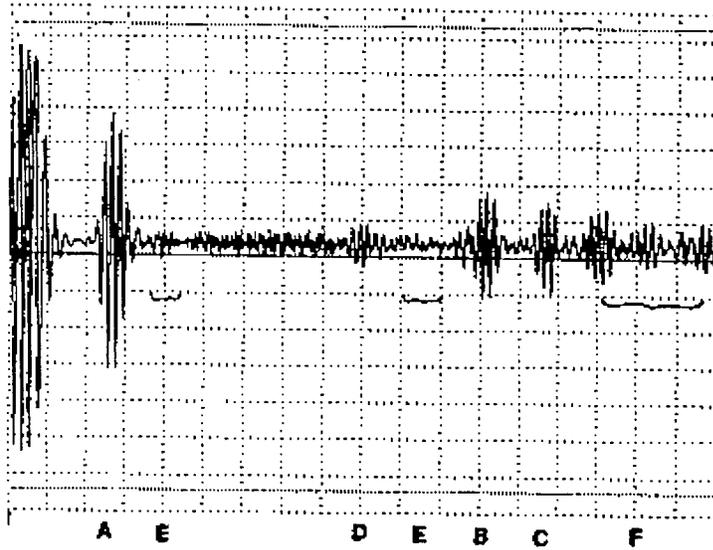
Figure 3.5 Typical amplitude-time waveform.

- A = direct propagation from the transmitter to the receiver located about 0.9 m from the transmitter
- B = same waveform as A after traveling to END 1 and back to the receiver
- C = corresponding reflection from END 2
- D = scattering from slot located on the plate centerline at a distance of 61 cm from END 1
- E = coherent noise background after the first arrival signal
- F = scattering of transmitter side lobe and/or peripheral portions of the main lobe from the plate edge and end

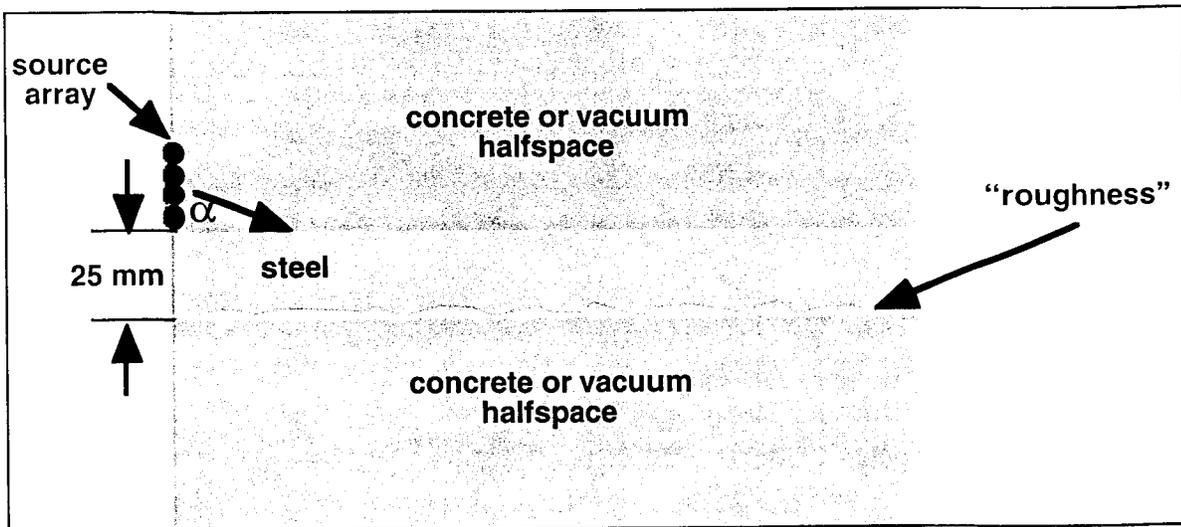
Fig. 4.1 Range independent OASES simulation scenario – approximate model of containment scenario.

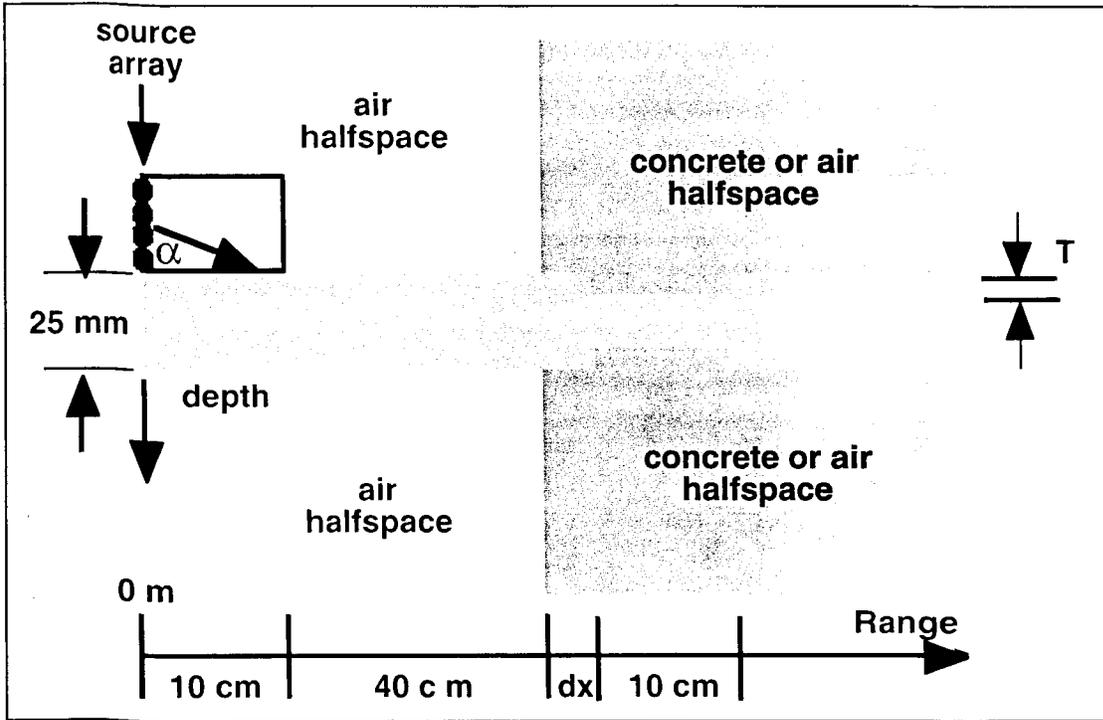
Fig. 4.2 Range-dependent numerical simulation scenario for steel containment scenario.

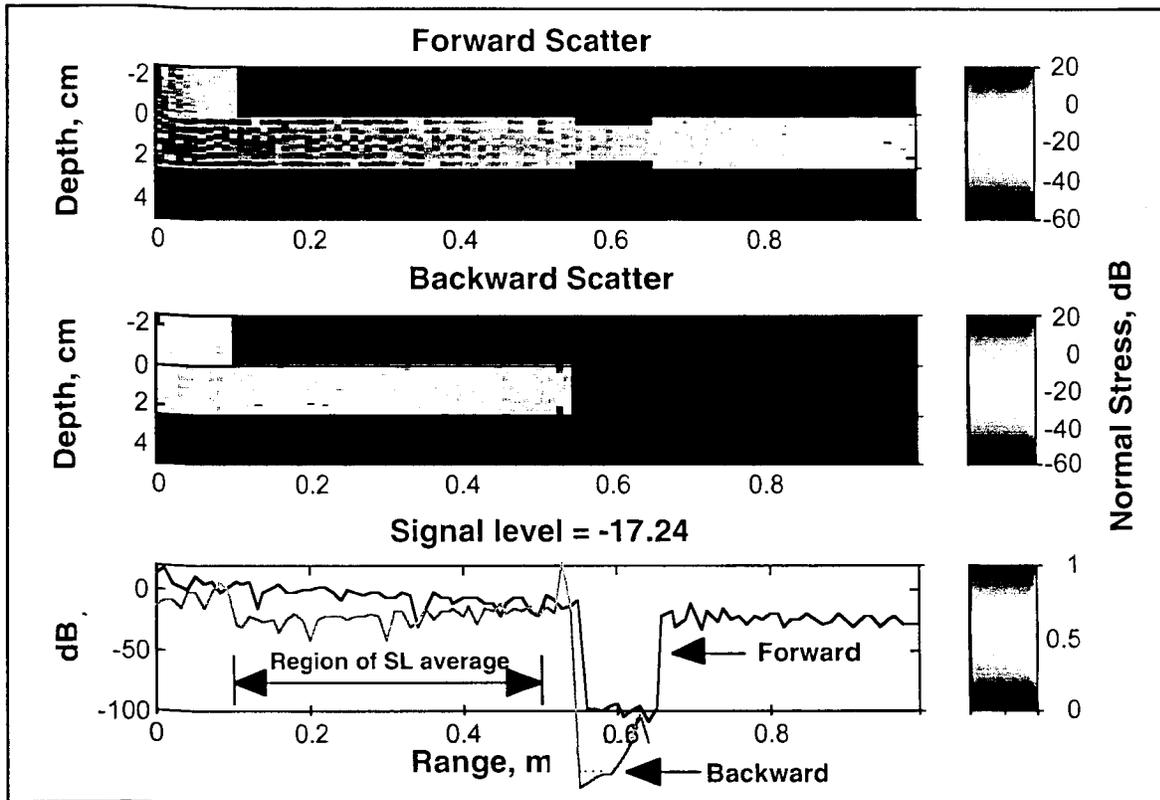
Fig. 4.3 Results of simulation scenario for a steel layer surrounded by air only

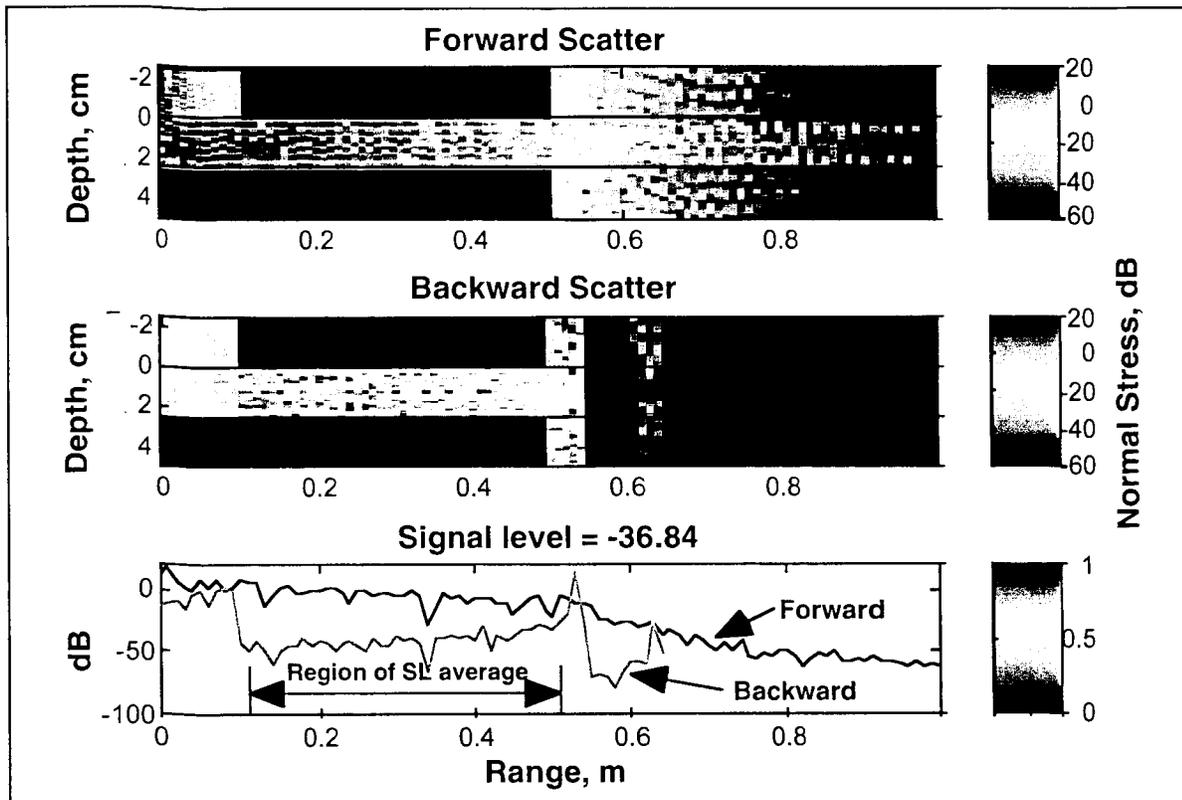
Fig. 4.4 Results of simulation scenario for embedded steel containment.

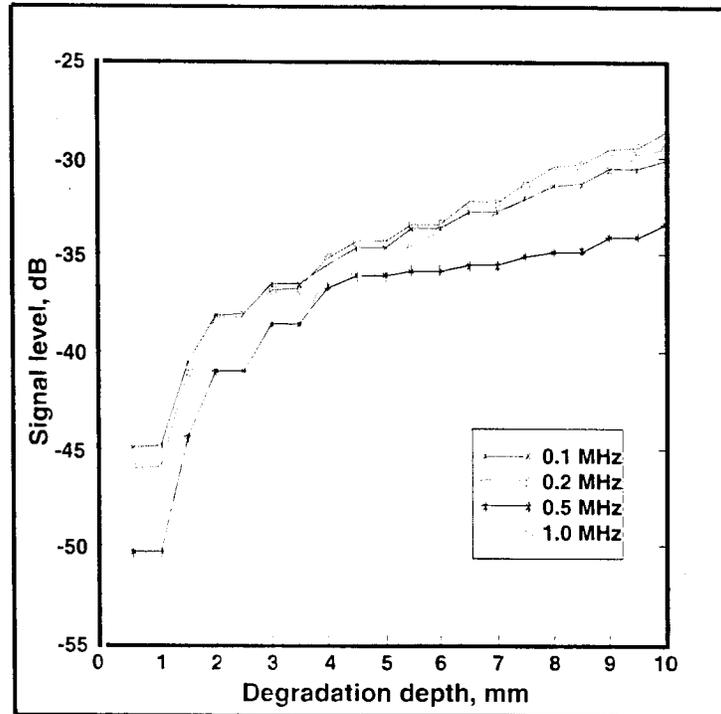
Fig. 4.5 Signal level from a degradation located 5 cm below air/concrete interface as a function of degradation depth and frequency.

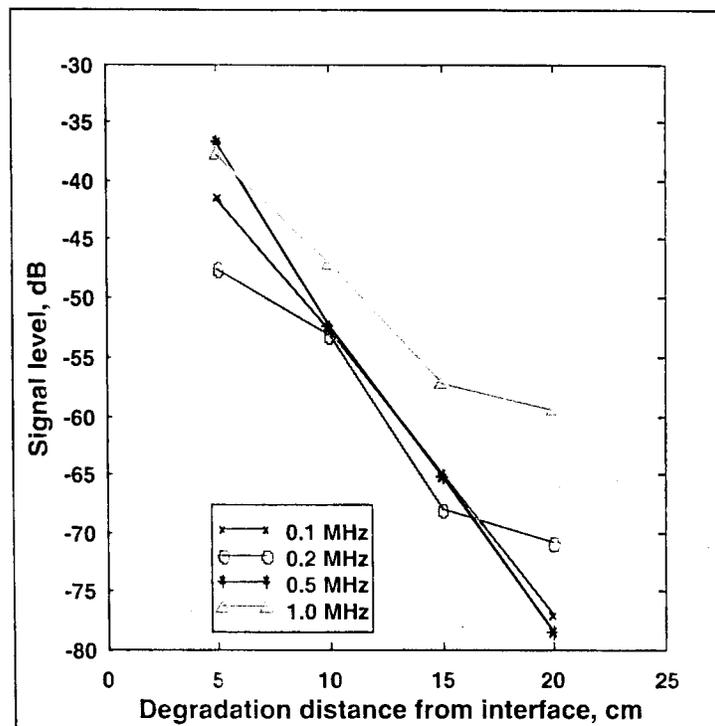
Fig. 4.6 Signal level from a 4-mm-deep degradation as a function of degradation distance from interface and frequency.

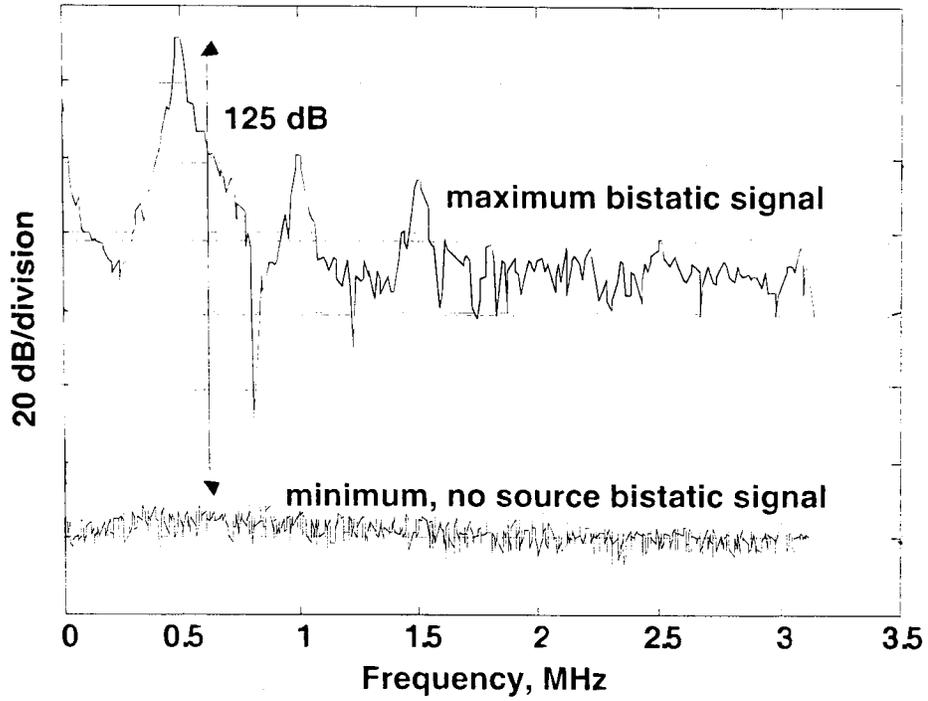
Fig. 4.16 Power spectral densities of maximum and minimum signals.

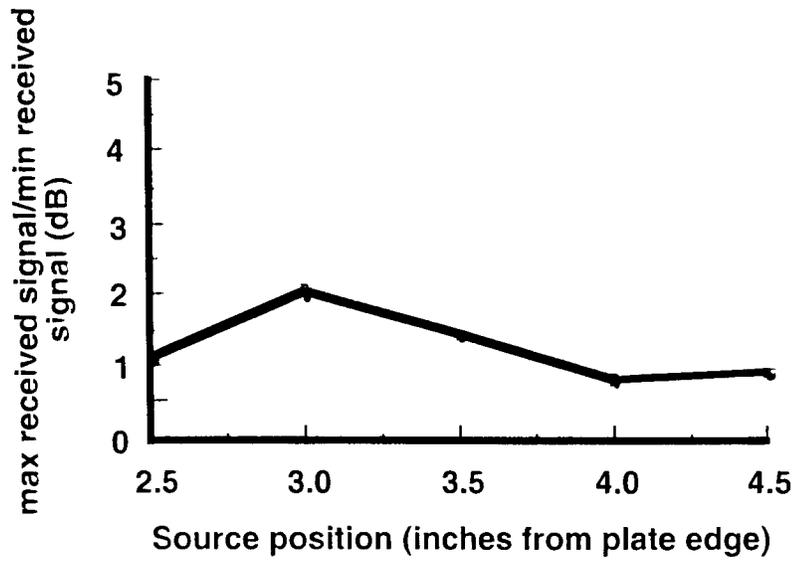
Fig. 4.17 Received signal ratios for different source/receiver separation distances.

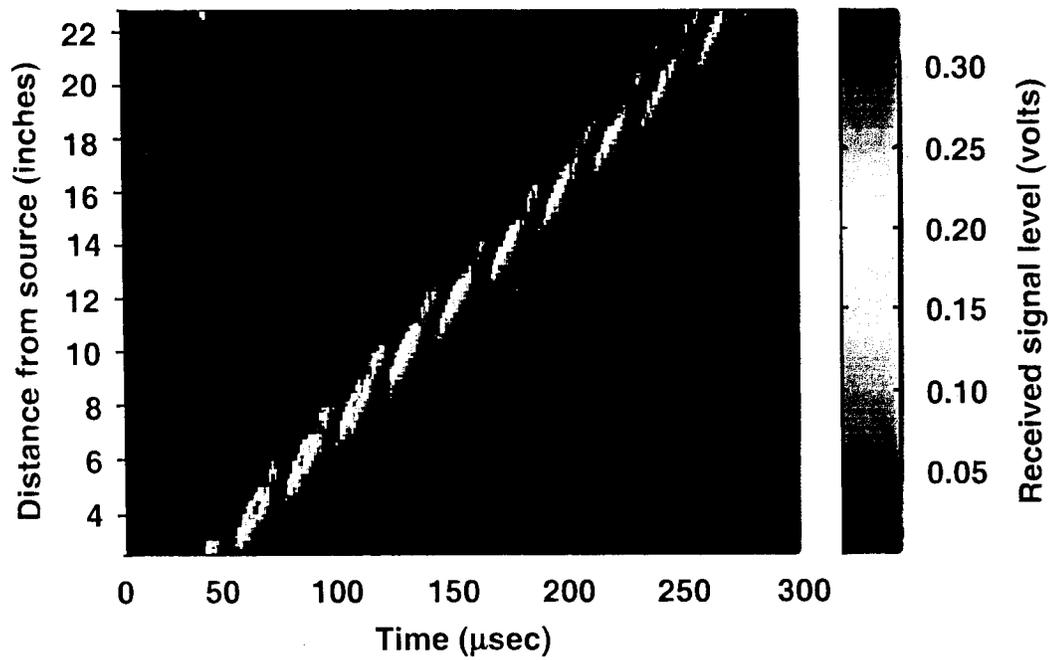
Fig. 4.19 Combined envelopes of received signals at several locations relative to a fixed source (forward-travelling waves).

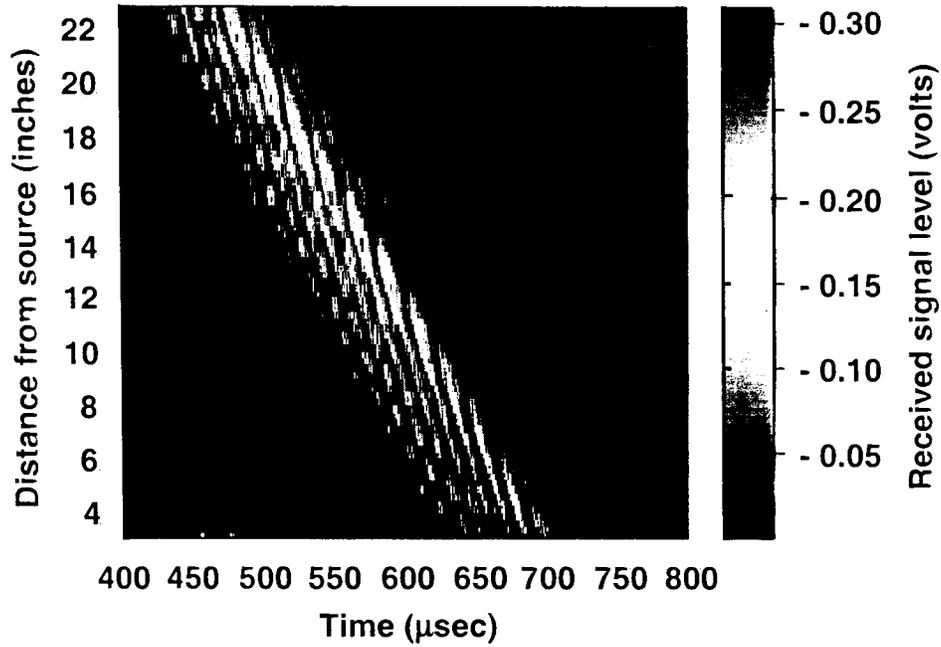
Fig. 4.20 Combined envelopes of received signals at several locations relative to a fixed source (backward-travelling reflected waves).

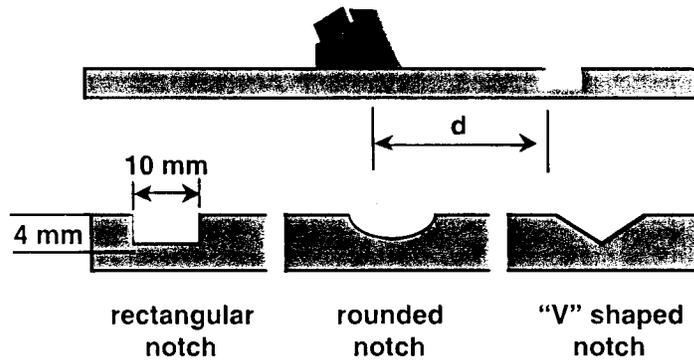
Fig. 4.21 Schematic of test setup for degradation shape study.

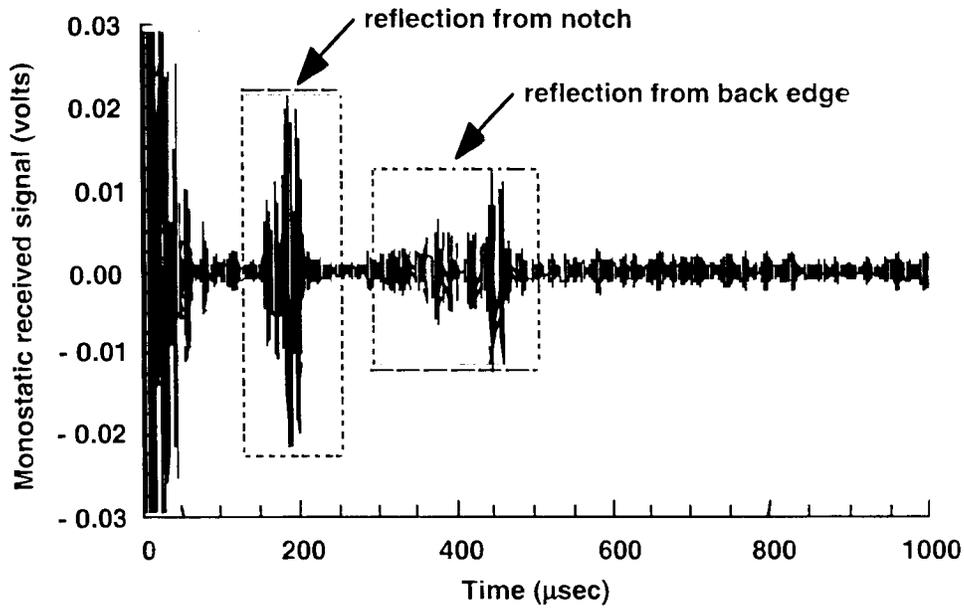
Fig. 4.22 Sample reflected return signal from rectangular notch.

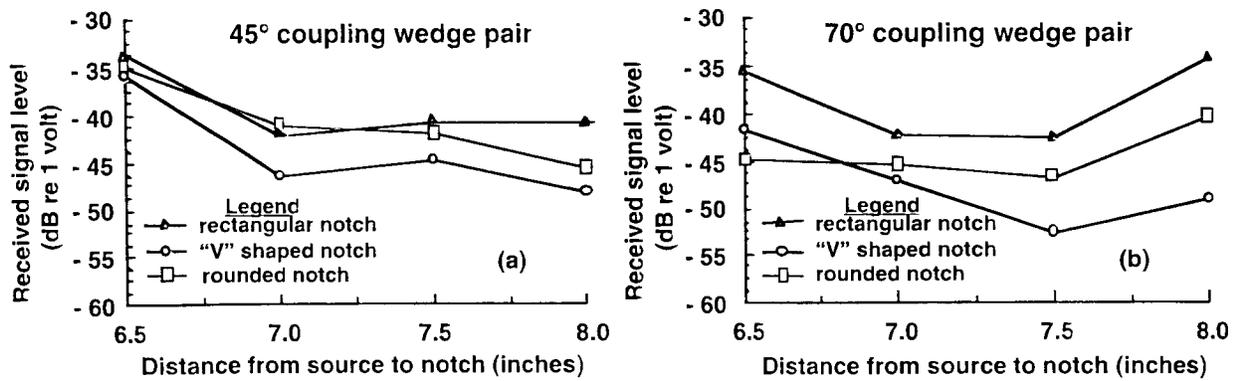
Fig. 4.23 Results of degradation shape study.

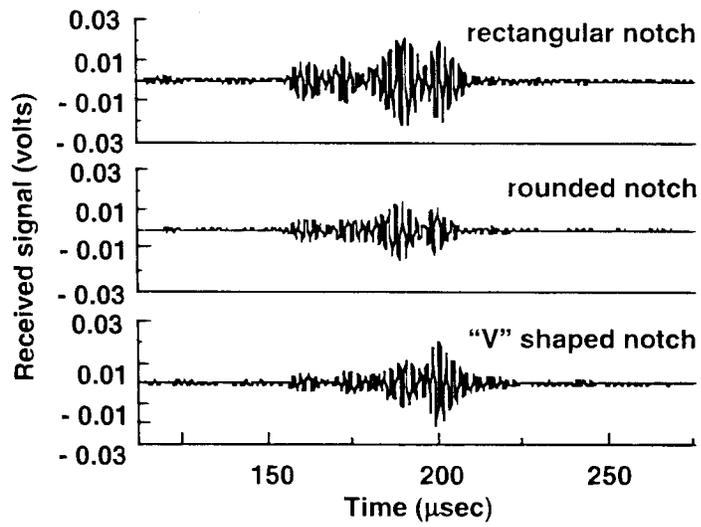
Fig. 4.24 Time-windowed returns from different notch geometries.

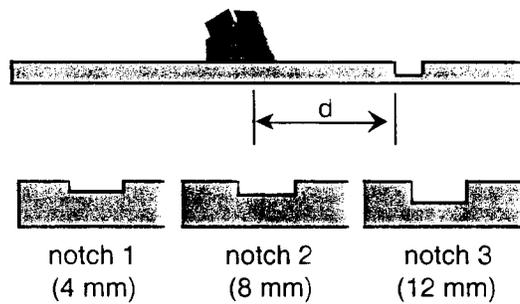
Fig. 4.25 Test setup for degradation depth study

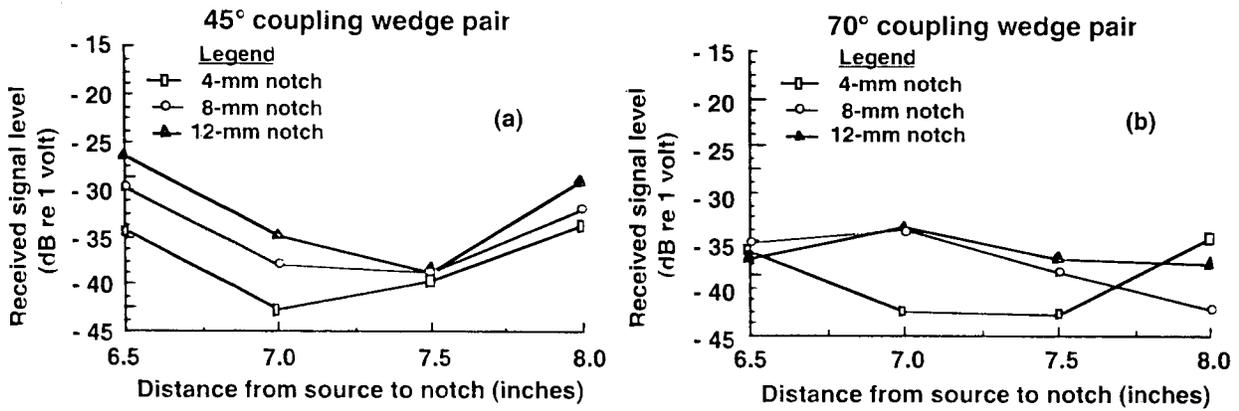
Fig. 4.26 Results of degradation depth study.

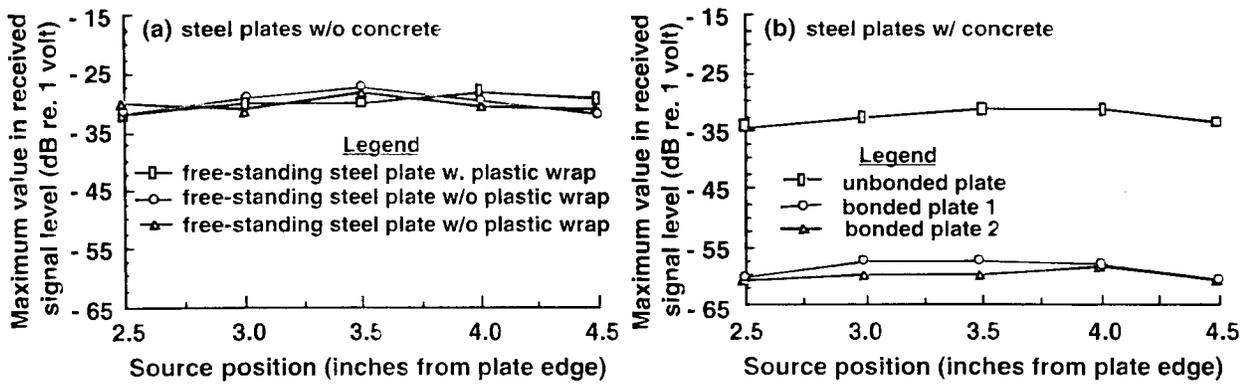
Fig. 4.29 Transmitted signal level: (a) free-standing steel plates and (b) steel plates embedded in concrete over part of their length.

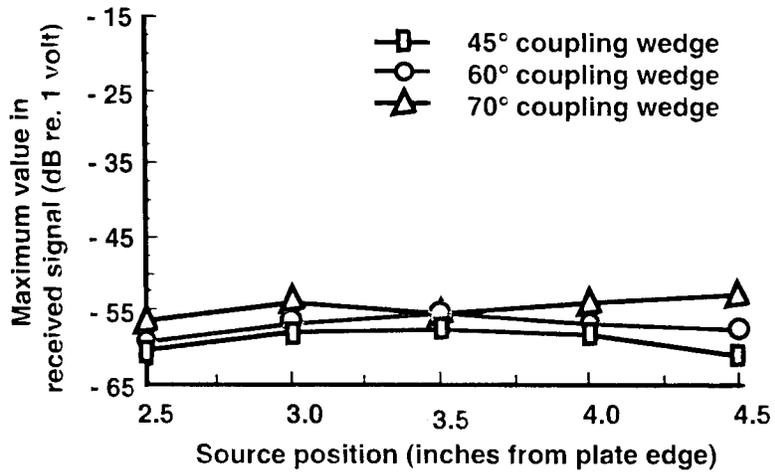
Fig. 4.30 Effect of coupling wedge angle on transmitted signal levels for a bonded steel plate embedded in concrete over part of its length.

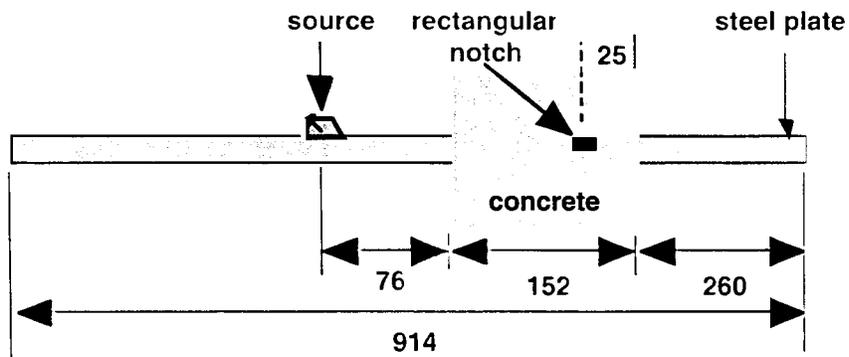
Fig. 4.31 Test setup for simulated field conditions to investigate role of competing signals.

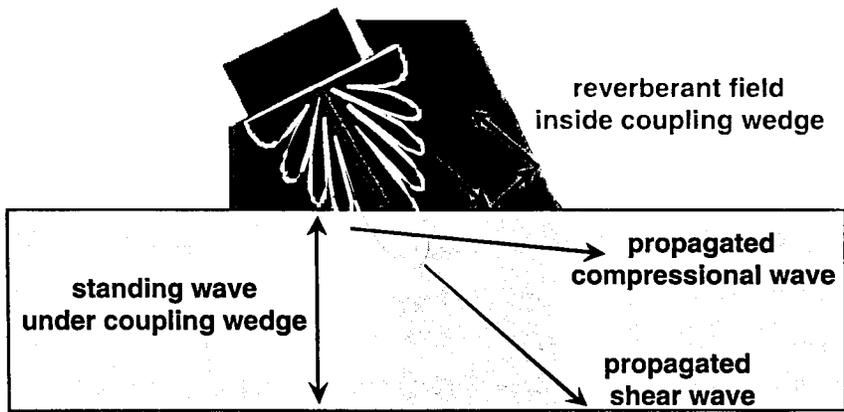
Fig. 4.32 Mechanisms of source "self noise."

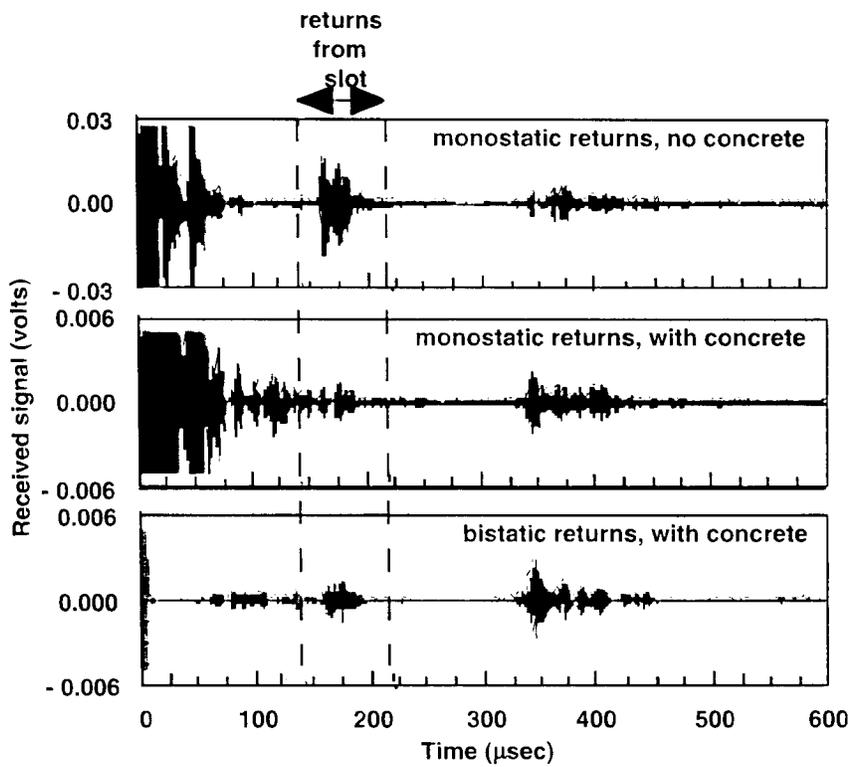
Fig. 4.34 Time histories of reflected signals from rectangular notch for three different conditions.

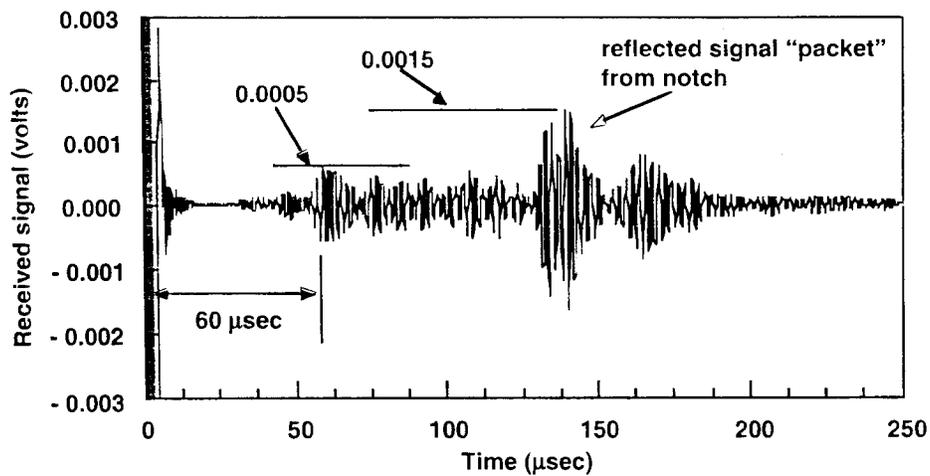
Fig. 4.35 Bistatic measured return from rectangular notch in a bonded steel plate embedded in concrete over part of its length.

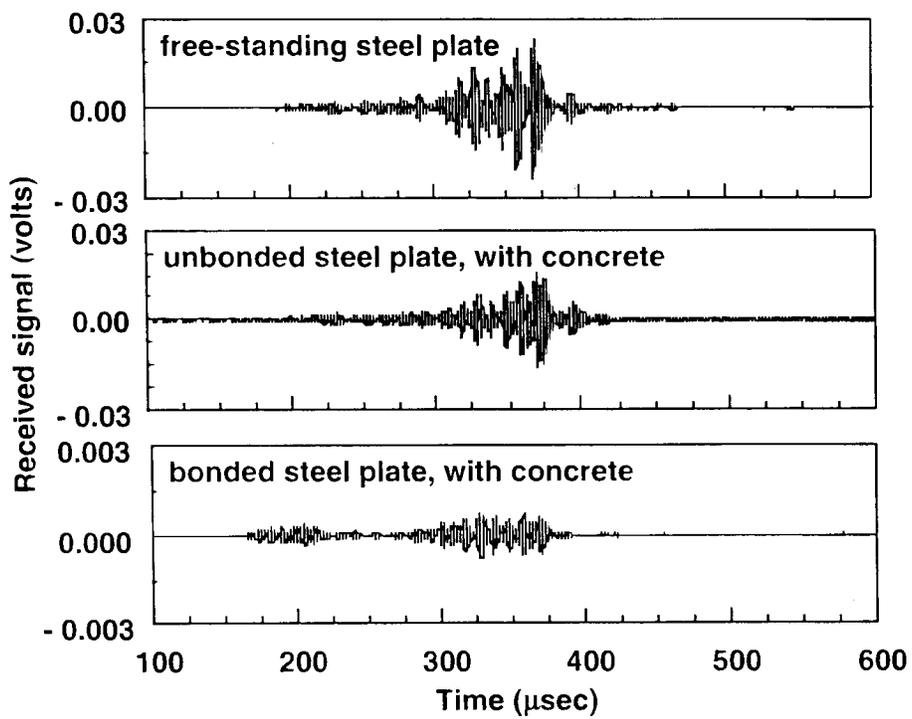
Fig. 4.36 Time histories of signals transmitted through free-standing steel plate, unbonded steel plate with concrete, and bonded steel plate with concrete.

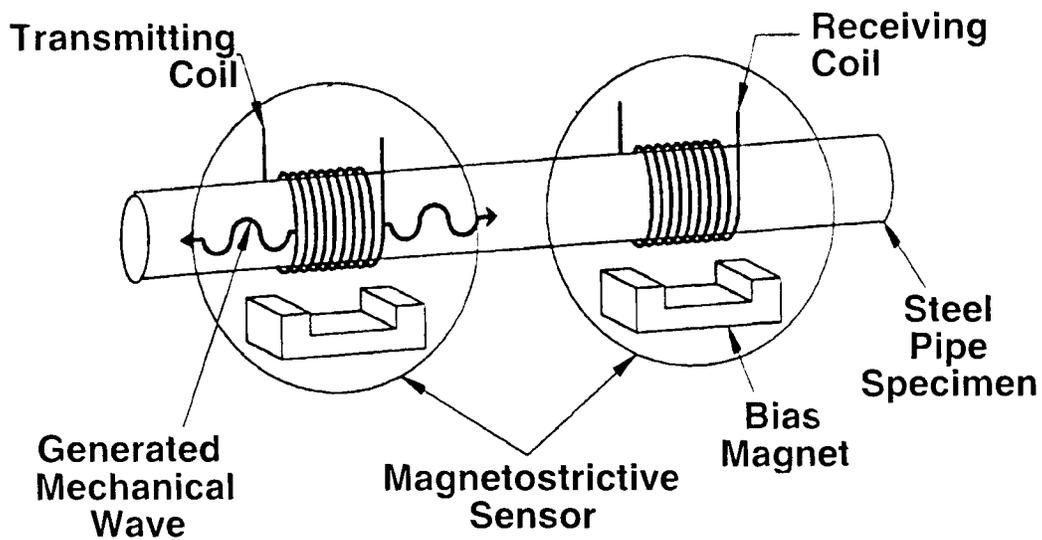
Fig. 5.1 Schematic of magnetostrictive sensor setup for generation and detection of guided waves in pipes.
