**INSPECTION OF INACCESSIBLE REGIONS OF NUCLEAR POWER PLANT  
CONTAINMENT METALLIC PRESSURE BOUNDARIES**

**D. J. Naus  
Metals and Ceramics Division  
Oak Ridge National Laboratory  
Oak Ridge, Tennessee 37831-8056**

**June 2002**

**Prepared for the  
U.S. Nuclear Regulatory Commission  
Office of Nuclear Regulatory Research  
Under Interagency Agreement No. 1886-N604-3J**

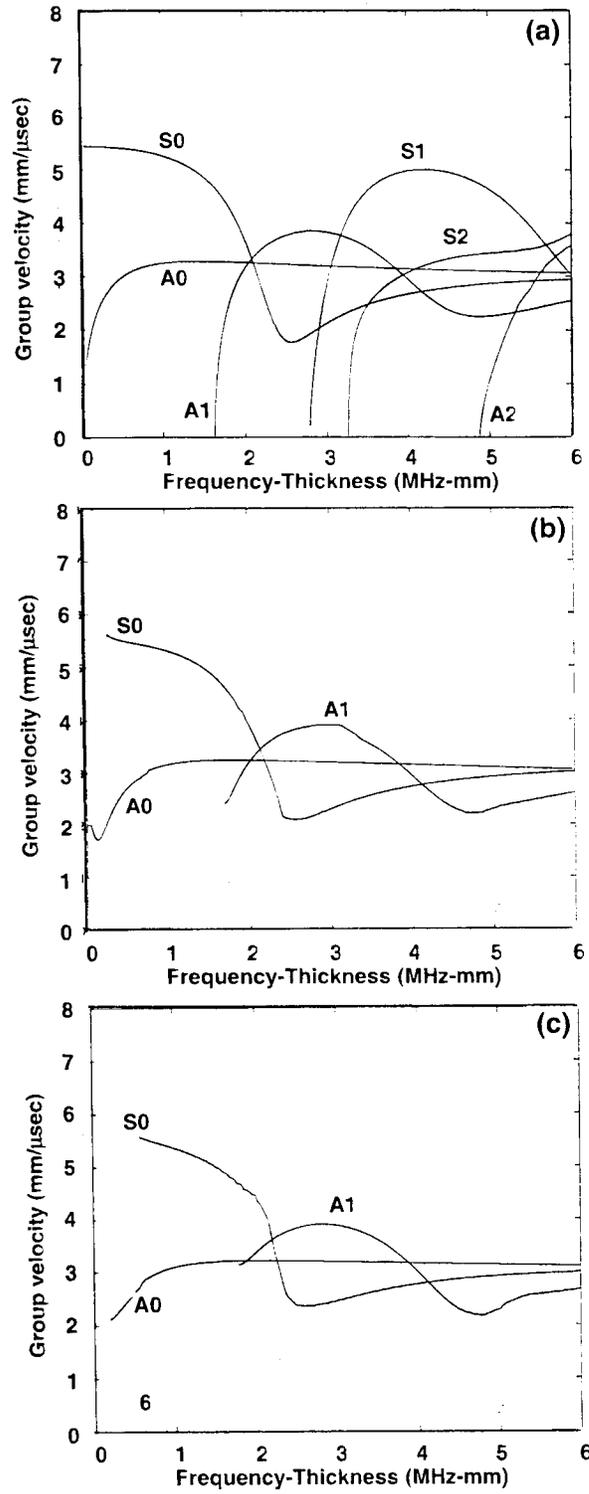
Fig. 5.2 Calculated dispersion curves for longitudinal guided waves in a plate for three conditions: (a) plate is free, (b) plate is backed by concrete on one side, (c) plate is backed by concrete on both sides.

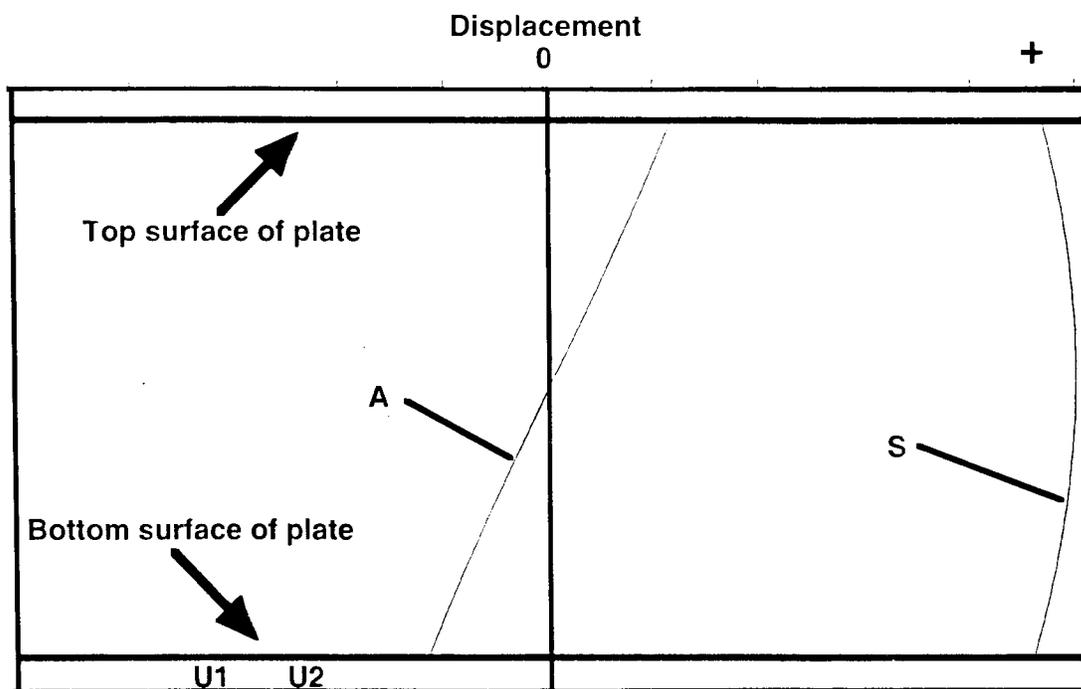
Fig. 5.3 Displacements of antisymmetric (A) and symmetric (S) wave modes across plate thickness.

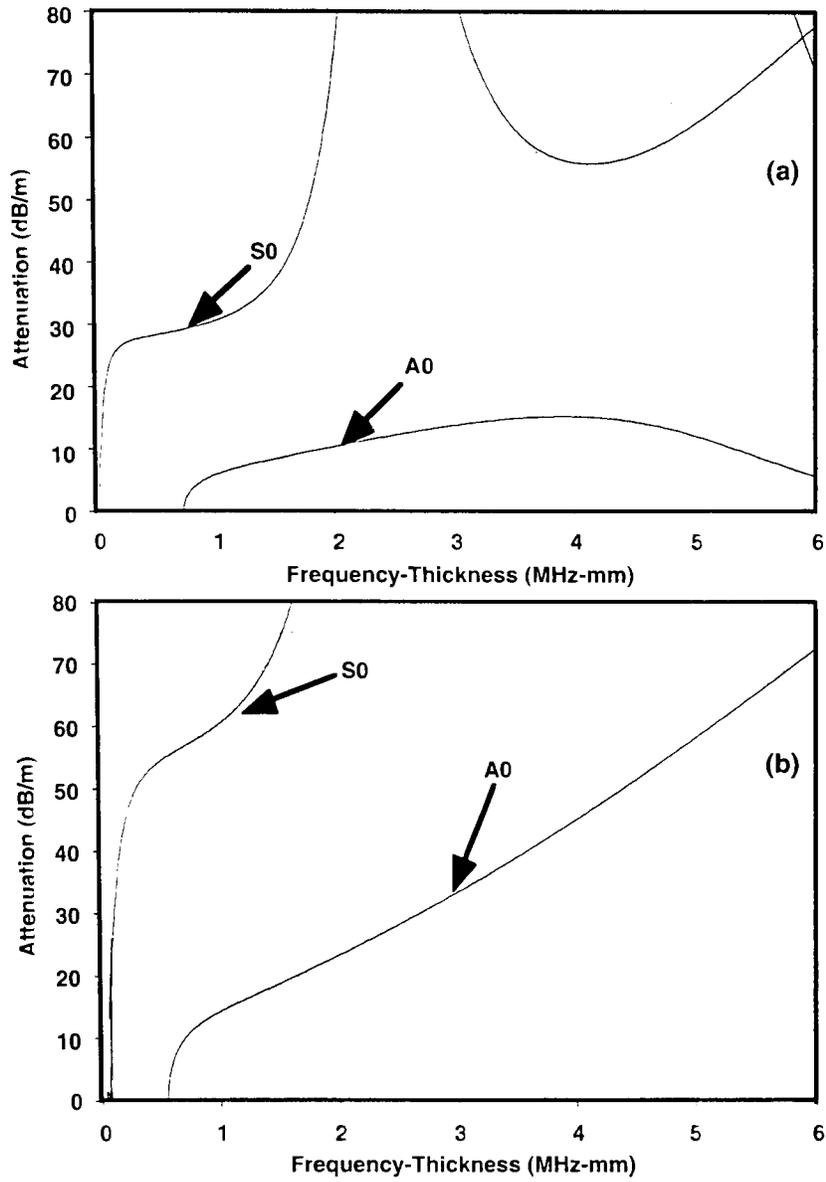
Fig. 5.4 Calculated wave attenuation for: (a) plate backed by concrete on one side and (b) plate backed by concrete on both sides.

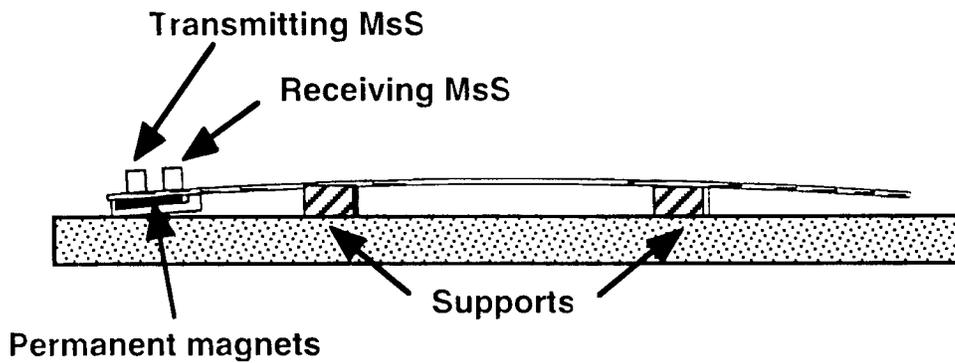
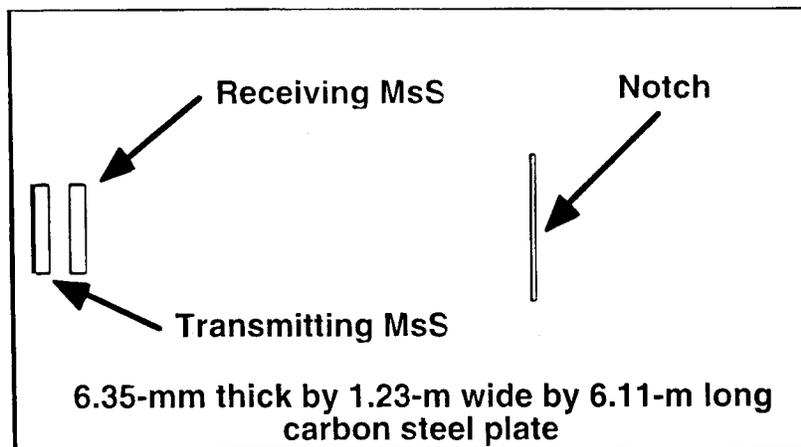
Fig. 5.6 Schematic of plate test article with setup for MsS probes.  
(Permanent magnets are arranged on bottom of plate for convenience).

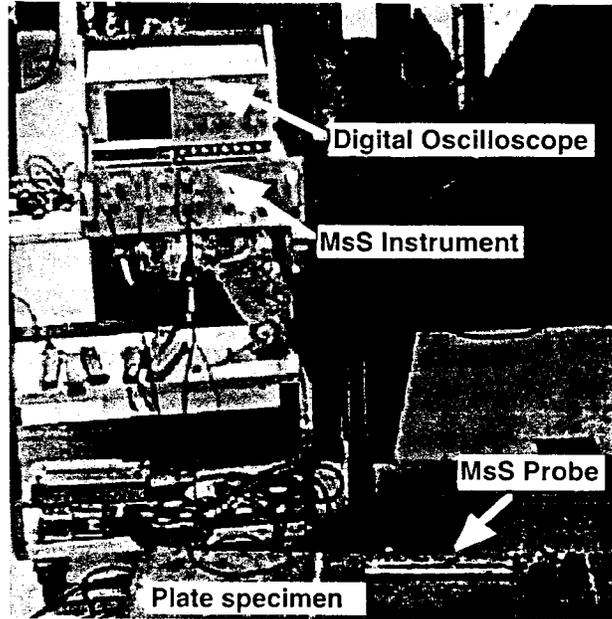
Fig. 5.7 Photograph of the overall experimental arrangement.

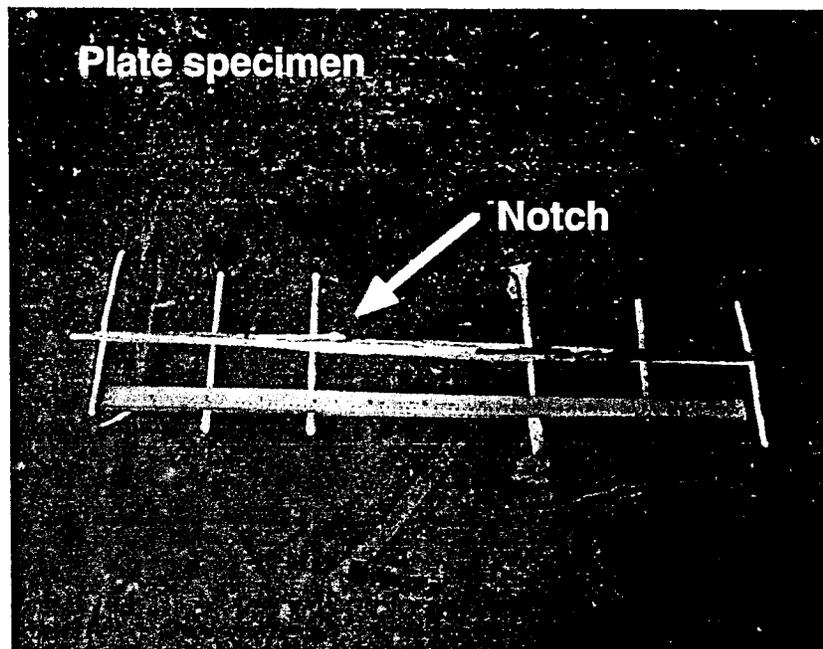
Fig. 5.8 Photograph of the 30-cm-long notch in plate specimen.

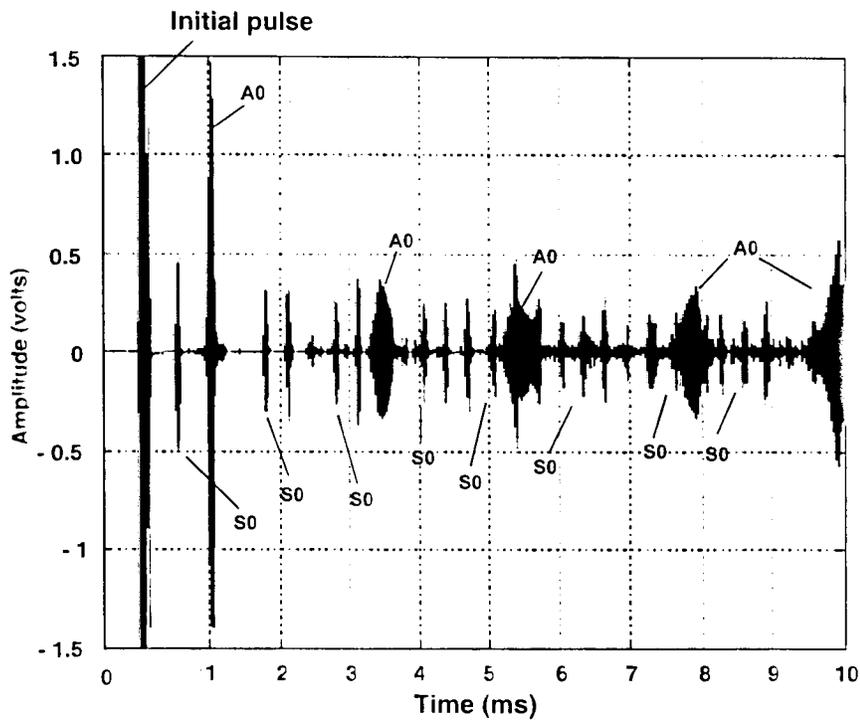
Fig. 5.9 MsS data from plate specimen using pitch-catch technique.

Fig. 5.10 Time-frequency representation of data in Fig. 5.9 obtained by using short-time fourier transform (STFT).

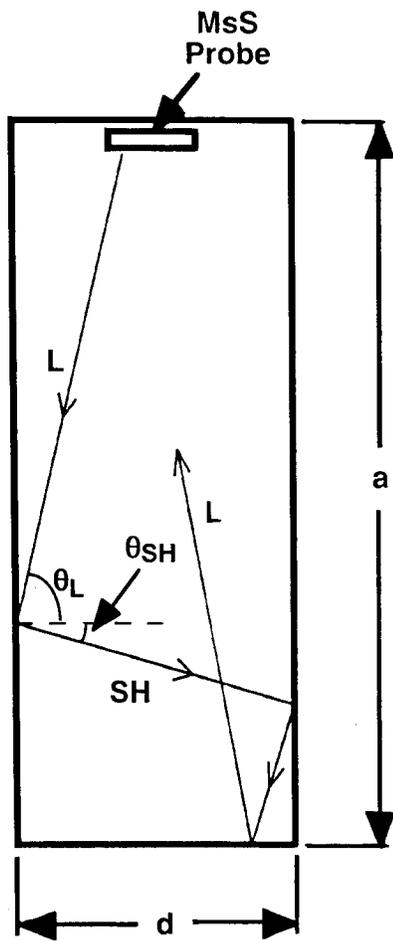
Fig. 5.11 Illustration of mode conversion at the lateral boundaries of a finite-sized plate.

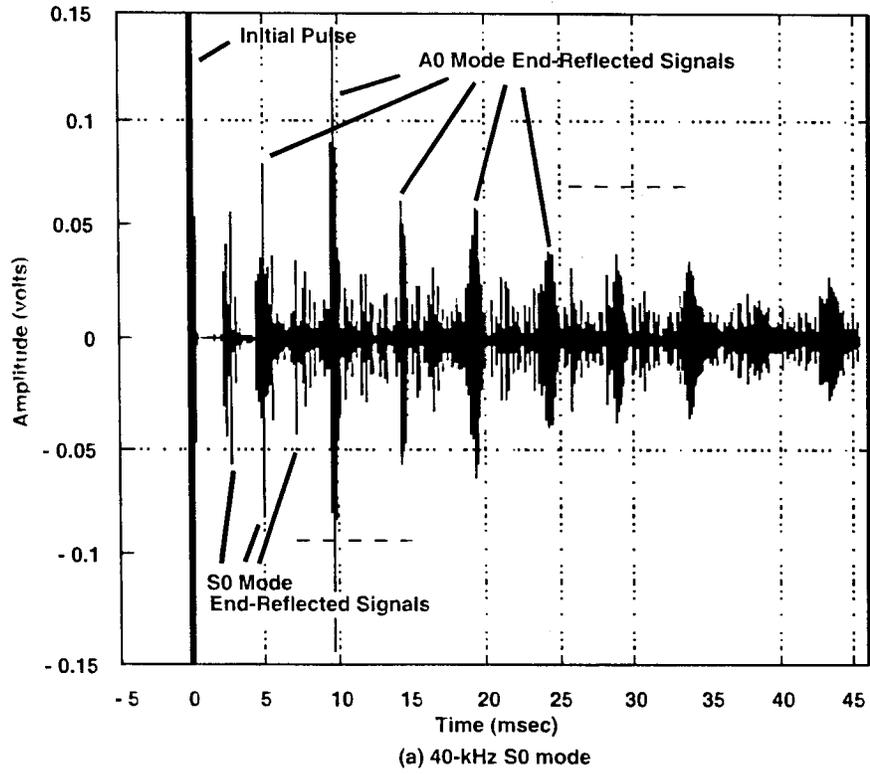
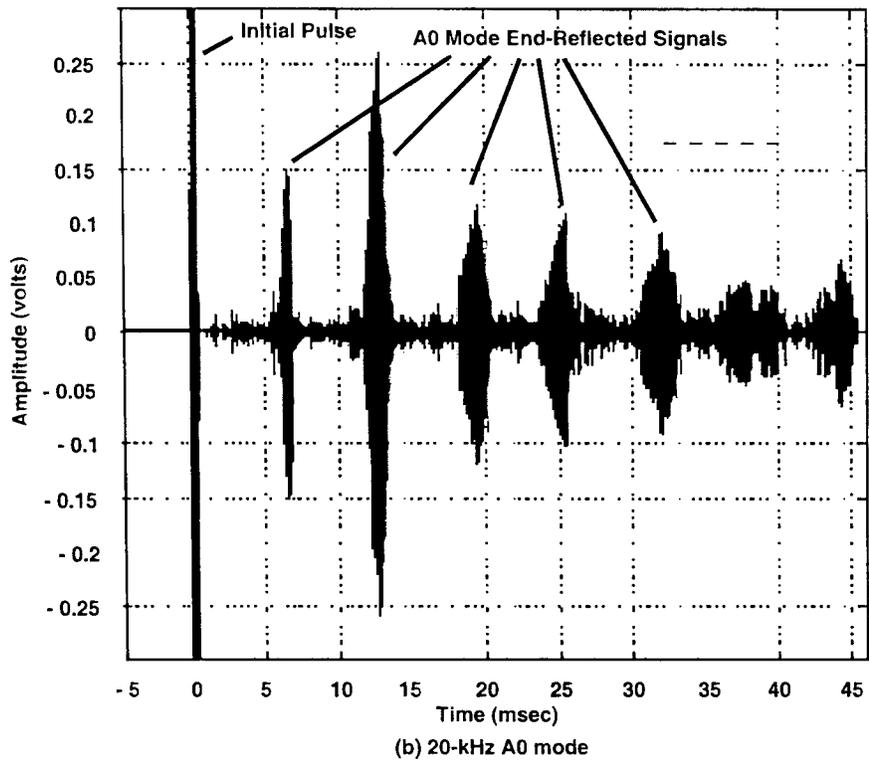
Fig. 5.13 MsS data using pulse-echo mode for steel plate prior to introducing a defect. Dotted lines indicate that signals continue to occur.

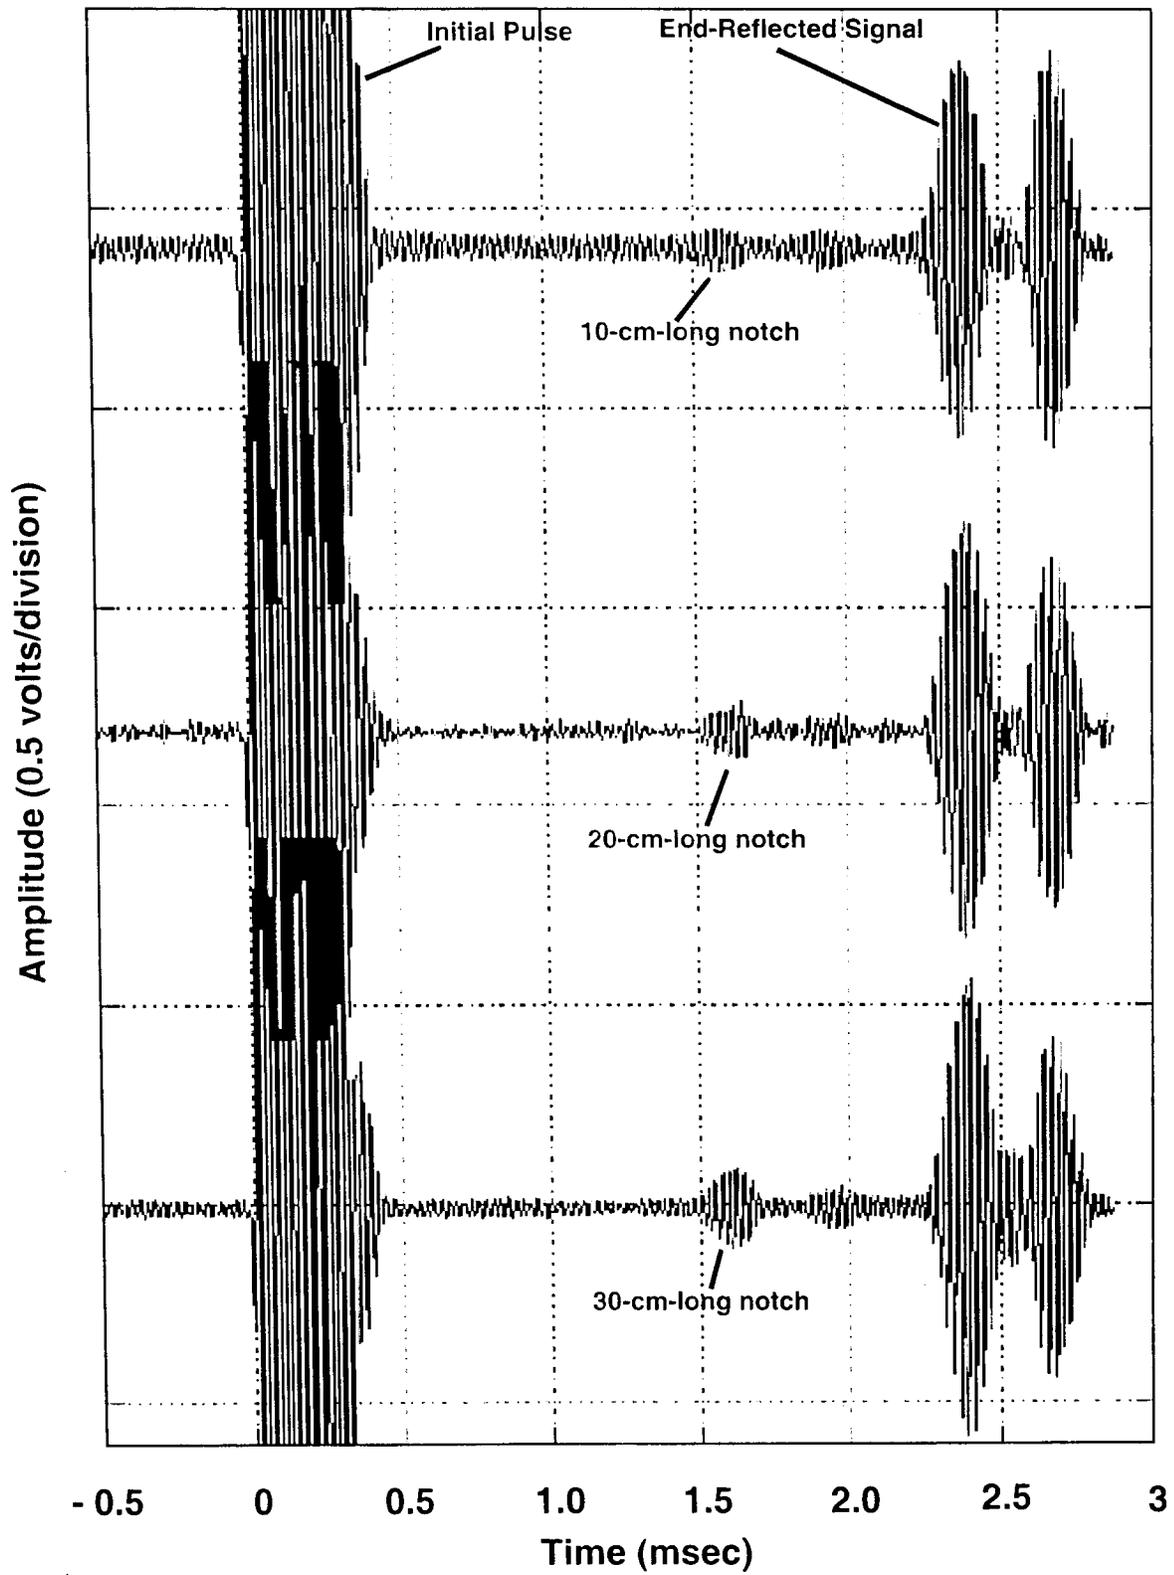
Fig. 5.14 Pulse-echo data for 40-kHz S0 mode obtained from plate containing different length notches.

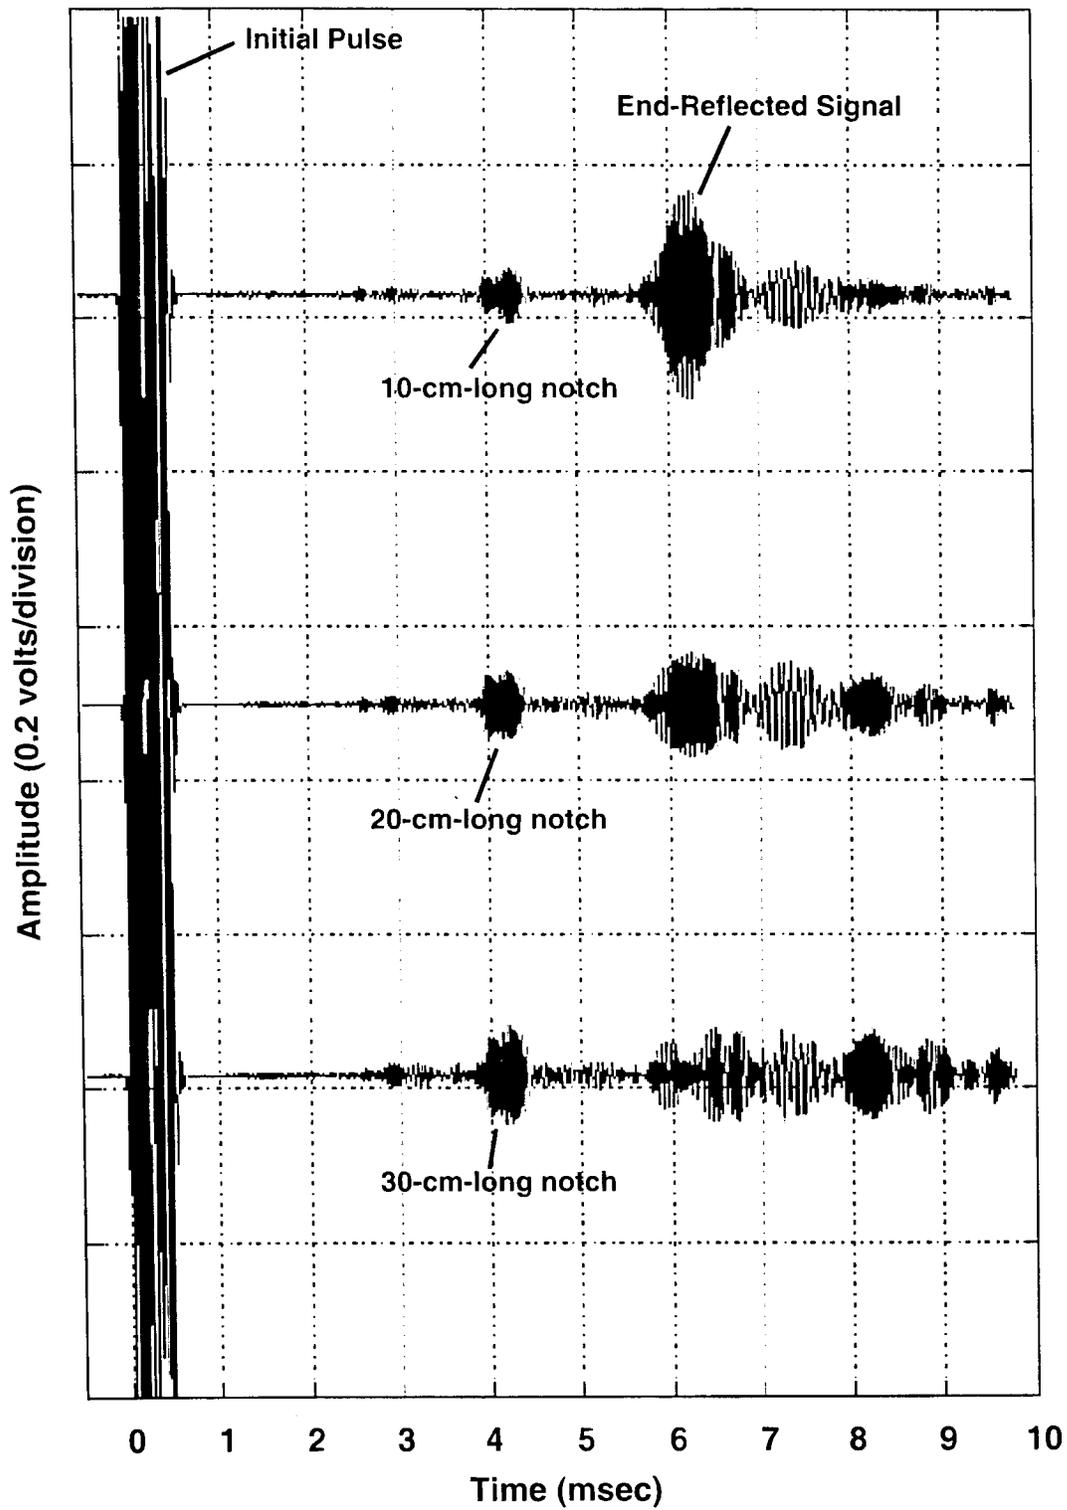
Fig. 5.15 Pulse-echo data for 20-kHz A0 mode obtained from plate containing different length notches.

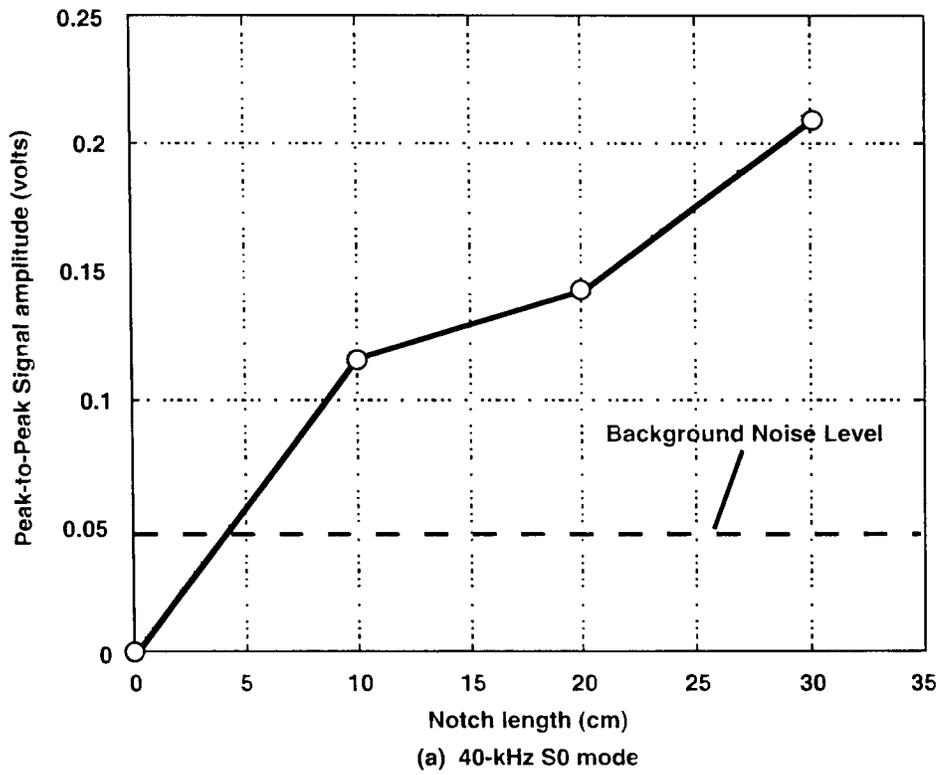
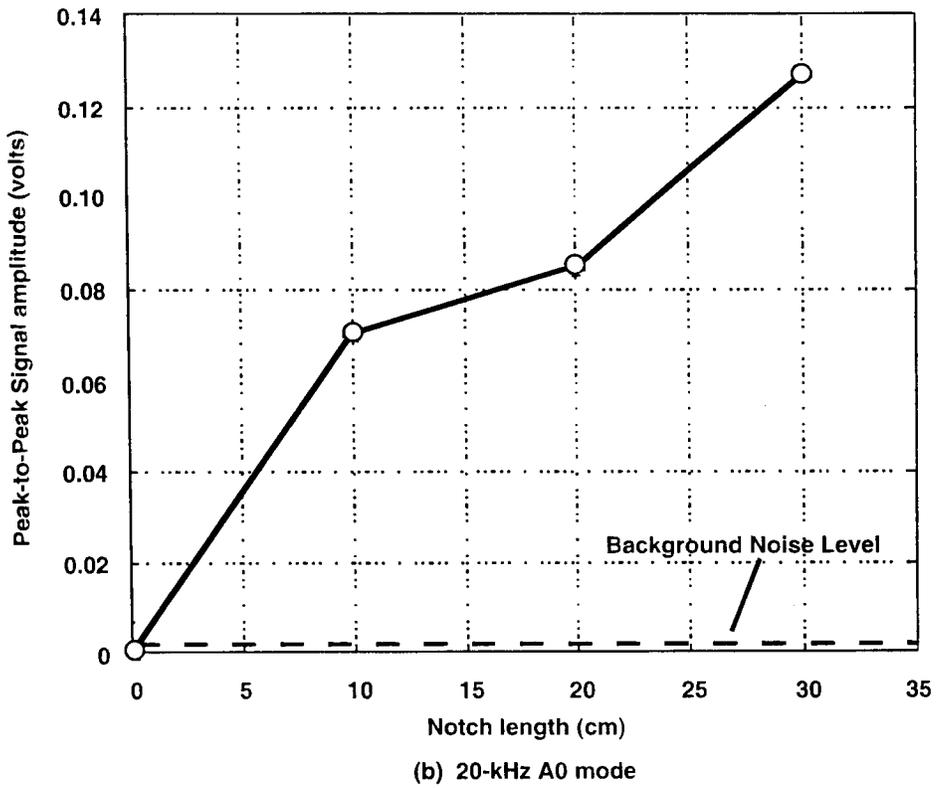
Fig. 5.16 Plots of signal amplitude versus notch length.

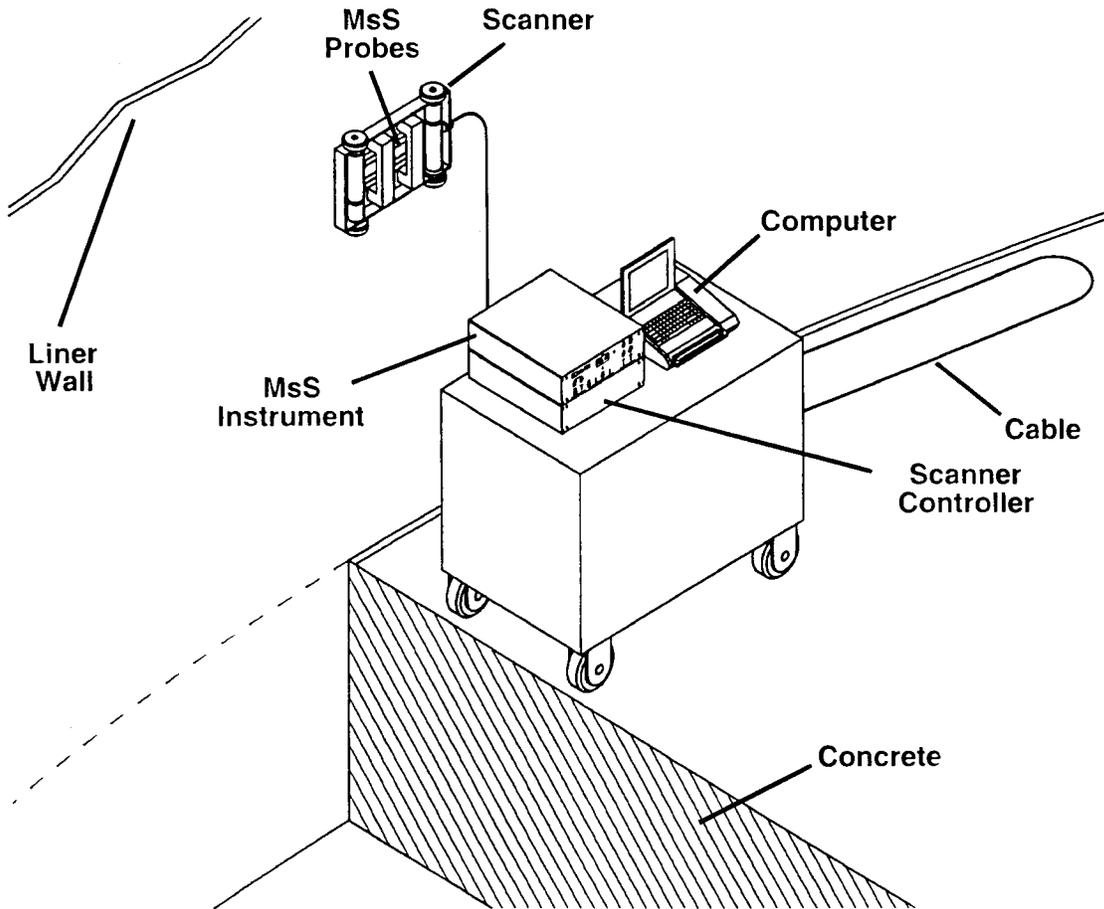
Fig. 5.17 Conceptual drawing of MsS system deployed for liner inspections.

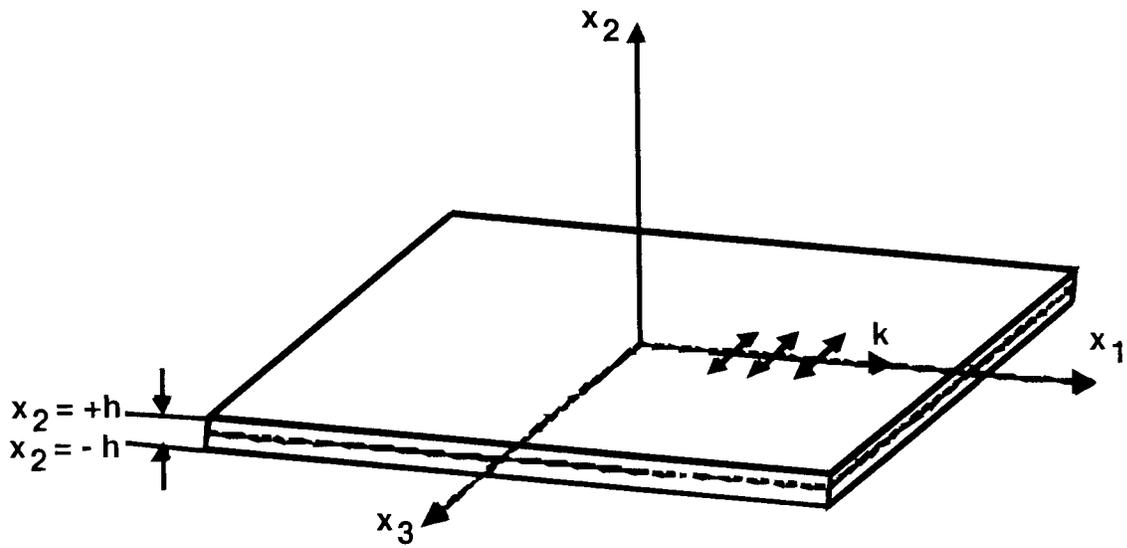
Fig. 6.1 SH wave propagation mode where propagation is along  $x_1$  and particle displacements are along  $x_3$ .

(Particle displacements for Lamb wave propagation mode are in  $x_1$ - $x_2$  plane.)

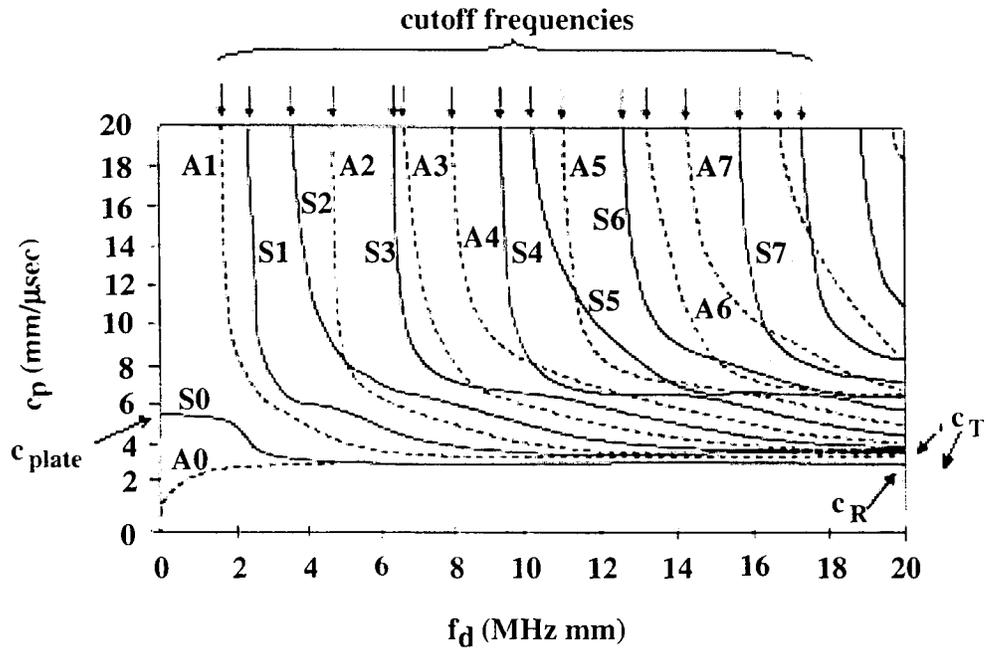
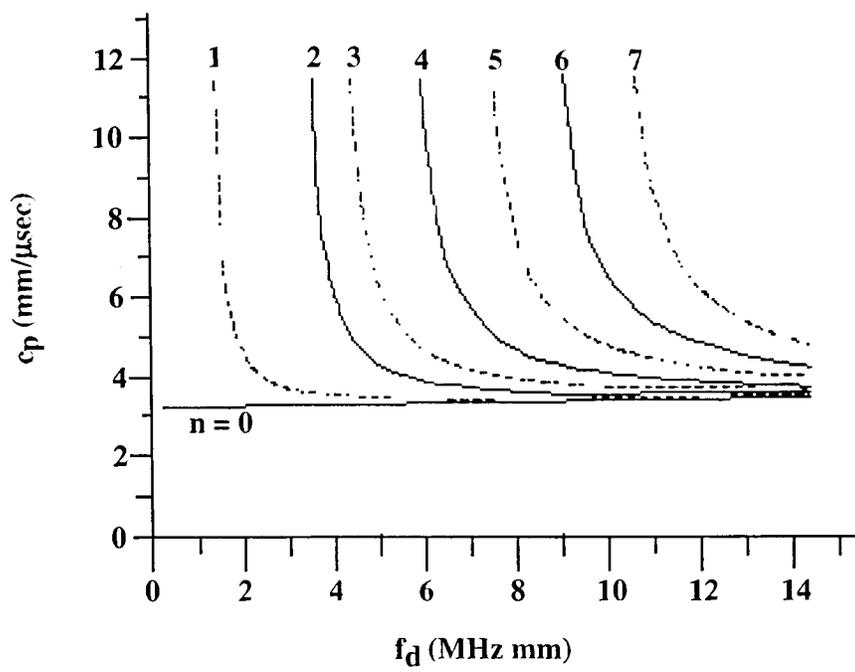
(a) Sample Lamb wave phase velocity dispersion curves

(b) Sample SH mode phase velocity dispersion curves: solid curves denote symmetric modes and dashed curves antisymmetric mode

Fig. 6.2 Sample dispersion curves for steel plate ( $c_T = 3.1 \mu\text{m/msec}$ ).

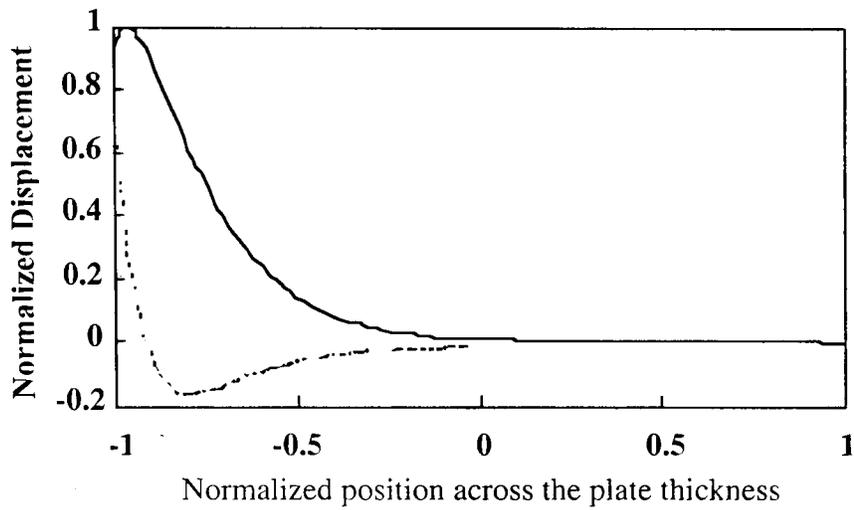
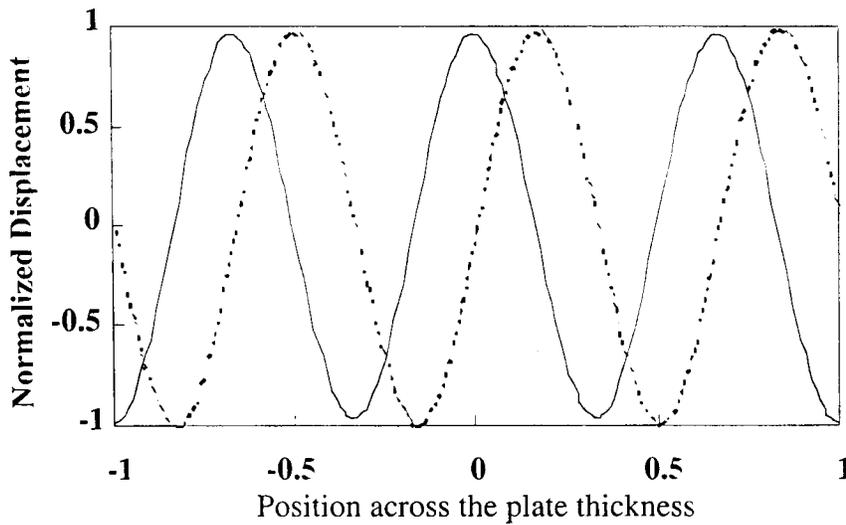
(a) Wave structure for the pseudo-surface wave mode

(b) Wave structure for the A3 mode

Fig. 6.3 Wave structures for the pseudo-surface mode and A3 mode at frequency of 565 kHz.

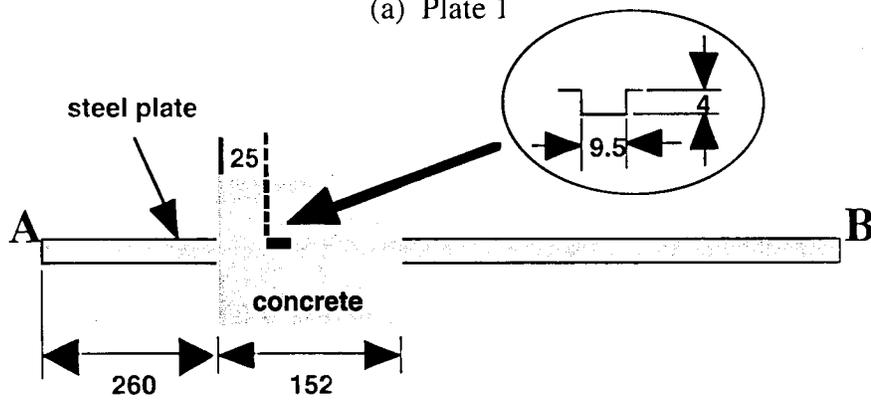
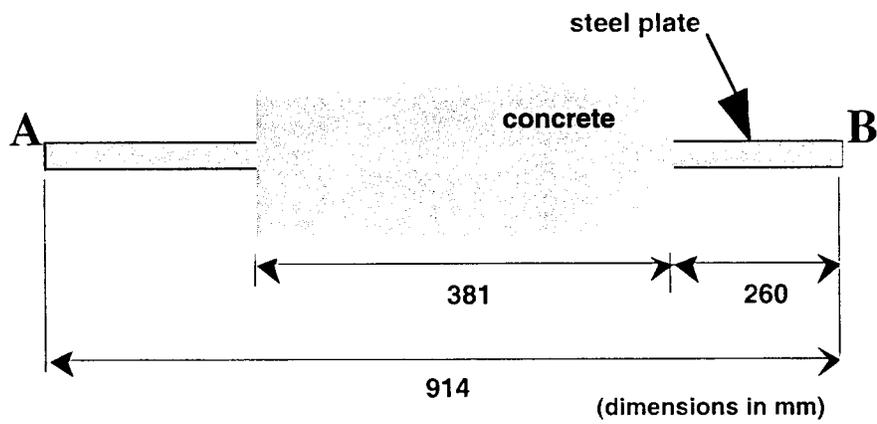
(b) Plate 2

(c) Plate 3

Fig. 6.4 Schematics of plate specimens.

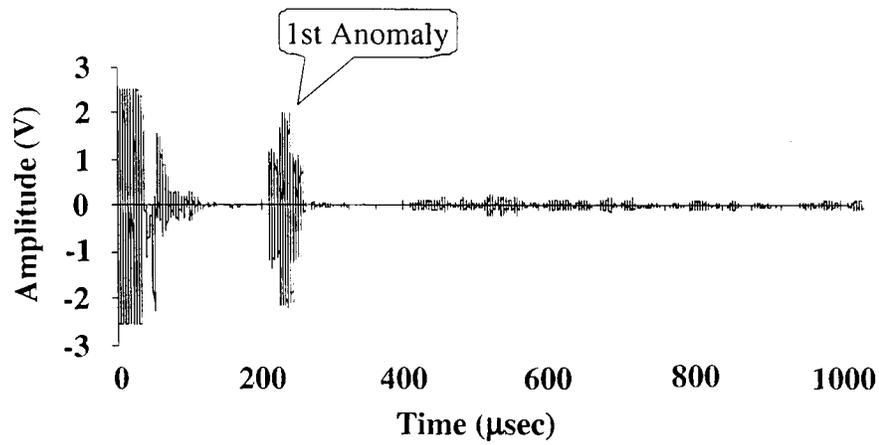
(b) Pulse echo signal plate 1: transducer at position A top surface

Fig. 6.8 Pseudo-surface Lamb wave mode for plate inspections.

(Frequency = 565 kHz; wedge angle = 62°)

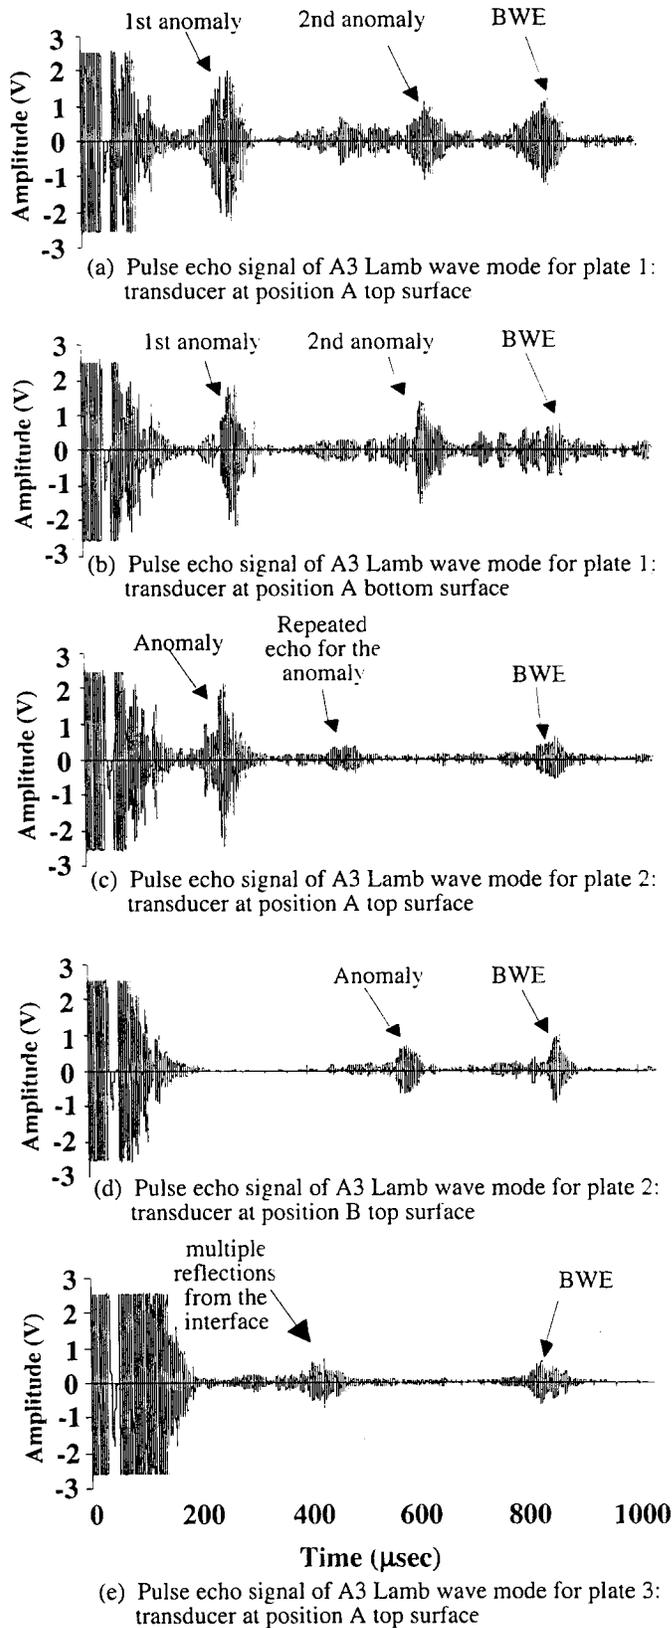
Fig. 6.9 Pulse-echo signals for the A3 Lamb wave mode.

(Frequency = 565 kHz, wedge angle = 38°.)

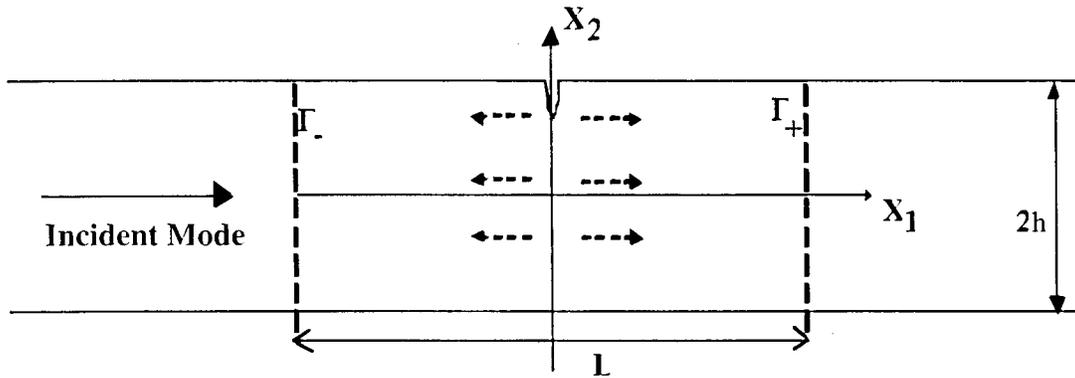
(a) Plate model, solid and dashed arrows show incident and scattering modes, respectively. (Area contained between  $\Gamma_{\pm}$  lines is used for BEM modeling)

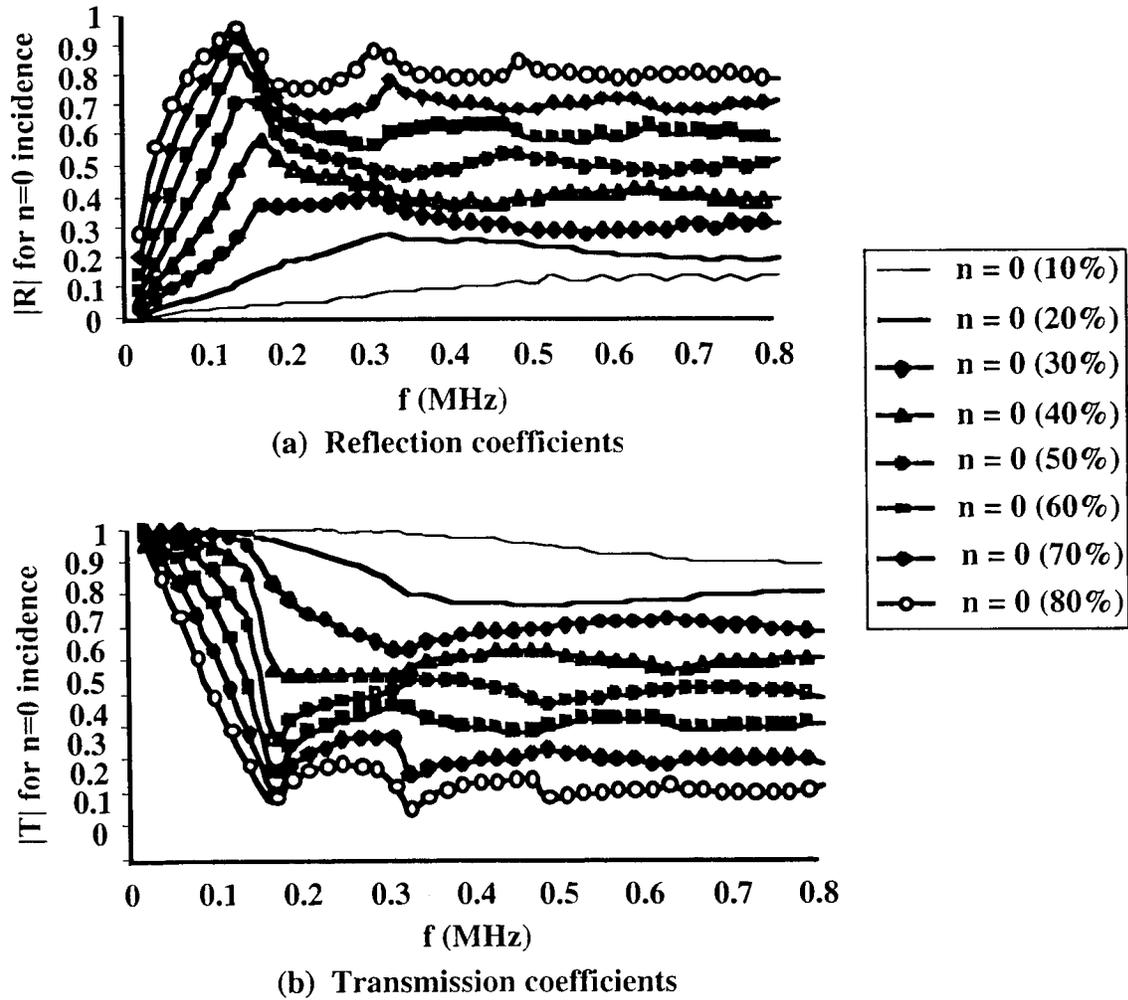
Fig. 6.12 Reflection and transmission coefficients.

( $n = 0$  mode under  $n = 0$  incident mode for 0.3-mm elliptical notch width and 10 to 80 percent through-plate thickness depth)

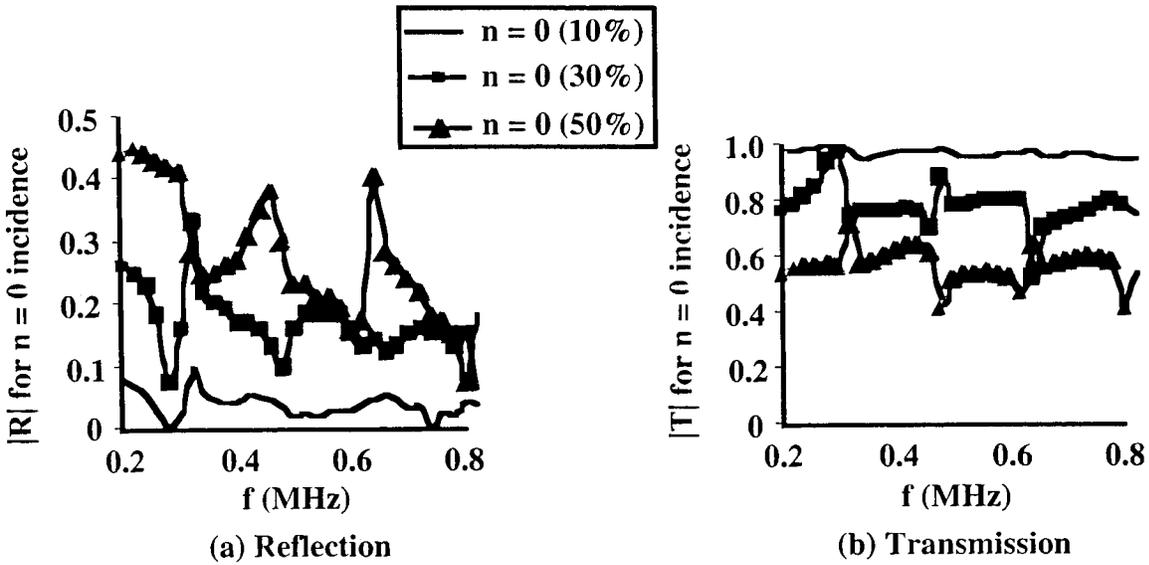
Fig. 6.14 Reflection and transmission coefficients for 6.35-mm elliptical defect width and either 10, 30 or 50 per cent through-plate thickness depth.

( $n = 0$  mode under  $n = 0$  incident mode)

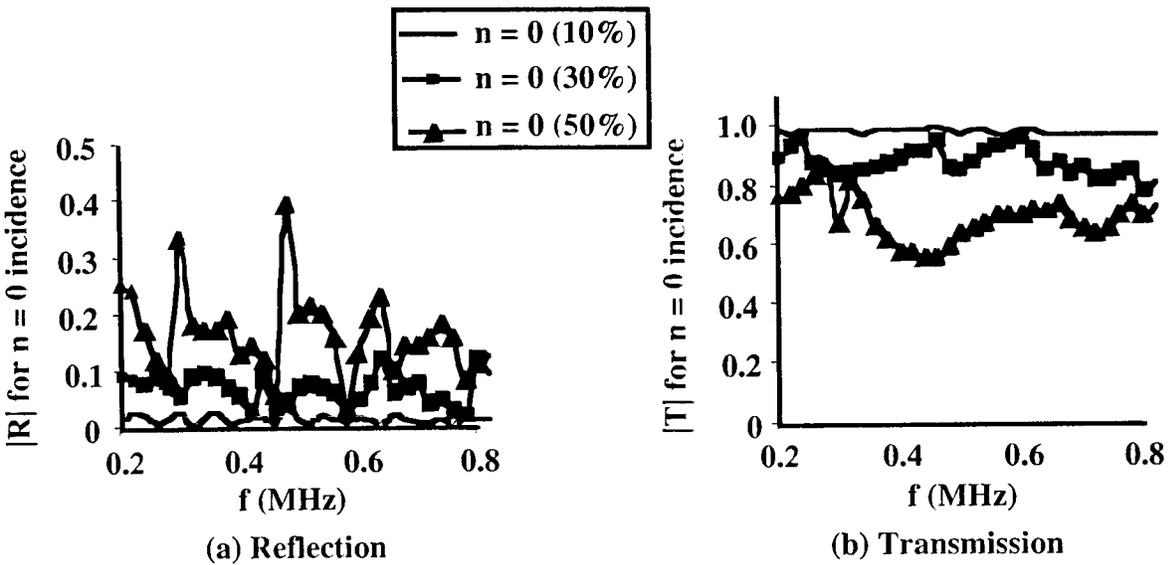
Fig. 6.15 Reflection and transmission coefficients for 12.7-mm elliptical defect width and either 10, 30 or 50 per cent through-plate thickness depth.

( $n = 0$  mode under  $n = 0$  incident mode)

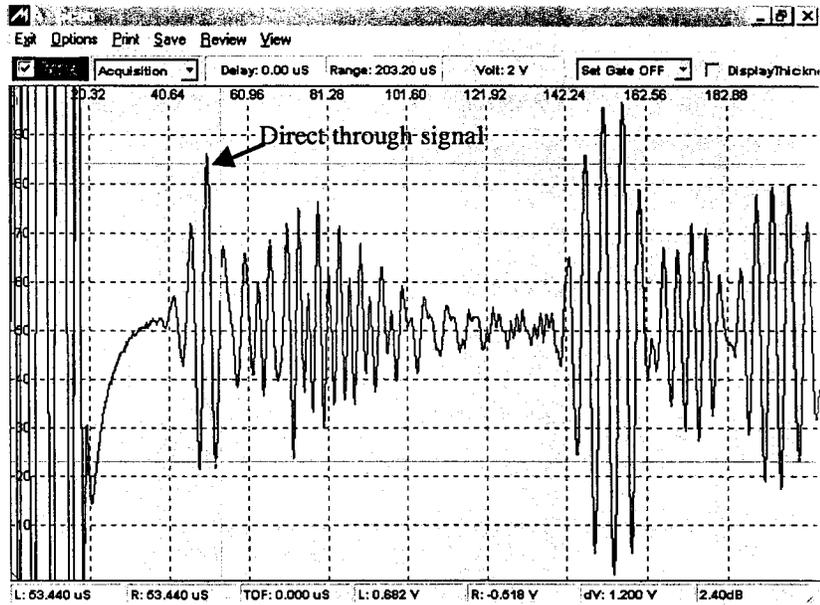
Fig. 6.17. Through-transmission signal from a 0.3-mm-wide notch 10 percent through depth of 10-mm-thick plate.

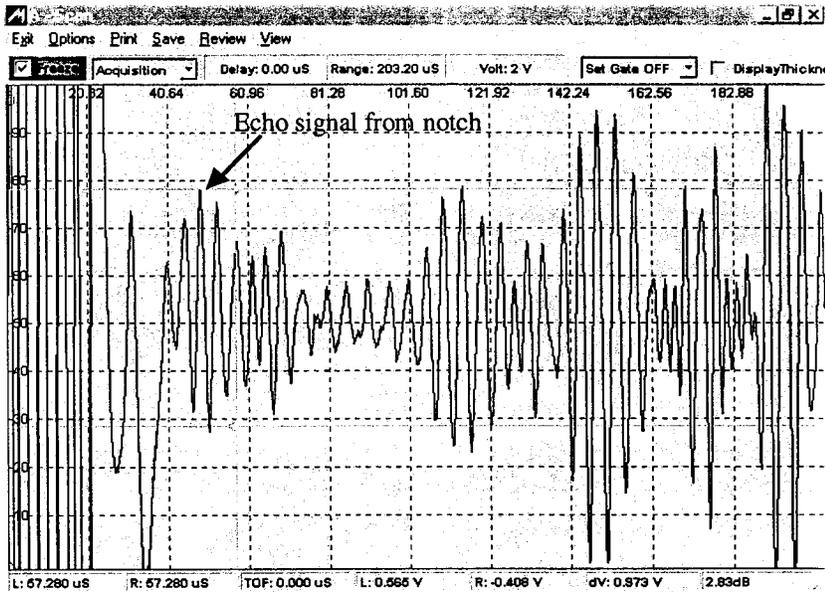
Fig. 6.18. Pulse-echo signal from a 0.3-mm-wide notch 30 percent through depth of 10-mm-thick plate.

(SH wave of mode 0)

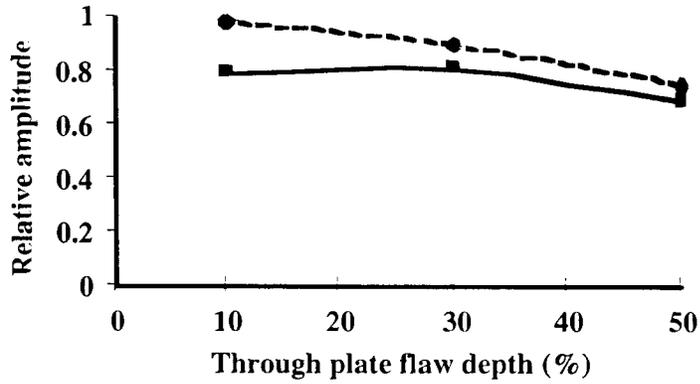
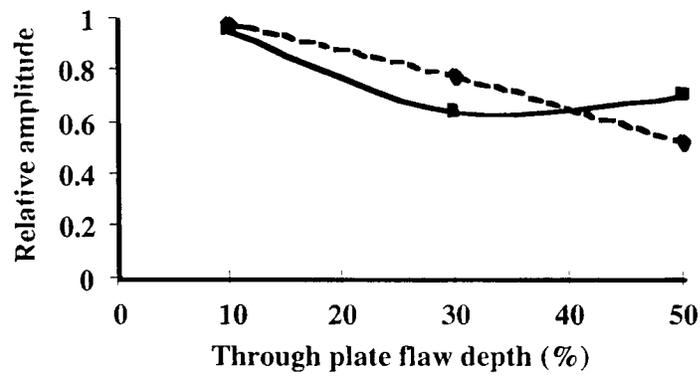
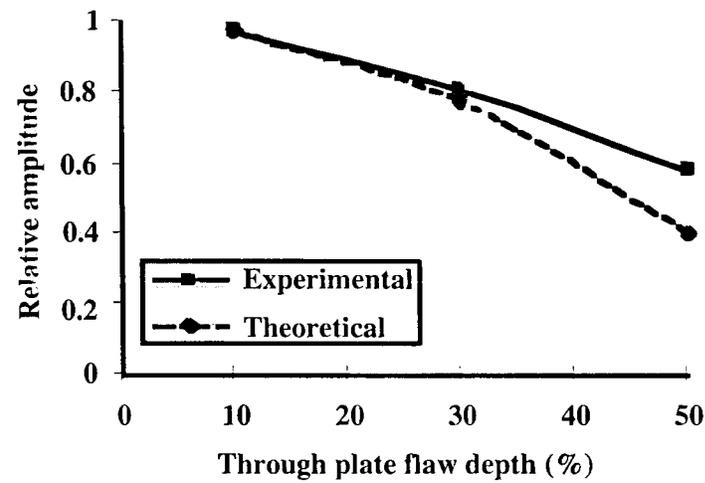
(a) 0.5 in. notch defect

(b) 0.25 in. notch defect

(c) 0.012 in. notch defect

Fig. 6.19 Theoretical and experimental relative amplitude results for 12.7-mm, 6.35-mm, and 0.3-mm-wide notches of different depth in a 10-mm-thick plate.
