# Hydrological and Geological Features Contributing to a Seepage Event at Yucca Mountain

Paper Number H43A-03

2006 American Geophysical Union Annual Spring Meeting,  
Baltimore, MD, May 25-26, 2006

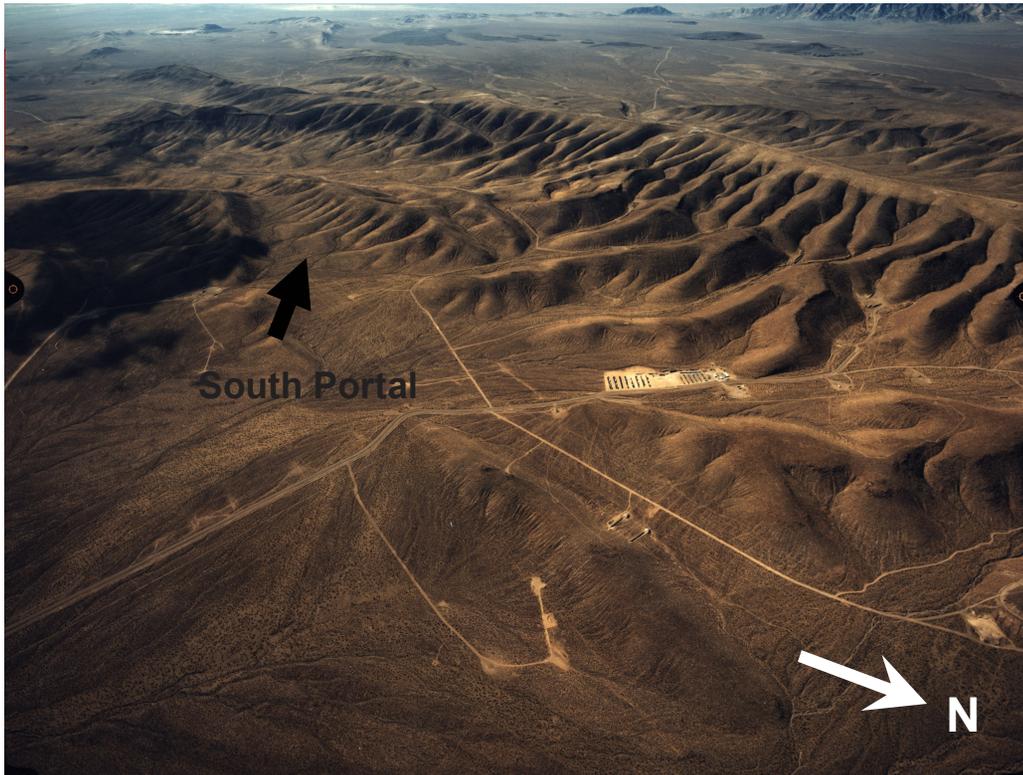
Figure 1. Photograph of east flank of YM looking southwest. Arrow indicates approximate location of south portal of ESF. Note the photograph was taken prior to construction of the ESF.

## Yucca Mountain (Figure 1)

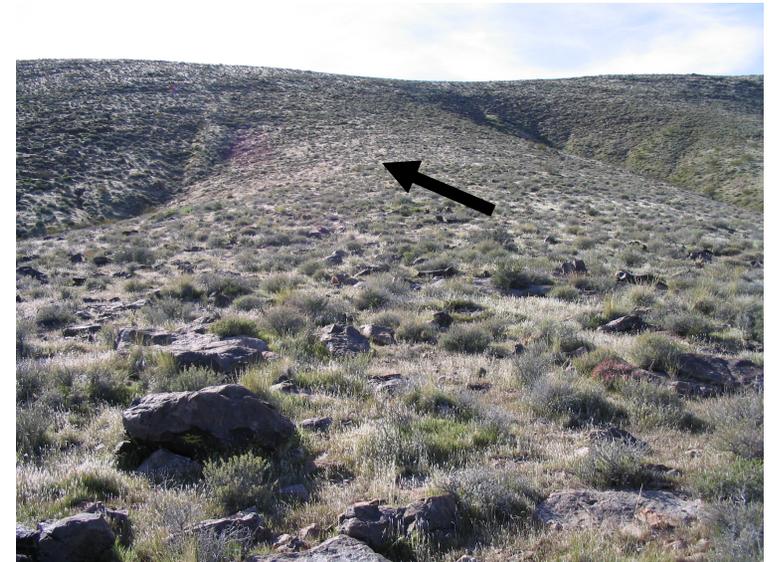
Figure 8. Photograph looking westward up the ridge from point A on Figure 6. Arrow points to approximate projected location of seepage in tunnel. At point of arrow, approximate distance between bottoms of washes is 90 m.

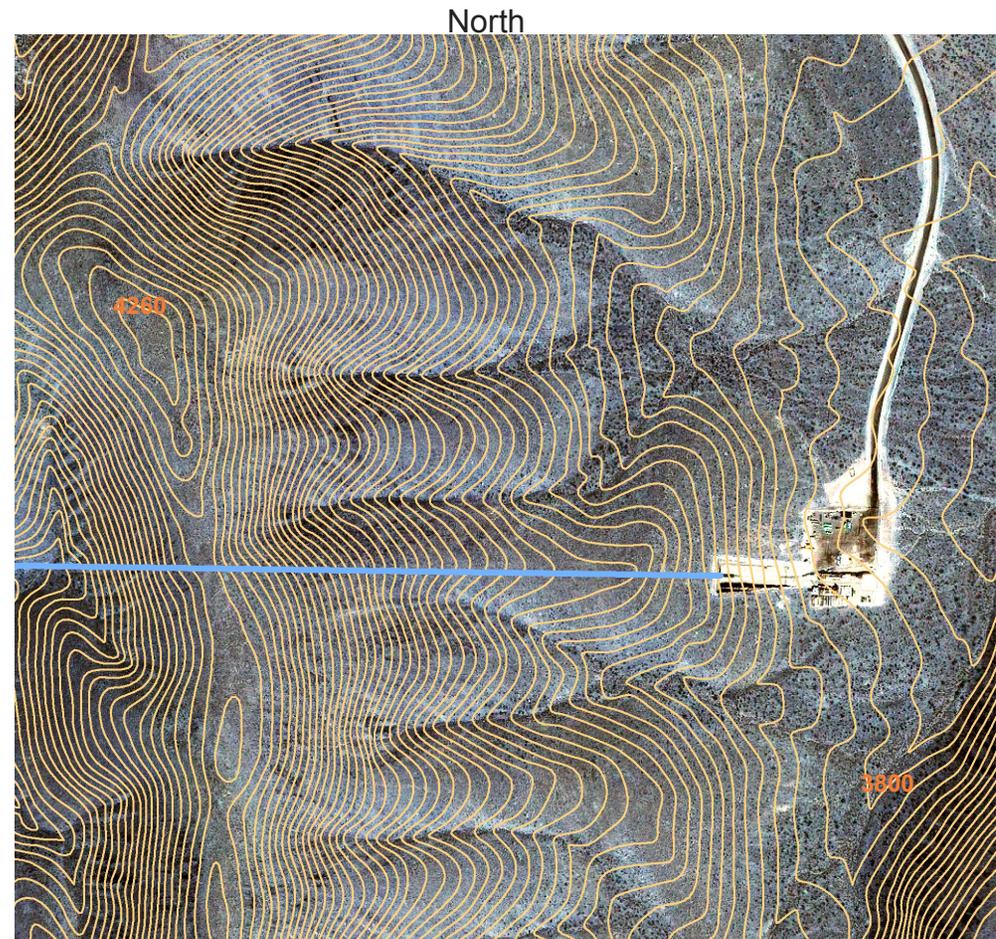
Figure 9. Contour lines (10-ft intervals) draped on satellite image of South Portal area of ESF. Width of image is approximately 1 km. Two contours spanning the relevant range are labeled.

1. Focusing of runoff in wash channels on either side of ridge and lateral diversion towards tunnel
  - Washes ~30 m and ~60 m offset to the south and north from the tunnel; note that depth to tunnel is only about 60 to 80 m; hence significant lateral diversion would be required
  - No known structural features capable of lateral diversion to north or south; note that stratigraphic contacts dip at a low angle to the east.
2. Water infiltrated in a distributed manner on the ridge through extensively fractured nonlithophysal unit.
  - The topography above the seepage location suggests that little runoff could have been contributed from upslope areas
  - Possible focusing of percolation may have occurred within the bedrock because of lithologic contacts or faults and fractures.
