Seismic Responses of Underground Excavations in Jointed Rock Mass

A. Ghosh and S.M. Hsiung

**Center for Nuclear Waste Regulatory Analyses
Southwest Research Institute®
San Antonio, Texas**

GoldenRocks 2006

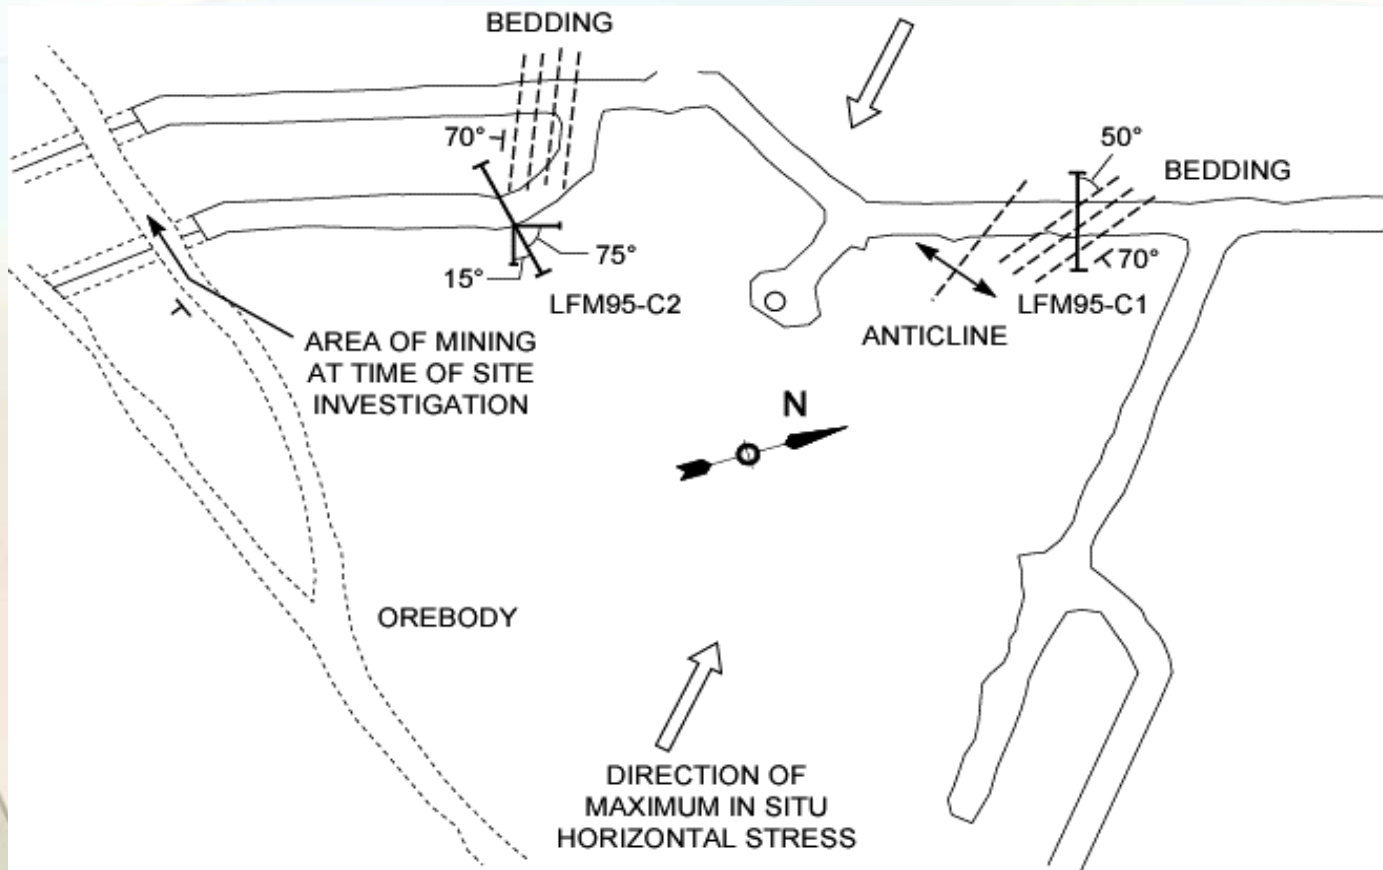
Instrumentation Locations of Field Study

- Locations of instrumentation at the 5,210 ft level of the Lucky Friday mine

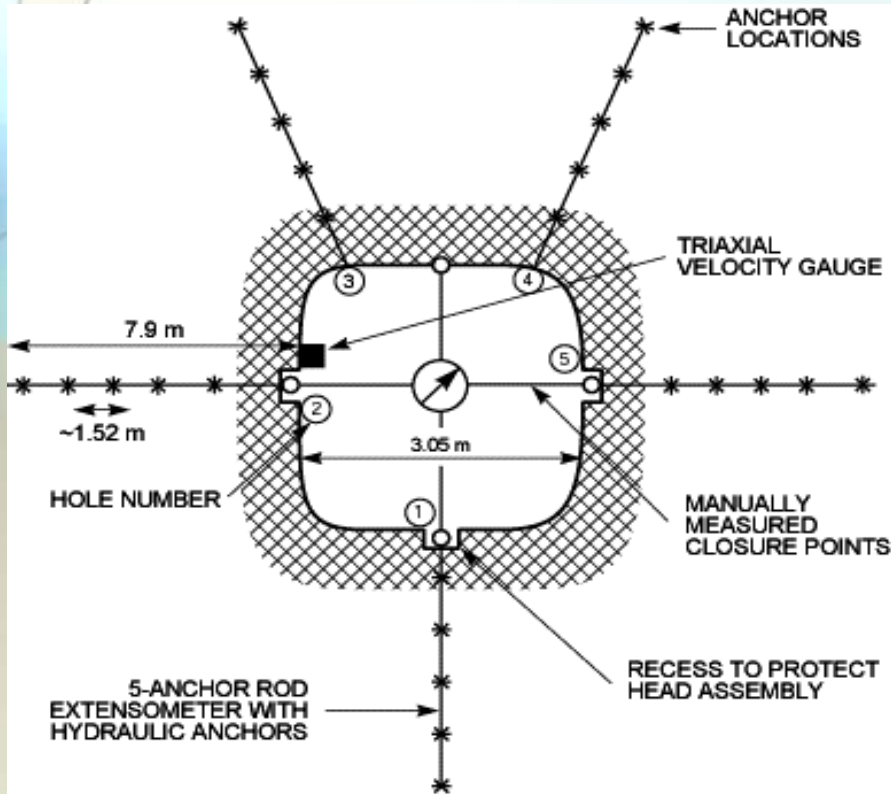
(a) LFM 95-C1 Site

Instrumentation Arrays

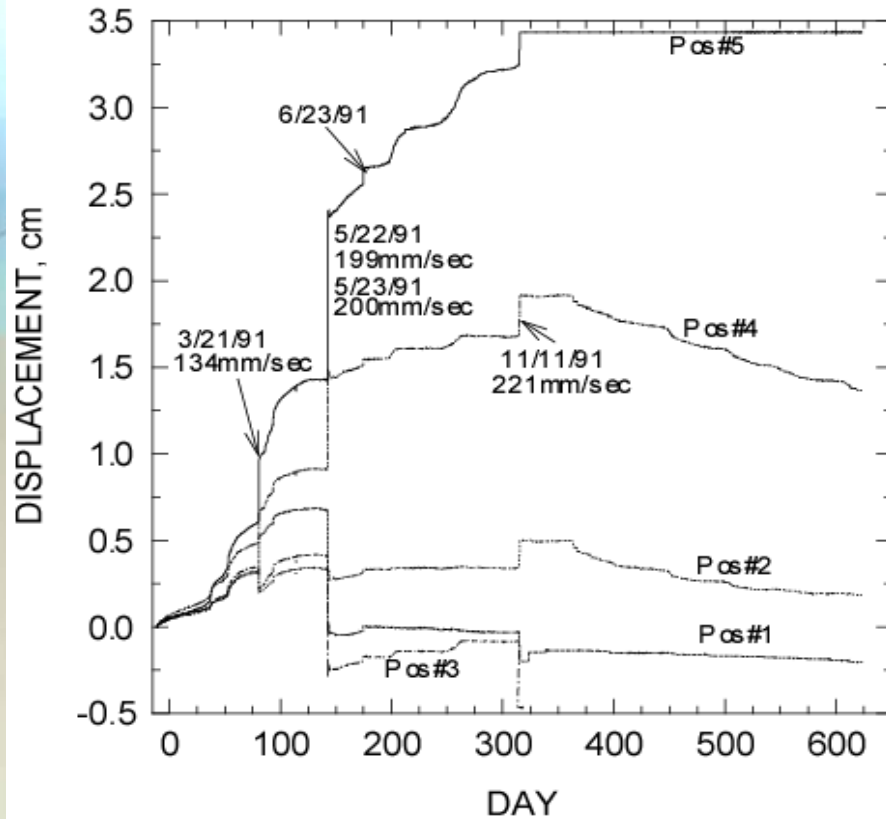
Extensometer No. 1

Seismicity-Induced Step Changes in Displacements at LFM95-C2 Site

- **Ground motions induce step changes in displacements of the rock mass around excavations and excavation closures**
- **A seismic threshold appears to exist before significant permanent rock mass deformation will occur and begin to accumulate**
- **Accumulation of rock mass displacements around excavations may cause instability or damage of the excavations**

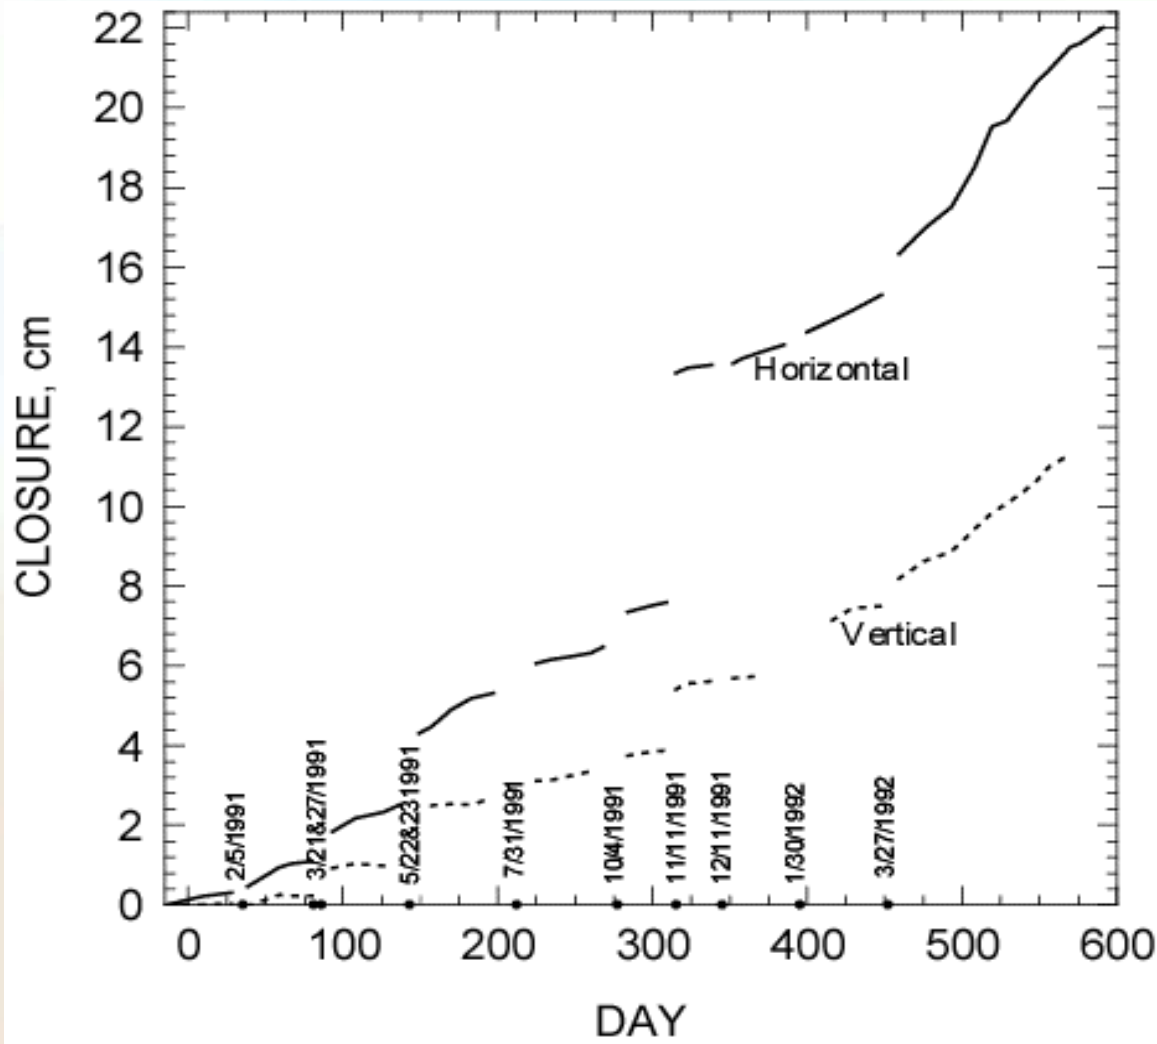
Seismicity-Induced Step Changes in Closure at LFM95-C2 site

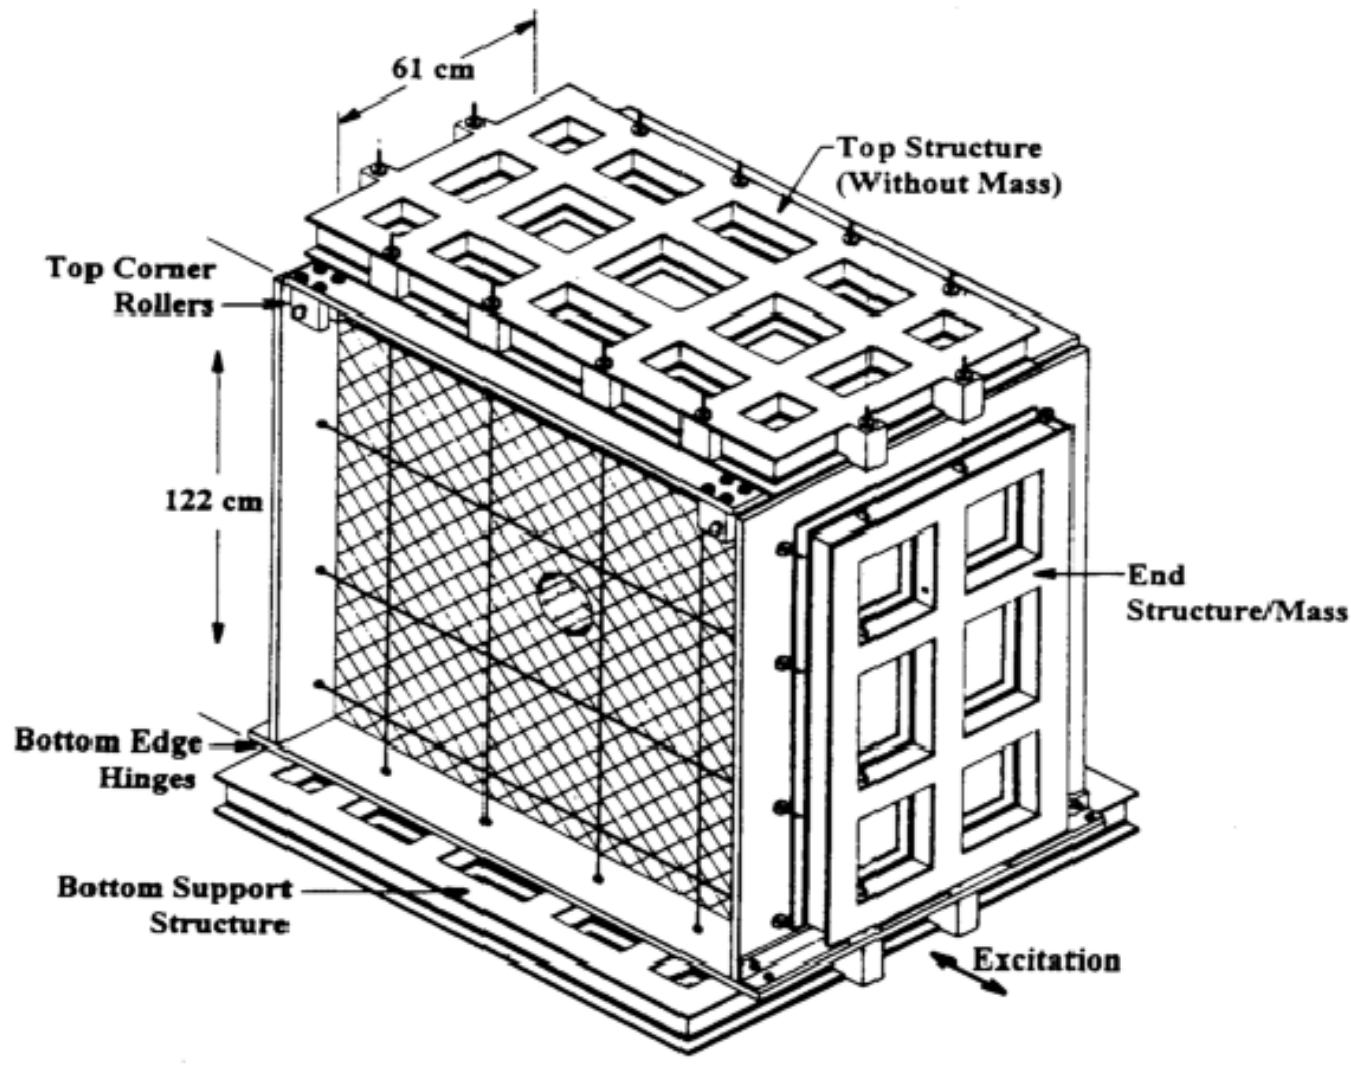
Small Scale Rock Mass Experimental Setup

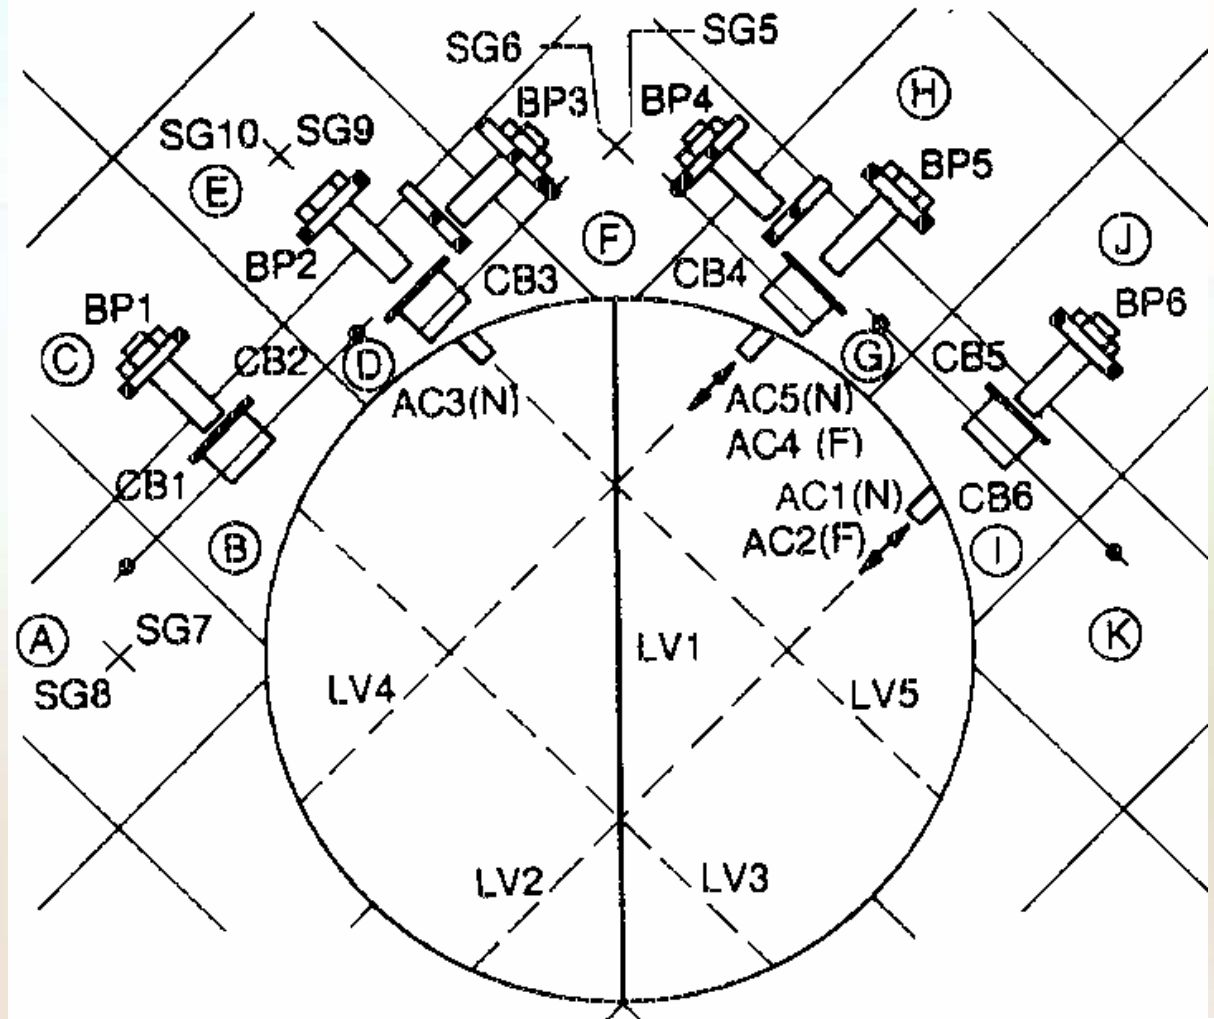
Instrumentation on One Side of the Model

Nomenclature

LV: LVDT

CB: Cantilever
beam

BP: Bentley probe

AC: Accelerometer

SG: Strain gage

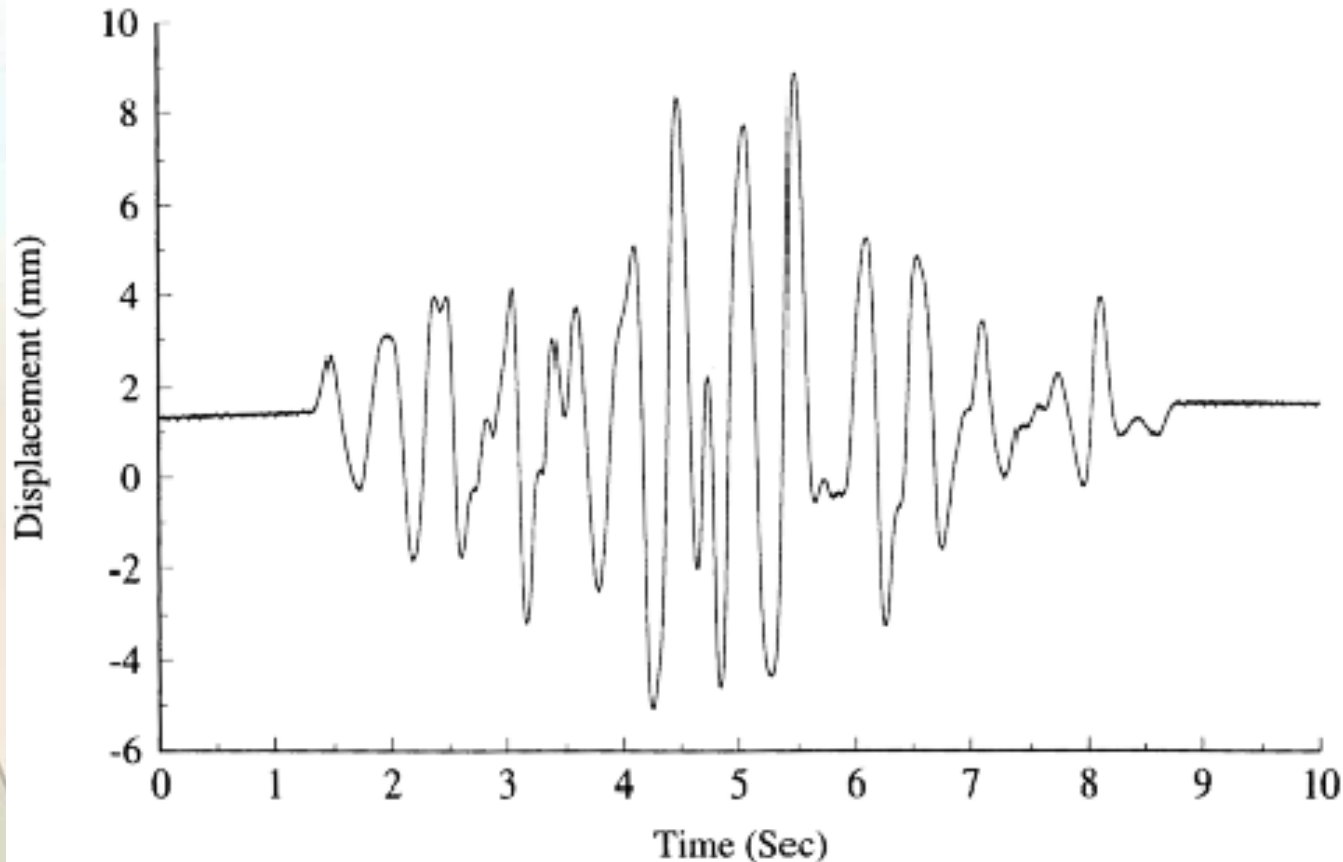
Displacement Input Signal

- **Displacement amplitude of this signal was scaled up or down for various excitation levels.**

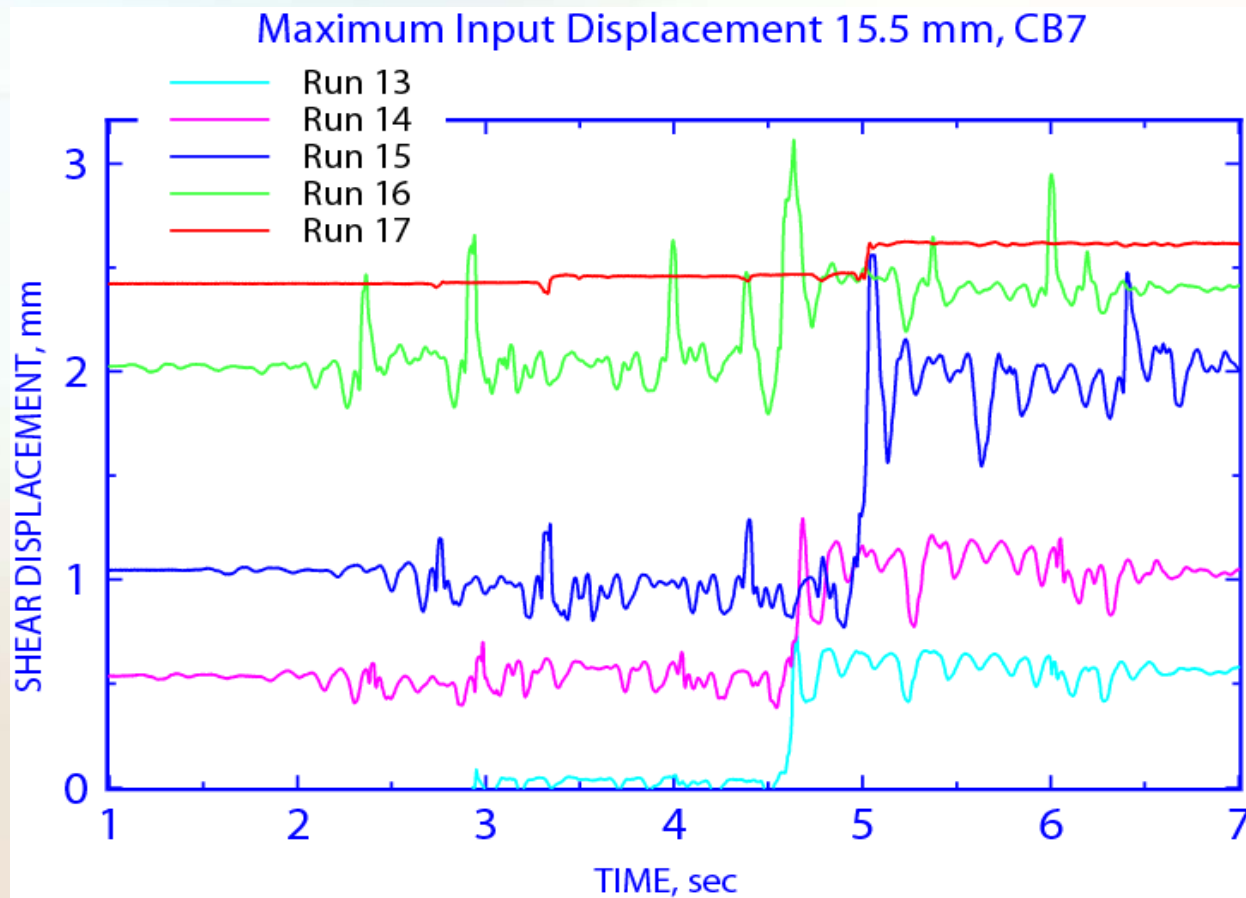
Accumulation of Joint Shear Displacements for Five Repetitive Runs

- **Joint shear displacement measured by CB7 located at the far side of the tunnel with a maximum input displacement of 15.5 mm**
- **Tests (Runs) were repeated 5 times using the same seismic motion**

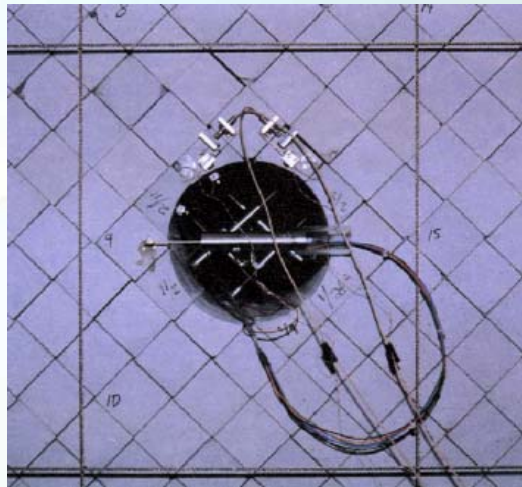
Run 13

Visual Observation of Accumulation of Joint Normal and Shear Displacements

- Maximum input displacement of 15.5 mm
- Same seismic motion was used for each run

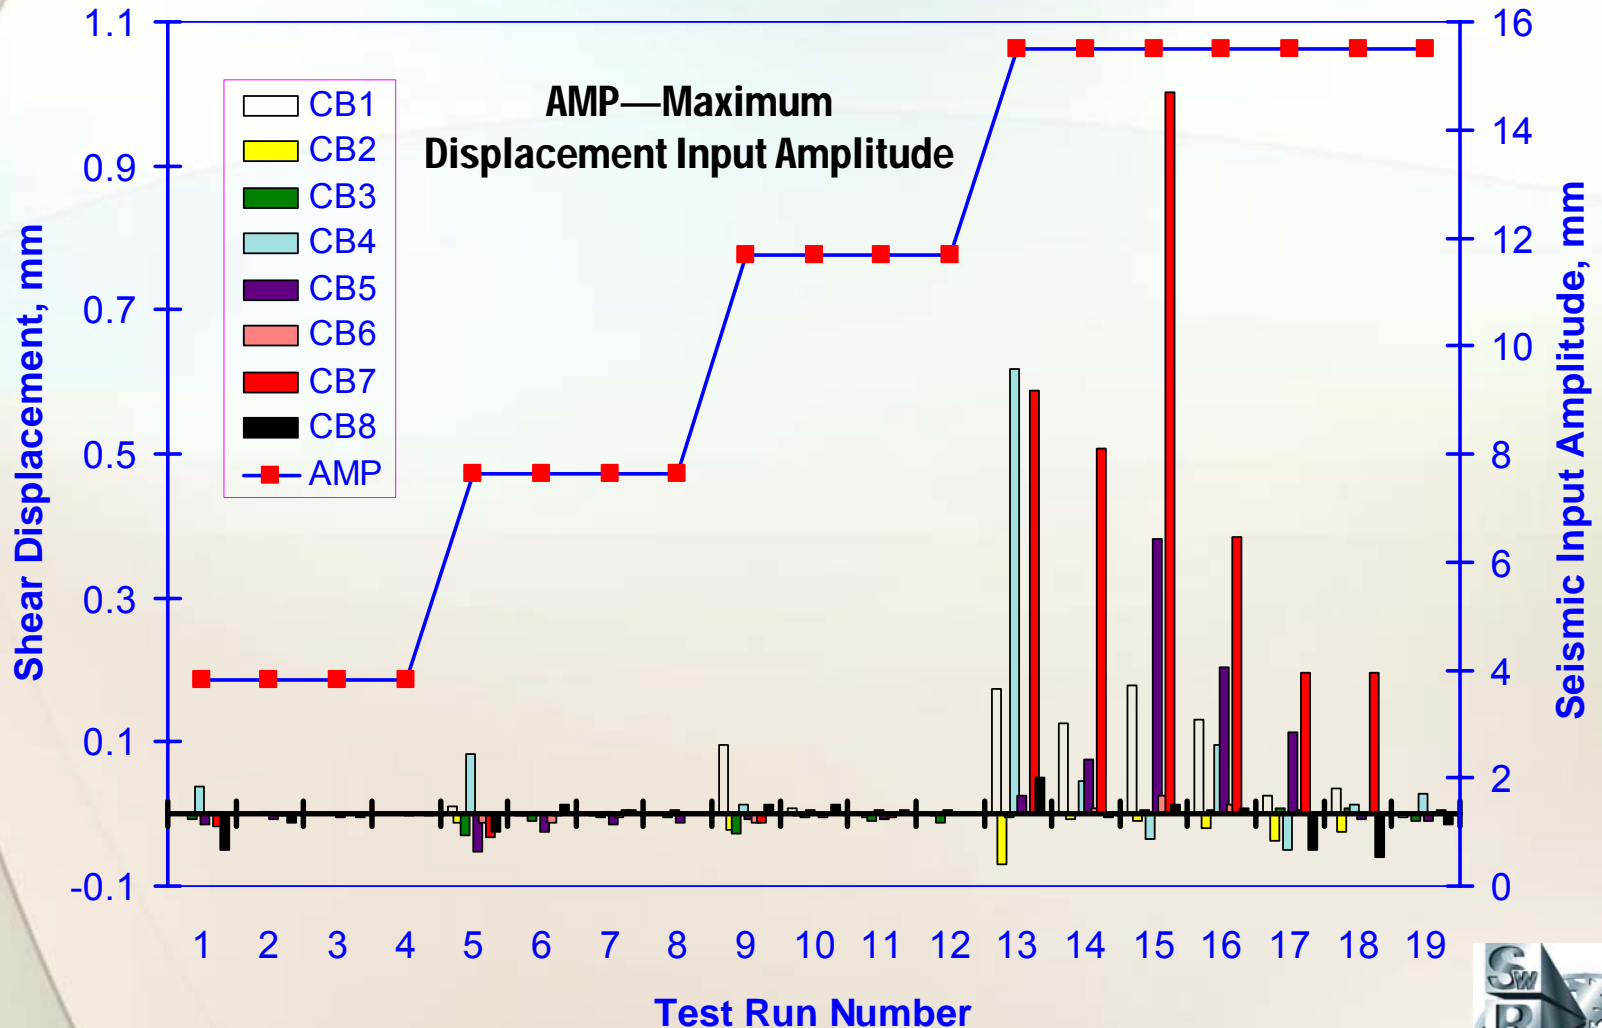
Increments of Permanent Joint Shear Displacements From Small-Scale Experiments

- **Observations demonstrate the fatigue behavior of rock mass reduces the strength of rock mass over time**
- **Damage to an excavation may occur due to a number of seismic events with relatively smaller magnitudes**
