Environmentally Assisted Cracking in Light Water Reactors

**Annual Report
January—December 2003**

Argonne National Laboratory

**U.S. Nuclear Regulatory Commission
Office of Nuclear Regulatory Research
Washington, DC 20555-0001**

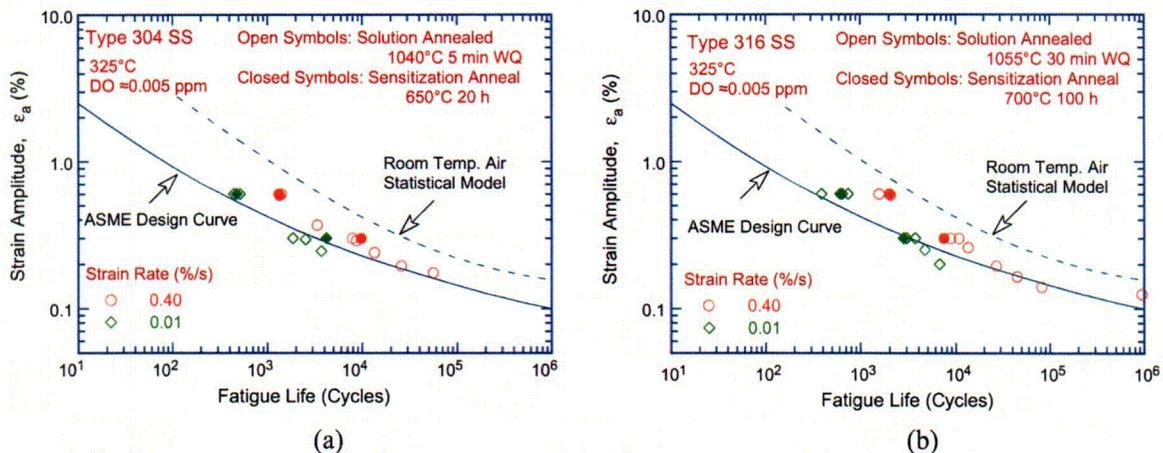
Figure 5. Effect of sensitization annealing on fatigue life of Type (a) 304 and (b) 316 stainless steel in low-DO water at 325°C (Refs. 10,11). WQ = water quenched.

These results are consistent with the data obtained at Mitsubishi Heavy Industries, Ltd. (MHI)¹⁰⁻¹² and Ishikawajima-Harima Heavy Industries Co. (IHI)¹³ on solution-annealed and sensitized Type 304, 316, and 316NG SS (Figs. 5 and 6). For example, in low-DO (< 0.005 ppm) water, environmental effects on the fatigue life of Type 304 and 316 SS are significant irrespective of material heat treatment (Fig. 5). In high-DO (8 ppm) water, the fatigue life of solution-annealed Type 304 SS is a factor of ≈ 2 longer than that of the sensitized steel (Fig 6a). A sensitization anneal appears to have little or no effect on the fatigue life of Type 316NG SS in high-DO water at 288°C (Fig. 6b). Fatigue lives of solution-annealed and sensitized Type 316NG SS are comparable.

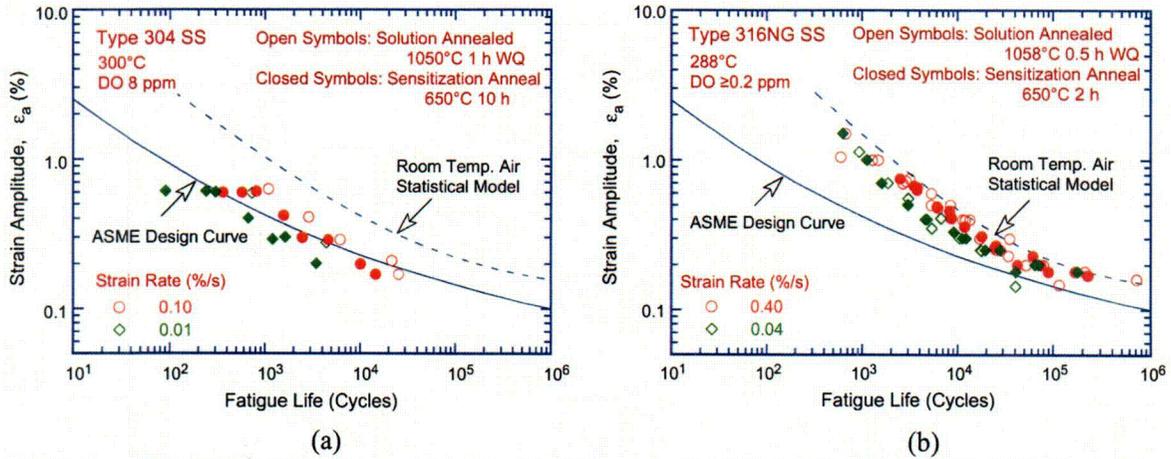
Figure 6. Effect of sensitization anneal on the fatigue lives of Type (a) 304 and (b) 316NG stainless steel in high-DO water (Refs. 12,13). WQ = water quenched.

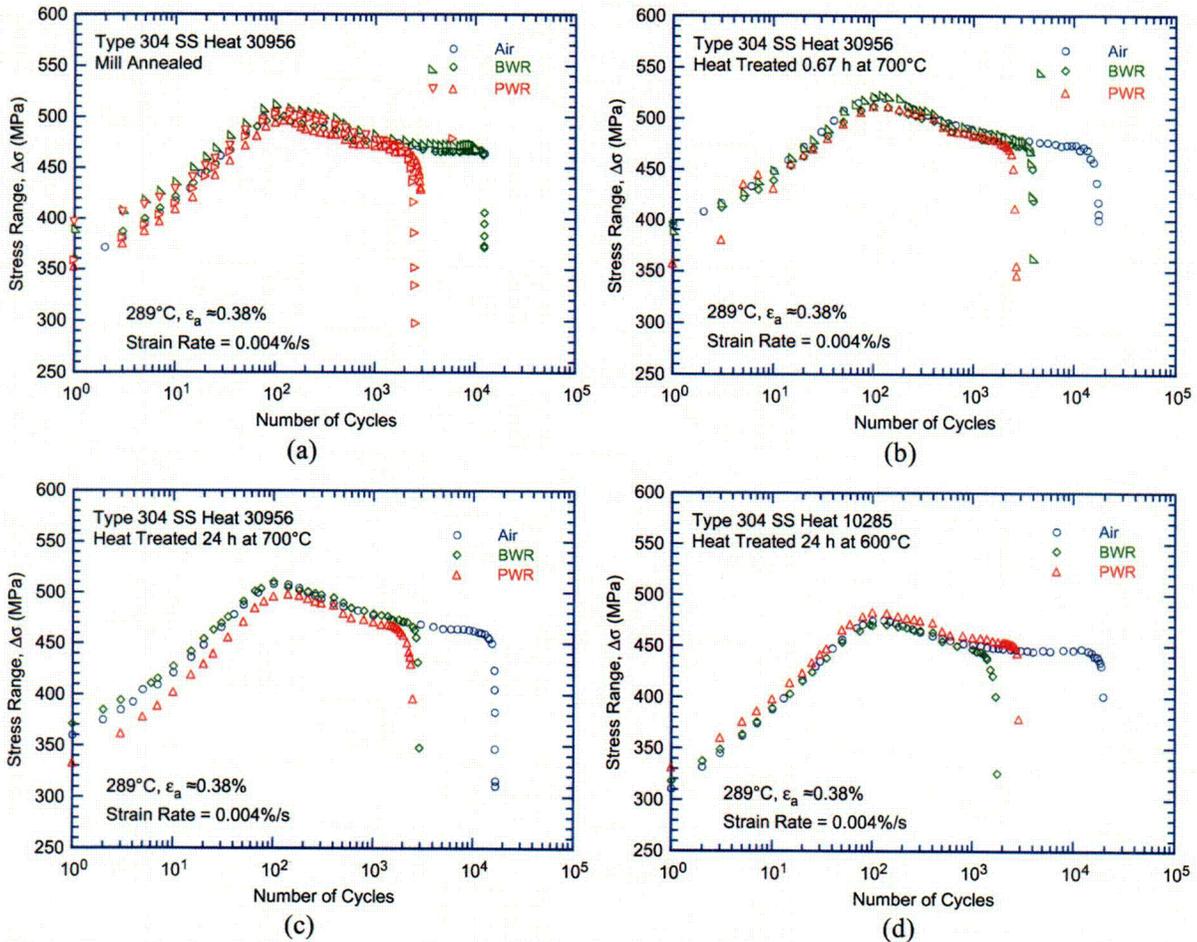
Figure 7. Cyclic stress response of Heat 30956: (a) MA, (b) MA + 0.67 h at 700°C, and (c) MA + 24 h at 700°C; and Heat 10285, (d) MA + 24 h at 600°C in air, BWR, and PWR environments at 289°C.

The cyclic stress response of the various materials in air, BWR, and PWR environments at 289°C is shown in Fig. 7. As expected, the cyclic strain-hardening behavior of Type 304 SS under various heat treatment conditions is identical; only the fatigue life varies in the environments.

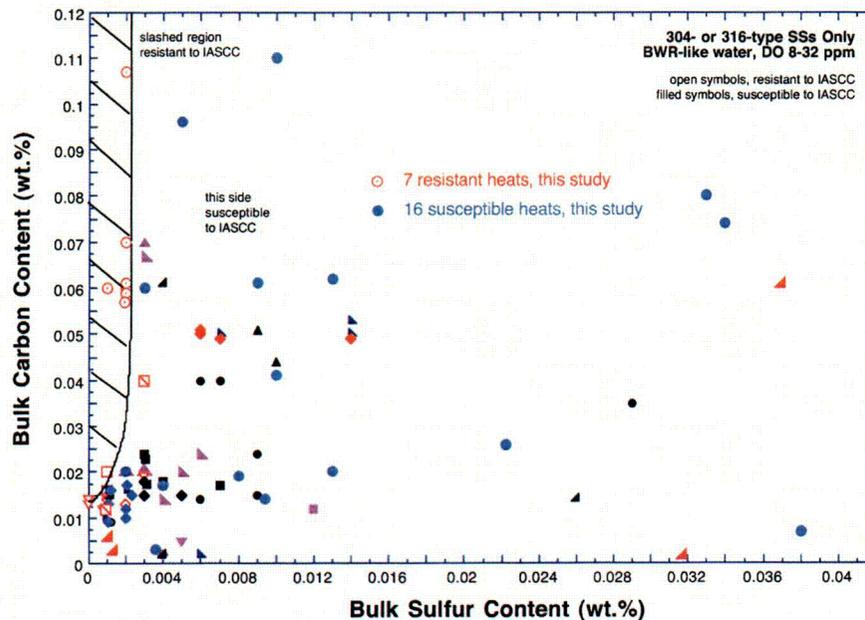
Figure 21. Range of bulk S and C contents in which 304- or 316-type steels are resistant or susceptible to IASCC, including four susceptible heats tested at 1.3 dpa in this study.

In Fig. 21, which is similar to Fig. 19, data points for four susceptible heats tested after irradiation to 1.3 dpa (i.e., Heats L22, L11, L13, and L8) are also included. It was assumed that the four heats are also susceptible to IASCC at 3 dpa, although they were not tested at this damage level.

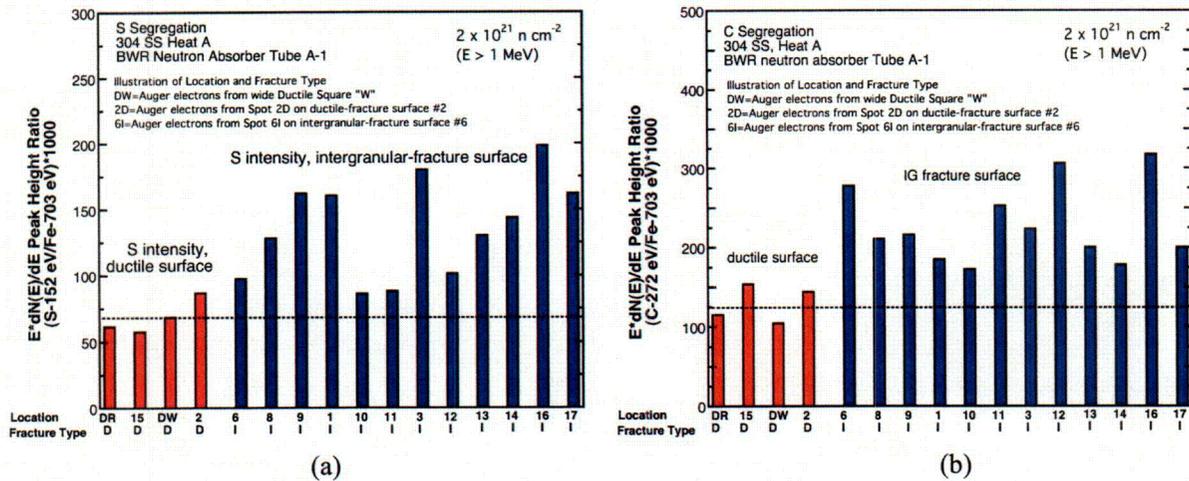
Figure 23. Summary of AES analysis of grain-boundary segregation of S (a) and C (b) in BWR neutron absorber tube fabricated from Type 304 SS Heat A and irradiated to 3 dpa: S and C peak heights from ductile (denoted "D") and IG (denoted "I") fracture surfaces are compared.

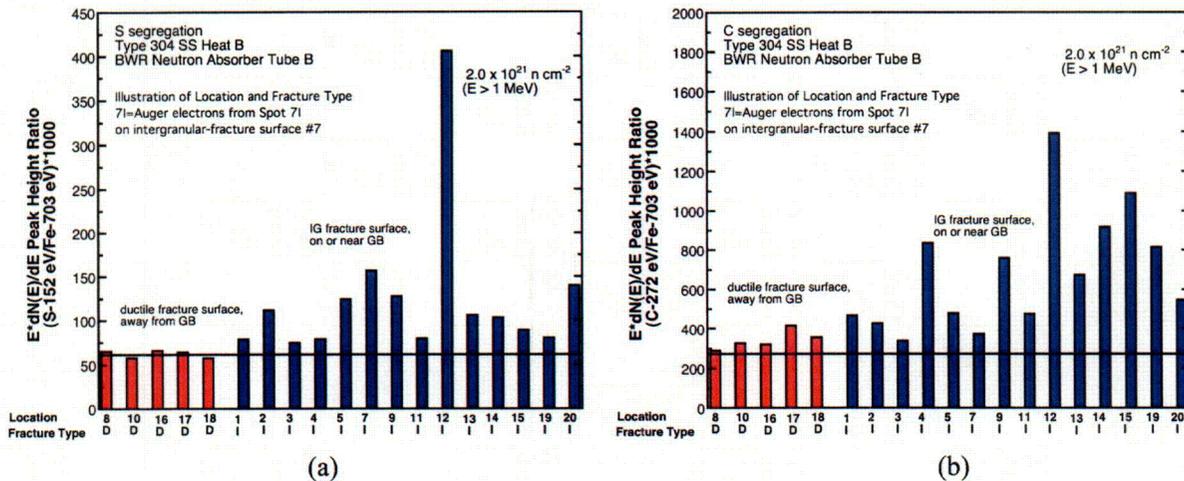
Figure 24. Summary of AES analysis of grain-boundary segregation of S (a) and C (b) in BWR neutron absorber tube fabricated from Type 304 SS Heat B and irradiated to 3 dpa: S and C peak heights from ductile (denoted "D") and IG (denoted "I") fracture surfaces are compared.

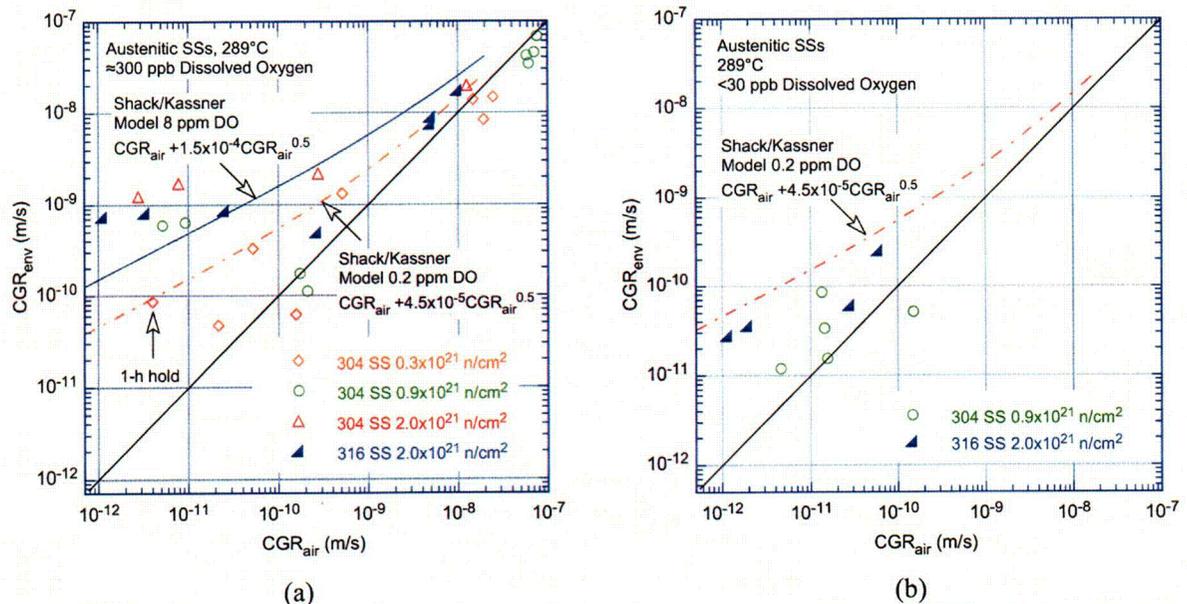
Figure 40. CGR data for irradiated austenitic SSs under continuous cycling at 289°C in high-purity water with (a) ≈ 300 ppb and (b) < 30 ppb dissolved oxygen.

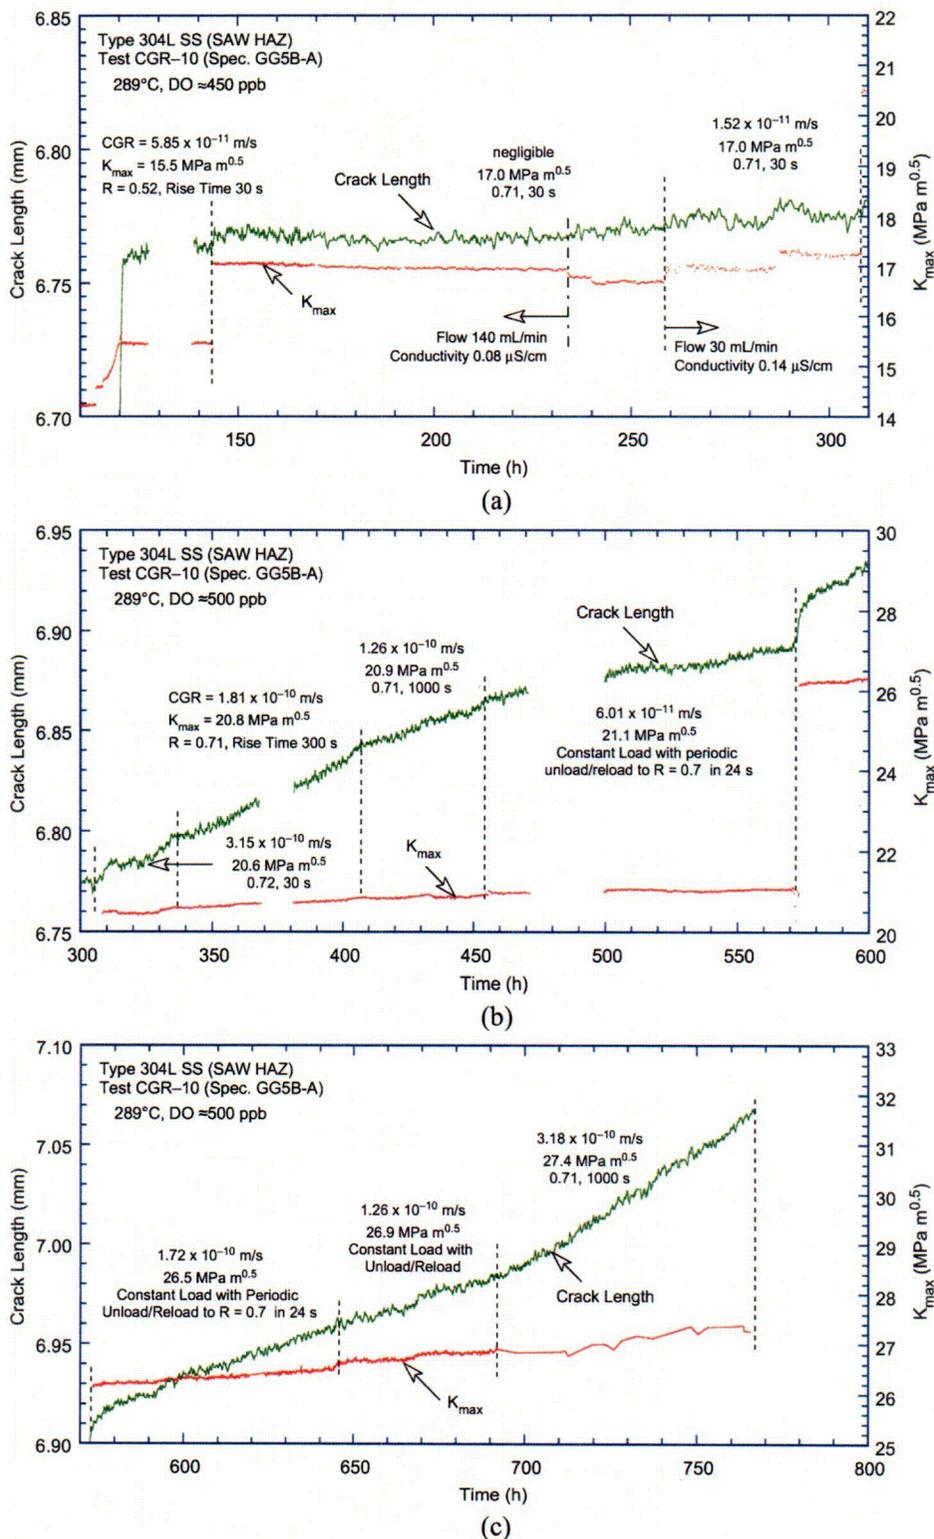
Figure 42. Crack length vs. time plots for nonirradiated HAZ specimen of Grand Gulf Type 304L bottom shell H5 weld in high-purity water at 289°C during test periods (a) precracking-3, (b) 4-6, and (c) 7-8.

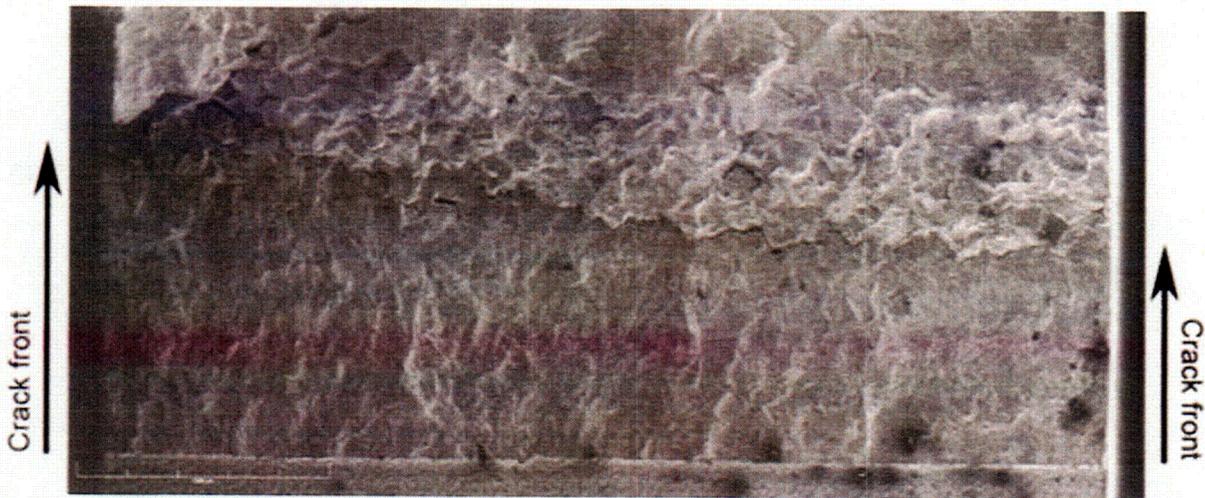
Figure 50. Micrograph of the fracture surface of Specimen 85-3A-TT tested in high-DO water at 289°C.

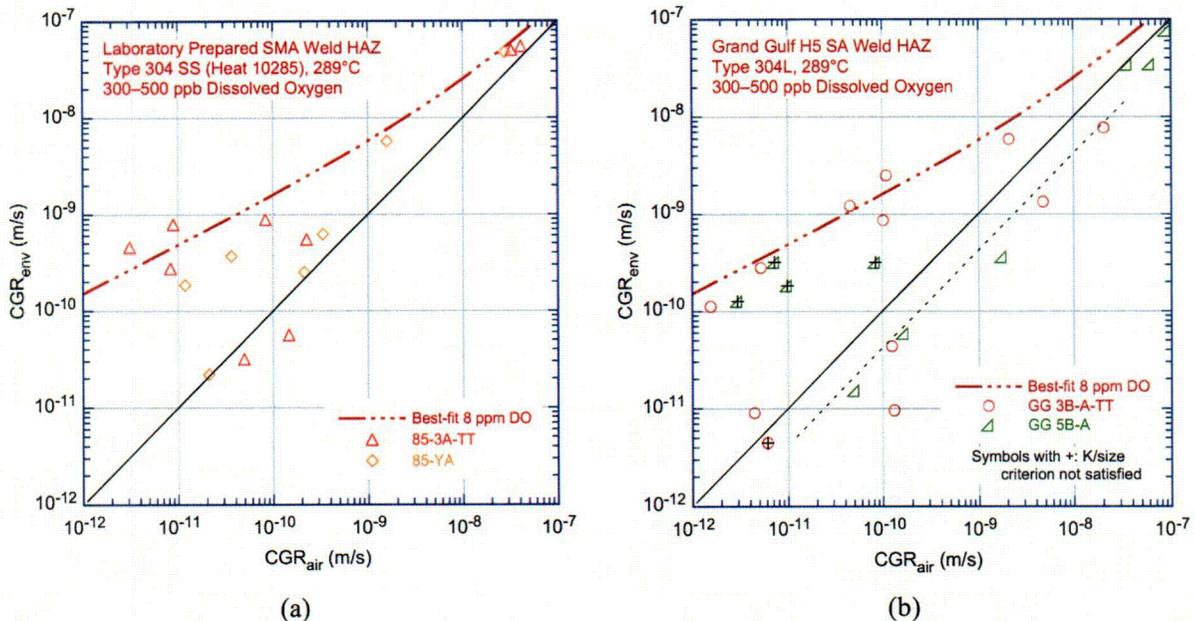
Figure 57. CGR data for nonirradiated specimens of (a) laboratory-prepared Type 304 SS SMA weld HAZ and (b) Type 304L SA weld HAZ from the Grand Gulf core shroud under continuous cycling at 289°C in high-purity water with 300-500 ppb dissolved oxygen.

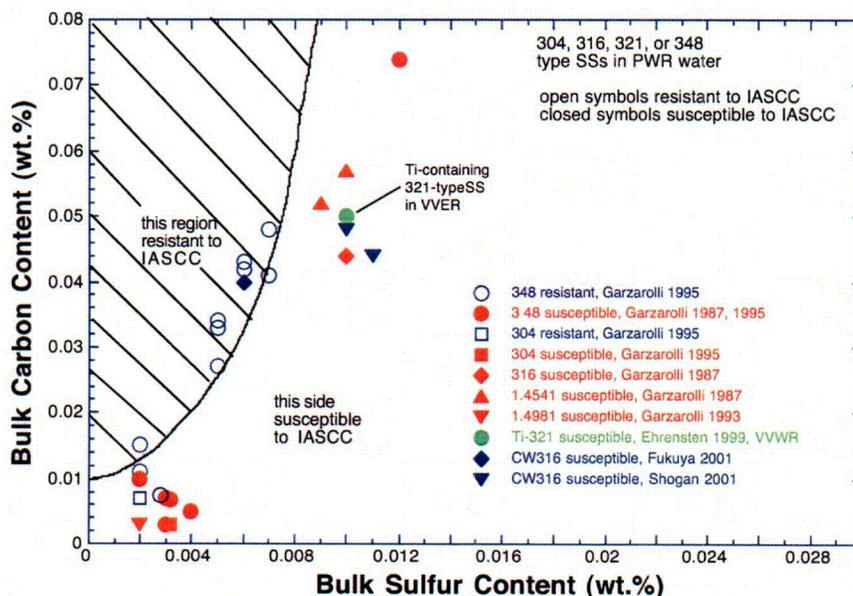
Figure 59. Representation of IASCC resistance or susceptibility of austenitic stainless steels as function of bulk S and C contents. Data obtained from PWR- or VVER-irradiated specimens in PWR, VVER, or PWR-like water reported in 1987-2004.

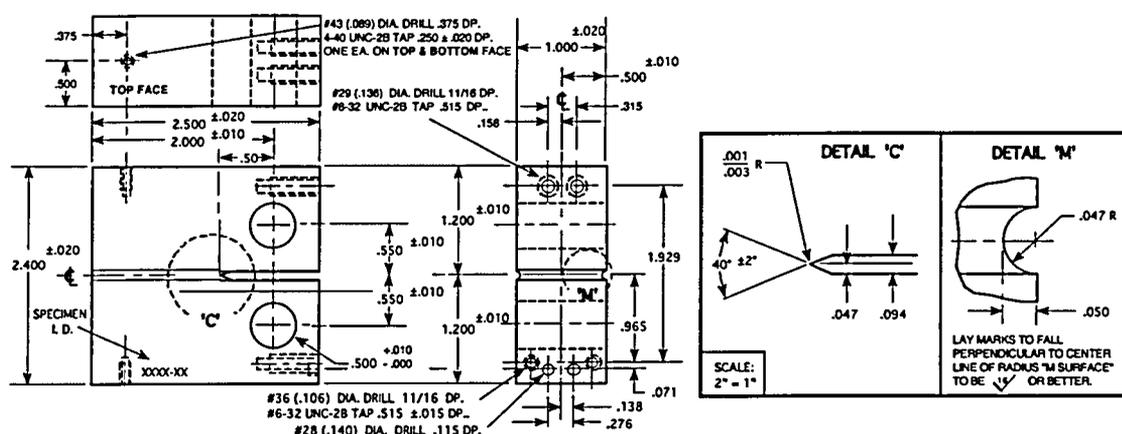
Figure 60. Configuration of compact-tension specimen used for this study (dimensions are in inches).

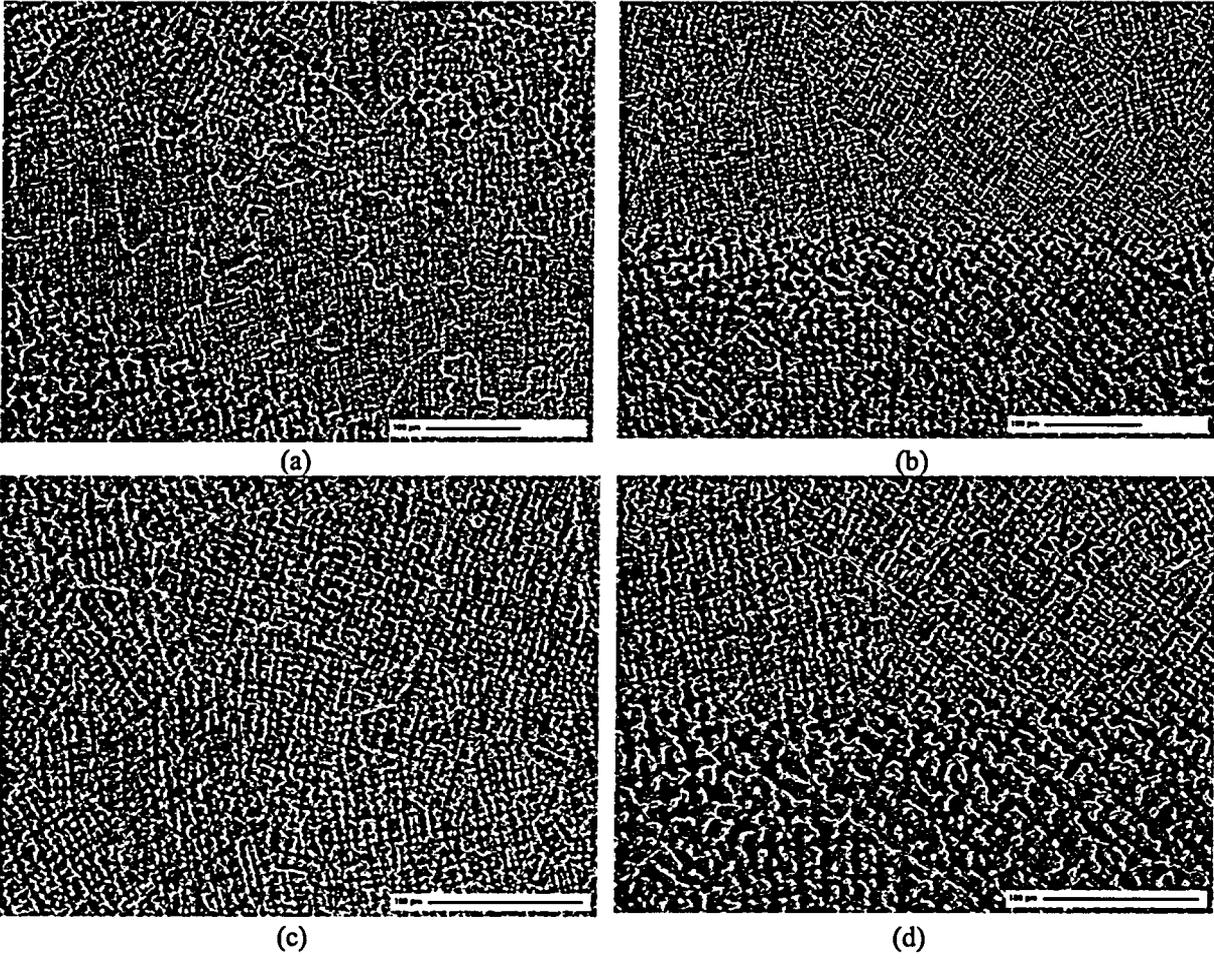
Figure 70. Examples of dendritic microstructure at a weld passes on sample 3B (a,b) and high magnification micrographs at the respective locations (c,d).

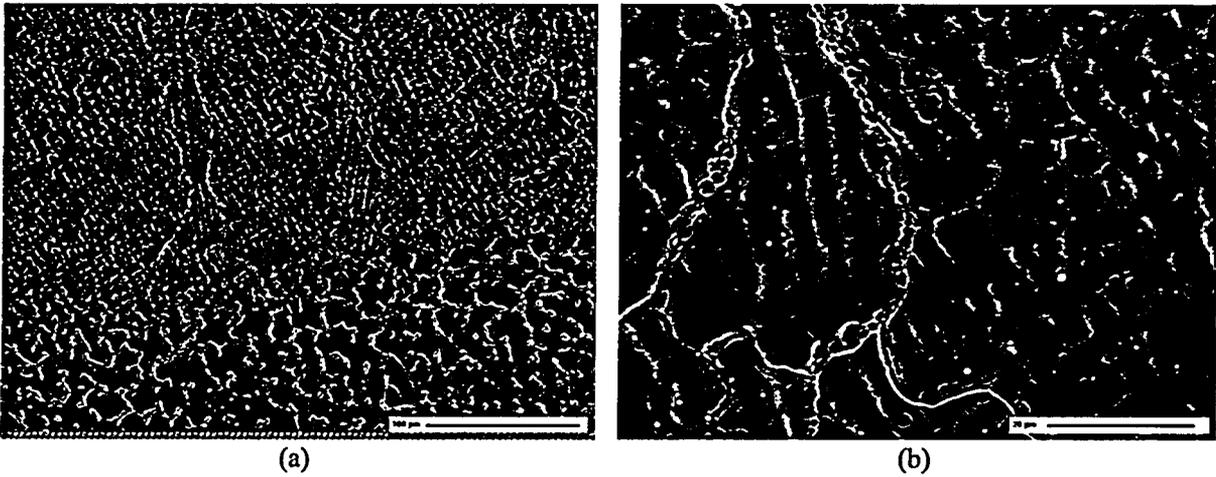
Figure 71. (a) Dendritic microstructure on sample 3B and (b) high magnification of a region from (a).

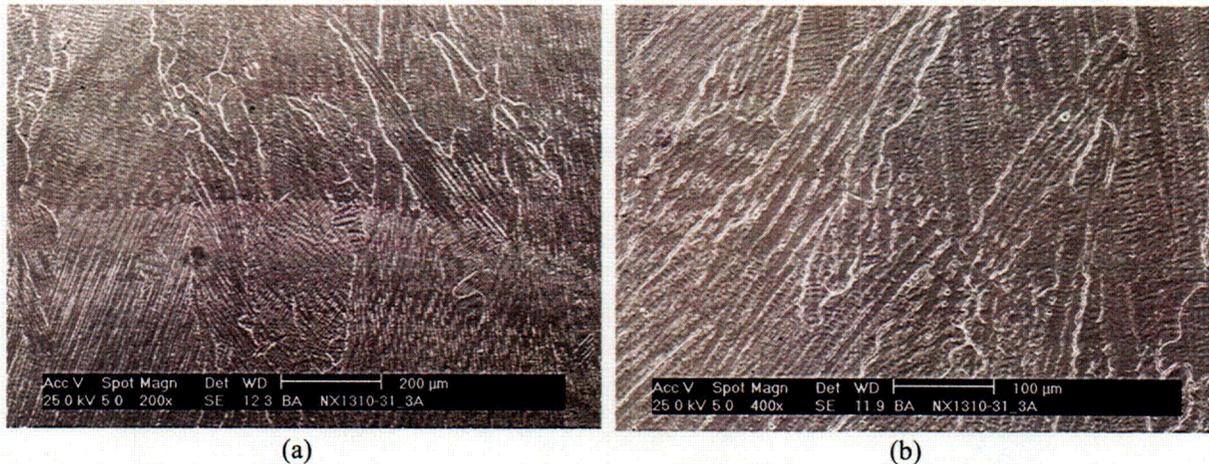
Figure 72. Dendritic microstructure observed on the surface of sample 3A at (a) 100 \times and (b) 200 \times magnifications.

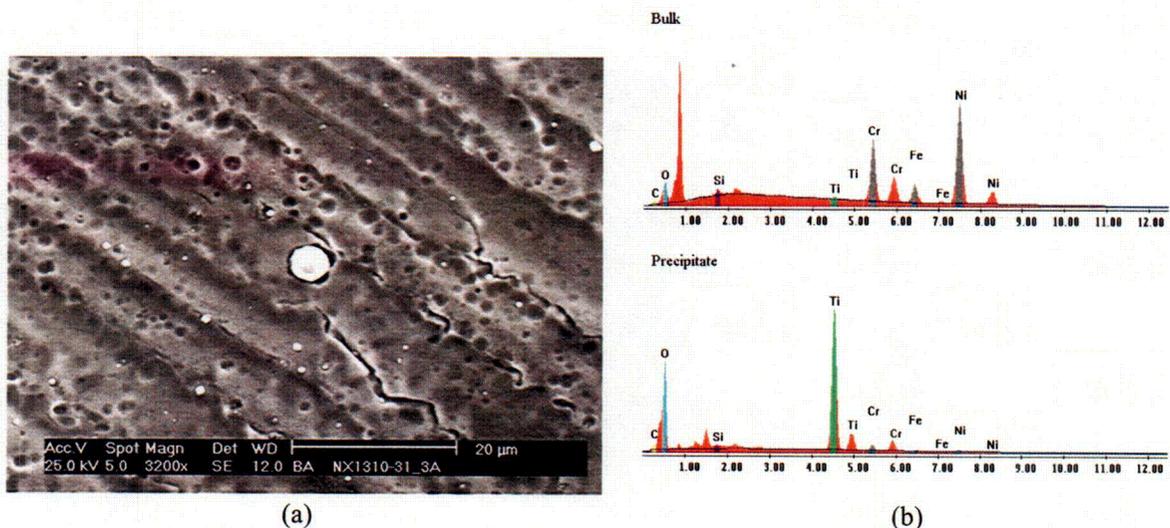
Figure 73. (a) Micrograph showing one of the matrix precipitates observed on the surface of sample 3A and (b) EDX spectra resulting from the bulk and the precipitate shown in (a).

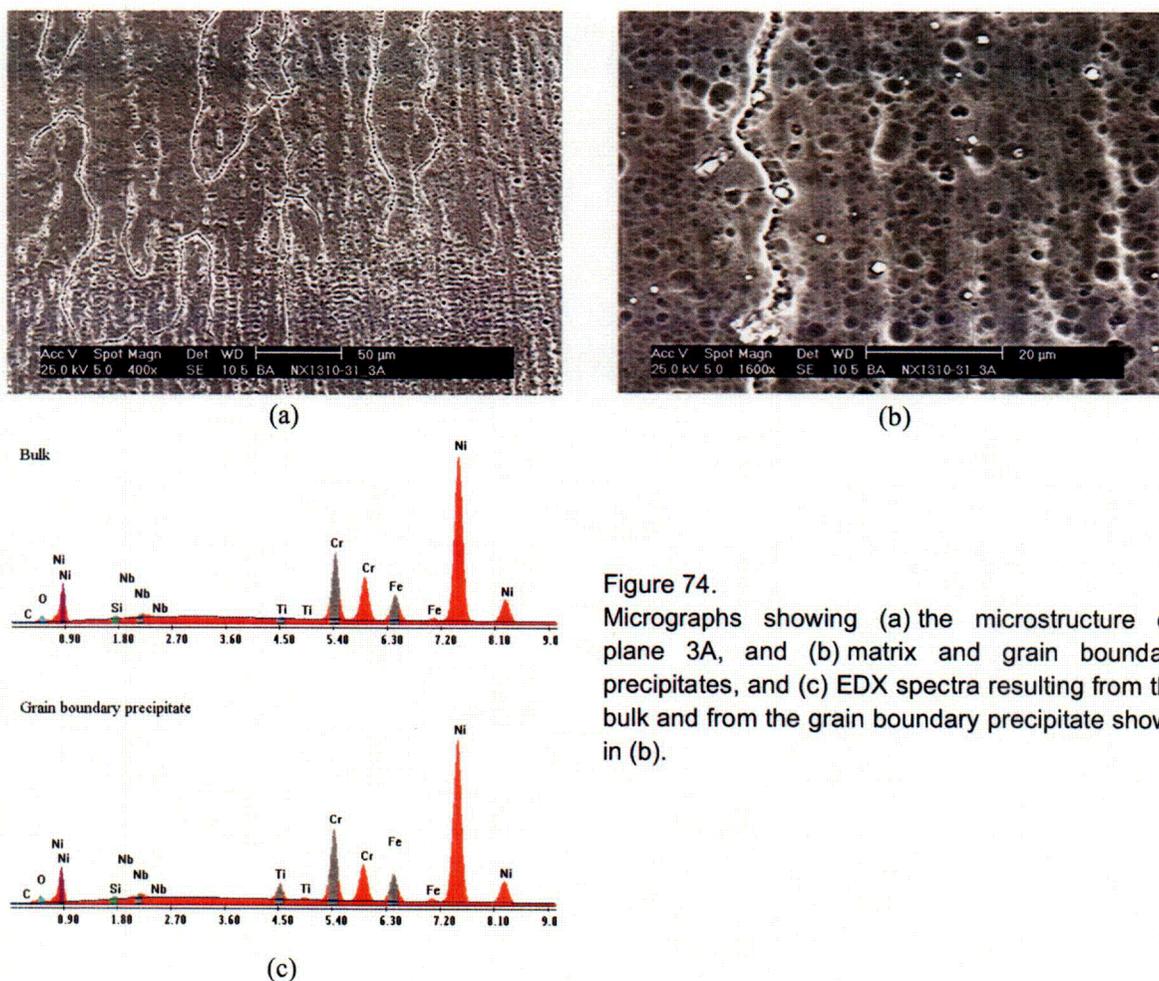
Figure 74. Micrographs showing (a) the microstructure on plane 3A, and (b) matrix and grain boundary precipitates, and (c) EDX spectra resulting from the bulk and from the grain boundary precipitate shown in (b).

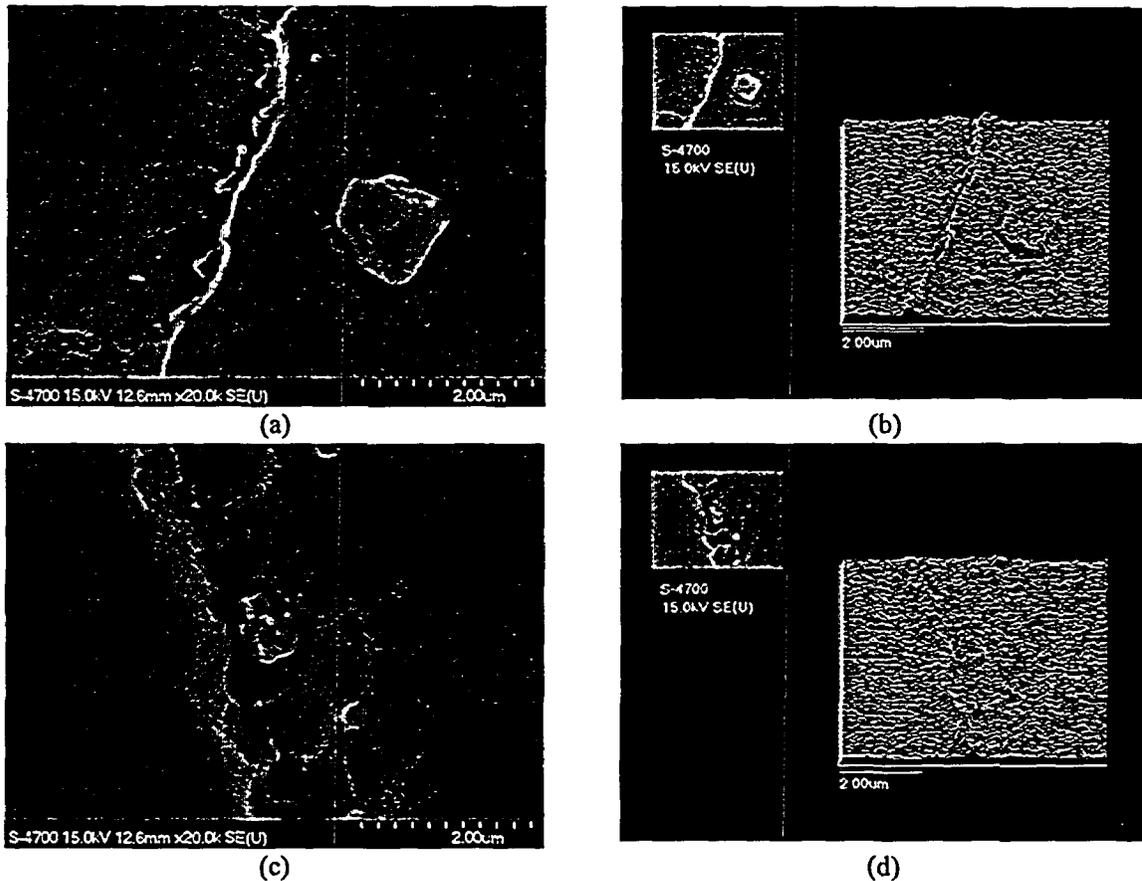
Figure 75. Micrographs showing Ti-rich precipitates in the weld material (a,c), and maps showing the topography at the locations where the high magnification micrographs were taken (b,d).

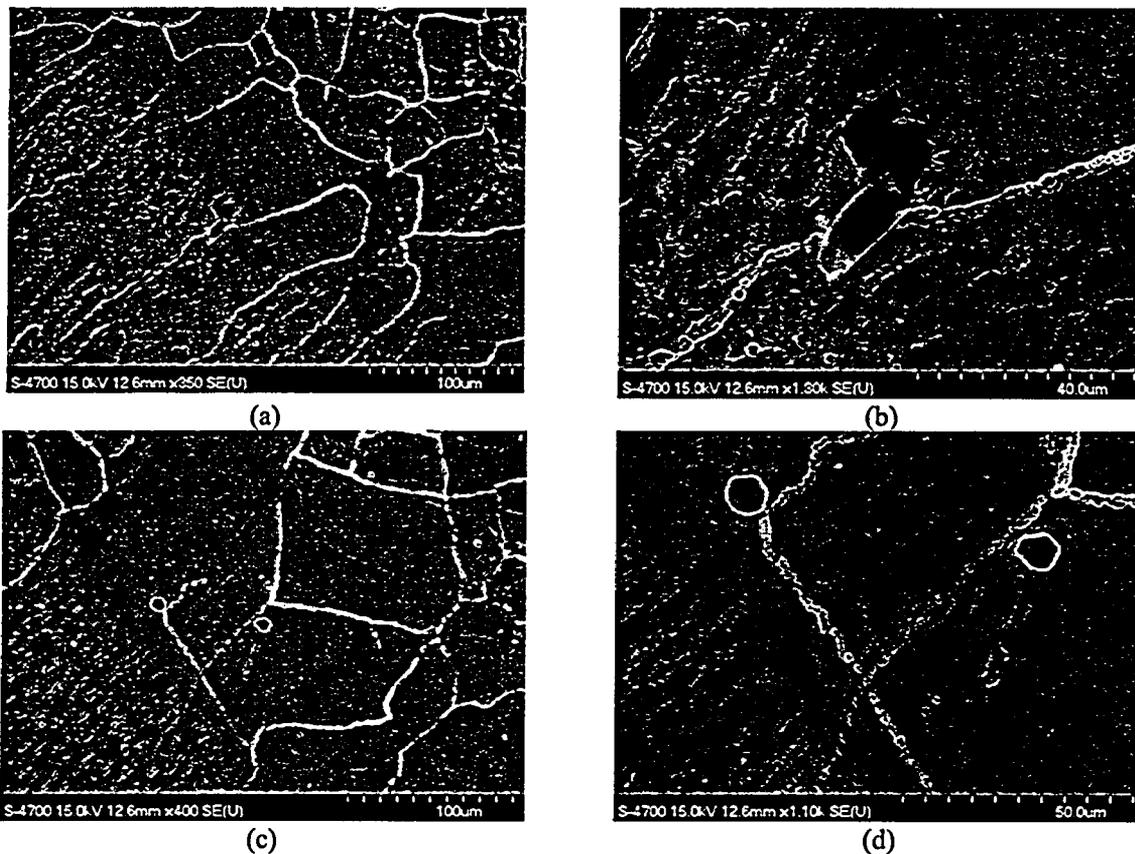
Figure 76. Micrographs showing the heat affected zone (a,c), and high magnification micrographs showing precipitates in the heat affected zone (b,d).

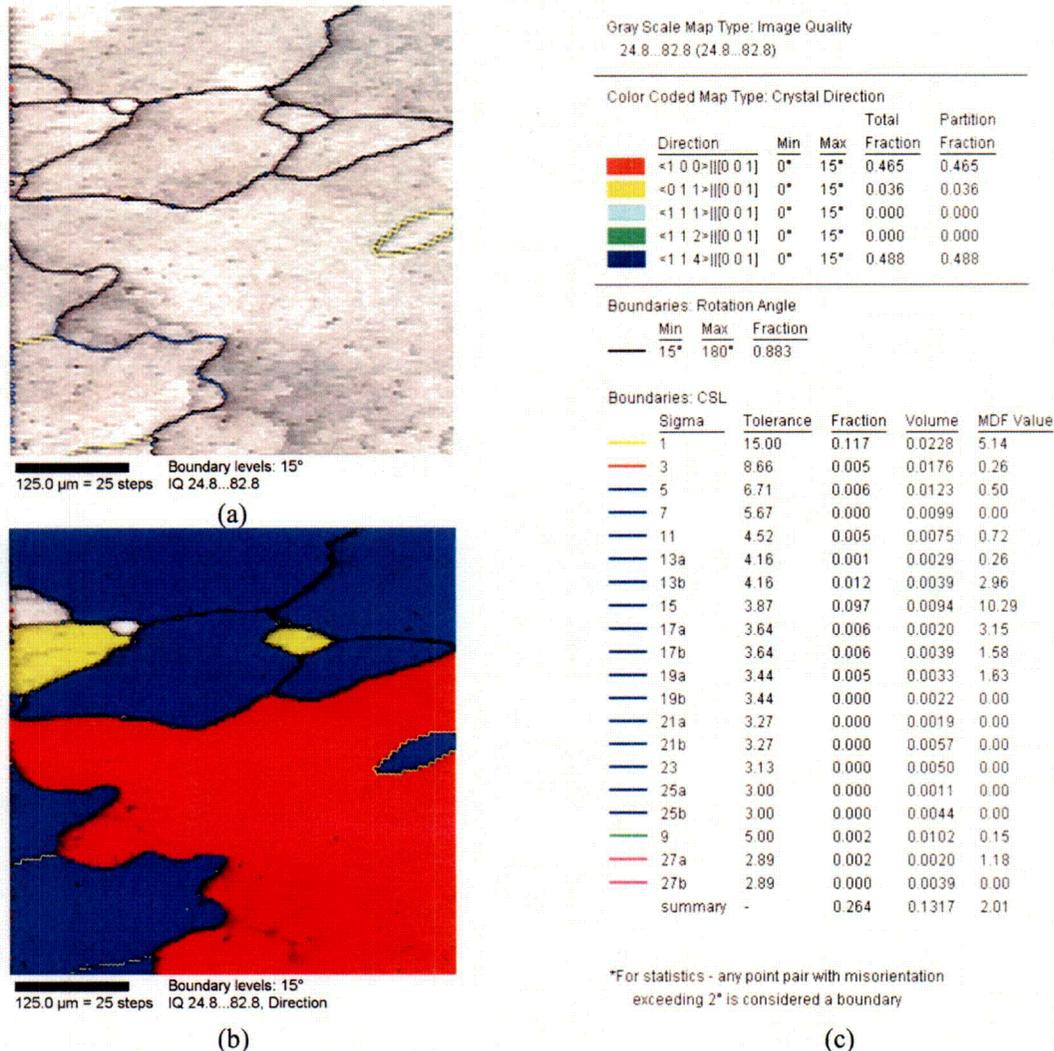
Figure 77. (a) OIM map of the weld, on plane "B", sample 3B; (b) the same OIM map showing the orientation of each grain; and (c) legends for crystal directions and the resulting grain boundary character distribution.

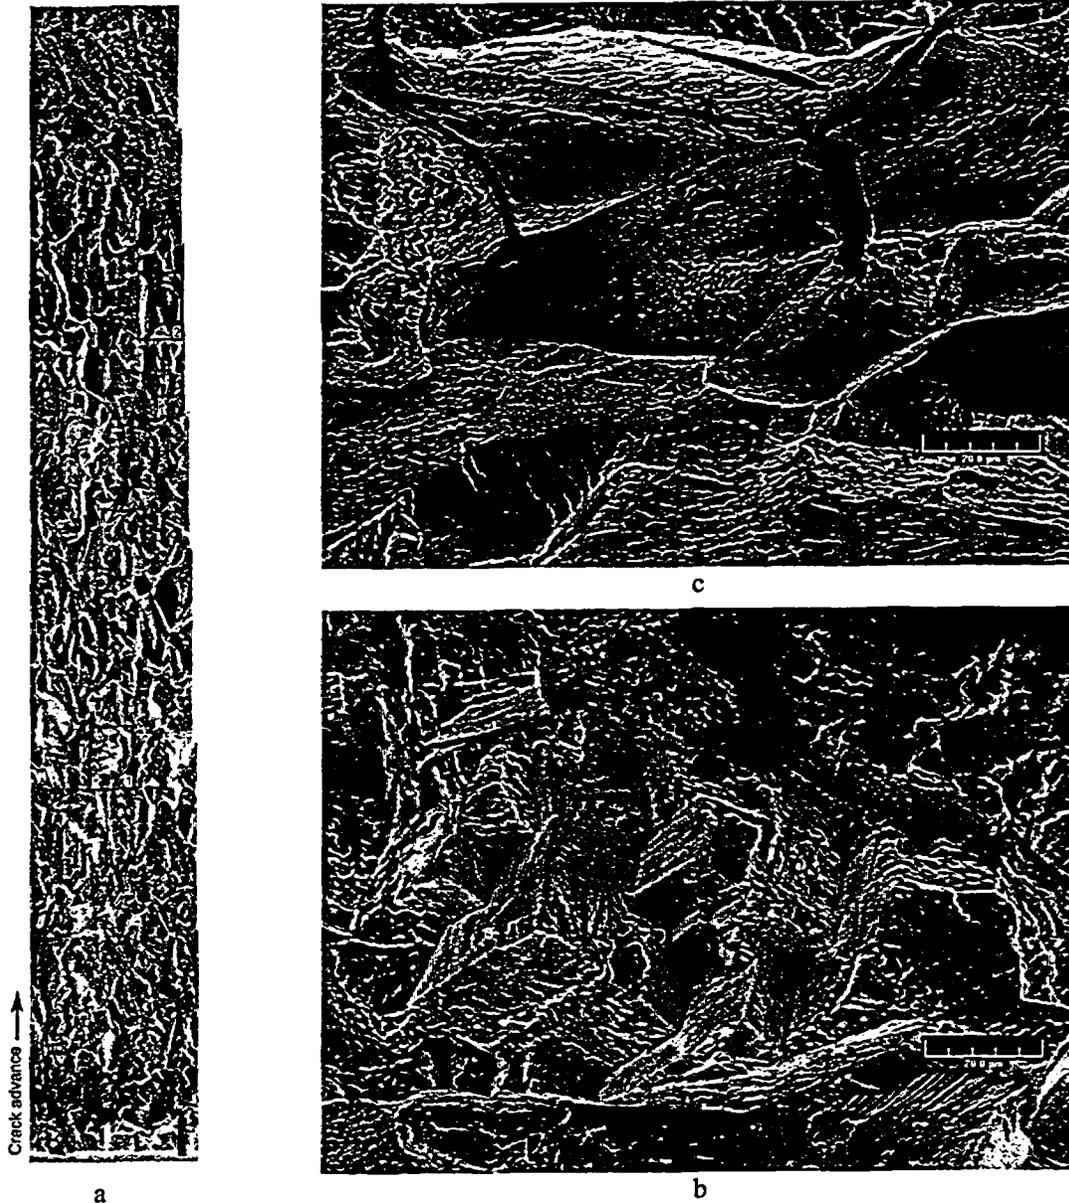
Figure 84. (a) Selected portion of the crack surface of Alloy 600 round robin specimen RR-1 tested in PWR water at 320°C showing the changes in fracture morphology, and (b,c) micrographs taken at the boxed positions 1 and 2, respectively, in (a).

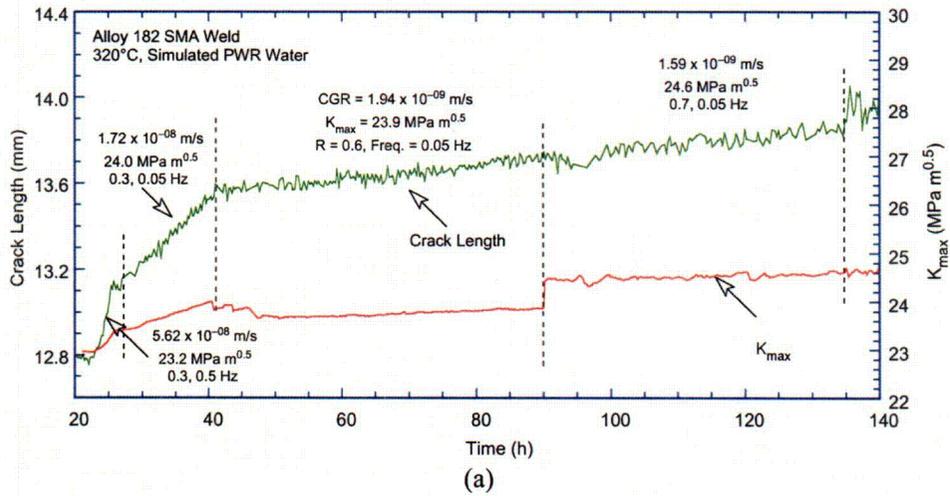
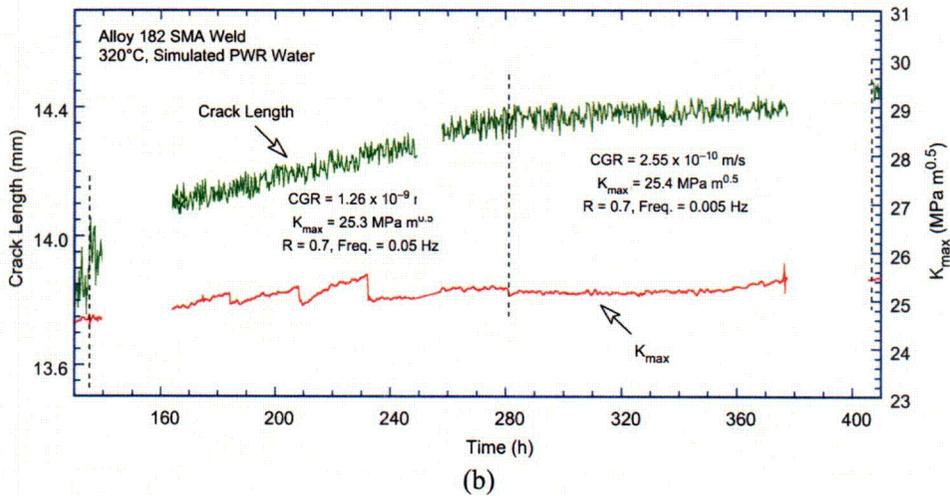
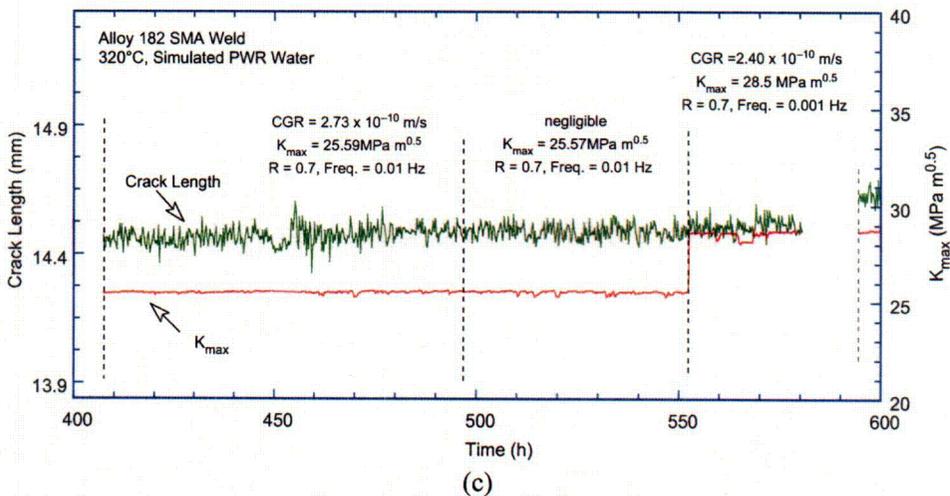
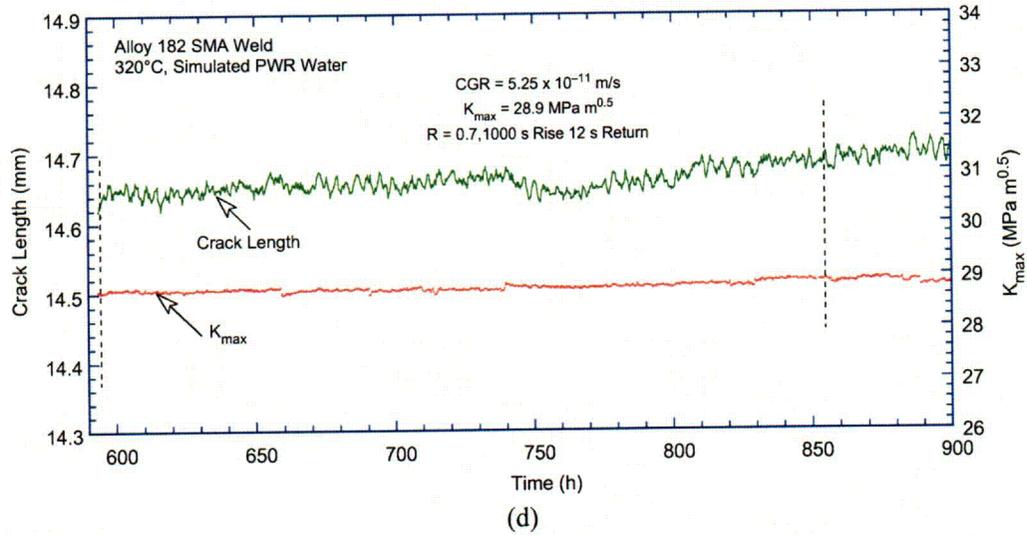
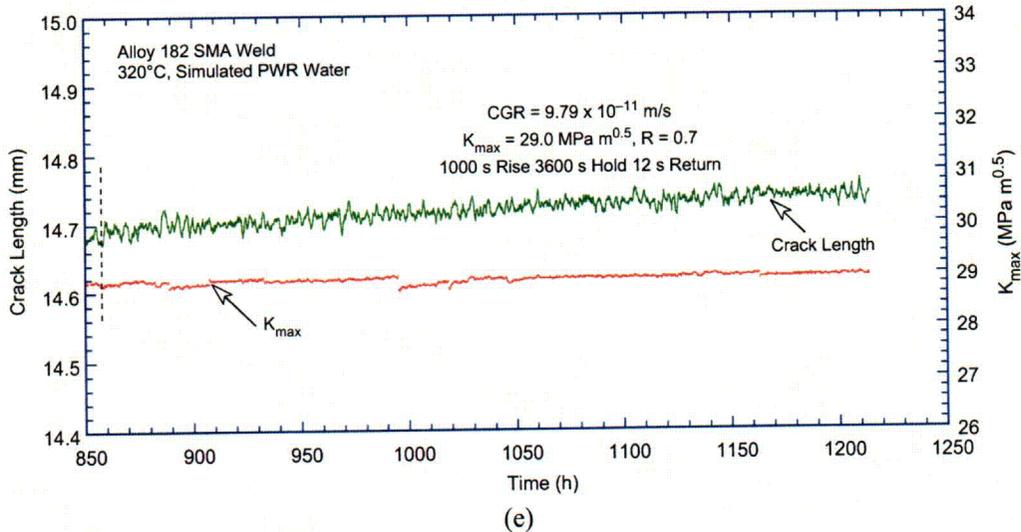
Figure 85. Crack length vs. time plot for Alloy 182 SMA weld-metal specimen in simulated PWR environment at 320°C during test periods (a) 1-4a, (b) 4b-5, (c) 6-8, (d) 9, and (e) 10.

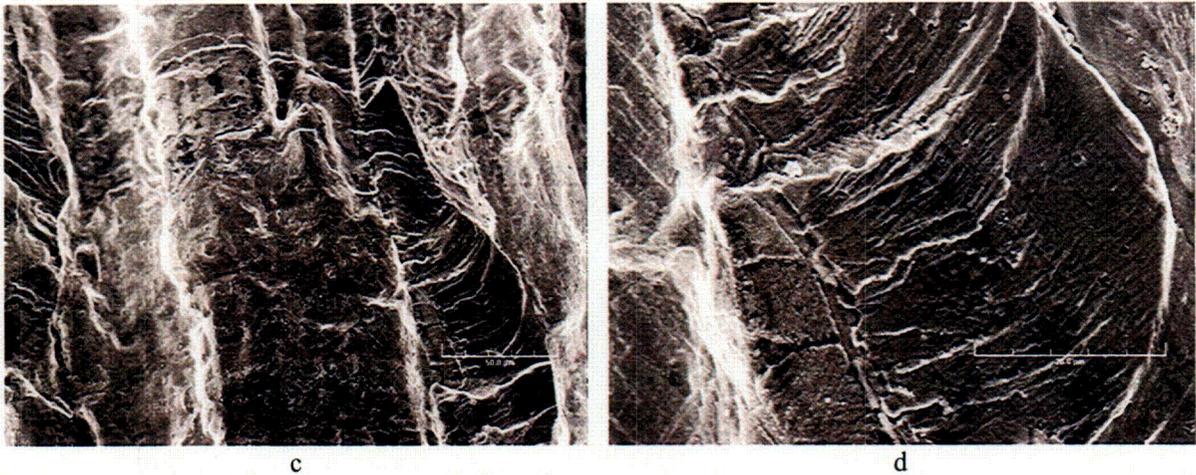
Figure 91. (a,c) Photomicrographs detailing the fracture in a region during test periods with a hold time and/or a high rise time, and (b,d) high magnification micrographs.
