NUREG/CR-3263
SAND83-2622
RV
Printed April 1984

Status Report: Correlation of Electrical Cable Failure With Mechanical Degradation

Otmar Stuetzer

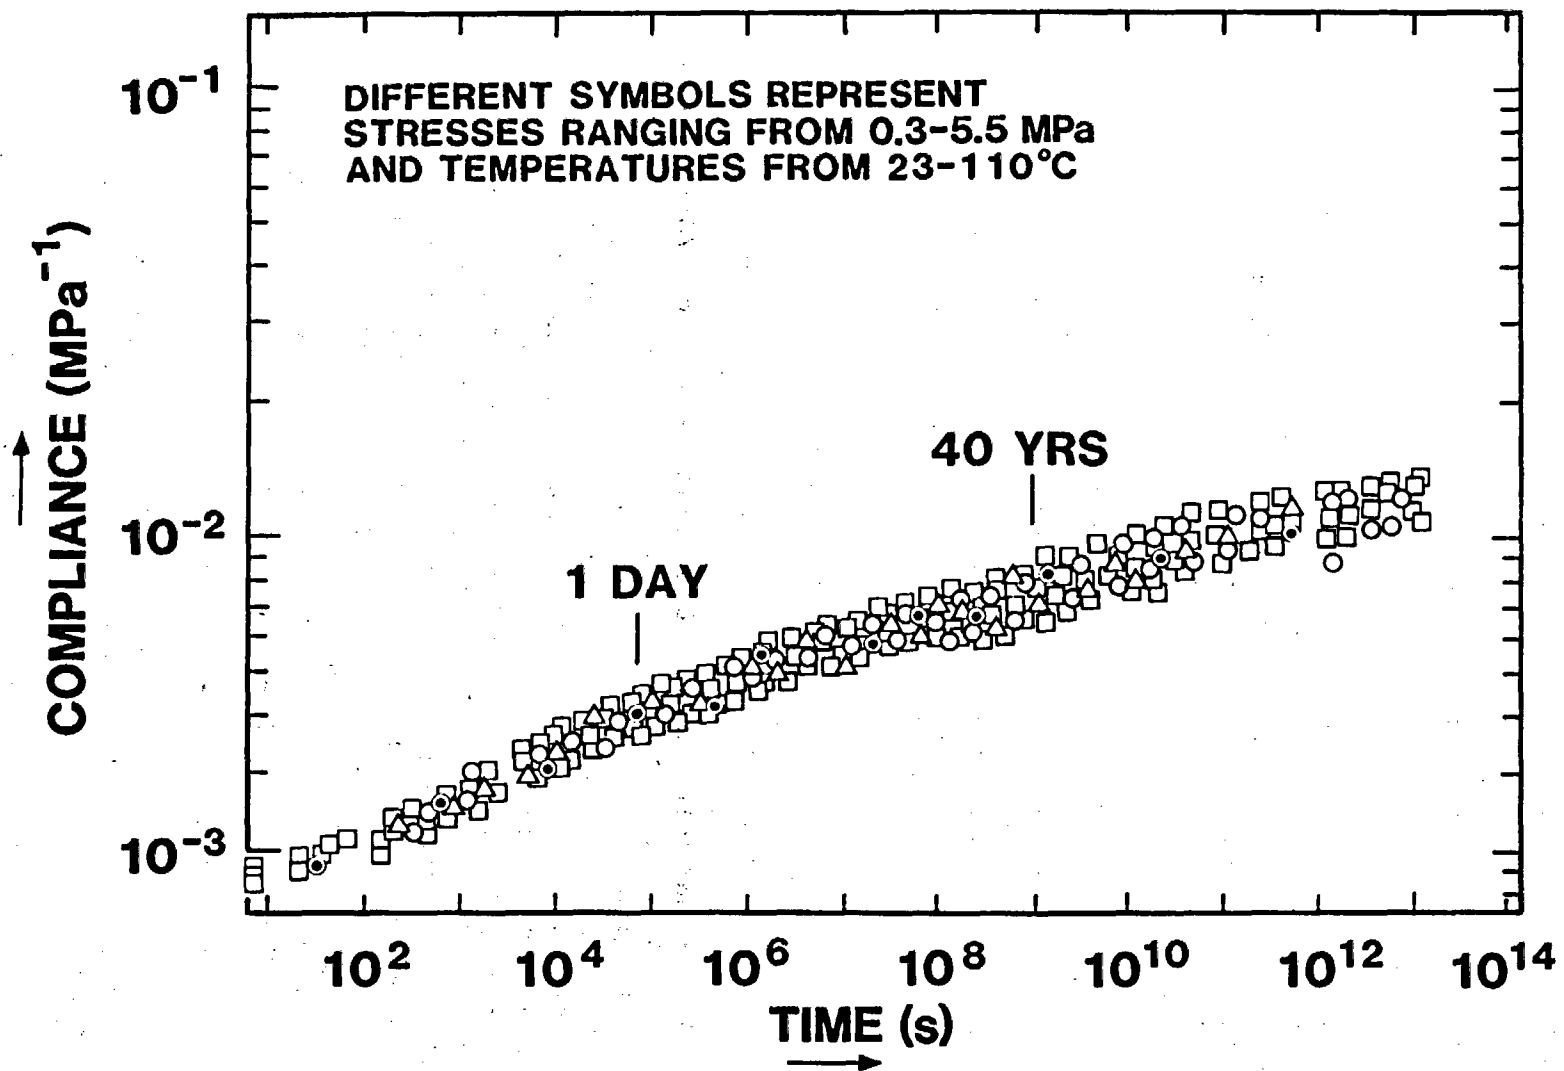
Figure 15. Room-Temperature Master Curve for High-Density Polyethylene in Creep
(After Aloisio and Brockway, Ref. 27)

For the same material, curves representing the time dependence of J , measured at different temperatures, starting times, and stresses, are similar. Consequently, the curves can be obtained from one another by translation of the horizontal or vertical or both axes, and by scale changes. Figure 15 shows a Bell Telephone Laboratories "master curve" obtained by shifting many measurements to obtain overlay with a room-temperature curve.²⁷ At room temperature and within the validity range, Figure 15 predicts a strain of less than 4% in 40 years for high-density polyethylene (HDPE) under a

stress of 600 psi (4.1 MPa). This confirms that creep is exceedingly slow under most circumstances.

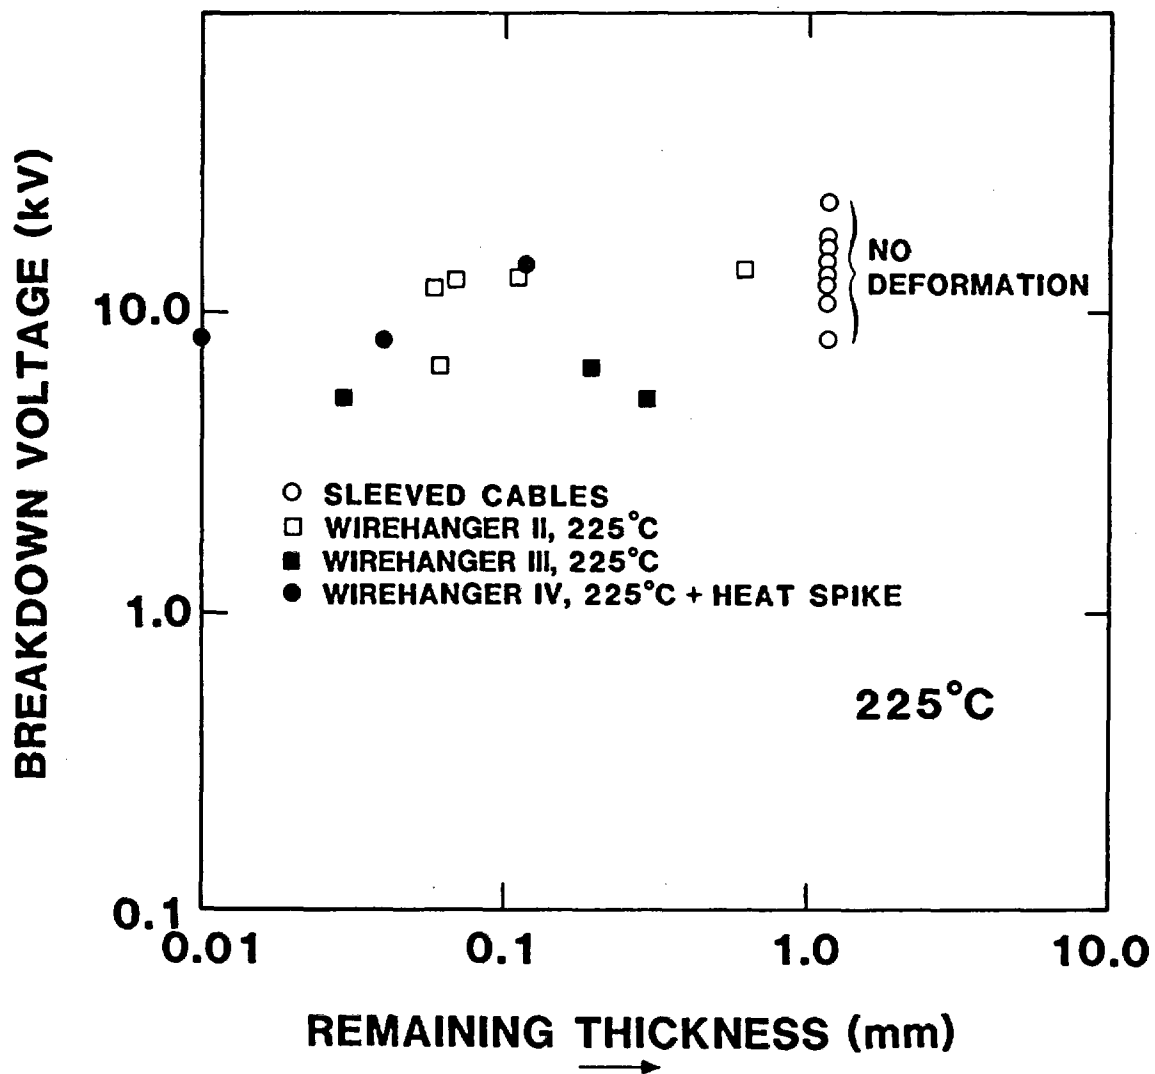
Figure 24. DC Breakdown Voltage vs Remaining Polymer Thickness at 225°C

a) Program -- In the main test facility described in Section III, 6 experiments are being conducted in heat chambers maintained at 75°, 100°, 125°, 150°, 175°, and 225°C. A seventh experiment is taking place in the open at room temperature. In each test, creep versus time is measured by X-ray observation of the gradual reduction of insulator thickness in 6 cable samples. Each cable is hung over a 4.8-mm diameter steel rod and the cable-ends carry 0.45-kg lead weights. For three of the six cables in each test, an ac voltage of 480 V, between cable wire and support, generates an electrical field tending to pull cable wire and support together. The small mechanical stress of about 3 Pa (0.4×10^{-3} psi), which increases rapidly with decreasing distance, induced by the
