WOLF CREEK

Subject: Docket 50-482: Wolf Creek Nuclear Operating Corporation's
Response to Request for Additional Information Regarding 10 CFR
50.55a Requests I2R-37 and I2R-38

**Response to Request for Additional Information (RAI) Regarding 10 CFR 50.55a (Relief)
Requests I2R-37 and I2R-38**

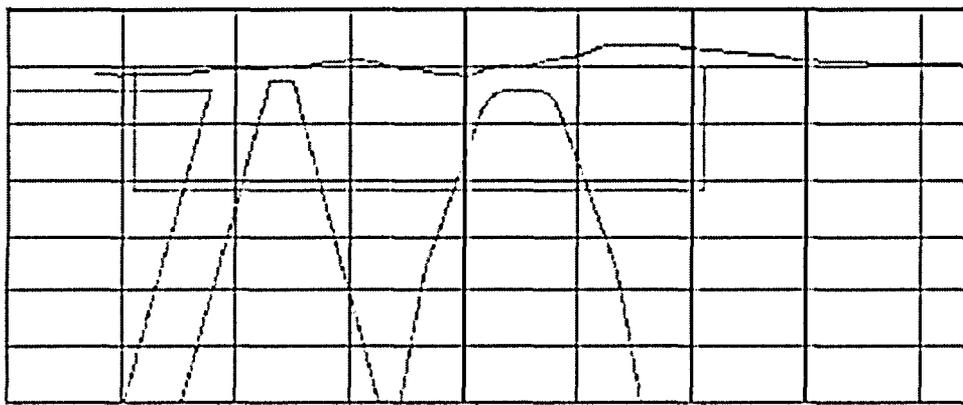
Figure 1

The surface irregularities are located around the inside diameter of the subject welds and are the result of counterbore tapers and/or grinding of the root pass. These surface irregularities do not meet the criteria for smoothness as stated on the Performance Demonstration Qualification Summary (PDQS) for the procedure.

Examination of these welds was performed using a qualified and demonstrated procedure, PDI-ISI-254-SE. During the qualification of this procedure, the detection of axial flaws was limited due to severe irregularities in the inside diameter (ID) contact surfaces of the Performance Demonstration Initiative (PDI) test set. The detection of circumferential flaws met the Appendix VIII criteria on these surfaces with severe irregularities during the PDI performance demonstration. The attached figures 1 and 2 illustrate examples of mapped ID surface irregularities that limited the detection of axial flaws during the qualification of the vendor's procedure, but did not limit the detection of circumferential flaws.

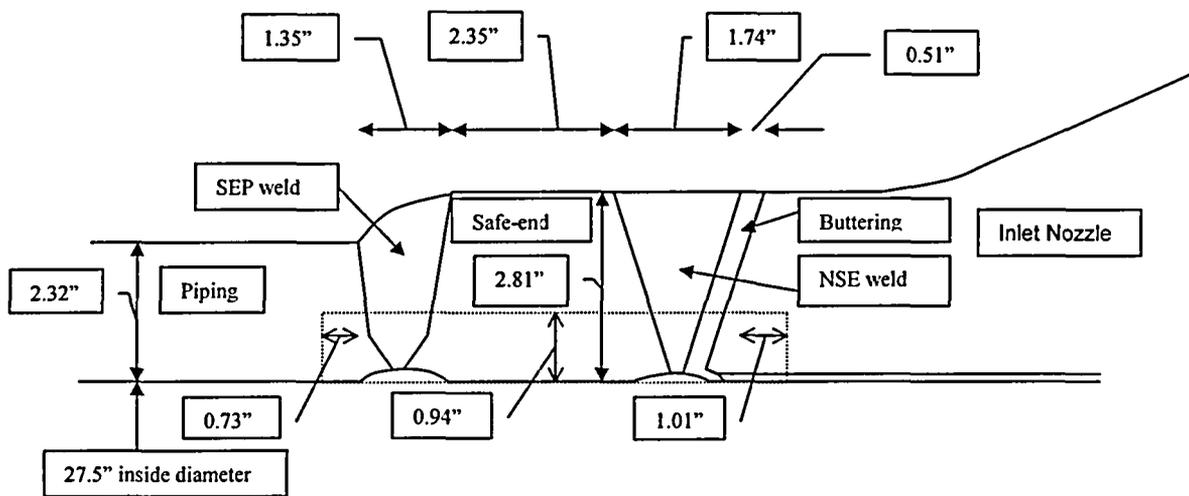
Figure 3
Inlet piping to safe-end and safe-end to inlet nozzle welds

See attached Figures 3 and 4 for dimensions and the table below for the component and weld material.

Per Figure IWB-2500-8(c) of ASME Section XI, the volume required to be examined is the inside surface extending up to 1/3 of the thickness of the piping and extending out to 1/4" past the edge of the weld crown on each side of the weld. The volume that was actually examined is shown by the dotted line box in the Figures 3 and 4. The figures show that the examined volume extends well beyond that required by the Code. This additional volume was added by the vendor as a "conservative scan factor".

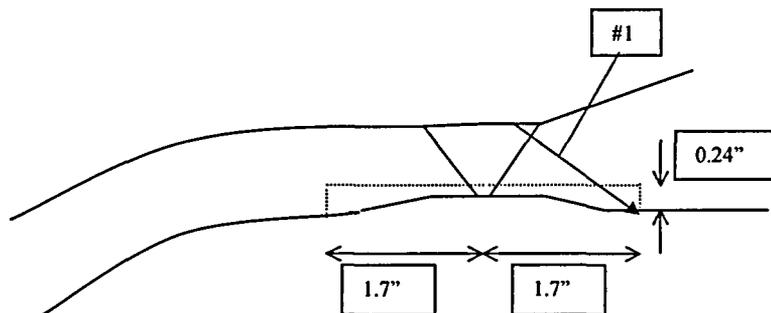
BB-02-FW301; 6" 180 degree return (SA-312 TP304) to 6" flange (SA-312 TP304) with weld filler material of 308.

Joint size: 6" sch. 160, nominal OD 6.625", nominal thickness 0.719"; counterbore ID 5.325"

This examination area extends to 0.25" beyond the counterbore as required. The amount of axial coverage obtained by the best effort examination, utilizing the supplemental 60 degree longitudinal wave search unit, is 85.2% of the area on the far side of the weld. Arrow #1 in the diagram above depicts the extent of the best effort examination perpendicular to the weld. The best effort parallel scan was conducted to the extent possible from the weld crown. This scan examined 32.4% of the area on the far side of this weld.
