**Edwin I. Hatch Nuclear Plant
Request to Implement an Alternative Source Term**

**EPRI Technical Report 1007896, Seismic Evaluation Guidelines
for HVAC Duct and Damper Systems**

Final Report, April 2003

ABSG Consulting

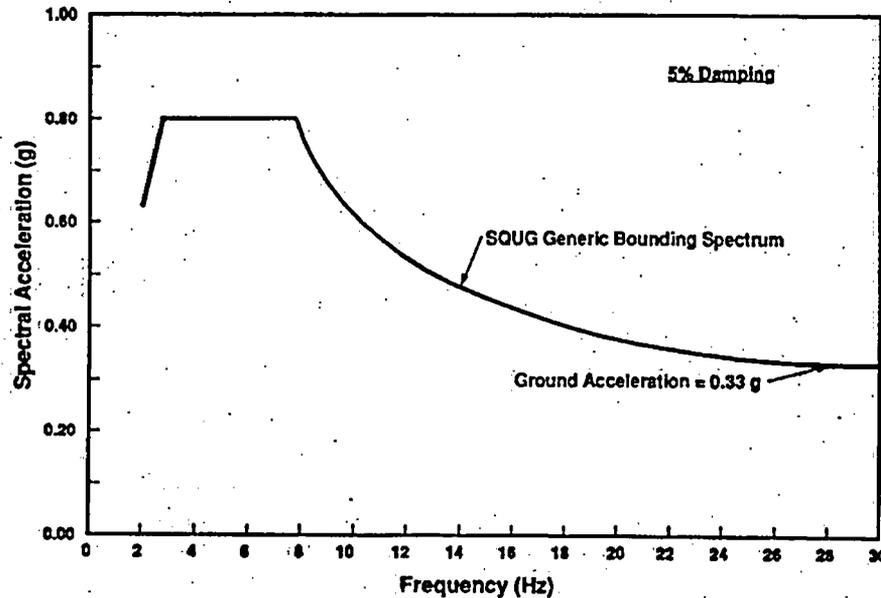
Figure 2-1
Seismic Motion Bounding Spectrum

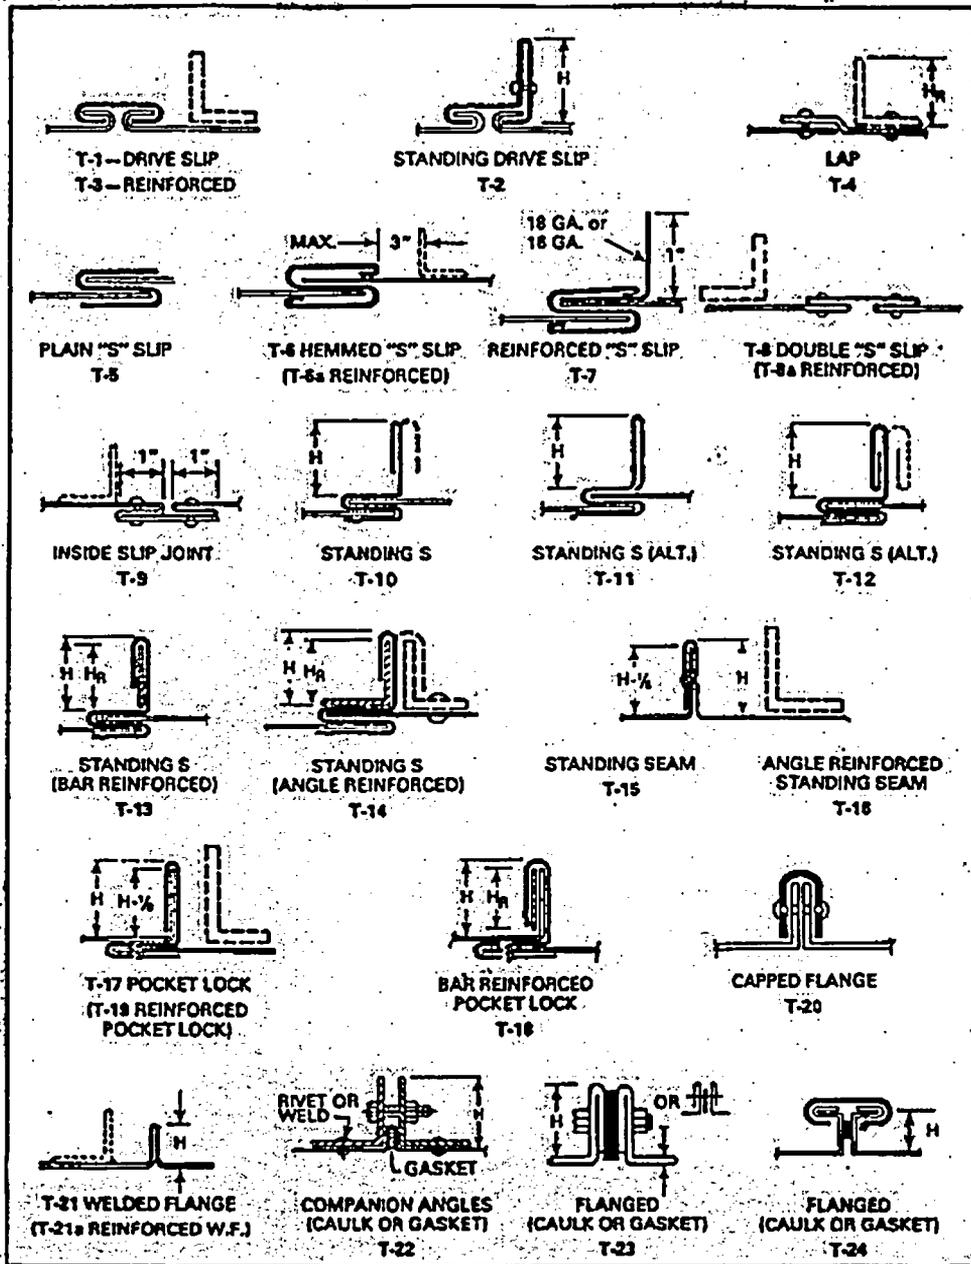
Figure 3-1
SMACNA Duct Joints

HVAC joints should be visually inspected to verify their structural integrity. Joints (including connected tees and elbows) that are observed to be loose, incomplete, corroded, or otherwise suspect (such as those repaired with duct tape or fiberglass, or missing rivets, screws, etc.) should be reviewed in detail. Seismic experience data have shown that such joints are often the point of excessive leakage or failure of HVAC systems in an earthquake. A corroded riveted duct joint failed at the Caxton Paper Mill as a result of the 1987 New Zealand earthquake (see Appendix A, Section A.2.1). In addition, HVAC without pressure boundary requirements and with runs consisting of slip joints without pocket locks, rivets or screws should be reviewed to assure that the differential displacement between the two adjoining ducts due to seismic loading will not cause joint separation. Figure 3-1 shows different SMACNA duct joints as described in Reference [4] to aid in identifying slip-type joints.

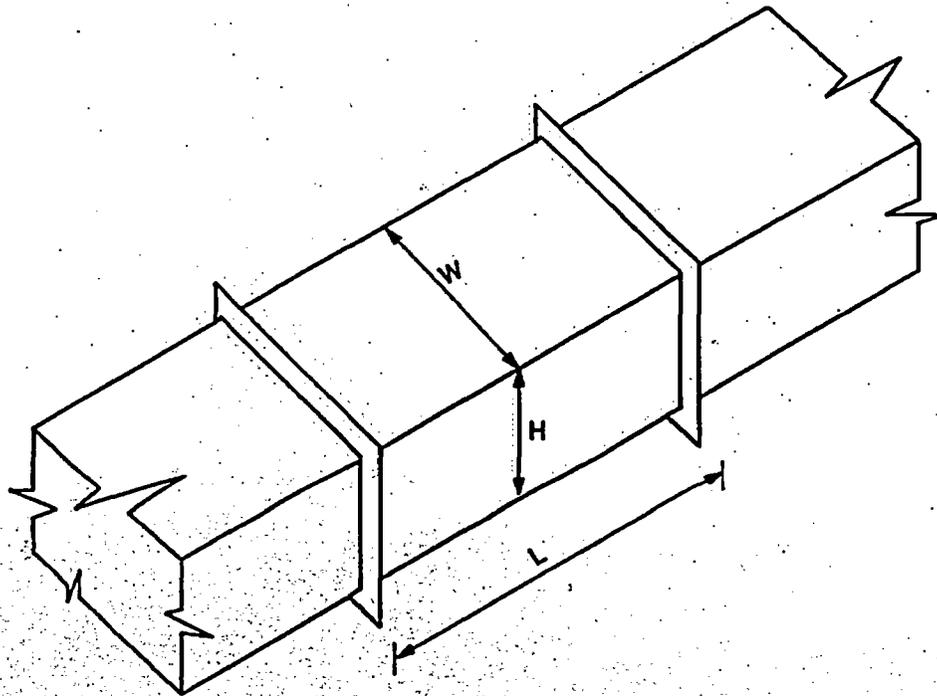
For a given rectangular duct, the largest cross-sectional dimension (i.e. width or height) is used for stress analysis (see Figure 4-1). The applicable plate bending equations are dependent on the ratio of this maximum duct dimension, S , to the duct stiffener spacing, L .

$$S = \text{Max}(H, W)$$

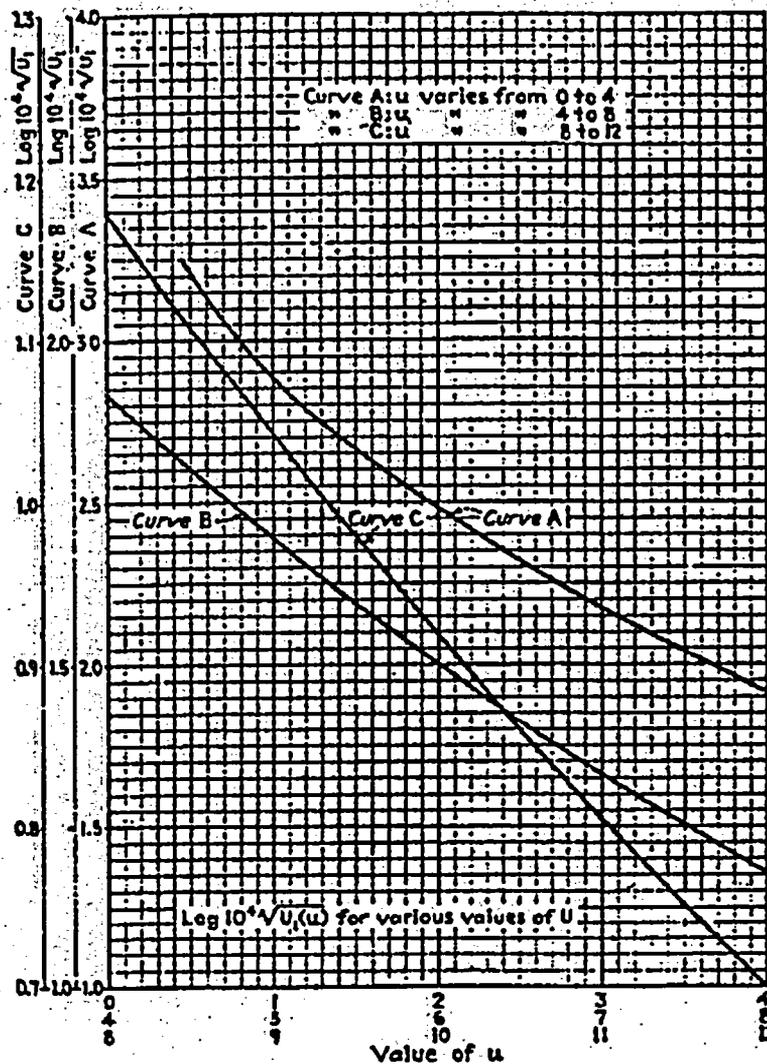
Figure 4-2
Value of u for Rectangular Ducts [15]

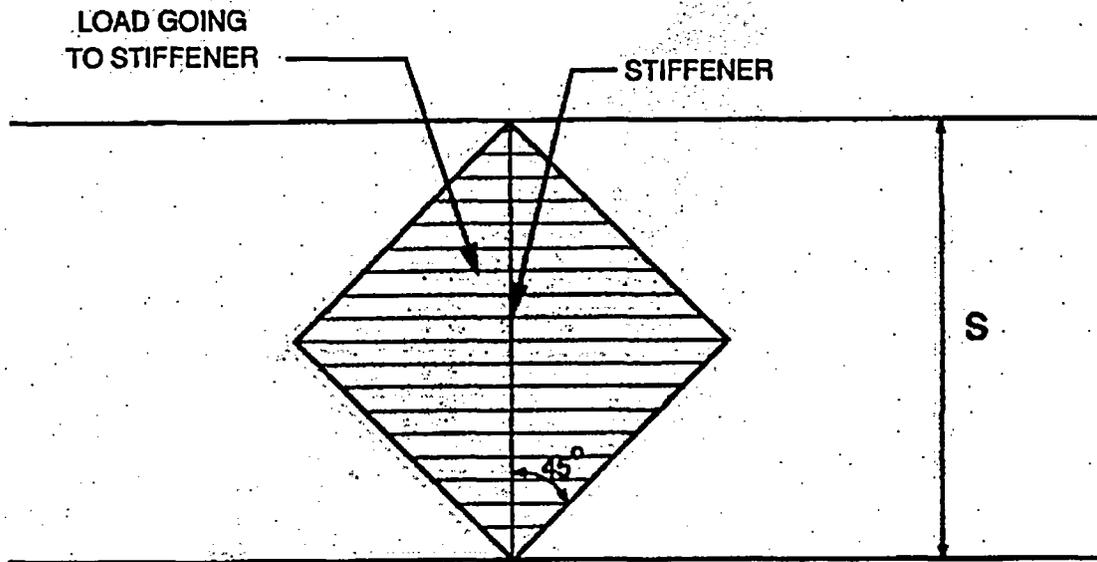
- I = Moment of inertia of the stiffener (in⁴)
 c = Distance between neutral axis and extreme fiber of stiffener (in)
 E = Young's Modulus of stiffener (psi) adjusted for temperature. Use 29.5x10⁶ psi for stainless steel, and 9.2x10⁶ psi for aluminum. Slightly higher values may be obtained using more detailed analysis from Reference [7].
 d = maximum stiffener displacement (in)

Figure 4-3
Load Going to Stiffener on a Rectangular Duct When $L/S \geq 10.0$ [6]

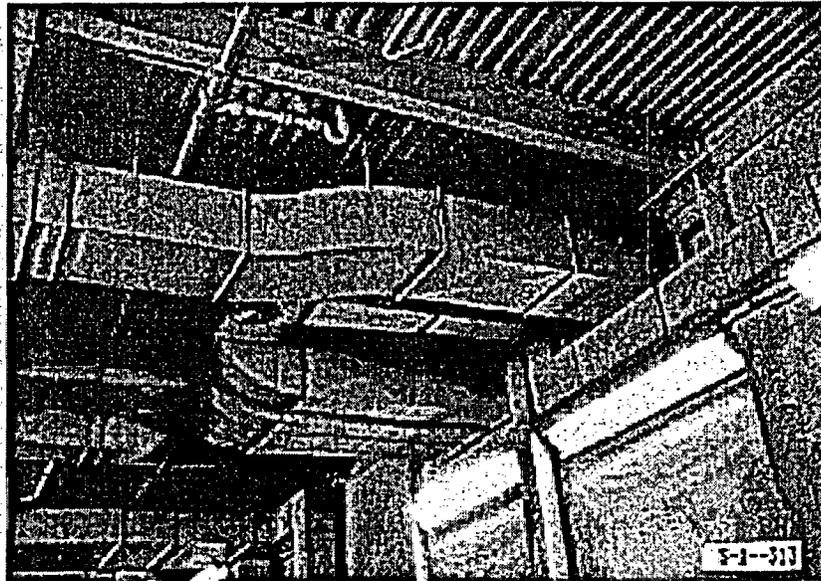
Figure A-1
Sylmar Converter Station, 1971 San Fernando Earthquake. Strap-Hung and Wall-Mounted Duct with Wall Penetrations

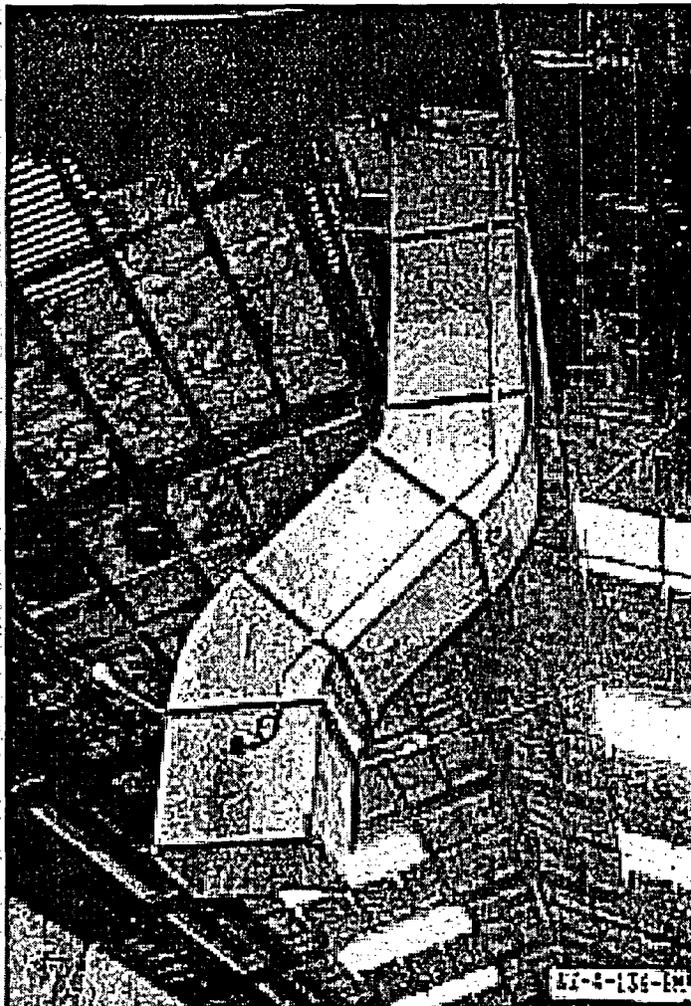
Figure A-4
Bay Milk Products, 1987 New Zealand Earthquake. Long Vertical Cantilever Supported by
the Roof at One End and Guy Wires at the Other

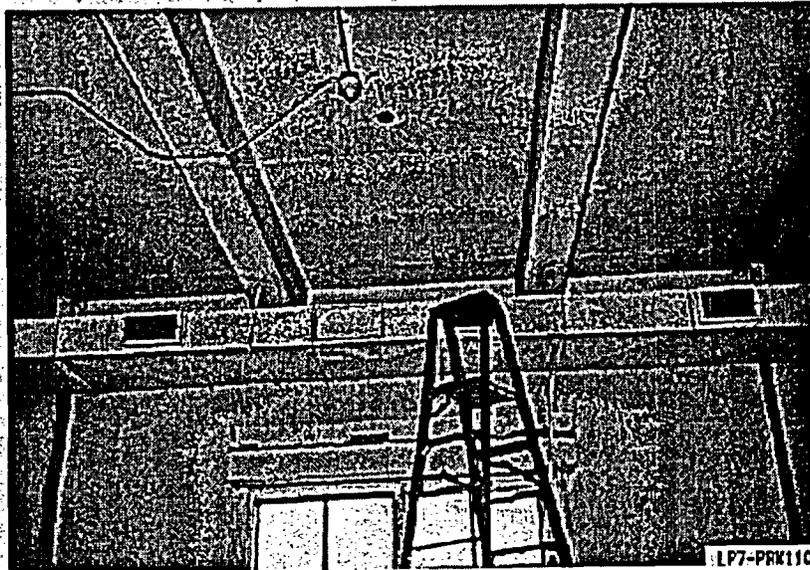
Figure A-7
Pacific Bell Watsonville, 1989 Loma Prieta Earthquake. Run of Trapeze Rod-hung Rectangular Duct

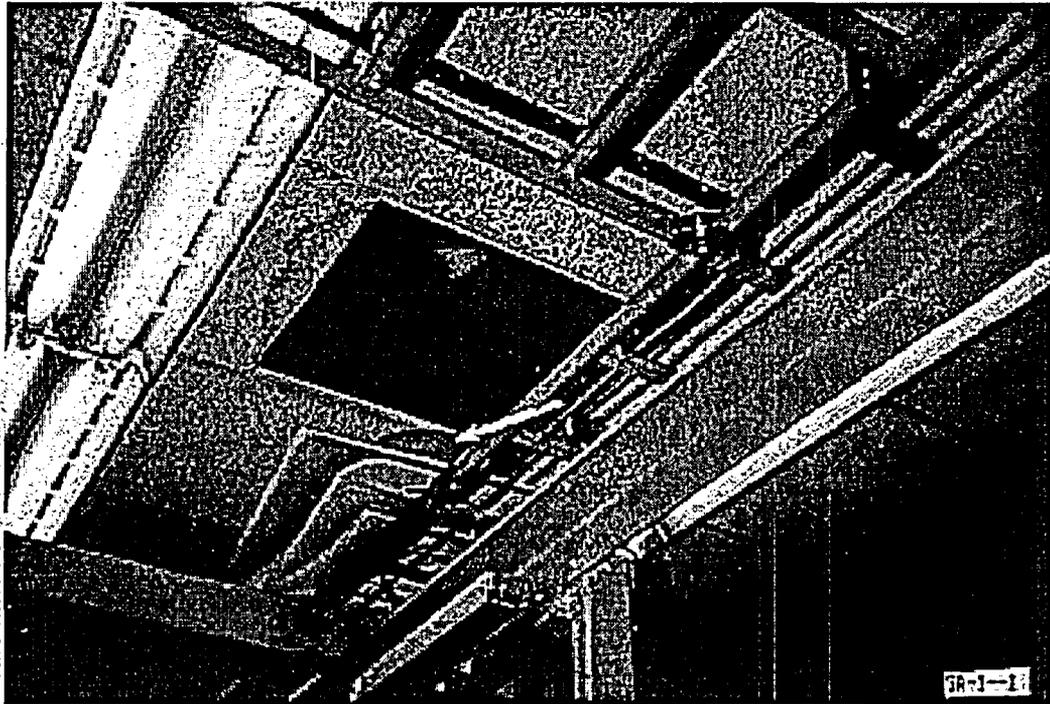
During the earthquake, an HVAC diffuser fell from a suspended ceiling. The diffuser was slipped into place and supported from the ceiling, but was not attached to the HVAC ducting (see Figure A-8).

Figure A-8
Gates Substation, 1983 Coalinga Earthquake. An HVAC Diffuser Fell from the Suspended Ceiling

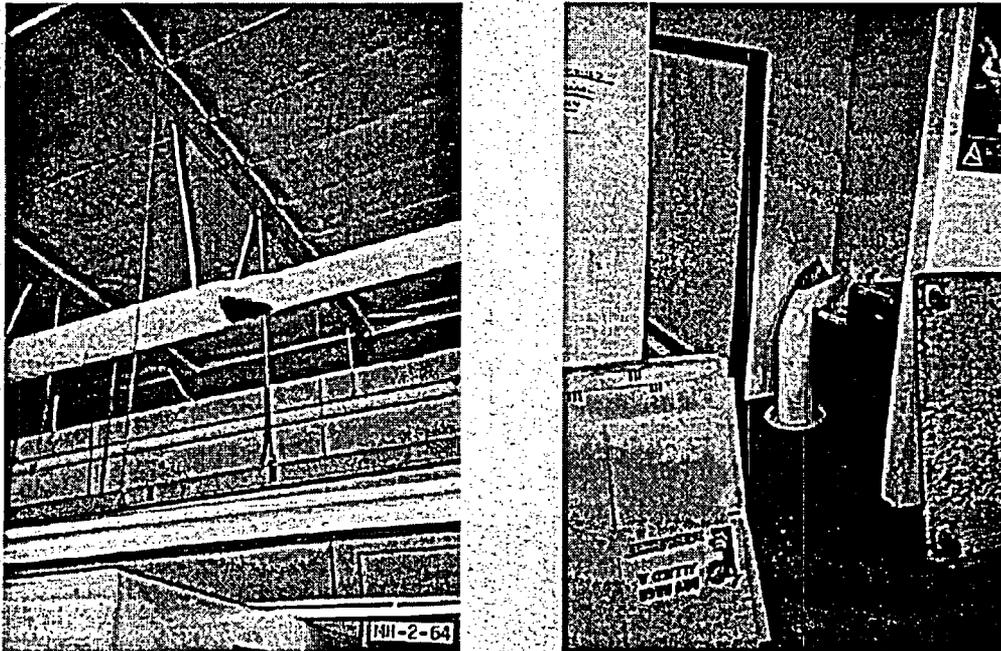
At the Wiltron Facility, a four foot long vertical cantilevered section of HVAC ductwork broke from its supporting header and fell to the floor (see Figure A-9). The round duct was constructed of riveted lap joints which failed under the cantilever's inertial loads.

Figure A-9
 Wiltron Facility, 1984 Morgan Hill Earthquake. A 4-Foot Long Vertical Cantilever Broke from its Supporting Header and Fell

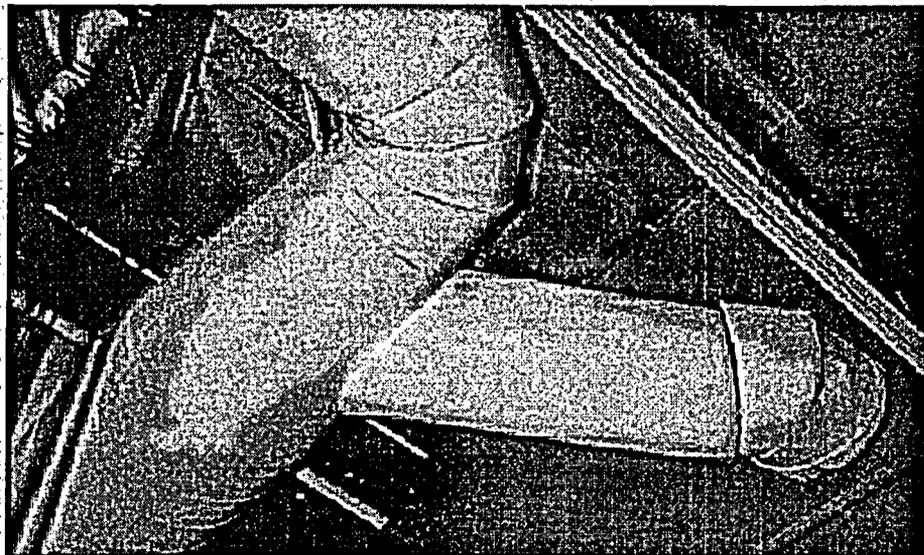
Another section of HVAC duct at the same facility split a seam where a branch line entered a wall penetration (see Figure A-10). The damaged section was approximately ten inches in diameter, branching off of an estimated twenty inch diameter header. The seam pulled apart near the wall, approximately four feet from the branch point. The branch apparently was not flexible enough to accommodate the header motion, and the seam was too weak to resist the imposed differential displacement.

Figure A-10
Wiltron Facility, 1984 Morgan Hill Earthquake. A Branch Line Tore at a Wall Penetration
Due to Flexible Header Motion

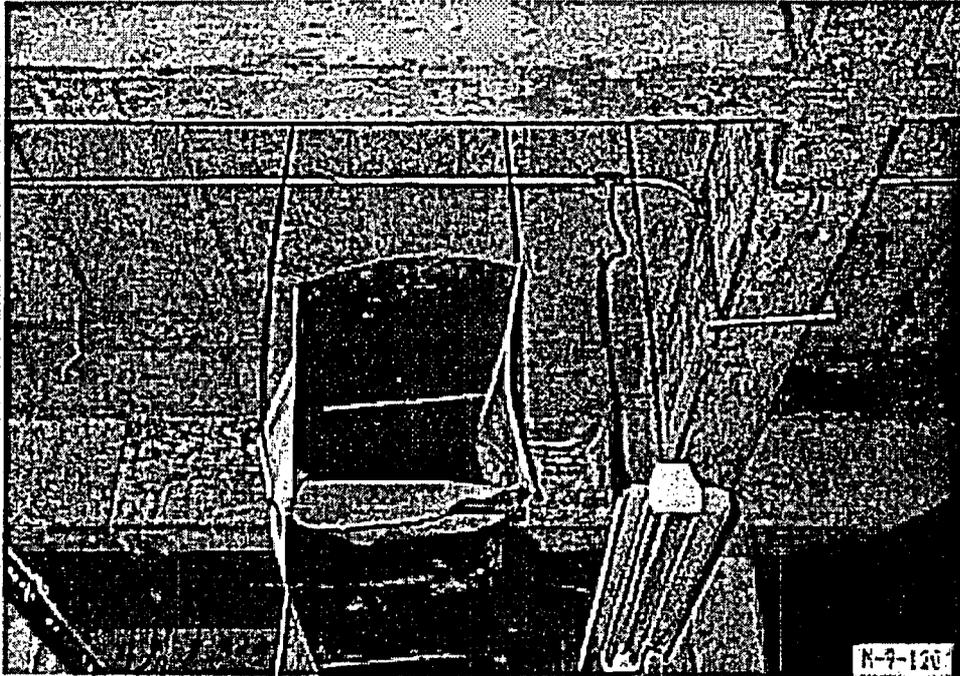
HVAC ducting was damaged on the second floor of the packaging plant's switchgear building. The second floor slab is approximately fifteen feet above grade. The two-story concrete-frame structure is about 120 feet long, fifty feet wide, and has eccentric rigidity due to the asymmetric location of brick in-fill and partial concrete walls. The eccentricity created high torsional accelerations in some regions of the structure. In one of these areas, the last section in a long duct run jumped off the final support. The resulting cantilever failed at an adjacent support (see Figure A-11). The HVAC duct section was of pocket lock construction and was not positively attached to the rod hung trapeze support. Had it been attached, the damage would likely have been avoided. Also in the same area, one of the duct's rod supports pulled its expansion anchor from the concrete ceiling. The concrete quality was questionable and the ribs on the non-drilling shell anchor's cone expander were flat rather than slanted.

Figure A-11
Fertimex Packaging Plant, 1985 Mexico Earthquake. A section of Duct Tore when the Duct Jumped off the Final Support in a Long Run

Ducts should be secured to their supports to preclude the possibility of displacing, falling or sliding off during a seismic event. Systems do not have to be secured to every support unless the supports are at the maximum spacing described in Section 3.2.1. The HVAC duct should be securely attached to the last hanger support at the terminal end of the duct run. Similarly, supports configured to limit the lateral movement of the HVAC duct system should also be attached to the duct. Seismic experience data indicate that a mode of failure for HVAC duct systems subject to earthquake loading is the duct falling off of end supports. An example of this occurred at the Fertimex plant during the 1985 Mexico City earthquake (Figure A-11 of Appendix A).

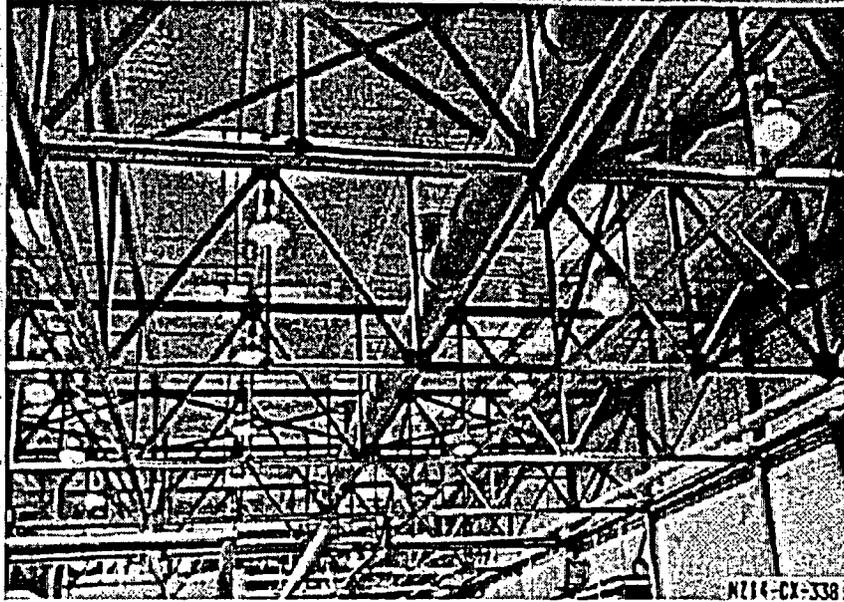
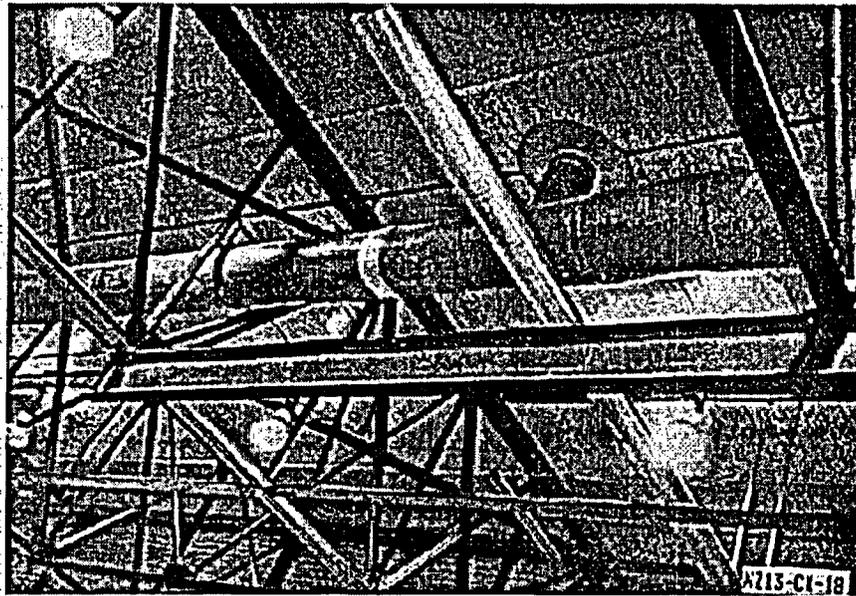
At Paper Machine Building No. 2, there were several instances of sheared ductwork joints; however, no sections fell to the floor. The circular duct was mounted near the ceiling and constructed of riveted lap joints (see Figure A-12).

Figure A-12
Caxton Paper Mill, 1987 New Zealand Earthquake. A long, Unrestrained Run of Duct
Constructed of Riveted Lap Joints (Top) and a Taped Repair of a Sheared Joint (Bottom)

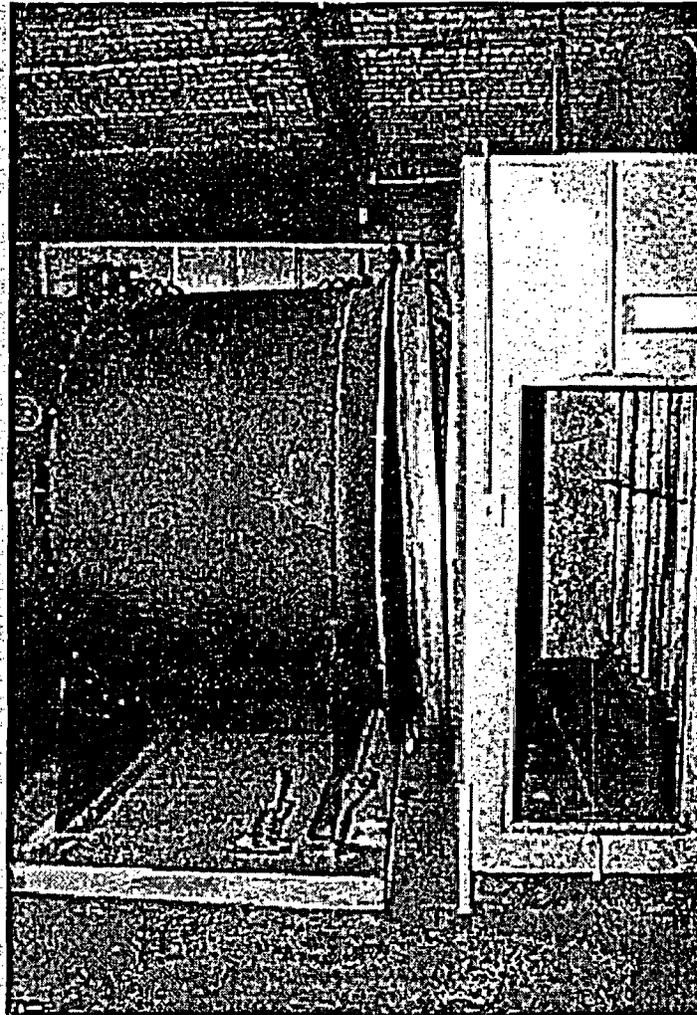
Nonstructural damage was also extensive and included HVAC duct. Roof-mounted HVAC equipment at Ticor was severely damaged and the system was shut down. Most of the equipment was mounted on vibration isolators without lateral (seismic) restraints. Two axial fans had shifted off their mounts, rupturing their duct attachments (see Figure A-13).

Figure A-13
Ticor Facility, 1987 Whittier Earthquake. A Flexible Bellows has Torn Due to the Motion of an Attached Fan on Vibration Isolation Mounts

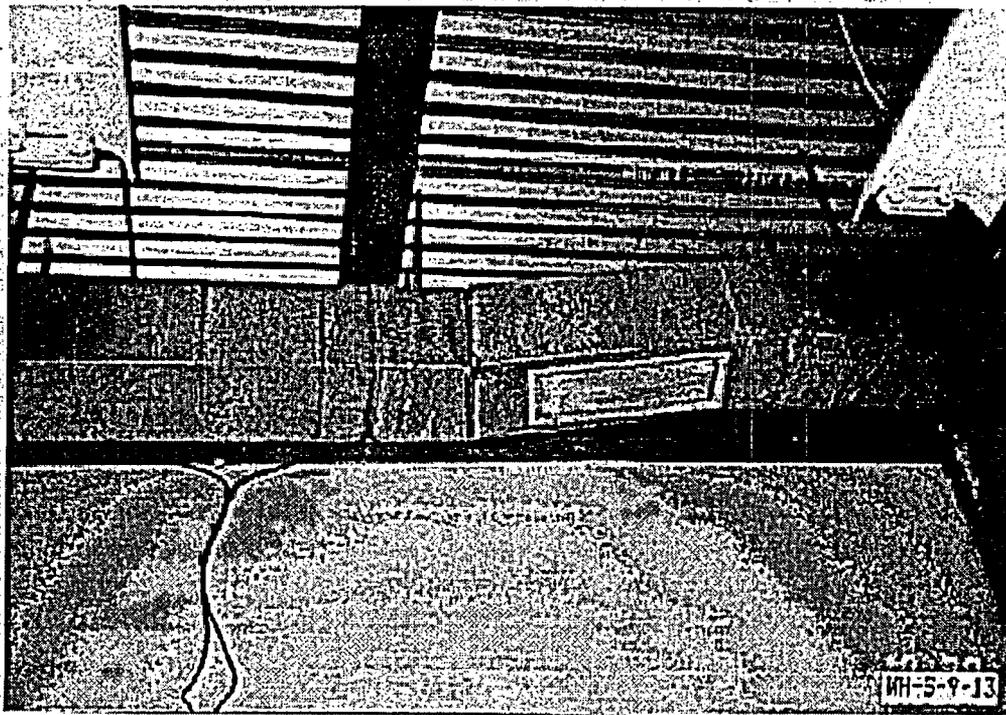
HVAC ducts in the space above the raised ceiling experienced movement and permanent distortion without excessive leakage, failure or loss of function. In addition, a duct above the battery racks, approximately twelve inches by twelve inches, deformed but did not fall. The long run was supported at the ceiling by sheet metal straps and had no companion angles or stiffeners. The duct deformed at the joints of an angled offset section which contained an HVAC register (see Figure A-14).

Figure A-14
Sanwa Data Processing Center, 1987 Whittier Earthquake. A Duct above the Battery Racks Deformed at the Joints of an Angled Offset Section

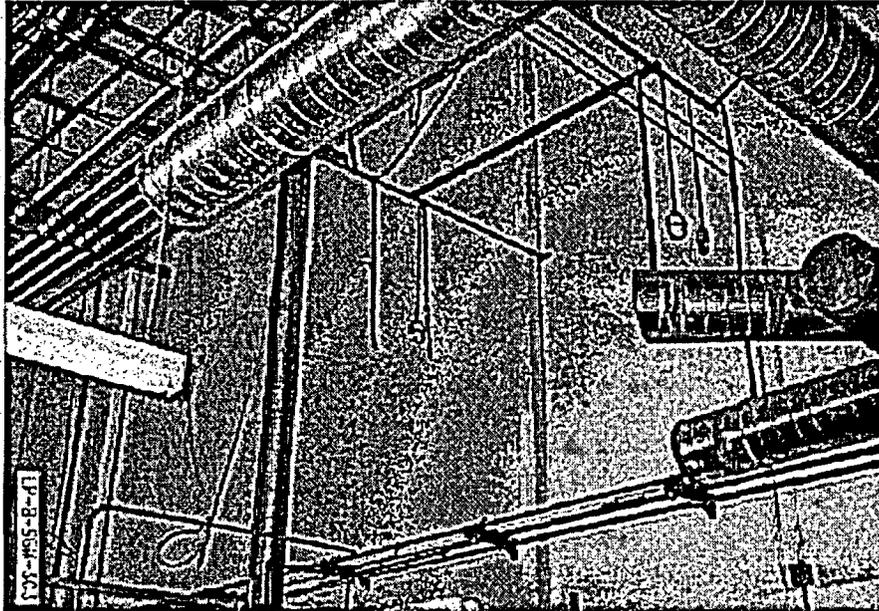
The sections of Seagate's circular duct are lap jointed (without rivets or bolts) and hung from the ceiling with sheet metal straps. During the earthquake, a portion of the duct fell to the floor when a strap broke at the duct connection and the attached section pulled free of its joints (see Figure A-16).

Figure A-16
Seagate Technology, 1989 Loma Prieta Earthquake. A Strap Support Broke and the Attached Duct Fell to the Floor

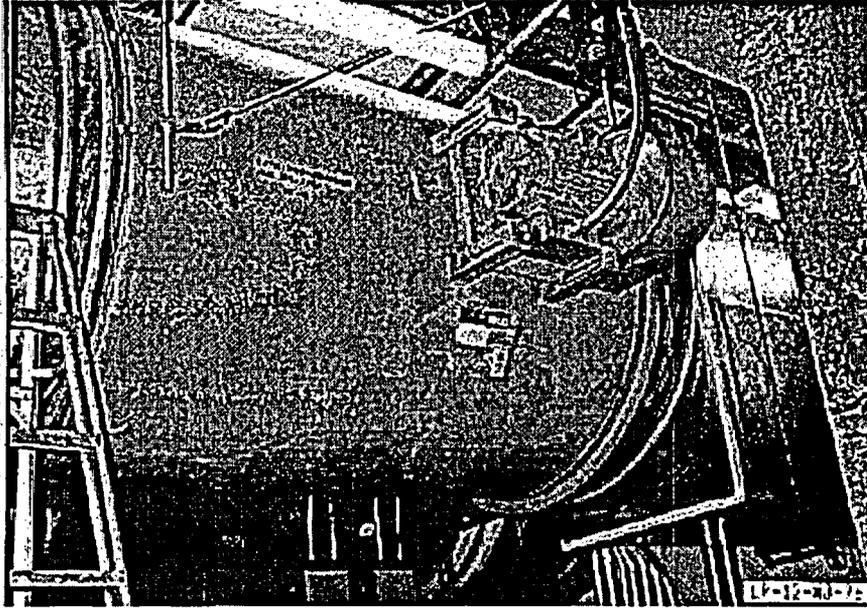
Building number six at the Watkins-Johnson Instrument Plant is a prefabricated steel structure. Constructed in 1967, the structure has an HVAC penthouse, roughly thirty feet above grade. Inside the penthouse, the flexible bellows connecting circular HVAC ducting to an in-line axial fan tore (see Figure A-17). The duct was rod hung and the fan was supported with a rod hanger/spring arrangement. The bellows were not designed to resist the differential motion imposed by the earthquake.

Figure A-17
Watkins-Johnson Instrument Plant, 1989 Loma Prieta Earthquake. The Flexible Bellows Connecting HVAC Ducting to an In-Line Axial Fan Tore

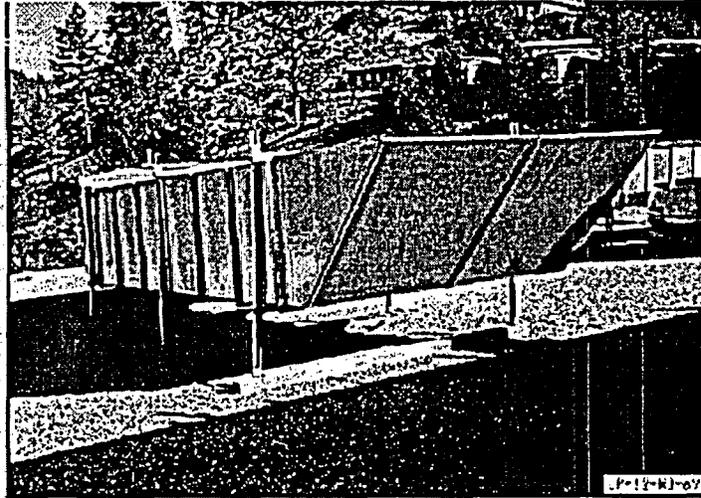
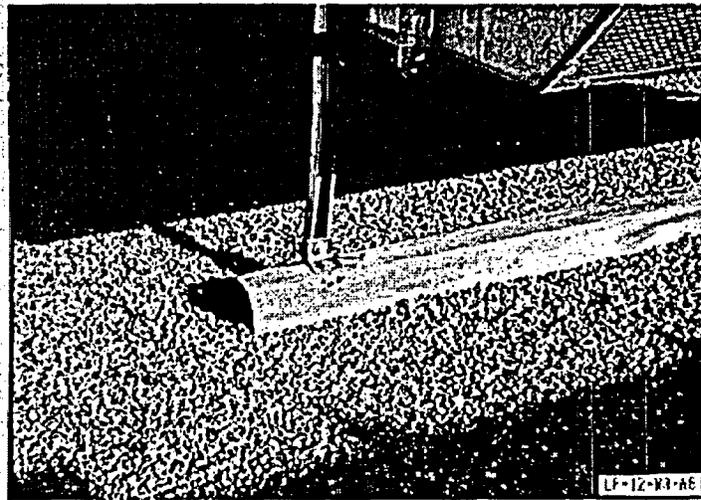
Figure A-18
Watkins-Johnson Instrument Plant, 1989 Loma Prieta Earthquake. The Support Anchorage
for a Roof-Mounted Duct was Distressed

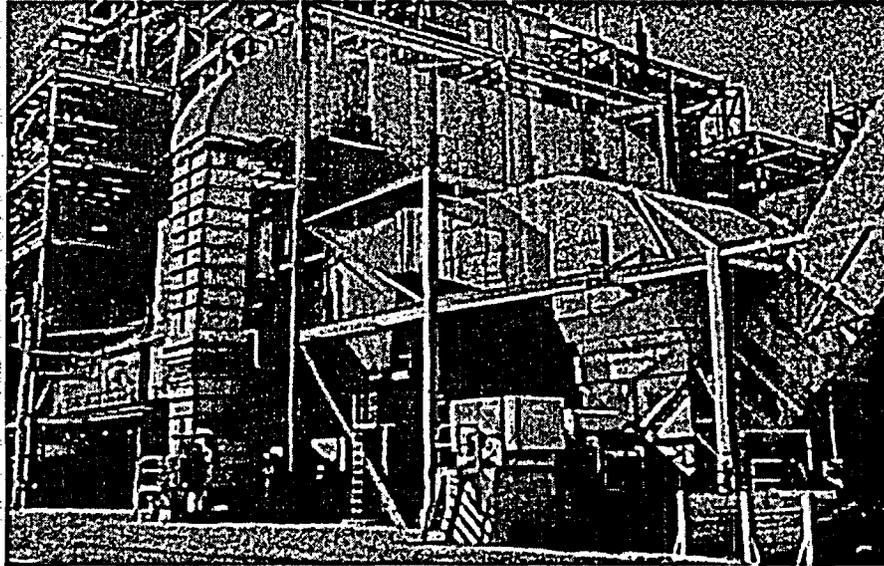
Figure A-20
Valley Steam Plant Forced Draft System, 1971 San Fernando Earthquake

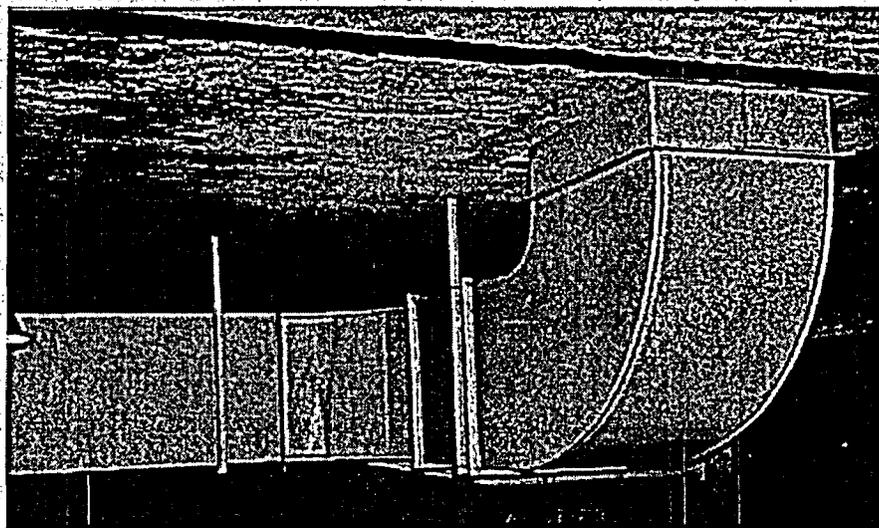
Figure A-21
Drop IV Hydro Plant, 1979 Imperial Valley Earthquake. Ceiling Mounted Ducting

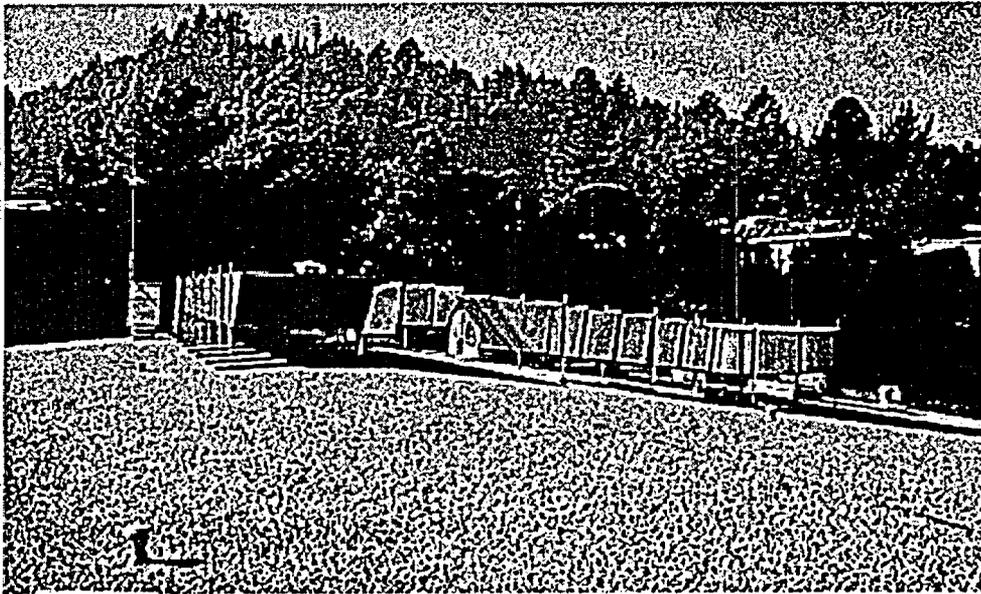
Figure A-23
Watkins-Johnson, 1989 Loma Prieta Earthquake. HVAC Ducting Atop Roof Level

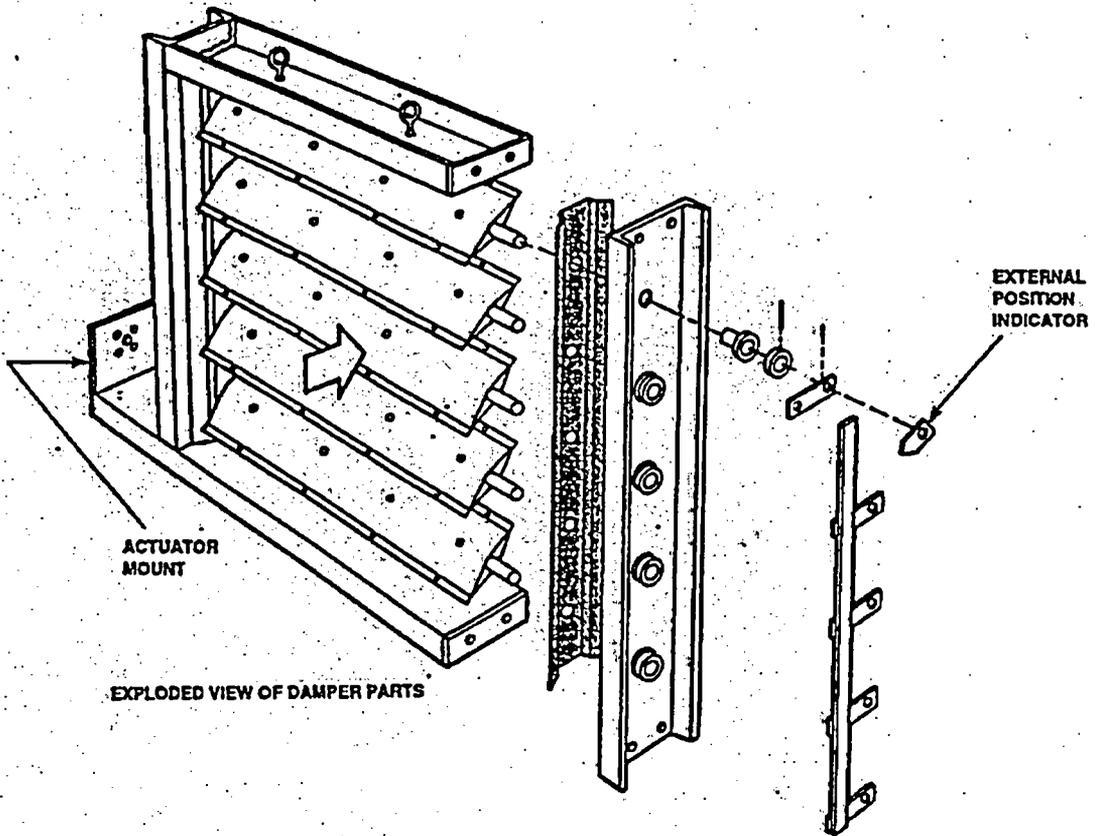
Figure B-1
Exploded View of a Typical Damper

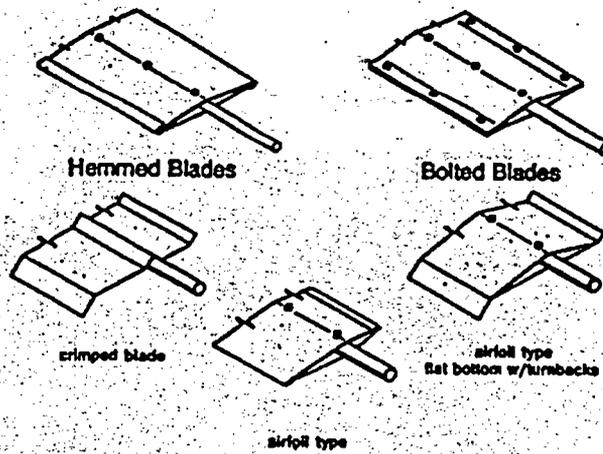
Figure B-2
Typical Damper Blades or Louvers

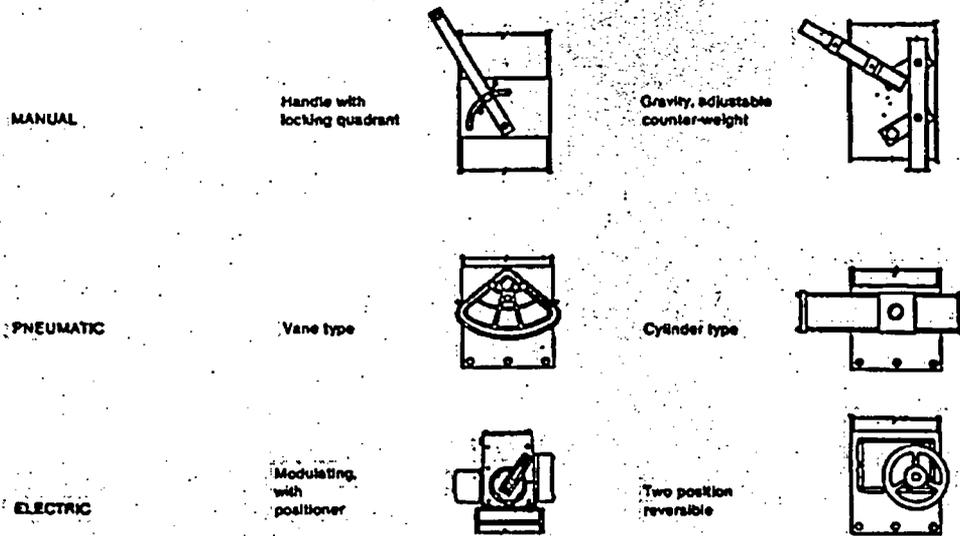
Figure B-3
Typical Damper Actuators

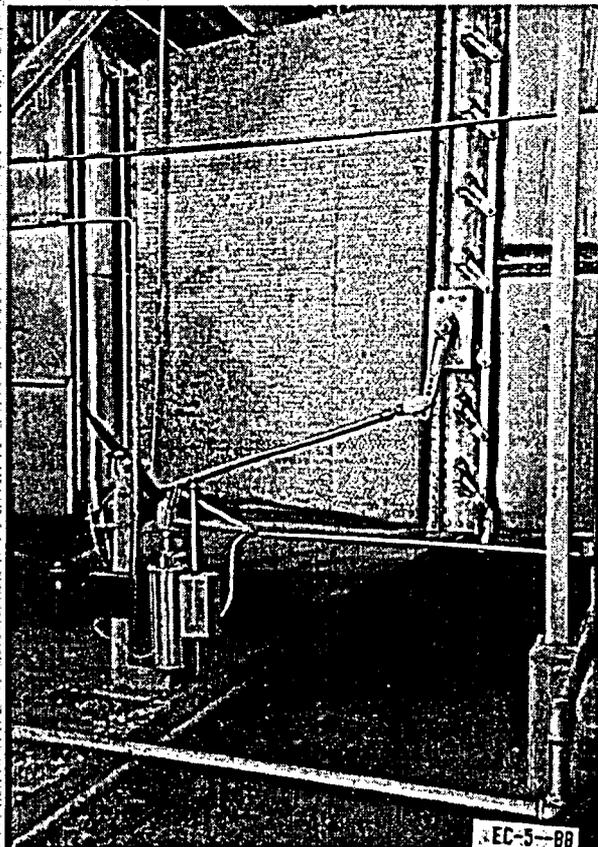
Figure B-4
Pneumatic Damper at El Centro Steam Plant Subjected to the 1979 Imperial Valley Earthquake

Figures B-4 through B-18 present examples of dampers within the database. The database inventory of dampers includes at least 175 examples, representing 20 sites and 14 earthquakes studied. Of this inventory, there are no instances of seismic damage.

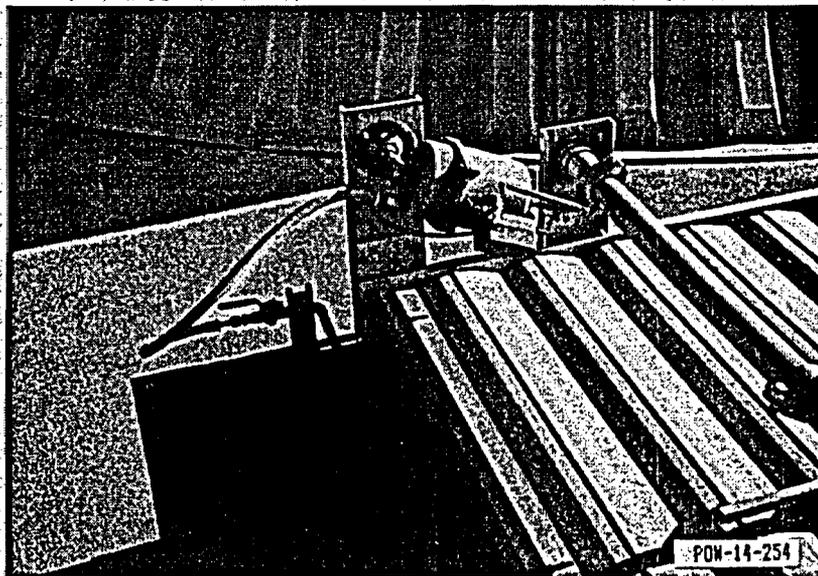
Figure B-6
Pneumatic Actuator at the Puente Hills Landfill Gas and Energy Recovery Plant

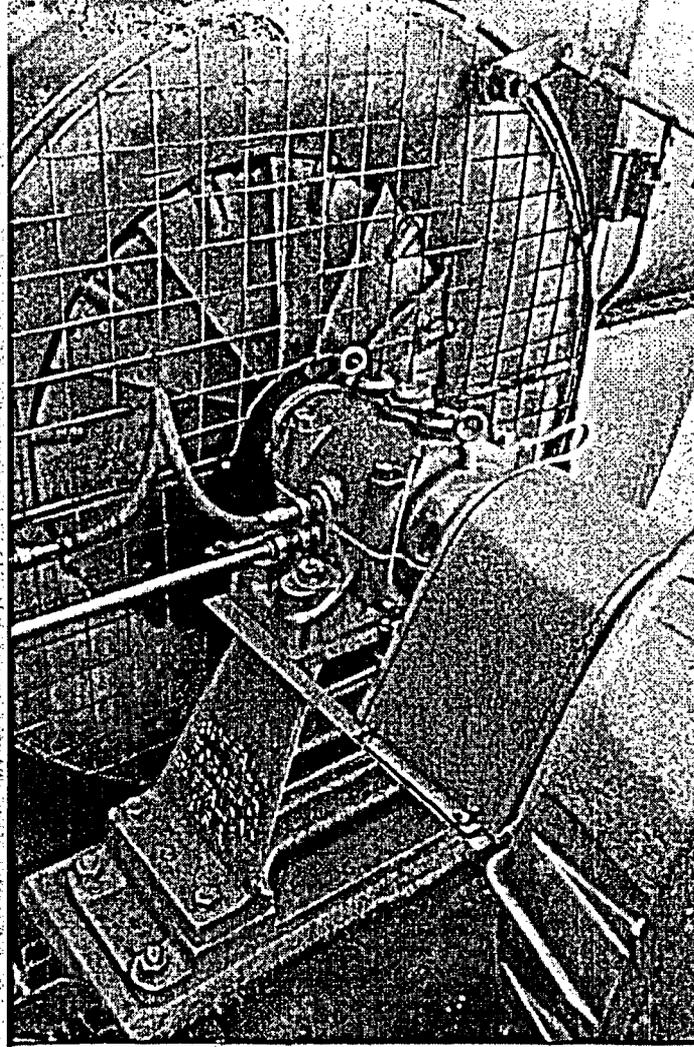
Figure B-7
Radial Type Damper at the El Centro Steam Plant which was Subjected to the 1979
Imperial Valley and 1987 Superstition Hills Earthquakes

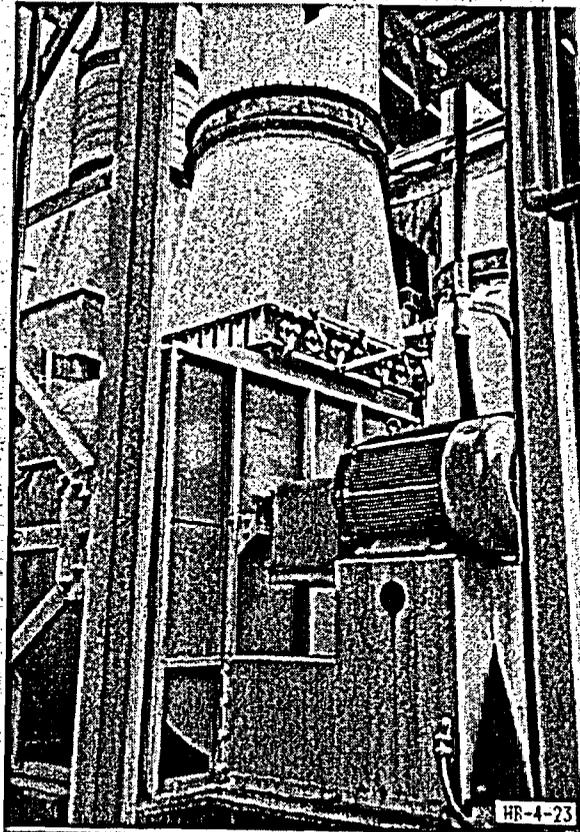
Figure B-8
Louver Type Damper at Humboldt Bay Power Plant

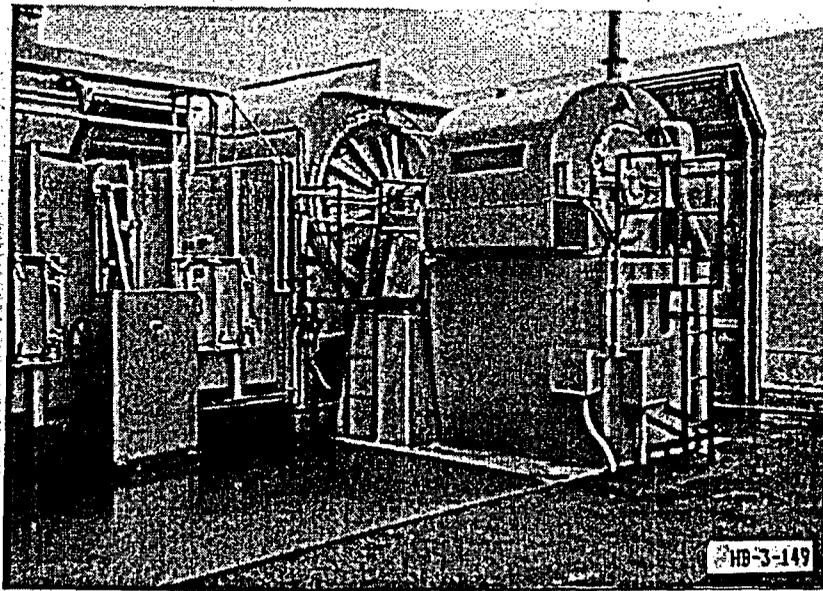
Figure B-9
Radial and Louver Type Dampers at the Humboldt Bay Power Plant which Experienced the 1975 Ferndale Earthquake

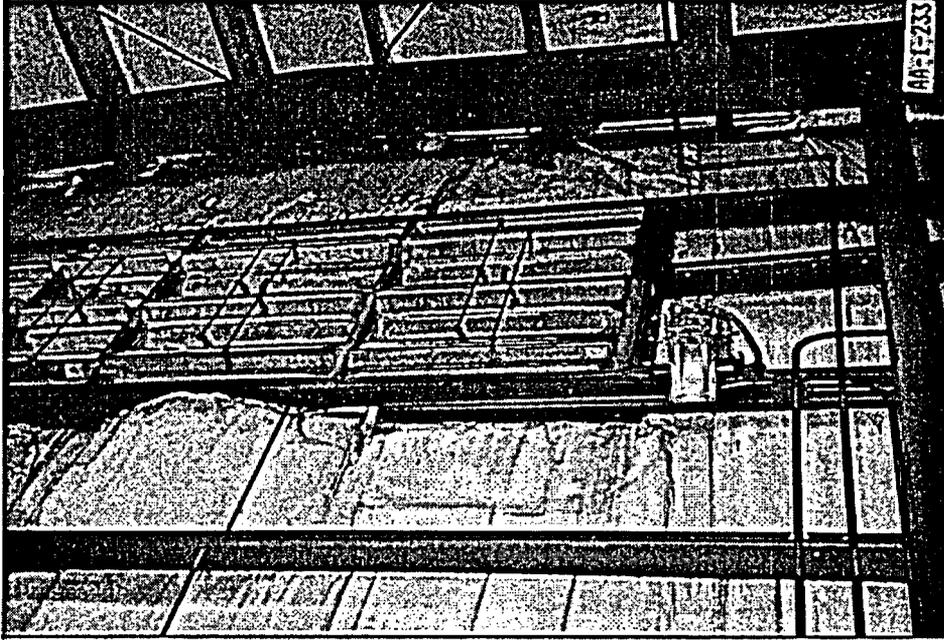
Figure B-10
Motor-operated Damper at Adak Naval Station, which Experienced the 1986 Adak Alaska Earthquake

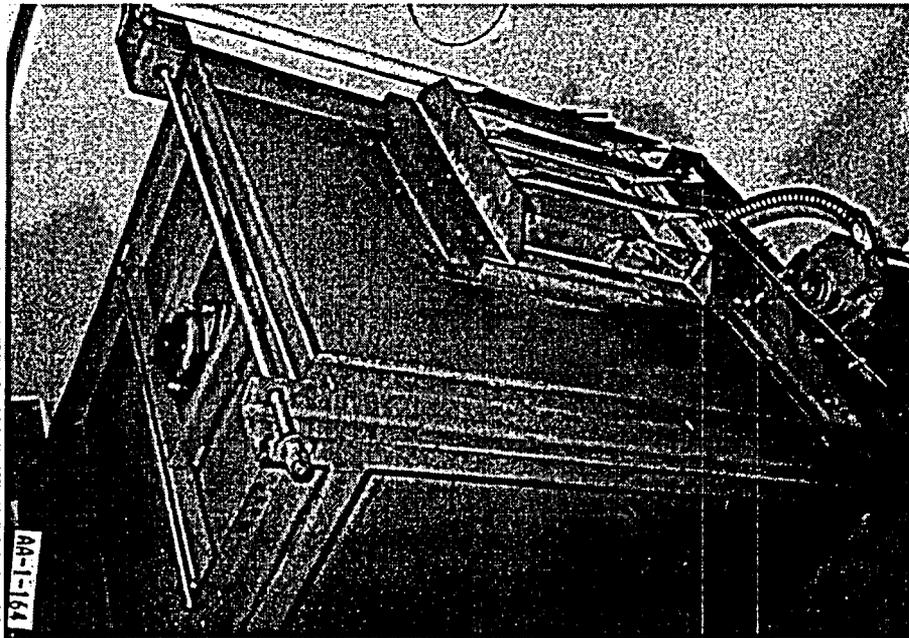
Figure B-11
Damper at Adak Naval Station

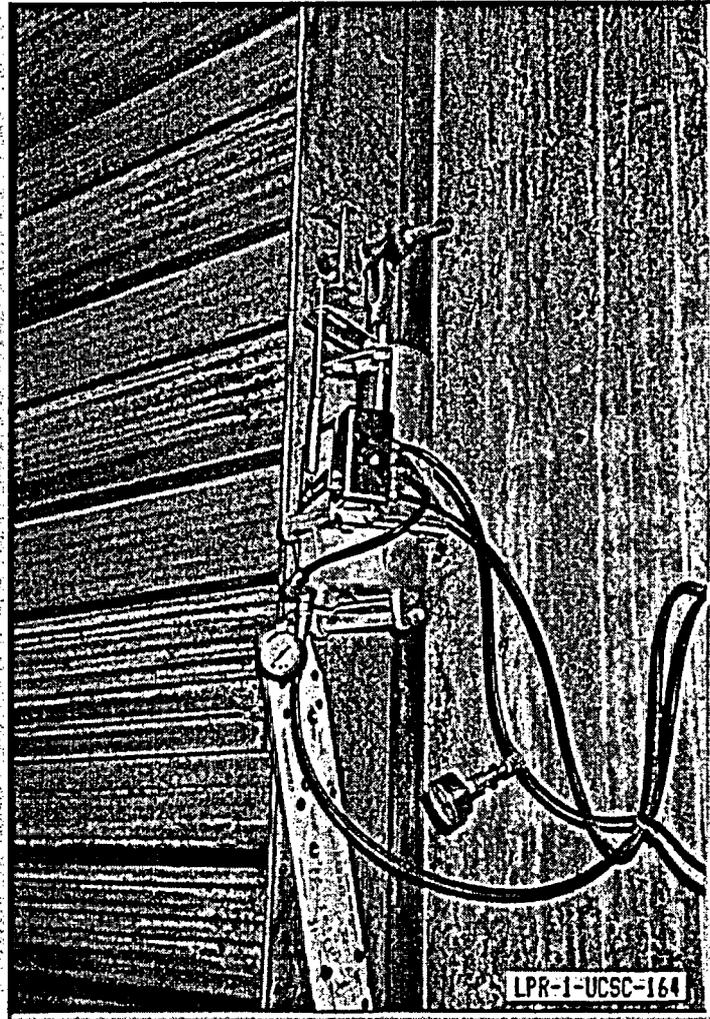
Figure B-12
Pneumatically Controlled damper at UC Santa Cruz Applied Science Building Subjected to 1989 Loma Prieta Earthquake
