**Edwin I. Hatch Nuclear Plant
Request to Implement an Alternative Source Term**

**EPRI Technical Report 1007896, Seismic Evaluation Guidelines
for HVAC Duct and Damper Systems**

Final Report, April 2003

ABSG Consulting

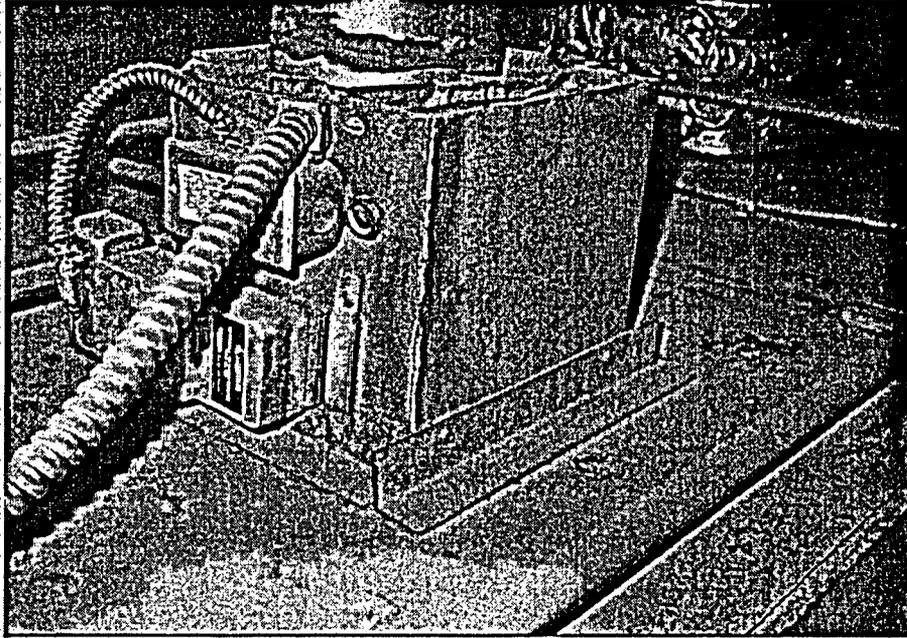
Figure B-13
Electric Motor for a Fire Damper at AES Placerita Cogeneration Plant Experienced the 1994 Northridge Earthquake

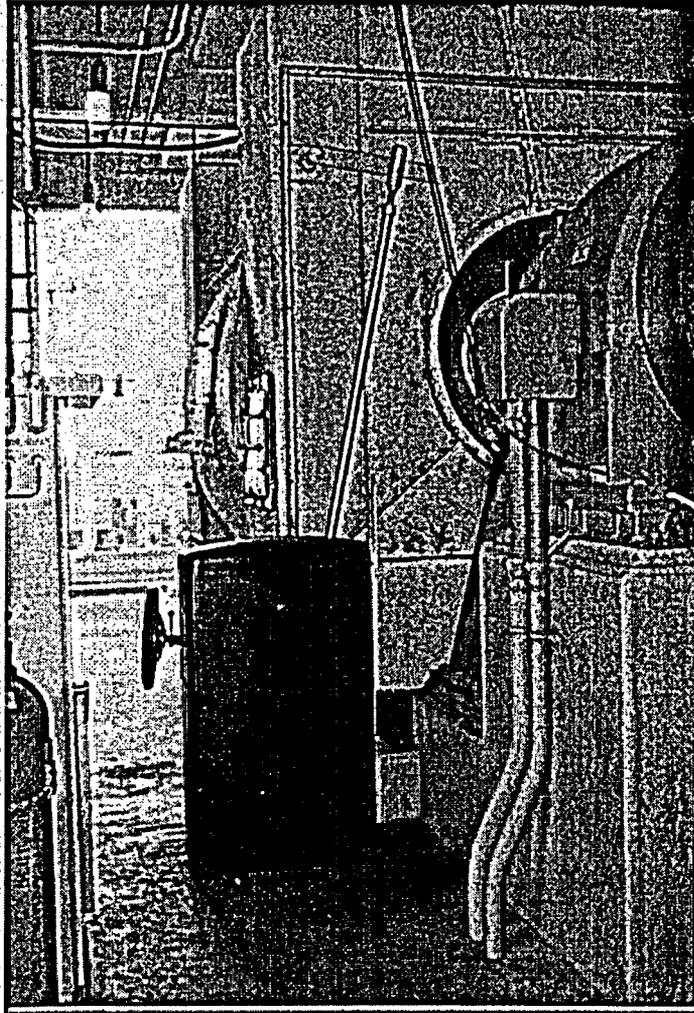
Figure B-14
Pneumatic Damper with Long Actuator at Valley Steam Plant which Experienced the 1971 San Fernando and the 1994 Northridge Earthquakes

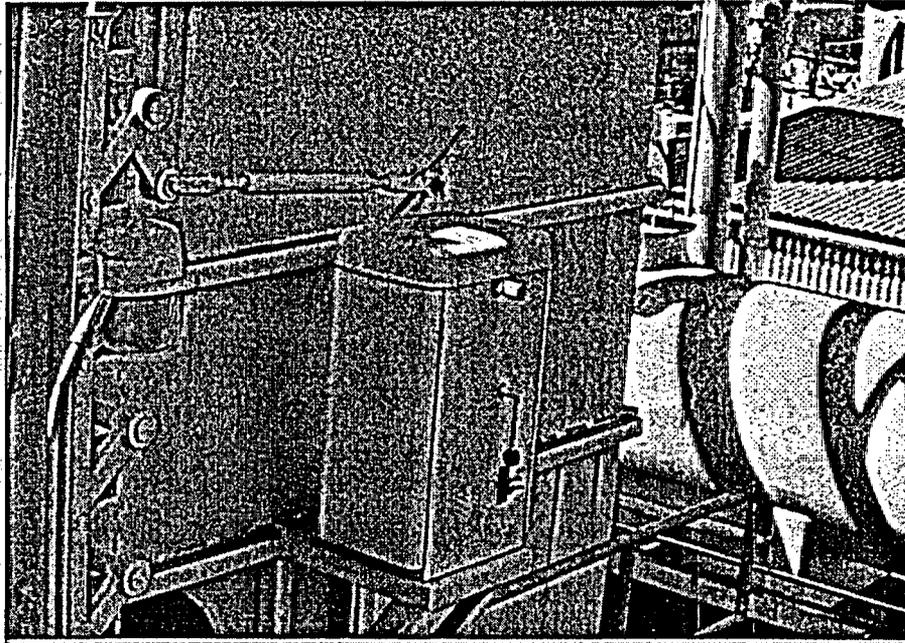
Figure B-15
Pneumatic Louver Control Damper at Pasadena Power Plant which Experienced Several Database Earthquakes

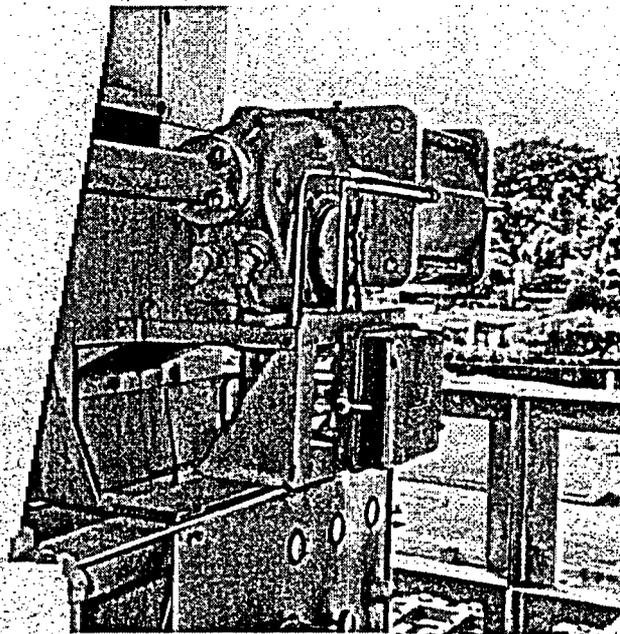
Figure B-16
Heavy Pneumatic Controller with Independent Support for a Large Damper at Pasadena Power Plant Located Very High in the Boiler Structure

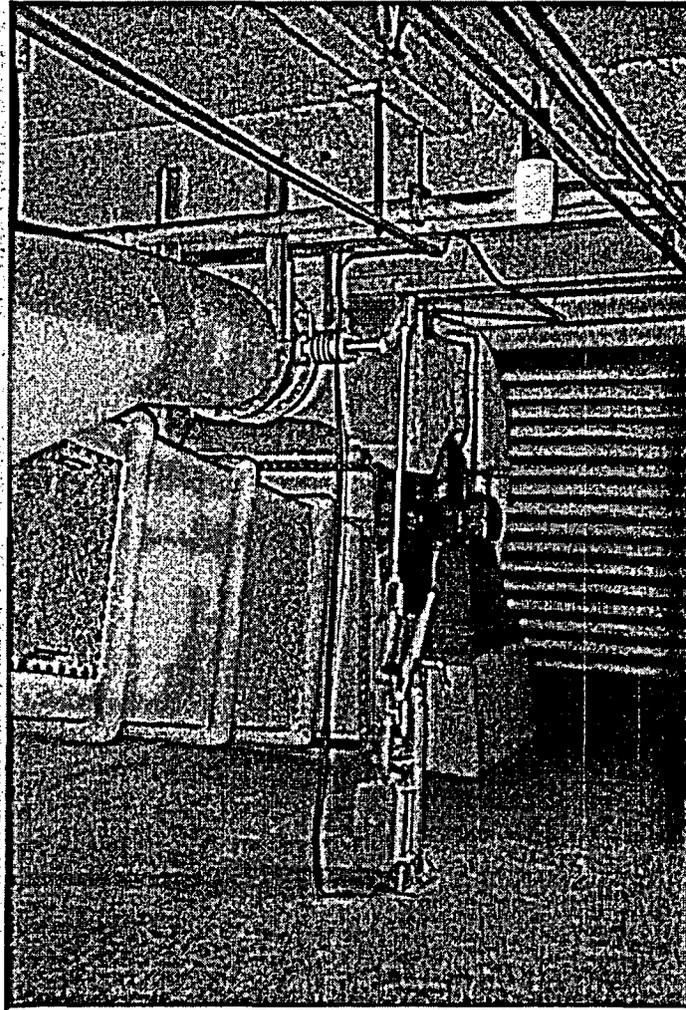
Figure B-17
Floor-mounted Air Operated Damper with Remove Actuator at Burbank Power Plant
Experienced the 1971 San Fernando and the 1994 Northridge Earthquakes

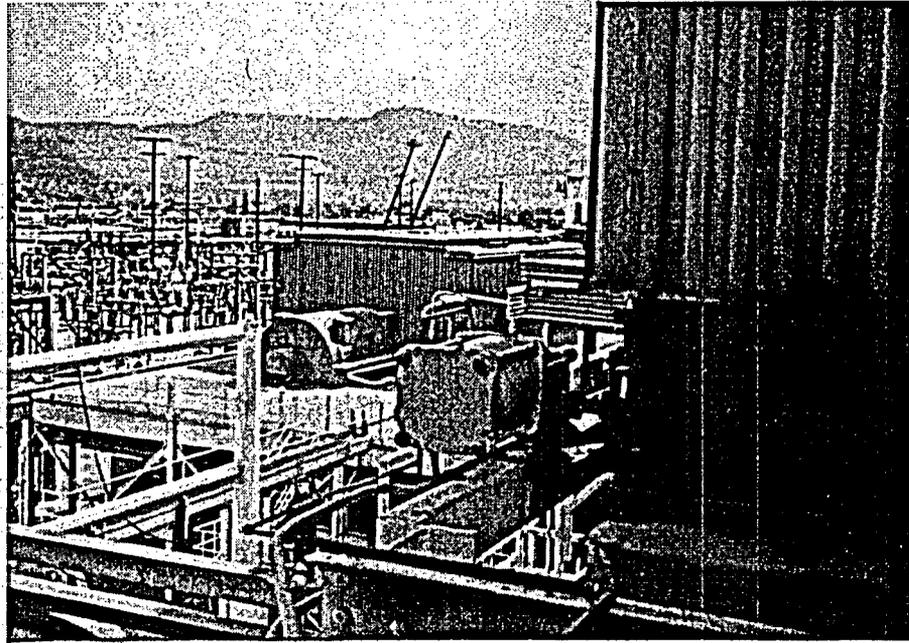
Figure B-18
Large Independently Supported Damper Controller at the Burbank Power Plant

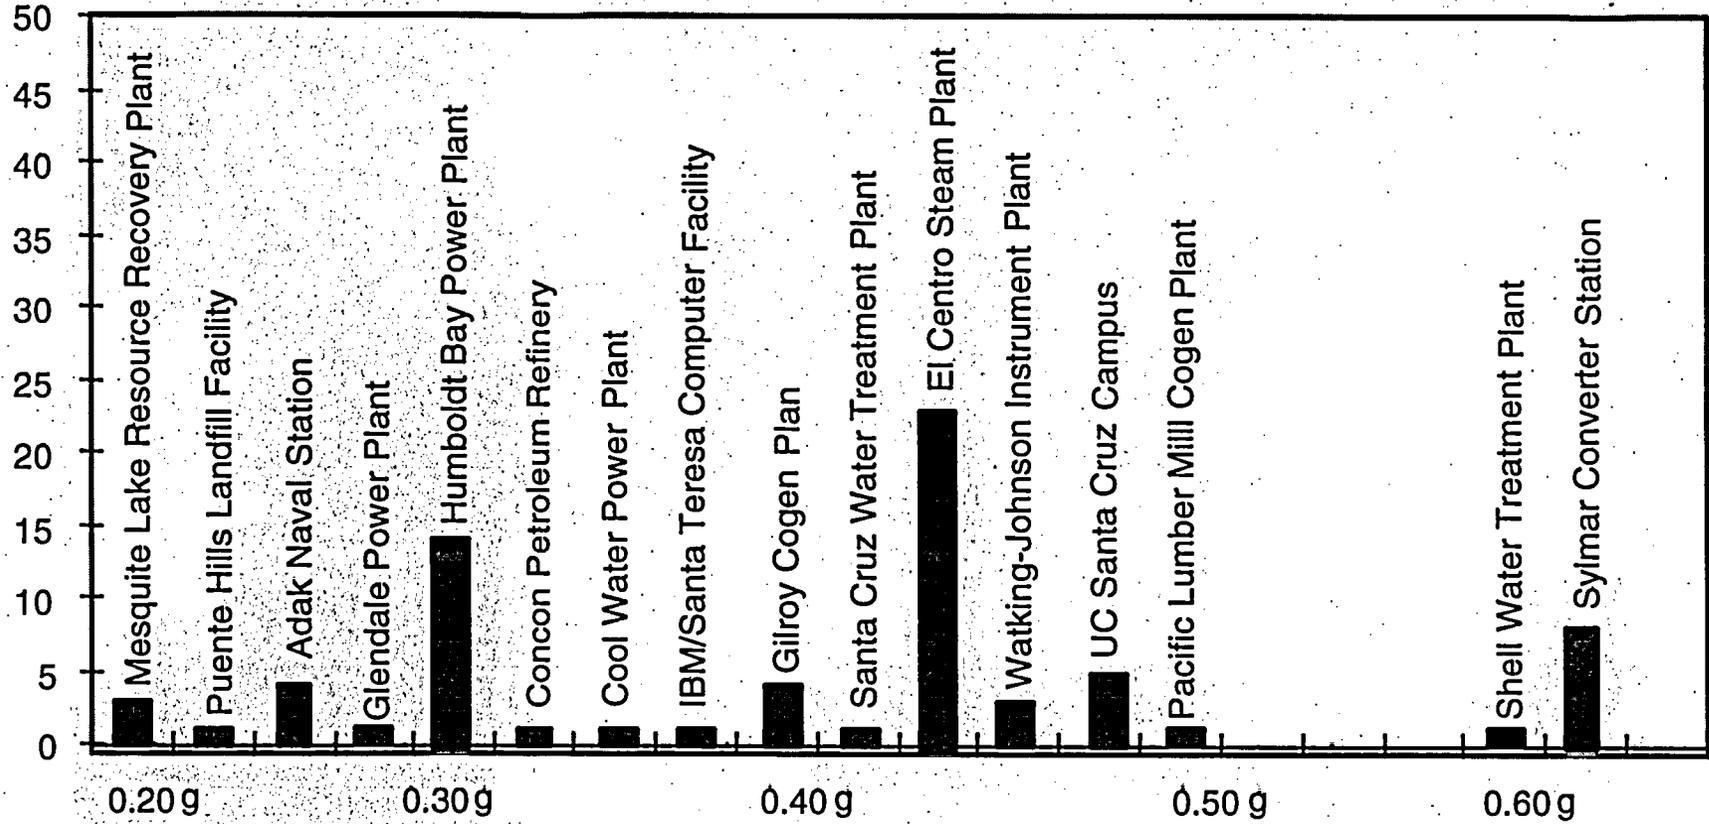
Figure B-19
Inventory of Dampers within Experience Database

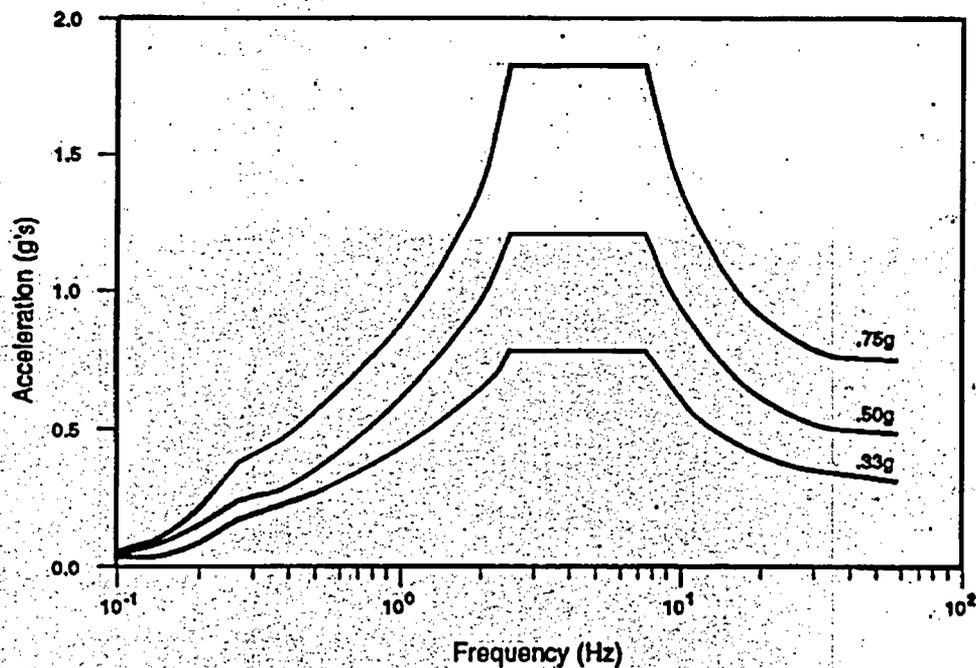
Figure E-1
Bounding Rod Fatigue Spectra

This attachment describes a screening method for evaluating rod hangers for fatigue based on the use of rod fatigue bounding spectra (shown in Figure E-1) and generic rod fatigue evaluation screening charts (shown in Figure E-2 through E-6).

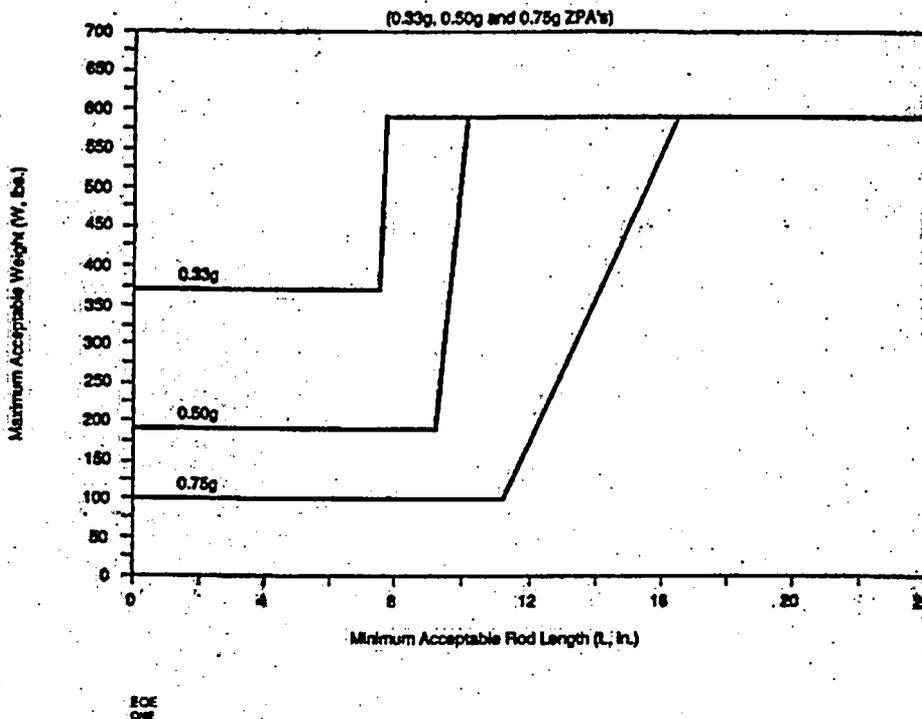
1/4" THREADED RODS

Figure E-2
Fatigue Elevation Screening Chart for 1/4 inch Diameter Manufactured All-thread Rods.
 Weight Corresponds to the Total Supported Load (i.e., on both Rods). Length Corresponds to Clear Length

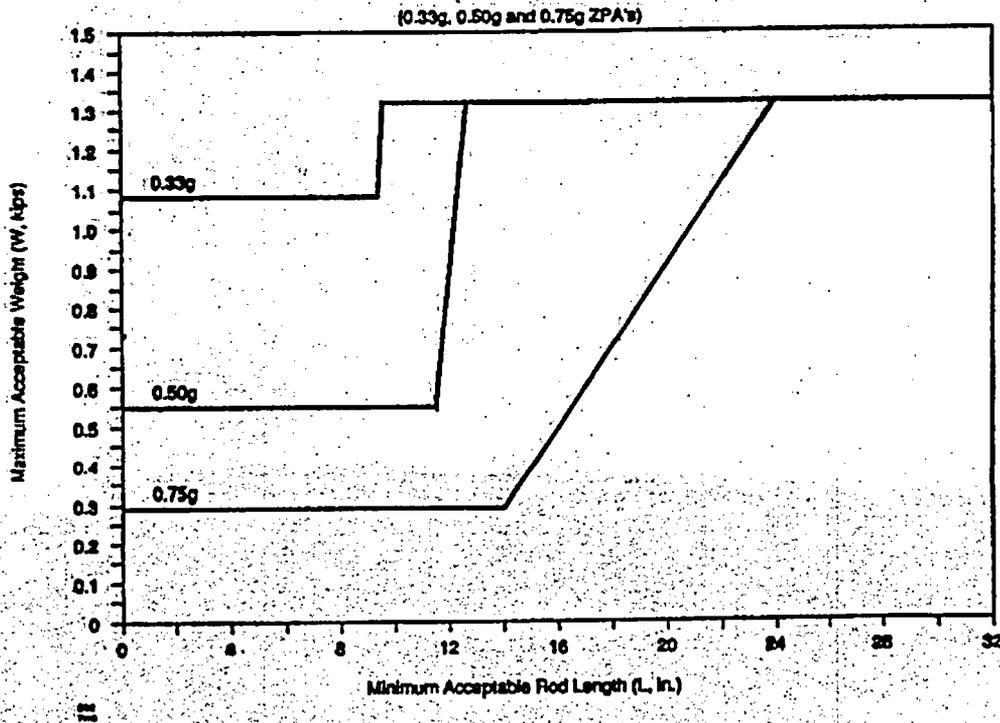
3/8" THREADED RODS

Figure E-3
 Fatigue Evaluation Screening Chart for 3/8 inch Diameter Manufactured All-thread Rods.
 Weight Corresponds to the Total Supported Load (i.e., on both Rods). Weight Corresponds
 to Clear Length

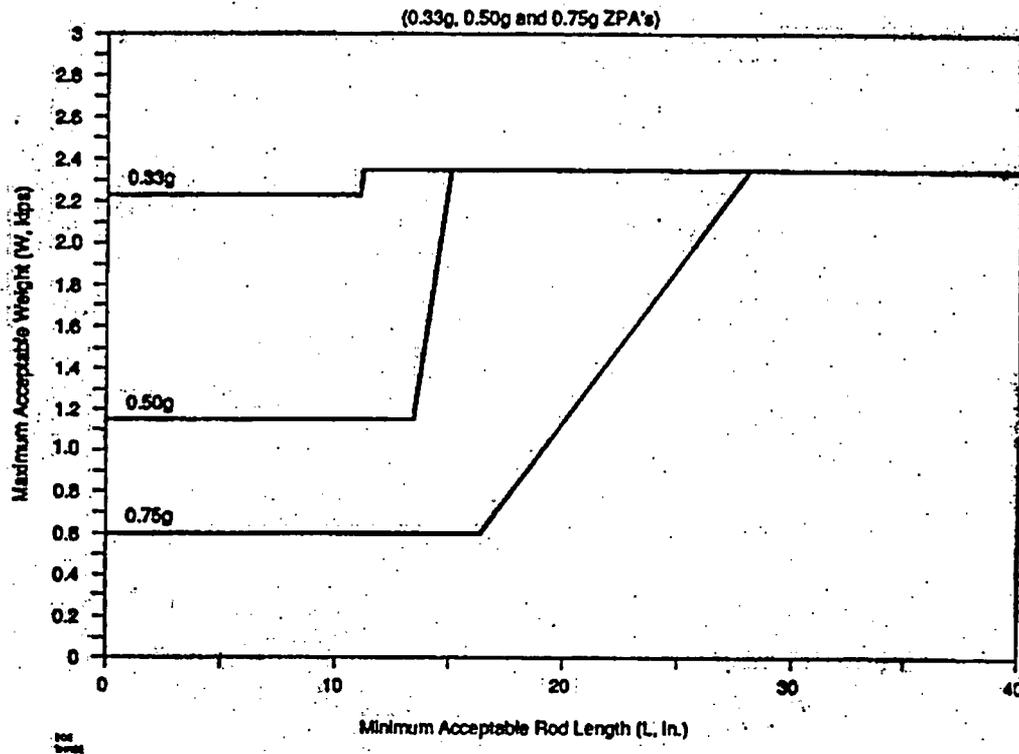
1/2" THREADED RODS

Figure E-4
Fatigue Evaluation Screening Chart for 1/2 - inch Diameter Manufactured All-thread Rods.
 Weight Corresponds to the Total Supported Load (i.e., on both Rods). Length Corresponds to Clear Length

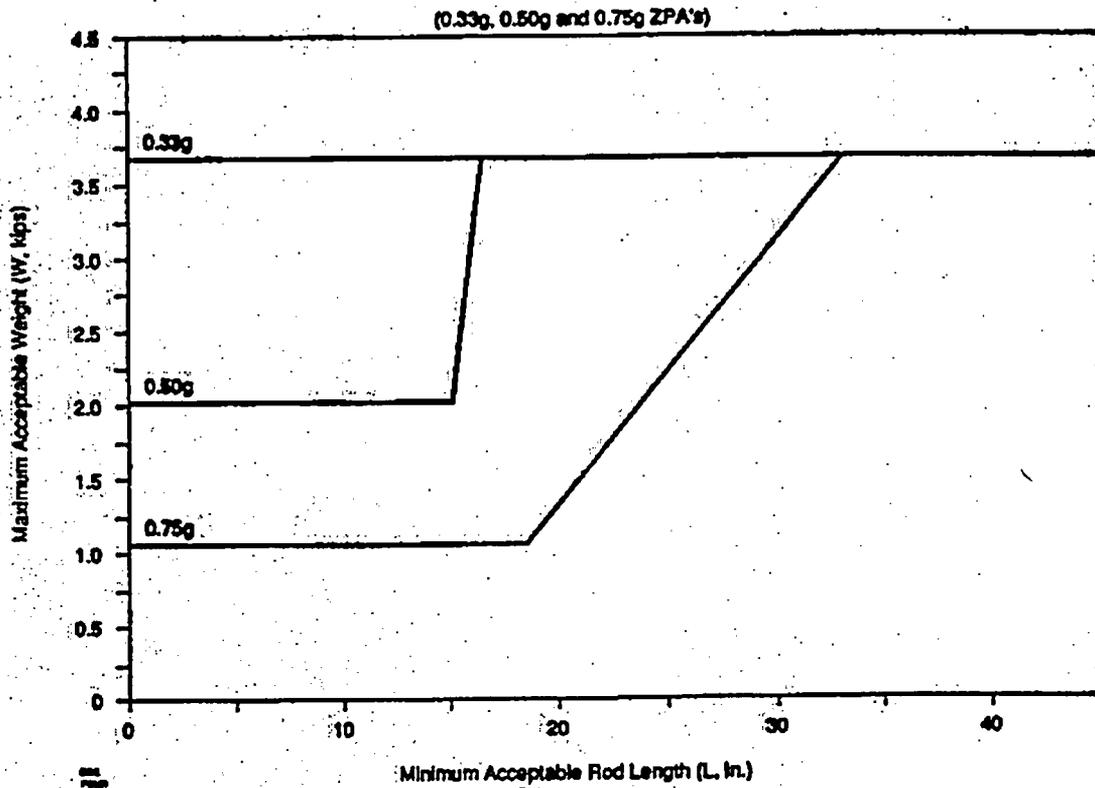
5/8" THREADED RODS

Figure E-5
Fatigue Evaluation Screening Chart for 5/8-inch Diameter Manufactured All-thread Rods.
Weight Corresponds to the Total Supported Load (i.e., on both Rods). Length Corresponds to Clear Length

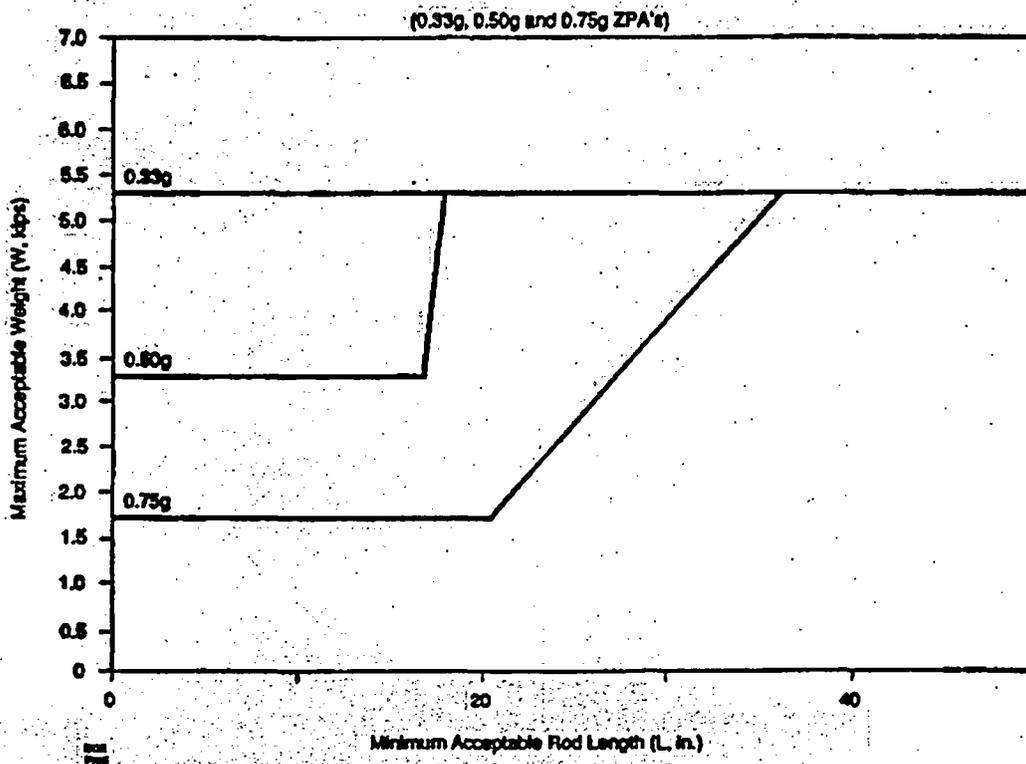
3/4" THREADED RODS

Figure E-6
 Fatigue Evaluation Screening Chart for 3/4-inch Diameter Manufactured All-thread Rods.
 Weight Corresponds to the Total Supported Load (i.e., on both Rods). Length Corresponds
 to Clear Length

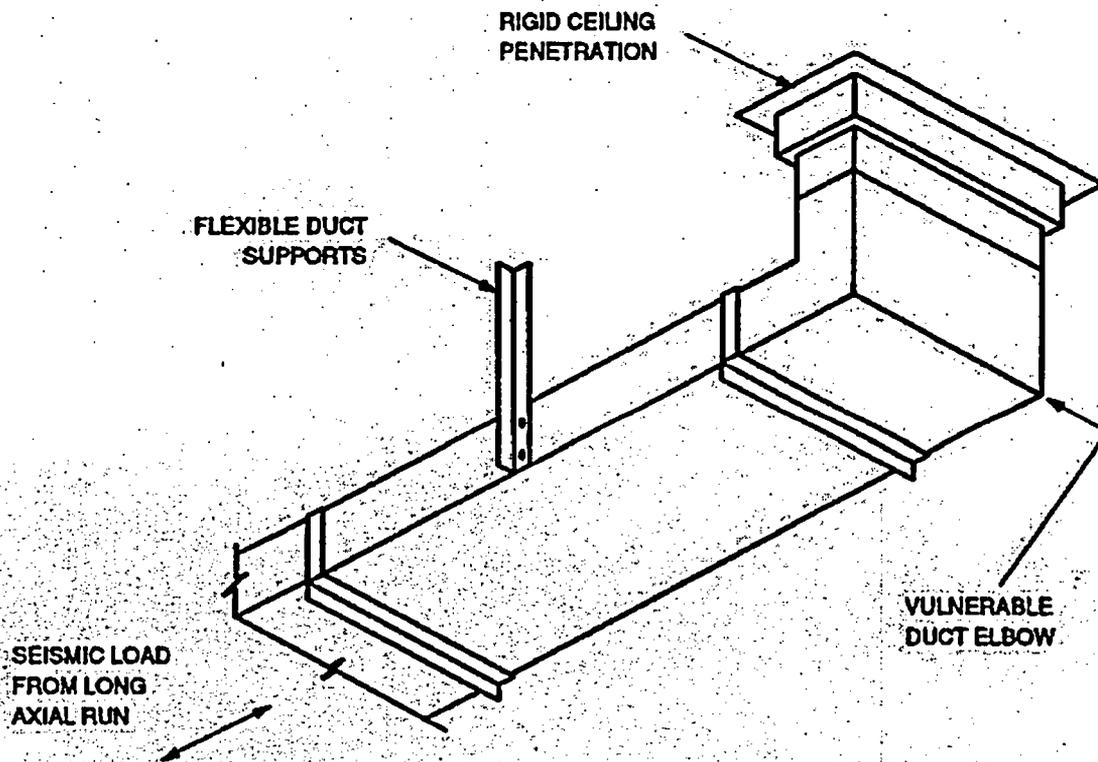
Figure F-1
Vulnerable Duct Elbow Adjacent to Rigid Lateral Restraint

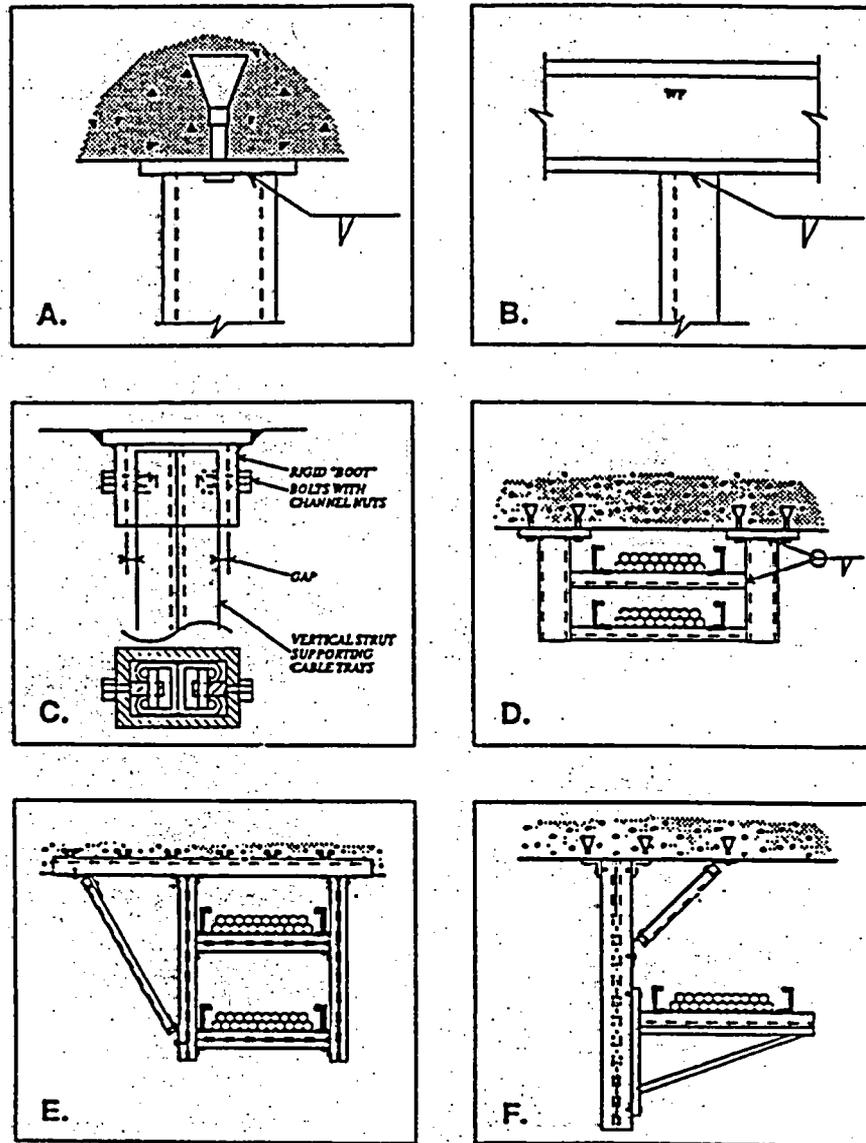
Figure F-2
Examples of Potentially Non-Ductile Connection Details and Configurations

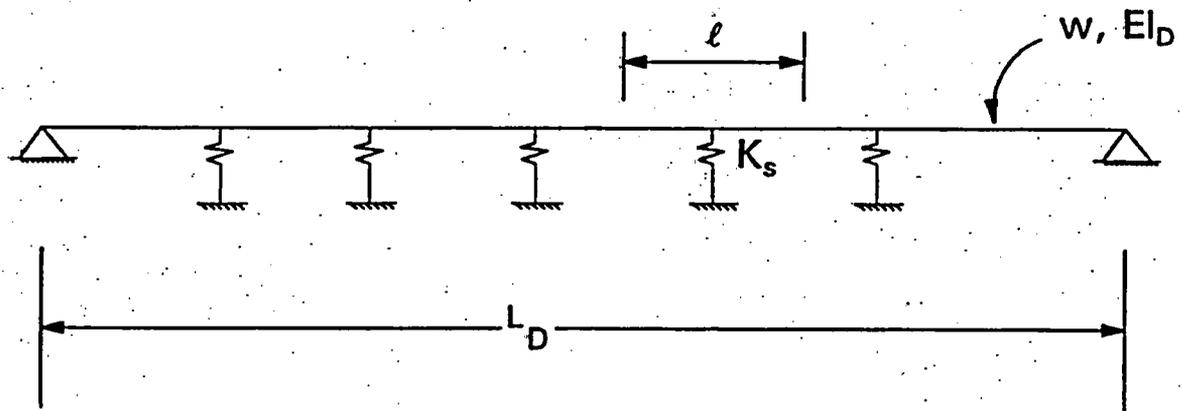
Figure F-3
System Frequency Estimation using Beam-on-elastic-foundation Approximation

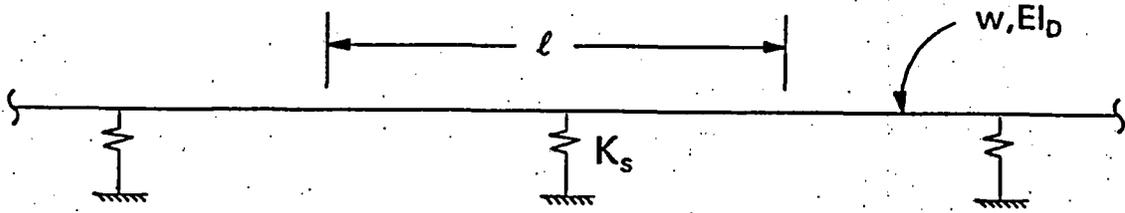
Figure F-4
Dunkerley's Equation Frequency Estimation Methodology
