**D. Ashley - Firebar-D material**

Attached is part 2 of the GE report on Firebar-D.

Table 9. UT Characterization of Damage by Bay Number

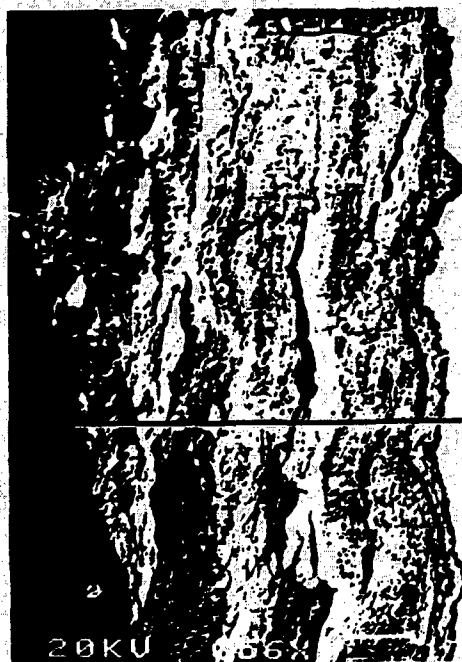
LINE REPRESENTS ENERGY  
DISPERSION LINE PROFILE  
LOCATION.

Figure 19. OYSTER CREEK PLUG 1 (19C)

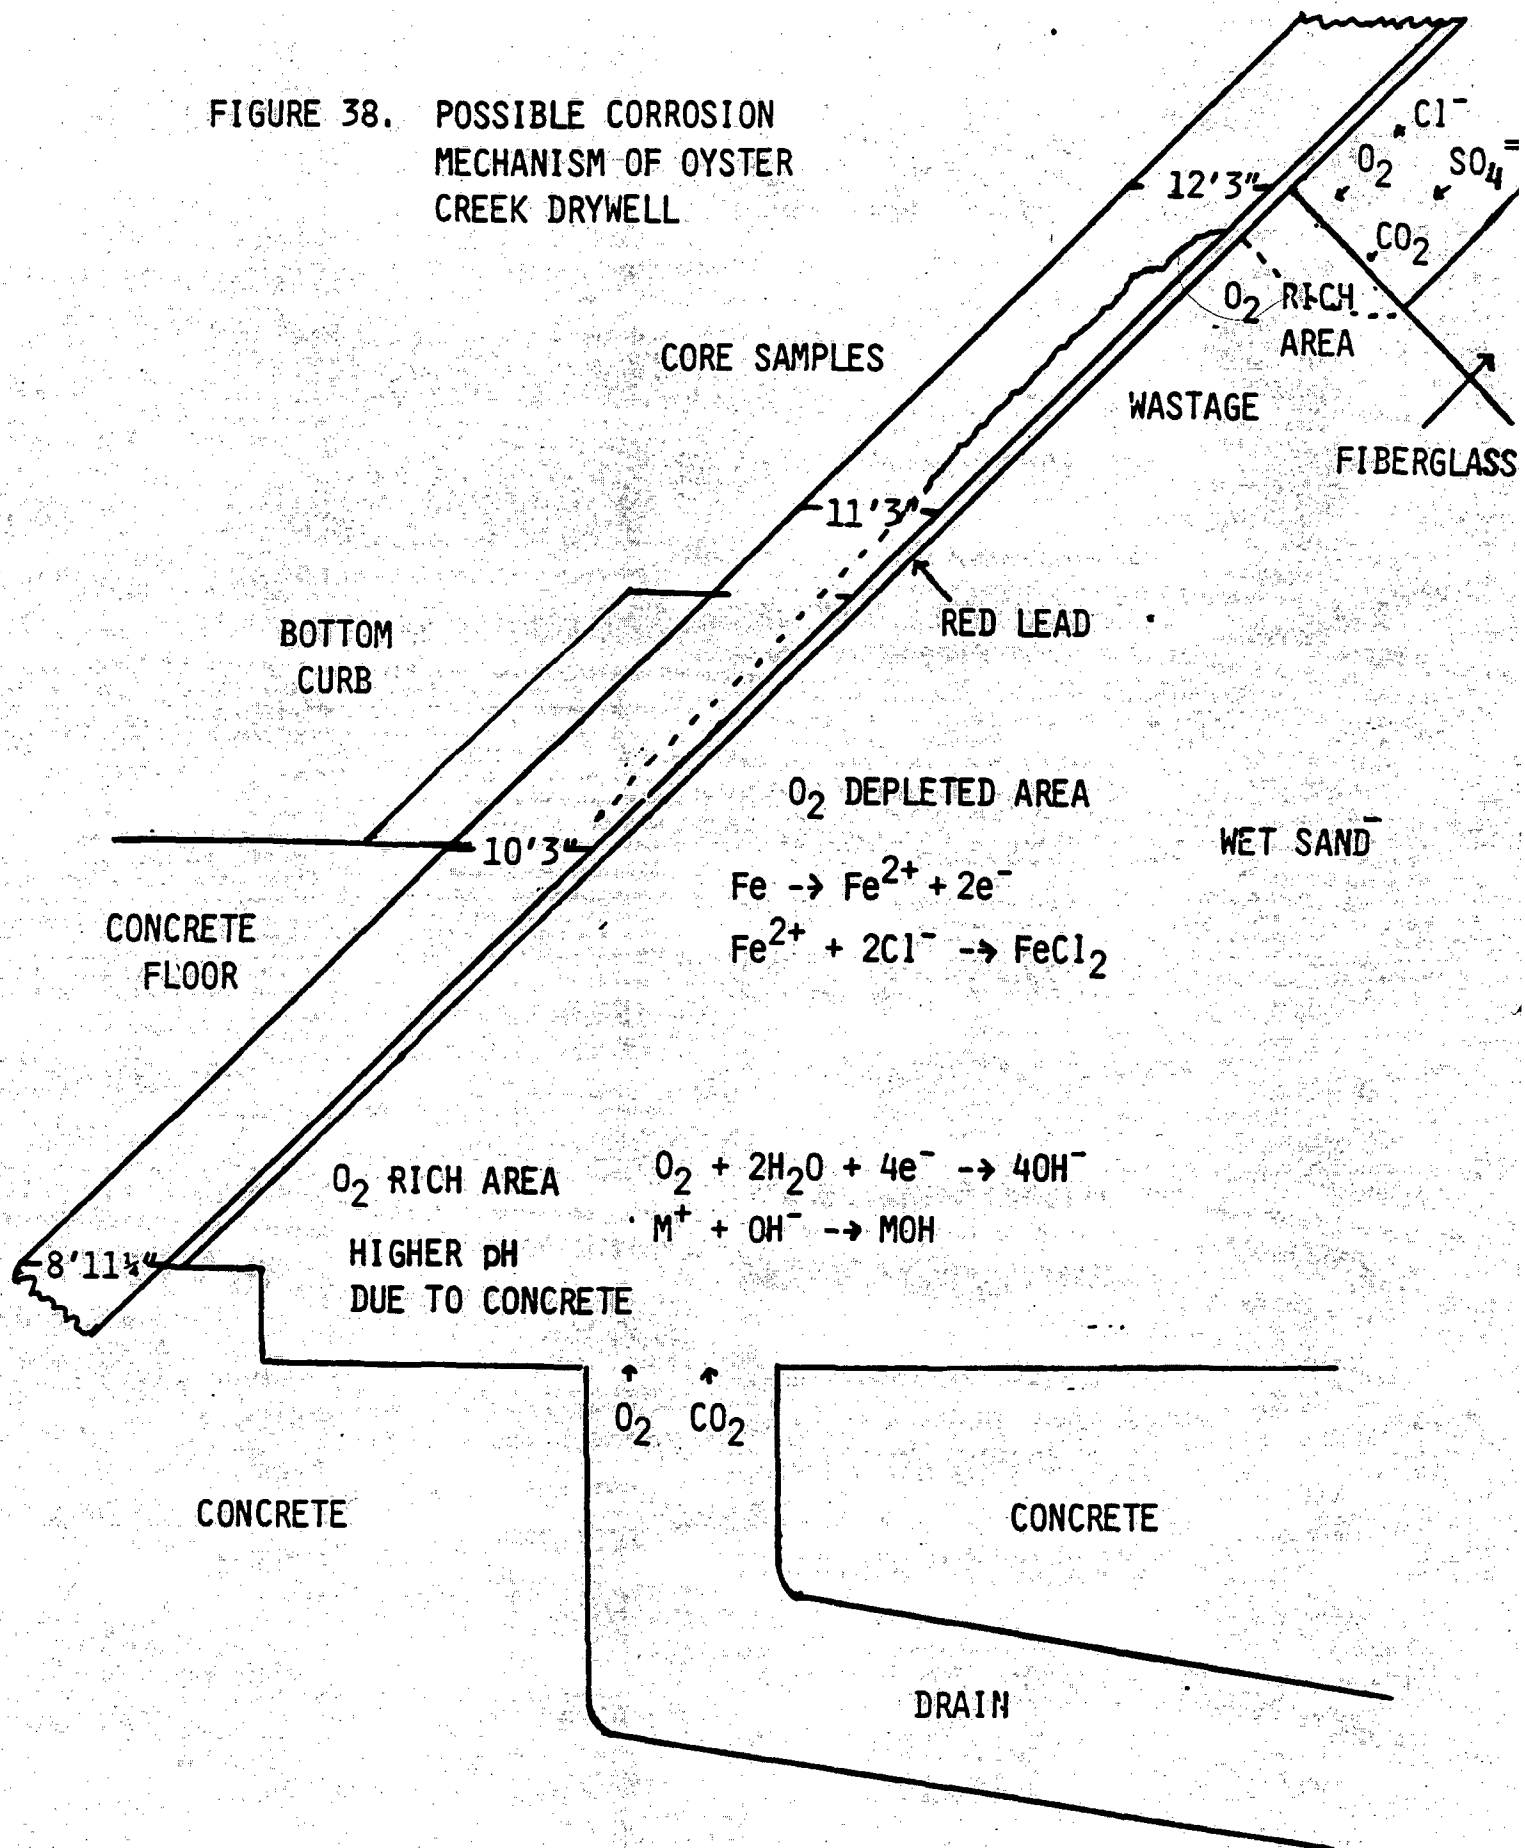
FIGURE 38. POSSIBLE CORROSION MECHANISM OF OYSTER CREEK DRYWELL
