DEPARTMENT OF THE ARMY  
OFFICE OF THE DEPUTY CHIEF OF STAFF FOR LOGISTICS  
WASHINGTON, D.C. 20310

Attached is an application to amend this license to add 110 pounds of Thorium 232 contained in sheet metal. Individual pieces of the sheet metal are bonded to the underside of the case of the AN/PDR-56 Radiacmeter to serve as check sources.

Thermal Neutron Irradiation of Sodium-Bonded  
Solid Solution (U,Pu)C Fuel

LA-4951

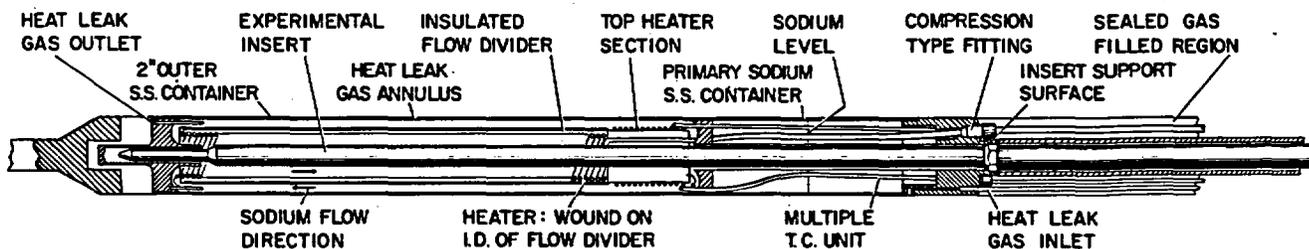
Fig. 3.  
In-core portion of thermal neutron irradiation experiment.

Figure 3 illustrates the in-core section of a cell with an experimental insert in place. The outside diameter of the cell was 2 in. and its overall length was 22 ft. At the lower end of the cell were the 13-in.-long, electrically heated sodium loop and the variable conductivity heat leak. The concentric legs of the sodium loop were separated by an argon-filled, stainless steel flow divider. The main resistance heaters were wound on the inner surface of the flow divider. Above the insulated flow divider was another heater-wound section that was used at startup to ensure melting of sodium downward from the free surface. The heat leak annulus was formed by the primary sodium container and the cell outer tube. The upper quarter of the annulus was 0.012 in. thick and the remainder was 0.020 in. thick. Thermal conductivity of the annulus was altered by changing the composition of the helium-nitrogen gas mixture flowing through it. Helium, at 10 psig, was used as the cover gas over the sodium in the cell. Three stainless steel-sheathed, chromel-alumel thermocouples were placed in the outer section of the sodium loop. Their junctions were positioned at the top and base

The experimental insert, occupying the central portion of the cell (Fig. 3), consisted of fuel pins and thermocouples sodium-bonded to an 18-in.-long, 0.60-in.-diam stainless steel secondary container. The secondary container was attached to a 26.5-ft.-long tubular extension, and the entire insert was installed in the cell as a unit. During operation, sodium in the annulus between the experimental insert and the flow divider was heated by the fuel in the insert and by the heaters wound onto the inside of the flow divider. Sodium rose in this annulus and then descended into the annulus between the flow divider and the heat leak wall, transferring heat through the heat leak gas annulus to the reactor cooling water. A helium purge was directed through the volume above the sodium level in the insert and was exhausted from the experiment through a molecular sieve, which was monitored continuously for fission product gases.

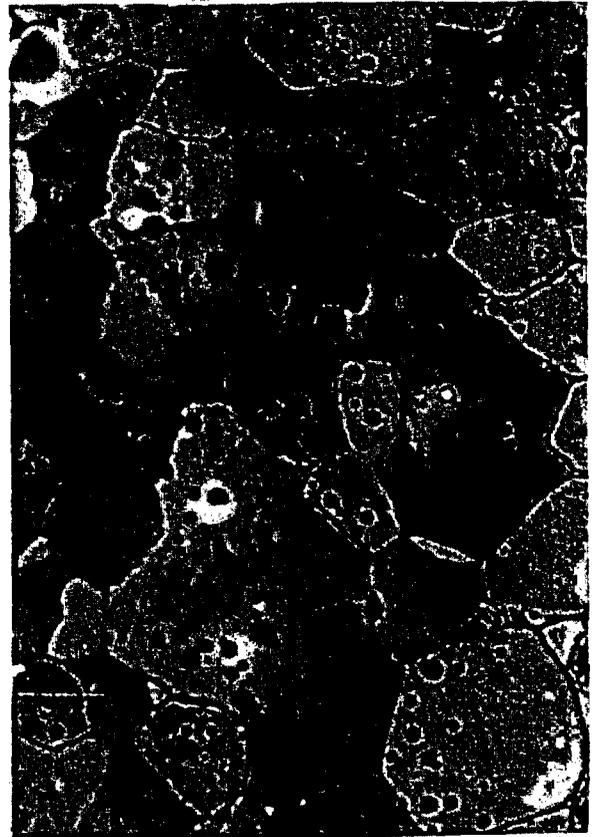
a. Fuel microstructure free from additional phases.

b. Fuel microstructure exhibiting small white inclusions of plutonium- and silicon-rich material.

Representative microstructure of fuel before irradiation.

carbide, fully enriched in  $^{235}\text{U}$ . Chemical and isotopic analyses and immersion densities for the various fuel batches used are shown in Tables I, II, and III, and representative microstructures are shown in Fig. 4. Various fuel batches contained a second phase that was plutonium- and silicon-rich and uranium- and carbon-poor with respect to the matrix, and that also contained small amounts of metallic contaminants. This phase comprised  $<0.5$  vol% of the fuel and appeared as small, white inclusions located principally at triple points and pores (Fig. 4b).

Two fuel sections from OWREX-15 were examined and appeared to have undergone no significant changes during irradiation (Fig. 25). White inclusions having the appearance and distribution of the plutonium- and silicon-rich inclusions sometimes seen in the as-fabricated fuel (Fig. 4b), were observed in both irradiated sections.

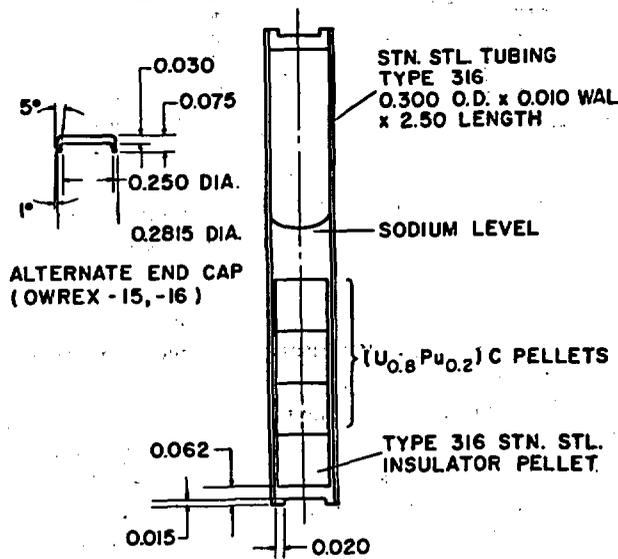
Fig. 5.

OWREX fuel capsule and alternate end cap.

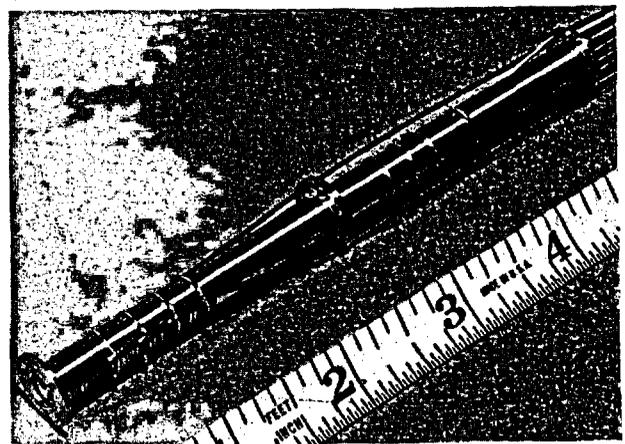
Fig. 6.

Fuel capsules before insertion in secondary container.

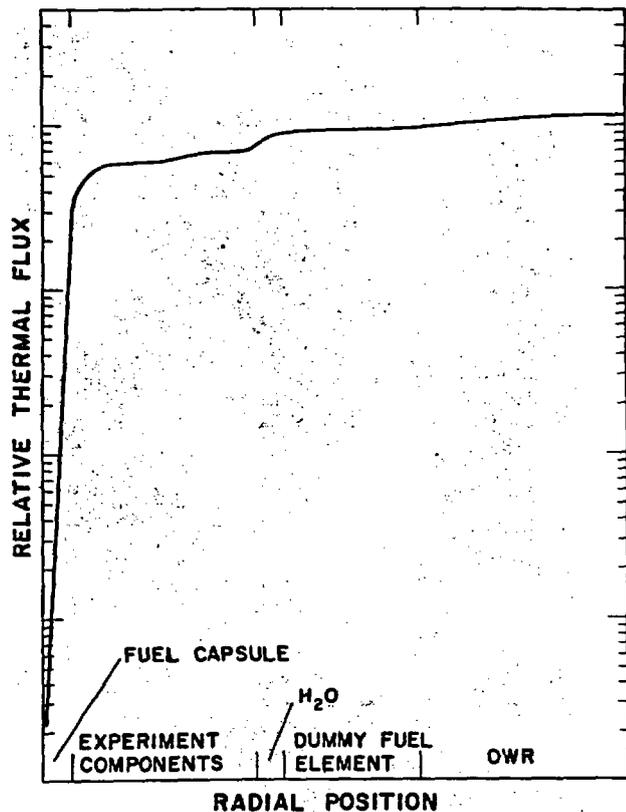
Fig. 7.

Predicted thermal flux distribution for  $(^{235}\text{U}_{0.8}\text{Pu}_{0.2})\text{C}$  irradiations.

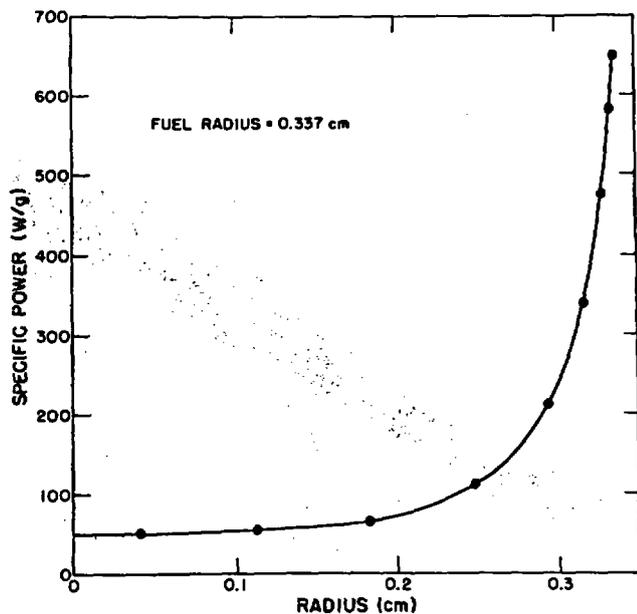
Predicted radial power distribution in  $(^{235}\text{U}_{0.8}\text{Pu}_{0.2})\text{C}$  at reactor power of 6 MW.

Radial temperature gradients through fuel, bond, and cladding at the beginning of life were approximated using the specific power values shown in Fig. 8. Heat was assumed to flow only in the radial direction, and fuel and clad were assumed to be coaxial. The temperature drop associated with the outward flow of heat through a hollow cylinder can be expressed as<sup>15</sup>

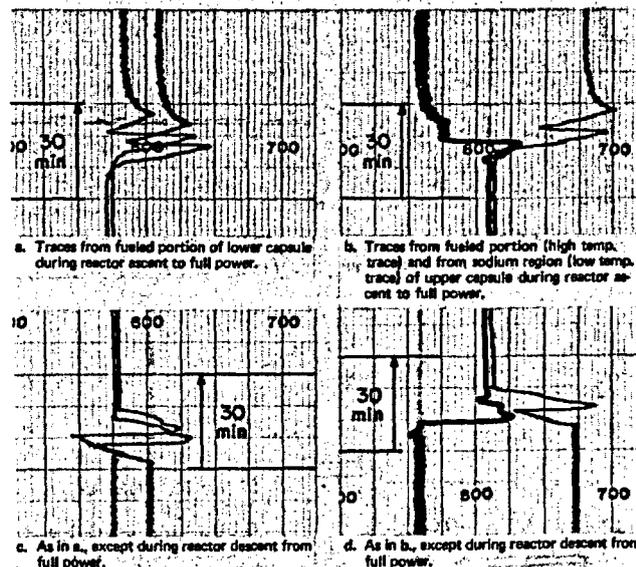
Fig. 9.

Response of OWREX-16 fuel capsule thermocouples to normal reactor startup and shutdown.

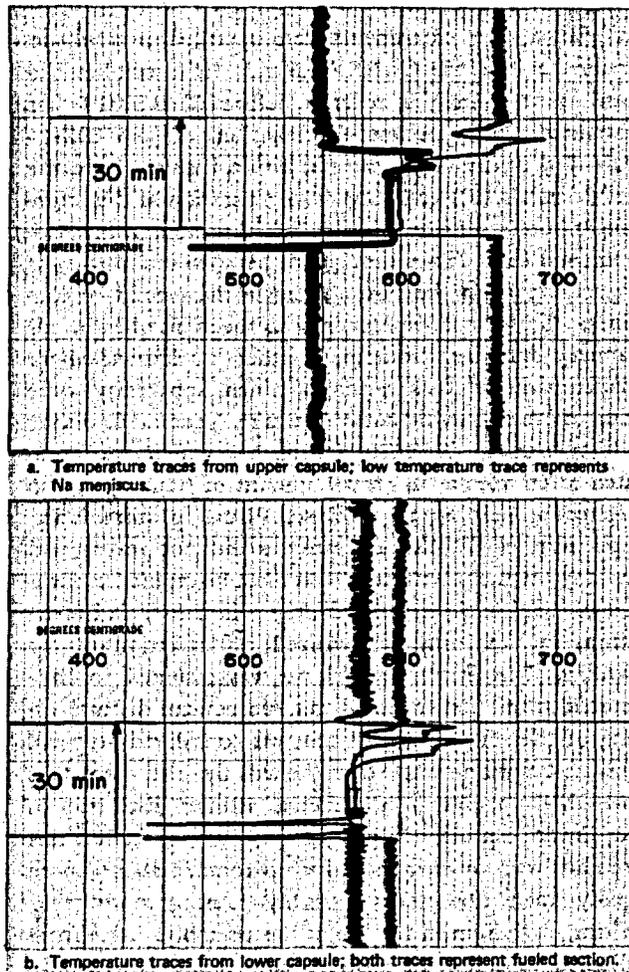
Response of OWREX-16 fuel capsule thermocouples to reactor scram and subsequent normal ascent to power.

Temperature traces recorded during a scram and subsequent startup are shown in Fig. 10. Nitrogen was substituted for the helium-nitrogen mixture as reactor power

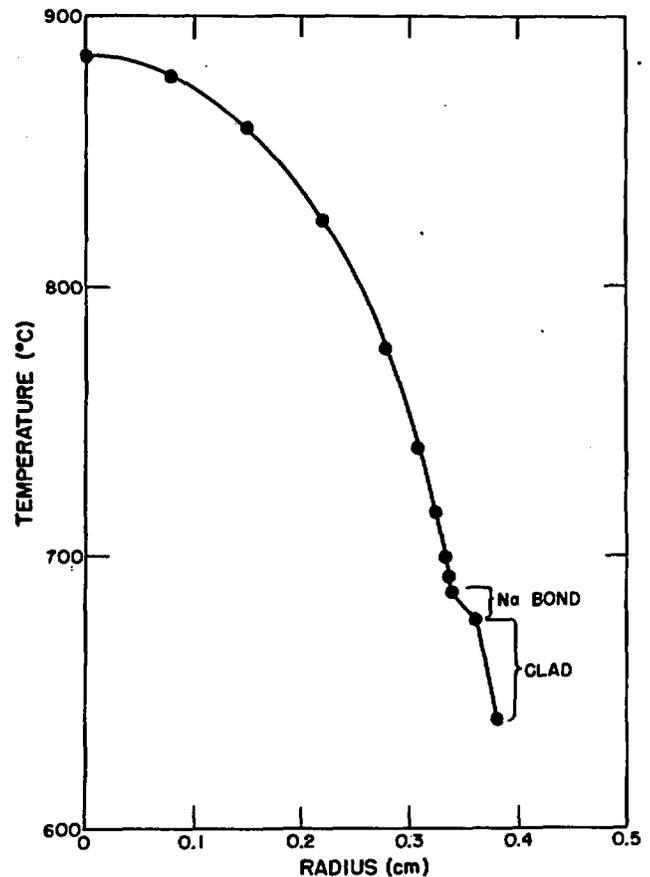
Fig. 11.

Beginning-of-life radial temperature distribution in (U,Pu)C fuel capsule, neglecting end effects.

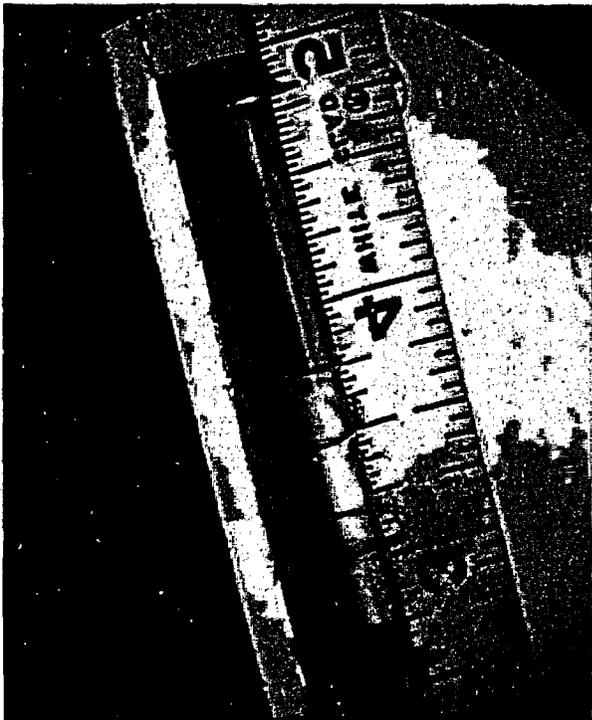
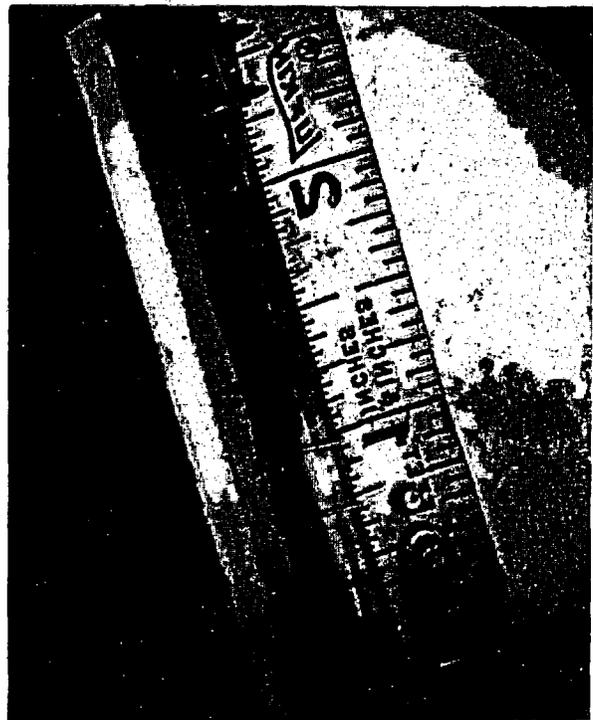
*Fig. 16.*

*OWREX-16 fuel capsules after removal from secondary container. (Stains near wire ties were caused by sodium-air reaction products.)*

Upon visual examination, all capsules appeared frosted or lightly etched in the region of high heat flux and discolored over the remaining surface area (Figs. 13,16). Light scratching of the capsules removed the discoloration, indicating a surface phenomenon, and subsequent metallographic examination of cladding sections failed to associate a microstructural feature with the discolored surfaces. Because control of oxygen in the secondary bonding sodium was crude at best, the exterior appearance of the capsules was not of primary importance.

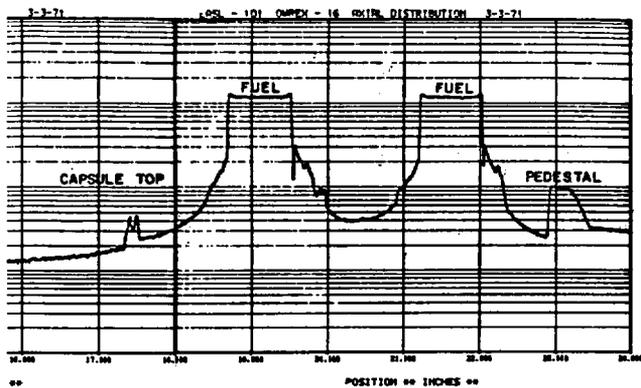
Fig. 17.  
Axial distribution of gamma-emitting species in OWREX-16 assembly ( $E > 100$  keV).

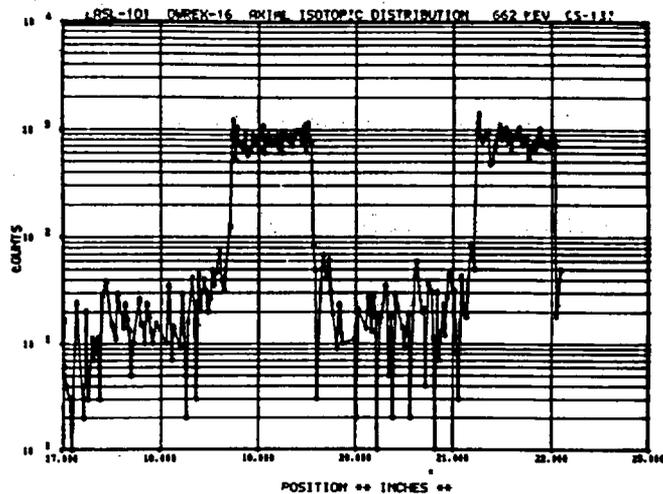
Fig. 19.  
Axial distribution of <sup>137</sup>Cs in the OWREX-16 assembly.

Apart from the fueled regions of the capsules, fission product activity was detected at ~18.5 and 21 in. (Figs. 19, 20, and 21), the regions of the sodium menisci. An additional region of activity was found at 19.8 in., ~¼ in. below the fuel stack in the top capsule, and a similar region of activity was noted in the lower capsule but is not shown in the figures. Because all these regions contained all the fission products for which a search was made, the activities most likely were associated with fuel chips and smaller particles that either sank to the bottom or were suspended at the meniscus.

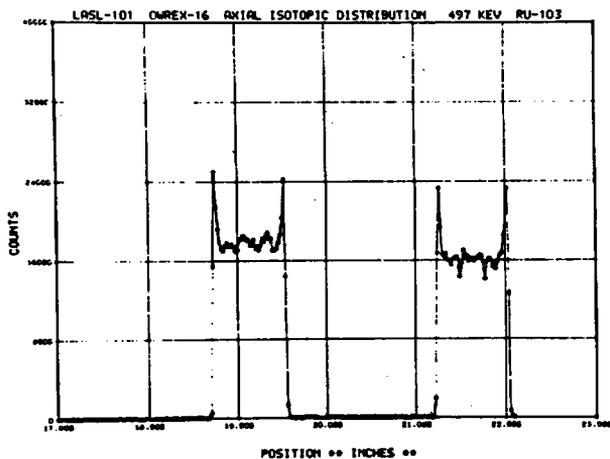
Fig. 18.  
Axial distribution of <sup>103</sup>Ru in the OWREX-16 assembly.

characteristic accentuated in Fig. 18 is the drop in activity corresponding to the fuel pellet-pellet interfaces.

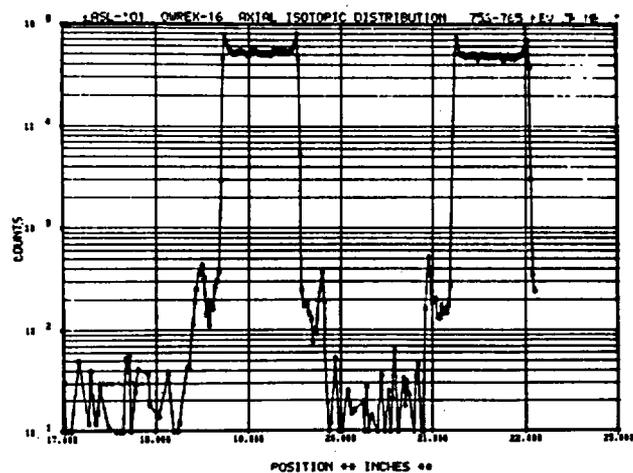
Fig. 20.  
Axial distribution of <sup>95</sup>Zr-<sup>95</sup>Nb in the OWREX-16 assembly.

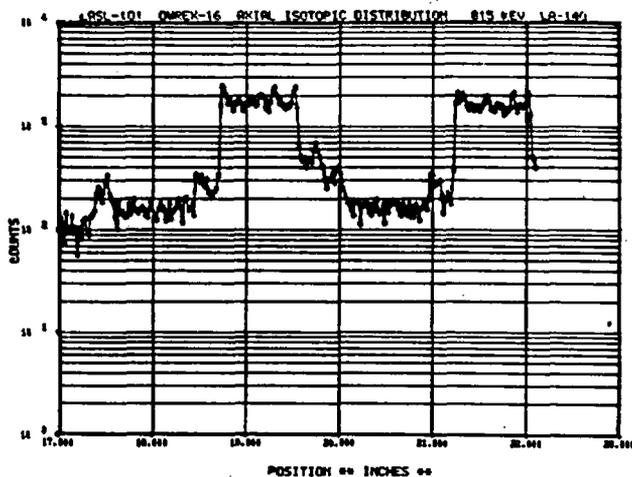
Fig. 21.  
Axial distribution of  $^{140}\text{Ba}$ - $^{140}\text{La}$  in the OWREX-16 assembly.

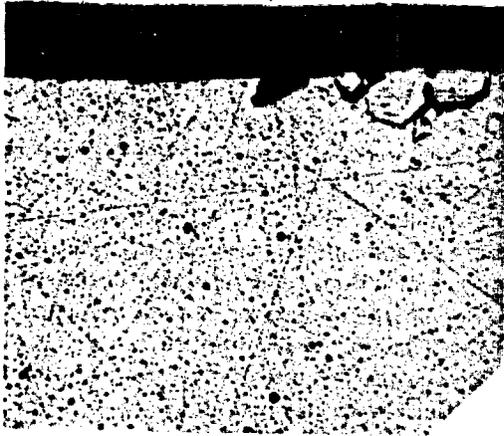
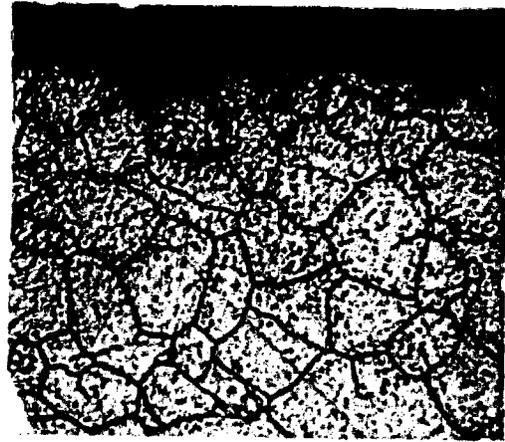
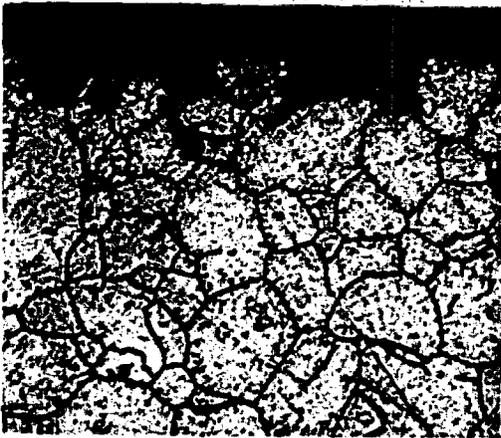
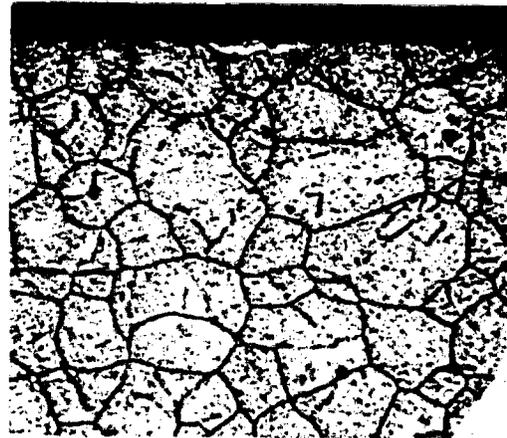
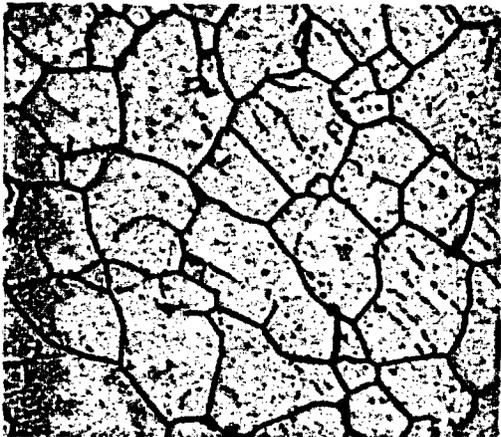
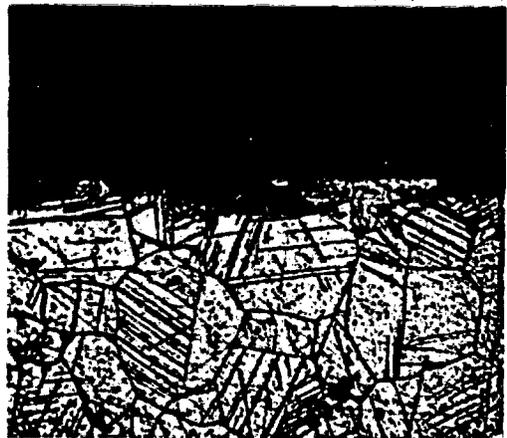
Fig. 23.

Type 316 stainless steel from OWREX-14 irradiation. (a) Inner surface of transverse cladding specimen OA90, as-polished, 300X, (b, c, d) inner surface of transverse cladding specimen OA90, oxalic acid electrolytic etch, 525X, (e) center of wall from transverse cladding specimen OA90, oxalic acid electrolytic etch, 525X, (f) fuel contact surface of insulator, Sec. OA88, oxalic acid electrolytic etch, 525X.

**2. Metallography.** Transverse Sec. OA90 from OWREX-14 is shown in Fig. 23 after this portion of the experiment operated for 2340 h at a cladding inner surface temperature of  $\sim 700^\circ\text{C}$ . Isolated regions were found in which the cladding had been penetrated intergranularly and from which surface grains had been removed during polishing (Fig. 23a). Whether this pullout was a result of irradiation or of storage before metallographic examination was not established. In the etched condition the cladding inner surface exhibited heavier-than-average concentrations of precipitates, assumed to be  $M_{23}C_6$ -type carbides, in a few locations (Figs. 23b, 23c), and an additional few white, precipitate-free surface zones (Fig. 23d). Fuel from this section achieved 4.4 at.% burnup but could not be distinguished from control specimens. The longitudinal cladding section (not shown) comprising the remaining fueled portion of the OWREX-14 upper capsule showed inter- and intragranular precipitates and grain pullout along the inner surface. The longitudinal cladding section from the sodium meniscus region showed none of the unusual characteristics of the other cladding sections. The stainless steel insulator pellet, Sec. OA88, on which the carbide fuel had rested is shown in Fig. 23f. Precipitates were visible in the slip planes near the surface, accompanied by a thin, intermittent, precipitate-free layer at the surface. Pullout of surface grains was not observed in this specimen. Because significant fuel-clad interaction was not observed in the higher temperature capsule from OWREX-14, the lower temperature capsule was not examined.

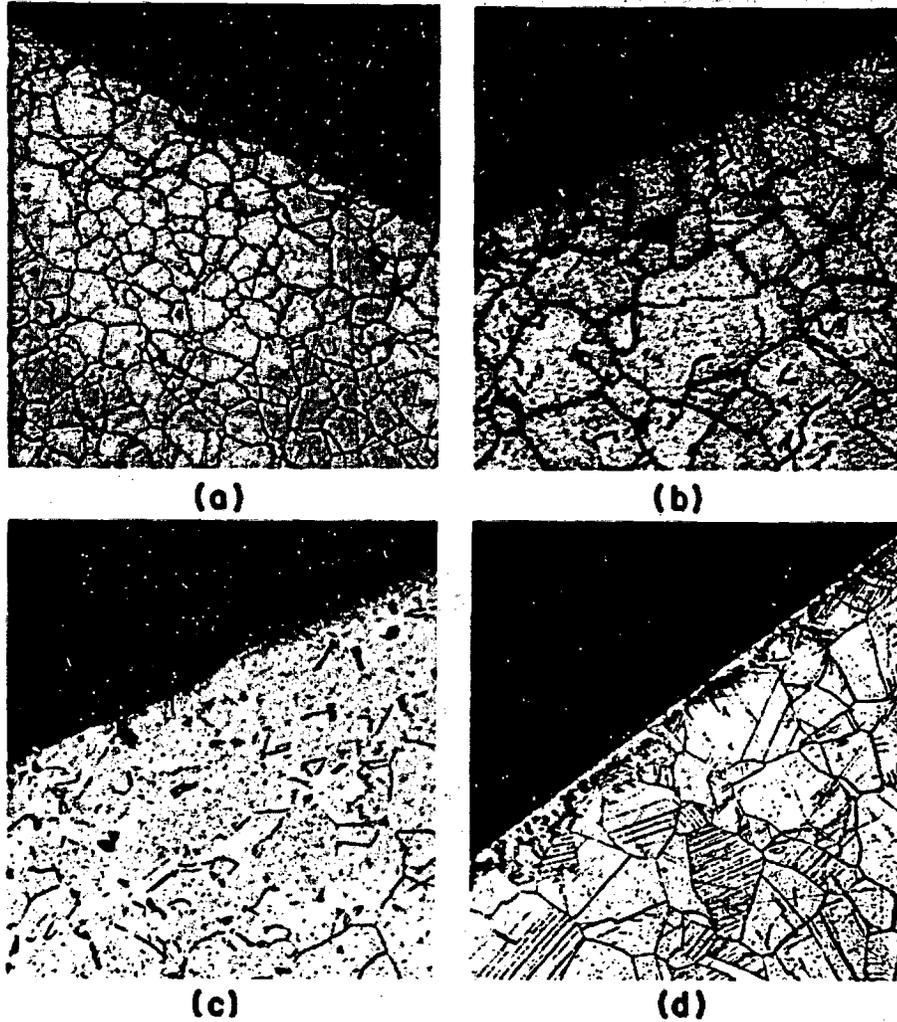
**Fig. 24.**  
*Type 316 stainless steel from OWREX-15 irradiation, oxalic acid electrolytic etch, (a) inner surface of transverse cladding specimen OA94, 300X, (b, c) inner surface of longitudinal cladding specimen OA96 at high temperature end of capsule, 525X, (d) fuel contact surface of insulator pellet, Sec. OA98, 300X.*

The upper fuel capsule from OWREX-15 was examined destructively after operating for 3650 h at elevated temperature and attaining 7.3 at.% fuel surface burnup. Cladding inner surfaces that operated at  $\sim 700^\circ\text{C}$  showed intermittent inter- and intragranular precipitates (Secs. OA94 and OA96), Figs. 24a and 24b. At other locations in the same sections, the oxalic acid etchant failed to delineate some grain boundaries (Fig. 24c), and overetched others, primarily in the vicinity of triple points. Intragranular precipitates imparted a stippled appearance to the cladding. Repeated polishing and etching revealed the same structures. Because the oxalic acid etchant was specific for carbides, the white grain boundaries apparently were deficient in carbides relative to the remainder of the cladding.

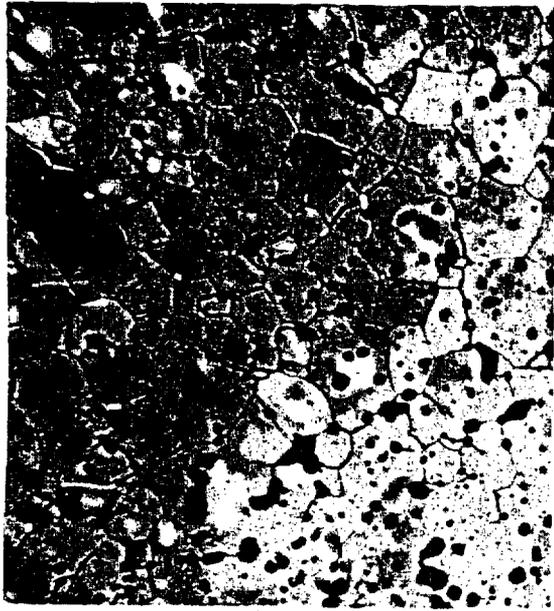
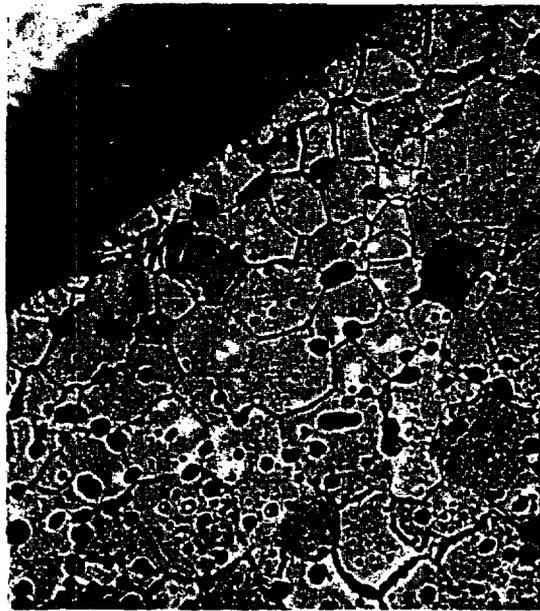
Fig. 25.  
OWREX-15 fuel, lactic-acetic-nitric acid etch (2:2:1), 300X, (a) fuel interior from longitudinal Sec. OA93, (b,c) fuel surface from transverse Sec. OA95.

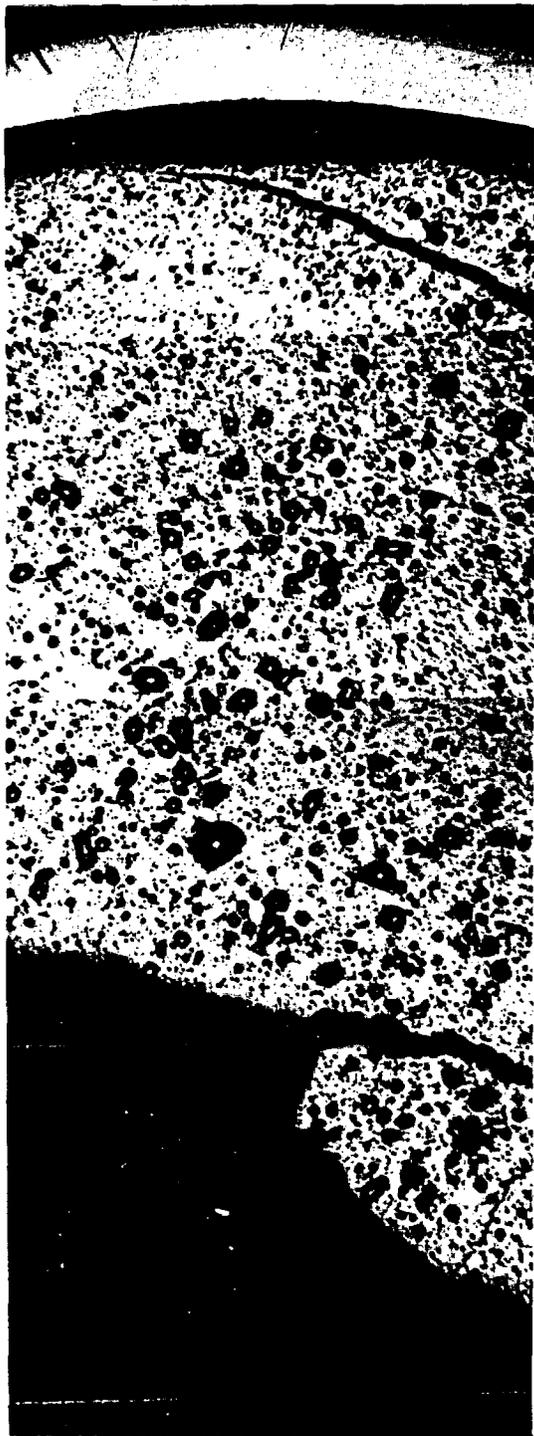
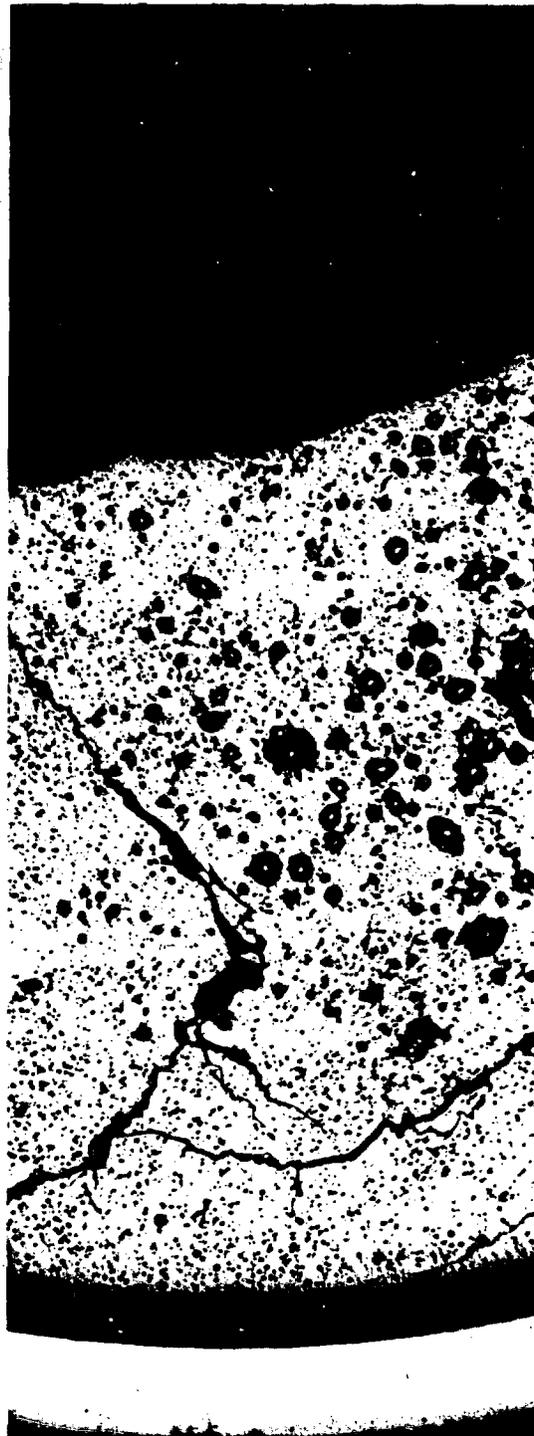
*Low temperature, fuel/cladding transverse Sec. 1B27 from OWREX-16. Cladding inner surface operated at  $\sim 610^{\circ}\text{C}$ . As-polished, 50X.*

OWREX-16 operated for  $\sim 6700$  h at an elevated temperature and reached a fuel surface burnup of  $\sim 13$  at.%. Both capsules were examined destructively. Fuel-clad sections from the highest temperature portion of the top capsule and from the lowest temperature portion of the bottom capsule are shown in Figs. 26 and 27. The difference in operating temperature between these sections was  $\sim 100^\circ\text{C}$ . The low temperature section appeared unchanged except for cracking of fuel and weeping of sodium reaction products from fuel pores, accounting for the large dark blobs visible in Fig. 26. An annular region of fine cracks, beginning  $\sim 0.010$  in. beneath the fuel surface and extending inward another 0.030 in. was visible in the higher temperature section, Fig. 27. The polished specimen showed no other features.

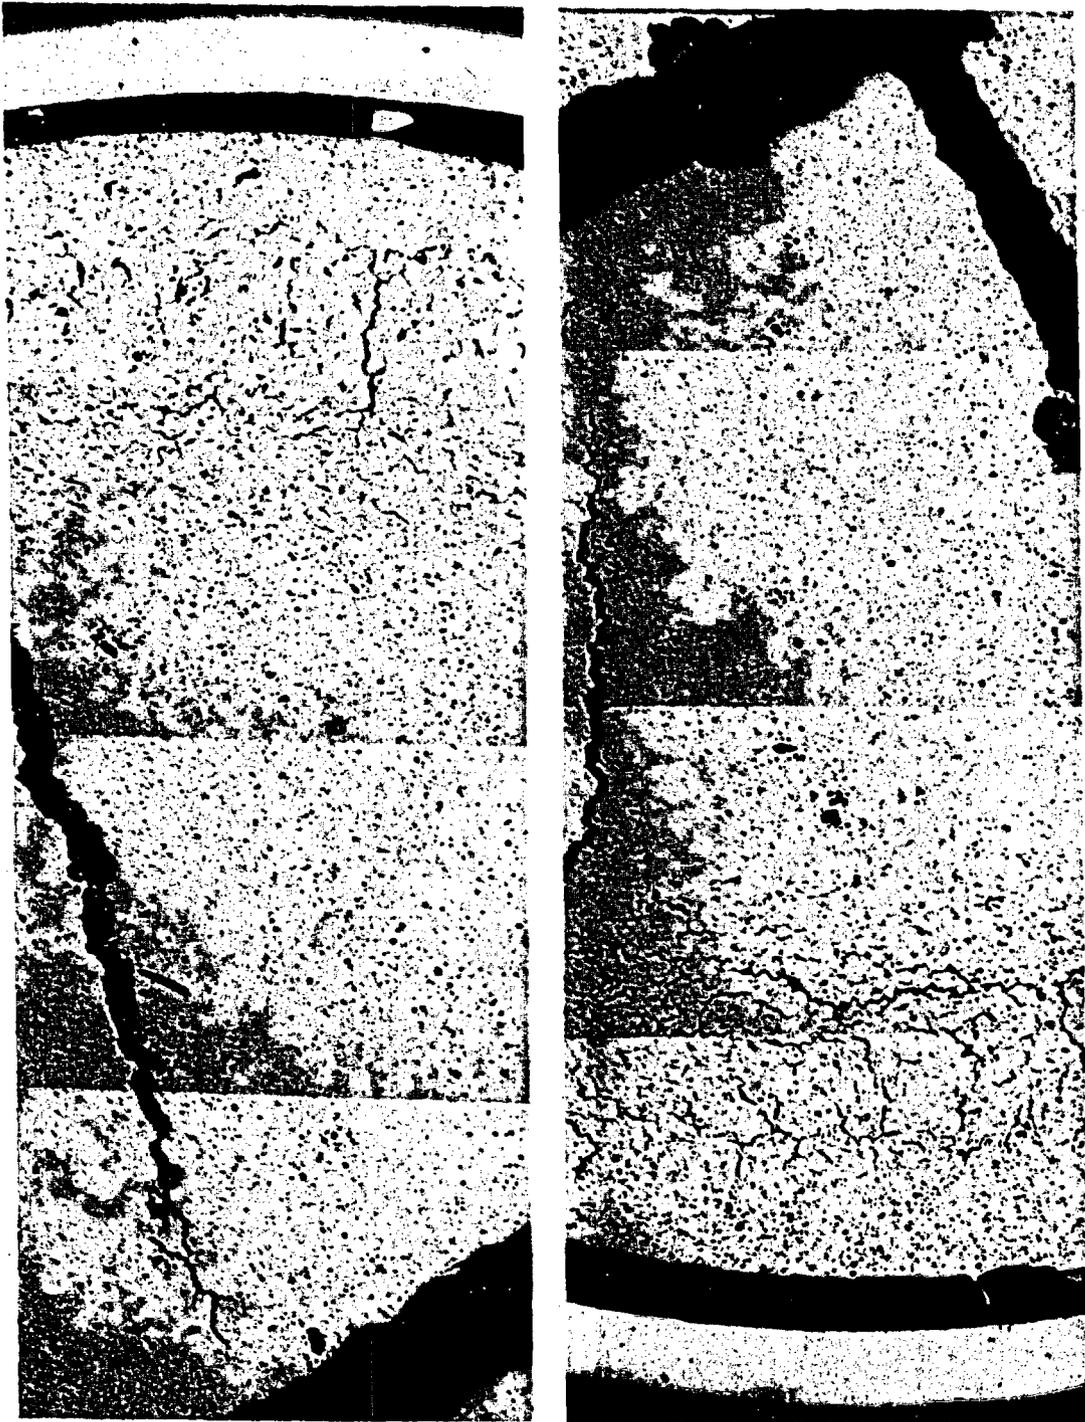
Fig. 27.

*High temperature fuel/cladding transverse Sec. 1B23 from OWREX-16. Cladding inner surface operated at  $\sim 710^{\circ}\text{C}$ . As-polished, 50X.*

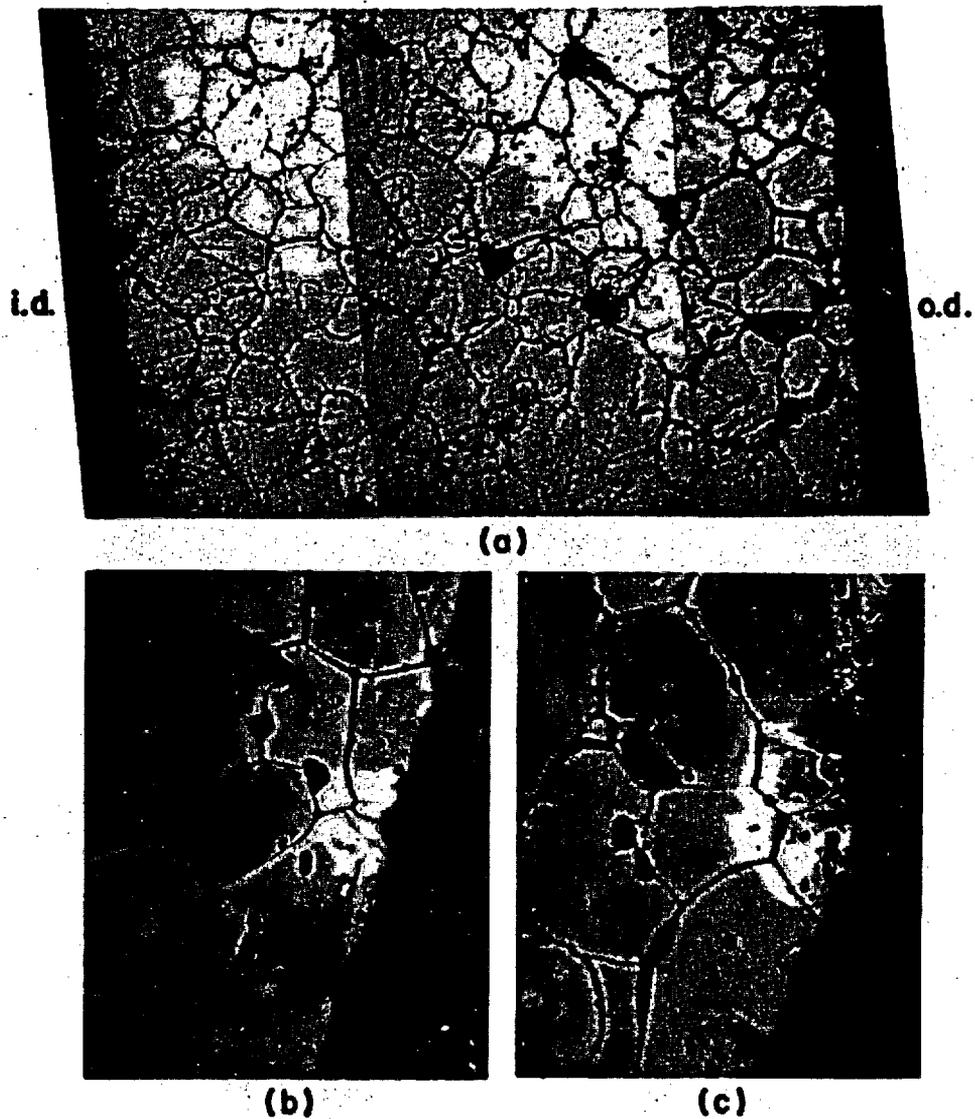
**Fig. 28.**  
*Fuel/cladding transverse Sec. 1B27 from the lower temperature OWREX-16 capsule. The cladding inner surface operated at an estimated 610°C. (a) Cladding section, oxalic acid electrolytic etch, 525X, (b,c) fuel surface, lactic-acetic-nitric acid etch. 525X.*

The etched capsule wall from the colder section is shown in Fig. 28a. The inner surface showed a slight nonuniform precipitate, assumed to be  $M_{23}C_6$ -type carbides. The exterior portions of the wall contained significant grain boundary precipitates, assumed to be  $M_{23}C_6$ -type carbides deriving from poor control of oxygen or carbon levels in the secondary bonding sodium during assembly and operation of the experiment. Etched fuel from the colder section is shown in Figs. 28b and 28c. The only obvious departure in appearance from as-fabricated material was staining caused by the weeping of sodium reaction products. Small light-colored inclusions were observed throughout the fuel and were assumed to be the silicon- and plutonium-rich material found in control samples.

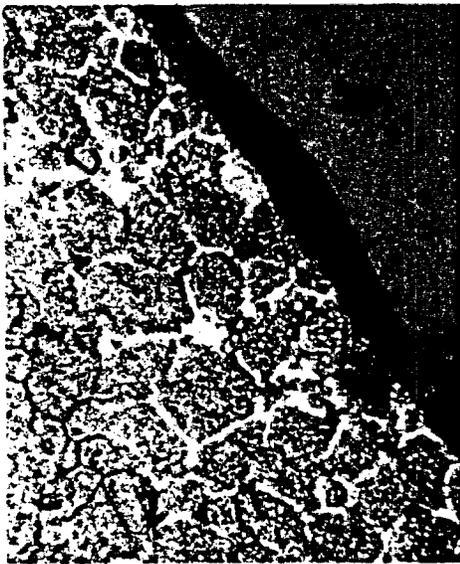
Fig. 29.  
Type 316 stainless steel from transverse Sec. 1B23, OWREX-16. Cladding inner surface operated at an estimated 710°C. Oxalic acid electrolytic etch, 525X.

An increase of  $100^\circ\text{C}$  in operating temperature caused a significant change in the postirradiation appearance of the etched cladding, as shown by transverse Sec. 1B23, Fig. 29. The cladding had a stippled appearance throughout, and exhibited heavier grain boundary precipitates along the outside surface than along the inner surface. At intervals along the inner third of the cladding wall, grain boundaries failed to etch, producing the white network visible in Figs. 29a and 29b, and material in the vicinity of some triple points took on a coarse, black appearance. An additional few regions along the inner surface exhibited a thin, white layer and an intergranular phase (Fig. 29c). Repeated polishing and etching of the cladding did not alter its appearance.

All the insulator pellets (Figs. 23, 24, and 31) and a few regions of the clad inner surface (Fig. 29c) exhibited

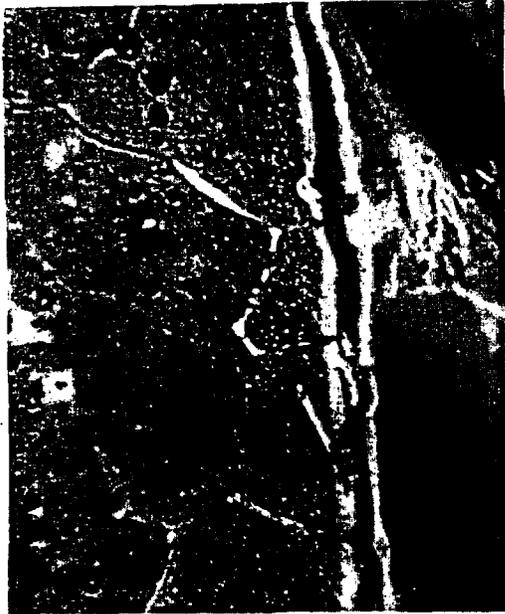
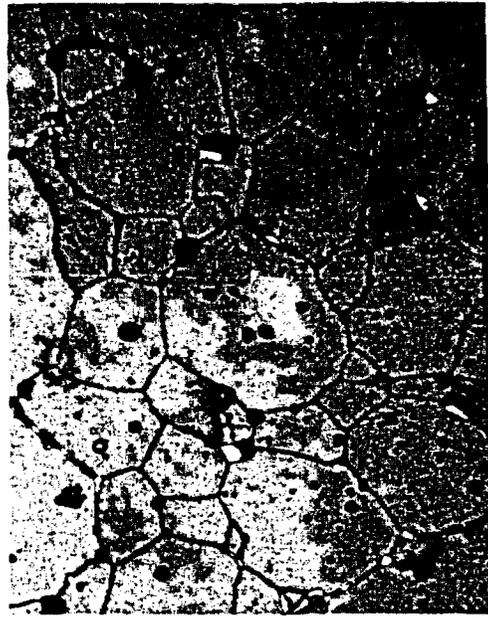
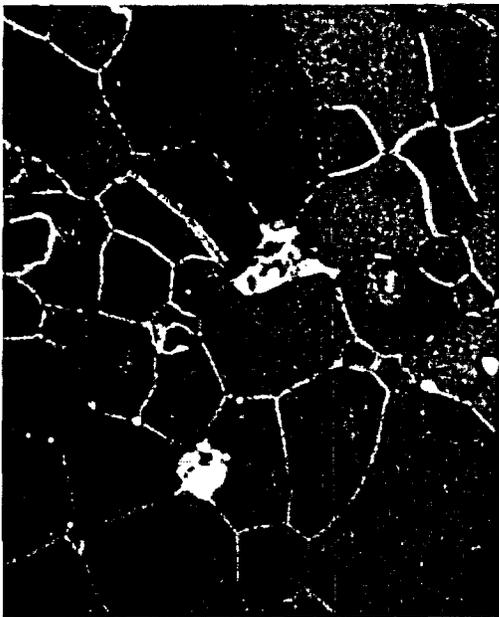
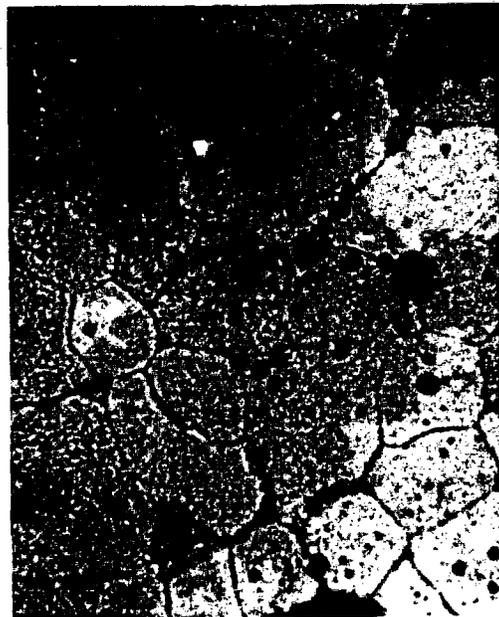
*Fuel transverse Sec. 1B23, OWREX-16, after irradiation to surface burnup of ~13 at.%. Lactic-acetic-mitric acid etch, 525X. (a) Fuel surface, (b, c) outer 0.020 in. of fuel, (d) fuel center.*

The microstructure of etched fuel in the high temperature, transverse section from OWREX-16 is shown in Fig. 30. The structure appeared unchanged from that of controls. However, the light-colored inclusions were more in evidence than would have been expected based on the results of routine metallographic inspections made on control pellets. Inclusions were visible throughout the irradiated sample, but variations in concentration with radial position, such as might be expected if the distribution of the phase were influenced by burnup or temperature gradient, could not be determined in the brief examination allotted this specimen.

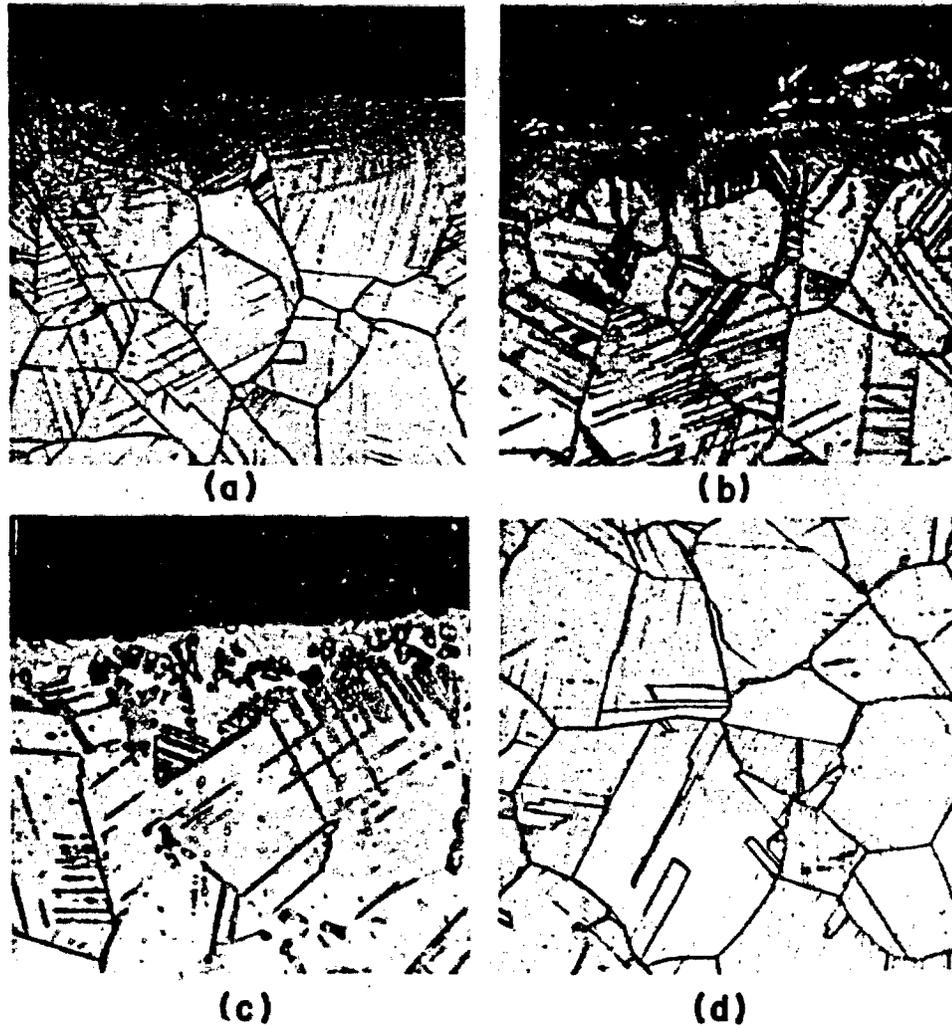
**Fig. 31.**  
*Type 316 stainless steel insulator pellets 1B26 and 1B28, OWREX-16. Surfaces in contact with fuel operated at estimated temperatures of 570 to 600°C. Oxalic acid electrolytic etch, 525X. (a) Lower temperature insulator pellet surface, (b) higher temperature insulator pellet surface at corner, (c) higher temperature insulator pellet surface at center, and (d) higher temperature insulator pellet interior.*

Microstructures of the insulator pellets from both OWREX-16 capsules (Table VII) appear in Fig. 31. The fuel contact surface of the colder insulator pellet showed the same structure throughout: heavy intragranular precipitates to a depth of  $\sim 0.001$  in. and to a thin, intermittent, precipitate-free surface zone (Fig. 31a). The higher temperature insulator pellet was not uniform across the surface that had contacted fuel. The edges of the upper surface of the insulator pellet exhibited the heavy precipitate (Fig. 31b) observed in the OWREX-15 insulator pellet, whereas the surface at the pellet center exhibited an angular or crystalline-appearing phase beneath which some coarse, spheroidized precipitates appeared (Fig. 31c). The normal microstructure of this insulator pellet, in a region removed from the fuel contact surface, is shown in Fig. 31d.

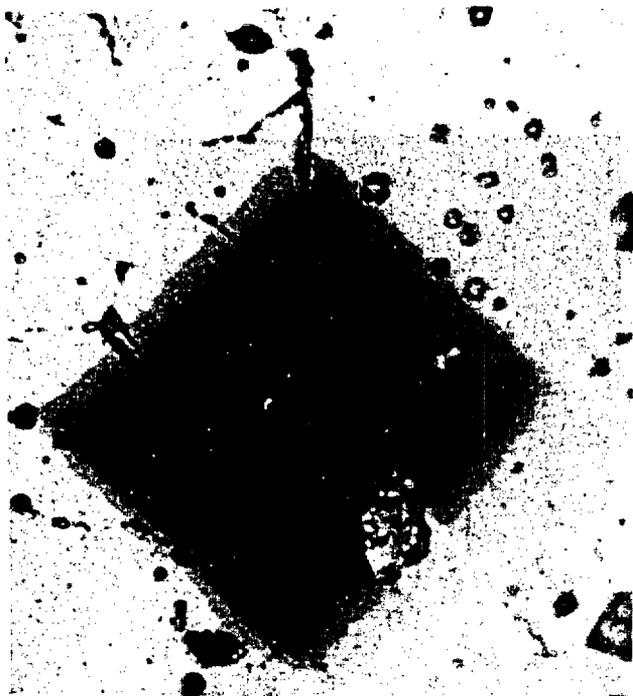
Fig. 32.

*OWREX-16 fuel, transverse Sec. 1B23 adjacent to fuel pellet surface, as-polished, 525X. Microprobe examination of darkened area revealed small regions enriched in noble metal fission products. Light blob at edge of darkened region was caused by release of entrapped sodium from the fuel.*

Fuel lying within 100 to  $200 \mu\text{m}$  of the pellet surface in Sec. 1B23 was examined (Fig. 32). Significantly higher concentrations of plutonium, ruthenium, palladium, rhodium, and silicon, and significantly lower concentrations of uranium were observed in the light inclusions than in the fuel matrix. Concentrations of other major fission products were not detected. Interior regions of the fuel were not examined for possible noble metal fission product concentrations so that, although light-colored inclusions were observed here, the assumption that every light-colored inclusion contained concentrations of noble metal fission products is not warranted. Nor is the assumption warranted that all fission product containing inclusions were silicon- and plutonium-rich with respect to the matrix. A source of silicon external to the fuel was sought by examining cladding and fuel for silicon gradients. Silicon was readily observable in the cladding, but no gradient was detected. Silicon inhomogeneities were present in the fuel but, again, no gradient was detected. Therefore, it is likely that the noble metal fission product-containing inclusions observed with the microprobe were present as plutonium- and silicon-rich inclusions in the as-fabricated fuel, and that fission products migrated to these inclusions during irradiation. Noble metal-containing inclusions have been observed in carbides irradiated to 4 to 5% burnup of heavy atoms<sup>19</sup> and have been produced in lower burnup uranium carbide by a postirradiation heating technique,<sup>20</sup> so that the concentration of noble metals in inclusions in the OWREX-16 fuel is not totally unexpected.

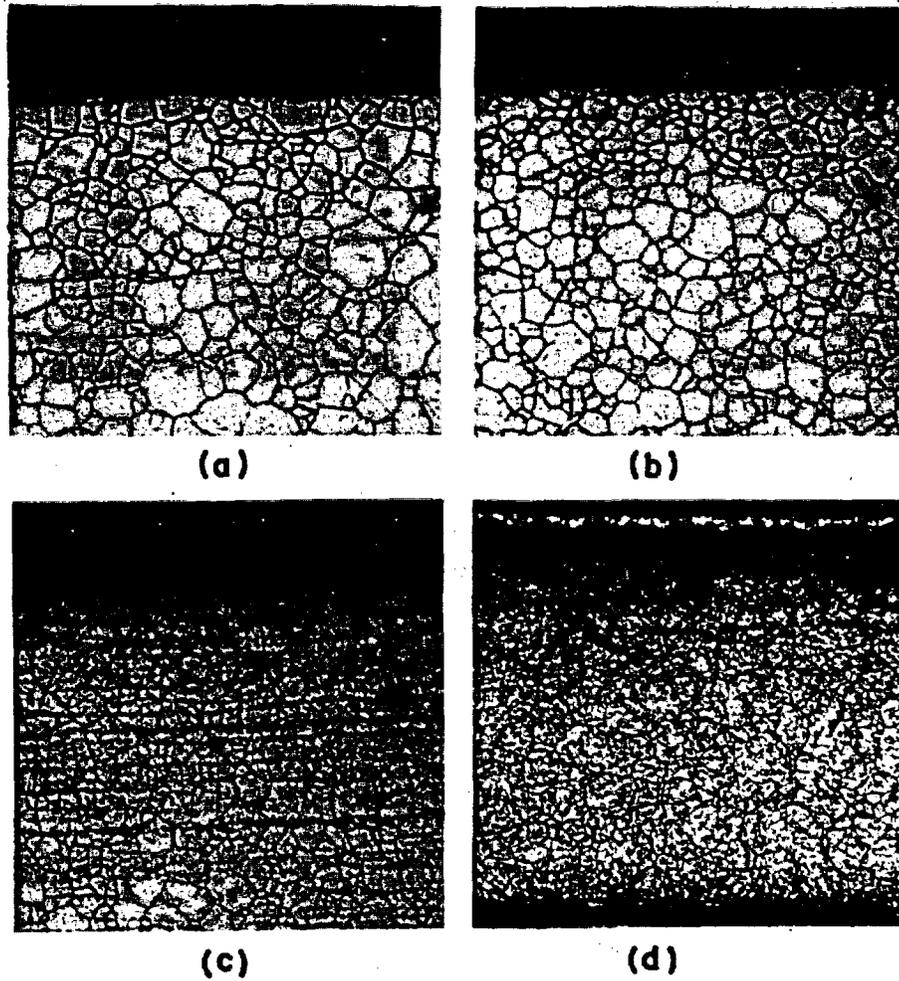
**Fig. 33.**

*Carburization of Type 316 stainless steel that was sodium-bonded to stoichiometric and hyperstoichiometric, solid solution carbides. Oxalic acid electrolytic etch, 300X. (a) stoichiometric fuel, 1000 h at 550°C, (b) hyperstoichiometric fuel, 1000 h at 650°C, (c) hyperstoichiometric fuel, 1000 h at 750°C, and (d) hyperstoichiometric fuel, 4000 h at 700°C.*

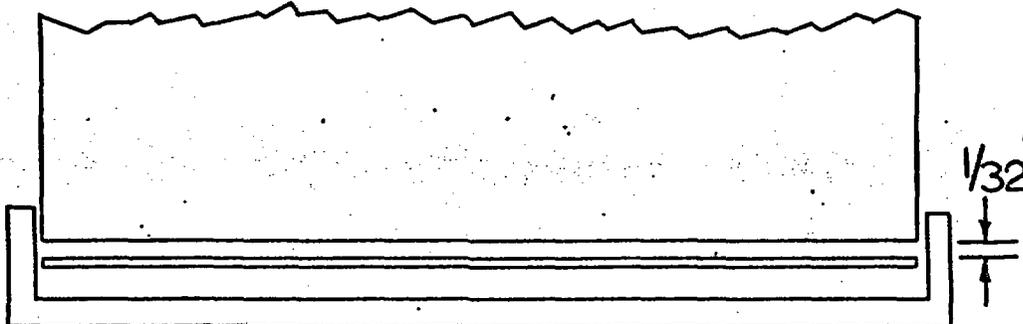
FIG. 6-1 CALIBRATION JIG

7. Switch to the 100K range.
8. Note the reading on the meter scale. It should be 60,000 cpm.
9. Note the reading on the electrostatic voltmeter. It should be between 950 and 1,250 volts.
10. Note the reading on the VTVM. It should be greater than 100 millivolts.
11. If the reading at step 8 is not 60,000 cpm then adjust R14 until it is. If, in order to get a reading of 60,000 cpm, the reading of step 10 is reduced to less than 100 millivolts then FULL CALIBRATION must be performed except that a lower voltage tap should not be used.

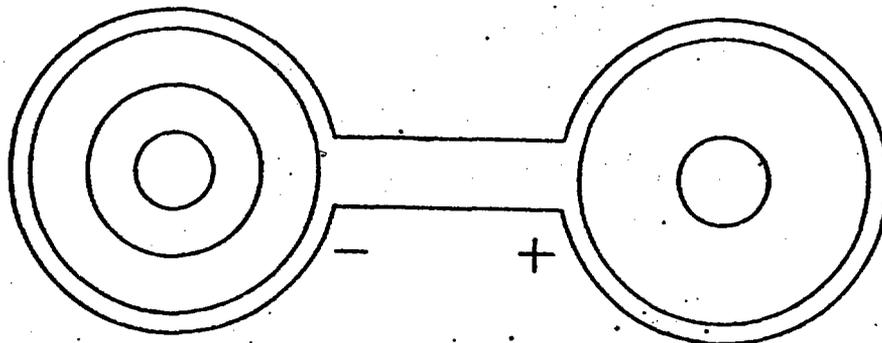
FIG. 5-2 BATTERY POLARITY
