### **SAFT-UT Images of the Most Significant Flaws**

This appendix contains the results of a nondestructive examination of nuclear reactor vessel weldment for the presence of fabrication defects. Sections of material, approximately 1219 mm (4 ft.) in length, were cut from an unused nuclear reactor vessel, the Midland Vessel, by Babcock and Wilcox (Booth 1998) and sent to the EPRI NDE Center. PNNL conducted a sequence of inspections using the Synthetic Aperture Focusing Technique for Ultrasonic Testing (SAFT-UT) on this vessel material under the sponsorship of the U.S. Nuclear Regulatory Commission for the purpose of detecting and characterizing the fabrication (preservice) defects. The results of these SAFT-UT inspections are the subject of this report.

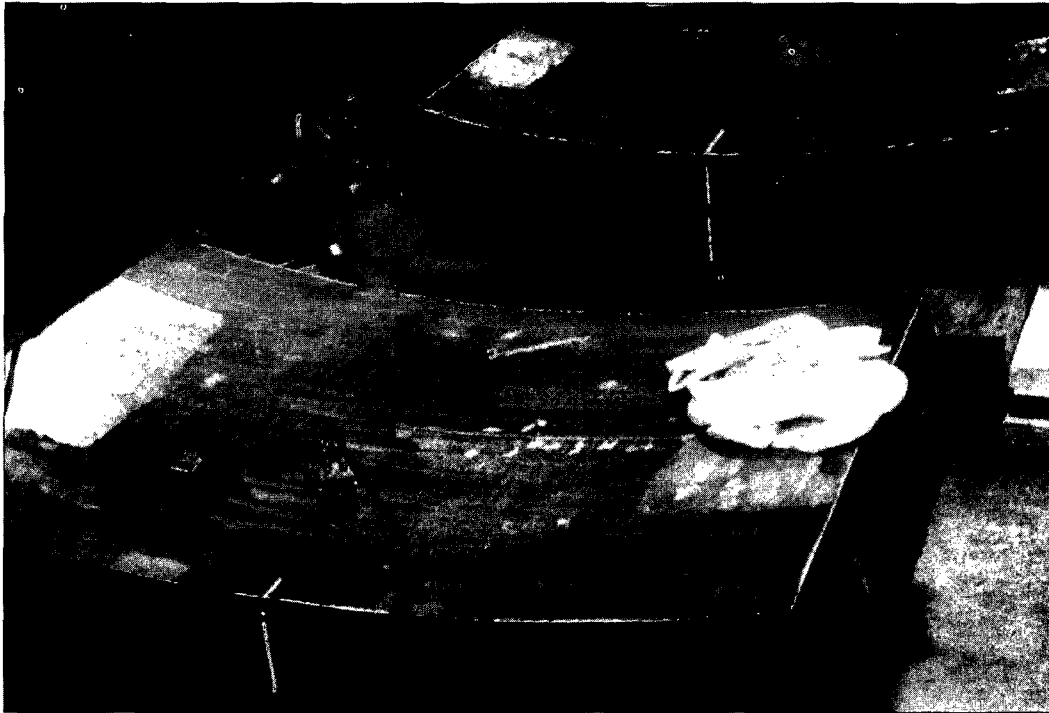
**Figure 3.1 Photo of Material Removed from the Midland Vessel**

Four of the blocks that were cut from the beltline weld of the Midland vessel were inspected by SAFT-UT. The inspections covered a total of 4166 mm (164 in.) of circumferential weld length by collecting 155 files containing 650 Mbytes of data. Figure 3.1 shows some of the Midland blocks at the EPRI NDE Center when the SAFT-UT inspections were starting. Figure 3.2 shows the SAFT-UT system during the inspections. Figures 3.3 and 3.4 show the scanning configuration on Block 1-8.

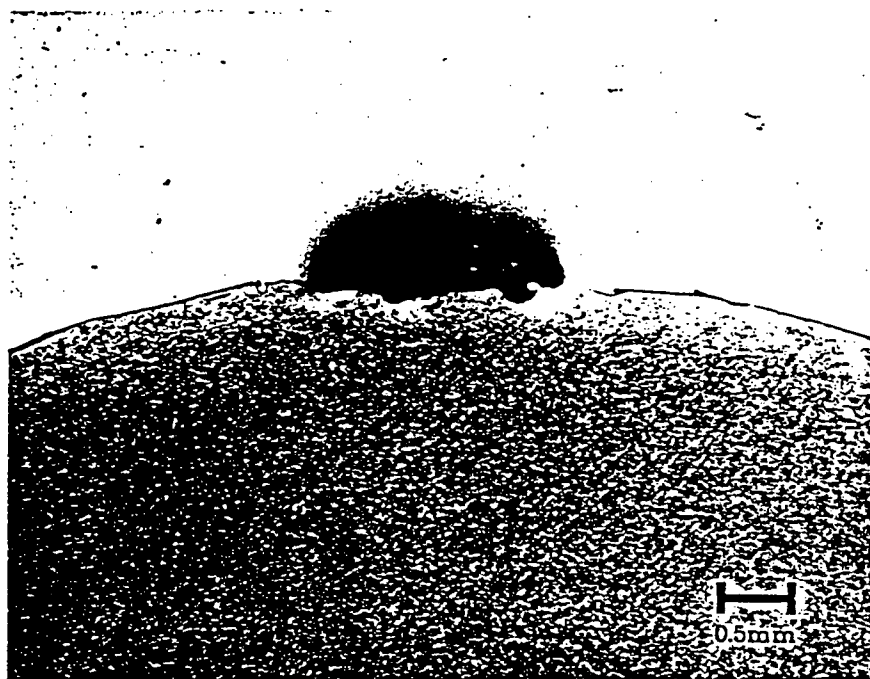
**Figure 4.9 DA Photograph of Midland Flaw 1-8 #10a**  
Photographs provided by the EPRI NDE Center

(b) As polished and etched, magnification: 20X
