**Attachment 3  
To  
W3F1-2007-0010**

**Non-Proprietary Copies of Westinghouse Documents  
Associated with the SG Batwing Issue**

DESIGN CRITERIA  
FOR  
SUPPORT BAR  
STABILIZER  
FOR  
STANDARD PLANTS

**Title: Evaluation of Degraded Batwing Tube Supports in the  
Waterford 3 Steam Generators at 3716 MWt Power Uprate  
Conditions**

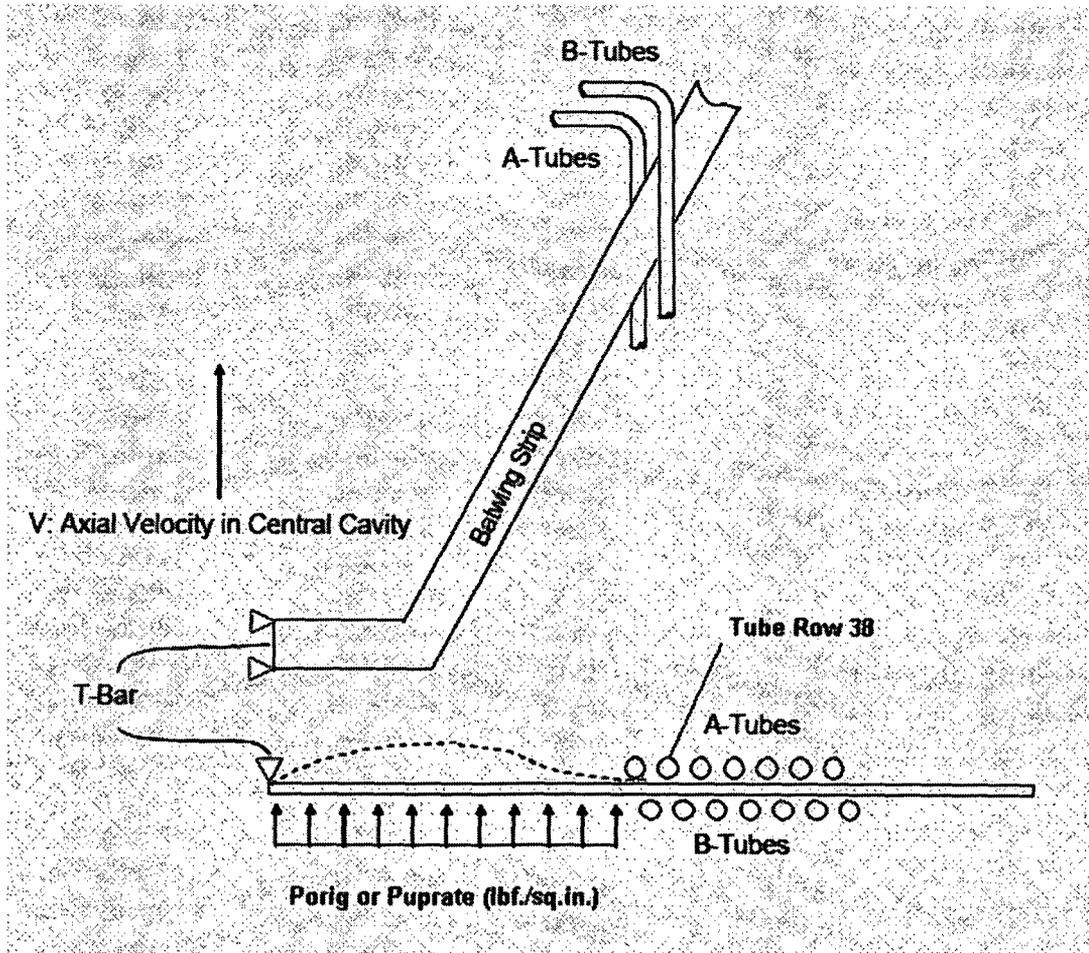
**Figure 6-2**  
**Wear Model with Quasi-Static Pressure Load applied with the Central Cavity**

The forces ( $F_{orig}$  and  $F_{uprate}$ ) that oppose the y or vertical component of the full Batwing Bar with the original thickness and the forces ( $F_{rorig}$  and  $F_{ruprate}$ ) that oppose the y or vertical component of the full Batwing Bar with reduced bar thickness are calculated as follows:

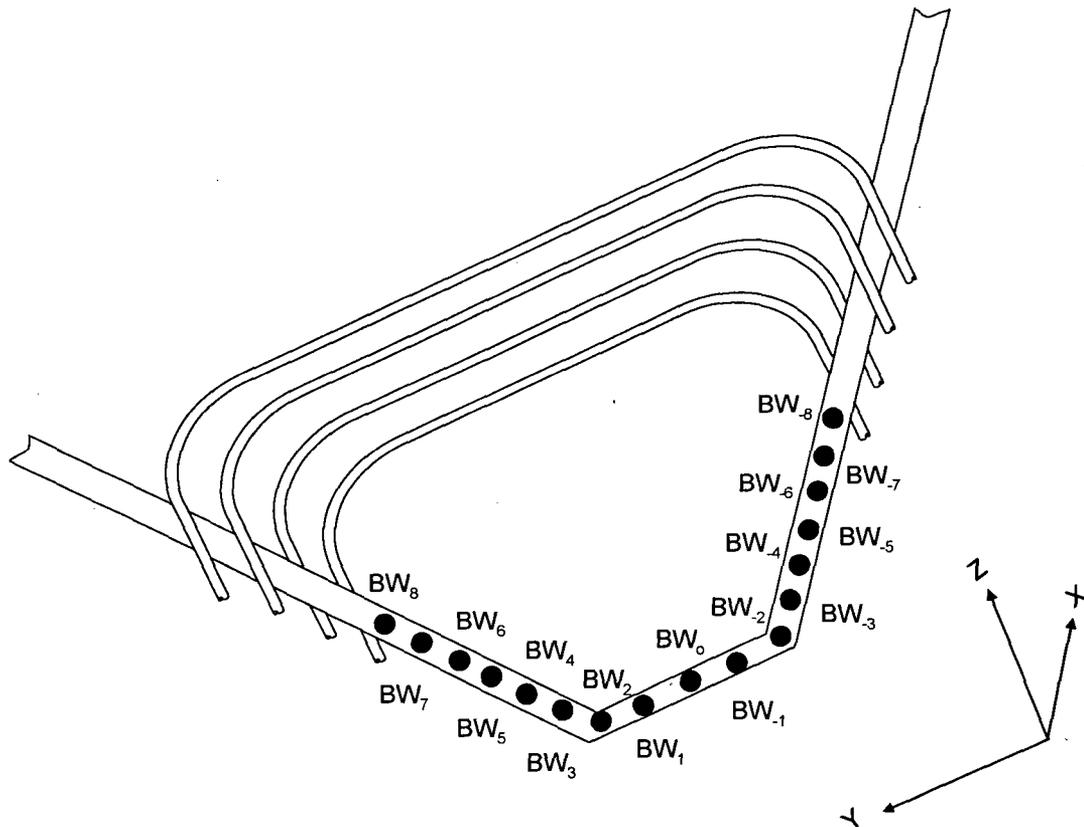
**Figure 2-2 Locations of Velocity Assessment**

It is clear that multiple batwings could fail. It is necessary to determine the impact of batwing spacing change on thermal hydraulic characteristics within the central stay cavity. Changes in thermal hydraulic conditions can affect wear volume over years of operation. Wear volume calculation depends on contact force between the batwing and tube and sliding distance of tube under fluid dynamic pressure over the horizontal span of the U-bend. Both contact force and fluid dynamic pressure depend on fluid density and velocity at batwing within the central cavity and over the horizontal span of the tube-bend (see Figure 2-2).

Fluid density and velocity for these two regions can be assessed under non-failure and multiple-failure of the batwings. Velocity is assessed at 17 discrete points along the batwing (i.e. at  $BW_n$  points; 8 on hot and cold leg side each, and one point at the center). For the as-designed or the intact batwing the secondary fluid density, velocity, and dynamic pressure at the 17 points along batwing are calculated using the ATHOS model of the Waterford 3 steam generators. The dynamic pressure is used to obtain a quasi-static load on the batwing strip at each of the 17 points. Tables 2-1 and 2-2 provide an area-averaged value of the quasi-static load over the 9 points on the hot and cold leg, respectively. The tables include quasi-static loads for all three analyzed conditions, i.e. 3390 MWt with 4.7% SGTP (Cycle 12), and the uprated power level of 3716 MWt with 5.3% SGTP and 20% SGTP. These tables provide data for eight batwings within the central cavity region and one batwing outside the cavity. The tables compare the loads for both the as-designed (intact) as well as batwings with multiple failures.

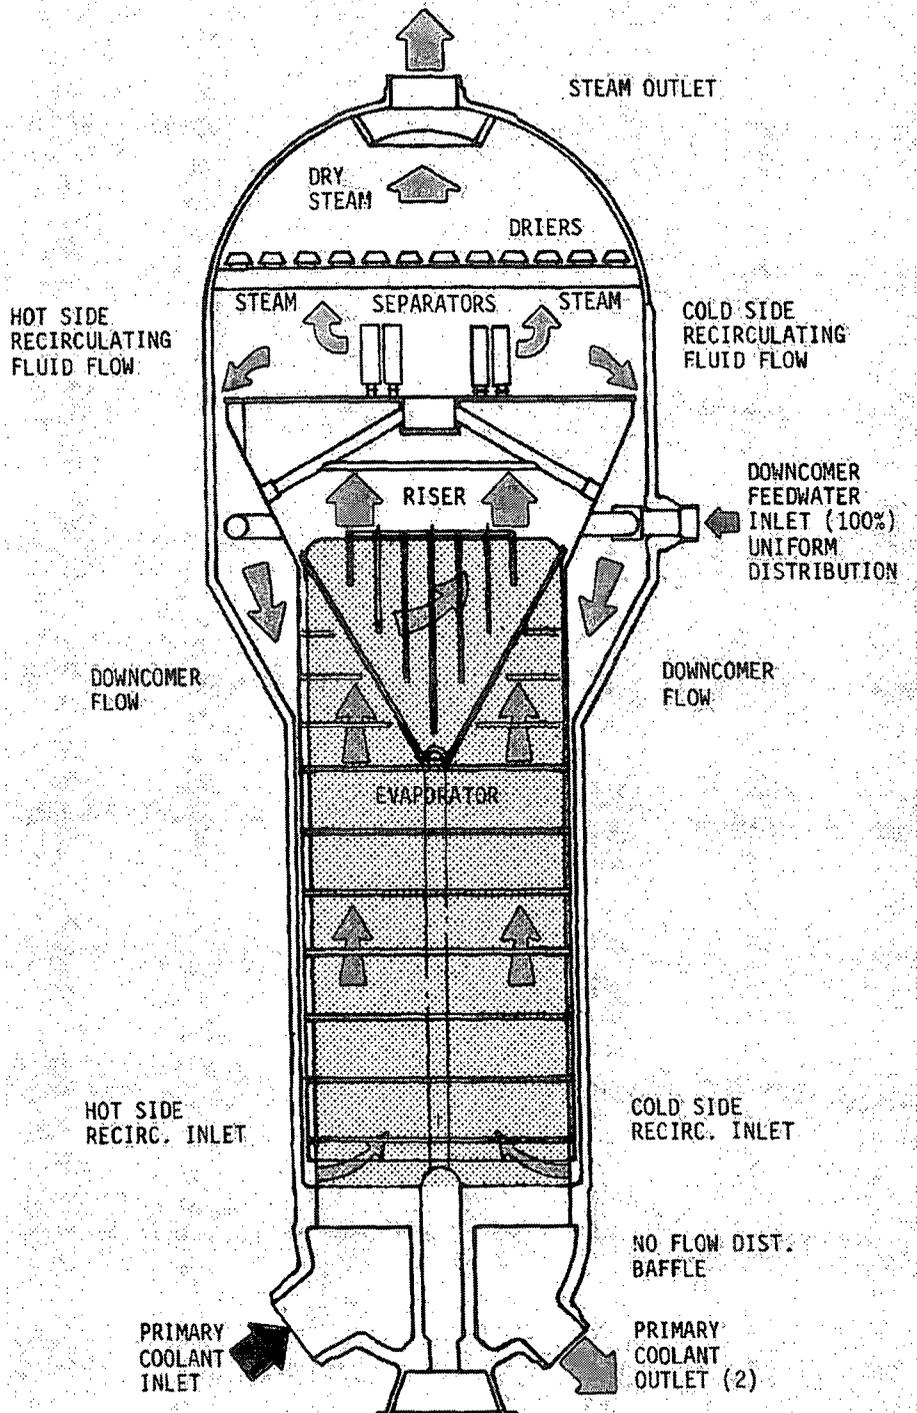
Figure 3-3 Schematic of the Waterford-3 Steam Generators

Figure 3-3 illustrates the Waterford-3 steam generator which includes the batwing and grid support locations in the tube bundle. Figure 3-4 depicts the mesh layout of the ATHOS computational model that provides finer meshes in the upper tube bundle where the batwings are located. The batwings are not included in the computational model as the batwings are thin and lined up in the vertical directions and thus have a negligible impact on the predominantly axial flow in the U-bend region. These finer meshes will adequately define fluid conditions in the central cavity and U-Bend regions. Thermal and hydraulic parameters are similar between the original full power and uprated power conditions. Figures 3-5, 3-6, 3-7 and 3-8 show velocity vectors, velocity contours, density contours, and void fraction contours, respectively, at 3716 MWt with 20% SGTP, along the symmetry plane, IX=1 (middle of the hot leg) and IX=18 (middle of the cold leg).

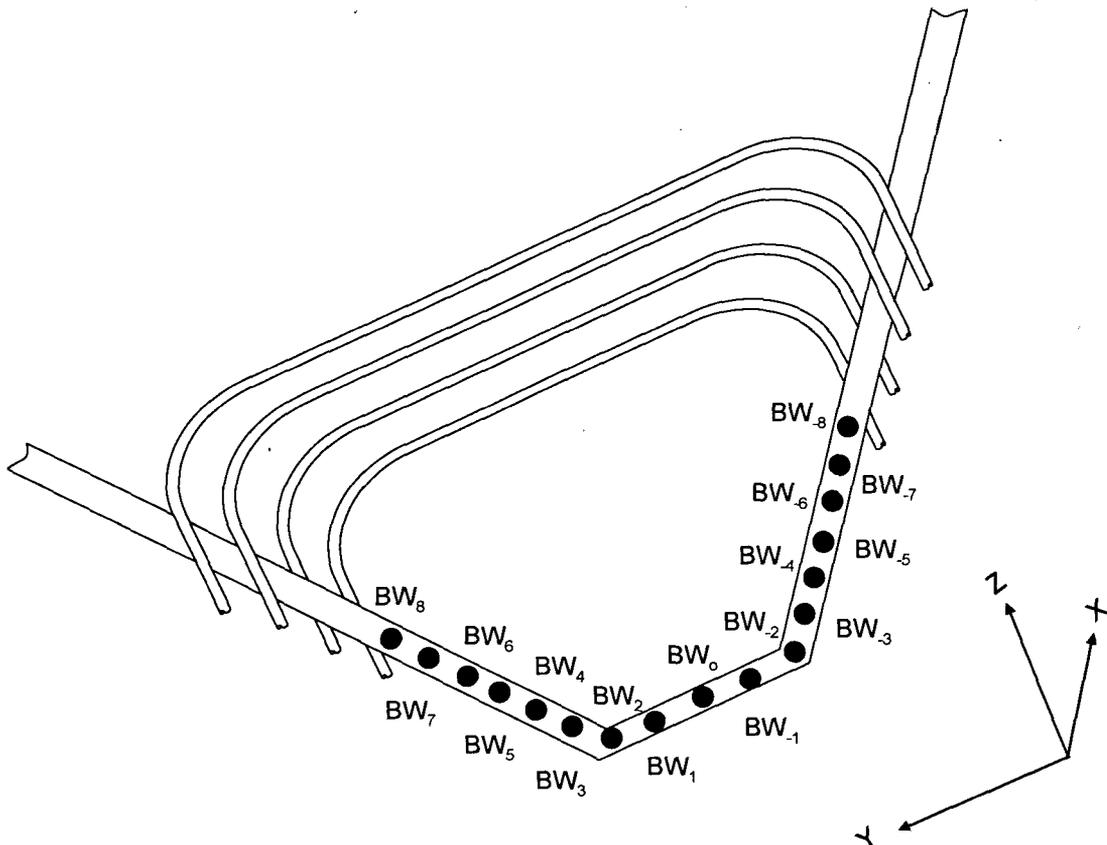
**Figure 3-9 Locations of Thermal Hydraulic Inputs at Batwing and U-tube Horizontal Span**

According to the methodology described in Section 3.1, fluid density and axial velocity are needed only for the batwings. It was decided that input for the horizontal span is not required for evaluation of the failed batwings. Figure 3-9 illustrates locations to define fluid density and axial velocity. For the batwing, there are 17 points for extracting fluid density and axial velocity from results of ATHOS calculation. All 17 points are on the Y-Z plane parallel to the lateral face of the batwing, but away from the batwing lateral surface by a normal distance of 0.388 inch in the direction of X-coordinate. According to the fluid density and velocity, the dynamic pressure (see Equation 3-3) can be calculated at each point and then a quasi-static load (see Equation 3-2) can also be calculated.

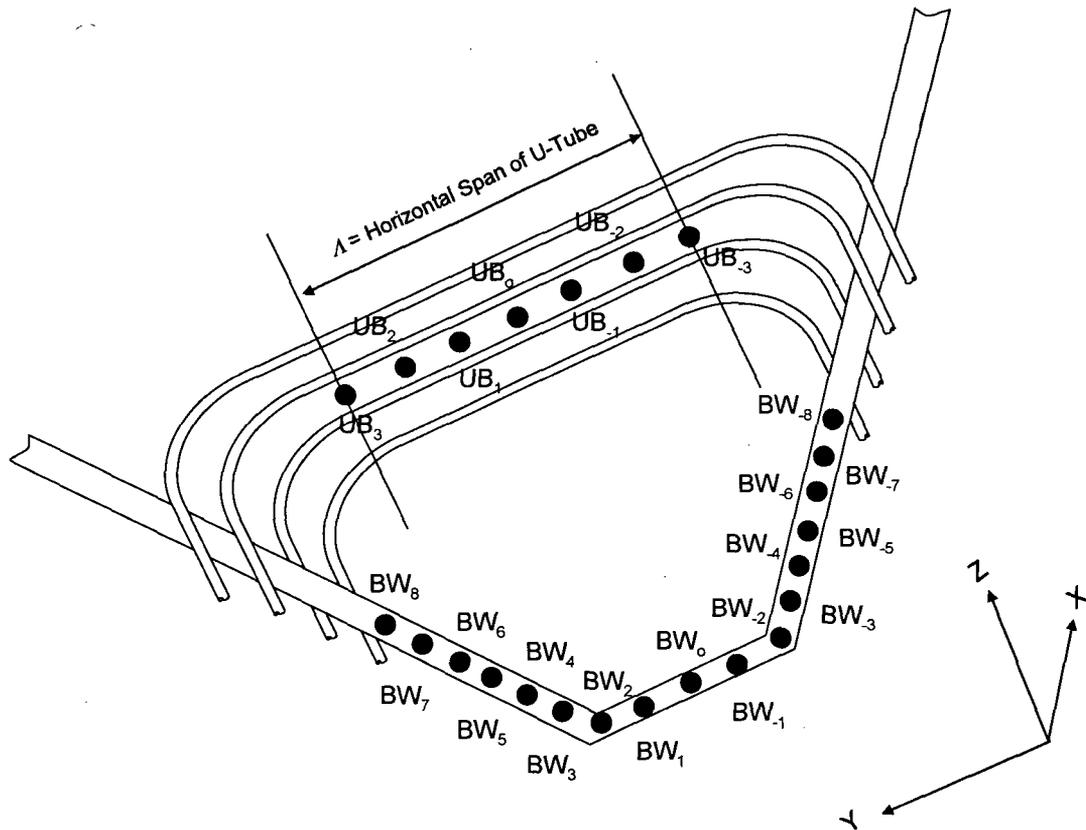
**Figure A-1**  
**Points for Defining Thermal Hydraulic Conditions**  
**On the Batwing and the Horizontal Span**

This appendix defines coordinates of selected points for defining thermal hydraulic conditions for both the batwings and the tube horizontal spans. Figure A-1 illustrates 17 selected points on the batwing and seven points on the horizontal span.

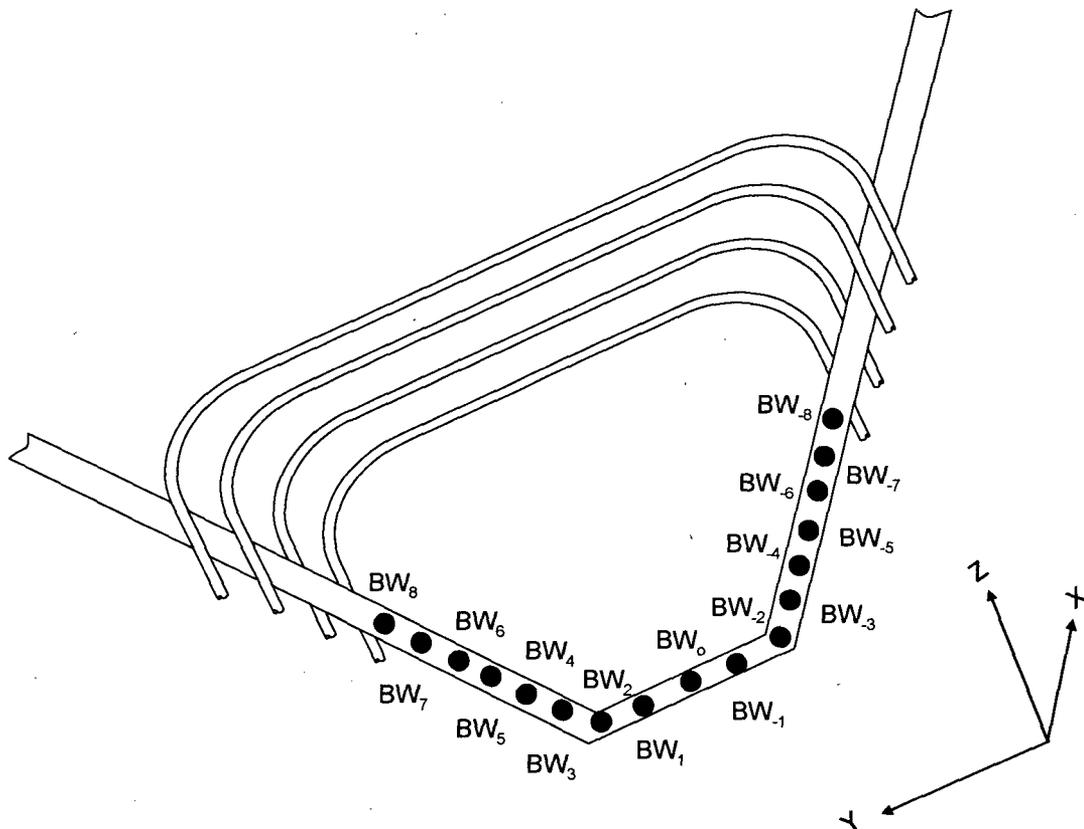
Figure C-1 Locations of 17 points for extracting velocity, density and flow area

Figure C-1 identifies locations of 17 points for extracting the secondary velocity, density, and flow area from ATHOS results, using the homogeneous model, for Batwing #69. Table C-1 lists coordinates for those 17 points for Batwing #69. There is no need to extract ATHOS results for the horizontal span of the U-bend.

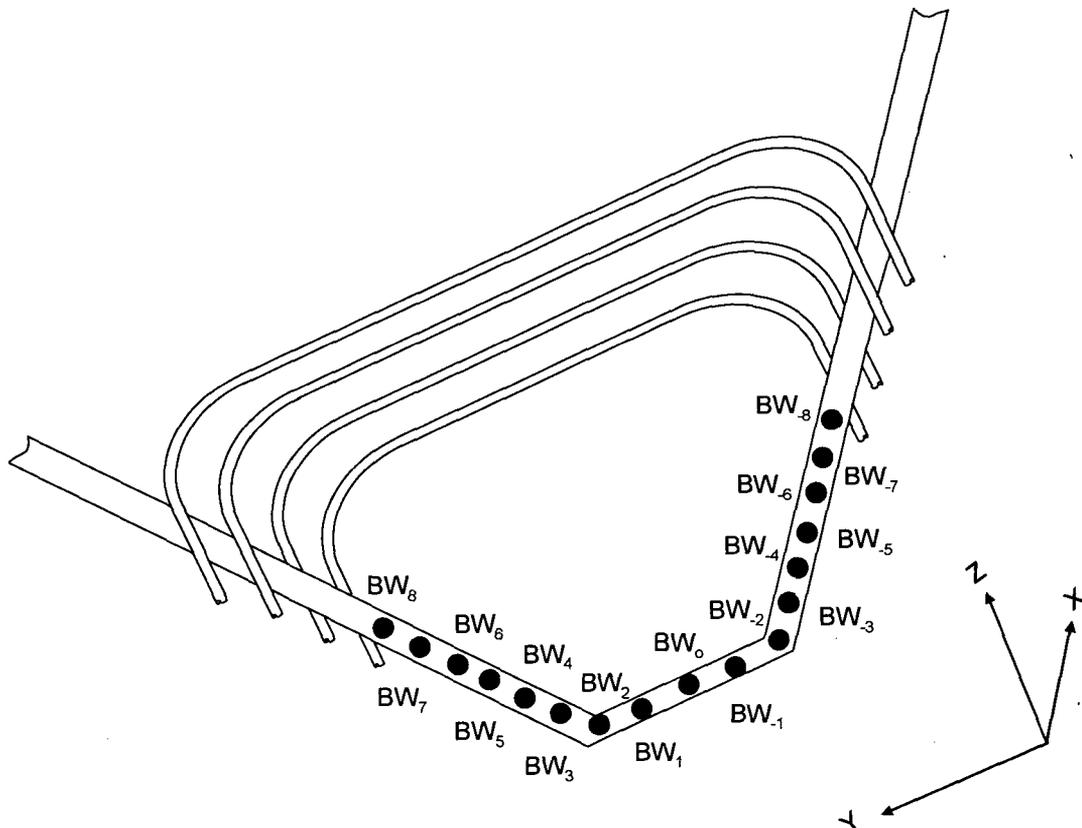
**Figure 2-2 Locations of Velocity Assessment**

It is clear that multiple batwings could fail. It is necessary to determine the impact of the change of the batwing spacing on thermal hydraulic characteristics within the central stay cavity. Changes in thermal hydraulic conditions can affect wear volume over years of operation. Wear volume calculation depends on contact force between the batwing and tube and sliding distance of the tube under fluid dynamic pressure over the horizontal span of the U-bend. Both contact force and fluid dynamic pressure depend on the fluid density and the velocity at the batwing within the central cavity and over the horizontal span of the tube-bend (see Figure 2-2).

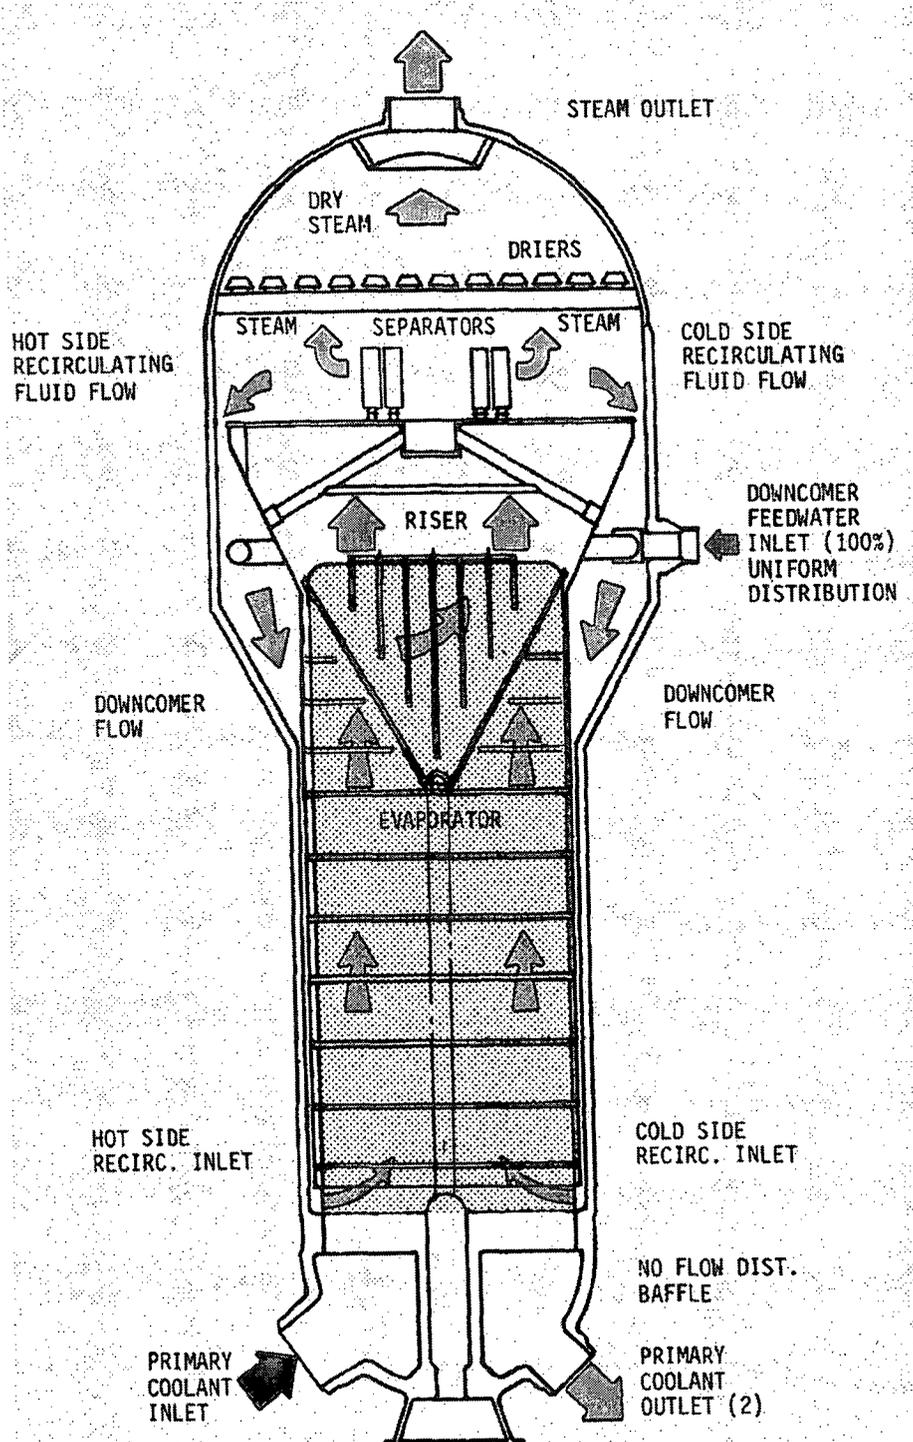
Figure 3-1 Schematic of the Waterford Unit 3 Steam Generators

Figure 3-1 illustrates the Waterford Unit 3 steam generator which includes the batwing and grid support locations in the tube bundle. Figure 3-2 depicts the mesh layout of the ATHOS computational model that provides finer meshes in the upper tube bundle where the batwings are located. The batwings are not included in the computational model as the batwings are thin and lined up in the vertical directions and thus have a negligible impact on the predominantly axial flow in the U-bend region. These finer meshes will adequately define fluid conditions in the central cavity and U-Bend regions. Thermal and hydraulic parameters are similar between the original full power and uprated power conditions. Figures 3-3 through 3-6 show velocity vectors, velocity contours, density contours, and void fraction contours at 3716 MWt with 20% SGTP, along the symmetry plane, IX=1 (middle of the hot leg) and IX=18 (middle of the cold leg).

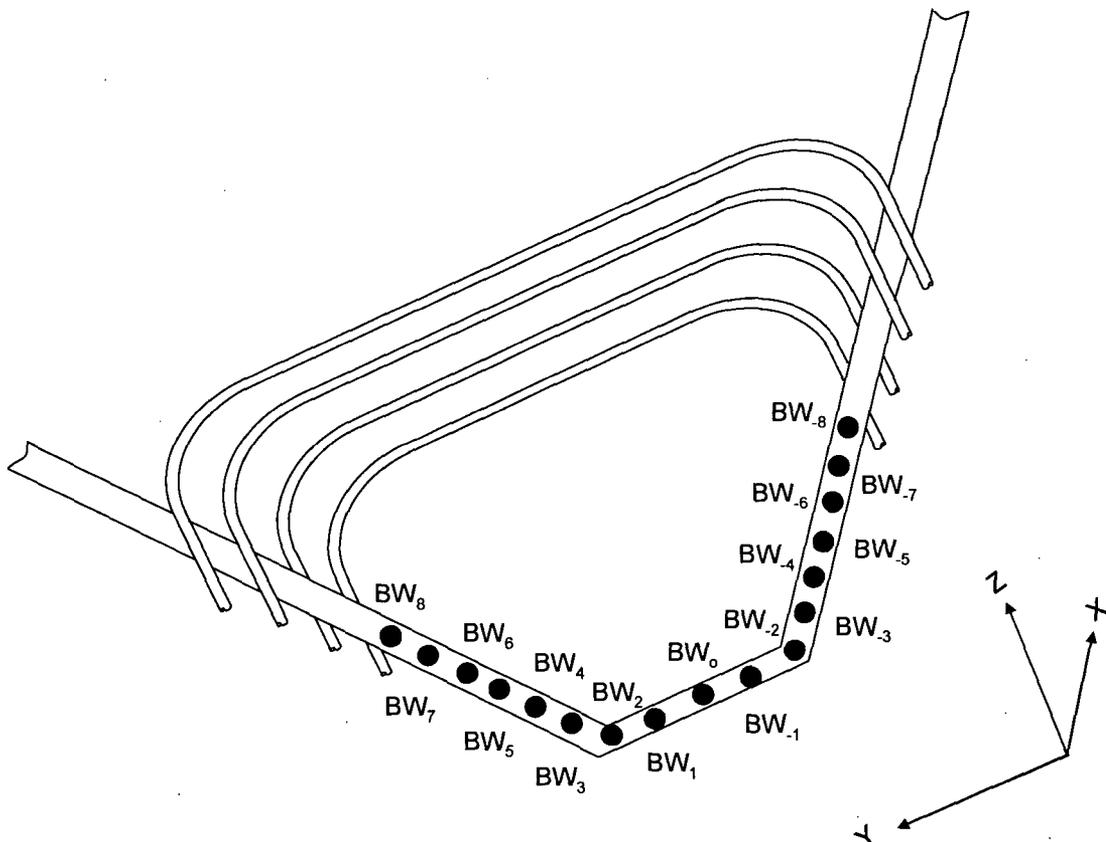
**Figure 3-7 Locations of Thermal Hydraulic Inputs at Batwing and U-tube Horizontal Span**

Fluid density and axial velocity are needed only for the batwings. It was decided that input for the horizontal span is not required for evaluation of the failed batwings. Figure 3-7 illustrates locations to define fluid density and axial velocity. For the batwing, there are 17 points for extracting fluid density and axial velocity from results of ATHOS calculation. All 17 points are on the Y-Z plane parallel to the lateral face of the batwing, but away from the batwing lateral surface by a normal distance of 0.388 inch in the direction of X-coordinate. According to the fluid density and velocity, the dynamic pressure can be calculated at each point and then a quasi-static load can also be calculated.

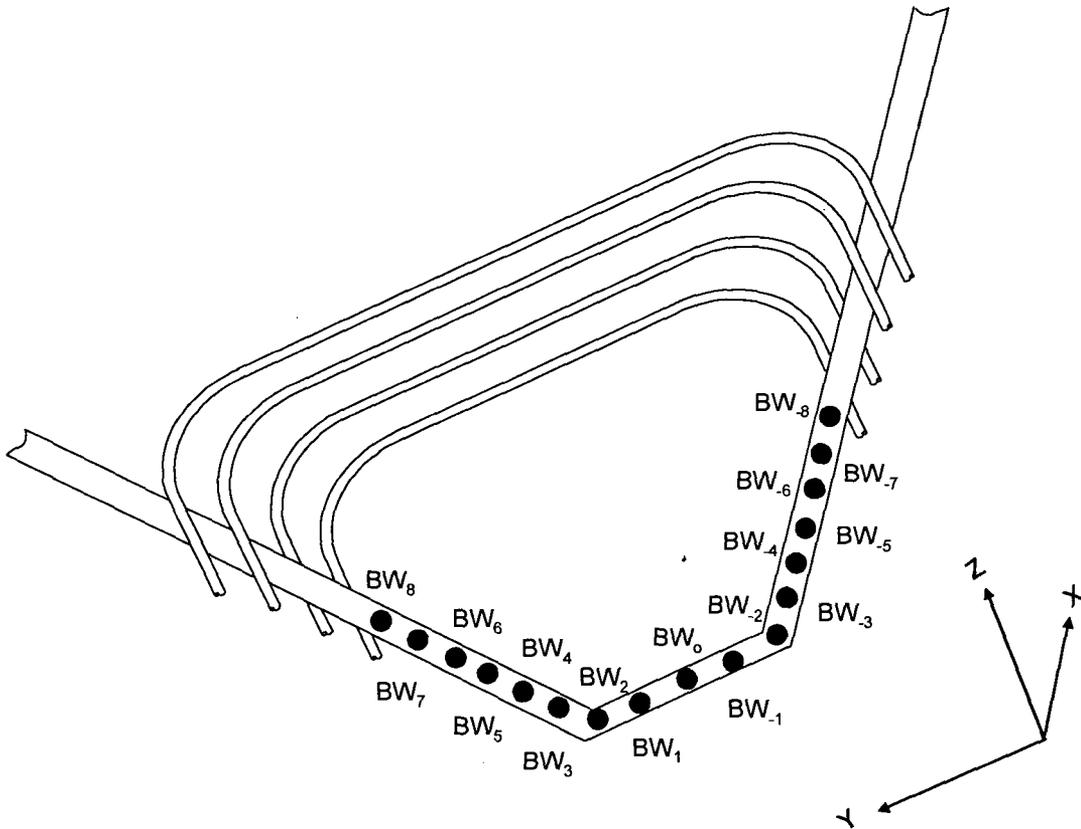
Figure C-1 Locations of 17 points for extracting velocity, density and flow area

Figure C-1 identifies locations of 17 points for extracting the secondary velocity, density, and flow area from ATHOS results, using the homogeneous model, for Batwing #69. Table C-1 lists coordinates for those 17 points for Batwing #69. There is no need to extract ATHOS results for the horizontal span of the U-bend.
