9. CFD Modeling of Fluid Flow in CRDM Nozzle and Weld Cracks and through Annulus

In this section, we describe the results of the detailed computational fluid dynamics (CFD) modeling effort that we undertook to develop a better understanding and definition of the thermal hydraulic conditions in the CRDM nozzle annulus and developing wastage cavity at both CRDM Nozzles 2 and 3.

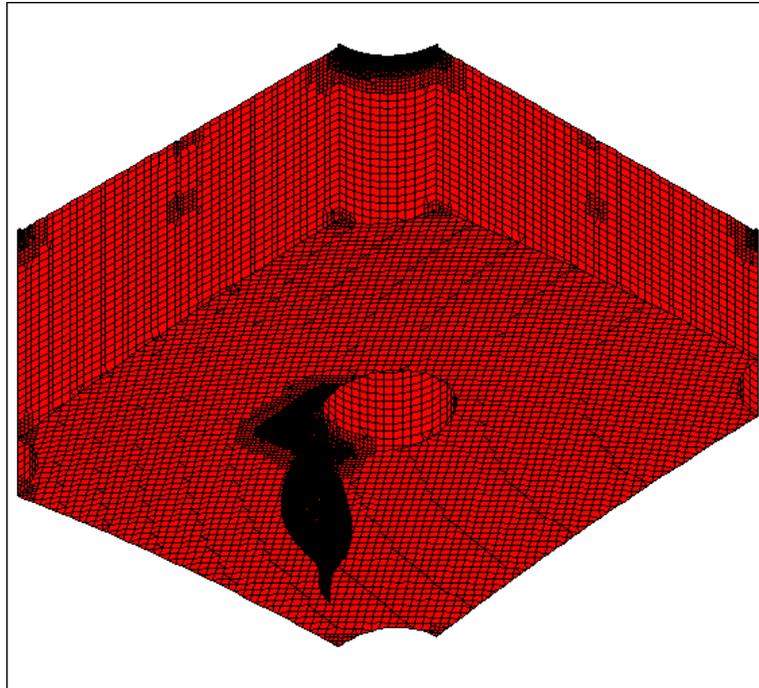
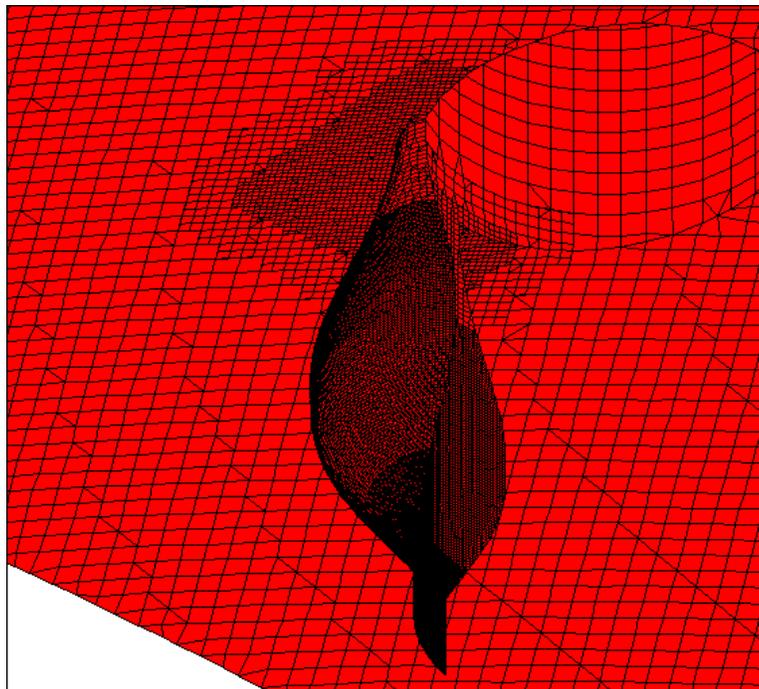
Figure 9.1(a) CFD Model Mesh for Case 3 Small Wastage Cavity

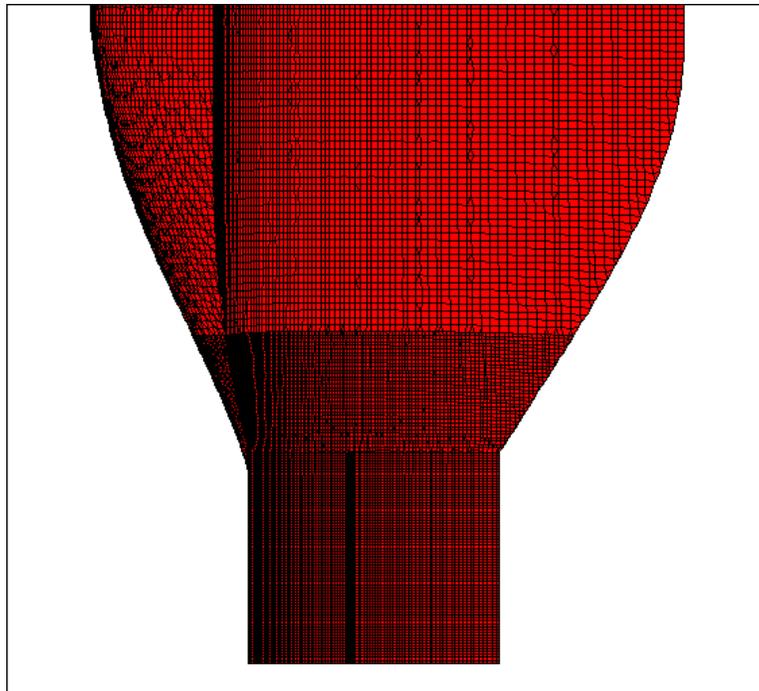
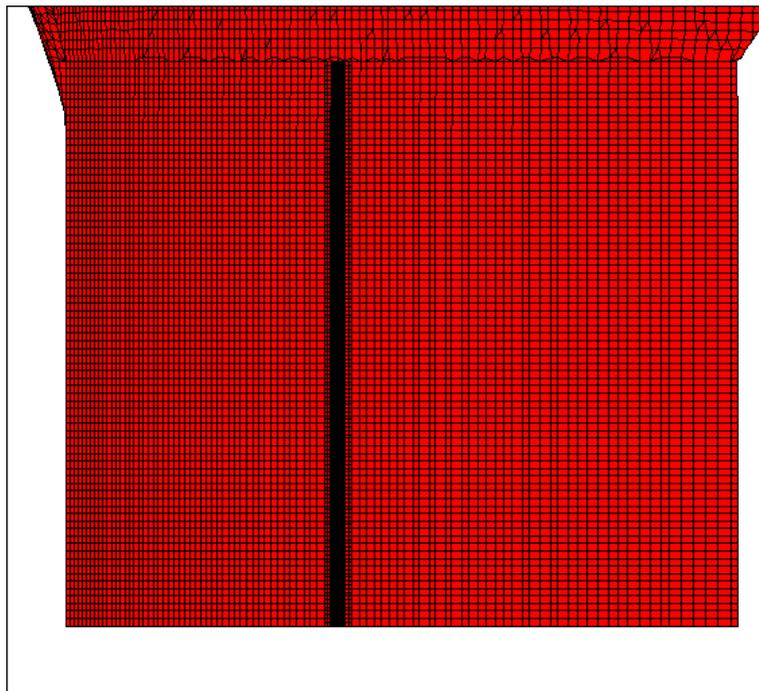
Figure 9.1(b) CFD Model Mesh for Case 3 Small Wastage Cavity

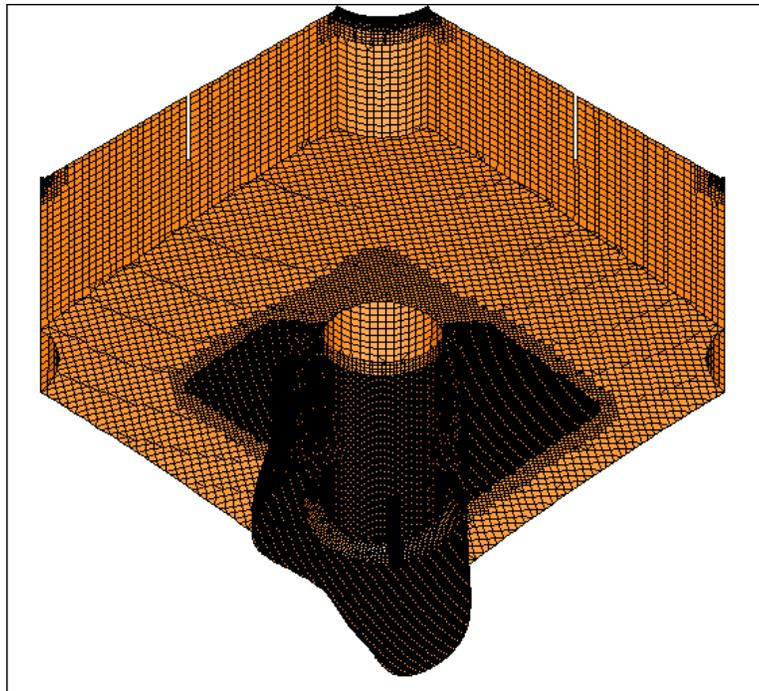
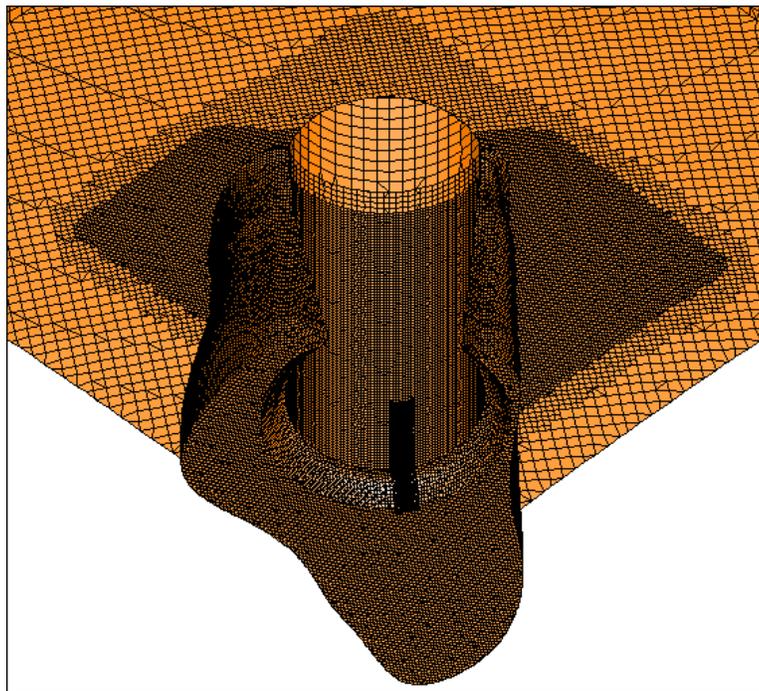
Figure 9.2(a) CFD Model Mesh for Case 4 Large Wastage Cavity

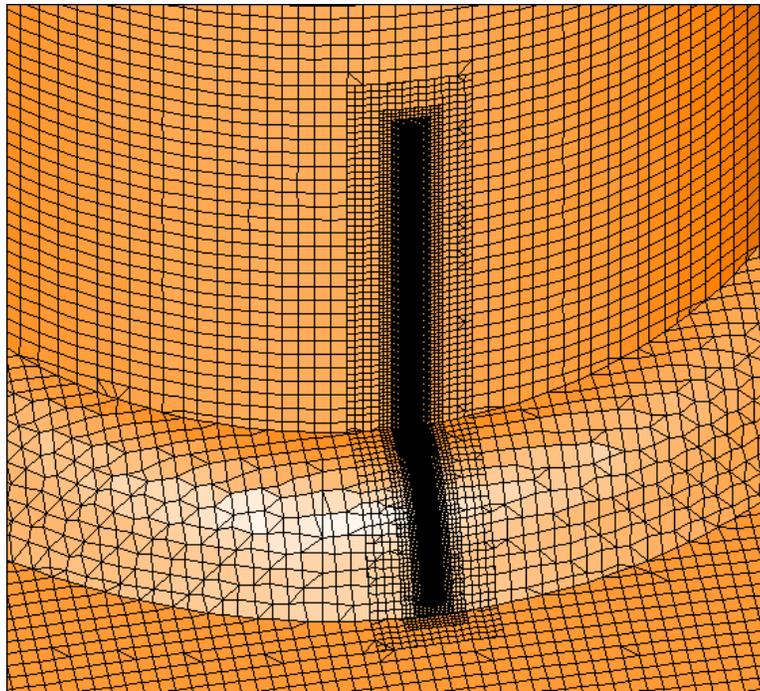
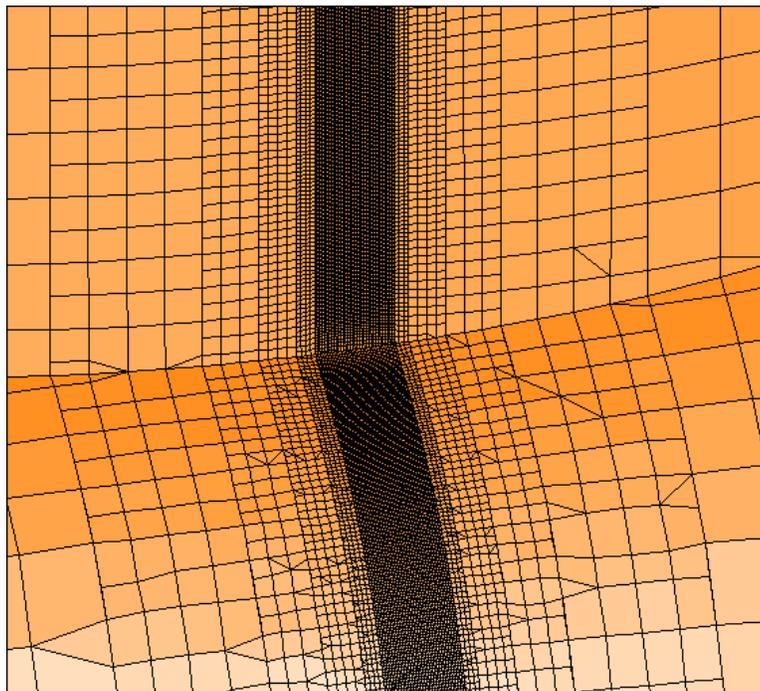
Figure 9.2(b) CFD Model Mesh for Case 4 Large Wastage Cavity

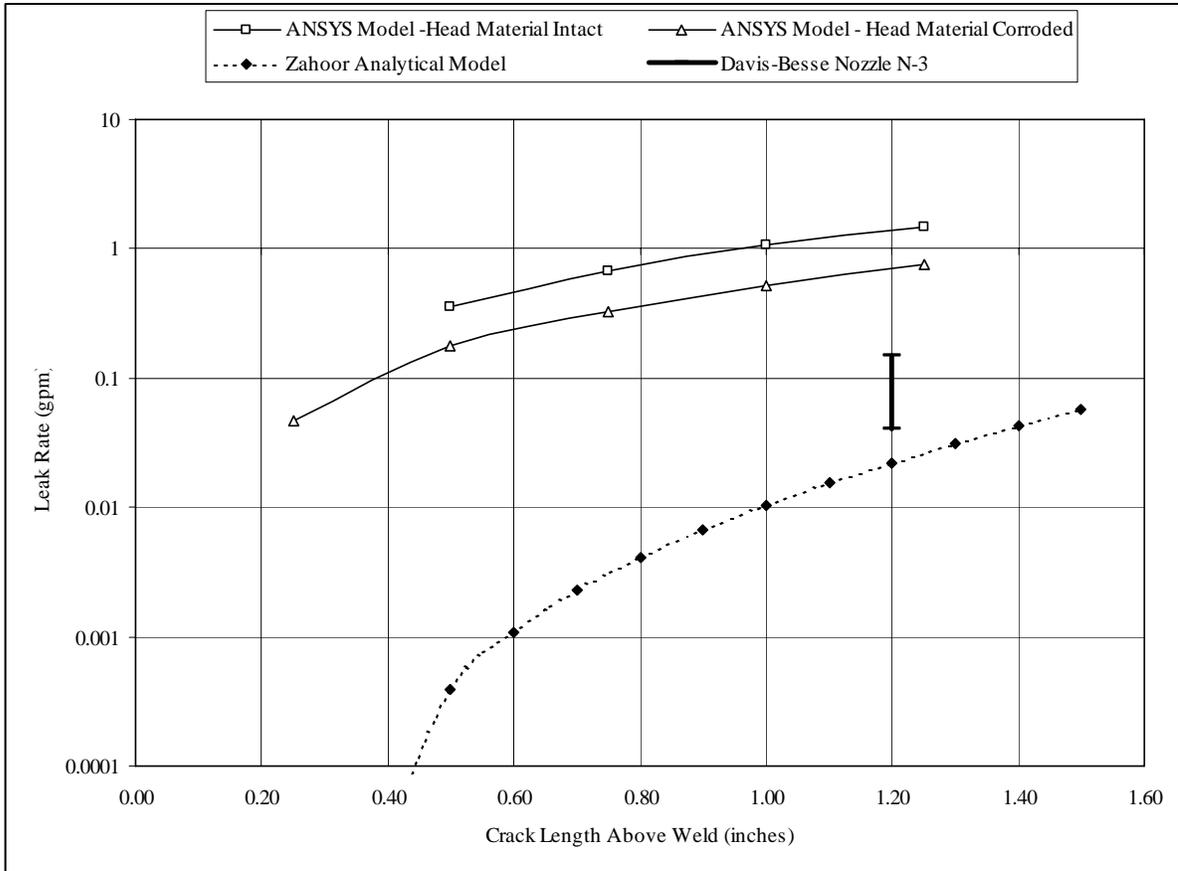
Figure 9.3 Calculated Leak Rate vs. Crack Length Above the J-Groove Weld as Calculated by Dominion Engineering, Inc.^{1,2}

Before we could begin the CFD modeling of the environmental conditions present in the annulus and wastage cavity at a cracked CRDM nozzle, we need to establish the relationship between PWSCC crack length and crack leak rate. Our initial effort to evaluate the leak rate from CRDM nozzle PWSCC cracks began with a review of the calculations completed by Dominion Engineering, Inc., shown in Figure 9.3.^{6,7}

These results, which show calculated leak rates for crack lengths ranging up to 1.6 inches, were based upon available data obtained for fluid leakage through thin-walled steam generator tubes. Based upon these results, the Root Cause Report attempted to compare the leak rates from the CRDM nozzle cracks identified by UT examination of Nozzles 2 and 3. The FENOC Root Cause Report noted:⁸

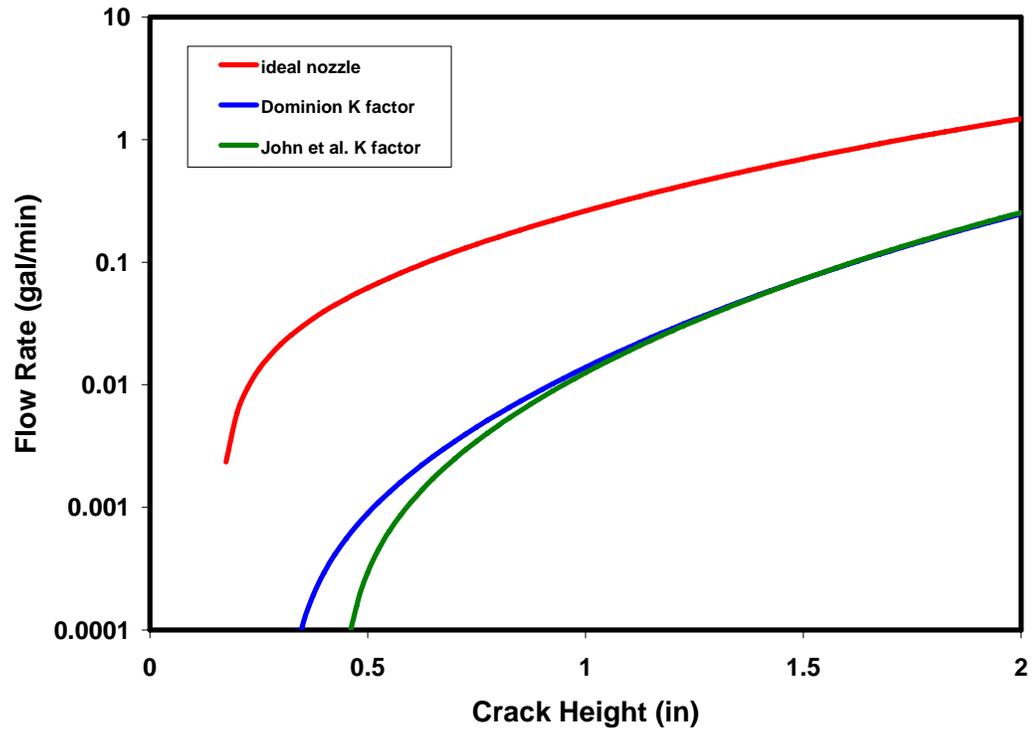
Figure 9.4 CRDM Nozzle Leak Rate vs. Crack Height.

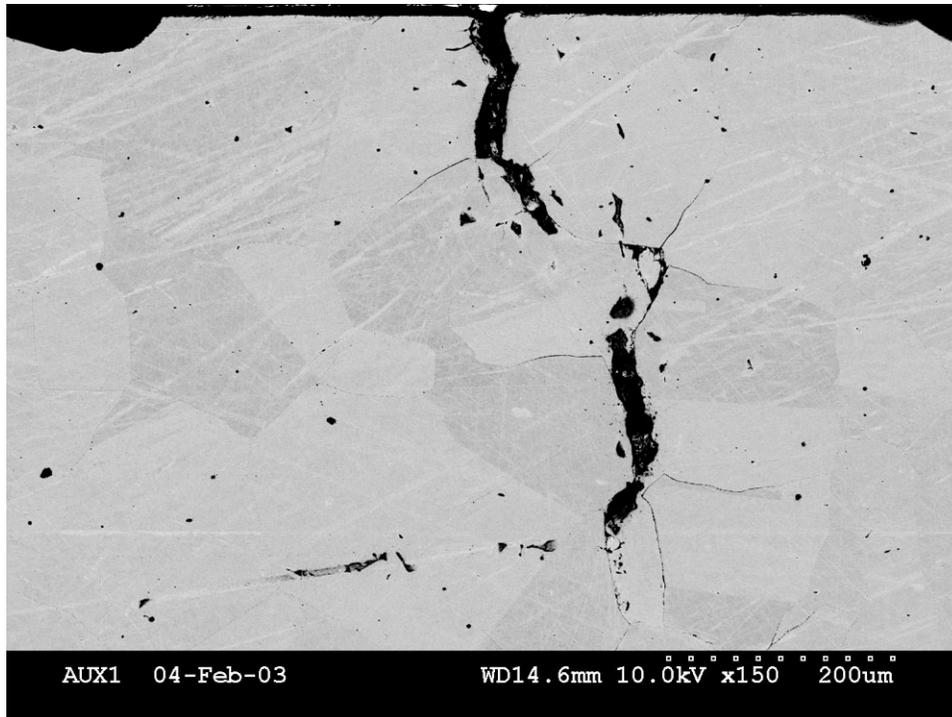
Figure 9.5 Scanning electron micrograph of CRDM Nozzle 3 crack at 180° location showing typical dimensions of PWSCC nozzle crack widths. Note the maximum crack width is about 20 μm (0.0008 inches).¹⁰

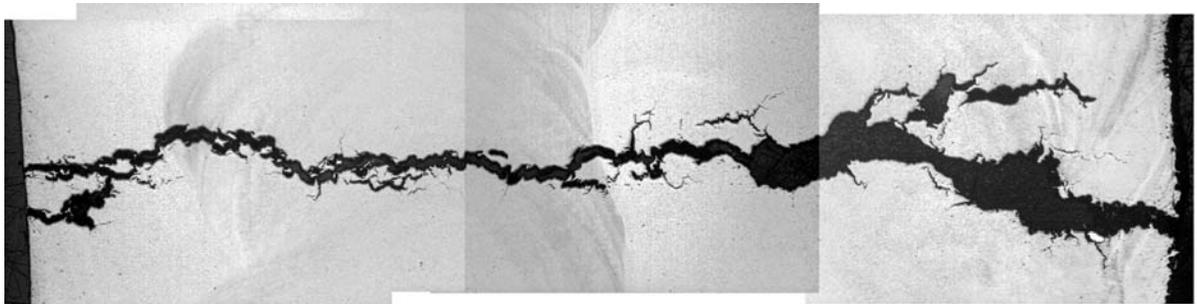
Figure 9.6 Optical micrograph of J-groove weld crack in CRDM Nozzle 3 at 10° location showing large crack width. Note the nominal crack width is about 400 μm (0.016 inches) or about 20 times larger than the PWSCC crack in the same nozzle shown above.¹¹

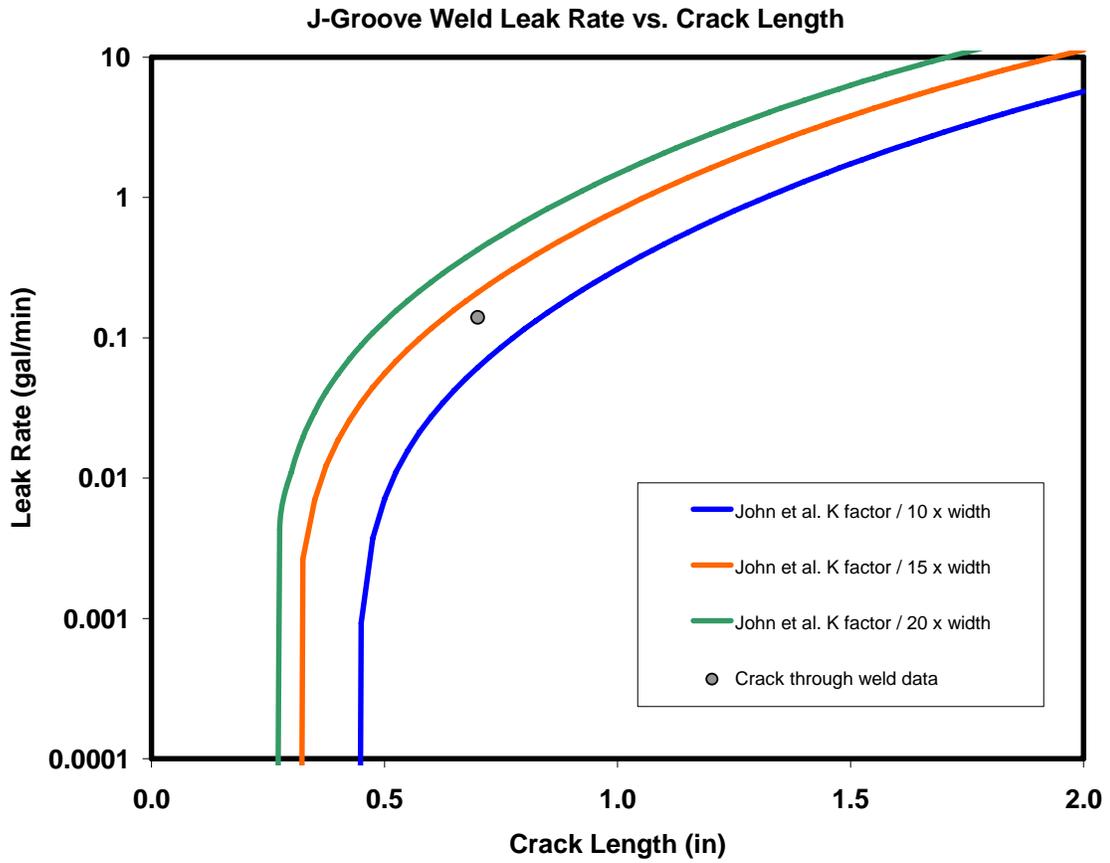
Figure 9.7 Calculated leak rate vs. crack length for a J-groove weld crack with crack widths that are 10 times, 15 times, and 20 times wider than typical PWSCC nozzle cracks.

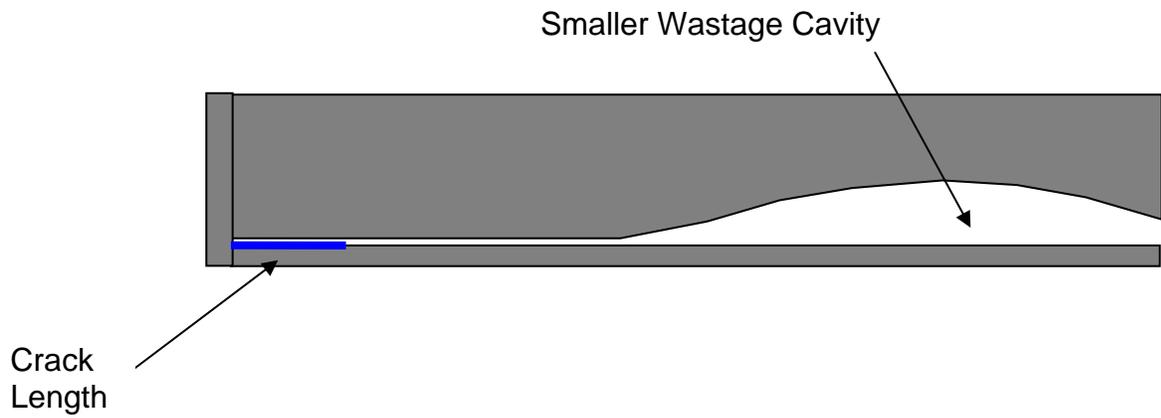
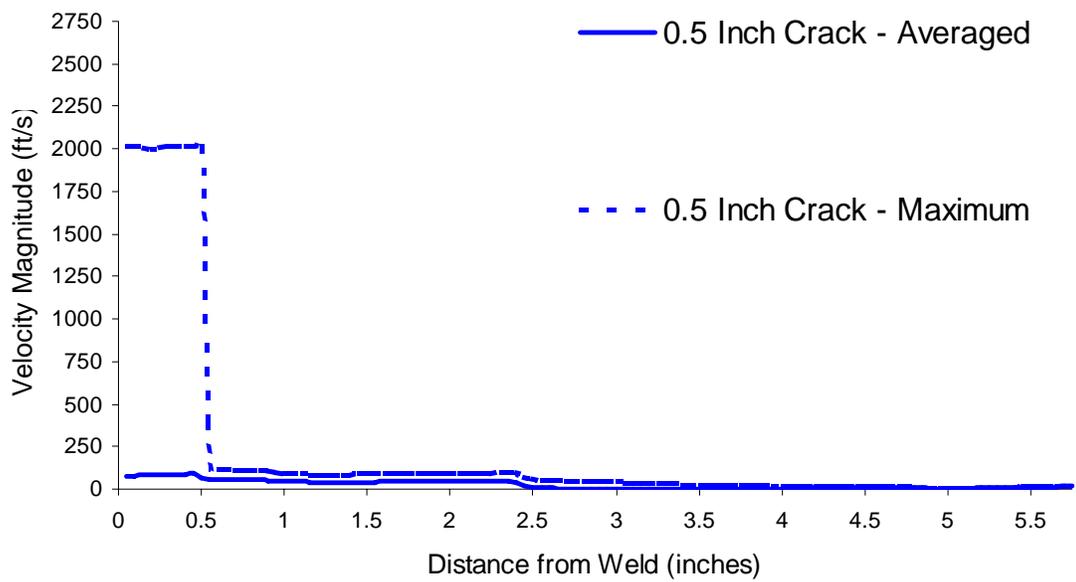
Figure 9.8 Case 1: Maximum and average fluid velocity magnitude within wastage as a function of distance to the J-groove weld for a 0.5-inch crack with a leak rate of 0.001 gpm.

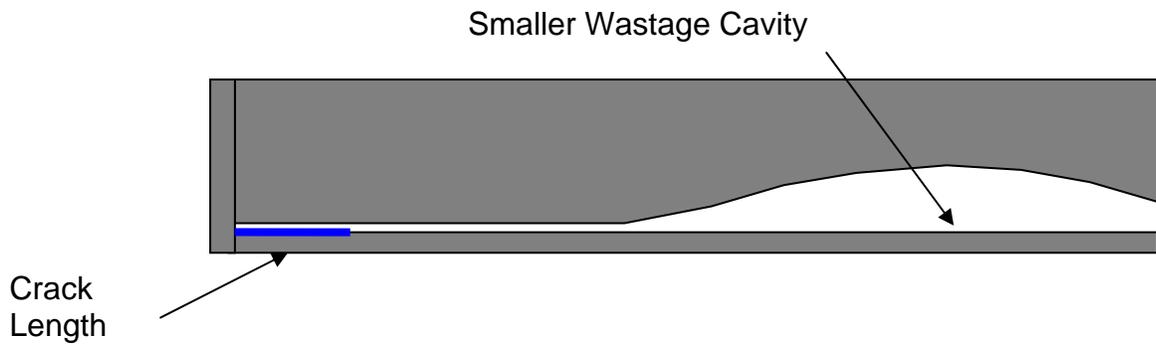
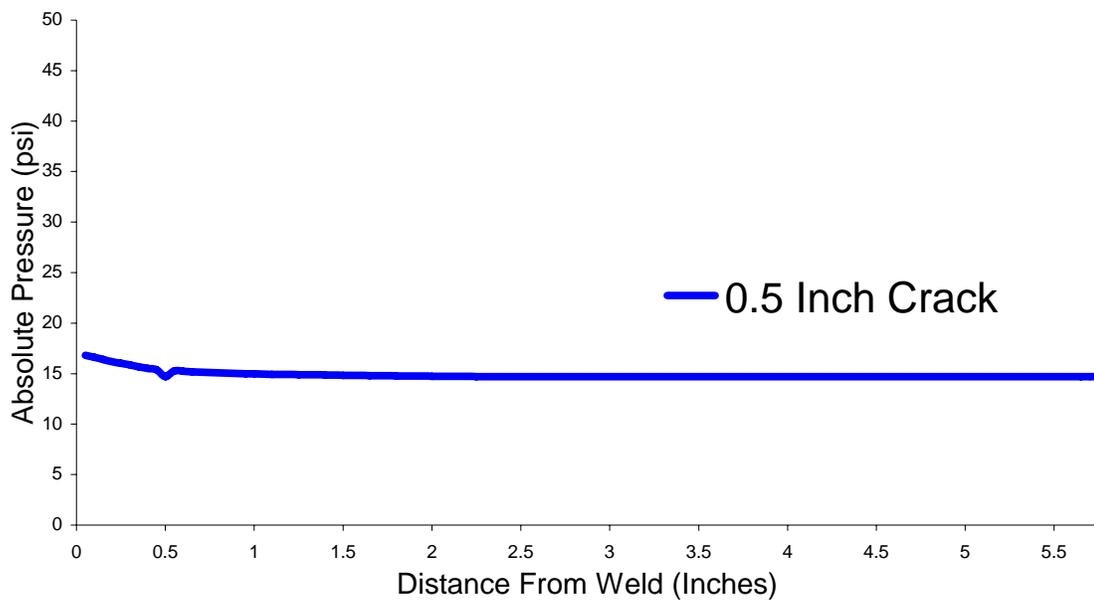
Figure 9.9 Case 1: Average fluid pressure within wastage as a function of distance to the J-groove weld for a 0.5-inch crack with a leak rate of 0.001 gpm.

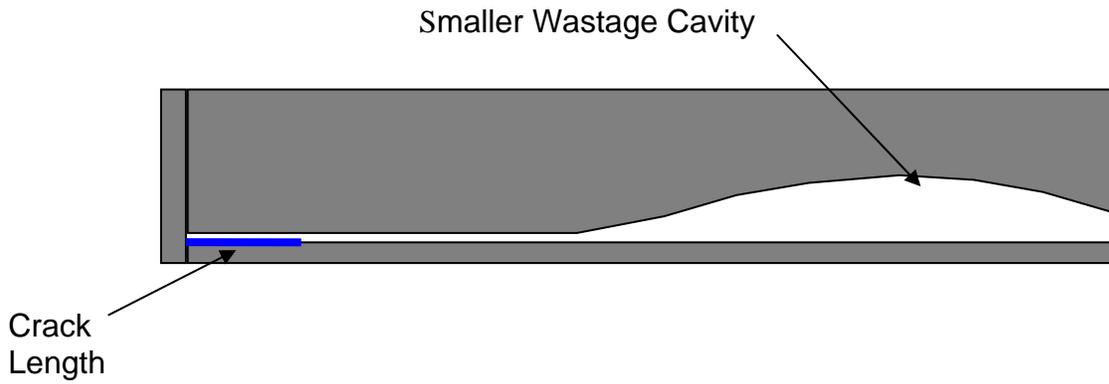
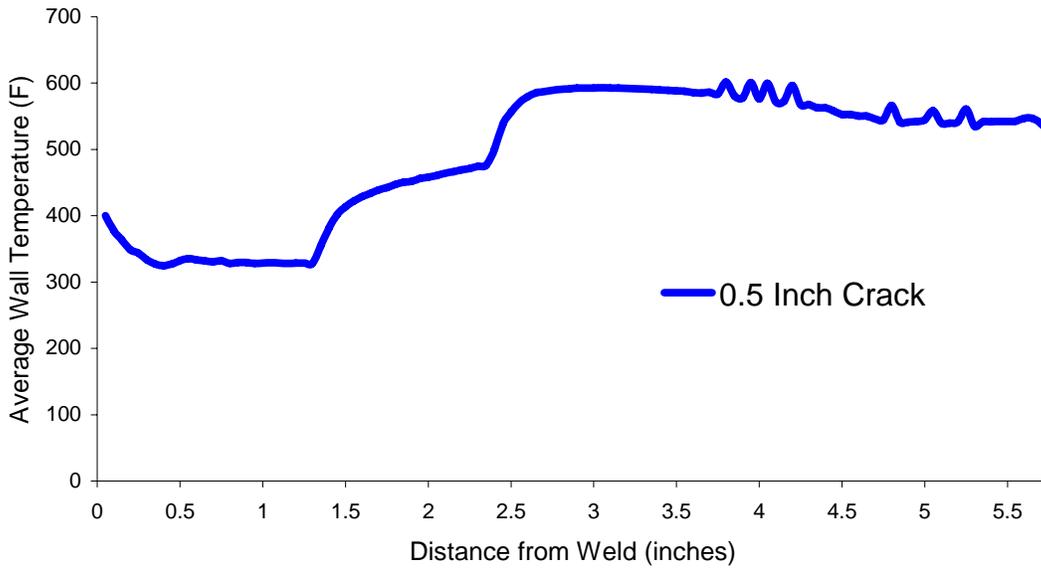
Figure 9.10 Case 1: Average wall temperature within wastage as a function of distance to the J-groove weld for a 0.5-inch crack with a leak rate of 0.001 gpm.

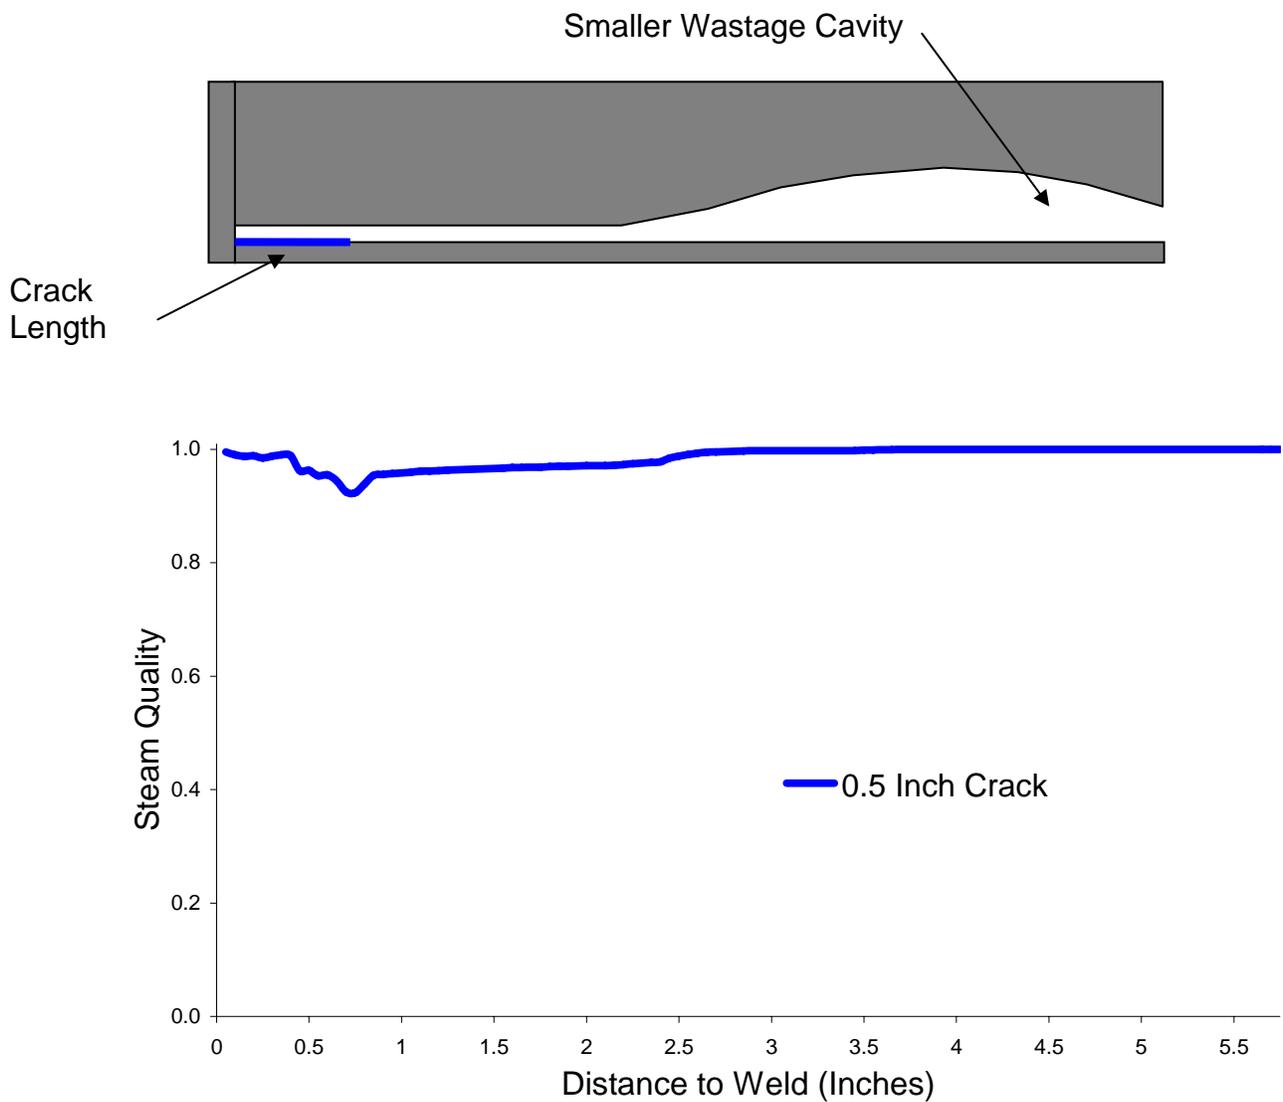
Figure 9.11 Case 1: Average steam quality within wastage as a function of distance to the J-groove weld for a 0.5-inch crack with a leak rate of 0.001 gpm.

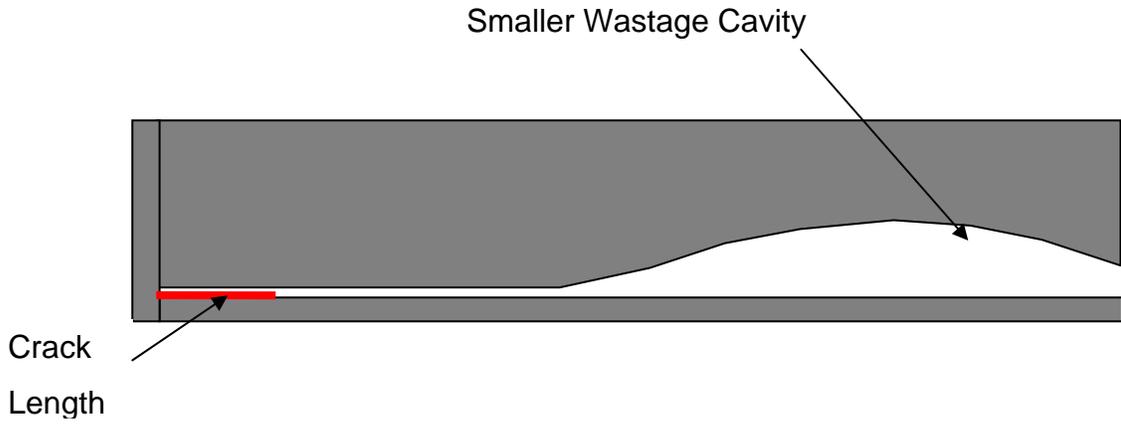
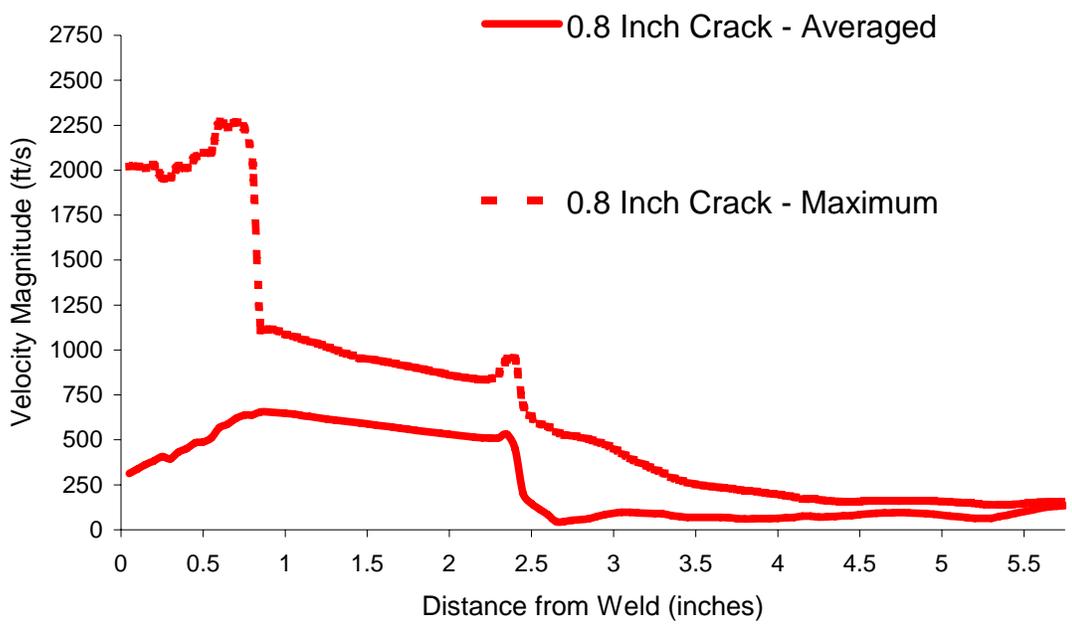
Figure 9.12 Case 2: Maximum and average fluid velocity magnitude within wastage as a function of distance from the J-groove weld for a 0.8-inch crack with a leak rate of 0.01 gpm.

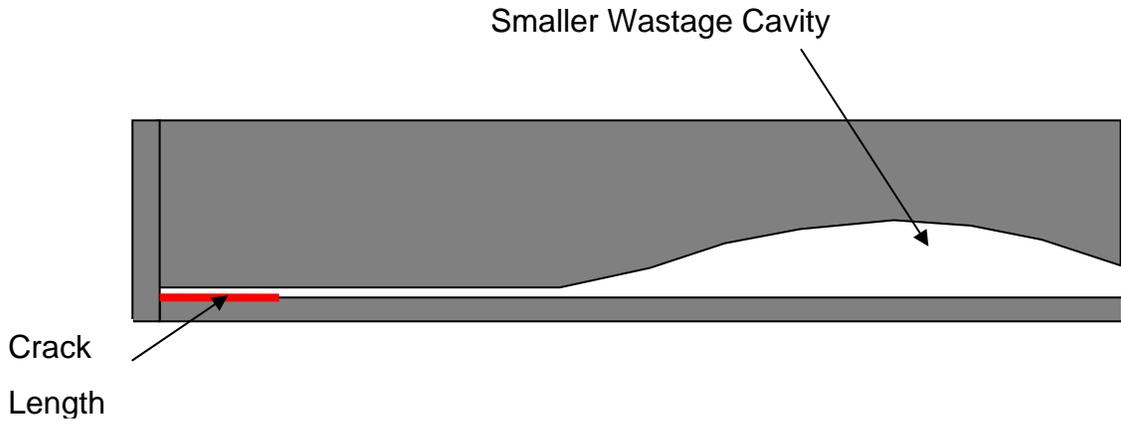
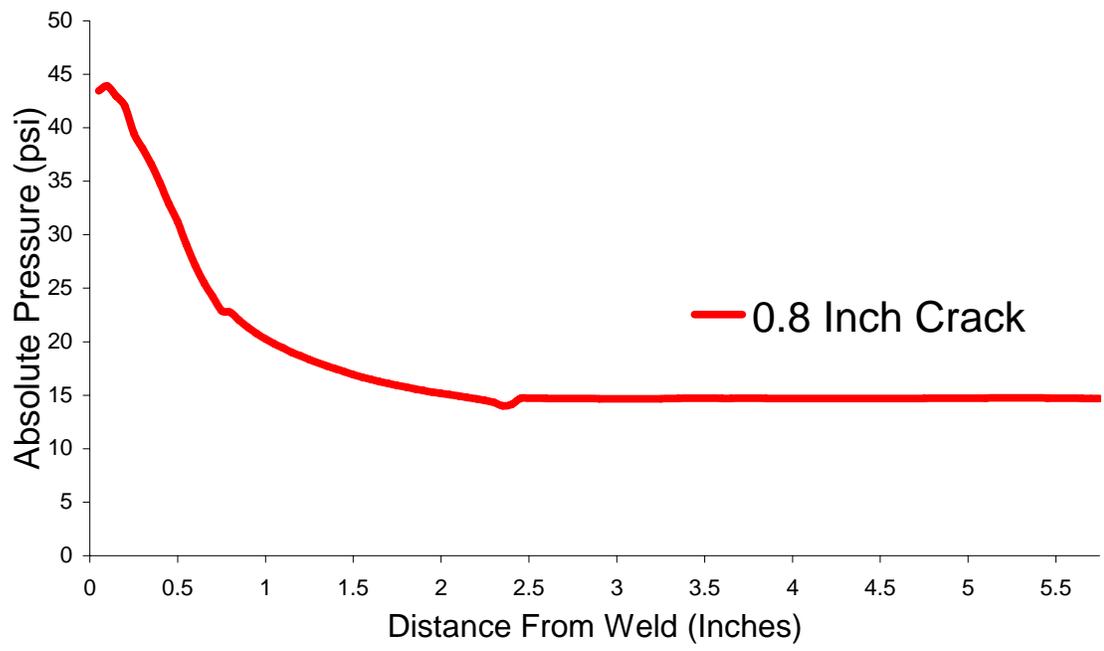
Figure 9.13 Case 2: Average fluid pressure within wastage as a function of distance to the J-groove weld for a 0.8-inch crack with a leak rate of 0.01 gpm.

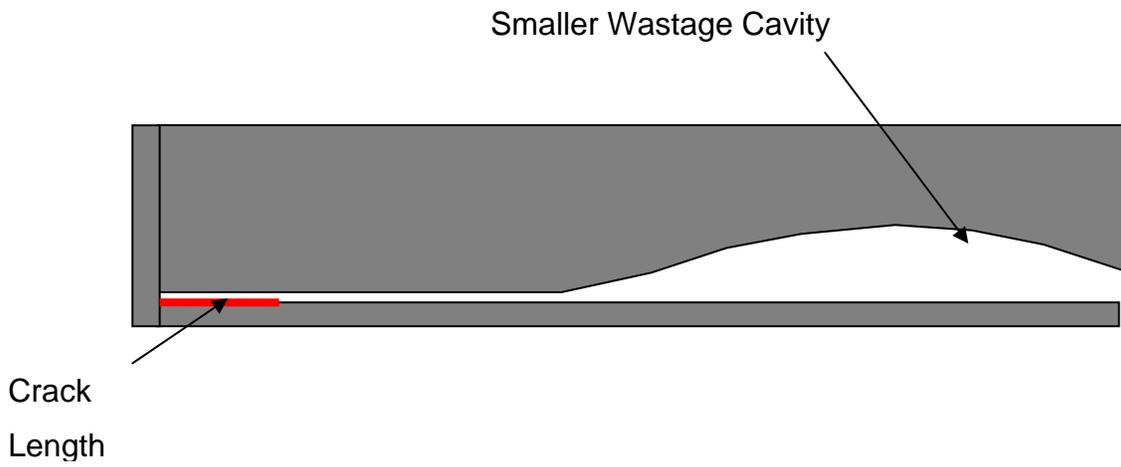
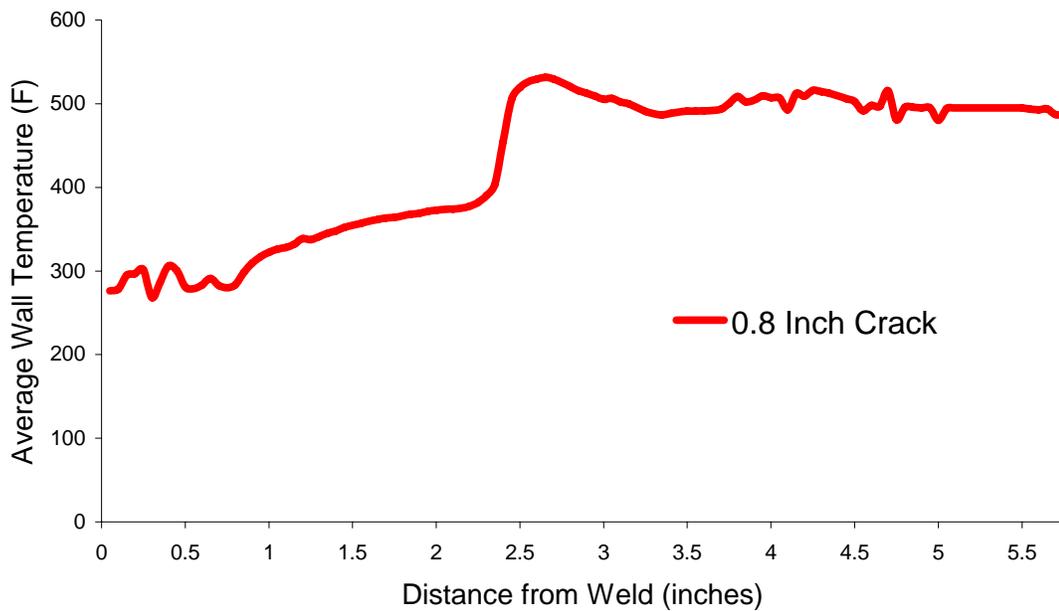
Figure 9.14 Case 2: Average wall temperature within wastage as a function of distance to the J-groove weld for a 0.8-inch crack with a leak rate of 0.01 gpm.

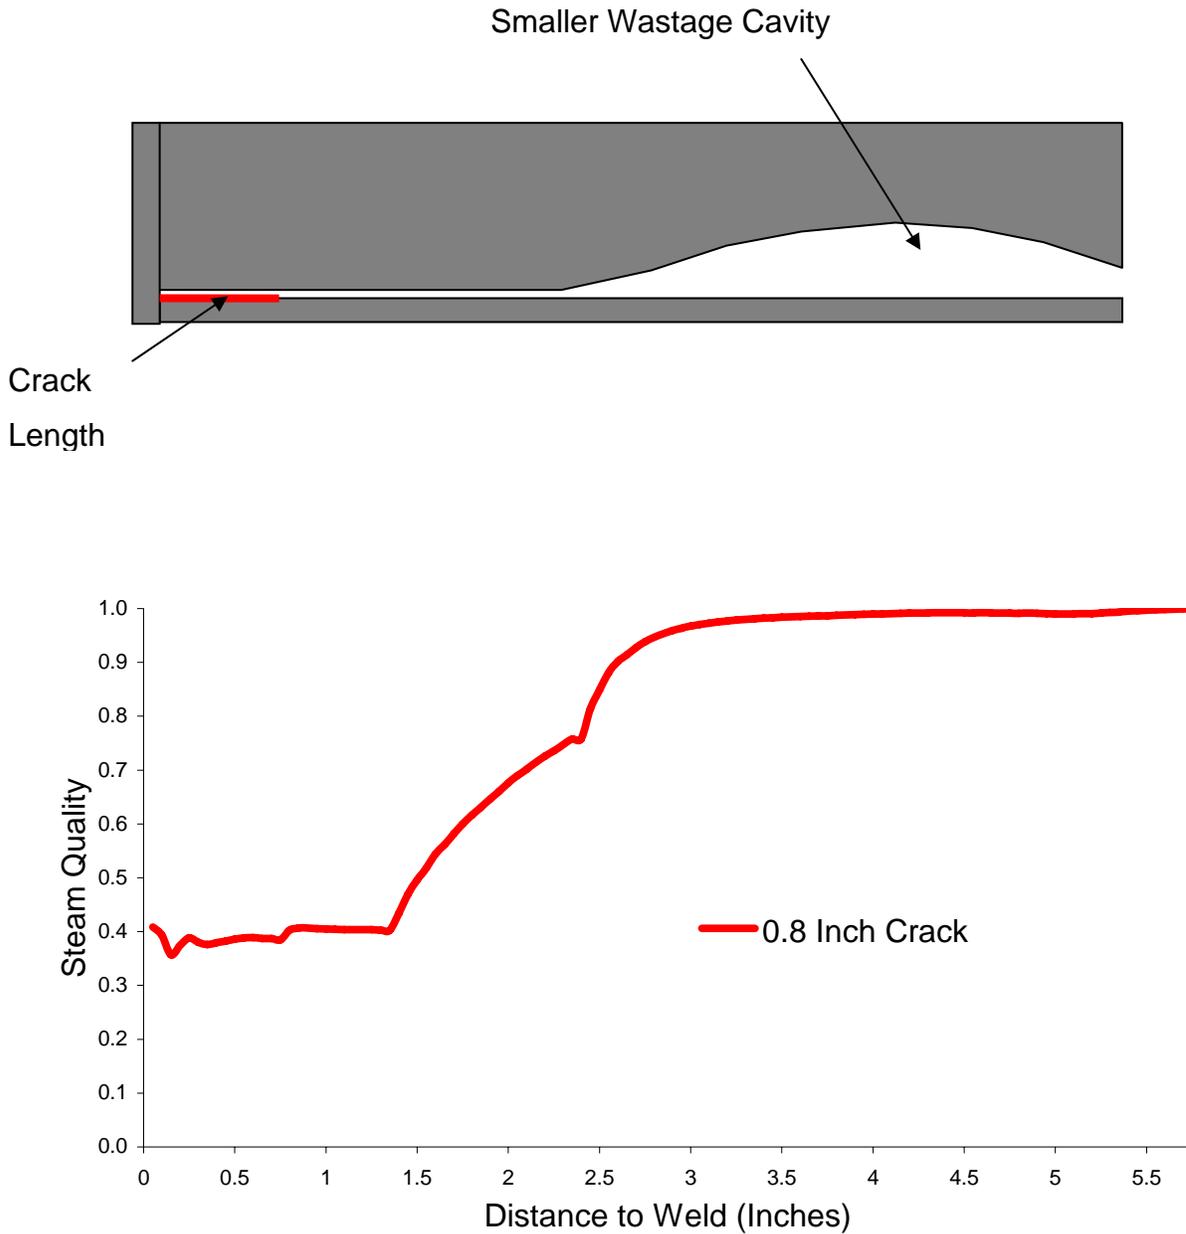
Figure 9.15 Case 2: Average steam quality within wastage as a function of distance to the J-groove weld for a 0.8-inch crack with a leak rate of 0.01 gpm.

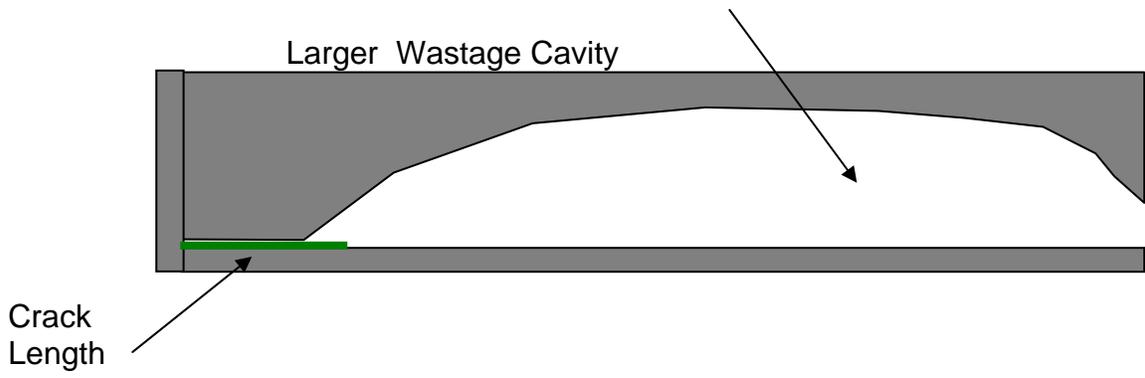
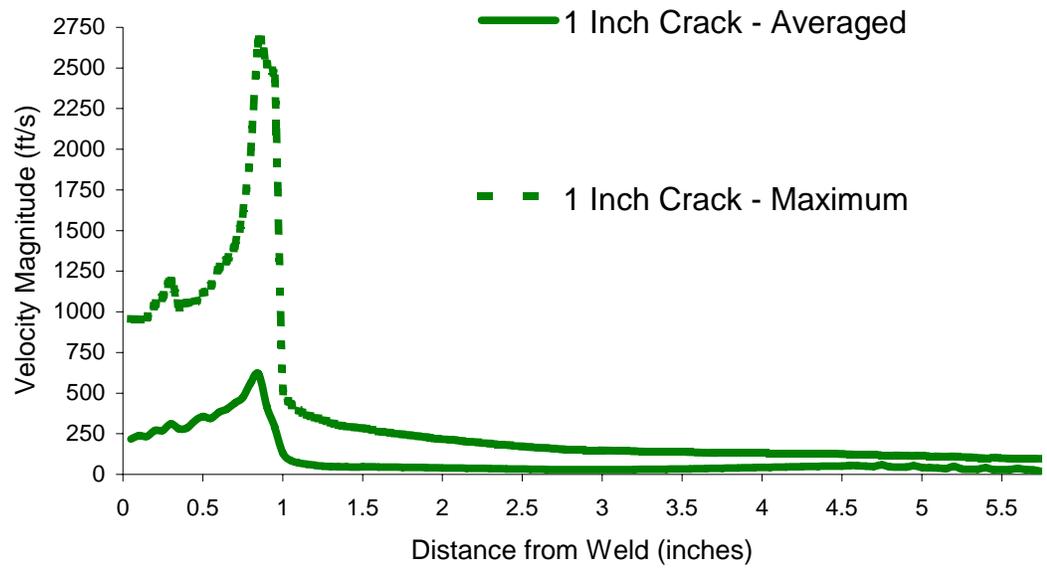
Figure 9.16 Case 3: Maximum and average fluid velocity magnitude within wastage as a function of distance to the J-groove weld for a 1.0-inch crack with a leak rate of 0.02 gpm.

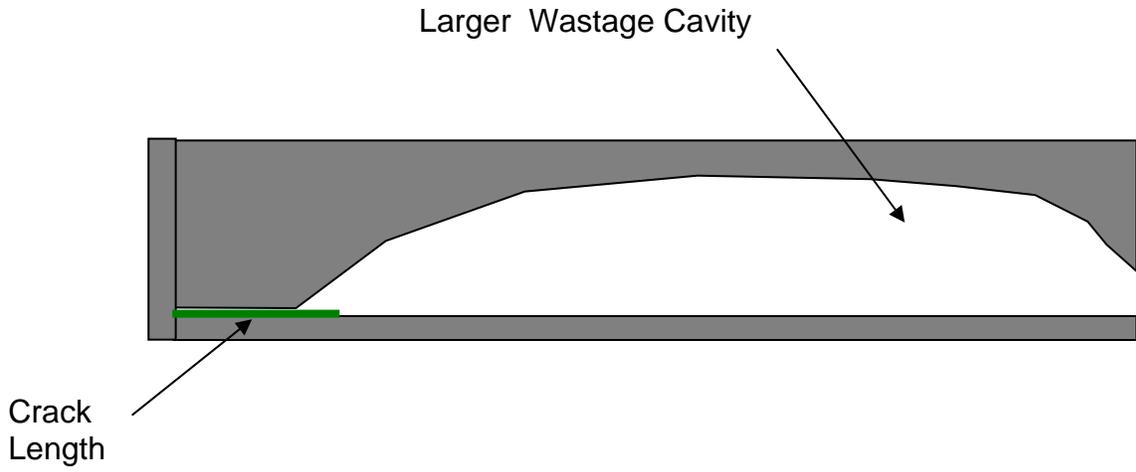
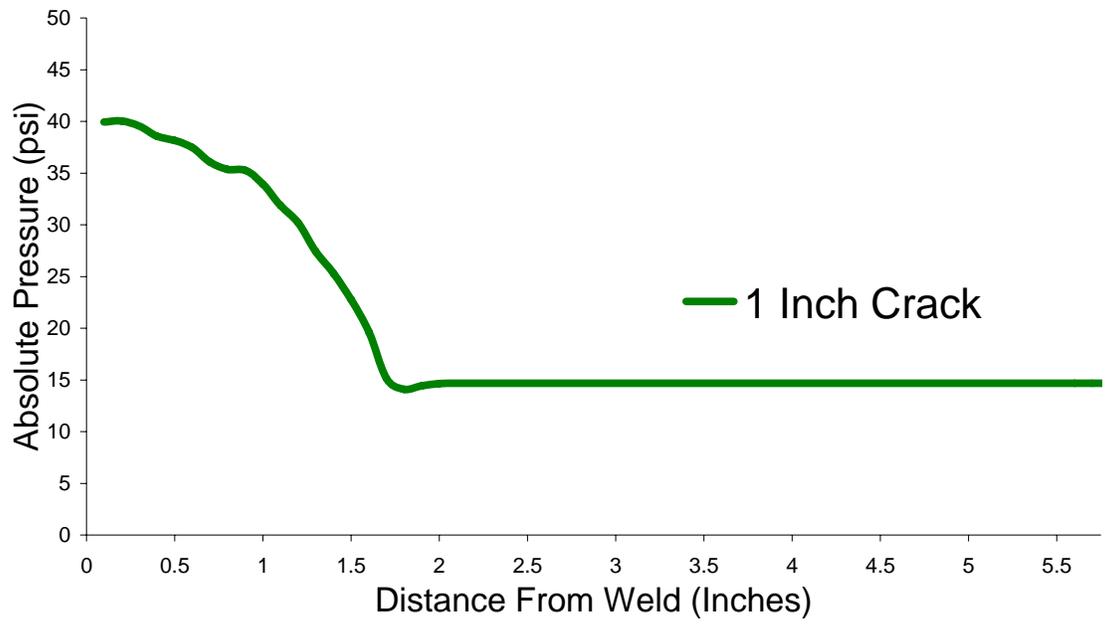
Figure 9.17 Case 3: Average fluid pressure within wastage as a function of distance to the J-groove weld for a 1.0-inch crack with a leak rate of 0.02 gpm.

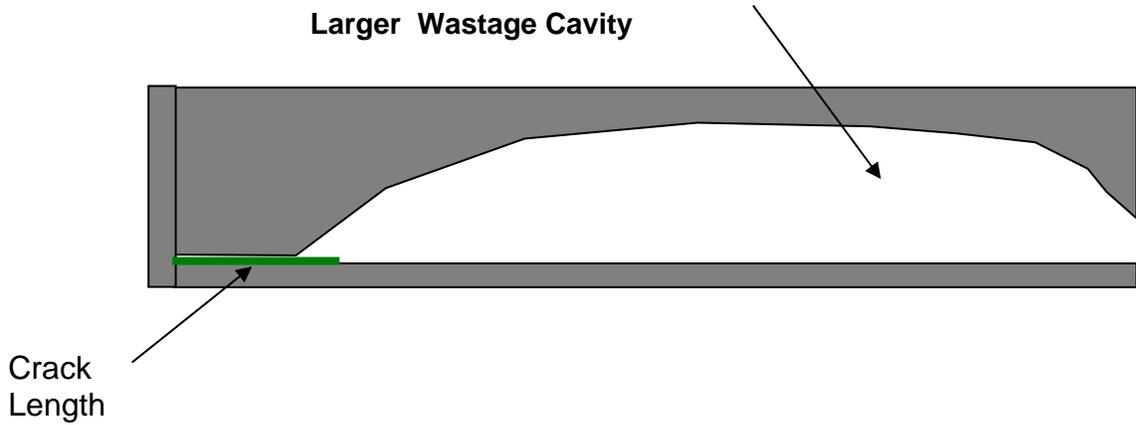
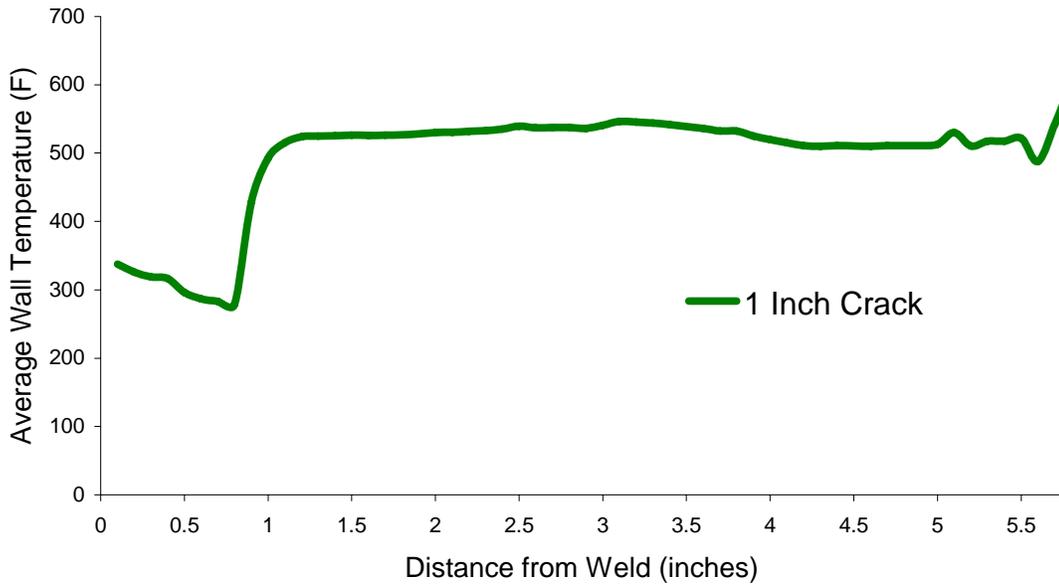
Figure 9.18 Case 3: Average temperature within wastage as a function of distance to the J-groove weld for a 1.0-inch crack with a leak rate of 0.02 gpm.
