9. CFD Modeling of Fluid Flow in CRDM Nozzle and Weld Cracks and through Annulus

In this section, we describe the results of the detailed computational fluid dynamics (CFD) modeling effort that we undertook to develop a better understanding and definition of the thermal hydraulic conditions in the CRDM nozzle annulus and developing wastage cavity at both CRDM Nozzles 2 and 3.

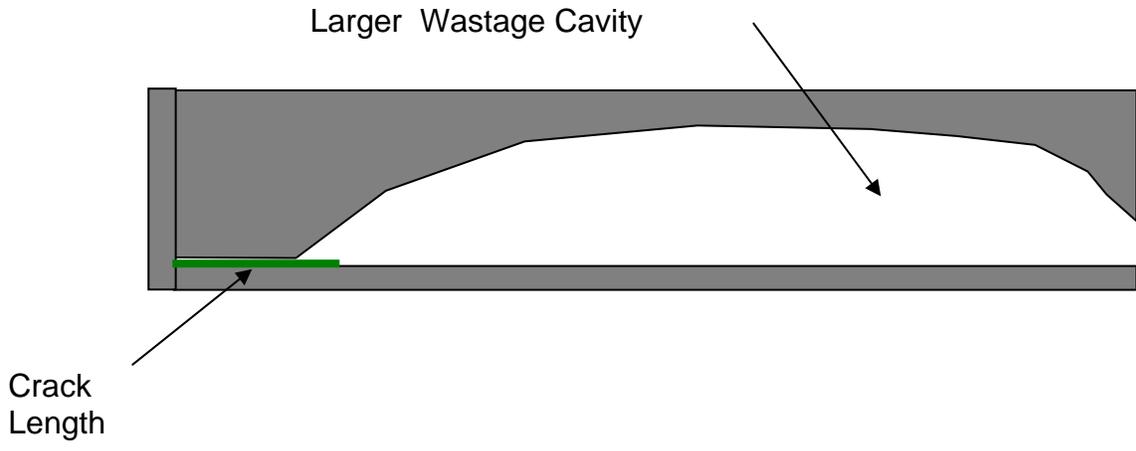
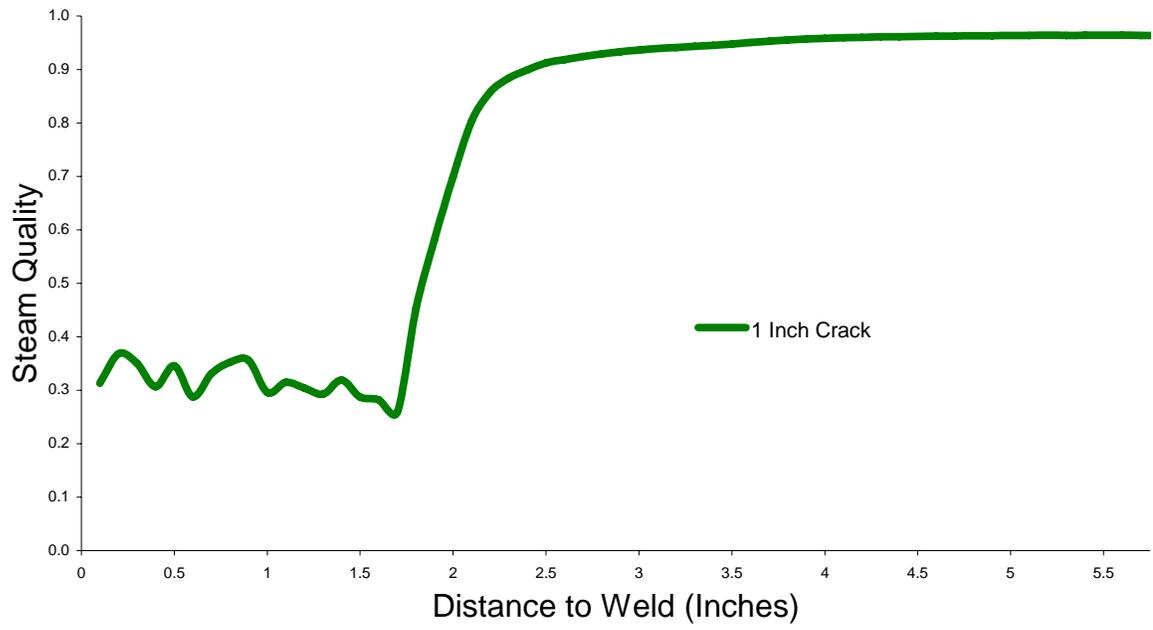
Figure 9.19 Case 3: Average steam quality within wastage as a function of distance to the J-groove weld for a 1.0-inch crack with a leak rate of 0.02 gpm.

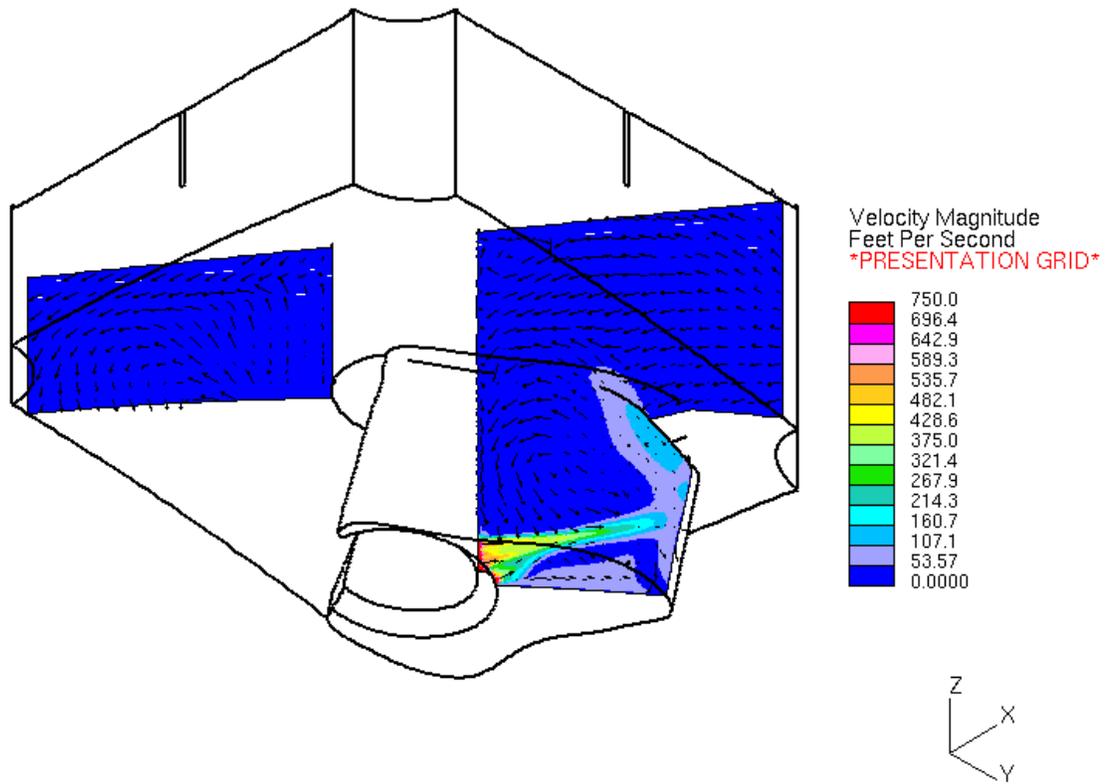
Figure 9.20 Velocity magnitude contours for the final wastage state sectioned directly through crack. The viewpoint is looking up from below RPV head.

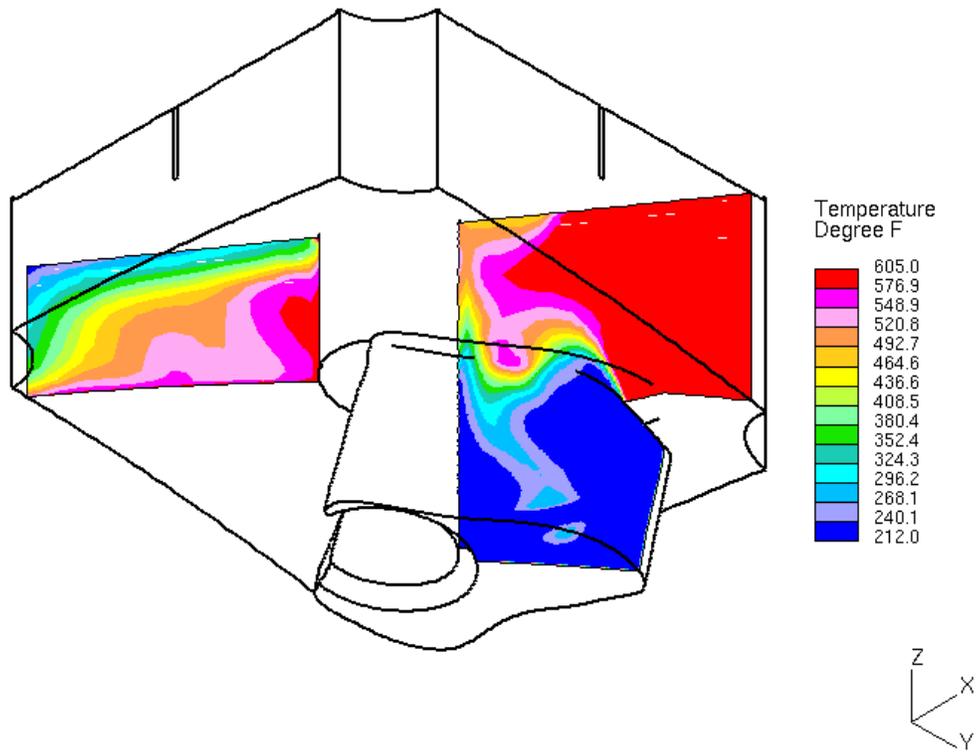
Figure 9.21 Temperature contours for the final wastage state sectioned directly through crack. The viewpoint is looking up from below RPV head.

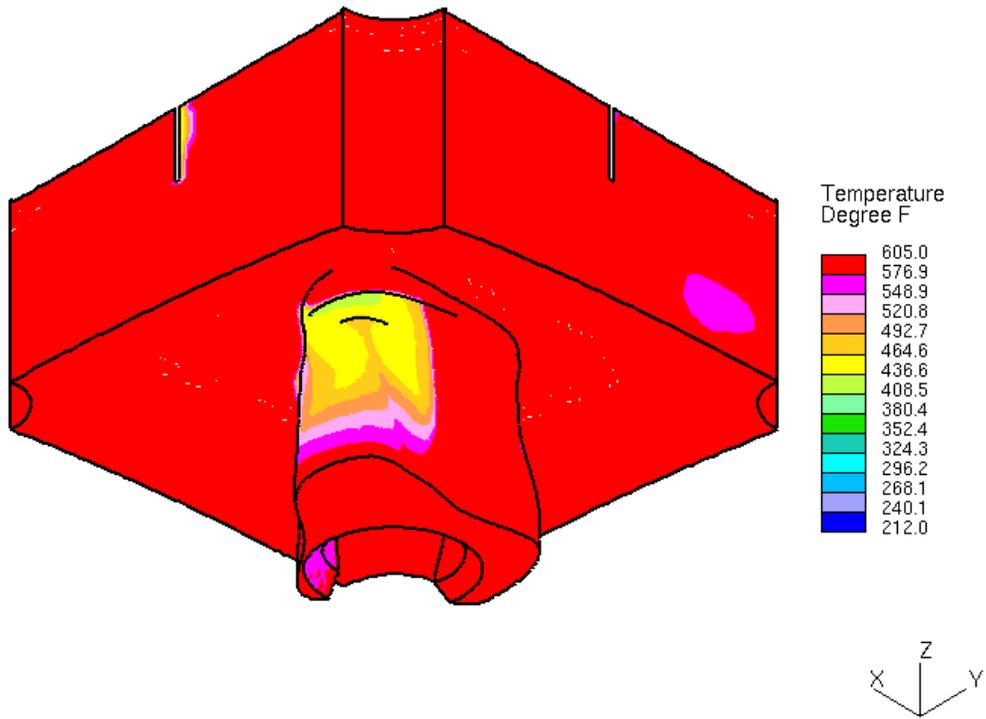
Figure 9.22 Cavity wall temperature contours for the final wastage state. The viewpoint is looking up from below RPV head from a different orientation than Figures 9.17 and 9.18 to show the cavity wall temperatures directly opposite the cracks.

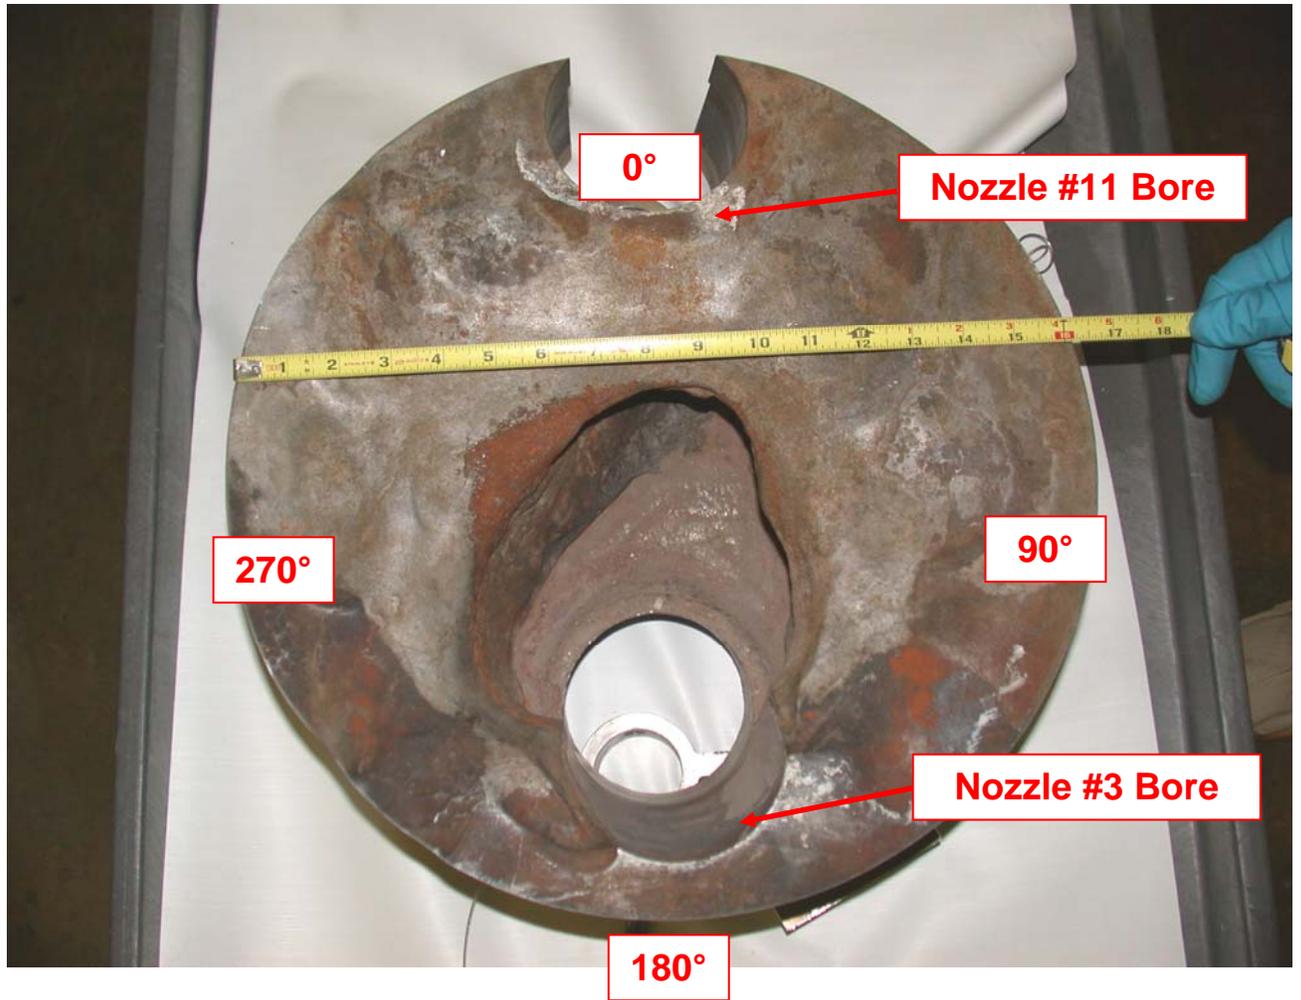
Figure 9.23 Top View of Wastage Cavity on Davis-Besse RPV Head.¹³

The significant conclusion that can be reached by studying this image is the fact that boric acid corrosion alone did not form this cavity. If only concentrated aqueous boric acid corrosion was causing the wastage cavity growth, the cavity would have formed on a line that was directly toward the “down hill” direction due to the effects of gravity. Since the cavity is slightly angled to the right in this figure and since the CRDM nozzle and weld cracks that leaked to form this cavity were situated at approximately 10 degrees, it is obvious that the accelerated flow resulting from the leaking nozzle and weld cracks dramatically influenced the formation of the wastage cavity.

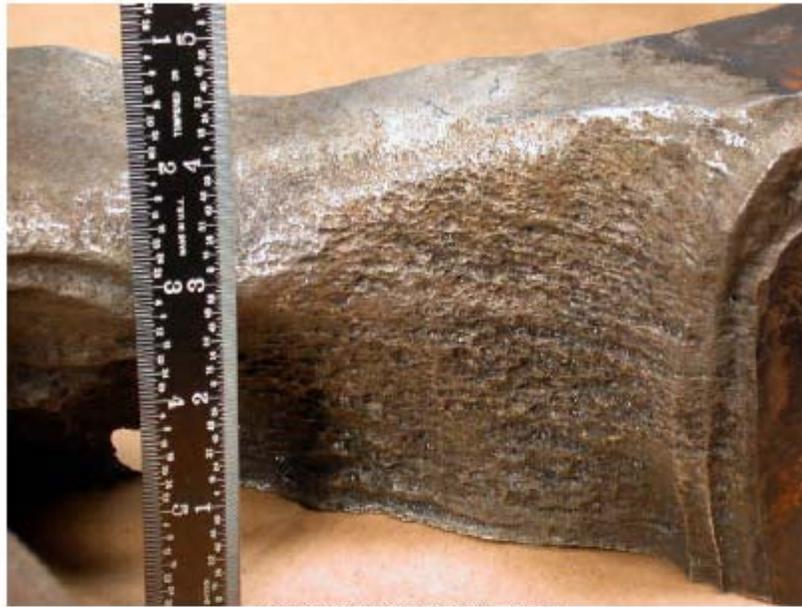
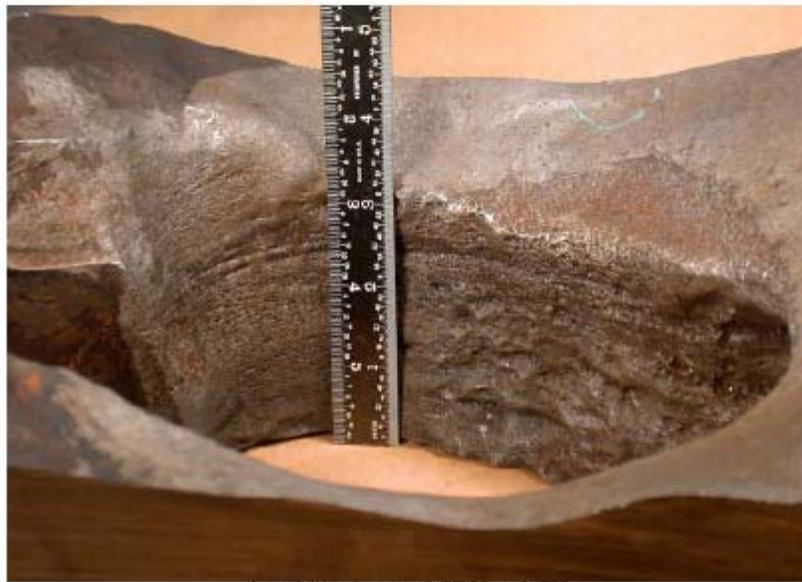
Figure 9.24 Wastage Cavity Sidewalls Viewed at Low Magnification Looking Toward 90° and 270°. ¹⁴

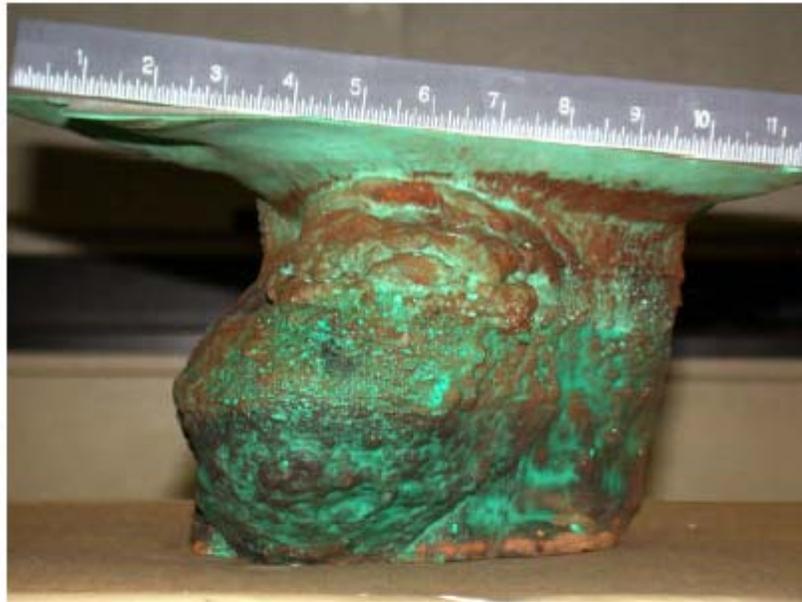
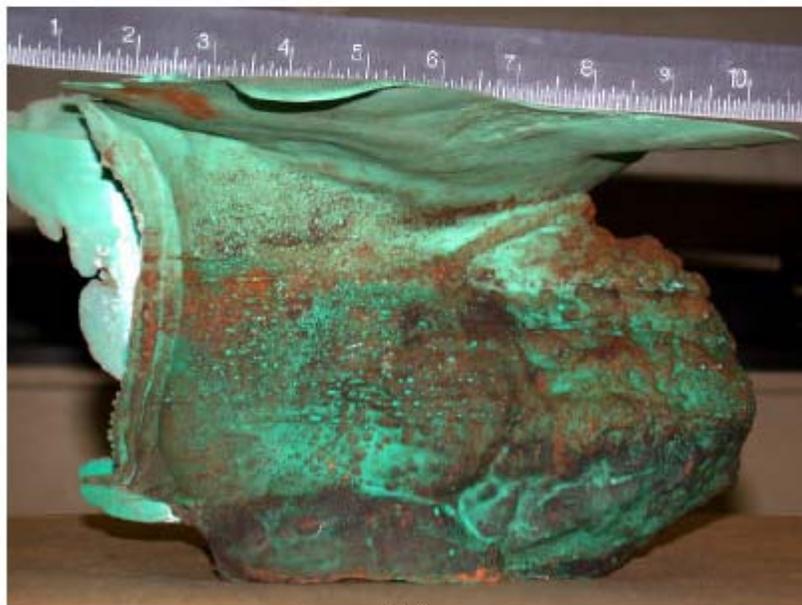
Figure 9.25(a) Dental Mold of Wastage Cavity Looking Towards 0° and 90°. ¹⁵

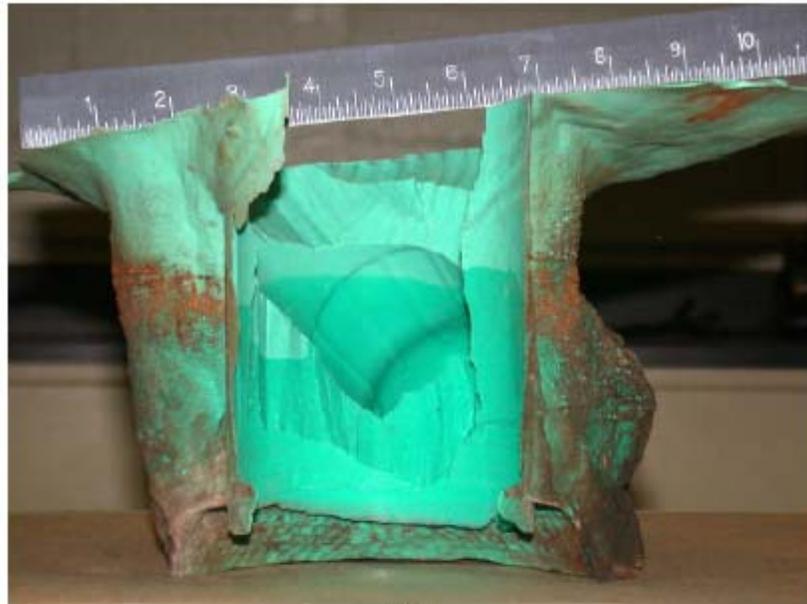
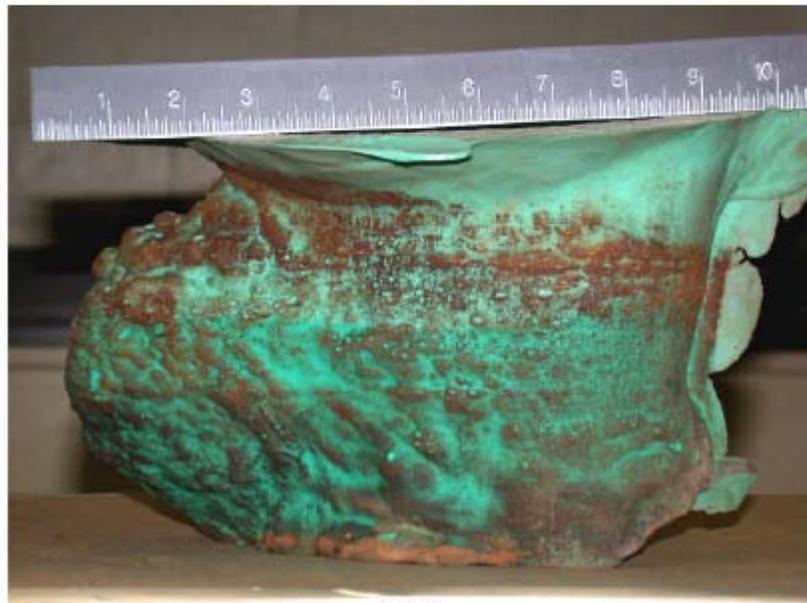
Figure 9.25(b) Dental Mold of Wastage Cavity Looking Towards 180° and 270°. ¹⁶

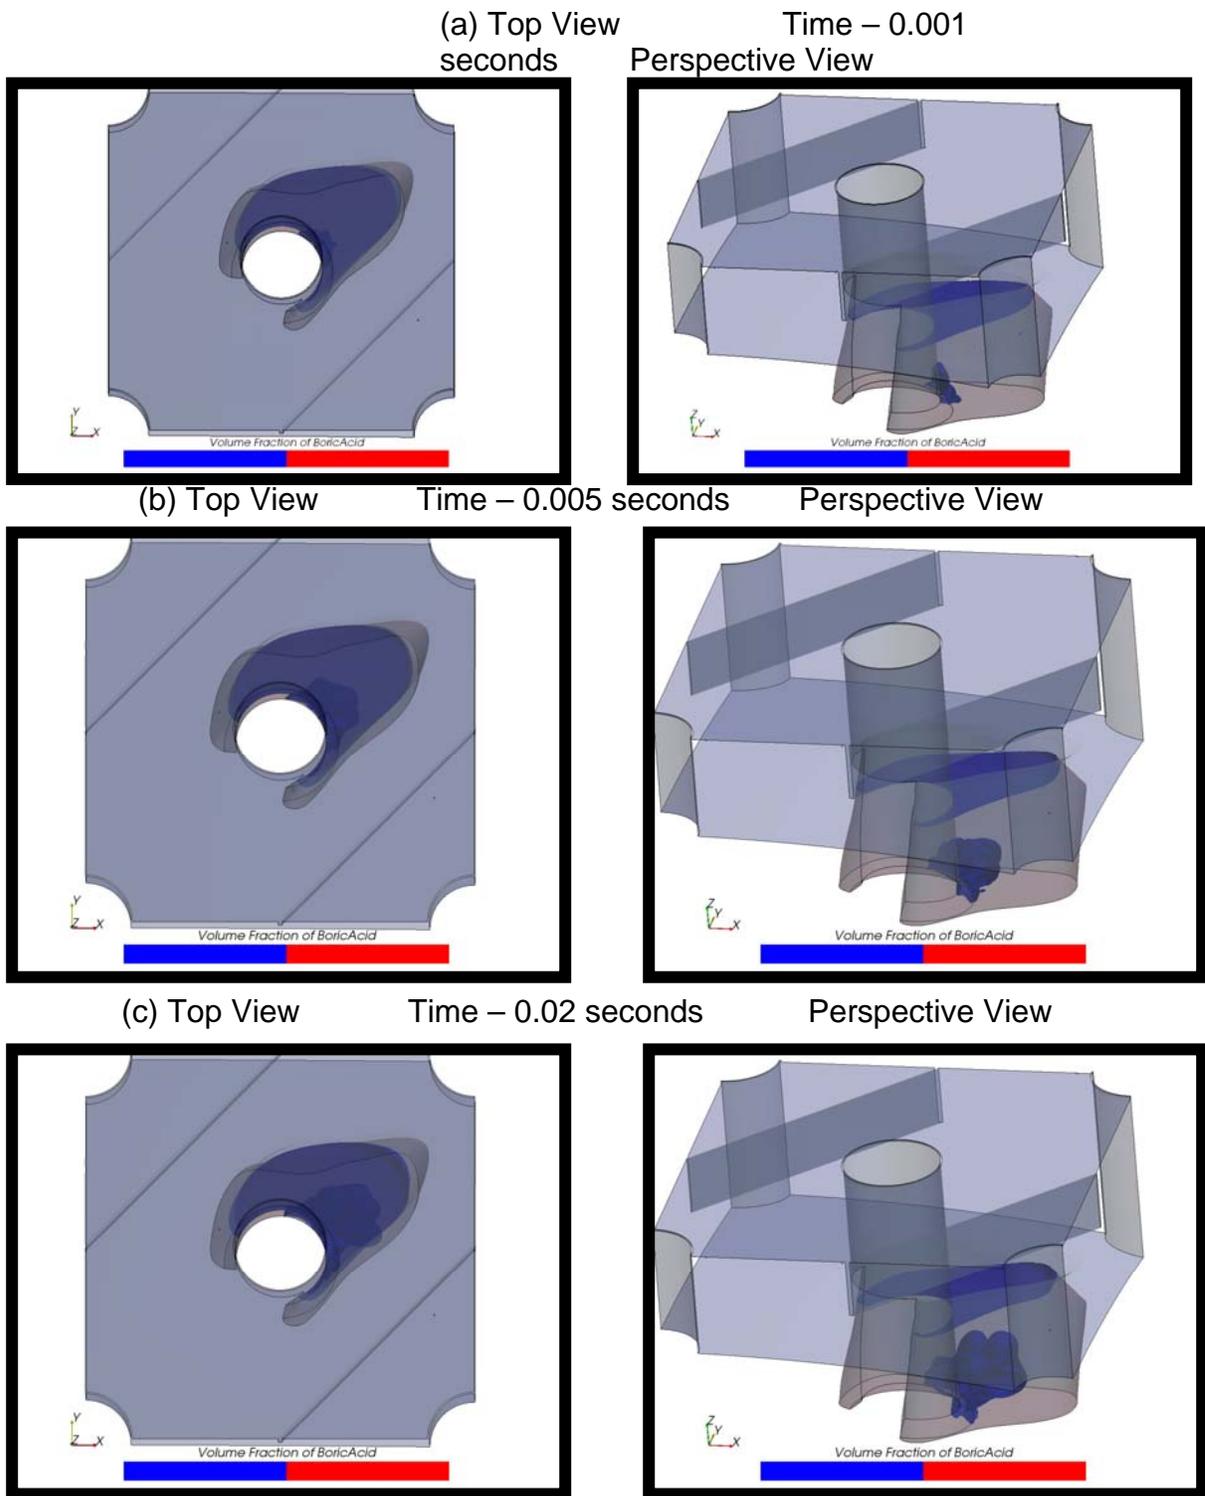
Figure 9.26 Transient analysis results for final wastage cavity filled with boric acid solution for time steps from 0.001 seconds to 0.02 seconds.

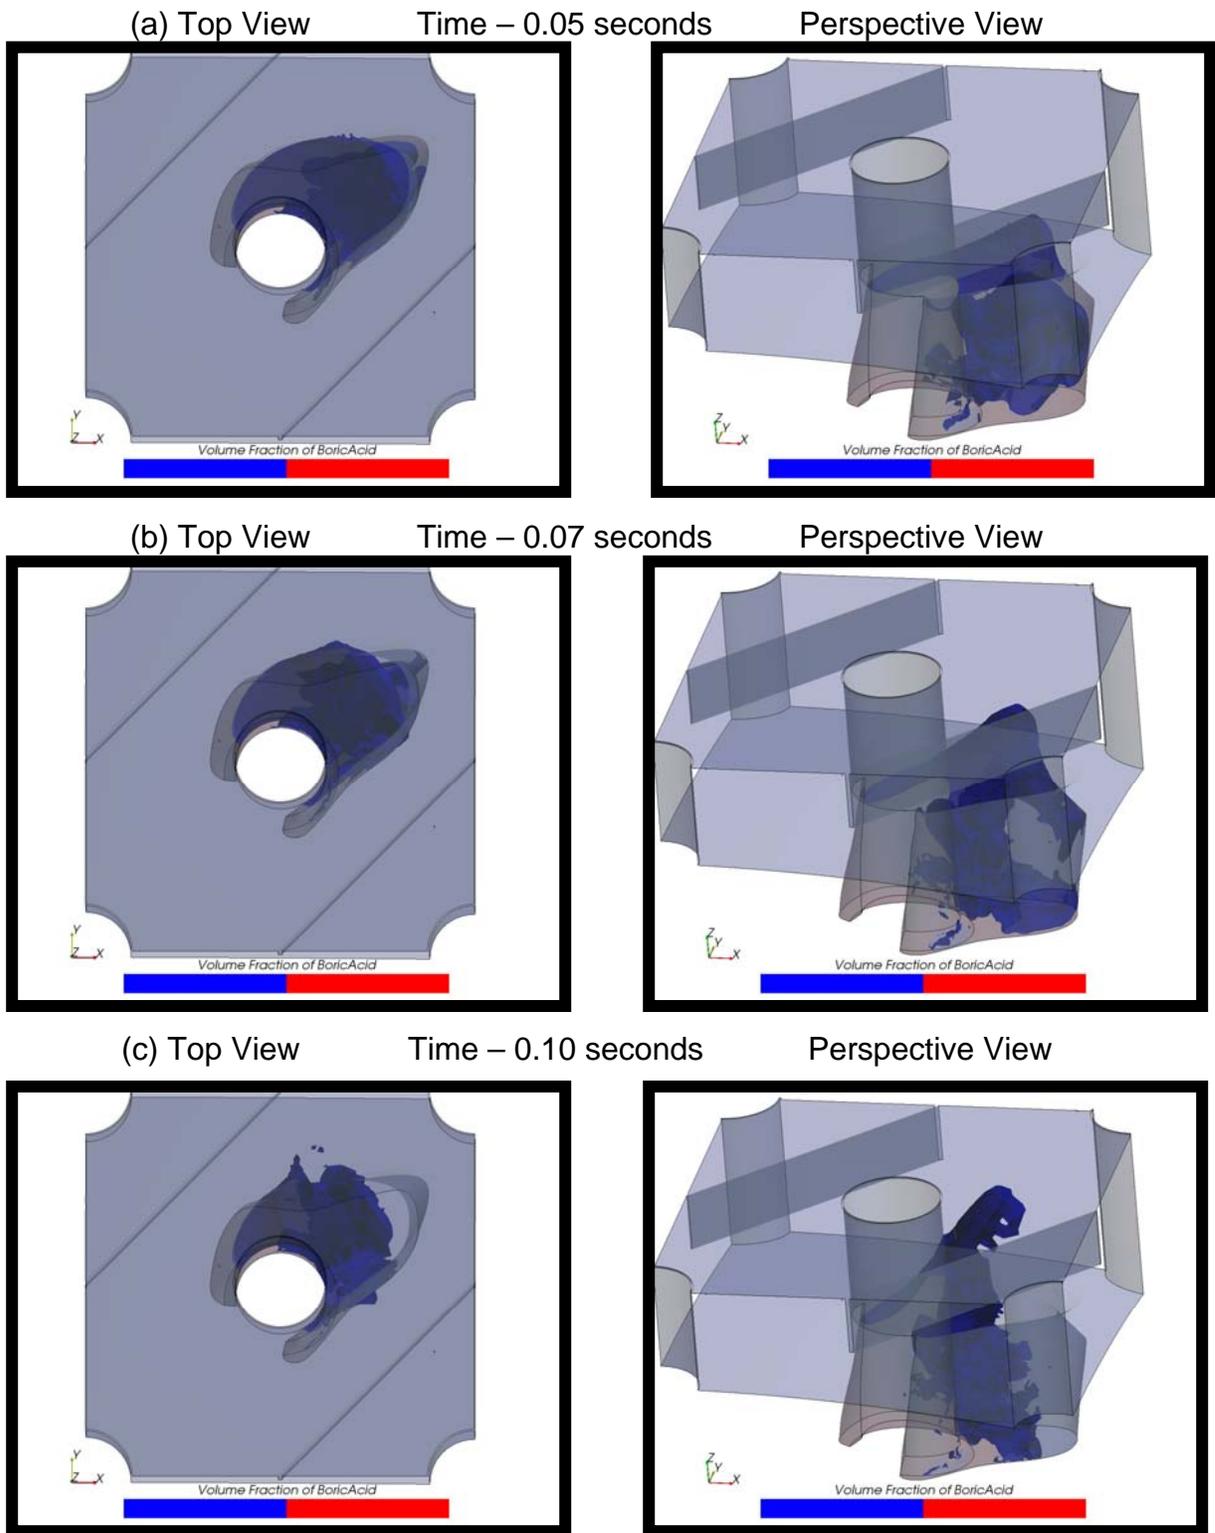
Figure 9.27 Transient analysis results for final waster cavity filled with boric acid solution for time steps from 0.05 seconds to 0.10 seconds.

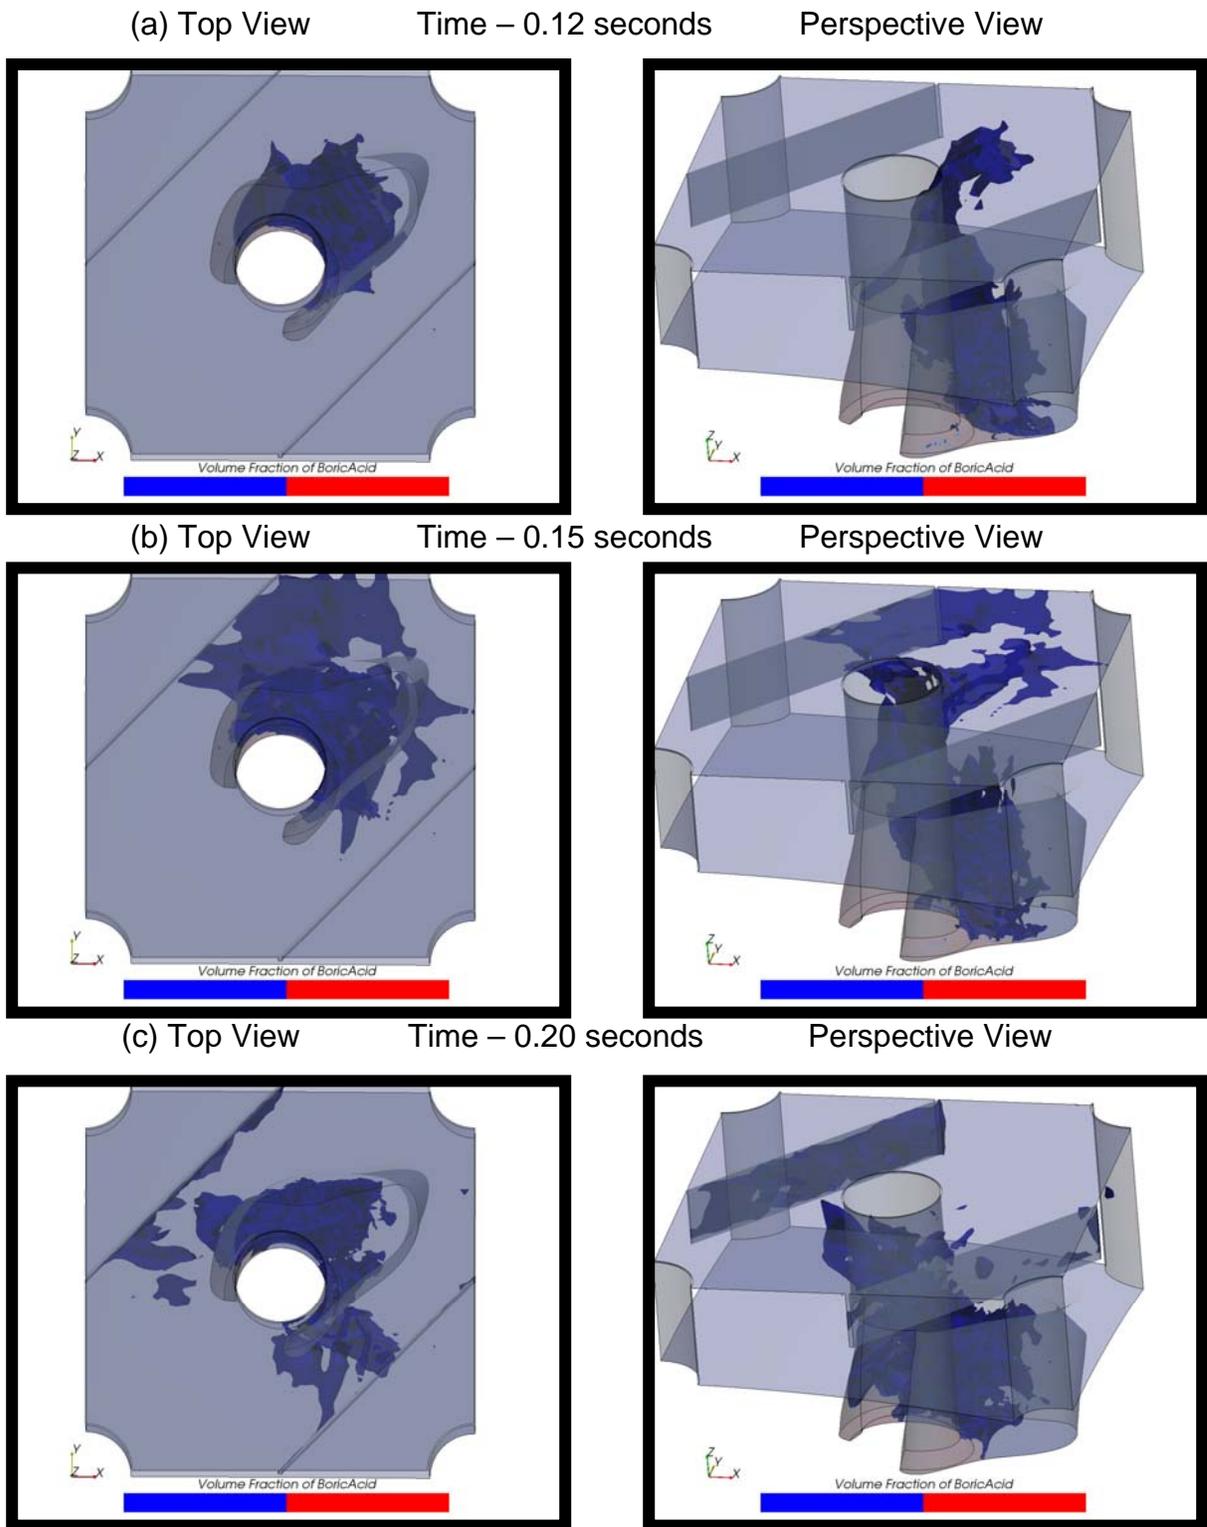
Figure 9.28 Transient analysis results for final wadged cavity filled with boric acid solution for time steps from 0.12 seconds to 0.20 seconds.

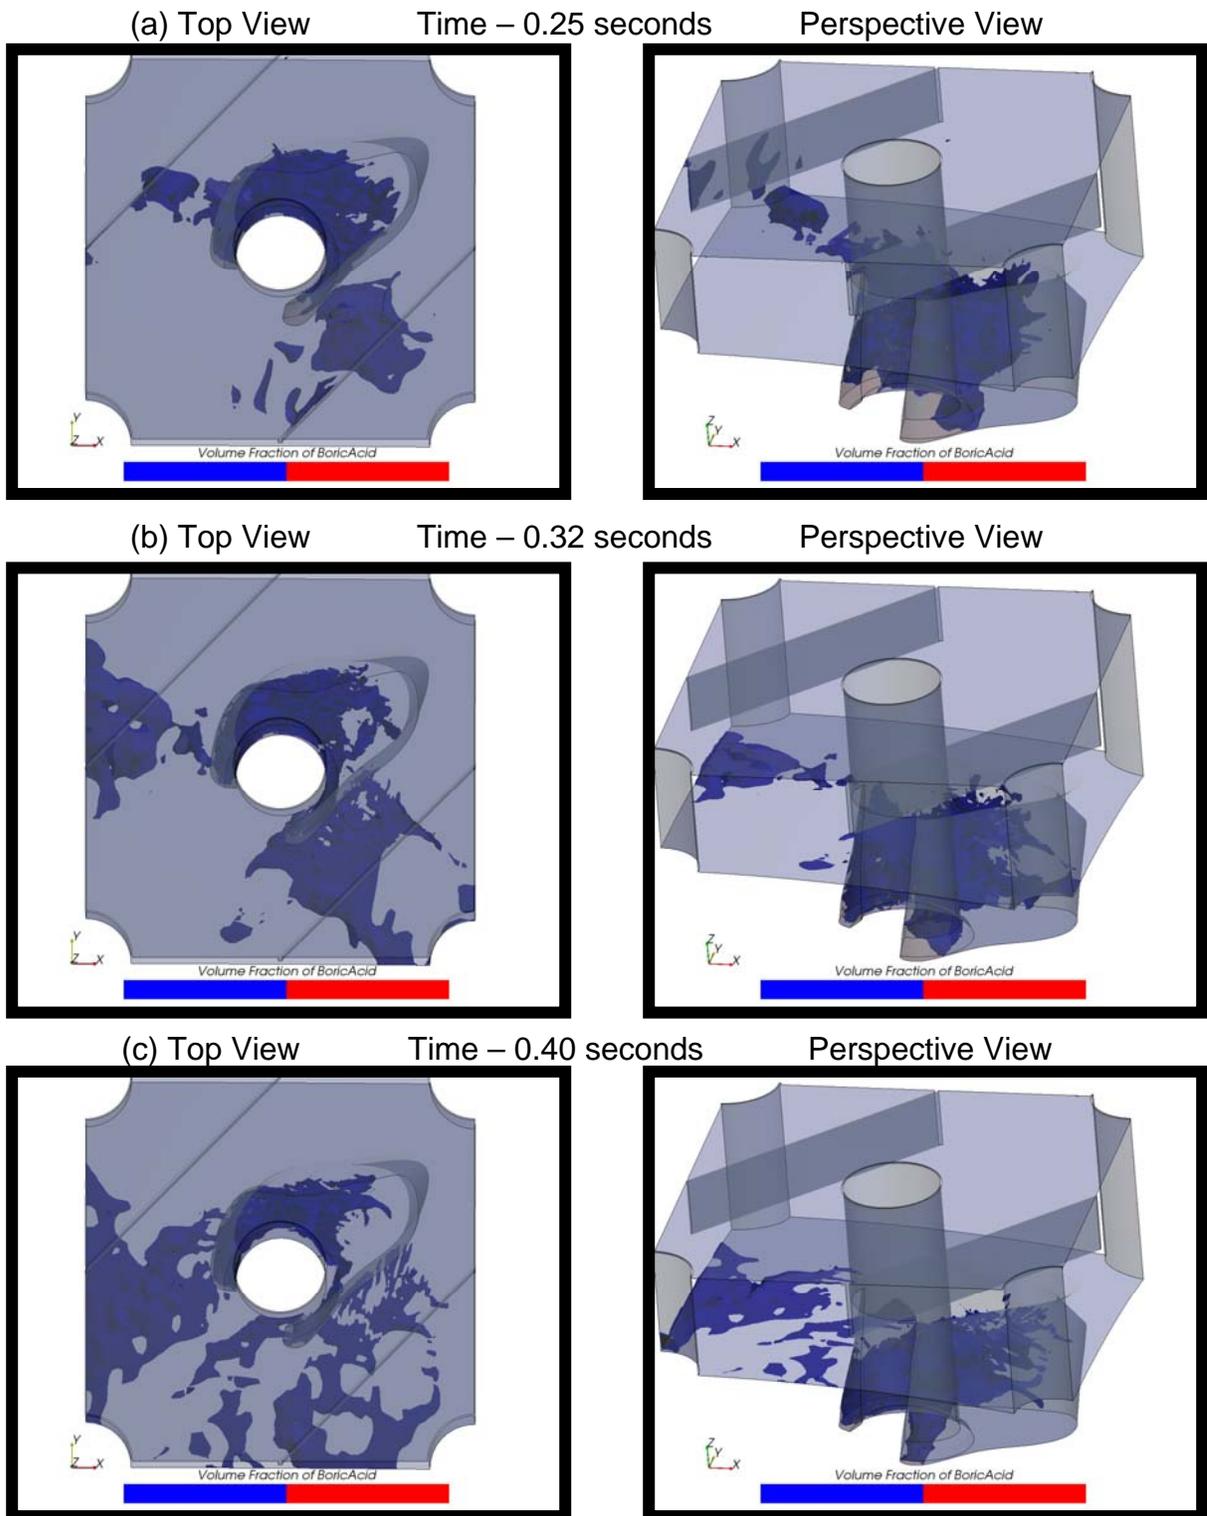
Figure 9.29 Transient analysis results for final wastage cavity filled with boric acid solution for time steps from 0.25 seconds to 0.40 seconds.
