8th PINC Meeting
Feb 5-6, 2007

Proposed CRDM and BMI Mockups using NA 2 Nozzle 31 Results

Proposed CRDM and BMI Mockups **Presentation Outline**

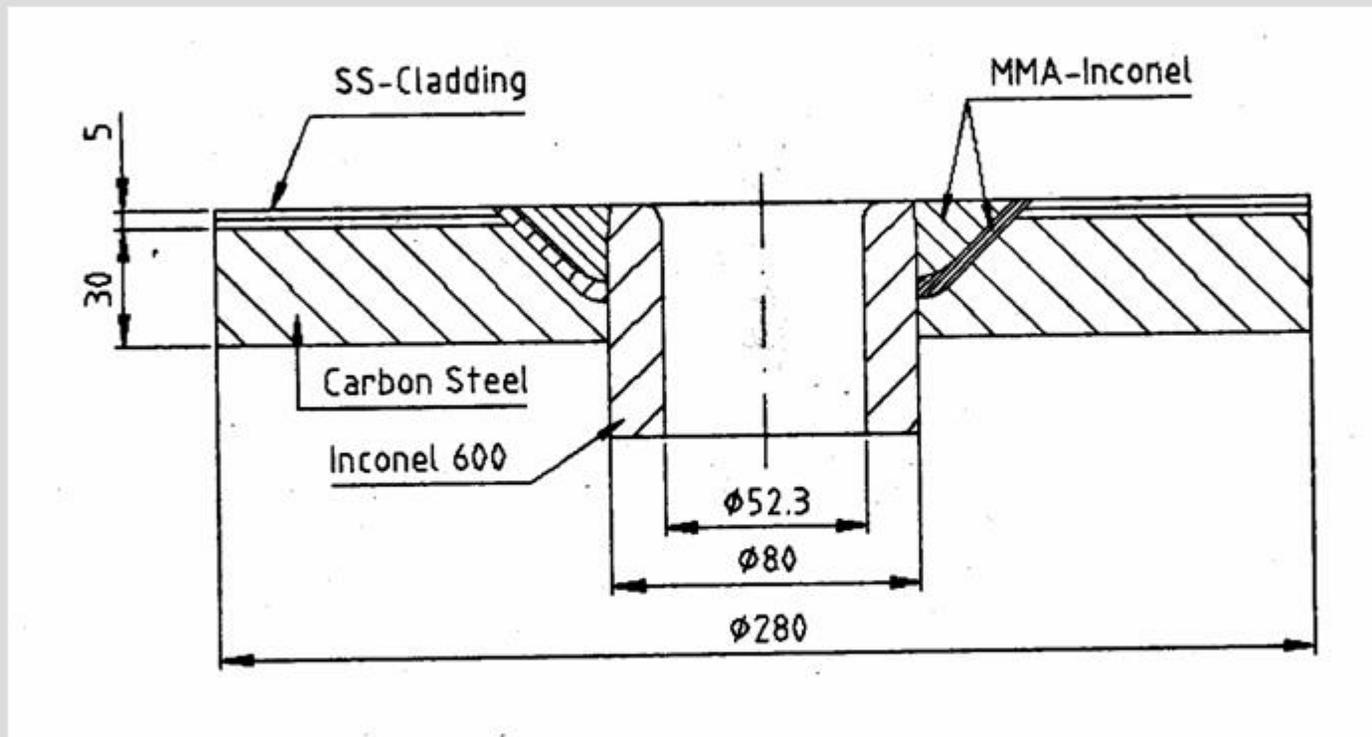
Proposed CRDM and BMI Mockups Existing Test Blocks

- ▶ Design drawing shows how test block is made
- ▶ Cracks are distributed in the surface of the weld metal

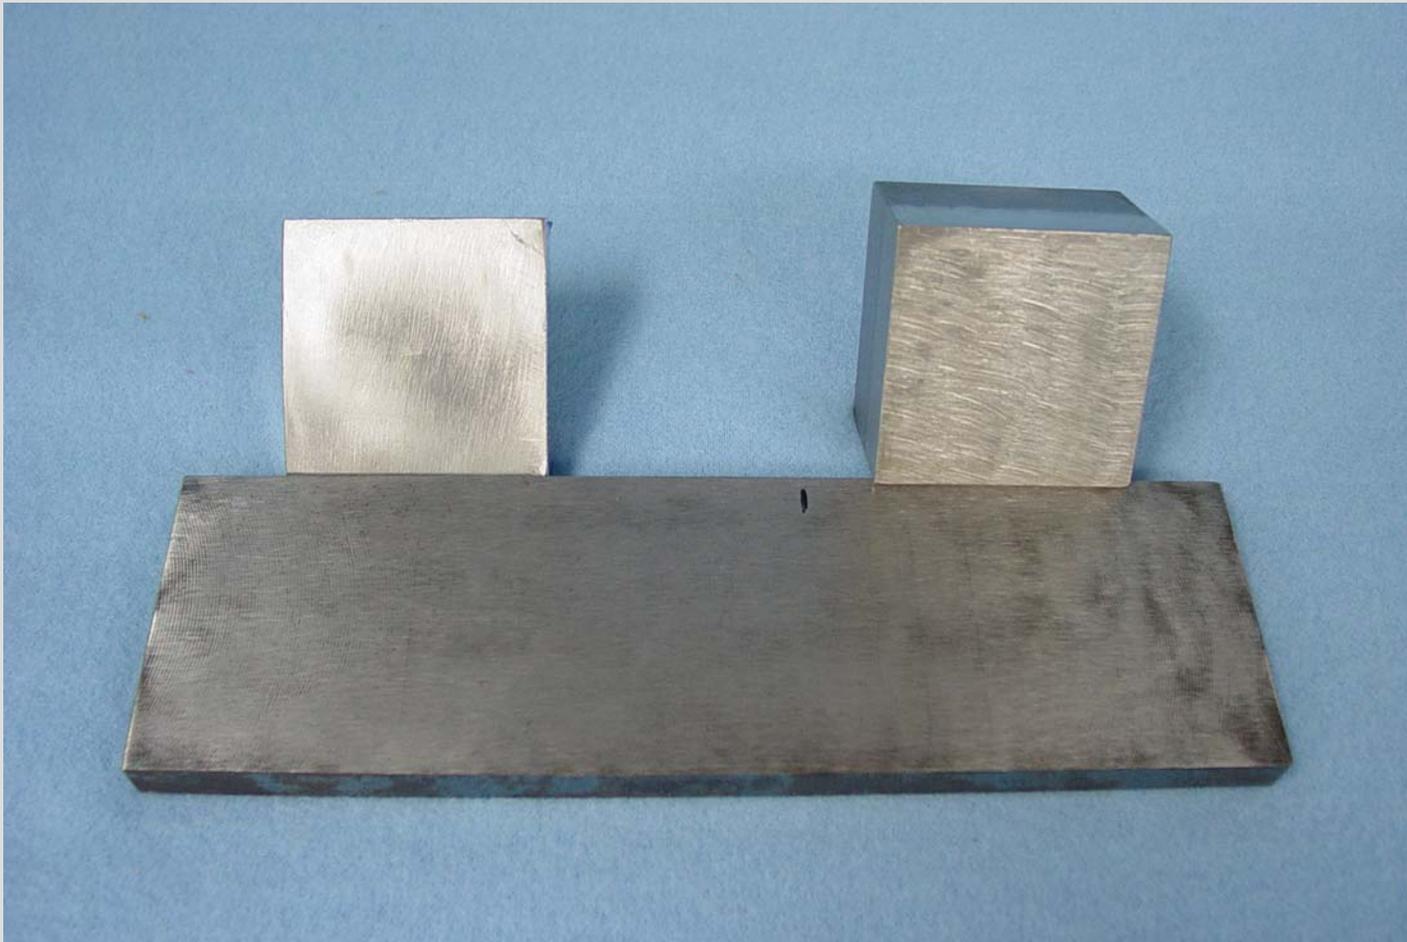
- ▶ Alloy 182 Coupons (TFC, WSC, SCC)

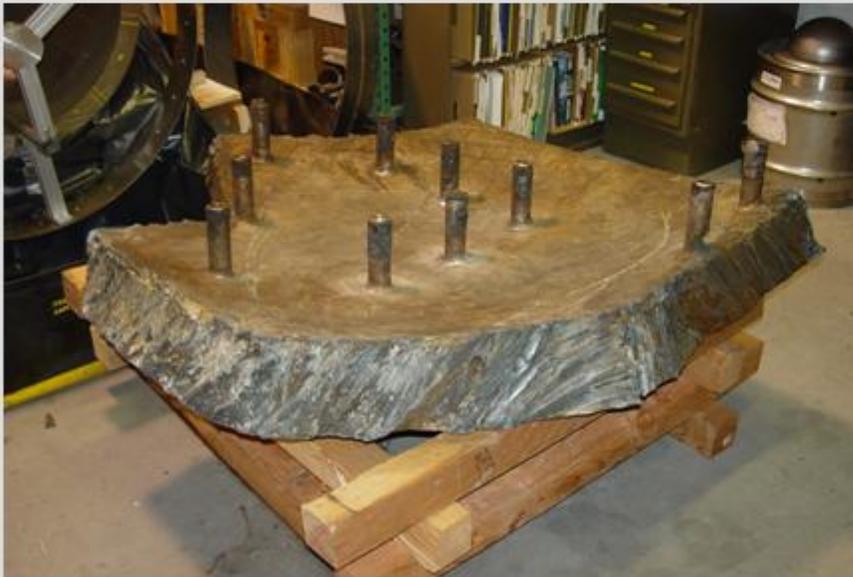
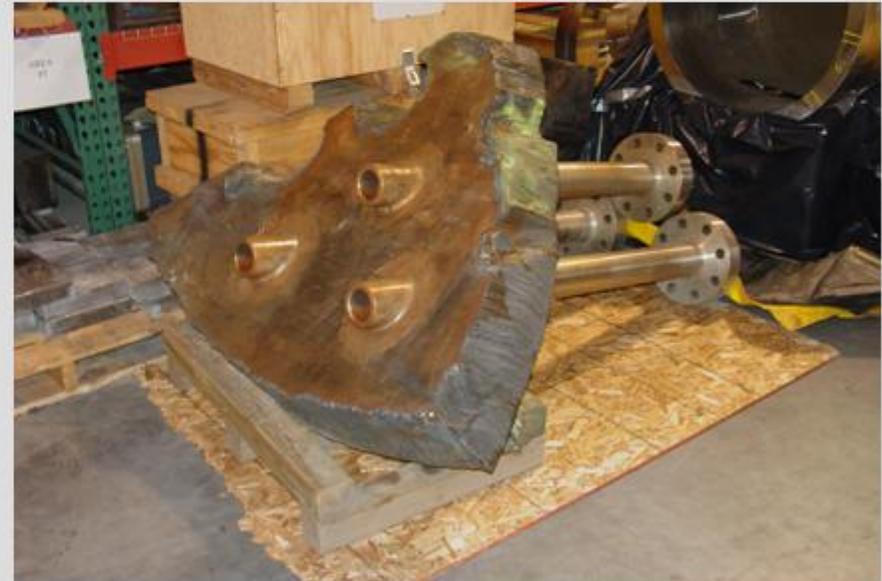
- ▶ Alloy 182 Coupons
- ▶ WNP-1 BMI Nozzle Penetrations
- ▶ WNP-1 CRDM Nozzle Penetrations

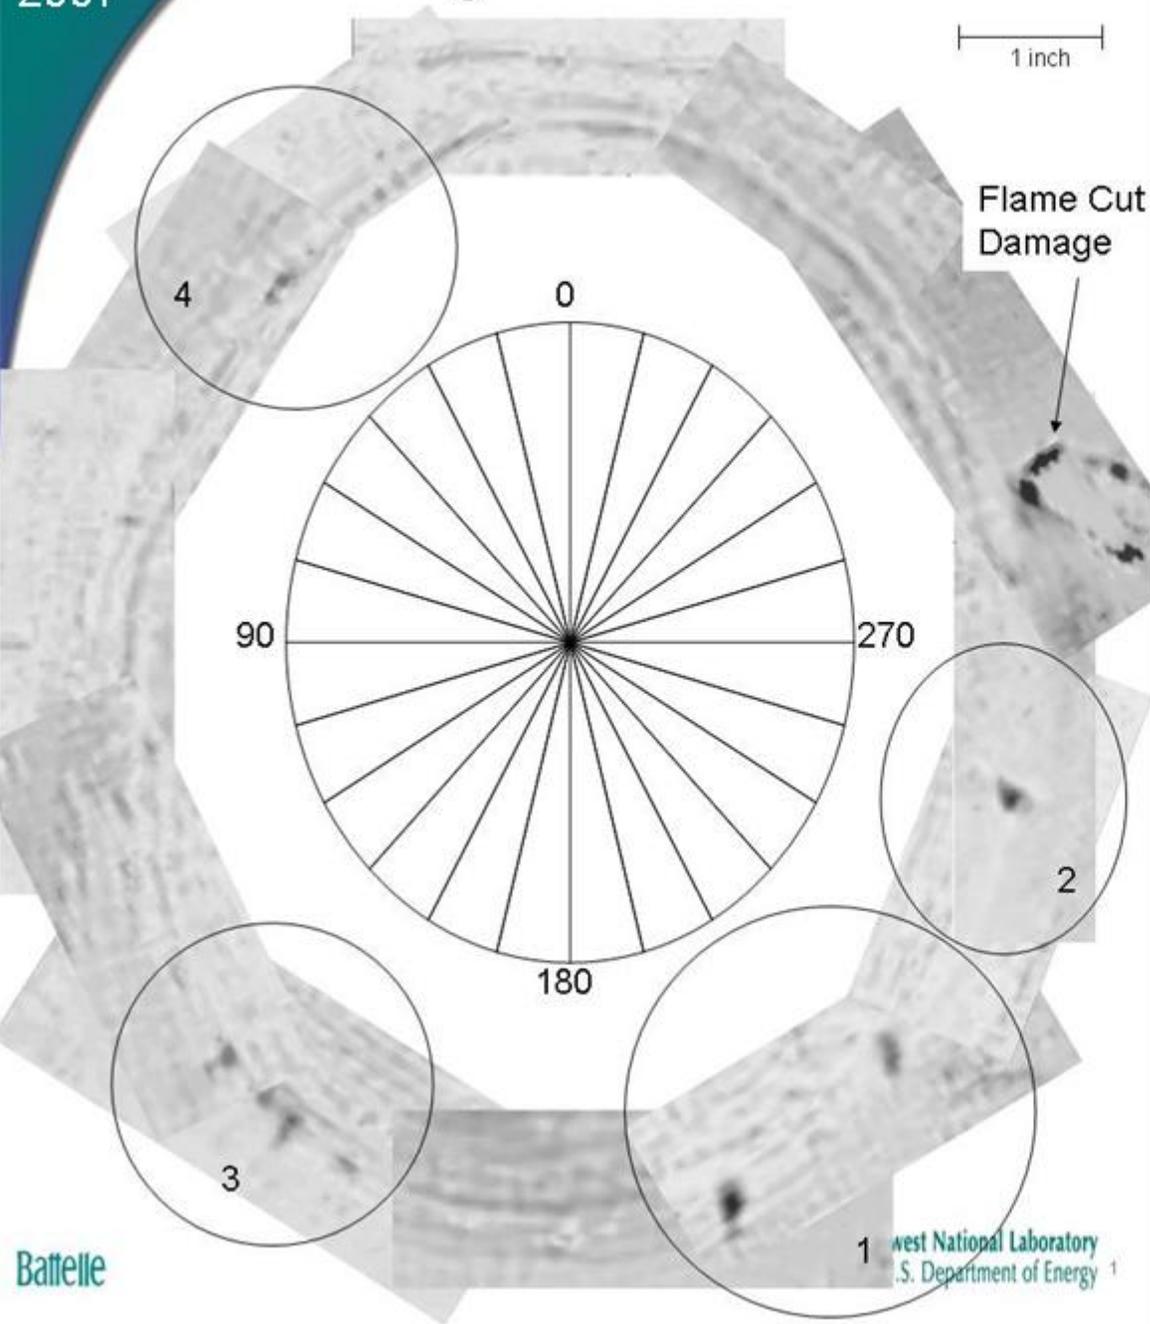
Zero Degree Probe Rotation

- ▶ Plus point probe
- ▶ 350 KHz
- ▶ Zero degree probe rotation

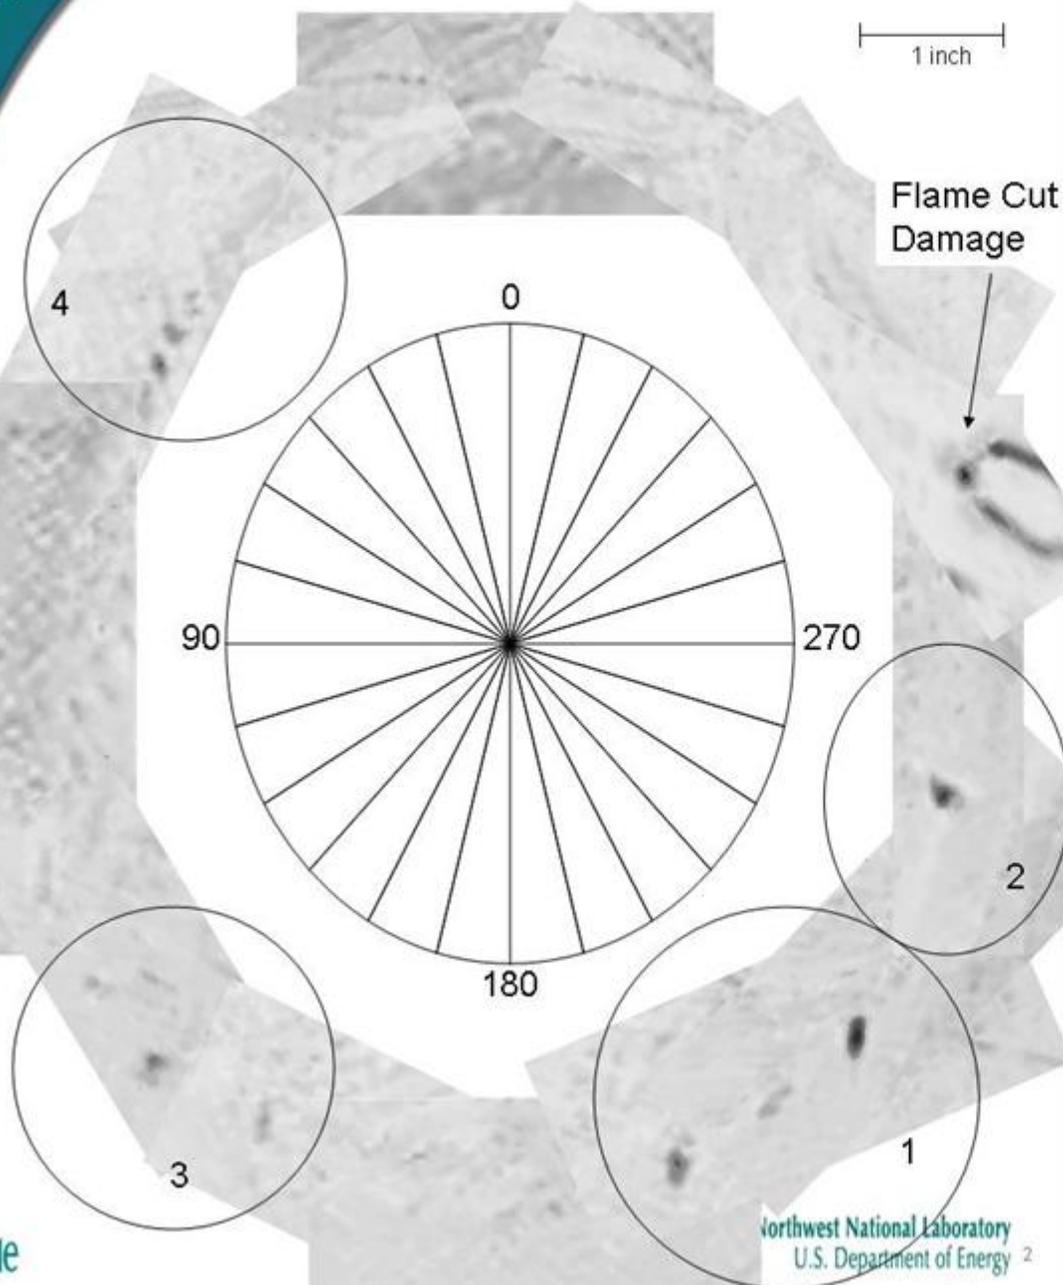
45 Degree Probe Rotation

Flame Cut
Damage

- ▶ Plus point probe
- ▶ 350 KHz
- ▶ 45 degree probe rotation

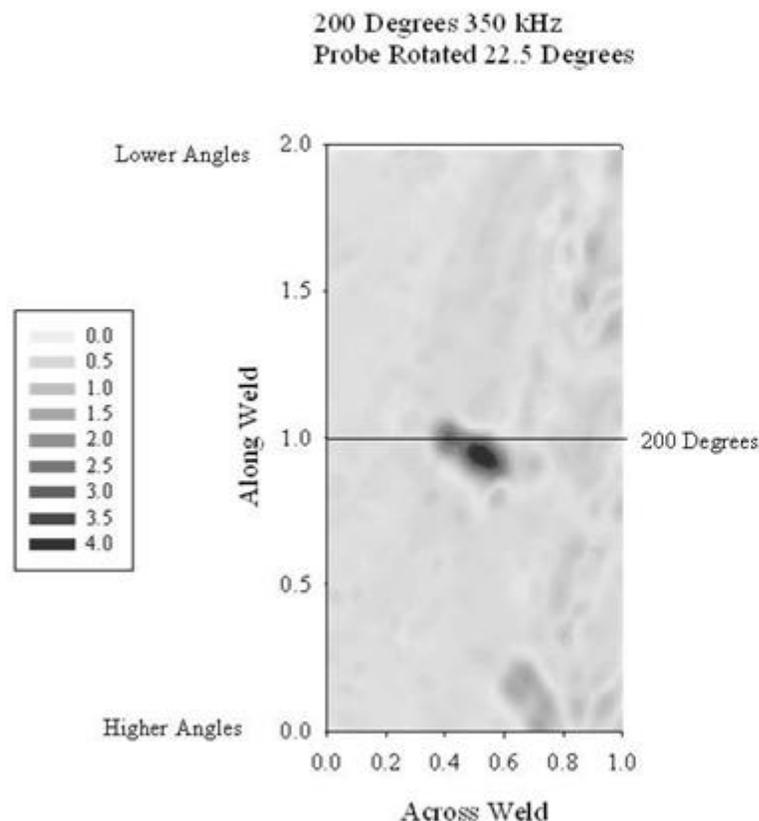
Indication at 200 degrees
Confirmed with PT
Highest voltage response is 4.6 V
Indication is 7 mm long

- ▶ Plus point probe
- ▶ 350 KHz
- ▶ Indication at 200 degrees
- ▶ Confirmed with PT and VT

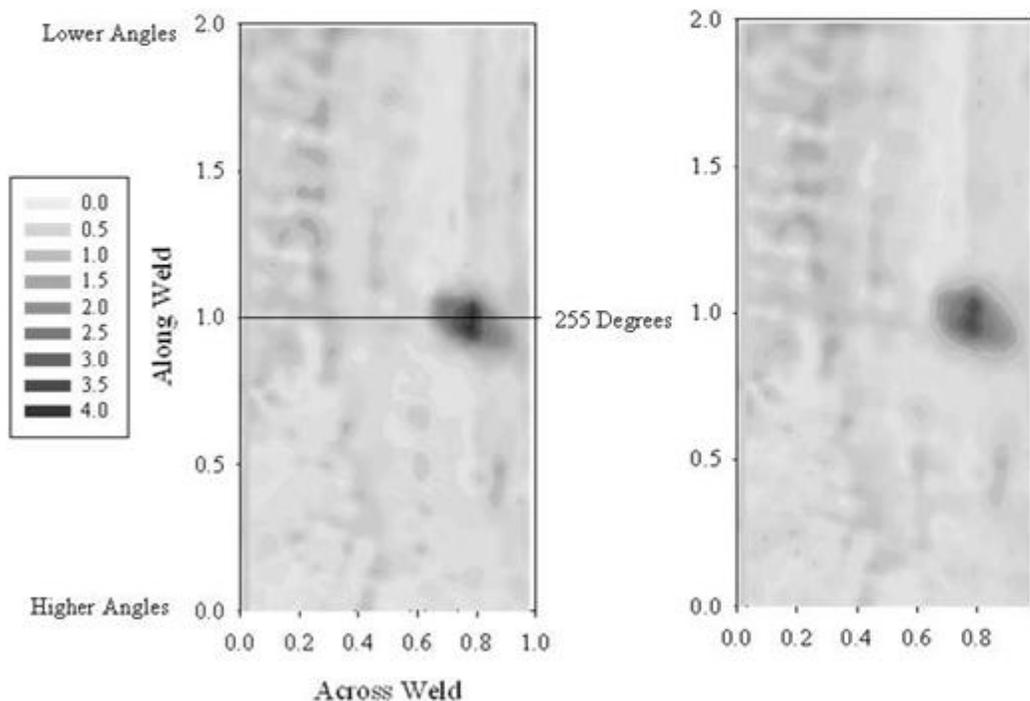
255 Degrees 350 kHz
Zero Probe Rotation

Indication at 255 degrees
No PT indication
Highest voltage response is 4.2 V
Indication is 8 mm long

- ▶ Plus point probe
- ▶ 350 and 150 KHz
- ▶ Indication at 255 degrees
- ▶ No PT indication

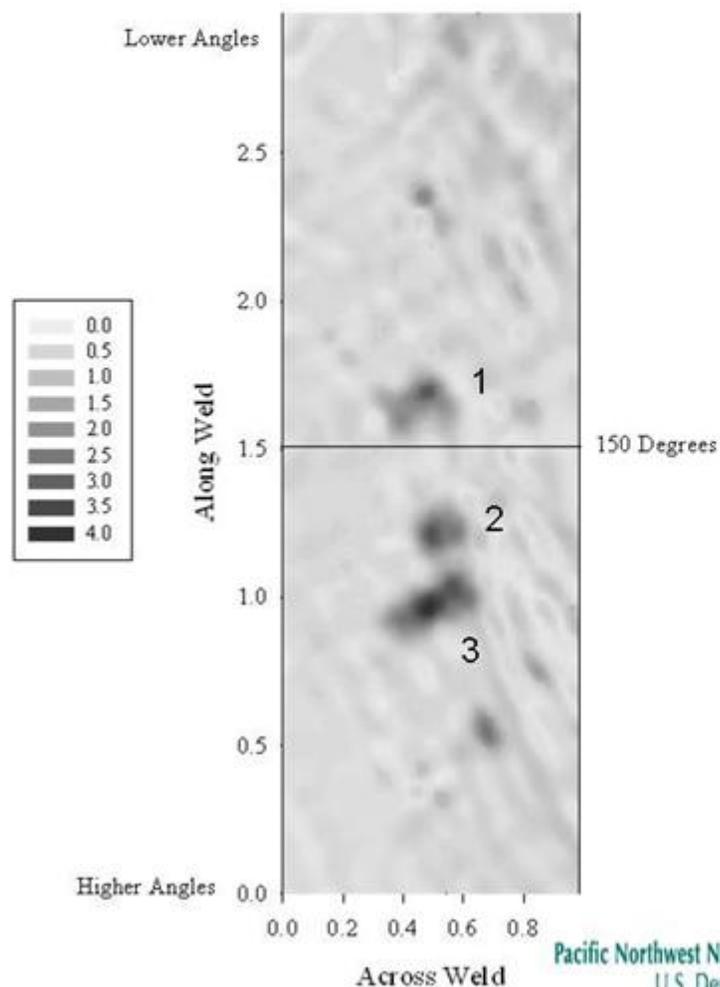
150 Degrees 350 kHz
Probe rotated 45 Degrees

Indications near 150 degrees
No PT indications
Indication 1: Max 3.1 Volts, 5 mm long
Indication 2: Max 3.3 V, 4 mm long
Indication 3: Max 4.1 V, 8 mm long

- ▶ Plus point probe
- ▶ 350 KHz
- ▶ No PT indication

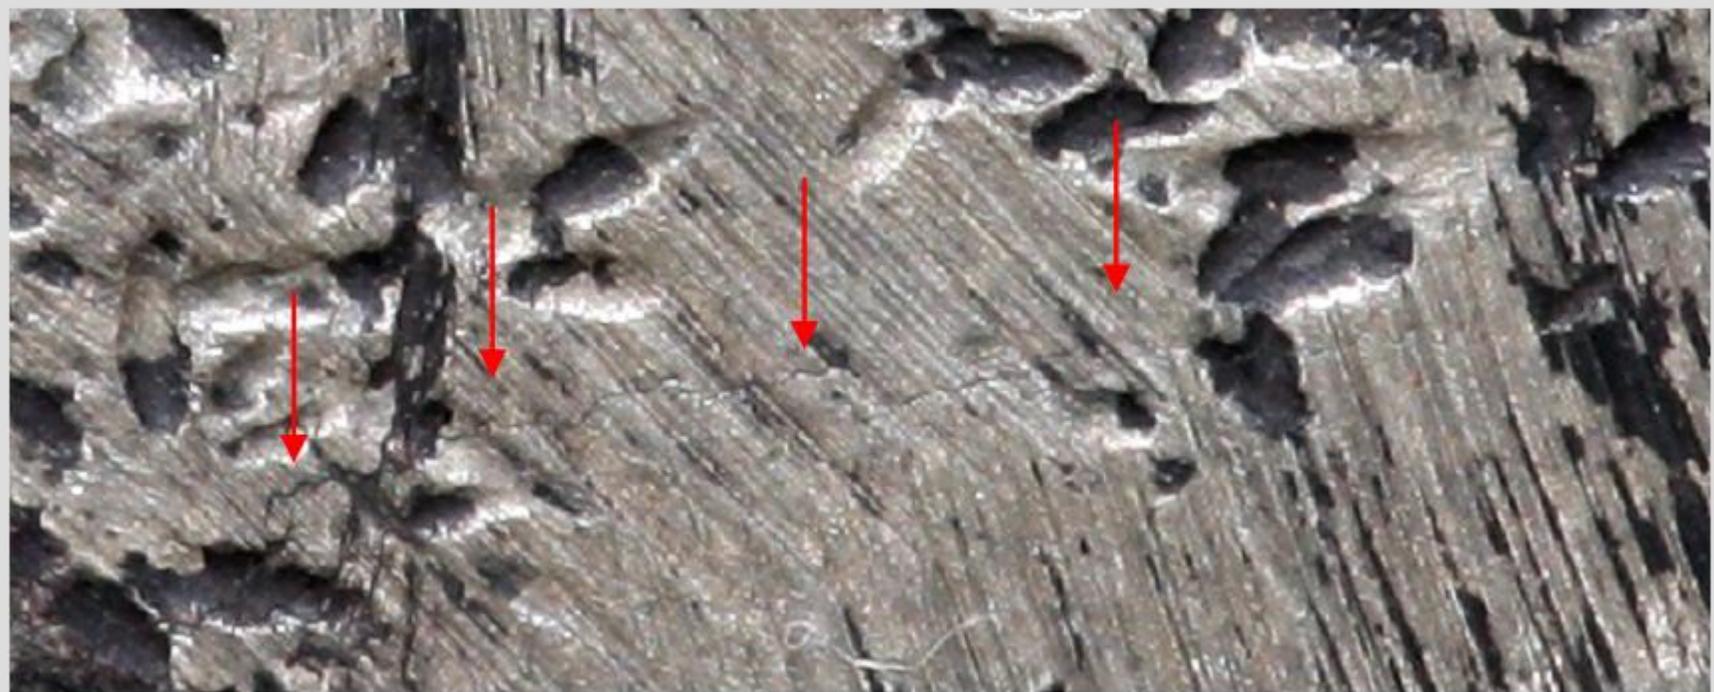
NDE of PWSCC in NA2 Nozzle Visual Testing Images Flaw at 200 Degrees

► Flaw is approximately 4 mm long

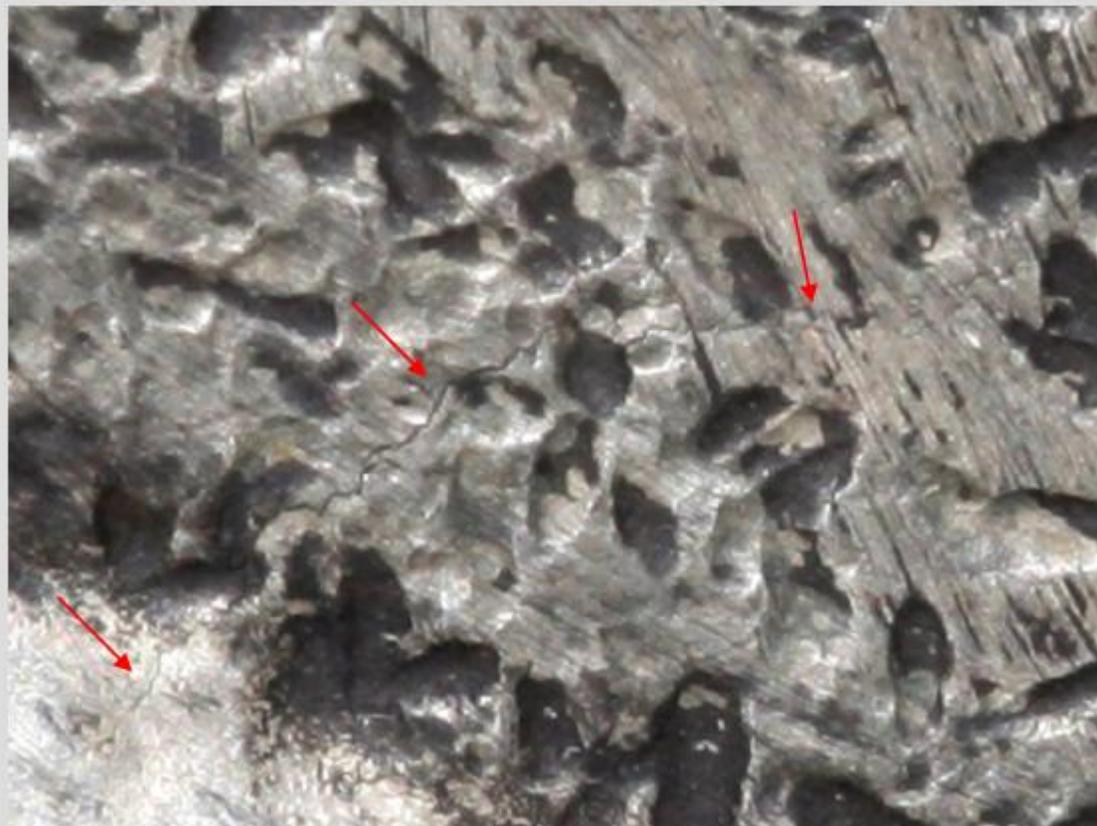
NDE of PWSCC in NA2 Nozzle Visual Testing Images Flaw at 225 Degrees

- ▶ Flaw is approximately 4 mm long

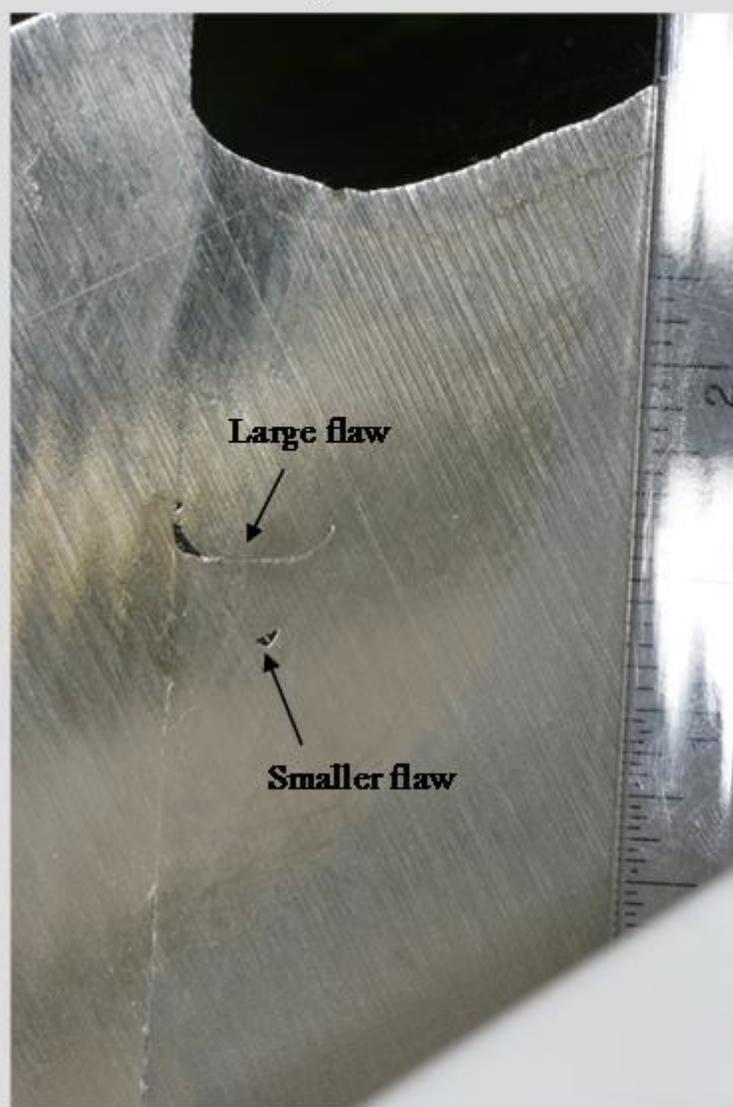
15 Degree Face

- ▶ Ultrasonic indication was recorded from inside tube
- ▶ Cut was made through ultrasonic indication
- ▶ Indication was in fusion zone of seal weld with tube

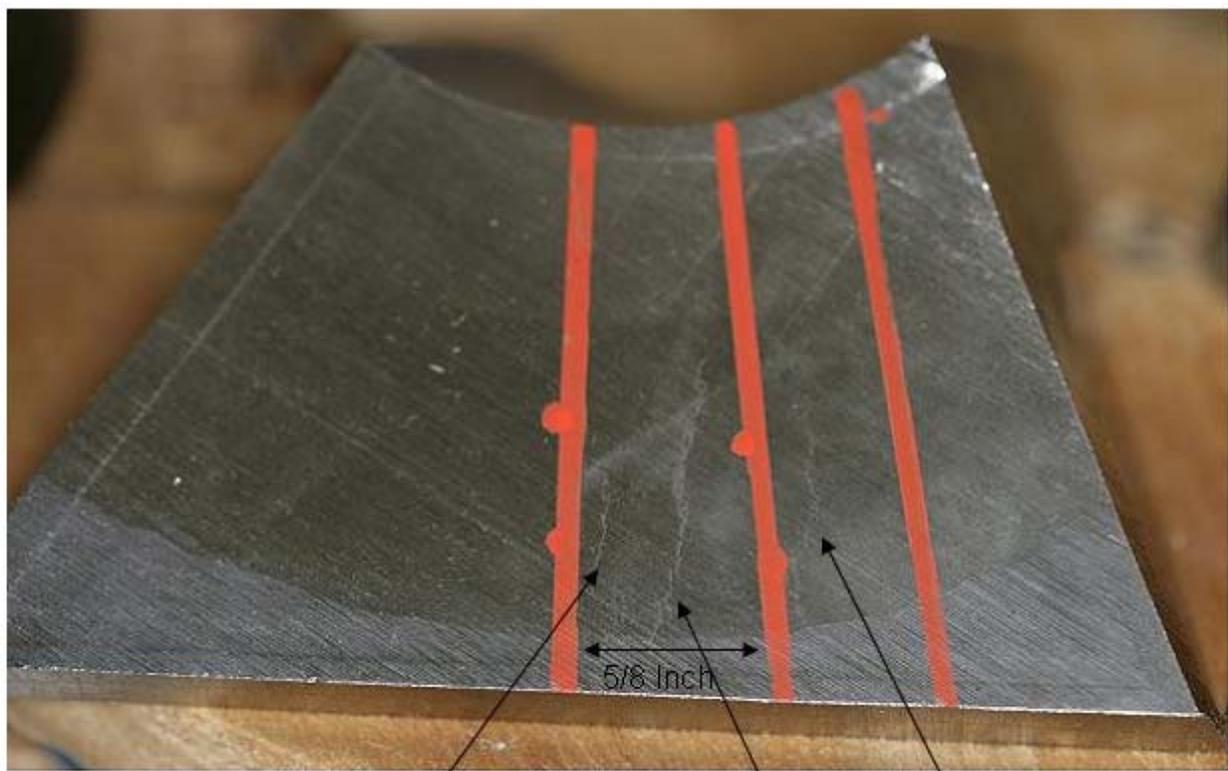
Wetted Surface Section Dry Side

Secondary crack #1

Through-wall crack

Secondary crack #2

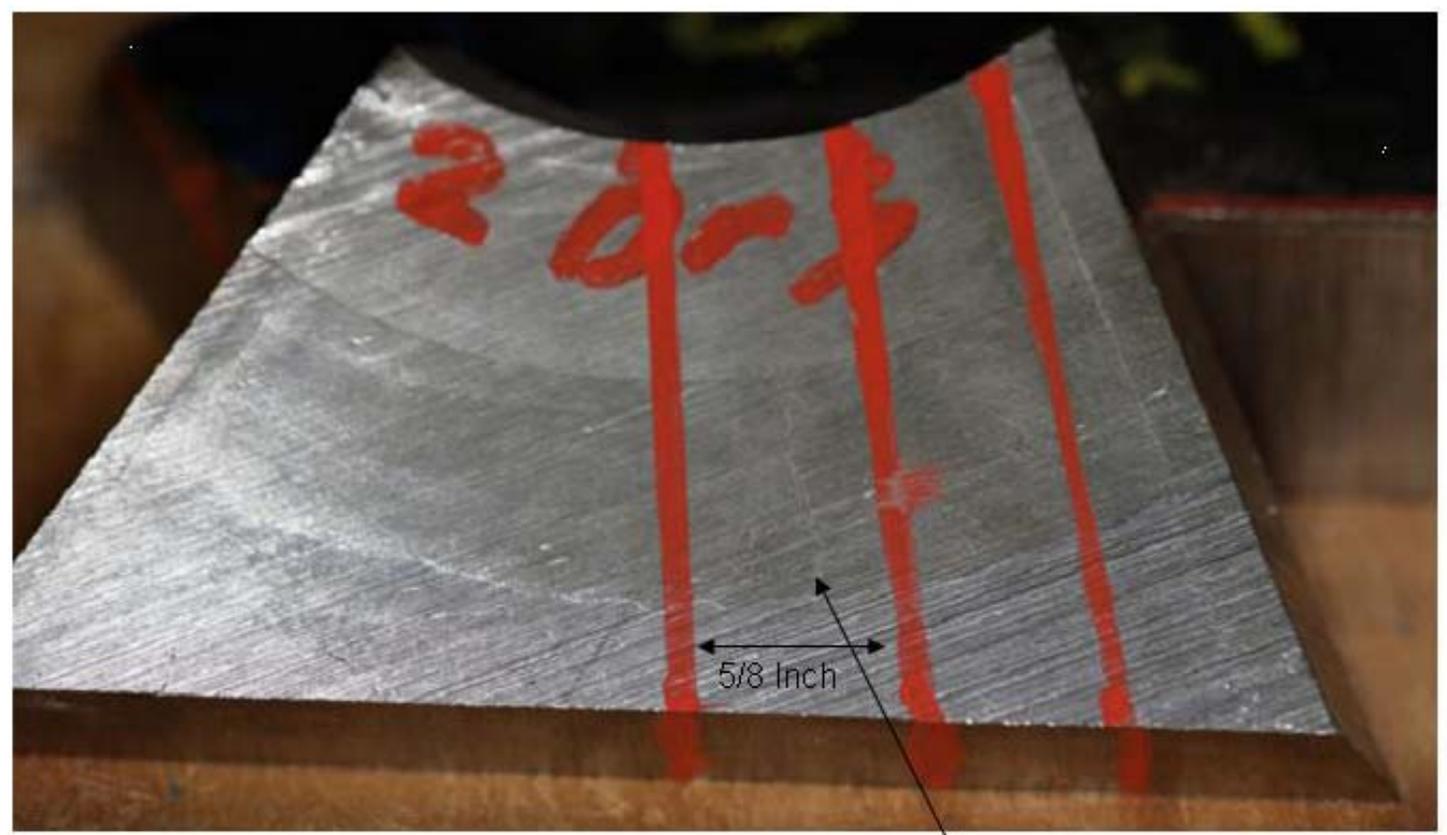
Middle Section Dry Side

Through-wall crack
