NUREG/CR-6933  
PNNL-16292

**Assessment of Crack Detection in  
Heavy-Walled Cast Stainless  
Steel Piping Welds Using  
Advanced Low-Frequency  
Ultrasonic Methods**

**Pacific Northwest National Laboratory**

**U.S. Nuclear Regulatory Commission  
Office of Nuclear Regulatory Research  
Washington, DC 20555-0001**

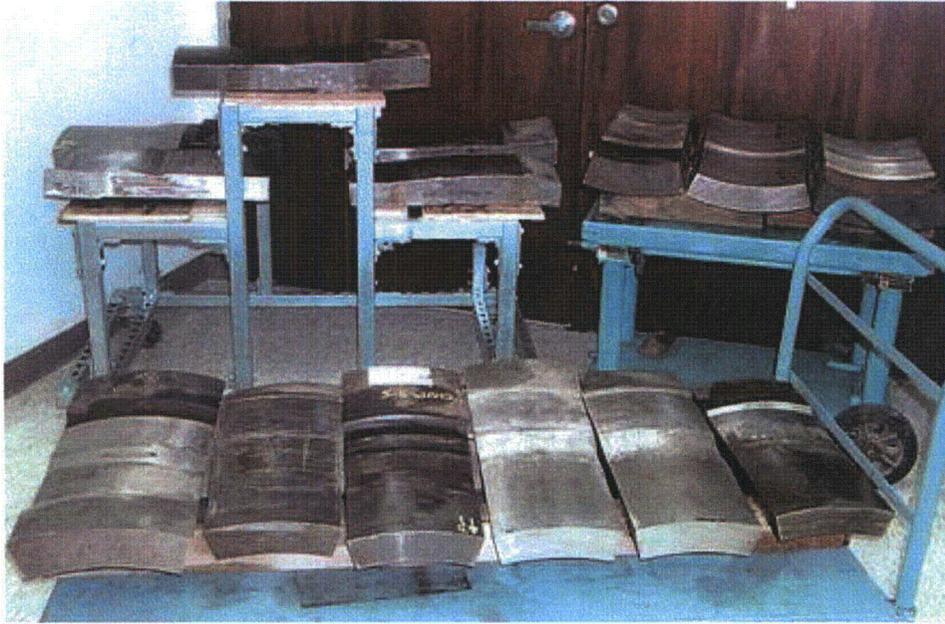
**Figure 4.7 Westinghouse Owners Group Specimens Showing Varied Inside and Outside Surface Geometries Typical of Field-Installed Components**
